Full scale testing of wind turbine blade to failure - flapwise loading

**Erik R. Jørgensen, Kaj. K. Borum, Malcolm McGugan,
Christian L. Thomsen, Find M. Jensen, Christian P. Debel
og Bent F. Sørensen**

Abstract A 25m wind turbine blade was tested to failure when subjected to a flapwise load. With the test setup, it was possible to test the blade to failure at three different locations.

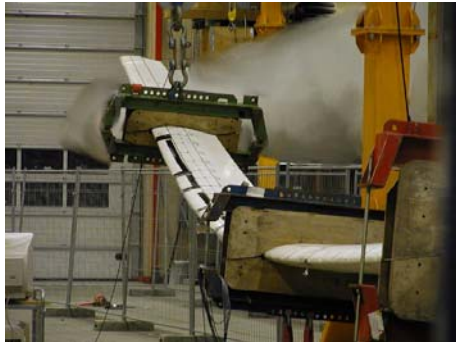
In test of section 1 (19.3m to 23.3m) the blade failed 20.1m from the root, with a load introduction as given in figure 4. In the figures below the large deflection in this test is seen as well as a picture of the failed section of the blade.

Figure 7 Test of section 1, large deflection is seen in this test.

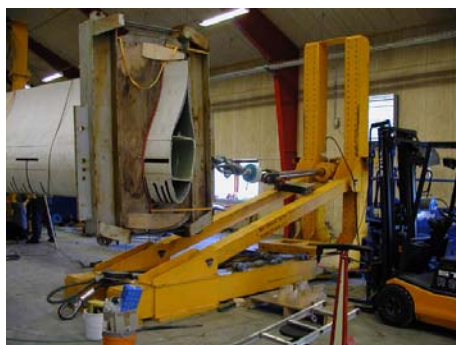
In test of section 3 the blade failed 4.4m from the root, with a load introduction as given in figure 6.

Figure 10 Test of section 3 with load introduction at 11.3m *Figure 11 Failure 4.4m from the root.*

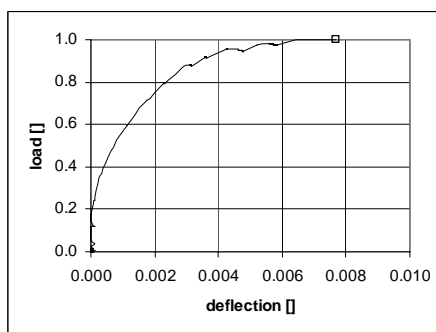
The local deflection at 4.3m is shown in figure 20 and it is seen this curve that it is close to a not stable situation, i.e. the deflection is increasing even though there is no increase in the load.

Figure 20 Local deflection at 4.3m, load at 11.3m

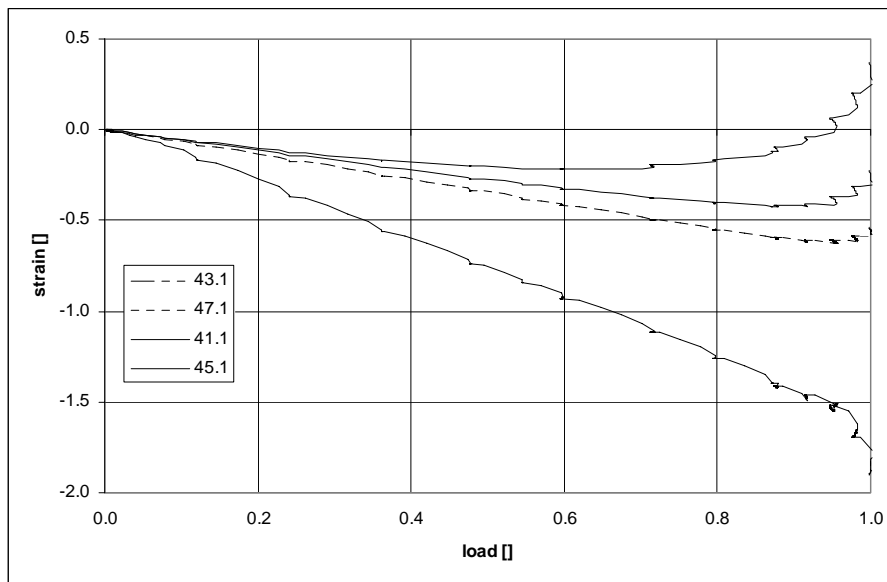
During test of section 3, the blade failed at 4.4m close to the largest chord. In the figure below the strain is shown as function of the load for the strain gauges located in the area of where the failure happened. The strain is seen to be non-linear especially for strain gauge “45.1” which is close to the location where the blade finally failed.

Figure 28 Measured strain on four locations during test of section 3, showing non-linear behaviour

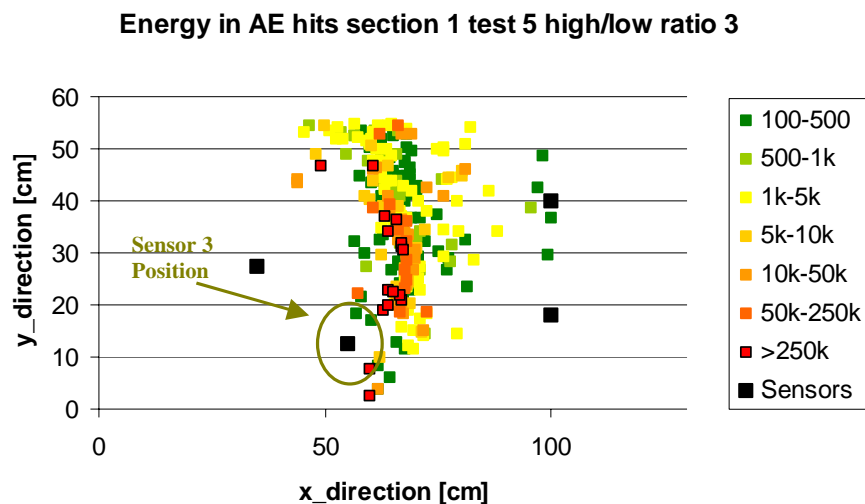
A LABVIEW system location plot was generated from data sampled during loading up to 77% of the load at failure. This plot corresponded exactly with the failure that occurred during a subsequent loading.

Figure 31 LABVIEW system localisation of AE events prior to failure. High activity events distributed along ultimate failure chord. Note position of sensor 3.

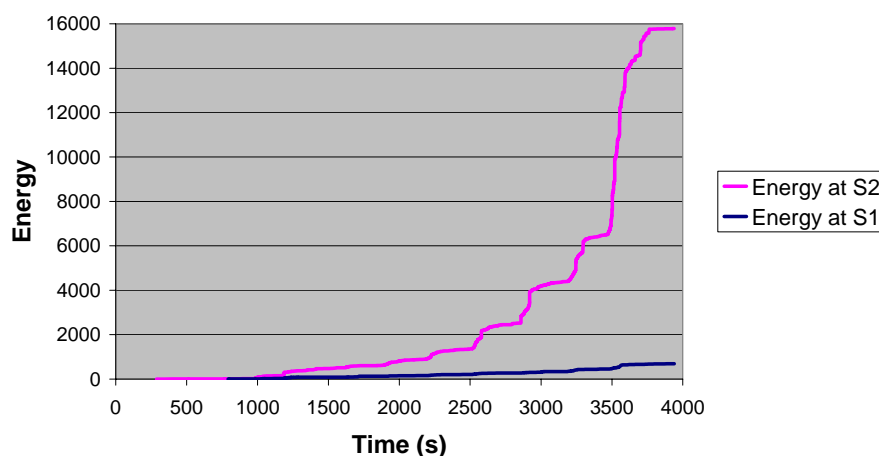
In the first loading sequence for this test section there was an accumulated stress wave energy count of 16000 recorded at SPARTAN sensor 2, positioned as a guard at the 15.3m loading yoke. By comparison there was only 700 recorded at SPARTAN sensor 1 positioned at the 11.3m clamping yoke, far closer to the desired failure chord. At a load cell voltage of 3.63V, it was suggested, by the AE operatives, that the load should be released and the blade inspected. This was due to a rapid increase in the activity level for SPARTAN sensor 2 during the load increase to 3.63V, followed by an extremely long period during load hold where AE activity continued.

Figure 32 Cumulative stress wave energy trace showing the relative activities at S2 (loading yoke) and S1 (close to desired failure chord). Note also the rapid increase in stress wave activity at S2 indicating that failure is approaching.

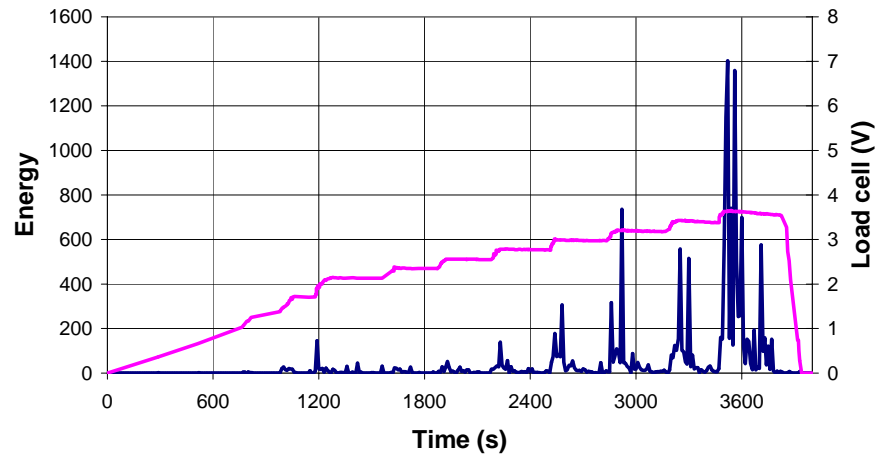
Figure 33 Stress wave activity (blue) detected during step-wise loading of the blade (section 2). The high activity levels and long “die-off” time during load hold indicates the blade is close to failure.
