An Overview of Stress Corrosion in Nuclear Reactors from the Late 1950s to the 1990s

Spencer H. Bush
Alan D. Chockie

February 1996

STATENS KÄRNKRAFTINSPEKTION
Swedish Nuclear Power Inspectorate

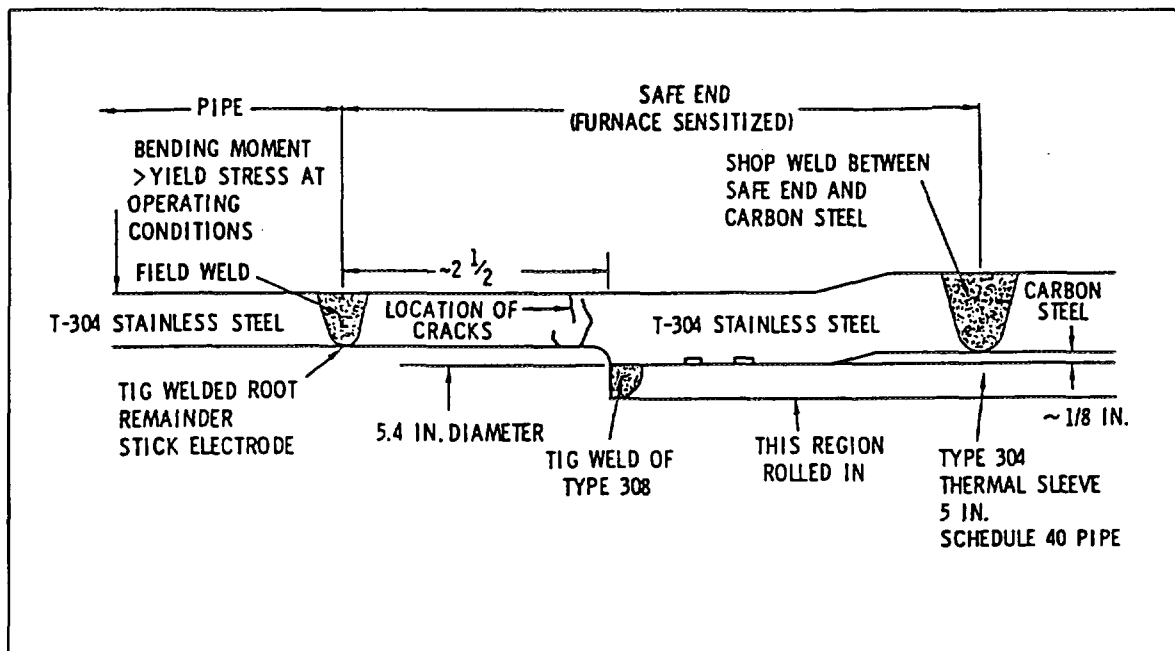
Figure 1: Schematic diagram showing safe end configuration.

The stress relief temperature of 6200°C (11500°F) led to severe sensitization of the 304 stainless steel. Table 4 presents this phenomenon. As can be seen, 13 reactors representing almost all the older domestic BWRs operating had a total of 244 sensitized safe ends. The calculated failure rate is quite high; however, most sensitized safe ends were removed or weld clad on the inside. Nine Mile Point 1 nearly suffered a double ended guillotine break (DEGB) after three months of commercial operation. A design error placed supports on the 10-inch core spray line without accounting for the change in height of the vessel due to heat-up. As a result very high bending stresses, combined with the severe sensitization, led to extensive cracking. The crack was detected during an outage because of water leaking through the IGSCC cracks. Figures 1 and 2 illustrate the geometry of safe end and crack size, and the micrograph in Figure 3 illustrates a through-wall crack.

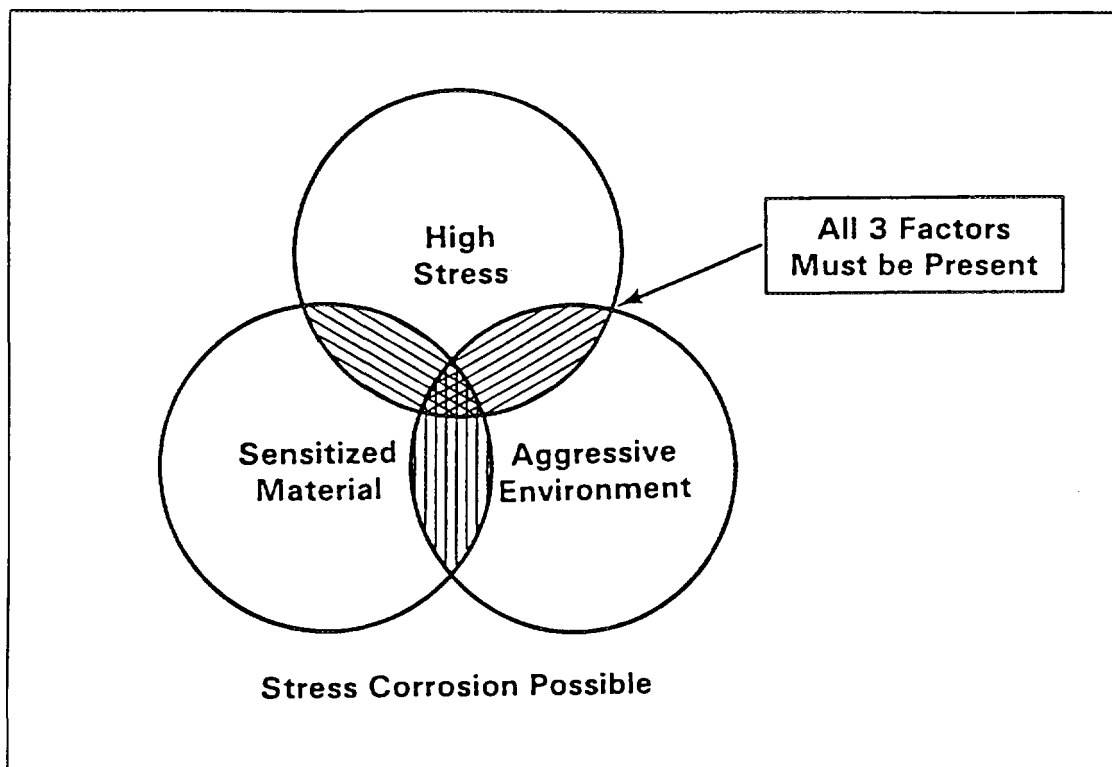
Figure 7: *Conditions leading to stress corrosion.*

Figure 7 illustrates the interdependence of material, environment, and stress factors most correctable by long-term solutions. Generally, action on two or preferably all three variables is preferred.

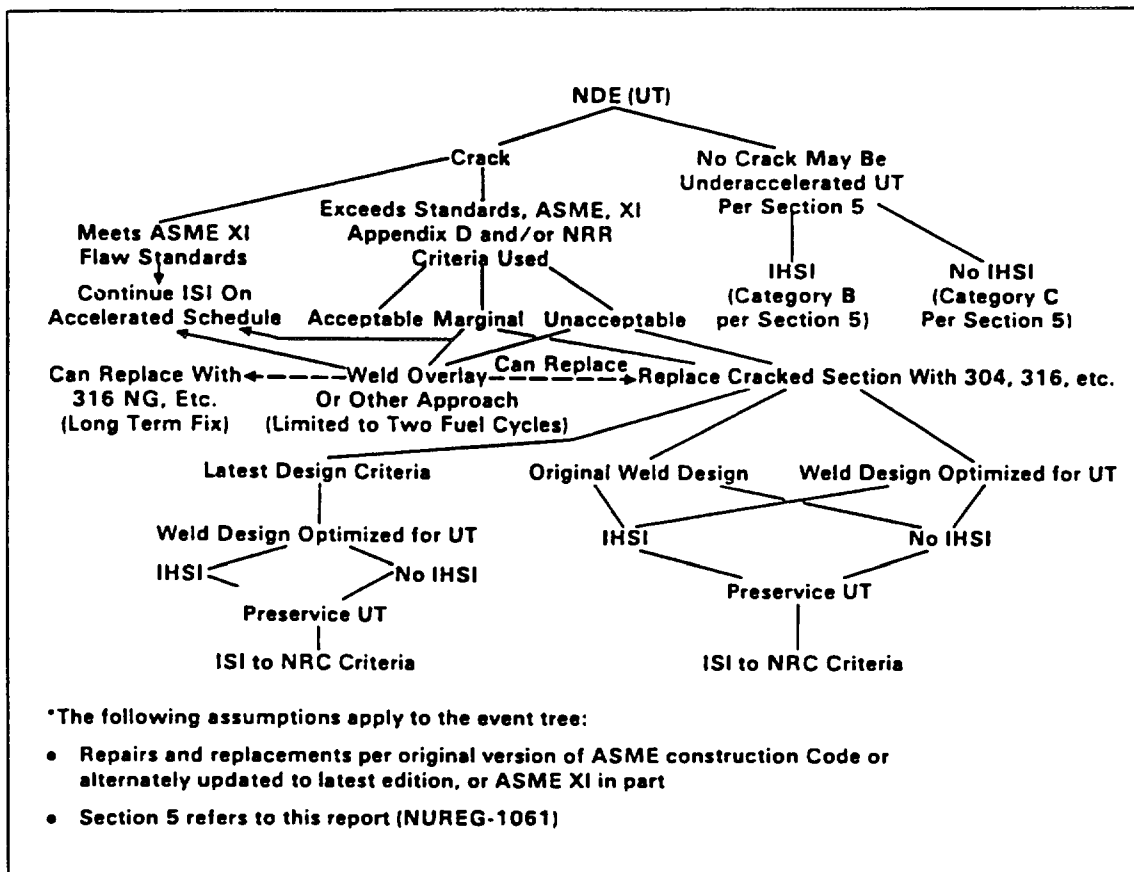
Figure 8: *Short-term solutions for replacement, repair, or continued operation without repair.*

Figure 8 shows both near-term and long-term solutions, as well as suggested actions related to volumetric examination and enhanced leak detection. The long-term materials solution is Type 316NG stainless steel in most countries, except Germany where a Type 347 NG is preferred.

The information in Table 13 confirms that both short-term and long-term solutions are covered as is the accelerated NDE of NUREG-0313, Revision 2 (1986). Figure 8 presented an event tree approach that includes several of the solutions cited in Table 13. Note the caveat with respect to continued use of overlay clad. This has been relaxed on the basis of ability to conduct UT through the clad and no evidence of continued IGSCC growth.

Short-term solutions include induction heating stress improvement (IHSI), clam shell reinforcements and last pass heat sink welding (HSW). In Japan, IHSI on uncracked pipe is considered a permanent fix by reducing-reversing residual tensile stresses.
