Re: Ramp Test of H-194 Containing FSI-1

Summary of Results

Project No. TM-448

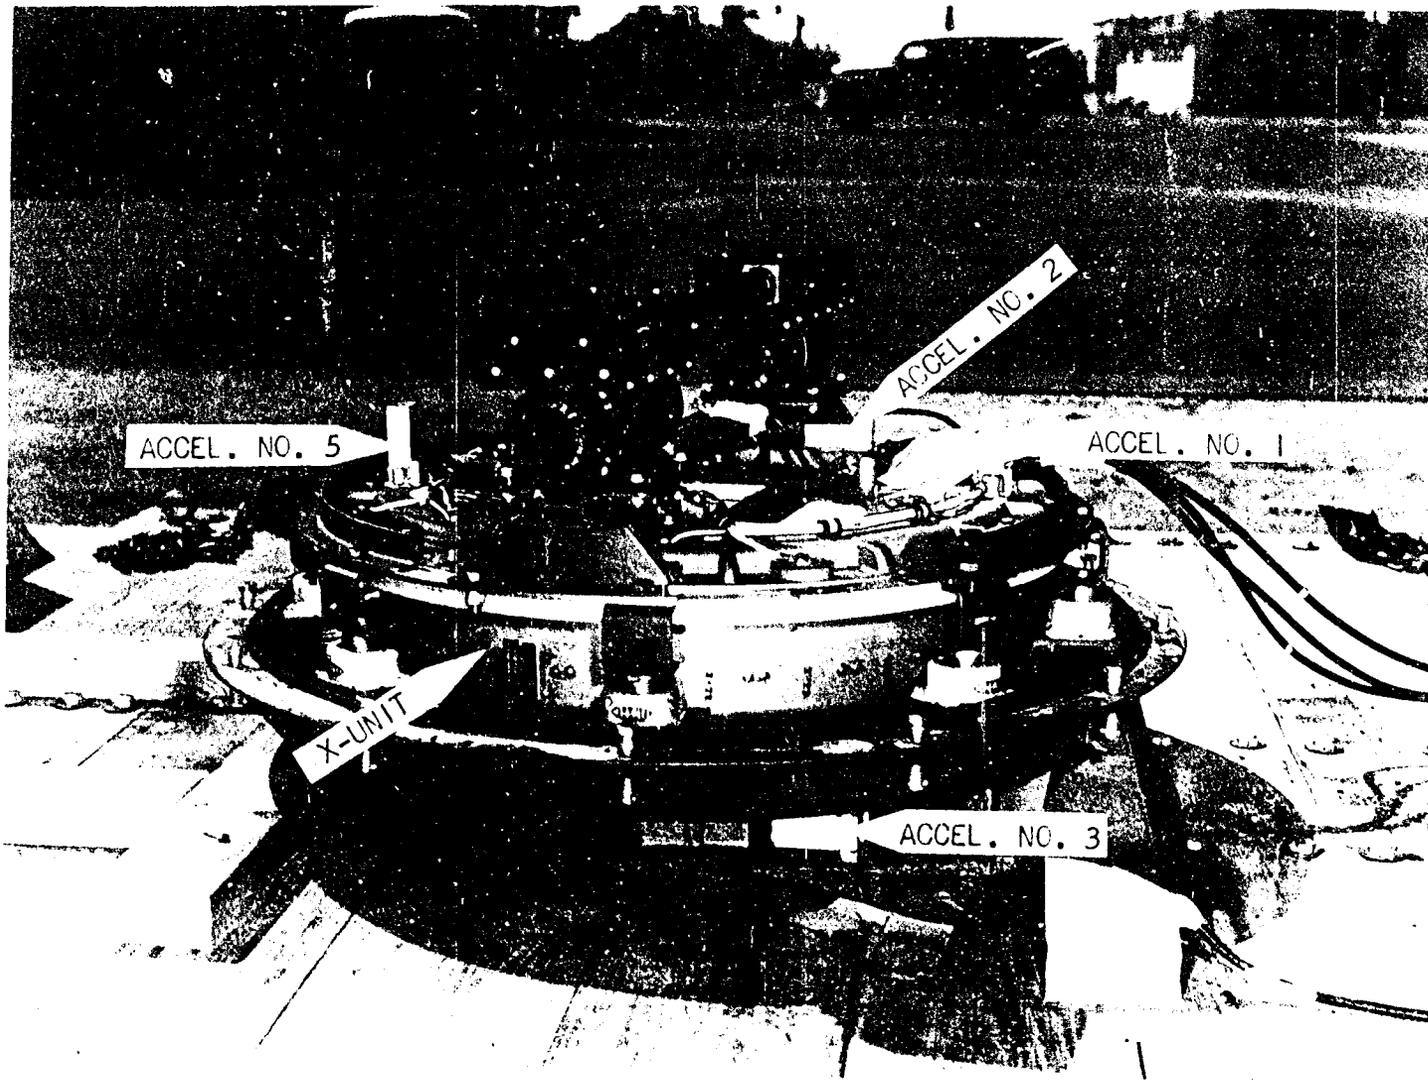
FIG. 1 -- INSTRUMENTATION OF FSI-1 -- PAMP TEST OF H-194 CONTAINING FSI-1

The FSI-1 mounted in an H-194 container was instrumented as shown in Fig. 1. Figure 2 shows the H-194 fastened to the ramp dolly.

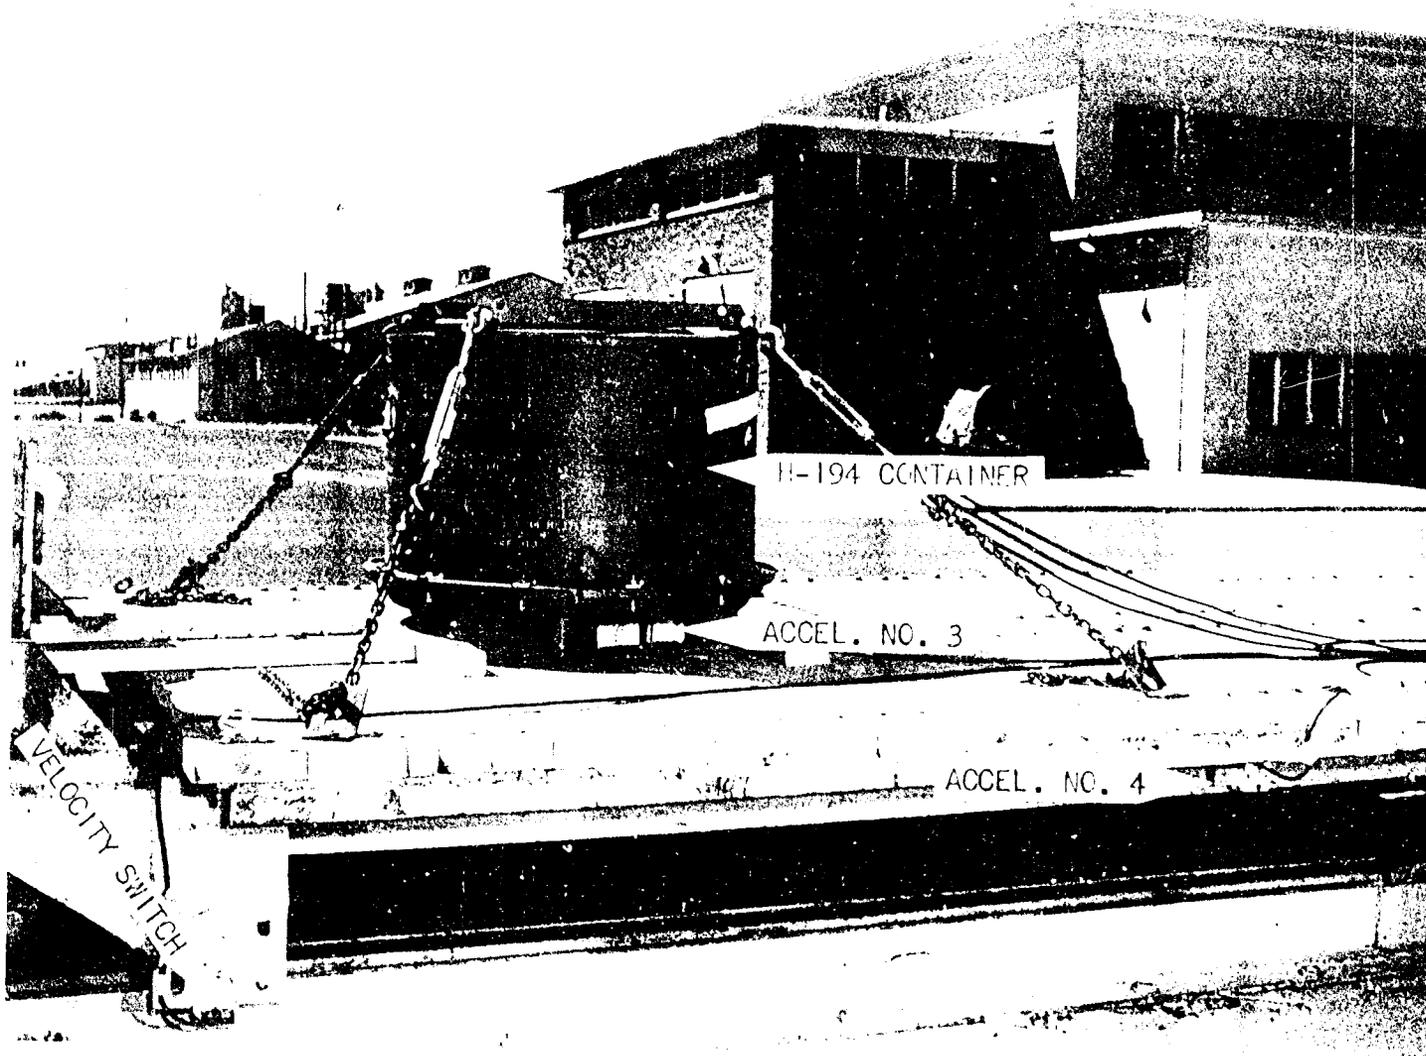
FIG. 2 -- H-194 MOUNTED ON PAM DOLLY -- PAM TEST OF H-194 CONTAINING FSI-1

Figure 2 shows the H-194 container fastened on the ramp dolly.

To measure velocity, a microswitch fastened to the ramp dolly (Fig. 2) was triggered by actuating arms 4.00 feet apart on the track. The time required for 4 feet of travel was recorded on the oscillograph.
