# Effect of Hurricane Andrew on the Turkey Point Nuclear Generating Station from August 20-30, 1992

Jointly sponsored by the Institute of Nuclear Power Operations and the  
U.S. Nuclear Regulatory Commission

March 1993

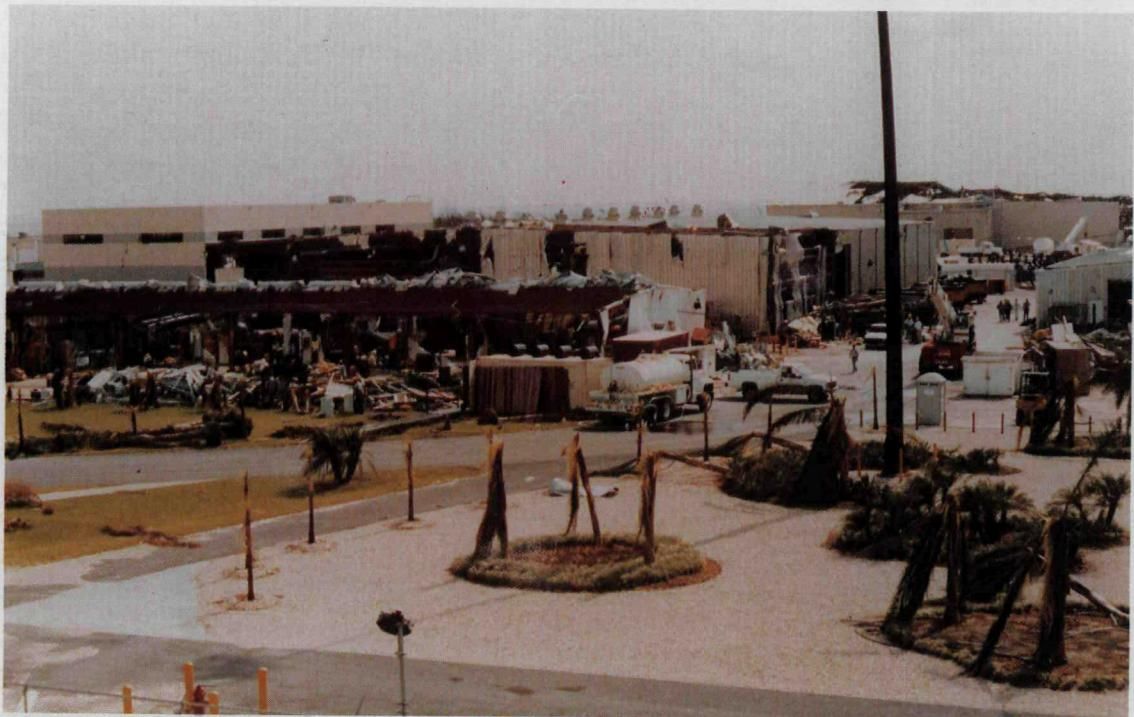
Figure 3.5 View From the Security Building

The security system sustained extensive damage to equipment such as lighting, cameras, intrusion detection equipment, protective area fencing, and the entrance building.
