## Dual-Band Infrared (DBIR) Imaging Inspections of Boeing 737 and KC-135 Aircraft Panels

P. K. Bhagat  
Manager, Nondestructive Inspection R&D  
Aging Aircraft Program  
FAA Technical Center  
Atlantic City Airport, NJ 08505

N. K. Del Grande, K. W. Dolan, P. F. Durbin  
Nondestructive Evaluation Section  
Engineering Sciences Division

27 August 1993

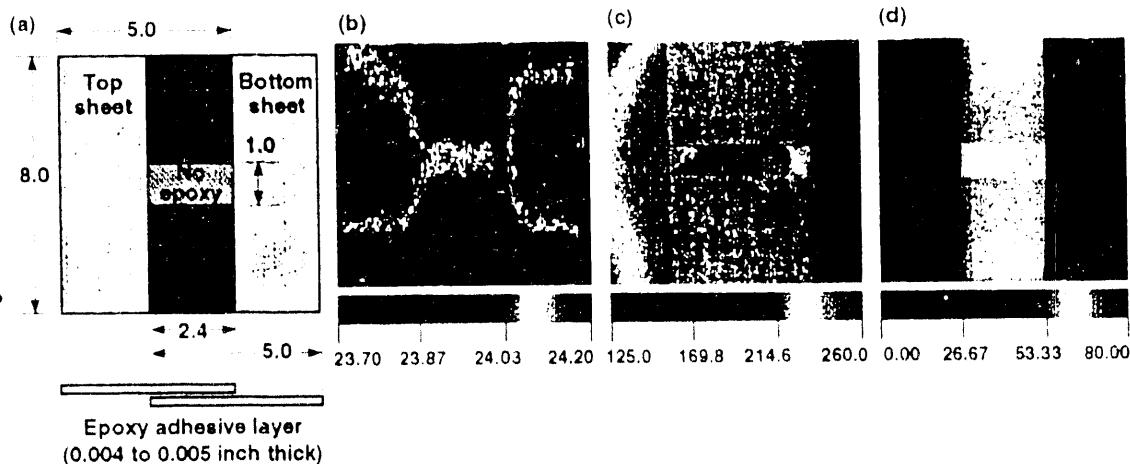
The Boeing 737 lap joint specimen<sup>12</sup> in Figure 7 has a rectangular (0.1 mm thick) air layer (with no epoxy) shown at the center of the diagram in (a) which replicates a disbond site. The 10  $\mu\text{m}$  IR image shows the disbond site as 0.4 or 0.5  $^{\circ}\text{C}$  warmer (where it was flash heated) than the epoxy-glue sites which surround it in (b). The ultrasound image shows a better bond quality at decreasing values for the epoxy-glue sites in (c). The reverse geometry x rays at 100 keV scatter differently through two overlapping (0.9 mm thick) aluminum sheets with a 0.1 mm air gap than through the same two sheets with an equally thick epoxy-glue layer in (d).

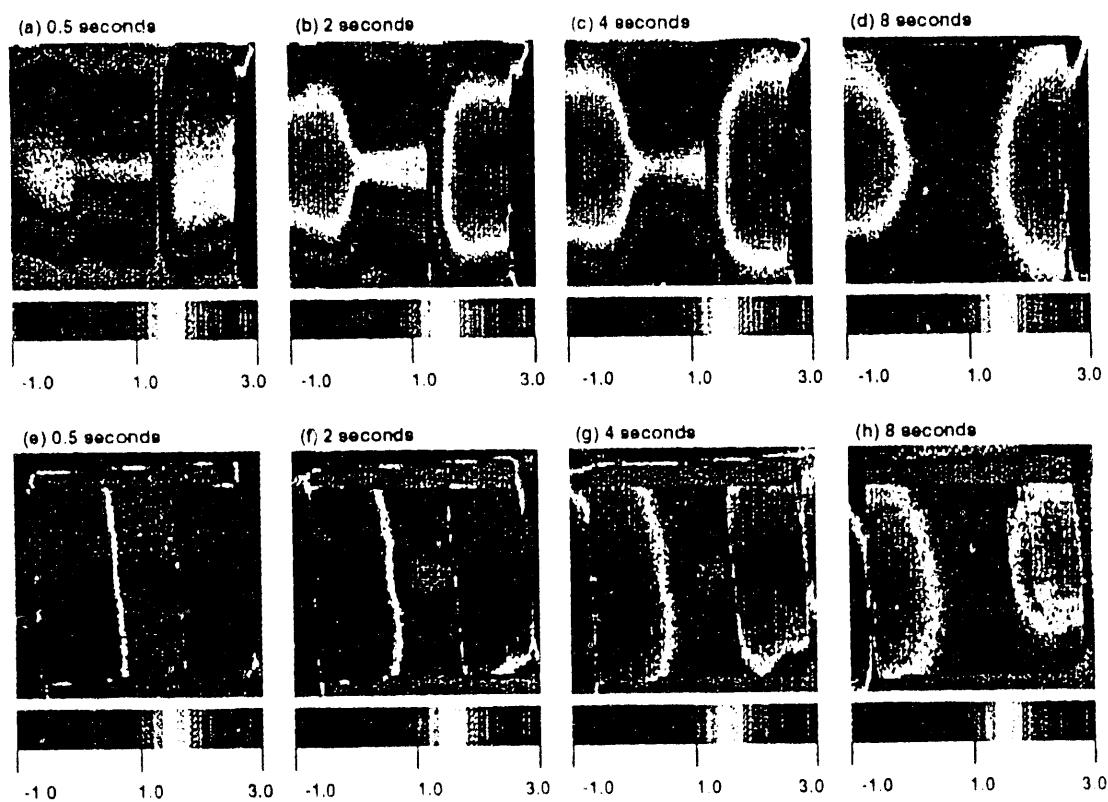
Figure 8

In Figure 8, we see the warmer than ambient, flash-heated, front-surface disbond site temperatures at 0.5, 2.0, 4.0 and 8.0 s after the flash (taken at 10  $\mu\text{m}$  in top row images: a, b, c, d) and corresponding cooler than ambient, simultaneously recorded back-surface disbond site temperatures (taken at 5  $\mu\text{m}$  in bottom row images: e, f, g, h). For symmetric lap joint disbands, the front-surface disbond site pattern is rectangular, whereas the back-surface disbond site pattern is circular. At 0.5 s, much of the heat transfer is two dimensional, across the lap to the back side in the transverse direction (parallel to the surface).

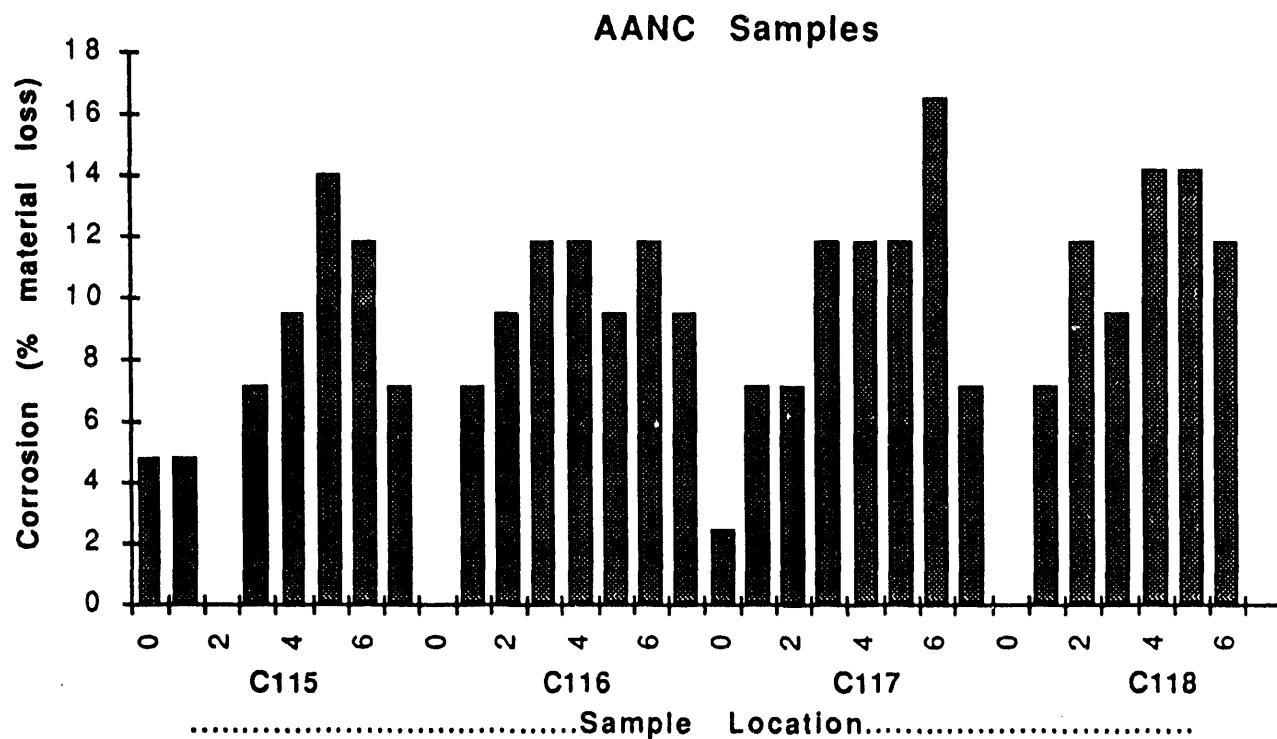
Figure 14. Corrosion chart showing sites between lap joint rivets for FAA/AANC Library Panels C115 and C116 without and C117 and C118 with 27 days exposure to solutions expected to cause corrosive action. See Table 1 and Appendix B.

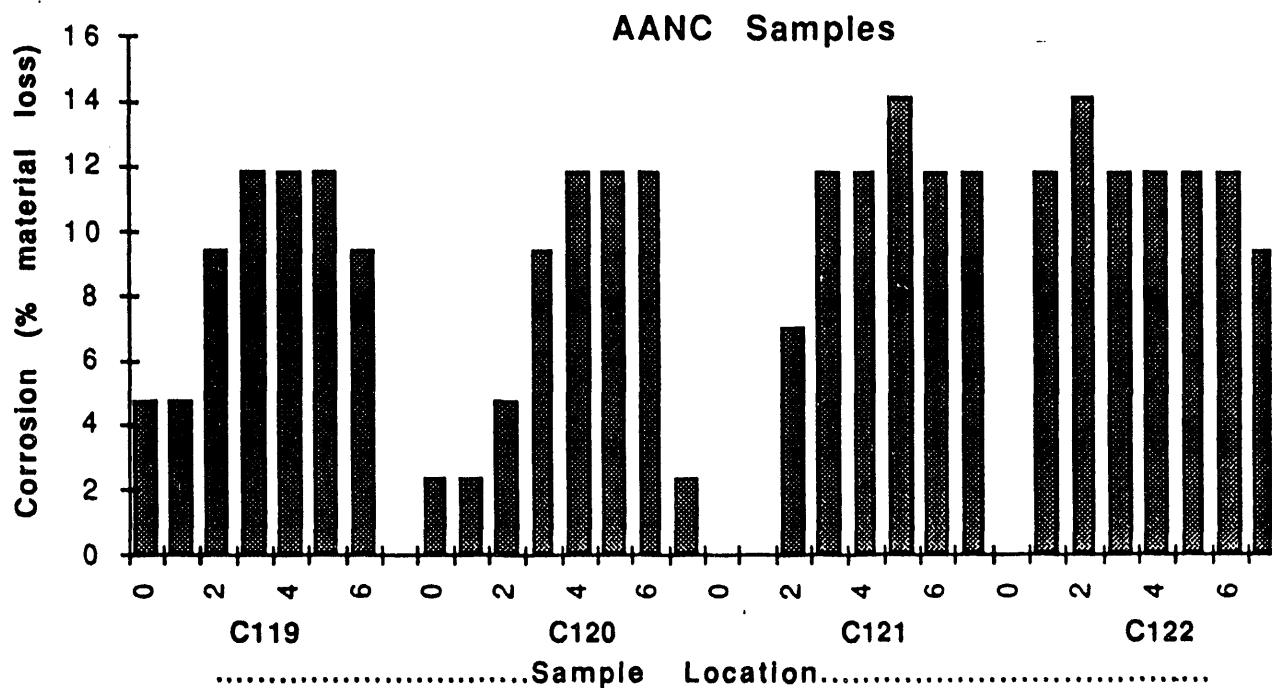
Figure 15. Corrosion chart showing sites between lap joint rivets for FAA/AANC Library Panels C119 and C120 with 42 days and C121 and C122 with 54 days exposure to solutions expected to cause corrosive action. See Table 1 and Appendix B.

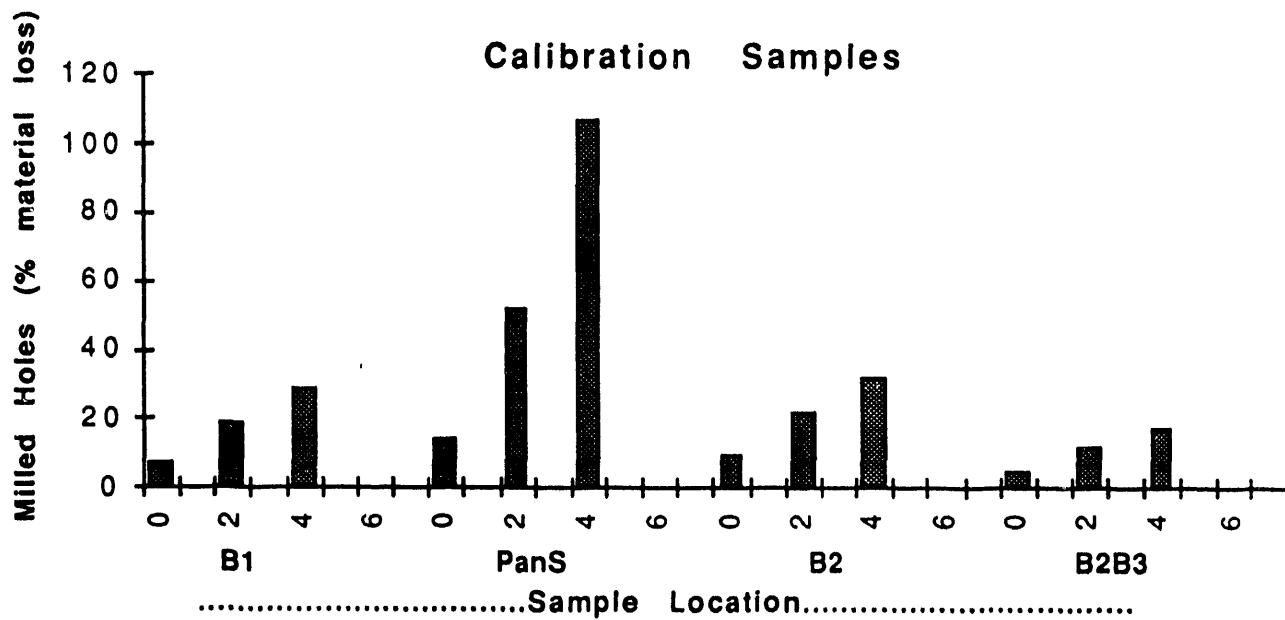
Figure 16. Chart showing thickness losses which were proportional to surface temperature rises at 0.4 s after flash-heating calibration samples: B1 (1.1 mm), PanS (1.0 mm), B2 (2.3 mm) and B2B3 (3.9 mm). Samples were black-painted aluminum plates with milled flat-bottom holes. See Table 1 for statistical errors and Appendix A for the color-coded thermal images.

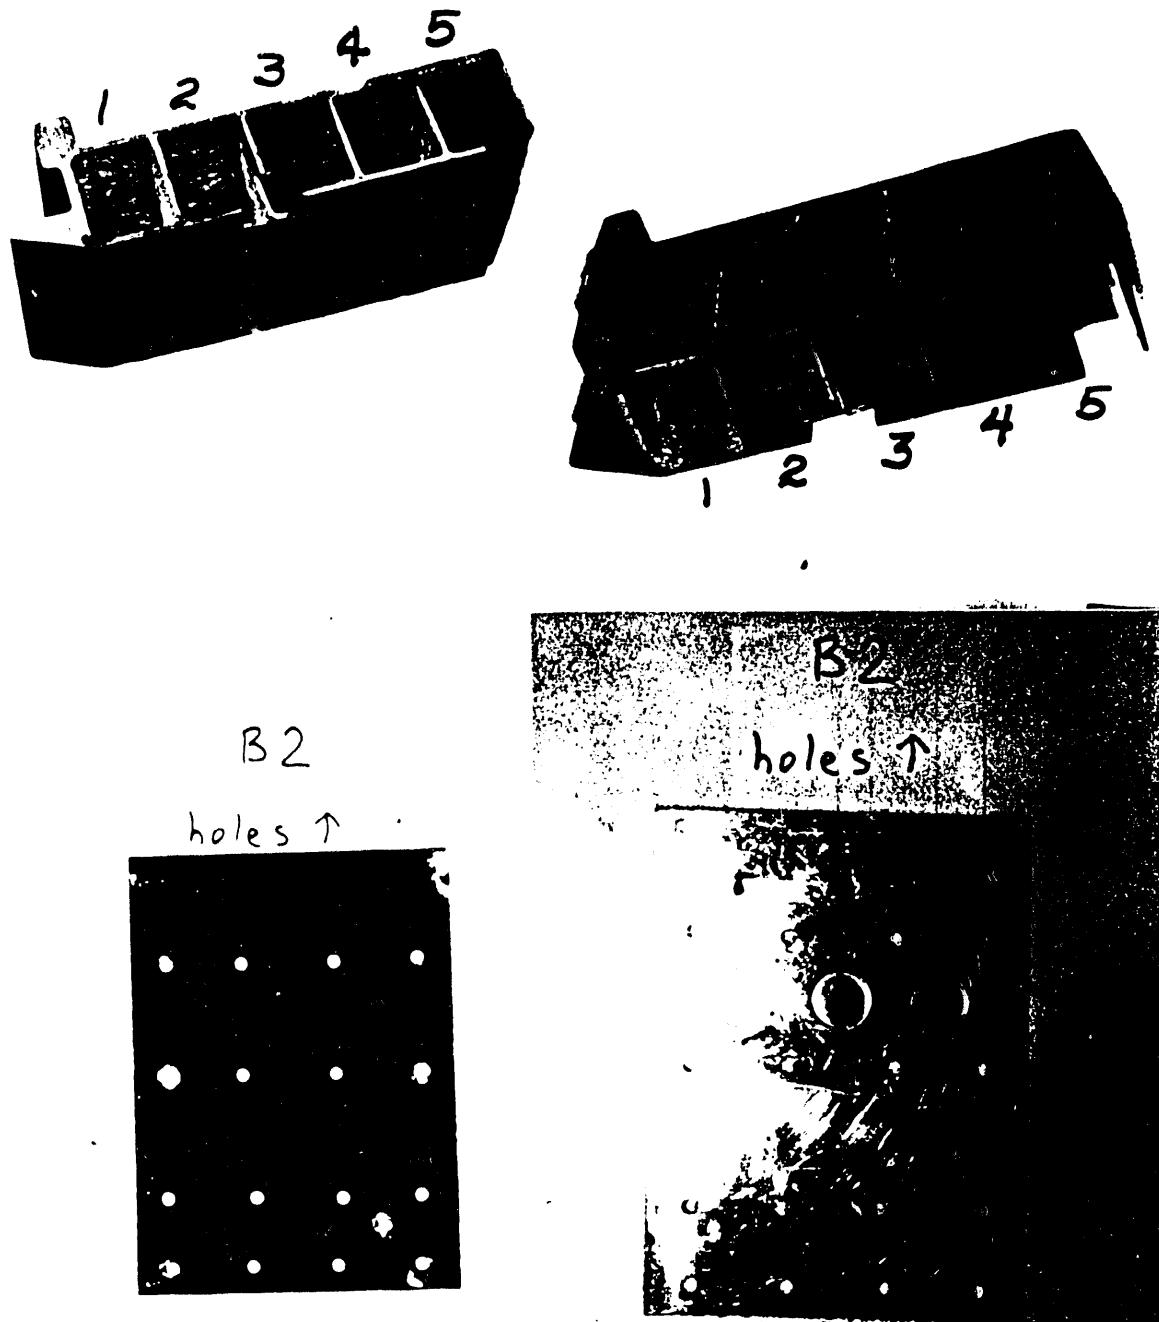
Figure A-9. Top left: front side of F-18 wing box structure which was painted black to absorb four or five times the heat absorbed by an unpainted aluminum surface. Note thickness differences left and right of slot between channel two and channel three. Top right: wing box structure showing corrosion by-products at back face of front side. Bottom left and right: front and back side of 2.3 mm aluminum plate with 0.23 mm, 0.46 mm and 0.66 mm flat bottom holes flash-heated from the front.

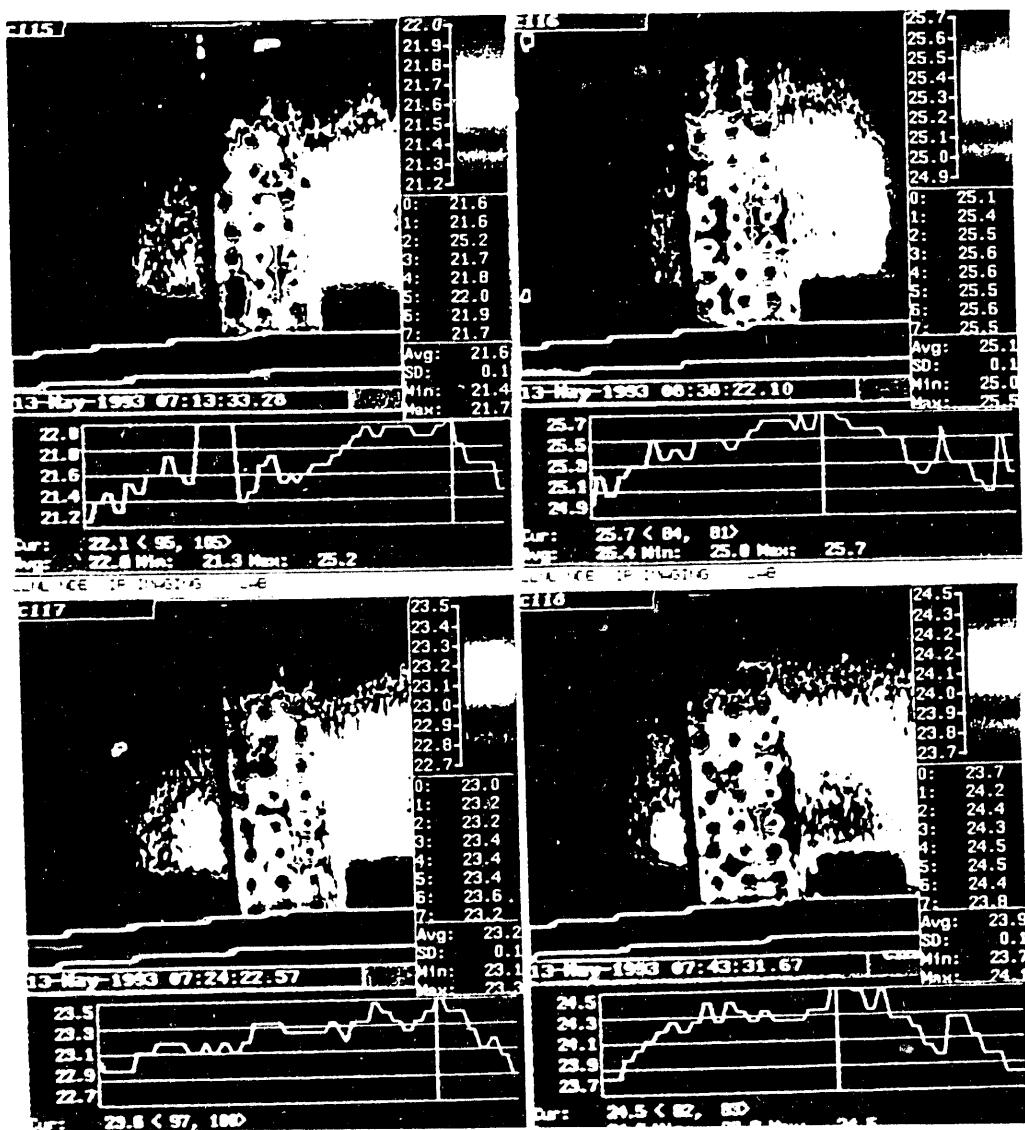
Figure B-3. Agema 880 DBIR System long wavelength (10  $\mu$ m) color-coded temperature patterns in  $^{\circ}$ C at 0.4 s after the heat-flash. Top row, left to right, panels C115 and C116 were not exposed to solutions expected to cause corrosive action, while bottom row, left to right, panels C117 and C118 were exposed for 27 days to solutions expected to cause corrosive action (see Table 1, Figure 14).

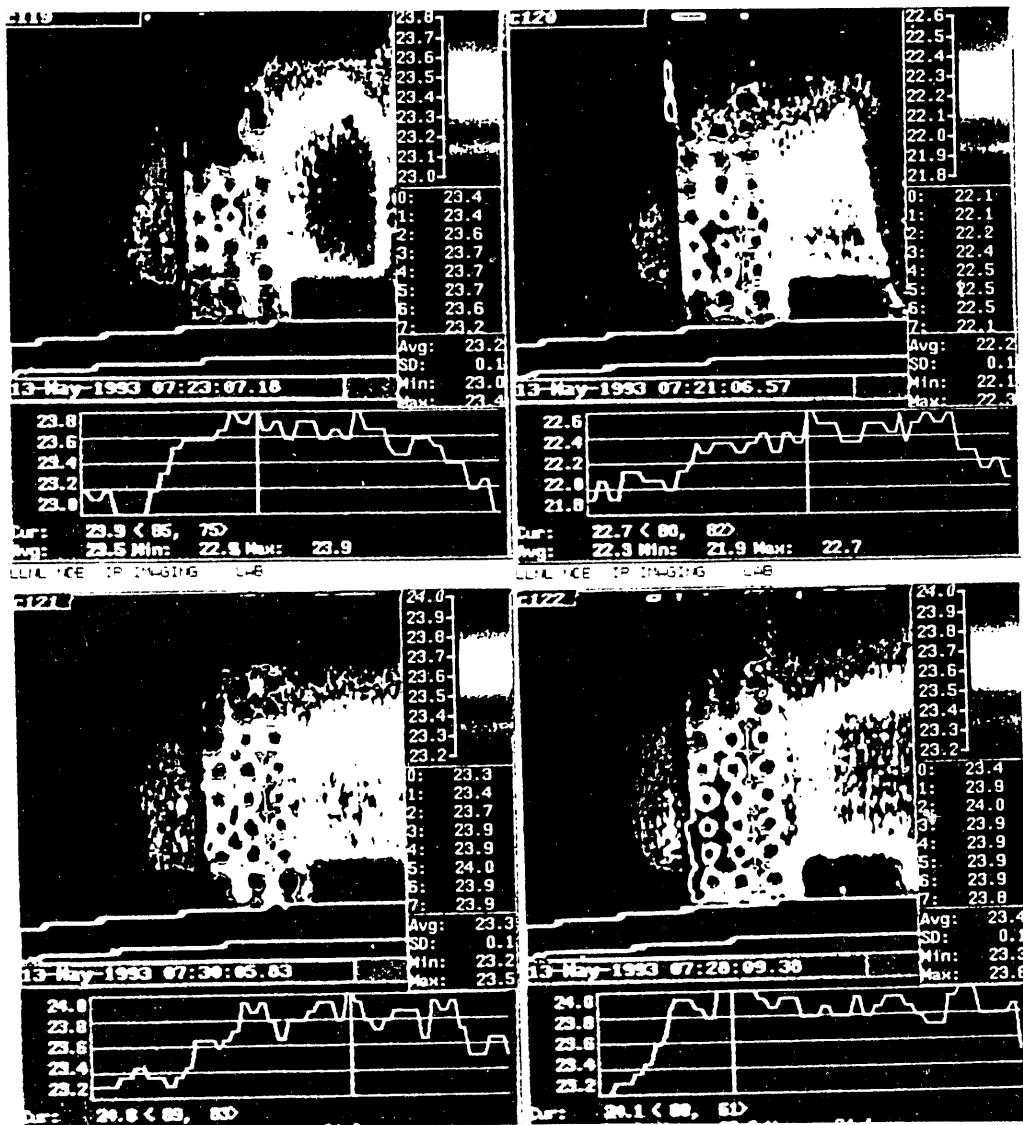
Figure B-4. Agema 880 DBIR System long wavelength (10  $\mu\text{m}$ ) color-coded temperature patterns in  $^{\circ}\text{C}$  at 0.4 s after the heat-flash. Top row, left to right, panels C119 and C120 were exposed for 42 days to solutions expected to cause corrosive action, while bottom row, left to right, panels C121 and C122 were exposed for 54 days to solutions expected to cause corrosive action (see Table 1, Figure 15).

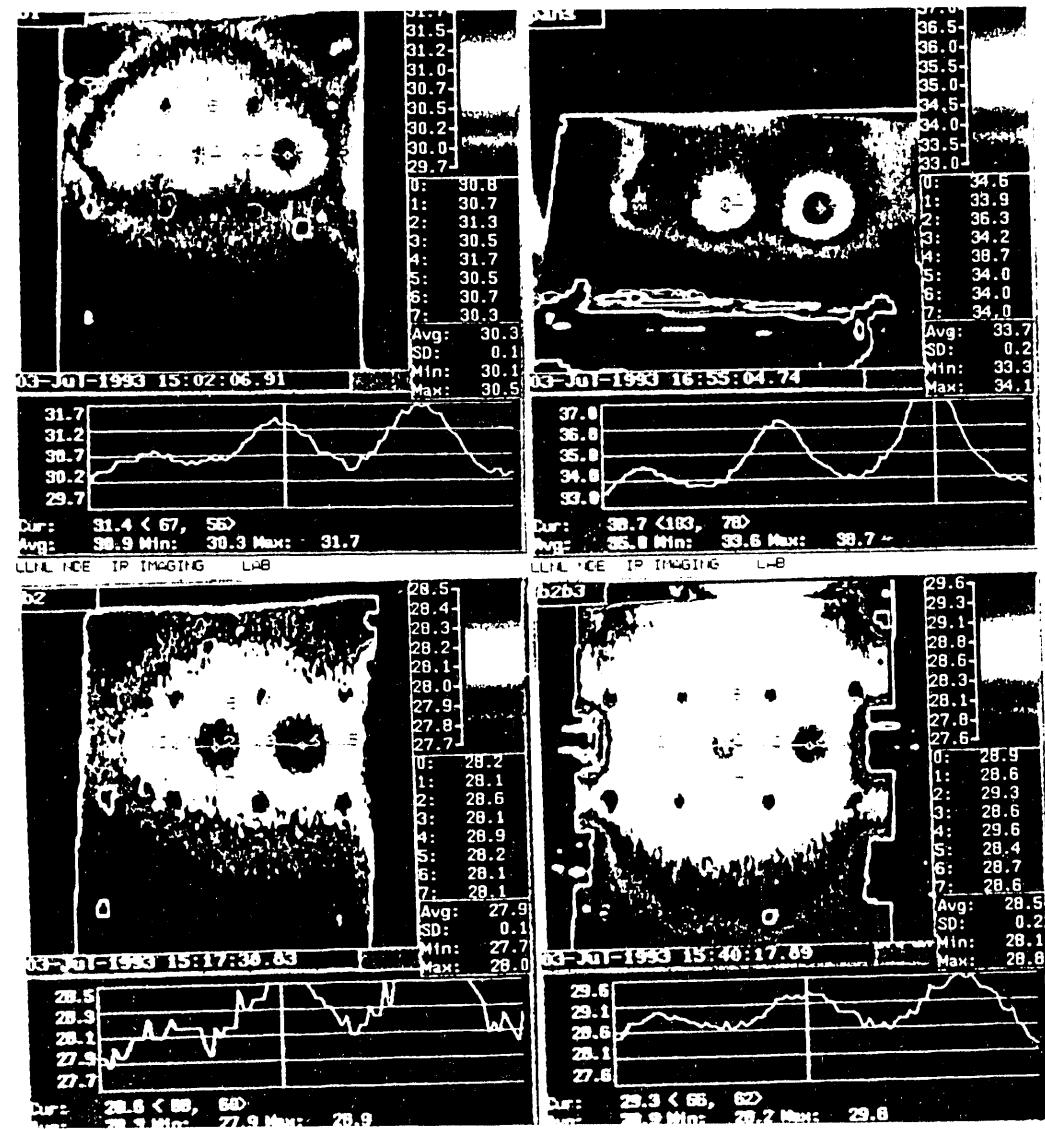
Figure B-5. Agema 880 DBIR System long wavelength (10  $\mu\text{m}$ ) color-coded temperature patterns in  $^{\circ}\text{C}$  at 0.4 s after the heat-flash. Top row, left to right, show panel B1 (1.1 mm, with 9%, 19% and 28% thickness-loss holes) and panel S (1.0 mm, with 20%, 40% and 62% thickness-loss holes), while bottom row, left to right, show panel B2 (2.3 mm, with 10%, 19% and 28% and composite panel B2B3 (3.9 mm, with 6%, 12% and 17% thickness-loss holes). See Table 1, Figure 16.

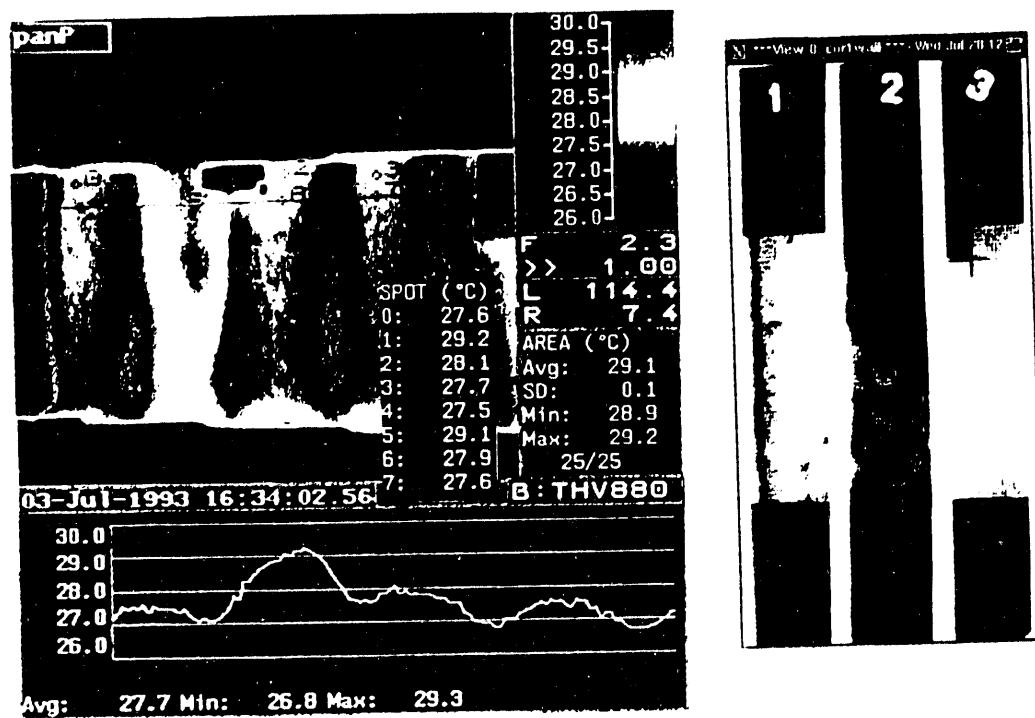
Figure B-6. Left: Agema 880 DBIR System long wavelength (10  $\mu$ m) color-coded temperature patterns in °C at 0.4 s after the heat-flash for F-18 wing box structure spot temperatures 0-7 and area box temperature (near spot 5) corresponded to sites where channel thickness measurements were made. The thickness loss per degree Celsius for the 2.9 mm (uncorroded thickness) structure was 22.1% (or 0.643 mm). Right: x-ray radiograph of corroded wing box structure showing three channels from left side of the flash-heated front face, which was painted black.

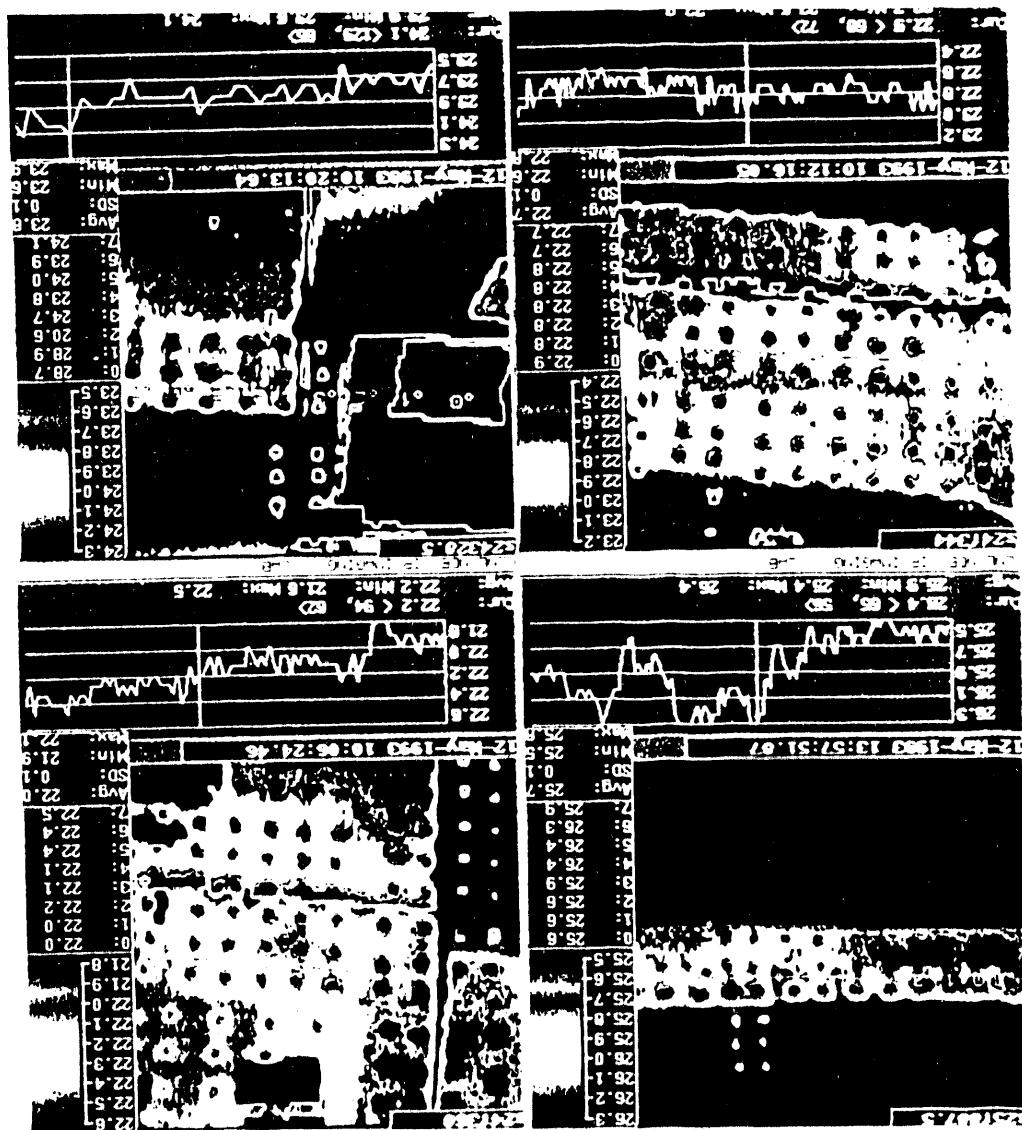
Figure B-12. Boeing 737, Stringer 24 Agema 880 DBIR System long wavelength (10  $\mu$ m) color-coded temperatures in  $^{\circ}$ C at 0.4 s after flash, as shown in four images from top row, left to right, Station f328 and Station f312.4 (40% aft, toward next station) and bottom row, left to right, Station f294.5.8 (80% aft of Station f294.5) and Station f294.5.3 (30% aft of Station f294.5). See Table 3, Figure 22.

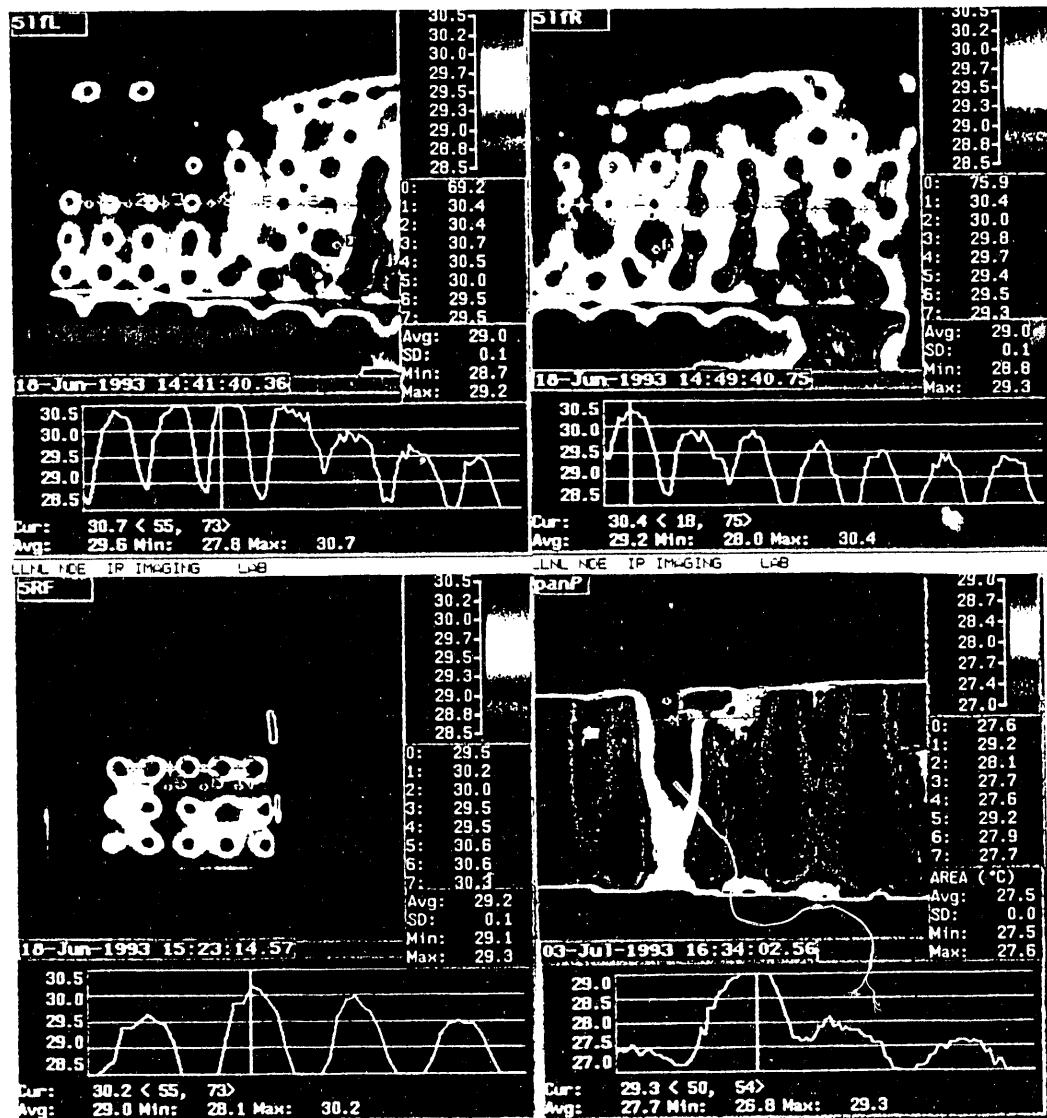
Figure C-6. Top row, left to right: two (left and right) Panel 5 left end piece images of Agema 880 DBIR System long wavelength (10  $\mu$ m) color-coded temperatures in °C at 0.4 s after flash. Bottom row, left: Panel 5 right end piece image of Agema 880 DBIR System long wavelength (10  $\mu$ m) color-coded temperatures in °C at 0.4 s after flash. Bottom row, right: F-18 wing box structure with varying amounts of material loss from corrosion used to establish the correlation between above-ambient surface temperature and aluminum channel thickness loss. Temperature data at spots 0 through 7 are included in Table 5.
