WSRC-TR--91-378

SUMMARY REPORT FOR 1990 INSERVICE INSPECTION (ISI) OF SRS 100-L REACTOR TANK (U)

Westinghouse Savannah River Company
Savannah River Site
Aiken, South Carolina 29808

Publication Date: July 12, 1991

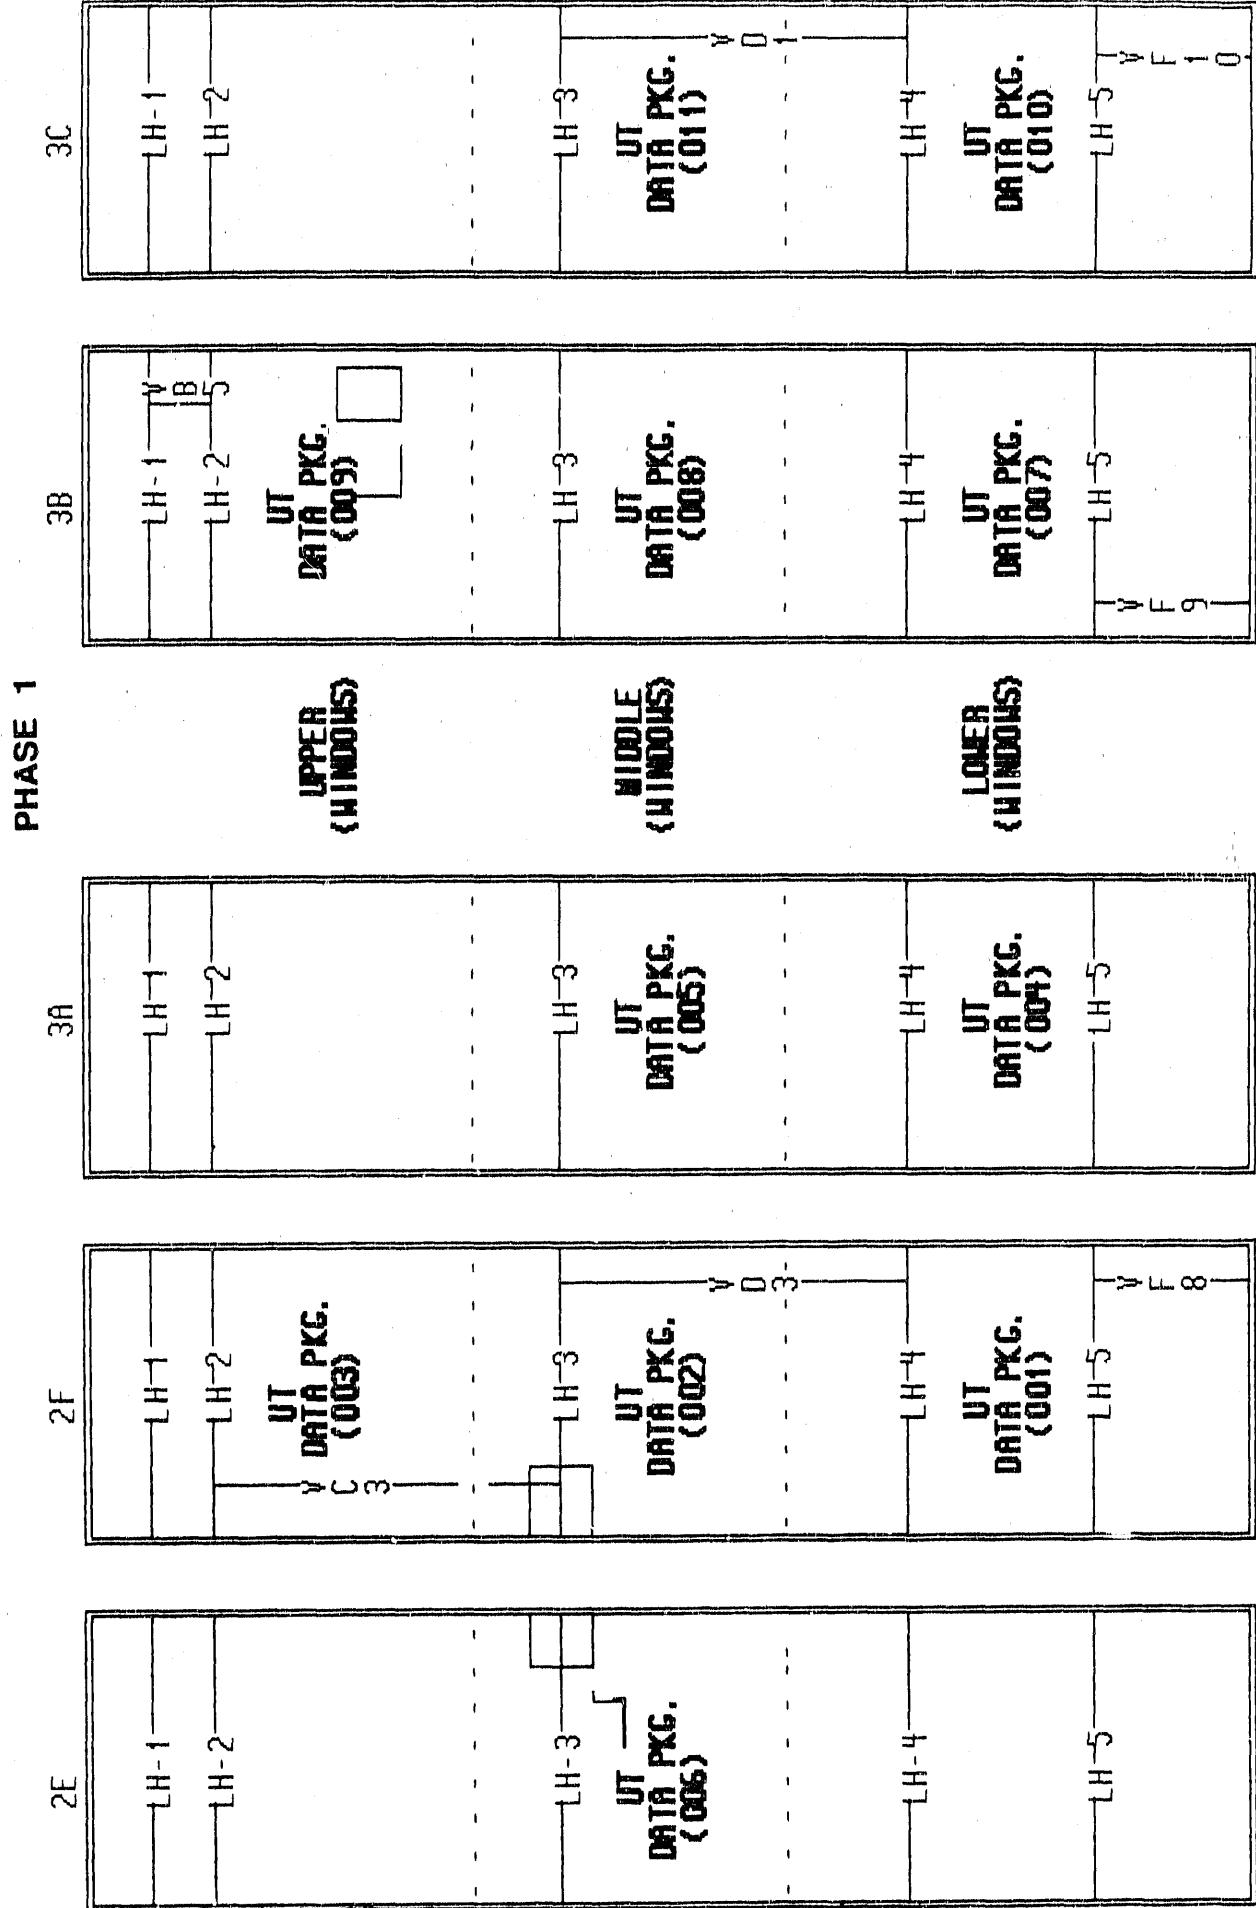
FIGURE 1-A. L REACTOR EXAMINATION ENVELOPES

As in the other reactors, the upper and lower vertical welds are not continuous over the entire height of the main tank shell, but are offset at the mid-girth weld as shown in Figures 1-A, 1-E, and 1-G. Figure 2 consolidates all these welds in a single display. The offsets are greater than in P and K tanks (4 inches), however, and vary in "left-right" relative position. This reflects the six plates of different circumferential lengths used in L tank, as compared to 4 plates of approximate equal length used to fabricate P and K. The bottom vertical weld is rotated clockwise from the top weld, as viewed from the center of the tank, for L-VC3/L-VD3, but counterclockwise from the top for L-VC1/L-VD1 and L-VC2/L-VD2.
