Type B Investigation of the  
Iridium Contamination Event at the  
High Flux Isotope Reactor  
on September 7, 1993

Investigation Board

Date Published: March 1994

Prepared by  
MARTIN MARIETTA ENERGY SYSTEMS, INC.  
Oak Ridge, Tennessee 37831  
for the  
U.S. DEPARTMENT OF ENERGY  
under contract DE-AC05-84OR21400

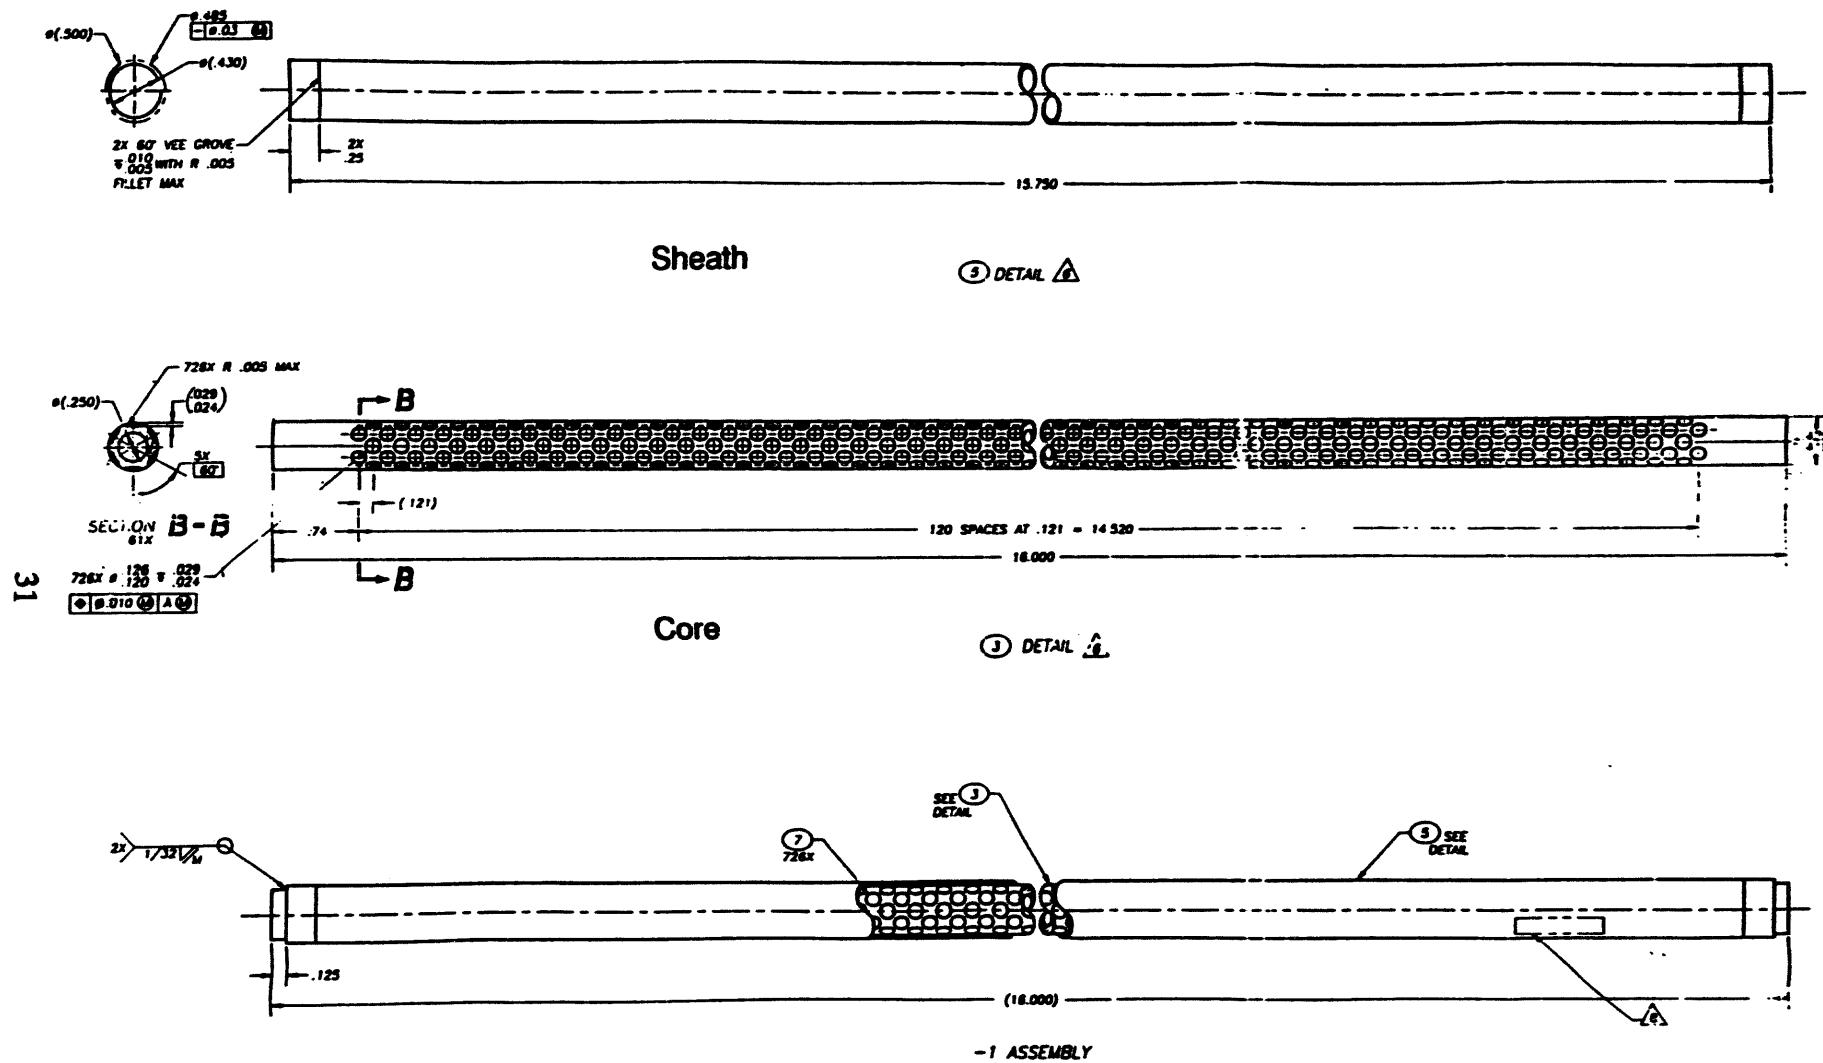
Fig. 4.2. Iridium-target design details.

The target rod that failed is designated IR-75. As indicated in Fig. 4.2, it is made up of two pieces of 6061-T6 aluminum tubing: the core, which has the pellets inset in shallow recesses in the outer surface, and an outer sheath that retains the pellets and is attached to the core by circumferential welds at either end. As a result of the welding process, the T6 high-strength condition is not retained over the full length of the assembly. The strength is less toward the welds, and this reduced strength may extend as much as 2 inches from the weld (based on calculated temperatures during welding), which is where the rupture occurred.

The first major operation in Building 3525 was to cut off both ends of the target rod at the usual cutoff location [ $\sim 0.4$  inches from the end, (Figs. 4.2 and 4.13)]. The cut surface (plane A, Fig. 4.13) was polished, and then the wall thickness of the sheath was checked (Fig. 4.14). The wall thickness appeared to be reasonably uniform. (The design drawing does not specify tolerances on concentricity of inner and outer surfaces. The dimensional tolerance on wall thickness, assuming concentricity, is  $\pm 0.005$  in.)

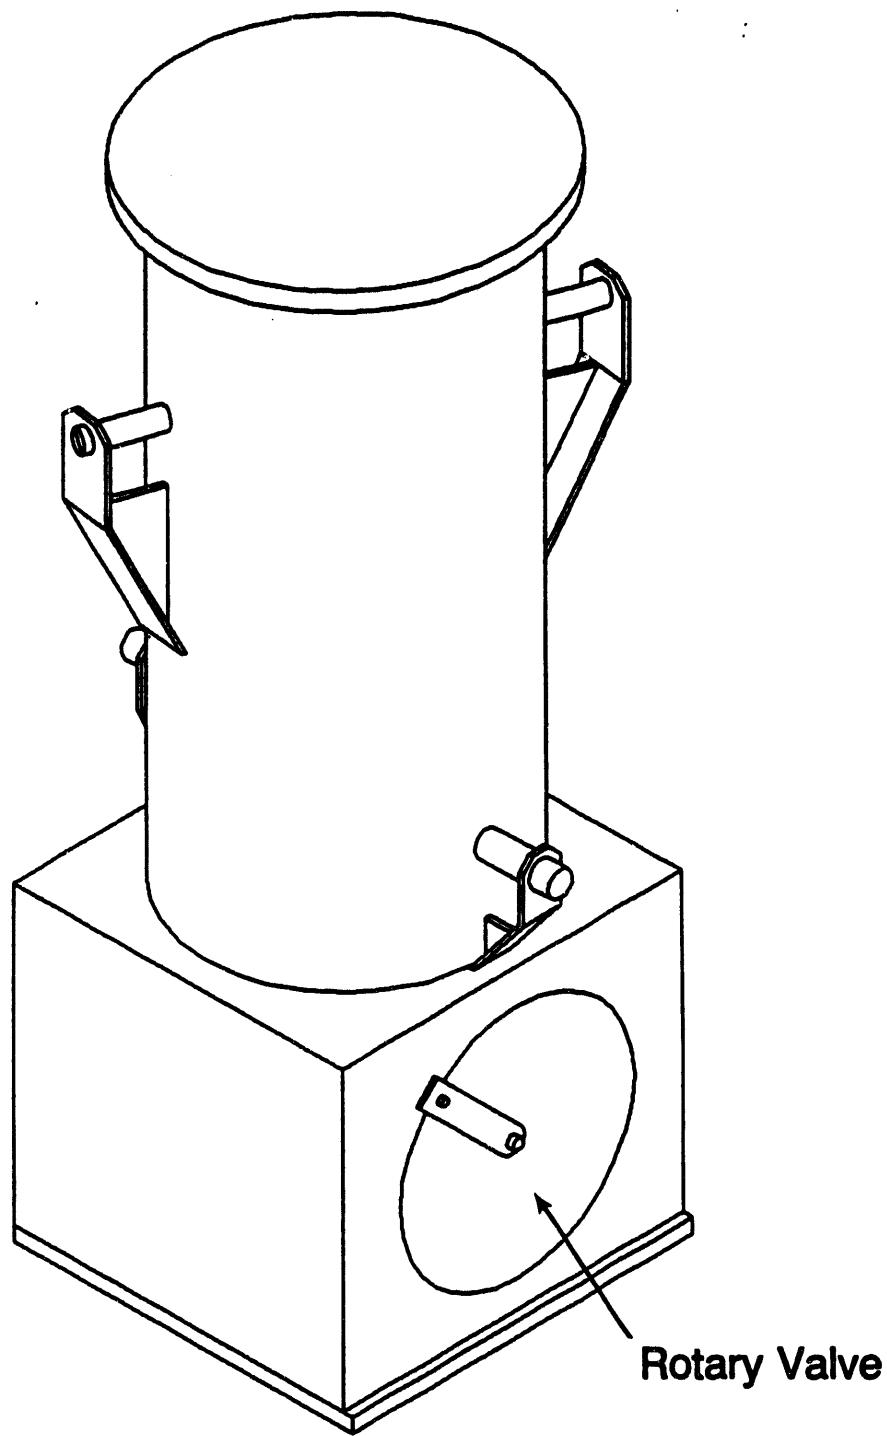
Fig. 4.3. Iridium target-rod shipping cask (HRLEL carrier).

The cask (Figs. 4.3 and 4.4) was loaded from the bottom, after the rotary valve in the bottom section of the cask was opened, and after the cask was lowered so that the bottom end extended several inches into the reactor pool water. The can (Fig. 4.5), containing seven target rods, with target rod IR-75 in position 5 (Fig. 4.6), was pulled up into the upper part of the cask (Fig. 4.4) into a dry cavity. Water in the can drained through holes directly beneath each target rod and through holes in the side of the can. Drainage from the annulus between the target rod and tubular target-rod holder (Fig. 4.5) tends to be relatively slow because the bottom end of the target rod covers the drain hole even when the target rod is in an extreme lateral position. If the target rod is tilted or the end of the target rod is uneven (weld variability), the drainage rate tends to be enhanced. The drainage time is also influenced by the time required to raise the can out of the pool up into the dry cavity in the cask.

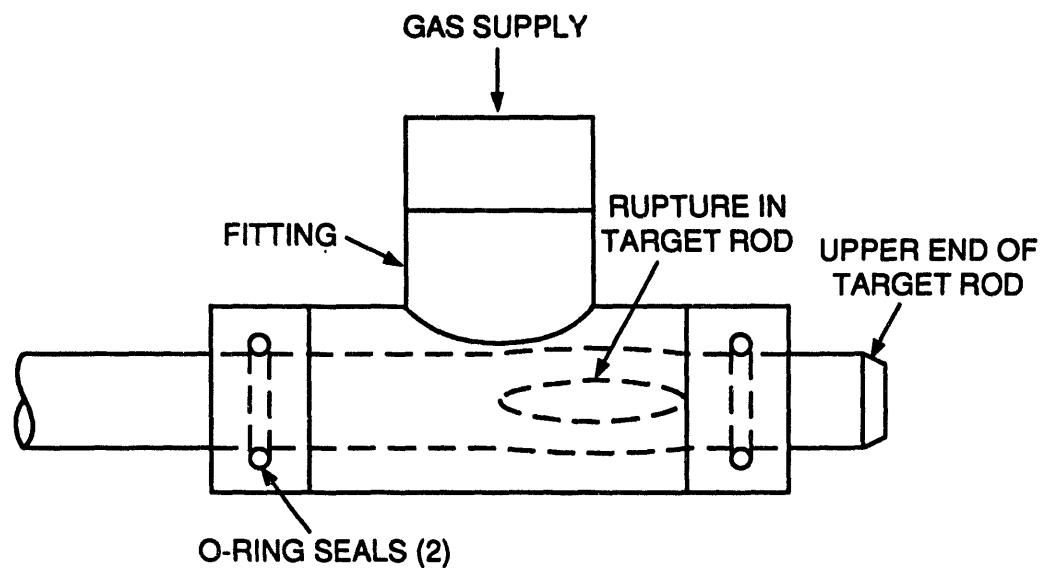
Fig. 4.9. Schematic of assembly for pressurizing void space in ruptured target rod IR-75.

A visual inspection of the target rod did not positively reveal a leak site, although there was suspect porosity on the surface of the welds. Thus, internal pressure was applied with nitrogen gas, through a fitting applied over the rupture (Fig. 4.9) with the exposed areas of the target rod placed under water. With 15-psi differential pressure, there were no bubbles, but with 30 psi, bubbles emanated from a location in the weld at the upper end (Fig. 4.10). There were no additional indications of leaks, even at 60 psi.

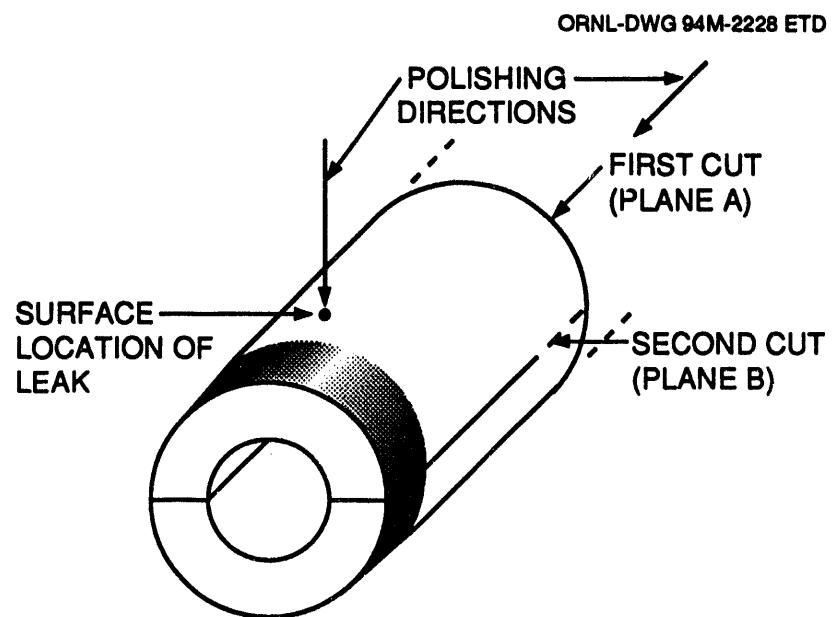
Fig. 4.13. Cutting sequence and polishing directions for upper end of iridium target rod IR-75.

In an effort to learn more about the apparent leakage path and the whisker in the weld, the cutoff end from the upper end of the target rod was cut in half, using a longitudinal cut (Fig. 4.13, second cut), with the leakage site at  $\sim 90^\circ$  to the cutting plane (plane B). The two pieces were potted, and the outer surface (opposite from cutting plane B) of the piece with the leak site was polished in a direction normal to cutting plane B (Fig. 4.13). This was done in an effort to trace the whisker and leakage path. Polishing revealed a small hole (Fig. 4.15) that extended radially inward from the outer surface to the annulus between the core and sheath.

Cutting plane B (Fig. 4.13) on the potted piece without the leak site was polished to show the cross section of the weld (Fig. 4.19). Some porosity was detected (Fig. 4.20), but at this particular location (90° from leak site) there is no evidence of a nonbond or cavity at the end of the sheath or of a chamfer on the inner corner of the sheath. There is, however, an unfused interface between the inner surface of the sheath and outer surface of the core at the end of the narrower of the two clearances shown (Fig. 4.19).
