# Aging, Loss-of-Coolant Accident (LOCA), and High Potential Testing of Damaged Cables

Prepared by  
R. A. Vigil/SEA  
M. J. Jacobus/SNL

Prepared for  
Division of Reactor Controls and Human Factors  
Office of Nuclear Reactor Regulation  
U.S. Nuclear Regulatory Commission  
Washington, DC 20555-0001  
NRC FIN L1903

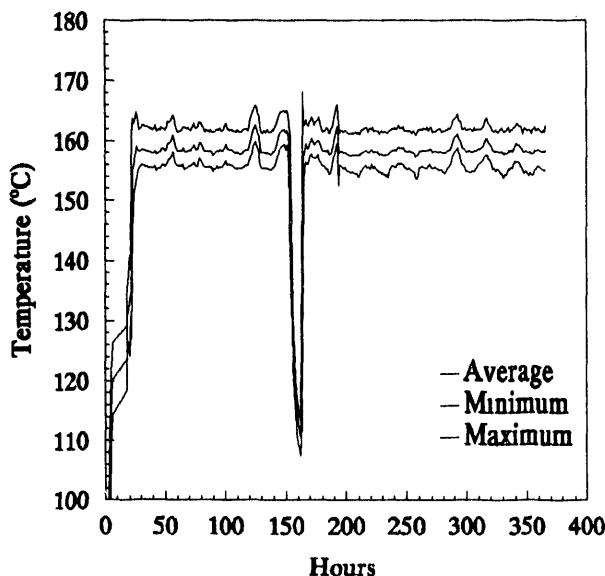
**Figure 2 Thermal Aging Profile**

thermal aging. Note the drop in temperature at approximately 6 days. This anomaly in temperature was caused by a failed electric circulation heater. The defective electric circulation heater was removed while the remaining electric circulation heater maintained the chamber temperature above 100°C until a new electric circulation heater was added to restore the chamber to the desired temperature. The drop in temperature existed for approximately 24 hours. The thermal aging was extended by 24 hours to compensate for this anomaly. The effect of this anomaly is an insignificant increase in the total thermal aging.

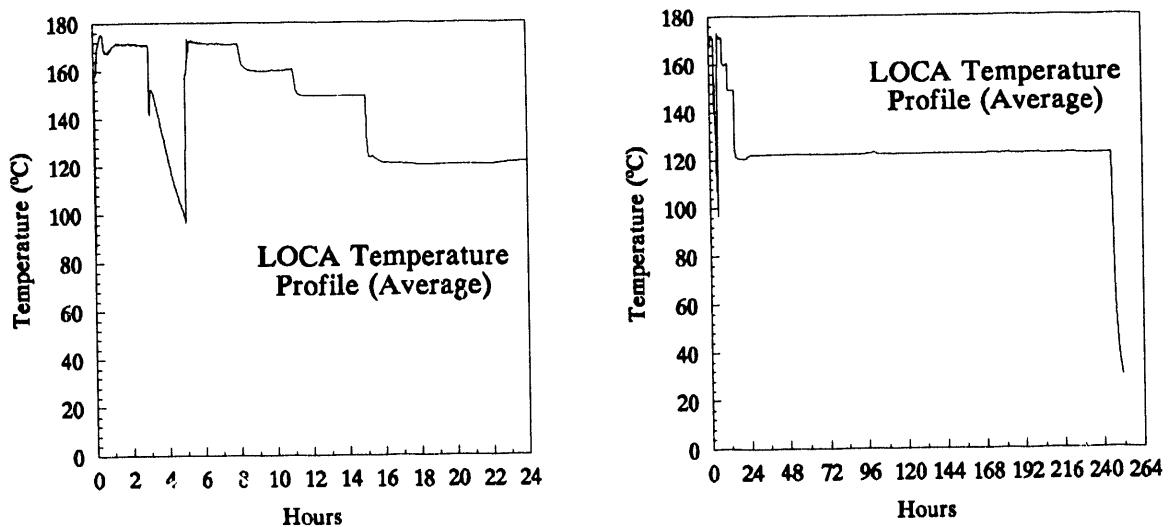
Figure 4 LOCA Simulation Temperature Profiles

Following aging, the cables were subjected to the LOCA simulation. The temperature and pressure profiles during the LOCA simulation are shown in Figures 4 and 5, respectively. Plots for the first 24 hours of the accident simulation are shown along with overall test profiles. The IR of each cable during the accident simulation is shown in Appendix A. The power supply energizing the test cables failed unexpectedly at approximately 30 hours into the LOCA simulation. A new power supply was installed at approximately 46 hours into the LOCA simulation—this accounts for the brief transient noted in many of the insulation resistance graphs. The only effect of the failed power supply was a loss of continuous IR data during the outage.

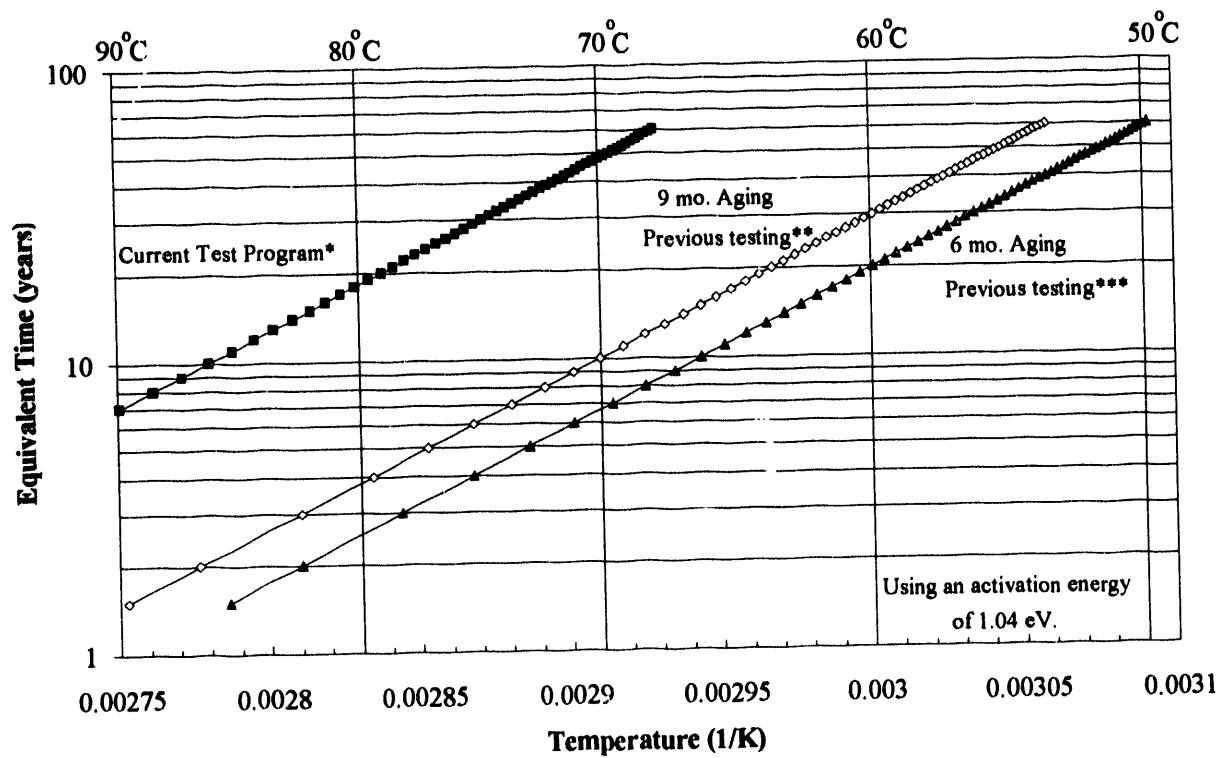
**Figure 7 Equivalent Time-Temperature Corresponding to the Thermal Aging in this program and Previous Sandia Testing**

To apply the data to lifetimes of other than 40 years, the Arrhenius theory can be used to equate the test conditions to a temperature for any given lifetime (or conversely, a lifetime at any given temperature). This is shown in Figure 7, where the thermal aging data from the previous testing and the current testing is compared, using an activation energy of 1.04 eV. The top curve is based on the current testing and is obviously the most severe of the thermal aging conditions. The middle curve corresponds to 9 month of aging at 98°C (208°F) and the lower curve corresponds to 6 months of aging at 98°C (208°F).

- \* All Okonite cables failed.
- \*\* 1 of 4 Okonite cables failed.
- \*\*\* 0 of 3 Okonite cables failed.

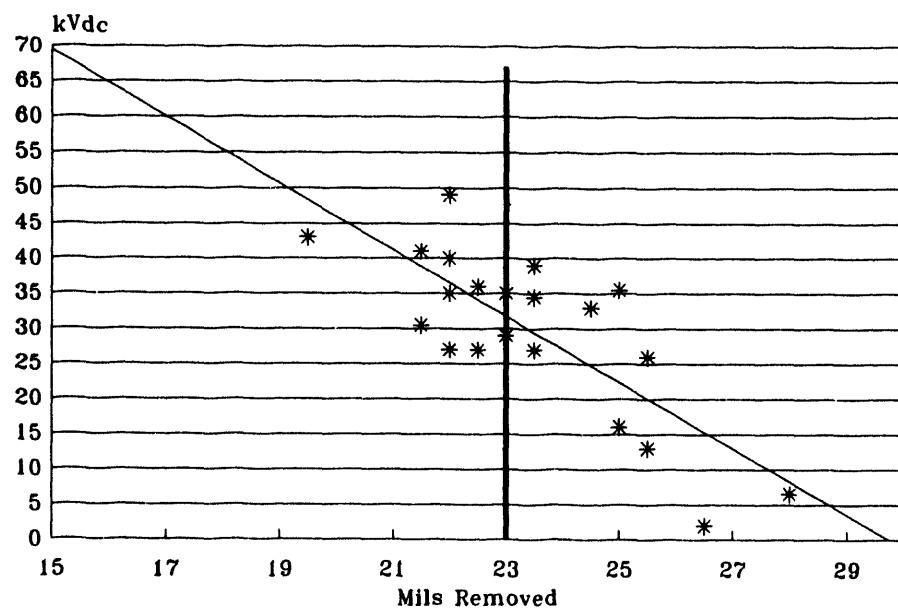
**Figure 9 Breakdown Voltages for Damaged Brand Rex Cables Tested in Water**

The results from the Phase III testing show the differences in breakdown voltages between Brand Rex cables cycled at 35 kVdc and the uncycled Brand Rex cables from Phase I. The 35 kVdc cycling voltage criterion was determined by examining the results of numerous breakdown tests of damaged (milled) Brand Rex cables as shown in Figure 9 and from previous Sandia tests [2]. The 35 kVdc test voltage will detect when Brand Rex cables have insulation damage greater than 23 mils provided that the cables are tested in water. Twenty-five cables were cycled as in Phase I for a total of 60 minutes at 35 kVdc (30 minutes
