**Phased Construction Completion Report
for Bldg. K-1401 of the
Remaining Facilities Demolition Project at the
East Tennessee Technology Park
Oak Ridge, Tennessee**

Date Issued—October 2008

Prepared for the
U.S. Department of Energy
Office of Environmental Management

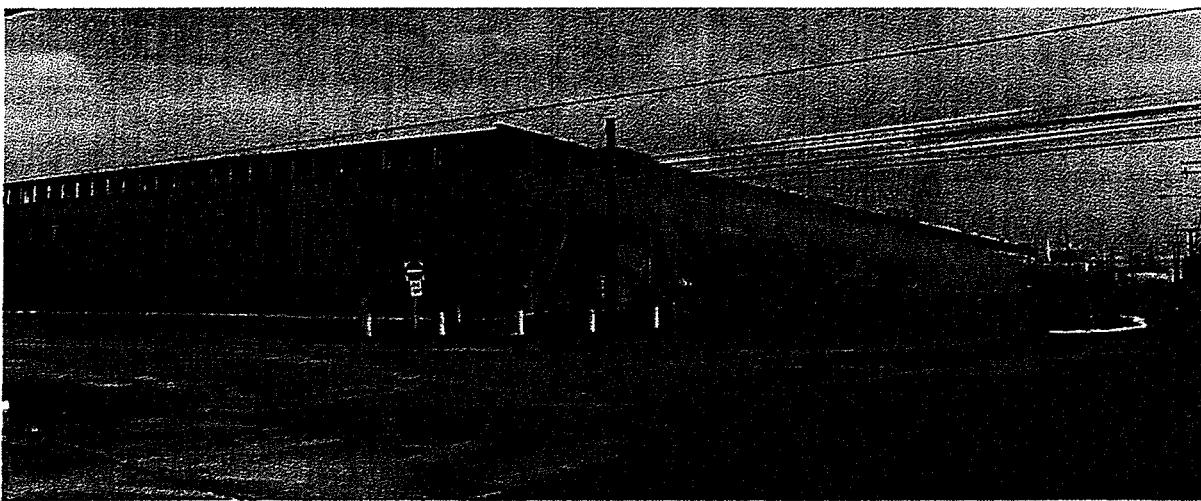
Fig. 3. Bldg. K-1401.

Bldg. K-1401 (Fig. 3) was demolished as follows:
