INVESTIGATION OF CRACKING AND ERRATIC BEHAVIOR
OF THE URANIUM-TITANIUM ALLOY

**OAK RIDGE
Y-12
PLANT**

E. L. Bird

Date of Issue: July 7, 1993

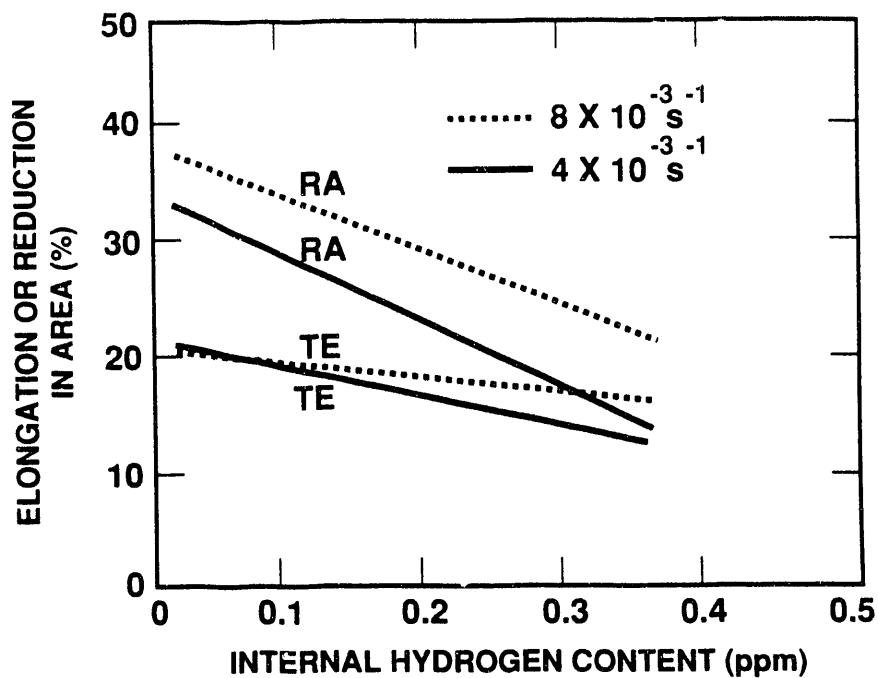
Material that was outgassed (vacuum solution heat treated) for 1 h resulted in an internal hydrogen level of 0.36 ppm, whereas material that was outgassed for 8 h resulted in 0.02 ppm hydrogen. Tensile specimens taken from these two test groups were pulled at two different speeds by varying the crosshead velocity, which in effect, changes the strain rate. Table 3 shows these results. No significant differences in strength resulted from either hydrogen or strain rate. However, the effects of both hydrogen and strain rate on ductile properties is evident, as shown in Fig. 8. Fracture morphologies associated with each test condition revealed mixed fracture modes with slightly more microvoid coalescence observed in the test group with lower hydrogen content. In addition, secondary cracking (shown in Fig. 9) was observed in the higher hydrogenated specimens.

Figure 8. Ductility versus hydrogen content for aged uranium-0.8 titanium tested at two strain rates.
