**ADVANCED PARTICLE FILTER**

Technical Progress Report No. 11  
January through March 1993

Westinghouse Science and Technology Center  
Pittsburgh, Pennsylvania

# **TIDD ADVANCED PARTICLE FILTER**

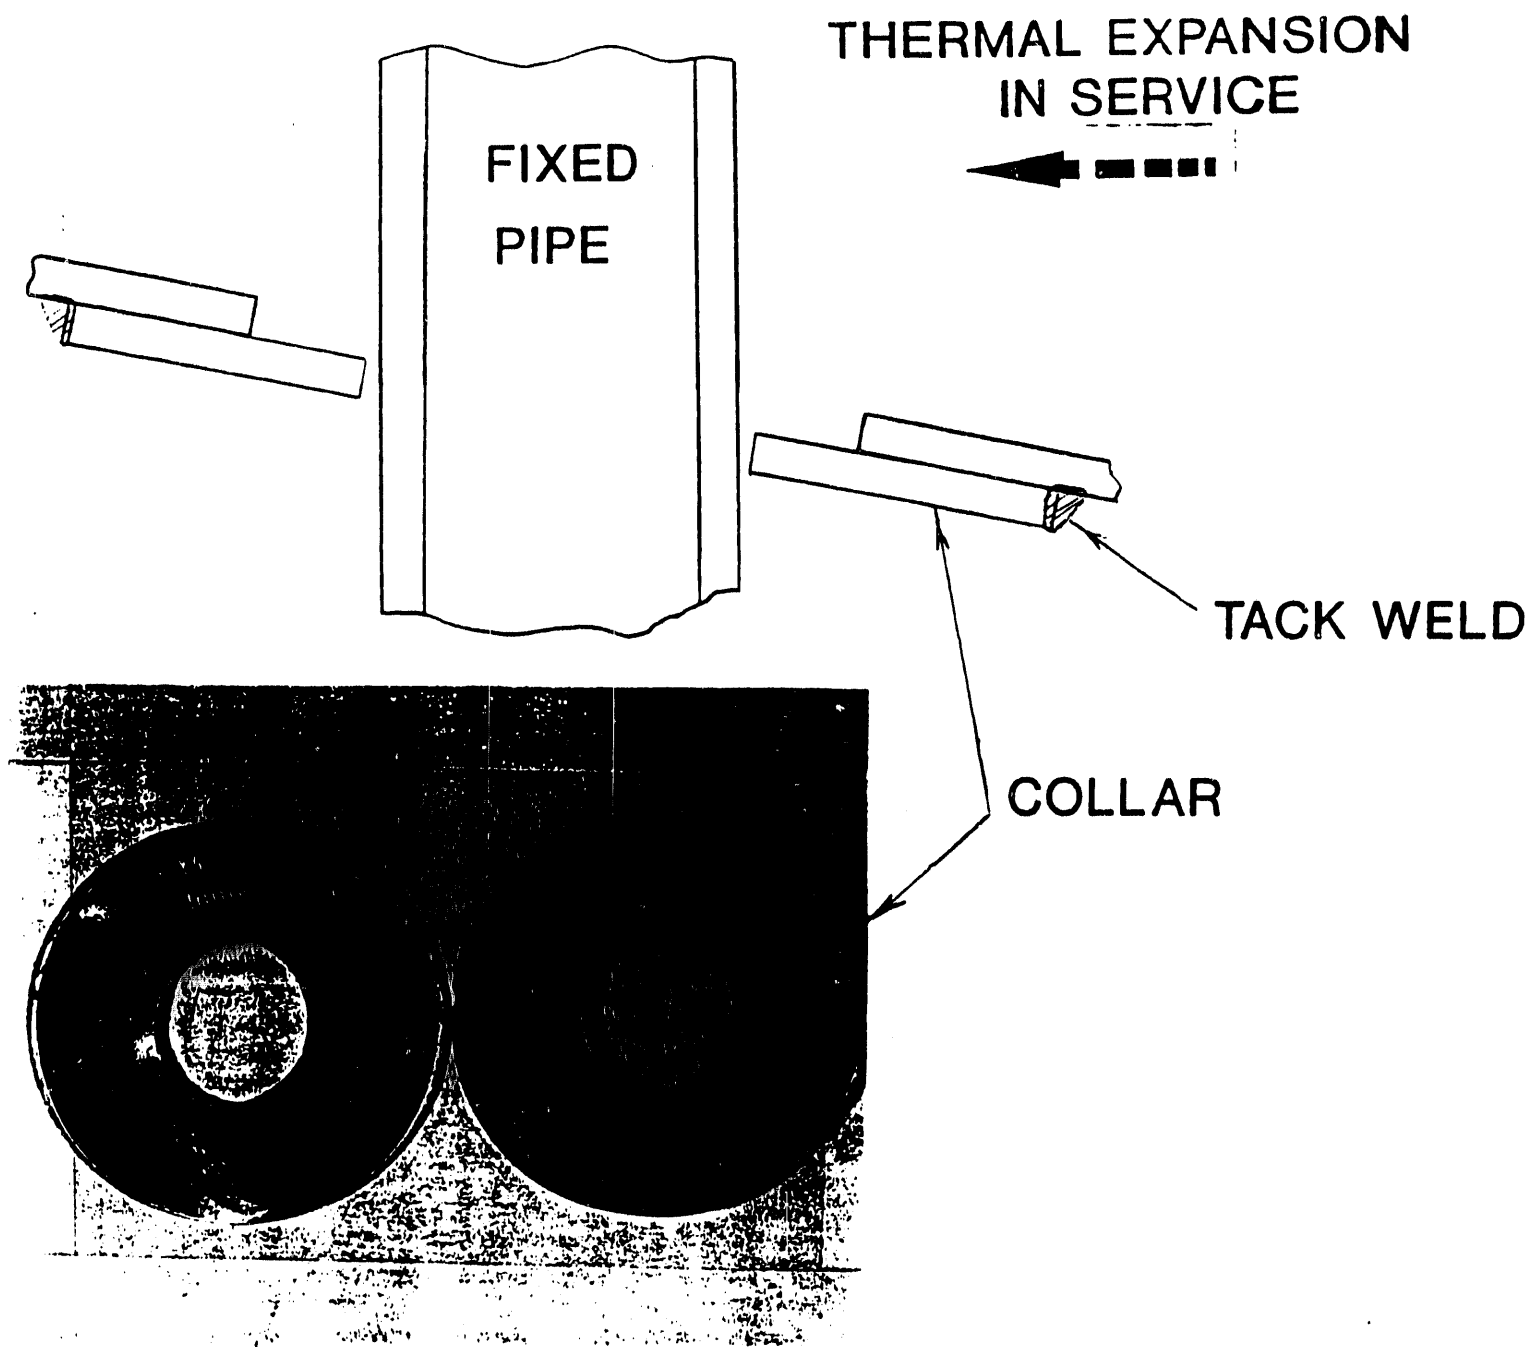
Holes for back pulse pipe feedthrough in the stainless steel dome liner had previously been sealed by stainless steel collars tack welded in place. Lateral thermal expansion of the liner relative to the fixed back pulse pipes caused distortion of the collars and breaking of their tack welds (See Figure 1). A floating collar was designed that did not require tack welds (See Figure 2). These collars were fabricated and reinstalled with the dome liner. The assembled dome has been returned to site.

Figure 1 - Breakage of Collar Tack Welds Due to Thermal Expansion

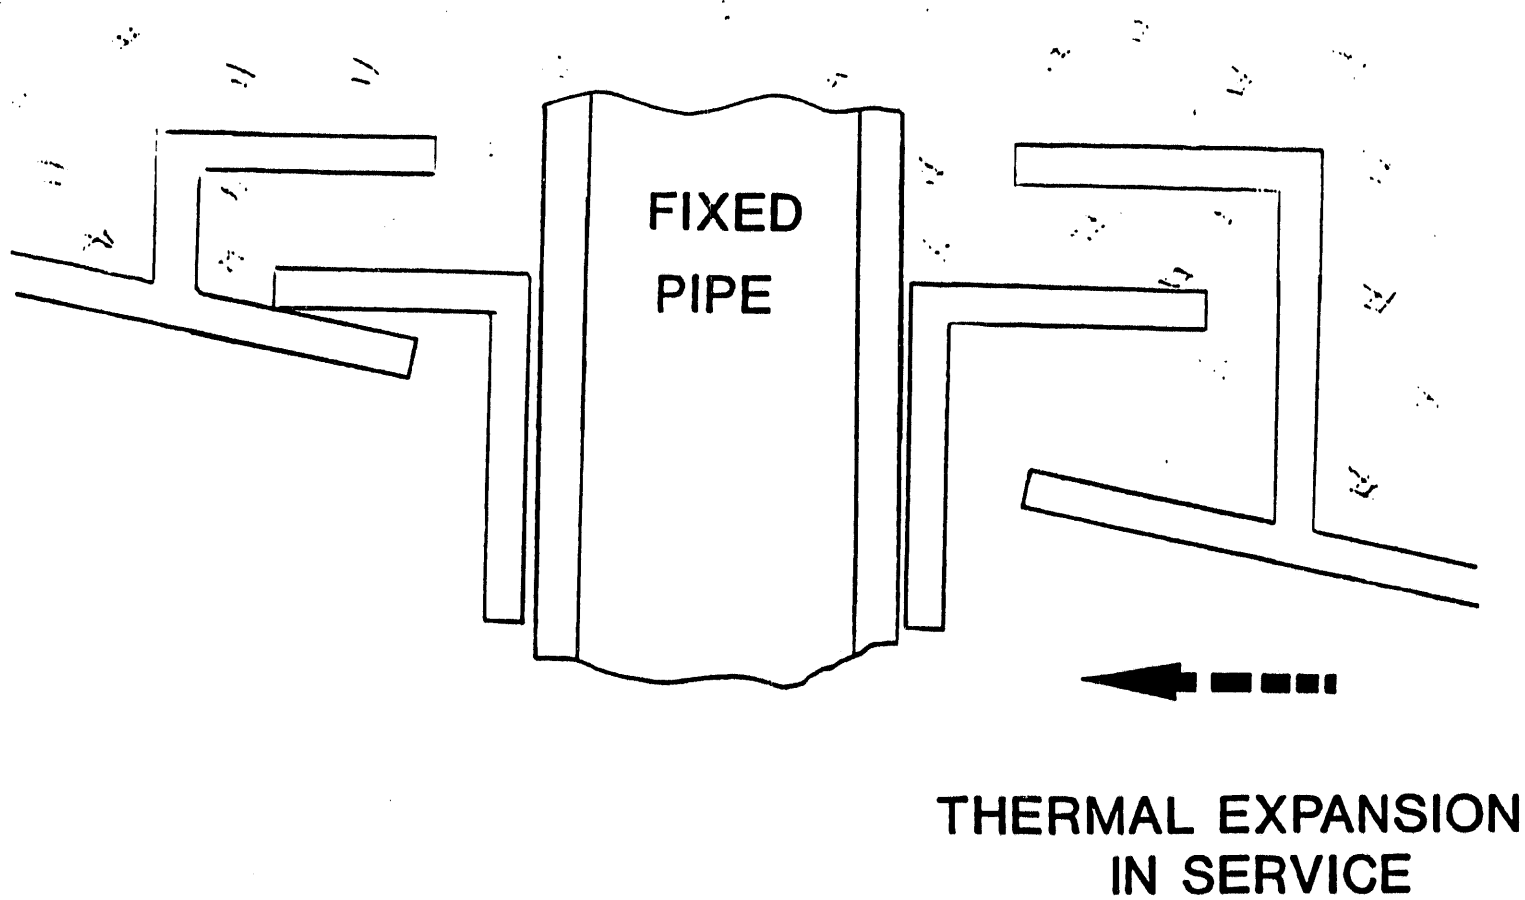
**Figure 2 - Floating Collar Design to Accommodate Thermal Expansion**

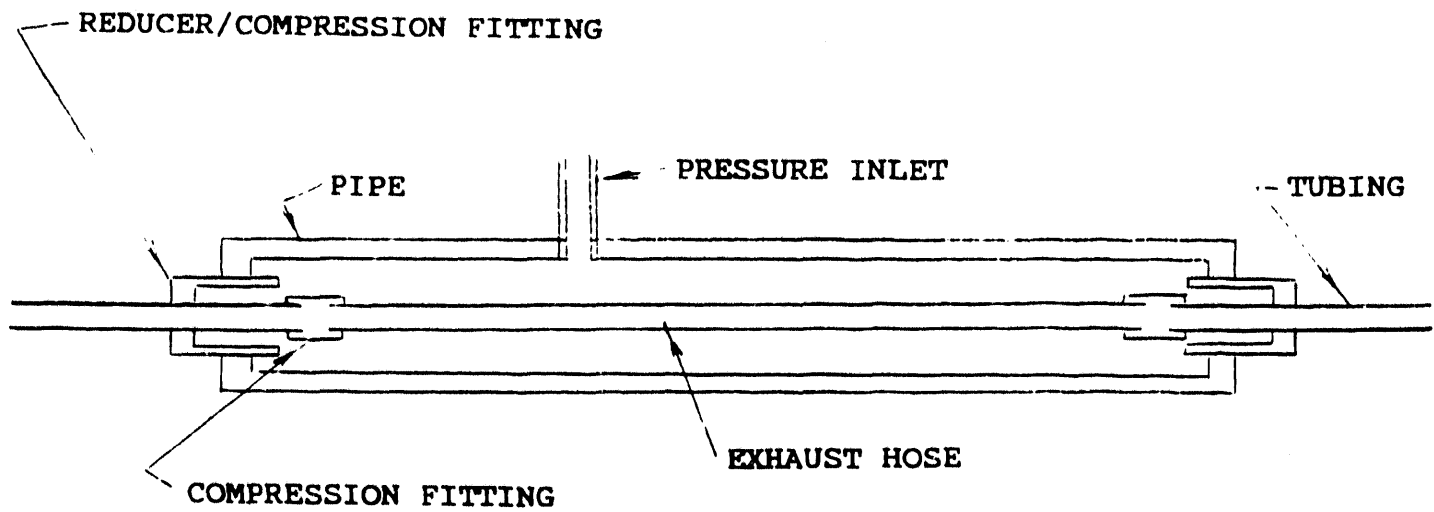
Figure 5 - Schematic Illustration and Photograph of Exhaust Hose Pressure Test

experimental arrangement is shown in Figure 5. Visual examination through the bore of this assembly confirmed that the hose maintained its shape. Two identical hoses will be used to supply and exhaust air to the pneumatic vibrator inside the Tidd APF manway. The capability to withstand external pressure is necessary when the APF vessel is pressurized to 150 psig and the air supply to the vibrator is shut off.

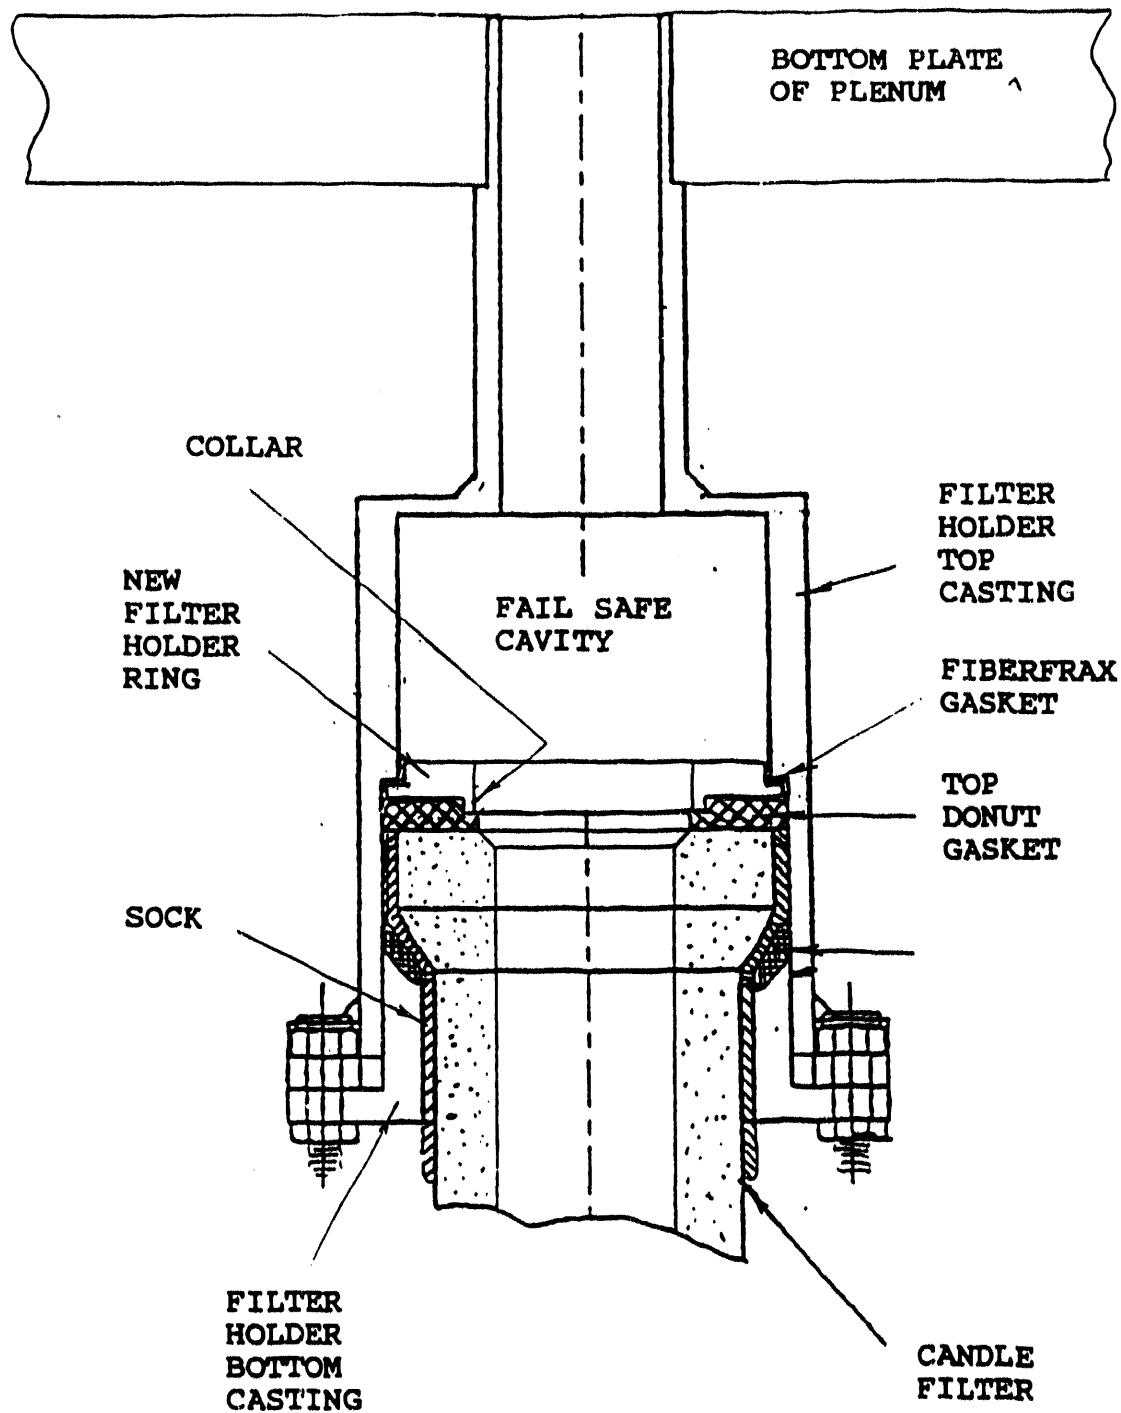
Figure 4 - Modified Filter Holder Ring with Gasket Containment Collar -  
Shown Installed

Thorough inspection of all candle filters has been completed and is documented separately in the report attached. Ash was cleaned from all internal components, and candle filters have been replaced in all three bottom plenums. An improved top gasket and filter holder ring has been designed and procured to reduce the potential for gasket slippage during back pulsing (See Figure 4). Installation of this hardware is scheduled for May 1993.

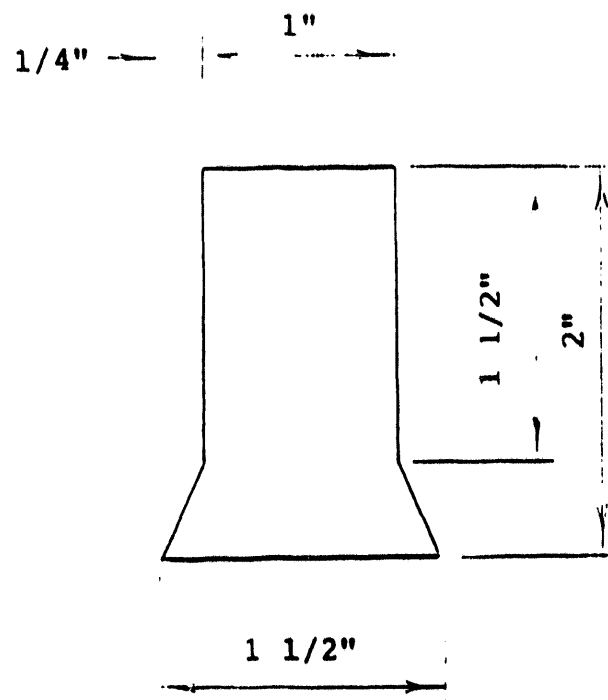
AEP expressed a need to check design and to retrofit as required the cluster assemblies such that they would function for tubesheet differential pressures of 10 psi. Finite element stress analysis was performed and concluded that reinforcement of the bottom plates of the bottom plenums would be appropriate to satisfy performance requirements. Reinforcing bars and weldments depicted in Figure 6 were designed to fit across two major chords of each of the three bottom plenums (6 bars total).

Figure 6 - Reinforcing Bar Configuration

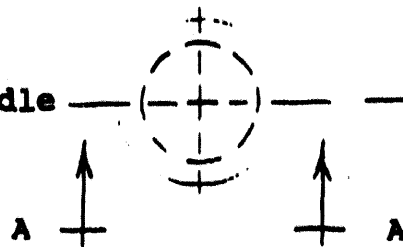
- (F1) eight fracture surfaces were relatively dirty with ash
- (F2) fracture orientations were primarily transverse to the candle axis
- (F3) 22 out of 23 candles were broken within approximately 4 inches of the upper flange of the filter elements
- (F4) 15 out of 23 candles showed a break somewhat angled to the candle axis
- (F5) the low/high point of 14 angled breaks was oriented in line with a radius thru the candle/cluster center lines (See Figure 4)

Figure 4 - Orientation of Plane of Fracture Surface with Respect to  
Candle/Support Tube Radial Line

The transverse orientation of fractures (ref. F2) suggests a mechanical rather than thermal source of candle damage. Radially outward displacement of top plenum candles (ref. P1) and radial orientation of many fracture surfaces (ref. F5) suggest radial outward loading as the cause of mechanical damage. One possible breakage scenario could be the following:

- (1) Replacement of all top gaskets**
- (2) Replacement of all filter holder rings with a built-in gasket containment collar**
- (3) Inclusion of solid spacers between filter holder bottom castings and main filter holder housings to rigidize the assembly**
- (4) Elimination (blanking off) of the top plenum inner row candle locations (15) to eliminate nearest-neighbor bridge points**
- (5) Inclusion of regenerator (heat exchanger) devices in each filter holder housing to minimize possible back pulse-induced thermal stress effects**

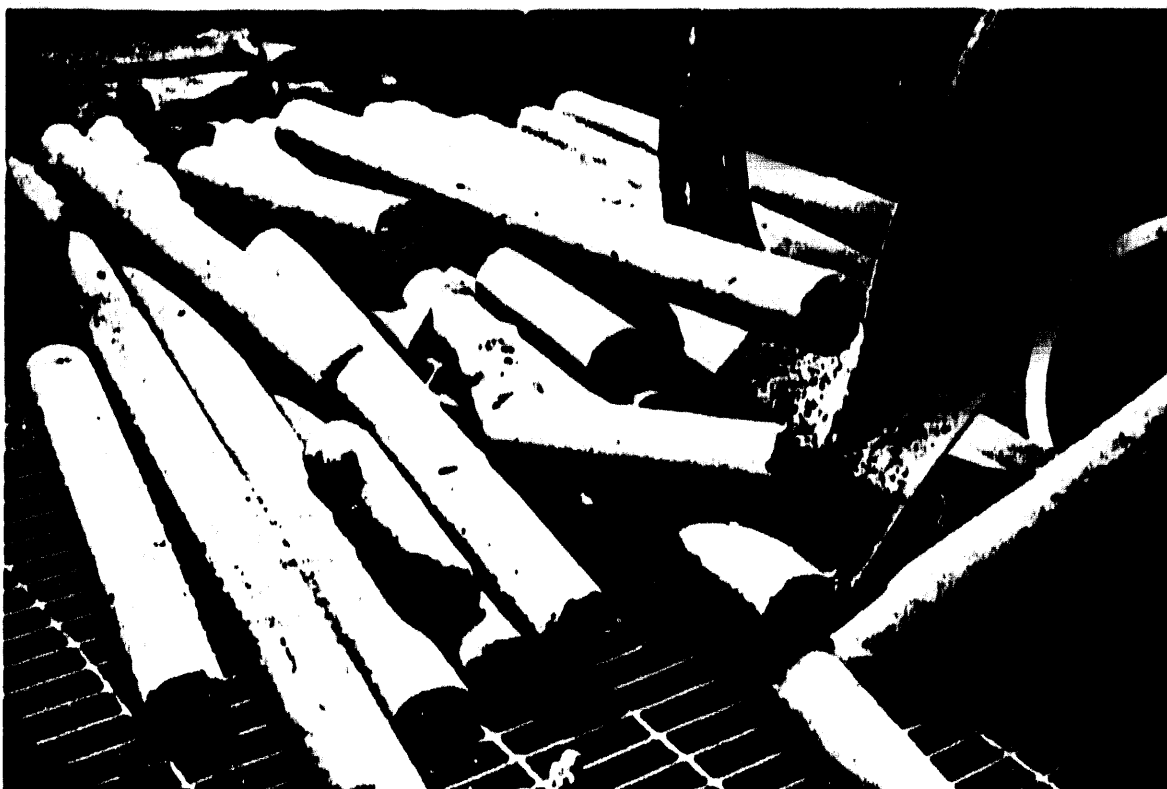
After cooling and prior to lifting the candle clusters out of the filter vessel, dust was removed from the APF ash hopper. Broken candle sections were encountered during the ash removal effort (Figure 3.6). Initial inspection of the three bottom plenum candle arrays via the manway entrance on December 16, 1992 indicated that candles had broken in each candle filter array. Fifteen candles had broken in the bottom plenum of Cluster A, four in Cluster B, and two in Cluster C (Figure 3.7).<sup>(1)</sup> Segments of these twenty-one failed candles were initially considered to have fallen into the ash hopper in the Westinghouse APF vessel. In the bottom plenum of Cluster B, one candle was identified as hanging below the bottom level of the attached candles, indicating that it had also fractured, but was supported in the array via the packed ash which was bridged between adjacent candles.

**Figure 3.6 - Candle Filter Segments Removed From The Ash Hopper**

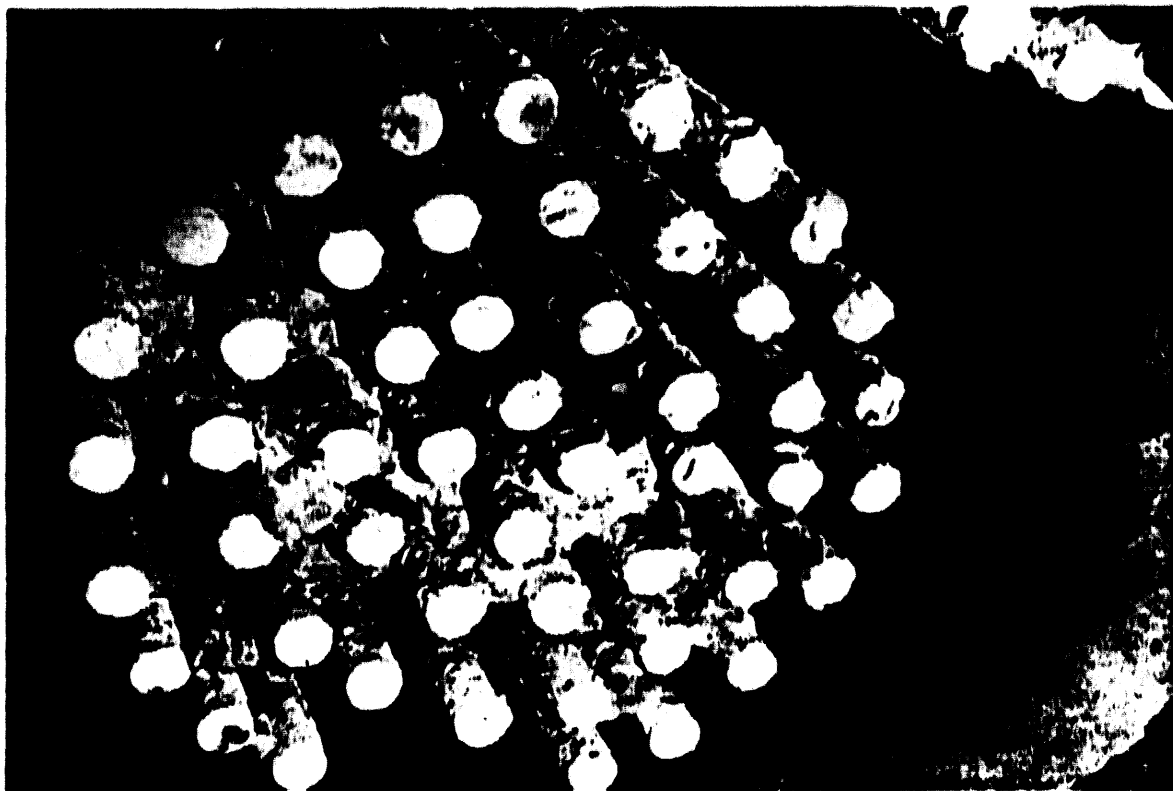
When viewed from the manway, severe bridging of ash was evident in the bottom plenum of Cluster B (Figure 3.8), while only marginal ash bridging was identified along the bottom to the mid-section of candles located in the bottom plenum of Cluster C (Figure 3.9). The bottom plenum of Cluster A (Figure 3.10) was virtually free of ash buildup, but had the greatest number of candles that failed during testing at Tidd.

**Figure 3.9 - Photo Of Bottom Cluster C In The Westinghouse APF System  
During The December 16, 1992 Manway Inspection**

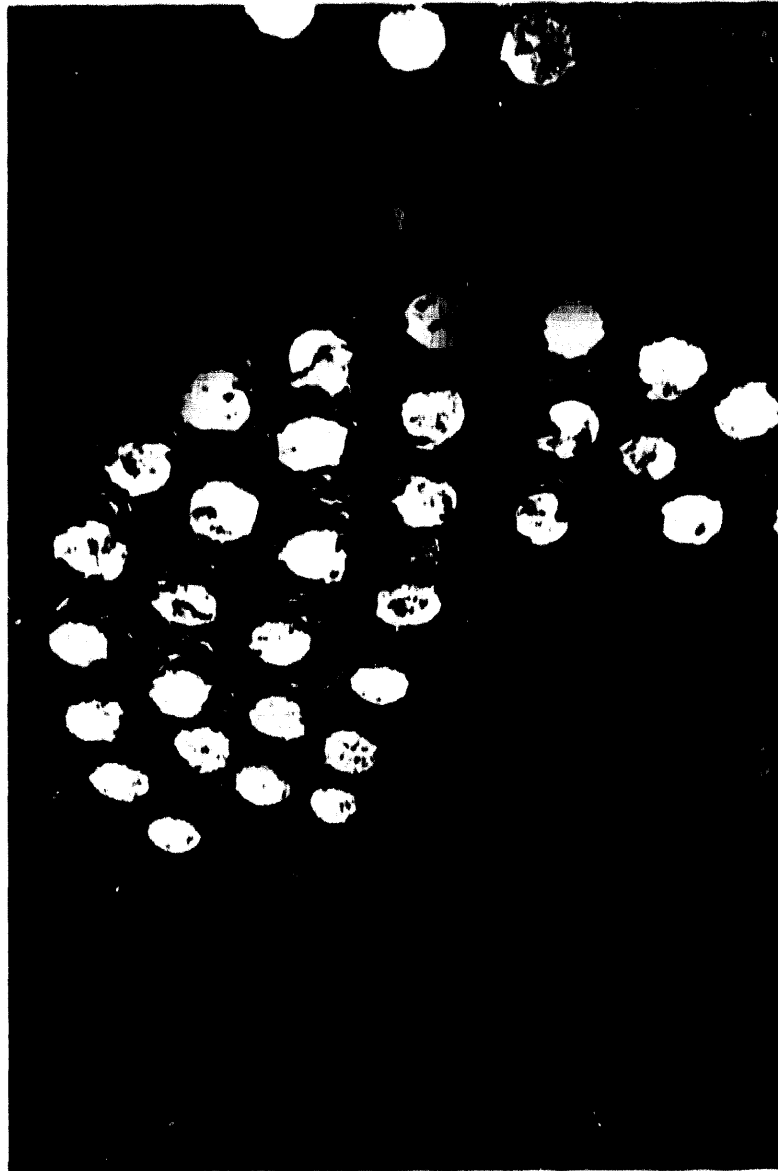
Figure 3.10 - Photo Of Bottom Cluster A In The Westinghouse APF System  
During The December 16, 1992 Manway Inspection

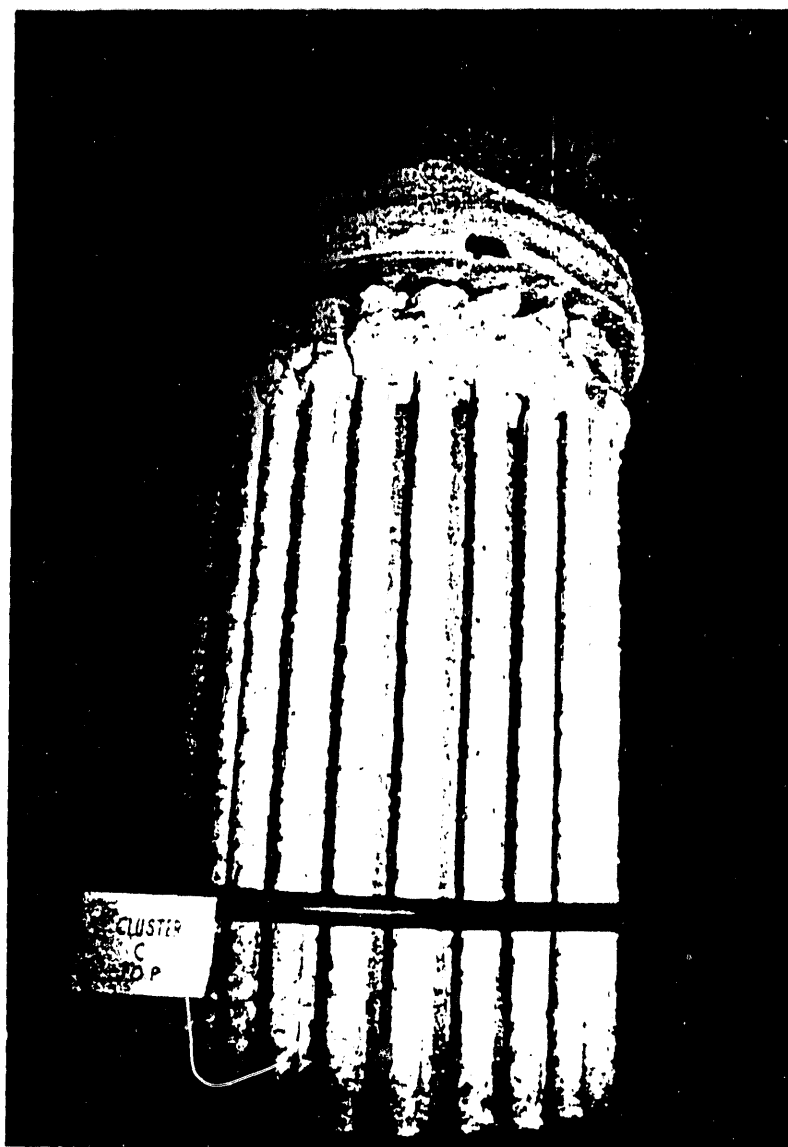
Figure 4.7 - Candle Filter Cluster C/T After 500 Hours  
Of Hot Gas Filtration

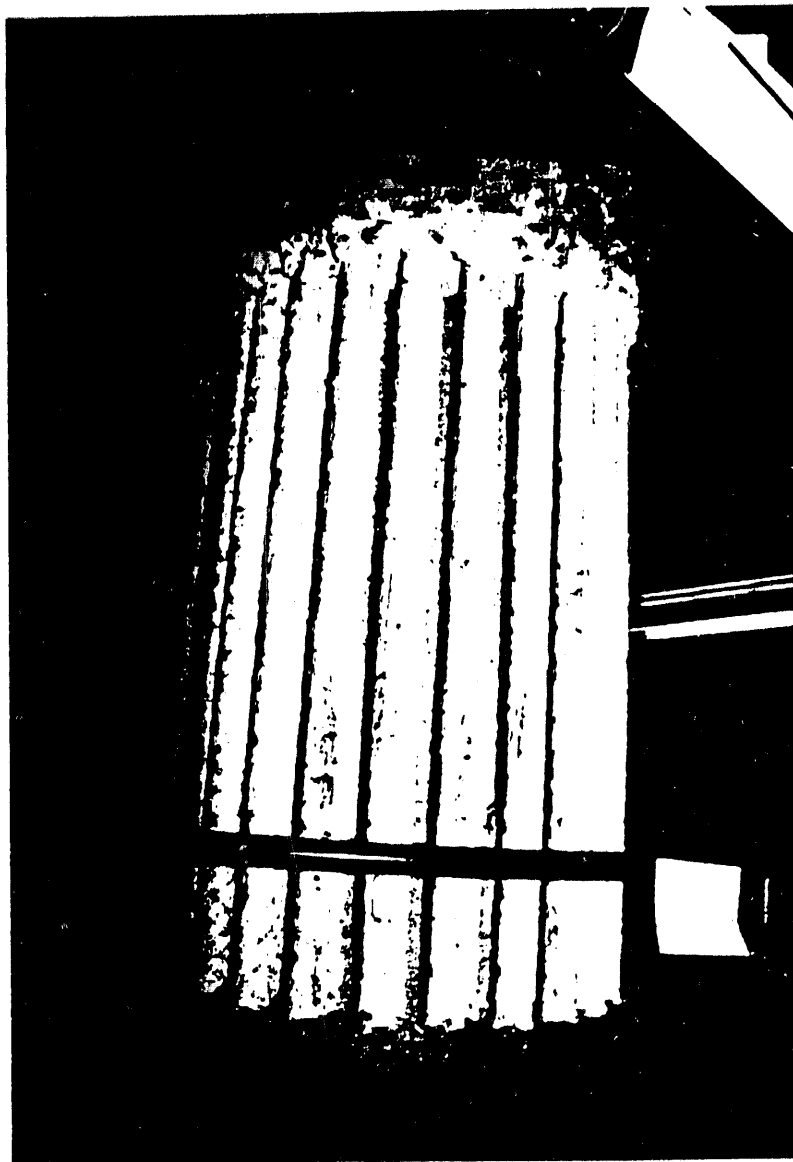
Figure 4.8 - Candle Filter Cluster C/M After 500 Hours  
Of Hot Gas Filtration

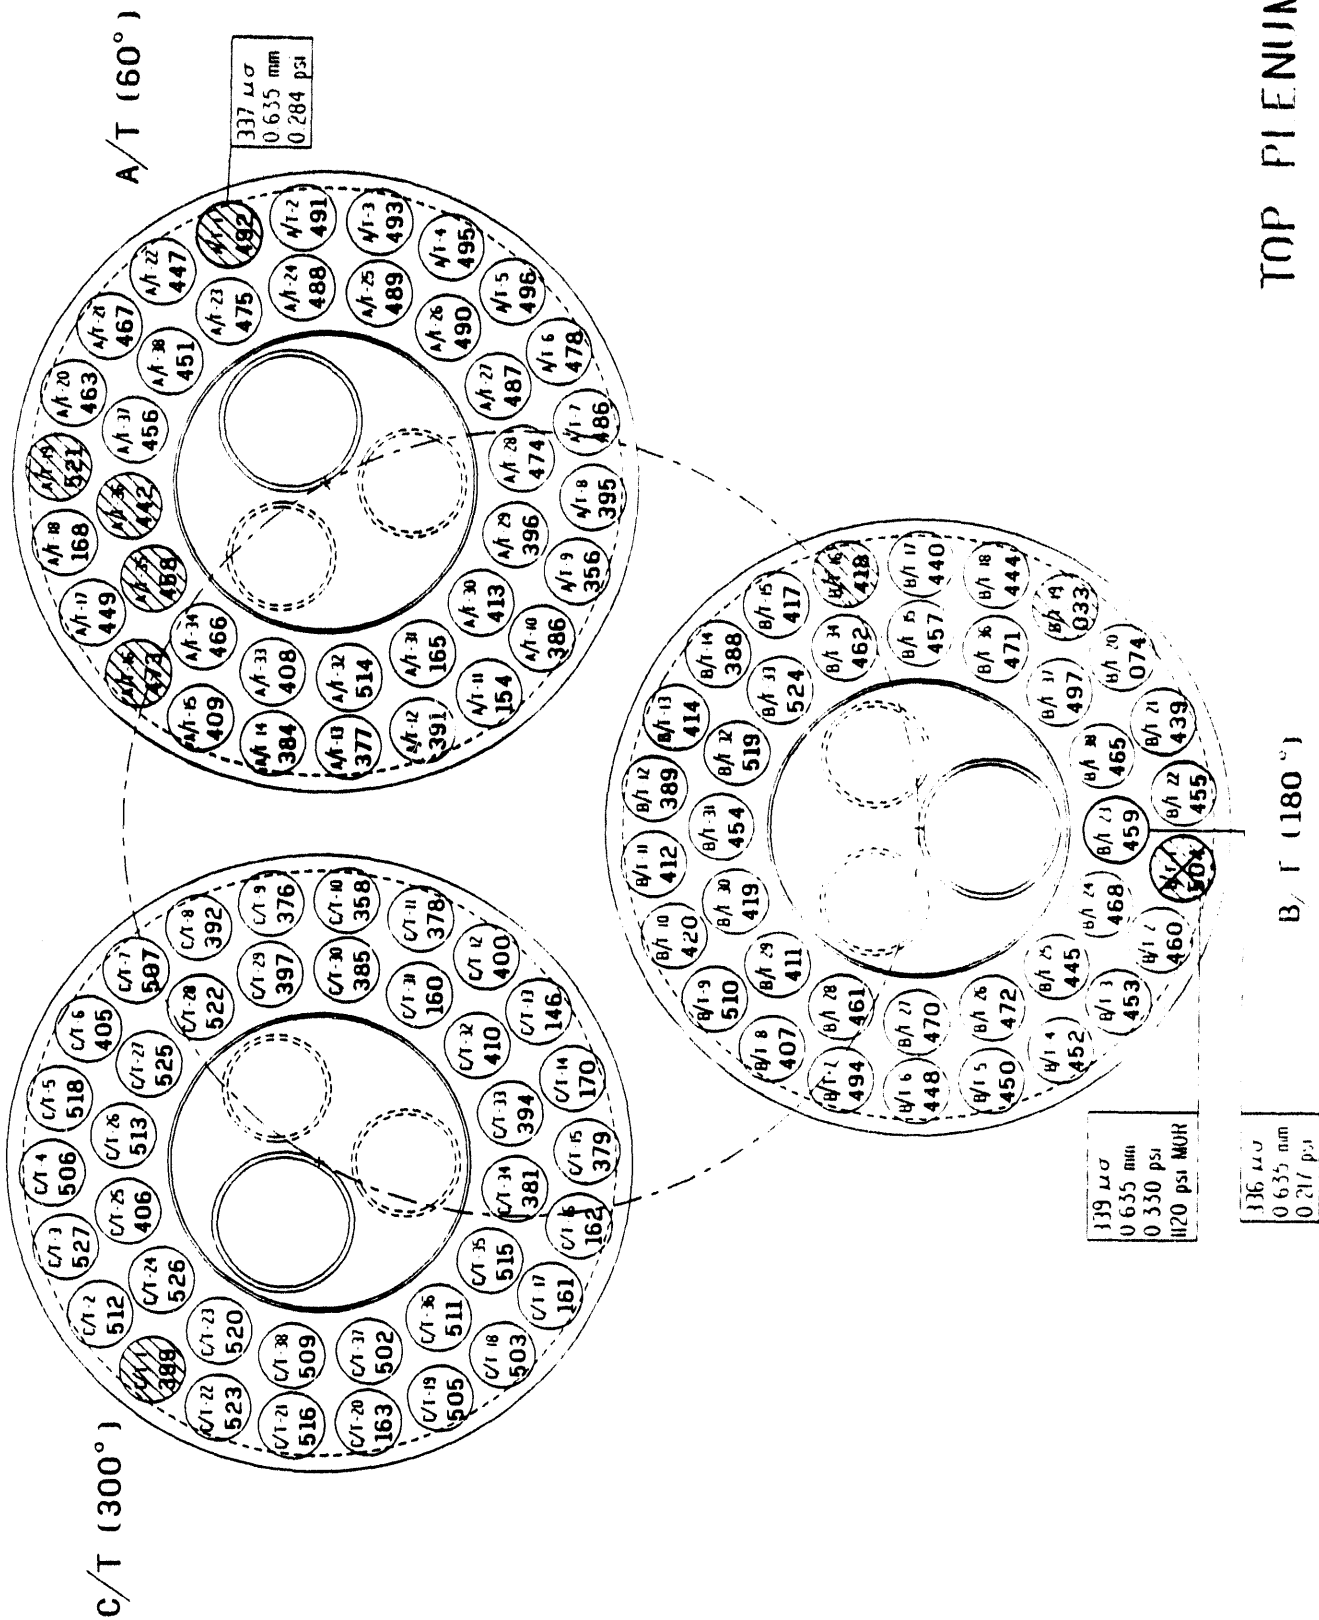
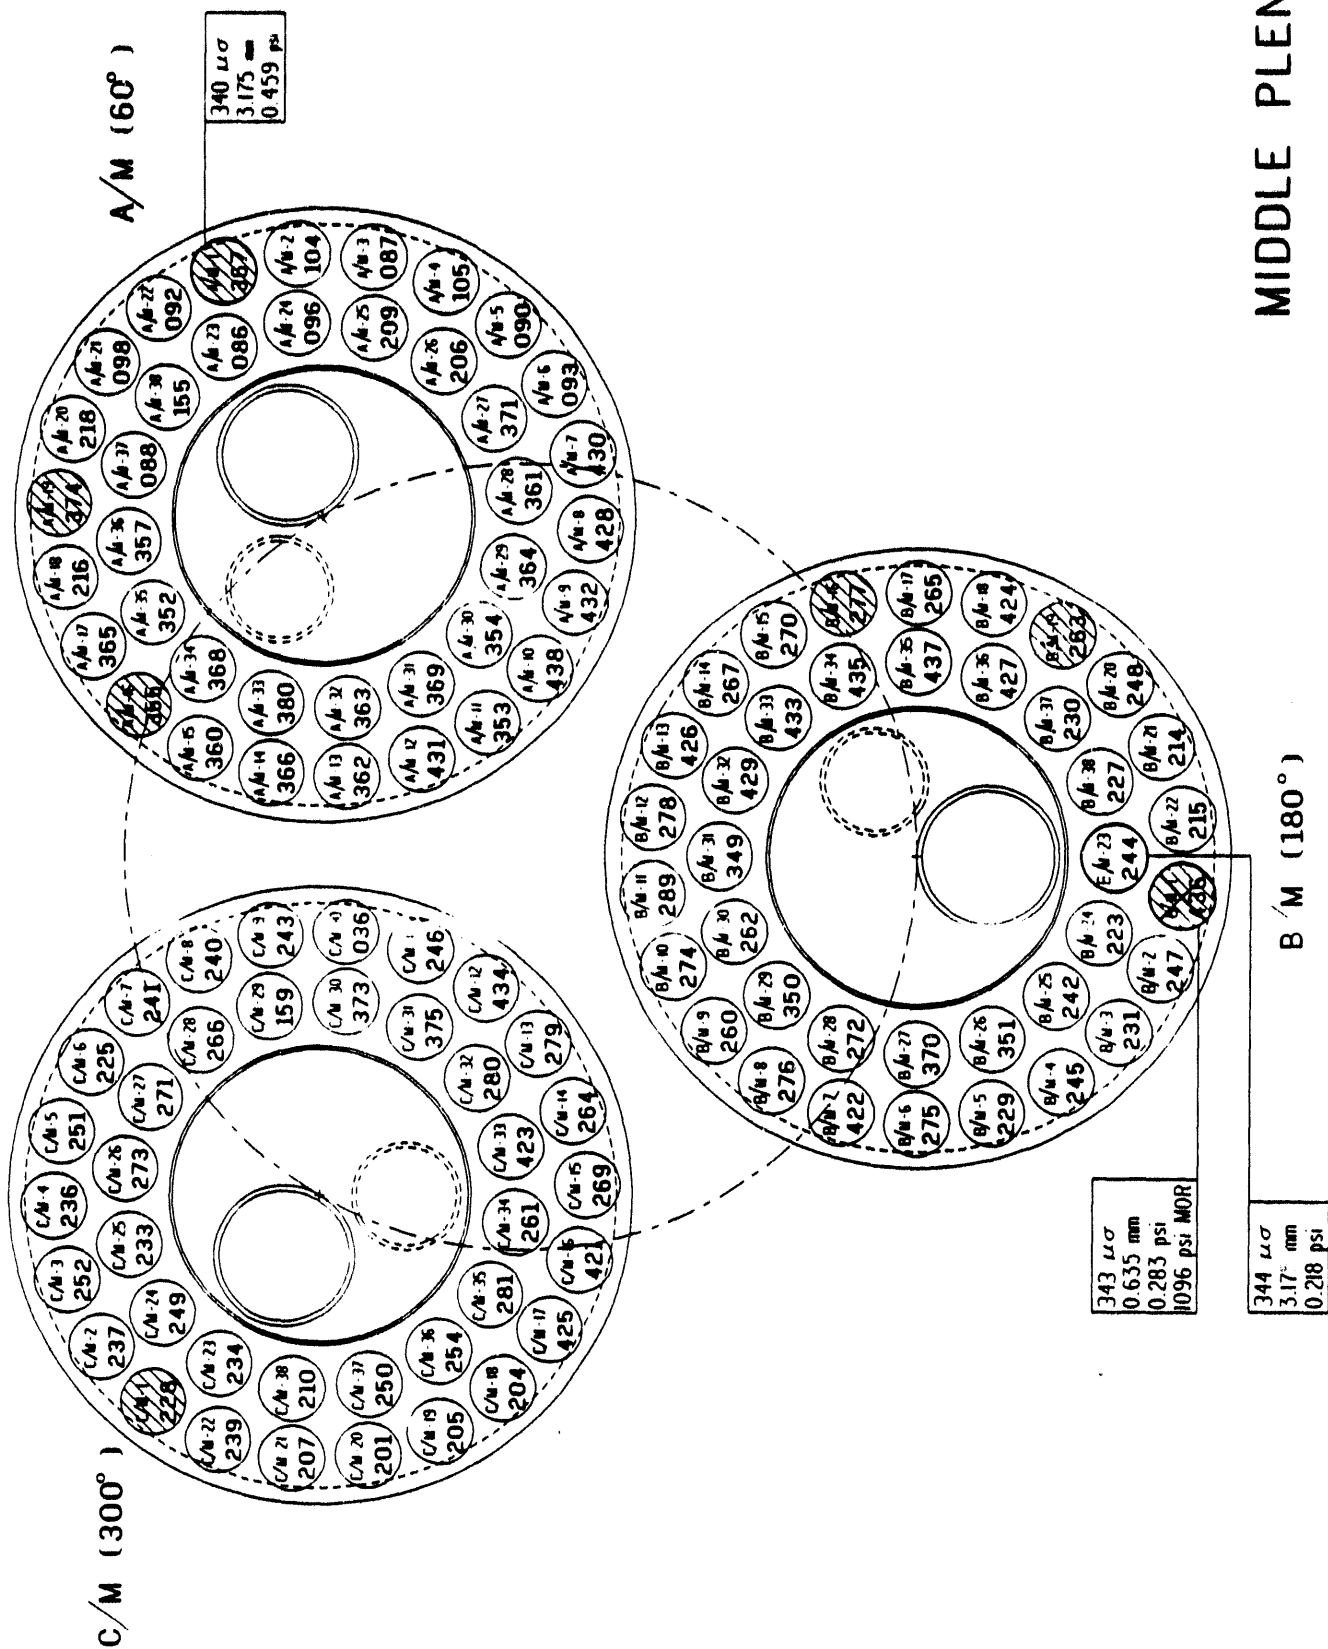
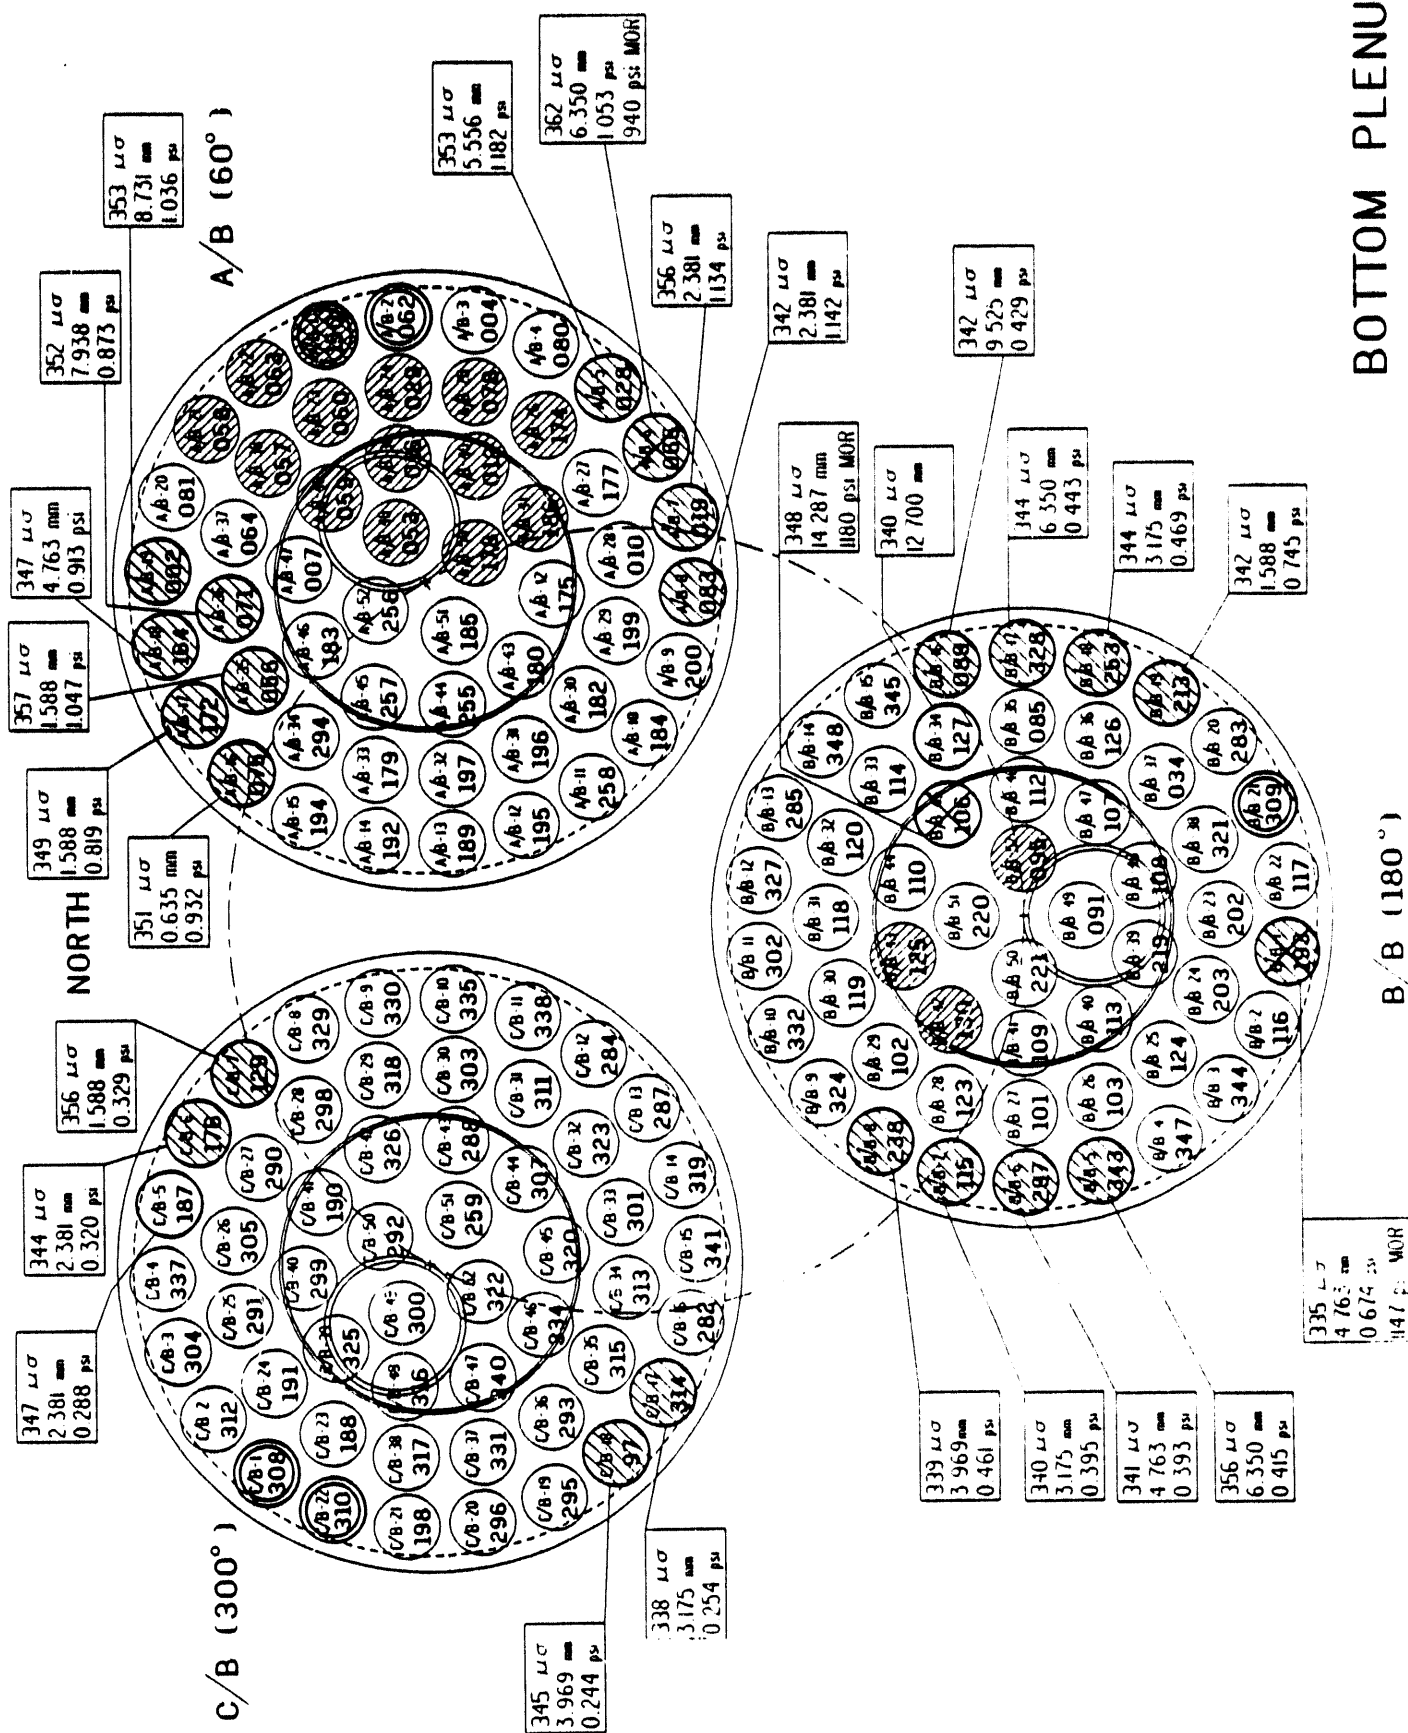
Figure 4.10 - Location of Candle Filters That Underwent In-Depth Physical/Chemical Post-Test Characterizations

Figure 4.10 identifies the location of the candle filters that underwent in-depth physical and chemical post-test characterization. Post-test characterization of each filter element included pressure drop, length, and bow, as well as time-of-flight (TOF) measurements. The results of these analyses are presented in this section. A comparison of these results will be made with similar as-manufactured candle measurements. A discussion of the changes that resulted in the morphology and composition of the filter matrix is presented in Section 6. Strength characterization which included both C-ring compression and burst strength testing, as well as Auger analysis and gravimetric analysis to determine the extent of oxidation that may have occurred in the clay bonded silicon carbide matrix are presented in Section 7.

FRACTURE 12/92: CANDLE LENGTH REMAINING IN FLANGE / MOUNT  
> 1100 mm

FRACTURE 12/92: CANDLE LENGTH REMAINING IN FLANGE / MOUNT  
< 165 mm

INITIAL SURVEILLANCE CANDLE: DURING INITIAL INSPECTION  
LOWER PORTION WAS REMOVED DURING LIFT.  
FRACTURE OCCURED NEAR FLANGE / MOUNT.

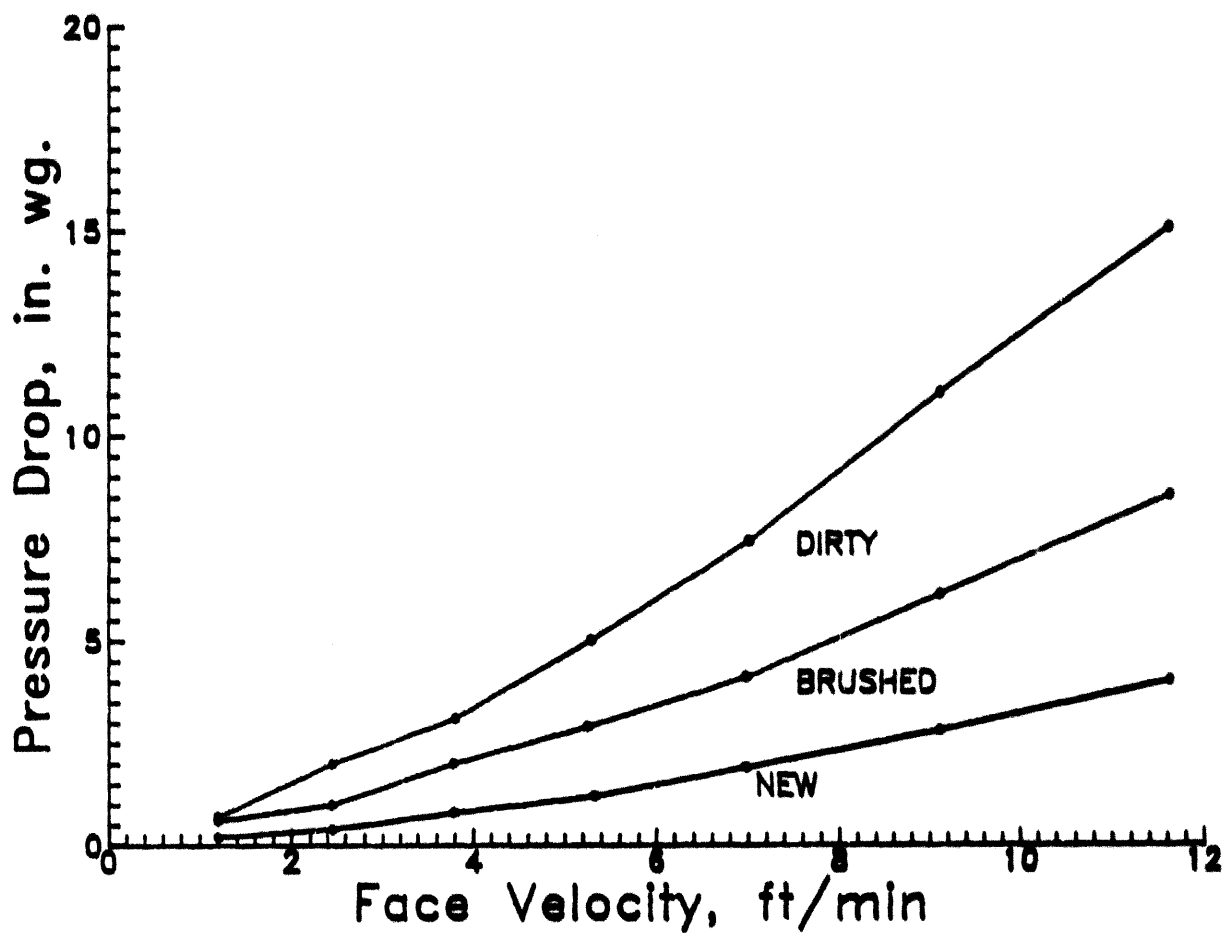
manufactured clay bonded silicon carbide candle filters, the dumpling-like ash deposits and thin white sorbent layer restrict air flow through the filter, and consequently a higher pressure drop across the 500 hour PFBC exposed candle filter resulted. In principle when the ash and sorbent fines are removed from the filter OD (i.e., vacuumed brushed), the pressure drop should decrease to an intermediate value (i.e., between the pressure drop for the original, as-manufactured candle filter and the "dirty" candle after field testing). As process temperature increases the projected pressure drop increases across the field tested candle filters (Figures 4.11 through 4.14).

Figure 4.11 - Room Temperature Measurement Of The Pressure Drop Across The Clay Bonded Silicon Carbide Candle Filters

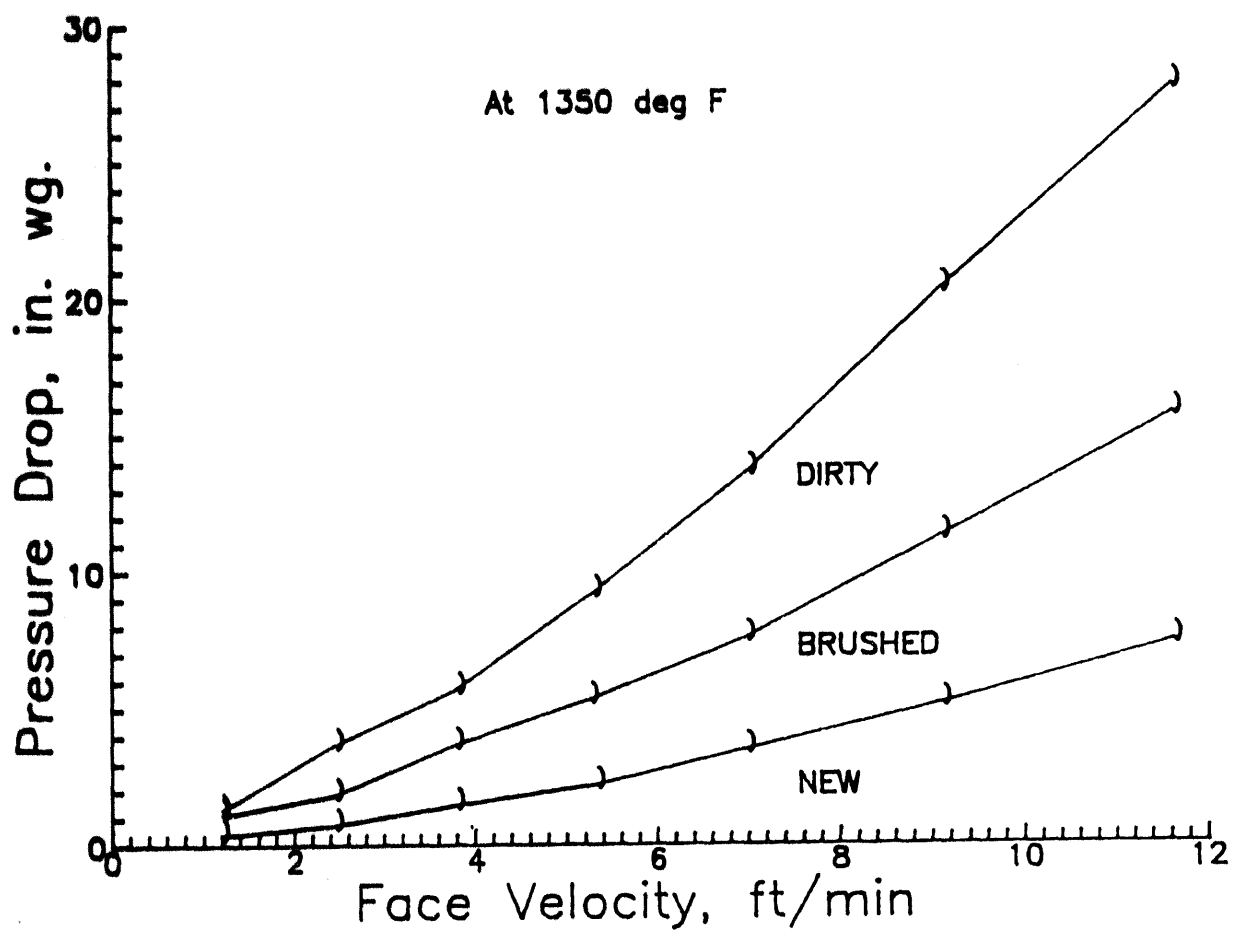
Based on previous experience using the clay bonded silicon carbide candle filters, a factor of 1.95 was used to calculate the projected pressure drop across the filter at high temperature, in comparison to the room temperature data. In contrast, laboratory data generated at Westinghouse STC indicated that a 2.5 factor resulted between the room temperature and high temperature pressure drop data for the alumina/mullite filter elements.

Figure 4.12 - Pressure Drop Across The Clay Bonded Silicon Carbide Candle Filters Projected At 730°C (1350°F) Hot Gas Filtration Temperatures
