**ADVANCED PARTICLE FILTER**

Technical Progress Report No. 11  
January through March 1993

Westinghouse Science and Technology Center  
Pittsburgh, Pennsylvania

# **TIDD ADVANCED PARTICLE FILTER**

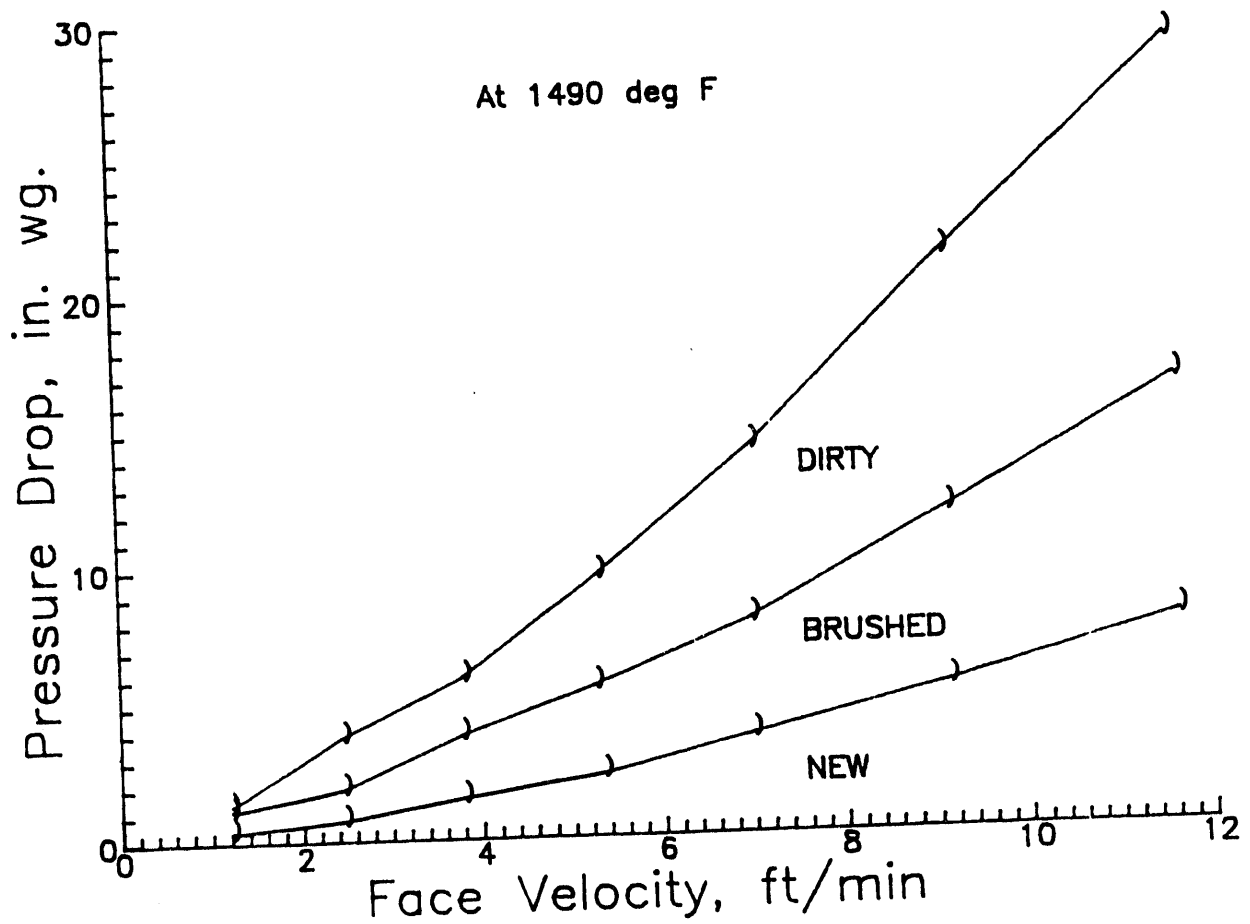
Figure 4.13 - Pressure Drop Across The Clay Bonded Silicon Carbide Candle Filters Projected At 810°C (1490°F) Hot Gas Filtration Temperatures

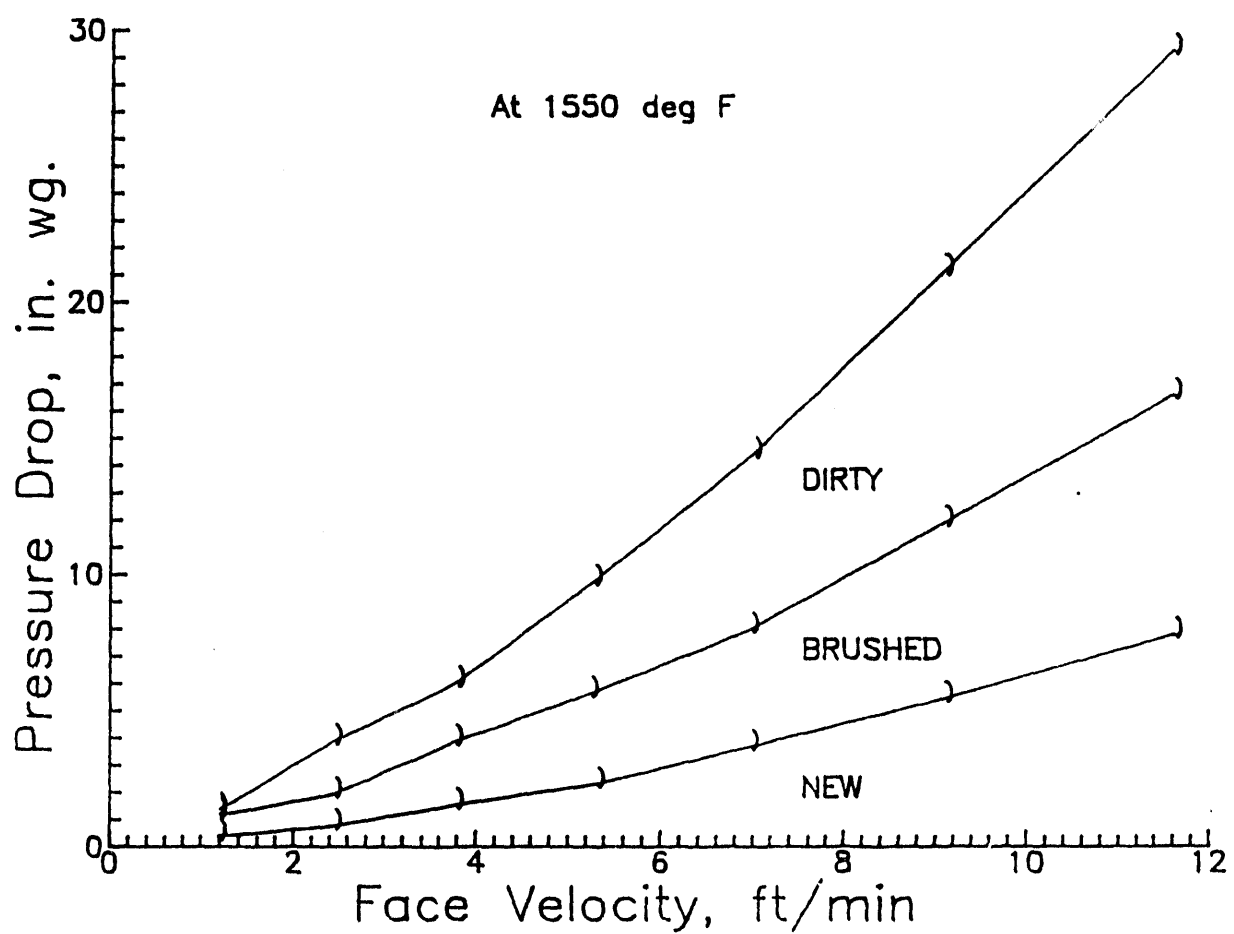
Figure 4.14 - Pressure Drop Across The Clay Bonded Silicon Carbide Candle Filters Projected At 843°C (1550°F) Hot Gas Filtration Temperatures

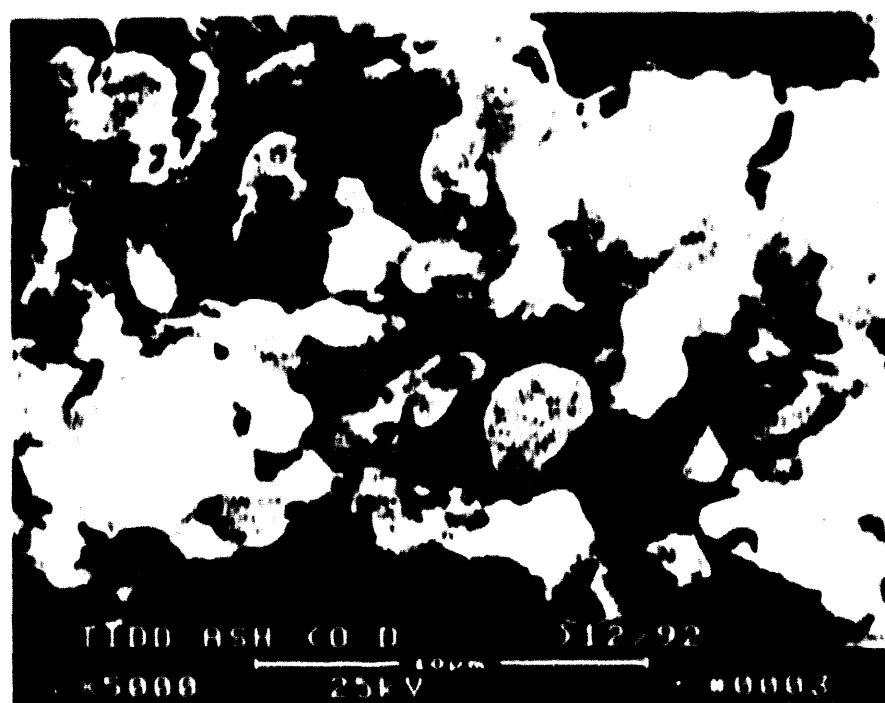
In an attempt to resolve whether there was a compositional difference in the pinkish-orange versus white deposit layers, the pinkish-orange ash (Figure 5.5) was further characterized. Figure 5.13 details the morphology of the fines that were contained in this layer. Round agglomerates that consisted of micron and submicron fines were evident. Compositionally the fines consisted of:

Figure 5.13 - Morphology Of The Ash Fines Formed Along The Dumping Surface That Was Adjacent To The Candle OD Wall

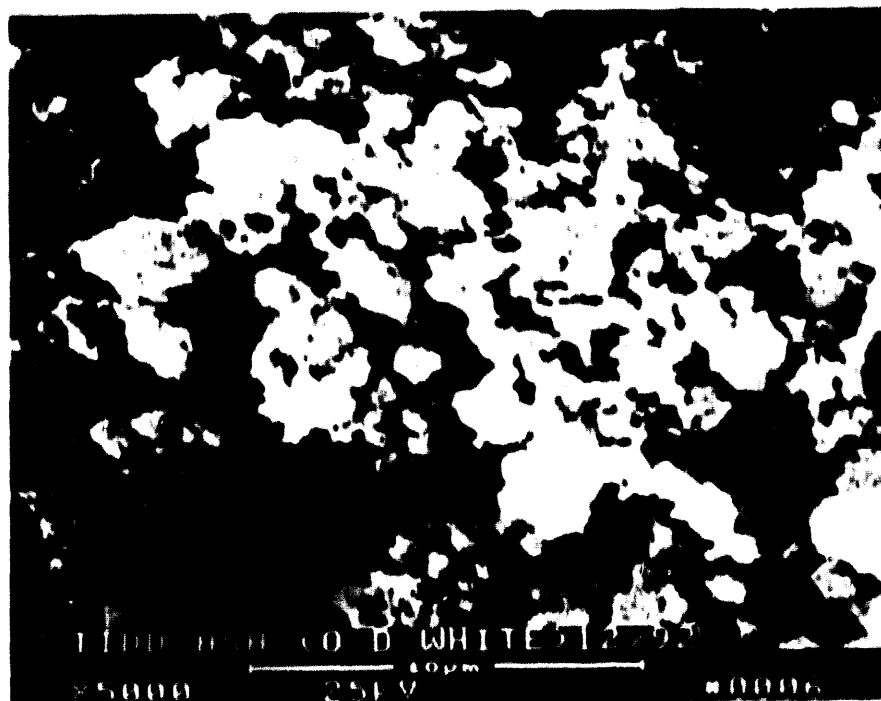
In contrast, the morphology along the white area of the dumpling deposit is shown in Figure 5.14 and 5.15. The particle size of fines in the white deposit area appeared to be somewhat smaller (i.e.,  $< 1 \mu\text{m}$ ) than the fines in the pinkish-orange ash deposit (Figure 5.13, Photo 3; Figure 5.15; Photo 6). Compositionally the white area consisted of:

Based on these analyses, we concluded that the white areas were enriched with the dolomitic sorbent material, while both ash and sorbent were present in the pinkish-orange dust cake layer. The sorbent layer was typically a thin "egg-shell-like" layer in comparison to the 5-15 mm thick dumpling which was predominantly a mixture of ash and sorbent fines.

Figure 5.14 - Morphology Of The White Sorbent Material Formed Along The Dumping Surface That Was Adjacent To The Candle OD Wall

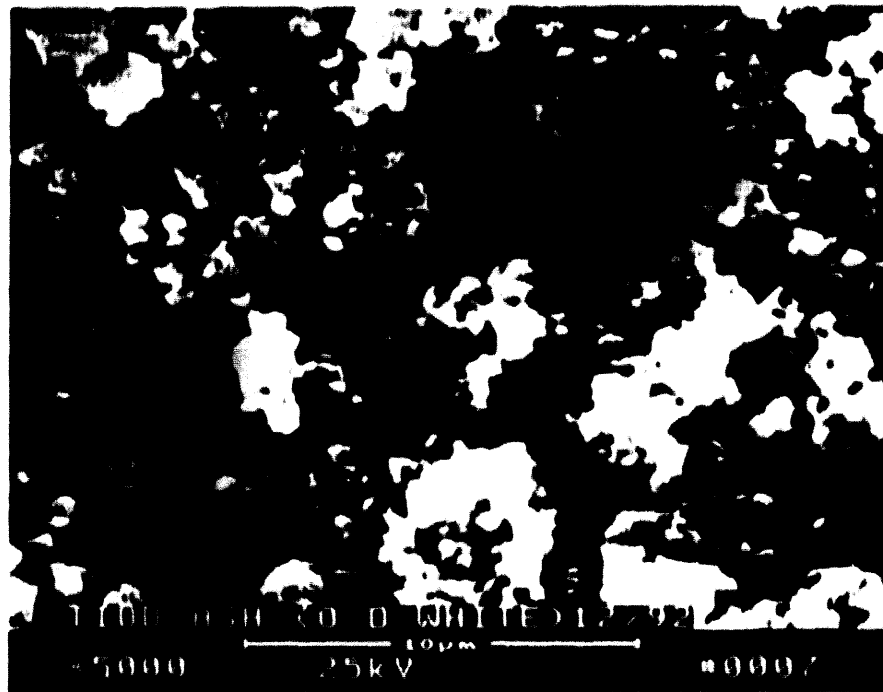
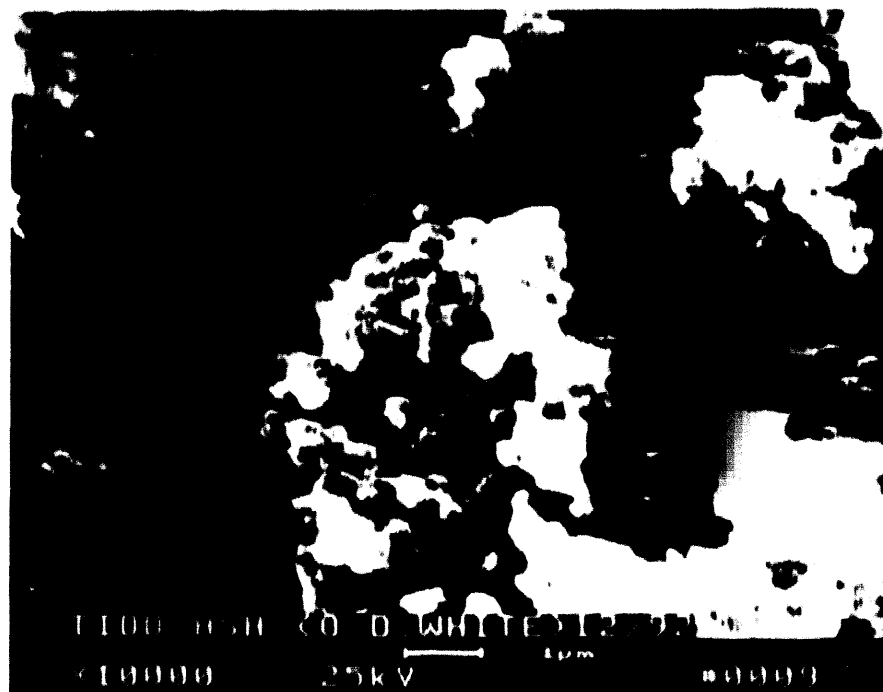
Figure 5.15 - Higher Magnification Micrographs Illustrating The Morphology Of The White Sorbent Material Formed Along The Dumping Surface That Was Adjacent To The Candle OD Wall

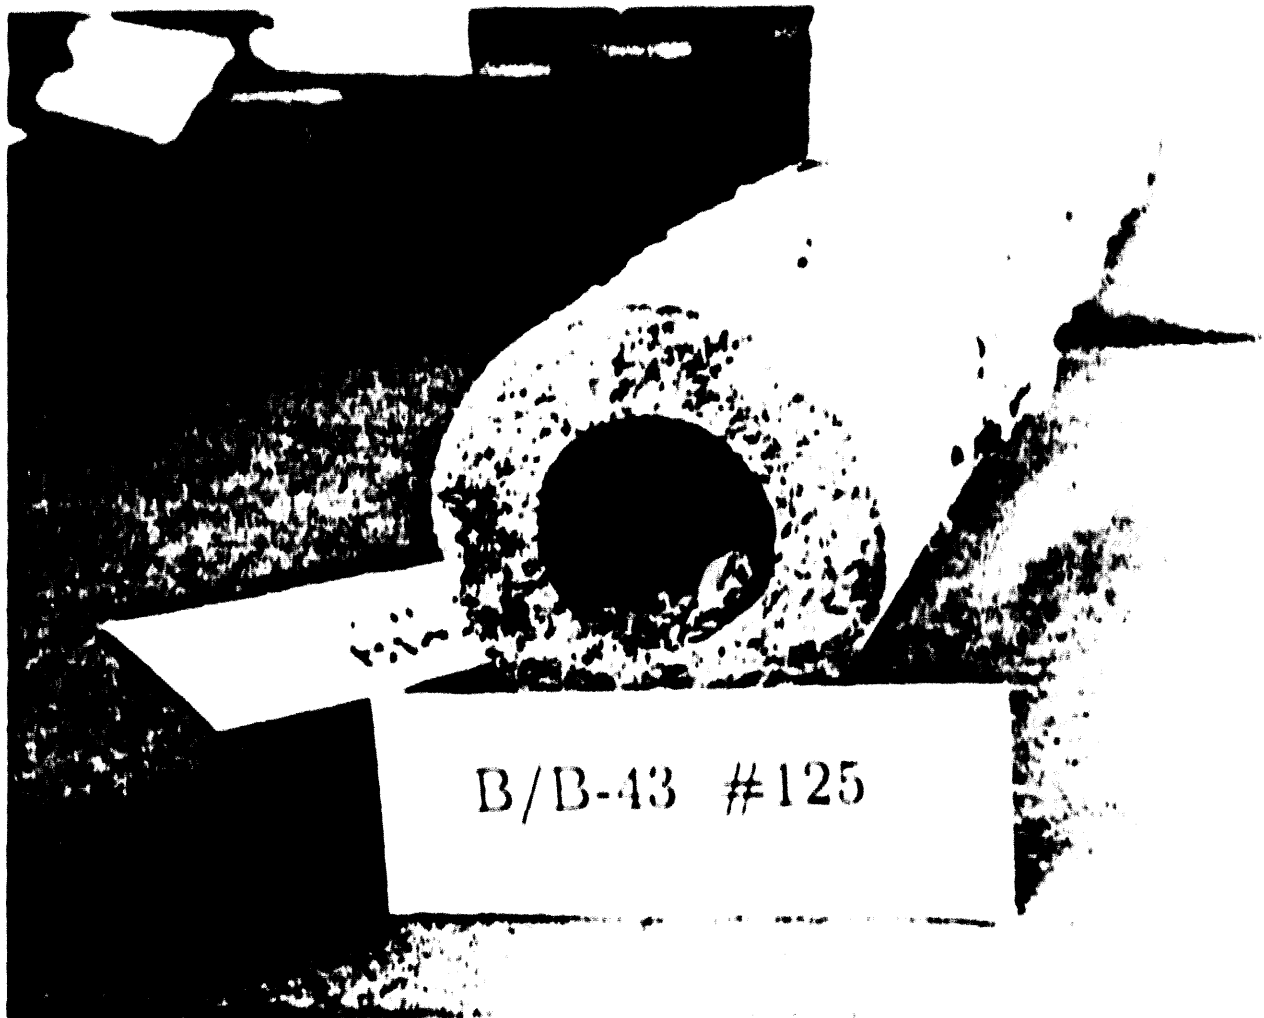
Figure 5-18 Candle With Attached Ash Dumplings

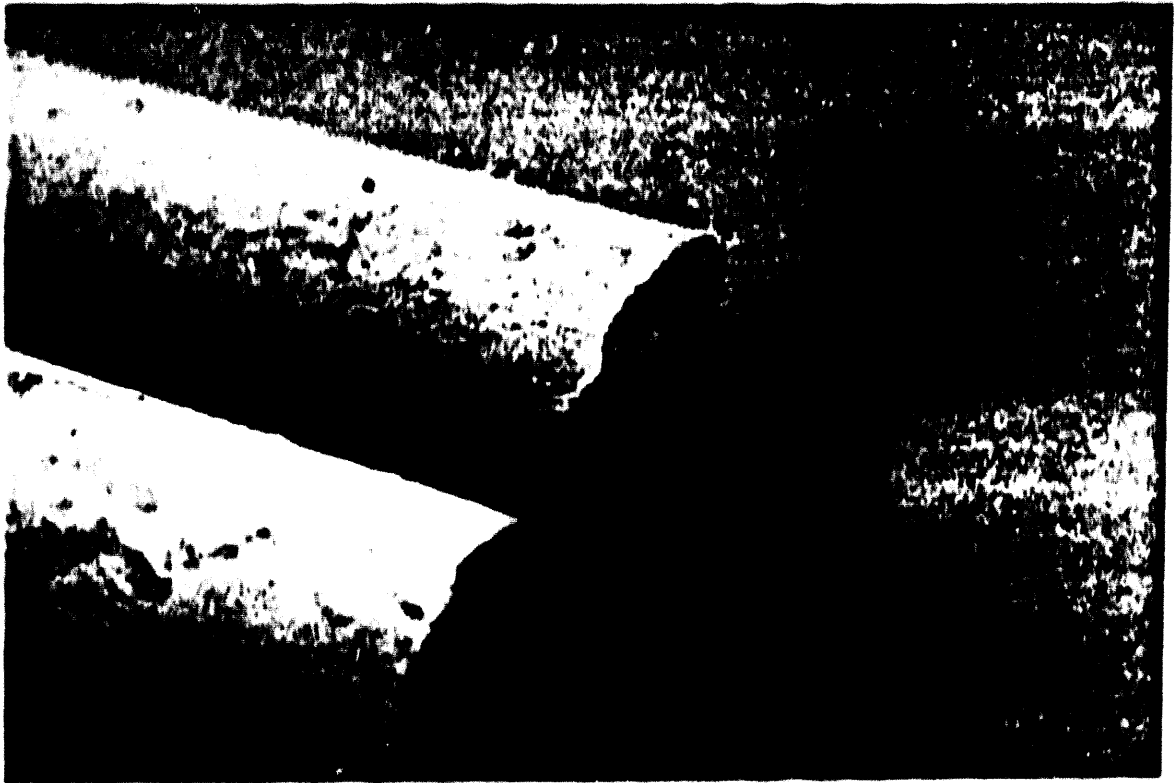
Again in these areas the white sorbent layer was not present. Dumping or scale-like ash deposits were most likely present along the candle wall, which upon impact with either the ash in the hopper or contact with the filter vessel wall, were stripped from the candle surface, exposing the candle membrane.

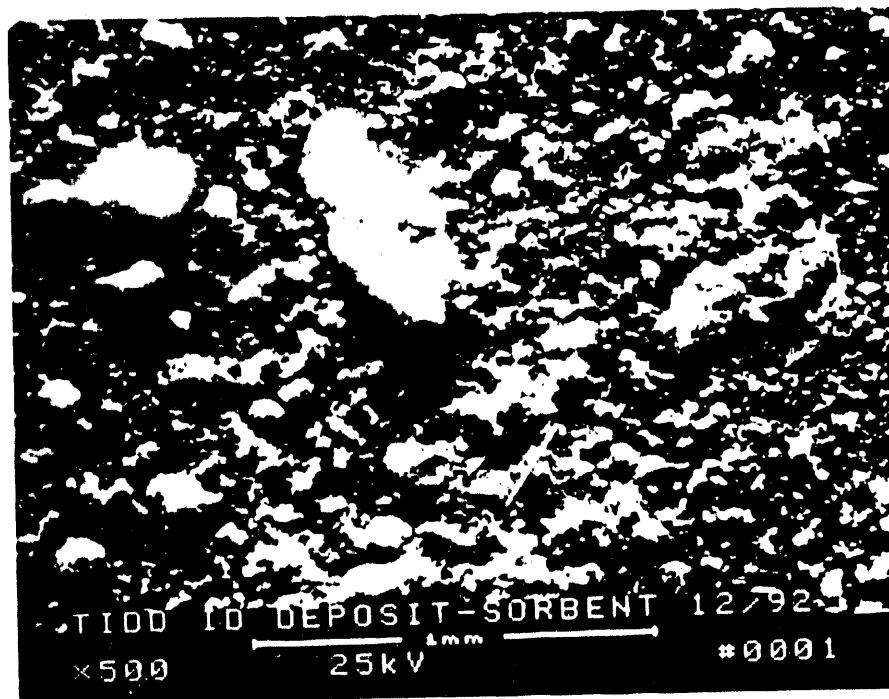
After removal of the fractured candle filter segments that remained firmly held in the Westinghouse APF filter holder mounts, it was apparent that the white sorbent layer coated many of the broken candle ID surfaces (Figure 5.18). EDAX analyses indicated the presence of the sulfated dolomitic material which was carried through the Westinghouse APF vessel during system shutdown (Figures 5.19 and 5.20). High magnification micrographs of the candle filter ID sulfated sorbent deposit are shown in Figure 5.20.

Figure 5.18 - Sorbent Deposit Along The ID Surface Of The Fractured Candle Filters

Based on this information, it appeared that sorbent carryover occurred at least twice during the 500 hours of hot gas filtration testing — once when the candles were intact and the sorbent coated the candle OD surface (Figure 5.17), and at a later point in time when sections of the candles failed, resulting in the sorbent coating the candle ID surfaces (i.e., either prior to or at test termination).

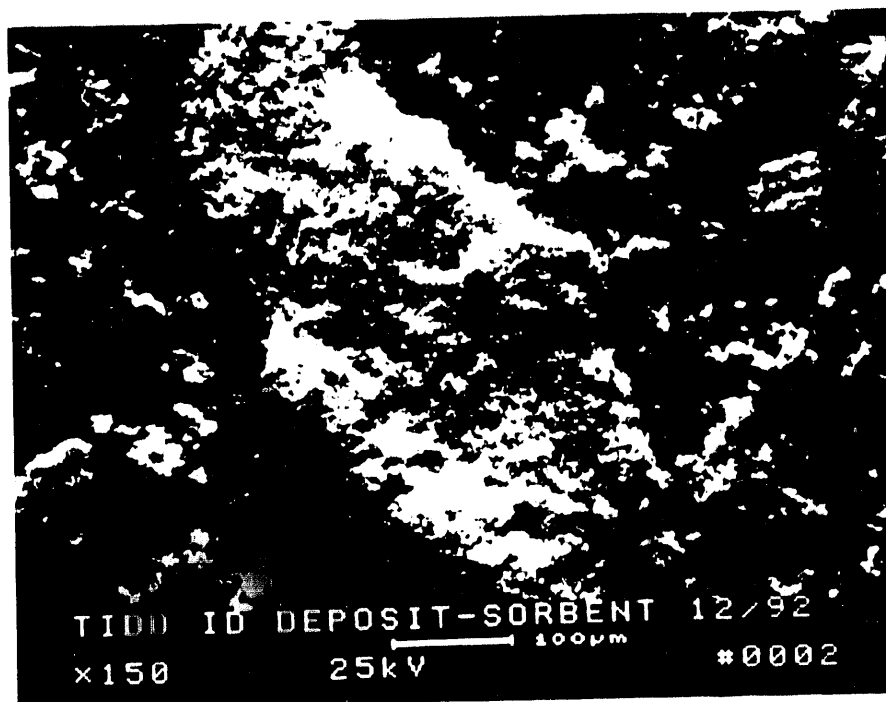
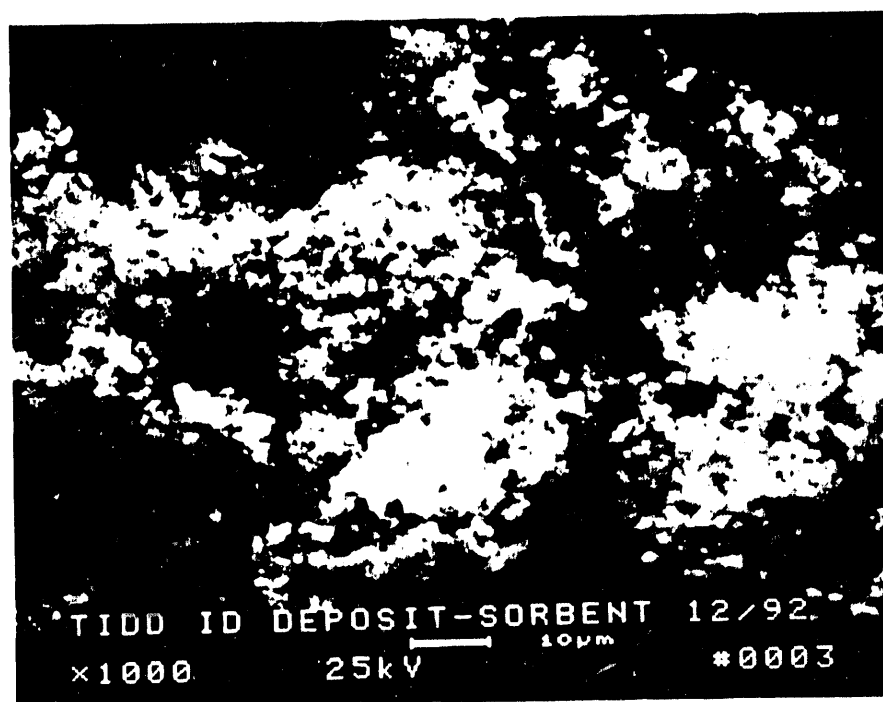
Figure 5.19 - Morphology Of The Fine Layer Of Sulfated Sorbent Material That Was Removed From The ID Wall Of The Fractured Candle Filters

Figure 5.20 - Higher Magnification Micrographs Illustrating The Morphology Of The Sulfated Sorbent Fines Deposited Along The Fractured Candle Filter ID Surfaces

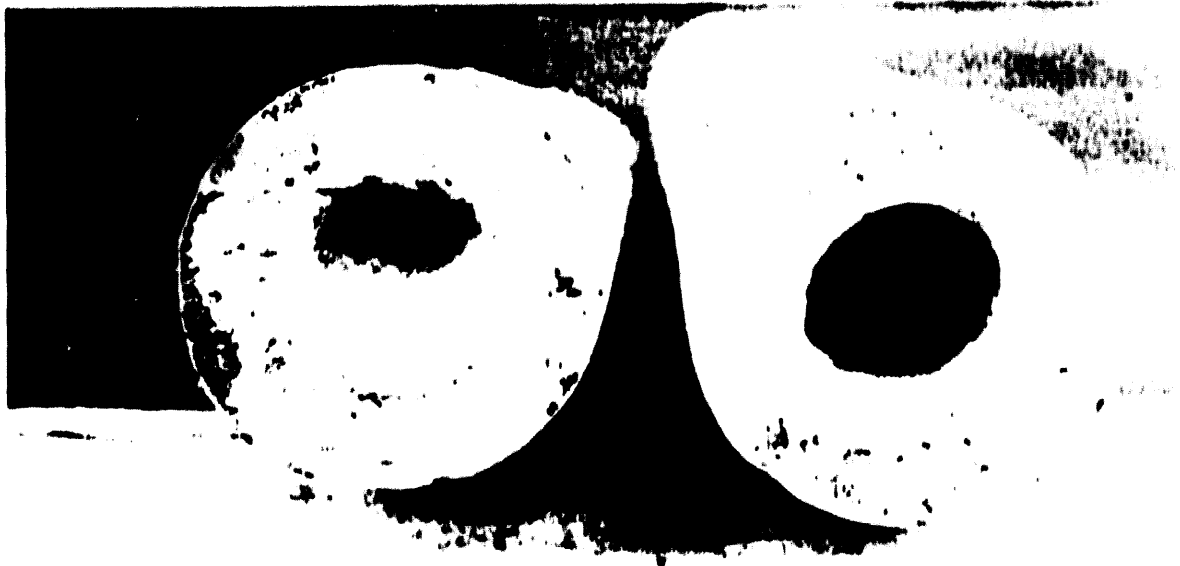
In contrast to the relatively "fluffy" or "talc-like" consistency of the ash and/or sorbent material deposited along the ID or OD surfaces of the candles, a very hard, cement-like ash was removed from the bottom of the Westinghouse APF vessel, as well as from the ID of candles that had plummeted to the bottom of the ash hopper (Figure 5.21). A section of the cement-like deposit was removed from one of the candle IDs, and is shown in Figure 5.22. Notably the deposit was very dense, and had characteristic white striations in the pinkish-orange ash/sorbent deposit (Figure 5.23).

Figure 5.21 - Cement-Like Ash Deposit Formation In The ID Of  
Candles That Had Fallen Into The Bottom Of The  
Ash Hopper

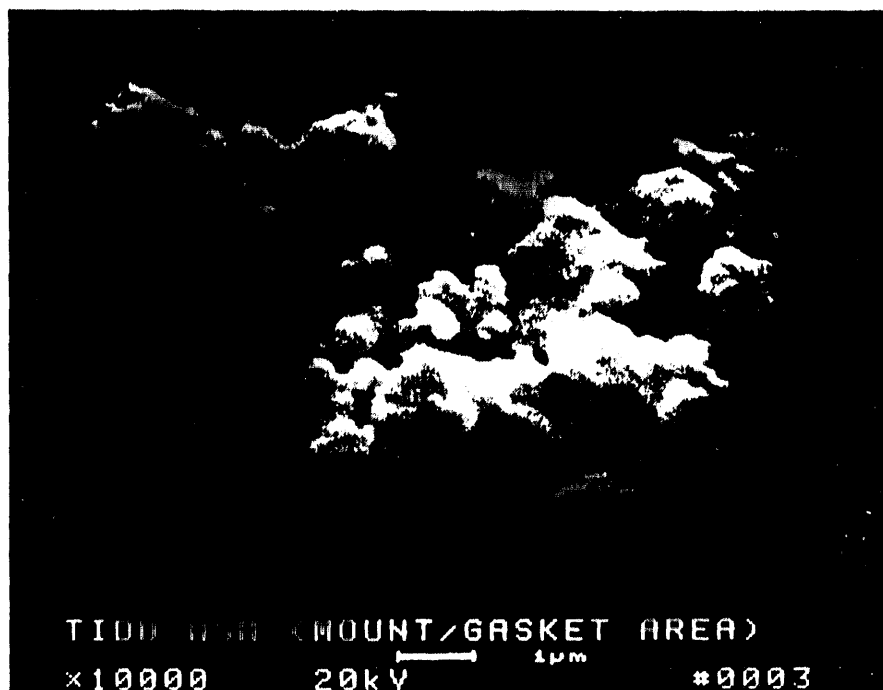
Figure 5.32 - Higher Magnification Of The Ash Agglomerates Formed In The Flange Mount/Gasket Area Of The Candle Filter Holder

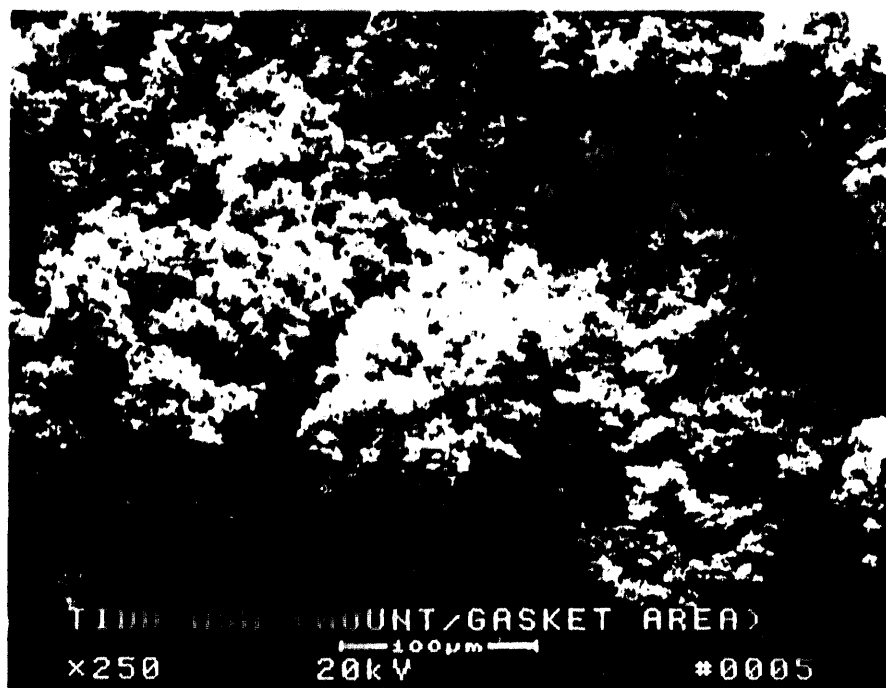
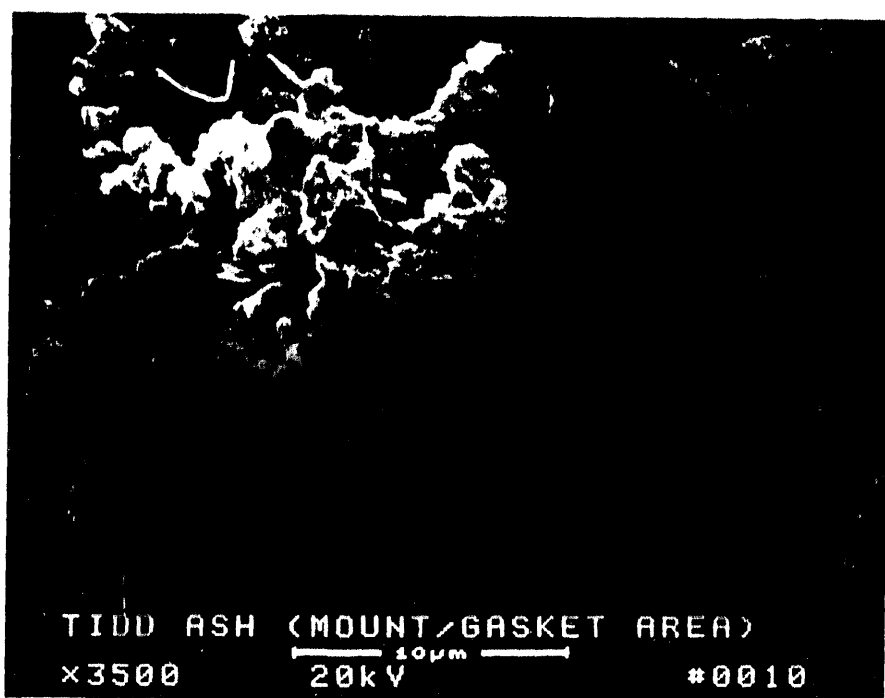
Figure 5.33 - Ash Agglomerates Formed In The Flange Mount/Gasket Holder Area Of The Candle Filter

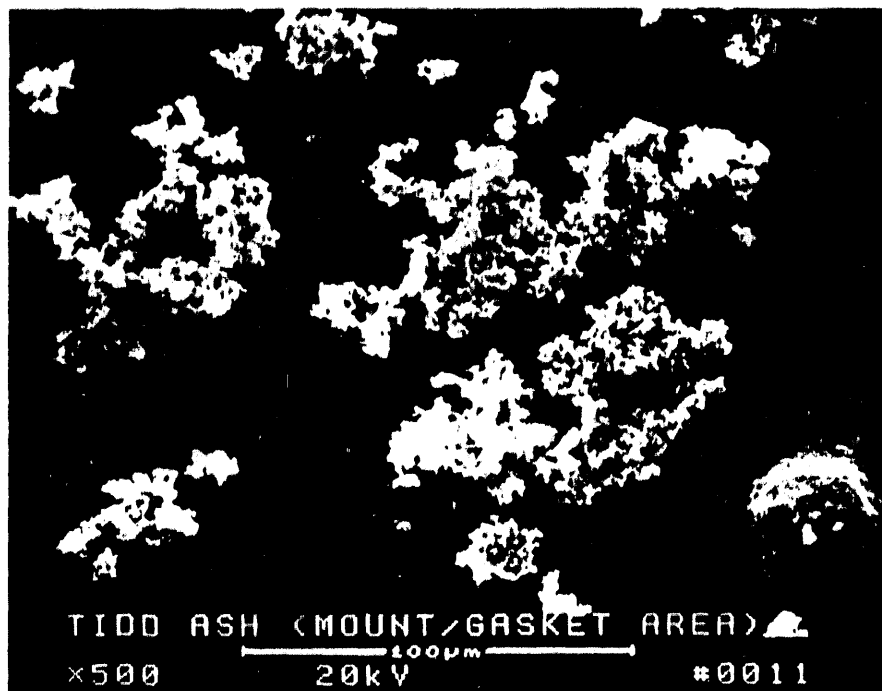
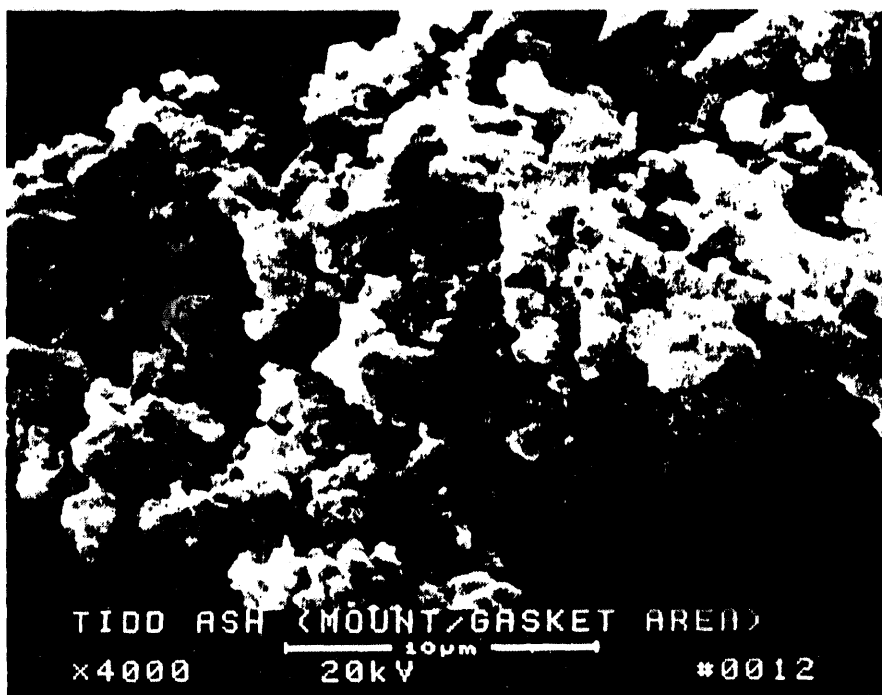
Figure 5.34 - Ash Agglomerates Formed In The Flange Mount/Gasket Area  
Of The Candle Filter Holder

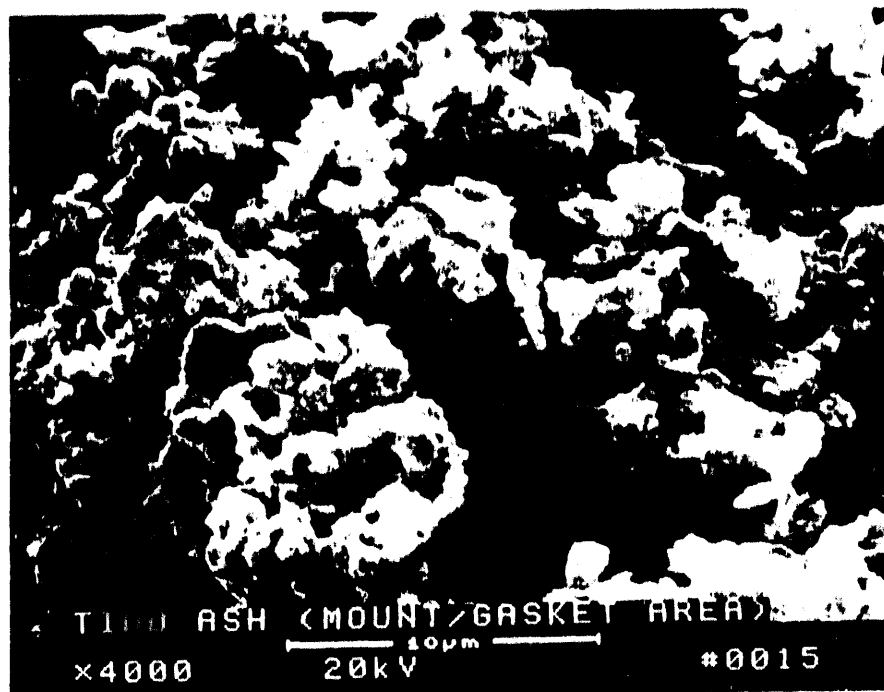
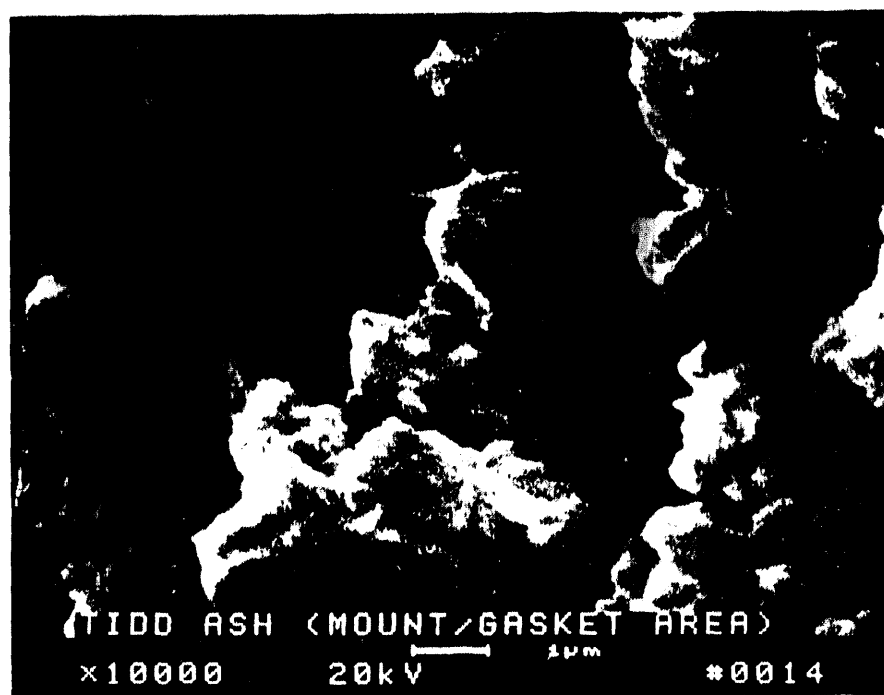
Figure 5.35 - Ash Agglomerates Formed In The Flange Mount/Gasket Area Of The Candle Filter Holder

What was rather unique in this ash material were several interconnecting areas between adjacent ash particles. As shown in Photo 14 of Figure 5.35 there appears to be a "bond-like" channel connecting two adjacent cenosphere ash particles. Further effort would be required to verify the extent of bonding in this material, as well as to qualitatively identify the composition of the interconnecting "bond-like" channel material.

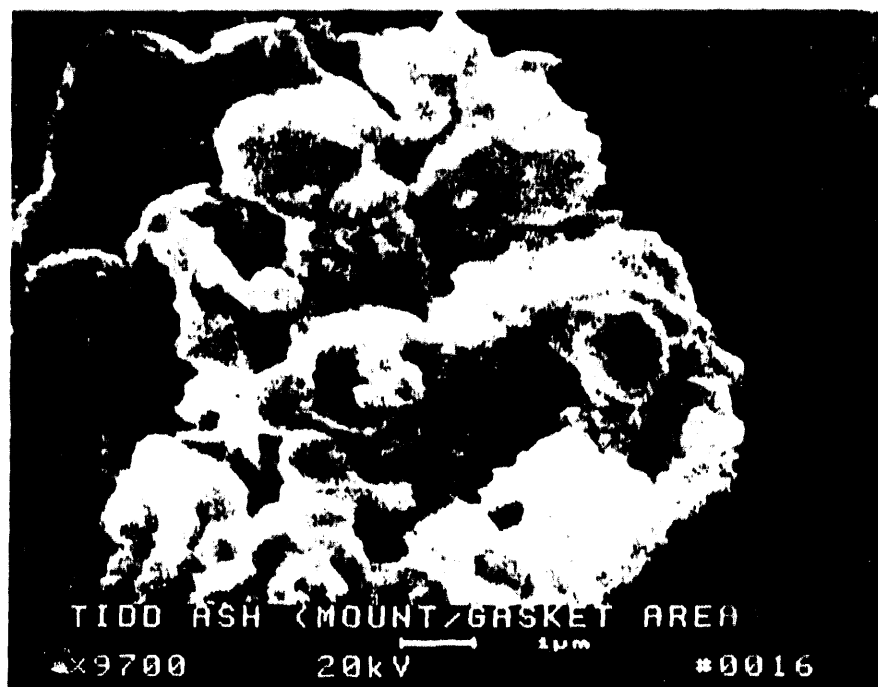
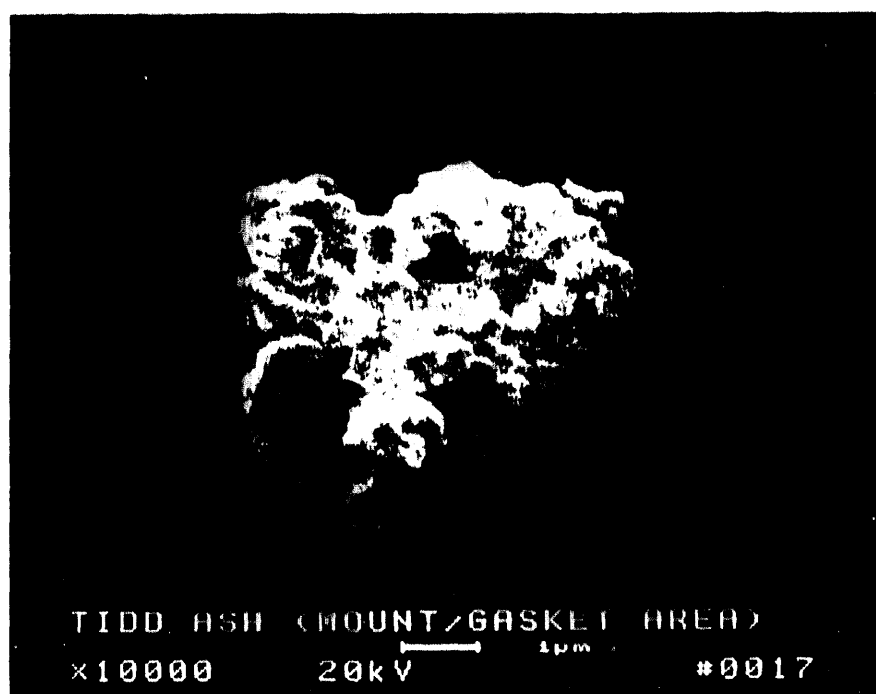
Figure 5.36 - Ash Agglomerates Formed In The Flange Mount/Gasket Area Of The Candle Filter Holder

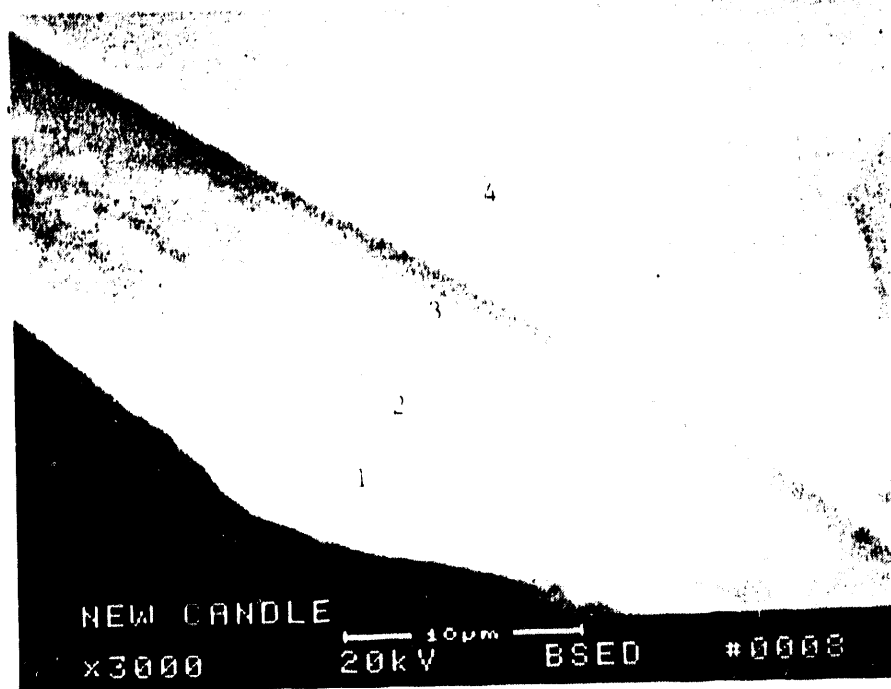
Figure 6.5 illustrates a cross-sectioned area along the matrix where the 10-15 thick  $\mu\text{m}$  binder coating was evident along a silicon carbide grain. EDAX analysis through the binder phase indicated the presence of an enriched aluminosilicate phase at the surface of the binder phase. Moving through the binder towards the silicon carbide grain, the concentration of aluminum appeared to decrease, while the concentration of silicon and sodium appeared to increase. The concentration of potassium appeared to remain relatively constant through the binder wall. Area 4 in Photo 8 of Figure 6.5 contained silicon, with only minor concentrations of carbon. Note that the Link XL EDAX system which was used in these analyses had the capabilities to detect both carbon and oxygen. When low concentrations of carbon are present in a sample, quantitative results for carbon are somewhat in question.

Figure 6.5 - Micrograph And EDAX Analysis Through The Binder Phase That Coats A Silicon Carbide Grain

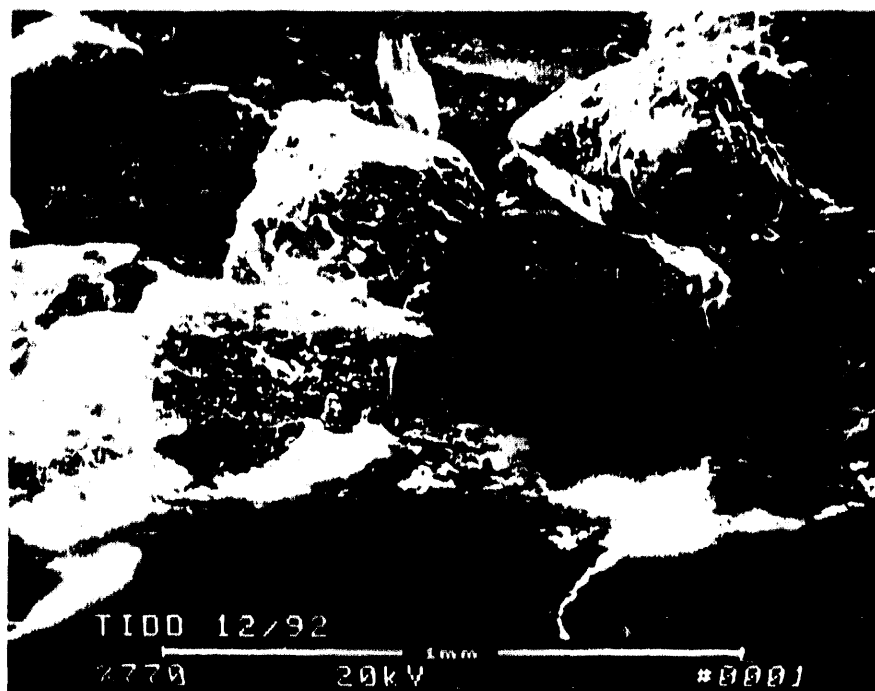
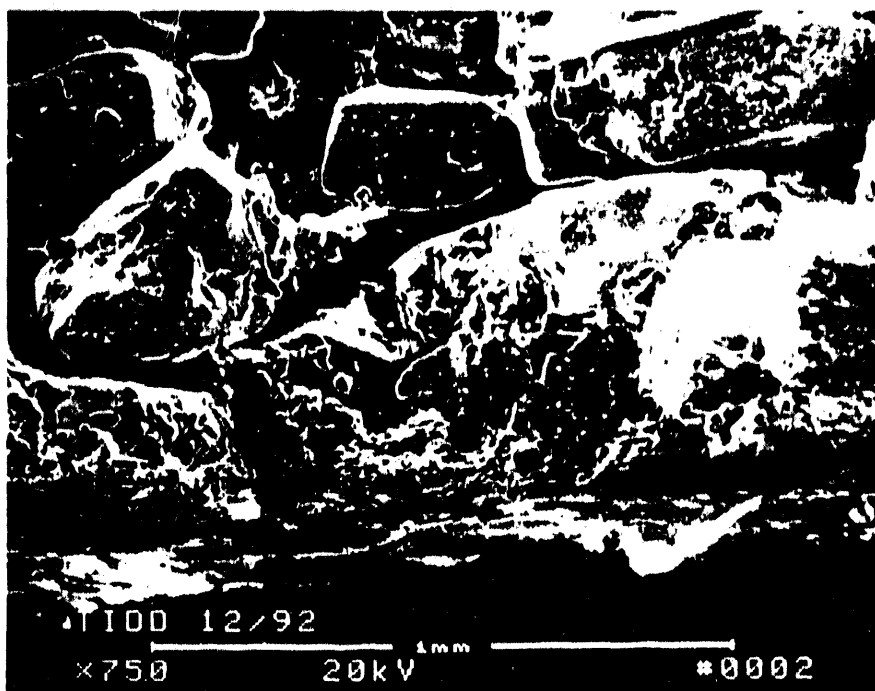
Figure 6.7 illustrates the morphology of the cross-sectioned silicon carbide matrix at higher magnifications. Photo 2 in Figure 6.7 illustrates the "bonding" of aluminosilicate membrane to the underlying silicon carbide grains. The OD membrane layer remained virtually intact after 500 hours of exposure in the PFBC gas environment. No apparent penetration of fines was evident through the OD membrane. All pores along the OD membrane appeared to be completely open. In the area that was characterized it was difficult to determine whether the extent of binder phase had been retained between adjacent grains. Several "patchy or blotchy" areas were evident along the binder coated SiC grains which may be attributed to binder "pull-away" during sample preparation, or perhaps to isolated phase enrichment.

Figure 8.7 - Micrographs Illustrating The Morphology Of The 500 Hour PFBC Exposed Clay Bonded Silicon Carbide Matrix Near The OD Wall

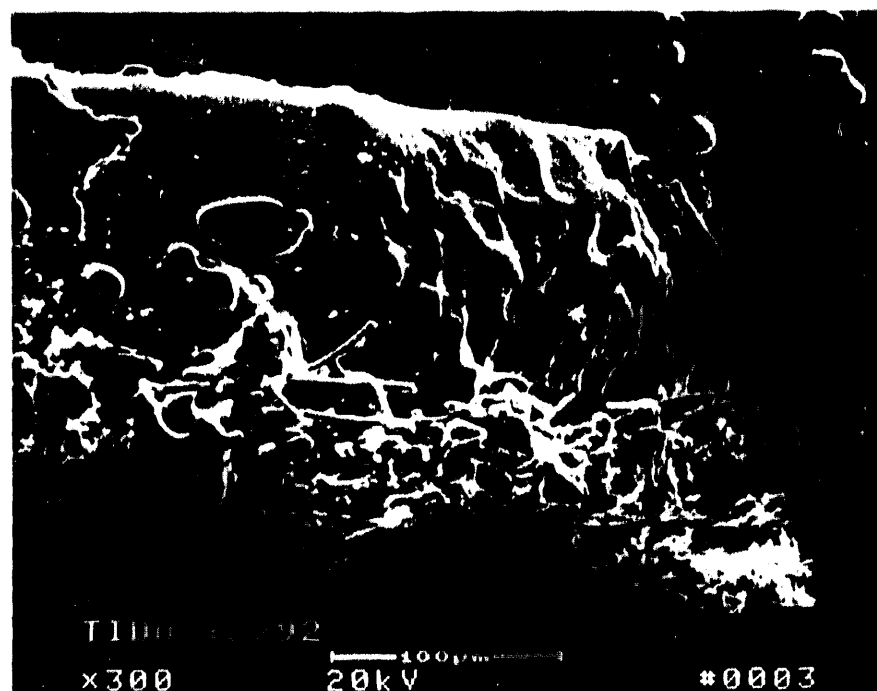
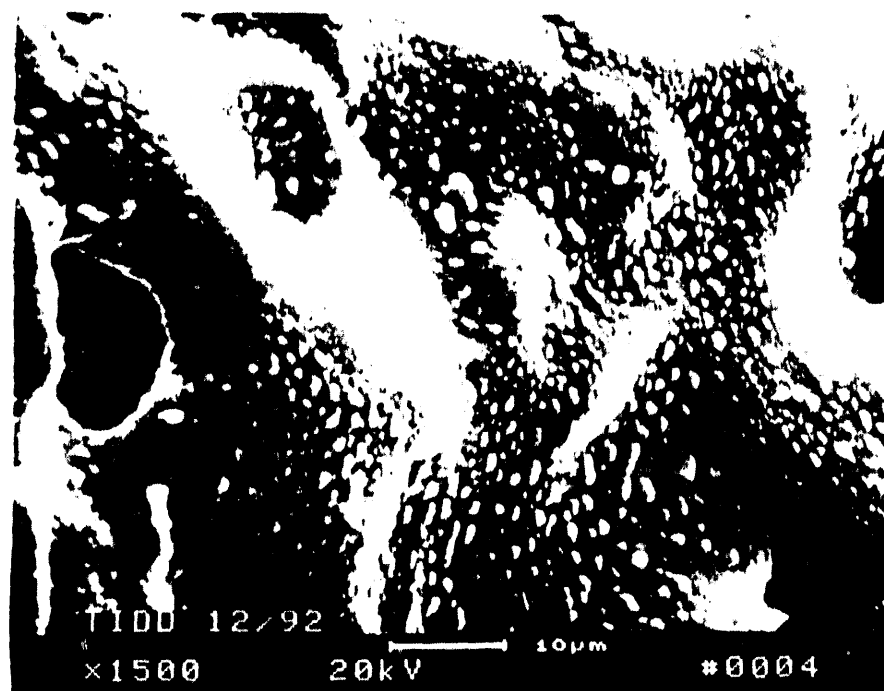
A higher magnification micrograph illustrating the attachment of the membrane layer to the subsurface silicon carbide grains is shown in Photo 3 of Figure 6.8. Even at 300x, a somewhat mottled surface feature was evident along the binder phase surface that coated each silicon carbide grain. At the membrane/grain interface, EDAX analysis indicated the presence of 77.61% Si, 16.63% Al, 3.72% K, 1.69% S, and 0.35% Fe (Normalization Factor (NF) = 0.766).

The mottling of the binder phase surface was evident in the micrograph shown in Photo 4 of Figure 6.8. Note that the particle-laden, bumpy texture of the binder phase existed along the first grain layer, immediately below the fibrous OD membrane. The rounded nature, extensive quantity, as well as the micron- and submicron-size of the

Figure 6.8 - Morphology Of The Membrane/Grain Interface Along The Cross-Sectioned Clay Bonded Silicon Carbide Wall. Extensive Aerosol Droplet Particle-Like Features Are Evident In This Area

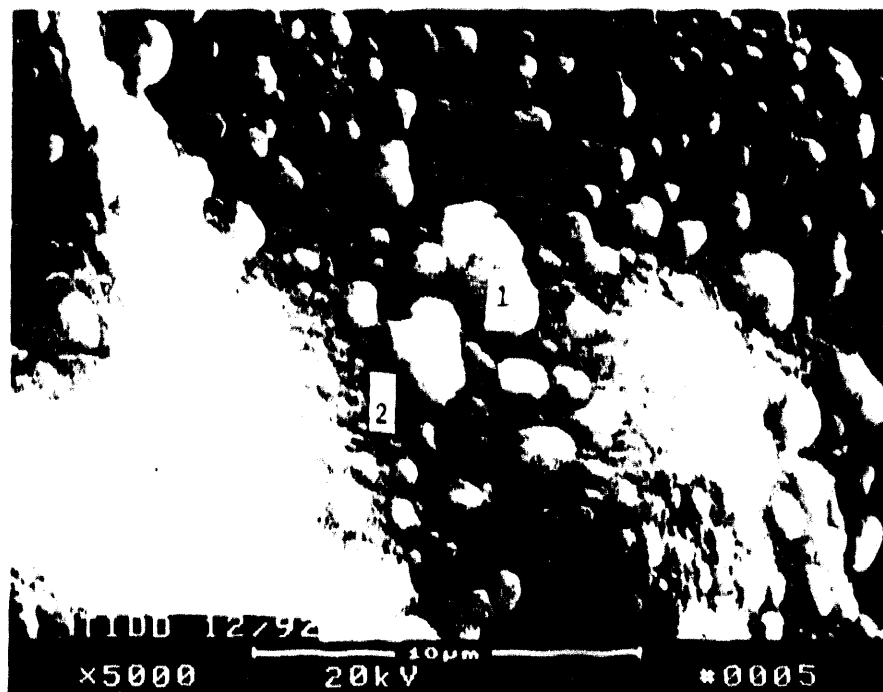
A higher magnification micrograph of the "aerosol" droplet-enriched area along the first silicon carbide grain layer in the Schumacher Dia Schumalith candle filters after exposure at Tidd is presented in Figure 6.9. The composition of Area 1 in Photo 5 of Figure 6.9 indicated the presence of 49.68% Si, 21.02% S, 12.70% Al, 10.19% Ca, 4.64% K, 1.00% Ti, and 0.78% Fe (NF = 0.678). The underlying substrate (Area 2, Photo 5, Figure 6.9) below the micron- and submicron-size particles consisted of 68.42% Si, 18.60% Al, 6.12% K, 5.47% S, 0.78% Ti, and 0.62% Fe (NF = 0.688). The relative sulfur to calcium atomic percent ratio implied that in addition to a "sorbent-enriched phase" (i.e.,  $\text{CaSO}_4$ ) which was attached to the binder coated silicon carbide grain surface, sulfur was also sorbed into the binder phase coating. Note that the binder phase also appeared to be mottled, no longer having the smooth, featureless texture shown in Figures 6.3 and 6.4.

Figure 6.9 - Micrograph Illustrating The Morphology Of The Sulfur- And Calcium-Enriched Micron And Submicron Fines Along The Sulfur-Containing Binder Coating

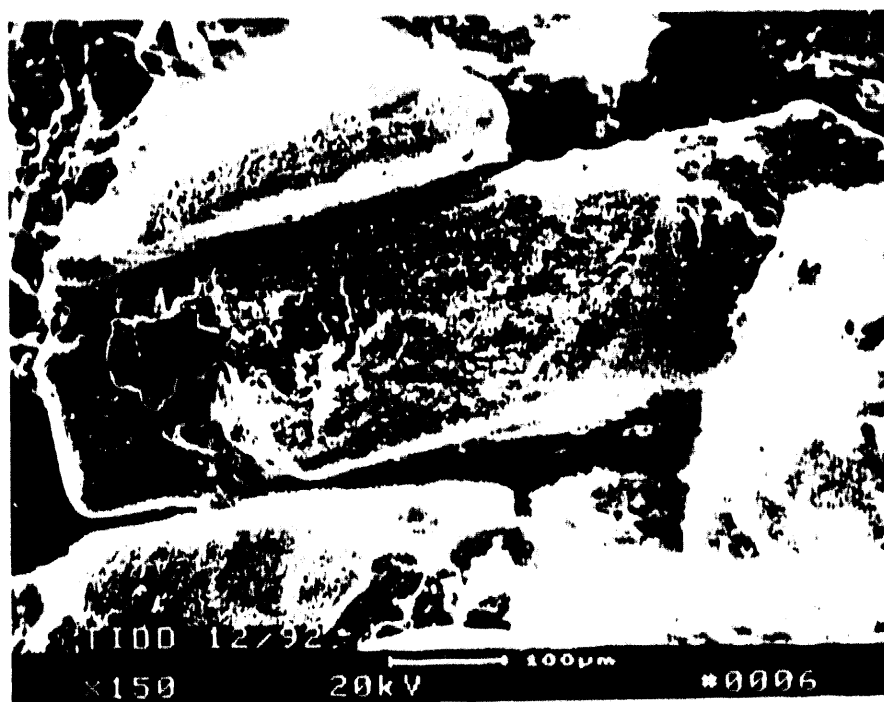
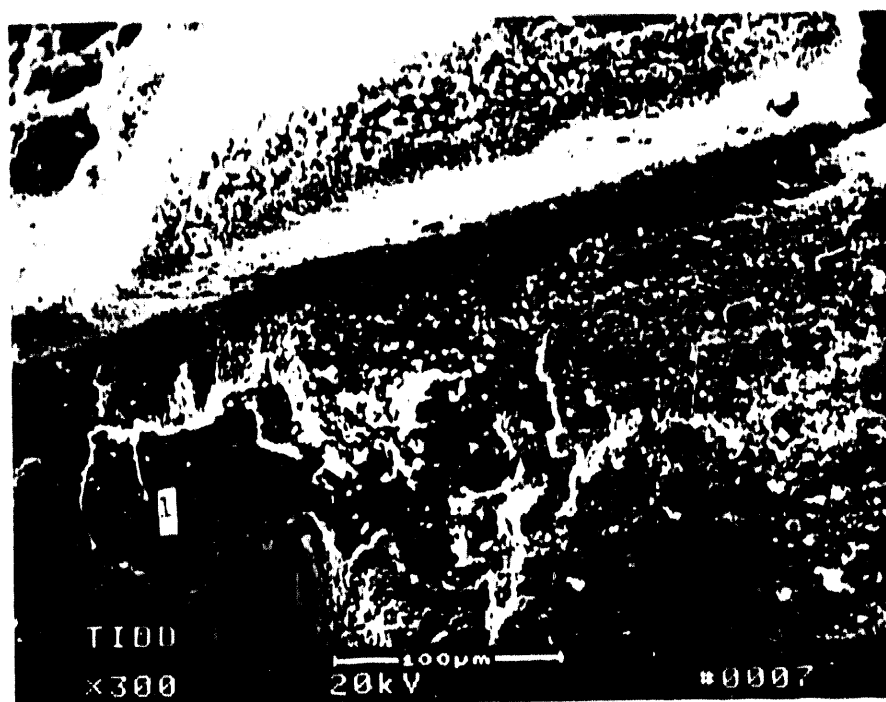
The high magnification micrographs shown in Figure 6.10 illustrate the morphology of a grain in the upper right section of Photo 2, Figure 6.7. Area 1 in Photo 7, Figure 6.10, is silicon-enriched (i.e., SiC or  $\text{SiO}_2$ ). In this effort we utilized an SEM which did not have the capabilities for detecting oxygen or carbon. At the second grain layer from the OD surface, extensive changes along the binder surface of the silicon carbide grains were evident.

Figure 8.10 - Morphology Of The Binder Coated Silicon Carbide Grains At The Second Grain Layer From The OD Wall Of The PFBC Exposed Schumacher Dia Schumalith Candle Filters
