**ADVANCED PARTICLE FILTER**

Technical Progress Report No. 11  
January through March 1993

Westinghouse Science and Technology Center  
Pittsburgh, Pennsylvania

# **TIDD ADVANCED PARTICLE FILTER**

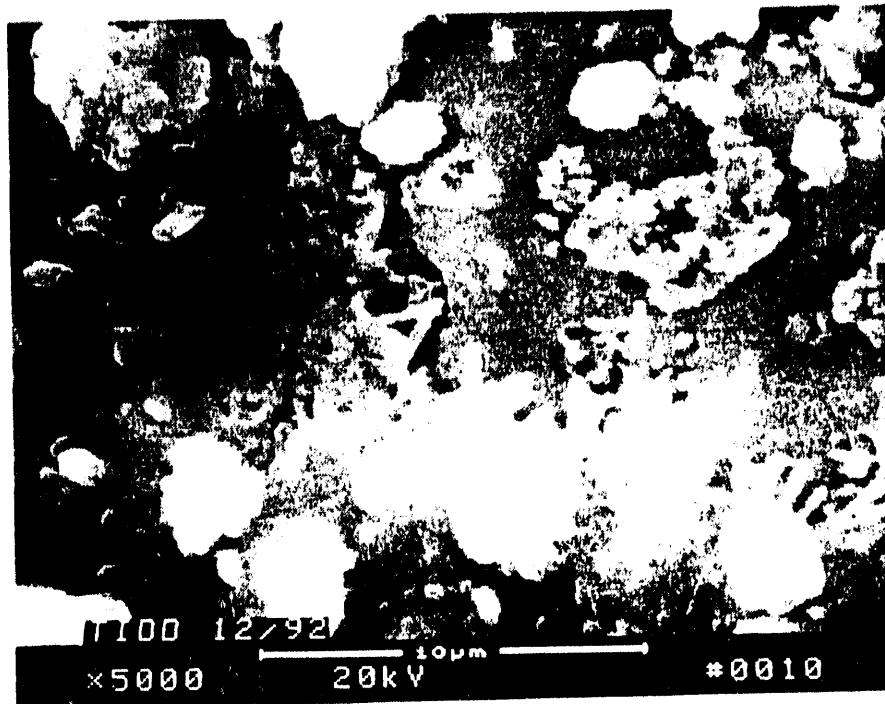
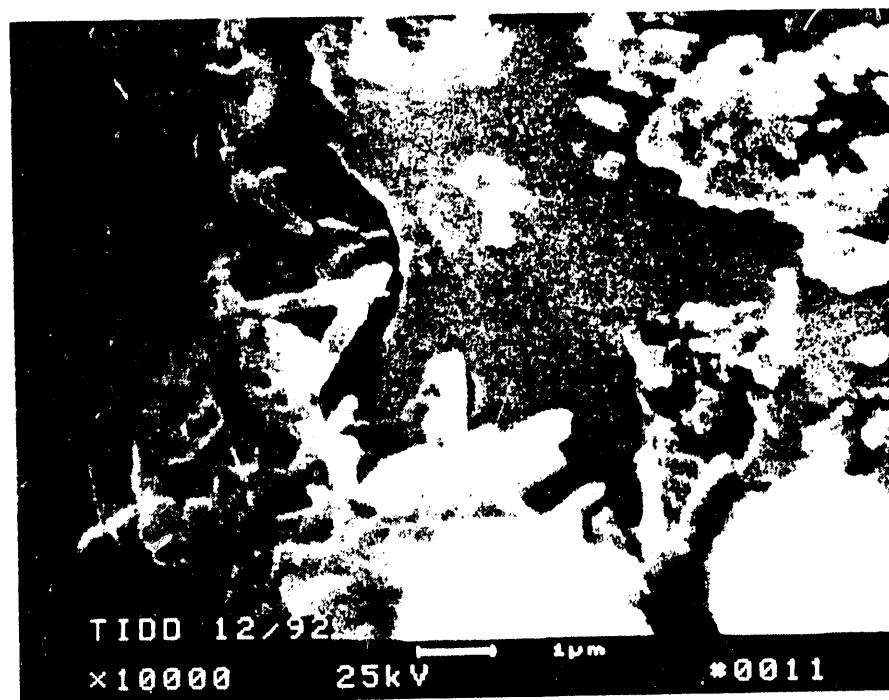
Figures 6.11 through 6.13 detail the morphology of the binder coating along the second grain layer in the clay bonded silicon carbide matrix. Crystalline-like particles were evident. Based on the characteristic morphology of these particles, bonding or an attachment of these particles to the underlying binder phase was implied. In several locations below the attached particles, deterioration of the binder was evident, as well as the formation of rod-like features. The formation of the rod-like phase was considered to result from mullitization of the binder phase.

Figure 6.12 - Mullitization Of The Binder Phase Beneath The Surface Deposited Phase

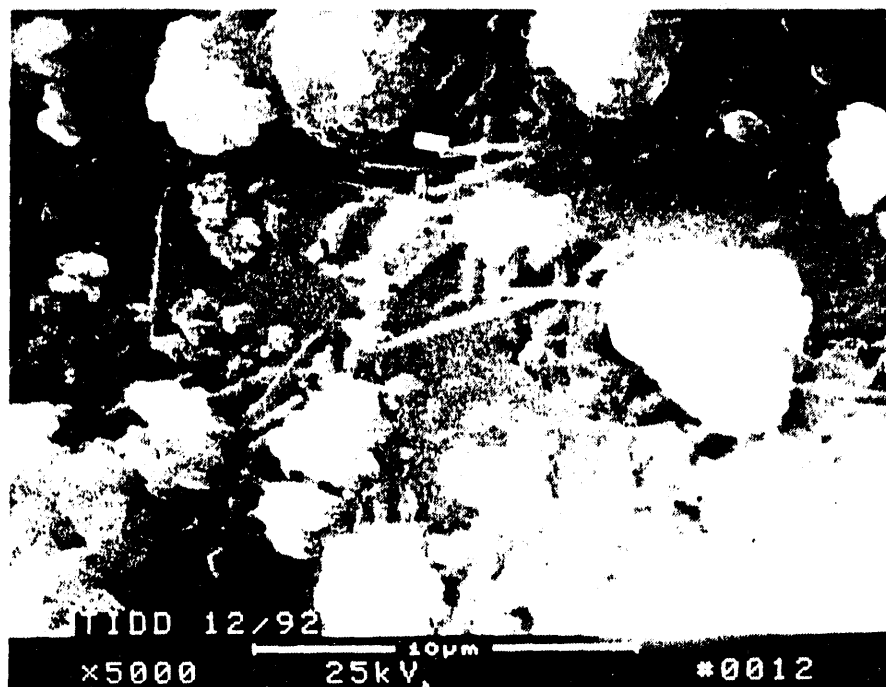
Figure 6.13 - Mullitization Of The Binder Phase Beneath The Surface Deposited Phase

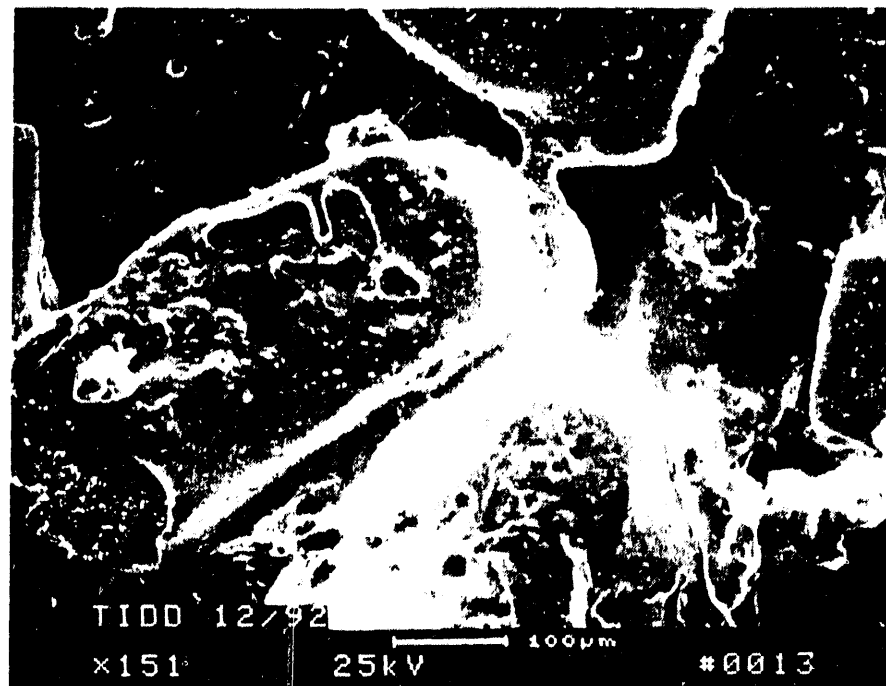
Another series of micrographs (Figures 6.14 through 6.18) detail the morphology of the third and fourth grain layers in the silicon carbide matrix (upper left side of Photo 2, Figure 6.7). The "aerosol" droplet phase formation was evident along the surface of the binder interconnecting channels which bonded adjacent silicon carbide grains together. The flattened surface where the particles were attached to the binder phase implied either bonding of the particles, or the result of a gas phase reaction (i.e., sulfur oxides) with the binder substrate which then led to the production of the mottled surface.

Figure 6.14 - Morphology Of The Third And Fourth Grain Layers In The Silicon Carbide Matrix. Surface Binder Phase Changes Are Evident.

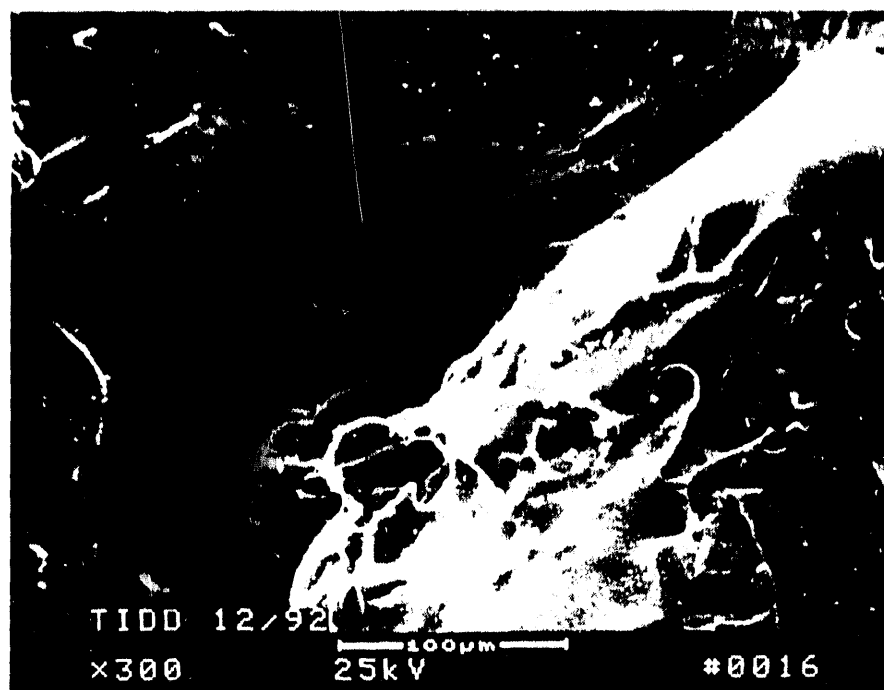
Figure 6.16 (Photo 16) attempts to detail the morphology of the binder phase along two adjacent silicon carbide grains (approximately at the center of Photo 13, Figure 6.14). Once again surface mottling was apparent along the binder phase. The somewhat smoother areas of the grain surface were apparently areas where the binder interconnect channel had been fractured during sample preparation.

Figure 8.16 - Morphology Of The Interconnecting Binder Phase Between Adjoining Silicon Carbide Grains

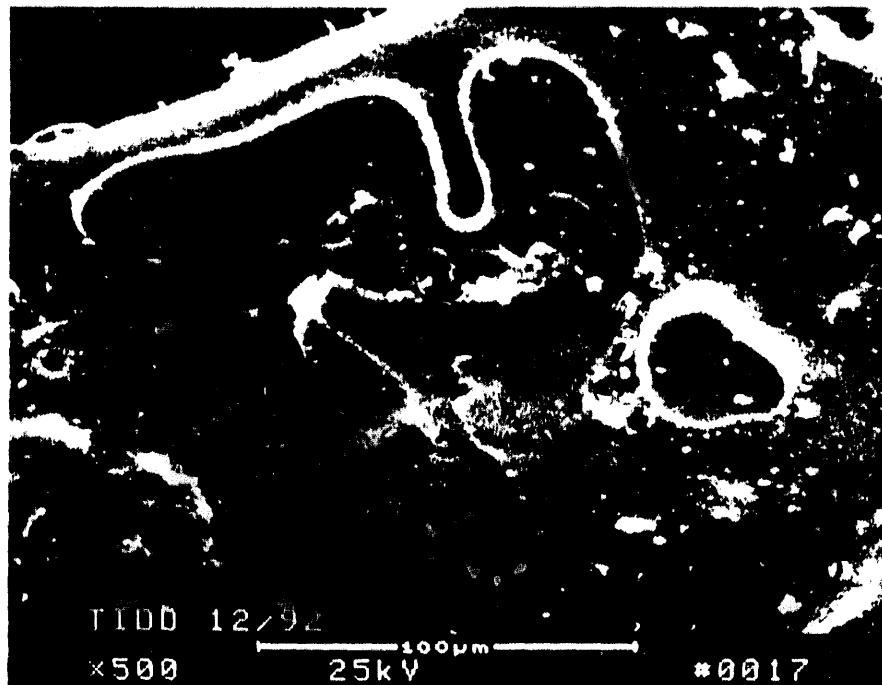
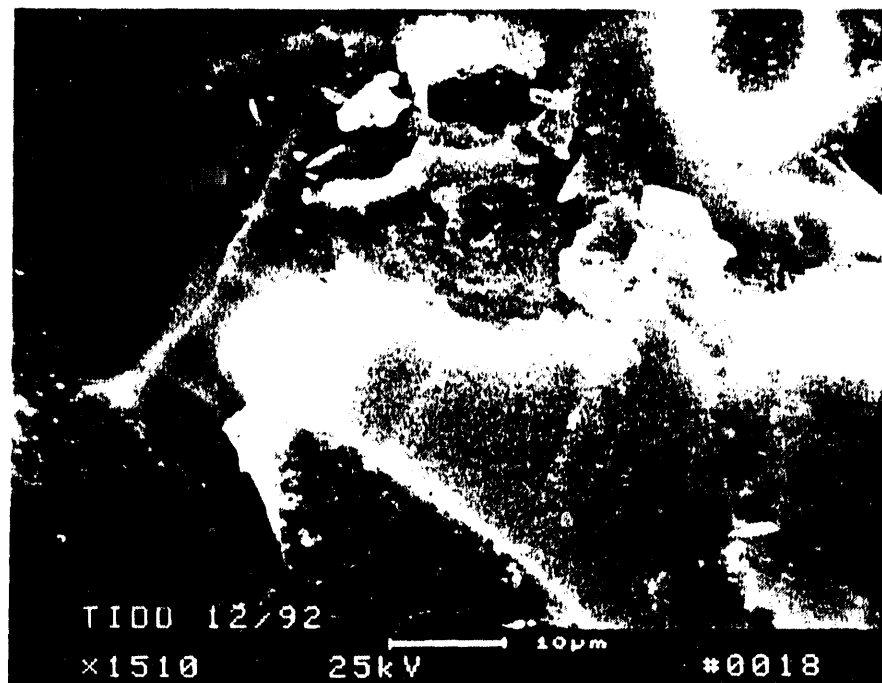
Figure 6.17 presents higher magnification micrographs of the "patchy", fractured, binder interconnect areas along the silicon carbide grain shown in Photo 13 and 14, Figure 6.14. The surface mottling effect of the binder phase is evident in these micrographs. Area 1 in Photo 19 of Figure 6.18 was determined to contain aluminum, silicon, potassium, and titanium, indicative of the binder phase which had fractured between two adjoining grains.

Figure 6.17 - Micrographs Illustrating That The Binder Phase Change That Results In The Clay Bonded Silicon Carbide Candle Filters Is Limited To The Surface Of The Binder Coating And Interconnect Areas

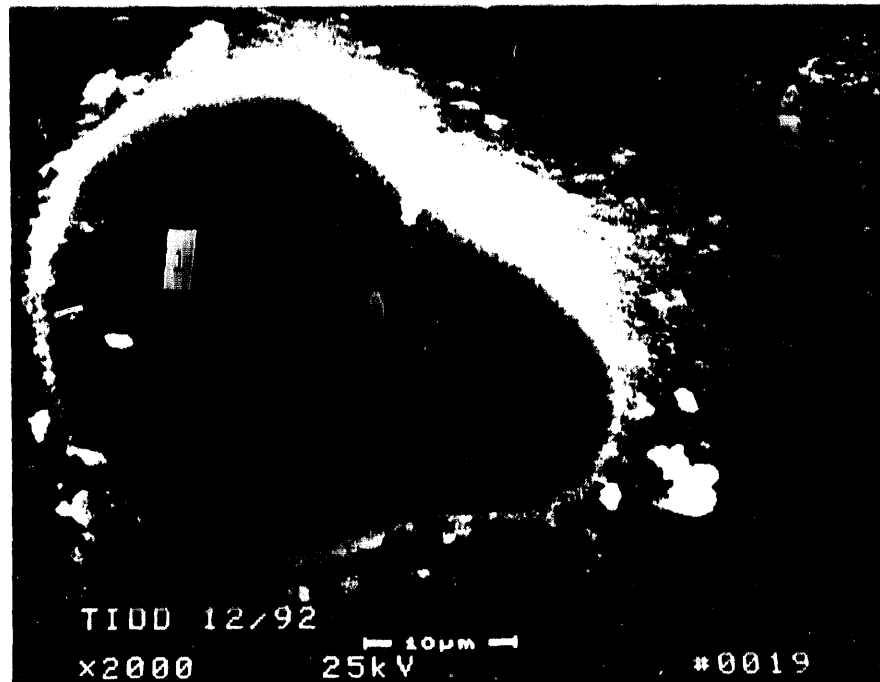
Figure 6.18 - Micrograph Illustrates The Morphology Of A Cross-Sectioned Binder Interconnect Channel

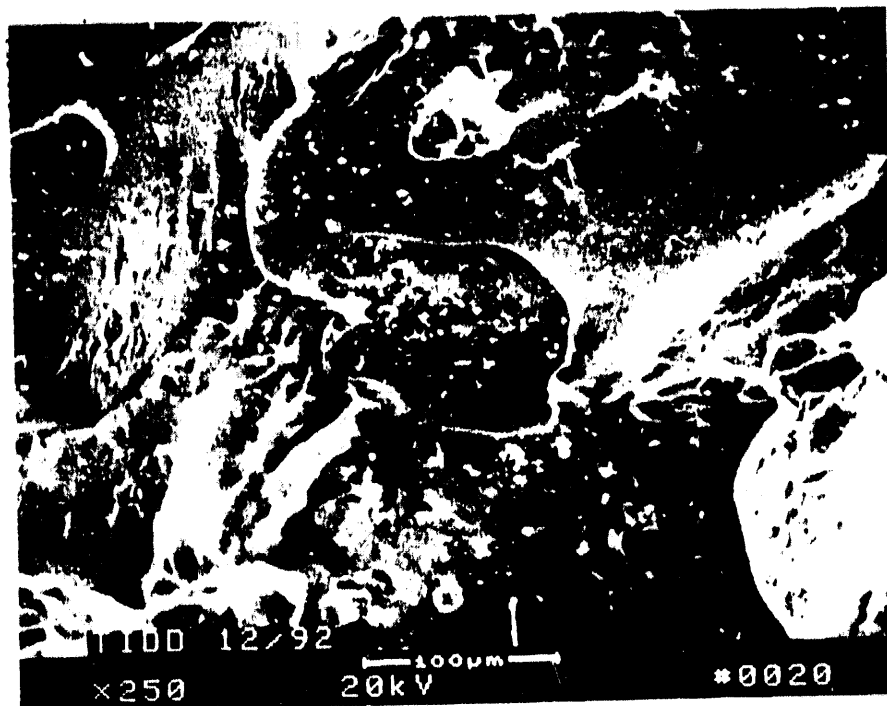
Figure 6.19 illustrates the morphology of the binder coated silicon carbide grains at another location near the OD surface of the clay bonded silicon carbide candle filter wall.

Figure 8.19 - Micrograph Illustrating The Morphology Of The Binder Coated Silicon Carbide Grains At An Alternate Location Near The OD Candle Filter Surface

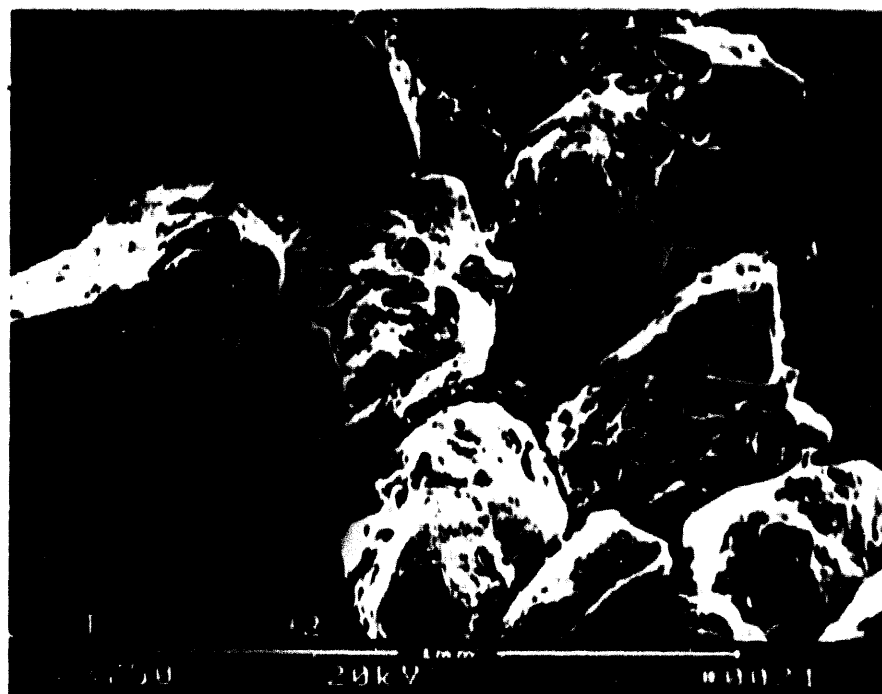
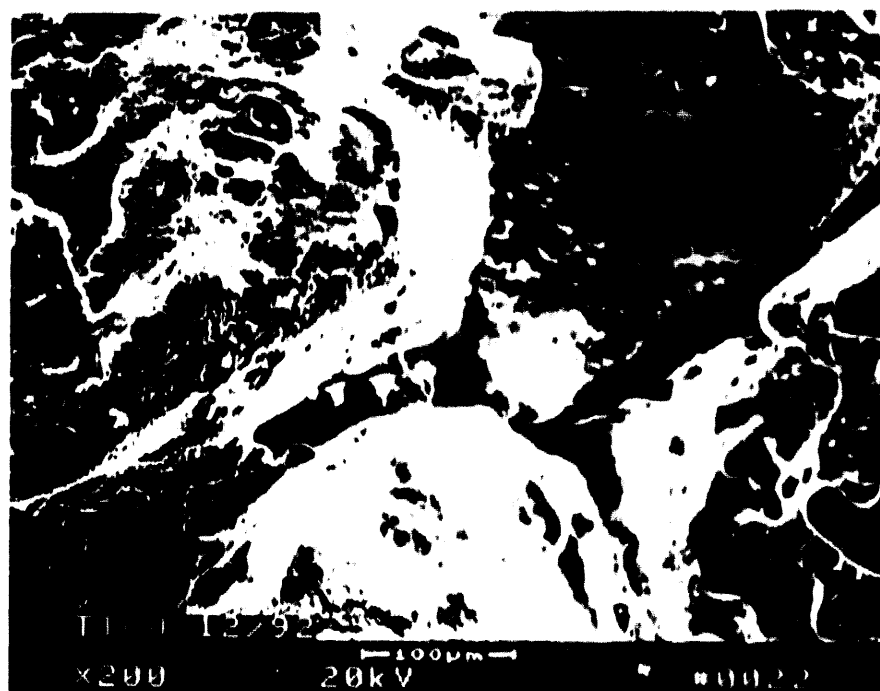
Moving inward from the OD, extensive mottling of the binder surface was evident as shown in Figures 6.20 through 6.22. Photo 23 in Figure 6.21 illustrates that mottling was a surface feature of the binder phase. Along the binder interconnect areas, the mottled area was ~5  $\mu\text{m}$  thick. Area 1 of Photo 23 in Figure 6.21 was identified to consist solely of silicon (i.e., SiC), while Area 2 was identified to be enriched with sulfur in the binder coating surface (71.04% Si, 13.47% S, 9.43% Al, 3.73% K, 2.33% Na; NF = 0.727). Calcium was not detected in these analyses.

Figure 8.20 - Micrographs Illustrating The Morphology Of The Binder Phase Along The Clay Bonded Silicon Carbide Grains Near The OD Surface

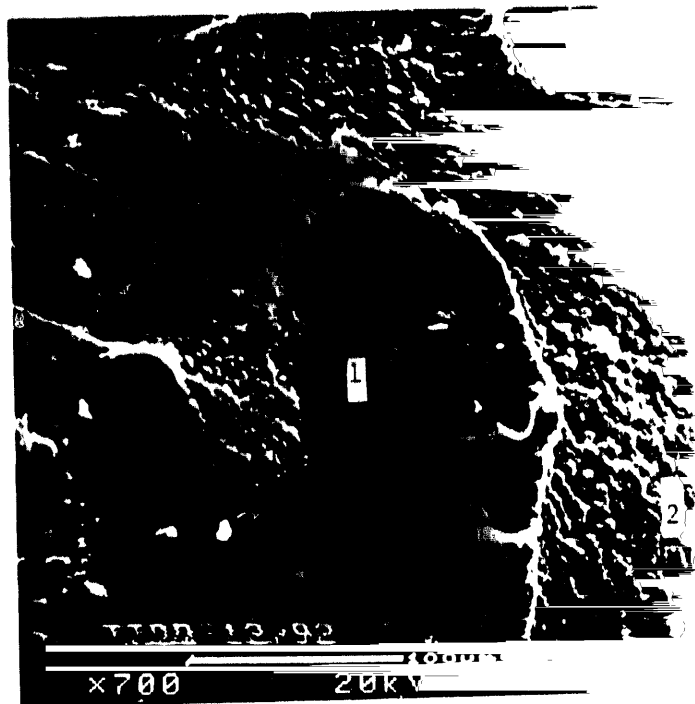
Figure 6.21 - High Magnification Micrographs Illustrating the Morphology Of The Sulfur-Enriched Phase. The Sulfur-Enriched Phase Is  $\sim 5 \mu\text{m}$

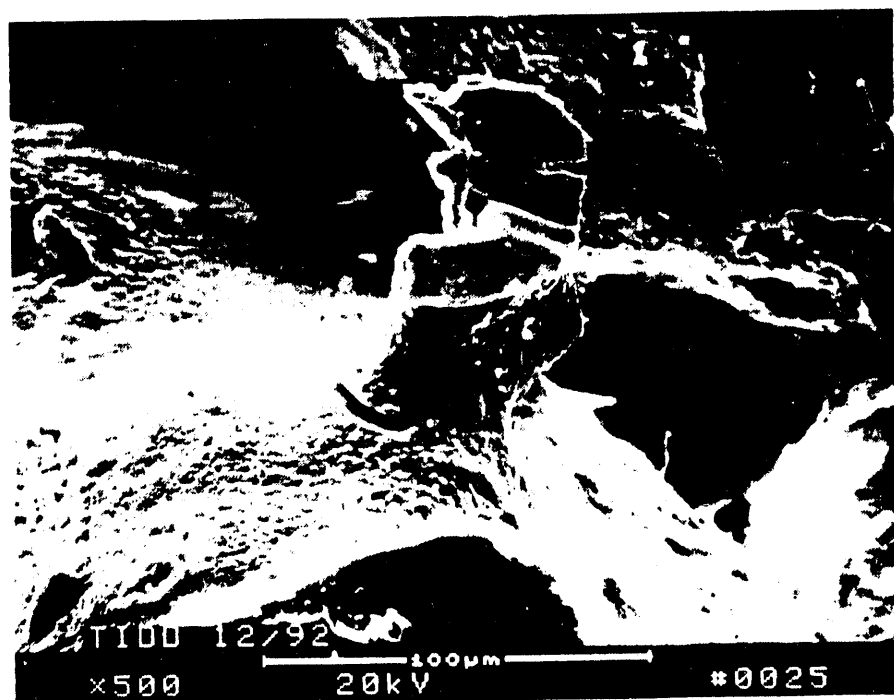
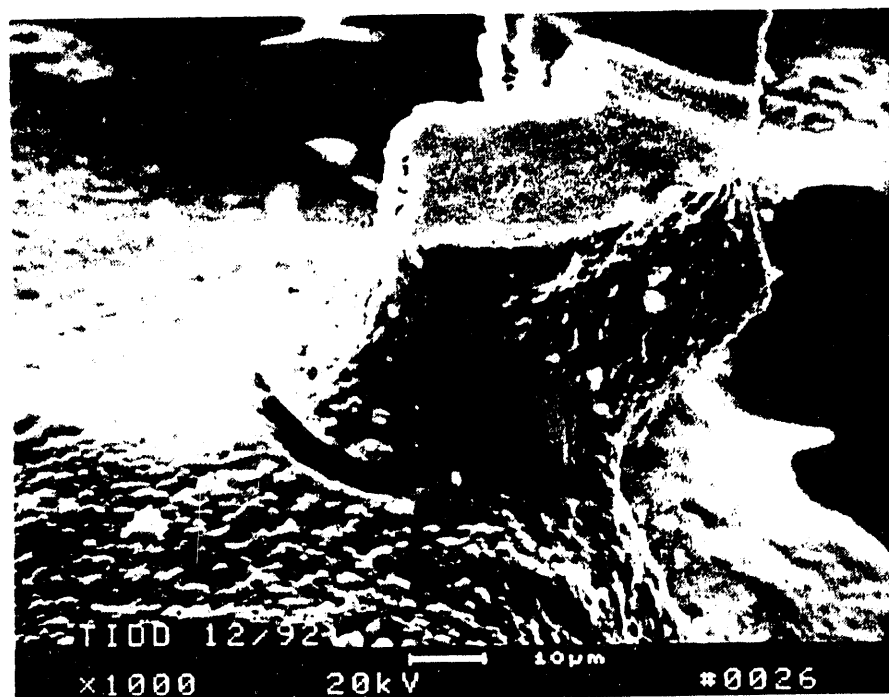
Figure 6.22 shows another area along the silicon carbide matrix where the mottled sulfur-enriched aluminosilicate binder phase existed extensively along the binder coated grain surface, as well as along the surface of the binder interconnect channel areas. Note the fracture along the binder interconnect area at the base of an adjoining silicon carbide grain. Once again the phase change that had occurred within the binder was a surface effect, which was supported by negligible change in the binder interconnect channels.

Figure 8.22 - Micrographs Illustrate That The Sulfur-Enriched Phase Is A Surface Effect Which Extends  $\sim 5 \mu\text{m}$  Into The Binder Interconnect Area

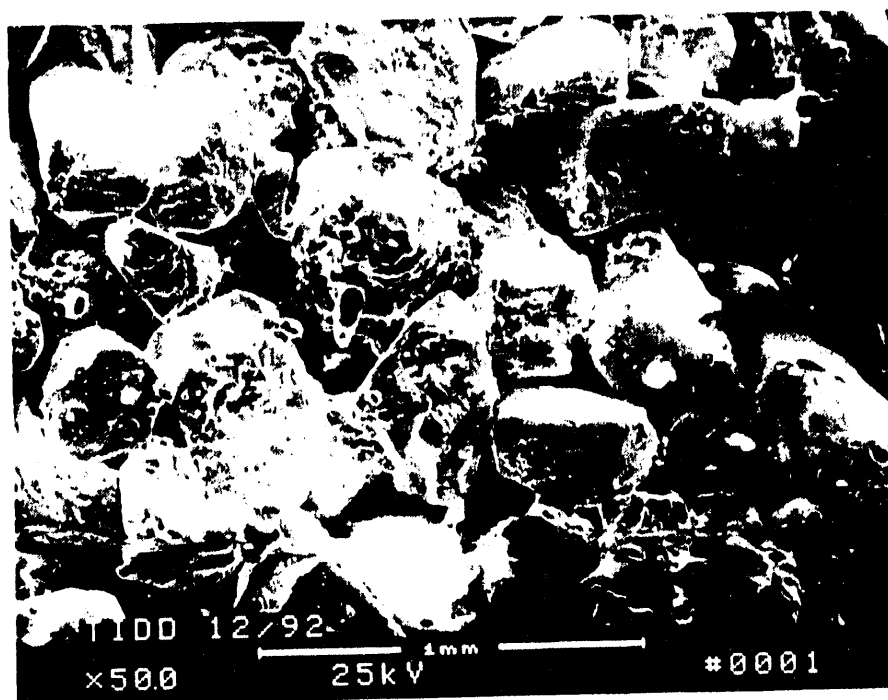
Figures 6.23 through 6.28 illustrate the morphology of the silicon carbide matrix at approximately 5 grain layers from the candle filter OD surface. Once again the binder coating along the silicon carbide grains contained extensive mottled surface features. The rather rounded, crystalline-like phase appeared as discrete agglomerates, which had grown into an extensive mat that completely covered the binder surface layer (Figure 6.24).

Figure 6.23 - Micrographs Illustrating The Morphology Of The Binder Coated Silicon Carbide Grains At ~5 Grain Layers From OD Surface Of The Candle Filter

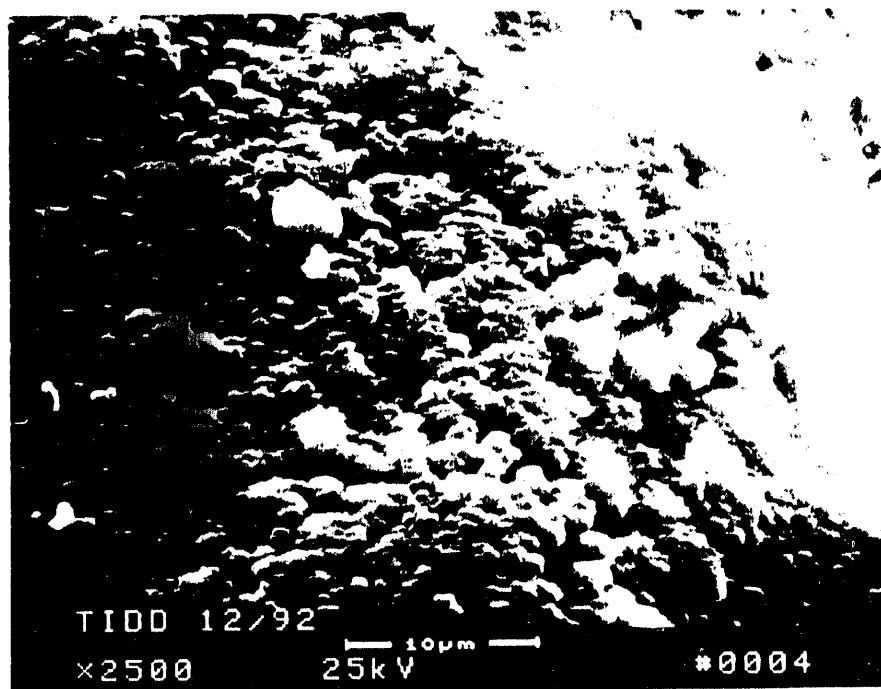
Figure 6.24 - High Magnification Micrographs Illustrating The Extensive Binder Surface Phase Formation Along The Silicon Carbide Grains That Are ~5 Grain Layers Below The OD Membrane Surface

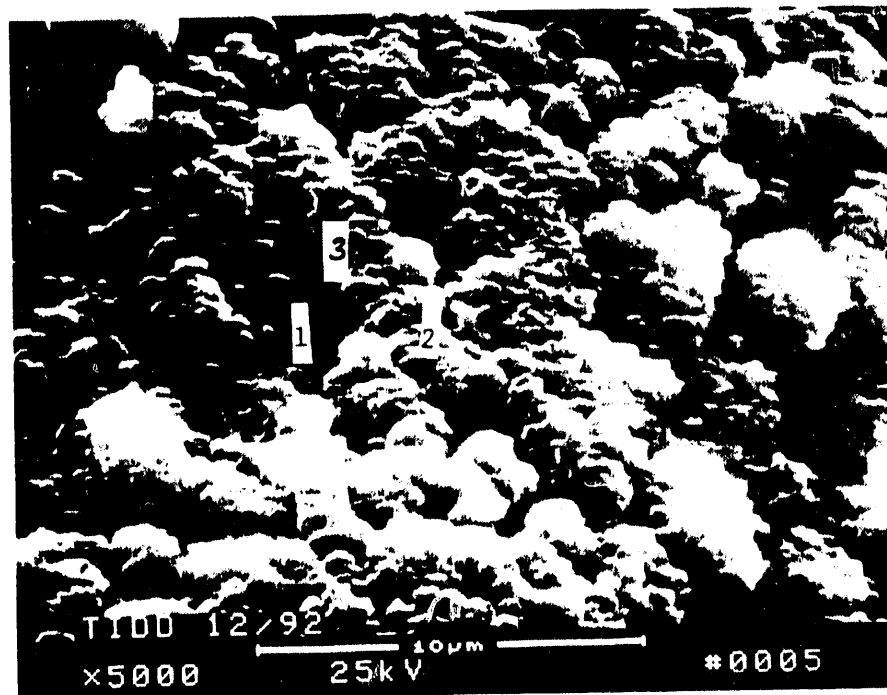
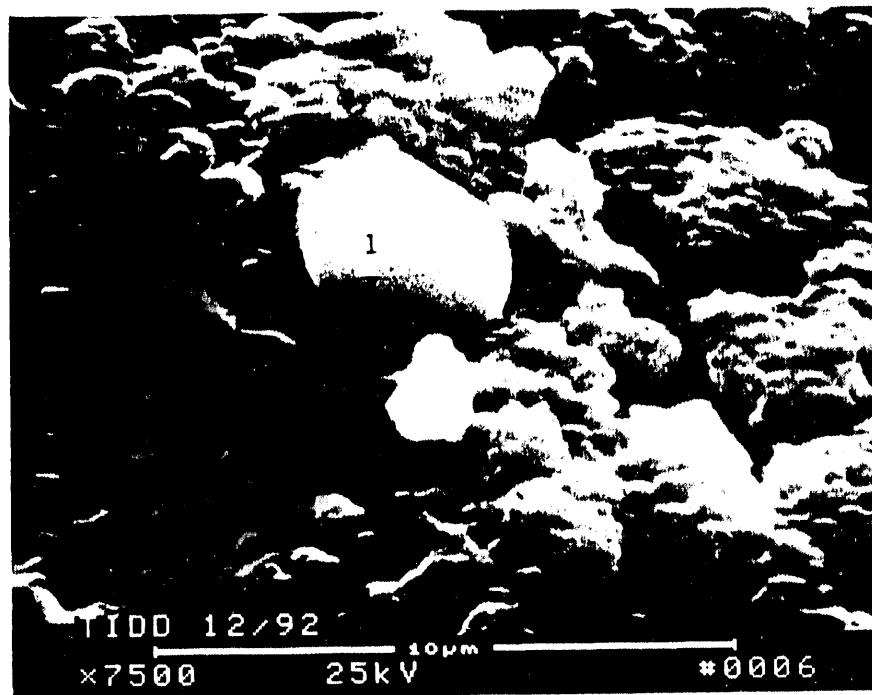
EDAX analyses of Area 1 in Photo 5 of Figure 6.25 indicated the presence of 83.86% Si, 8.80% Al, 5.18% K, 1.66% S, and 0.50% Na (NF = 0.824). Area 1 was considered to represent the binder surface phase that coated the silicon carbide grain, and which also served as the substrate layer for the formation of the sulfur-enriched crystalline phase. The extensive phase that formed along the binder surface (Area 2 in Photo 5 of Figure 6.25) was identified to contain 83.77% Si, 9.38% S, 4.67% Al, 1.65% K, and 0.54% Na (NF = 0.825). The smaller particles that formed on the binder substrate (Area 3, Photo 5, Figure 6.25)

Figure 6.25 - High Magnification Micrographs Detailing The Morphology Of The Binder Phase Along The Silicon Carbide Grains That Are ~5 Grain Layers Below The OD Membrane Surface

contained 82.83% Si, 10.31% Al, 3.44% K, and 3.42% S (NF = 0.817). Note the relatively low concentration of sodium detected in the binder phase, as well as the absence of calcium in this area.

The rather globular, 2-3  $\mu\text{m}$  particle shown in Photo 6, Figure 6.25, was a randomly occurring feature which contained 34.13% S, 31.97% Si, 23.59% Ca, 9.98% Al, and 0.33% Fe (NF = 0.684). The composition of this particle was representative of a fly ash fine that had been carried over and deposited within the silicon carbide matrix.

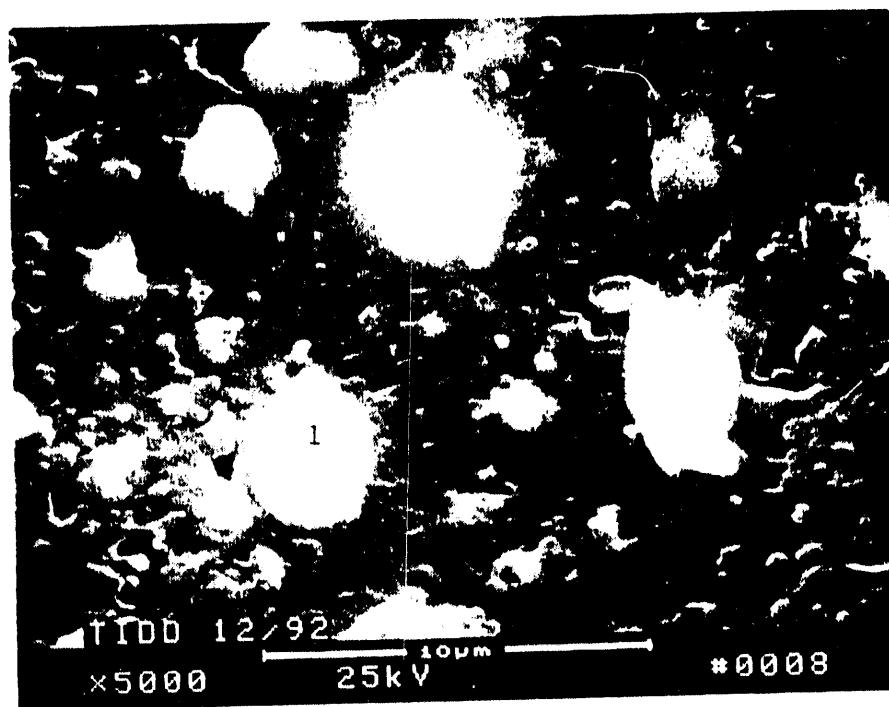
Figure 6.28 - Micrographs Illustrating The Morphology Of The Sulfur-Enriched Binder Phase And Deposited Fly Ash Particles

Figure 6.26 (Photo 7) is a high magnification micrograph which details the morphology of the surface phase which had formed along the binder coated grains. Note the rather crystalline-like appearance of the agglomerates which appeared to contain submicron, rounded surface features.

At another location along the silicon carbide grain (Photo 2 of Figure 6.23), we encountered surface features which indicated the attachment of 2-5  $\mu\text{m}$  fines along the binder phase. Area 1 in Photo 8, Figure 6.26, was identified to consist of 38.06% Si, 28.86% S, 16.96% Ca, 12.18% Al, 2.60% K, 0.90% Fe, and 0.44% Ti (NF = 0.661). The underlying binder phase beneath the ash fines was seen to coalesce, deteriorating the binder layer in many areas, as well as tending to enhance the formation of the mullite rod-like features.

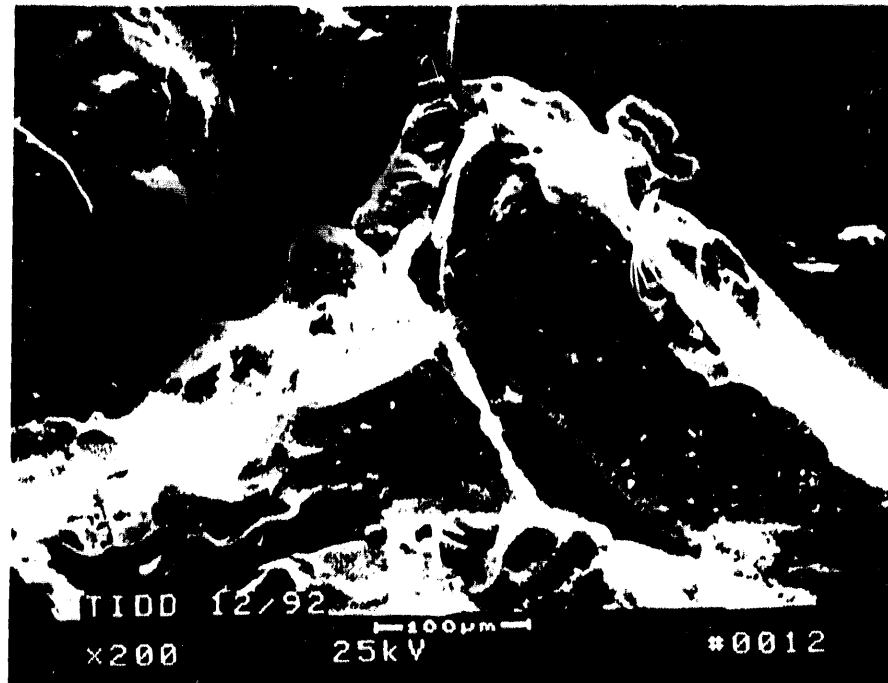
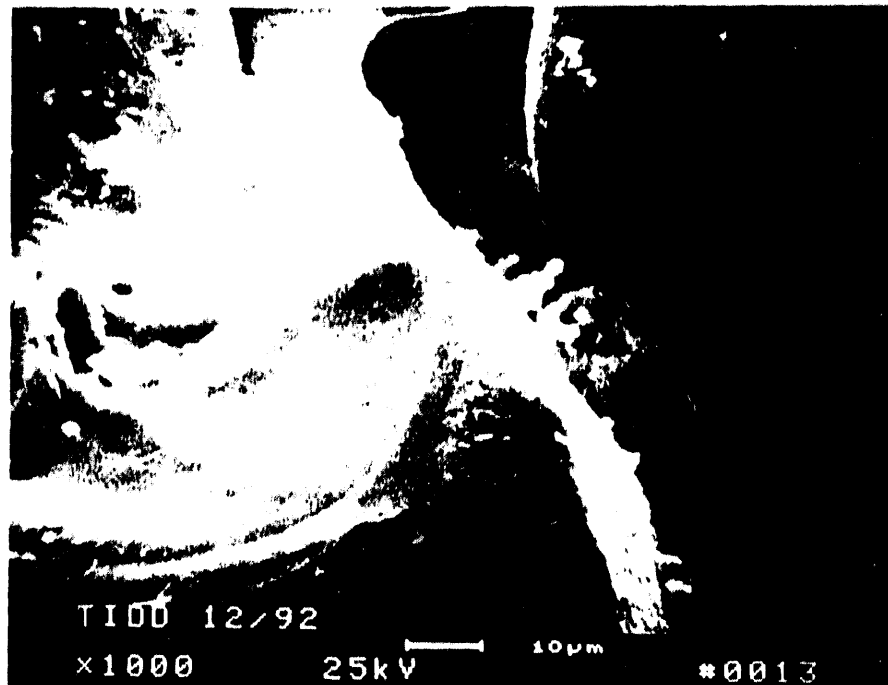
Figure 8.29 - Micrographs Illustrating The Morphology Of The Silicon Carbide Grains At ~5 mm Below The Membrane Coated OD Surface

Figures 6.29 through 6.32 illustrate the morphology of the silicon carbide grains at approximately 5 mm from the membrane coated candle filter OD surface. Fine particle agglomerates were seen to accumulate along the crevices between two adjacent grains (Photo 13, Figure 6.29). EDAX analysis of the fines indicated the presence of 38.72% Si, 31.13% S, 10.54% Ca, 10.01% Mg, 6.79% Al, 1.67% K, and 1.14% Fe (NF = 0.632), representing ash and sorbent constituents. The composition of Area 2 in Photo 14 of Figure 6.30 was principally a silicon-containing phase. Surface mottling was also apparent in this area.

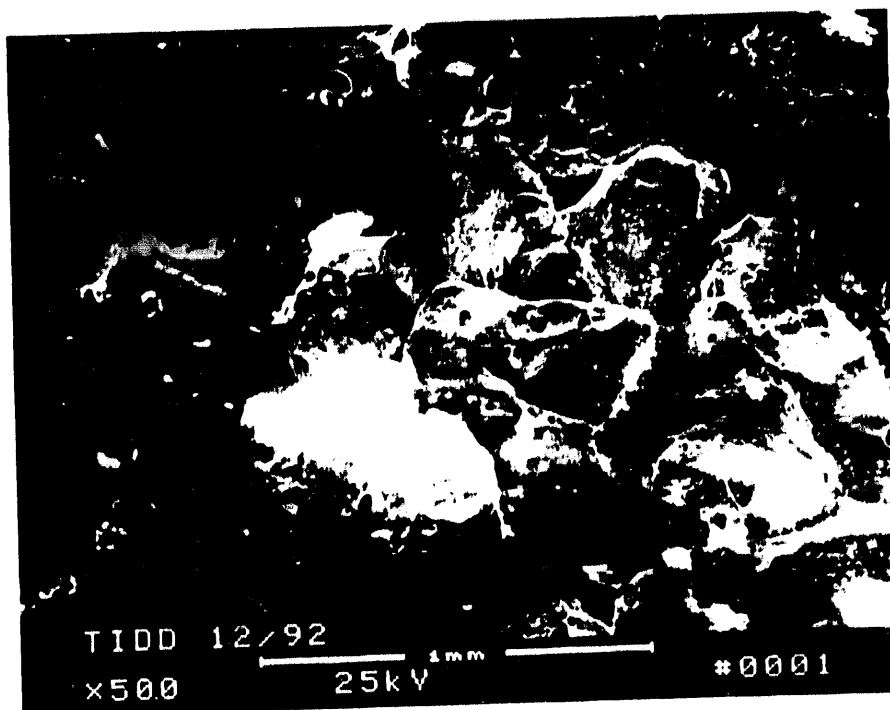
Figure 6.35 - Micrographs Illustrating The Morphology Of The Clay Bonded Silicon Carbide Grains At ~10 mm From The Membrane Coated OD Surface

Figures 6.35 through 6.39 illustrate the morphology of the clay bonded silicon carbide grains at ~10 mm from the membrane coated OD surface (i.e., 5 mm from the ID). Isolated areas of fines were detected along the binder, not only in crevices that formed between two adjoining grains, but were also deposited along the surface of the silicon carbide

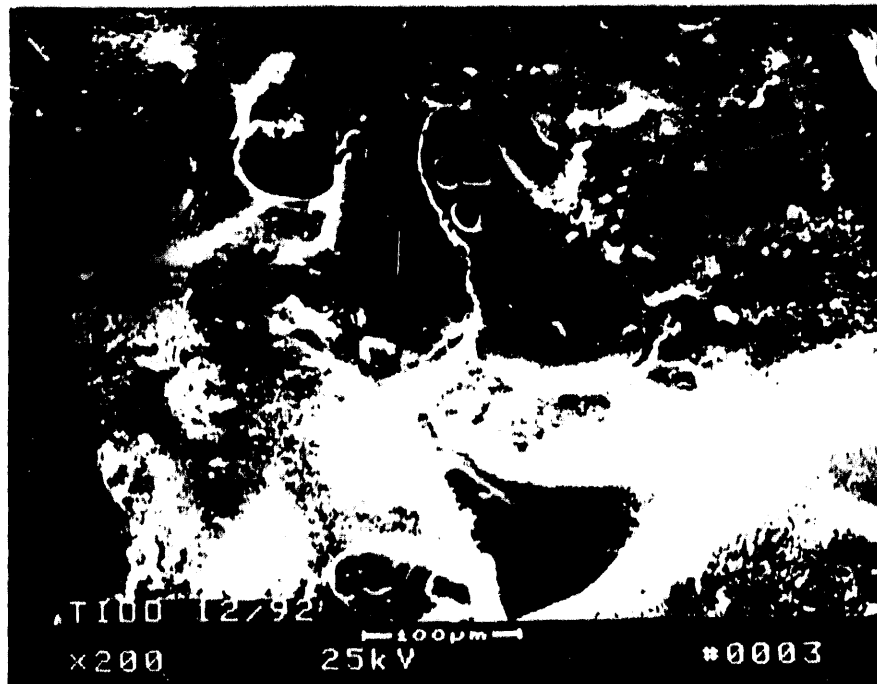
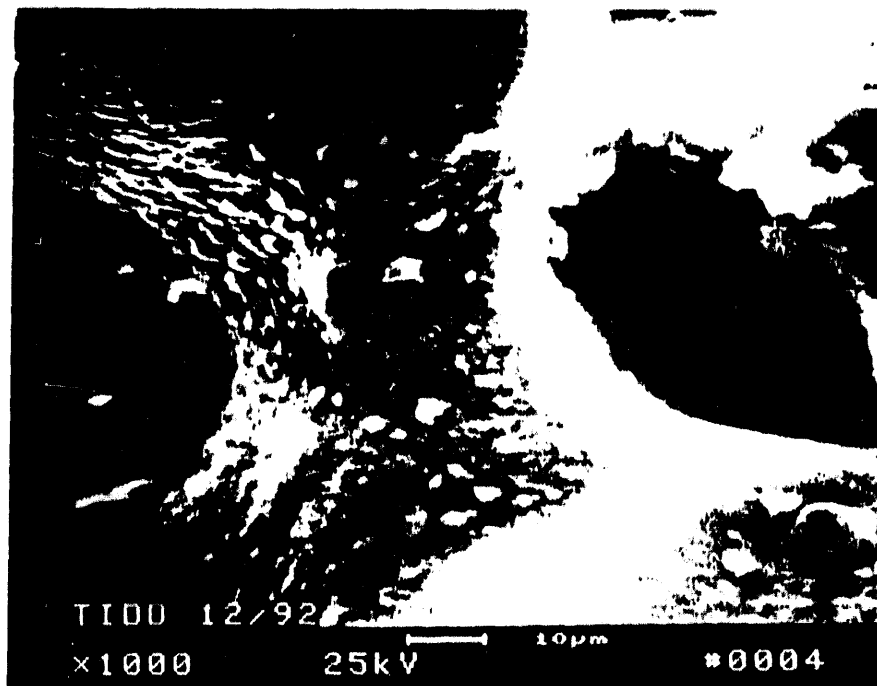
Figure 8.38 - Higher Magnification Micrographs Illustrating The Morphology Of The Binder Coating Along The Silicon Carbide Grains And Binder Interconnect Channels At ~10 mm From The Membrane OD Covered Wall

grains. Again extensive mottling was evident in the binder phase surface that coated the silicon carbide grains, as well as along the interconnect binder channels (Photos 3 and 4 in Figure 6.36).

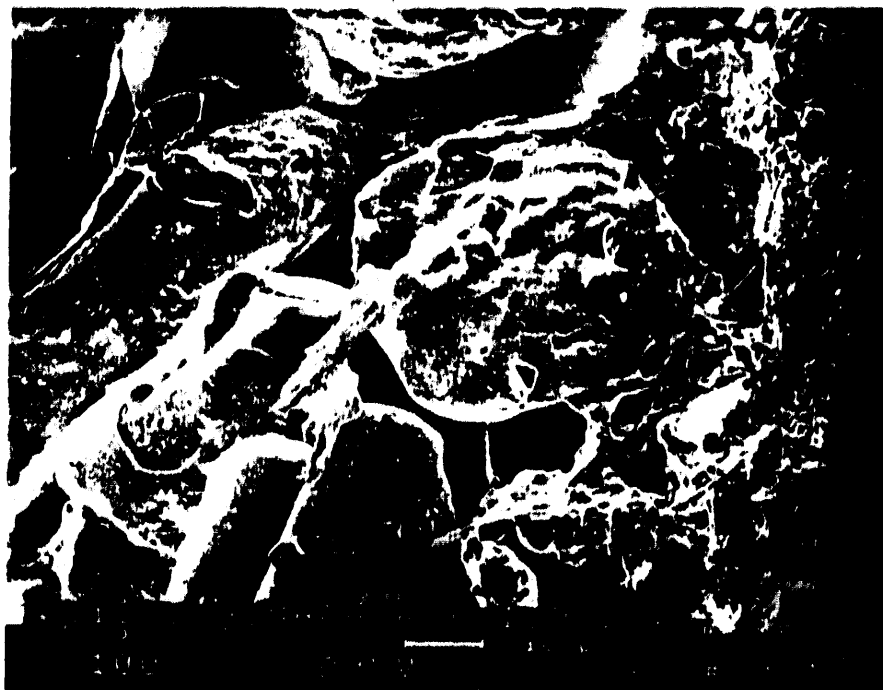
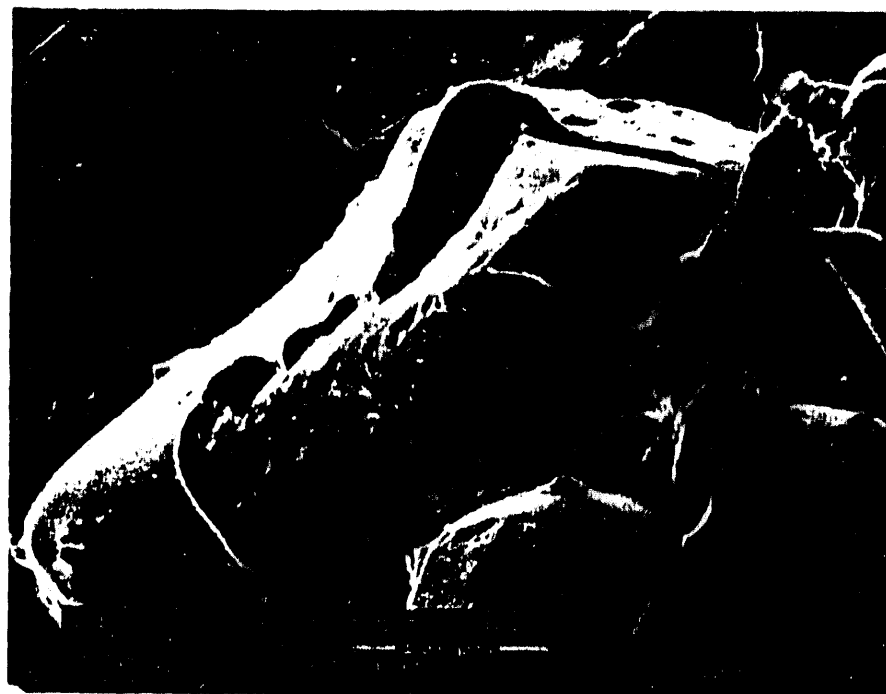
determination. During sample preparation the C-rings were cut wet. A C-ring section that was strength tested at room temperature was subjected to SEM/EDAX characterization using the Link XL EDAX system. The morphology of the silicon carbide matrix adjacent to the aluminosilicate fibrous membrane is shown in Figure 6.57. At high magnification the morphology of the binder phase appeared to be mottled (Figure 6.58). EDAX analysis of Area 1 in Photo 3 of Figure 6.58 indicated the presence of 73.049% O, 20.401% Si, 3.081% Al, 2.781% Na, and 0.687% K, indicative of a thin binder phase coating along the debindered silicon carbide grain. Area 1 shown in Photo 4 of Figure 4.58 contained 71.966% O, 19.820% Si, 4.030% Al, 2.977% Na, and 1.207% K, also representative of the binder phase that coated the underlying silicon carbide grain. Area 2 in Photo 4 of Figure 6.58 appeared to consist of the raised agglomerate phase which was previously described. In this sample, the agglomerate consisted of 73.434% O, 18.036% Si, 3.701% Na, 3.257% Al, 0.902% K, and 0.669% Mg. Note the absence of both sulfur and calcium in this area.

Figure 8.57 - Micrographs Illustrating The Morphology Of The Silicon Carbide Grains Within The Filter Material That Had Been C-Ring Sectioned For Strength Analysis. This Section Was Cut Wet During Sample Preparation.

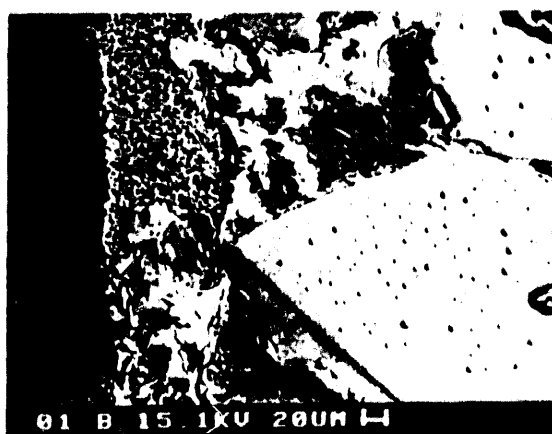
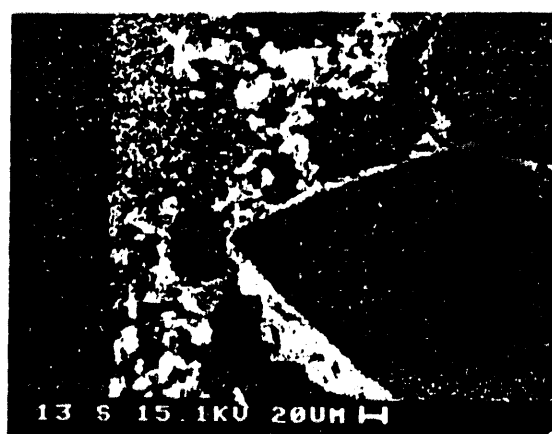
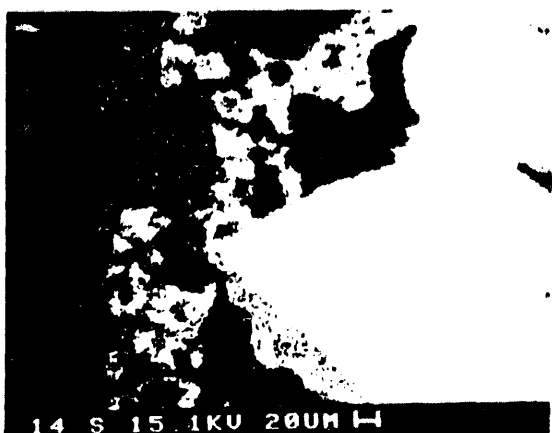
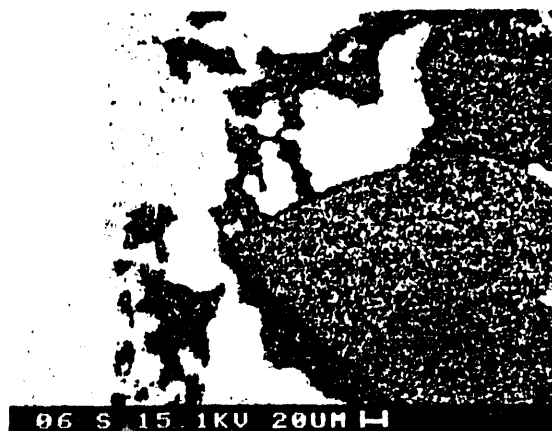
Elemental microprobe analysis (EMA) was performed along a fractured cross-section of the clay bonded silicon carbide matrix that had been exposed for 500 hours to the PFBC oxidizing environment. Figure 6.67 shows the morphology of the mounted, polished, and gold coated cross-section of material that was used in this effort. Note the variation in the thickness of the clay binder phase that coated the silicon carbide grains (i.e., BSE (back-scatter electron) micrograph, silicon-, aluminum-, and oxygen-enriched areas).

Figure 6.67 - Elemental Microprobe Analysis Across A Polished Section Of The 500 Hour PFBC Exposed Clay Bonded Silicon Carbide Matrix

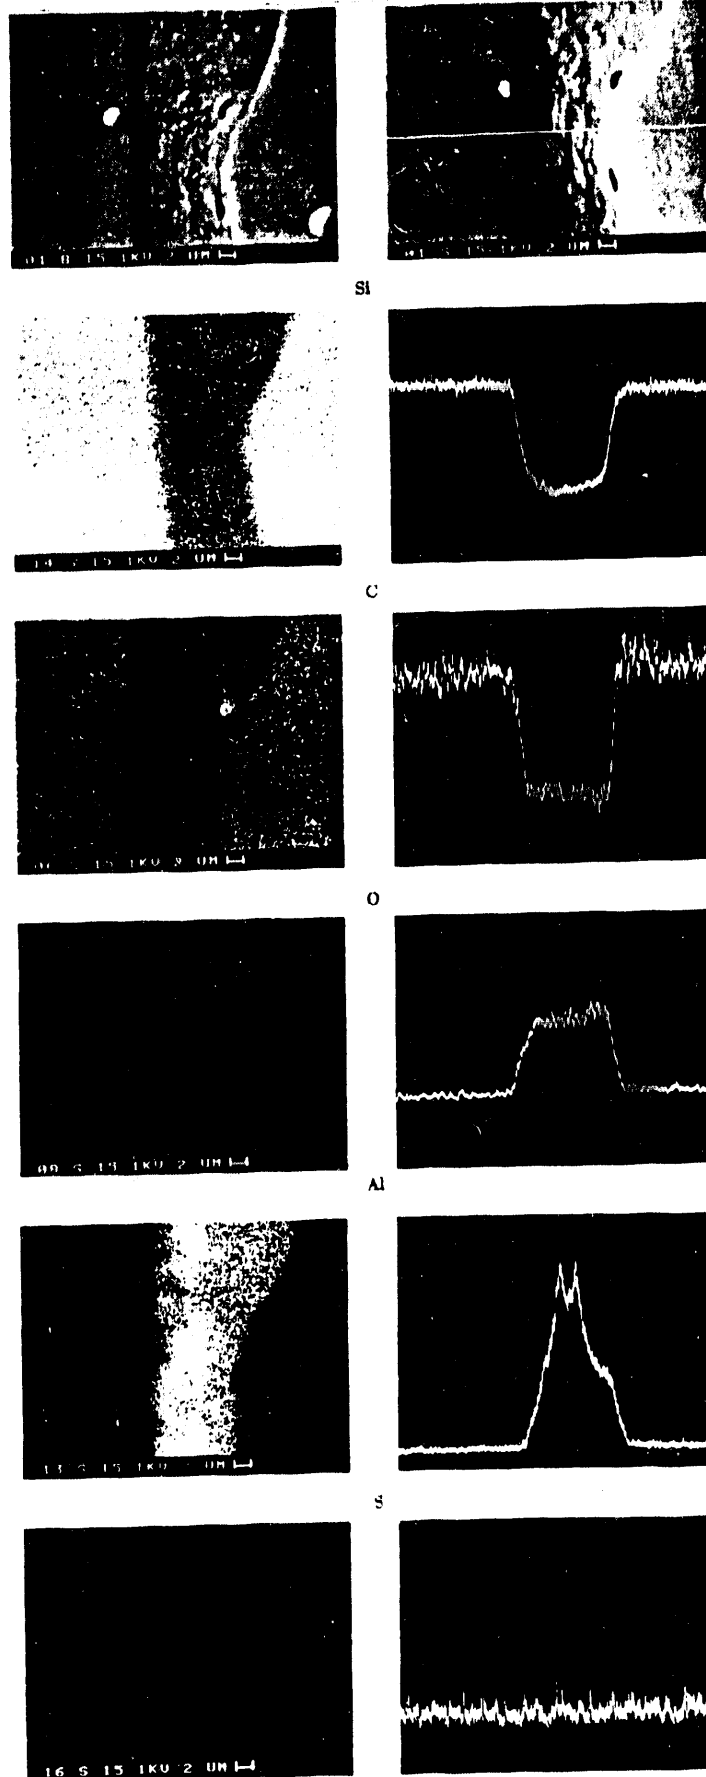
We attempted to qualitatively track the presence of silicon, carbon, aluminum, oxygen, and sulfur through a binder interconnect area (i.e., between two adjacent grains) in the PFBC exposed clay bonded silicon carbide matrix. As shown in Figure 6.68, oxygen, aluminum, and silicon were present in the binder interconnect area, while silicon and carbon were present in the adjoining silicon carbide grains. Line traces across the area indicated in the upper right micrograph detail the relative concentration of each element. The concentration of aluminum significantly increased near the mid-section of the binder interconnect phase, and was depleted close to each adjoining silicon carbide grain. At this magnification, the presence of an oxide formation along the silicon carbide grains, at the grain-binder interface was not apparent. Higher resolution micrographs and line traces are needed to resolve this concern.

Figure 6.68 - Elemental Microprobe Analysis And Line Traces Across A Polished Section Of The 500 Hour Exposed PFBC Clay Bonded Silicon Carbide Matrix

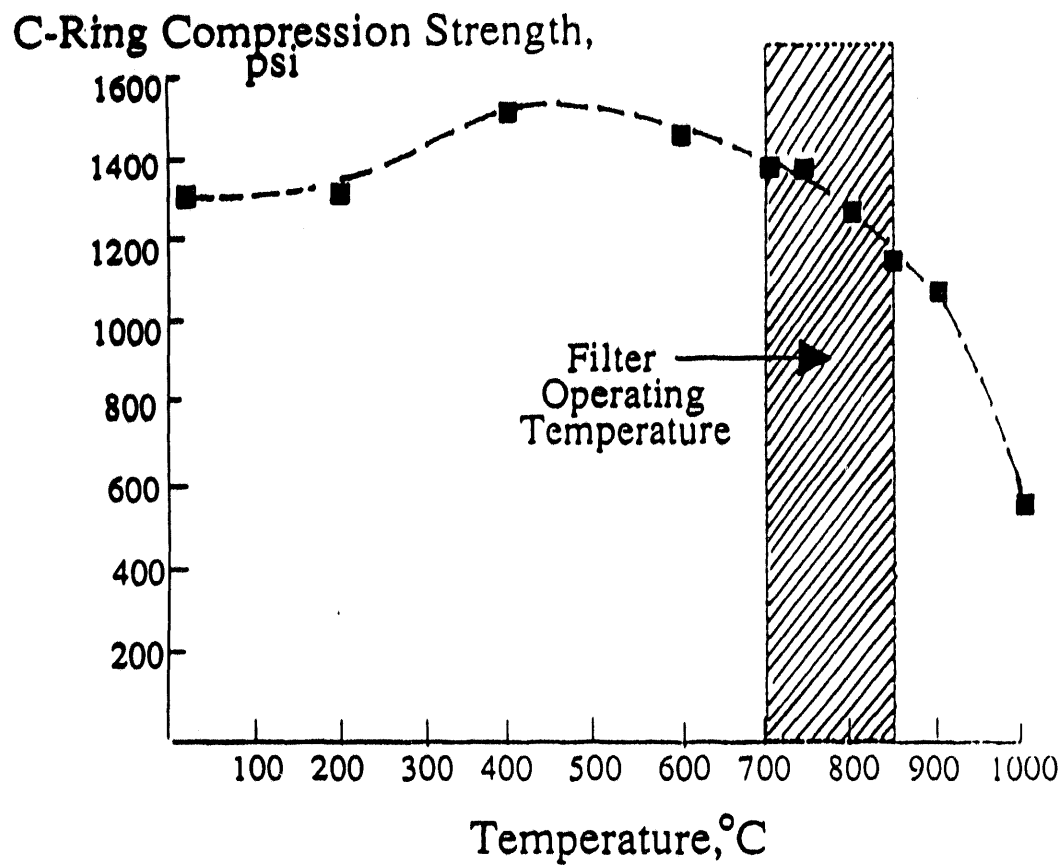
A full length candle filter was sectioned for C-ring compression strength analysis. Typically the 9 to 10 mm thick C-ring sections were prepared without chamfering along the edge of the coarse clay bonded silicon carbide structure. Between 5 and 10 C-rings were tested at temperatures ranging between 25 and 1000°C. As shown in Table 7.1 and Figure 7.1, strength appears to increase between room temperature and 400°C (70 and 752°F). Thereafter, the strength of the clay bonded silicon carbide matrix decreases as temperature increases. Note that an ~10%  $1\sigma$  variation results in the reported strength values.

Figure 7.1 - C-Ring Compression Strength Of An As-Manufactured Clay Bonded Silicon Carbide Schumacher Dia Schumalith F40 Candle As A Function Of Temperature

- The as-manufactured clay bonded silicon carbide Schumacher Dia Schumalith F40 matrix retain its initial strength up to temperatures of  $\sim 750$ - $800^{\circ}\text{C}$ . Thereafter a reduction in the as-fabricated strength of the matrix resulted. A brittle fracture characteristic of the
