**ADVANCED PARTICLE FILTER**

Technical Progress Report No. 11  
January through March 1993

Westinghouse Science and Technology Center  
Pittsburgh, Pennsylvania

# **TIDD ADVANCED PARTICLE FILTER**

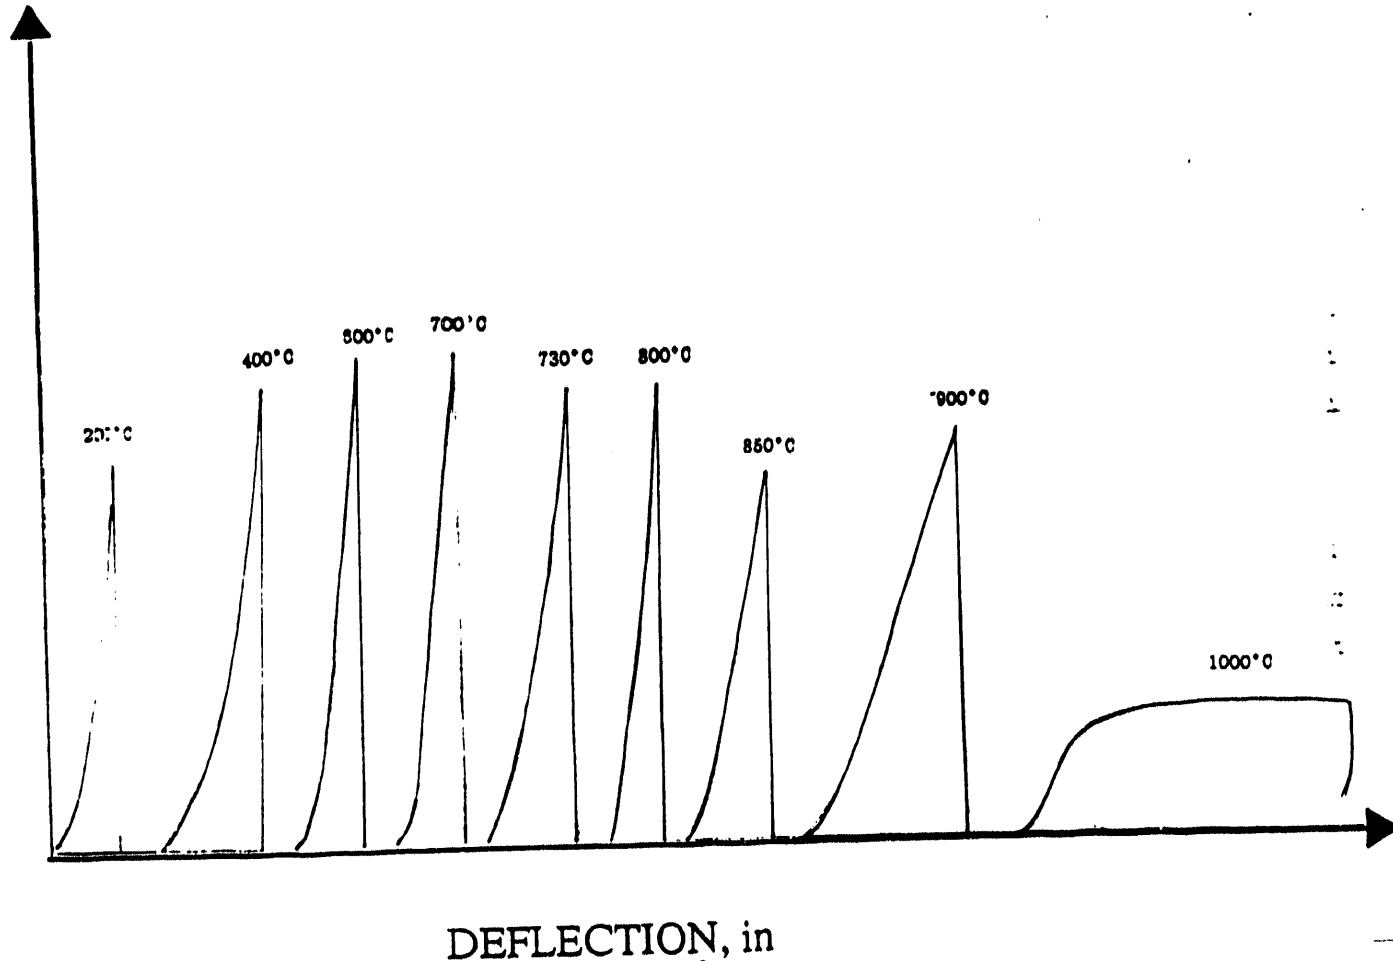
material strength in comparison to their as-manufactured room temperature strength. As shown in Figure 7.2, the brittle characteristics of the clay bonded silicon carbide matrix are retained to temperatures of 900°C. The material exhibits a plastic characteristic at temperatures between 900°C (1652°F) and 1000°C (1832°F) and 1832°F).

Figure 7.2 - O-Ring Compression Load Versus Deflection Curves For The Schumacher Dia Schumalith As-Manufactured Matrix As A Function Of Temperature

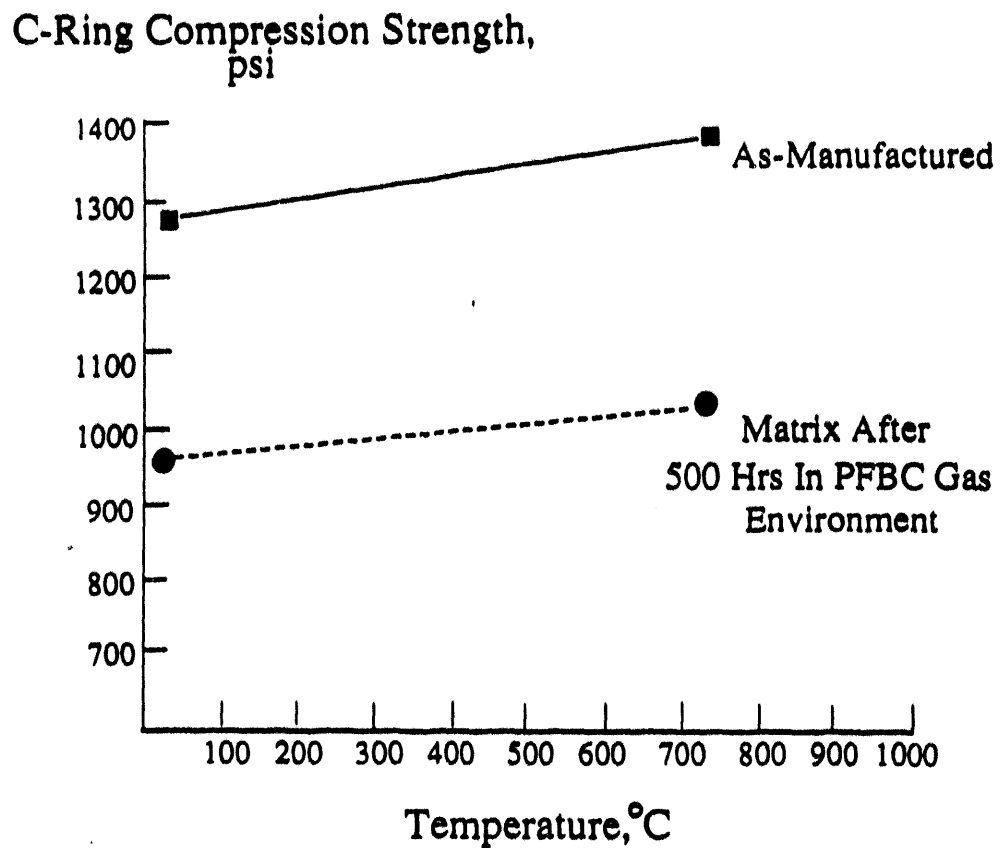
Note in Table 7.2 and Figure 7.3 that the strengths of the as-manufactured and failed candle section at 730°C (1346°F) were somewhat higher than their corresponding room temperature strengths. We suspect that the phase changes and/or crystallization which occurred along the pore cavity wall (Discuss in Section 6) enhanced the hot strength of the PFBC exposed filter material over its room temperature strength. Figure 7.4 provides the load versus deflection curves for the clay bonded silicon carbide matrix after exposure in the PFBC gas environment. Brittle fracture characteristics of the exposed matrix resulted during C-ring compression testing.

Figure 7.3 - Comparison Of The As-Manufactured And 500 Hour PFBC Gas Exposed Clay Bonded Silicon Carbide Filter Material Strengths

- O-ring strength analysis of the candle filter segments removed from the ash hopper indicated that the matrix retained 75% of its as-fabricated strength at room temperature test conditions. At process temperatures of 730°C, the failed filter segments retained 73% of their as-fabricated hot strength. A 10%  $1\sigma$  value was typical for all room temperature and hot strength O-ring compression strength measurements performed to date.

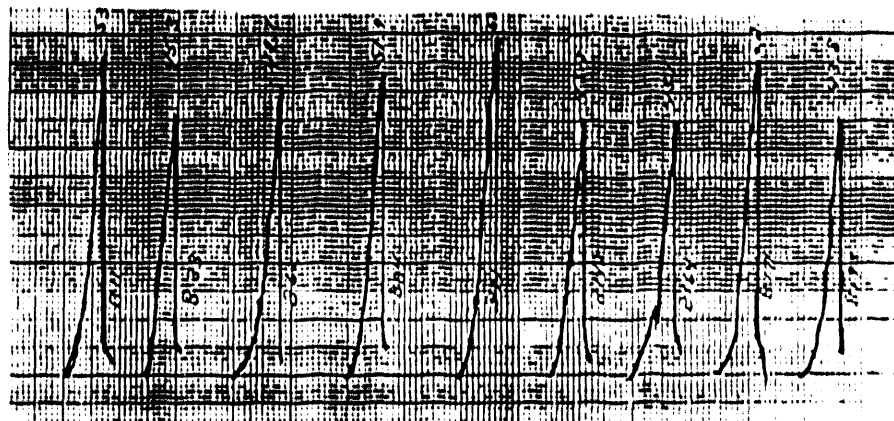
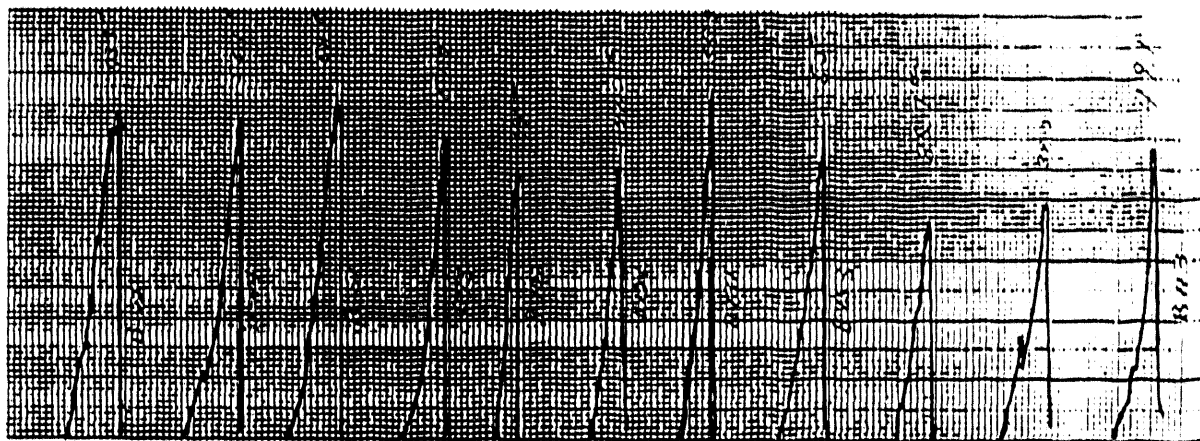
A section of the clay bonded silicon carbide filter that had been removed from the Westinghouse APF ash hopper was subjected to strength characterization. We are not able to identify the total length of operating time that the ~305 mm (~12 inch) candle filter segment had experienced, prior to the candle breaking. Table 7.2 and Figure 7.3 present the room temperature and hot strength (730°C; 1346°F) data for the as-manufactured matrix, as well as comparable strength data for the fractured candle filter segment. After 500 hours of exposure in the PFBC gas environment, a 25-27% reduction in strength of the candle filter matrix was observed at both room temperature and at process operating temperatures of 730°C (1346°F).

Figure 7.4 - Load Versus Deflection Curves For The Clay Bonded Silicon Carbide Matrix That Was Removed From The Ash Hopper

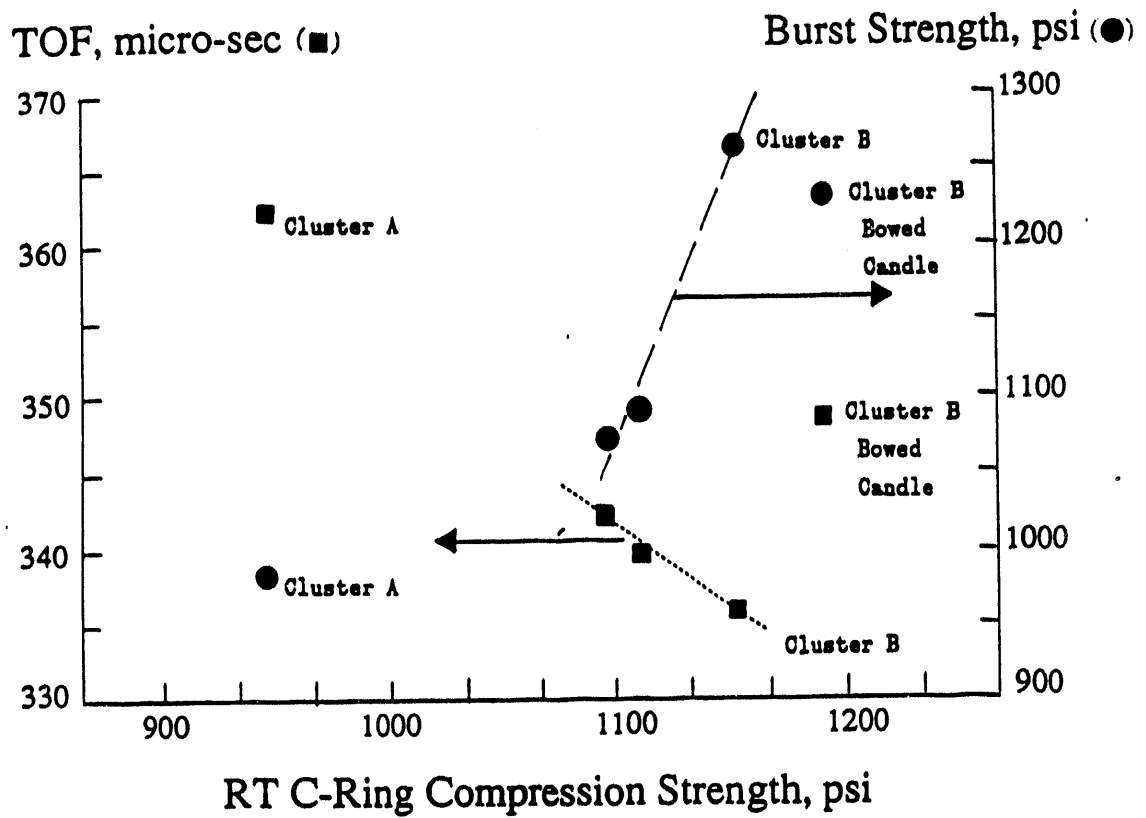
A direct correlation between room temperature O-ring compression and burst strength of the 500 hours PFBC exposed clay bonded silicon carbide matrix was indicated for candles that were located in a common cluster or location within the Westinghouse APF vessel (Figure 7.5). What was also interesting to note was that as the candle TOF value increased, the room temperature O-ring compression strength of the clay bonded silicon carbide matrix decreased, again for candle filters that were located within a common cluster or location within the Westinghouse APF vessel. Cluster A candles and the bowed Cluster B candle tended to deviate from the TOF/O-ring compression and burst strength/O-ring compression relationship.

Note that the O-ring compression strength tests detail any changes or flaws that have been introduced along the candle OD surface during process operation. In contrast the burst strength data provide information with regard to more typically macroscopic changes that have occurred along the candle ID surface. Based on the limited strength data that have been generated to date, as well as the physical characteristics of the primary fracture along each failed candle filter element, thermal fatigue due to pulse cycling does not appear to significantly contributed to changes within the clay bonded silicon carbide candle filter matrix. O-ring

Figure 7.5 - Correlation Of TOF And Burst Strength Data With Room Temperature C-Ring Compression Strength Data For Candle Filters That Have Been Exposed To 500 Hours Of PFBC Gas Environment

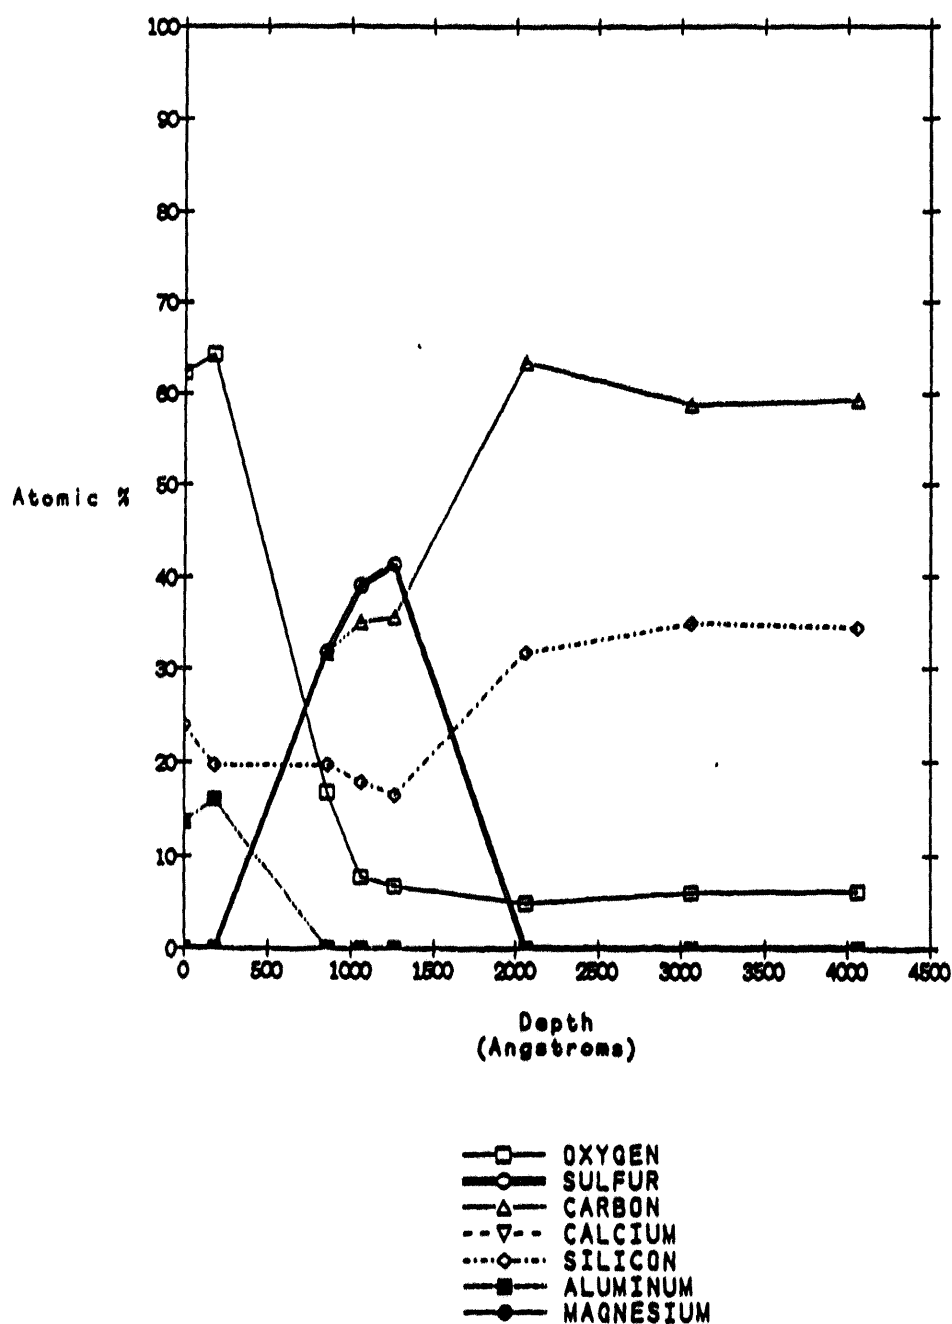
Auger analysis was performed along the section of the candle filter matrix that had fallen into the ash hopper. Table 7.5 and Figure 7.6 detail the results of the Auger analysis along the binder coated silicon carbide grains that experienced PFBC gas conditions. Through a depth of  $\sim 4000\text{\AA}$  ( $\sim 4\text{ }\mu\text{m}$ ) we noted that considerable change had occurred within the binder phase. Along the external binder surface (i.e., pore cavity wall), oxygen (O), silicon (Si), and aluminum (Al) were detected. Along this area sulfur (S) was not detected until  $860\text{\AA}$  ( $0.860\text{ }\mu\text{m}$ ) had been sputtered away. Carbon (C) was also detected in this layer, while the concentration of silicon and oxygen decreased, and aluminum became virtually absent in the binder matrix. The carbon and sulfur content continued to increase as the sputtering depth increased, while the oxygen and silicon concentration continued to decrease. Deeper into the binder coated grains, the concentration of carbon increased in parallel with silicon, implying that the silicon carbide grain had been located. Note the low concentration of oxygen which also existed in this area ( $2060\text{\AA}$  or  $2\text{ }\mu\text{m}$ ). Further sputtering slightly enhanced the carbon and silicon atomic concentration, while oxygen was present at  $\sim 6$  atomic percent. The low concentration of oxygen in the silicon- and carbon-enriched matrix implied that a very thin oxide coating existed between the binder and the silicon carbide grain. Additional analyses are needed to further substantiate these results.

Figure 7.6 - Auger Depth Of Profile Through The Binder Phase Of The Clay Bonded Silicon Carbide Candle Filter After Exposure To The PFBC Gas Environment
