Title: Los Alamos National Laboratory W76 Pit Tube Lifetime Study

Los Alamos National Laboratory W76 Pit Tube Lifetime Study

Number: W-9-TR-0143U LA-UR-XX-XXXX	Revision	Effective Date: April 3, 2012
	A

Terri Abeln, W-9, Surveillance Oversight

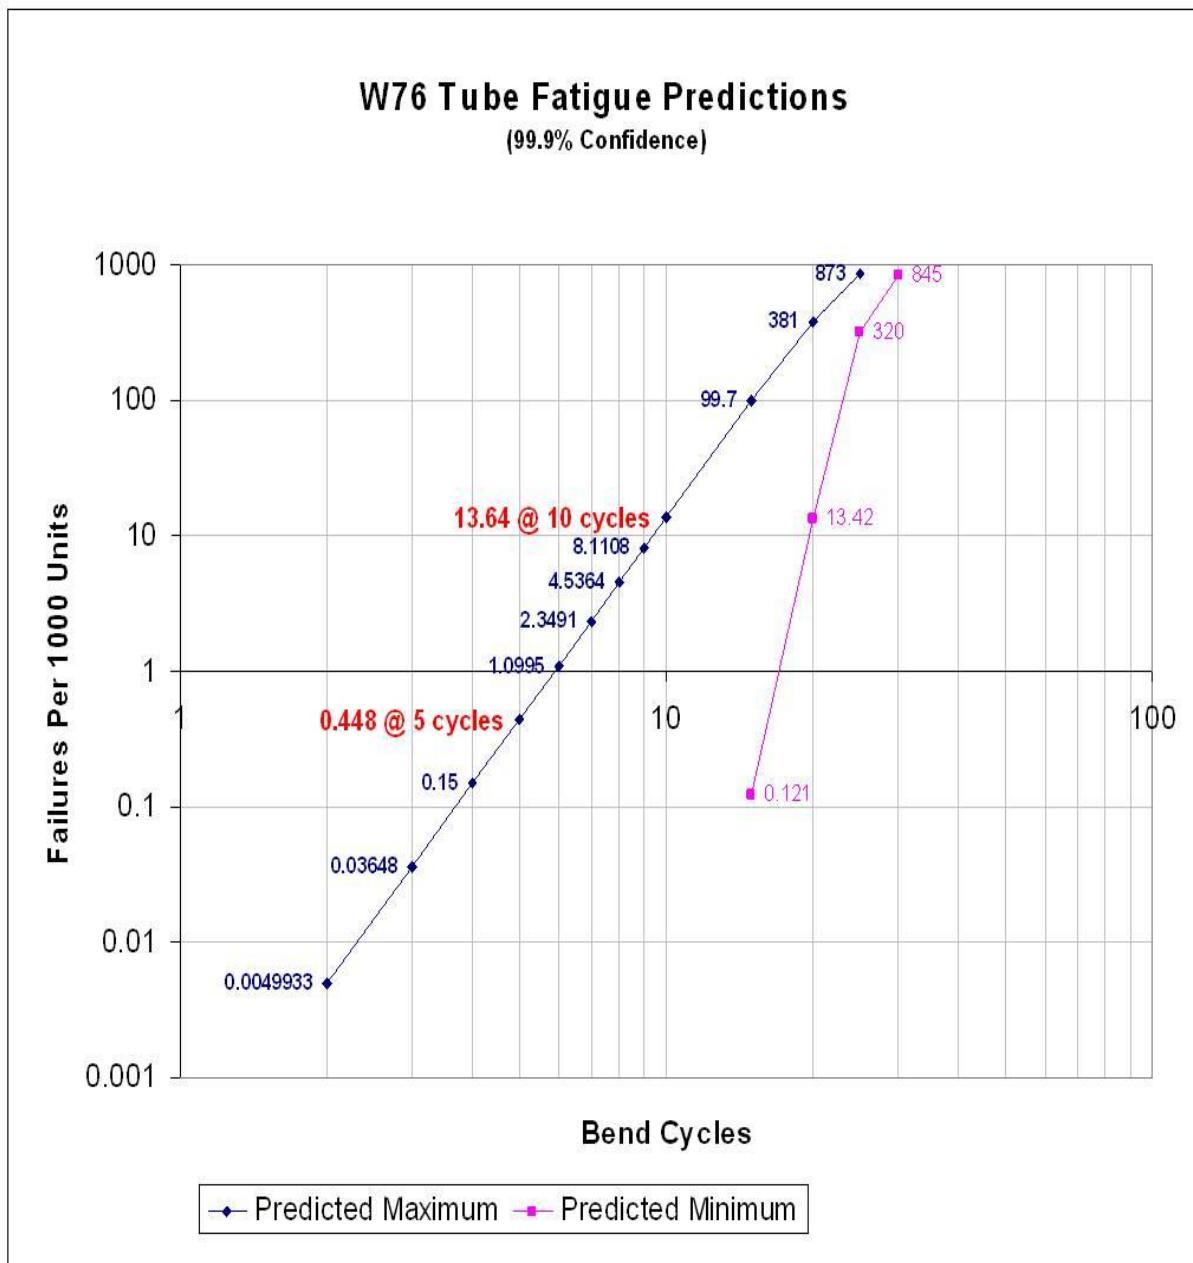
Graph 1

Graphical representation of failure prediction based on Weibull distribution. The middle line is the regression fit to the actual data points (triangles).
