Investigation of the Hydrogen Release Incident at the AC Transit Emeryville Facility

May 8, 2013

Chris San Marchi, Aaron Harris and Daniel Dedrick
Sandia National Laboratories

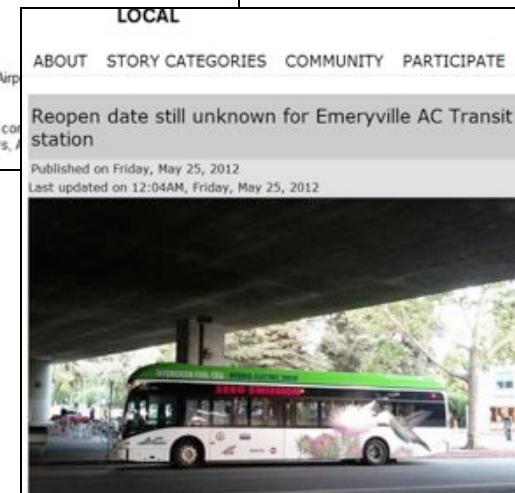
May 4, 2012: Witnesses reported loud “boom”, followed by continuous “jet” sound

- Hydrogen release and subsequent fire
- No injuries or fatalities
- Minimal damage
- Widely misrepresented in the press

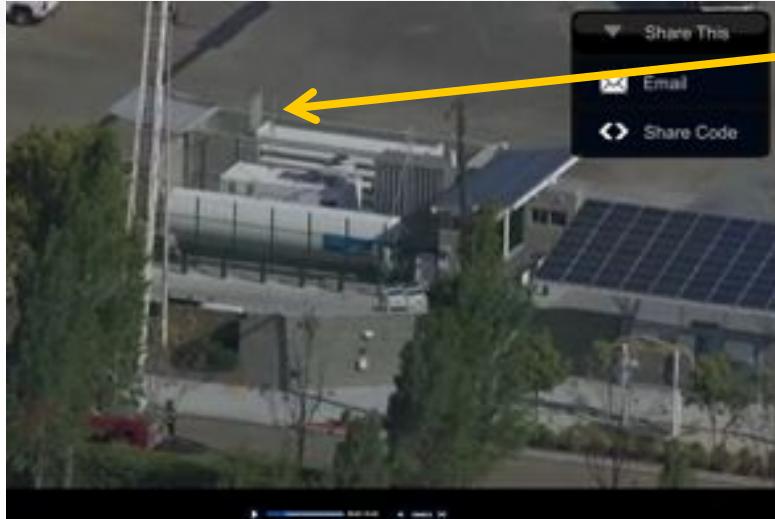
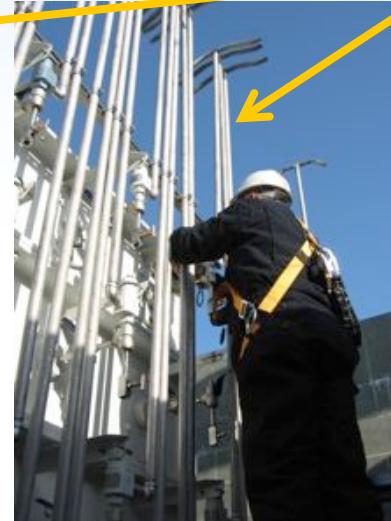
Incident Timeline

- Pressure relief valve fails, releasing hydrogen
- Hydrogen ignites and impinges on nearby canopy
- Employee presses e-stop isolating high pressure gas storage

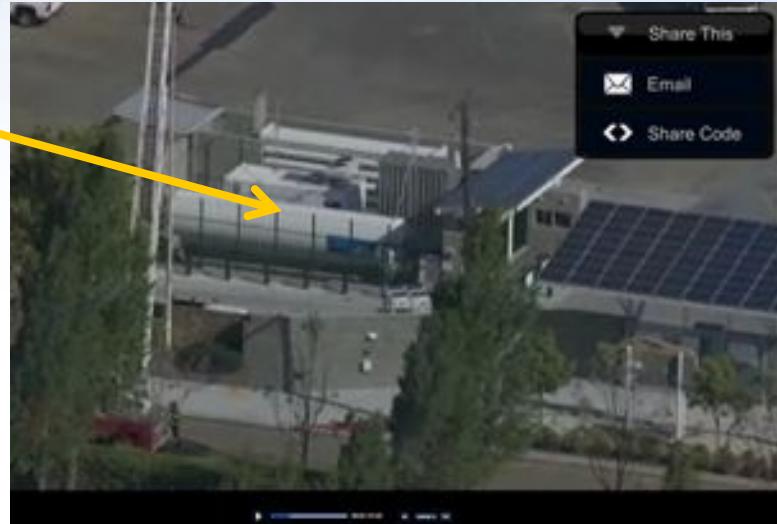
- 07:45 Valve failure
- 07:57 Fire Department arrives
- 08:10 – 09:00 Response to incident escalates
- Approx. 09:00 Evacuations of nearby businesses and schools ordered
- Approx. 10:00 Storage area entered and failed valve isolated
- 10:58 Incident command terminated
