241-AZ Farm Annulus Extent of Condition Baseline Inspection

J.K. Engeman, C.L. Girardot, B.J. Vazquez
Washington River Protection Solutions
Richland, WA 99352
U.S. Department of Energy Contract DE-AC27-08RV14800

Abstract: This report provides the results of the comprehensive annulus visual inspection for tanks 241-AZ-101 and 241-AZ-102 performed in fiscal year 2013. The inspection established a baseline covering about 95 percent of the annulus floor for comparison with future inspections. Any changes in the condition are also included in this document.

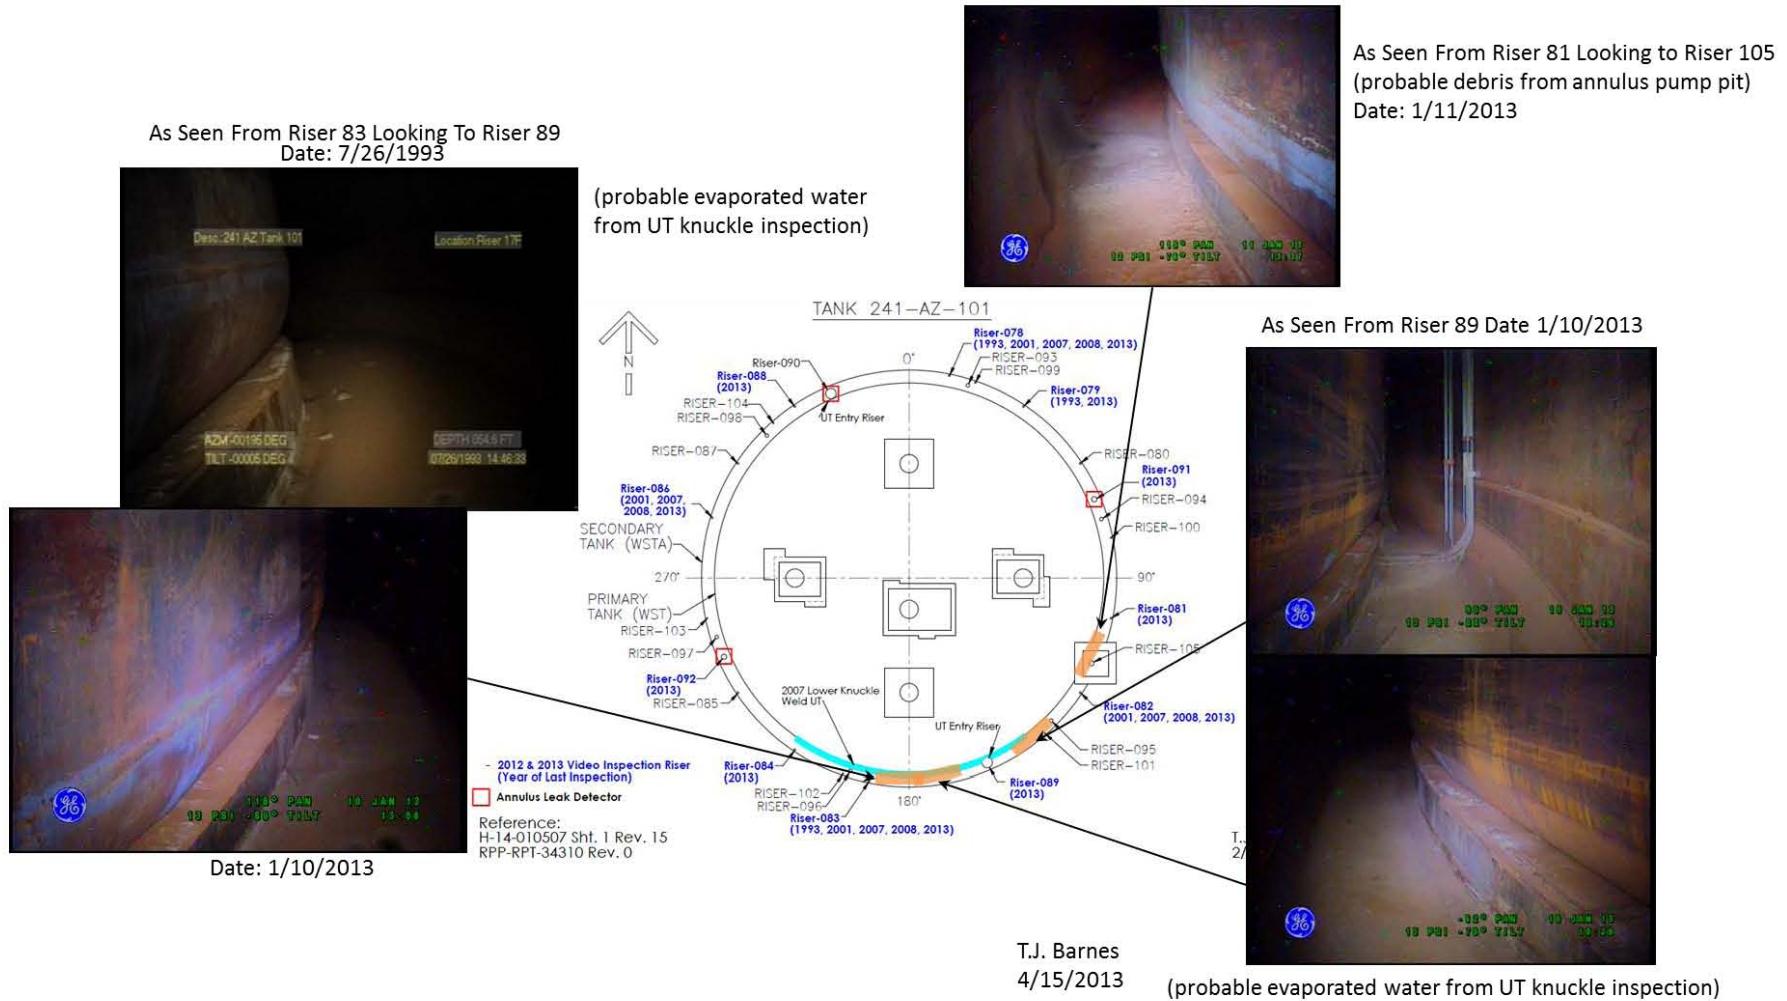
Figure ES-3. Tank AZ-101 Baseline Inspection Results Showing Additional Material on the Annulus Floor Attributed to Ultrasonic Inspections, ENRAF Installation, and Debris Accumulation

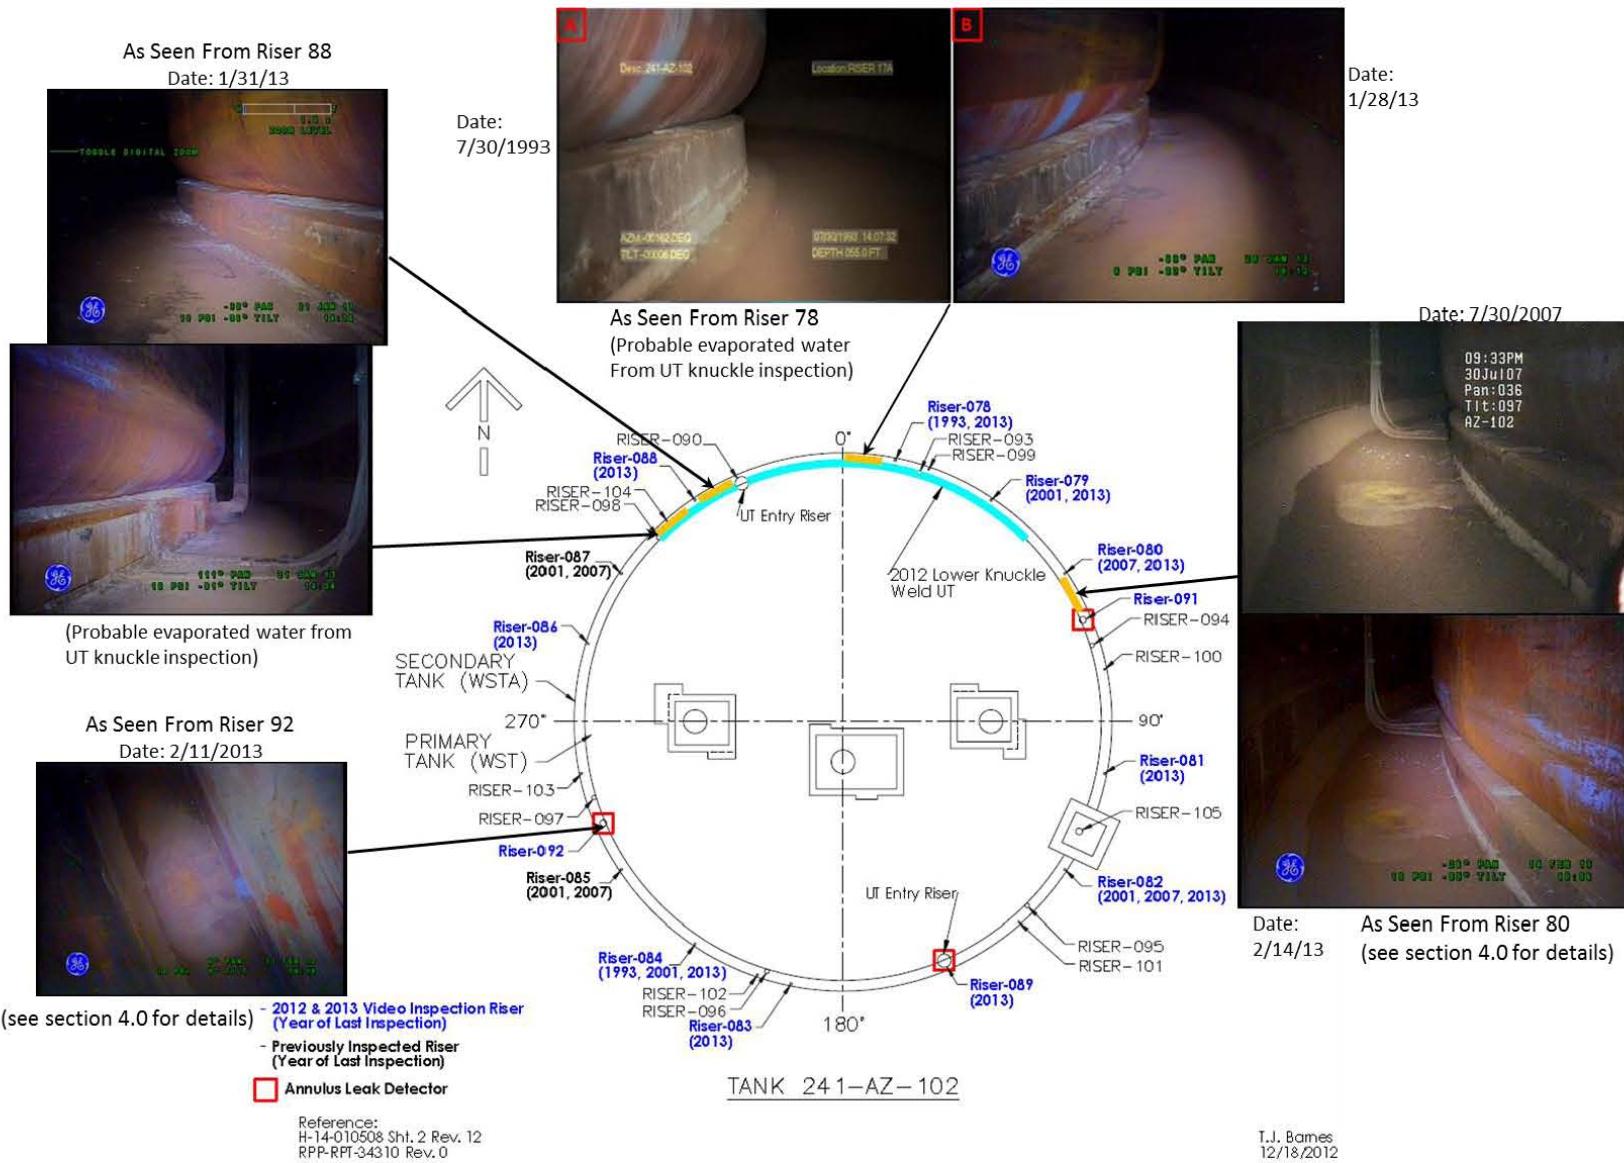
Figure ES-4. Tank AZ-102 Baseline Inspection Results Showing Additional Material on the Annulus Floor Attributed to Ultrasonic Inspections and ENRAF Installation

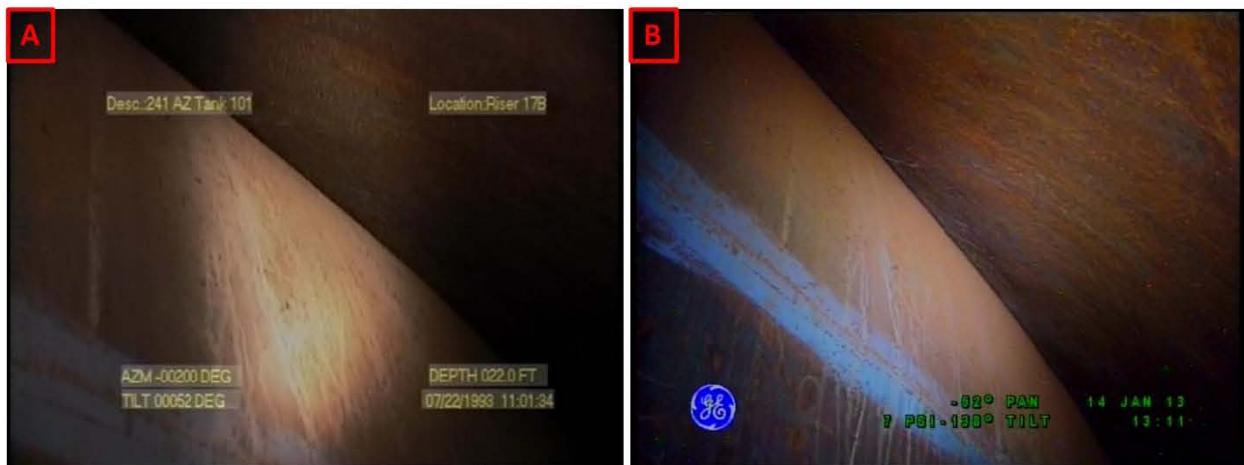
Figure 2-6 and Figure 2-7 show comparisons of the upper haunch area between inspections performed in 2001 and 2013. In both of these figures, white streaks can be seen on the primary tank. These white streaks, which are commonly seen among the DSTs, are referred to as laitance flow attributed to the pouring of the concrete dome during construction. There were no significant changes in the condition of this area from 2001 to 2013. No areas of interest were identified in the top knuckle region during the 2013 inspection.

Figure 2-7. Riser 79 Upper Haunch Comparisons Between Inspections on July 22, 1993 (A) and January 14, 2013 (B) Looking Towards Riser 99

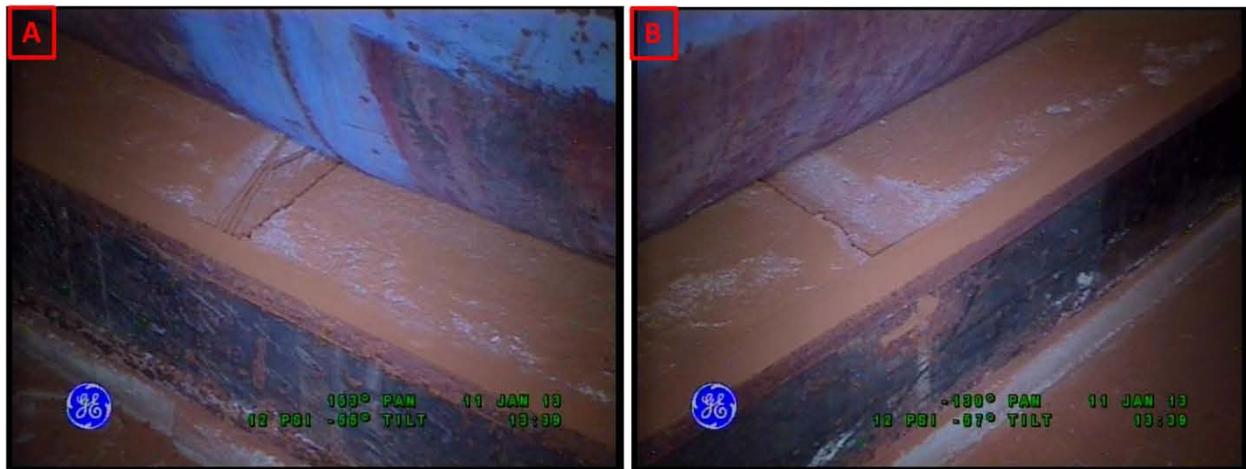
Figure 2-12. Riser 81 Lower Knuckle and Annulus Floor Condition on January 11, 2013

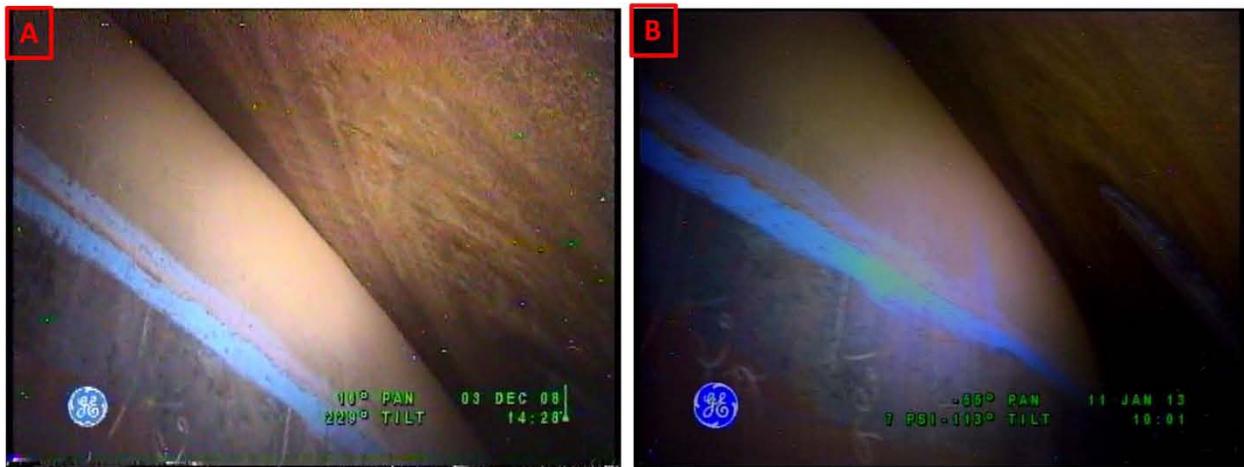
The tank dome and upper haunch area were not visible during the 2001 and 2007 inspections. Figure 2-13 and Figure 2-14 show comparisons of the upper haunch area between inspections performed in 2008 and 2013. There were no significant changes in the condition of this area from 2008 to 2013. No areas of interest were identified in the top knuckle region during the 2013 inspection.

Figure 2-14. Riser 82 Upper Haunch Comparisons Between Inspections on December 3, 2008 (A) and January 11, 2013 (B) Looking Towards Riser 105

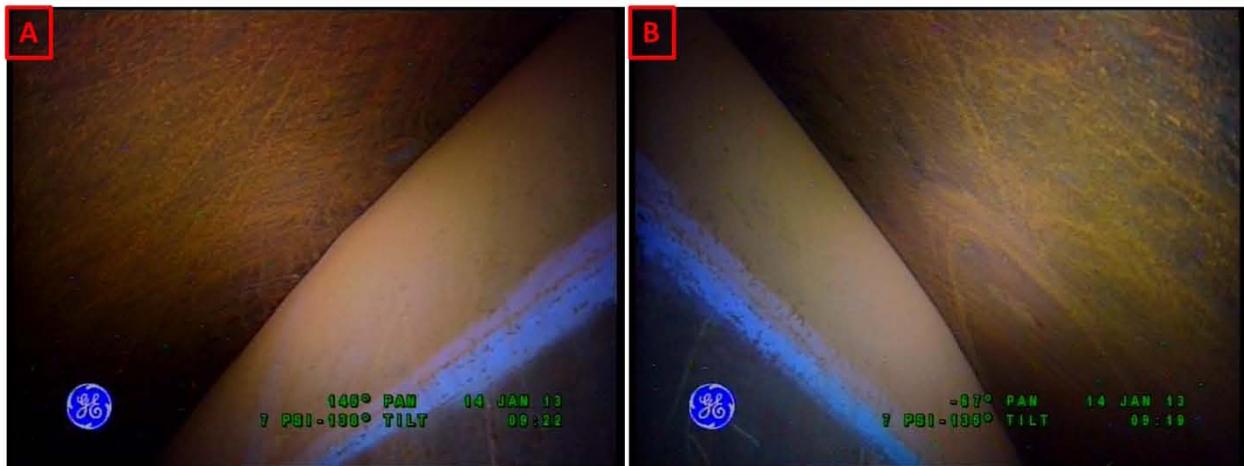
Figure 2-23 shows the general condition of the upper haunch area in January 2013. No areas of interest were identified in the top knuckle region during the 2013 inspection.

Figure 2-23. Riser 84 General Condition of the Upper Haunch on January 14, 2013
Looking Towards Riser 85 (A) and Looking Towards Riser 102 (B)

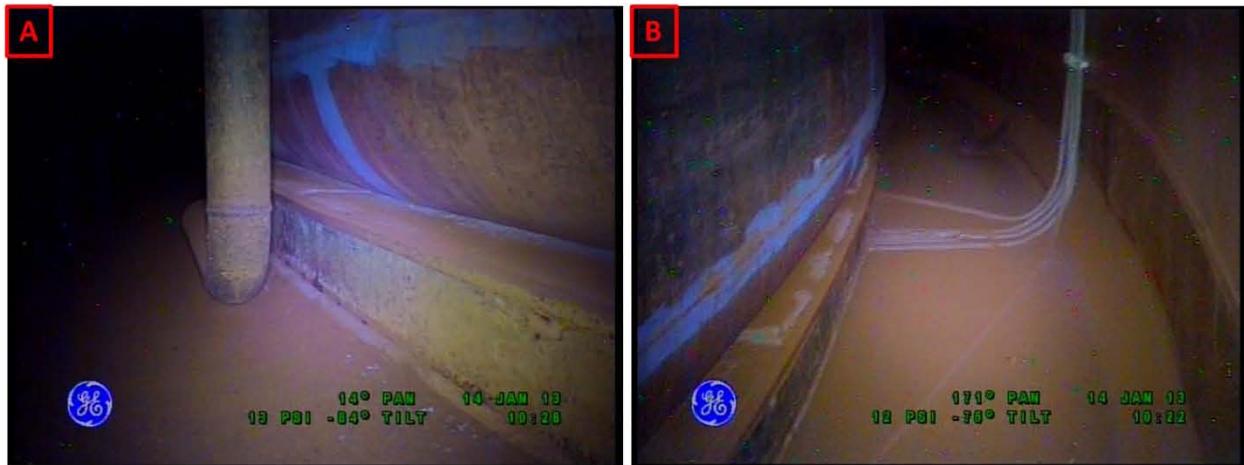
Figure 2-24 shows the general condition of the lower knuckle and annulus floor in January 2013. A beachline can also be seen along the annulus floor in Figure 2-24 which is likely the result of evaporated couplant water used during UT examinations. Figure 2-25 shows the general condition of the refractory slots in January 2013 and no anomalies were noted. No anomalies were identified on the lower knuckle of the primary tank, insulating refractory, refractory slots, stiffener ring, or annulus floor during the 2013 inspection.

Figure 2-24. Riser 84 Lower Knuckle and Annulus Floor Condition on January 14, 2013
Looking Towards Riser 85 (A) and Looking Towards Riser 102 (B)

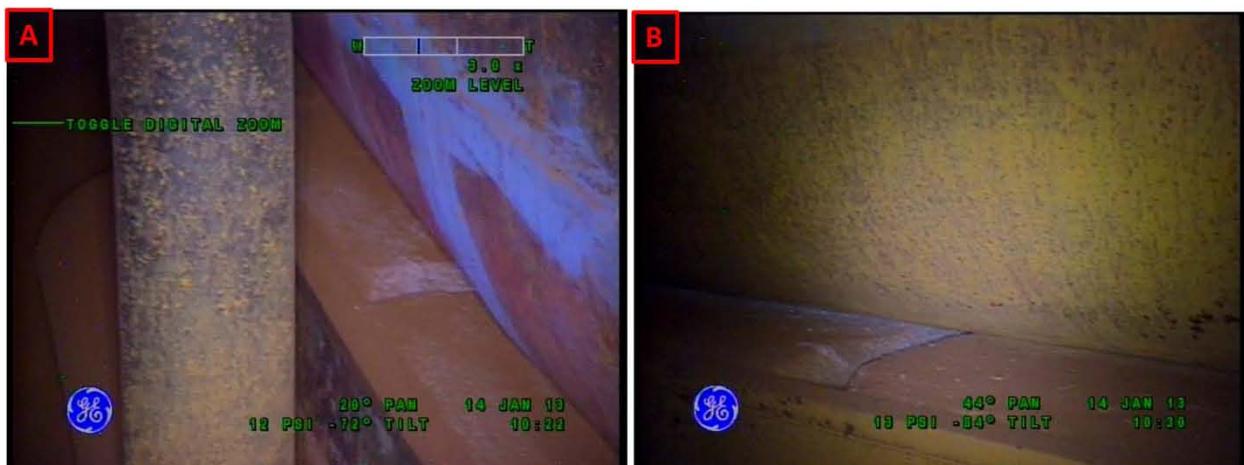
Figure 2-25. Riser 84 General Condition of the Refractory Slots on January 14, 2013

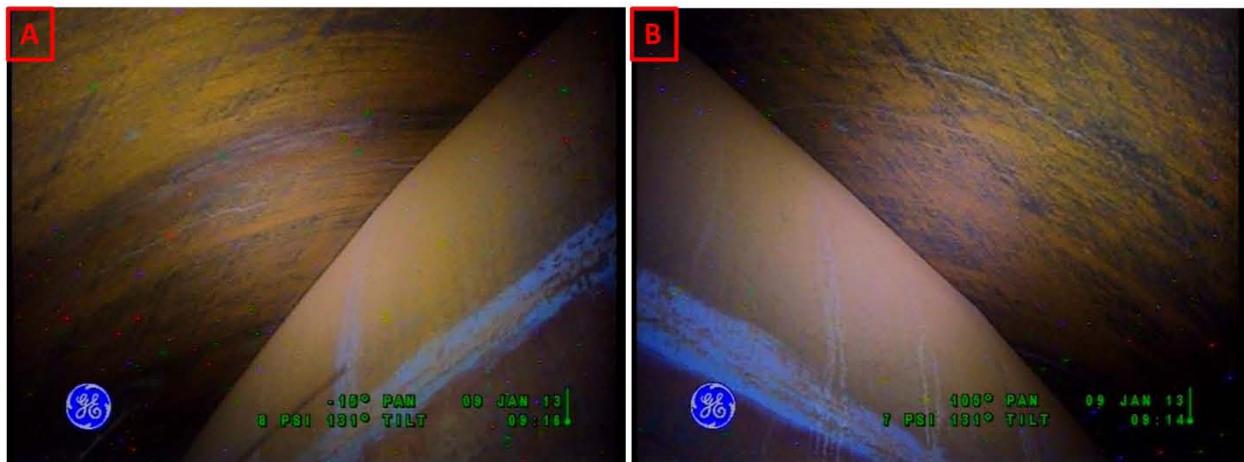
Figure 2-31 shows the general condition of the upper haunch area in January 2013. No areas of interest were identified in the top knuckle region during the 2013 inspection.

Figure 2-31. Riser 88 General Condition of the Upper Haunch on January 9, 2013 Looking Towards Riser 90 (A) and Looking Towards Riser 104 (B)

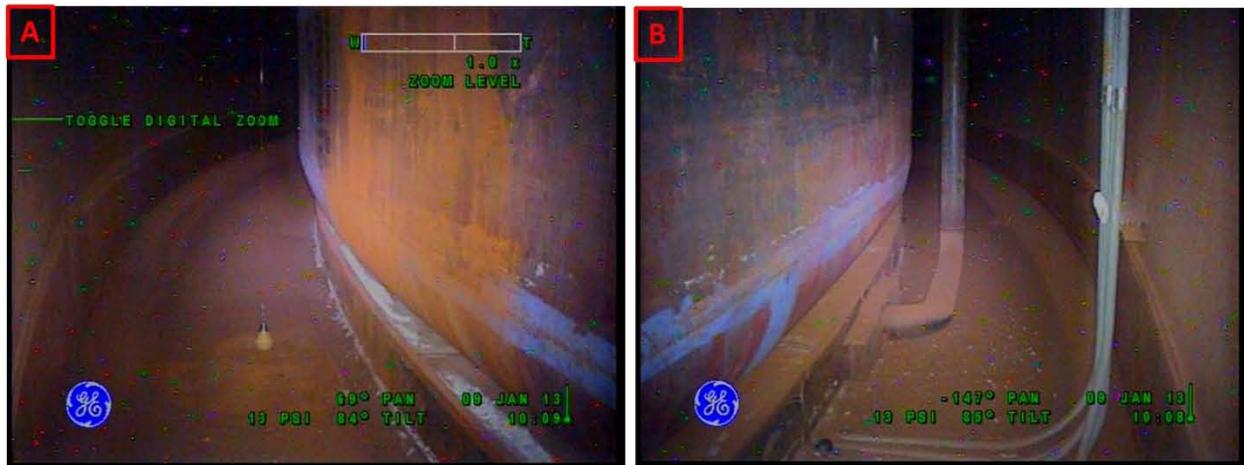
Figure 2-32 shows the general condition of the lower knuckle and annulus floor in January 2013. A beachline can also be seen along the annulus floor in Figure 2-32 which is likely the result of evaporated couplant water used during UT examinations. Figure 2-33 shows the general condition of the refractory slots in January 2013 and no anomalies were noted. No anomalies were identified on the lower knuckle of the primary tank, insulating refractory, refractory slots, stiffener ring, or annulus floor during the 2013 inspection.

Figure 2-32. Riser 88 Lower Knuckle and Annulus Floor Condition on January 9, 2013
Looking Towards Riser 90 (A) and Looking Towards Riser 104 (B)

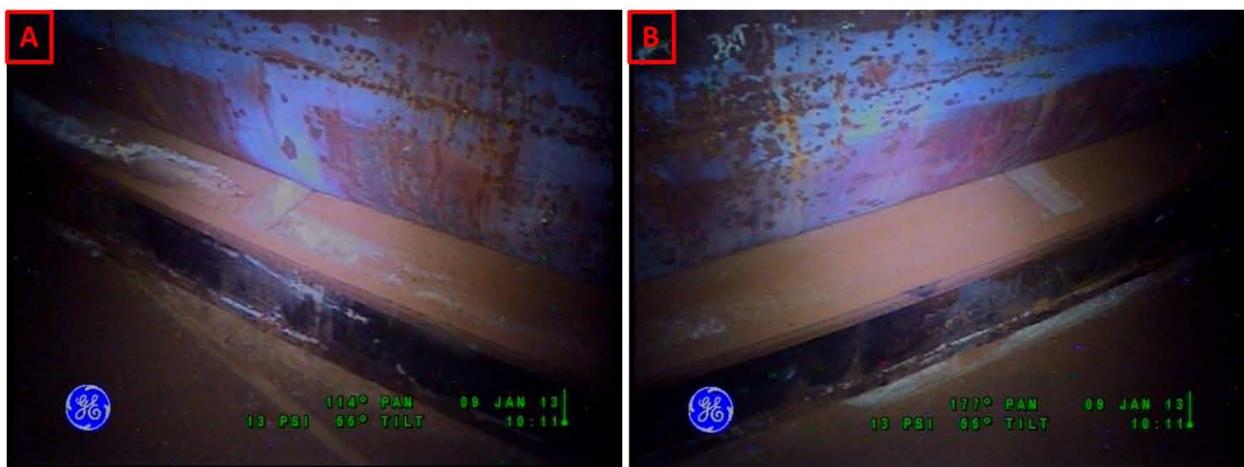
Figure 2-33. Riser 88 General Condition of the Refractory Slots on January 9, 2013

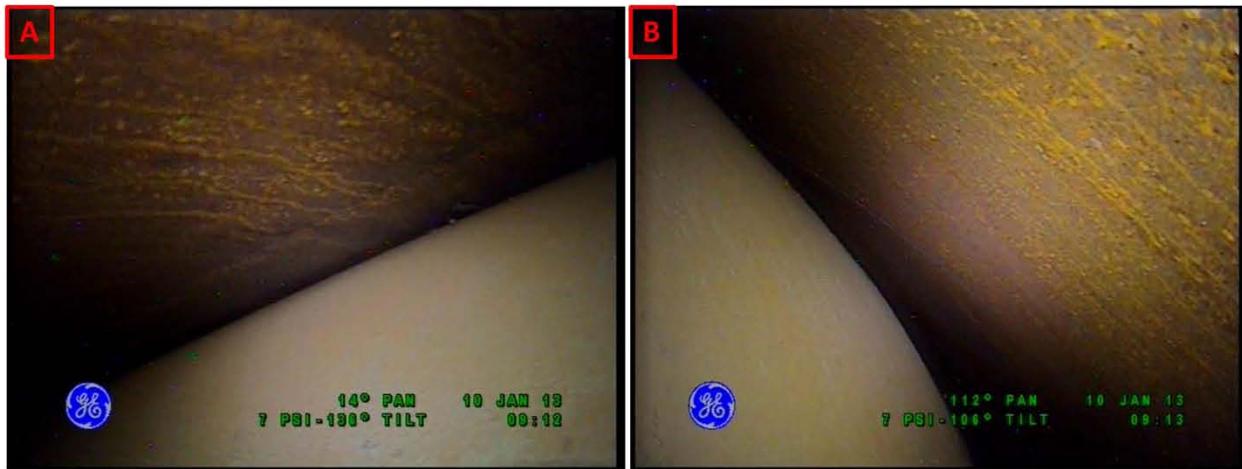
Figure 2-34 shows the general condition of the upper haunch area in January 2013. No areas of interest were identified in the top knuckle region during the 2013 inspection.

**Figure 2-34. Riser 89 General Condition of the Upper Haunch on January 10, 2013
Looking Towards Riser 83 (A) and Looking Towards Riser 101 (B)**

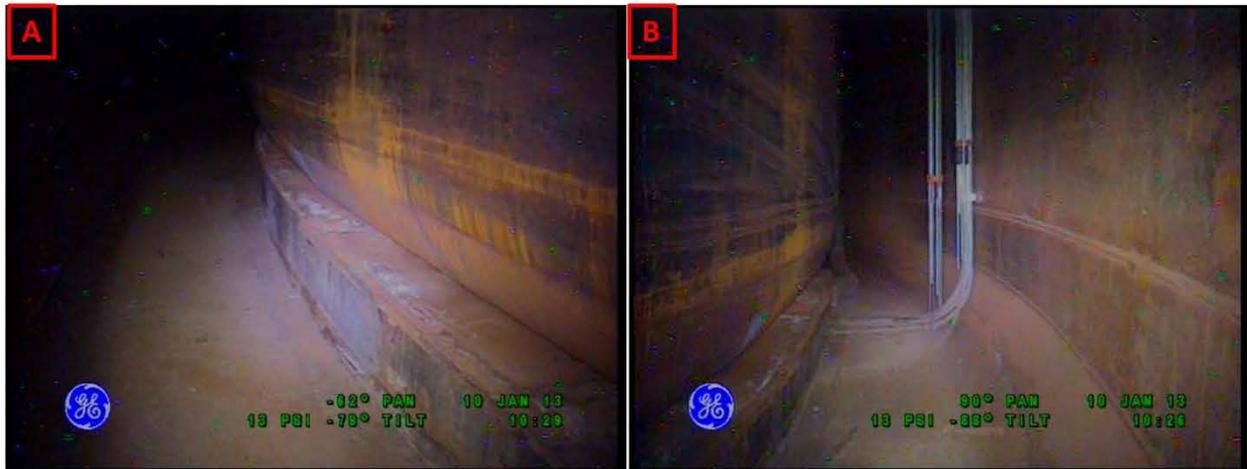
Figure 2-35 shows the general condition of the lower knuckle and annulus floor in January 2013. A beachline and can also be seen along the annulus floor in Figure 2-35 which is likely the result of evaporated couplant water used during UT examinations. Riser 89 is one of the risers that is utilized for UT examinations which explains why there is more areas of discoloration seen on the annulus floor compared with other risers of tank AZ-101. Figure 2-36 shows the general condition of the refractory slots in January 2013 and no anomalies were noted. No anomalies were identified on the lower knuckle of the primary tank, insulating refractory, refractory slots, stiffener ring, or annulus floor during the 2013 inspection.

Figure 2-35. Riser 89 Lower Knuckle and Annulus Floor Condition on January 10, 2013
Looking Towards Riser 83 (A) and Looking Towards Riser 101 (B)

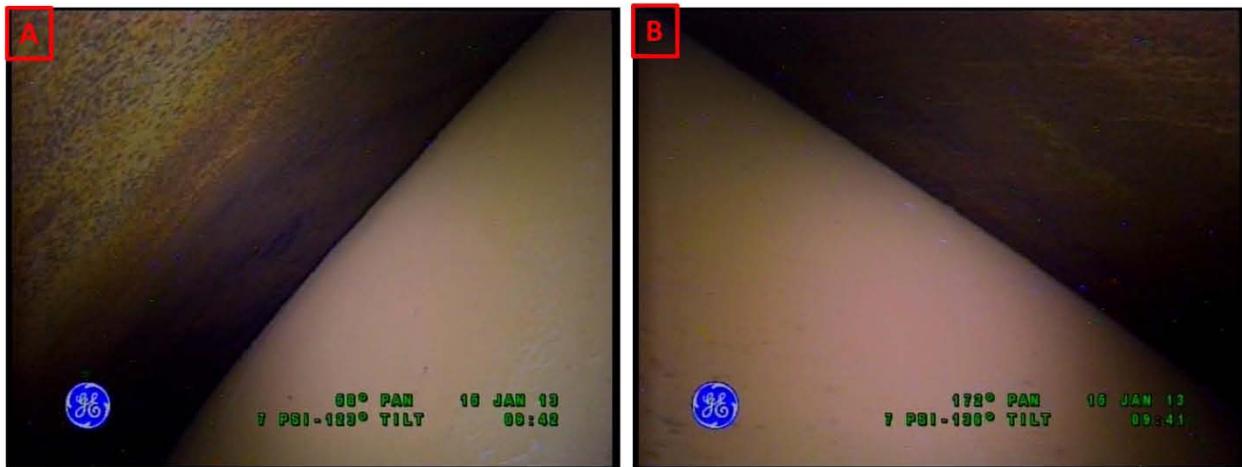
Figure 2-37 shows the general condition of the upper haunch area in January 2013. No areas of interest were identified in the top knuckle region during the 2013 inspection.

**Figure 2-37. Riser 91 General Condition of the Upper Haunch on January 15, 2013
Looking Towards Riser 94 (A) and Looking Towards Riser 80 (B)**

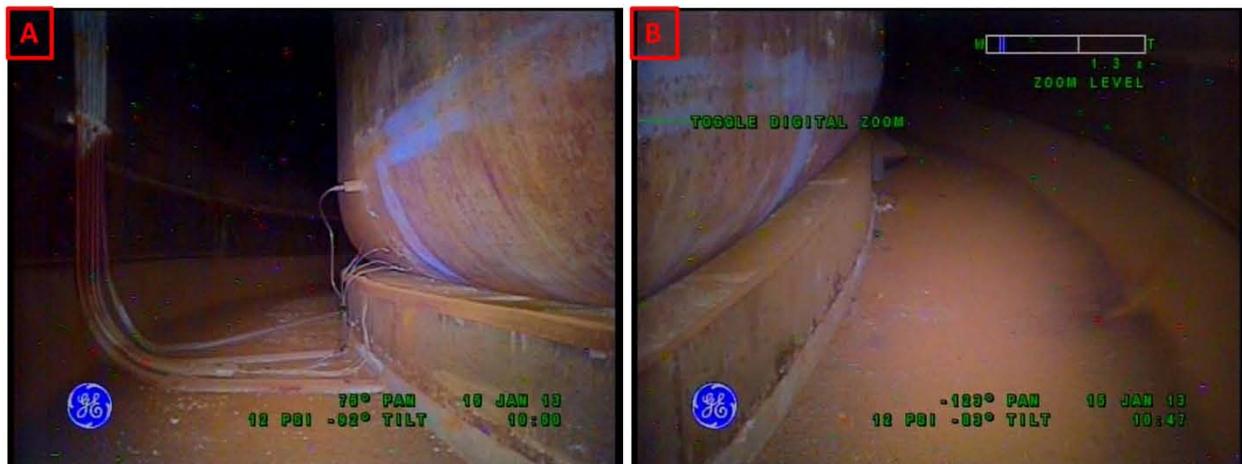
Figure 2-38 shows the general condition of the lower knuckle and annulus floor in January 2013. A beachline can also be seen along the annulus floor in Figure 2-38 which is likely the result of evaporated couplant water used during UT examinations. Figure 2-39 shows the general condition of the refractory slots in January 2013 and no anomalies were noted. No anomalies were identified on the lower knuckle of the primary tank, insulating refractory, refractory slots, stiffener ring, or annulus floor during the 2013 inspection.

**Figure 2-38. Riser 91 Lower Knuckle and Annulus Floor Condition on January 15, 2013
Looking Towards Riser 94 (A) and Looking Towards Riser 80 (B)**

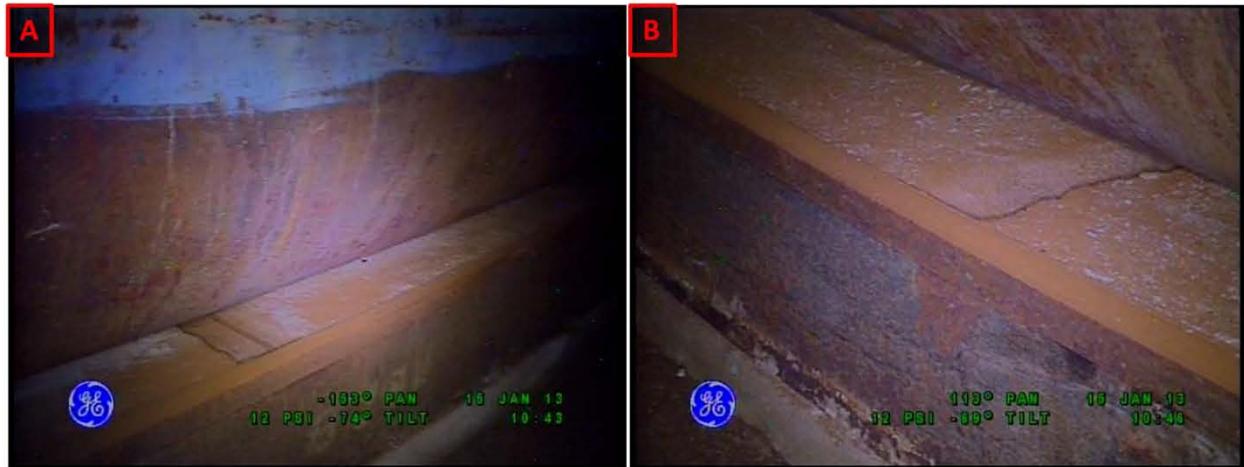
Figure 2-39. Riser 91 General Condition of the Refractory Slots on January 15, 2013

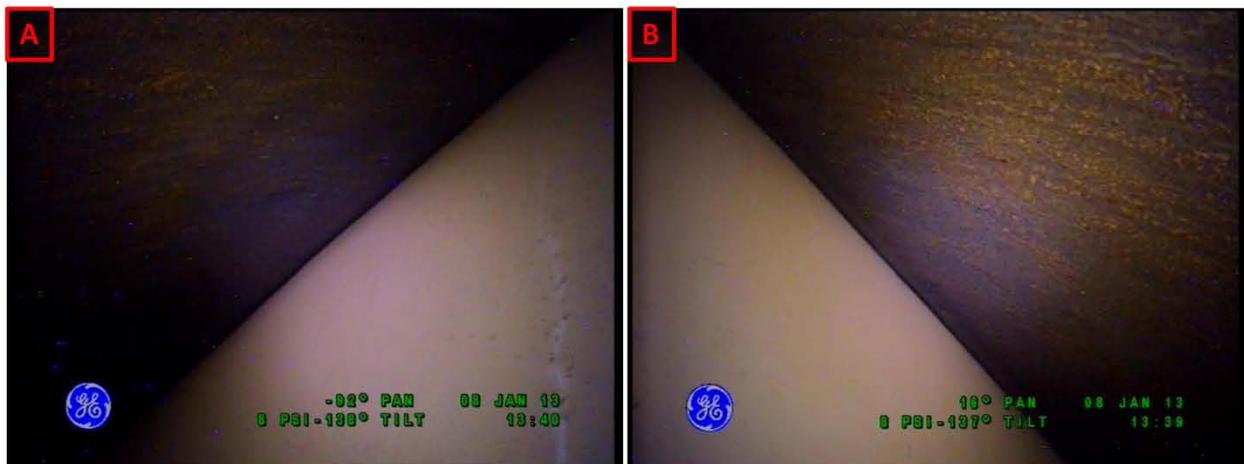
Figure 2-40 shows the general condition of the upper haunch area in January 2013. No areas of interest were identified in the top knuckle region during the 2013 inspection.

Figure 2-40. Riser 92 General Condition of the Upper Haunch on January 8, 2013 Looking Towards Riser 97 (A) and Looking Towards Riser 85 (B)

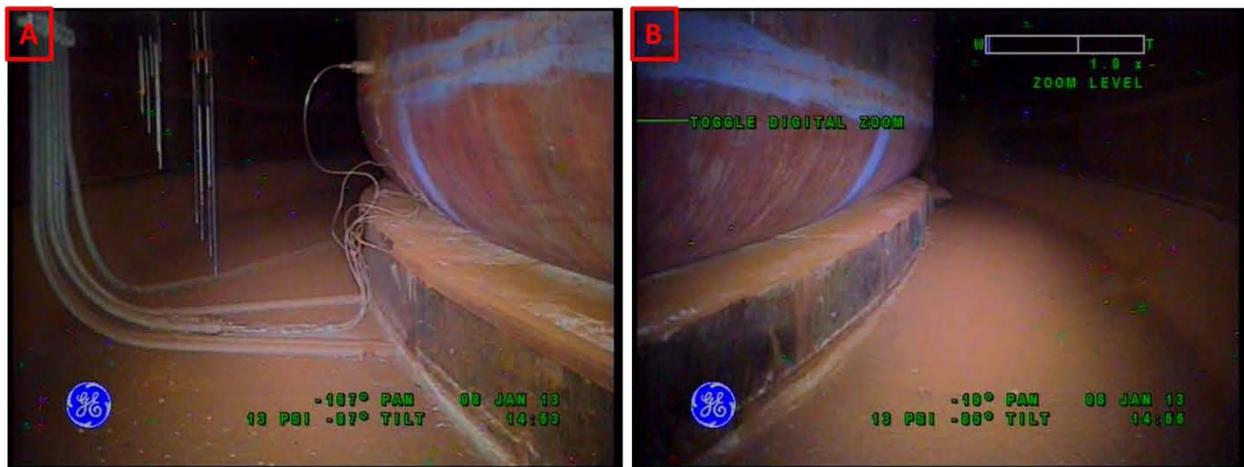
Figure 2-41 shows the general condition of the lower knuckle and annulus floor in January 2013. A beachline can also be seen along the annulus floor in Figure 2-41 which is likely the result of evaporated couplant water used during UT examinations. Figure 2-42 shows the general condition of the refractory slots in January 2013 and no anomalies were noted. No anomalies were identified on the lower knuckle of the primary tank, insulating refractory, refractory slots, stiffener ring, or annulus floor during the 2013 inspection.

Figure 2-41. Riser 92 Lower Knuckle and Annulus Floor Condition on January 8, 2013
Looking Towards Riser 97 (A) and Looking Towards Riser 85 (B)

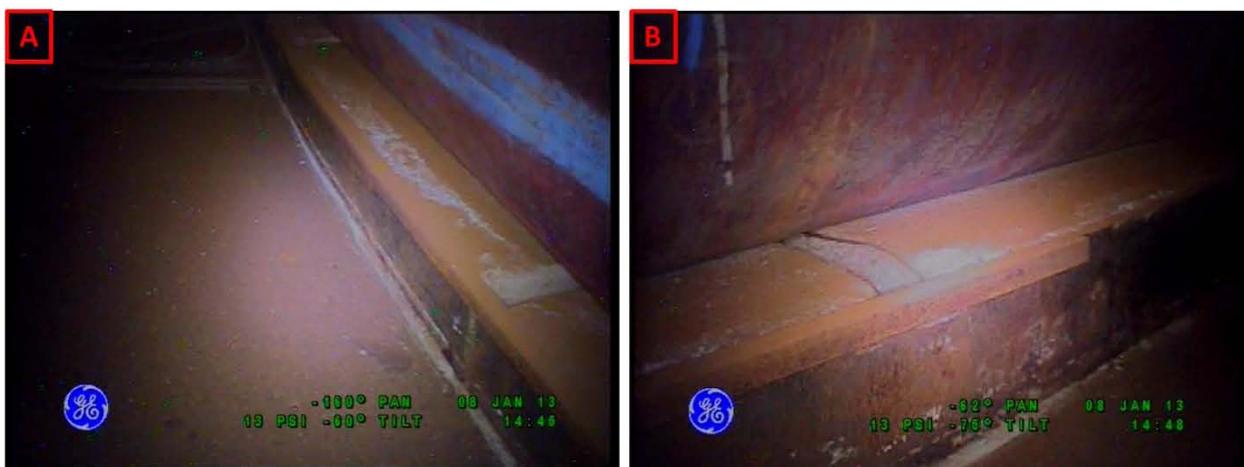
Figure 2-42. Riser 92 General Condition of the Refractory Slots on January 8, 2013

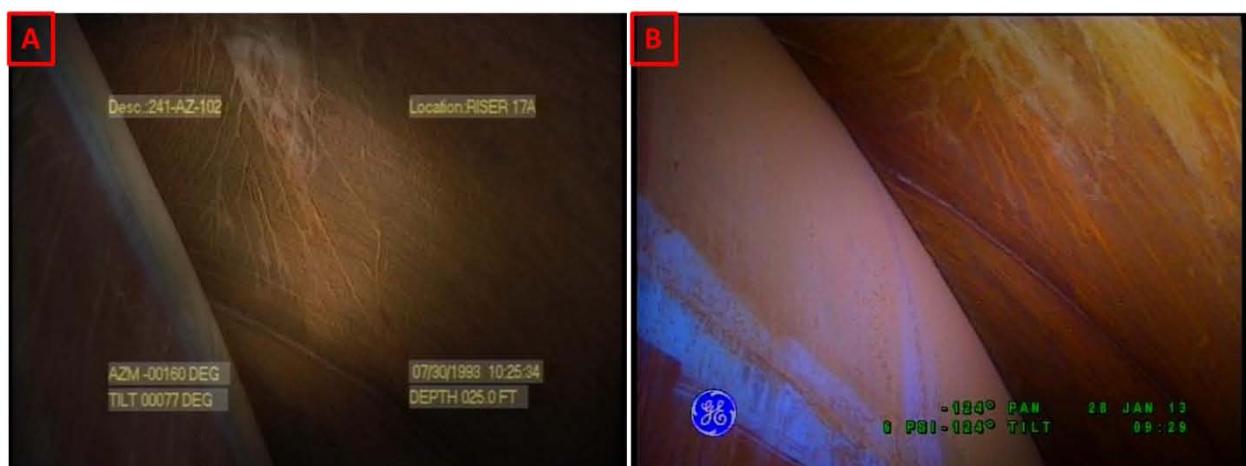
Figure 3-1 and Figure 3-2 show comparisons of the upper haunch area between inspections performed in 1993 and 2013. Since the camera was lower in the 1993 inspection, it is difficult to compare the top knuckle area with the 2013 inspection. However, there appears to be no significant changes in the condition of this area from 1993 to 2013. No areas of interest were identified in the top knuckle region during the 2013 inspection.

Figure 3-2. Riser 78 Upper Haunch Comparisons Between Inspections on July 30, 1993 (A) and January 28, 2013 (B) Looking Towards Riser 90

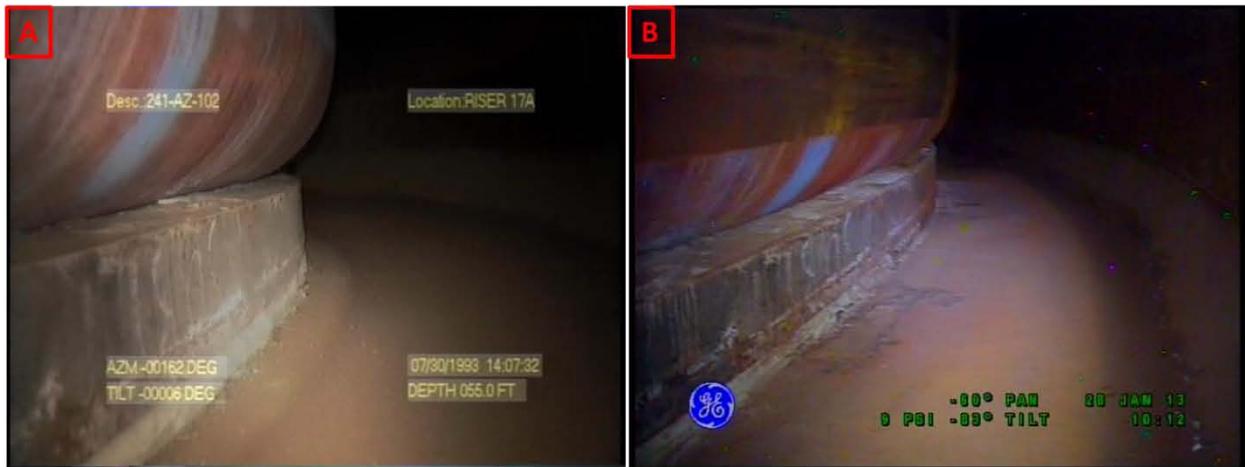
Figure 3-3 and Figure 3-4 show comparisons of the lower knuckle and annulus floor between inspections performed in 1993 and 2013. There appears to be no significant change in the condition of this area between 1993 and 2013. However, in Figure 3-4B there appears to be more staining on the annulus floor in 2013 compared to 1993. This is attributed to the previous UT examinations performed in nearby Riser 90 of the lower knuckle weld. The scanner path can be seen on the tank wall in Figure 3-4B. A beachline can also be seen along the annulus floor in Figure 3-3 and Figure 3-4 which is likely the result of evaporated couplant water used during UT examinations. Figure 3-5 shows the 1993 and 2013 comparison of the condition of the refractory slot and no significant changes in the condition were noted. No anomalies were identified on the lower knuckle of the primary tank, insulating refractory, refractory slots, stiffener ring, or annulus floor during the 2013 inspection.

Figure 3-4. Riser 78 Lower Knuckle and Annulus Floor Comparisons Between Inspections on July 30, 1993 (A) and January 28, 2013 (B) Looking Towards Riser 90

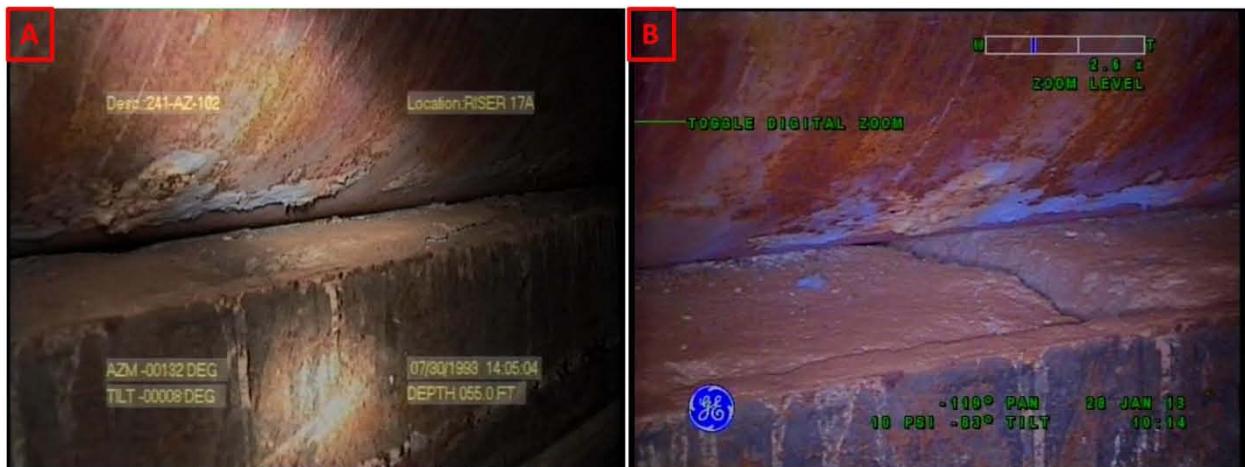
Figure 3-5. Riser 78 General Condition of the Refractory Slots on July 30, 1993 (A) and January 28, 2013 (B)

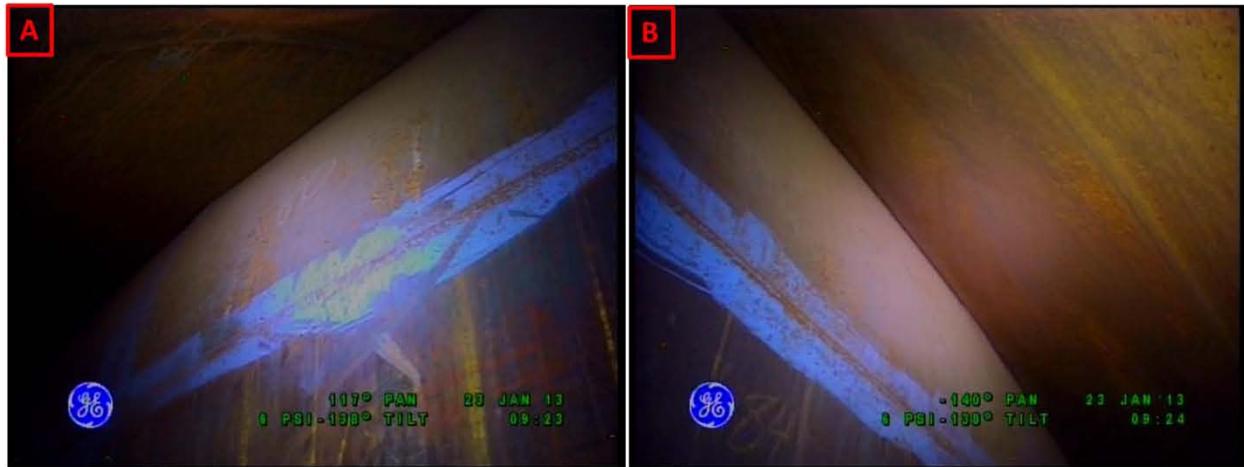
The tank dome and upper haunch area were not visible during the 2001 inspection. Figure 3-6 shows the general condition of the upper haunch area in January 2013. No areas of interest were identified in the top knuckle region during the 2013 inspection.

Figure 3-6. Riser 79 General Condition of the Upper Haunch on January 13, 2013 Looking Towards Riser 80 (A) and Looking Towards Riser 99 (B)

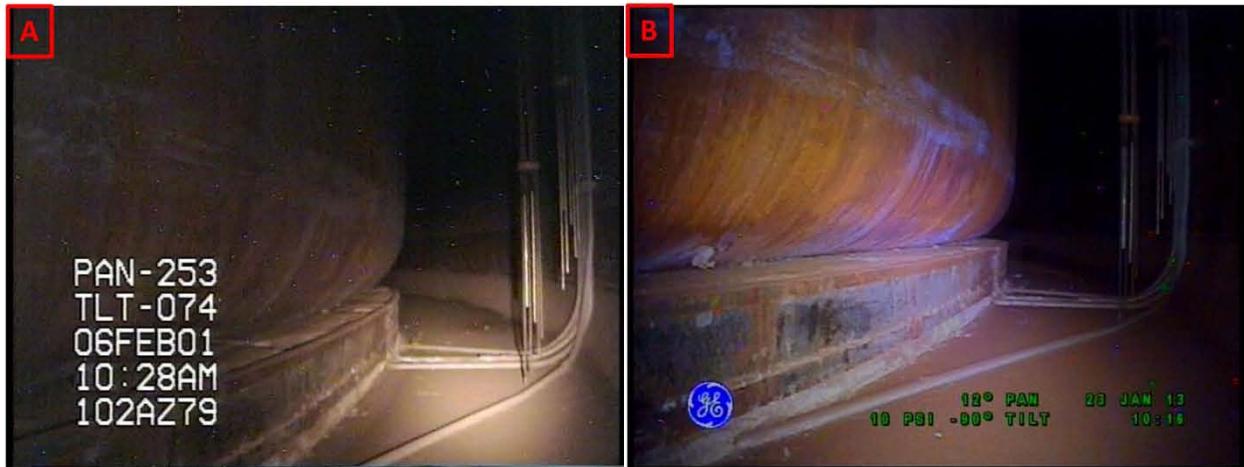
Figure 3-7 and Figure 3-8 show comparisons of the lower knuckle and annulus floor between inspections performed in 2001 and 2013. There appears to be no significant change in the condition of this area between 2001 and 2013. Figure 3-9 shows the general condition of the refractory slots in 2013 and no anomalies were noted. No anomalies were identified on the lower knuckle of the primary tank, insulating refractory, refractory slots, stiffener ring, or annulus floor during the 2013 inspection.

Figure 3-8. Riser 79 Lower Knuckle and Annulus Floor Comparisons Between Inspections on February 6, 2001 (A) and January 23, 2013 (B) Looking Towards Riser 99

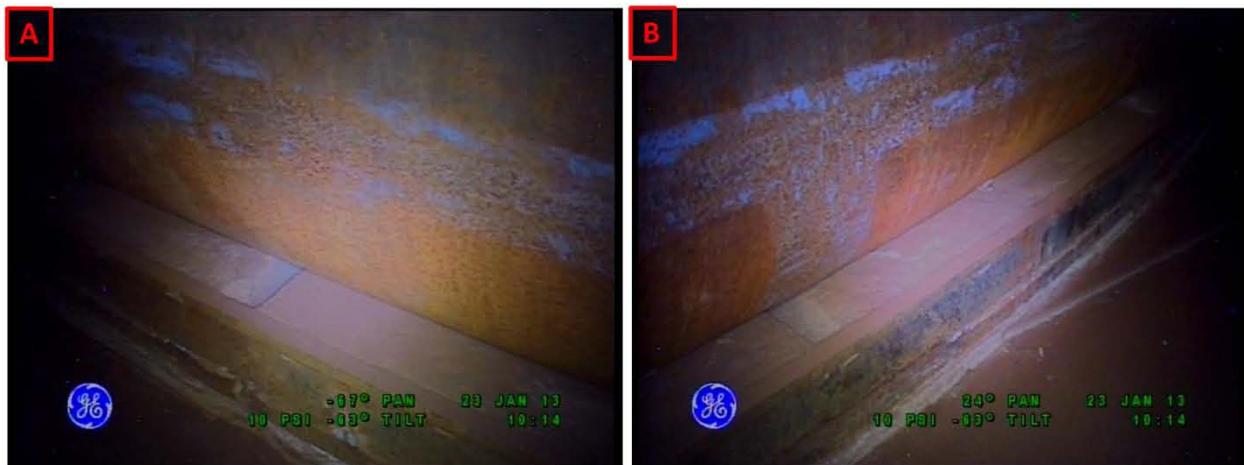
Figure 3-9. Riser 79 General Condition of the Refractory Slots on January 23, 2013

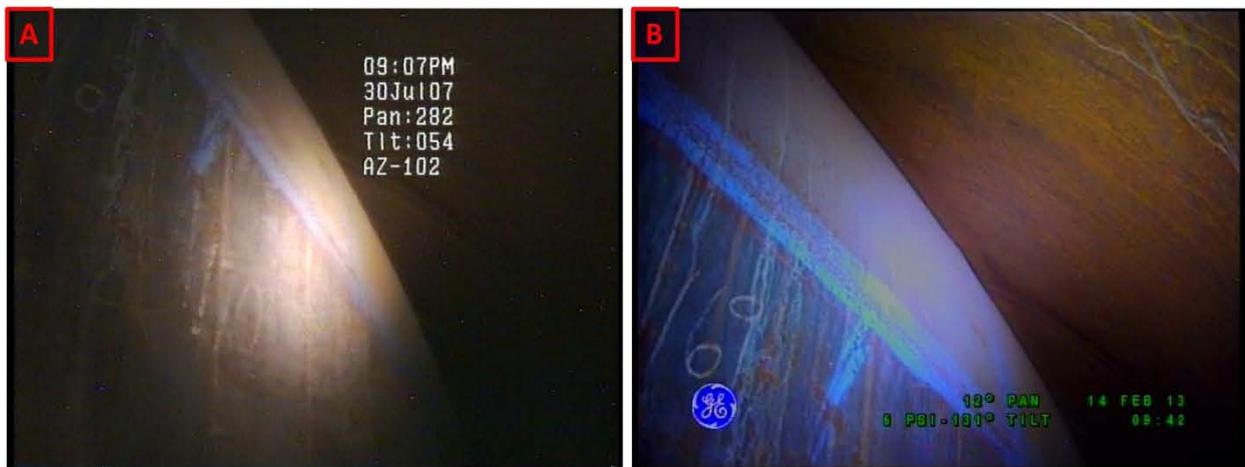
Figure 3-10 and Figure 3-11 show comparisons of the upper haunch area between inspections performed in 2007 and 2013. Since the camera was lower in the 2007 inspection, it is difficult to make any comparisons with the 2013 inspection of the top knuckle area. The camera was also at this lower position in the 2011 inspection. However, there appears to be no significant changes in the condition of this area from 2007 to 2013. No areas of interest were identified in the top knuckle region during the 2013 inspection.

Figure 3-11. Riser 80 Upper Haunch Comparisons Between Inspections on July 30, 2007 (A) and February 14, 2013 (B) Looking Towards Riser 79

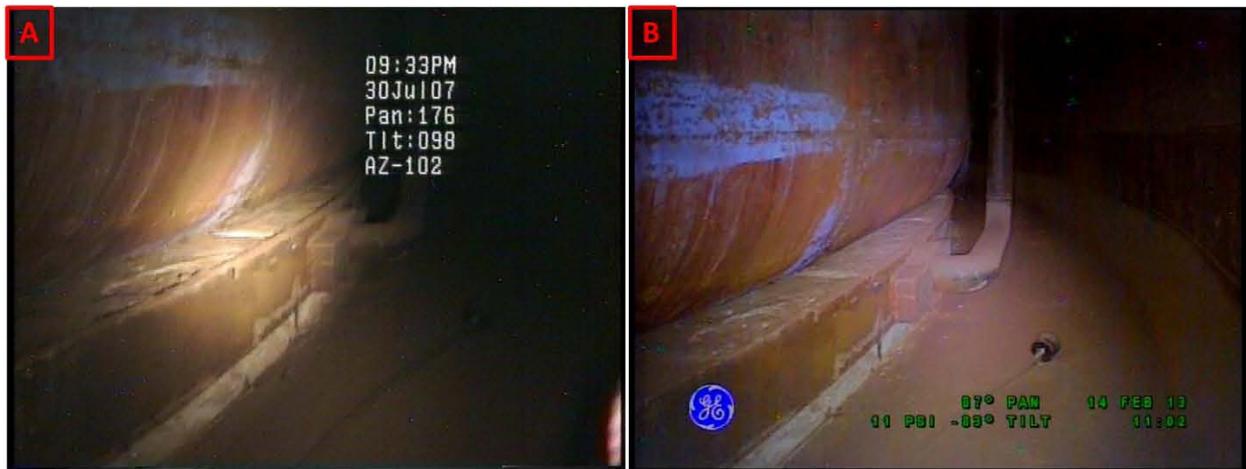
Figure 3-12 and Figure 3-13 show comparisons of the lower knuckle and annulus floor between inspections performed in 2007, 2011, and 2013 and between 2007 and 2013, respectively. There appears to be no significant change in the condition of this area between 2007 and 2013. A beachline can also be seen along the annulus floor in Figure 3-12 and Figure 3-13 which is likely the result of evaporated couplant water used during UT examinations. In Figure 3-12, there is a distinct area on the annulus floor showing discoloration. This area is located under Riser 91, the location of the annulus leak detector ENRAF, which cannot be seen in this figure as the plummet was found to be suspended approximately 32 inches above the annulus floor (PER-2013-0274, AZ-102 Annulus Leak Detector ENRAF). This discoloration is likely to be the result of the

annulus ENRAF installation in December 2003 (see Section 4.0 for additional details). Unfortunately, no previous inspections viewed this area prior to 2007 to provide further insight. This anomaly does not appear to be a region of concern. Figure 3-14 shows the general condition of the refractory slots in 2007 and 2013 and no anomalies were noted. No anomalies were identified on the lower knuckle of the primary tank, insulating refractory, refractory slots, stiffener ring, or annulus floor during the 2013 inspection.

Figure 3-13. Riser 80 Lower Knuckle and Annulus Floor Comparisons Between Inspections on July 30, 2007 (A) and February 14, 2013 (B) Looking Towards Riser 79

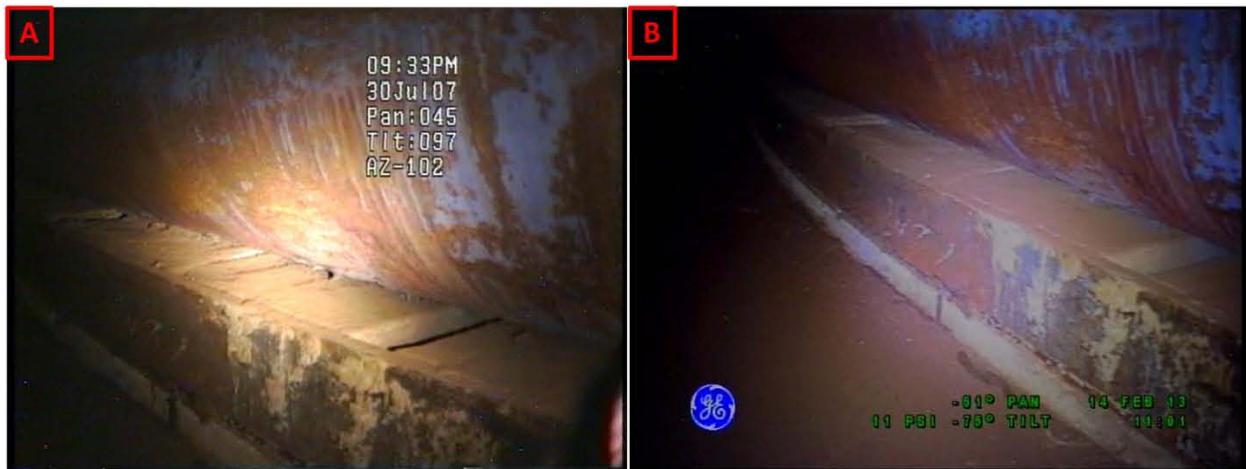
Figure 3-14. Riser 80 General Condition of the Refractory Slots on July 30, 2007 (A) and February 14, 2013 (B)
