241-AZ Farm Annulus Extent of Condition Baseline Inspection

J.K. Engeman, C.L. Girardot, B.J. Vazquez
Washington River Protection Solutions
Richland, WA 99352
U.S. Department of Energy Contract DE-AC27-08RV14800

Abstract: This report provides the results of the comprehensive annulus visual inspection for tanks 241-AZ-101 and 241-AZ-102 performed in fiscal year 2013. The inspection established a baseline covering about 95 percent of the annulus floor for comparison with future inspections. Any changes in the condition are also included in this document.

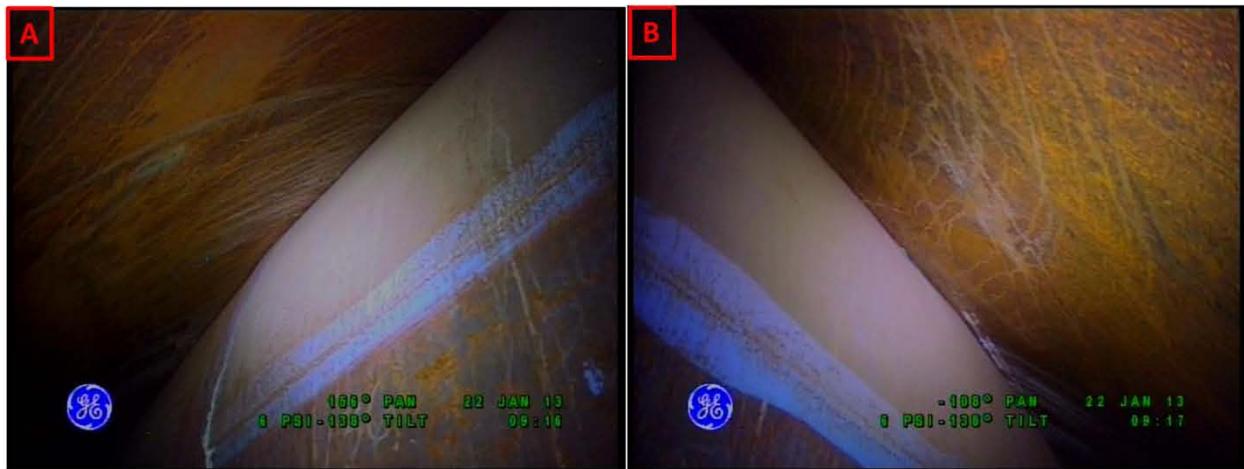
Figure 3-15 shows the general condition of the upper haunch area in January 2013. No areas of interest were identified in the top knuckle region during the 2013 inspection.

**Figure 3-15. Riser 81 General Condition of the Upper Haunch on January 22, 2013
Looking Towards Riser 105 (A) and Looking Towards Riser 100 (B)**

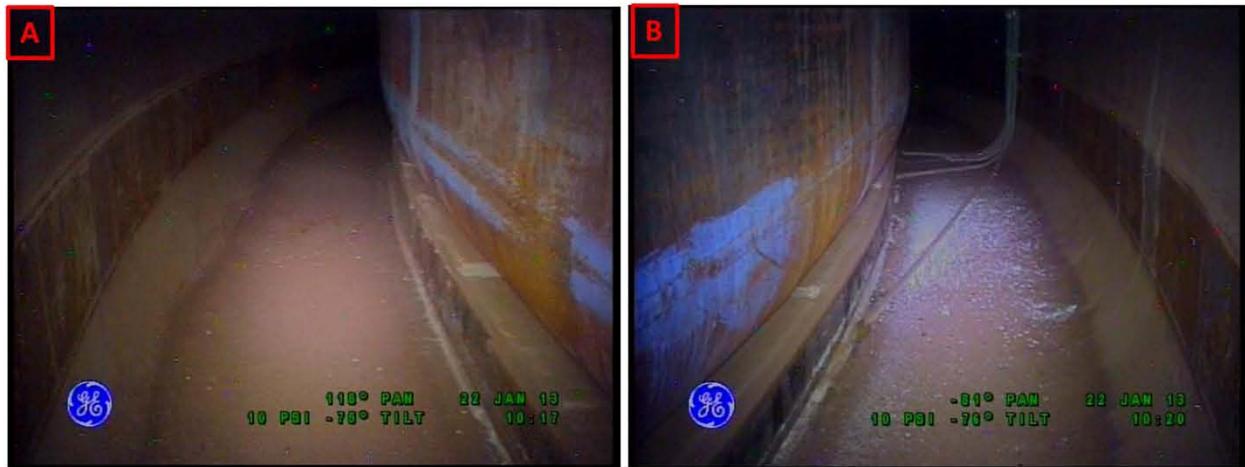
Figure 3-16 shows the general condition the lower knuckle and annulus floor in January 2013. In Figure 3-16B, there appears to be some unknown white debris along the annulus floor. The location of the white debris appears to match a small amount of white debris at the top of the secondary top knuckle. No previous inspections were performed in Riser 81 for comparison; however, white material does not appear to be coming from the primary tank. A beachline can also be seen along the annulus floor in Figure 3-16 which is likely the result of evaporated couplant water used during UT examinations. Figure 3-17 shows the general condition of the refractory slots in 2013 and no anomalies were noted. No anomalies were identified on the lower knuckle of the primary tank, insulating refractory, refractory slots, stiffener ring, or annulus floor during the 2013 inspection.

Figure 3-16. Riser 81 Lower Knuckle and Annulus Floor Condition on January 22, 2013
Looking Towards Riser 105 (A) and Looking Towards Riser 100 (B)

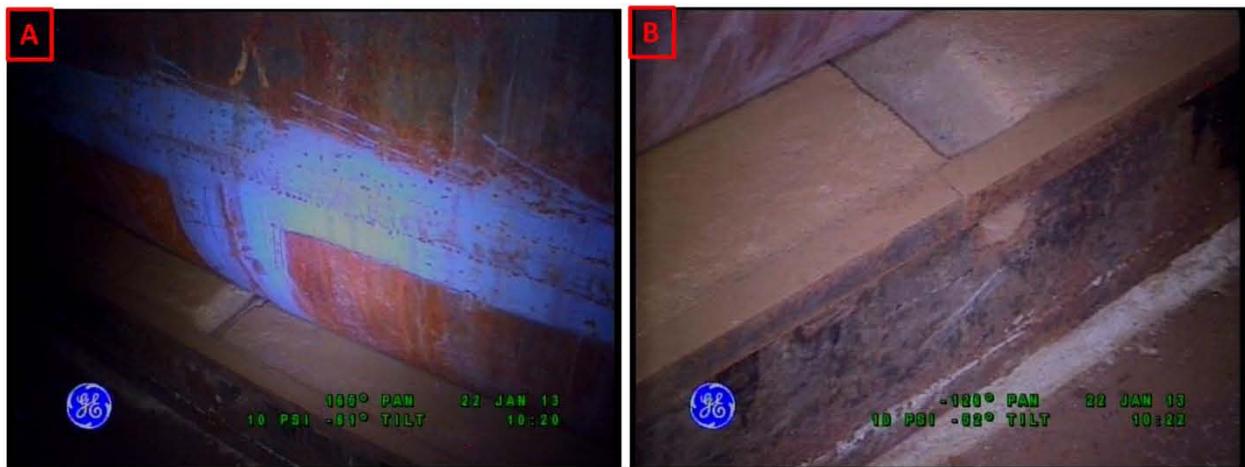
Figure 3-17. Riser 81 Lower Knuckle and Annulus Floor Condition on January 22, 2013

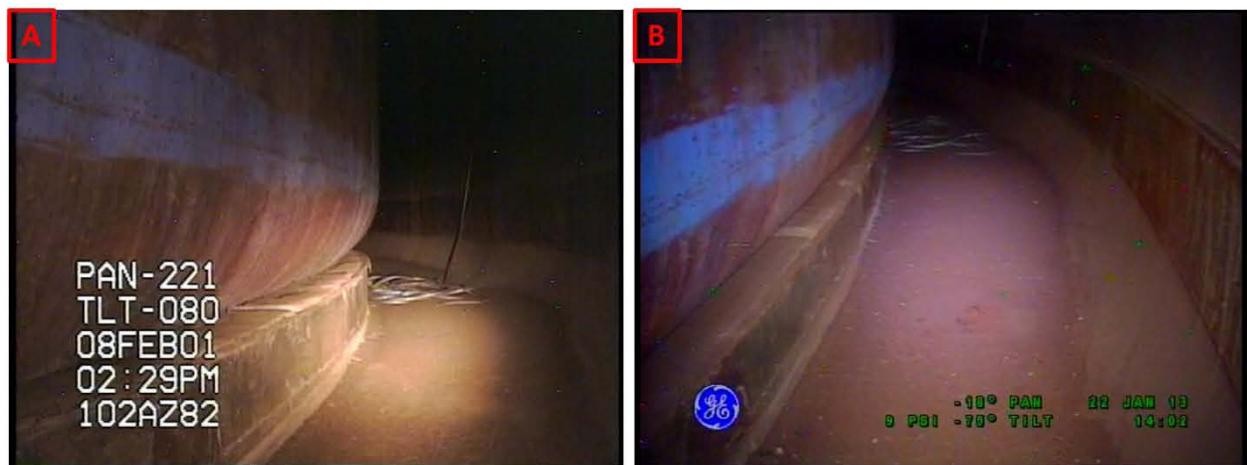
Figure 3-19 and Figure 3-20 show comparisons of the lower knuckle and annulus floor between inspections performed in 2001 and 2013. There appears to be no significant change in the condition of this area between 2001 and 2013. Figure 3-21 shows the general condition of the refractory slots in 2013 and no anomalies were noted. No anomalies were identified on the lower knuckle of the primary tank, insulating refractory, refractory slots, stiffener ring, or annulus floor during the 2013 inspection.

Figure 3-20. Riser 82 Lower Knuckle and Annulus Floor Comparisons Between Inspections on February 8, 2001 (A) and January 22, 2013 (B) Looking Towards Riser 105

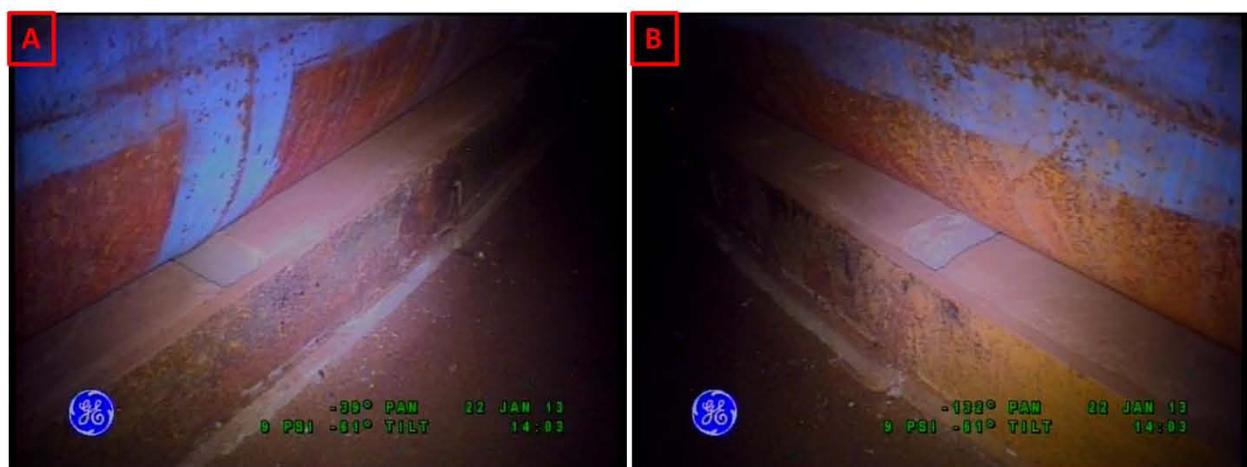
Figure 3-21. Riser 82 General Condition of the Refractory Slots on January 22, 2013

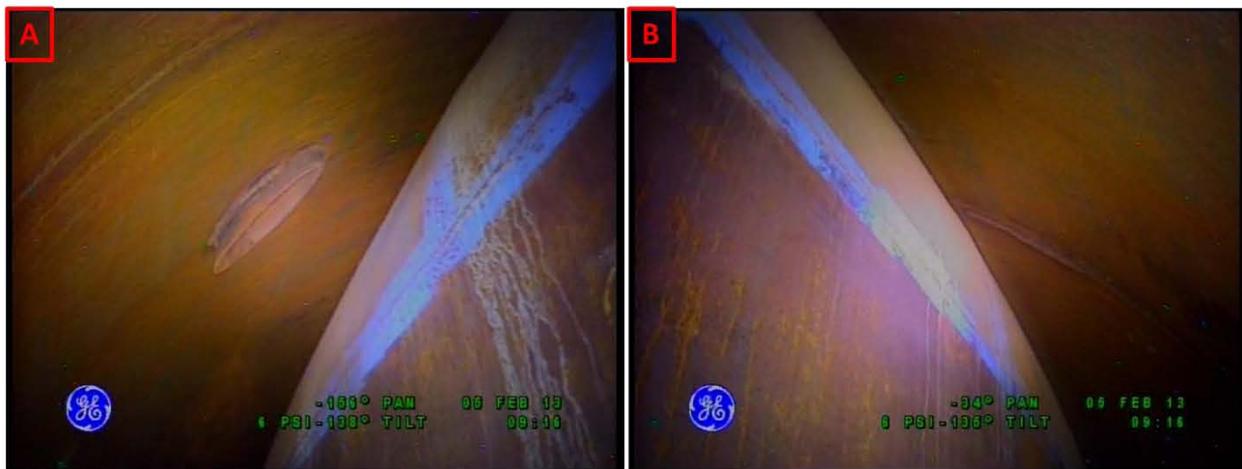
Figure 3-22 shows the general condition of the upper haunch area in January 2013. In Figure 3-22A, white streaks can be seen on the primary tank. These white streaks, which are commonly seen among the DSTs, are referred to as laitance flow which can be attributed to the pouring of the concrete dome during construction. No areas of interest were identified in the top knuckle region during the 2013 inspection.

**Figure 3-22. Riser 83 General Condition of the Upper Haunch on February 5, 2013
Looking Towards Riser 96 (A) and Looking Towards Riser 89 (B)**

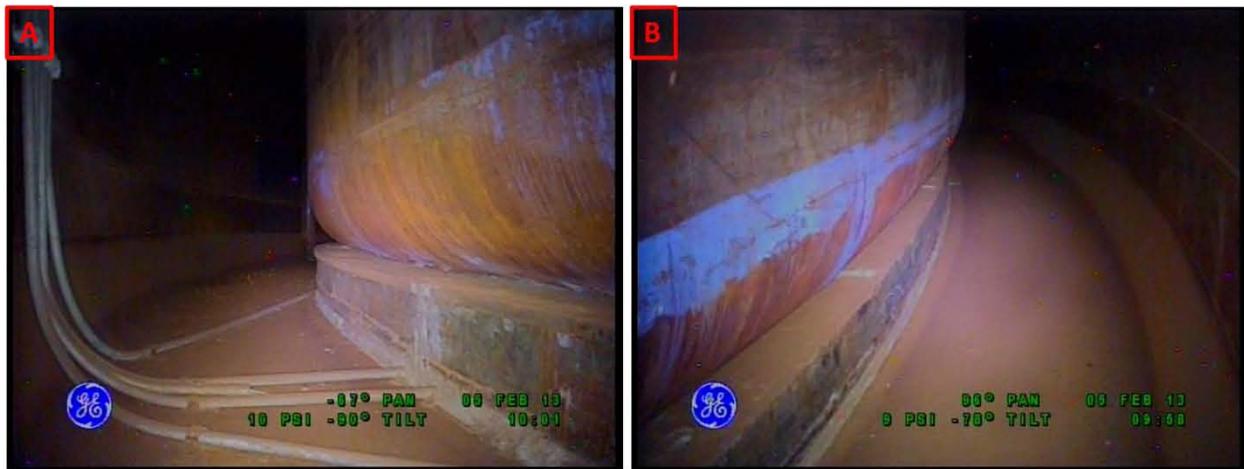
Figure 3-23 shows the general condition of the lower knuckle and annulus floor in January 2013. A beachline can also be seen along the annulus floor in Figure 3-23 which is likely the result of evaporated couplant water used during UT examinations. Figure 3-24 shows the general condition of the refractory slots in 2013 and no anomalies were noted. No anomalies were identified on the lower knuckle of the primary tank, insulating refractory, refractory slots, stiffener ring, or annulus floor during the 2013 inspection.

**Figure 3-23. Riser 83 Lower Knuckle and Annulus Floor Condition on February 5, 2013
Looking Towards Riser 96 (A) and Looking Towards Riser 89 (B)**

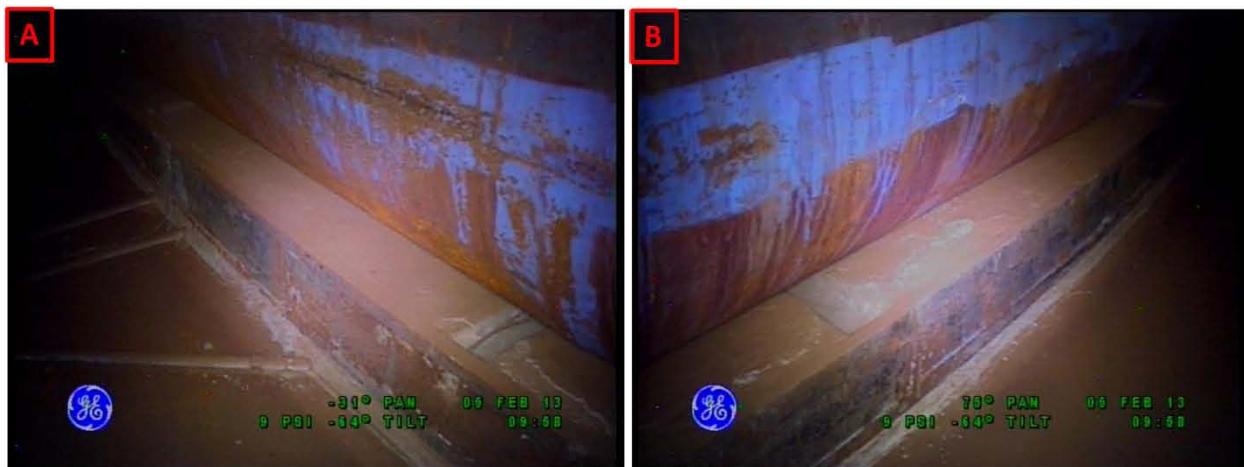
Figure 3-24. Riser 83 General Condition of the Refractory Slots on February 5, 2013

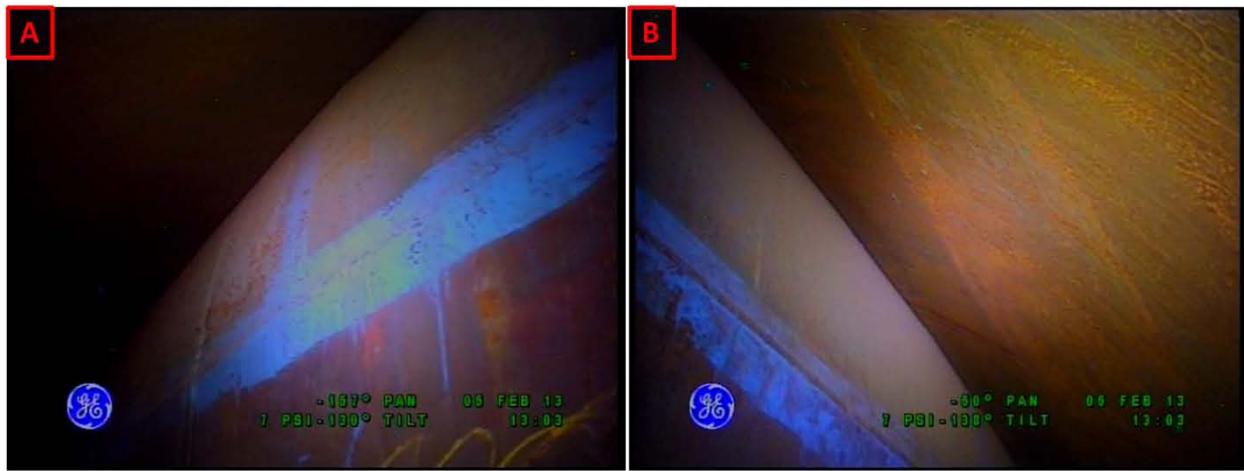
The tank dome and upper haunch area were not visible during the 1993 and 2001 inspections. Figure 3-25 shows the general condition of the upper haunch area in February 2013. No areas of interest were identified in the top knuckle region during the 2013 inspection.

**Figure 3-25. Riser 84 General Condition of the Upper Haunch on February 5, 2013
Looking Towards Riser 85 (A) and Looking Towards Riser 102 (B)**

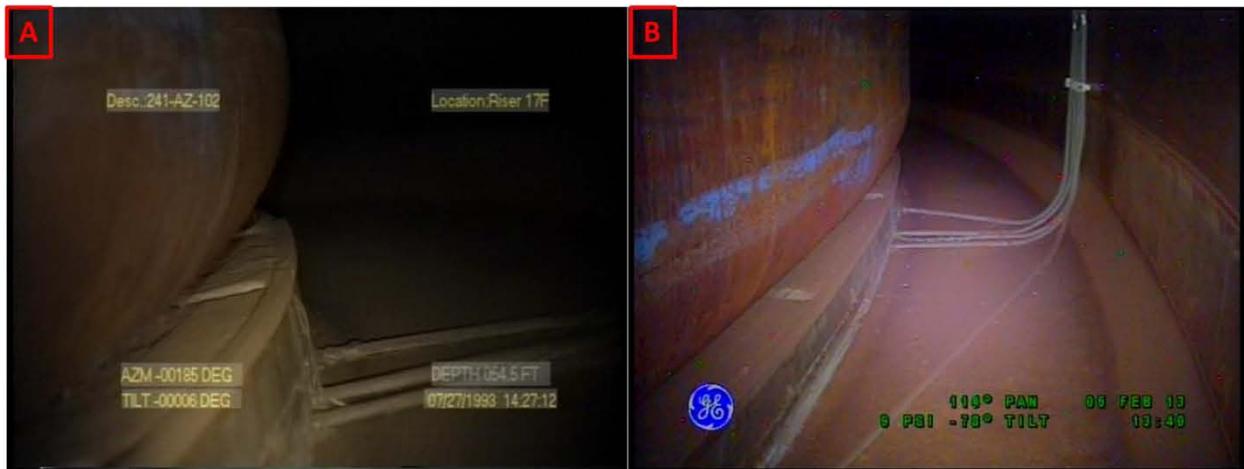
Figure 3-26 and Figure 3-27 show comparisons of the lower knuckle and annulus floor between inspections performed in 1993 and 2013. There appears to be no significant change in the condition of this area between 1993 and 2013. A beachline can also be seen along the annulus floor in Figure 3-27 which is likely the result of evaporated couplant water used during UT examinations. Figure 3-28 shows the general condition of the refractory slots in February 2013 and no anomalies were noted. No anomalies were identified on the lower knuckle of the primary tank, insulating refractory, refractory slots, stiffener ring, or annulus floor during the 2013 inspection.

Figure 3-27. Riser 84 Lower Knuckle and Annulus Floor Comparisons Between Inspections on July 27, 1993 (A) and February 5, 2013 (B) Looking Towards Riser 102

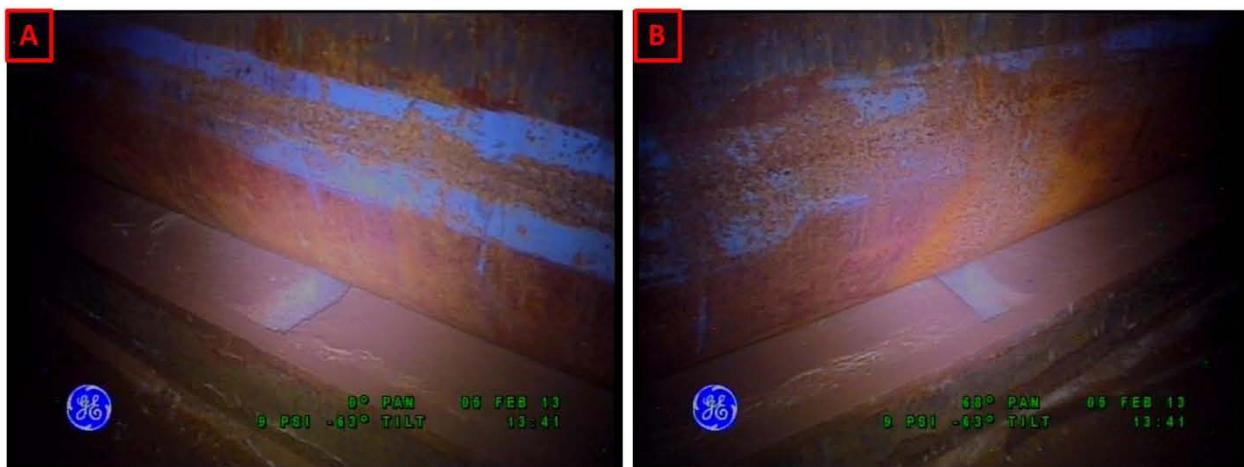
Figure 3-28. Riser 84 General Condition of the Refractory Slots on February 5, 2013

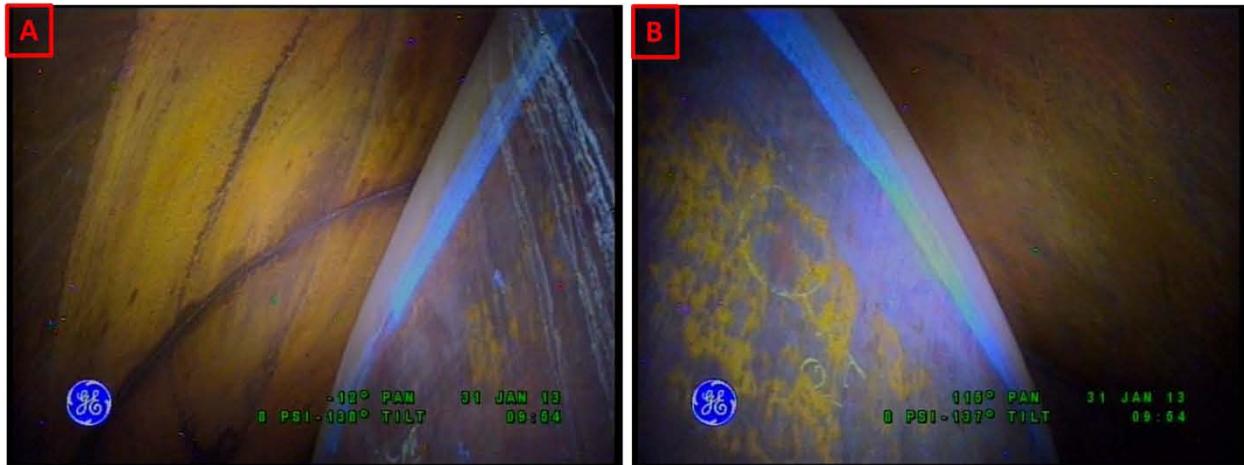
Figure 3-29 shows the general condition of the upper haunch area in January 2013. In Figure 3-29A, white streaks can be seen on the primary tank. These white streaks, which are commonly seen among the DSTs, are referred to as laitance flow attributed to the pouring of the concrete dome during construction. No areas of interest were identified in the top knuckle region during the 2013 inspection.

**Figure 3-29. Riser 86 General Condition of the Upper Haunch on January 31, 2013
Looking Towards Riser 87 (A) and Looking Towards Riser 103 (B)**

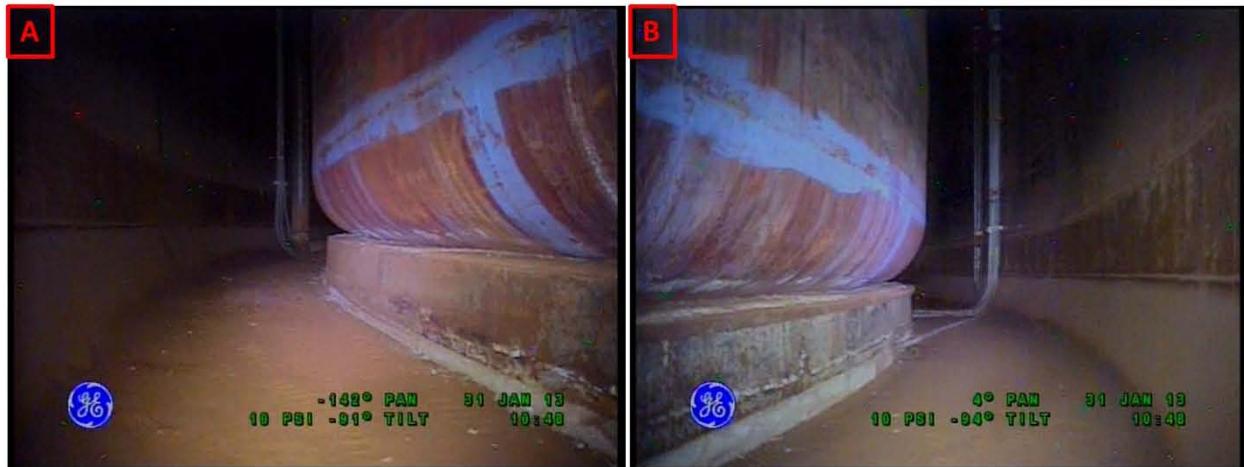
Figure 3-30 shows the general condition of the lower knuckle and annulus floor in January 2013. Figure 3-31 shows the general condition of the refractory slots in January 2013 and no anomalies were noted. No anomalies were identified on the lower knuckle of the primary tank, insulating refractory, refractory slots, stiffener ring, or annulus floor during the 2013 inspection.

**Figure 3-30. Riser 86 Lower Knuckle and Annulus Floor Condition on January 31, 2013
Looking Towards Riser 87 (A) and Looking Towards Riser 103 (B)**

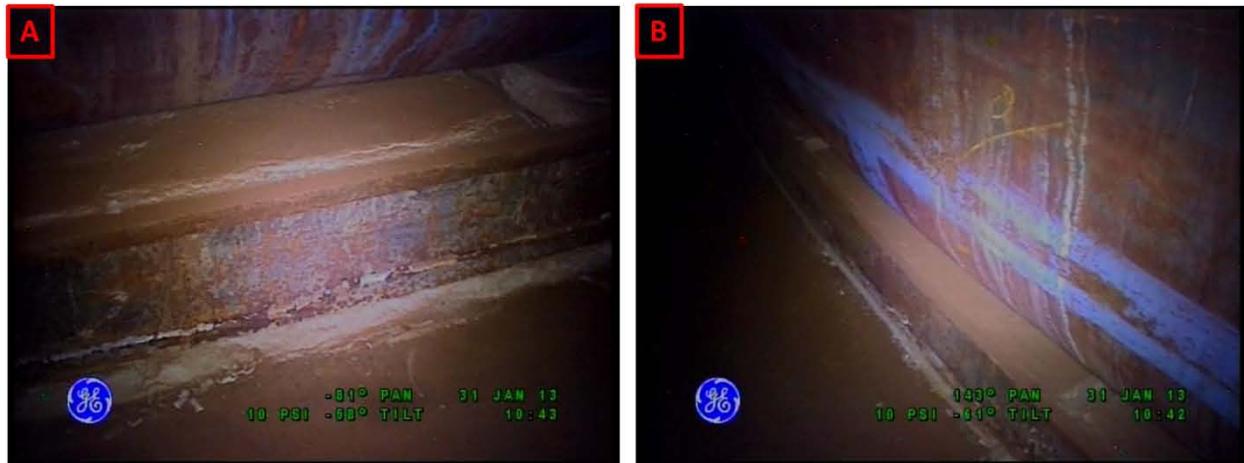
Figure 3-31. Riser 86 General Condition of the Refractory Slots on January 31, 2013

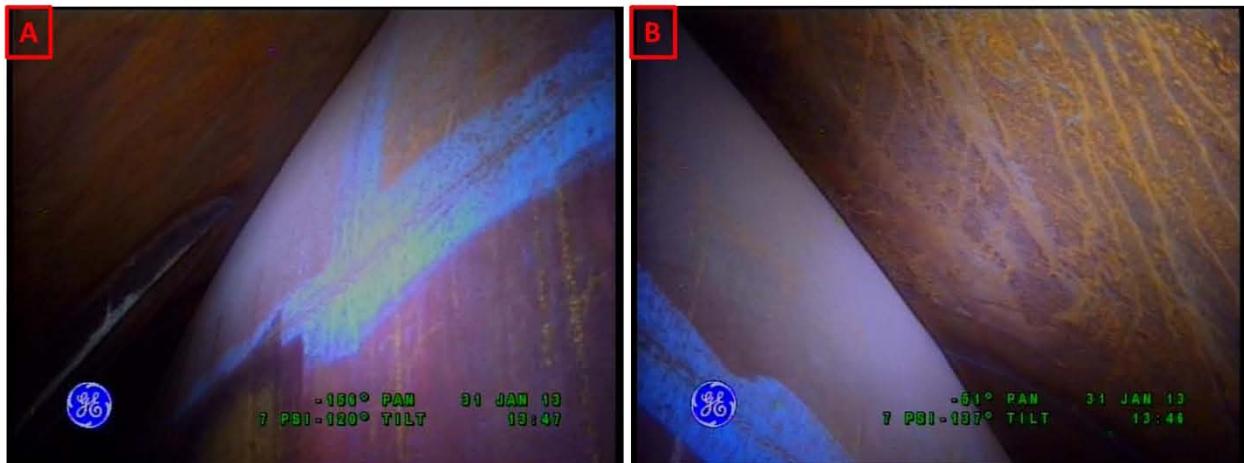
Figure 3-32 shows the general condition of the upper haunch area in January 2013. No areas of interest were identified in the top knuckle region during the 2013 inspection.

**Figure 3-32. Riser 88 General Condition of the Upper Haunch on January 31, 2013
Looking Towards Riser 90 (A) and Looking Towards Riser 104 (B)**

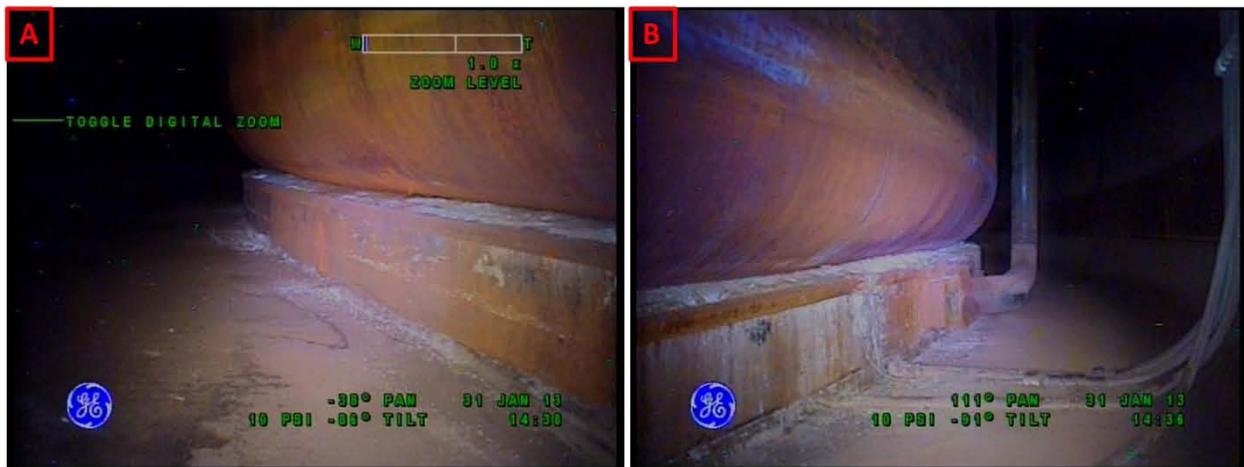
Figure 3-33 shows the general condition of the lower knuckle and annulus floor in January 2013. The stains on the annulus floor shown in Figure 3-33A are likely from the UT examinations that were performed in nearby Riser 90. Figure 3-34 shows the general condition of the refractory slots in January 2013 and no anomalies were noted. No anomalies were identified on the lower knuckle of the primary tank, insulating refractory, refractory slots, stiffener ring, or annulus floor during the 2013 inspection.

Figure 3-33. Riser 88 Lower Knuckle and Annulus Floor Condition on January 31, 2013
Looking Towards Riser 90 (A) and Looking Towards Riser 104 (B)

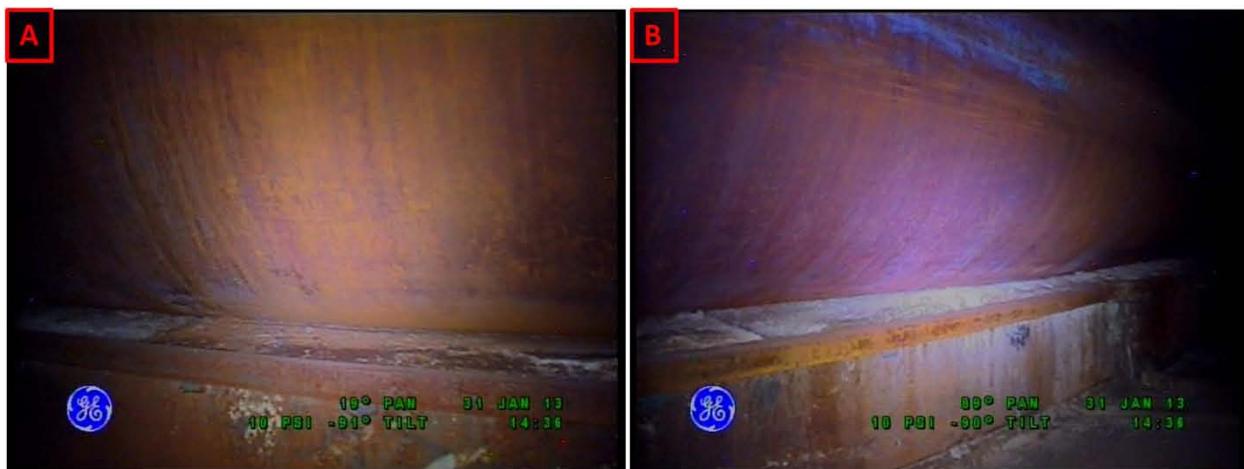
Figure 3-34. Riser 88 General Condition of the Refractory Slots on January 31, 2013

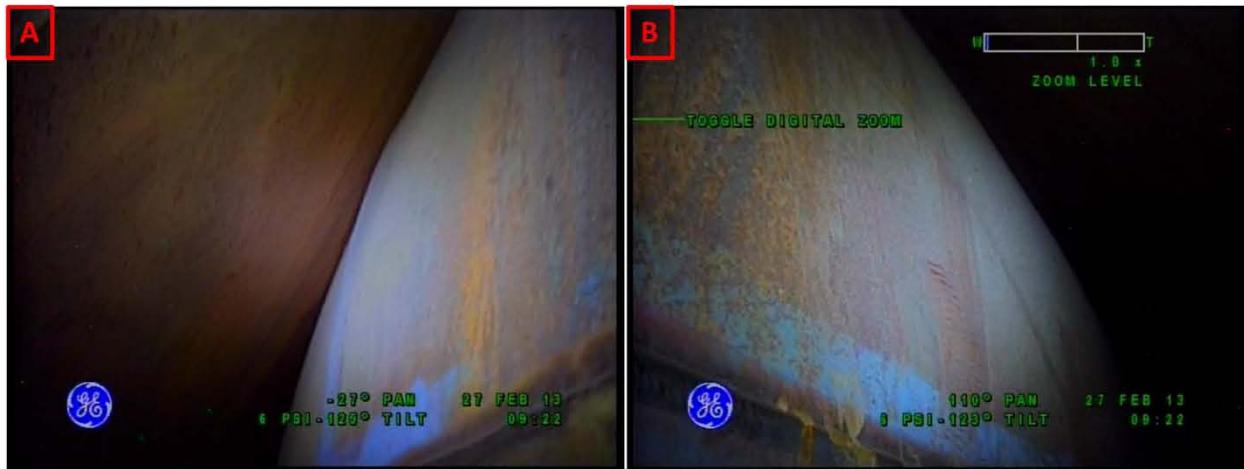
Figure 3-35 shows the general condition of the upper haunch area in February 2013. No areas of interest were identified in the top knuckle region during the 2013 inspection.

**Figure 3-35. Riser 89 General Condition of the Upper Haunch on February 27, 2013
Looking Towards Riser 83 (A) and Looking Towards Riser 101 (B)**

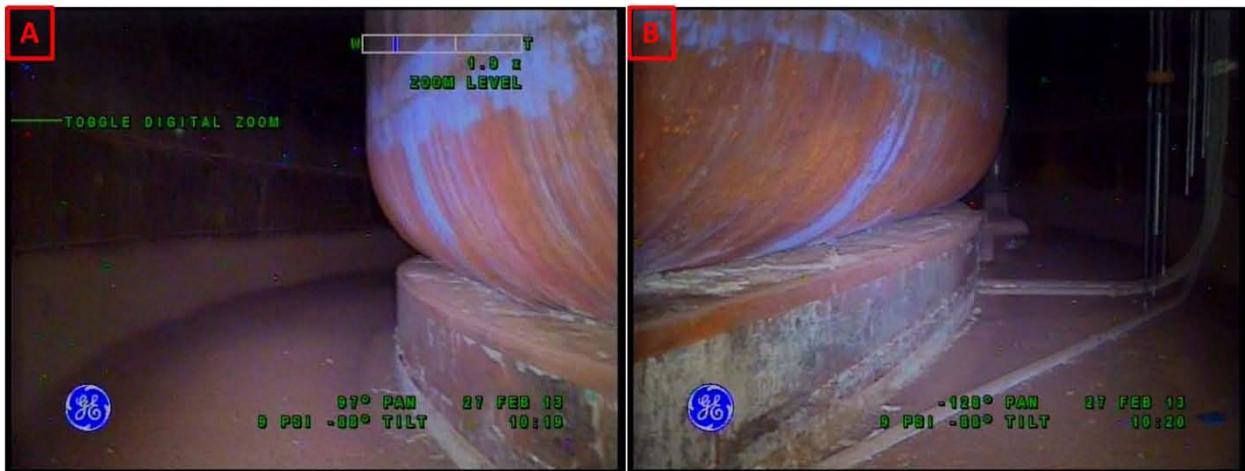
Figure 3-36 shows the general condition of the lower knuckle and annulus floor in February 2013. A beachline can also be seen along the annulus floor in Figure 3-36A which is likely the result of evaporated couplant water used during UT examinations. Figure 3-37 shows the general condition of the refractory slots in February 2013 and no anomalies were noted. No anomalies were identified on the lower knuckle of the primary tank, insulating refractory, refractory slots, stiffener ring, or annulus floor during the 2013 inspection.

Figure 3-36. Riser 89 Lower Knuckle and Annulus Floor Condition on February 27, 2013
Looking Towards Riser 83 (A) and Looking Towards Riser 101 (B)

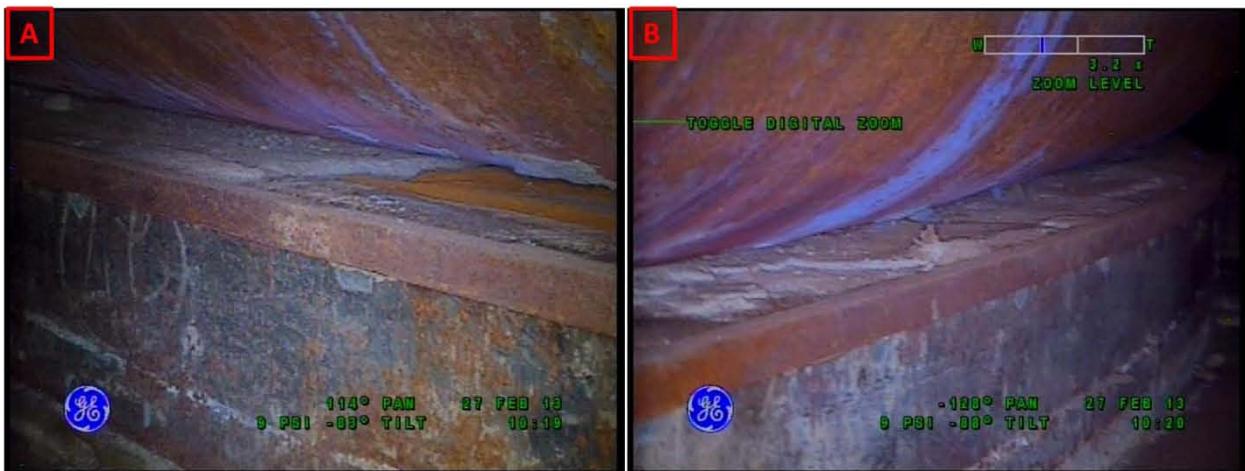
Figure 3-37. Riser 89 General Condition of the Refractory Slots on February 27, 2013

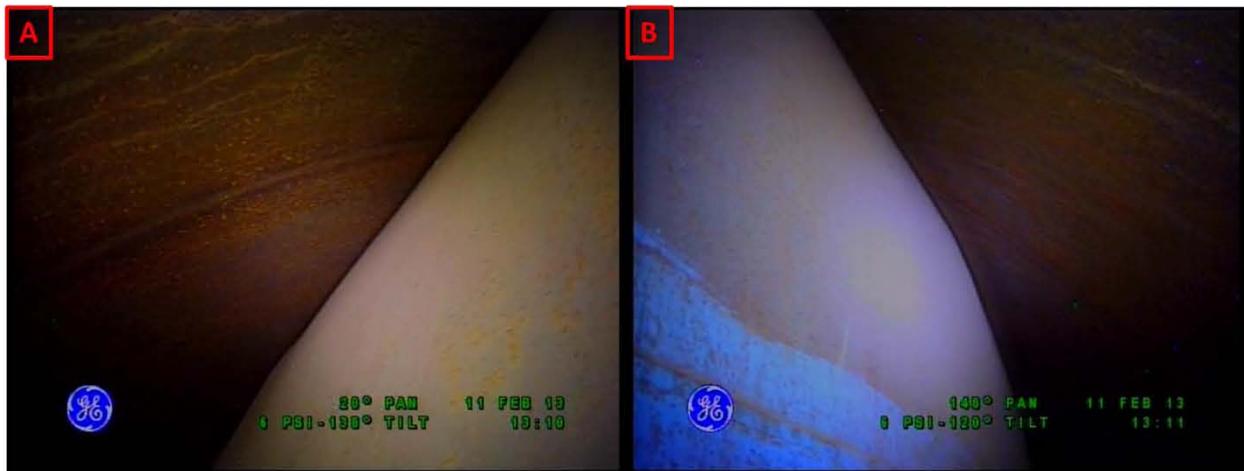
Figure 3-38 shows the general condition of the upper haunch area in February 2013. No areas of interest were identified in the top knuckle region during the 2013 inspection.

**Figure 3-38. Riser 92 General Condition of the Upper Haunch on February 11, 2013
Looking Towards Riser 97 (A) and Looking Towards Riser 85 (B)**

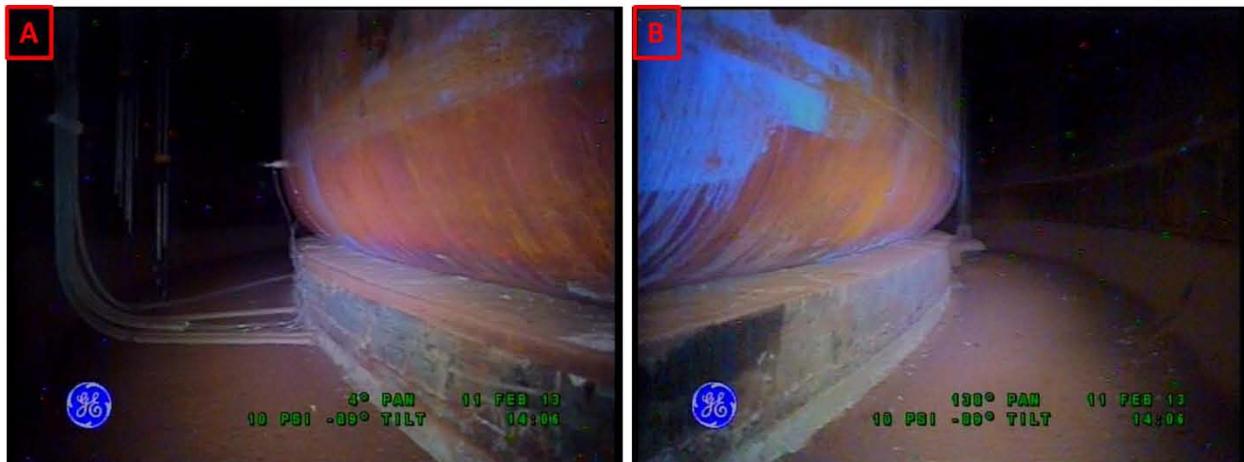
Figure 3-39 shows the general condition of the lower knuckle and annulus floor in February 2013. A beachline can also be seen along the annulus floor in Figure 3-39B which is likely the result of evaporated couplant water used during UT examinations. Figure 3-40 shows the general condition of the refractory slots in February 2013 and no anomalies were noted. No anomalies were identified on the lower knuckle of the primary tank, insulating refractory, refractory slots, stiffener ring, or annulus floor during the 2013 inspection.

**Figure 3-39. Riser 92 Lower Knuckle and Annulus Floor Condition on February 11, 2013
Looking Towards Riser 97 (A) and Looking Towards Riser 85 (B)**

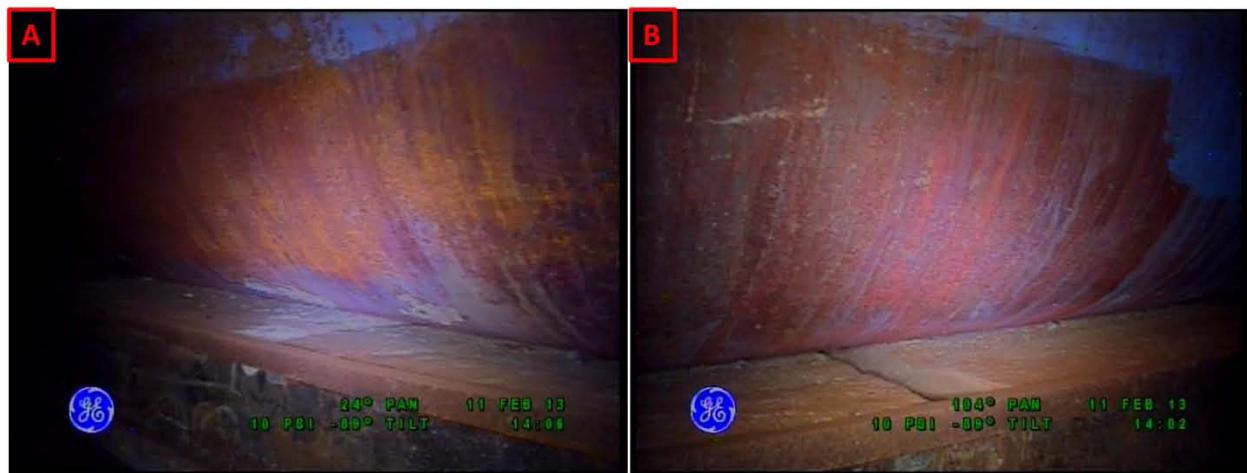
Figure 3-40. Riser 92 General Condition of the Refractory Slots on February 11, 2013

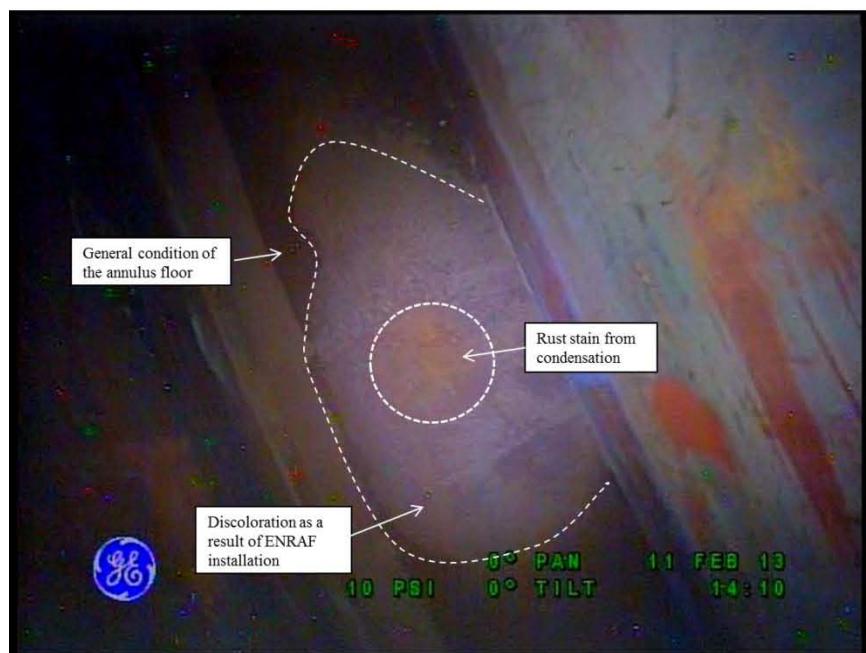
In the risers where the annulus ENRAF is located, typically an area of discoloration can be seen on the annulus floor (see Figure 4-1 and Figure 4-2 for an example from tank AZ-102). The lighter area on the annulus floor is believed to be the result of the annulus ENRAF installation performed in 2003. During installation, compressed air was used to blow away any debris from the annulus floor at the bottom of the applicable riser (Work Package 2E-03-01479/M). After using compressed air, a mechanical grabber was then used to remove the debris. This lighter discoloration appears to be lower in elevation when compared to the darker annulus floor surrounding this area (see Figure 4-2D). The darker area appears to be corrosion product from the primary tank and secondary liner. In the center of the lighter region, there is typically a smaller rust stain which is located directly underneath the ENRAF plummet. This rust stain can be attributed to the accumulation of moisture resulting from air condensing in the ENRAF equipment located above grade. These anomalies seen in the ENRAF risers do not appear to be a region of concern.

Figure 4-1. Top Down View of the Annulus Floor as seen from Riser 92 on February 11, 2013

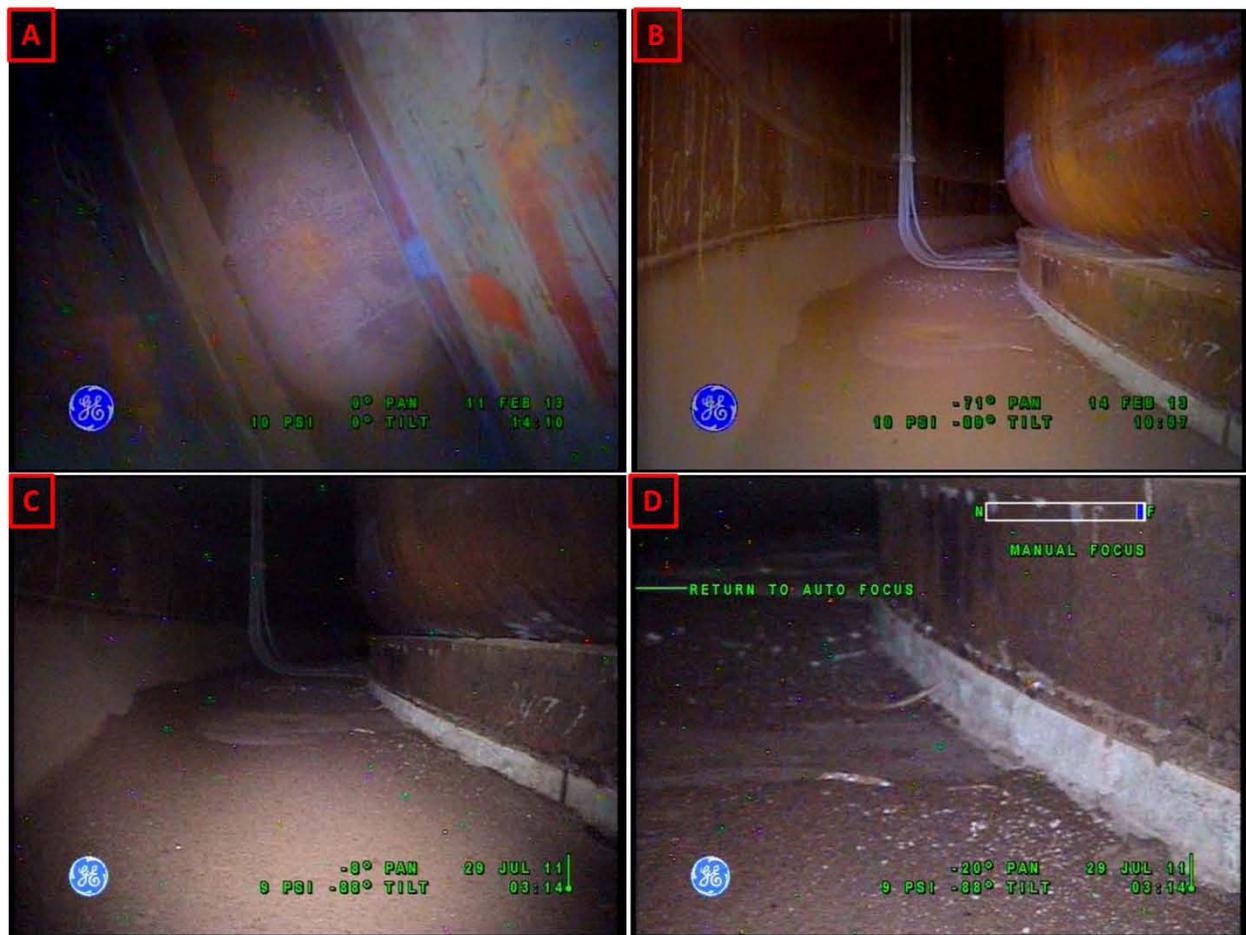
Figure 4-2. Annulus Floor Discoloration in Tank AZ-102 as seen from Riser 92 in 2013 (A), from Riser 80 in 2013 (B), from Riser 80 in 2011 (C), and Close Up View Showing Elevation Differences as seen from Riser 80 in 2011 (D)
