Purpose of Document: Identifies leak causes and locations for B Farm tanks

# Hanford Single-Shell Tank Leak Causes and Locations - 241-B Farm

**Abstract:** This document identifies 241-B Tank Farm (B Farm) leak cause and locations for the 100 series leaking tank (241-B-107) identified in RPP-RPT-49089, Hanford B-Farm Leak Inventory Assessments Report. This document satisfies the B Farm portion of the target (T04) in the Hanford Federal Facility Agreement and Consent Order milestone M-045-91F.

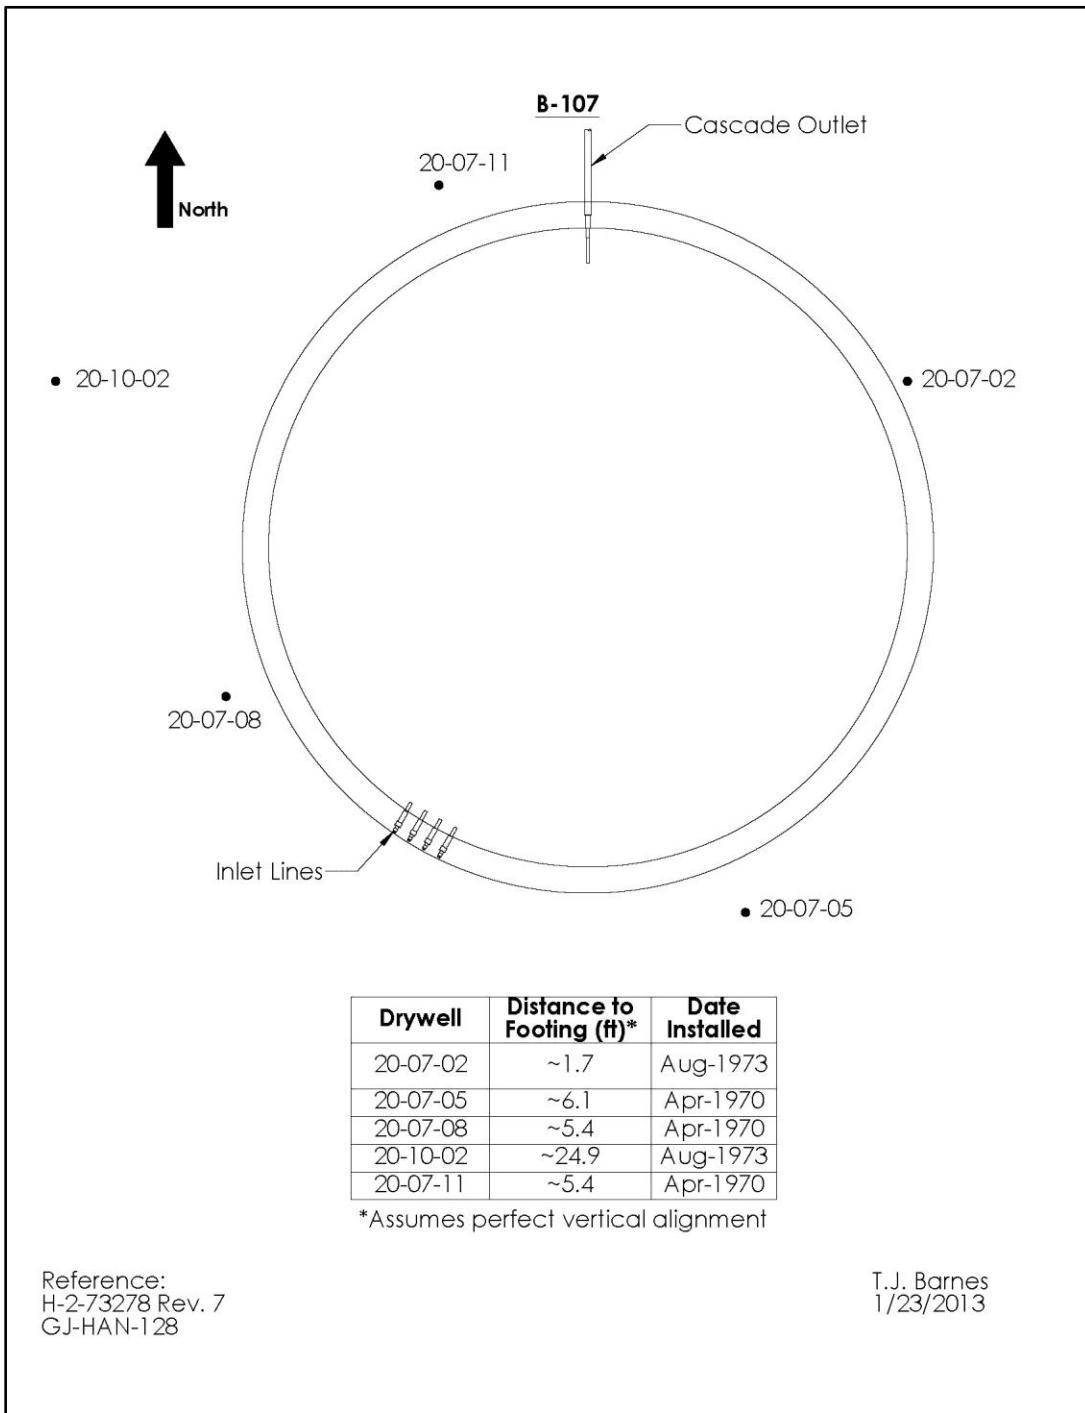
**Figure 2-1. B Farm Tank B-107 and Associated Drywells**  
 Tank inner ring is steel liner, outer ring is outer edge of tank footing

Figure 2-1 shows a simplified schematic of the B Farm tank B-107 with location of the drywells, cascade line, and spare inlet nozzles.

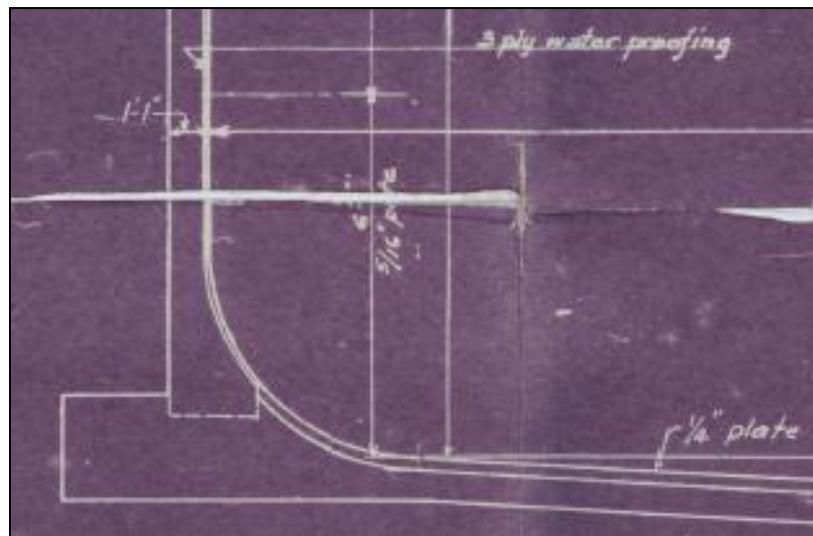
**Figure 3-1. B C T U Tank Farm Knuckle Configuration with Three-Ply Waterproofing (BPF-73550, Sheet B5)**

Figure 3-1 shows the detail of the knuckle liner to the grout and three-ply asphaltic waterproof membranes between the bottom, sidewall intersection, and sidewalls (BPF-73550, Sheet B5).

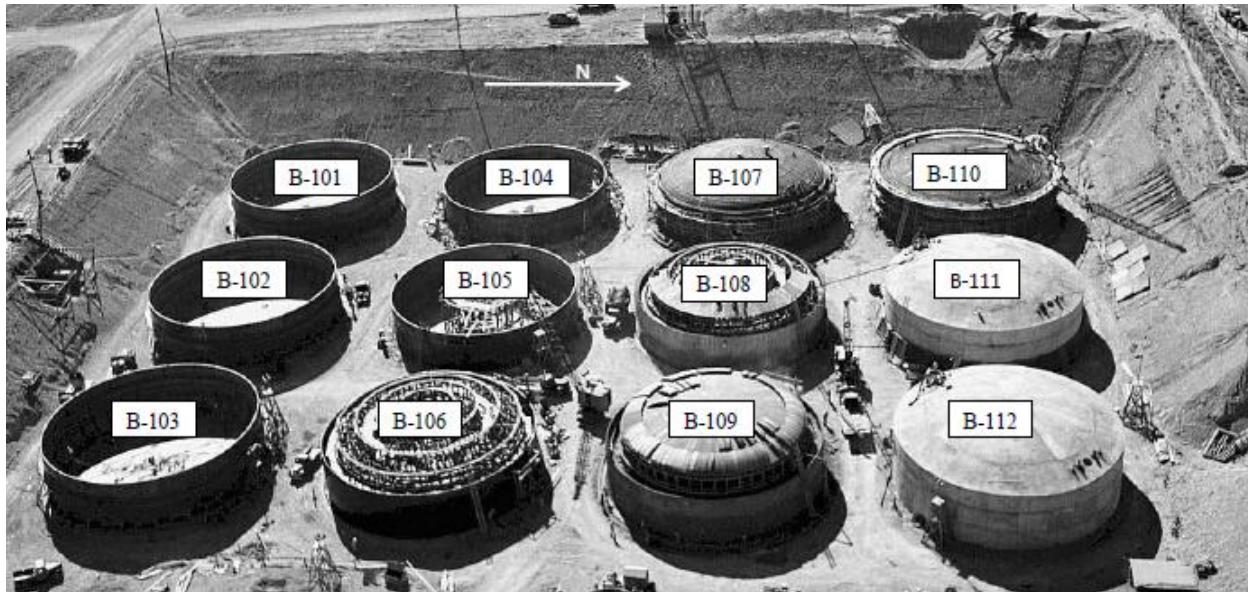
**Figure 3-2. B Farm Construction Photograph, September 25, 1944 (P6145 N1600681)**

The B Farm construction temperatures were examined to determine if the tank liner fabrication occurred at or below the ductile-to-brittle temperature transition (see Section 4.3.2). The photograph in Figure 3-2 shows the B Farm under construction on September 25, 1944.

2. Pg. 3-2, Fig. 3-2. The photo caption should state that the photo is looking south, as there isn't a map showing all tanks in B Farm. Please add.

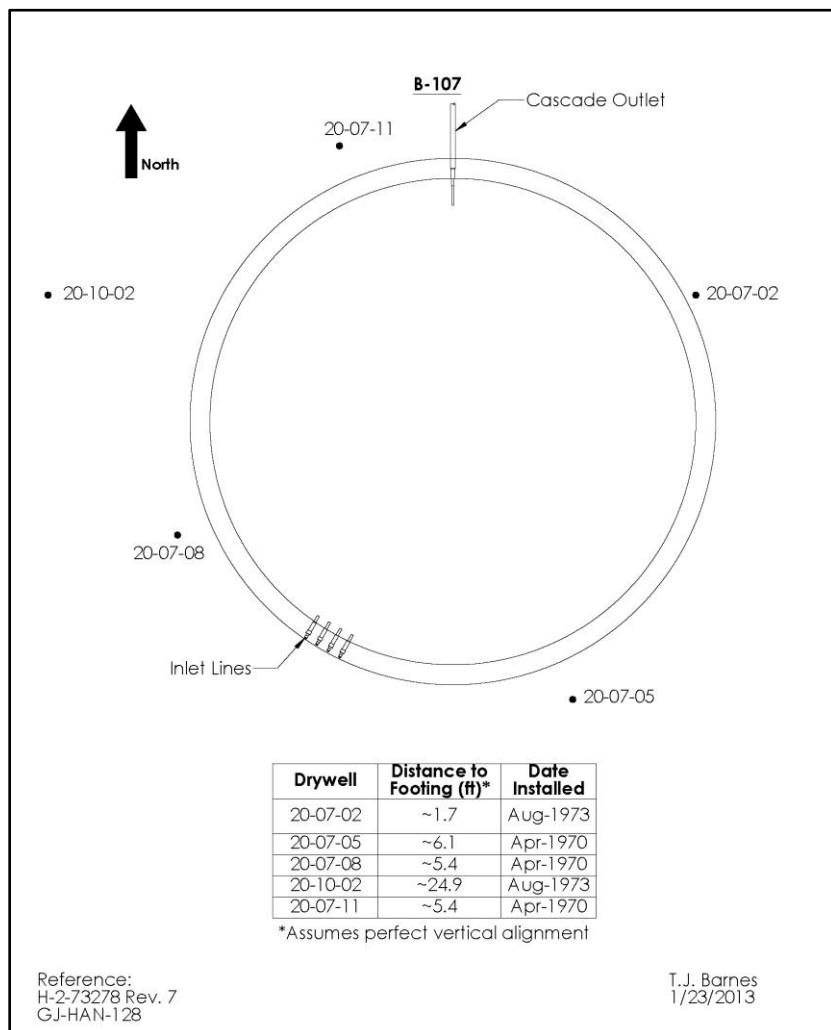
**Figure 4-1. Tank B-107 Associated Drywells**

This section provides information on the historical waste loss event associated with single-shell tank (SST) 241-B-107 (B-107). There are five drywells located around tank B-107 with specified distances from the drywell to the tank footing shown in Figure 4-1: 20-07-05, 20-07-08, and 20-07-11 installed in April 1970 and 20-07-02 and 20-10-02 installed in August 1973.

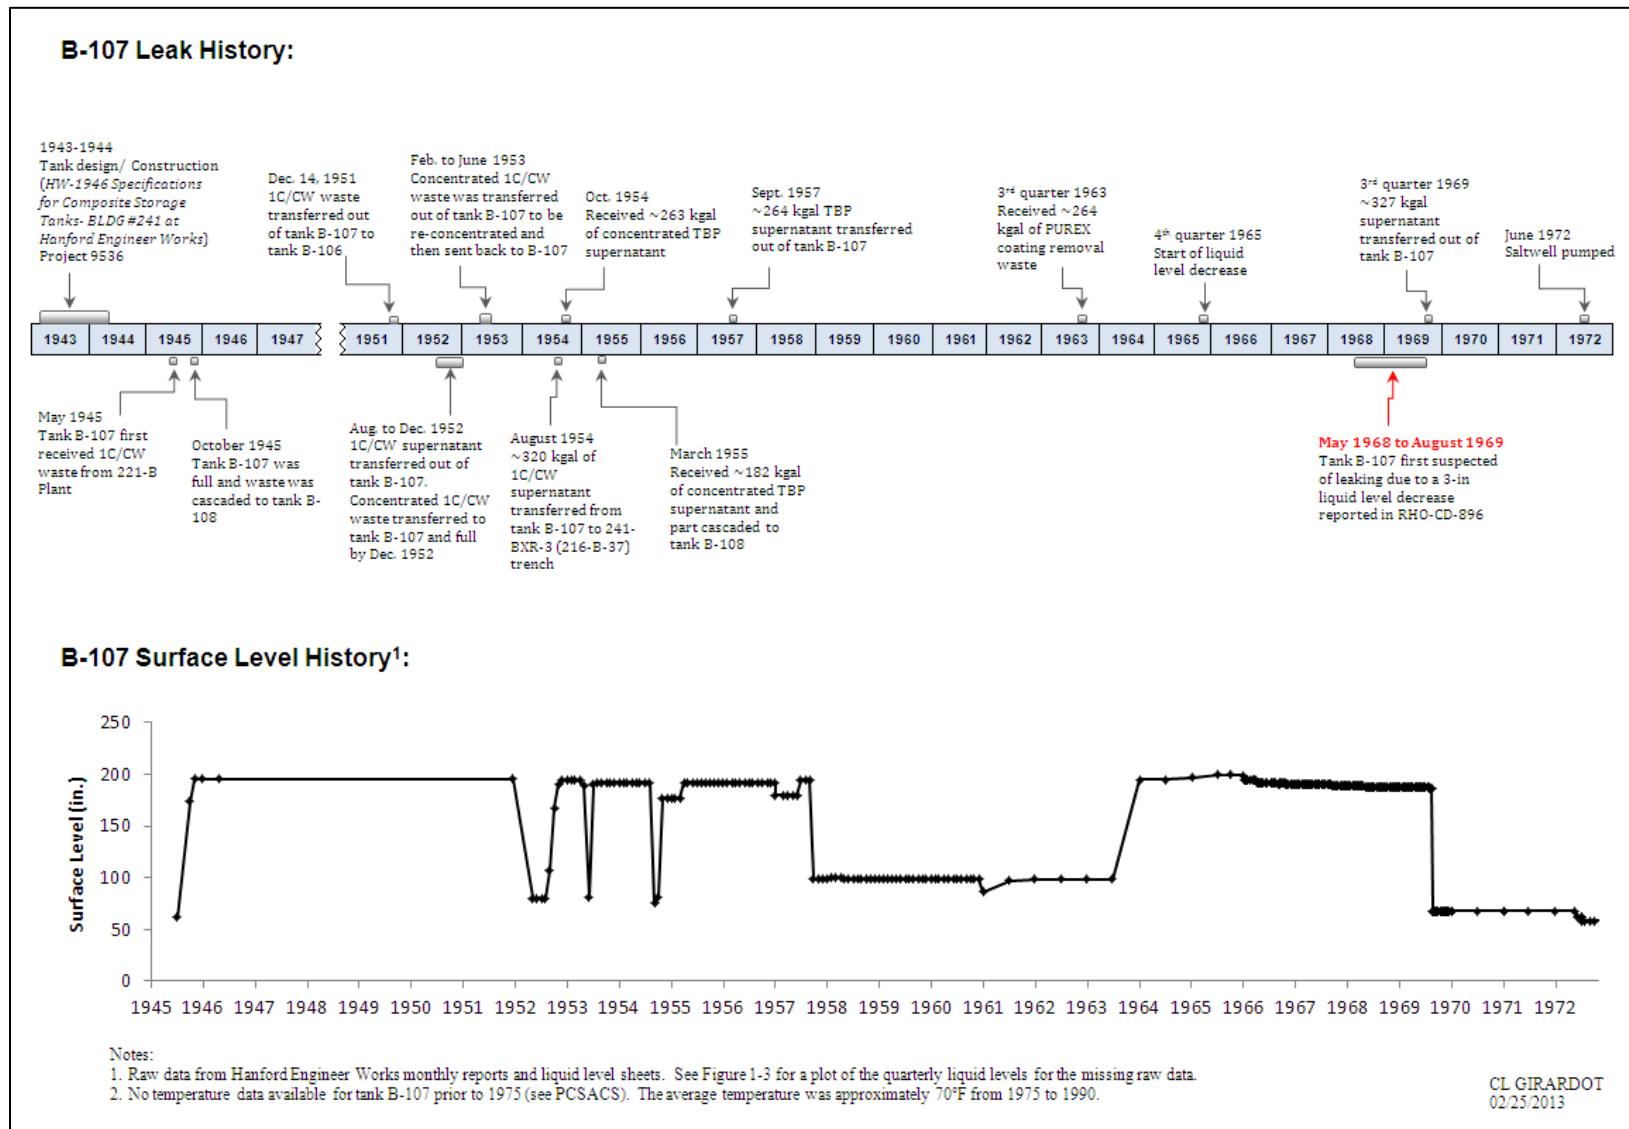
Figure 4-2. Operational Leak History of Tank B-107

The operational history of tank B-107 leak related details including liquid level is charted in Figure 4-2.

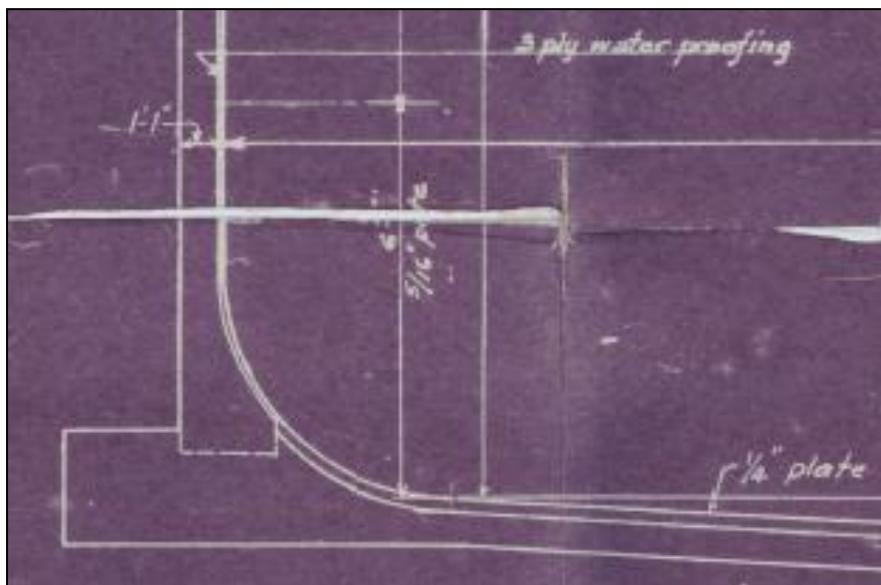
**Figure 4-3. B C T U Tank Farm Knuckle Configuration with Three-Ply Waterproofing  
BPF-73550, Sheet B5**

The steel bottoms of the B Farm tanks intersect the sidewall on a 4-ft radius knuckle transition (BPF-73550, Drawings D-2 and D-3). Figure 4-3 shows the detail of the rounded knuckle transition, the three ply asphaltic membrane waterproofing between the liner and the concrete, a notched footing construction joint, and the concrete shell. These features are common to all B Farm tanks (see Section 3.1.1).

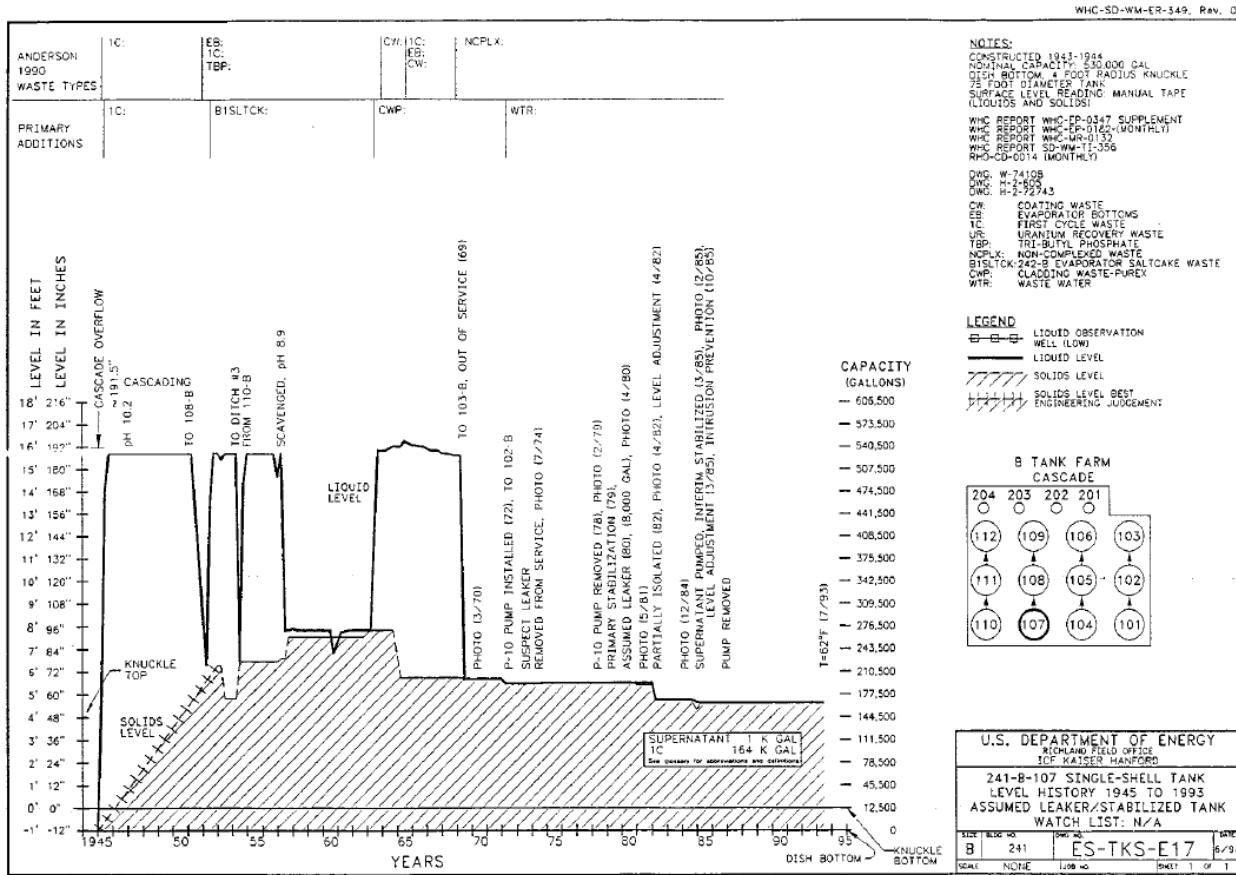
**Figure 4-6. Tank B-107 End of Quarter Surface Level**

The liquid level plot in Figure 4-6 indicates the transfers into and out of the tank. The liquid levels are end of quarter levels so this figure may not reflect all significant transfers into and out of tank B-107 that occurred during the operational history of the tank. See Figure 4-2 for historical monthly liquid level readings.
