241-AZ Tank Farm Construction Extent of Condition Review for Tank Integrity

T.J. Barnes, K.D. Boomer, J.R. Gunter, T.J. Venetz
Washington River Protection Solutions, LLC
Richland, WA 99352
U.S. Department of Energy Contract DE-AC27-08RV14800

Abstract: This report provides the results of an extent of condition construction history review for tanks 241-AZ-101 and 241-AZ-102. The construction history of the 241-AZ tank farm has been reviewed to identify issues similar to those experienced during tank AY-102 construction. Those issues and others impacting integrity are discussed based on information found in available construction records, using tank AY-102 as the comparison benchmark. In the 241-AZ tank farm, the second DST farm constructed, both refractory quality and tank and liner fabrication were improved.

July 2013

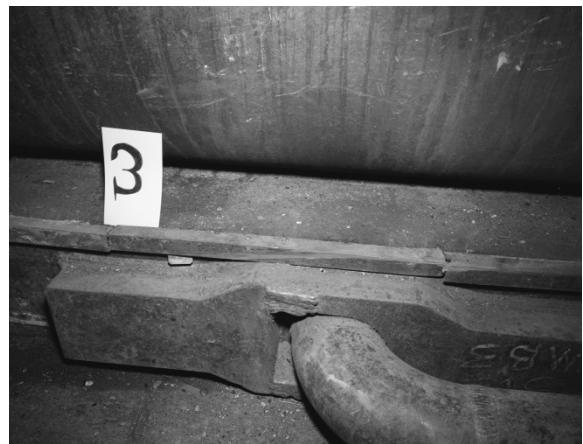
Following the installation of the ventilation piping, center air distribution ring, and thermocouple conduit, a 7 in. x 3/4 in. retainer ring was installed along the perimeter of the yet to be installed refractory. The retainer ring was to act as a form and to contain any spalling material during installation of the refractory. The ventilation piping and the thermocouple conduit penetrate through the retainer ring. Figure 4-8 shows the ventilation piping penetration. Figure 4-9 shows the work practices utilized for refractory pouring and shows a hole that was cut into the side of the secondary liner to allow entry of workers and materials. These holes were cut into both tanks AZ-101 and AZ-102. They were later sealed in January 1972 as is discussed in the daily logbooks. The logbook entries are summarized in Appendix A and provide additional details of the sealing which occurred between January 13th and 19th of 1972.

Figure 4-8. Refractory Retainer Ring and Ventilation Piping Interface (57482-17 Photo) (Taken 3/24/72)

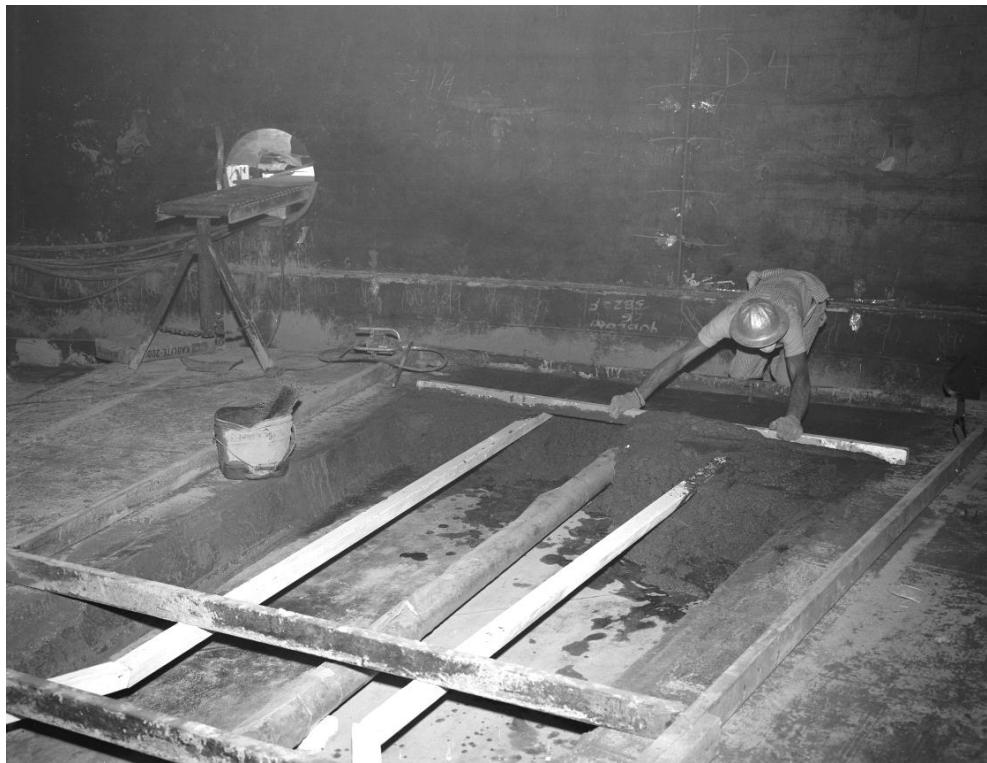
Figure 4-9. Tank AZ-101 Forms Placed and Refractory Being Poured (55952-6 Photo) (Taken 9/17/71)

This increased thickness is apparent in Figure 4-9, which shows a worker pouring a section of refractory. On March 24, 1972, inspection photographs, such as Figure 5-2, were taken of the refractory and the over-thickness can be seen where several inches of material extend below the retainer ring. The primary tank bottom was installed at a higher elevation than originally planned as a result of this design variation, but does not create conditions for any potential failure mechanism.

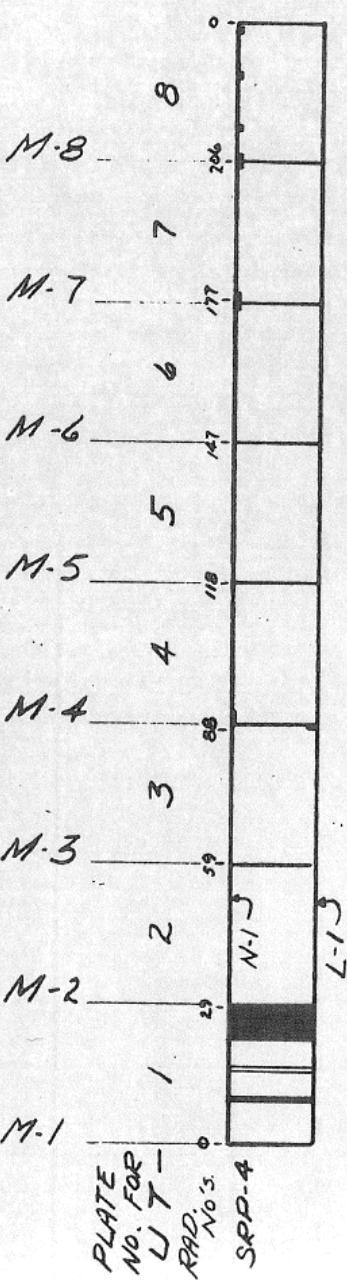
VERTICAL WELD IDENTIFICATION

WADCO CORPORATION	NONDESTRUCTIVE TEST REPORT NONDESTRUCTIVE TEST APPLICATIONS 306 BLDG., 300 AREA - TEL. 3682	REPORT NO. 72-41-1 DATE 3/27/72
<p>3. A strip 2 inches wide by 3 feet long between RT 16-17 revealed no lamination.</p> <p>4. In a 1 inch strip immediately below the longitudinal weld at top of the plate between RT 175 to 179, 187-188, 205-208, 213-214, 225-226, 234-235 no laminar type indications were noted.</p> <p>5. A 1 inch area below longitudinal weld at top of plate RT 89-92 revealed sporadic or intermittent reflectors parallel to the weld. However, there was no loss of back reflectors.</p> <p>6. Clockwise to the weld, bottom of the plate at RT 88 - a 4 inch long by 3 inch wide area was revealed to be laminated.</p> <p>All measurements are larger than actual discontinuity as areas were marked at extreme edge of 3/4 inch diameter transducers.</p>

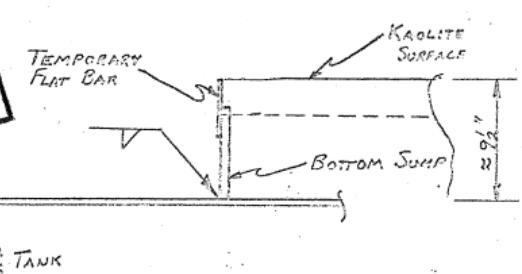
DEFICIENCY OR VARIATION REPORT			PDM STEEL COMPANY INDUSTRIAL SUPPLIES
Customer Contract No. <u>AT(45-1)-2176</u>		PDM Contract No. <u>30582</u>	
Component Name <u>Secondary Tank TK101</u>		DVR No. <u>#5</u>	
Part Name <u>Bottom Sump</u>	Piece No. <u>BS-2</u>	Drawing No. <u>8</u> Revision No. <u>2</u>	
Description of contract deviation/change/repair.			
<p>DESCRIPTION OF DEVIATION: The depth of Kaolite 2000 will be increased due to the irregular surface of the secondary bottom. The depth will vary between 8" and 10". The center elevation of secondary bottom requires the depth of Kaolite to be approximately 9 1/2". The increased depth will cause the primary tank to be higher in elevation than design calls for.</p> <p>RECOMMENDED DISPOSITION: The center sump will be welded to the secondary bottom with a temporary flat bar attached to the inside of the sump at the top to restrain the Kaolite during pouring (shown on sketch). The temporary flat bar will be removed after the Kaolite has been cured. Elevation readings on the surface of the Kaolite will be taken after pouring and the upper primary shell ring will be shortened accordingly (the difference between design thickness and actual).</p>

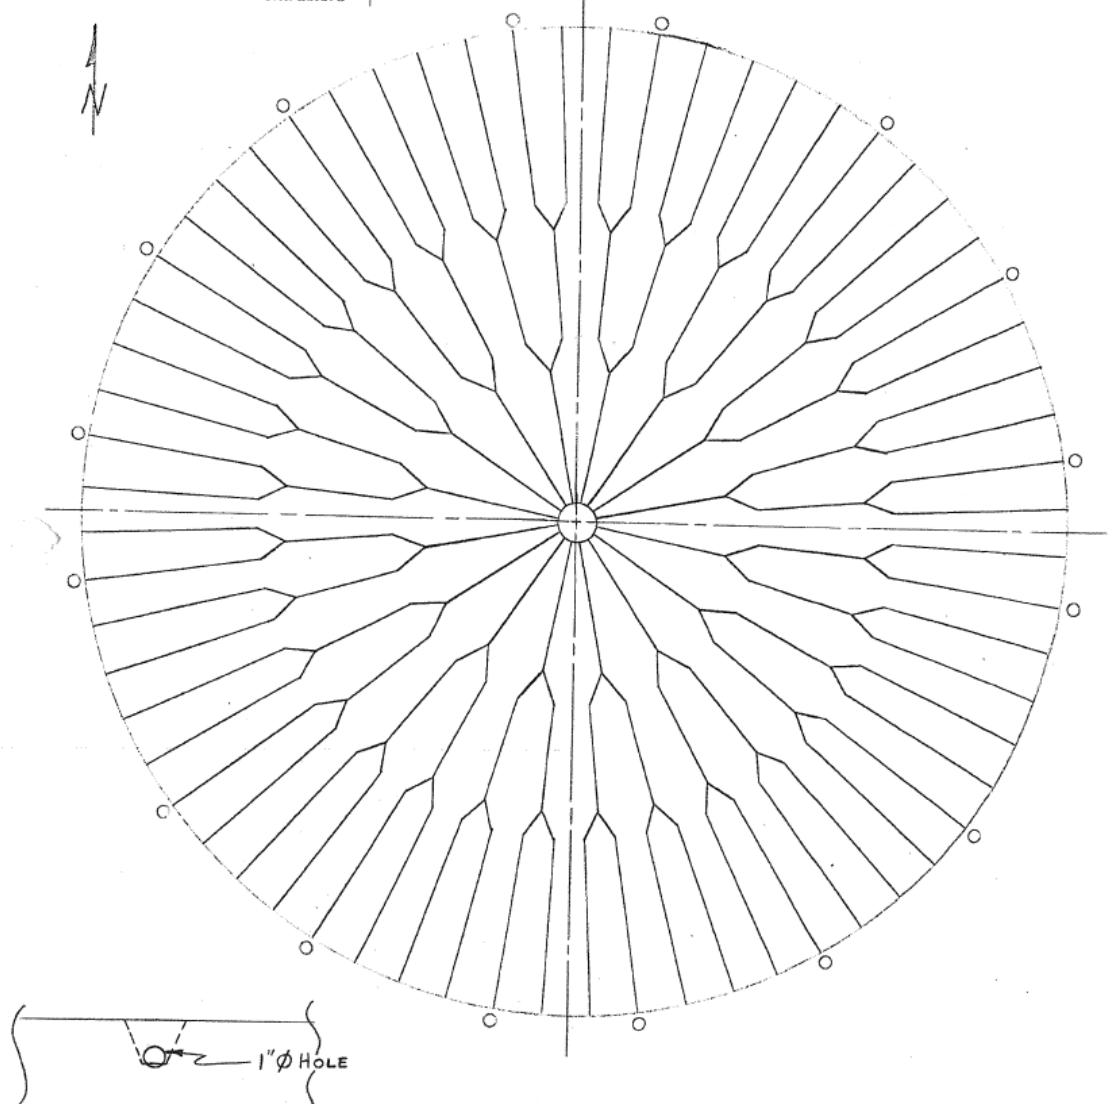
TANK 101

TYPICAL AT HOLE
LOCATIONS
