Novel Defect Detection Using Laser-Based Imaging and TIVA with a Visible Laser

International Symposium for Testing and Failure Analysis

San Jose, California
November 3-7th, 2013

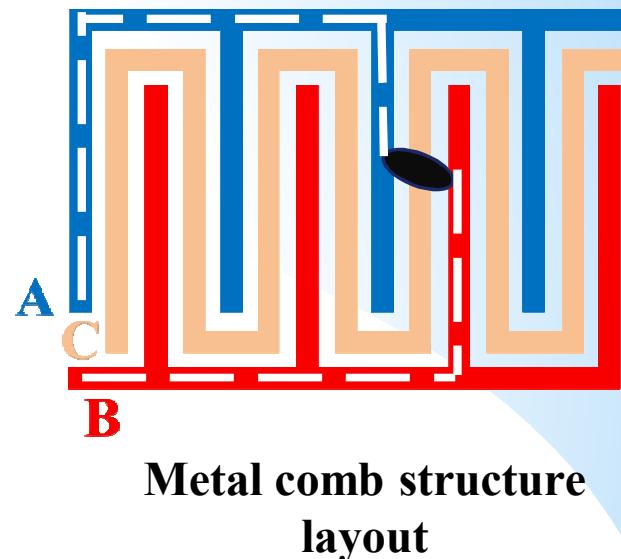
- Metal comb structures used as process monitors for back end of the line defects
- TIVA easily indicates current path but resolution is poor
- Reflected-light images more clearly define size and shape of defect sites than TIVA

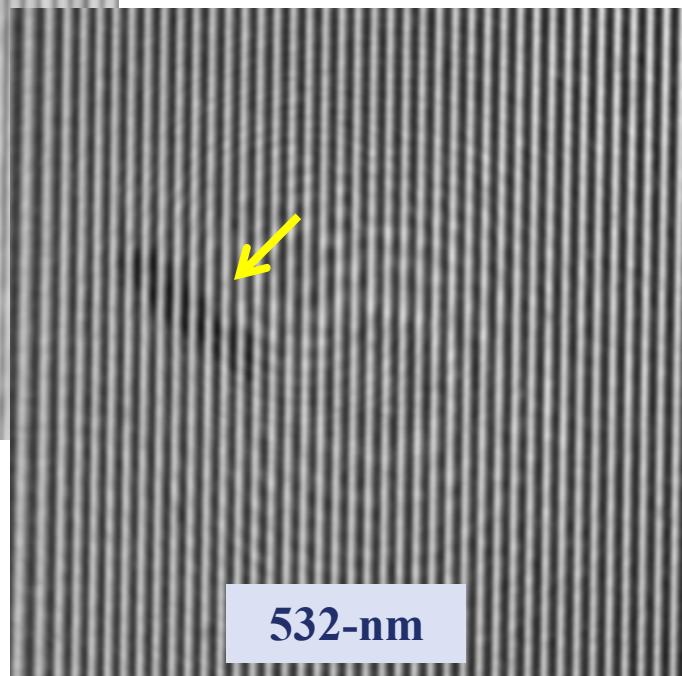
Contrast of the defect site varies
with incident laser wavelength

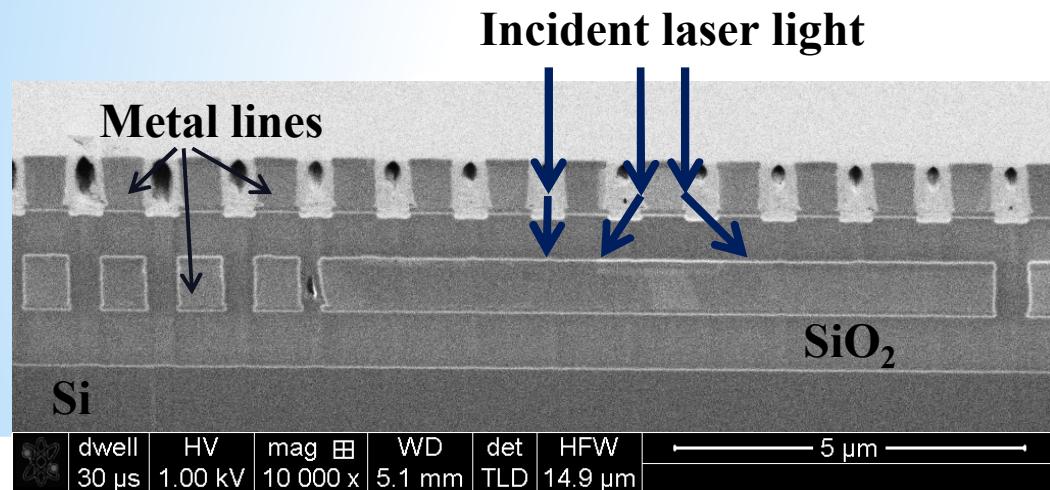
532-nm Reflected Light images at different focal planes

- Focus up and down did not change contrast of defect
- Likely constructive and deconstructive interference and resolution of incident wavelength
