Hanford Single-Shell Tank Leak Causes and Locations - 241-BY and 241-TY Farm

C.L. Girardot, D.G. Harlow

Washington River Protection Solutions
Richland, WA 99352
U.S. Department of Energy Contract

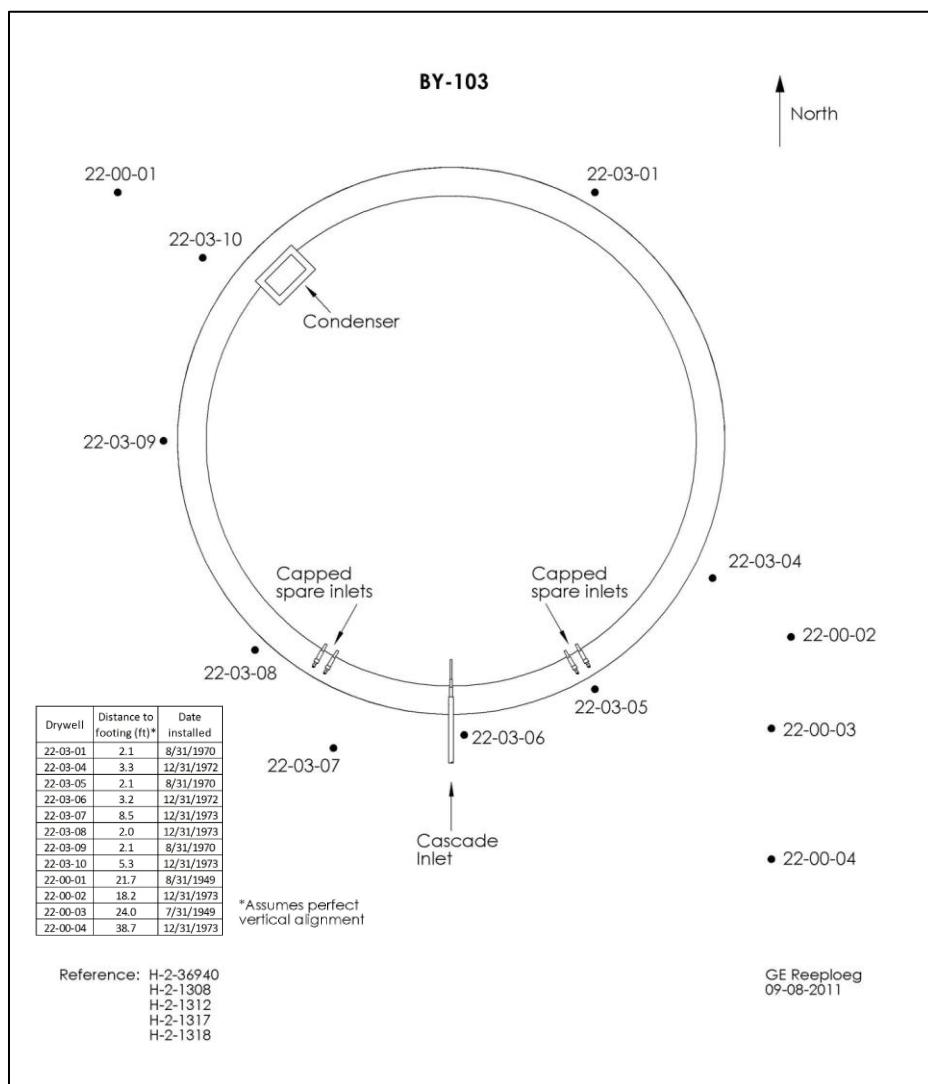
Figure 4-1. Tank BY-103 Associated Drywells
Tank inner ring is steel liner, outer ring is outer edge of tank footing

This section provides information on the historical waste loss event associated with Single-Shell Tank (SST) 241-BY-103 (BY-103). There are twelve drywells located around tank BY-103 with specified distances from the drywell to the tank footing shown in Figure 4-1: 22-00-01 and 22-00-03 installed in July 1949; 22-03-01, 22-03-05, and 22-03-09 installed in August 1970; 22-03-04 and 22-03-06 installed in December 1972; and 22-00-02, 22-00-04, 22-03-07, 22-03-08, and 22-03-10 installed in December 1973.

in drywell 22-03-09 at 34-ft BGS indicate a possible sidewall leak and the source of radioactivity at the 18-ft BGS level remains unclear since no pipes that were reported to have leaked are present in this area at these BGS levels (see Figure 4-1). Also, the nearby spare inlet lines at ~22-ft 1-in BGS do not appear to be a likely source location. Radioactivity detected in drywells 22-03-08 and 22-03-10 is likely the result of migration from the leak site that appears to be near drywell 22-03-09.

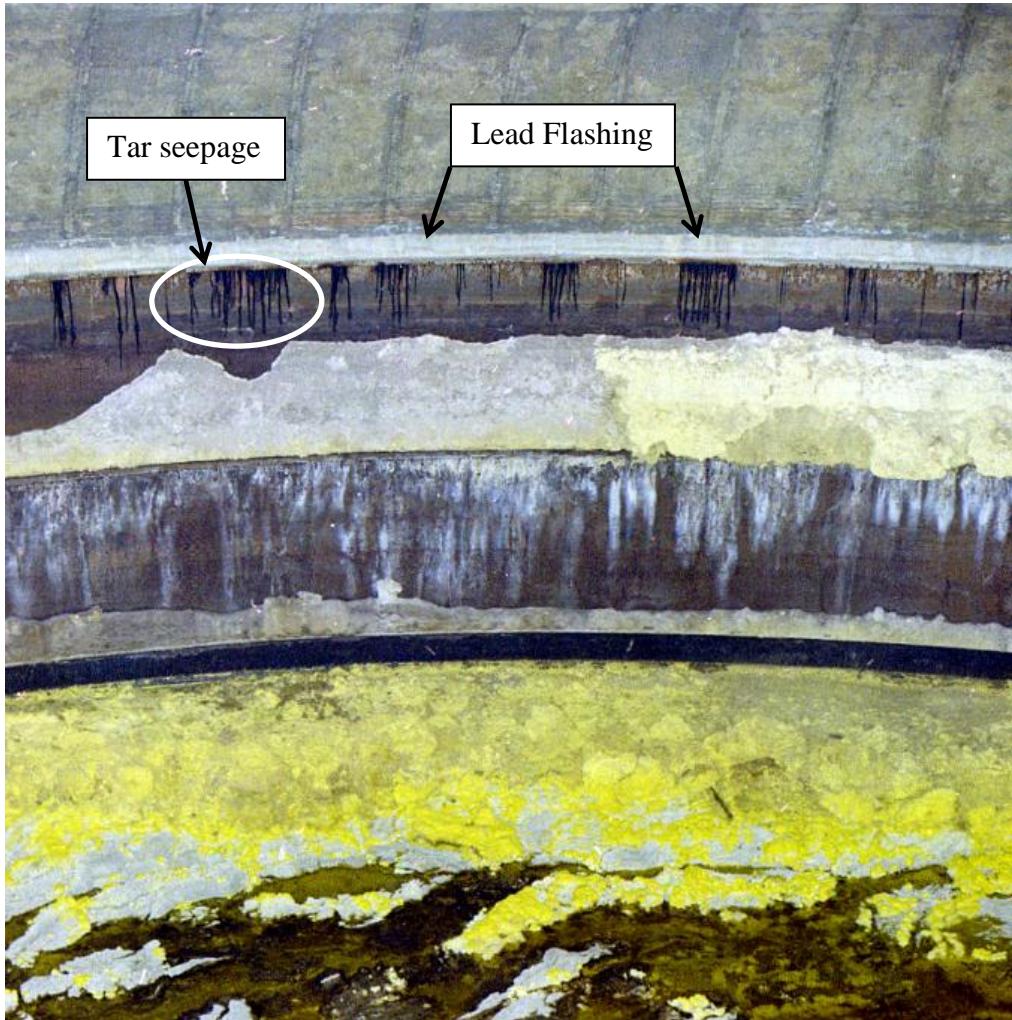
**Figure 4-4. Tank BY-103 Tar Seepage
March 5, 1981
(Photograph 9511211 11-CN)**

Tar seepage (asphalt) was visible below the lead flashing at the top of the liner in 1980 photographs of tank BY-103 (see Figure 4-4). In this case only a small portion of the tank circumference was affected. Several other BY and TY tanks experienced tar seepage at the top of the liner and in the side walls (ARH-1496, *Review of Storage Tank Integrity*). The report indicated the mastic compound (three-ply asphaltic membrane waterproofing) placed between the steel liner and the concrete wall during construction could cause the asphalt to flow through a breach in the liner and lead flashing connection at non-boiling waste temperatures. It is unknown if any other asphalt seepage was experience in tank BY-103 as photographs were not available of the tank wall below the level of the waste indicated in Figure 4-4.

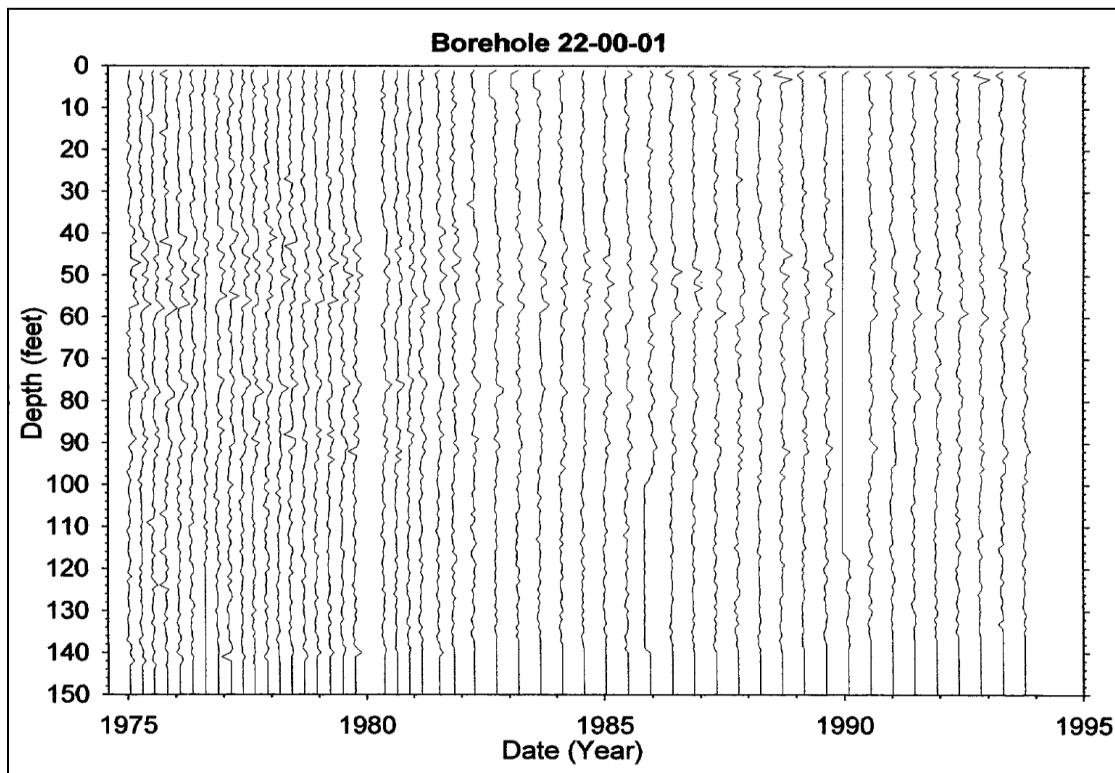
Figure 4-5. Tank BY-103 Drywell 22-00-01 (HNF-3532)

In February 1996, Cs-137 was the only man-made contaminant detected reported in this drywell from the surface to 6-ft, from 38 to 60-ft, from 76 to 82-ft, and from 86 to 97-ft BGS (GJ-HAN-20). It appears radioactivity detected in drywell 22-00-01 may not be associated with tank BY-103 as drywell 22-03-10 (installed December 1973), located between tank BY-103 and drywell 22-00-01, first reported radioactivity in early 1975 at a much higher BGS level (see Section 4.5.1.12). GJ-HAN-20 reports, “Contamination below 38 ft probably originated from a subsurface source, because the contamination does not extend to the surface at significant concentrations. Tank BY-103 or BY-106 is the likely source for this contamination.” It remains inconclusive the source of radioactivity detected in this drywell, therefore, drywell 22-00-01 is not included as part of the leak location for tank BY-103. Figure 4-5 shows the depths of radioactivity from 1975 to 1994 (HNF-3532).

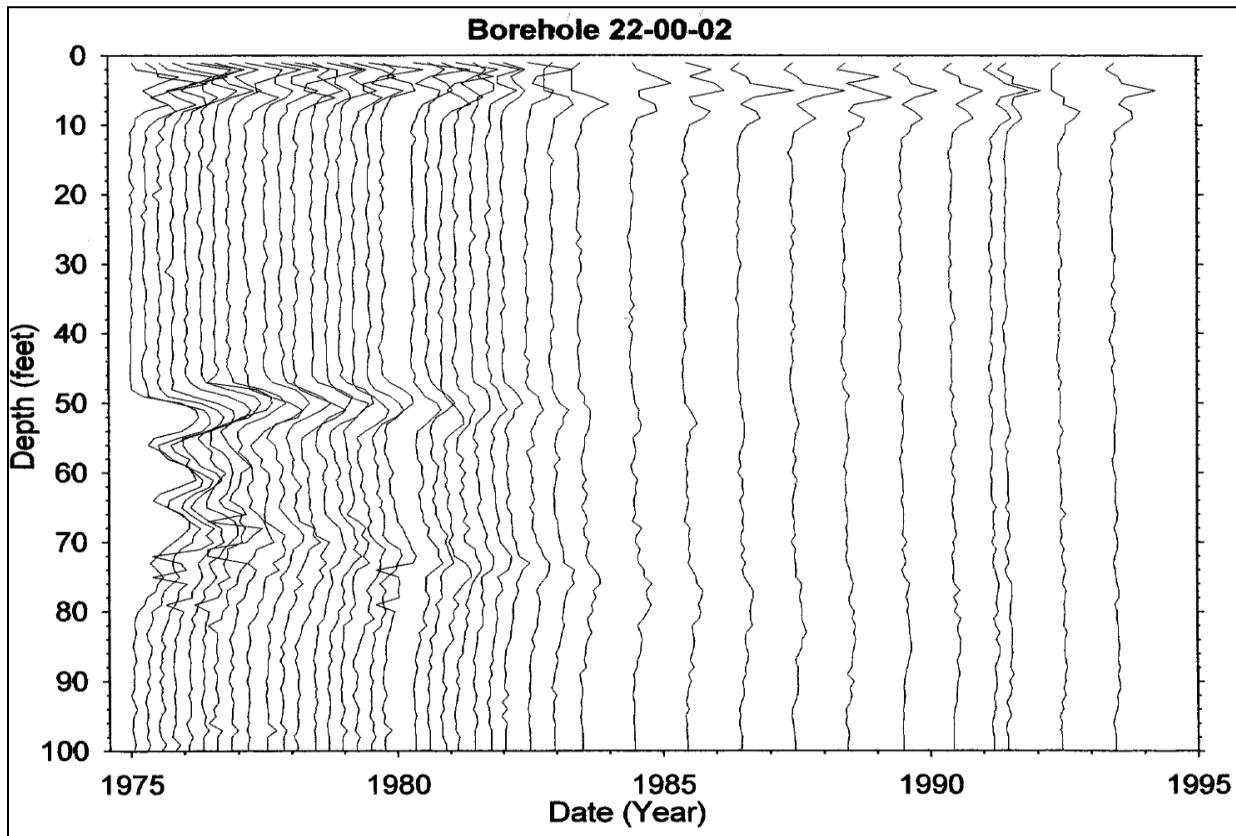
Figure 4-6. Tank BY-103 Drywell 22-00-02 (HNF-3532)

Document GJ-HAN-20 states that tank BY-103 is most likely the source of the Co-60 and Sb-125 that was detected at approximately 50-ft BGS. Figure 4-6 shows the depths of radioactivity from 1975 to 1994 (HNF-3532).

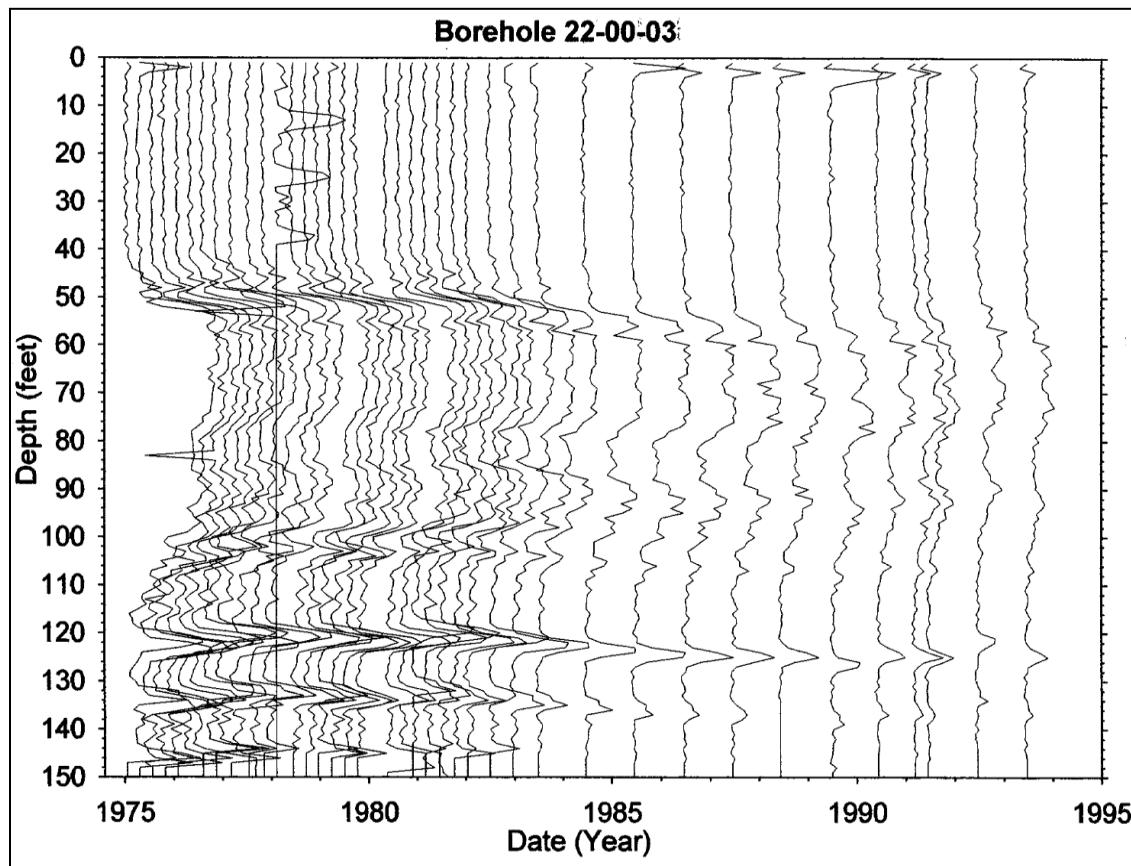
Figure 4-7. Tank BY-103 Drywell 22-00-03 (HNF-3532)

Drywell 22-00-03 was drilled July 31, 1949 with the first recoverable reading on September 9, 1959 as greater than 100K cpm from 42 to 150-ft BGS. Radioactivity continued to be detected in this drywell and was reported at > 1,000K cpm in December 1965 from 50-92-ft BGS which was indicated to be mostly Co-60. No data were recovered from December 1965 until August 22, 1972 with a peak reported at 212.3K cpm at 60-ft BGS (see Appendix A1). Radioactivity then slowly declined and on June 6, 1986 was reported at 14.1K cpm at 74-ft BGS.

In February 1996, Cs-137, Cs-60, and Sb-125 were the only man-made contaminants detected in this drywell (GJ-HAN-20). From the ground surface to about 102-ft BGS, Cs-137 was detected continuously at concentrations up to about 20 pCi/g. Co-60 was detected almost everywhere below 46-ft BGS at concentrations up to 13 pCi/g and Sb-125 was detected from 54 to 72-ft BGS at concentrations of about 2 pCi/g. Document GJ-HAN-20 states the Cs-137, Co-60, and Sb-125 detected in this drywell likely originated from tank BY-103. Tank BY-103 was first suspected of leaking in 1969 based on radioactivity being detected in drywell 22-00-03 (Internal letter "Integrity of tanks 241-BY-103 and 241-TY-103"). Figure 4-7 shows the depths of radioactivity from 1975 to 1994 (HNF-3532).

- No other data were available after 1975 except for Figure 4-7. The spike seen around 1980 at the bottom of the drywell does not seem to provide any additional information to a possible leak location. This will not be addressed in the report.

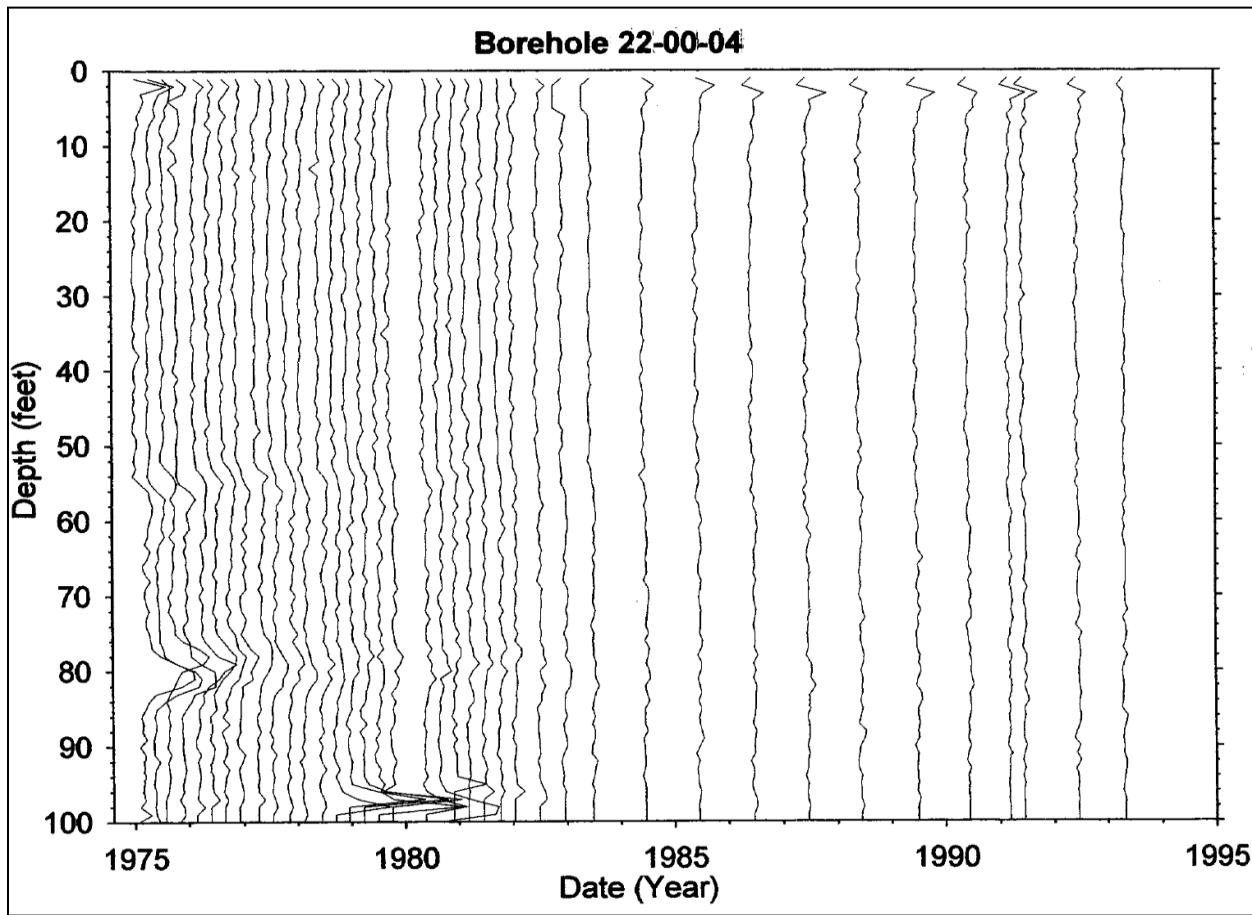
Figure 4-8. Tank BY-103 Drywell 22-00-04 (HNF-3532)

In February 1996, Cs-137 and Co-60 were the only man-made contaminants detected in this drywell (GJ-HAN-19, *Vadose Zone Monitoring Project at the Hanford Tank Farms Tank Summary Data Report for Tank BY-102*). From the ground surface to 33-ft BGS and from 95 to 99-ft BGS, Cs-137 was detected continuously and intermittently from 33 to 95-ft BGS. Concentrations of Cs-137 were measured at levels below 1 pCi/g. Co-60 was detected below 56-ft BGS at concentrations less than 1 pCi/g. Document GJ-HAN-19 states, “The Co-60 may have originated from a more distant subsurface source such as tank BY-103.” Figure 4-8 shows the depths of radioactivity from 1975 to 1994 (HNF-3532).

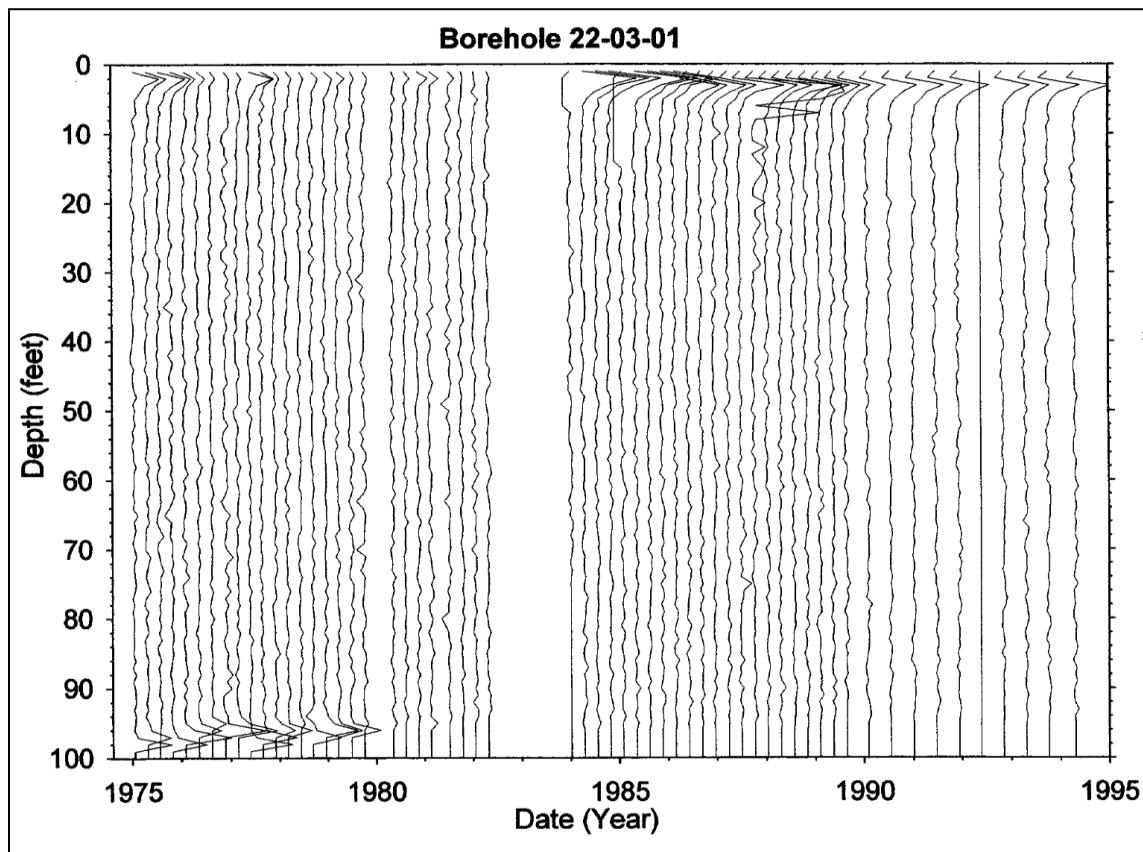
Figure 4-9. Tank BY-103 Drywell 22-03-01 (HNF-3532)

In February 1996, Cs-137 was the only man-made contaminant detected almost continuously in this drywell at concentrations of 2 pCi/g or less (GJ-HAN-20). Document GJ-HAN-20 states, "No evidence exists for a subsurface source of contamination near this borehole." Since historical records report little radioactivity in this drywell, drywell 22-03-01 is not included as part of the leak location for tank BY-103. Figure 4-9 shows the depths of radioactivity from 1975 to 1994 (HNF-3831).

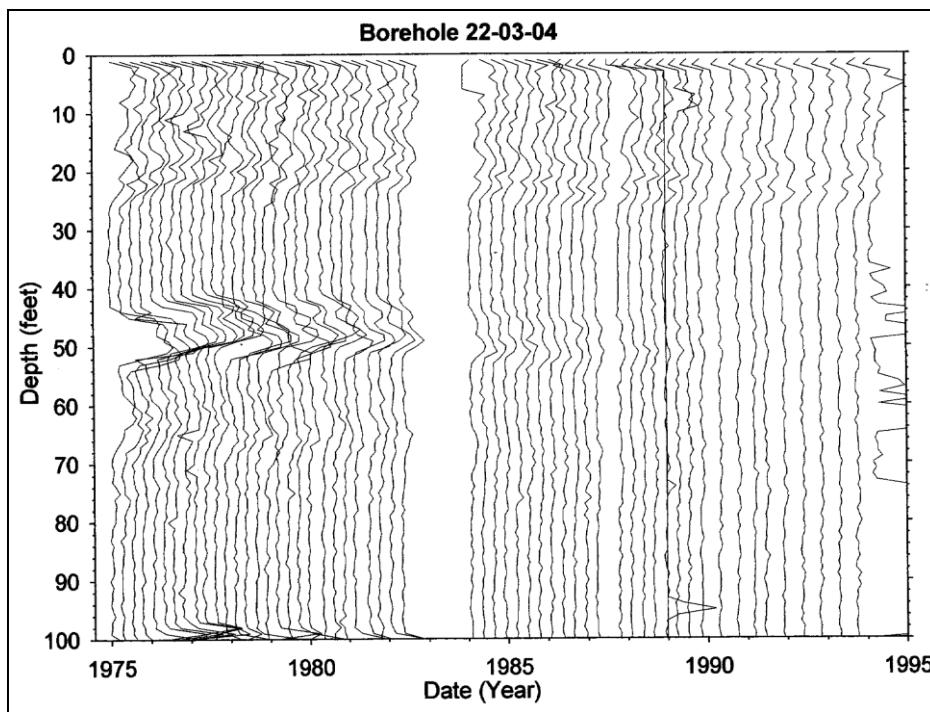
Figure 4-10. Tank BY-103 Drywell 22-03-04 (HNF-3532)

In February 1996, Cs-137, Co-60, and Sb-125 were the only man-made contaminants detected in this drywell (GJ-HAN-20). Cs-137 was detected continuously from the surface to about 32-ft BGS and discontinuously below 32-ft BGS with a maximum concentration of ~30 pCi/g. Co-60 was detected in two intervals: one near 49-ft BGS and the other near 75-ft BGS with a maximum concentration of about 1 pCi/g. Sb-125 was detected from 50 to 52-ft BGS at a maximum concentration of about 1 pCi/g. Document GJ-HAN-20 states, “The zone of Co-60 contamination from 45.5 to 58 ft probably originated from a leak of tank BY-103, at or near its bottom at 48 ft in depth. The lower zone of Co-60 contamination near 75 ft also originated from the subsurface, apparently from tank BY-103” and “Sb-125 originated from the subsurface, most likely from the same leak that produced the Co-60 contamination near 50 ft. The source was most certainly tank BY-103, which is the only tank near borehole 22-03-04.” This statement seems appropriate as there is no other nearby sources that would explain the Co-60 contamination. Figure 4-10 shows the depths of radioactivity from 1975 to 1994 (HNF-3532).

5. Pg. 4-10, Fig. 4-9. The spectral gamma log for borehole 22-03-04 shows two Co-60 peaks; one at ~45 ft. and the other at ~75 ft. The shallower one shows on Fig. 4-9, but the deeper

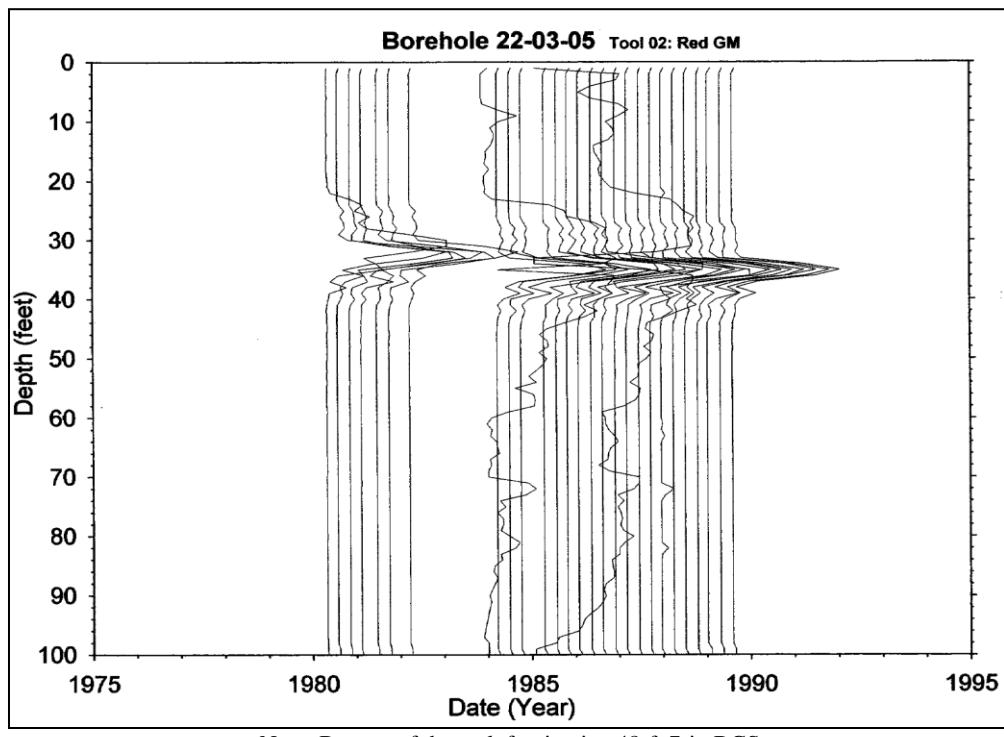
Figure 4-11. Tank BY-103 Drywell 22-03-05 (HNF-3532)

In February 1996, Cs-137 and Co-60 were the only man-made contaminants detected in this drywell (GJ-HAN-20). High concentrations of Cs-137 along the entire length of this drywell were reported with the maximum concentration 2,300 pCi/g at 45-ft BGS (GJ-HAN-20). Co-60 was detected near 50-ft BGS with concentrations at ~7 pCi/g. Document GJ-HAN-20 states, "When the tank was filled, the waste level was about 25 ft below ground level. Tank BY-103 or a subsurface pipe (such as the cascade line near depth 25 ft) for that tank is the most likely source of this contamination." Figure 4-11 shows the depths of radioactivity from 1980 to 1990 (HNF-3532) (see Section 4.5.2). It was not clear why data was not plotted from 1975 to 1980.

Radioactivity detected at the higher BGS levels in drywell 22-03-05 does not appear to be the result of leakage from the cascade inlet pipe nor the capped spare inlet lines (see Figure 4-1). The spare inlet nozzles and the cascade inlet pipe are located at approximately 22-ft 1-in BGS and radioactivity was detected at a much lower BGS level in drywell 22-03-05. It appears radioactivity detected at the higher BGS level in drywell 22-03-05 is likely the result of sidewall leak from tank BY-103.

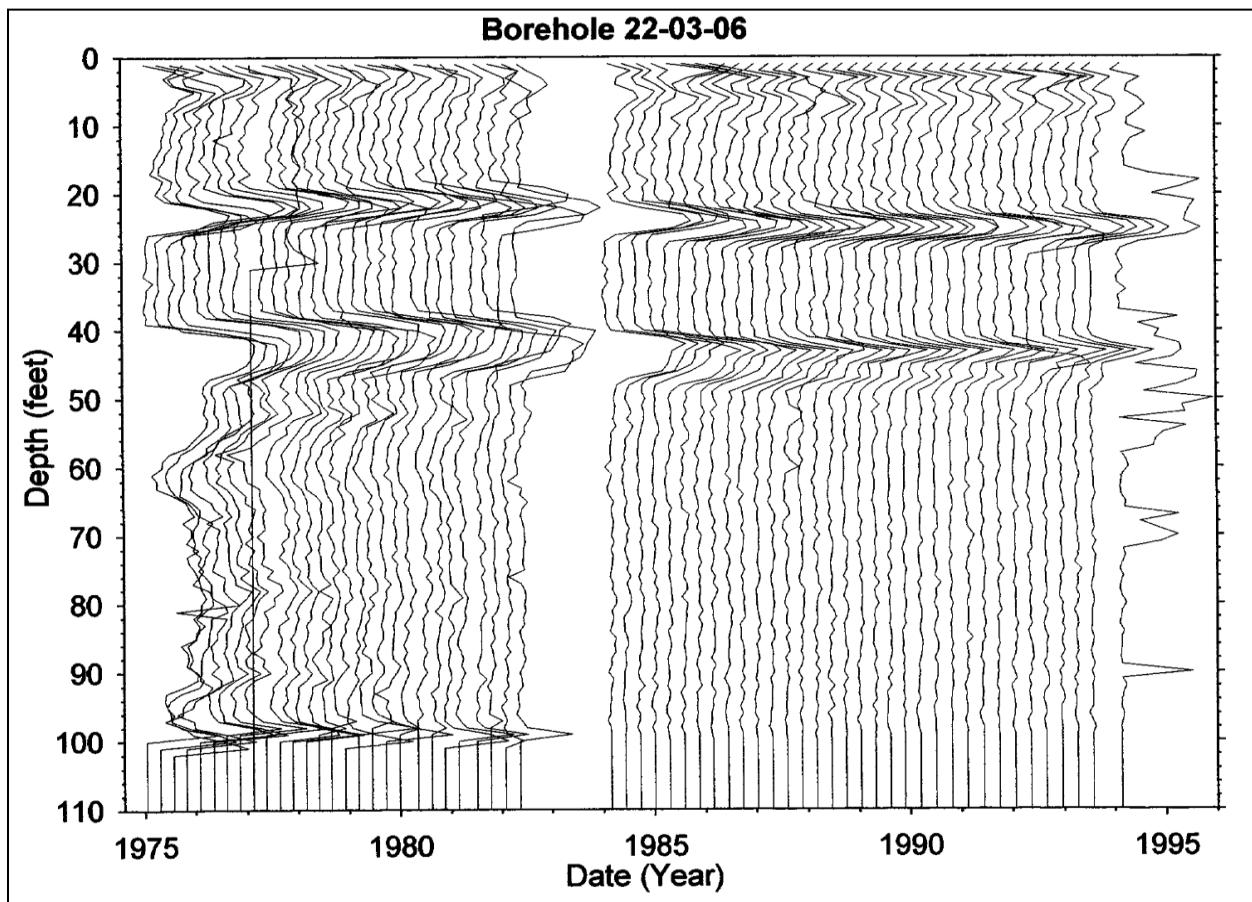
Figure 4-12. Tank BY-103 Drywell 22-03-06 (HNF-3532)

In February 1996, Cs-137, Co-60, and Sb-125 were the man-made contaminants detected in this drywell and the most likely source of this contamination is tank BY-103 (GJ-HAN-20). Also stated in this document, “The total gamma-ray peak near 24 ft might be due to contamination in or near the cascade line or other subsurface piping for tank BY-103, or the peak might be due to a leak from tank BY-103” (see Section 4.5.2). Figure 4-12 shows the depths of radioactivity from 1975 to 1994 (HNF-3532).

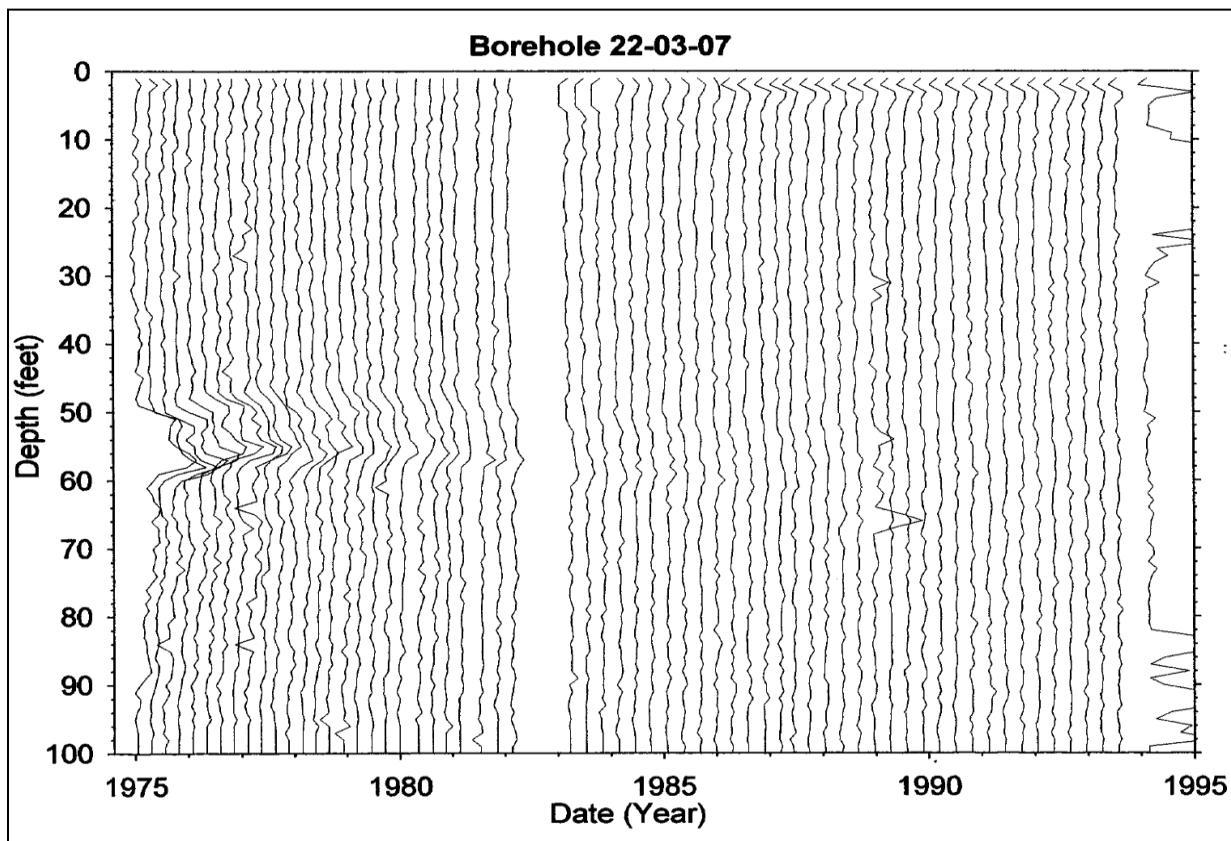
Figure 4-13. Tank BY-103 Drywell 22-03-07 (HNF-3532)

In February 1996, Cs-137 and Co-60 were the only man-made radionuclides detected in this drywell (GJ-HAN-20). From the ground surface to about 24-ft BGS, Cs-137 was reported at concentrations less than 10 pCi/g; however, no evidence exists for a subsurface source of Cs-137 at this drywell. From 53 to 94-ft BGS, Co-60 was detected at concentrations less than 0.5 pCi/g. Document GJ-HAN-20 states, “Tank BY-103 or its piping is the most likely source of the Co-60 contamination.” However, a tank BY-103 piping leak seems unrealistic at the depth of radioactivity with no radioactivity above 50-ft BGS. Figure 4-13 shows the depths of radioactivity from 1975 to 1994 (HNF-3532).

Note: Bottom of the tank footing is ~48-ft 7-in BGS

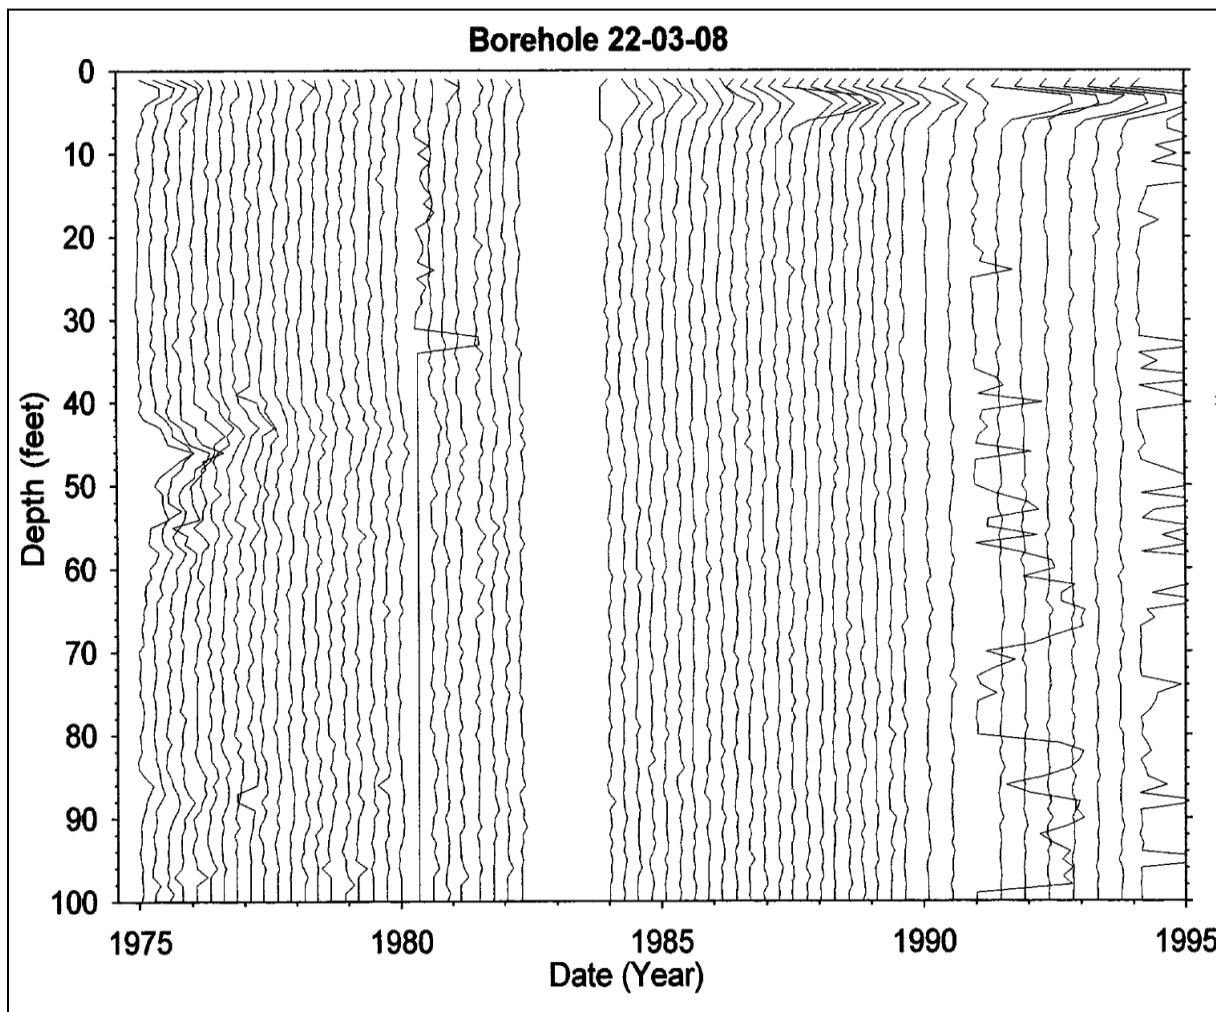
Figure 4-14. Tank BY-103 Drywell 22-03-08 (HNF-3532)

In February 1996, Cs-137 and Co-60 were the only man-made contaminants found in this drywell (GJ-HAN-20). From the ground surface to about 12-ft BGS, Cs-137 was detected continuously at concentrations less than 40 pCi/g. Co-60 was detected near 48 and 92-ft BGS at concentrations less than 0.4 pCi/g. Document GJ-HAN-20 reports, “No evidence for a deeper subsurface source, such as a tank leak, exists for Cs-137 at this borehole” and, “The Co-60 contamination near 48 ft most likely originated from tank BY-103, whose bottom is at that depth. The deeper Co-60 contamination probably also originated from tank BY-103, either migrating down through the sediments or following the casing.” Figure 4-14 shows the depths of radioactivity from 1975 to 1994 (HNF-3831).

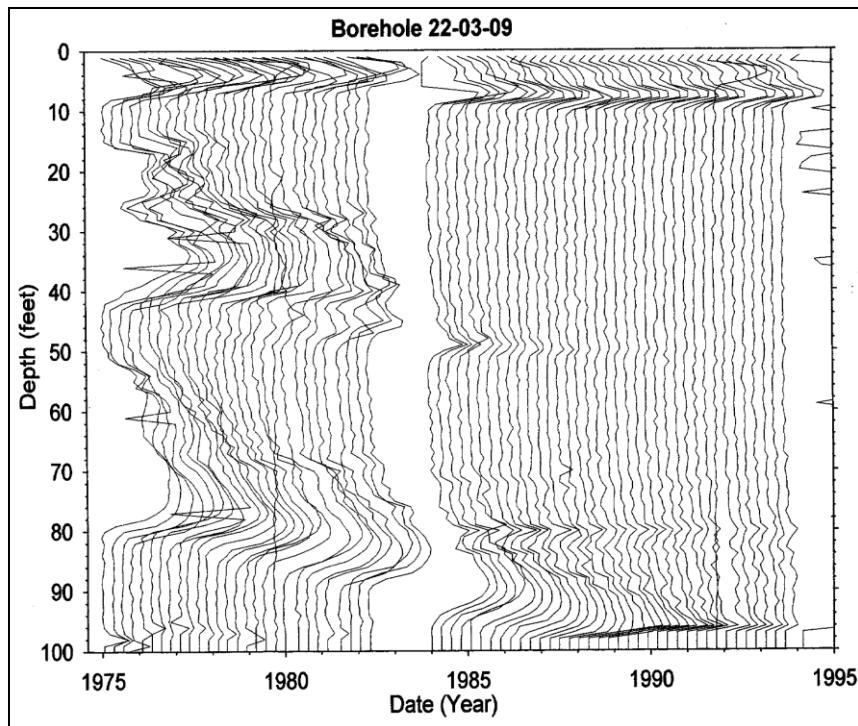
Figure 4-15. Tank BY-103 Drywell 22-03-09 (HNF-3532)

Drywell 22-03-09 was drilled on August 31, 1970 with the first recoverable reading in March 1971 which was reported to be less than 50K cpm (Internal letter “Integrity of Tanks 241-BY-103 and 241-TY-103”). The next available reading was on August 22, 1972 and radioactivity was reported to be 27.6K cpm from 57-62-ft BGS. Radiation readings were reported to be low and stable in drywell 22-03-09 until December 1972 when an increase in the spread of the readings was noted (from 58-71-ft BGS to 56-77-ft BGS) (Internal letter “Integrity of Tanks 241-BY-103 and 241-TY-103”). Additional peaks were reported on July 17, 1973 at 62.6K cpm at 18-ft BGS and on December 24, 1973 at 15K cpm at 34-ft BGS and continued through March 1987 (see Appendix A1). The source of the peak reported at 18-ft BGS remains unclear but is probably associated with buried piping and not the tank liner as 18-ft BGS is located above the tank liner.

Document HNF-3532 reports two broad peaks of radioactivity near 34-ft BGS and 68-ft BGS. In February 1996, Cs-137, Co-60, and Eu-154 were the only man-made contaminants detected in this drywell (GJ-HAN-20). From the ground surface to about 48-ft BGS, Cs-137 was detected; however, GJ-HAN-20 reports, “No evidence of a subsurface source of Cs-137 exists at this borehole.” Co-60 was detected near 6 and 49-ft BGS and Eu-154 was reported near 6-ft BGS. Document GJ-HAN-20 states, “The Co-60 near 49 ft probably originated from tank BY-103” and “Tank BY-106, (to be published), which is also an assumed leaker and is located about 16 ft west of borehole 22-03-09, is also a possible source for this contamination. Figure 4-15 shows the depths of radioactivity from 1975 to 1994 (HNF-3535).

Three peaks were reported for drywell 22-03-09 in 1972-1973 at 18-ft BGS, 34-ft BGS, and from 57 to 62-ft BGS. Radioactivity in drywell 22-03-10 was reported as less than values in April 1974; however, lower levels of radioactivity were reported beginning in January 1975 at 21-ft BGS. Radioactivity was also reported for drywell 22-03-08 in April 1974 at 46-ft BGS. It appears tank BY-103 leaked near drywell 22-03-09 as levels of radioactivity were much higher compared to the nearby drywells 22-03-08 and 22-03-10. It appears the peak detected

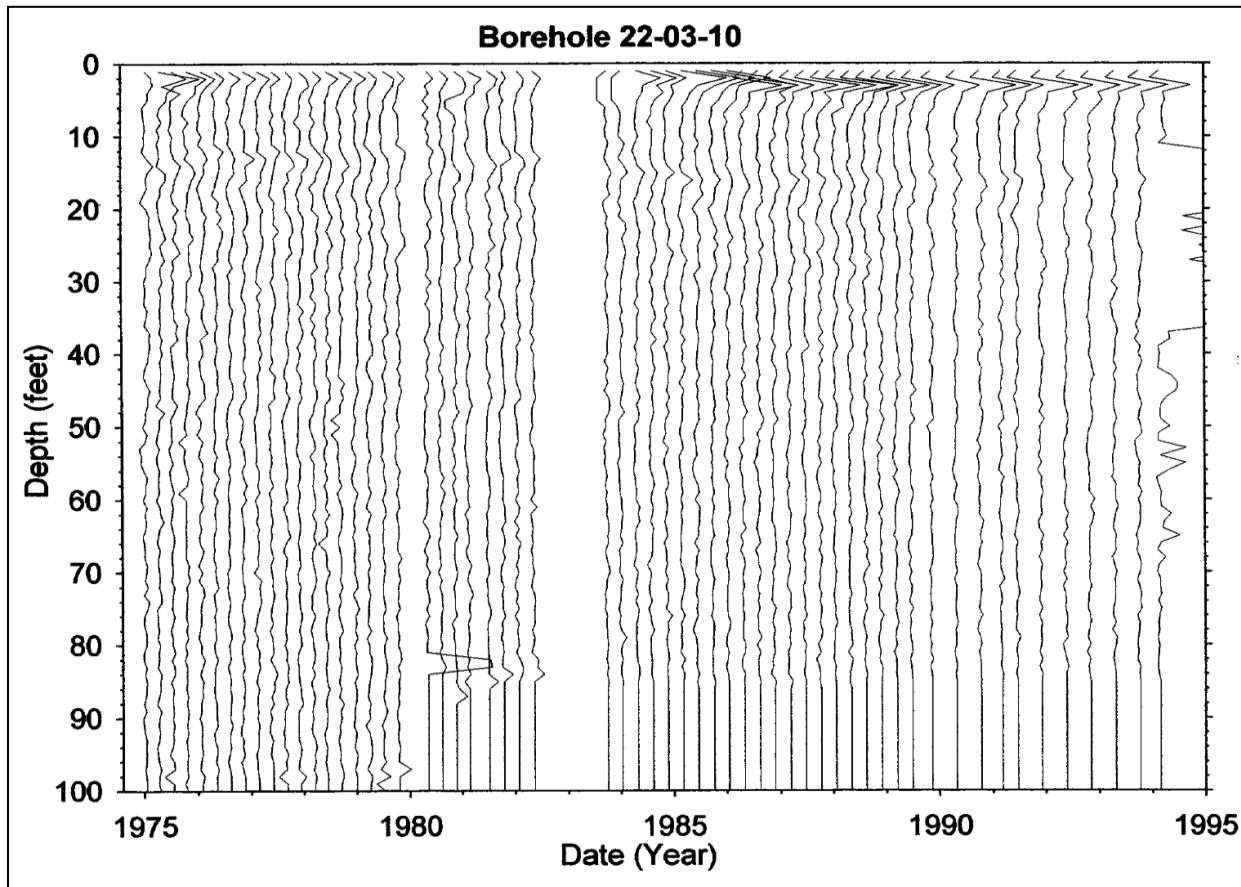
Figure 4-16. Tank BY-103 Drywell 22-03-10 (HNF-3532)

Drywell 22-03-10 was drilled on December 31, 1973 with the first recoverable reading on April 24, 1974 as less than values through September 24, 1974. On January 24, 1975 radioactivity was reported at 3.2K cpm at 21-ft BGS and remained relatively stable through March 1987 (see Appendix A1).

In February 1996, Cs-137 was the only man-made contaminant detected in this drywell, occurring continuously from the surface to 50-ft BGS at concentrations less than 50 pCi/g (GJ-HAN-20). Document GJ-HAN-20 reports, “Tank BY-103 (including its ancillary piping) is the most likely source of the subsurface contamination at this borehole. Tank BY-106 (to be published), which is located about 29 ft southwest of borehole 22-03-10, is also a possible source of the contamination.” Figure 4-16 shows the depths of radioactivity from 1975 to 1994 (HNF-3831).

There is a remote possibility that the drywell 22-03-10 radioactivity came from a leak at the tank condenser but no direct indication has been found. Indirectly, the storage of TBP waste between 110°F and 180°F for two years or PUREX HLW supernatant at a projected 180+°F for eight years could have produced condensate from the condenser which may have leaked out the gasket.

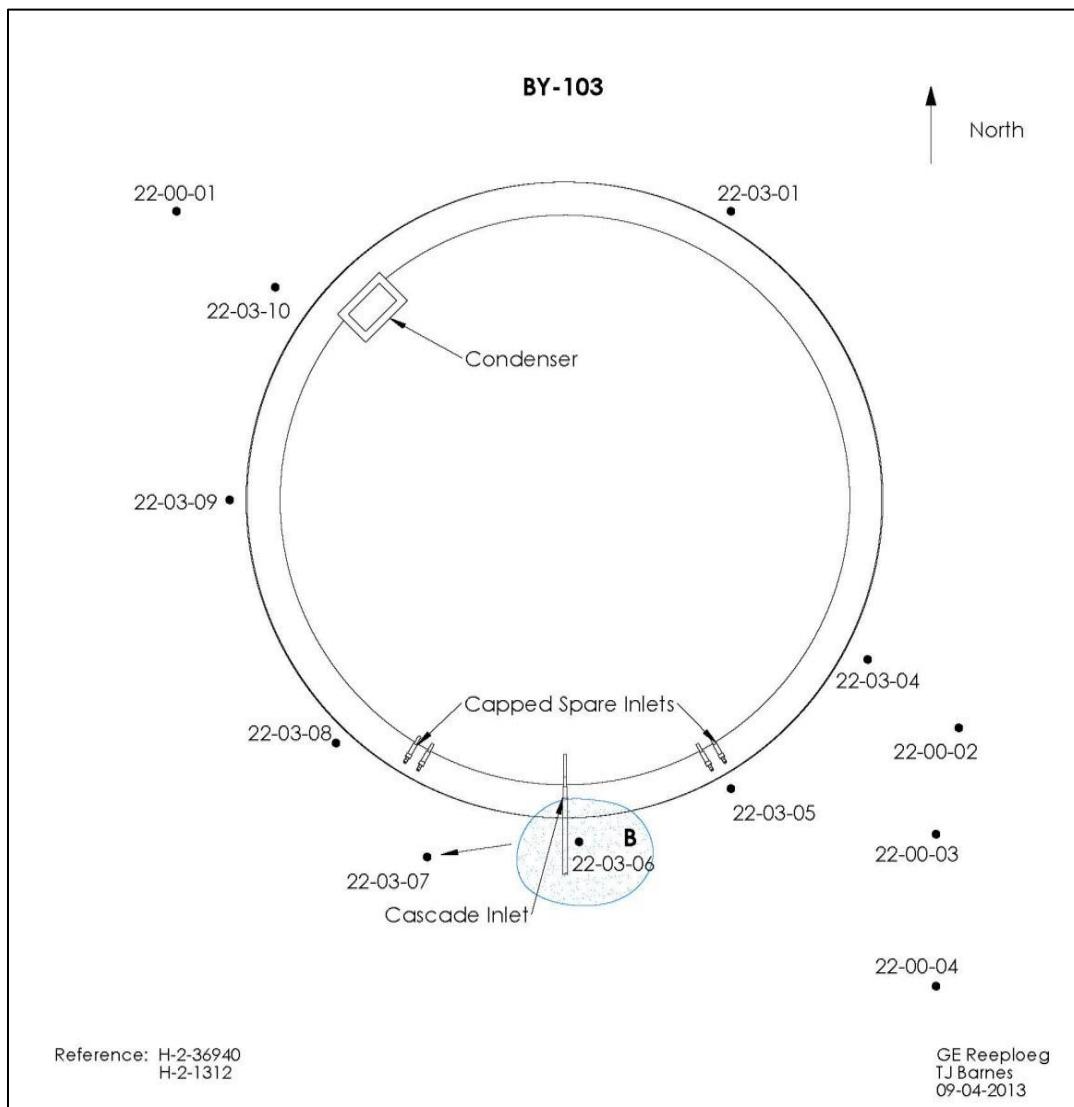
Figure 4-18. Tank BY-103 Possible Leak Location (February 1973)

The first recoverable reading for drywell 22-03-06 reported radioactivity at 45-ft BGS in February 1973 with a second peak at 27-ft BGS later detected in July 1974 (see site B in Figure 4-18). The peak detected at 45-ft BGS appears to be a separate leak site from site A (see Figure 4-17) near the tank footing. However, there may be migration from site A (see Figure 4-20). The peak detected at 27-ft BGS could be the result of sidewall leak and/or a leak from the cascade inlet line. Radioactivity was also reported in drywell 22-03-07 at 58-ft BGS in April 1974. It appears radioactivity detected in drywell 22-03-07 is likely from migration from site B and/or site C (see Figure 4-19).

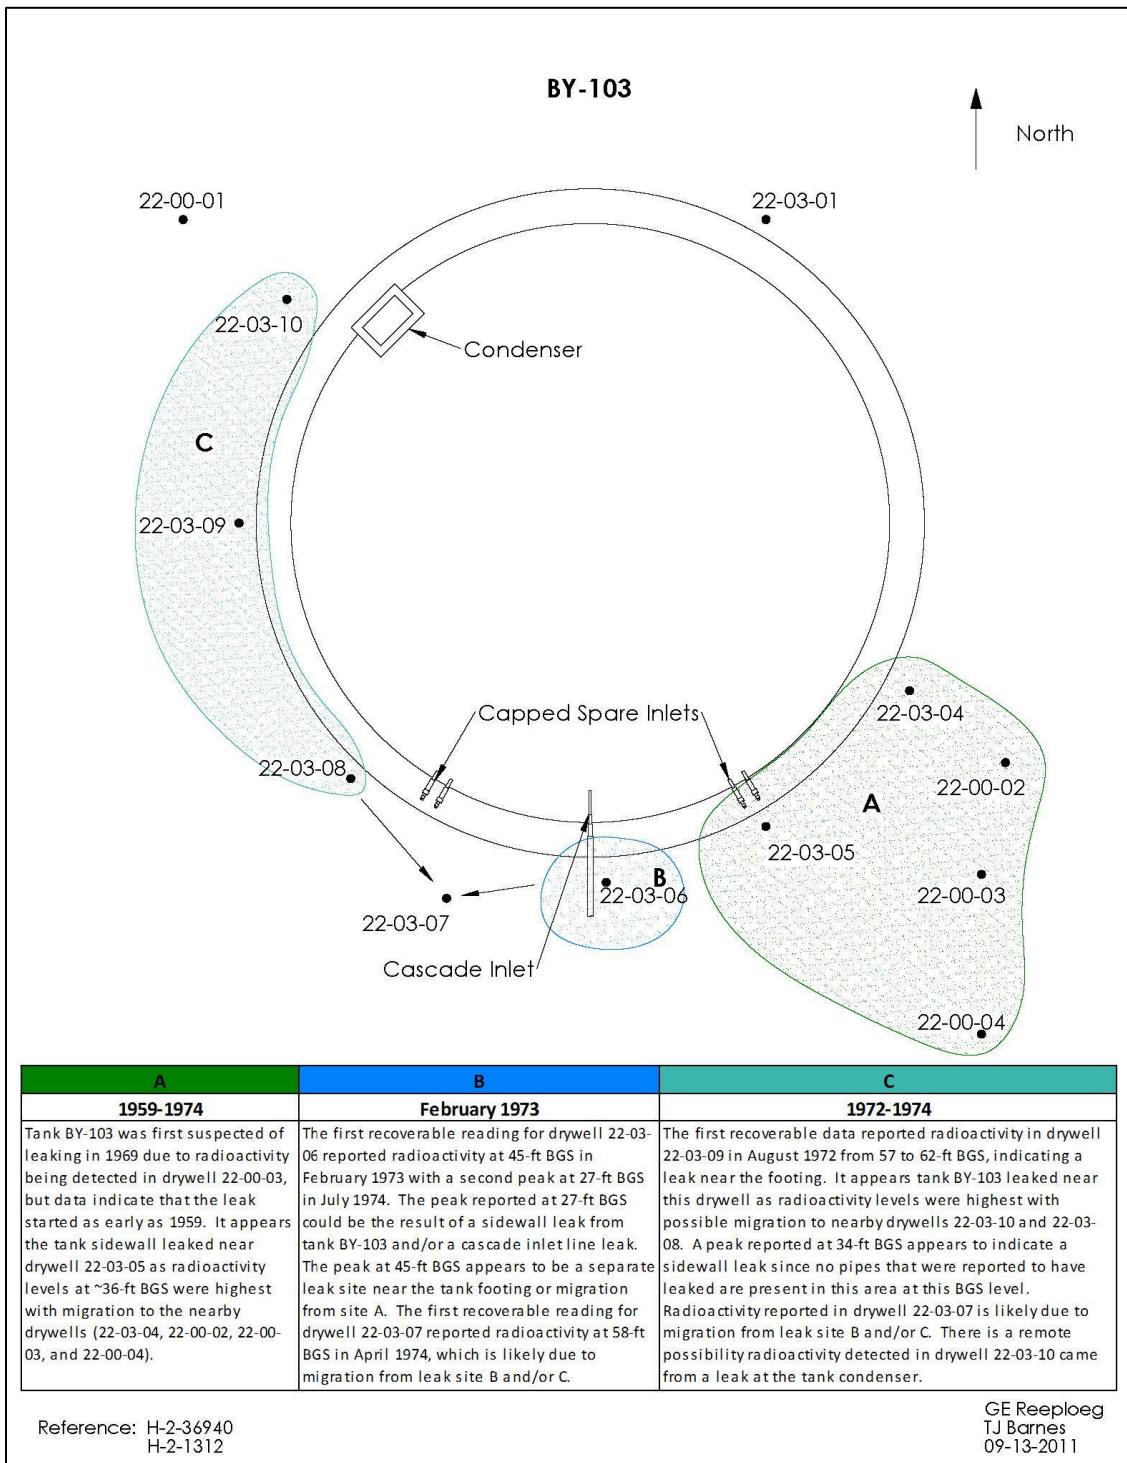
Figure 4-20. Tank BY-103 Possible Radial Leak Locations
 Tank inner ring is steel liner, outer ring is outer edge of tank footing

Tank BY-103 was first suspected of leaking in 1969 due to radioactivity being detected in drywell 22-00-03; however, the leak may have begun as early as 1959. Radioactivity was reported in drywells 22-03-04, 22-03-05, 22-00-02, 22-00-03, and 22-00-04 in 1959-1974. It appears a sidewall leak is present near drywell 22-03-05 due to radioactivity being the highest in this drywell as shown in site A (see Figure 4-20). It appears radioactivity detected in drywells 22-03-04, 22-00-02, 22-00-03, and 22-00-04 is due to migration from the leak near drywell 22-03-05 due to lower levels of radioactivity and BGS levels.

It appears radioactivity detected in drywell 22-03-06 (see site B in Figure 4-20) could be from a sidewall leak from tank BY-103 and/or a leak from the cascade inlet line. The source remains uncertain; however, it appears this is a separate leak site from sites A and C.

The first recoverable reading for drywell 22-03-09 reported radioactivity in August 1972 from 57 to 62-ft BGS. Two additional peaks were recorded July 1973 at 18-ft BGS and December 1973 at 34-ft BGS. Radioactivity was first detected January 1975 in drywell 22-03-10 at 21-ft BGS. Drywell 22-03-08 reported a peak at 46-ft BGS in April 1974. It appears tank BY-103 leaked near drywell 22-03-09 (see site C in Figure 4-20) as radioactivity levels were the highest compared to the surrounding drywells. It appears the peak detected in drywell 22-03-09 at 34-ft BGS indicate a possible sidewall leak since no pipes that were reported to have leaked are present in this area at this BGS level. The source of the 18-ft peak (located above the tank liner) detected in drywell 22-03-09 remains uncertain. There is a remote possibility that the drywell 22-03-10 radioactivity came from a leak at the tank condenser (see Section 4.5.2).

It appears radioactivity detected in drywell 22-03-07 is likely from migration from site B and/or site C (see Figure 4-20).

Leak locations in Figure 4-20 are based on peak readings and are a representation of possible initial boundaries of radioactivity.

No evidence was found for a liner bulge occurring in tank BY-103, and it remains unclear if a liner bulge once existed in the tank during its operation. However, tank BY-103 non-boiling temperatures are not likely to be a factor in causing a liner bulge.

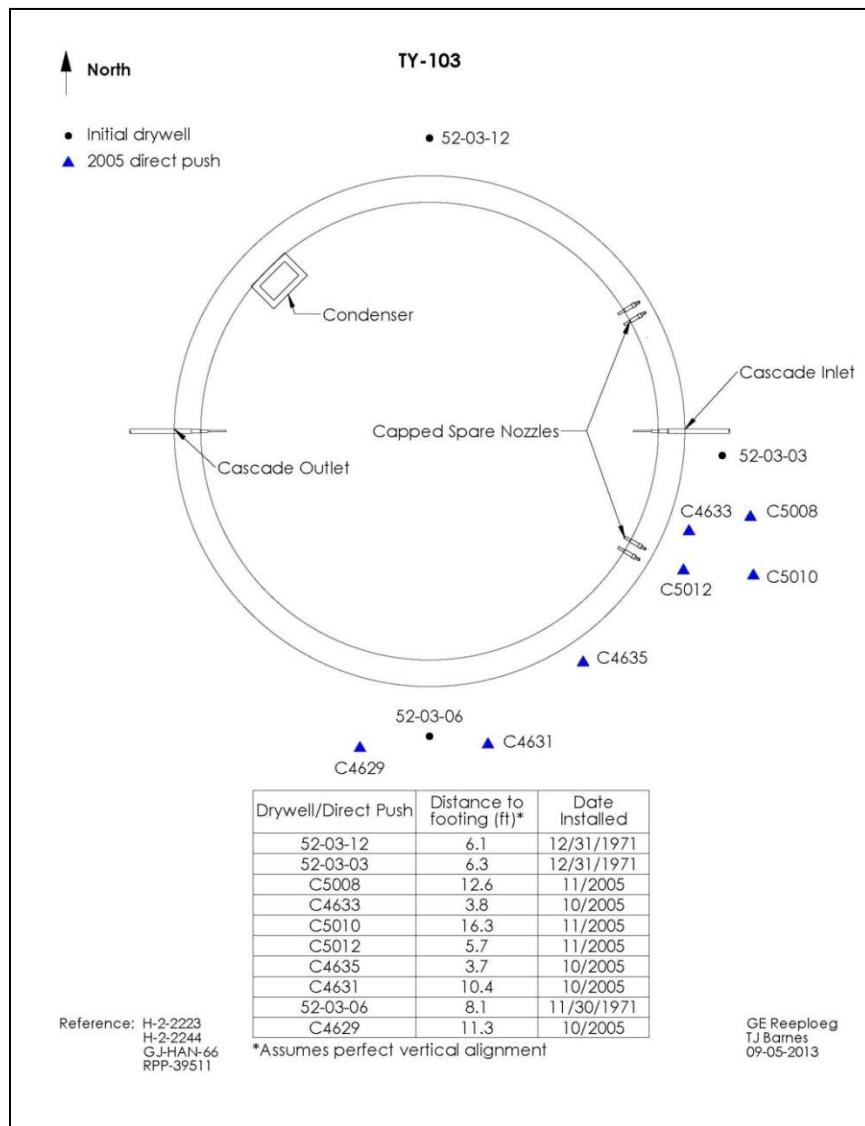
Figure 5-1. Tank TY-103 Associated Drywells
Tank inner ring is steel liner, outer ring is outer edge of tank footing

This section provides information on the historical waste loss event associated with SST 241-TY-103 (TY-103). There are three drywells located around tank TY-103 with specified distances from the drywell to the tank footing shown in Figure 5-1: 52-03-12 installed in November 1971 and 52-03-03 and 52-03-06 installed in December 1971. Seven direct pushes were installed in 2005: C4629, C4631, C4633, C4635, C5010, and C5012.
