Hanford Single-Shell Tank Leak Causes and Locations - 241-BY and 241-TY Farm

C.L. Girardot, D.G. Harlow

Washington River Protection Solutions
Richland, WA 99352
U.S. Department of Energy Contract

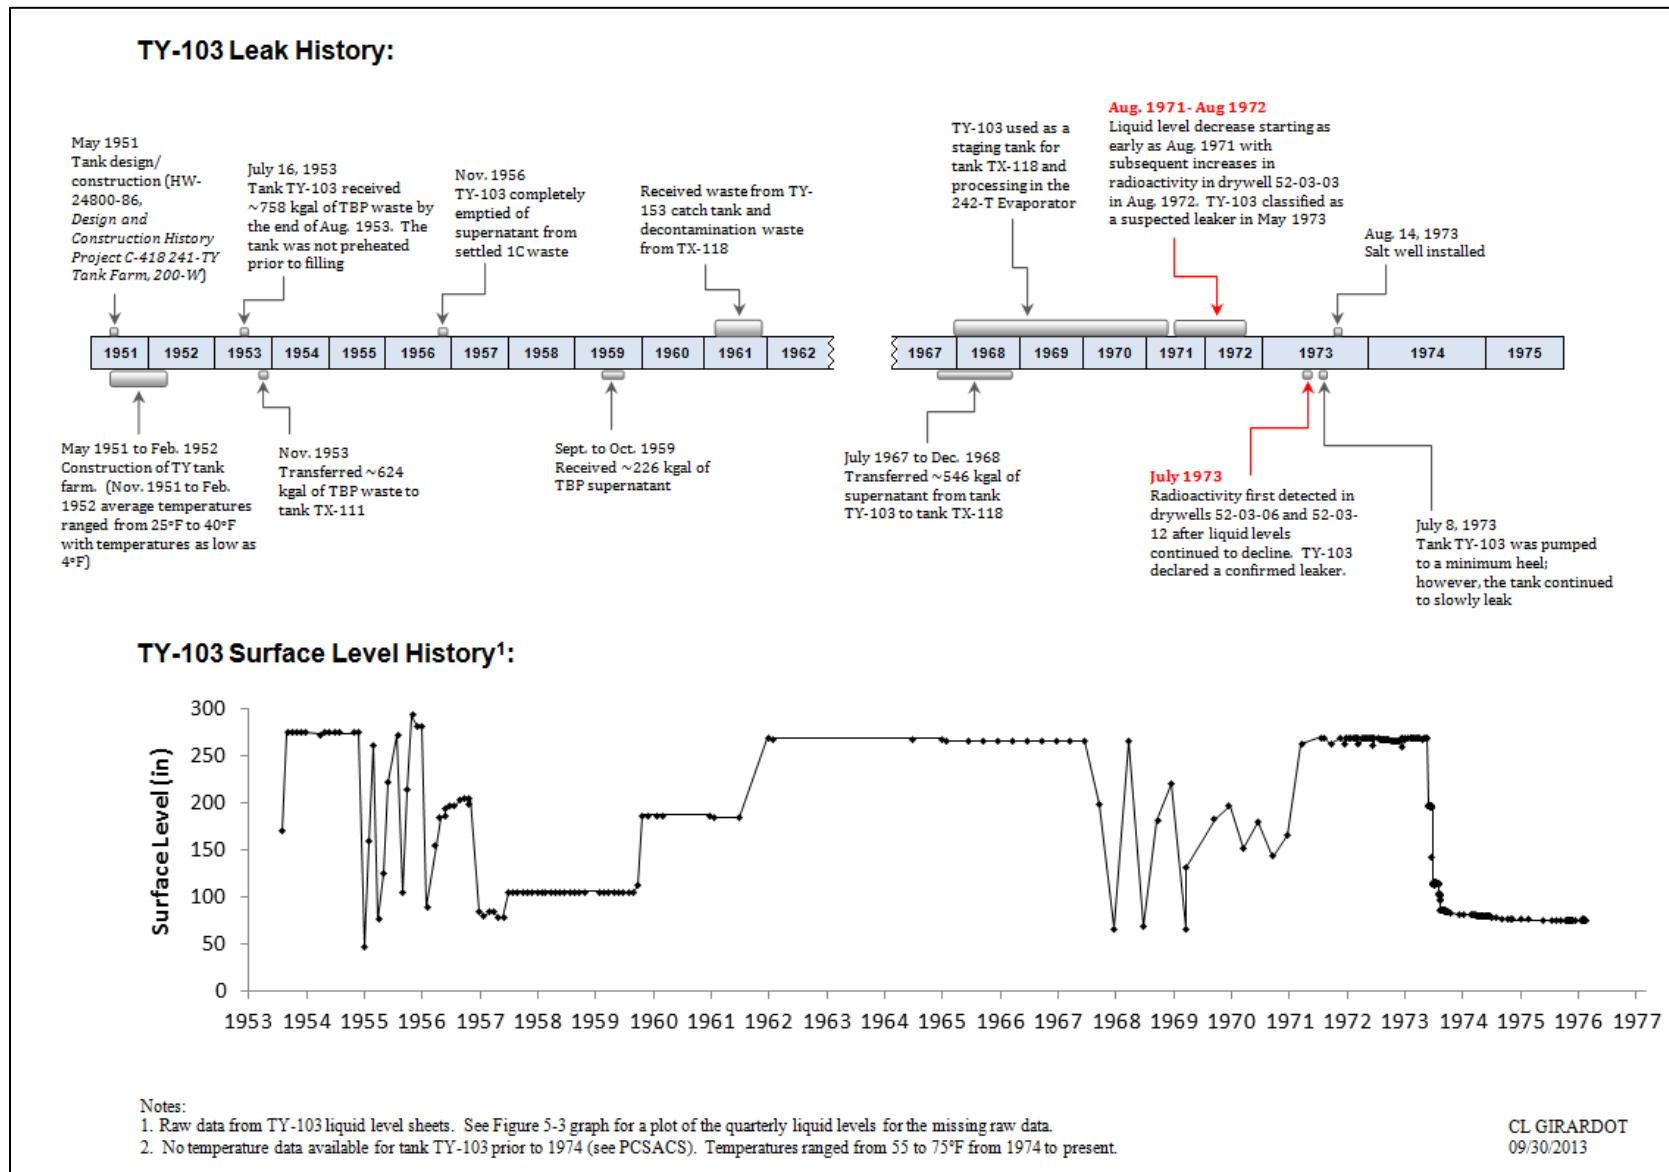
Figure 5-2. Operational Leak History of Tank TY-103

The operational history of tank TY-103 leak related details including liquid level is charted in Figure 5-2.

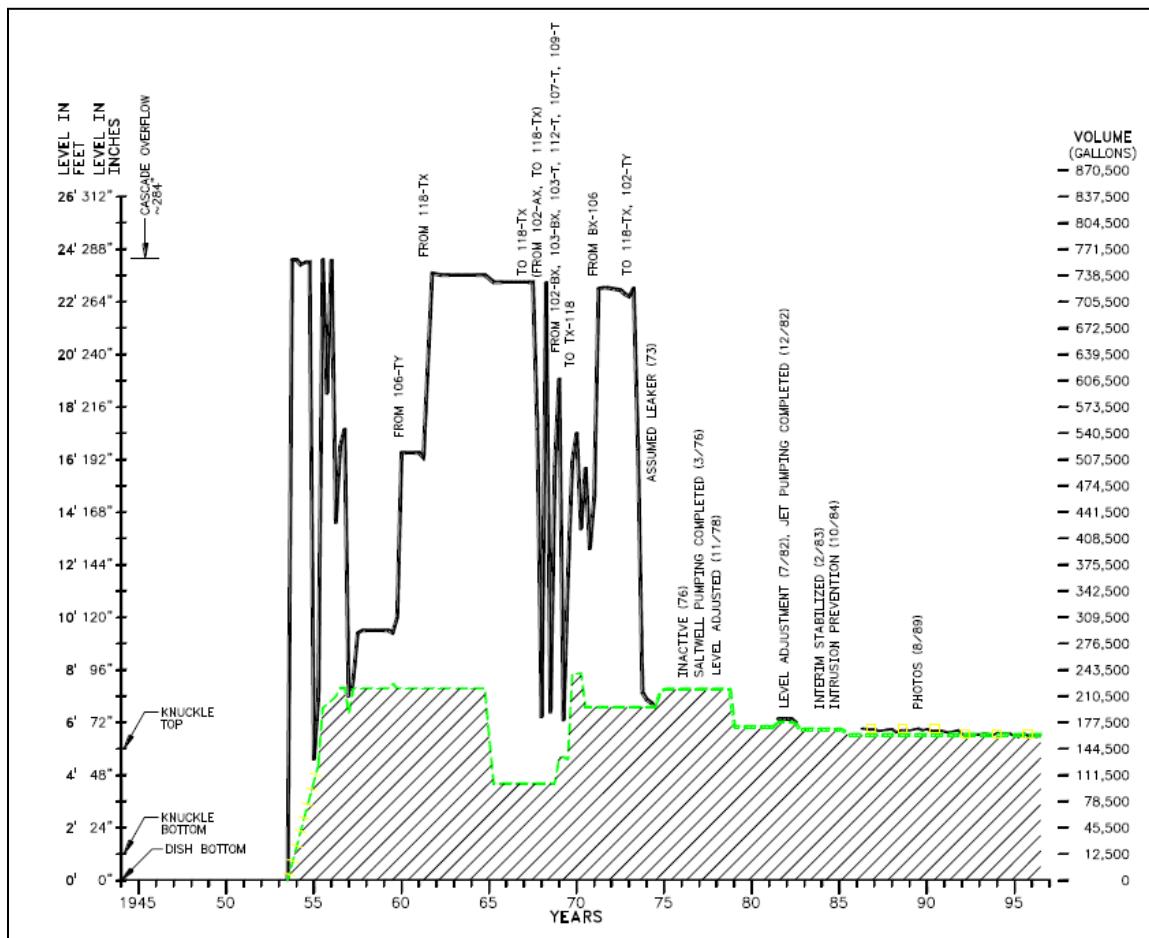
Figure 5-3. Tank TY-103 End of Quarter Surface Level

The liquid level plot in Figure 5-3 indicates the transfer activity into and out of tank TY-103. The liquid levels are end of quarter levels so this figure may not reflect all transfers into and out of the tank that occurred during the operational history of the tank. See Figure 5-2 for historical monthly liquid level readings.

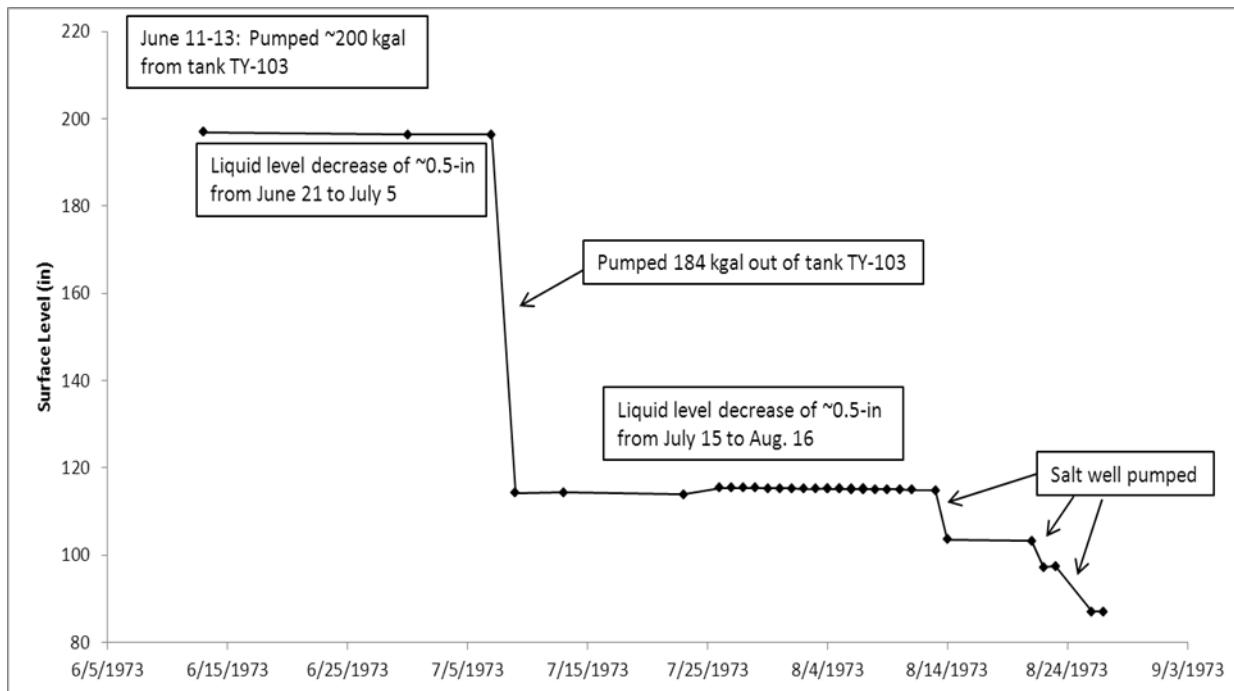
Figure 5-5. Tank TY-103 Liquid Level June to September 1973

During June 11-13, 1973, 200 kgal was pumped from tank TY-103 leaving the liquid level at ~196.9-in (see Figure 5-5). Tank TY-103 liquid levels dropped ~0.5-in over a period of 14 days with subsequent increases in radioactivity in the drywells (LET-ARHCO-TY-103).

Approximately 184 kgal was pumped from tank TY-103 on July 6, 1973 leaving the liquid level at ~114-in. Tank TY-103 had a 0.5-in liquid level drop from July 15 to August 6, 1973. Due to liquid level decreases a saltwell pump was installed on August 14, 1973, and tank TY-103 was pumped to the sludge level on August 14, 22 and 25, 1973 leaving the liquid level at 86.9 to 87-in (~150 kgal). Liquid levels remained relatively constant until September 1973 with saltwell pumping of the tank. Additional pumping of waste out of tank TY-103 occurred from October 1973 to October 1978.

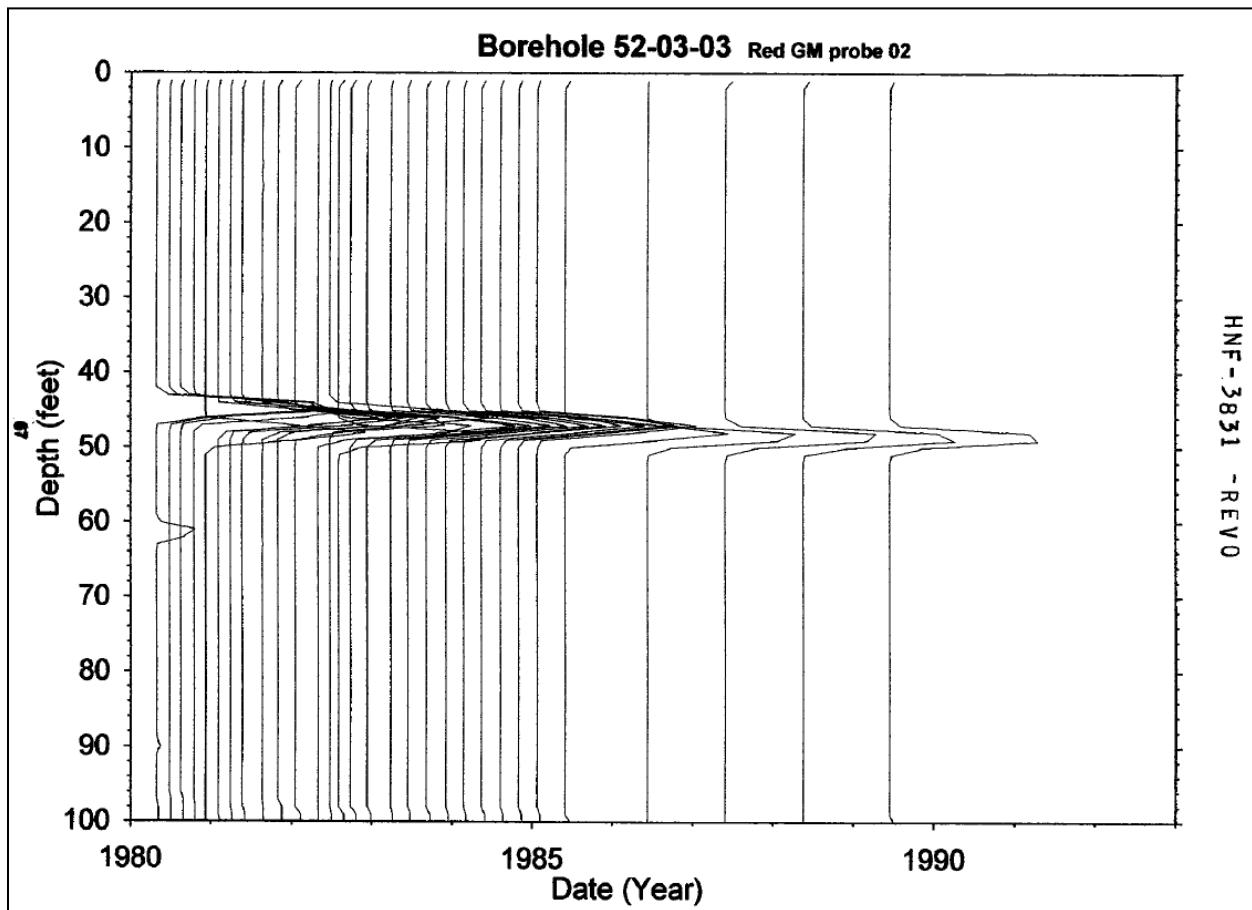
Figure 5-6. Tank TY-103 Drywell 52-03-03 (HNF-3831)

the knuckle near borehole 52-03-03." Figure 5-6 shows the depth of radioactivity from 1980 to 1990 (HNF-3831).

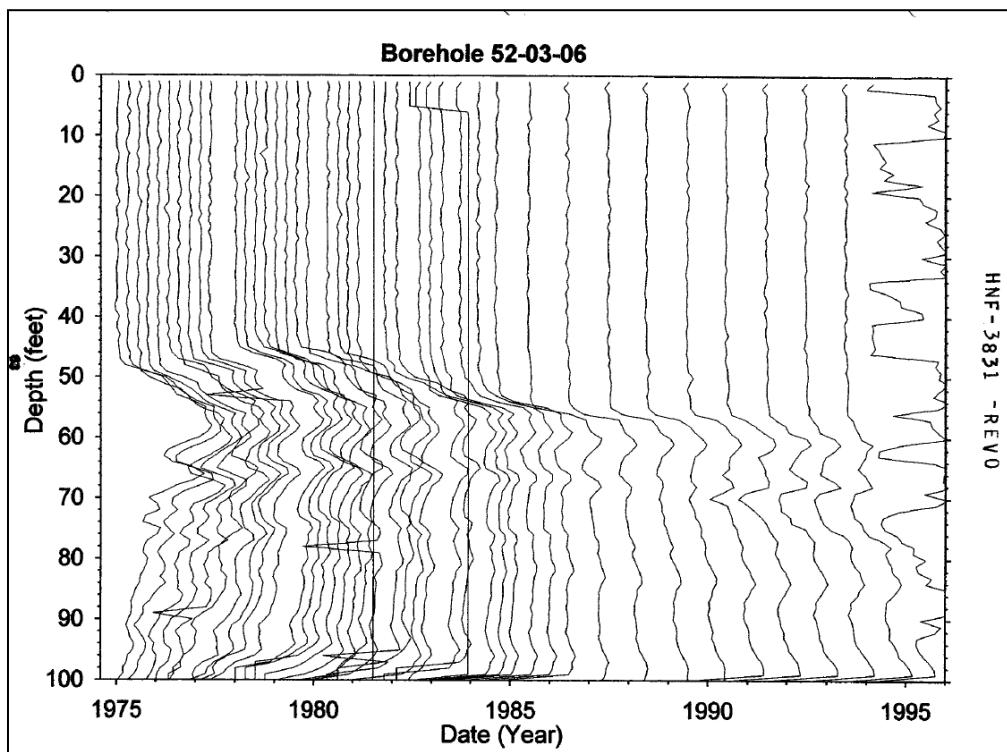
Figure 5-7. Tank TY-103 Drywell 52-03-06 (HNF-3831)

Figure 5-7 shows the continuing radiation depth to 1995 (HNF-3831). Drywell 52-03-06 is located between tanks TY-103 and TY-105, and it is possible contamination in this drywell could be associated with the leak from tank TY-103 and/or tank TY-105 (see Tank TY-105 segment). However, it seems unlikely contamination detected in this drywell is associated with tank TY-105 since tank TY-105 leaked in 1960 and radioactivity was reported as less than values prior to August 1972.

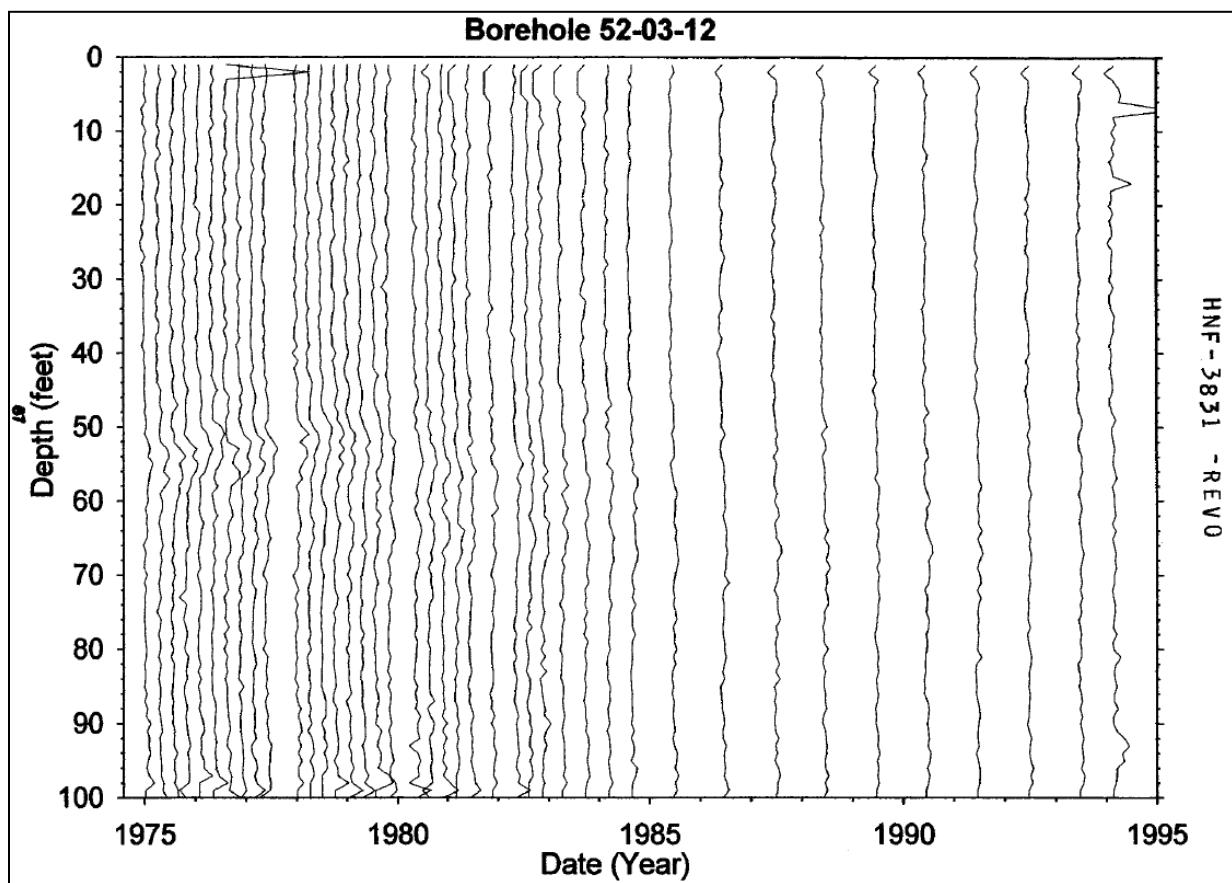
Figure 5-8. Tank TY-103 Drywell 52-03-12 (HNF-3831)

In May 1997, Cs-137 and Co-60 were the only man-made radionuclides detected in drywell 52-03-12 (GJ-HAN-66). From the ground surface to 3.5-ft BGS, Cs-137 was detected continuously with a maximum concentration of 3.6 pCi/g reported at 1-ft BGS. From 65 to 70-ft BGS and from 71 to 87.5-ft BGS, Co-60 was detected with the maximum concentration of 0.31 pCi/g reported at 66.5-ft BGS. Document GJ-HAN-66 states, “The SGLS detected relatively low concentrations of Co-60 from 65 to 87.5 ft. This contamination probably originated from a leak in tank TY-101 or TY-103.” Figure 5-8 shows the depth of radioactivity from 1975 to 1995 (HNF-3831).

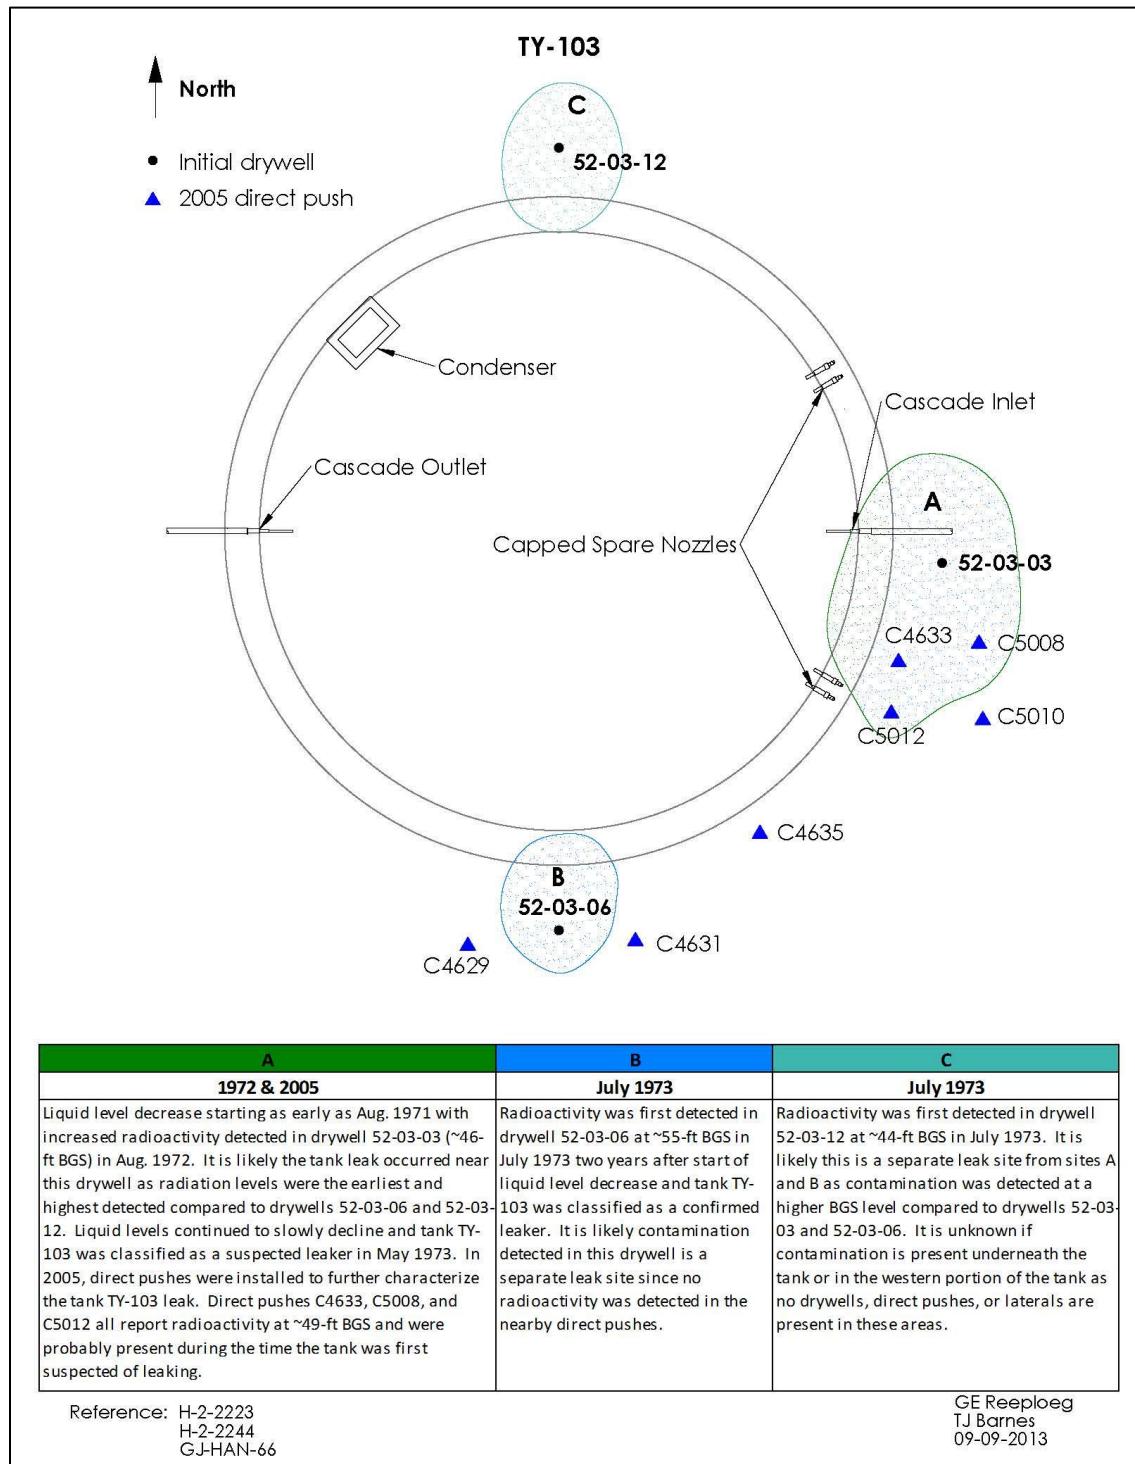
Figure 5-12. Tank TY-103 Possible Radial Leak Locations
 Tank inner ring is steel liner, outer ring is outer edge of tank footing

Tank TY-103 was first suspected of leaking as early as August 1971 due to liquid level decreases with subsequent increases in radioactivity in drywell 52-03-03 in August 1972 at or near the tank footing as shown in site A (see Figure 5-12). It is likely the tank first leaked near drywell 52-03-03 based on the significant amount of radiation detected in this drywell and as stated in GJ-HAN-66, “The zone of highly concentrated Cs-137 contamination in borehole 52 03-03 is close to the depth of the knuckle radius of the tank liner; it is likely that the tank leaked along the seam of the knuckle radius near this borehole.” In 2005, direct pushes were installed to further characterize the tank TY-103 leak and radioactivity was detected in direct pushes C4633, C5008, and C5012 which would have likely been present when the tank was first suspected of leaking.

Radioactivity was first detected concurrently in drywells 52-03-06 and 52-03-12 at or below the tank footing in July 1973 after liquid levels continued to decline. It is likely that contamination detected in drywell 52-03-06 (site B in Figure 5-12) is a separate leak site since radioactivity was not present in nearby drywells. Site C appears to be a separate leak site from sites A and B, as radioactivity detected in drywell 52-03-12 was at a higher BGS level compared to the other drywells.

Leak locations in Figure 5-12 are based on peak readings and are a representation of possible initial boundaries of radioactivity.

No evidence was found for a liner bulge occurring in tank TY-103, and it remains unclear if a liner bulge once existed in the tank during its operation. However, tank TY-103 non-boiling temperatures are not likely to be a factor in causing a liner bulge.

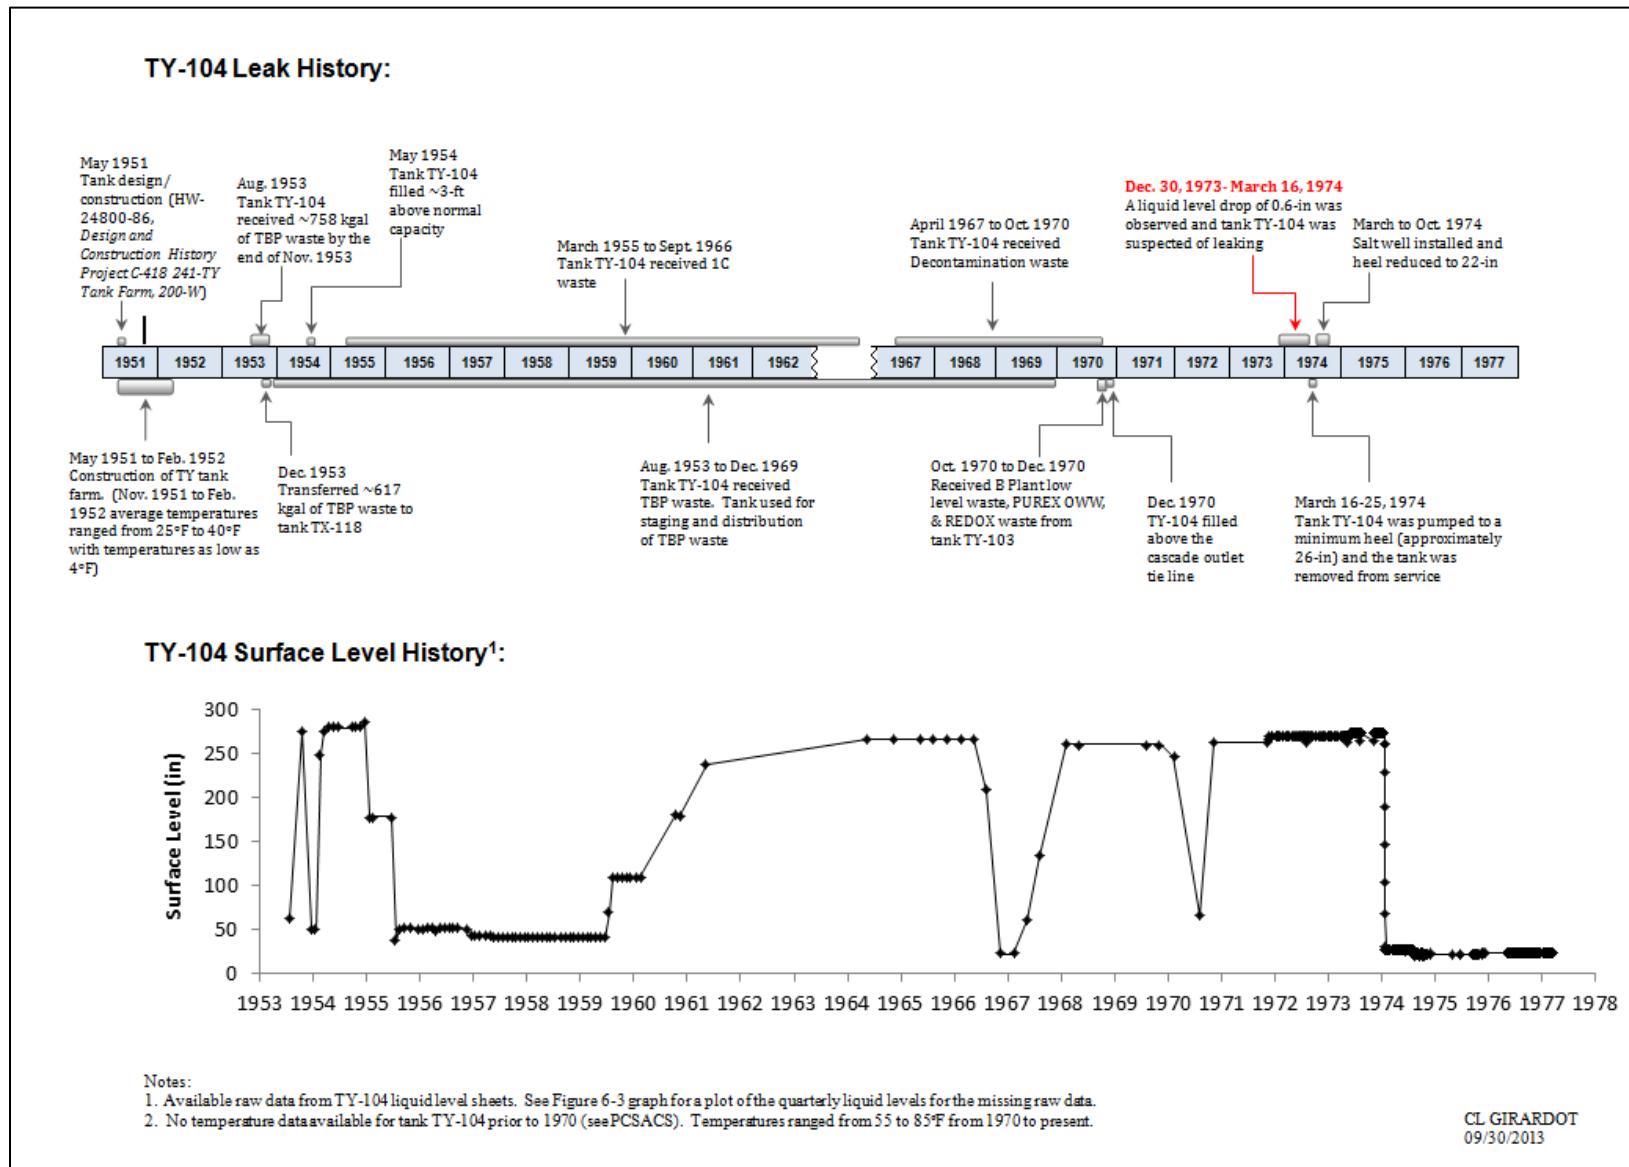
Figure 6-2. Operational Leak History of Tank TY-104

The operational history of tank TY-104 leak related details including liquid level is charted in Figure 6-2.

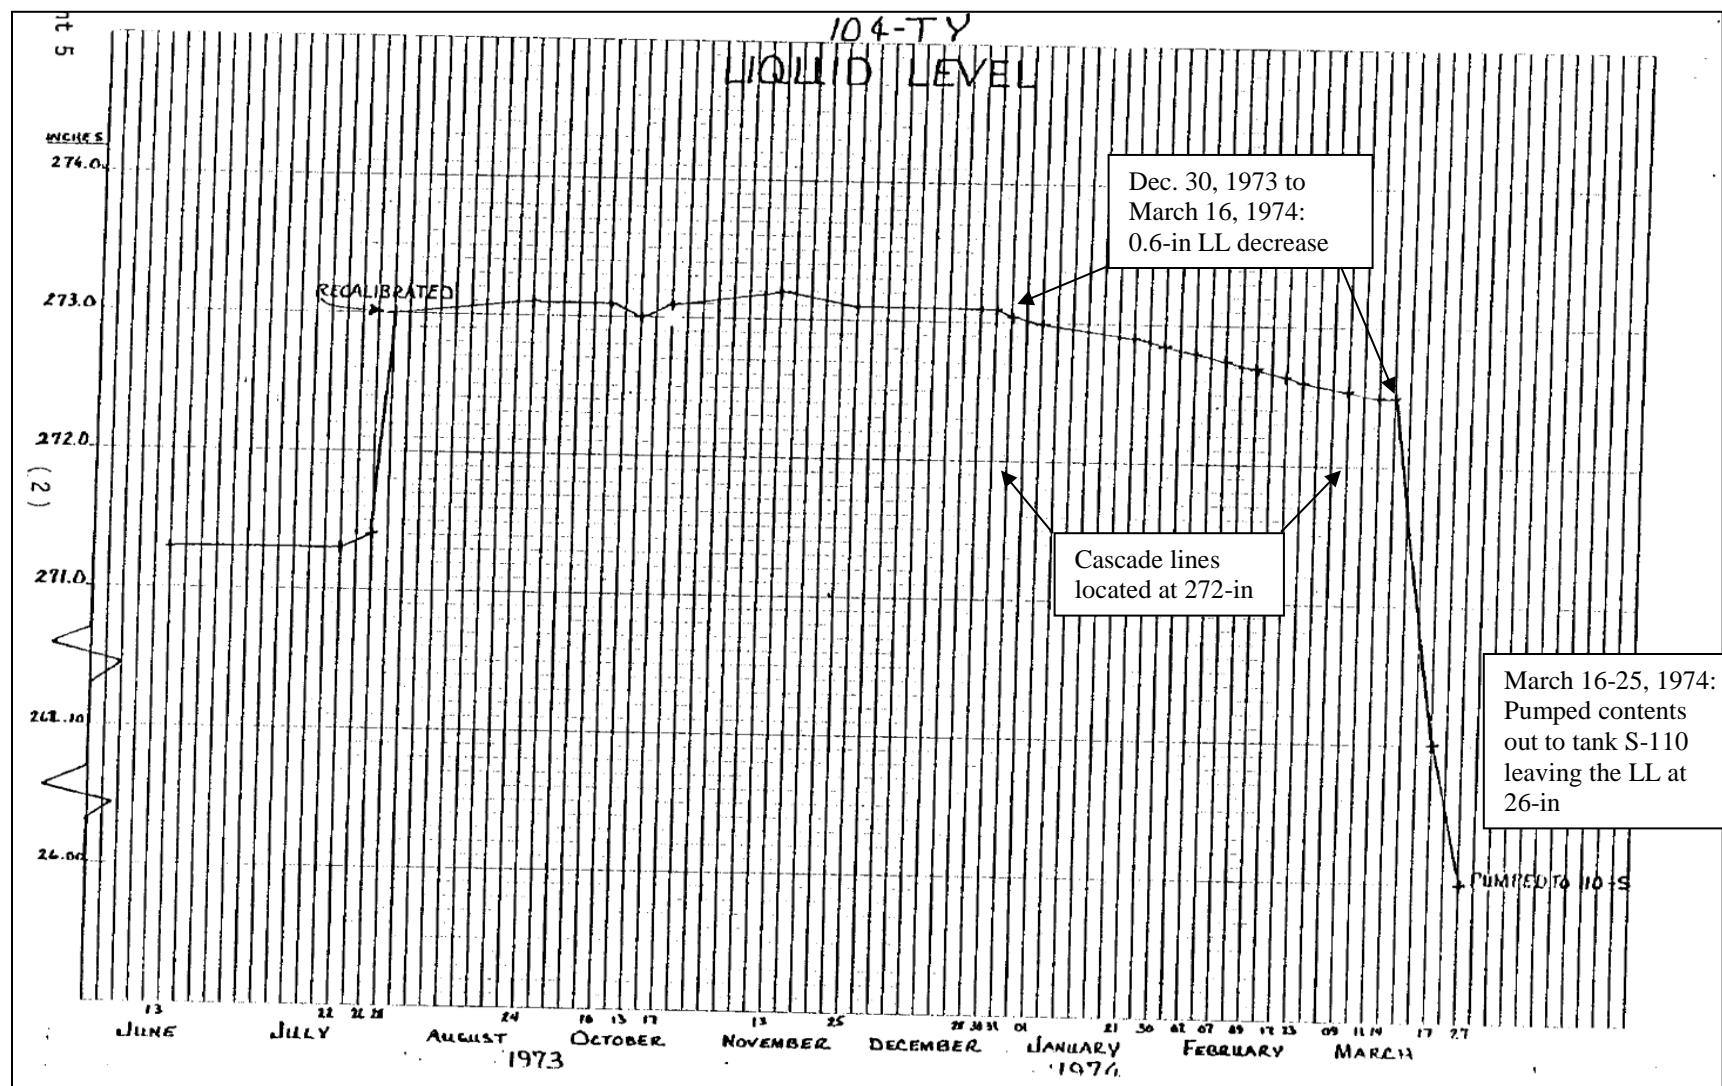
Figure 6-4. Tank TY-104 Liquid Level June 13, 1973 to March 27, 1974

Tank TY-104 was first suspected of leaking based on a liquid level decrease of 0.6-in between December 30, 1973 and March 16, 1974 (RHO-CD-1193) as shown in Figure 6-4. It was reported in Letter 72730-80-097 that the liquid level in tank TY-104 before and during the observed decrease was very consistent with no anomalies with the exception of the increase in liquid level in August 1973 that was attributed to instrument (FIC gauge) recalibration (Letter 72730-80-097, “Review of Classification of Six Hanford Single-Shell “Questionable Integrity (QI)” Tanks”). Also stated in this letter, the observed 0.6-in liquid level drop “far exceeds the in-tank repeatability limits (± 0.25 -in) for FIC liquid level gauges.”

Liquid level data for tank TY-104 is unavailable from the last transfer into the tank (December 1970) to June 1, 1973. After the August 1973 recalibration of the FIC gauge, liquid levels were holding at approximately 273.1-in (see Figure 6-4) until December 30, 1973. If this recalibration was correct, then the last transfer into tank TY-104 would have filled the tank above the cascade outlet tie line (located at 272-in) (H-2-2244). The liquid level dropped 0.6-in from December 30, 1973 to March 16, 1974 (~1-gal/hr) and liquid levels were reported to be 272.5-in on March 16, 1974 (RHO-CD-1193; SD-WM-TI-356). Due to this liquid level drop, tank TY-104 was removed from service and pumped to a minimum heel to tank S-110 from March 16-25, 1974 leaving the liquid level at 26-in. A salt well pump was installed in tank TY-104 and the heel was pumped to tank TY-102 by October 1974 leaving a heel of 22-in. The leak volume from tank TY-104 was estimated to be 1,400 gal based on a 0.5-in liquid level decrease (RHO-CD-1193).

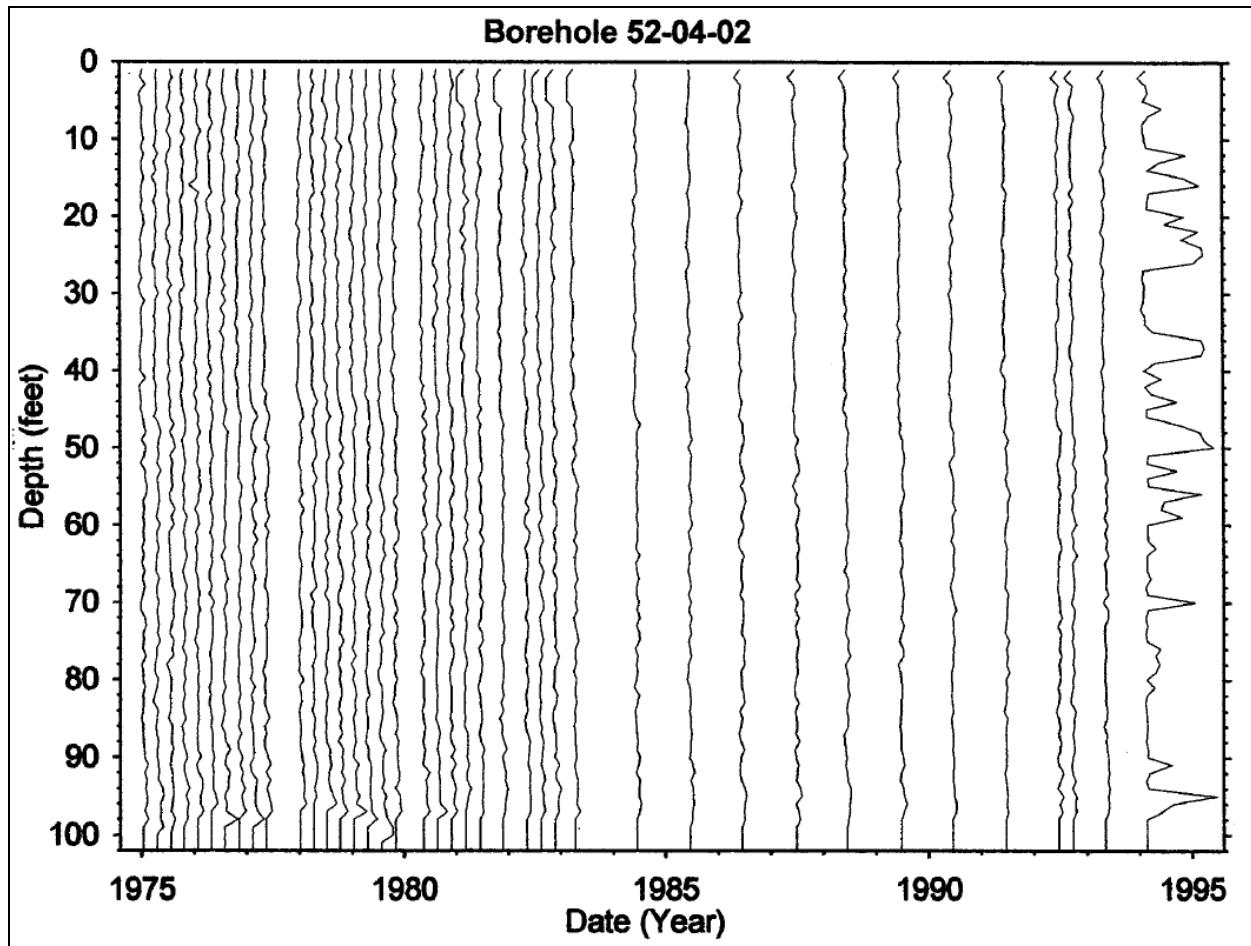
Figure 6-5. Tank TY-104 Drywell 52-04-02 (HNF-3831)

In May 1997, Cs-137 was the only man-made radionuclide detected in drywell 52-04-02 (GJ-HAN-67). Cs-137 was detected intermittently between 7.5 and 24-ft, at 89-ft, 91.5-ft, and at 97.5-ft BGS with concentrations less than 0.2 pCi/g below 1-ft BGS. Document GJ-HAN-67 states, "The Cs-137 contamination in this borehole is probably the result of surface spills that have migrated down into the backfill surrounding the borehole or surface contamination that adhered to the drill string and was carried downward during the drilling of this borehole." Since historical records report little radioactivity in this drywell, drywell 52-04-02 is not included as part of the leak location for tank TY-104. Figure 6-5 shows the depths of radioactivity from 1975 to 1995 (HNF-3831).

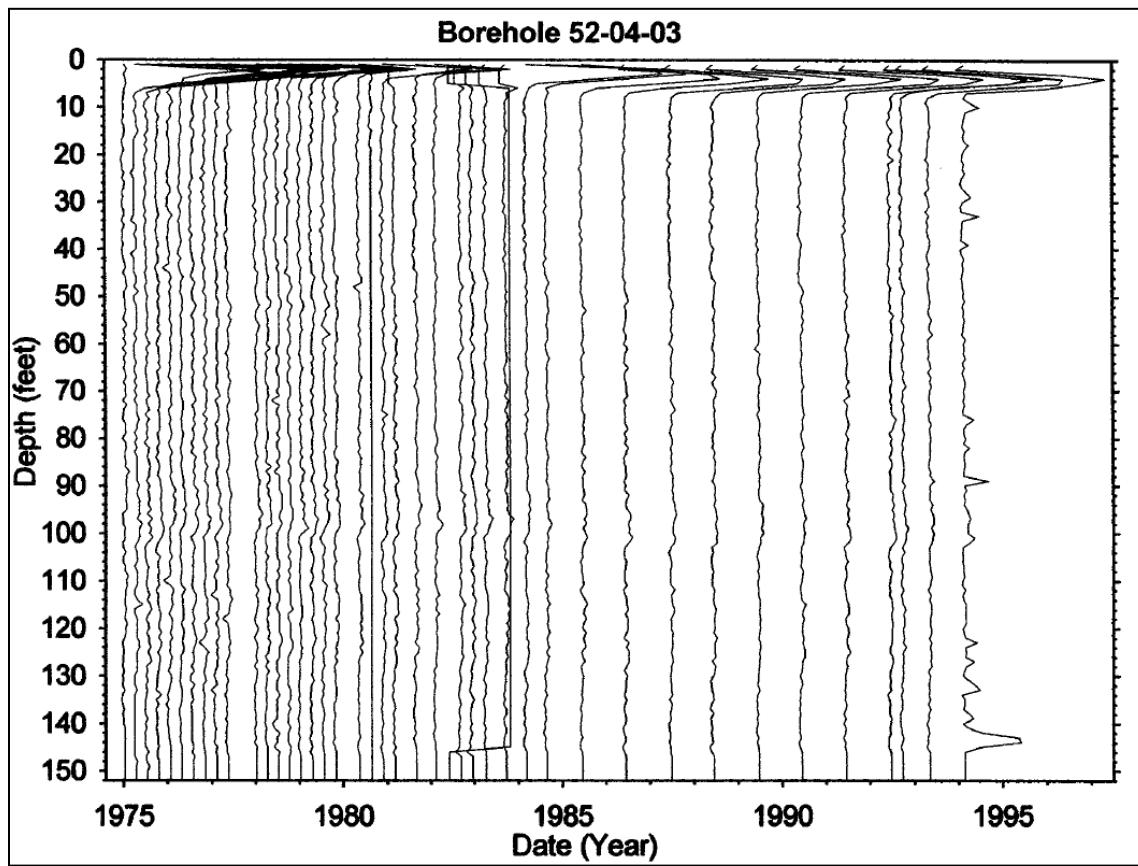
Figure 6-6. Tank TY-104 Drywell 52-04-03 (HNF-3831)

Drywell 52-04-03 was drilled in June 1952 with the first recoverable reading on July 11, 1973 as less than 12K cpm with the SP. Radiation readings were reported as less than values from July 1973 to June 1986 (see Appendix A3). Document HNF-3831 states that Cs-137 is only present at the surface at 0 to 8-ft BGS.

In May 1997, Cs-137 and Eu-154 were the only man-made radionuclides detected in drywell 52-04-03 (GJ-HAN-67). Cs-137 was detected from the ground surface to 5.5-ft BGS with concentrations as high as 2,200 pCi/g. Cs-137 was also detected from 16.5 to 18.5-ft BGS with concentrations up to 1 pCi/g, and at 45-ft, 51-ft, 55.5-ft, 65.5-ft, between 80.5 and 81-ft, at 92-ft, between 98 and 98.5-ft, and at 108-ft BGS at concentrations ranging from 0.2 to 0.5 pCi/g. Eu-154 was detected from 2 to 5-ft BGS with a maximum concentration of about 30 pCi/g. Document GJ-HAN-67 states that Cs-137 and Eu-154 contamination are probably related to a transfer line located on the northeast side of the tank. Figure 6-6 shows surface contamination from 1975 to 1995 with no radioactivity detected below the surface (HNF-3831). Surface contamination appeared to not be a concern as radiation readings were reported as less than values (see Appendix A3). Therefore, drywell 52-04-03 is not included as part of the leak location for tank TY-104.

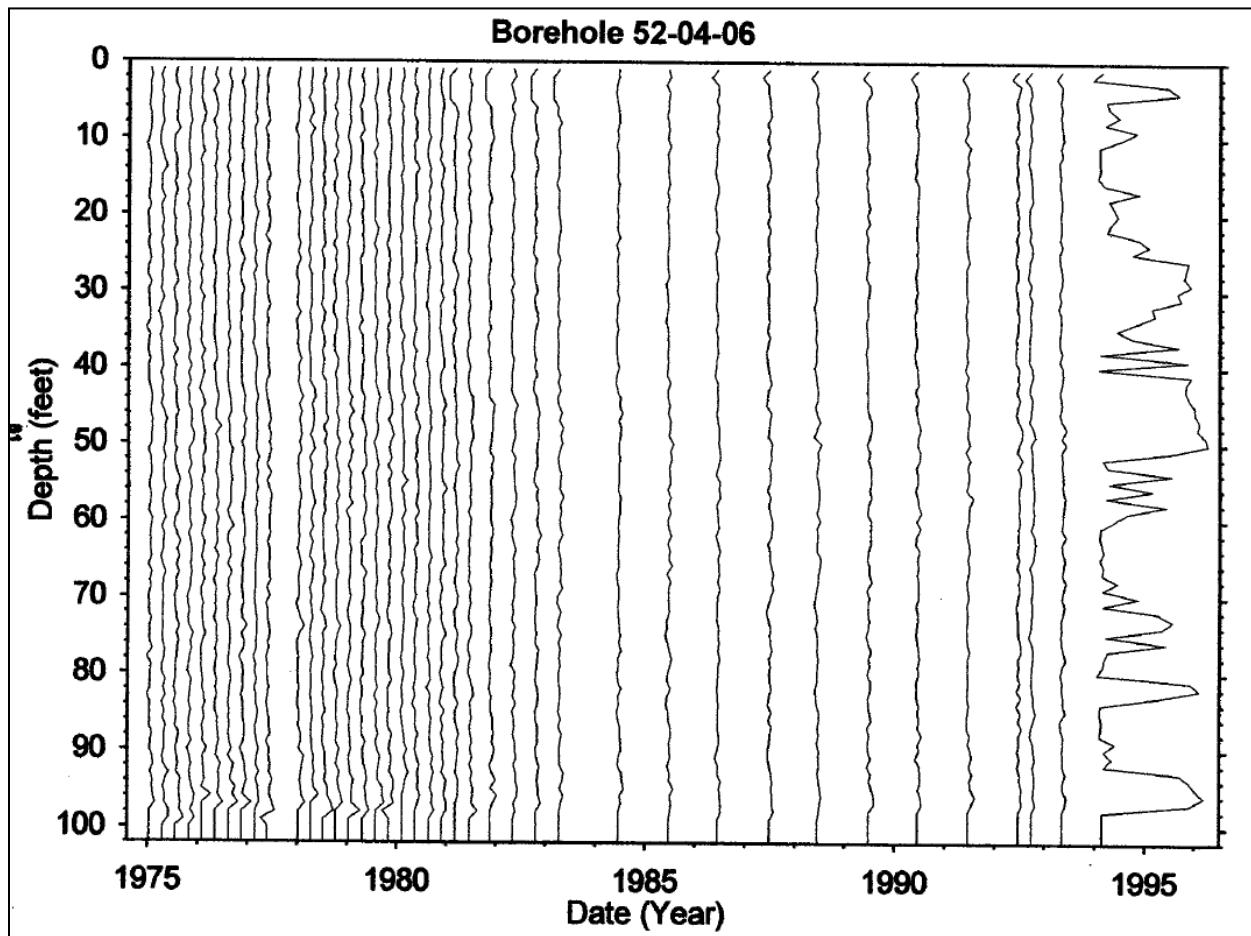
Figure 6-7. Tank TY-104 Drywell 52-04-06 (HNF-3831)

Drywell 52-04-06 was drilled in December 1971 with the first recoverable reading on July 11, 1973 as less than 12K cpm with the SP. Radiation readings were reported as less than values from July 1973 to June 1986 (see Appendix A3). Document HNF-3831 states that no significant levels of radioactivity are present about the survey probe detection threshold between 1975 and 1994 in this drywell. However, it was also stated in this document that Cs-137 was detected at the surface at 0 to 12-ft BGS and concentrations were less than 1 pCi/g.

In May 1997, Cs-137 was the only radionuclide detected in drywell 52-04-06 (GJ-HAN-67). Cs-137 was detected continuously from the ground surface to 12-ft BGS and at the bottom of the drywell with concentrations ranging from 0.2 to 1 pCi/g at the ground surface and at 0.2 pCi/g at the bottom of the drywell. Document GJ-HAN-67 states, "There is no indication of subsurface contamination at or below the operating level of the tanks." Therefore, drywell 52-04-06 is not included as part of the leak location for tank TY-104. Figure 6-7 shows depths of radioactivity from 1975 to 1995 (HNF-3831).

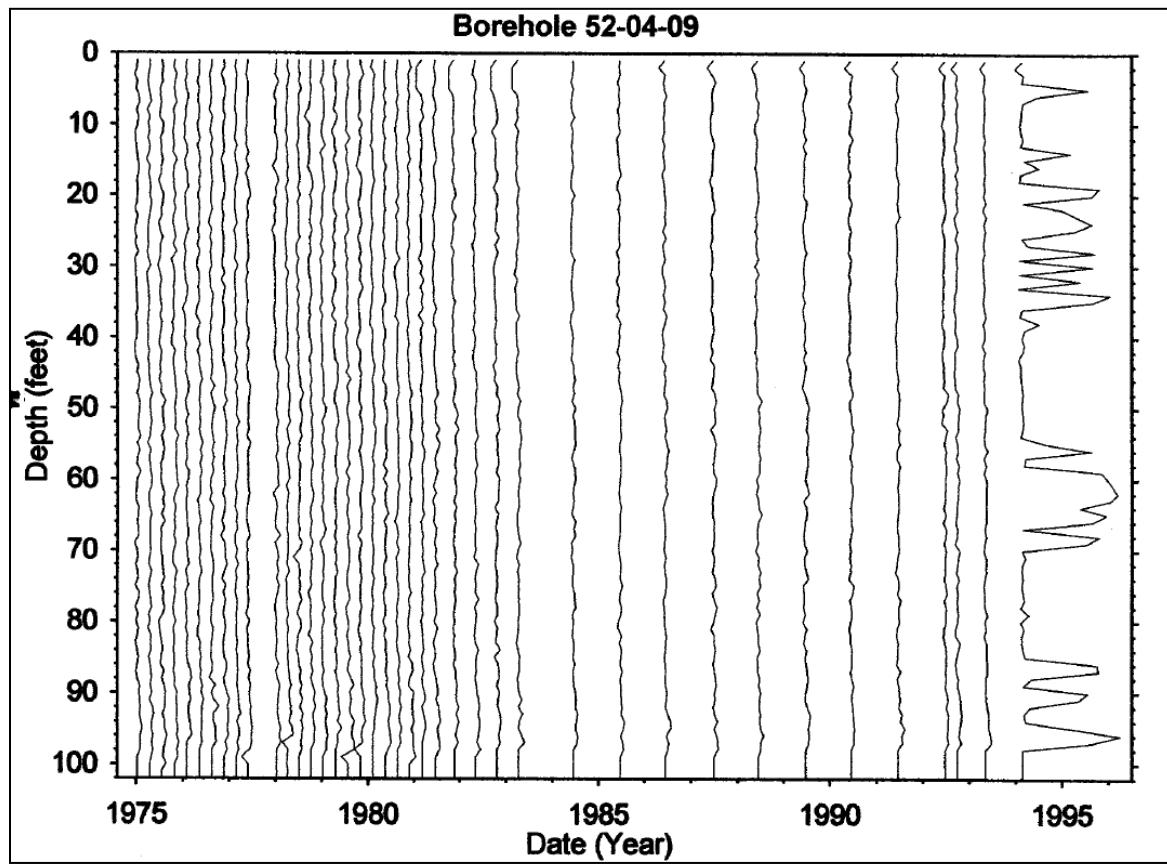
Figure 6-8. Tank TY-104 Drywell 52-04-09 (HNF-3831)

In May 1997, Cs-137 was the only man-made radionuclide detected in drywell 52-04-09 (GJ-HAN-67). Measurable Cs-137 was detected at the ground surface (about 0.2 pCi/g) and from 83.5-ft BGS to the bottom of the drywell (at or below 1 pCi/g). Document GJ-HAN-67 states, "The Cs-137 contamination detected by the SGLS between the depths of 83.5 ft and the bottom of the borehole probably originated from a subsurface source such as a leak from one of the tanks within this tank farm, but probably not from tank TY-104. A contaminant plume may have migrated downward from the source and intercepted borehole 52-04-09 at about the 84-ft depth." The conclusion was stated "The low-level contamination in boreholes 52-06-02 and 52-04-09 is related to surface spills or subsurface leaks, but the contamination is not associated with the operation of tank TY-104." Therefore, drywell 52-04-09 is not included as part of the leak location for tank TY-104. Figure 6-8 shows depths of radioactivity from 1975 to 1995 (HNF-3831).

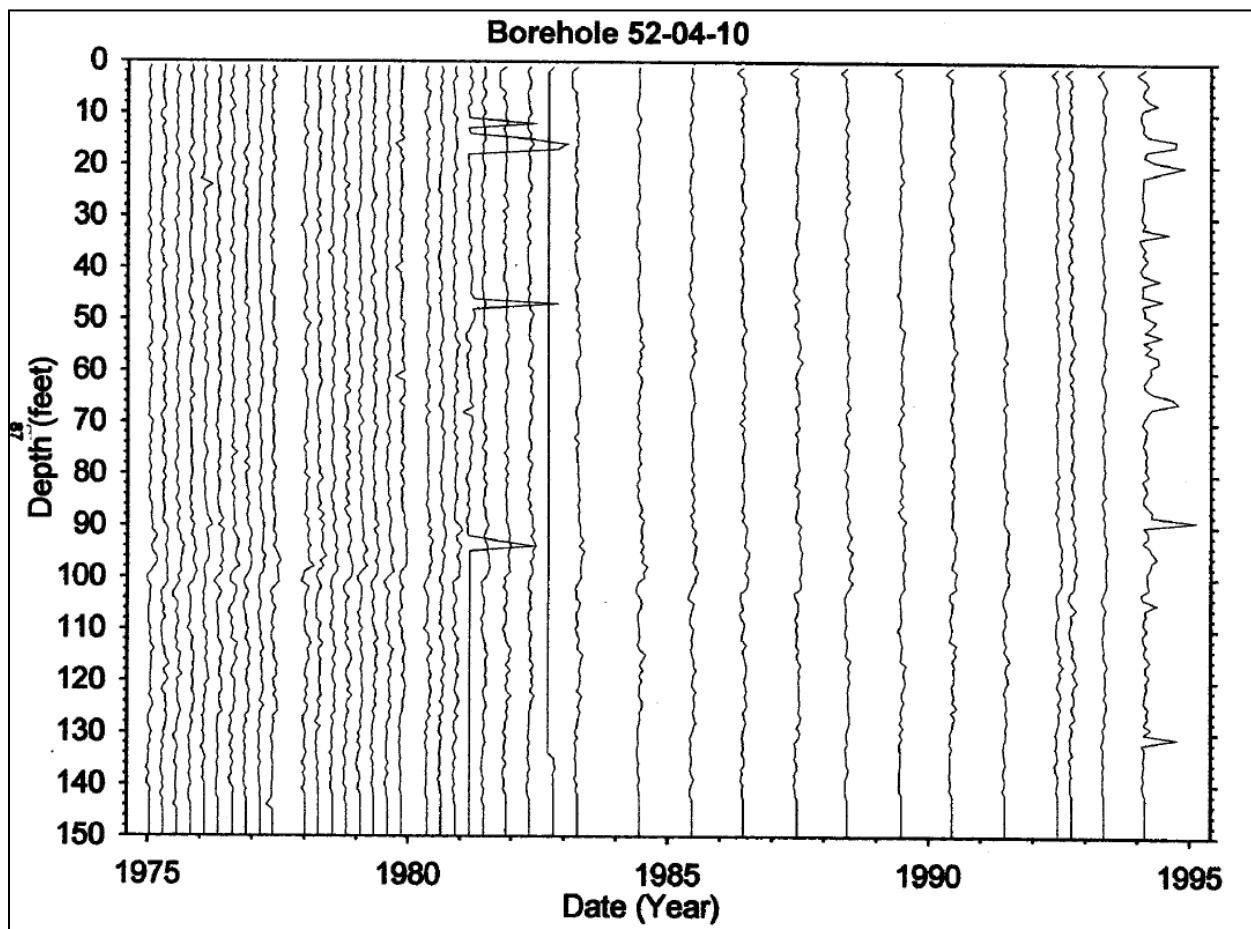
Figure 6-9. Tank TY-104 Drywell 52-04-10 (HNF-3831)

In May 1997, Cs-137 was the only man-made radionuclide detected in drywell 52-04-10 (GJ-HAN-67). Cs-137 was detected from the ground surface to 1-ft, at 67-ft, between 87 and 87.5-ft, at 99-ft, and at 129.5-ft BGS. The maximum concentration was about 1 pCi/g at 1-ft BGS. Document GJ-HAN-67 states that radioactivity detected was "probably from surface contamination that migrated along the outside of the casing by the action of surface water." Therefore, drywell 52-04-10 is not included as part of the leak location for tank TY-104. Figure 6-9 shows depths of radioactivity from 1975 to 1995 (HNF-3831).

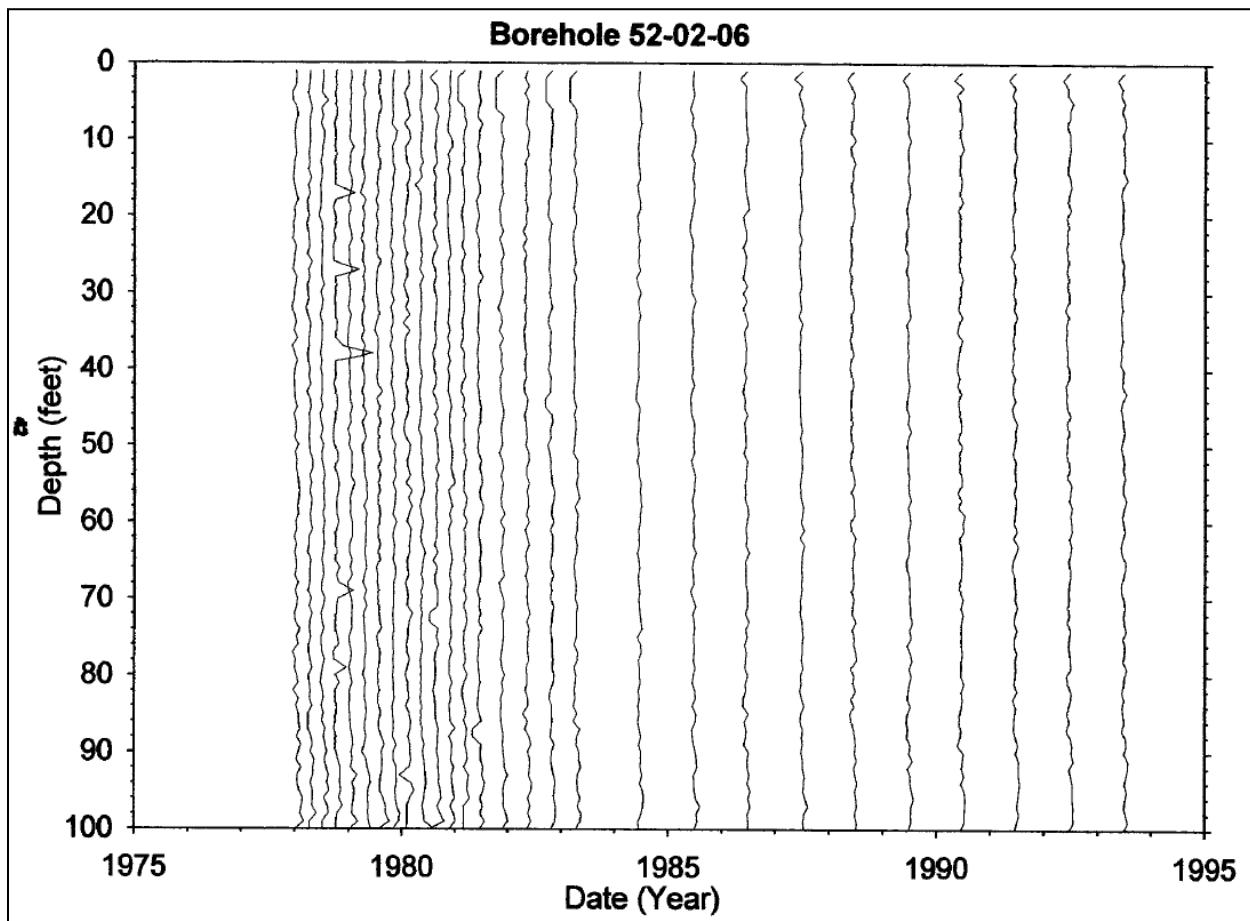
Figure 6-10. Tank TY-104 Associated Drywell 52-02-06 (HNF-3831)

In May 1997, Cs-137 was the only man-made radionuclide detected in drywell 52-02-06 (GJ-HAN-67). Cs-137 was detected continuously from the ground surface to 3-ft, 12.5 to 15-ft, and 19.5 to 20-ft BGS with the highest concentration of 1 pCi/g reported at 1-ft BGS. Document GJ-HAN-67 states the Cs-137 contamination probably originated from a surface spill and was carried downward either during drilling operation or by the action of surface water. It was also stated that, "There is no indication in the SGLS logs of contamination originating from subsurface leaks from underground tanks or their associated facilities." Therefore, drywell 52-02-06 is not included as part of the leak location for tank TY-104. Figure 6-10 shows depths of radioactivity from 1978 to 1995 (HNF-3831).
