Hanford Single-Shell Tank Leak Causes and Locations - 241-BY and 241-TY Farm

C.L. Girardot, D.G. Harlow

Washington River Protection Solutions
Richland, WA 99352
U.S. Department of Energy Contract

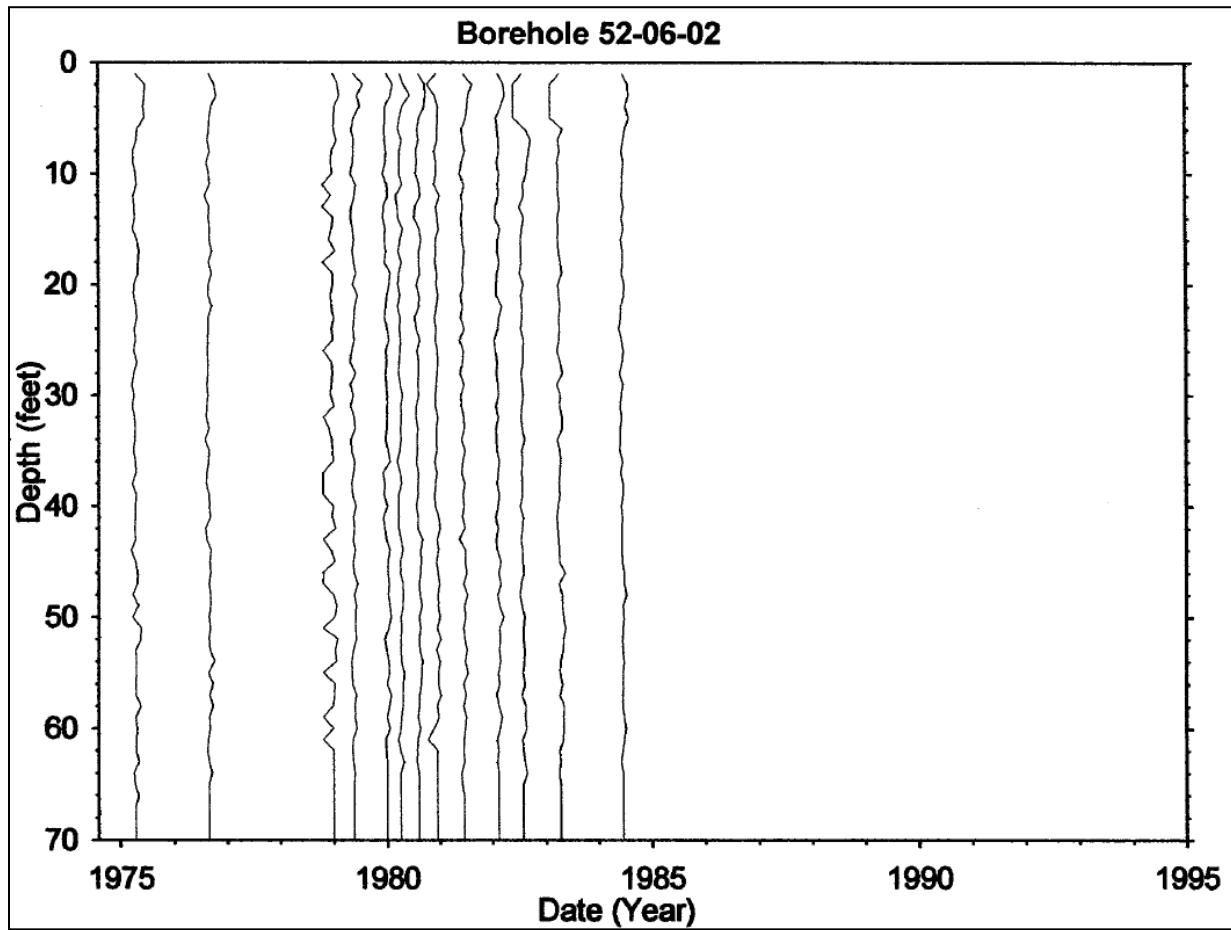
Figure 6-11. Tank TY-104 Associated Drywell 52-06-02 (HNF-3831)

In May 1997, Cs-137 was the only man-made radionuclide detected in drywell 52-06-02 which was detected continuously from the ground surface to 64-ft BGS (GJ-HAN-67). Measured Cs-137 concentrations between 3 and 6-ft BGS ranged from about 5 to 13 pCi/g, between 6 and 40-ft BGS concentrations ranged from 1 to 3 pCi/g, and the concentration was less than 1 pCi/g below 40-ft BGS. Document GJ-HAN-67 states, "Reasons for the relative continuity of the contaminated zone compared to other boreholes associated with tank TY-104 are unknown. However, the contamination in borehole 52-06-02 may be related to the much more pervasive surface contamination that occurs in the vicinity of tank TY-105." Drywell 52-04-03 is therefore not included as part of the leak location for tank TY-104. Figure 6-11 shows depths of radioactivity from 1975 to 1985 (HNF-3831).

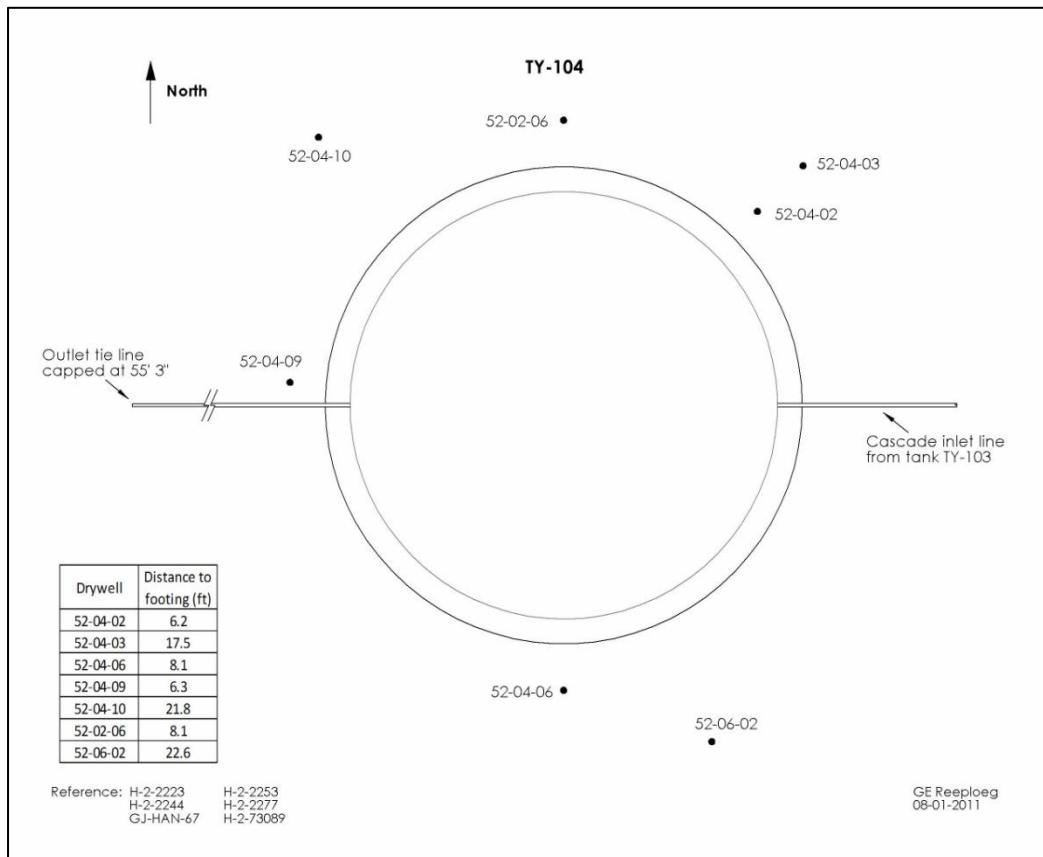
Figure 6-12. Tank TY-104 Associated Drywells and Cascade Lines
Tank inner ring is steel liner, outer ring is outer edge of tank footing

Waste from tank TY-103 cascades into tank TY-104 at the 3:00 position (see Figure 6-12) and the tank TY-104 cascade outlet tie line (tie line) is located at the 9:00 position (H-2-2253, 75-Foot Tank Nozzle and Piping Details). A cascade inlet pipe is located on tank TY-104 at the 276.5-in waste height. The tie line is located at the 272-in waste height and the capped line extends ~55-ft 3-in from the tank liner at a -2% gradient (see Figure 6-13). The tie line and sleeve were both capped and welded at ~55-ft 3-in from this tank liner. A valve is located along the tie line at 26-ft 2-in from the tank liner. The valve may have been closed. The 4-in Sch. 80 steel pipe was inside an 8-in Sch. 40 pipe sleeve from the tank wall to a slip fit steel connection at the valve end. The 4-in Sch. 80 steel pipe was inside a 6-in Sch. 40 with a slip fit steel pipe sleeve from the valve to the capped end (see Figure 6-13). Note that the tie line slip fit sleeve appears to be mainly for support and some protection from the soil as opposed to leak containment.

Note: A valve is located 26-ft from the tank liner on the TY-104 outlet tie line.

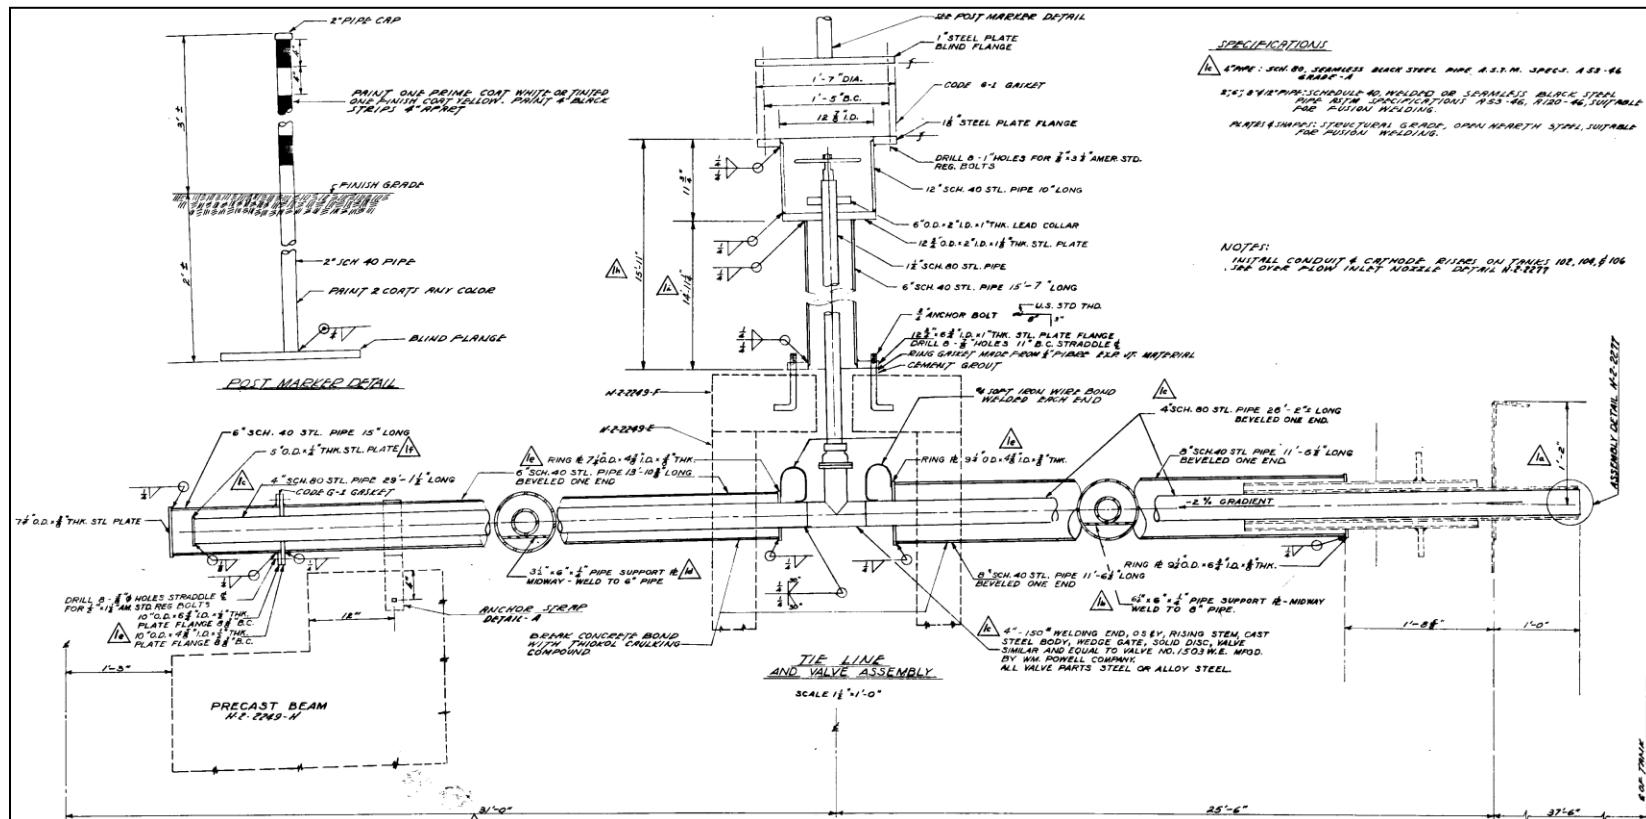
Figure 6-13. Tank TY-104 Outlet Cascade Tie Line Details

Tank TY-104 was filled above the tie line again in December 1970 (ARH-2074 D, *Chemical Processing Division Waste Status Summary October 1, 1971 through December 31, 1971*). After a recalibration in July 1973 and no further waste transactions since December 1970, the liquid level was reported to be at ~273-in in July 1973. If the recalibration was correct, tank TY-104 was overfilled once again above the tie line in December 1970 and remained above the tie line until the supernatant was pumped out of tank TY-104 after the liquid level started decreasing December 30, 1973 (see Section 6.4.1). Therefore, it is possible the tank TY-104 tie line leaked as opposed to a tank liner leak as there was waste in portions of the tie line since 1954; however, it remains inconclusive whether one or both may be leaking. Note that drywell 52-04-09 did not indicate any radioactivity; therefore, it is unlikely the tie line leaked at the tank wall penetration.

Bonding was used as indicated in Figure 6-13 to provide an electrical connection of the sleeve to the portion of the line at the valve. This indicates a purposeful effort was made to protect the exposed pipe from galvanic corrosion. The valve and slip fit ends of the pipe sleeve were protected in an enclosure similar to the 241-BX Farm photograph in Figure 6-14. However, this area is the most likely to leak or accumulate leakage which would provide moisture and possible electrical connection corrosion.

Tank TY-104 was overfilled in 1954 above the cascade tie line filling the tie line with TBP waste that would have remained in the tie line for 20 years until the leak was detected in December 1973. Tank TY-104 was overfilled above the cascade tie line for the second time in 1970. Corrosion could have occurred from storing TBP waste initially up to 180°F in 1954 leading to failure; however, temperatures likely cooled in the tie line after filling as ambient ground temperature was less than 55°F. The tie line could have corroded and started leaking through the slip fittings by December 30, 1973 causing the liquid level decrease. Another possible leak site could have occurred at the valve located 26-ft 2-in from the tank liner along the tie line. The valve welds, seat, and/or packing could have eventually failed (see Section 6.6). Drywell 52-04-09 did not pick up any radioactivity which indicated the tie line penetration through the tank wall was probably not a leak location. All other leaks would have entered the soil at least near the tie line valve because of the upper tie line pipe sleeve or further along the tie line which did not have any adjacent drywells.

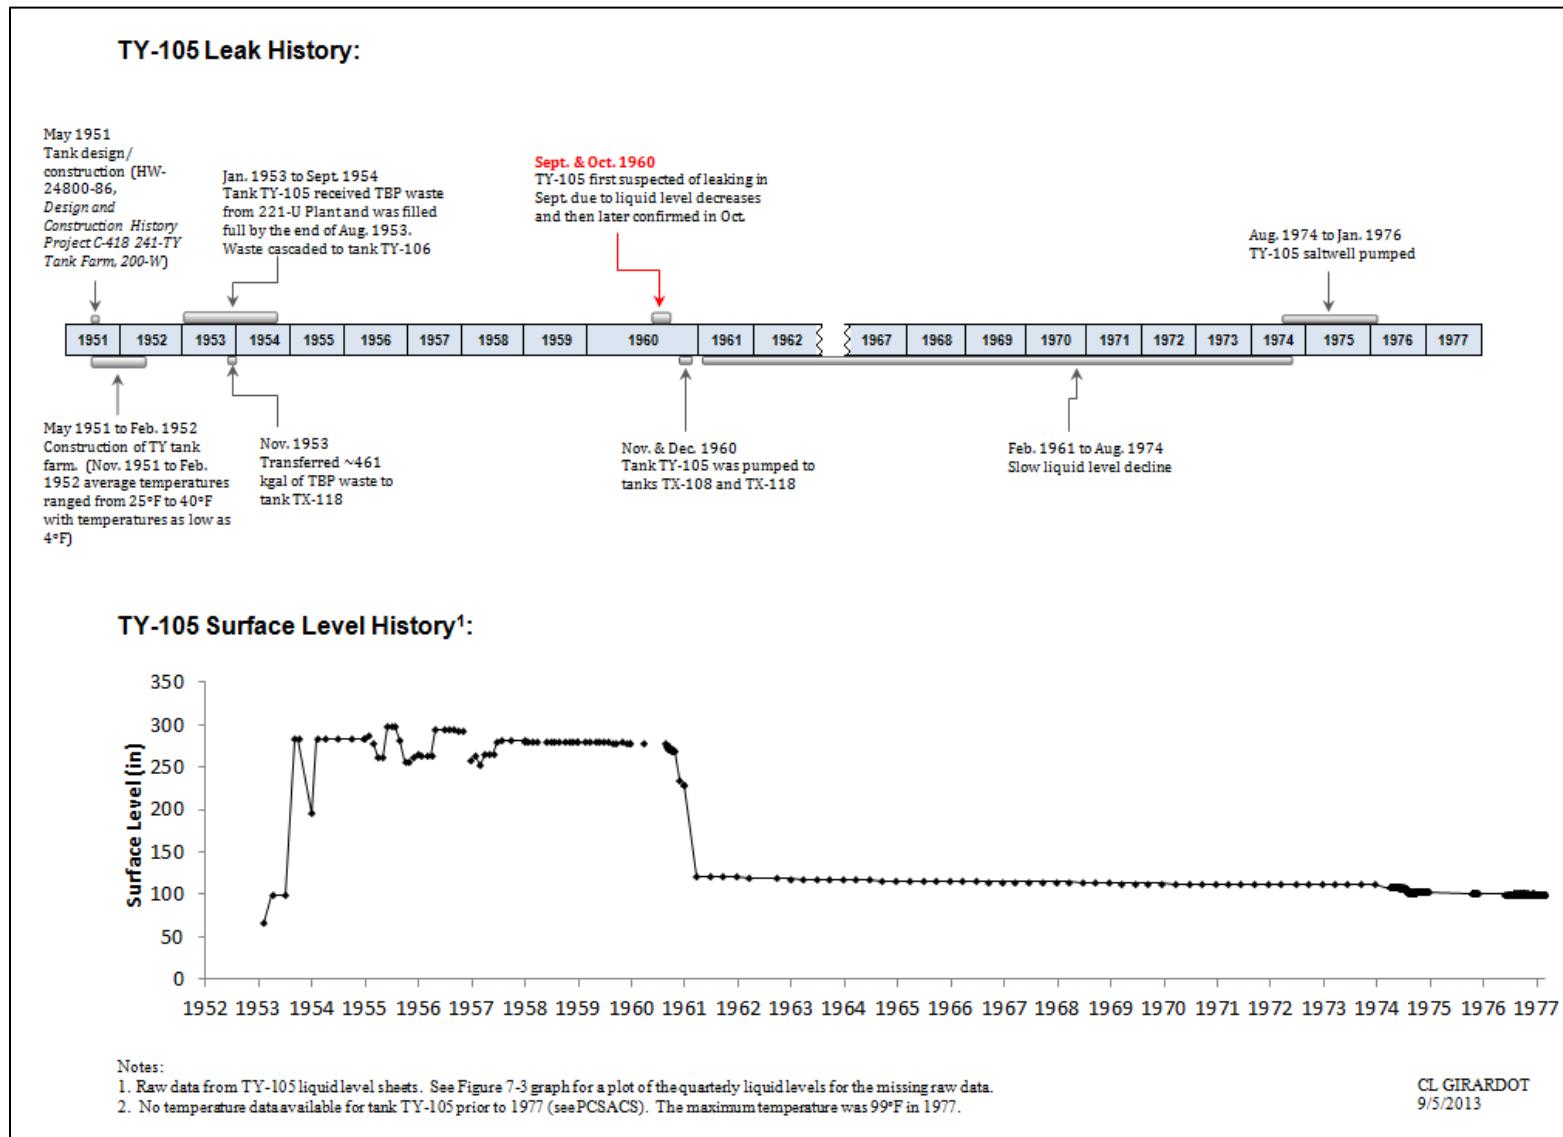
Figure 7-2. Operational Leak History of Tank TY-105

The operational history of tank TY-105 leak related details including liquid level is charted in Figure 7-2.

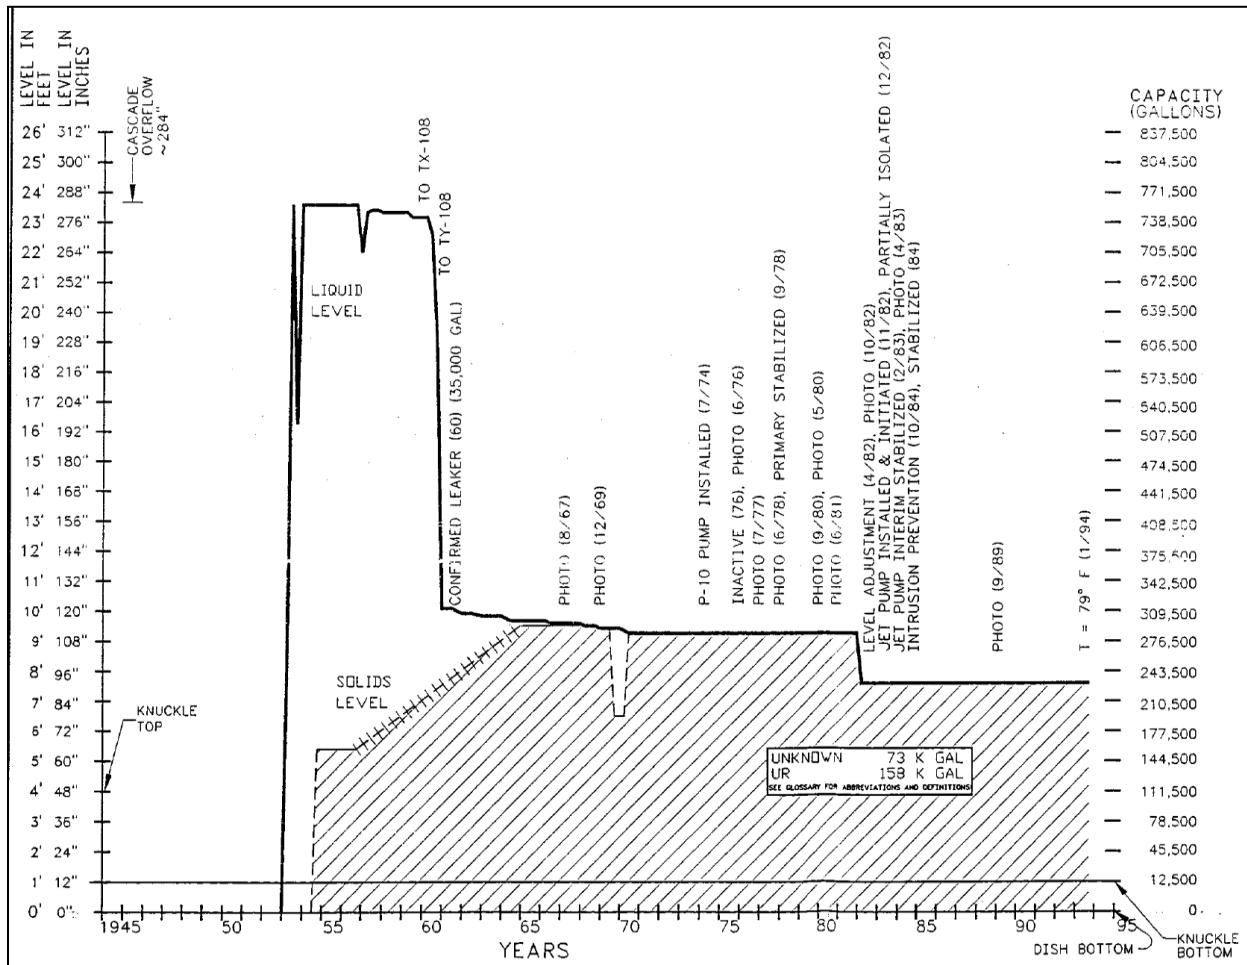
Figure 7-3. Tank TY-105 End of Quarter Surface Level

The liquid level plot in Figure 7-3 indicates the transfer activity into and out of tank TY-105. The liquid levels are end of quarter levels so this figure may not reflect all transfers into and out of the tank that occurred during the operational history of the tank. Over 5,000 kgal of waste cascaded from tank TY-105 to tank TY-106 over two years in 1953 and 1954 (WHC-SD-WM-TI-669, *Waste Status and Transaction Record Summary for the Northwest Quadrant of the Hanford 200 Area*). See Figure 7-2 for historical monthly liquid level readings.

Note: Tank TY-108 does not exist as referred to in this figure, the last transfer out of tank TY-105 was sent to tank TX-118 (HW-68292)

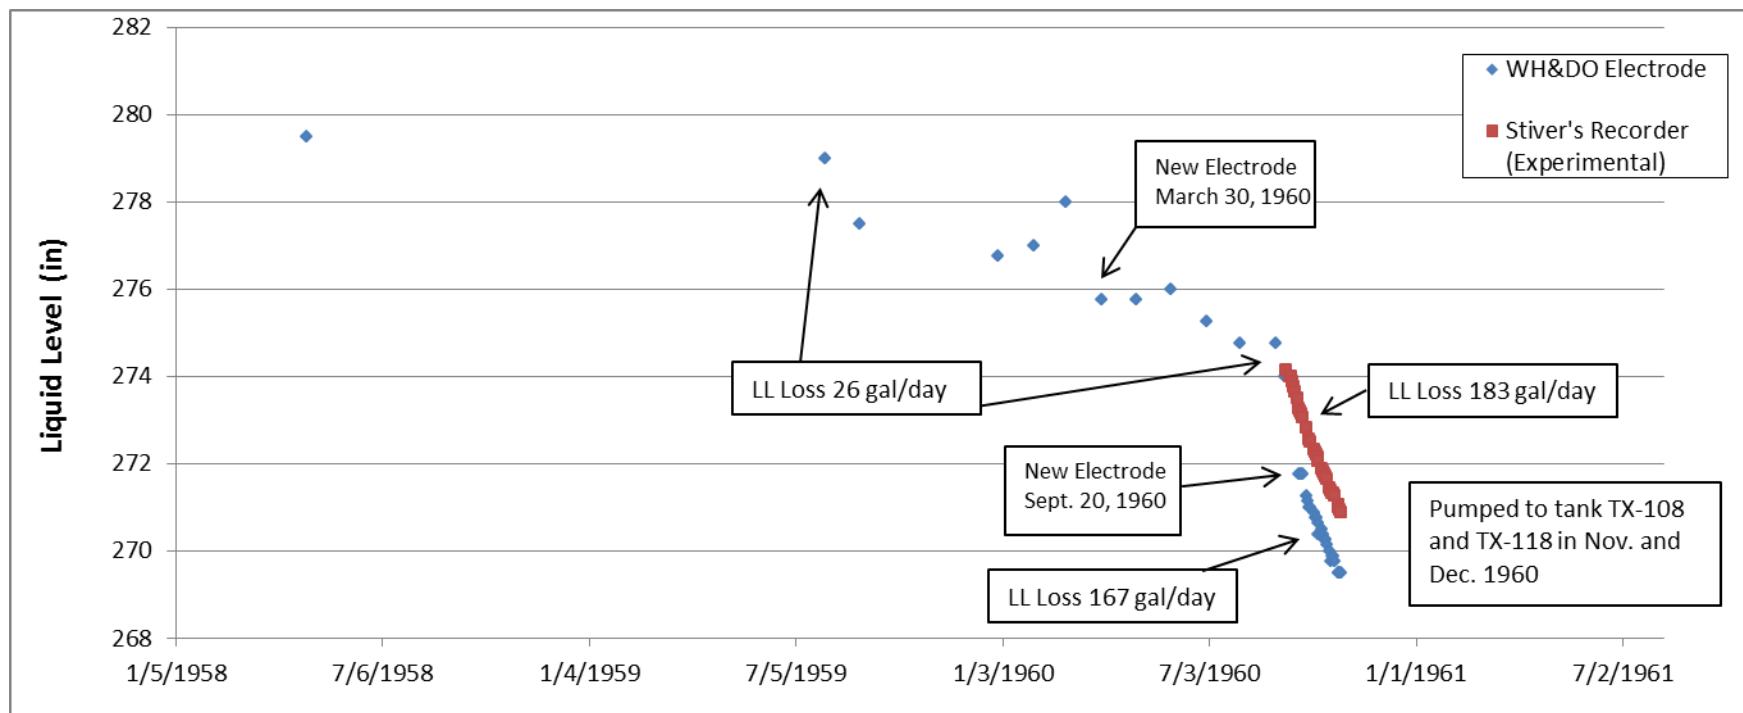
Figure 7-4. Tank TY-105 Liquid Level April 30, 1958 to October 27, 1960

Liquid levels were recovered with the Waste Handling and Decontamination Operations (WH&DO) electrode from April 30, 1958 to the end of October 1960 and with the Stiver's recorder in September and October 1960 (see next paragraph), which was placed in service in tank TY-105 on September 14, 1960 (see Figure 7-4). Tank TY-105 was first reported to be a suspected leaker in September 1960 due to liquid level decreases. Internal memo, "105-TY Waste Storage Tank" states, "The electrode has shown a decrease of 2-in (5,500 gal) since the end of August and daily checks, instituted September 15, show a loss of about 1/2-in per week.

The electrode readings are being confirmed by an independent measuring device developed by FEO and which is calibrated to 1/16-in. Drywells around the tank have been examined and no evidence of a leak has been found." It appears the liquid level could have started decreasing as early as July 1959 as shown in Figure 7-4. Decreasing liquid levels during this period could have at least partially been the result of evaporation; however, temperatures were not available to confirm the possible extent of evaporation. Document HW-72858, *Interim Report Waste Tank Liquid Level Measurement Systems 200-E and 200-W Areas*, states, "Reviewing the liquid level records on this tank," [i.e., tank TY-105], "as taken by the manual electrode method, and knowing that a leak existed, a possible trend was indicated that the tank may have been leaking for 6 months or longer."

It appears that the tank TY-105 liquid level started decreasing at a slow rate, ~26 gal/day from July 30, 1959 to August 30, 1960, and increased in September 1960 to ~175 gal/day (average of both sets of data) as indicated from the data graphed in Figure 7-4. As a result, the supernatant from tank TY-105 was transferred to tanks TX-108 and TX-118 in November and December 1960 leaving the liquid level at ~113-in. Liquid levels continued to slowly decline from February 1961 through August 1974 to ~27 kgal (RPP-RPT-42296) with saltwell pumping. However, the manual tape used to measure liquid level was reported to be contacting solid waste surfaces within the tank, raising uncertainty about the actual liquid level decline during this time. Evaporation may also have contributed to the liquid level decrease (RPP-RPT-42296).

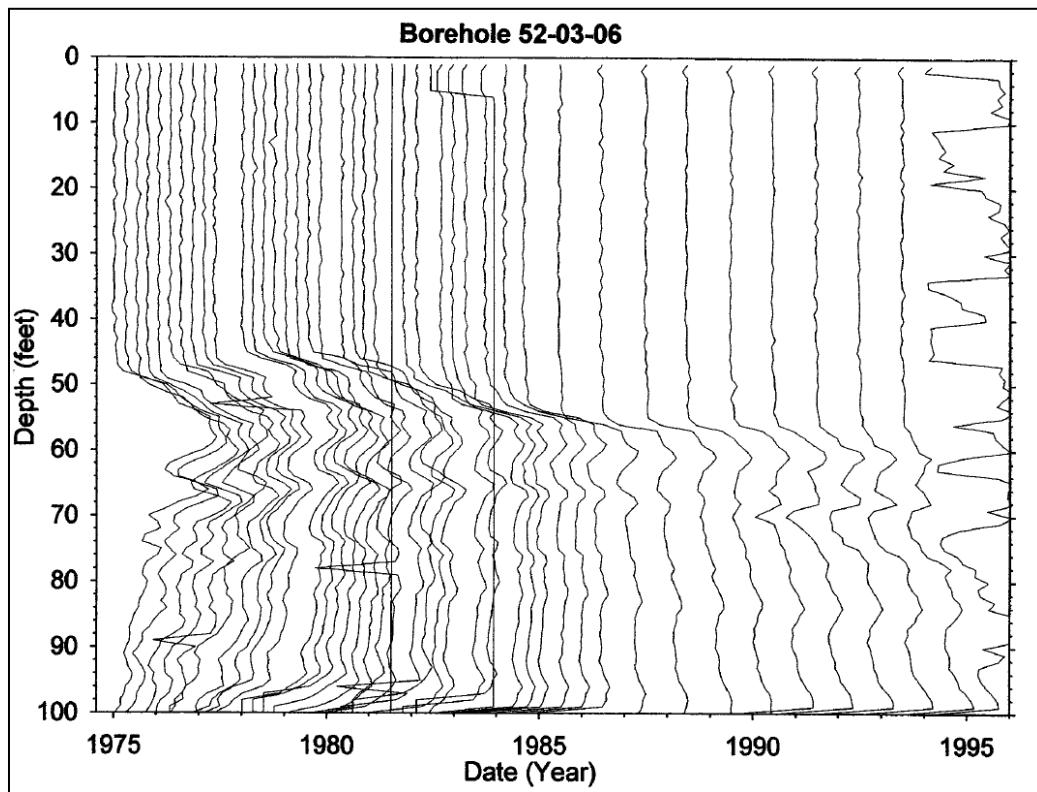
Figure 7-5. Tank TY-105 Associated Drywell 52-03-06 (HNF-3831)

Drywell 52-03-06 is located in between tanks TY-103 and TY-105. It is likely radioactivity in this drywell is associated with the leak from tank TY-103 due to similar timing and depth (see tank TY-103 Segment). Also, radioactivity was reported as less than values prior to August 1972, and tank TY-105 was first suspected of leaking in September 1960 due to liquid level decreases (see Tank TY-103 segment). Therefore, drywell 52-03-06 is not included in the leak location for tank TY-105. Figure 7-5 shows the depths of radioactivity from 1975 to 1995 (HNF-3831).

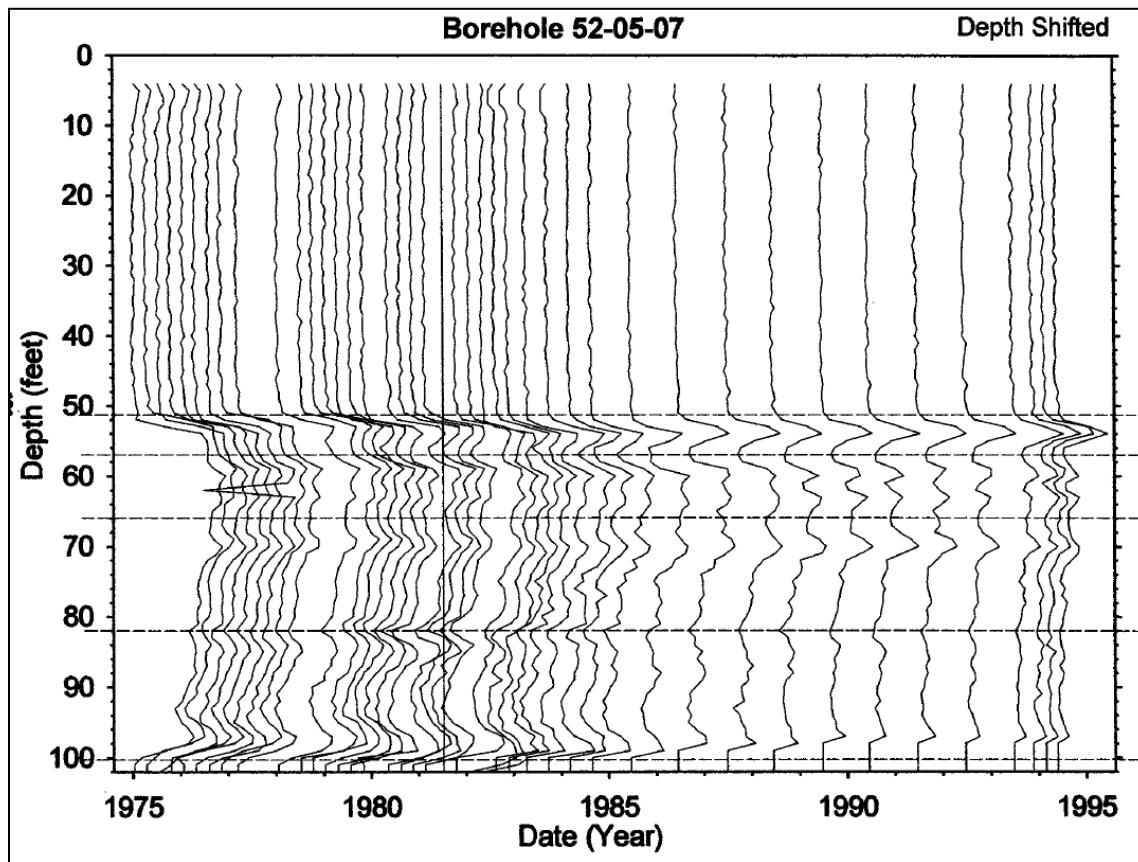
Figure 7-6. Tank TY-105 Drywell 52-05-07 (HNF-3831)

In April 1997, Cs-137 and Co-60 were the only man-made radionuclides detected in drywell 52-05-07 (GJ-HAN-68). Cs-137 was detected from the ground surface to 76.5-ft BGS and from 87 to 88-ft BGS with the maximum concentration of 32.4 pCi/g detected at 52.5-ft BGS. Co-60 was detected from 1 to 2.5-ft BGS, 5.5 to 7-ft BGS, and from 51.5 to 97-ft BGS with the maximum concentration of 7.1 pCi/g reported at 62-ft BGS. The historical gross gamma logs show three peaks between 55 and 70-ft (HNF-3831). The SGLS measured Cs-137 and Co-60 contamination between 51 and 97-ft BGS correlates with the historical gross gamma logs. As stated in GJ-HAN-68, “the contamination detected around borehole 52-05-07 probably originated from a leak from tank TY-105.” Figure 7-6 shows the depths of radioactivity from 1975 to 1995 (HNF-3831).

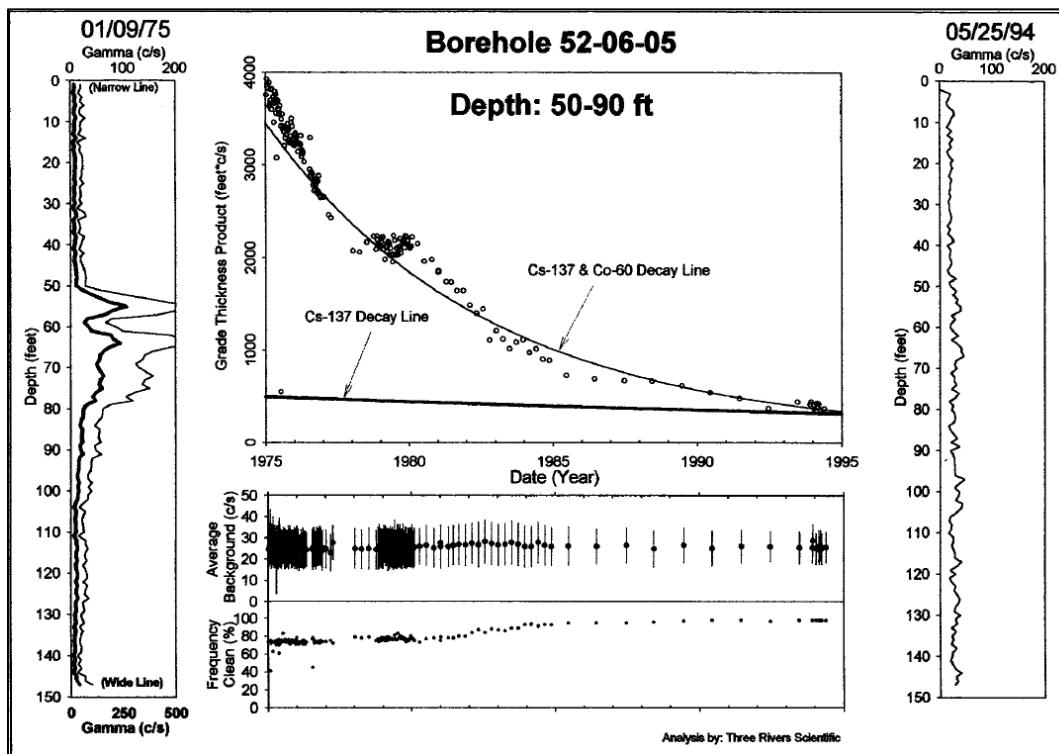
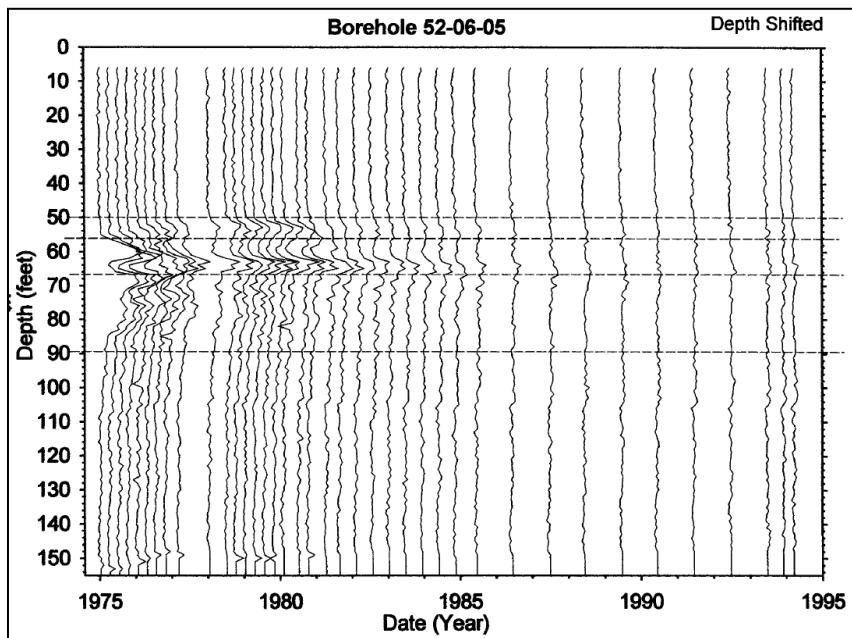
Radioactivity detected in drywell 52-06-05 appears to be the fairly mobile radioisotopes- short lived Ru-106 and also Co-60 both of which decayed away (see Figure 7-7). The tank TY-106 direct pushes near drywell 52-06-05 did not indicate radioactivity down to ~47-ft BGS and were not deepened as there was no indication of further radioactivity (RPP-RPT-39511). Since there was no Cs-137 detected near tank TY-106, indications are that the radioactivity detected in drywell 52-06-05 was the leading edge (mobile radioisotopes) from a tank TY-105 leak. Figure 7-8 shows depths of radioactivity from 1975 to 1994 (HNF-3831).

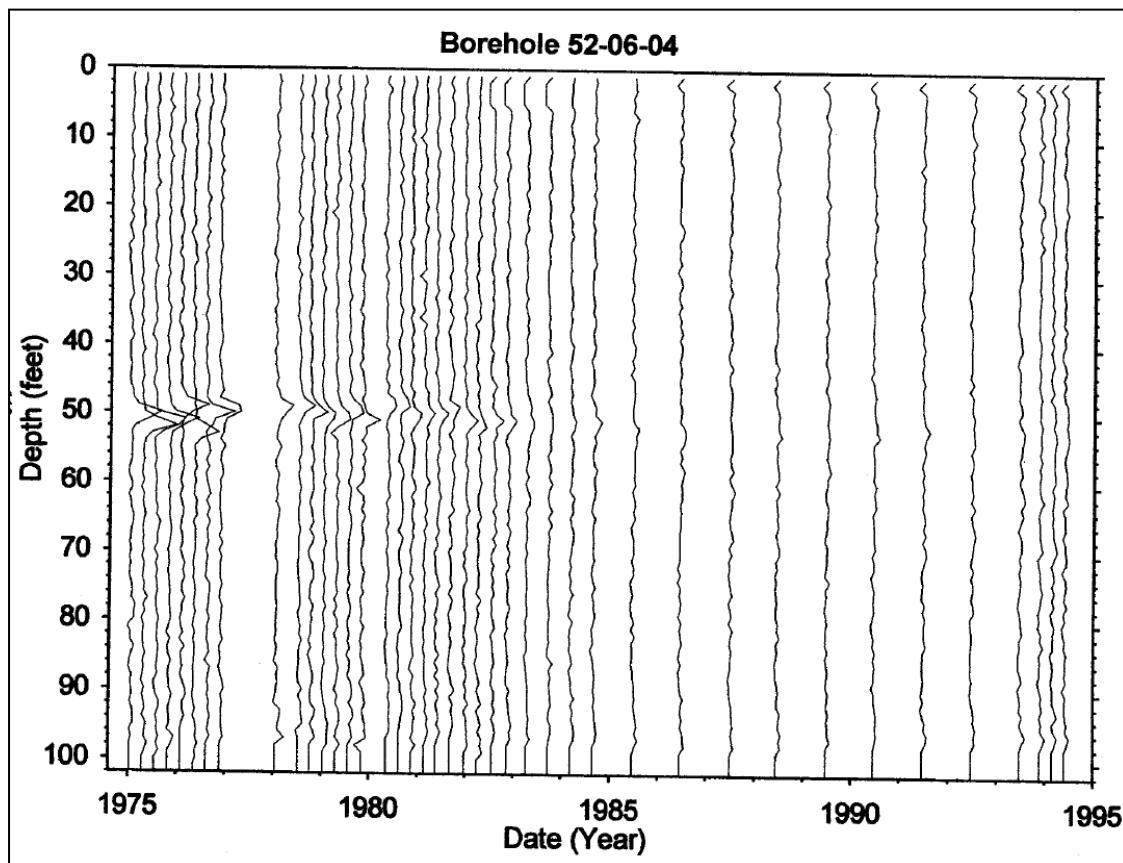
Figure 7-9. Tank TY-105 Associated Drywell 52-06-04 (HNF-3831)

In April 1997, Cs-137 was the only man-made radionuclide detected in drywell 52-06-04 (GJ-HAN-68). Cs-137 was detected from the ground surface to 53.5-ft and at 57-ft BGS with the maximum concentration of 1.2 pCi/g reported at 52-ft BGS. Document GJ-HAN-68 states, “it is possible that the Cs-137 contamination originated from a breach in either tank TY-105 or TY-106.” However, it seems likely radioactivity detected in this drywell was the result of the tank TY-105 leak (see Section 7.5.3). Radioactivity from 47-56-ft BGS was reported to be stable in document HNF-3831. Figure 7-9 shows depths of radioactivity from 1975 to 1994 (HNF-3831).

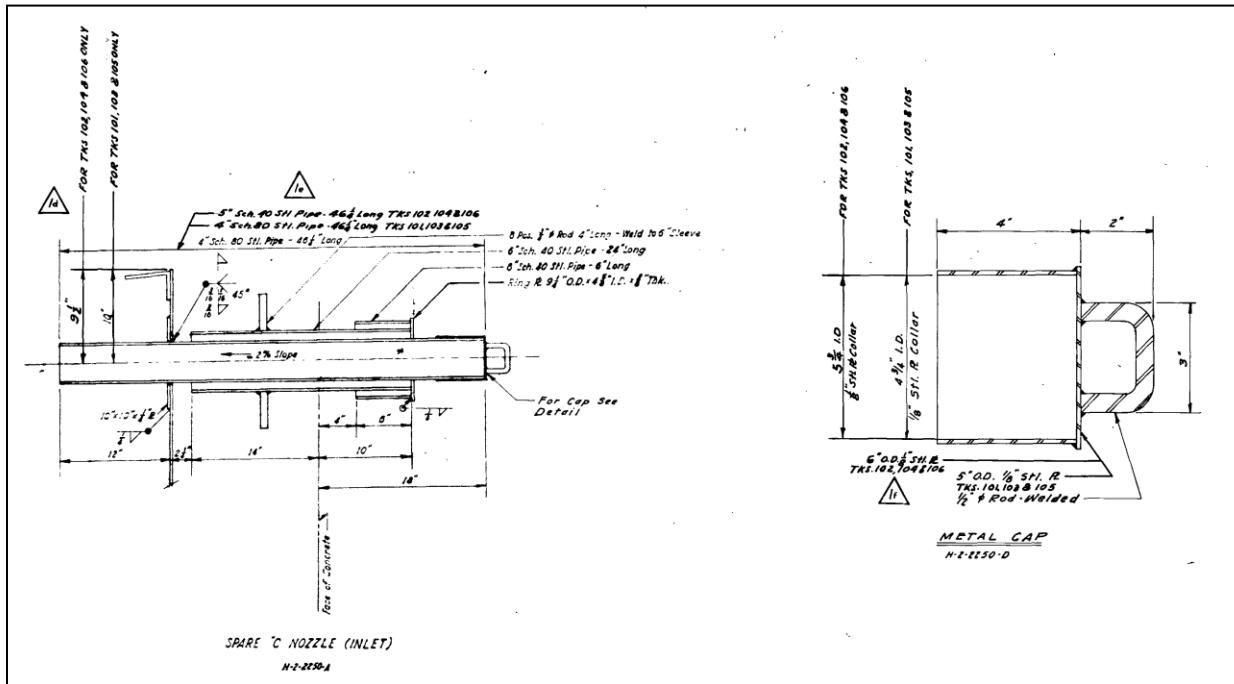
**Figure 7-10. Tank TY-105 Spare Inlet Nozzles
(H-2-2250)**

The peak radioactivity at ~24.5-ft detected in direct push C5018 (see Figure C4-2) could be from a liner leak or a leak out of one or both of the slip fit capped spare inlet lines (see Figure 7-10). The orientation of two of the spare inlet lines puts them directly in line with direct push C5018 which makes leakage from these lines a possible candidate for the peak at ~24.5-ft BGS. The lowest point (base) of the capped end of the spare inlet lines is at 11.2-in from the top of the liner (~21-ft 2½-in BGS).

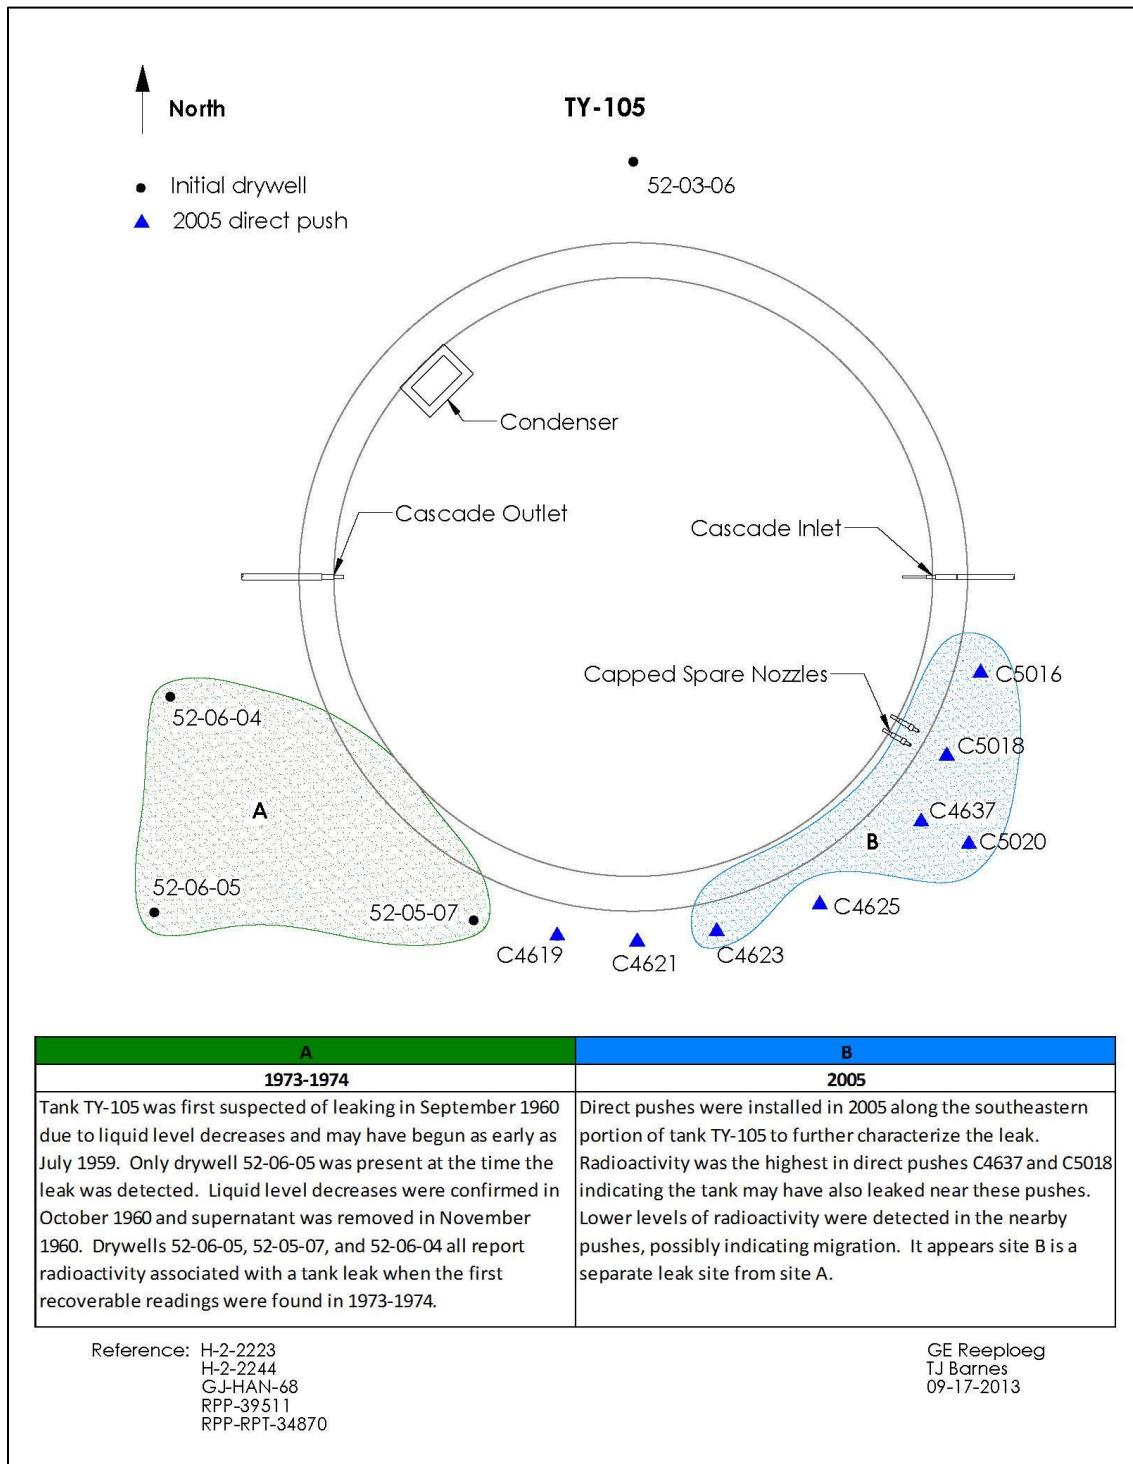
Figure 7-15. Tank TY-105 Possible Radial Leak Locations
 Tank inner ring is steel liner, outer ring is outer edge of tank footing

In 2005, direct pushes were installed along the southeast edge of tank TY-105. High levels of radioactivity were detected in direct pushes C4637 and C5018 with possible migration to the nearby direct pushes as shown in site B (see Figure 7-15). Site B appears to be a separate leak site from site A, as direct pushes located on the southern edge of tank TY-105 do not indicate any radioactivity associated with a tank leak or migration from leak site A.

Leak locations in Figure 7-15 are based on peak readings and are a representation of possible initial boundaries of radioactivity.

- We are saying tank TY-105 leaked near the locations in Figure 7-15. The Co-60 in 1996 more or less confirms the leak location we addressed. From the data sources as well as the GJ-HAN-xx documentation, individual drywells are addressed in separate subsections.

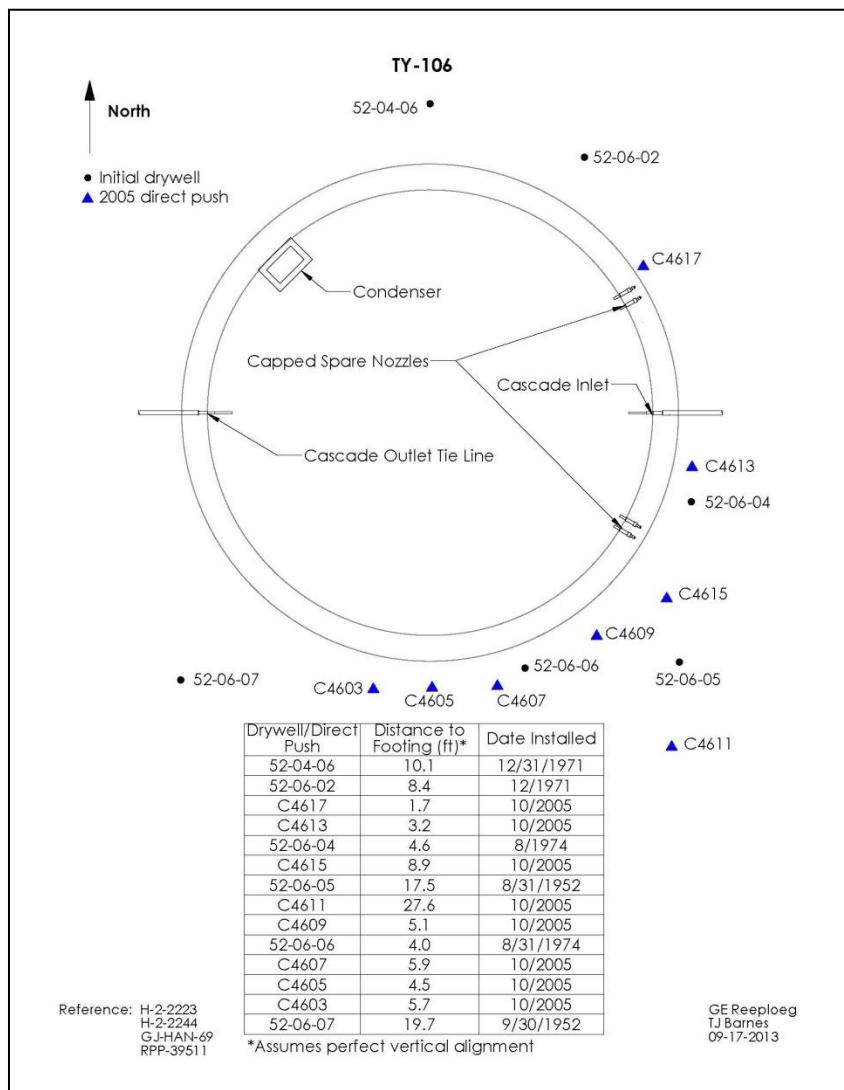
Figure 8-1. Tank TY-106 Associated Drywells
Tank inner ring is steel liner, outer ring is outer edge of tank footing

This section provides information on the historical waste loss event associated with SST 241-TY-106 (TY-106). There are six drywells located around tank TY-106 with specified distances from the drywell to the tank footing shown in Figure 8-1: 52-06-05 and 52-06-07 installed in 1952; 52-04-06 and 52-06-02 installed in December 1971; 52-06-04 and 52-06-06 installed in August 1974. Eight direct pushes were installed in 2005: C4617, C4613, C4615, C4611, C4609, C4607, C4605, and C4603.

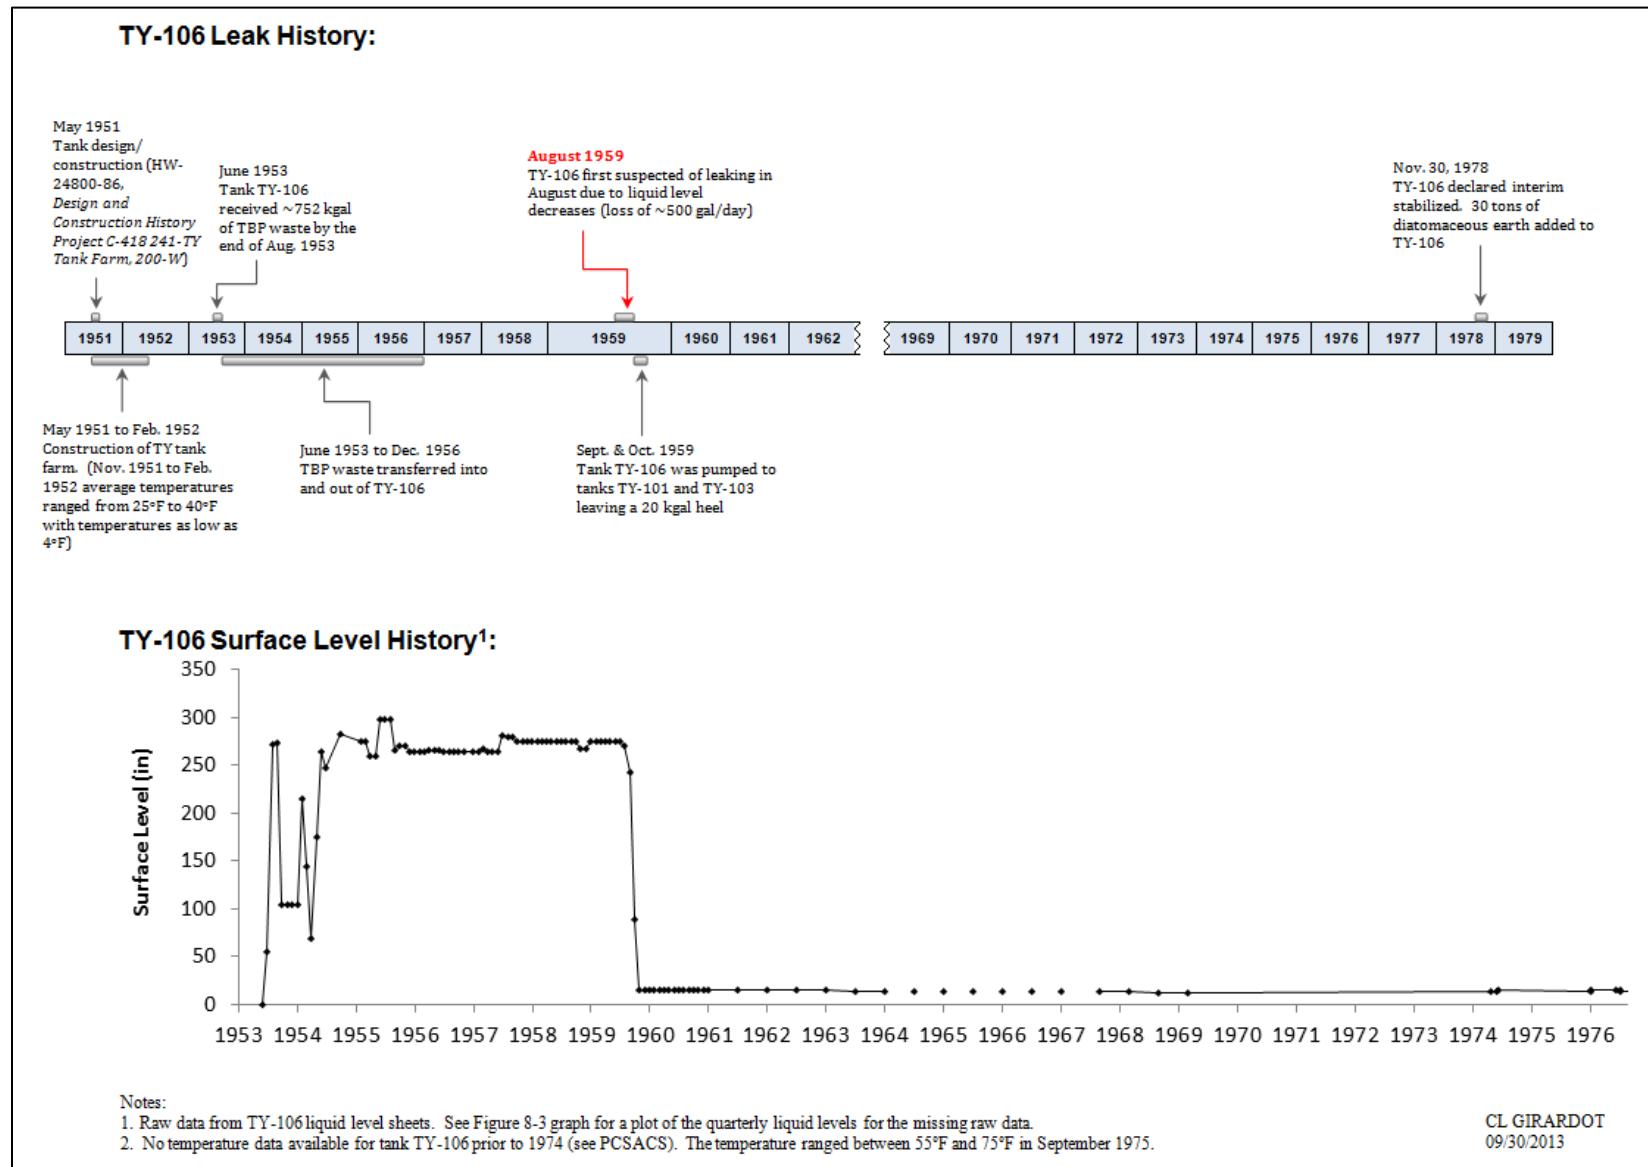
Figure 8-2. Operational Leak History of Tank TY-106

Tank TY-106 was first suspected of leaking in August 1959 when document HW-61952 indicated a loss of approximately 500 gal/day (see Section 8.4.1) and 74 kgal of waste was pumped to tank TY-101 initiated on August 28, 1959 (HW-61952; HW-61736-DEL, *Chemical Processing Department Monthly Report for August, 1959*). Tank TY-106 was removed from service and contents from tank TY-106 continued to be pumped to tank TY-101 and TY-103 in September and October 1959 leaving the volume at ~20 kgal (RPP-RPT-42296).

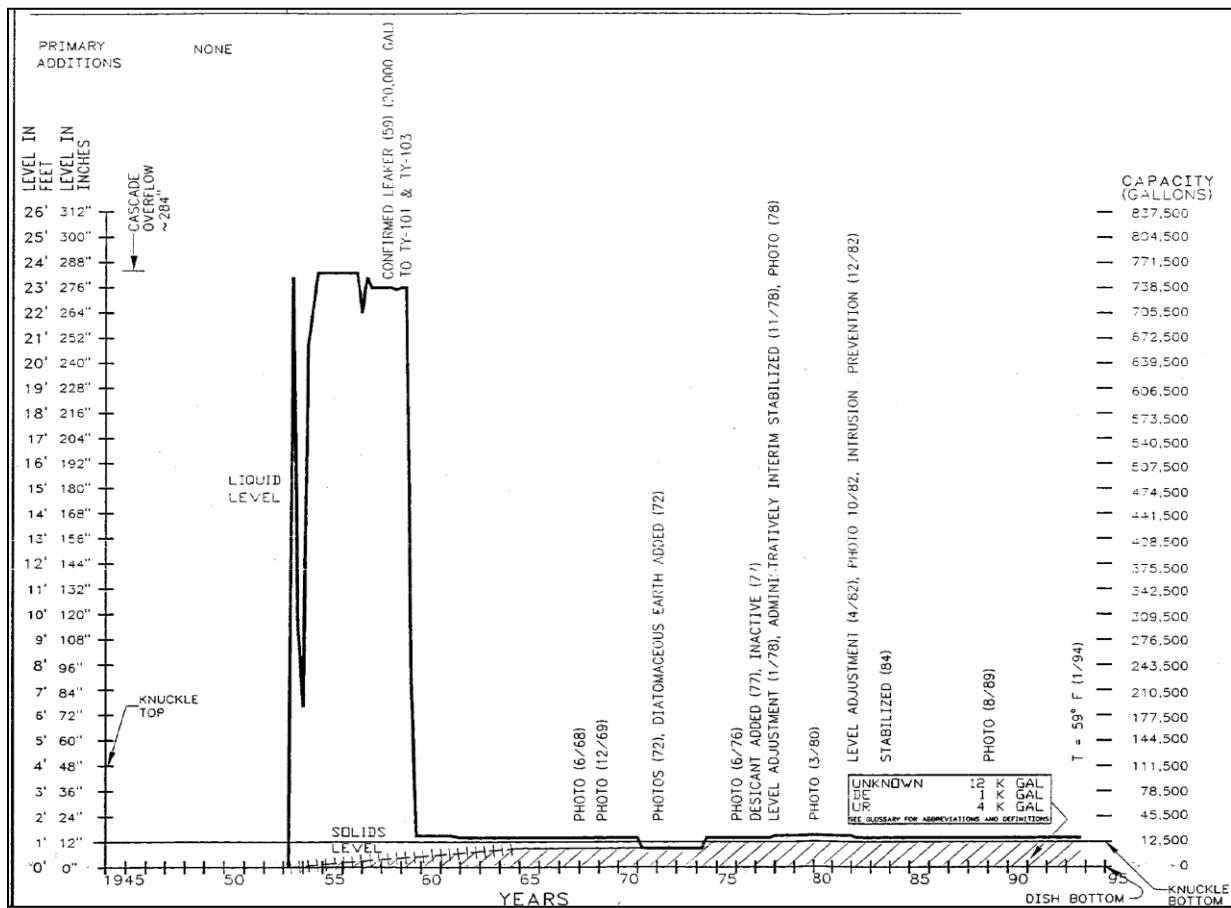
Figure 8-3. Tank TY-106 End of Quarter Surface Level

The liquid level plot in Figure 8-3 indicates the transfer activity into and out of tank TY-106. The liquid levels are end of quarter levels so this figure may not reflect all transfers into and out of the tank that occurred during the operational history of the tank. See Figure 8-2 for historical monthly liquid level readings. A total of 5,000 kgal was received in tank TY-106 through the cascade line from tank TY-105 over a two year period from 1953 to 1954.
