Hanford Single-Shell Tank Leak Causes and Locations - 241-BY and 241-TY Farm

C.L. Girardot, D.G. Harlow

Washington River Protection Solutions
Richland, WA 99352
U.S. Department of Energy Contract

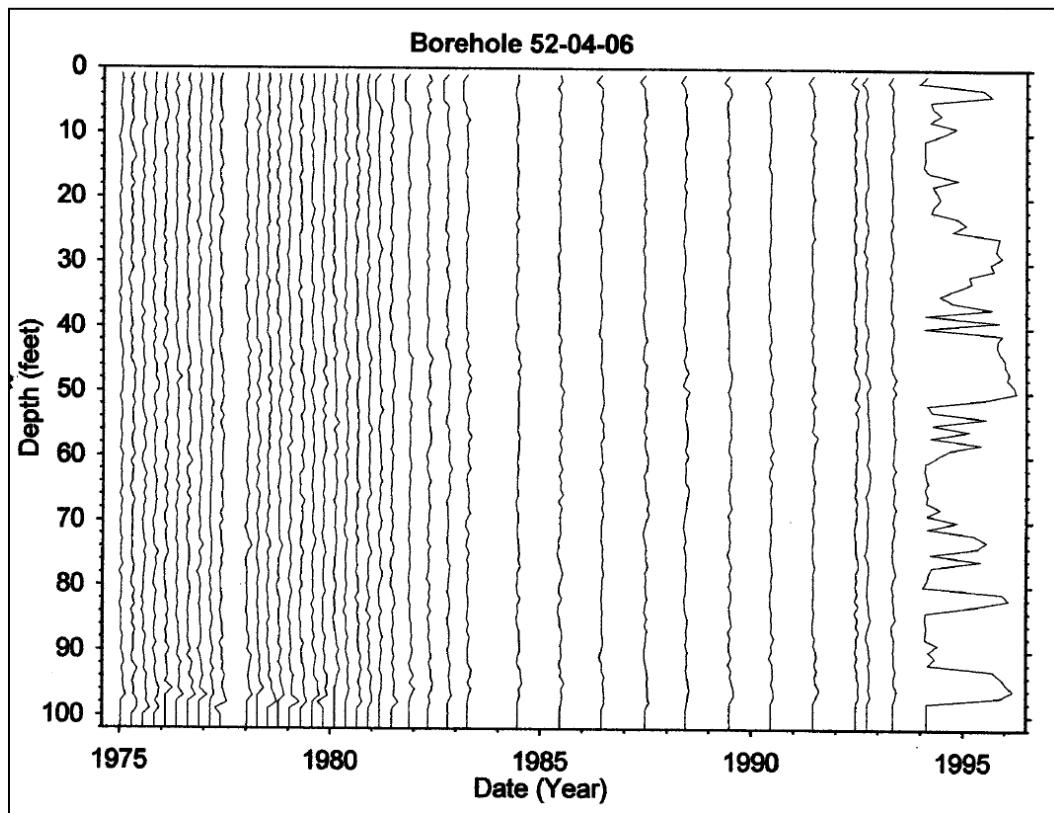
Figure 8-4. Tank TY-106 Associated Drywell 52-04-06 (HNF-3831)

In May 1997, Cs-137 was the only man-made radionuclide detected in drywell 52-04-06 (GJ-HAN-69). Cs-137 was detected from the ground surface to 12-ft BGS and at the bottom of this drywell with the highest concentration (0.79 pCi/g) at 1.5-ft BGS. Document GJ-HAN-69 states, "The near-surface contamination (0 to 12 ft) probably resulted from surface spills that have migrated down into the backfill surrounding the borehole or contamination that was carried down during the drilling of this borehole." Since historical records report less than values for radioactivity, drywell 52-04-06 is not included as part of the leak location for tank TY-106. Figure 8-4 shows depths of radioactivity from 1975 to 1994 (HNF-3831).

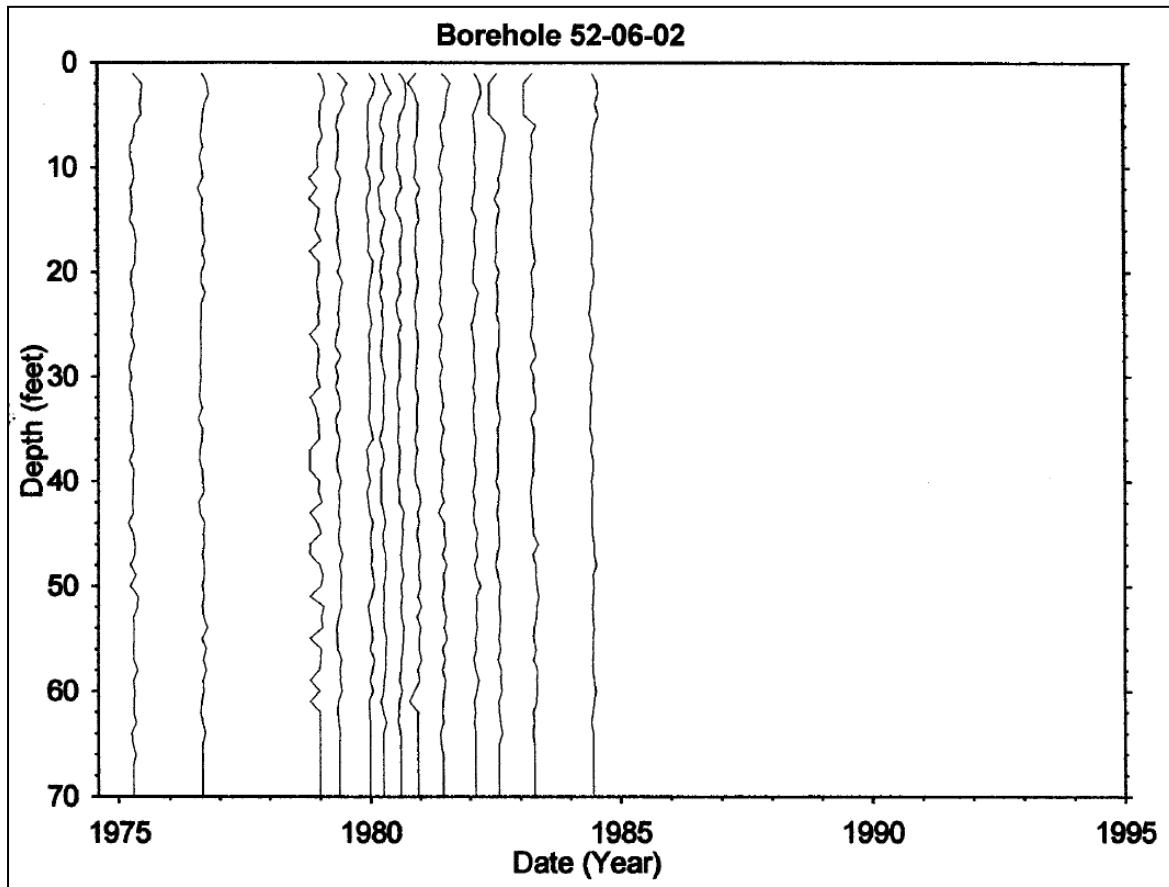
Figure 8-5. Tank TY-106 Drywell 52-06-02 (HNF-3831)

Drywell 52-06-02 was drilled in December 1971, 12 years after the tank TY-106 leak was first detected, with the first recoverable reading on April 4, 1974 as less than 12K cpm with the SP (scintillation probe). Radiation readings were reported as less than values from April 1974 to June 1986 (see Appendix C5). Document HNF-3831 states that Cs-137 contamination is only present at the surface from 0 to 10-ft BGS.

In May 1997, Cs-137 was the only man-made radionuclide detected in drywell 52-06-12 (GJ-HAN-69). Cs-137 was detected continuously from the ground surface to 65-ft BGS with the maximum concentration of 13.1 pCi/g reported at 4-ft BGS. As stated in GJ-HAN-67, “Reasons for the relative continuity of the contaminated zone compared to other boreholes associated with tank TY-104 are unknown. However, the contamination in borehole 52-06-02 may be related to the much more pervasive surface contamination that occurs in the vicinity of tank TY-105.” Drywell 52-06-02 is therefore not included as part of the leak location for tank TY-106. Figure 8-5 shows depths of radioactivity from 1975 to 1984 (HNF-3831).

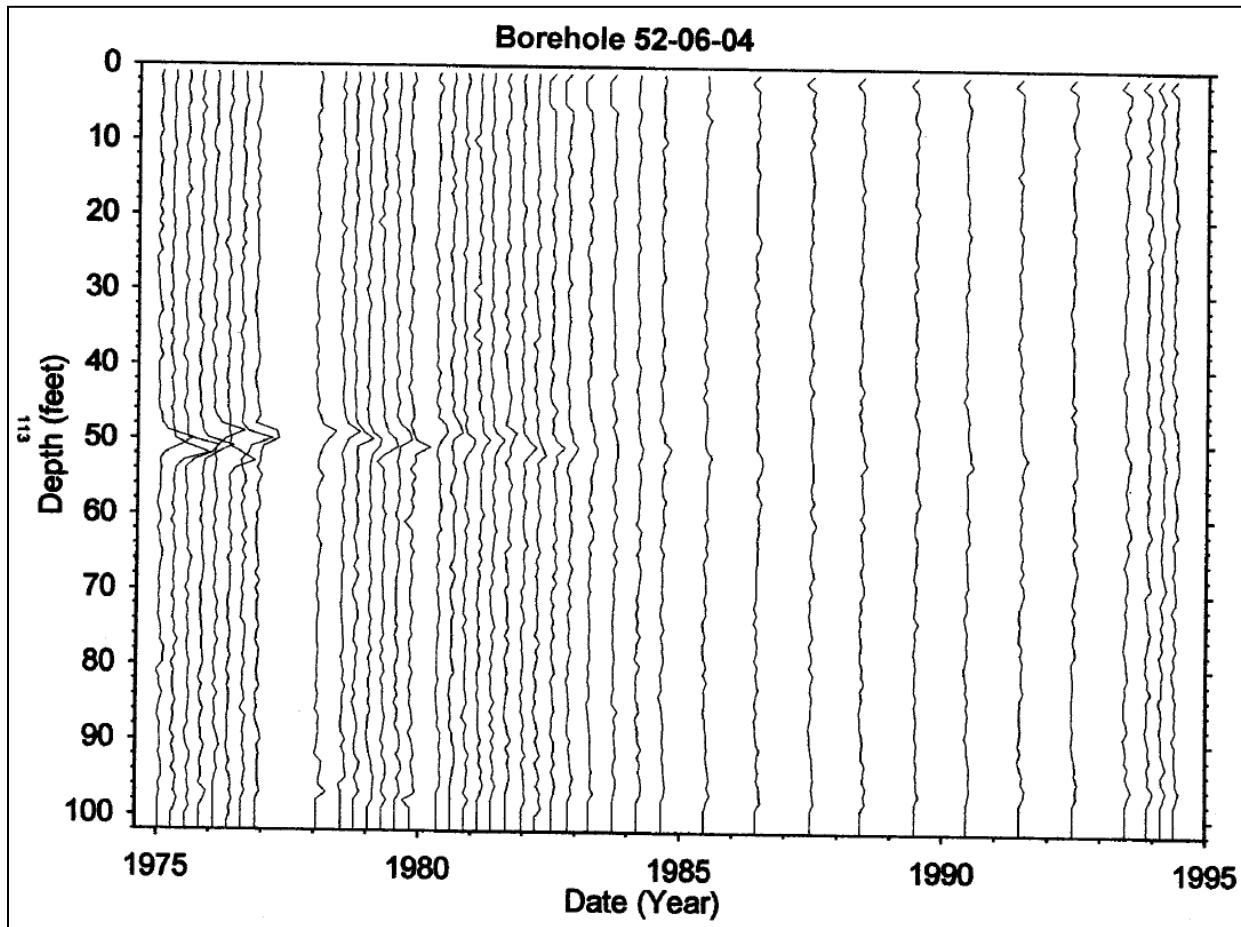
Figure 8-6. Tank TY-106 Drywell 52-06-04 (HNF-3831)

In May 1997, Cs-137 was the only man-made radionuclide detected in drywell 52-06-04 (GJ-HAN-69). Cs-137 was detected from the ground surface to 53.5-ft BGS and at 57-ft BGS with the maximum concentration of 1.2 pCi/g reported at 52-ft BGS. Radioactivity from 47 to 56-ft BGS was reported to be stable in document HNF-3831. Document GJ-HAN-68 states, "it is possible that the Cs-137 contamination originated from a breach in either tank TY-105 or TY-106." It appears radioactivity detected in this drywell was the result of the tank TY-105 leak; however, tank TY-106 cannot be entirely ruled out (see tank TY-105 Segment). Figure 8-6 shows depths of radioactivity from 1975 to 1994 (HNF-3831).

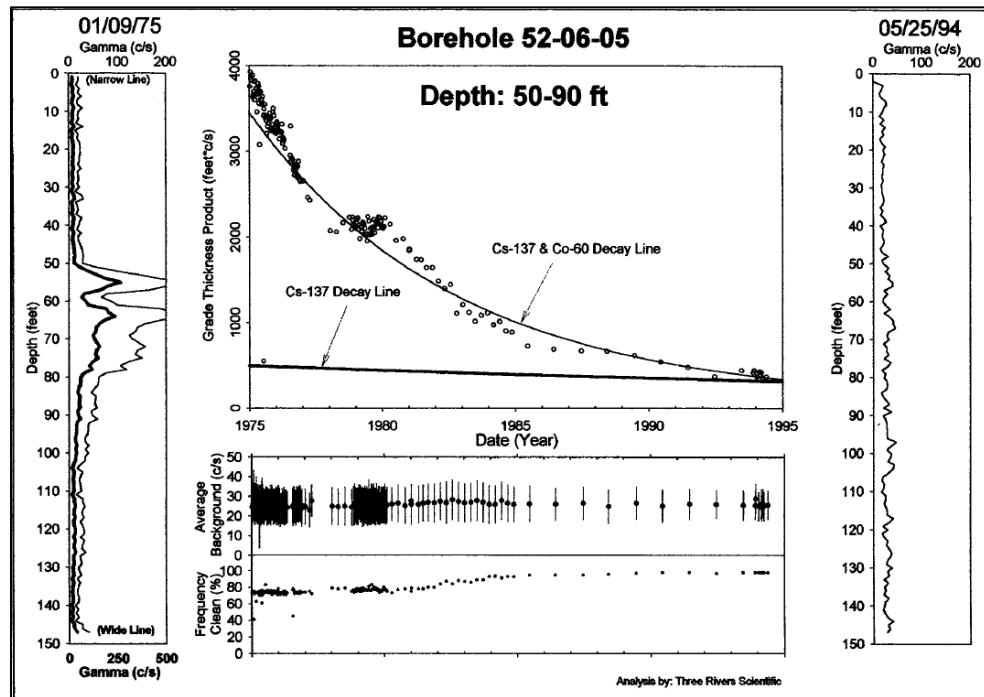
Figure 8-7. Tank TY-105 Associated Drywell 52-06-05 Cesium (HNF-3831)

In May 1997, Cs-137 and Co-60 were the only man-made radionuclides detected in drywell 52-06-05 (GJ-HAN-69). Cs-137 was detected from the ground surface to 133.5-ft BGS with the maximum concentration of 1.2 pCi/g reported at 111.5-ft BGS. Co-60 was detected at 2.5-ft BGS, from 52 to 90-ft BGS, from 92.5 to 98.5-ft BGS, and from 130 to 148-ft BGS with the maximum concentration of 3.2 pCi/g reported at 144.5-ft BGS. Radioactivity detected in drywell 52-06-05 appears to be the fairly mobile radioisotopes, short lived Ru-106 and also Co-60, both of which decayed away (see Figure 8-7). The tank TY-106 direct pushes near drywell 52-06-05 did not indicate radioactivity down to ~47-ft BGS and were not deepened as there was no indication of further radioactivity (RPP-RPT-39511). Since there was no Cs-137 detected near tank TY-106, indications are that the radioactivity detected in drywell 52-06-05 was the leading edge (mobile radioisotopes) from a tank TY-105 leak.

7. Pg. 8-14, Sect. 8.5.1.4. A comparison of Fig 8-7 with the spectral gamma log for this borehole leads one to speculate about several things: 1) is the 1970s data all Co-60? 2) what's the detection capability of the historical gross gamma log to Co-60? 3) can one infer Co-60 mobility from this comparison, as it appears to extend deeper than the base of the signature in the 1970s logs? Please address.

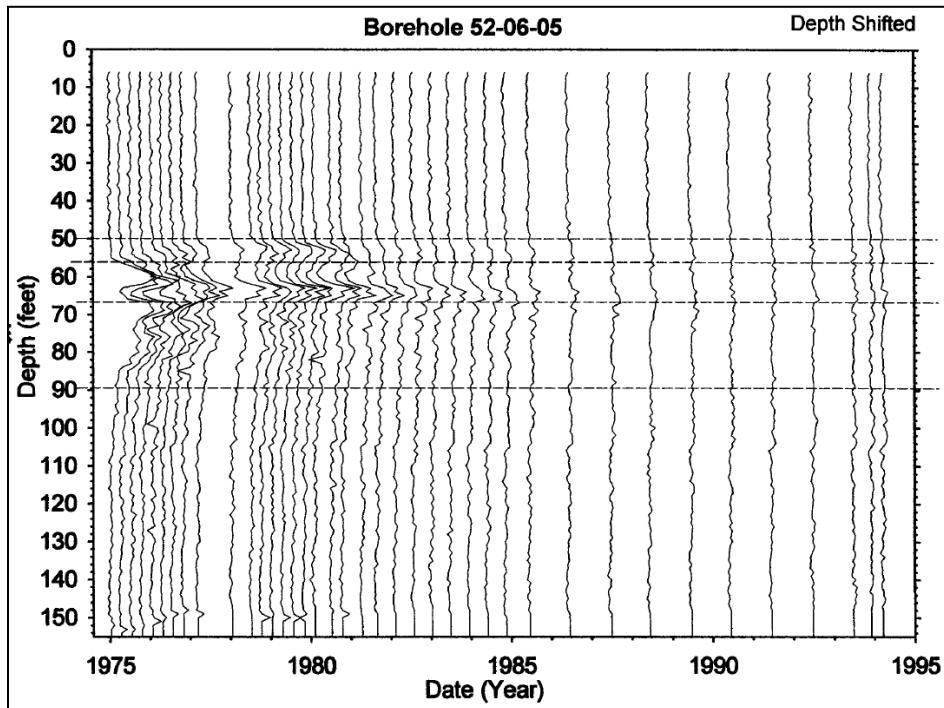
Figure 8-8. Tank TY-106 Drywell 52-06-05 (HNF-3831)

Two occurrence reports were written for increased activity in drywell 52-06-05 (OR-74-102, *Leakage Symptoms as Indicated by Dry Well Activity at Waste Tank 105-TY* and OR-74-88, *Symptoms Of Leakage As Indicated By Activity In Dry Well 52-06-05 At 106-TY Waste Tank*). Occurrence report OR-74-88 identifies the source of the drywell 52-06-05 contamination as tank TY-105. Figure 8-8 shows depths of radioactivity from 1975 to 1994 (HNF-3831).

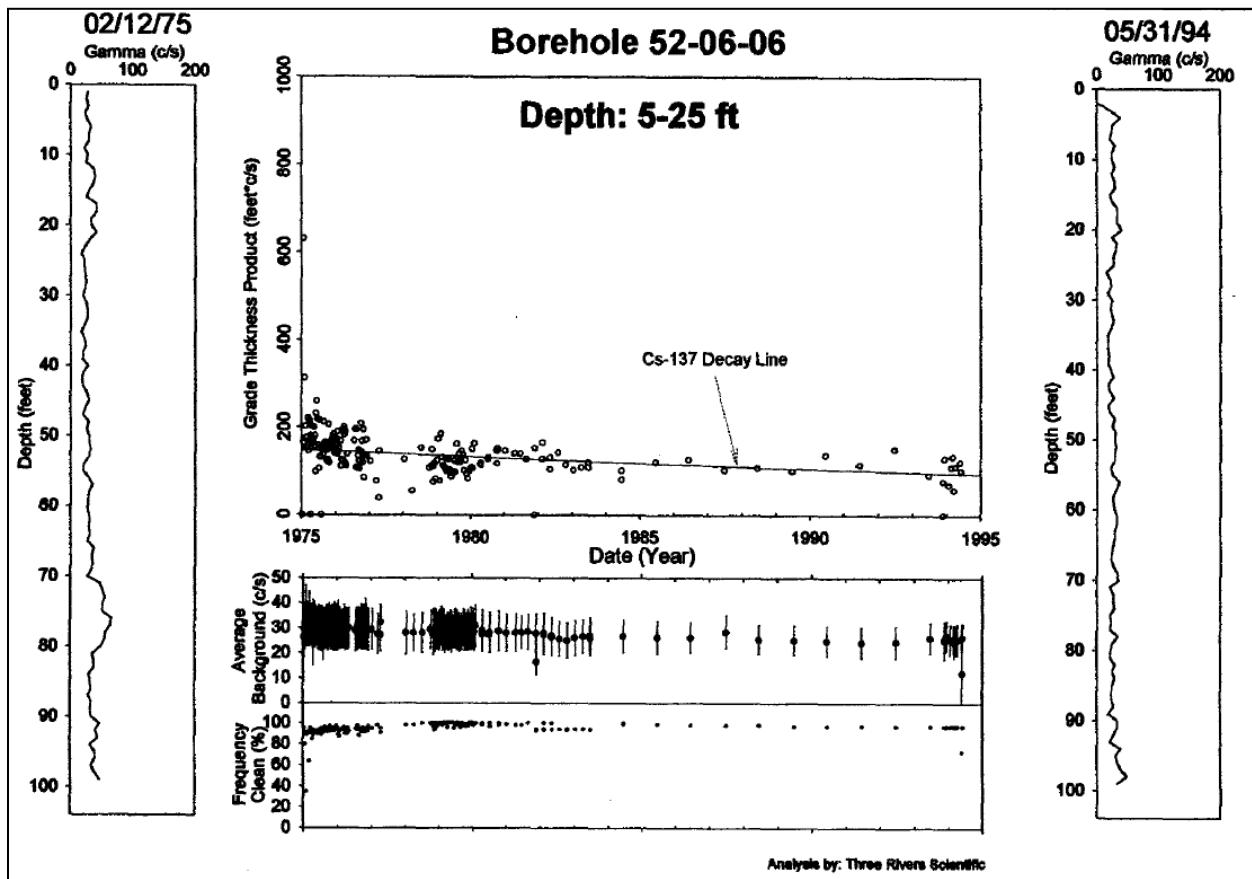
Figure 8-9. Tank TY-106 Drywell 52-06-06 Cesium (HNF-3831)

In May 1997, Cs-137 and Co-60 were the only man-made radionuclides detected in drywell 52-06-06 (GJ-HAN-69). Cs-137 was detected from the ground surface to 25-ft BGS and from 29 to 37-ft BGS with the maximum concentration of 6.1 pCi/g reported at 19-ft BGS. Co-60 was detected at 86-ft BGS and from 95.5 to 100-ft BGS with the maximum concentration of 0.29 pCi/g reported at 100-ft BGS. The GJ-HAN-69 Cs-137 logged in 1996 does not appear to indicate a separate leak of the tank liner at these BGS levels as the tank was pumped to a 20 kgal heel in 1959 and Figure 8-9 shows only Cs-137 decay through 1995 (see Section 8.5.3, 8.6.1, and 8.6.4).

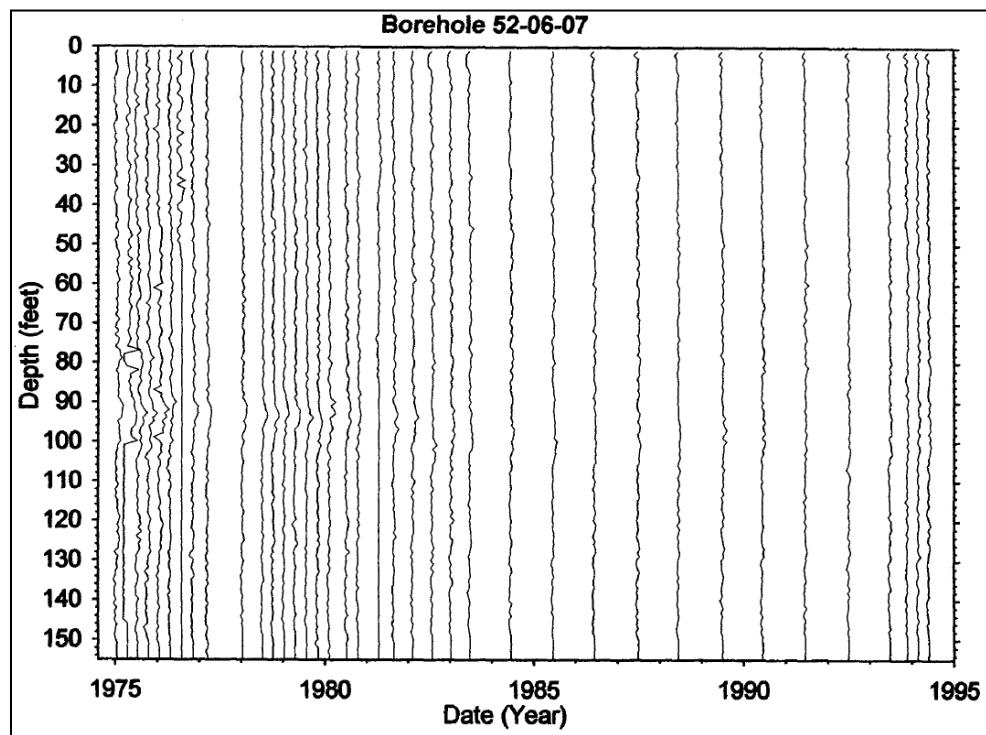
Figure 8-11. Tank TY-106 Drywell 52-06-07 (HNF-3831)

Therefore, drywell 52-06-07 is not considered as part of the leak location for tank TY-106. However, there is a remote possibility that the radioactivity reported in drywell 52-06-07 between 75-ft and 89-ft BGS was a part of the leading edge of a tank TY-106 leak near the southern edge of the tank but the depth seems too low to be a direct link. Also, the BGS level of the 6,000 cpm radioactivity reported in Internal memo "105-TY Waste Storage Tank Leak" remains unknown. The 1973-1974 drywell 52-06-07 radioactivity remains unexplained. Figure 8-11 shows some low level radioactivity in 1975 which decays away (HNF-3831) as is indicated by the Appendix C5 data.

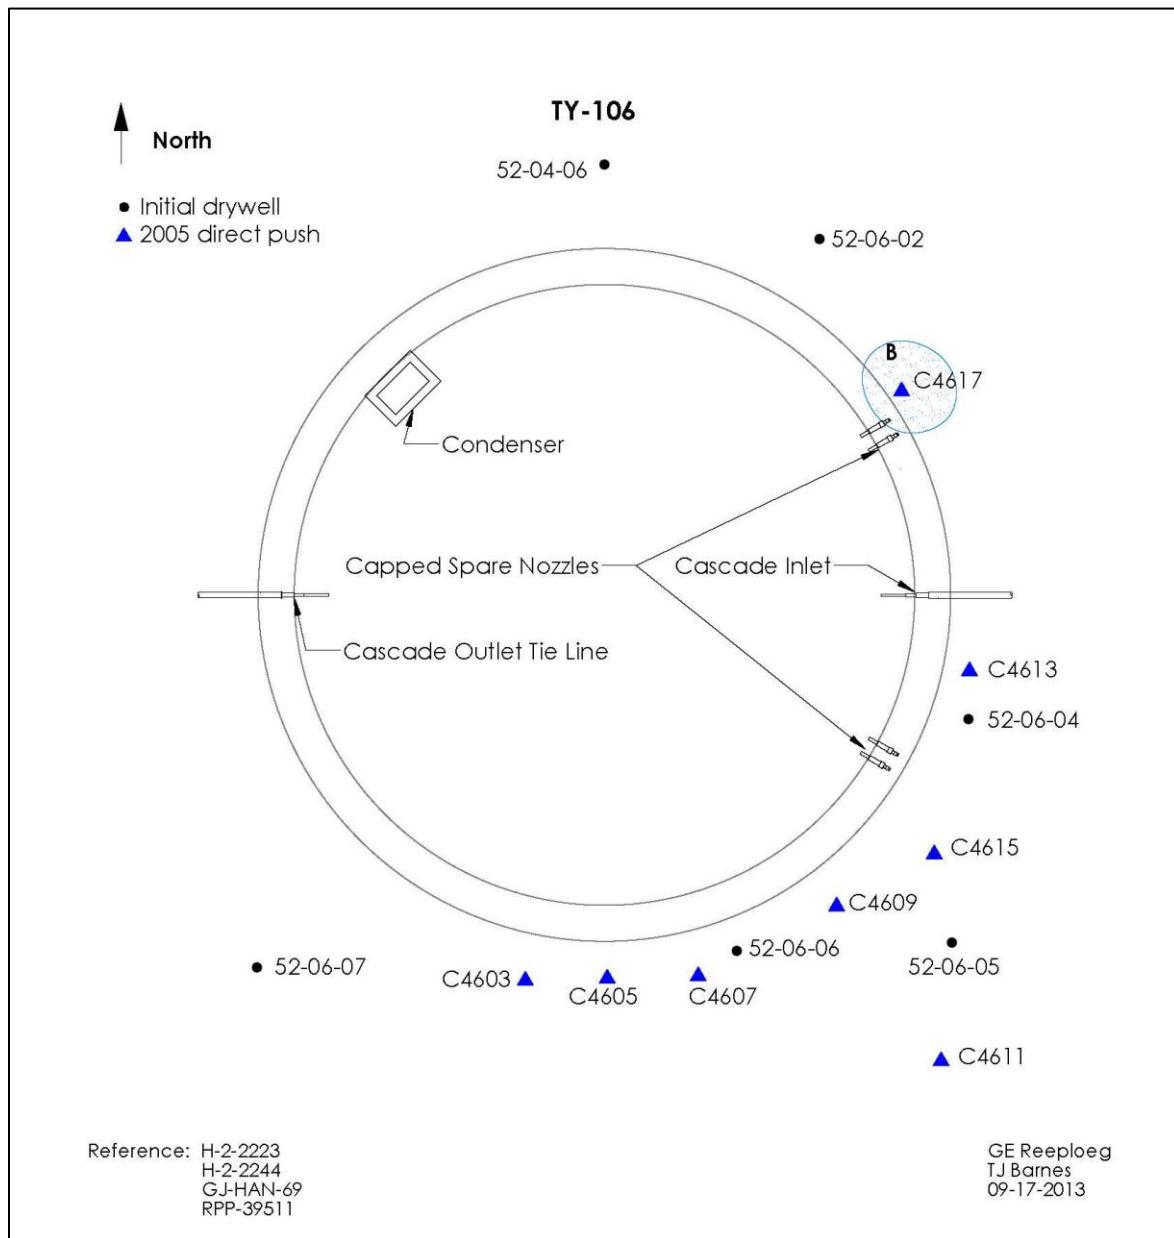
Figure 8-13. Tank TY-106 Possible Leak Location (2005)
Tank inner ring is steel liner, outer ring is outer edge of tank footing

In 2005 direct push C4617, located in the northeastern portion of tank TY-106 was constructed. Radioactivity was reported in direct push C4617 to be 58 pCi/g at 44-ft BGS. It is possible this is a separate leak location from sites A and C as no radioactivity was detected in the nearby drywells or direct pushes (see Figure 8-13).

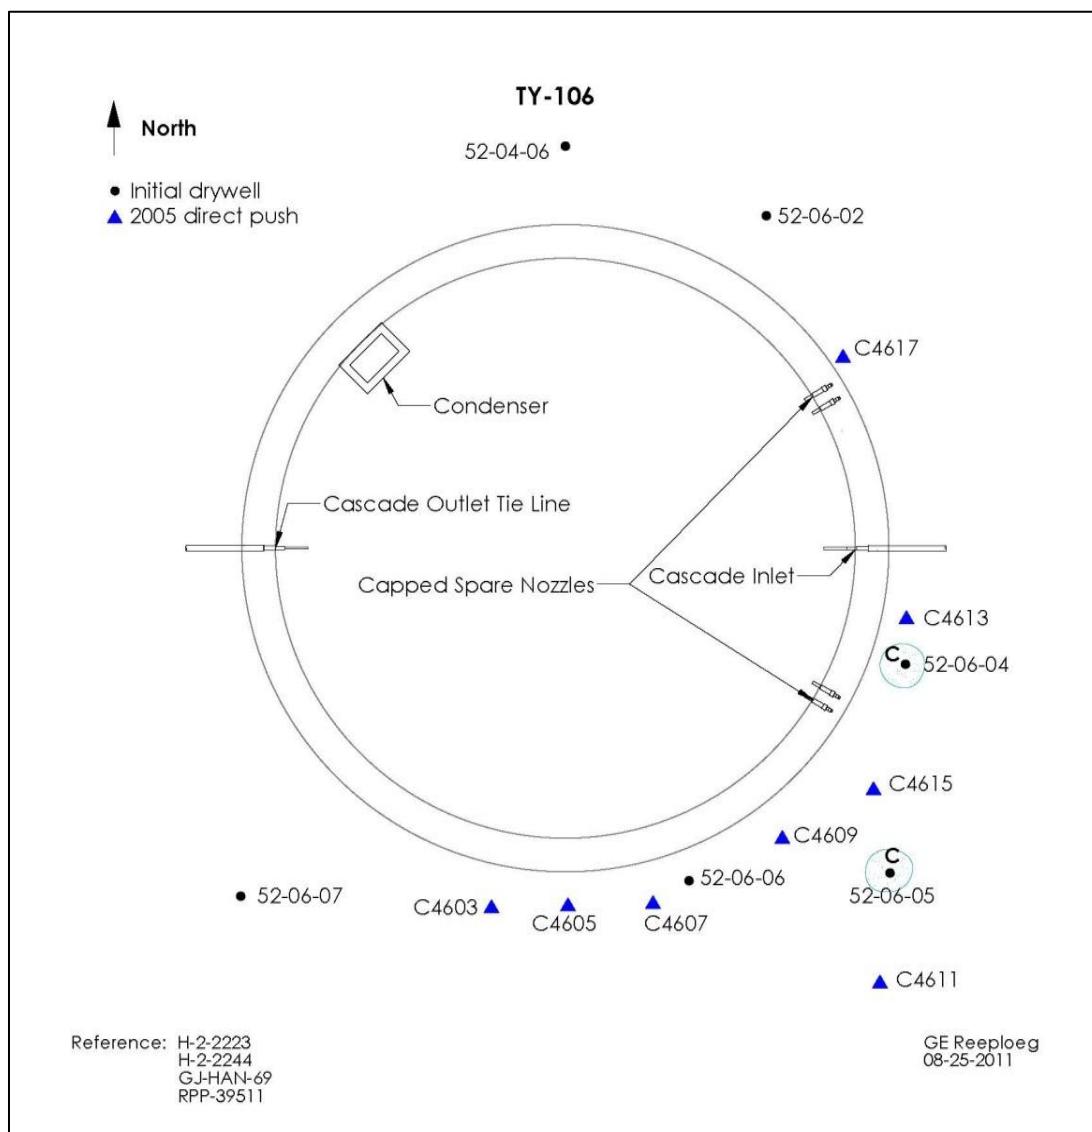
Figure 8-14. Tank TY-106 Possible Leak Location (1973-1974)
Tank inner ring is steel liner, outer ring is outer edge of tank footing

The first recoverable data reported radioactivity in drywells 52-06-04 and 52-06-05 between 52-ft and 62-ft BGS in 1973-1974, approximately 14 years after tank TY-106 was first suspected of leaking (see Site C in Figure 8-14). It appears radioactivity detected in these two drywells are from the tank TY-105 leak since the 2005 direct pushes located near these drywells do not report any radioactivity associated with a tank leak. However, there is a possibility that radioactivity detected in these drywells could be due to a leak from tank TY-106 and/or a combination of the tank TY-105 and TY-106 leaks. It is likely this is a separate leak location from sites A and B as no radioactivity was detected in the nearby drywells or direct pushes.

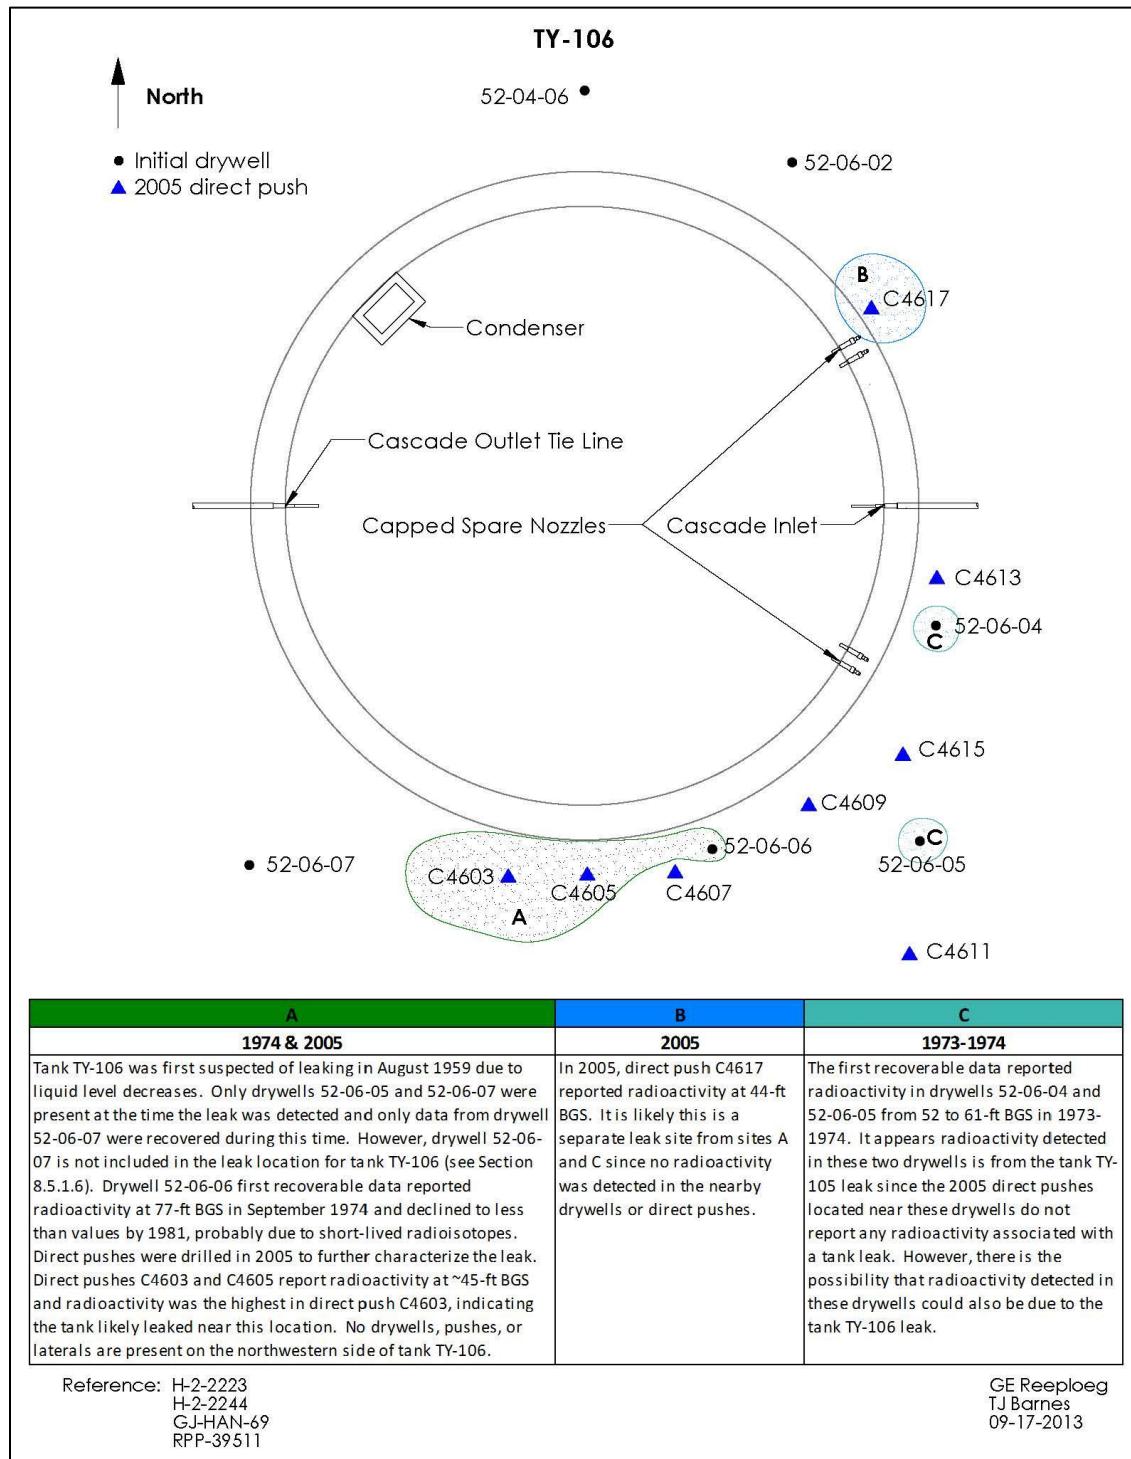
Figure 8-15. Tank TY-106 Possible Radial Leak Locations
 Tank inner ring is steel liner, outer ring is outer edge of tank footing

Tank TY-106 was first suspected of leaking due to liquid level decreases in August 1959. The first leak site was determined from 1974 drywell 52-06-06 and 2005 direct pushes C4603 and C4605 which reported radioactivity at or near the tank footing as shown in Site A (see Figure 8-15). It appears the leak site is located near direct push C4603 as radioactivity levels were the highest in 2005.

High levels of radioactivity were detected in direct push C4617 in 2005 as shown in site B (see Figure 8-15). Site B appears to be a separate leak site from sites A and C, as the nearby drywells and direct pushes do not detect any radioactivity associated with a tank leak.

Radioactivity was detected in drywells 52-06-04 and 52-06-05 at a lower BGS level in 1973-1974 as shown in site C (see Figure 8-15). It appears radioactivity detected in these drywells are the result of the tank TY-105 leak; however, it is possible radioactivity in these drywells could be the result of the tank TY-106 leak and/or a combination of the two leaks.

Leak locations in Figure 8-15 are based on peak readings and are a representation of possible initial boundaries of radioactivity.

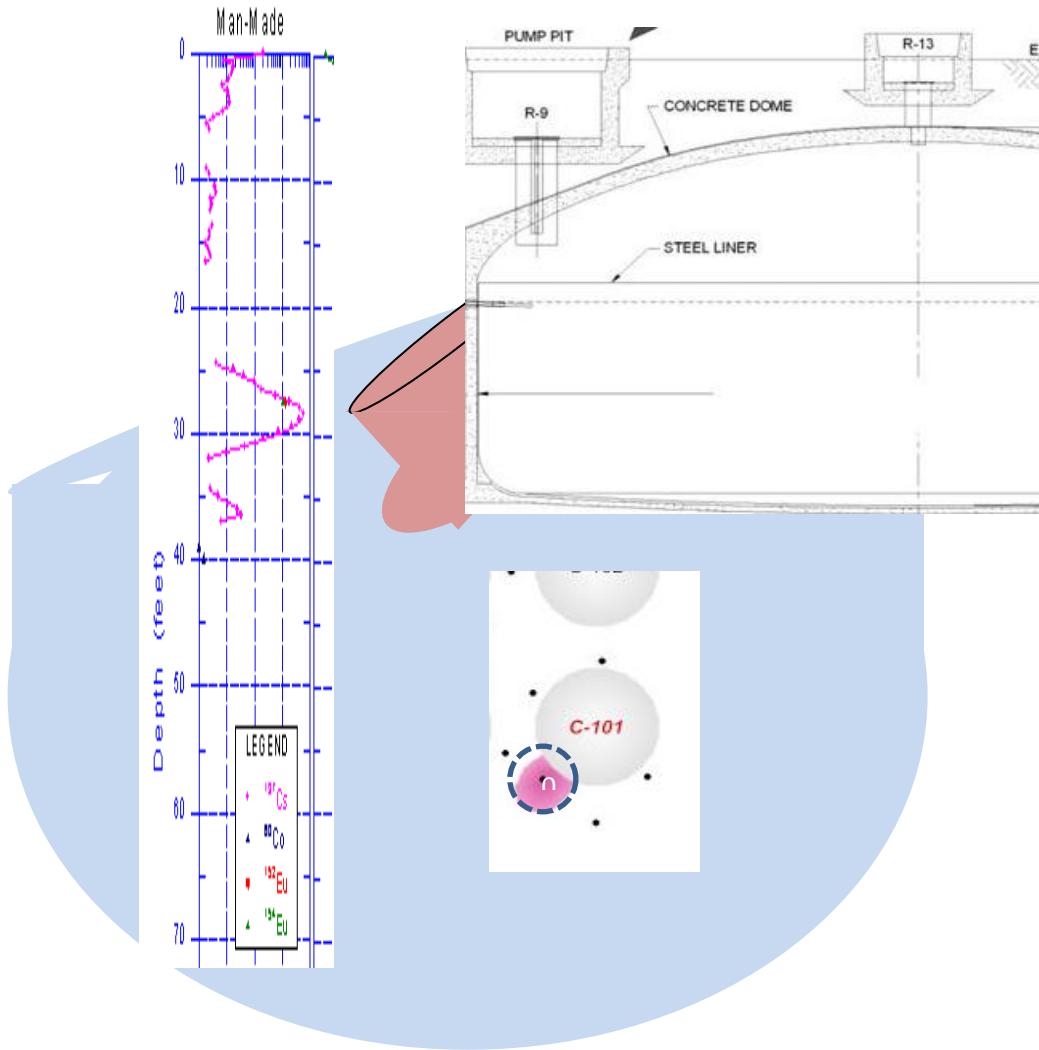
Figure 1. Tank 241-C-101 Conceptual Diagram of Postulated Cesium and Moisture Plume

Before receiving CWP1 waste, tank C-101 received PUREX waste (P1) that has a much higher cesium concentration than PUREX cladding waste. Ratioing the CWP1 supernate ^{137}Cs waste composition with the P1 supernate ^{137}Cs waste composition results in a means to estimate the mass (concentration) of the other prominent waste constituents contained in the estimated waste release. Table 1 displays the estimated waste inventory for the prominent tank C-101 waste release via the spare inlet. Figure 1 shows the assumed configuration of the release; inventory calculations are further described in RPP-ENV-33418. Based on an estimated release of 37,000 gal and assuming a 5% increase in moisture content within the wetted volume of the plume as a result of the release, the release may have spread over a soil volume of ~100,000 ft³(37,000 gal/0.05/ 7.48 gal/ft³), essentially the size of the tank itself.

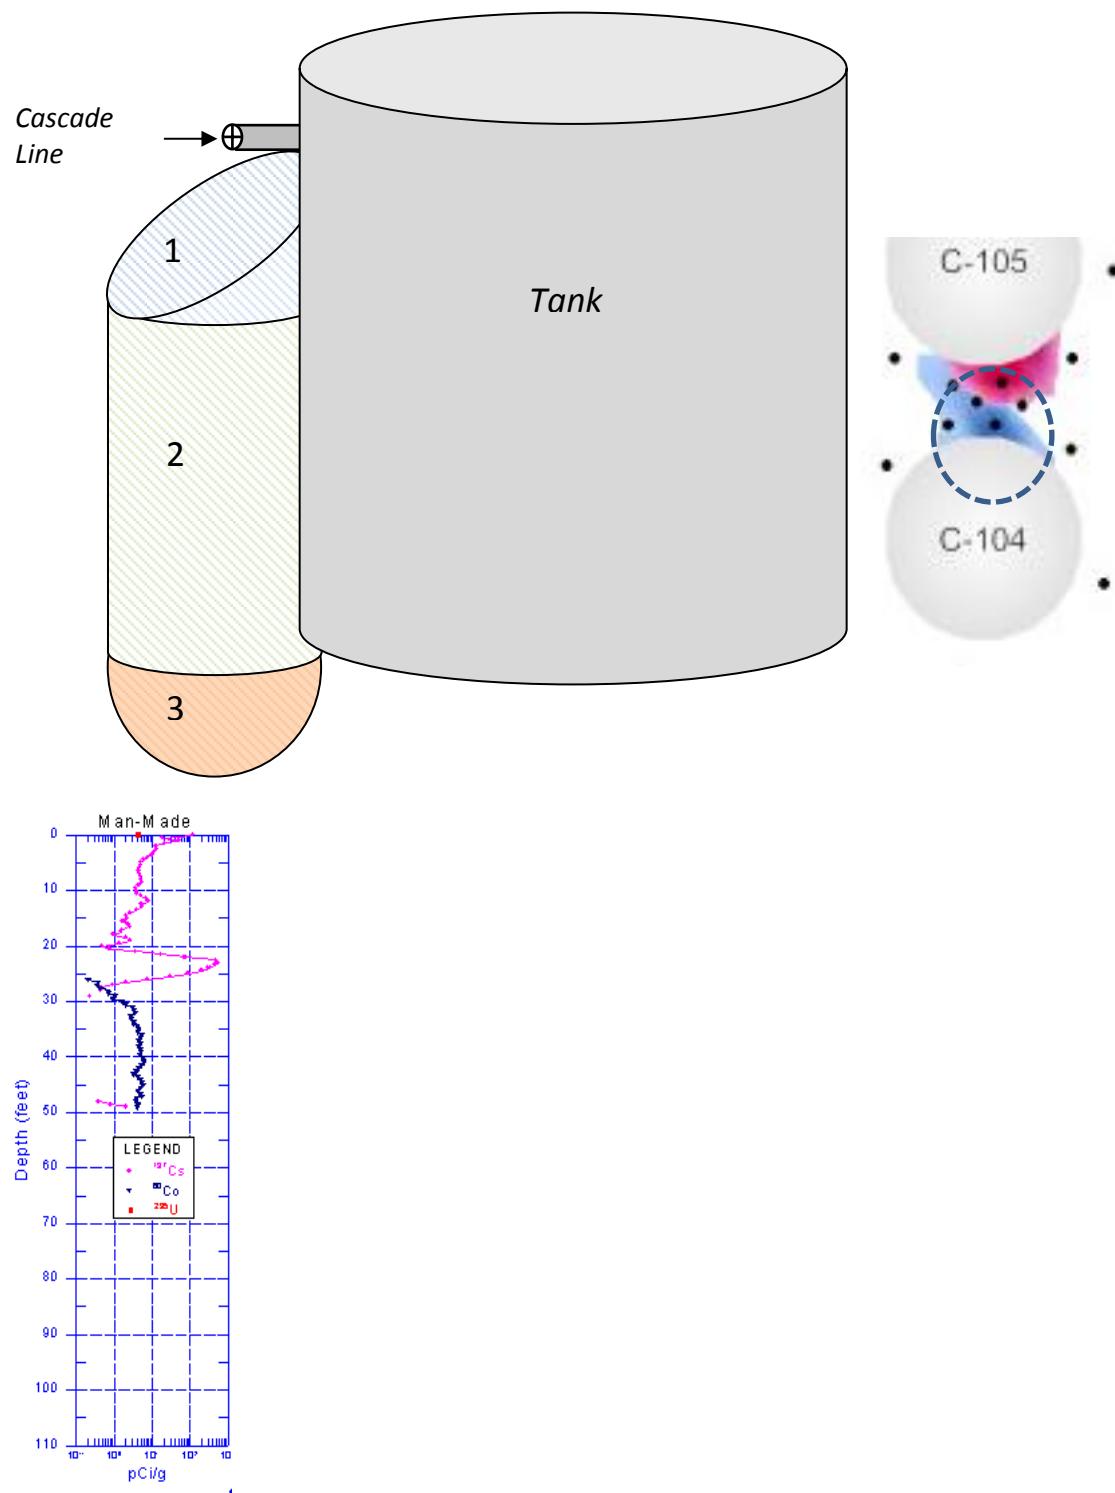
Figure 2: C-104 Conceptual Waste Plume Visualizations & Drywell Logging Data

For comparison purposes, if an assumed plume volume was described as an increase in the water (wetted) content from a “background” of ~4% to 9% (a 5% increase) would account for approximately 23,000 gallons (see calculations for a modeled Co plume in Table 2). Assuming the waste released was CWP1 the mass of ^{137}Cs was estimated to be slightly over 60 curies at 23,000 gallons and 80 curies for a 28,000 gallon release. This mass could easily be masked next to the tank at the soil cesium saturation concentration of ~1E7 pCi/g. Using CWP1 waste composition would also result in a ~28,000 gallons release; and ~1.3 Ci ^{60}Co at the time of the release. It was assumed that the ^{60}Co plume extended past the measured depth in the drywell to 80 feet; thereby resulting in a release that could have been ~28,000 gallons. Figure 2 shows the conceptual plume configurations and drywell data.
