# Hanford Single-Shell Tank Leak Causes and Locations - 241-U Farm

C.L. Girardot, D.G. Harlow

**Key Words:** leak location, leak cause, tank, integrity assessment, U Farm, U-104, U-110, U-112, leak assessment

**Abstract:** This document identifies 241-U Tank Farm (U Farm) leak causes and locations for the 100 series leaking tanks (241-U-104, 241-U-110, and 241-U-112) identified in RPP-RPT-50097, Rev. 0, Hanford 241-U Farm Leak Inventory Assessment Report. This document satisfies the U Farm portion of the target (T04) in the Hanford Federal Facility Agreement and Consent Order milestone M-045-91F.

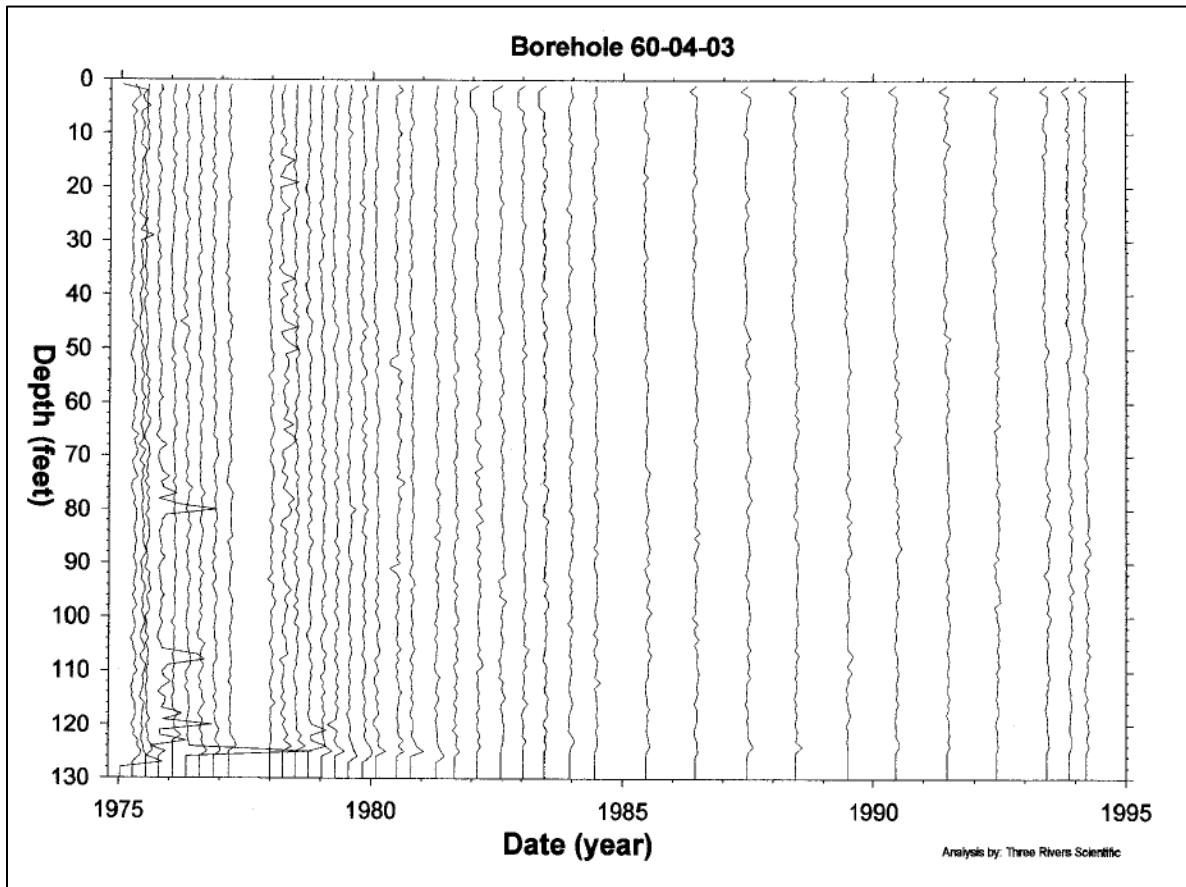
**Figure 4-6. Tank U-104 Drywell 60-04-03 (RPP-7729)**

Since historical radioactivity in this drywell is very low, and GJ-HAN-33 reported low levels of radioactivity, drywell 60-04-03 is not being included as part of the leak location for tank U-104. Figure 4-6 shows the depths of radioactivity from 1975 to 1995 (RPP-7729, *Analysis & Summary Report of Historical Drywell Gamma Logs for 241-U Tank Farm - 200 West*).

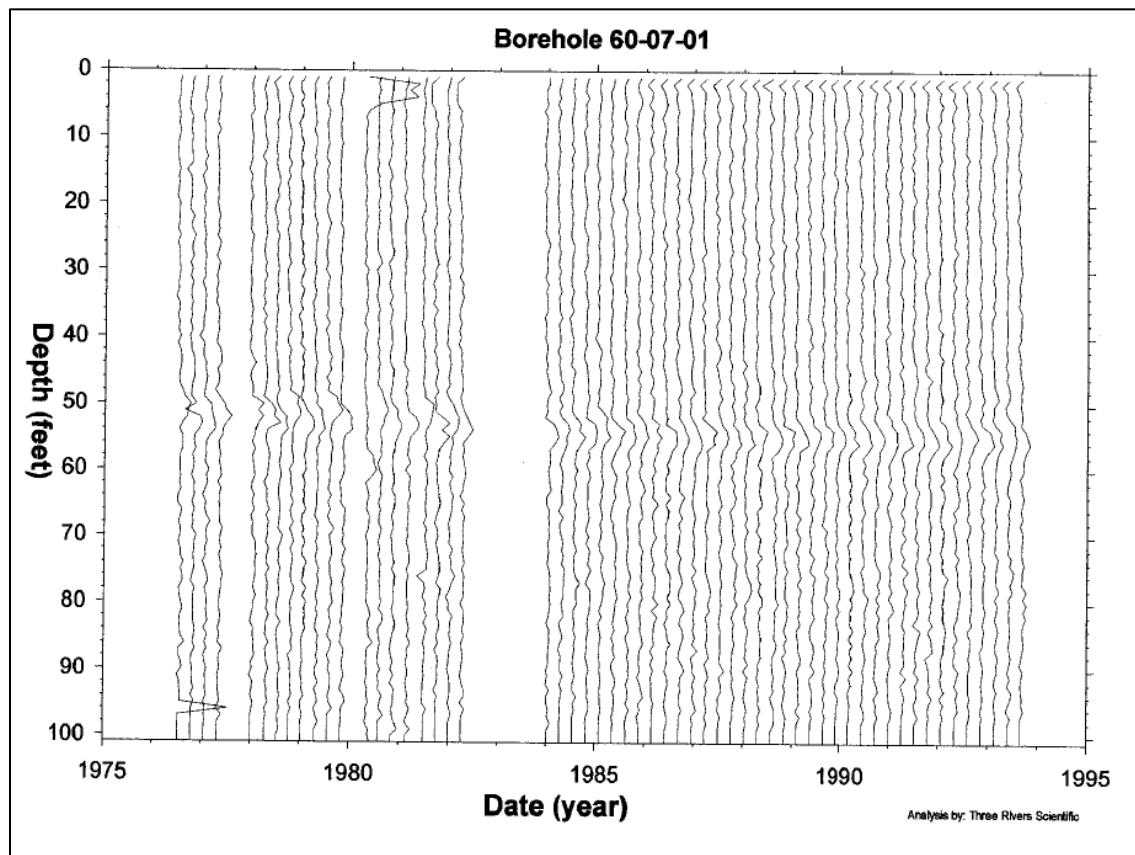
**Figure 4-7. Tank U-104 Drywell 60-07-01 (RPP-7729)**

Processed U-235 was detected continuously from 52 to 57-ft BGS, 73 to 77-ft BGS, intermittently between these two zones, and slightly below the lower zone. The maximum concentration of 9 pCi/g was measured at a depth of 55-ft BGS, 17-ft below the base of the tank. Processed U-238 was measured between 52 and 56-ft BGS at concentrations ranging between 100 and 200 pCi/g. Document GJ-HAN-33 states, "The processed U-235 and U-238 contamination most likely resulted from leakage from tank U-104." Figure 4-7 shows the depths of radioactivity from 1975 to 1995 (RPP-7729).

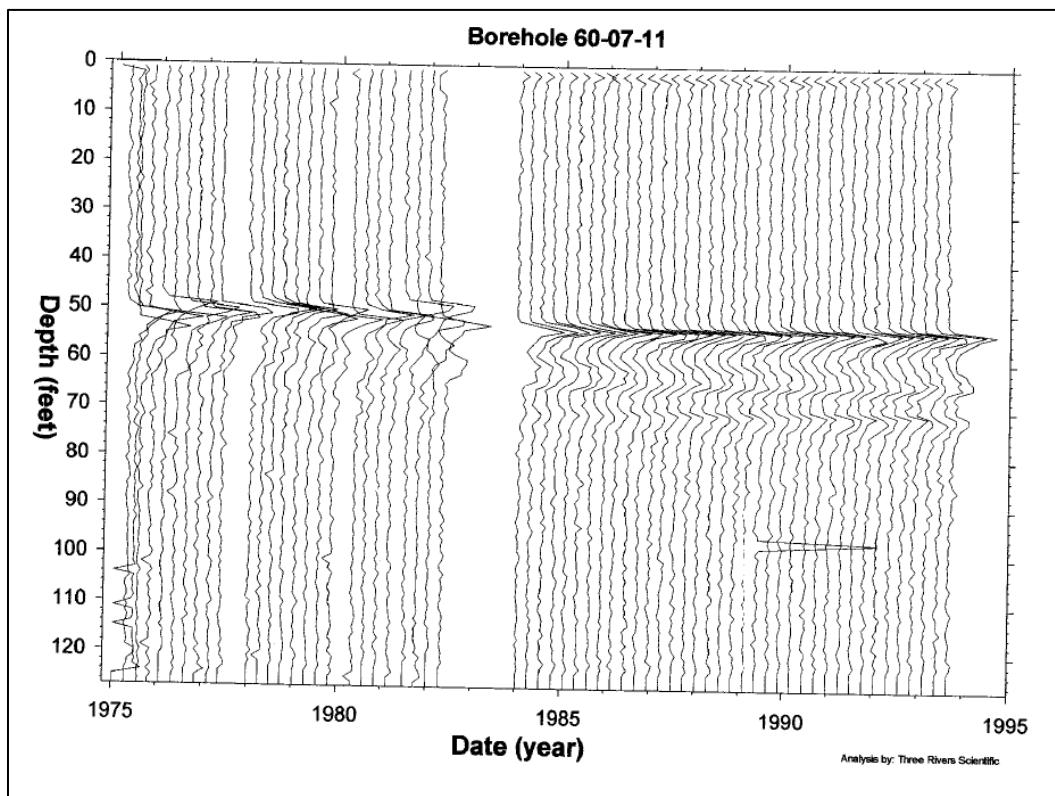
**Figure 4-8. Tank U-104 Drywell 60-07-11 (RPP-7729)**

Processed U-238 was detected at depths from 52 to 69-ft, from 70 to 82-ft, and from 83 to 93-ft BGS. The maximum U-238 concentration of more than 1,000 pCi/g was measured at 53-ft BGS. Document GJ-HAN-33 reported, "The processed U-235 and U-238 contamination most likely resulted from leakage from tank U-104." Figure 4-8 shows the depths of radioactivity from 1975 to 1995 (RPP-7729).

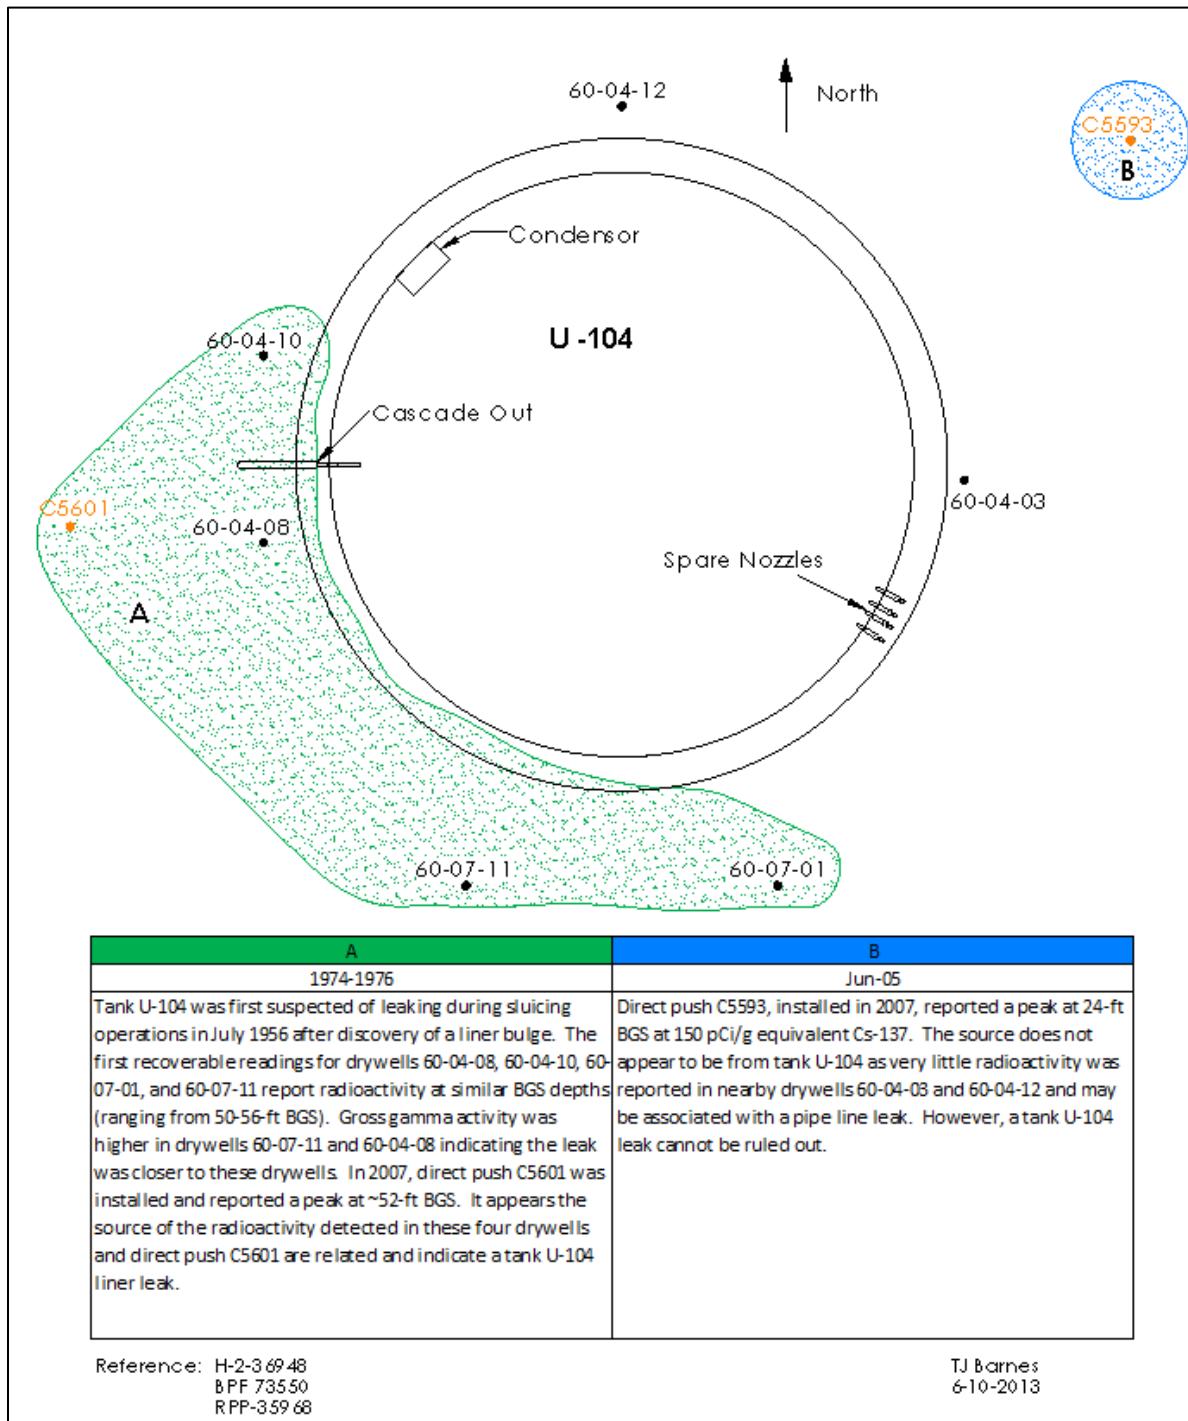
**Figure 4-14. Tank U-104 Possible Radial Leak Locations**  
 Tank inner ring is steel liner, outer ring is outer edge of tank footing

The first recoverable readings in 1974-1976 for drywells 60-04-08, 60-04-10, 60-07-01, and 60-07-11 indicate radioactivity at a depth ranging from 50-56-ft BGS. Gross gamma activity was higher in drywells 60-07-11 and 60-04-08 indicating the leak was closer to these drywells. Direct push C5601, installed in 2007, reports radioactivity at a similar depth (52-ft BGS). The peak uranium detected in these drywells starting at approximately the 50-ft BGS level is roughly 12-ft lower than the bottom of the tank footing indicating some sort of transport mechanism during the 18-yr period when the leak was first suspected to the first drywell data. It appears the source of the radioactivity detected in these four drywells and direct push C5601 are related and indicate a tank U-104 leak in the southwestern portion of the tank (see site A in Figure 4-14).

Direct push C5593, installed in 2007, reports maximum radioactivity (150 pCi/g equivalent Cs-137) detected at 24-ft BGS (see site B in Figure 4-14). The source may be associated with a pipeline leak as it does not appear to be from tank U-104 since very little radioactivity was reported in nearby drywells 60-04-03 and 60-04-12. The source of this radioactivity is unknown, therefore a tank U-104 leak source cannot be ruled out.

Leak locations in Figure 4-14 are based on peak readings and are a representation of possible initial boundaries of radioactivity.

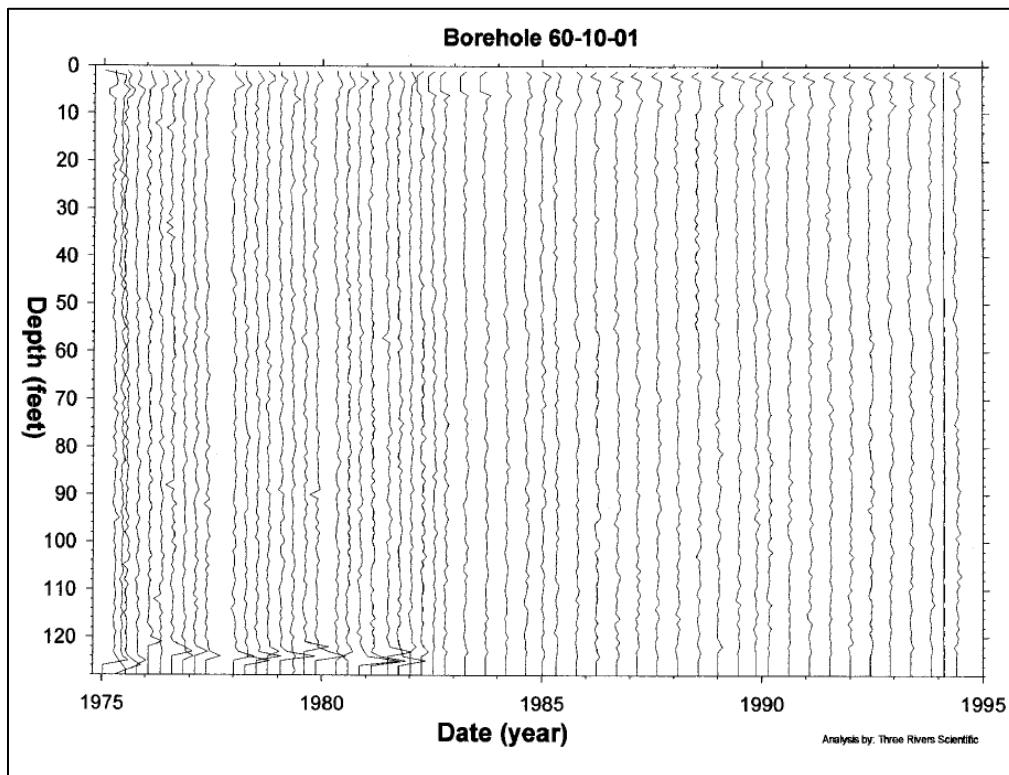
**Figure 5-5. Tank U-110 Drywell 60-10-01 (RPP-7729)**

Since historical radioactivity in this drywell is very low, and the GJ-HAN-39 report indicated low levels of radioactivity below the surface level, drywell 60-10-01 is not being included as part of the leak location for tank U-110. Figure 5-5 shows the depths of radioactivity from 1975 to 1995 (RPP-7729).

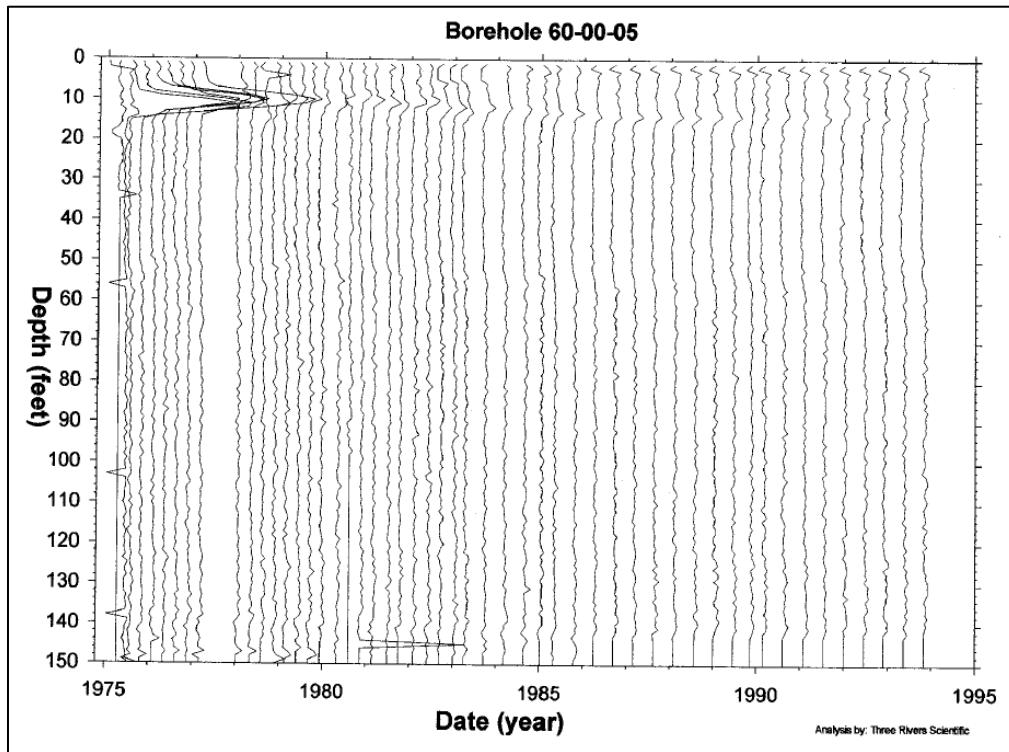
**Figure 5-7. Tank U-110 Drywell 60-00-05 (RPP-7729)**

Since historical radioactivity in this drywell is very low, and the GJ-HAN-39 report indicated low levels of radioactivity below the surface level, drywell 60-00-05 is not being included as part of the leak location for tank U-110. Figure 5-7 shows the depths of radioactivity from 1975 to 1995 (RPP-7729).

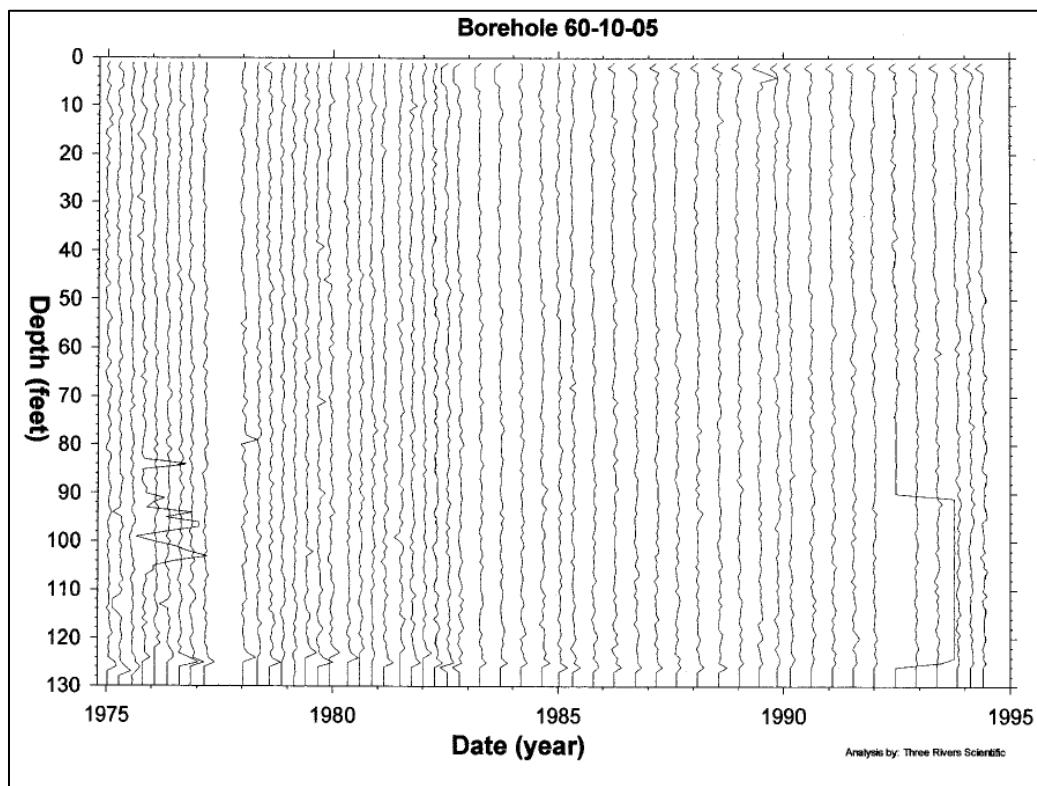
**Figure 5-8. Tank U-110 Drywell 60-10-05 (RPP-7729)**

Historical radioactivity in this drywell is very low, and the GJ-HAN-39 report indicated low levels of radioactivity, drywell 60-10-05 is therefore not being included as part of the leak location for tank U-110. Figure 5-8 shows the depths of radioactivity from 1975 to 1995 (RPP-7729).

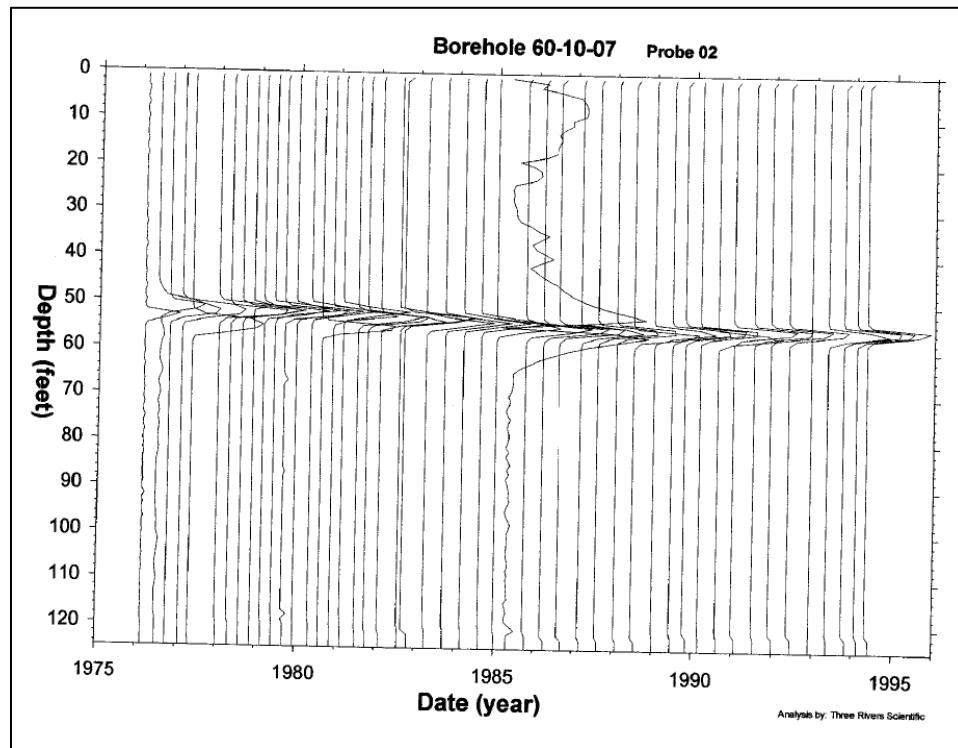
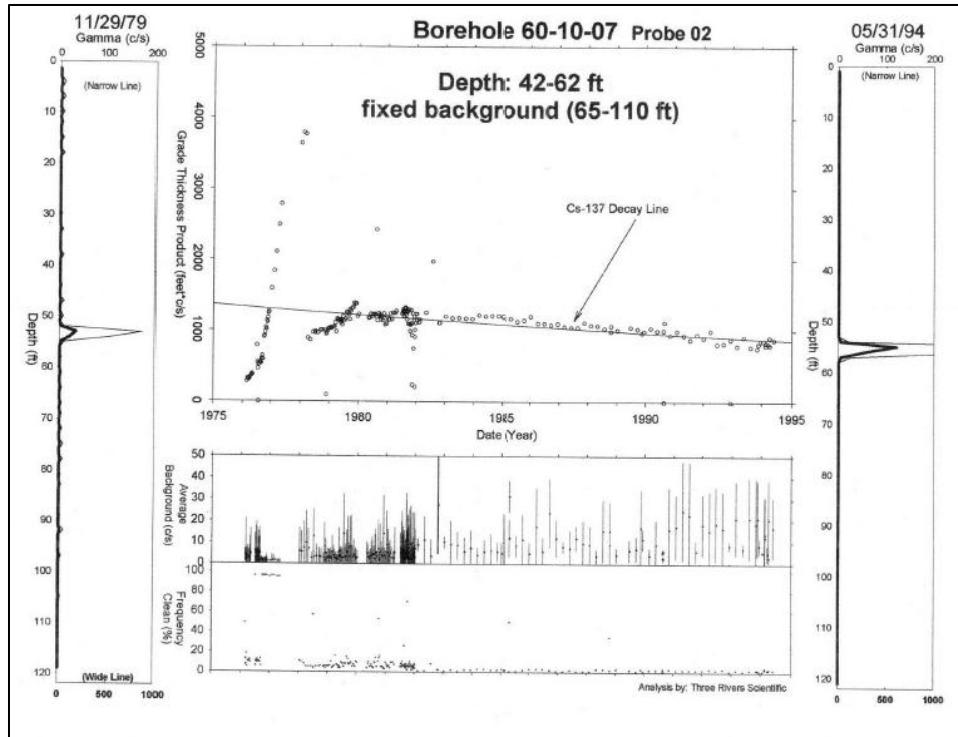
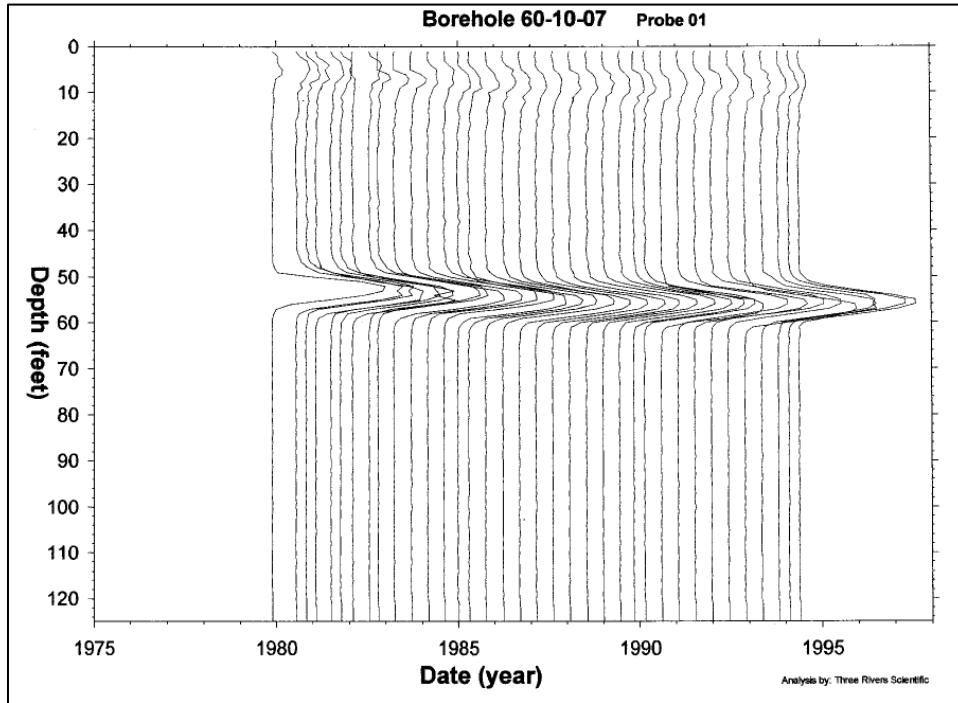
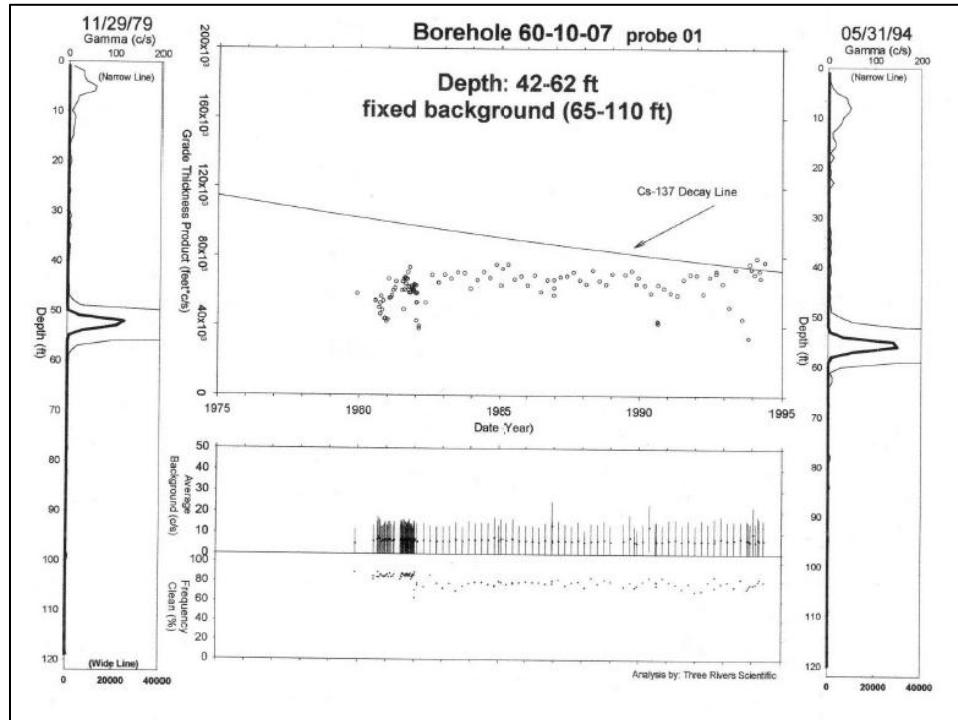
Drywell 60-10-07 was examined with the Green-GM probe (01), Red-GM probe (02), and the NaI probe (04) to monitor the large Cs-137 gamma variations in this drywell (see Figure 5-9, Figure 5-10, and Figure 5-12). The NaI probe is the most sensitive and was able to obtain data until about 1980 when the probe became saturated with high levels of radioactivity, making the data unreliable. The NaI probe shows the early influx of radioactivity. There is some conflict in the variability of the grade thickness product, used to eliminate variable sampling effects for a given zone, between the Green-GM probe, Figure 5-13, and the less sensitive Red probe, Figure 5-11. However, both the Green-GM probe and the Red probe indicate radioactivity Cs-137 below 50-ft BGS.

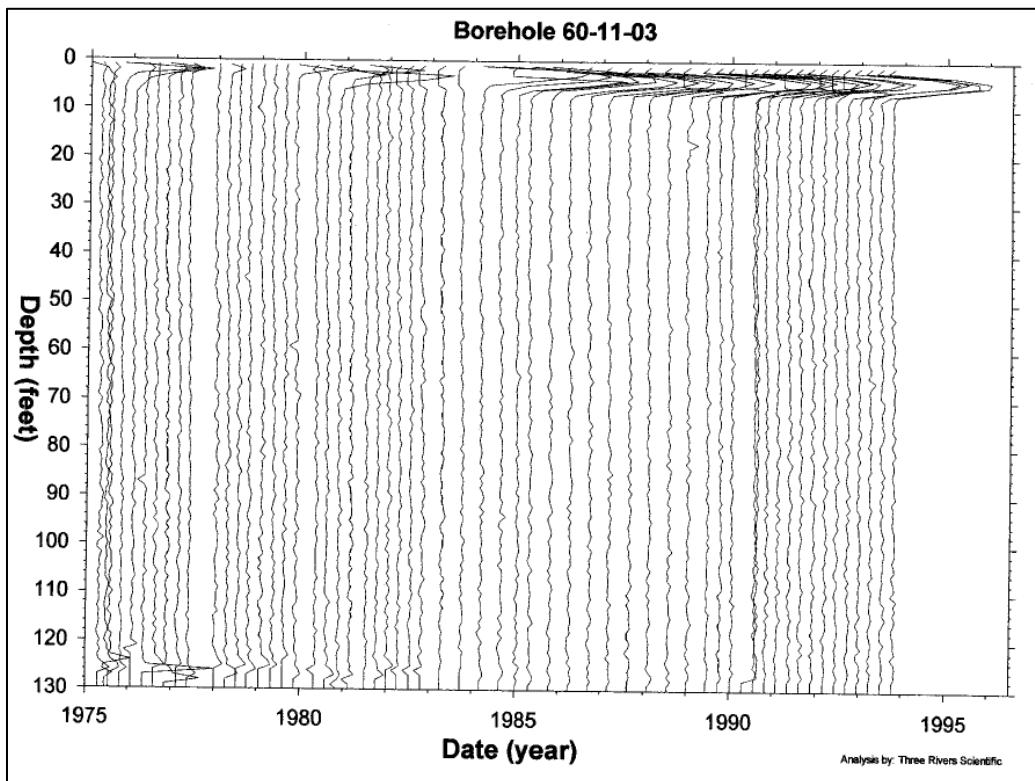
**Figure 5-14. Tank U-110 Drywell 60-11-03 (RPP-7729)**

Since historical radioactivity in this drywell is very low, and the GJ-HAN-39 report indicated low levels of radioactivity below the surface level, drywell 60-11-03 is not being included as part of the leak location for tank U-110. Figure 5-14 shows the depths of radioactivity from 1975 to 1995 (RPP-7729).

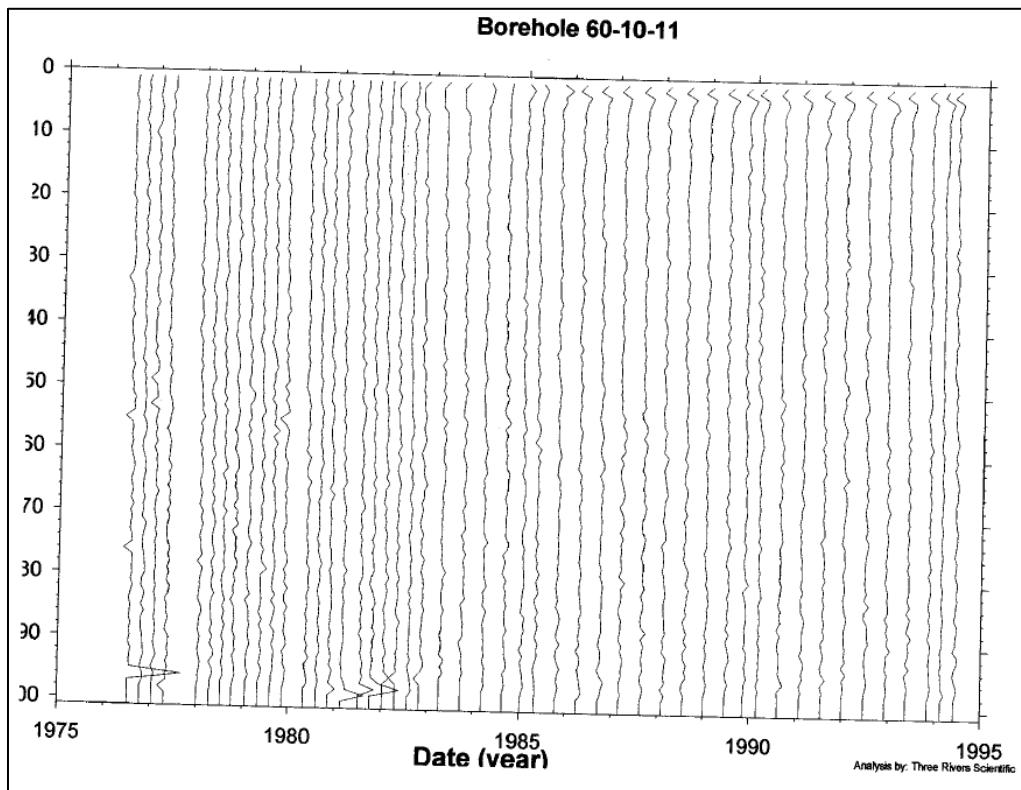
**Figure 5-15. Tank U-110 Drywell 60-10-11 (RPP-7729)**

Since historical radioactivity in this drywell is very low, and the GJ-HAN-39 report indicated low levels of radioactivity below the surface level, drywell 60-10-11 is not being included as part of the leak location for tank U-110. Figure 5-15 shows the depths of radioactivity from 1975 to 1995 (RPP-7729).

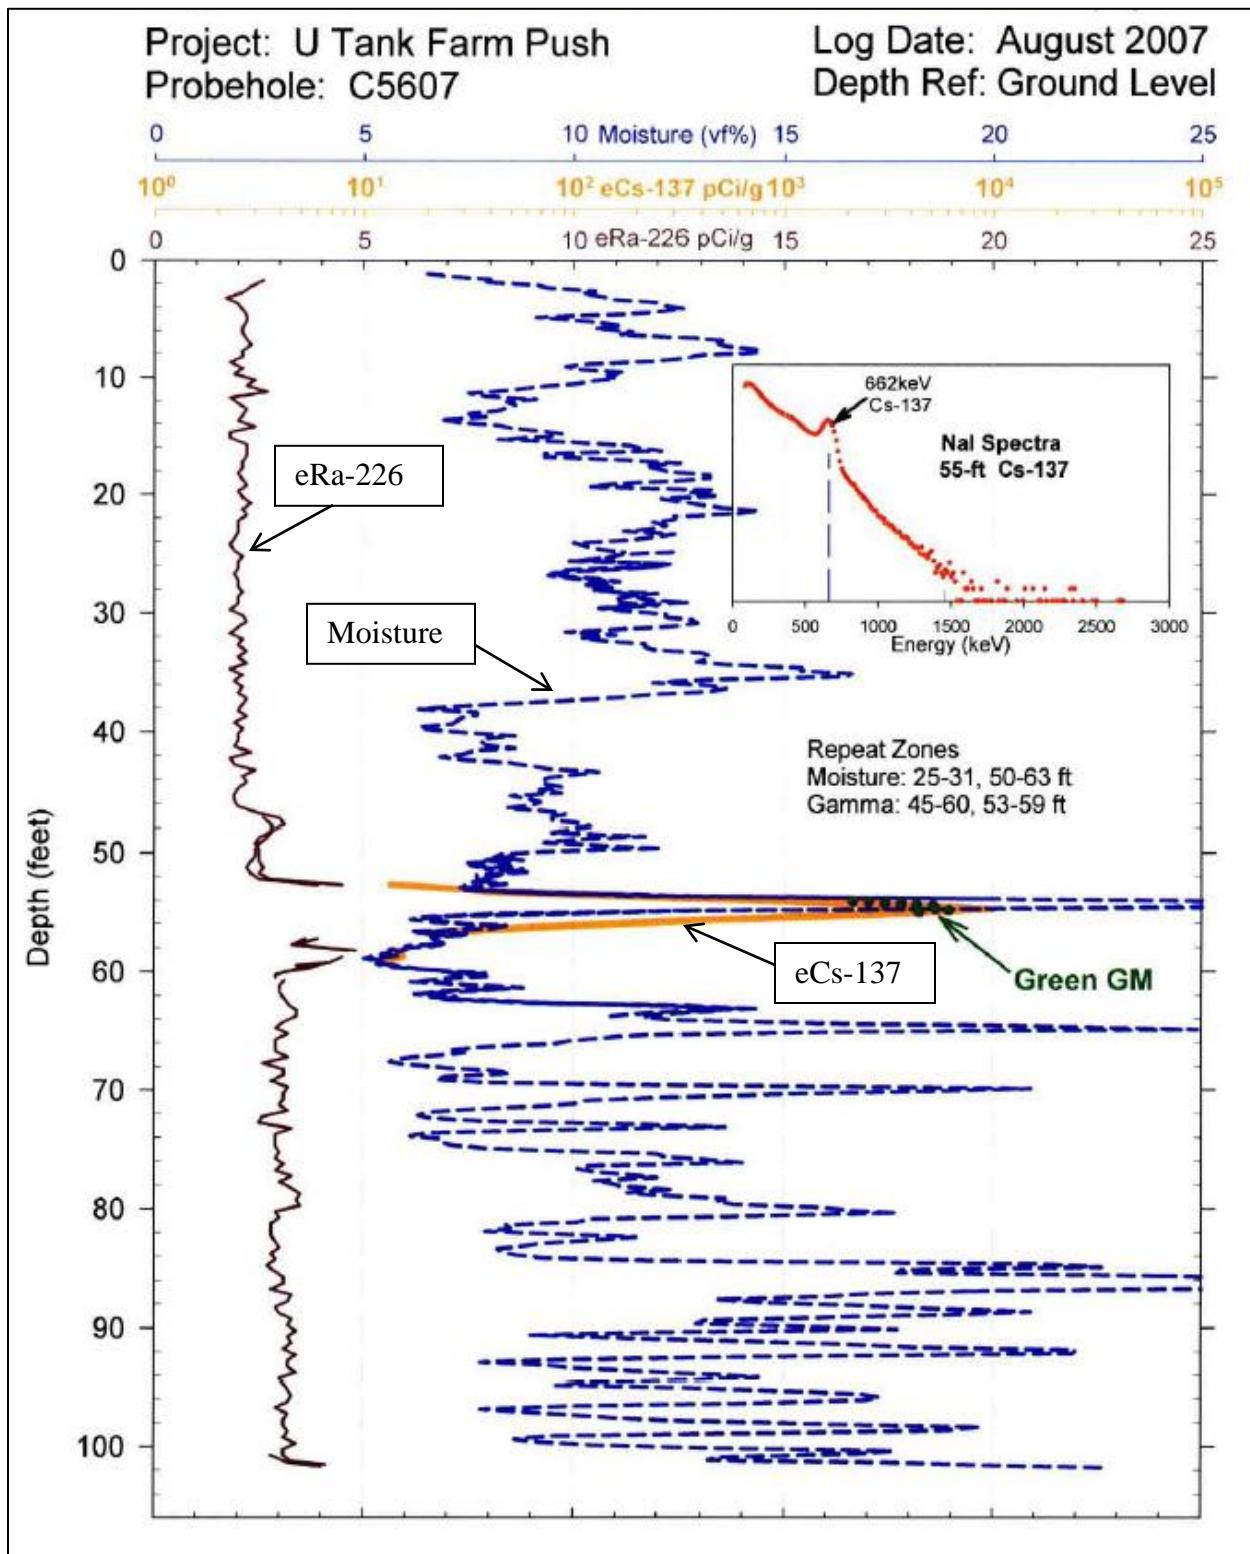
Figure 5-16. Gamma and Moisture Log for C5607 (RPP-36007)

In 2007, one direct push (C5607) was installed near tank U-110 for spectral gamma logging (see Figure 5-16). The C5607 direct push, located about 14-ft from drywell 60-10-07, was logged for moisture and gamma properties (RPP-36007). A peak Cs-137 activity of 9,950 pCi/g was found at about the same 55-ft BGS depth as drywell 60-10-07.

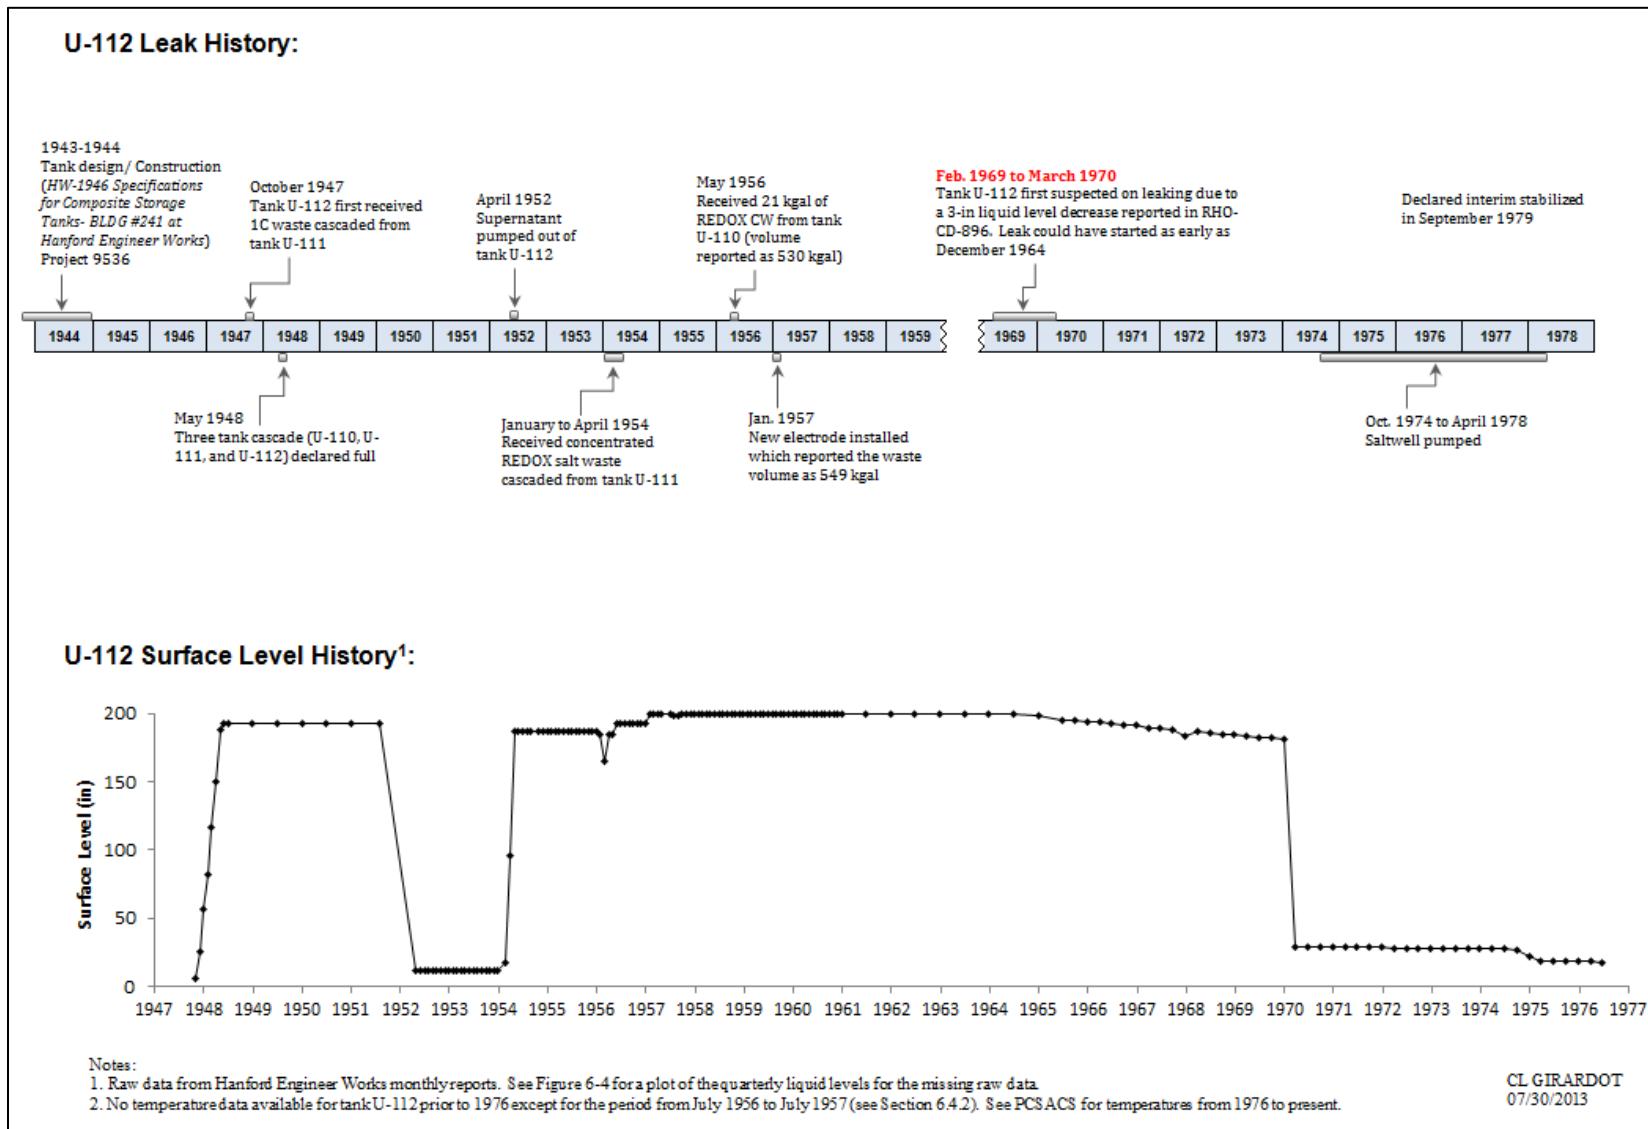
Figure 6-2. Operational Leak History of Tank U-112

Tank U-112 was first suspected of leaking based on a 3-in liquid level decrease between February 1969 and March 1970 and classified as a “questionable integrity” tank (RHO-CD-896). Tank U-112 was pumped to a minimum heel of 24.5-in and removed from service in March 1970.

The operational history of tank U-112 leak related details including liquid level is charted in Figure 6-2.

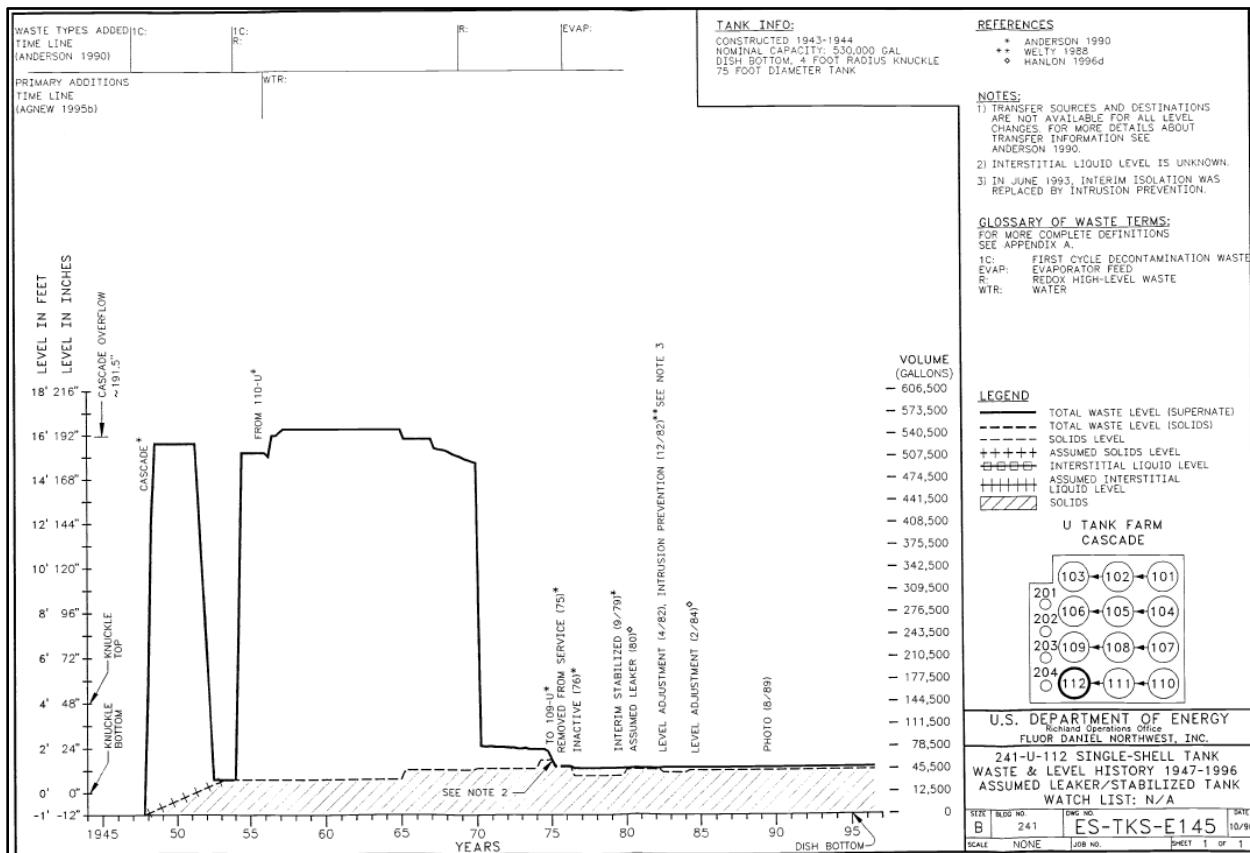
Figure 6-3. Tank U-112 End of Quarter Surface Level

The liquid level plot in Figure 6-3 indicates the transfer activity into and out of tank U-112. The liquid levels are end of quarter levels so this figure may not reflect all transfers into and out of the tank that occurred during the operational history. See Figure 6-2 for historical monthly liquid level readings.

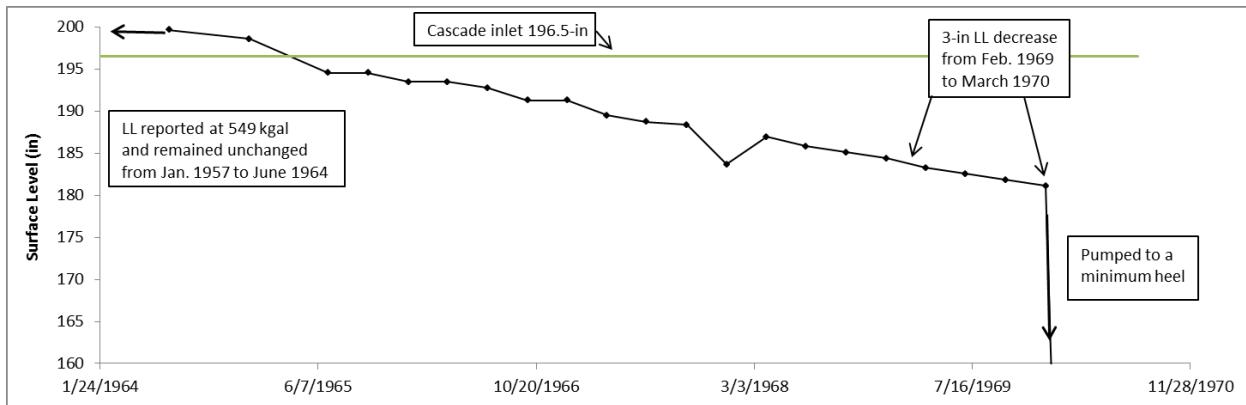
**Figure 6-4. Tank U-112 Liquid Level June 1964 through March 1970**

Tank U-112 was first suspected of leaking based on a 3-in liquid level decrease from 179-in in February 1969 to 176-in in March 1970 (RPP-CD-896). However, after reviewing historic liquid level data for tank U-112, it appears the leak could have started as early as December 1964 as the liquid level was declining in this earlier period (see Figure 6-4). It is not clear why RHO-CD-896 selected February 1969 through March 1970 for the leak determination when monthly data taken from December 1964 through March 1970 indicates the liquid level was decreasing much earlier.

Before June 30, 1965 the liquid level was reported to be above 196.5-in, the location of the cascade inlet line penetration. Since the liquid level was above this location and near the time when the liquid level started to decrease, it is possible there was a small leak from the cascade inlet line. However, since the liquid level continued to decrease below the location of the cascade inlet penetration then this likely indicated a tank liner leak. A sidewall leak seems

unlikely as peak radioactivity detected in drywell 60-12-01 was reported at approximately 50-ft BGS (see Section 6.5.1.1). It appears the leak is greater than the 8.5 kgal reported in RHO-CD-896 and could be as large as 47 kgal.

Response: Figure 6-4 shows the liquid level above the cascade inlet with the liquid level decreasing. However, the liquid level continued to decrease after reaching the cascade inlet which indicated a leak. Section 6.4.2 indicated that the U-110 liquid level slowly decreased (probably as a result of the waste temperature and evaporation). However, the third tank in the cascade, tank U-112 did not experience a decreasing liquid level e.g. lower temperature and less or no evaporation. How much of a temperature effect the 21 kgal of CW had on the 514 kgal of cascaded REDOX waste in tank U-112 is speculative without detailed temperature data, however, two months after receiving the 21 kgal of CW, sludge temperatures range between 70°F and 60°F. Therefore, the temperature of the REDOX waste in tank U-112 must have been relatively low at least compared to tank U-110. Therefore, a projected average temperature was indicated as near 100°F (see Sections 6.4.1 and 6.4.2).

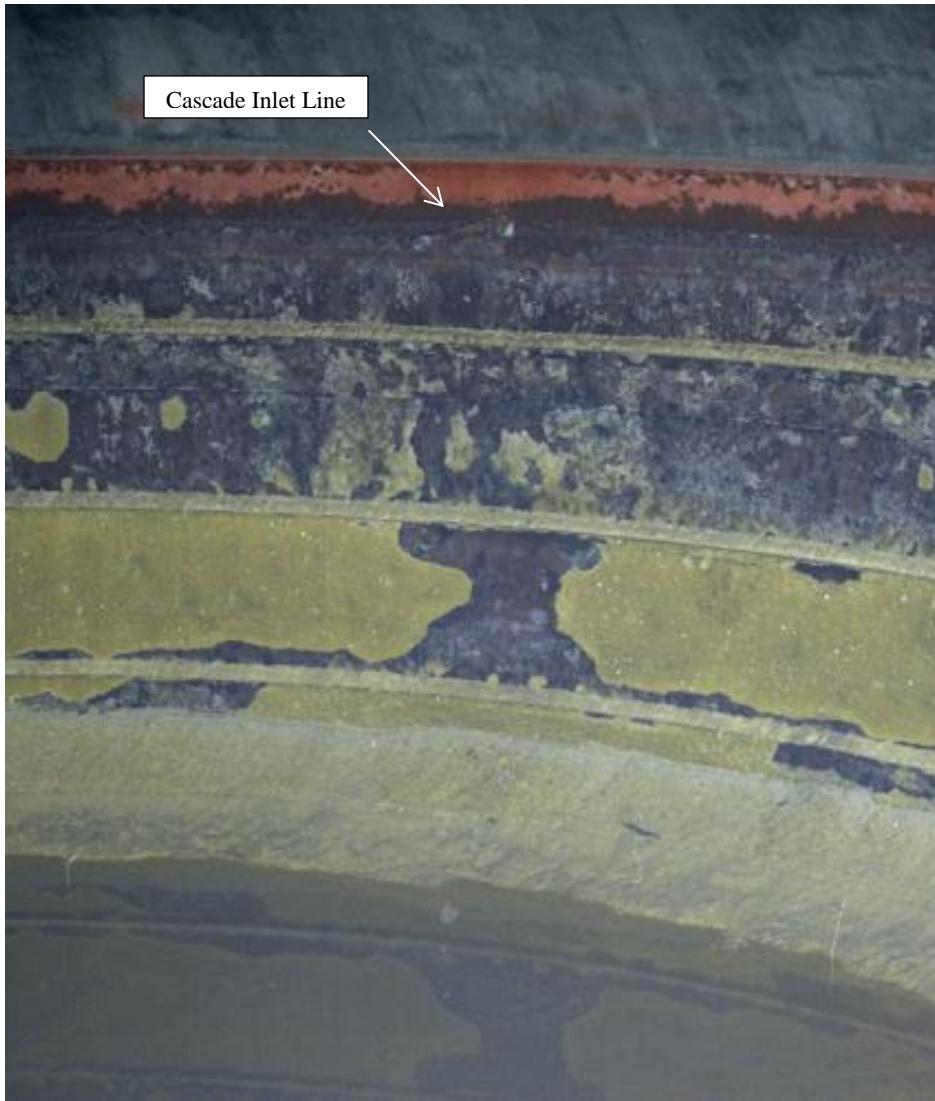
**Figure 6-5. Tank U-112 Photograph, June 5, 1975  
(753800-1CN)**

The earliest photographs recovered for tank U-112 were dated June 5, 1975. The photograph in Figure 6-5 shows the cascade inlet line and what may be an indistinct beach line above the cascade inlet line that may be a sign the tank was overfilled.

13. Pg. 6-5, para 5. 549 kgal would be about 19 kgal above the listed capacity for this tank and definitely an overfill which is supported by the “beach line” in Fig. 6-5. That raises the question of how reliable earlier LL were, given that this “new level” was found after replacing an electrode.

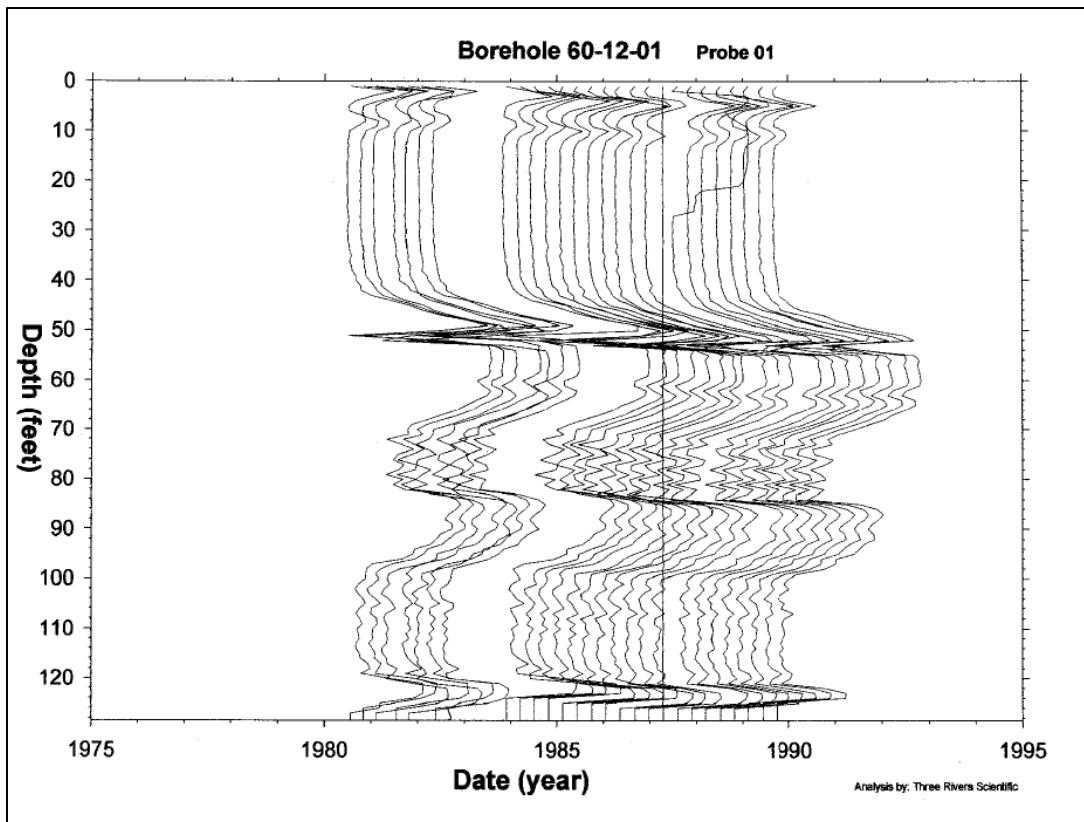
**Figure 6-9. Tank U-112 Drywell 60-12-01 (RPP-7729)**

In September 1996, significant Cs-137 contamination was detected in this drywell and contamination occurs continuously from the ground surface to the bottom (GJ-HAN-41, *Vadose Zone Characterization Project at the Hanford Tank Farms Tank Summary Data Report for Tank U-112*). From the ground surface to 3.5-ft BGS, between 50 and 68-ft and between 84 and 98-ft BGS, Cs-137 concentrations exceeded 2,000 pCi/g. Between 17 and 50-ft BGS, Cs-137 concentrations ranged from 1 to 9 pCi/g. Document GJ-HAN-41 reports, “The Cs-137 contamination encountered in the three depth intervals below the 50-ft depth probably resulted from a leak from tank U-112. The three separate contaminant plumes may have migrated from a single subsurface leak site to intersect the borehole.” Figure 6-9 shows the depths of radioactivity from 1980 to 1989 with the Green probe (01) (RPP-7729).

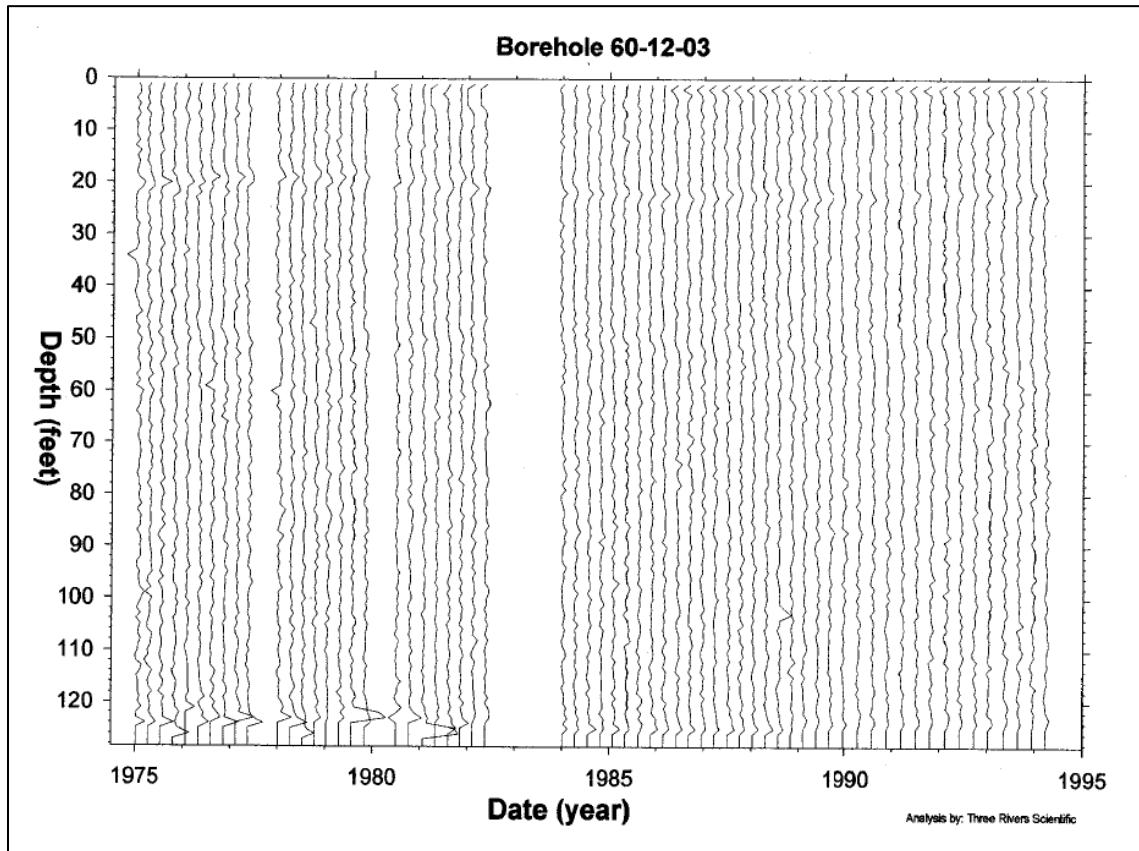
**Figure 6-10. Tank U-112 Drywell 60-12-03 (RPP-7729)**

Drywell 60-12-03 is located approximately 9.2-ft from the east side of tank U-112. Drywell 60-12-03 was drilled in June 1973 with the first recoverable reading on September 21, 1973 reported as less than values (see Appendix A3). Radioactivity continued to be reported as less than values through October 1986.

Since historical radioactivity in this drywell is very low, and the GJ-HAN-41 report indicated low levels of radioactivity, drywell 60-12-03 is not being included as part of the leak location for tank U-112. Figure 6-10 shows the depths of radioactivity from 1975 to 1995 (RPP-7729).
