# Hanford Single-Shell Tank Leak Causes and Locations - 241-U Farm

C.L. Girardot, D.G. Harlow

**Key Words:** leak location, leak cause, tank, integrity assessment, U Farm, U-104, U-110, U-112, leak assessment

**Abstract:** This document identifies 241-U Tank Farm (U Farm) leak causes and locations for the 100 series leaking tanks (241-U-104, 241-U-110, and 241-U-112) identified in RPP-RPT-50097, Rev. 0, Hanford 241-U Farm Leak Inventory Assessment Report. This document satisfies the U Farm portion of the target (T04) in the Hanford Federal Facility Agreement and Consent Order milestone M-045-91F.

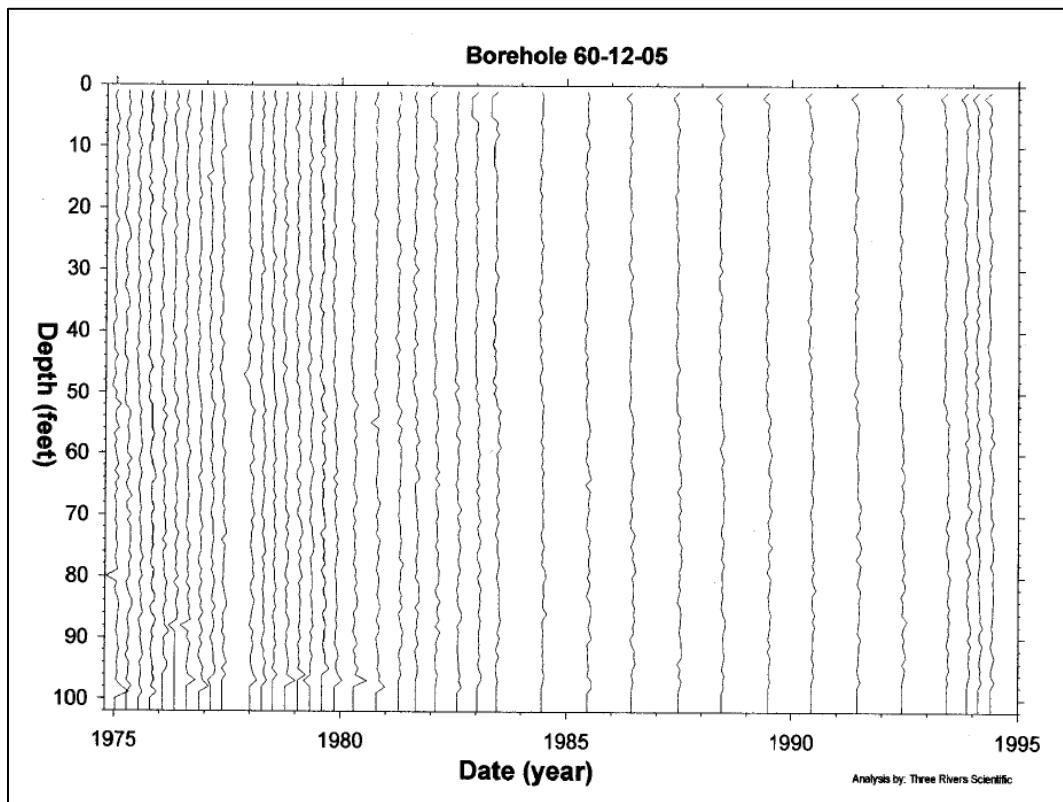
**Figure 6-11. Tank U-112 Drywell 60-12-05 (RPP-7729)**

Drywell 60-12-05 is located approximately 3.5-ft from the southeast side of tank U-112. Drywell 60-12-05 was drilled in June 1970 with the first recoverable readings reported on September 21, 1973 as less than values (see Appendix A3). Radioactivity continued to be reported as less than values through June 1986.

Since historical radioactivity in this drywell is very low, and the GJ-HAN-41 report indicated low levels of radioactivity, drywell 60-12-05 is not being included as part of the leak location for tank U-112. Figure 6-11 shows the depths of radioactivity from 1975 to 1995 (RPP-7729).

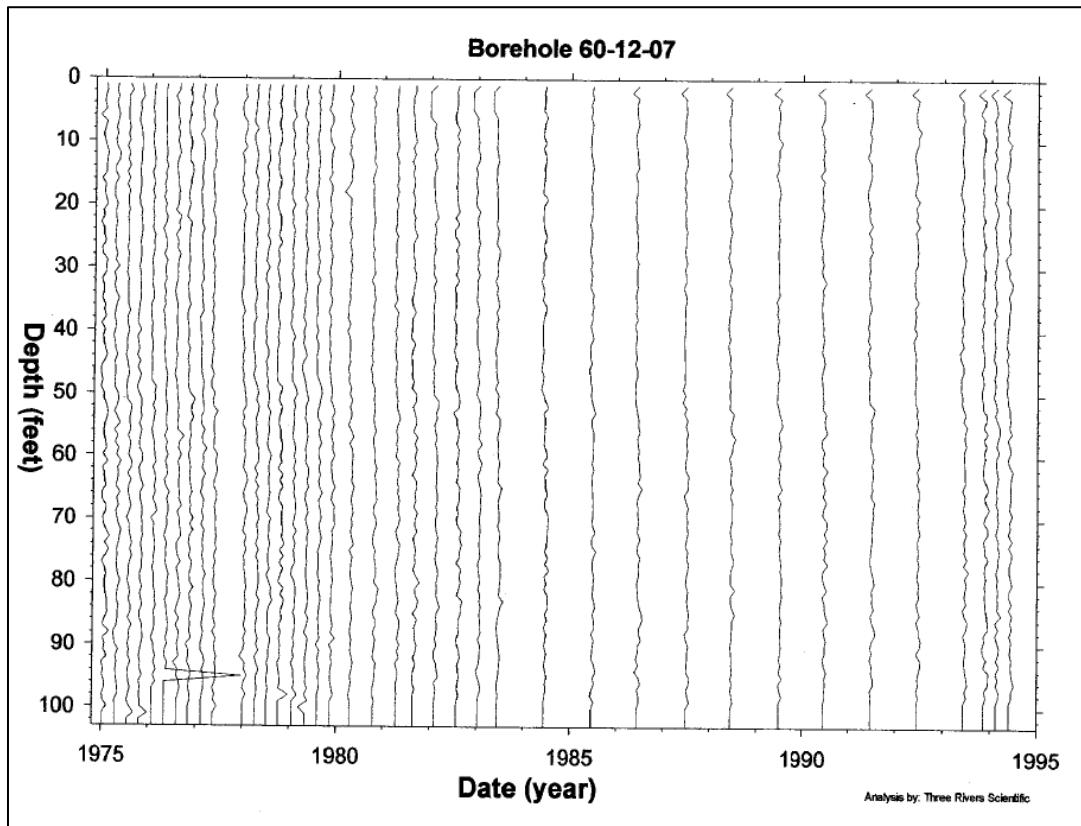
**Figure 6-12. Tank U-112 Drywell 60-12-07 (RPP-7729)**

Since historical radioactivity in this drywell is very low, and the GJ-HAN-41 report indicated low levels of radioactivity, drywell 60-12-07 is not being included as part of the leak location for tank U-112. Figure 6-12 shows the depths of radioactivity from 1975 to 1995 (RPP-7729).

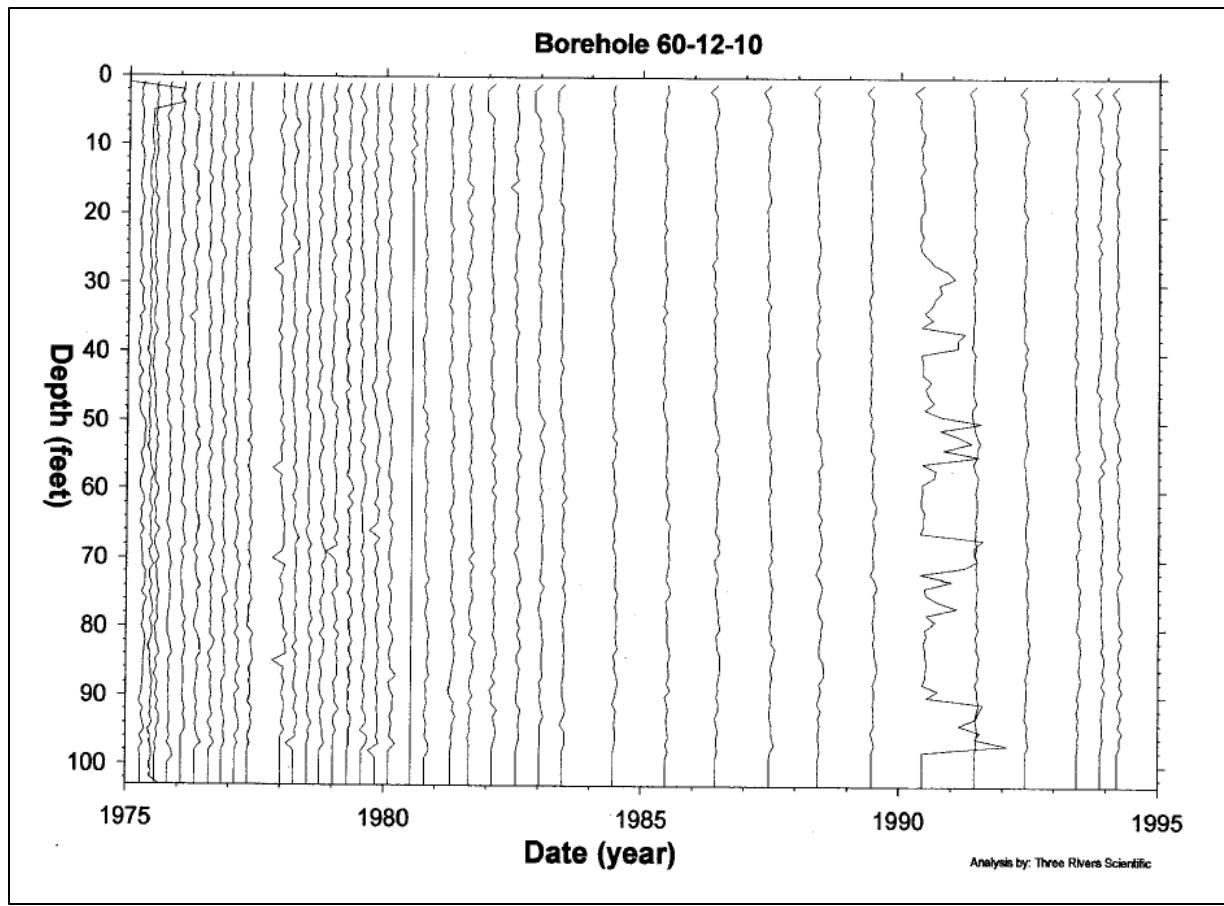
**Figure 6-13. Tank U-112 Drywell 60-12-10 (RPP-7729)**

Since historical radioactivity in this drywell is very low, and the GJ-HAN-41 report indicated low levels of radioactivity, drywell 60-12-10 is not being included as part of the leak location for tank U-112. Figure 6-13 shows the depths of radioactivity from 1975 to 1995 (RPP-7729).

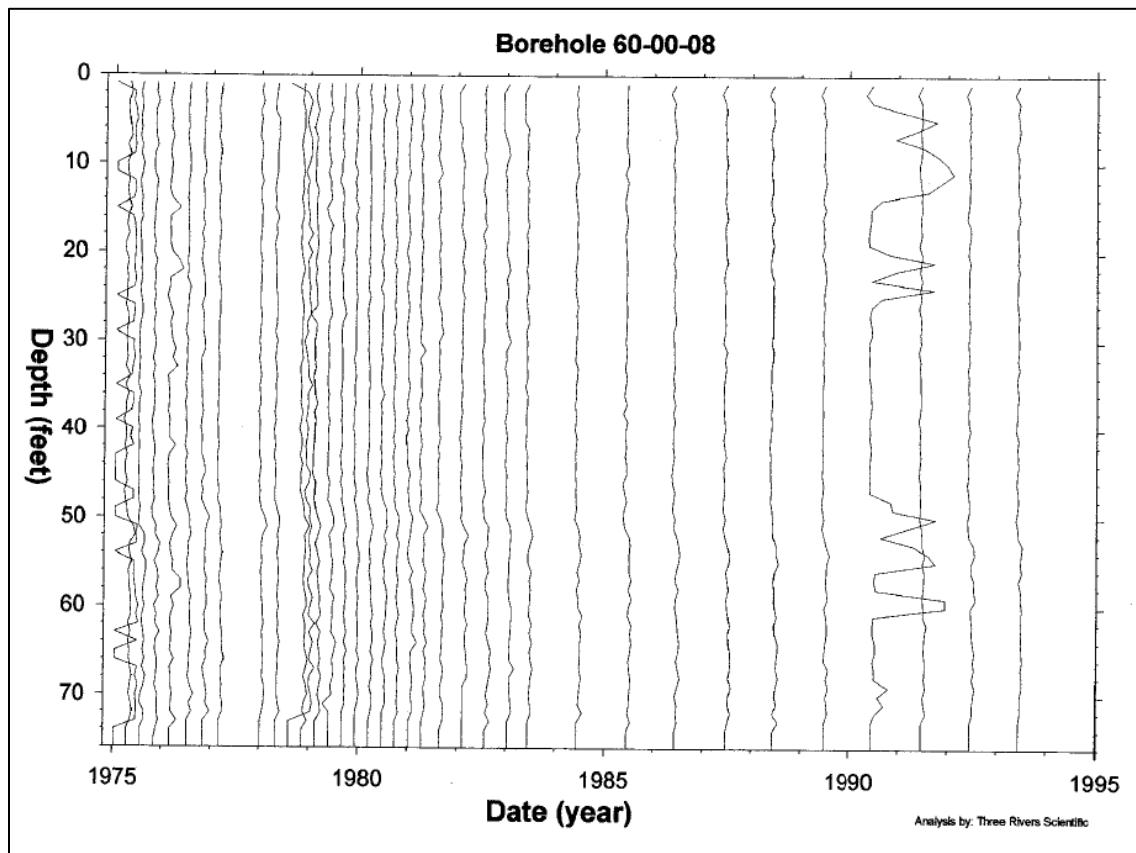
**Figure 6-14. Tank U-112 Drywell 60-00-08 (RPP-7729)**

Since historical radioactivity in this drywell is very low, and the GJ-HAN-41 report indicated low levels of radioactivity, drywell 60-00-08 is not being included as part of the leak location for tank U-112. Figure 6-14 shows the depths of radioactivity from 1975 to 1995 (RPP-7729).

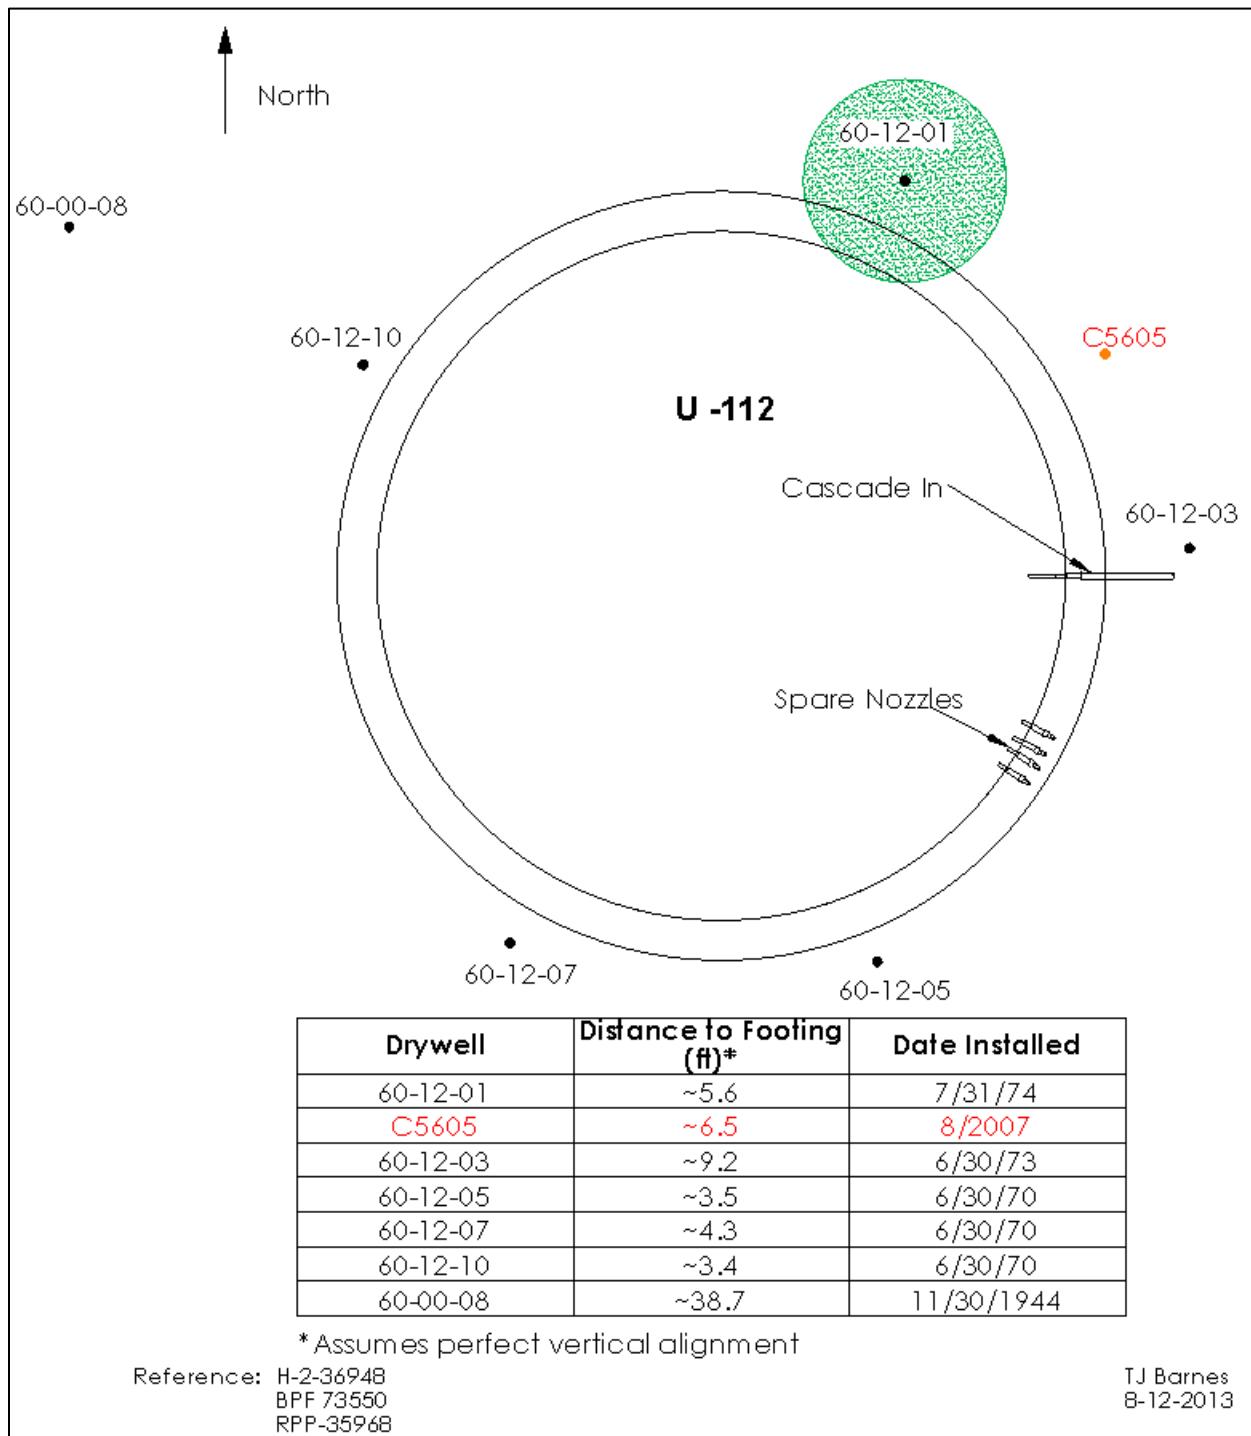
**Figure 6-15. Tank U-112 Possible Leak Location (1964)**  
 Tank inner ring is steel liner; outer ring is outer edge of tank footing

Tank U-112 had at least one liner leak site based on radioactivity detected in drywell 60-12-01, likely at or near the bottom of the tank. There is also a possibility of a small leak from the cascade inlet line which probably would not have been detected in any nearby drywells during this time.

Tank U-112 was first reported as leaking due to a 3-in liquid level drop between February 1969 and March 1970 (RHO-CD-896). However, it appears the tank U-112 leak could have started as early as December 1964 due to the liquid level decreasing from December 1964 until March 1970, when the tank was pumped down to minimum heel. The leak was detected in drywell 60-12-01 in the northeast portion of the tank when the drywell was drilled in 1974 (see Figure 6-15). No other drywells indicated a tank U-112 leak.

Liquid level evidence and drywell radioactivity indicate that the tank U-112 liner leaked in at least one location in the north north-east portion of the tank at or near the tank base.

There are several liner leak cause conditions that were examined and the one that probably caused the tank U-112 liner leak was chemistry-corrosion from pitting and SCC from the storage of REDOX and REDOX/CW waste. Tank U-112 may also have experienced deformation of the bottom liner during construction which may have resulted in stressing and weakening of the plates and welds.
