(6) Document Title: 241-AY-102 Leak Detection Pit Drain Line Inspection Report		(7) USQ No.: R- <input checked="" type="checkbox"/> N/A	USQ Evaluator Sign/Date

Document Number: RPP-RPT-56464, Rev 0

Purpose of Document: Report on visual inspection of 241-AY-102 Leak Detection Pit Drain Line.

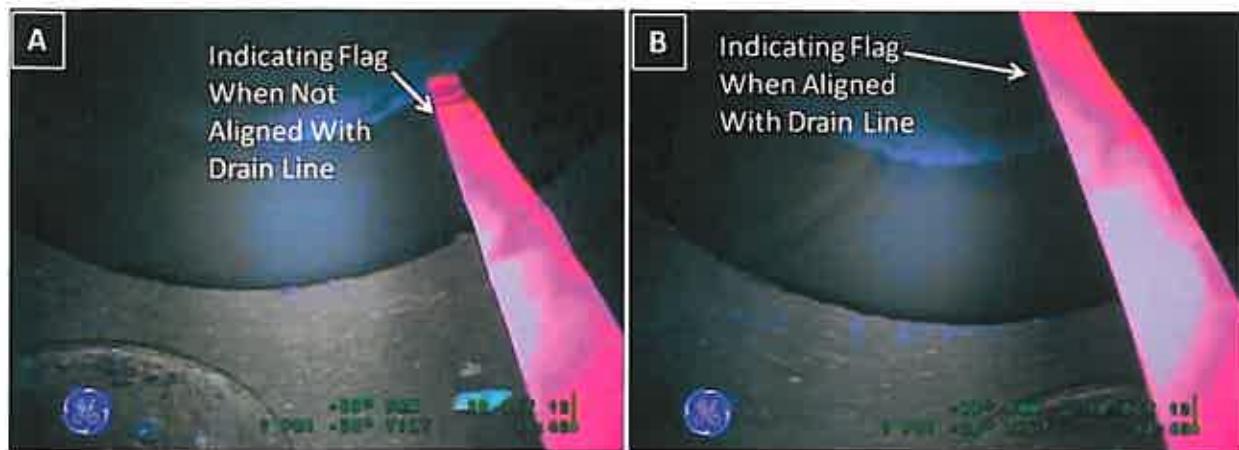
Figure 1-12. Tank AY-102 Leak Detection Pit Drain Line Airflow Test (October 2012)

During the 2012 inspections, a test confirmed the presence of airflow out of the 6-in. drain line and into the LDP riser (RPP-RPT-53793, Section 4.3.7). The annulus ventilation system was operating and indicated a negative 12-in. water column (WC) vacuum. The riser at the leak detection pump pit cover was sealed to maximize vacuum in the LDP. Using a red ribbon flag to allow visual indication of airflow, a camera was lowered into the LDP. Airflow was confirmed when the flag would deflect outward and upward when positioned in front of the LDP drain line (Figure 1-12).

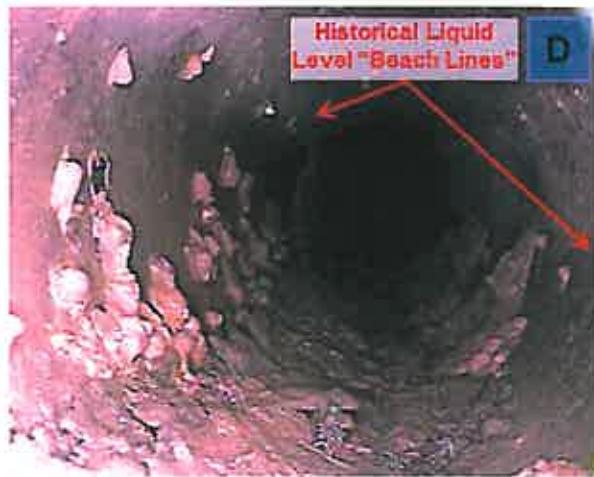
Figure 3-6. View of 6-in. Drain Line Directly After First Elbow

Figure 3-6 shows the straight section just after exiting the first elbow and indicates an increasing amount of sediment. (This figure is an example of a screenshot that does not show the true vertical configuration.) Most corrosion tubercles are present below the historical liquid level line.

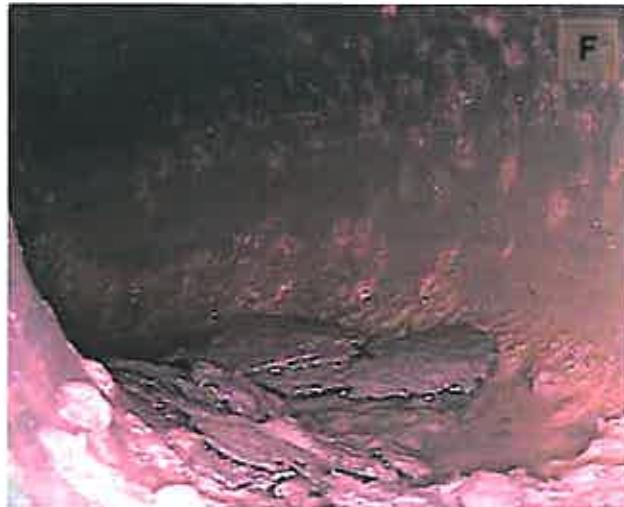
Figure 3-8. View of Second Elbow Prior to Entering

Section 3 is the second elbow of the piping expansion loop and the 4-ft long section between the second and third elbows. The section contained debris and corrosion products, as shown in Figure 3-8 through Figure 3-10. The waterline from previous filling of the LDP is clearly visible on the wall (Figure 3-8). This section was very wet, and standing liquid can be seen in shallow pools dammed up between the debris in the pipe, as shown in Figure 3-10. It was noted during

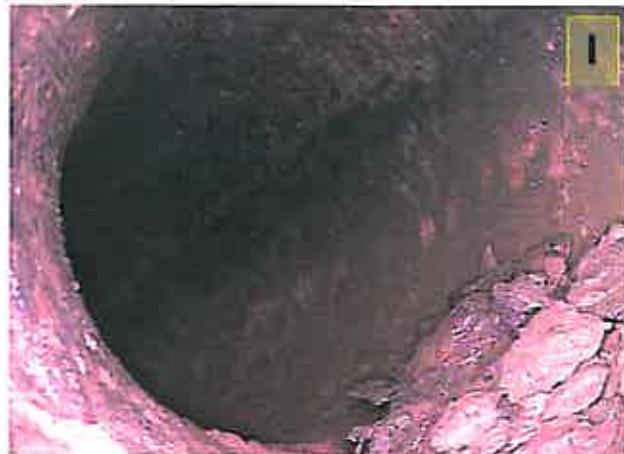
Figure 3-11. View of Third Elbow Prior to Entering

Section 4 is the third elbow of the piping expansion loop and the 4-ft long section between the third and fourth elbows. This section appears much drier than previous sections. Figure 3-11 shows considerable debris in the third elbow. There is a distinct color change from wet to dry in this section between the two elbows, as shown in Figure 3-12 and Figure 3-13. The corrosion debris on the bottom of the pipe, along with the waterline, is still evident. Traversing through this material was less challenging because crawler traction was better in the drier environment. The transition point (dark-to-light color at the bottom of the pipe) is the anticipated location of the liquid level prior to the pumping of the LDP on November 14, 2013.

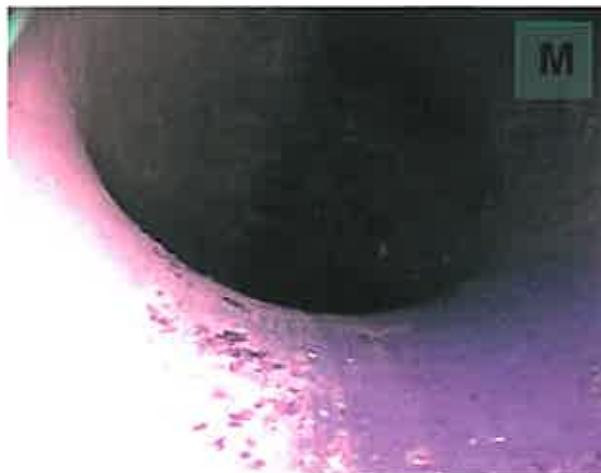
Figure 3-15. View of Fourth Elbow Prior to Entering

Section 5 is the 6.5-ft long section of the drain from the fourth elbow to the first 4-in. branch tee that drains the space under the tank annulus. The inspection did not detect any moisture in this region, including the bottom of the 6-in. pipe. There was no evidence of flow marking/remnants from the upstream 4-in. tees. As captured in Figure 3-14, the debris on the bottom of the pipe is flaky and dry compared to the wet debris that the crawler had to traverse through in the lower sections of the pipe expansion loop. Figure 3-14 through Figure 3-16 provide views of this region. Corrosion debris can still be seen on the bottom of the pipe. The volume of debris diminishes as the crawler progresses up the drain line and tubercles visible in earlier sections have disappeared. Overall, the drain pipe in this region is in good condition considering its age and the historic presence of liquid defined by the visible waterline.

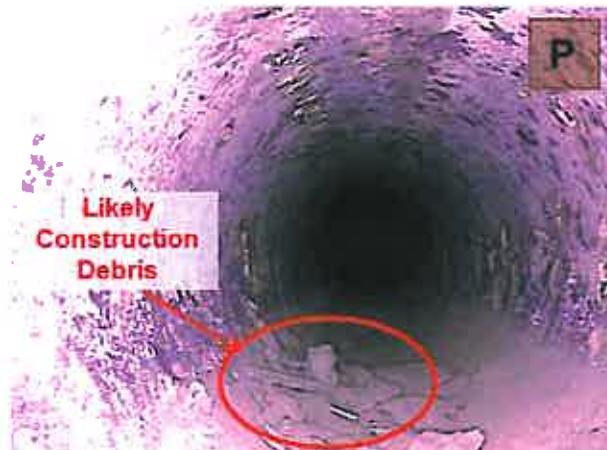
Figure 3-18. View of 6-in. Drain Line
Approximately 10 ft After the First Tee

The legacy stain from the waterline can be seen on the bottom third of the tee (Figure 3-17). Camera operability at this section of the drain line was limited, so additional views looking up into the tee 4-in. drain line were not performed. However, since the views gathered of the 4-in. branch connection were dry, this observation supports the conclusion that no liquid has recently traversed through the 4-in. line and into the 6-in. drain line. These features are shown in Figure 3-17 through Figure 3-19. Some of the debris in Figure 3-18 appears to be from construction (e.g., wood fragments).

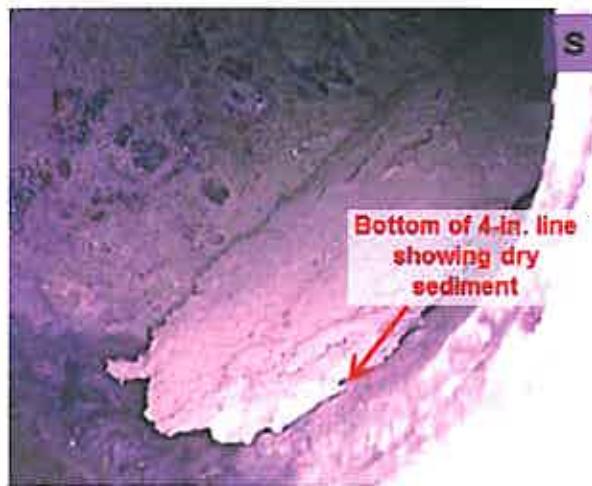
Figure 3-21. View of 4-in. Tee Connecting to 6-in. Drain Line

The 4-in. drain line from the second tee is dry and shows dry sediment in the bottom, similar to the first tee. This sediment may be blow sand or construction debris left in the system from construction. Debris and corrosion product were visible on the bottom of the 6-in. line (see Figure 3-21). As the crawler entered the moist region after the second tee, corrosion and tubercles were present again, indicating that this region has seen increased moisture over a long period of time. This corrosion formation and the condition of a section of the pipe sidewall can be seen in Figure 3-22.

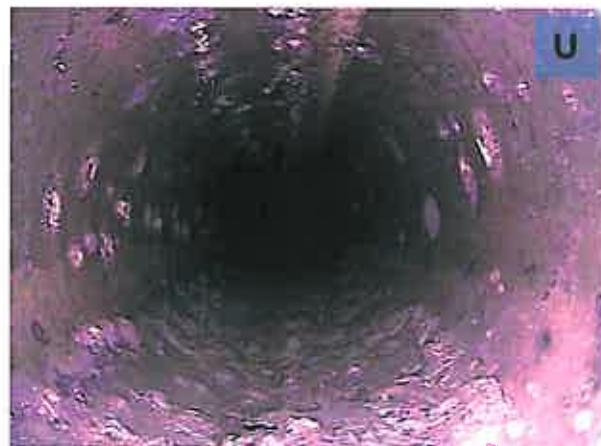
Figure 3-23 through Figure 3-25. Traversing this section was similar to driving through mud. The crawler did not have enough traction to overcome both the debris and the resistance from the crawler tether to reach the central plenum.

Figure 3-23. View of 6-in. Drain Line a Couple Feet after Second Tee

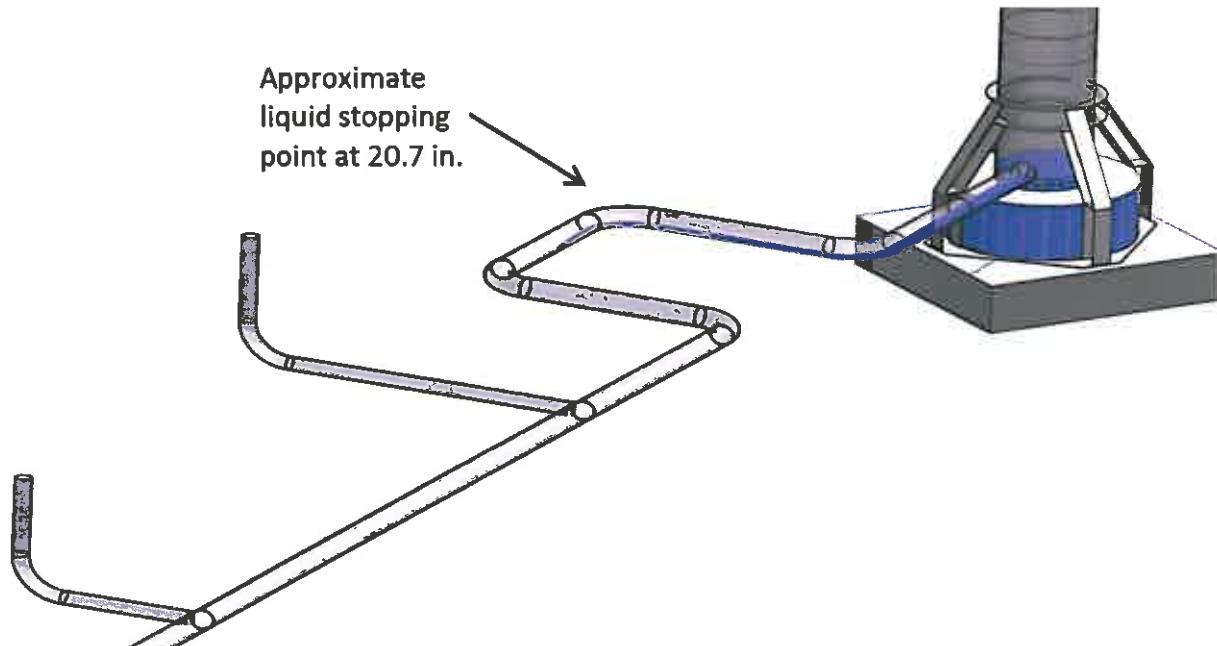
Prior to the robotic inspection of the 6-in. drain line on November 20, 2013, the LDP was pumped to reduce the amount of liquid present in the pit. On November 11, 2013, the liquid level in the LDP was measured to be 20.7 in. LDP pumping operations occurred on November 14, 2013, and the liquid level, following pumping, was measured to be 0.1 in. Figure 3-27 shows the liquid level in the 6-in. drain pipe, with 20.7 in. in the sump tank, as measured on November 11, 2013. Because the pit was not pumped until November 14, 2013, there were three additional days for the level to increase further than that shown in Figure 3-27.

Figure 3-27. Leak Detection Pit Drain Hydraulics

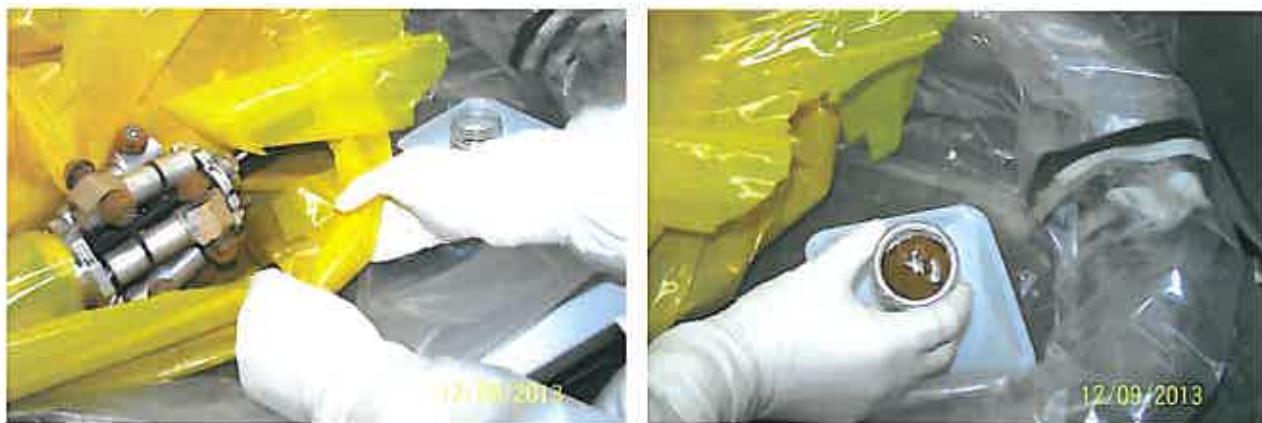
On completion of the field inspection the crawler was packaged in the field, and shipped to and examined at the 222-S Laboratory. About 3 grams of solids were collected from the wheels and crawler externals for analysis (Figure 3-29). Residues recovered from the crawler and tether were examined using chemical and radiological analyses found in RPP-PLAN-56497, *Sampling and Analysis Plan for Solids on the 241-AY-102A Leak-Detection Pit Robotic Pipe Crawler, Attached Cabling, and Sleeve*.

Figure 3-29. Crawler Solids Recovery in the 222-S Laboratory

Preliminary laboratory analysis of solid particulates recovered from the crawler yielded no evidence for phases that are characteristic of Hanford tank waste^{1,2}. Final results will be issued at a later date. The solids consisted, in a large part, of a very fine particulate and appeared dark orange to brown in color. A large majority of the total solids on the crawler were recovered. The particulates can be attributed to rust and/or mill scale, soil minerals, and cement and/or soil calcite.

Of these solids, the majority were composed of rust and scale. Minor amounts of silicate soil minerals and a calcium-rich phase were also found. The calcium-rich phase is probably derived from cement or groundwater precipitation. Traces of a phase consistent with graphite were also observed. This compound may have come from the dry lubricant that was scattered about the sliding joint of the tank concrete wall during construction. Additional details on the results of specific analysis that were performed are provided below.

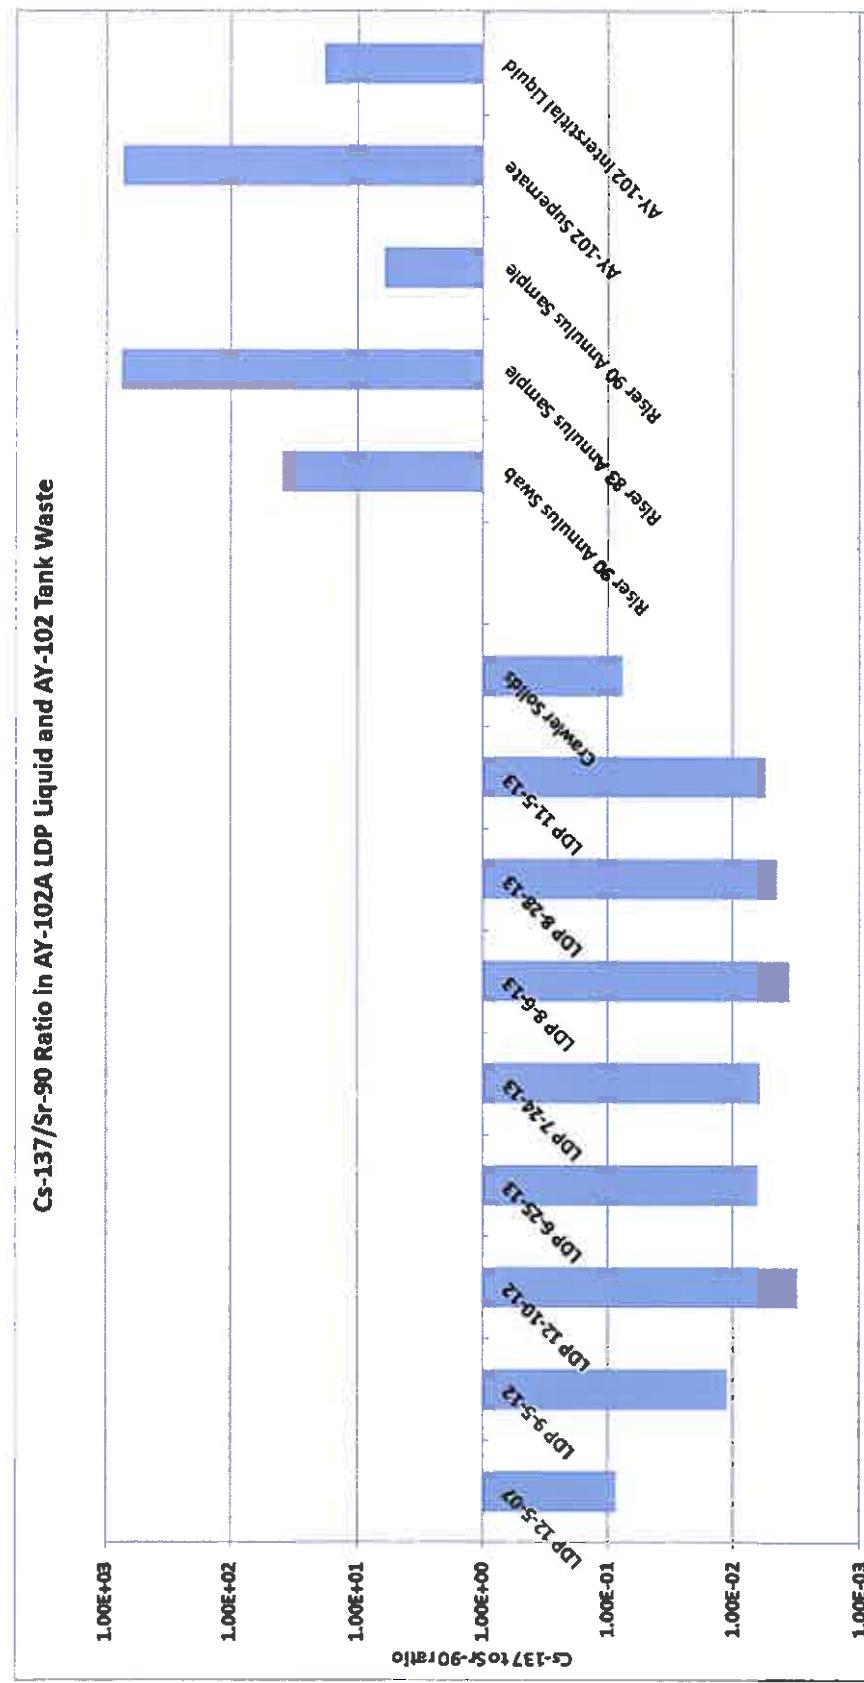
The chemical characterization of the solids was primarily iron from rust in the debris with trace quantities of cesium (Cs) and Strontium (Sr) (Table 3-1). The Cs-137 to Sr-90 ratio is similar to past LDP liquid samples from the pit and not similar to waste samples from the tank or the annulus (Figure 3-30). The overall concentration of radionuclides in the crawler sample compared to other Tank AY-102 samples is shown in Figure 3-31. The overall concentration of Sr-90 is similar to annulus materials, but the more mobile component, Cs-137, is much lower than any of the tank or annulus materials.

Figure 3-30. Cs-137/Sr-90 ratio from Crawler Solids Compared to other AY-102 Samples

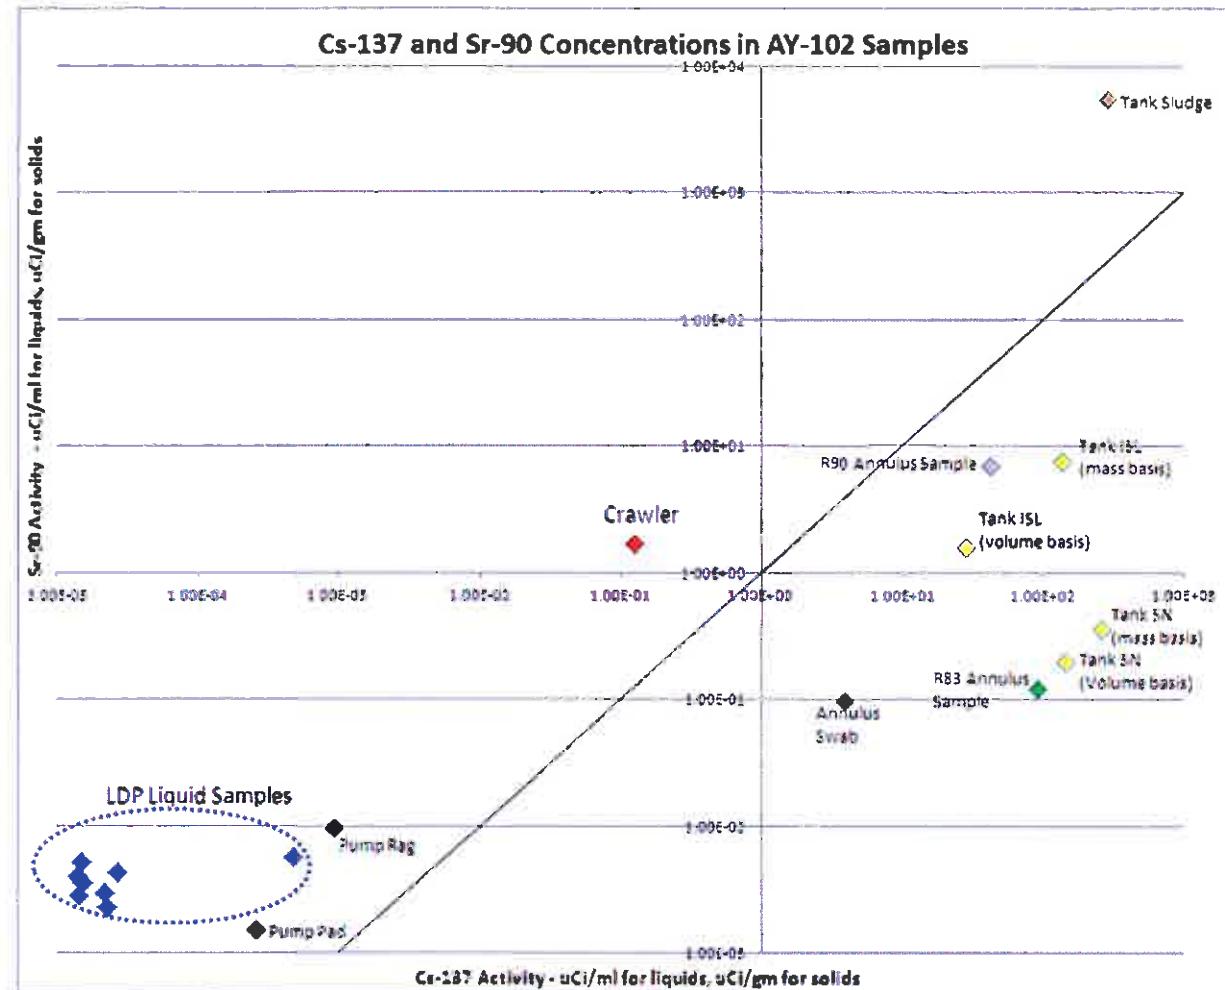
Figure 3-31. Cs-137 and Sr-90 Concentrations of the Crawler Solids Compared to other AY-102 Samples

Radionuclides, Cs-137 and Sr-90, were present in low concentrations and in a ratio similar the LDP samples. There was no evidence of particles with chemical signatures consistent with tank waste. Specifically, no sodium-rich, potassium-rich, nitrate, sulfate, or phosphorus bearing salts were found. These results indicate the material analyzed from the crawler was not tank waste.

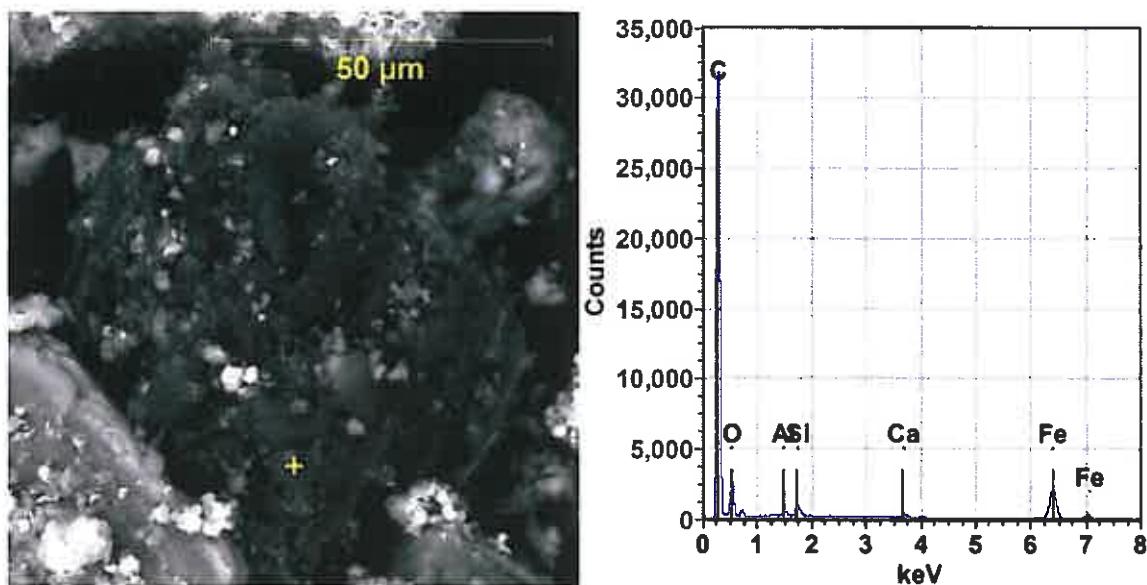
Figure 3-33. SEM Image (Left) and EDS Spectrum (Right) showing Graphite in Crawler Sample

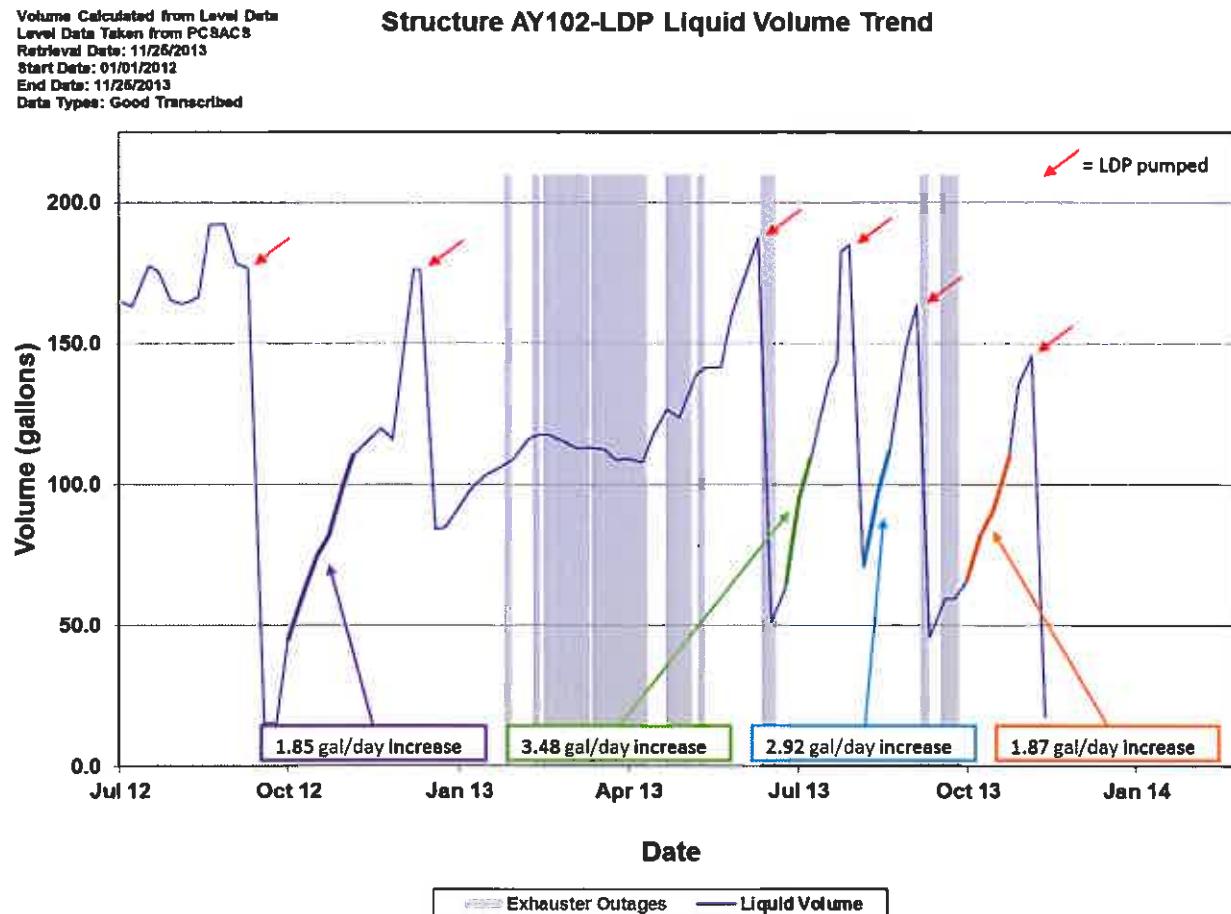
The level in the Tank 241-AY-102 (referred to herein as Tank AY-102) LDP was stagnant at about 25 in. from 2010 until the primary tank was discovered to be leaking. As part of the leak assessment, the LDP was pumped to ensure the integrity of the secondary liner. Since then, the LDP has been pumped regularly as it refills. When the annulus ventilation system is operating, the filling is nearly constant at a rate of 2 to 3 gal per day (

Figure A-1. Tank AY-102 Leak Detection Pit Level Showing Nearly Constant Level Increase

This increase occurs up to a specific liquid level where the liquid completely covers the 6-in. drain line at the entrance to the 24-in. riser for the LDP. After reaching this liquid level, the increase stops regardless of the operating status of the annulus ventilation system. Additional evidence of this level is shown by water lines in the drain line seen during the visual inspection.

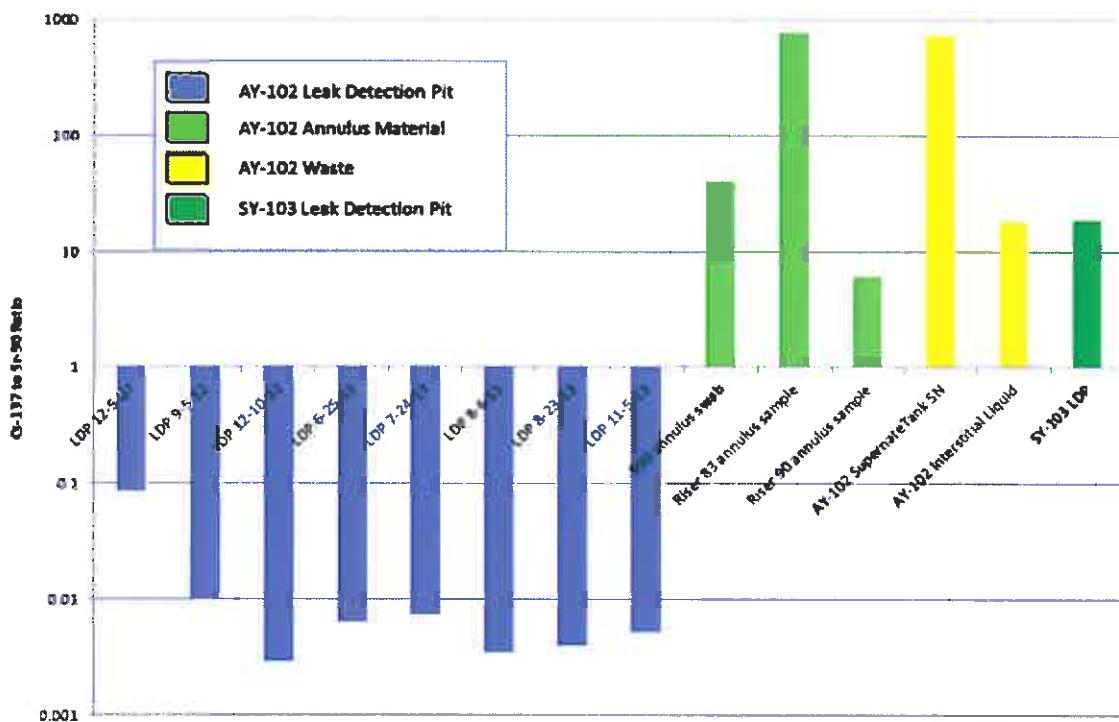
In Figure A-2, the ratio of ¹³⁷Cs to ⁹⁰Sr is shown for all LDP sampling events. The ratio is also shown for all Tank AY-102 annulus samples, the Tank AY-102 waste itself (supernatant and interstitial liquid), and Tank SY-103 LDP samples. This pit was contaminated when tank waste was misrouted during the 1970s and has been flushed extensively. The data shows that the material in the LDP is distinctly different than any of the material that has leaked into the annulus or waste in the tank.

Figure A-2. Ratio of $^{137}\text{Cs}/^{90}\text{Sr}$ in Tank AY-102 Leak Detection Pit Samples Compared to Other Sources Known to be Waste

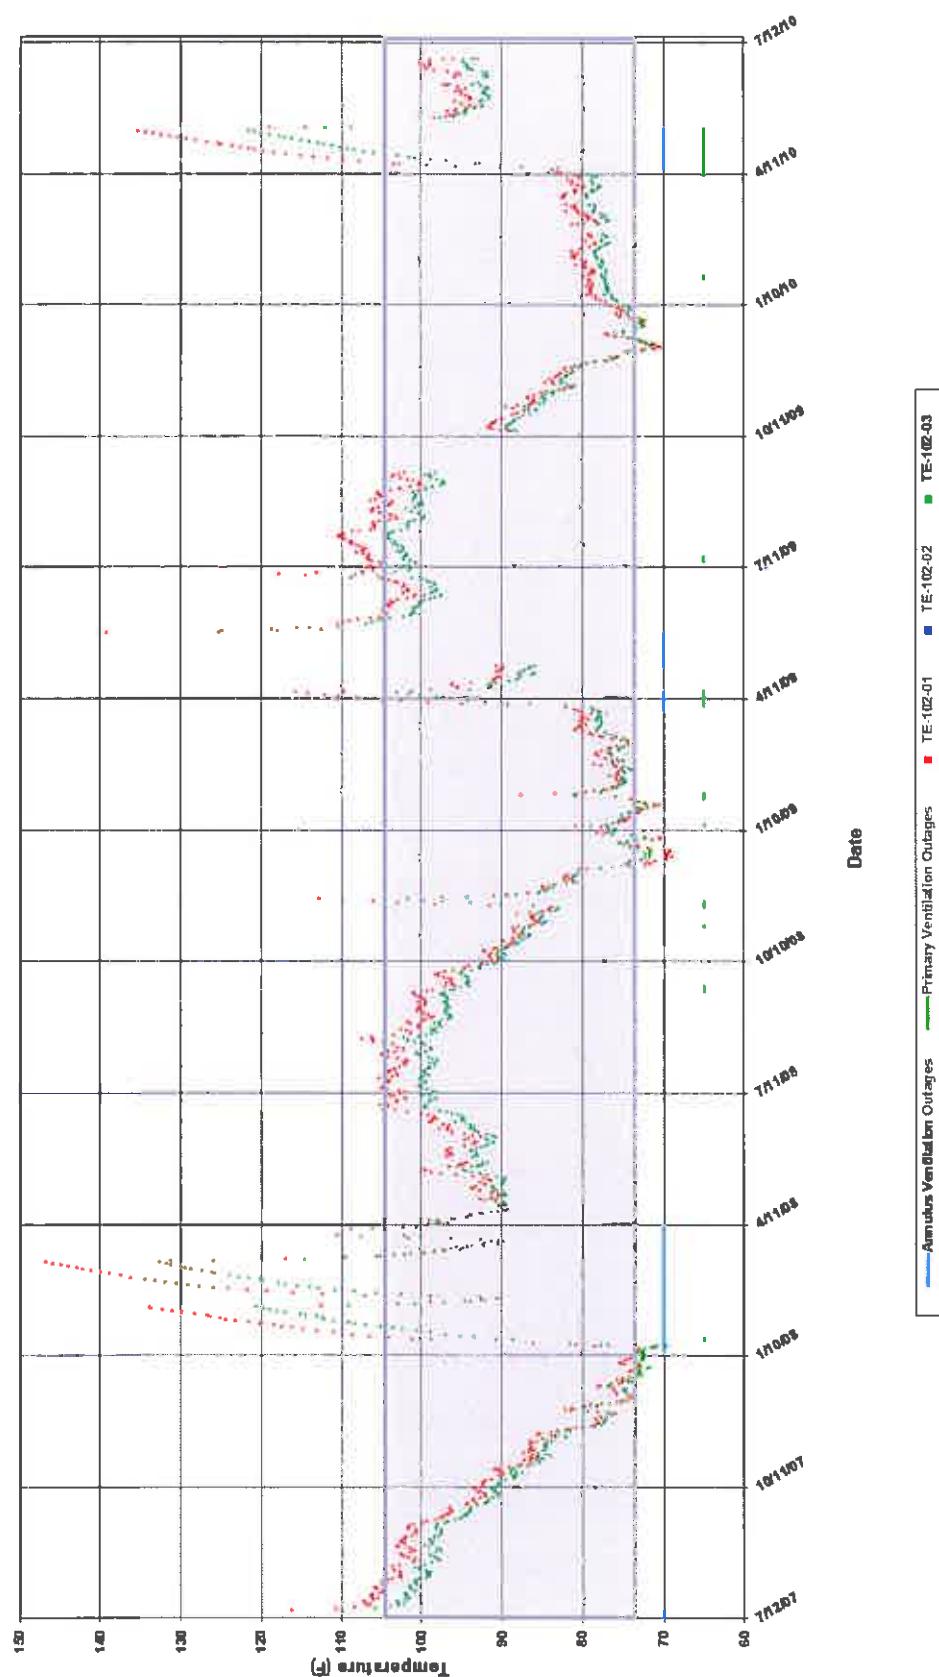
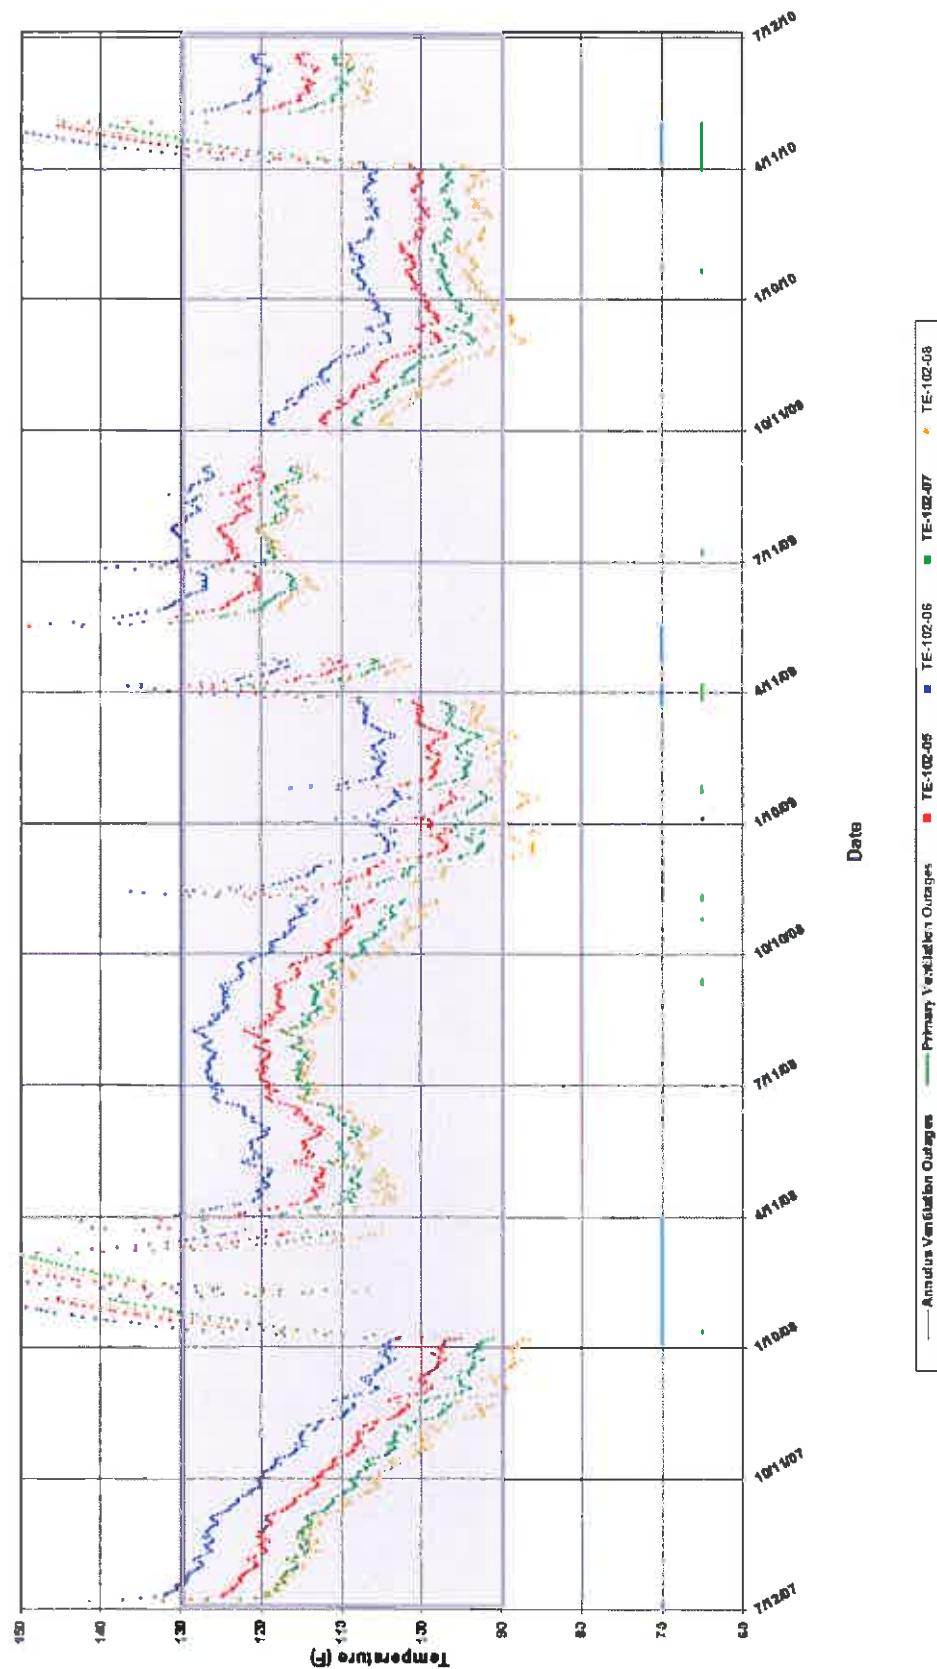
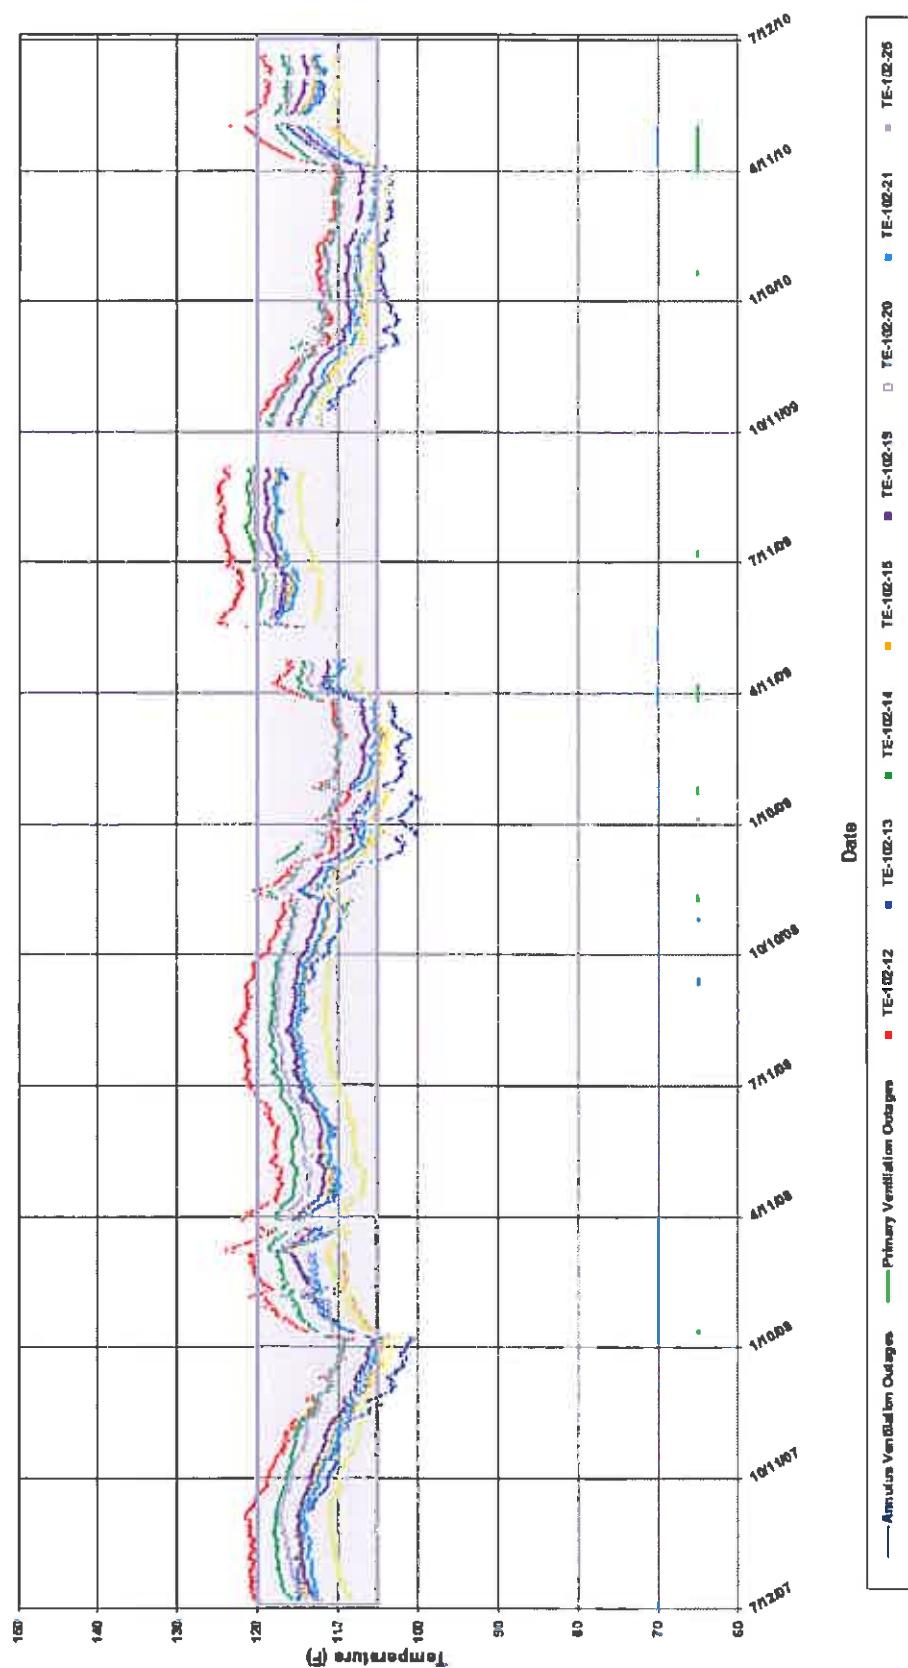
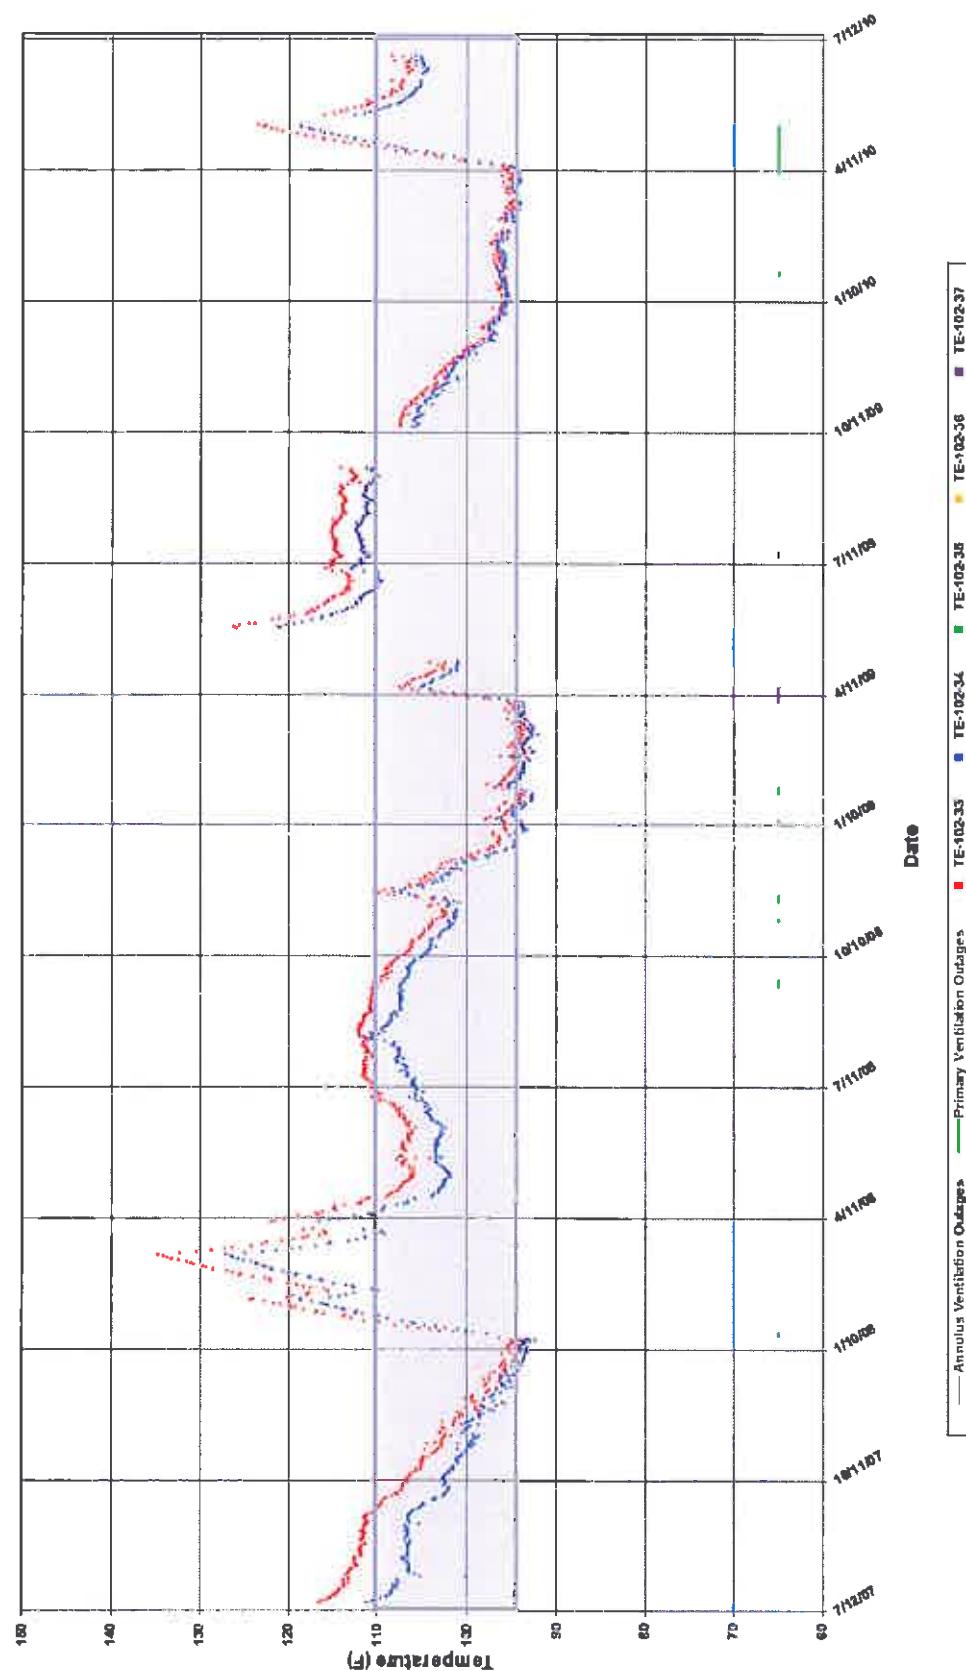
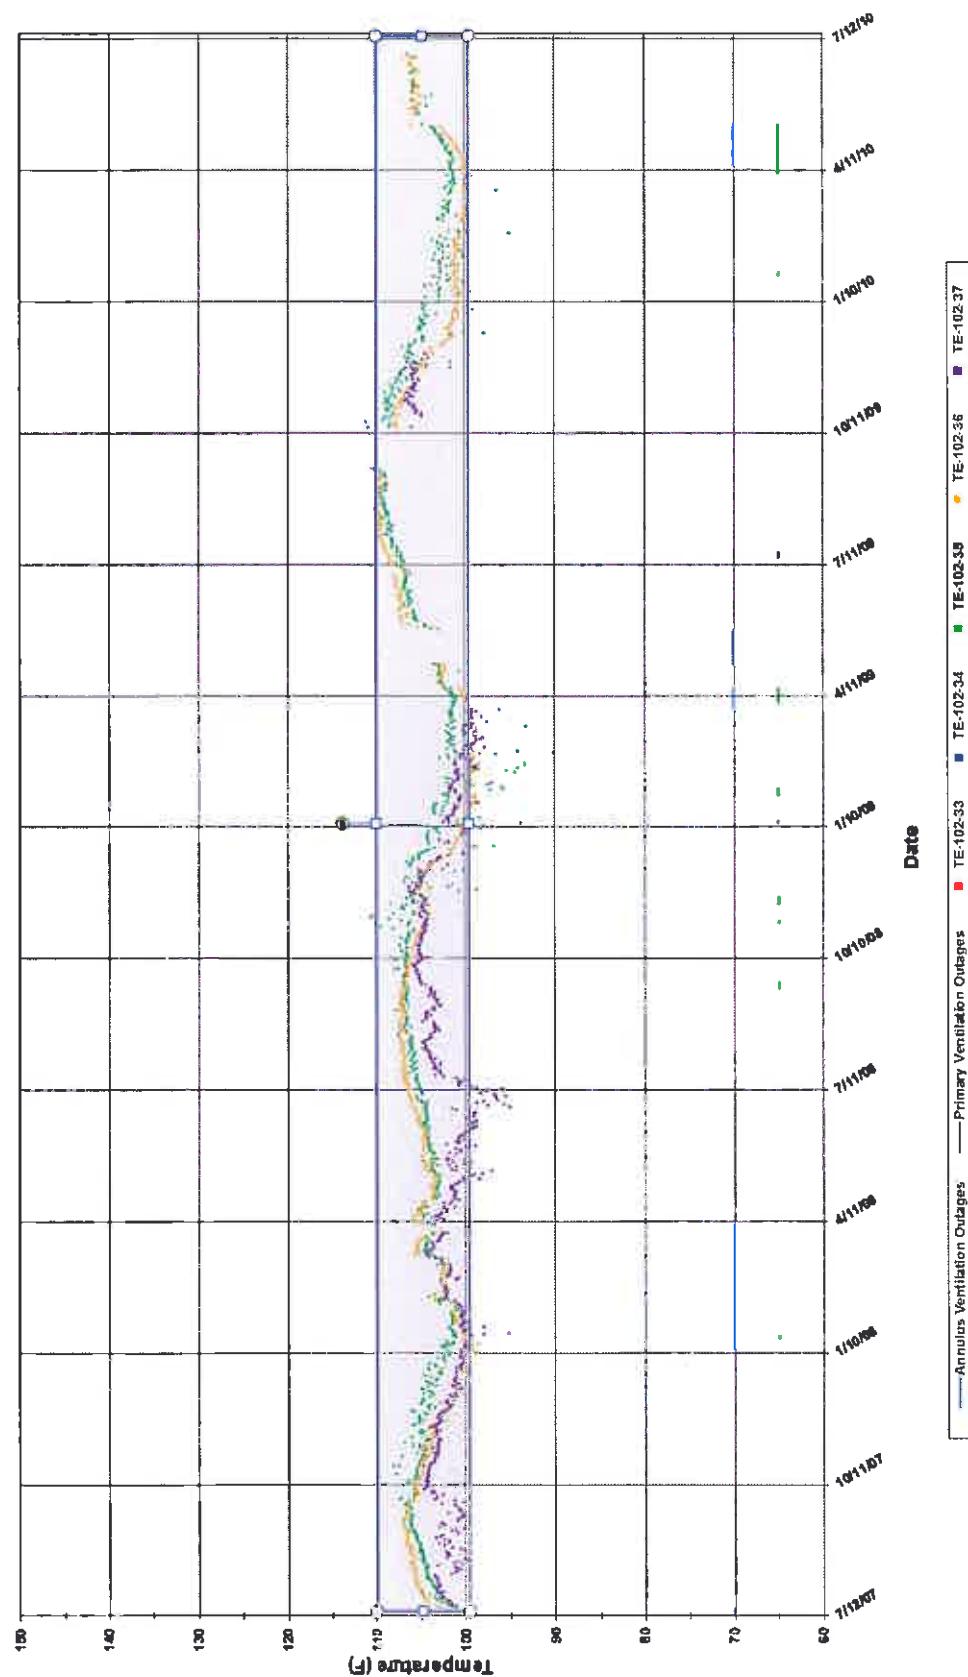
The inner thermocouples of the concrete foundation have not produced usable data since prior to 1980. The temperature of the concrete foundation at this location can be estimated by observing the temperature drop from the refractory to the foundation at the other two radial locations and applying it to the observed refractory temperatures.

Assuming the leak detection drain piping is pulling air/liquid that is in thermal equilibrium with the concrete, the air pulled in from the center of the tank is approximately 20 °F cooler than through the other drain legs. The cooler air could explain moisture dropping out in the tank-center portion of the drain piping and the warmer air preventing condensation in the middle section of the drain piping. Moisture in the section nearest the leak detection pit is explained by the observed filling of the pit via condensation on the pit sidewalls and potentially on the last section of the drain piping as the distance from the tank (the heat source) increases.
