# **Survey of Transport Airplane Structural Repairs and Alterations: Survey & Teardown Final Results**

**2011 Aircraft Airworthiness & Sustainment Conference**

**April 20, 2011**

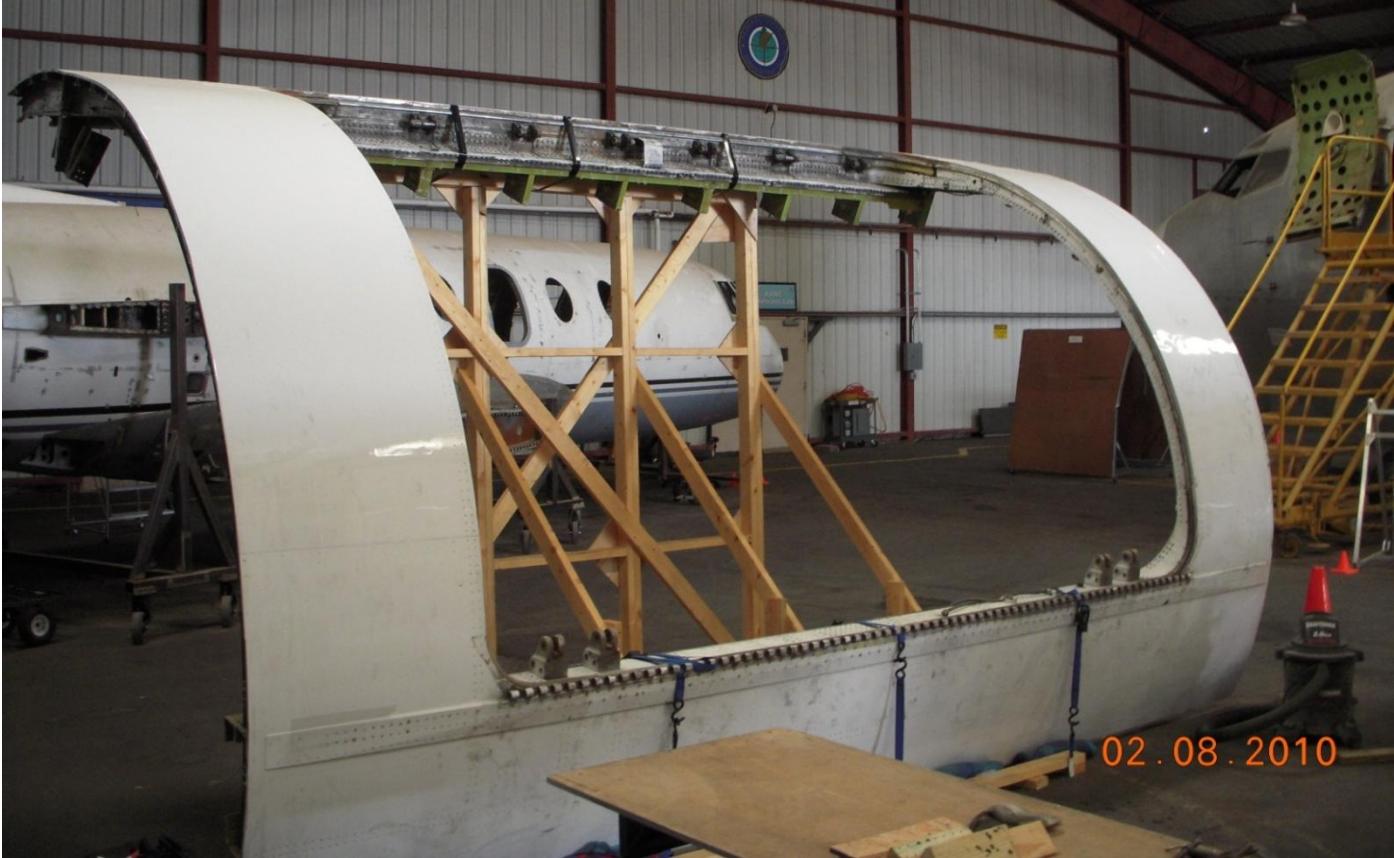
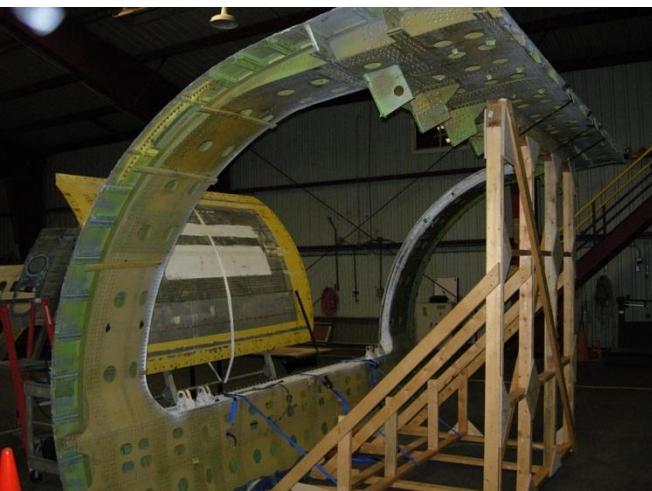
# B727 Passenger to Freight STC Conversion Cargo Door

- Passenger to Freight STC conversion Cargo Door
- Pemco STC and install – Full data package on hand
- Airplane registered as both N810EA and N936PG
- Specimen 5

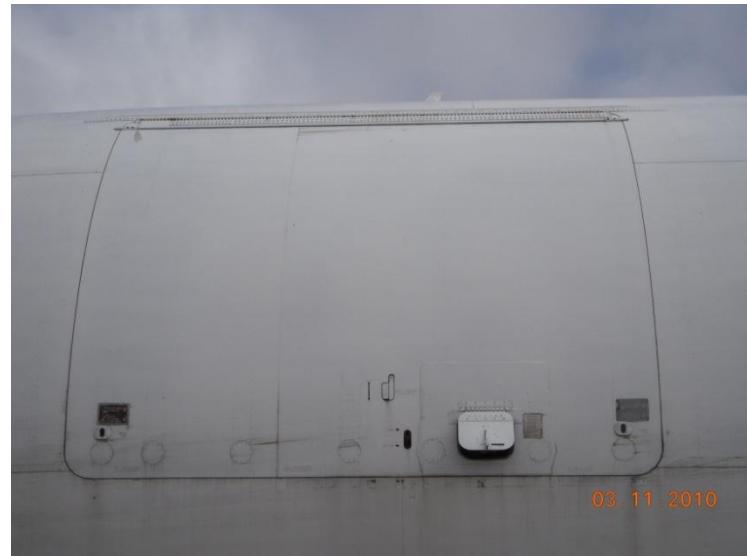
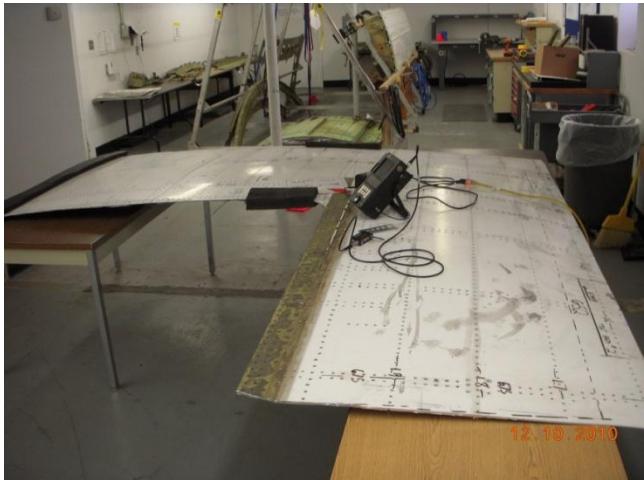
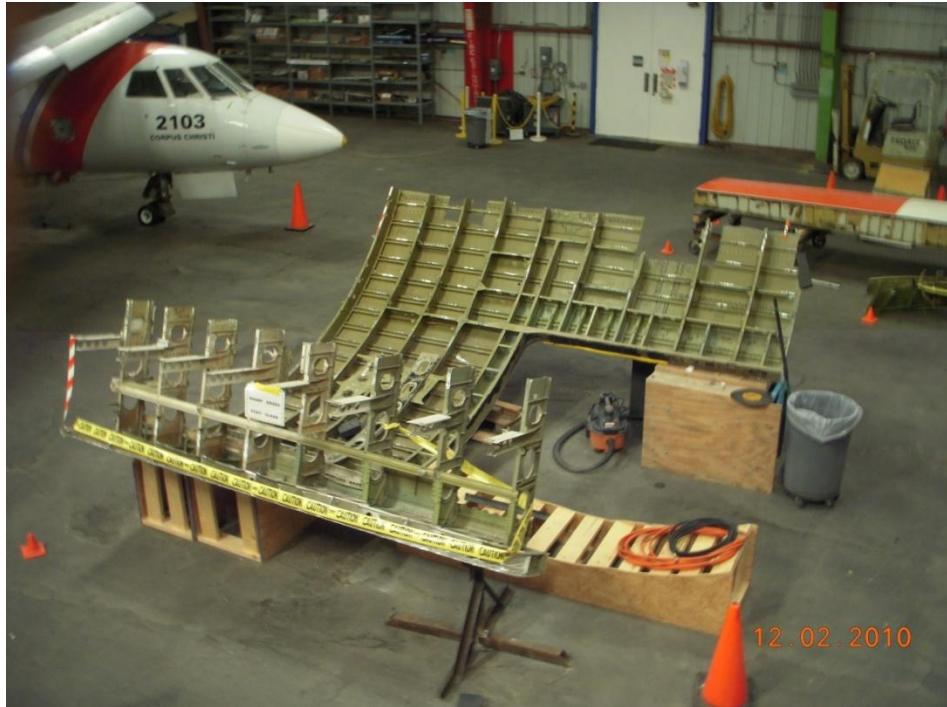
## Passenger to Freight STC Conversion Cargo Door

- Passenger to Freight STC conversion
- Cargo Door
- 35522 FC
- N600GC
- Specimen 6

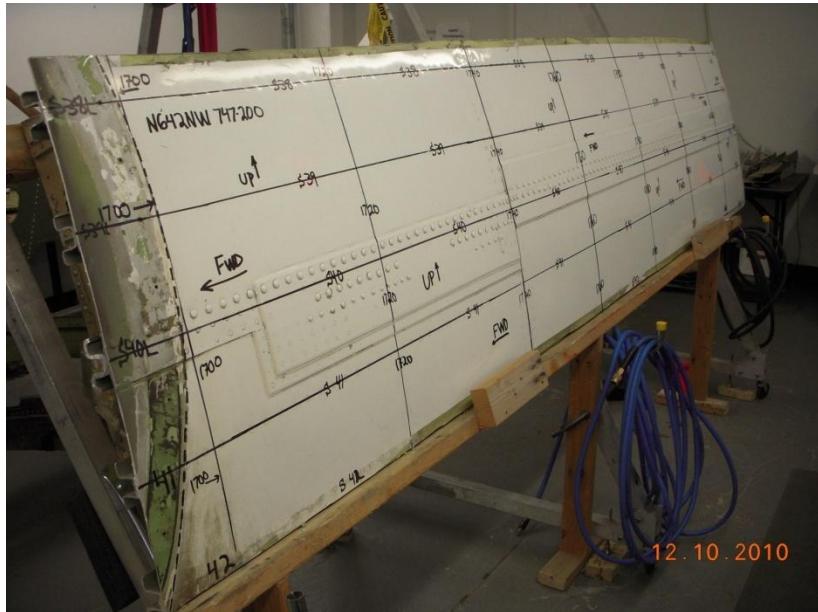
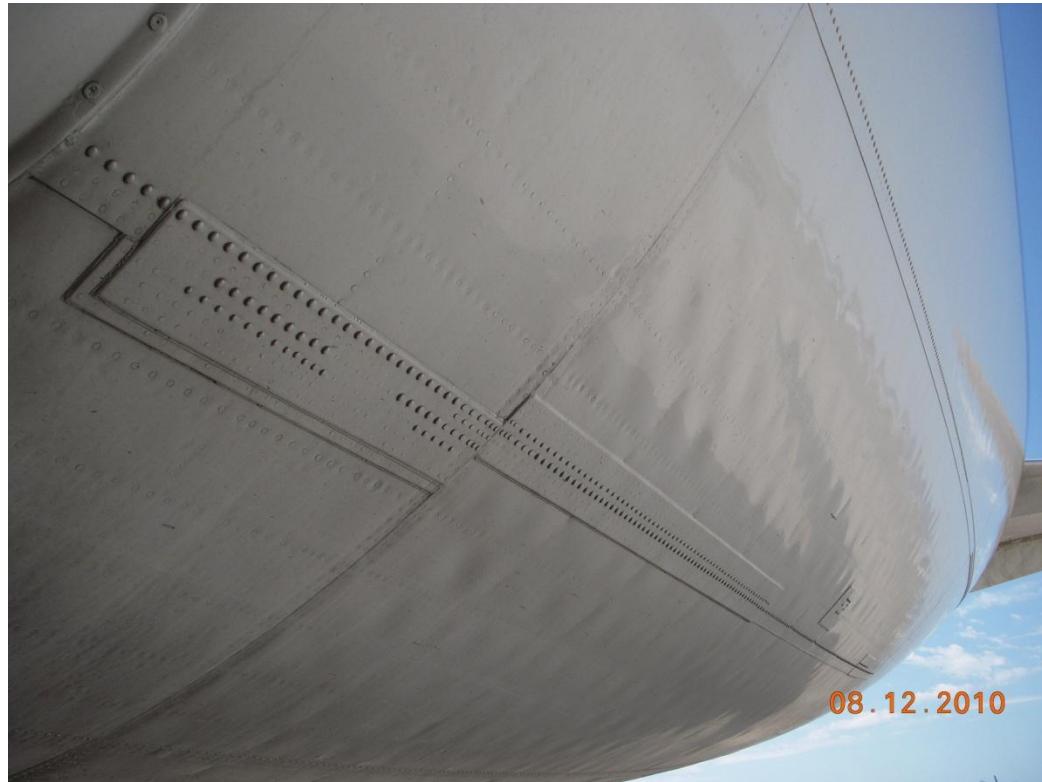
## N642NW BS 1700-1840, Str 38L-42L

# B747-200 Fuselage LH Aft Lower Lap Repair

### 25181 FH 3777 FC, LR1

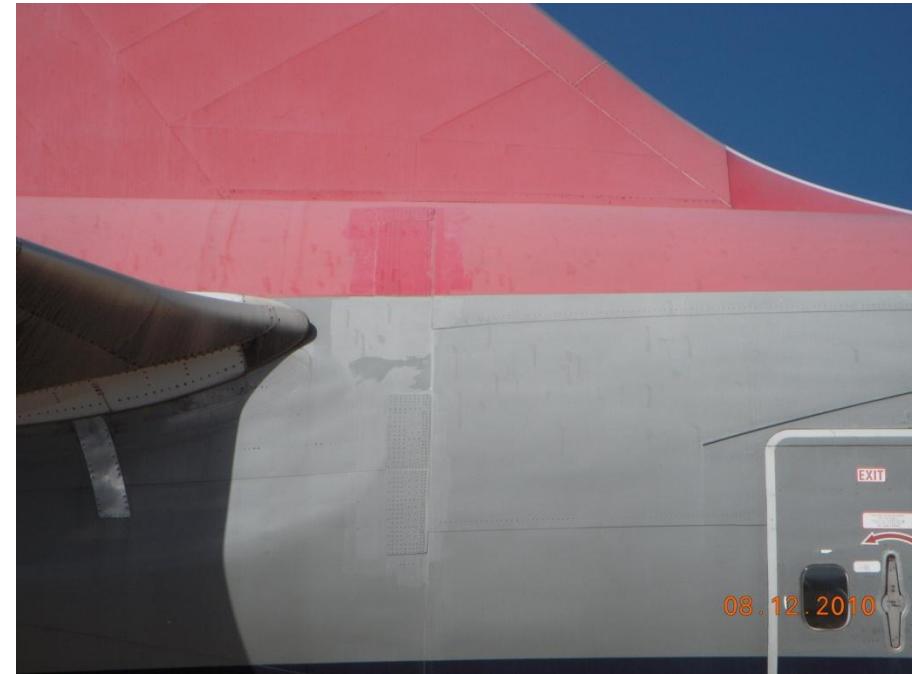
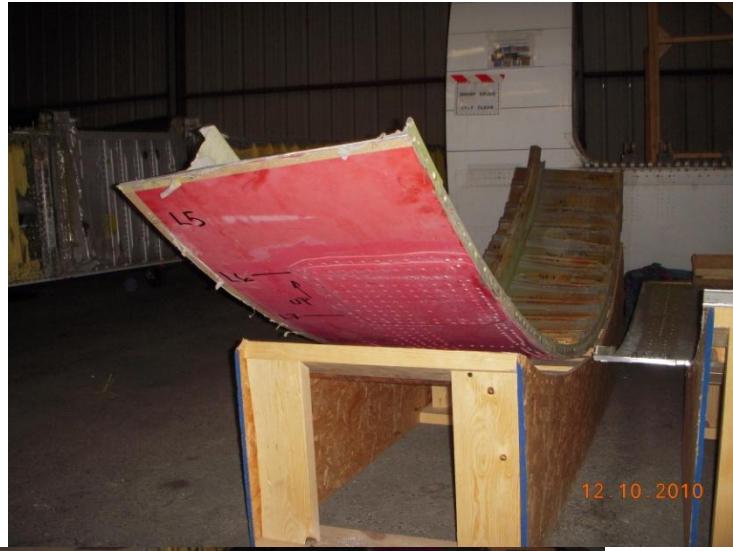
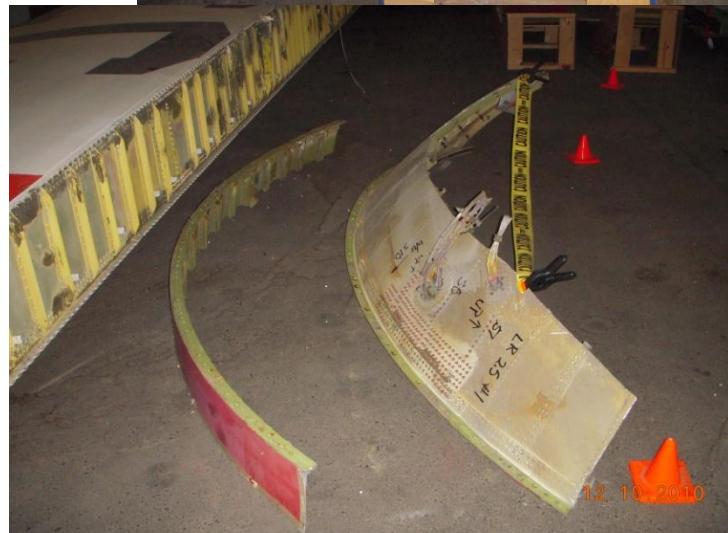
# B747-200, N634US, Fuselage Skin & APB Web & T-Chord, BS 2360, Str 1-22R Installed Approx. Mar 2000, LR2

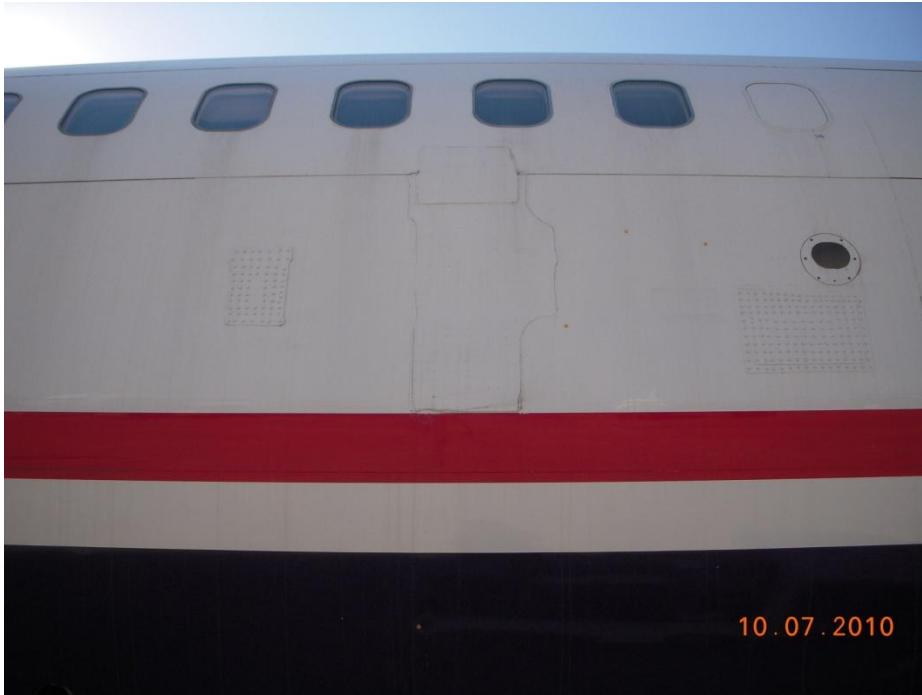
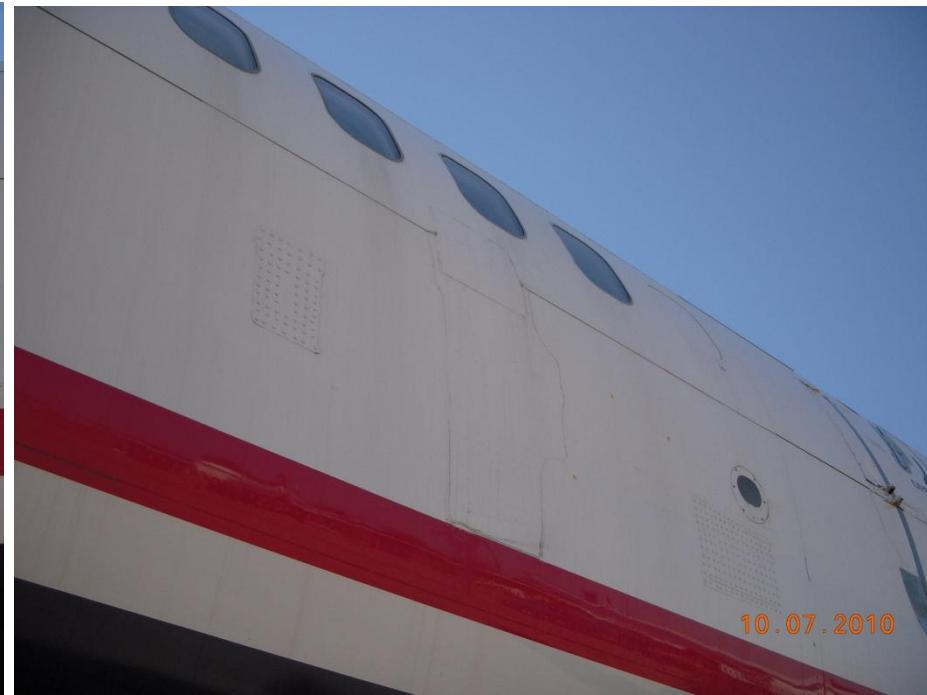
# B757-200, N920UW, Fuselage Fwd Skin BS 560-680, Str 12L-17L, 3 RAMs with Known FH/FC, LR3

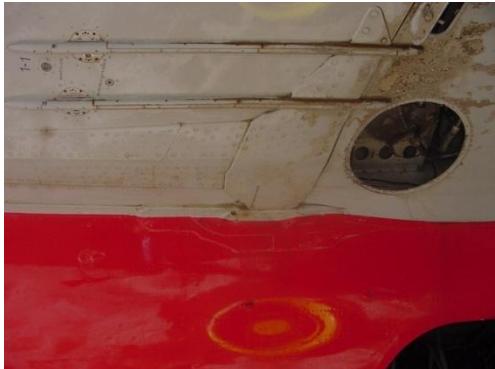
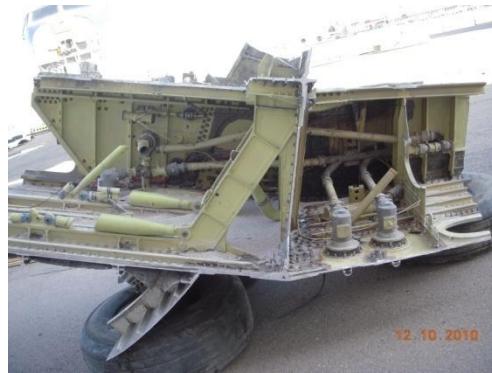
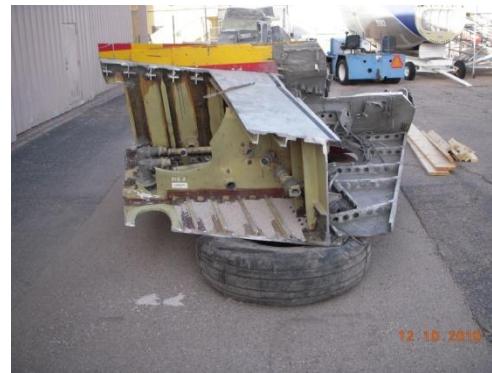
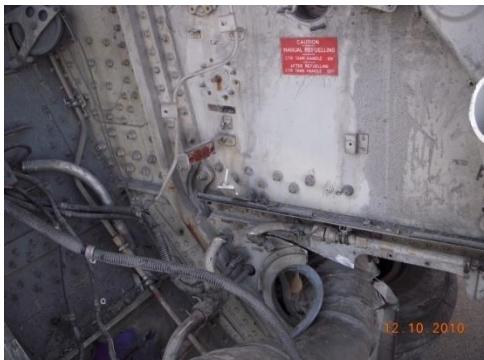
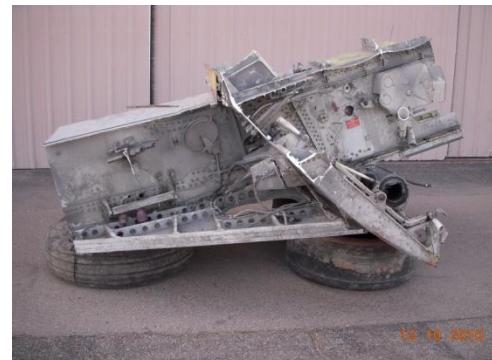
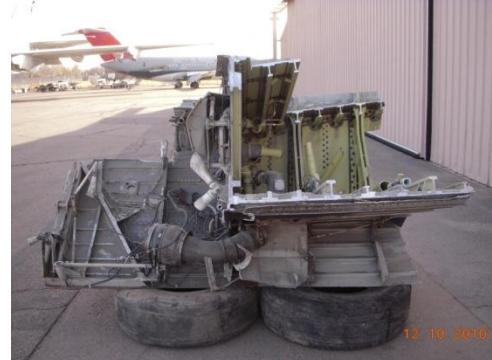
# A300-B4-200 MSN095 N226KW, LR4 Wing To Fuselage & Lower Rear Spar Repair

- 15821 FH & 10031 FC on Repair
- Airbus Engineered Repair installed in France

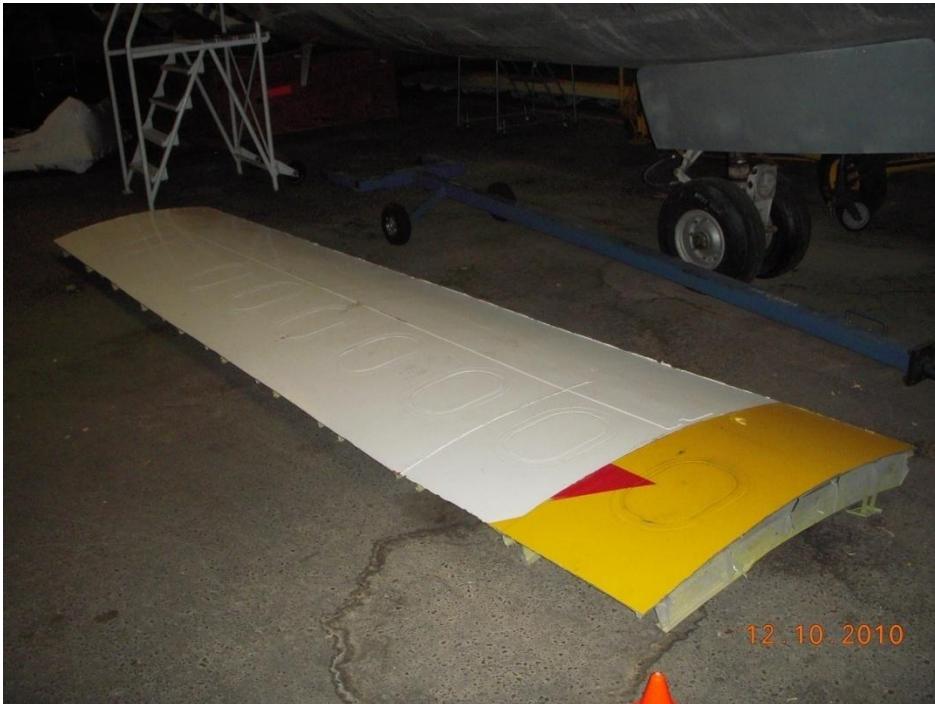
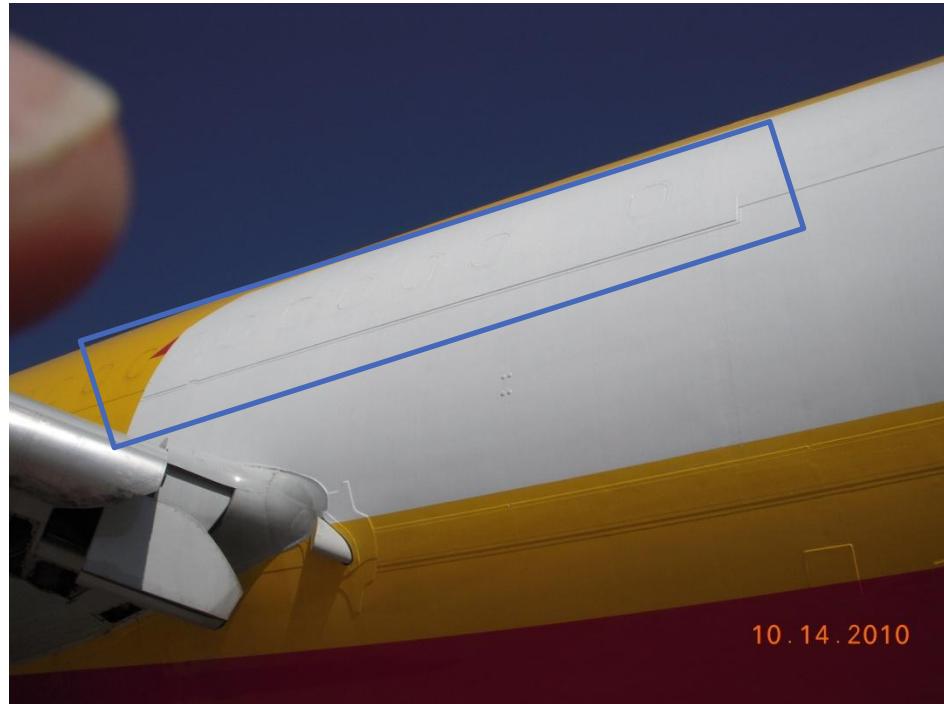
# A300-B4-203, N226KW, Lap Joint Repair Doubler below window belt RH, FR 34-41, Str 18R, LR5

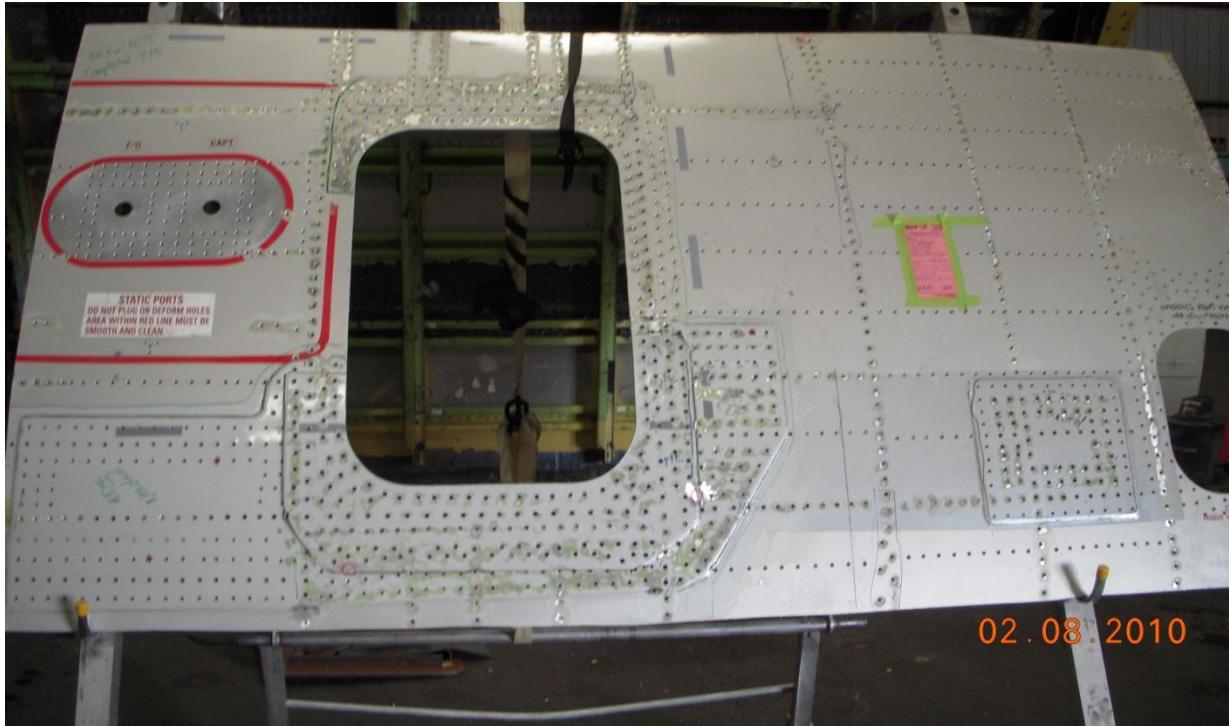
# A320-200, N327NW, Fuselage skin at Lower RH Avionics Access Door & Static Ports, 5997 FC, LR15

- Specimen of opportunity from N327NW
- Total Airplane Cycles 23909
- Teardown & Inspection Complete
