CONF-950739-1
SAND094-3230C

FAILURE ANALYSIS OF A FIBERGLASS-REINFORCED PLASTIC PRESSURE VESSEL

S. J. Glass, E. K. Beauchamp, M. Carr, T. R. Guess, S. L. Monroe, R. J. Moore, A. Slavin, and N. R. Sorenson, Sandia National Laboratories, Albuquerque, NM 87185.

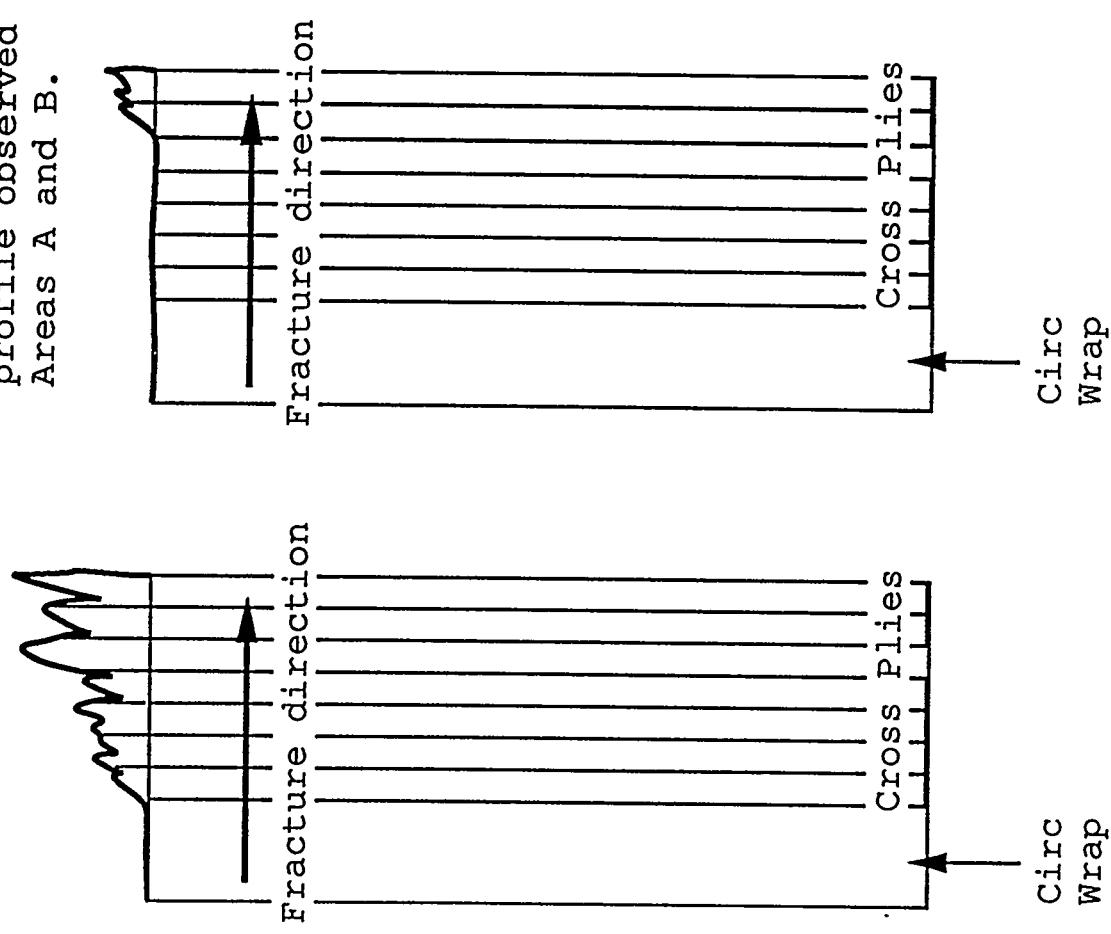
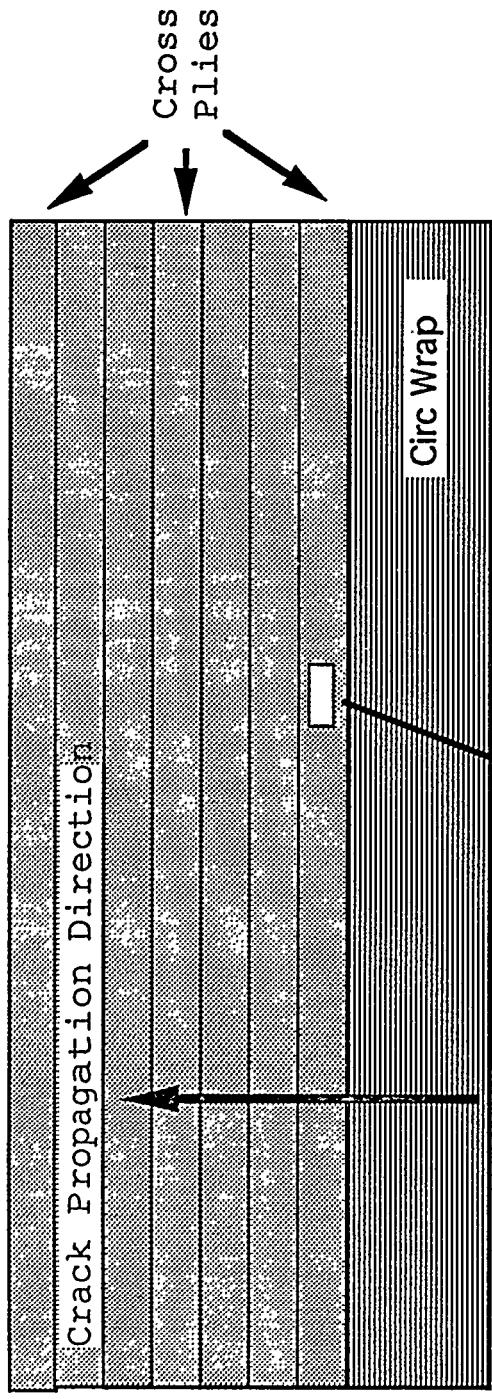
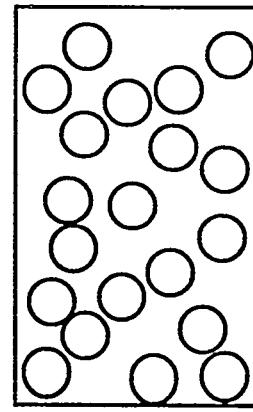
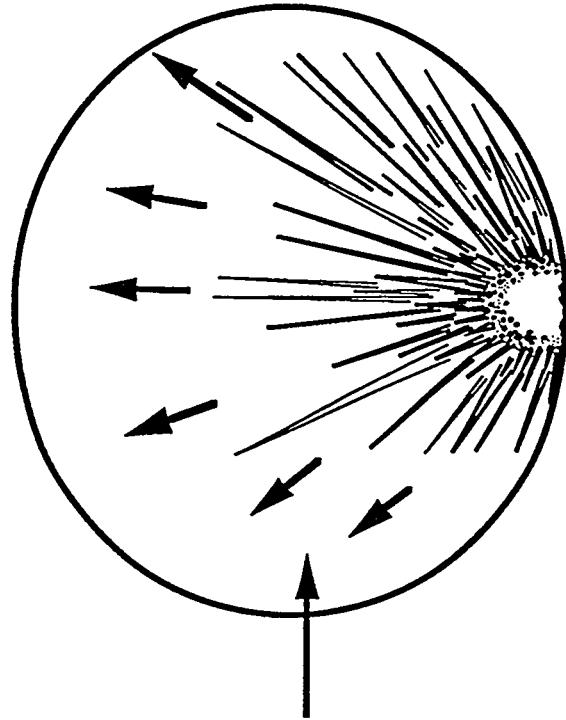
Macroscopic examination of the primary fracture surface revealed two areas (Fig. 2, Areas A and B) of planar circumferential (or hoop) fracture, normal to the longitudinal axis of the vessel, extending almost completely through the circ wrap and cross plies as shown in the schematic in Fig. 3A. If the vessel is exposed to sufficiently high axial tensile stresses, this type of planar hoop crack is expected in the circ wrap (a result of interfacial failure between the fibers and the epoxy matrix), but not in the cross plies. Fracture in the cross plies should exhibit extensive fiber pull-out producing a fracture surface that is not planar (Fig. 3B). The planar fracture surface of the cross ply region was the first evidence that the vessel had been compromised in some way that weakened the fibers.

Normal fracture profile. Planar fracture profile observed in Areas A and B.

Blow-up of cross
ply region.

Blow-up of individual
glass fiber. Hackle
marks indicate crack
propagation direction.

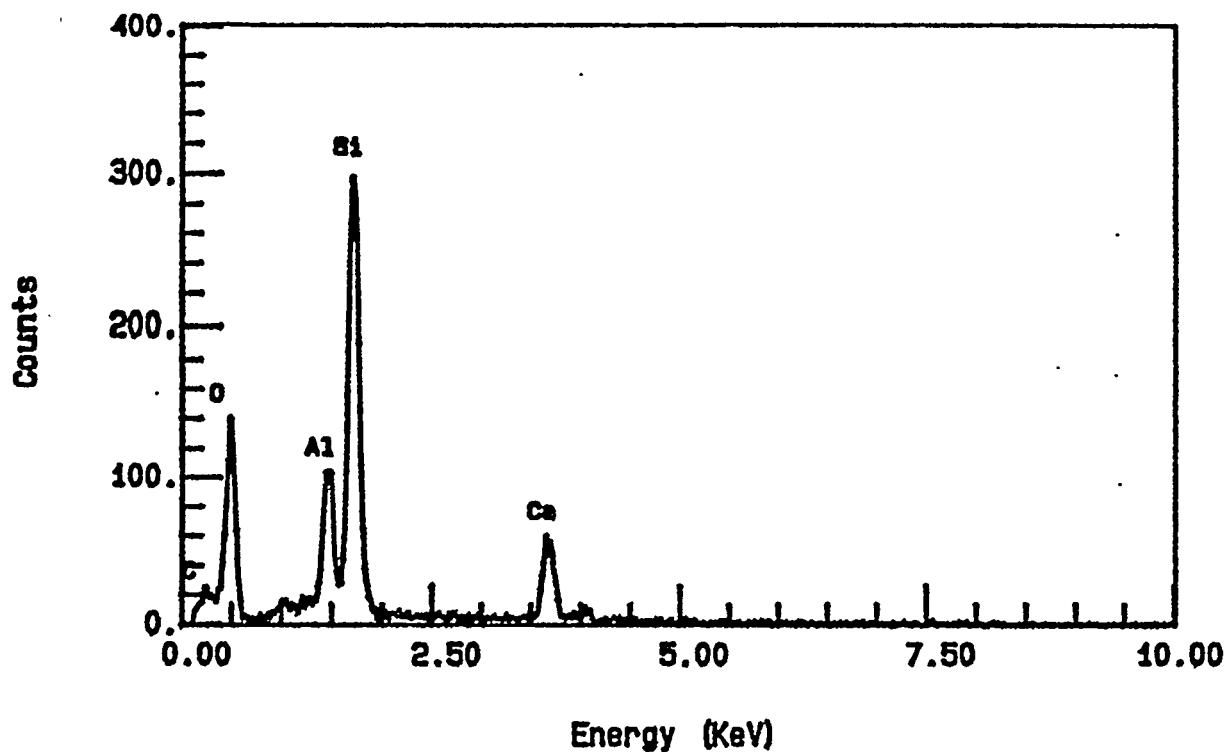
Fig. 6

Fig. 6A. SEM micrograph of a fractured fiber from a region of fracture exhibiting extensive fiber pull-out.

Fig. 6B. EDS verified the presence of Ca and Al as major constituents of E-glass fibers in the region of Fig. 6A.

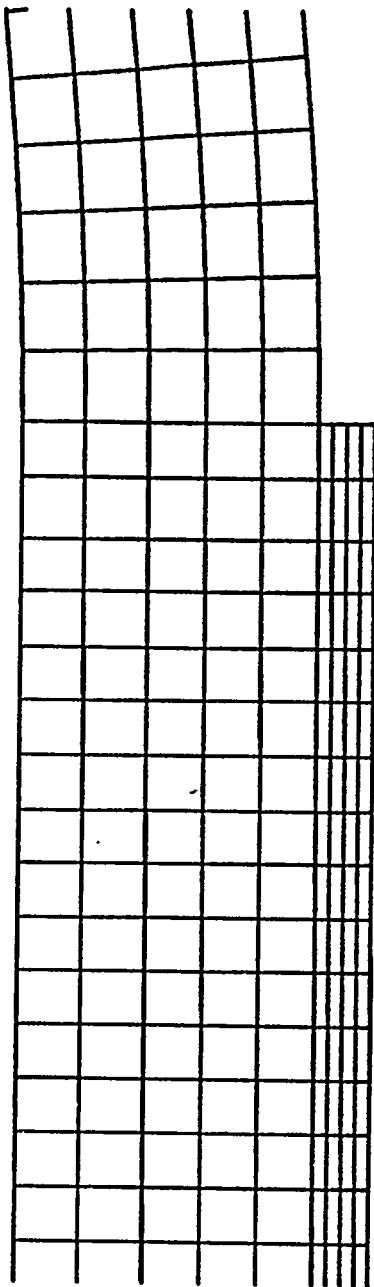
Figure 1. Finite Element Model Geometry and Mesh

Fig. 11 Finite element analysis model showing stresses in FRP vessel wall. Regions of high tensile stress (~49 MPa) were found above the radial constraint of the cradle, and correspond to the cracked regions of the vessel.
