# **Final Report for the Erosion-corrosion Analysis of Tank 241-AW-02E Feed Pump Pit Jumpers B-2 and 1-4 Removed from Service in 2013**

**J. S. Page**

Washington River Protection Solutions LLC

March 2014

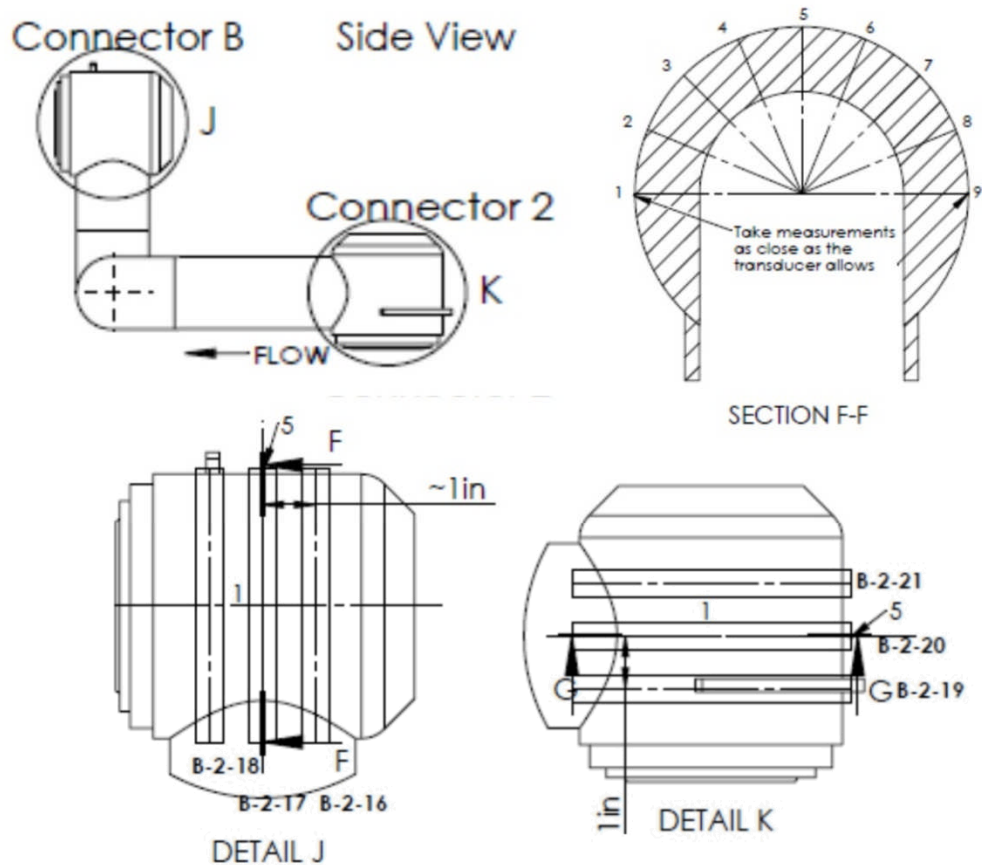
**Figure 2-7. Locations of Ultrasonic Transducer Thickness Measurements on the Connector Blocks of Jumper B – 2.**

Stainless steel connector blocks were welded to both ends of jumper B – 2. For each connector block, 3 bands of 9 UT measurement locations were requested as shown in Figure 2-7. The resulting UT thickness readings are displayed in Tables 2-6 and 2-7 and show very consistent measurements revealing the precision of the fabrication and lack of any erosion-corrosion.

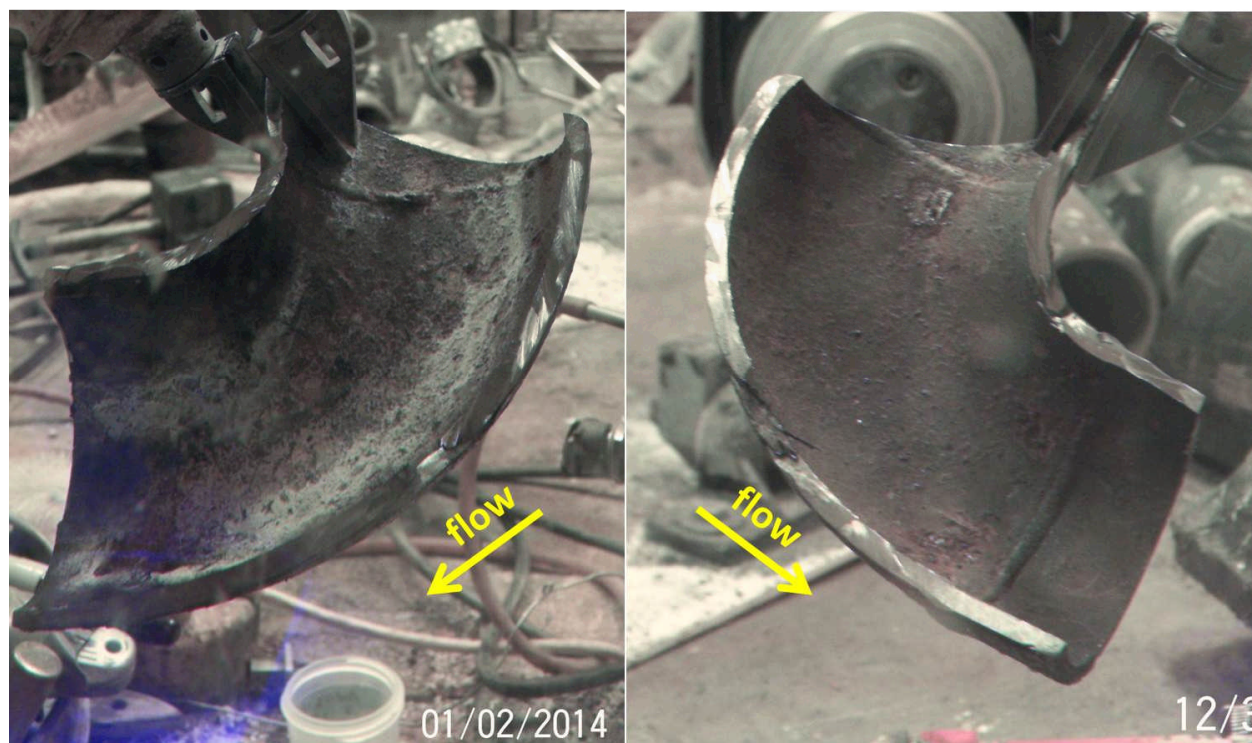
**Figure 2-12. Photos of the Clamshelled Sections of the First Elbow of Jumper B-2.**

The first elbow in the flow direction of jumper B – 2 and nearest to connector 2 was isolated and clamshelled using a combination of the portable band saw and cut-off wheel in the hot cell. The clamshell cut allowed a visual inspection of the extrados and intrados pipe walls of the 90-degree elbow to look for any wall thinning from erosion-corrosion of the flowing liquid. Figure 2-12 shows photos of the resulting sections of the elbow as taken through the hot cell window. Several observations were gained by this clamshell cut. First, there was no appreciable thinning of the pipe wall on the elbow. If wall thinning associated with impingement and erosion-corrosion had taken place, it would most likely be located at the extrados wall at the exit of the elbow with respect to the flow (“Complexities in predicting erosion-corrosion” [Poulson 1999]). In other words, it would be on the outside wall near the second weld where the flow arrow is

pointing. Second, the clamshell section in the left image represents the bottom side of the pipe. There is considerably more corrosion and residue on this section, possibly caused by pooling of the liquid when the flow was stopped. Third, the welds are intact with no visual erosion-corrosion near or on the welds.

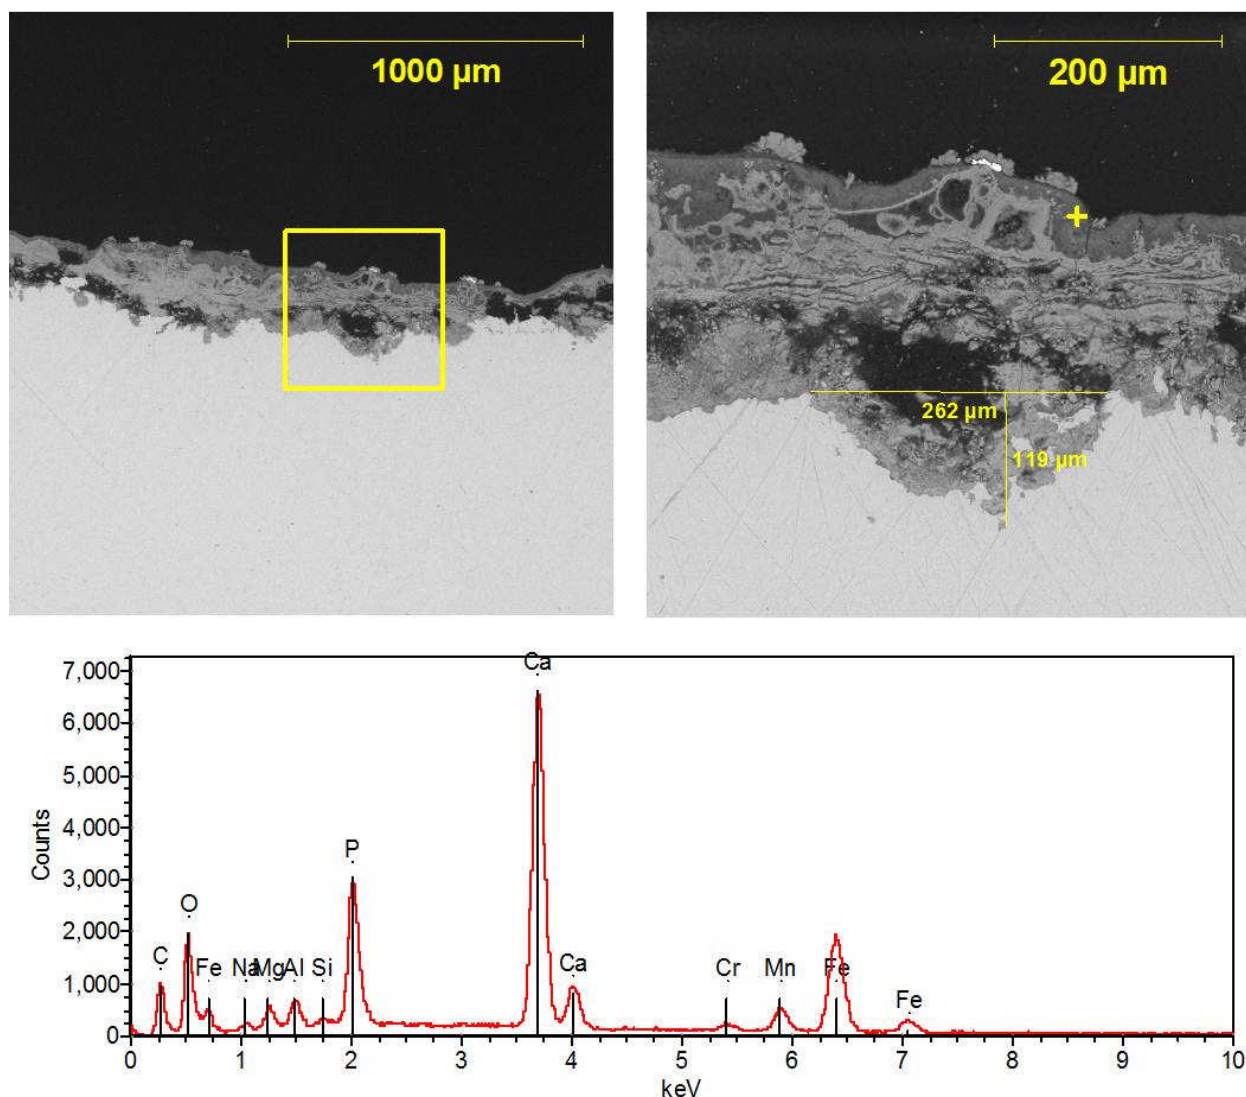
**Figure 2-18. Scanning Electron Microscopy Images of a Pit on Coupon #1 of Jumper B - 2 and an Energy Dispersive Spectroscopy Spectrum of a Tank Waste Layer.**

Another pit detected on the inner pipe surface of coupon #1 is shown in Figure 2-18. The pit is 10.2 mils wide and 4.6 mils deep with iron oxide/hydroxide in the pit and along the surface. Several smaller pits can also be seen near this pit in the left image with various morphologies ranging from undercutting to subsurface. A layer of tank waste residue was also detected on top of the corrosion layer. The EDS spectrum in Figure 2-18 was acquired at the yellow cross and shows the layer to be a calcium phosphate (similar to hydroxylapatite) with trace amounts of

sodium, magnesium, aluminum, and silicon. This tank waste layer was observed across the pipe cross-section, and it maintained a consistent elemental composition suggesting a single phase.

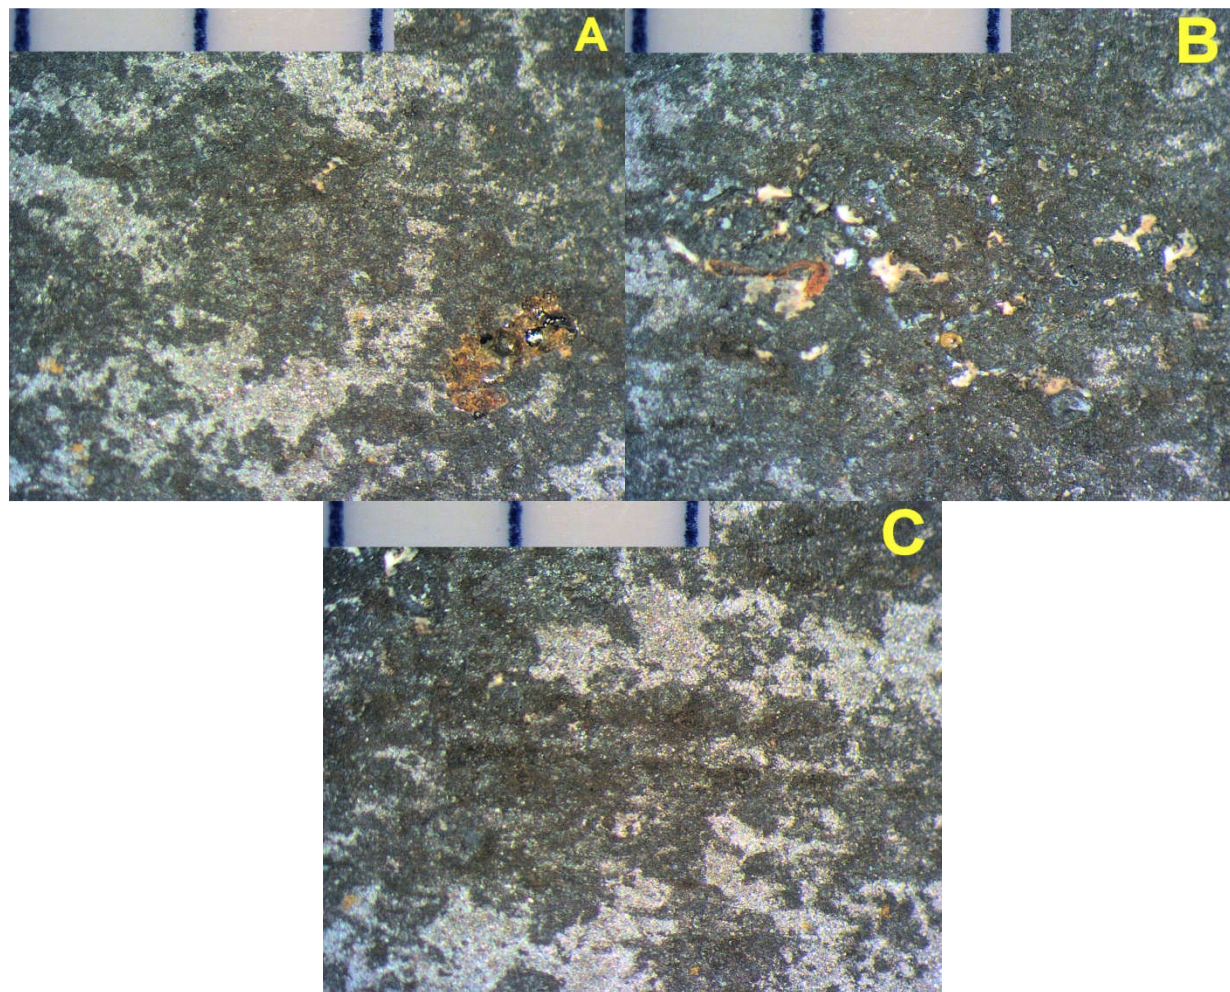
**Figure 2-23. Photomicrographs of Different Locations of the Cleaned Coupon #2 from the B - 2 Jumper.**

The following figure shows three photomicrographs which are magnified views of different areas on coupon #2. The scale bar in the figures is marked at 1/16-inch increments. Figure 2-23A shows that the surface of the pipe is a combination of bare metal (light-gray material) and pitted metal (dark-gray material). A spot of blistering orange-brown corrosion is seen in the lower right which was not fully removed during the citrate treatment. Figure 2-23B was taken on a location of the coupon which displayed flakes of a yellowed, shiny material adhered to the surface (possibly remnants of a tank waste layer). Figure 2-23C is an image that represents the majority of the pipe inner surface, containing a mix of bare metal and a thin layer of pitted metal.

Viewing the inner surface of coupon #2 from jumper B – 2 revealed no features which would positively indicate that erosion-corrosion occurred in this area of the pipe. The effects of erosion-corrosion are reported in the literature as displaying a range of features which are dependent on the Reynolds number of the flowing medium. A turbulent flow tends to produce scalloped or scale-like features on the surface of the pipe with sizes relative to the amount of turbulent flow (more turbulence creates smaller scallops). (Poulson 1991, and “Flow Accelerated Corrosion and Cracking of Carbon Steel Piping in Primary Water – Operating Experience at the Point Lepreau Generating Station,” [Gendron and Slade 2005]).

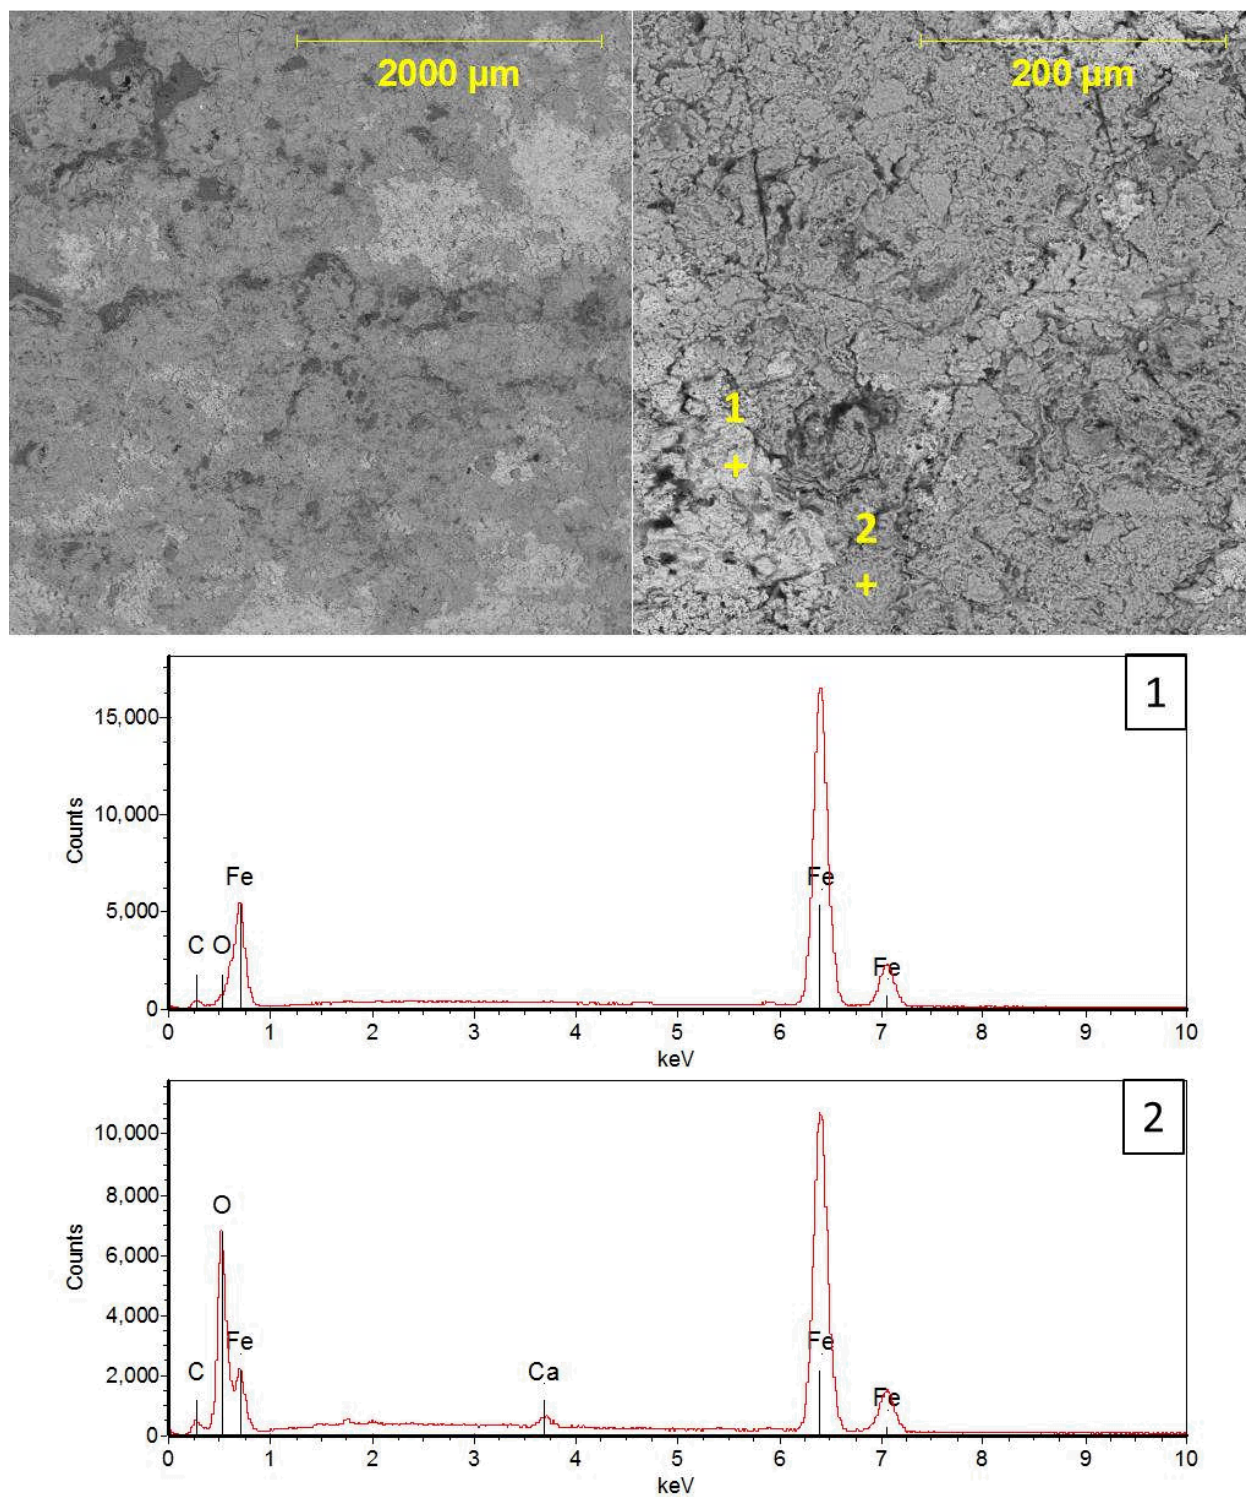
**Figure 2-24. Scanning Electron Microscopy Images and Energy Dispersive Spectrometry Images of Bare Metal and an Oxide Layer on Coupon #2 of Jumper B – 2.**

Figure 2-24 shows two BEI images taken at different magnifications. The left image is a general view of the coupon surface showing three shades of gray on the surface. Since BEI mode produces a brighter image for heavier elements, the brightest areas of the coupon are locations of bare metal while the darker locations are layers on the surface comprised of elements lighter than iron. This is confirmed in the EDS spectra acquired at the marked locations on the magnified image on the right. Spot #1 is from the brighter area, and the elements iron and carbon from the pipe are detected. Spot #2 is from the darker area and shows the presence of oxygen with trace calcium in addition to the metal, indicating a thin layer of oxide on the pipe surface. These different locations were also seen in the photos of the coupon, Figure 2-23, as lighter and darker areas.

The darkest areas in the images of Figure 2-24 are locations where a layer of tank waste residue remained on the coupon after the citrate treatment. The locations where this layer was detected

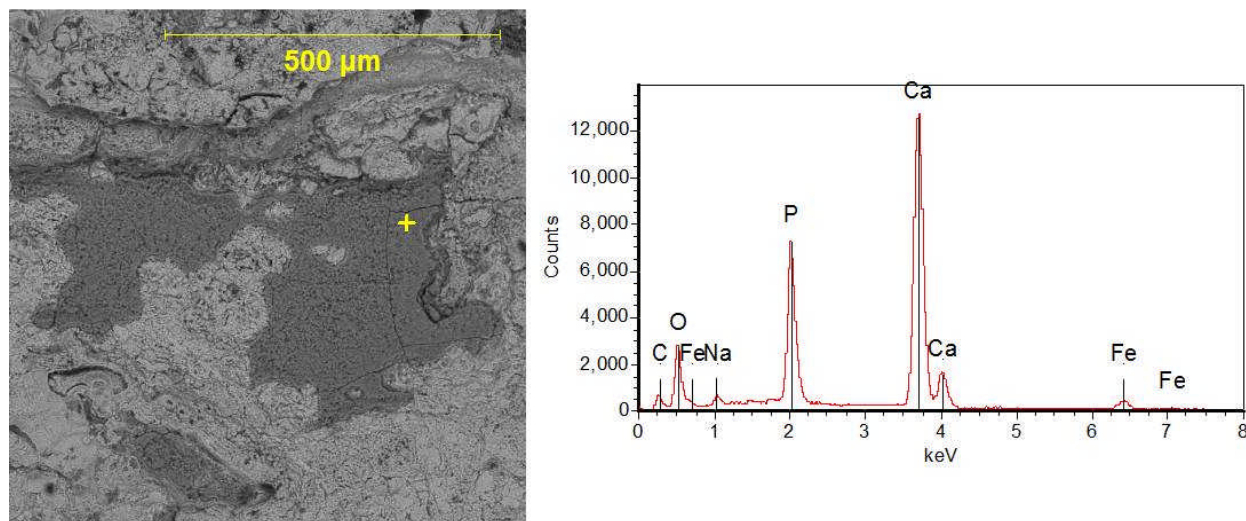
**Figure 2-25. Scanning Electron Microscopy Analysis of a Tank Waste Layer on Coupon #2 of Jumper B – 2.**

tended to be areas of thicker corrosion which may have resulted in a thicker waste layer or prohibited effective removal by the coupon cleaning and scrubbing process. Figure 2-25 shows an SEM image and resulting EDS spectrum of a patch of this tank waste layer. The elemental makeup of the waste suggests a form of calcium phosphate (such as hydroxylapatite).

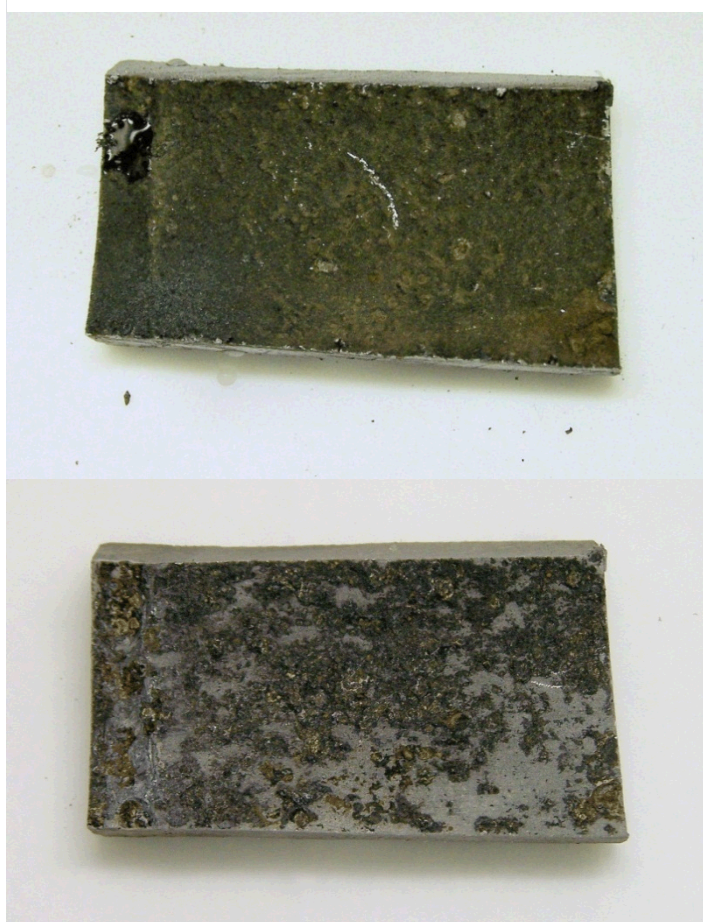
**Figure 2-28. Photos of Coupon #3 from Jumper B - 2 Before (Top) and After (Bottom) Corrosion Removal by the Ammonium Citrate Treatment.**

Photos of coupon #3 from jumper B – 2 were taken before and after the citrate treatment and are shown in Figure 2-28. The upper photo is from before the corrosion removal process, and a dark-brown, rough coating of corrosion and tank waste product is seen across the entire surface. A small scratch in the middle of coupon is from handling with tweezers. The left side of the coupon contains a weld. On the weld is a drop of water from wet tweezers that were used to transfer the coupons to the citrate bath. The lower photo was taken after the citrate treatment, and the surface is free of a majority of the brown layer. A large portion of the pipe surface is bare metal with darker areas (possibly a thin oxide layer). Overall, the total mass loss due to removal of the corrosion and tank waste layers was only 0.4%, indicating that there was only a minimal amount of corrosion and tank waste on the surface.

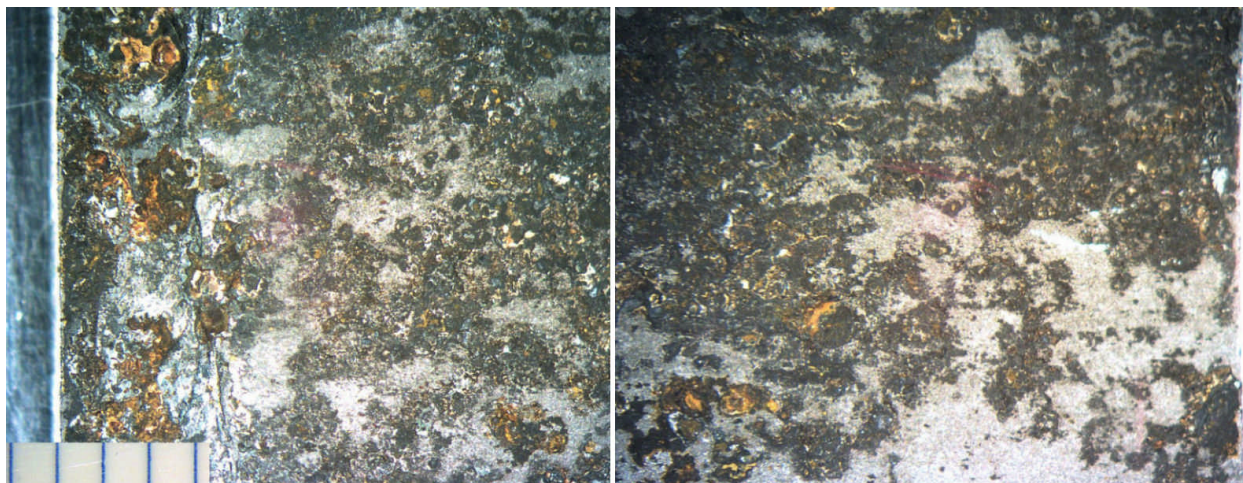
**Figure 2-29. Photomicrographs of Coupon #3 After the Corrosion Layer was Removed.**

The cleaned coupon was then imaged on the optical microscope to look for features which might indicate corrosion or erosion. Figure 2-29 is the combination of two images that show the majority of the span across the coupon since the size of coupon did not allow for a complete view at the lowest magnification. The scale bar in the lower left is in 1/16-inch increments.

A NIST-certified micrometer was used to measure the thickness of the cleaned coupon at the four corners. The resulting thicknesses were 0.232, 0.227, 0.227, and 0.224 inches, and the measured UT thicknesses near these locations were 0.222 and 0.211 inches. The inability to measure at the exact same locations (due to cutting near and on the UT spots and the coating on the outside of the pipe) and the presence of the weld may have contributed to any discrepancy.

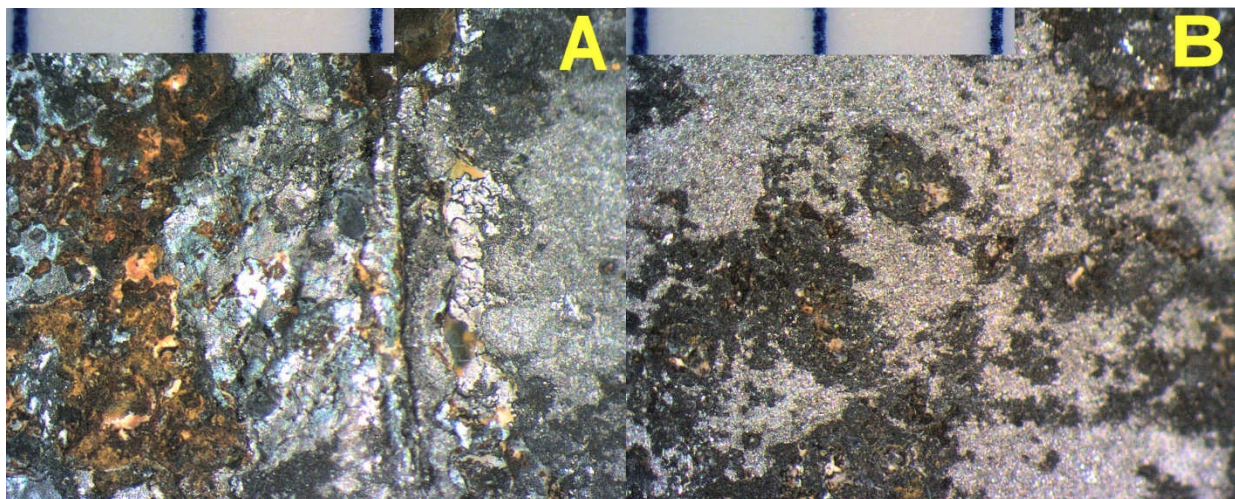
**Figure 2-30. Photomicrographs of Different Locations of the Cleaned Coupon #3 from the B – 2 Jumper.**

The following figure shows two photomicrographs which are magnified views of different areas on coupon #3. The scale bar in the figures is marked at 1/16-inch increments. Figure 2-30A shows the area at the weld where it joins with the pipe (dark line right of center). Some orange-brown corrosion (probably an iron oxide/hydroxide) is adhered to the weld. Overall, there is no scalloping on the pipe surface right of the weld (downstream), indicating no noticeable erosion-corrosion. Figure 2-30B is an image that represents the majority of coupon #3. There are areas of bare metal with patches of a darker, thin layer of the metal oxide and possibly some tank waste residue. The surface appears rough from general corrosion but shows no indications of erosion-corrosion.

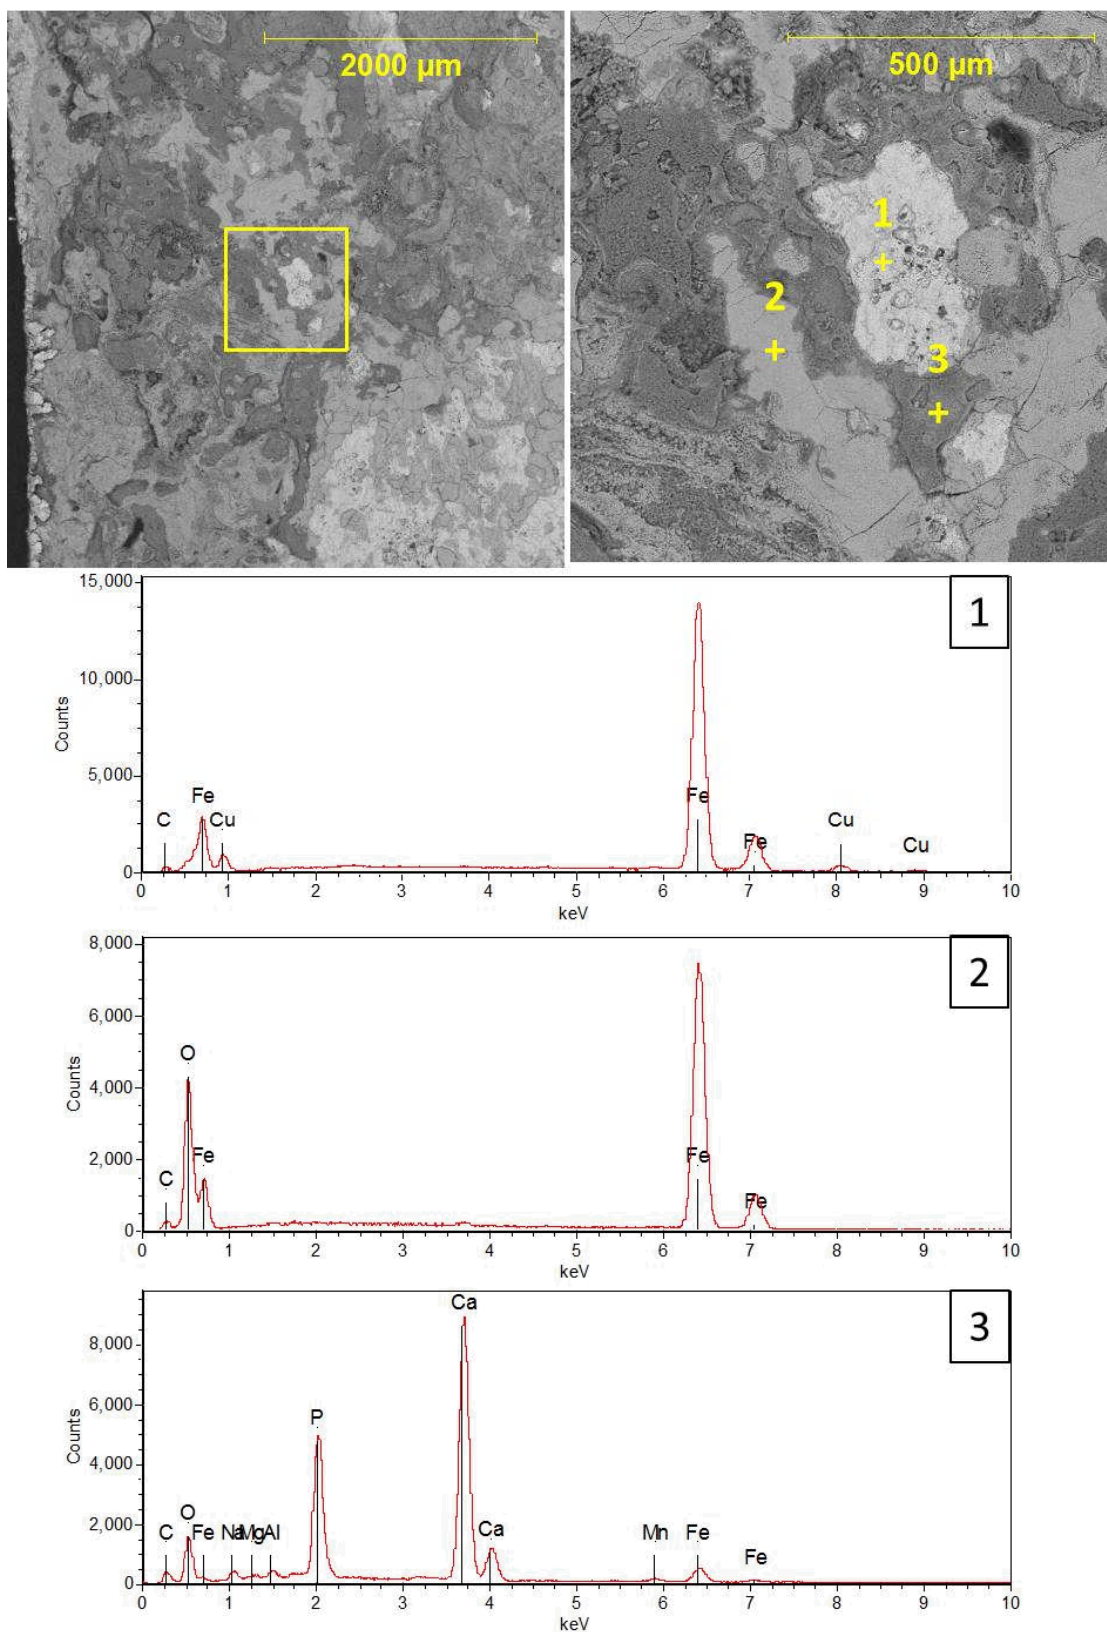
**Figure 2-31. Scanning Electron Microscopy Images and Energy Dispersive Spectrometry Spectra of the Weld on Coupon #3 of Jumper B – 2.**

Figure 2-31 shows two BEI images taken at different magnifications of the weld on coupon #3 of jumper B – 2. The left image is a general view of the weld showing layers of varying shades of gray on the surface. The brightest areas of the coupon are locations of bare metal, while the darker locations are layers of corrosion product and tank waste comprised of elements lighter than iron. This is confirmed in the EDS spectra acquired at the marked locations on the magnified image on the right. Spot #1 is from the brighter area, and the elements of iron and trace copper from the weld are detected. Spot #2 shows the presence of oxygen with iron indicating a layer of oxide on the weld surface. Spot #3 is part of a layer of tank waste which survived the ammonium citrate treatment and is comprised of a calcium phosphate phase such as hydroxylapatite. In general, the weld appears intact with minimal general corrosion and no indication of erosion-corrosion.

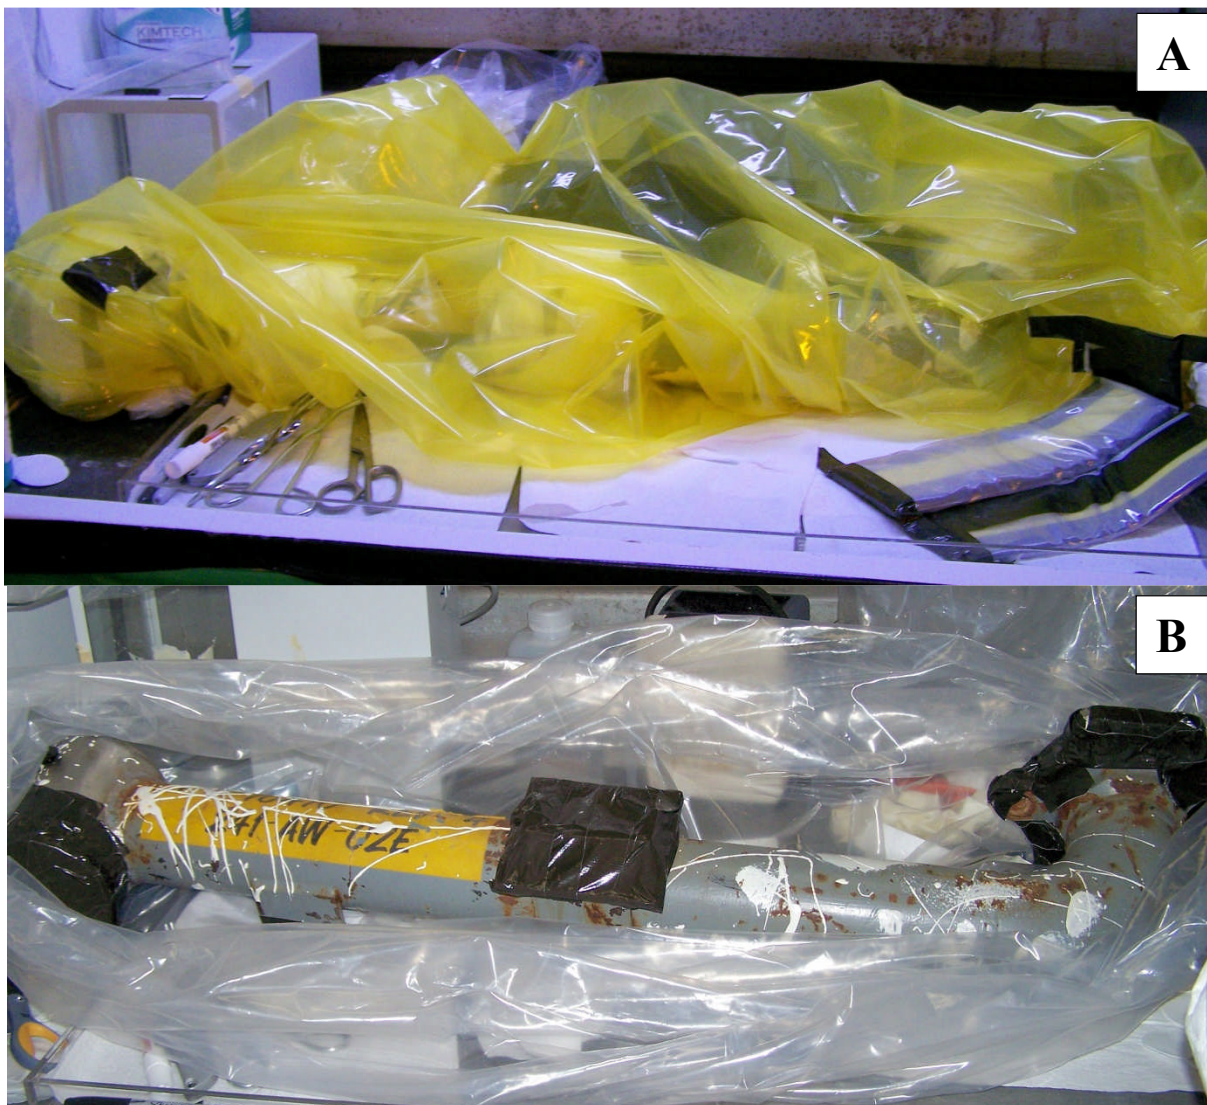
**Figure 3-1. Photographs of the Larger Jumper 1 – 4 Section Before and After Removal of the Packaging.**

Jumper 1 – 4 was received at the 222-S Laboratory in two sections packed inside an 85-gallon drum. The jumper was size reduced as part of the packaging in the field by unbolting the side fittings of a ball valve. This allowed the pieces to meet the size and weight restrictions required for the lab to handle in the hot cell. The larger section was ~3.5 ft long with a single long radius elbow and one Purex connector block, and the smaller section was ~1.0 ft long with a single Purex connector block, see Figure 1-3. The longer section was removed from the drum and placed in hood 1 of room 1-E. Figure 3-1 shows this jumper in its original packaging (A) and after cutting off tape/package and replacing the packaging with a new bag (B), which aided in the control of the removable contamination on the jumper. Similar to jumper B – 2, several locations on jumper 1 – 4 contained patches and splatters of a white paint. In addition, a large, yellow label was attached to the pipe near the connector block end of the jumper. The paint and label interfered with some of the requested UT measurements due to the thickness and roughness of the coatings. Several rust spots were also present on the jumper, especially on the bottom of the pipe, possibly from repeated hanging droplets of moisture during its lifetime in the pump pit. These rust spots were a source of higher levels of removable contamination and made it more challenging to decontaminate. Some areas of rust, where no UT measurements were planned, were covered with tape. The ends were also covered with rubber matting and tape. Similar to jumper B – 2, templates were used to mark the locations of the UT measurements. Notes were made on the UT data sheets (Attachment A) when the measurements were acquired in the areas of paint, label, or rust.

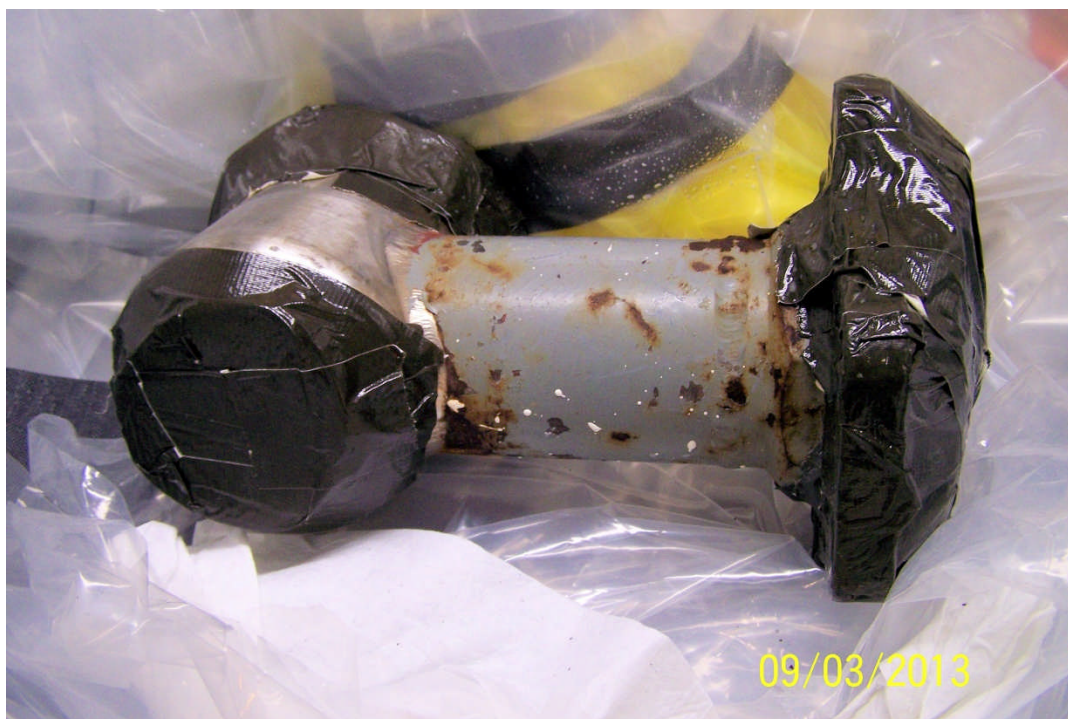
**Figure 3-2. Photo of the Smaller Section of Jumper 1 – 4 After Decontamination.**

The smaller section of jumper 1 – 4 was removed from the shipping drum and placed in hood 1 of room 1 – E after the decontamination process was finished on the longer section. During the packaging removal, high levels of removable contamination were measured on the pipe surfaces. The pipe was decontaminated using a series of wet and dry wipes with paper towels, and the ends were covered with three layers of rubber matting and tape to bring the removable contamination and dose levels down to enable the UT measurements. Figure 3-2 shows a photograph of the smaller jumper 1 – 4 section after decontamination.

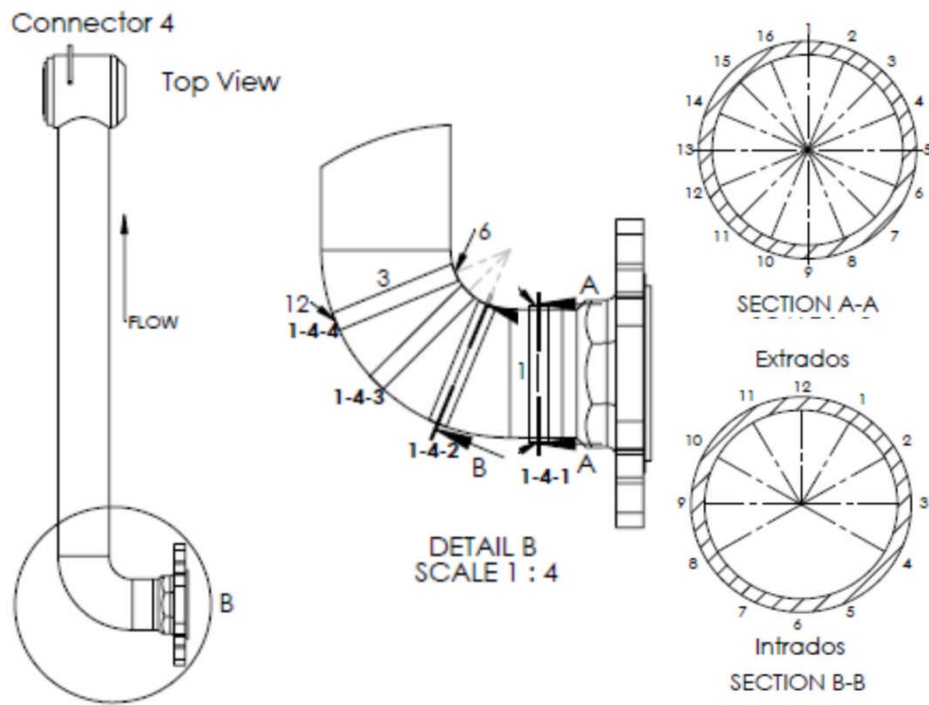
**Figure 3-3. Locations of Ultrasonic Transducer Thickness Measurements on the Inlet Area of Jumper 1 – 4.**

UT thickness measurements were acquired on the pipe and connector blocks. The 3-inch carbon steel pipe contained straight piping and one long radius 90-degree elbow. Measurements on the straight piping consisted of 16 equally-spaced points around the perimeter of the pipe forming a band. Figure 3-3 shows a drawing of the larger section of jumper 1 – 4 with several of these bands located on the inlet side of the pipe. The elbow sections consisted of 12 equally-spaced points around the pipe perimeter. The three points on the intrados of the bend were not requested (see Figure 3-3) due to the inability to properly lay the UT probe on the pipe surface in this area. The corresponding UT pipe wall thickness results for the labeled bands in Figure 3-3 are shown in Tables 3-1 and 3-2.

Similar to jumper B – 2, there was no significant thinned section on this area of the pipe. The thinnest measurement of 0.224 inches was located on the bottom of the elbow (as arranged in the drawing in Figure 3-3).

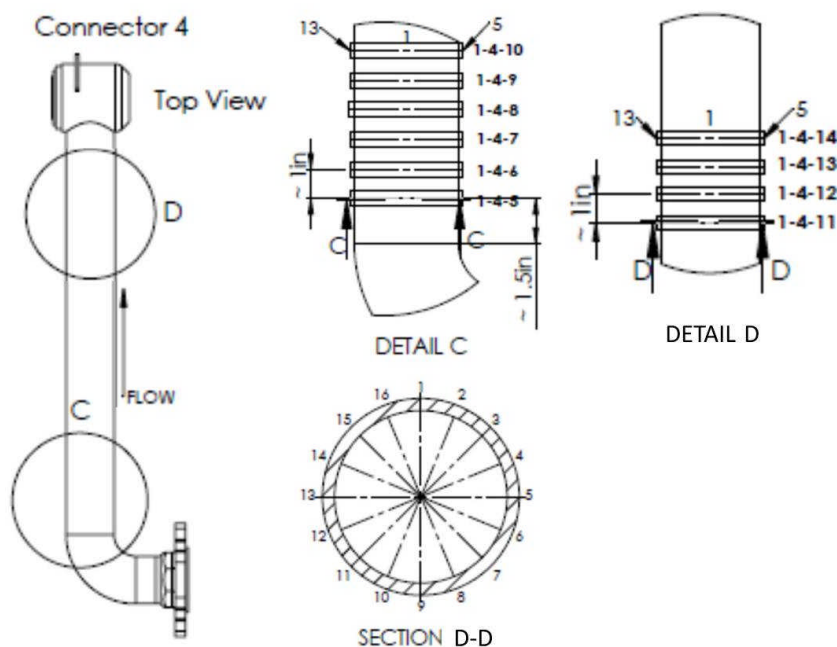
**Figure 3-4. Locations of Ultrasonic Transducer Thickness Measurements on the Outlet Area of Jumper 1 - 4.**

Two more straight sections were analyzed by the UT, Figure 3-4. The section closest to the outlet contained a large yellow label painted onto the pipe. Pipe thickness measurements were acquired over the label, but the quality of the measurement is suspect due to the roughness and thickness of the paint. The UT measurement results are shown in Tables 3-3 and 3-4. The locations of the coupons cut from the jumper are marked with the dashed box around the UT measurement results. The locations were chosen based on the UT results and through consultation with the customer.

The thinnest wall reading was measured on the straight section immediately after the elbow and was 0.211 inches. There were several locations on this section that contained droplets of the white paint (see Figure 3-1), however, the UT measurements were still obtained. The following straight section had a yellow label painted or applied to the surface. The thickness measurements in this location did produce results about a hundredth of an inch thicker than the pipe without a label. The discrepancy may have resulted from the different sound velocity and thickness of the label. In all, the UT measurements were above or around the nominal wall thickness of 0.216 inches, and no definitive areas of wall thinning were observed.

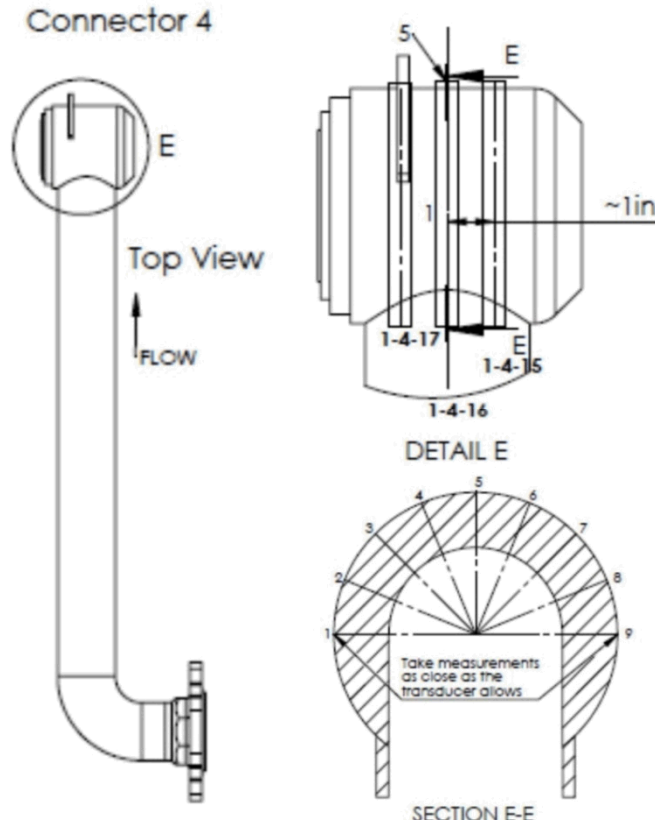
**Figure 3-5. Locations of Ultrasonic Transducer Thickness Measurements on Connector 4 of Jumper 1 - 4.**

The jumper section also contained a Purex connector block. A drawing of the connector block is in Figure 3-5 which shows the UT measurement locations around this pipe section. The results

for this pipe section are in Table 3-5. Many of the UT measurement locations on this connector contained either a bar welded to the surface or droplets/splatters of white paint, but the measurements that were acquired do show good consistency in the thicknesses, indicating the precision of the fabrication and lack of any erosion-corrosion.

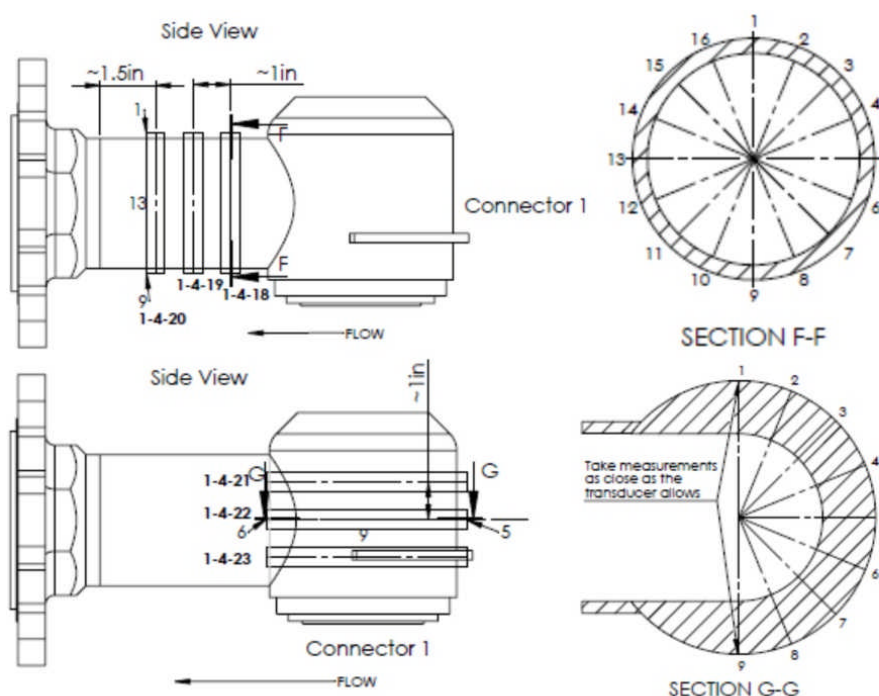
**Figure 3-6. Locations of Ultrasonic Transducer Thickness Measurements on the Straight Section and Connector 1 of the Smaller Pipe Section of Jumper 1 - 4.**

The smaller pipe section of jumper 1 – 4 contained one straight section and one Purex connector block. Figure 3-6 shows two drawings of this pipe section. The first drawing shows the measurements for the straight section, and the second drawing shows the locations for the measurements for the connector. Tables 3-6 and 3-7 contain the results from the UT pipe wall thickness measurements.

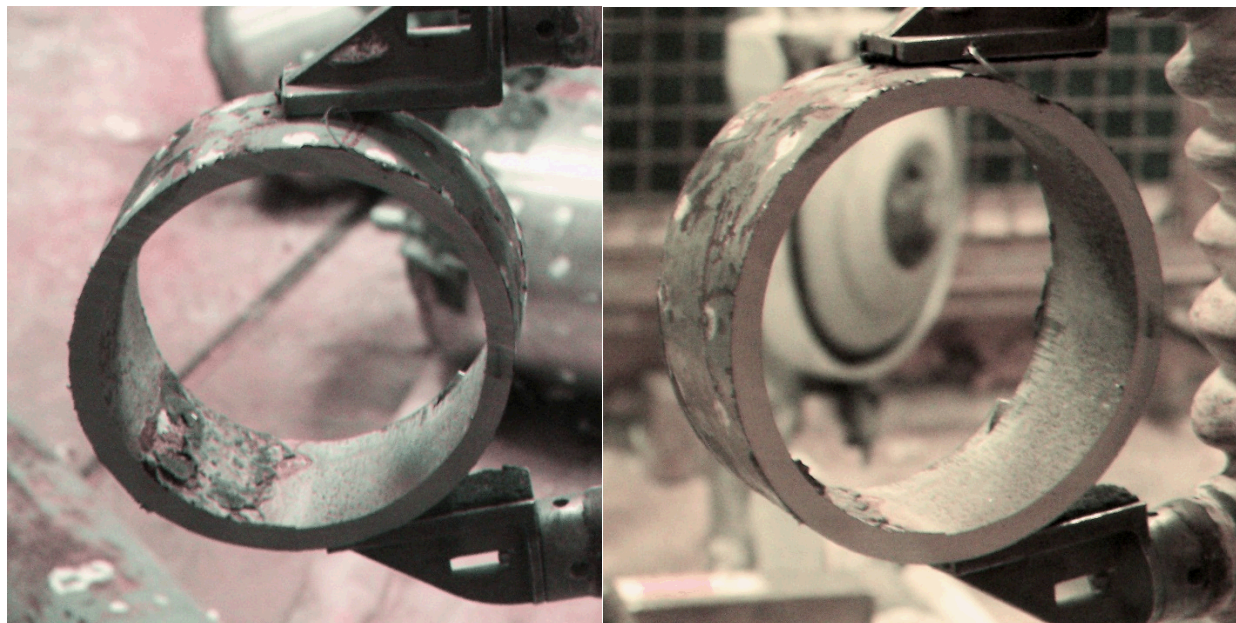
**Figure 3-7. Photos of a Ring Cut from the Short Pipe Section of Jumper 1 – 4.**

The smaller pipe section of jumper 1 – 4, containing connector 1, was cut first. Initial cuts removed the large flange (ball valve side fitting) and liberated an ~1.5-inch wide ring of straight pipe. Figure 3-7 shows this ring from two different angles. A majority of the inner surface of the ring appears free of residue and corrosion; however, an area of platy corrosion and/or tank waste residue can be seen in the left image which is located at the bottom of the pipe. In addition to the coupon selected by the UT measurements, a coupon which captured this platy material was also cut from this ring at that location.

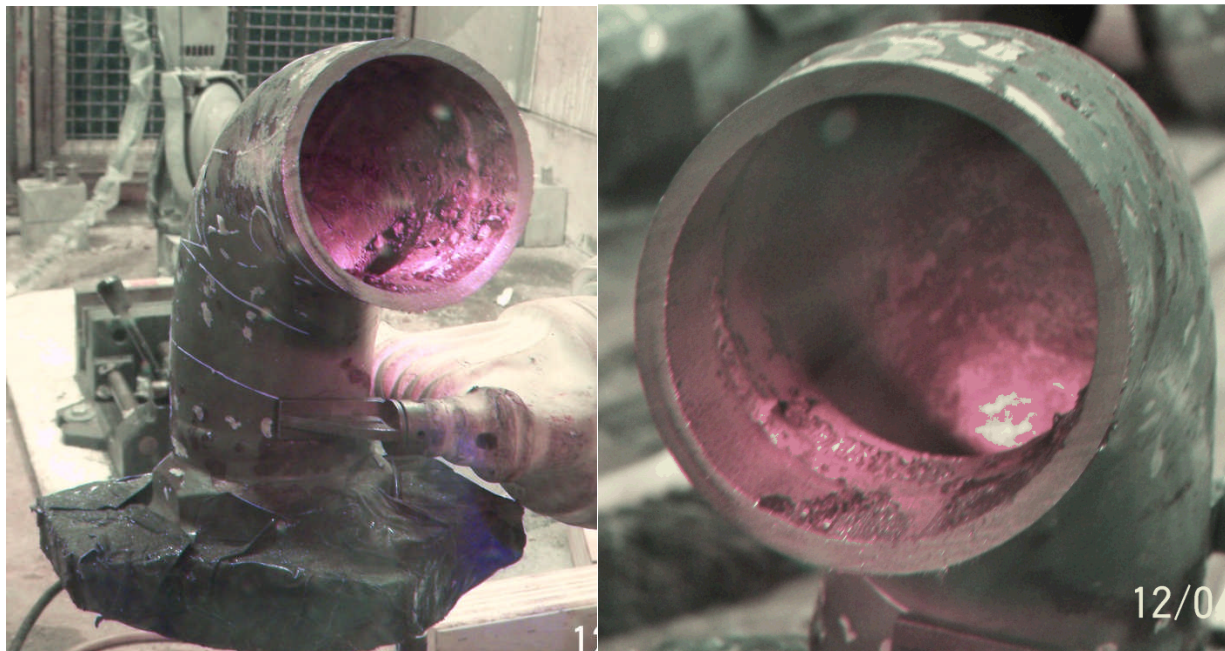
**Figure 3-9. Photos of the Elbow Section on Jumper 1 – 4.**

Two coupons were cut from the longer pipe section of Jumper 1 – 4. The first cut of this pipe section allowed a visual inspection of the inside of the elbow. Figure 3-9 shows two photos of the elbow at different viewing angles. Larger particles adhered to the wall were located on the bottom inner surface, and a thin residue appears to coat the entire inner wall. These particles were also observed in the straight pipe section immediately downstream of the elbow, Figure 3-10. A spatula was used to scrape and collect some of the particulate for X-ray diffractometry (XRD) and SEM analysis.

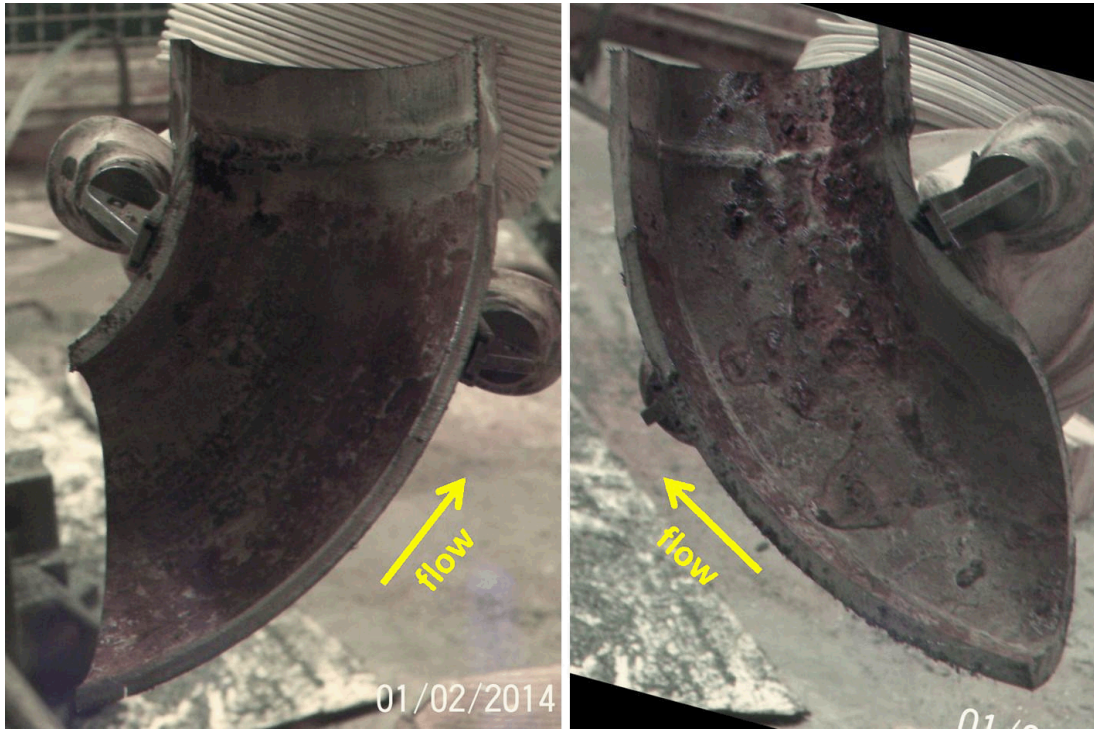
**Figure 3-11. Photographs of the Elbow in Jumper 1 – 4 which was Clamshelled to Allow Visual Observation of the Wall and Interior.**

The elbow in jumper 1 – 4 was isolated by cutting with the band saw and then clamshelled. The clamshell cut was accomplished using a combination of a portable band saw and cut-off wheel in the hot cell. The clamshell cut allowed a visual inspection of the extrados and intrados pipe walls of the 90-degree elbow to look for any wall thinning from impingement or erosion-corrosion of the flowing liquid. Figure 3-11 shows photos of the resulting sections of the elbow, taken through the hot cell window. Three observations were gained by this clamshell cut. First, there was not an appreciable thinning of the pipe wall on the elbow. If erosion-corrosion-associated wall thinning had taken place, it would most likely be located at the extrados wall between the weld and the center of the elbow (Poulson 1999). Second, the clamshell section in the right image was located on the bottom side of the pipe. There is considerably more corrosion and residue on this section as the liquid flowed on this section and possibly pooled when the flow was stopped. Third, the weld is intact with no visual erosion-corrosion near or on the weld.
