# **Final Report for the Erosion-corrosion Analysis of Tank 241-AW-02E Feed Pump Pit Jumpers B-2 and 1-4 Removed from Service in 2013**

**J. S. Page**

Washington River Protection Solutions LLC

March 2014

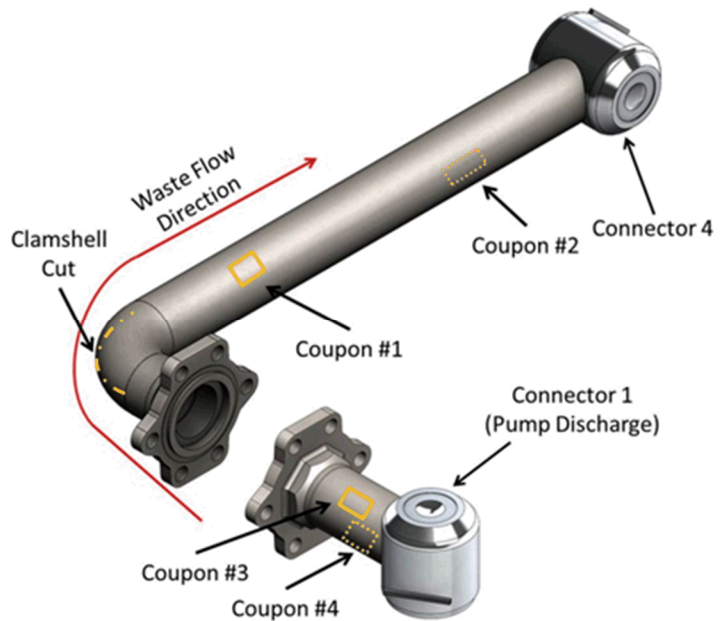
**Figure 3-12. Jumper 1-4 Showing the Locations of the Coupons.**

In total, four coupons were cut from jumper 1 – 4, and the elbow was clamshelled. Figure 3-12 shows the approximate locations of these cuts; for the exact locations see Figures 3-4 and 3-6 and Tables 3-3, 3-4, and 3-6.

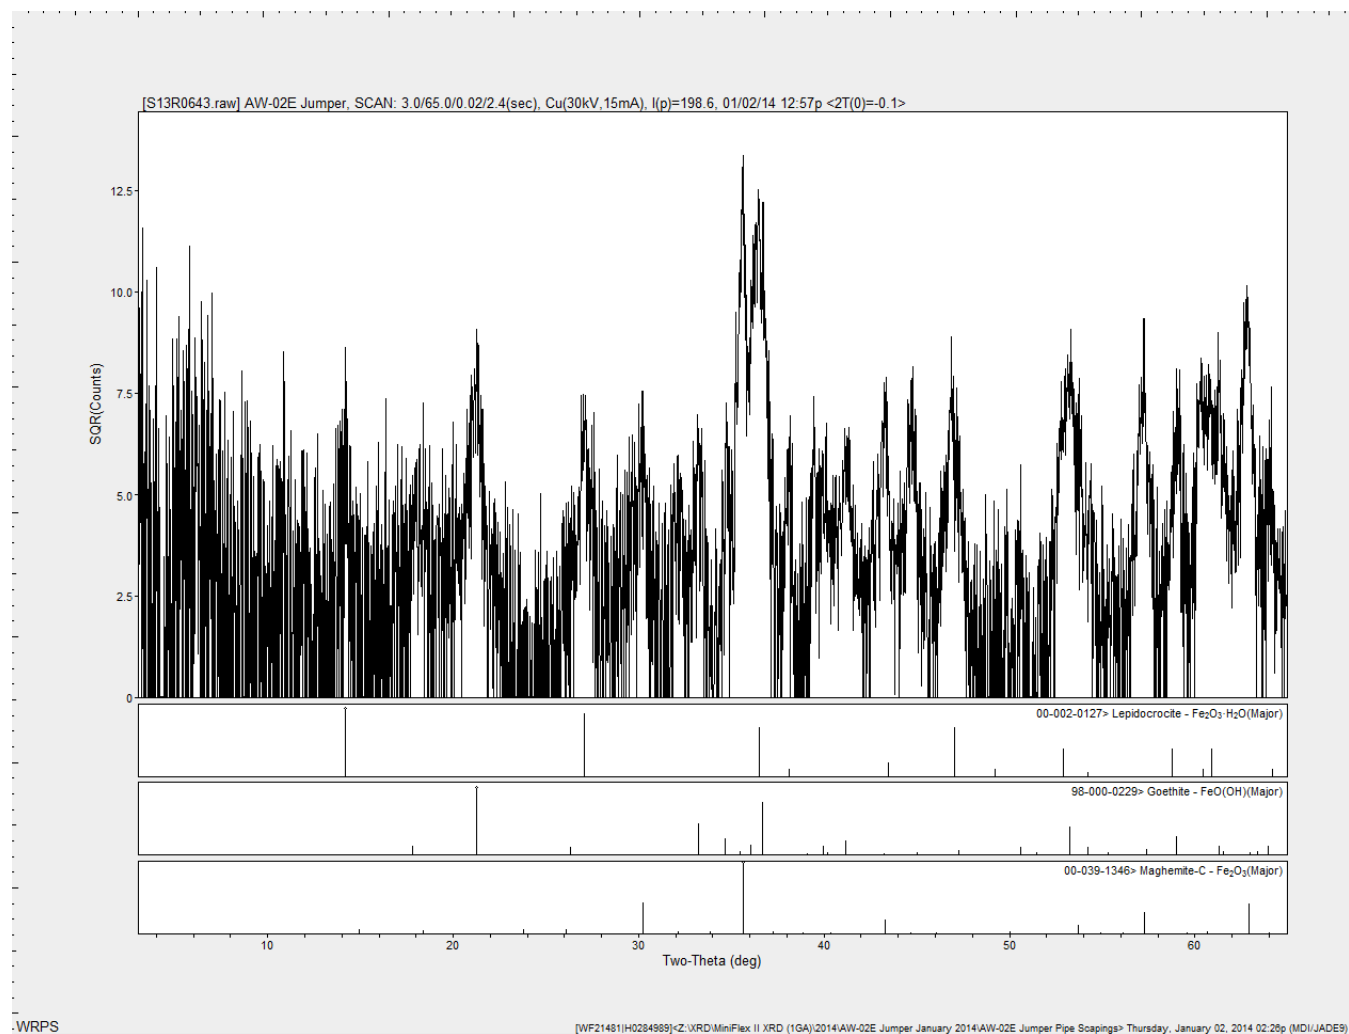
**Figure 3-13. X-ray Diffraction Pattern, Sample S13R000643.**

Three iron-bearing phases, consistent with particulate derived from steel, were observed in the pipe scrapings sample, Table 3-8. The three major phases were goethite [FeO(OH)], lepidocrocite [Fe<sub>2</sub>O<sub>3</sub>•H<sub>2</sub>O], and maghemite [Fe<sub>2</sub>O<sub>3</sub>], which are consistent with rust-type material. The low peak intensity and an increased background were observed in the raw spectrum during the XRD analysis of the sample. This suggests the presence of mostly amorphous material and few crystalline phases, contributing to the difficulty of phase identification. Figure 3-13 is the XRD spectrum with the background subtracted and phase peak matches below. At least one minor/trace phase could potentially remain unidentified in the diffraction pattern.

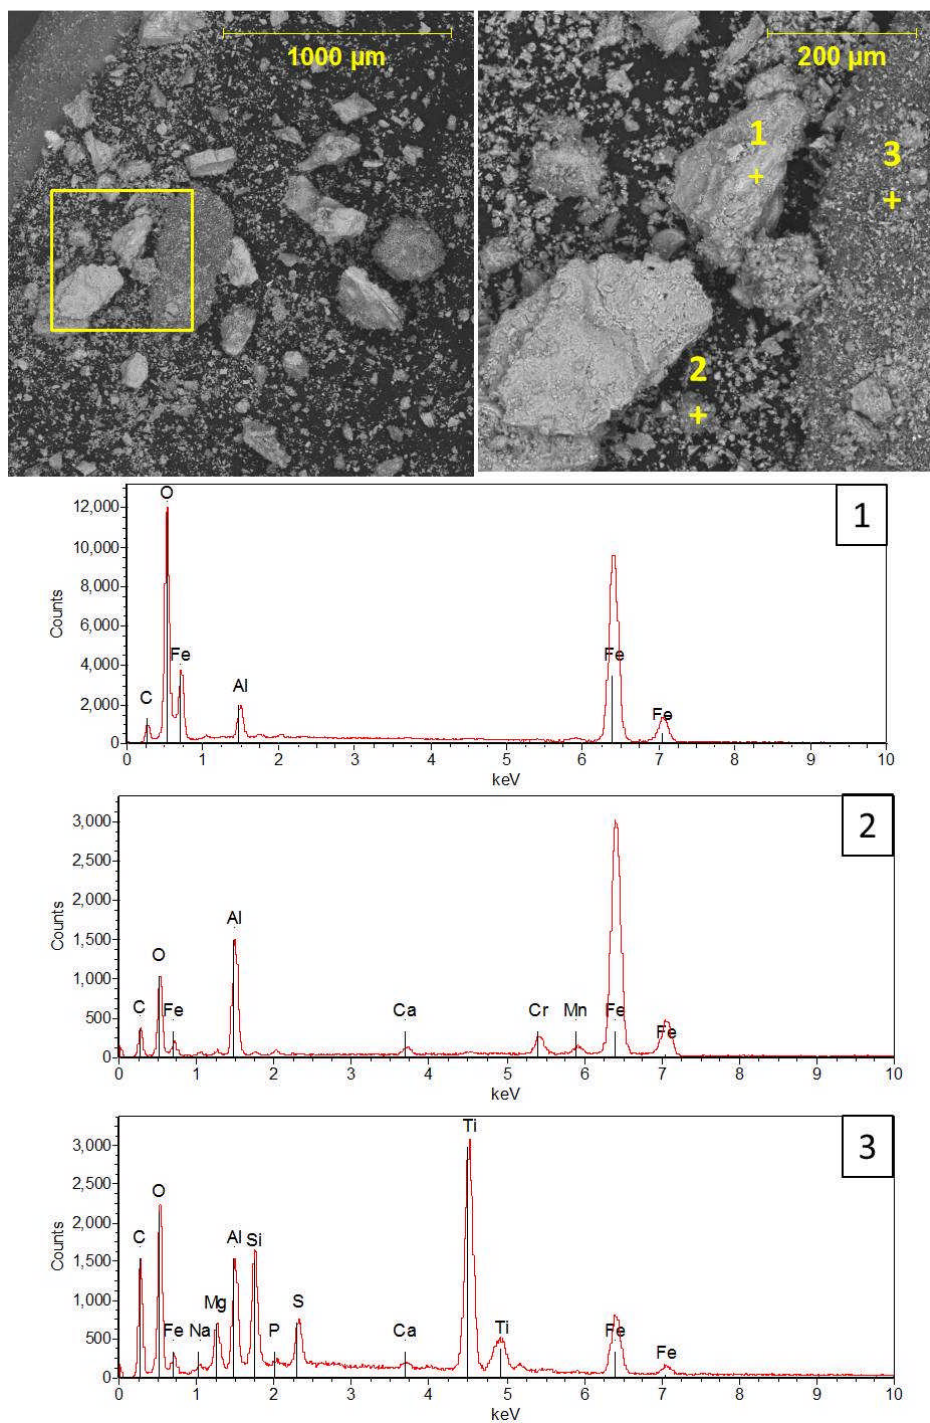
**Figure 3-14. Scanning Electron Microscopy and Energy Dispersive Spectrometry of the Pipe Scrapings from Jumper 1 – 4.**

Analysis of the scrapings by SEM confirmed the findings in the XRD analysis which determined the particulate to be mainly iron oxide/hydroxide. The SEM analysis also found various tank waste components and possible soil particles, Figure 3-14, embedded in the corrosion products.

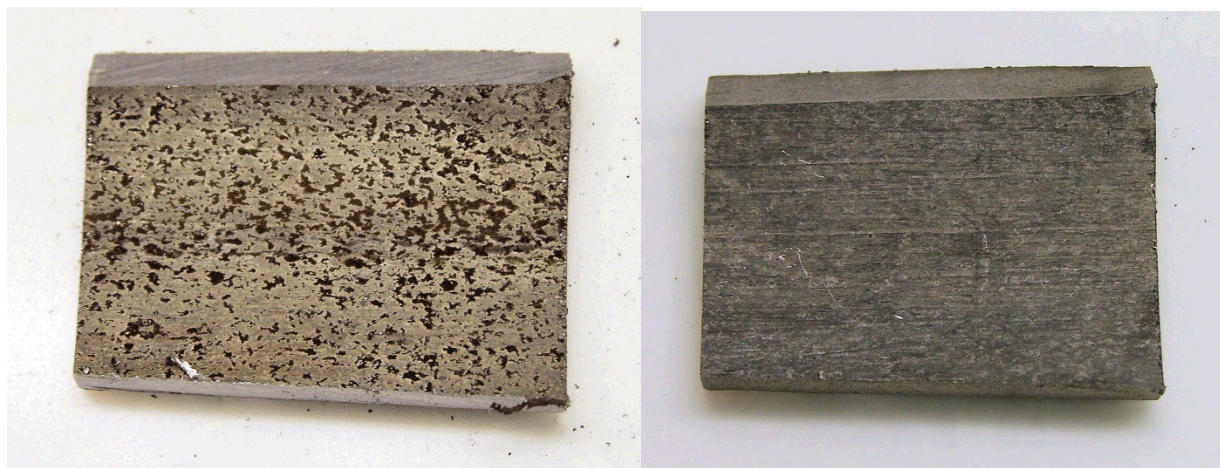
**Figure 3-15. Photographs of Coupon #1 of Jumper 1 – 4 Before and After the Ammonium Citrate Corrosion Removal Process.**

Photos of coupon #1 from jumper 1 – 4 were taken before and after the citrate treatment and are shown in Figure 3-15. The left photo was taken before the corrosion removal process, and a scattering of dark brown spots is seen across what appears to be a bare metal surface, although the sheen on the surface may be from a thin coating or residue. The right photo was taken after the citrate treatment, and the surface is free of the brown spots, leaving bare metal. Some horizontal striations can also be observed on the inner surface of the pipe. Overall, the total mass loss due to removal of the corrosion and tank waste layers was only 0.1%, indicating that there was only a minimal amount of corrosion and tank waste on the surface; this amount was even less than what was removed from the two B – 2 jumper coupons.

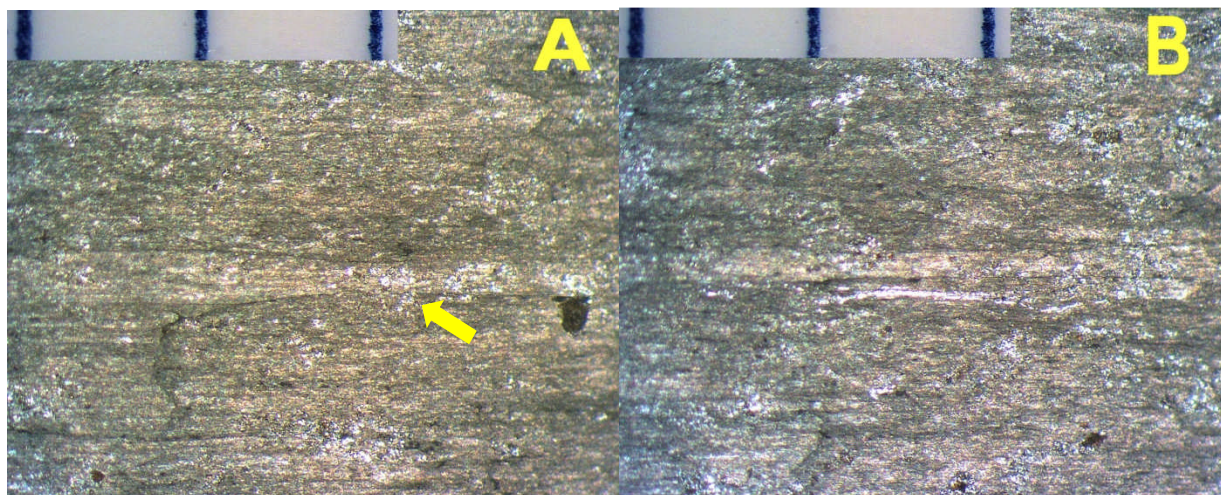
**Figure 3-17. Photomicrographs of Different Locations of the Cleaned Coupon #1 from the 1 – 4 Jumper.**

The following figure shows two photomicrographs which are magnified views of different areas on coupon #1. The scale bar in the figures is marked at 1/16-inch increments. Figure 3-17A shows that most of the inner pipe surface is rough, bare metal. One spot of dark-brown material at the right of the image, possibly corrosion, is still on the coupon. The area in the image also shows part of a striation. This striation appears to be from pipe manufacturing, as an area of small pits on the striation overlaps with the bare surface (see the arrow on the photo), suggesting the striation was present during general corrosion on the pipe wall. Overall, there is no scalloping on the pipe surface or other features that would positively indicate erosion-corrosion. Figure 3-17B is an image from another location on coupon #1. The surface appears rough from general corrosion but there are no indications of erosion-corrosion. The lack of a control sample limits the ability to more fully interpret the small differences between the UT and actual measured thicknesses that were observed.

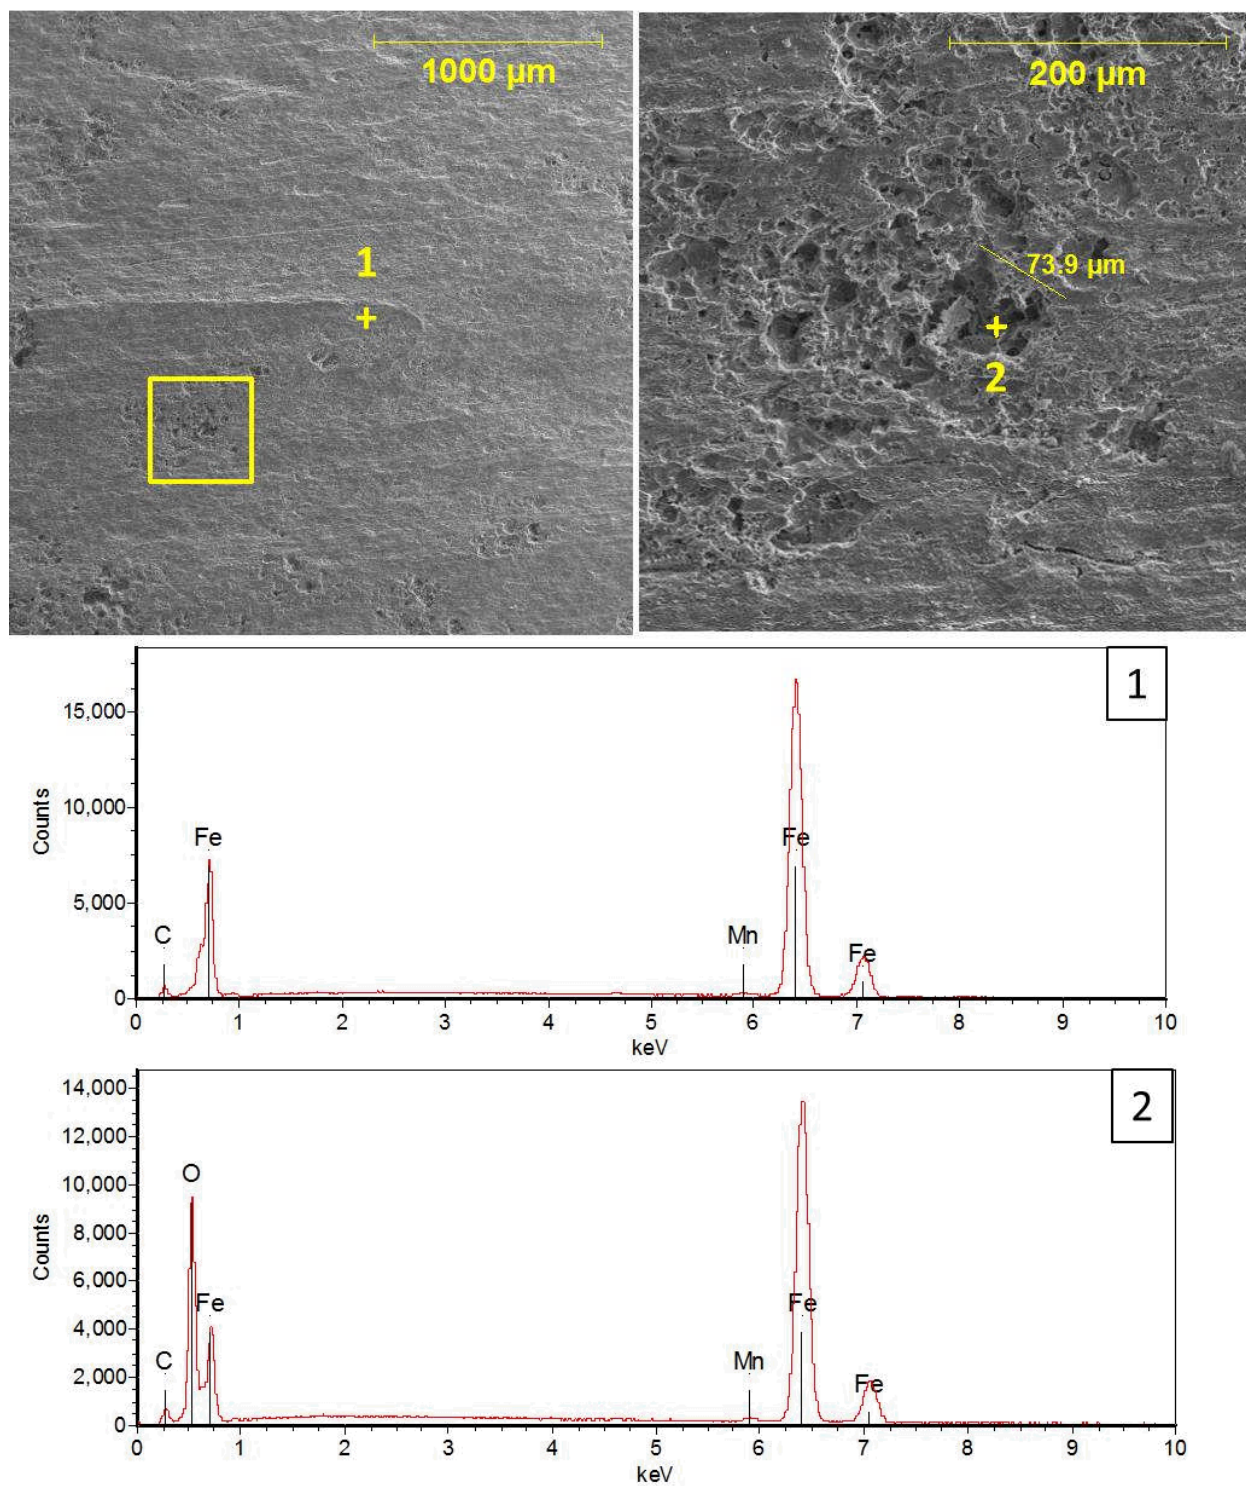
**Figure 3-18. Scanning Electron Microscopy Images and Energy Dispersive Spectrometry Spectra of the Surface of Coupon #1 of Jumper 1 – 4.**

Figure 3-18 shows two SEI images of a general area on coupon #1 of jumper 1 – 4 taken at different magnifications. The lower magnification left image shows a clean surface with some clusters of small pits. The EDS spot #1 was taken at the termination of one of the striations seen in Figure 3-16 and confirms that the surface is a bare metal free of an oxide. The magnified image on the right is from the area marked by the yellow box on the left. This image displays one of the clusters of small pits showing one pit which measured 2.9 mils (73.9  $\mu\text{m}$ ) across. The EDS spectrum acquired at spot #2 shows that an iron oxide is inside the pit.

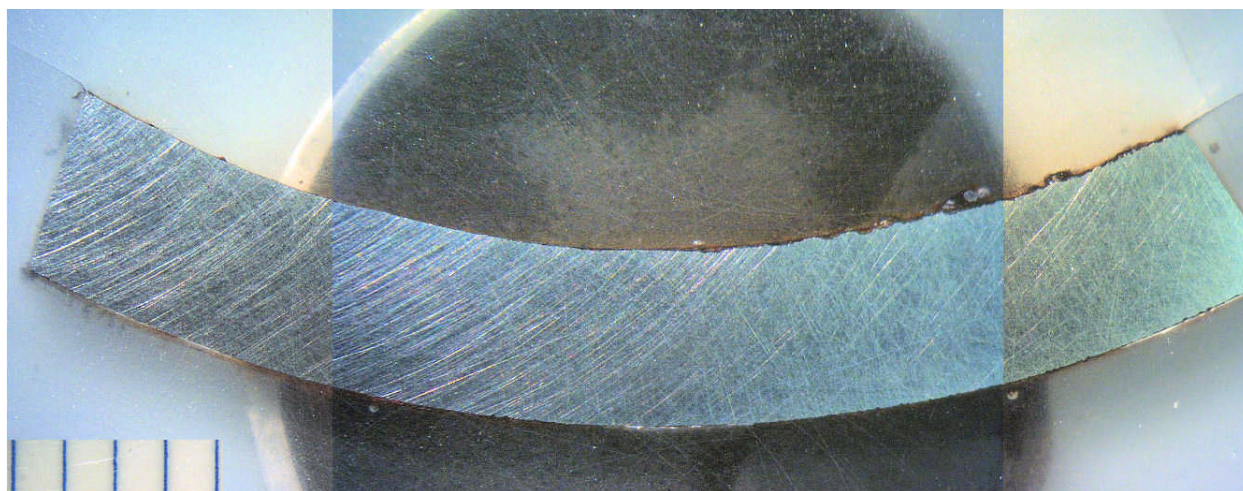
**Figure 3-21. Microphotograph of the Cross-Section Cut from Coupon #2 of Jumper 1 – 4.**

Visual inspection of the cross-section in Figure 3-21 shows that the pipe wall is intact with no areas of wall thinning due to erosion-corrosion. The right side of the image shows that the inner surface of the pipe here contains small pits along the cross-section and a thin layer of corrosion and/or tank waste. In contrast, the left side of the image appears less corroded at this magnification, indicating a non-uniform corrosion of the pipe.

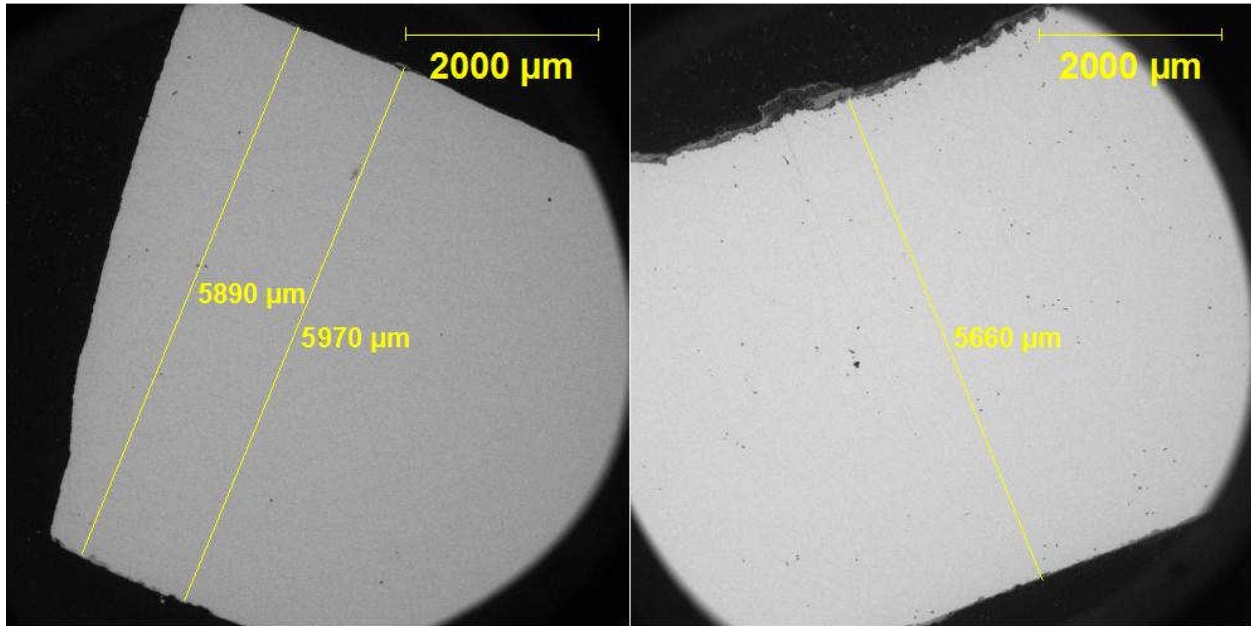
**Figure 3-23. Scanning Electron Microscopy Images at the Lowest Magnification with Measurements of the Pipe Wall Thicknesses.**

The cross-section was next analyzed by SEM, which provided further information on the integrity of this pipe section and the identification of the surface layer. Figure 3-23 contains two SEM images at the lowest instrument magnification to show and measure the entire wall thickness at two different locations on the cross-section (far left and far right sides). Conversion of the SEM-measured distances from micrometers to inches shows that the measurements in Figure 3-23 are 0.235 inches on the left and 0.223 inches on the right side of the cross-section. The UT measurements of this coupon ranged from 0.228 to 0.217, Table 3-4. The cross-section was cut in an area between the UT measurement locations, and although the SEM distances were slightly greater than the UT measurements, they are similar to what was measured by the UT.

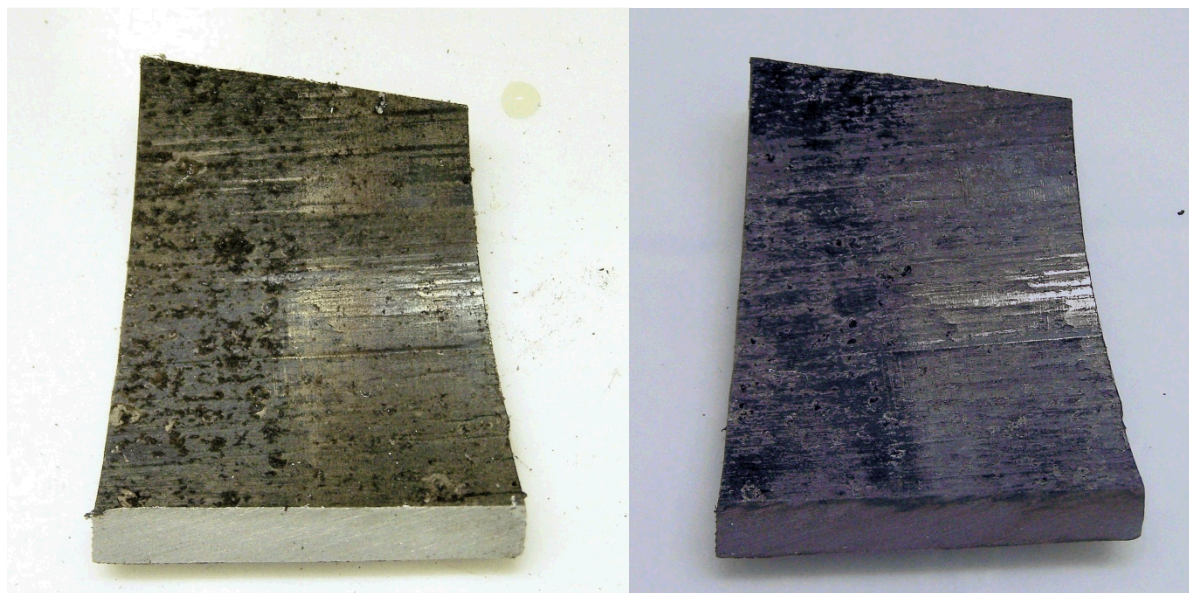
Photos of coupon #3 from jumper 1 – 4 were taken before and after the citrate treatment and are shown in Figure 3-27. The left photo is from before the corrosion removal process, and, like coupon #1 of jumper 1 – 4, a scattering of a dark-brown spots is seen across what appears to be a bare metal surface, although the sheen on the surface may be from a thin coating or residue. The right photo was taken after the citrate treatment, and the surface is free of the brown spots but black spots are scattered on the left side of the coupon. Some horizontal striations can also be observed on the inner surface of the pipe. Overall, the total mass loss due to removal of the corrosion and tank waste layers was only 0.1%, which indicates that there was only a minimal amount of corrosion and tank waste on the surface.

**Figure 3-27. Photographs of Coupon #1 of Jumper 1 – 4 Before and After the Ammonium Citrate Corrosion Removal Process.**

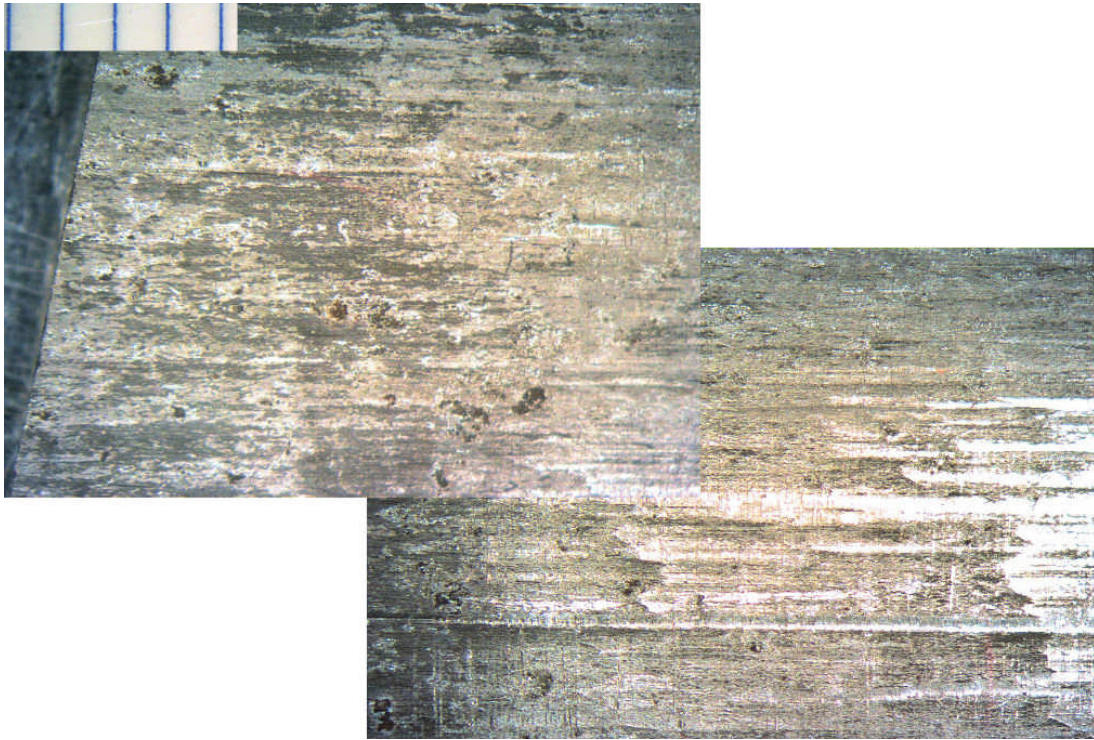
The cleaned coupon was then imaged on the optical microscope to look for features which might indicate corrosion or erosion. Figure 3-28 is the resulting mosaic of two combined images since the size of the coupon did not allow for a complete view at the lowest magnification. The scale bar in the upper left is in 1/16-inch increments.

**Figure 3-28. Photomicrograph of the Cleaned Coupon #3 from Jumper 1 – 4.**

A NIST-certified micrometer was used to measure the thickness of the cleaned coupon at the four corners. The resulting thicknesses were 0.213, 0.214, 0.209, and 0.205 inches, and the measured UT thicknesses near these locations were 0.225, 0.223, 0.216, and 0.214 inches. The inability to measure at the exact same locations (due to cutting near and on the UT spots and coatings on the outside of the pipe) may have contributed to any discrepancy. In general, the readings from the UT tend to be slightly thicker than what was measured directly by the micrometer.

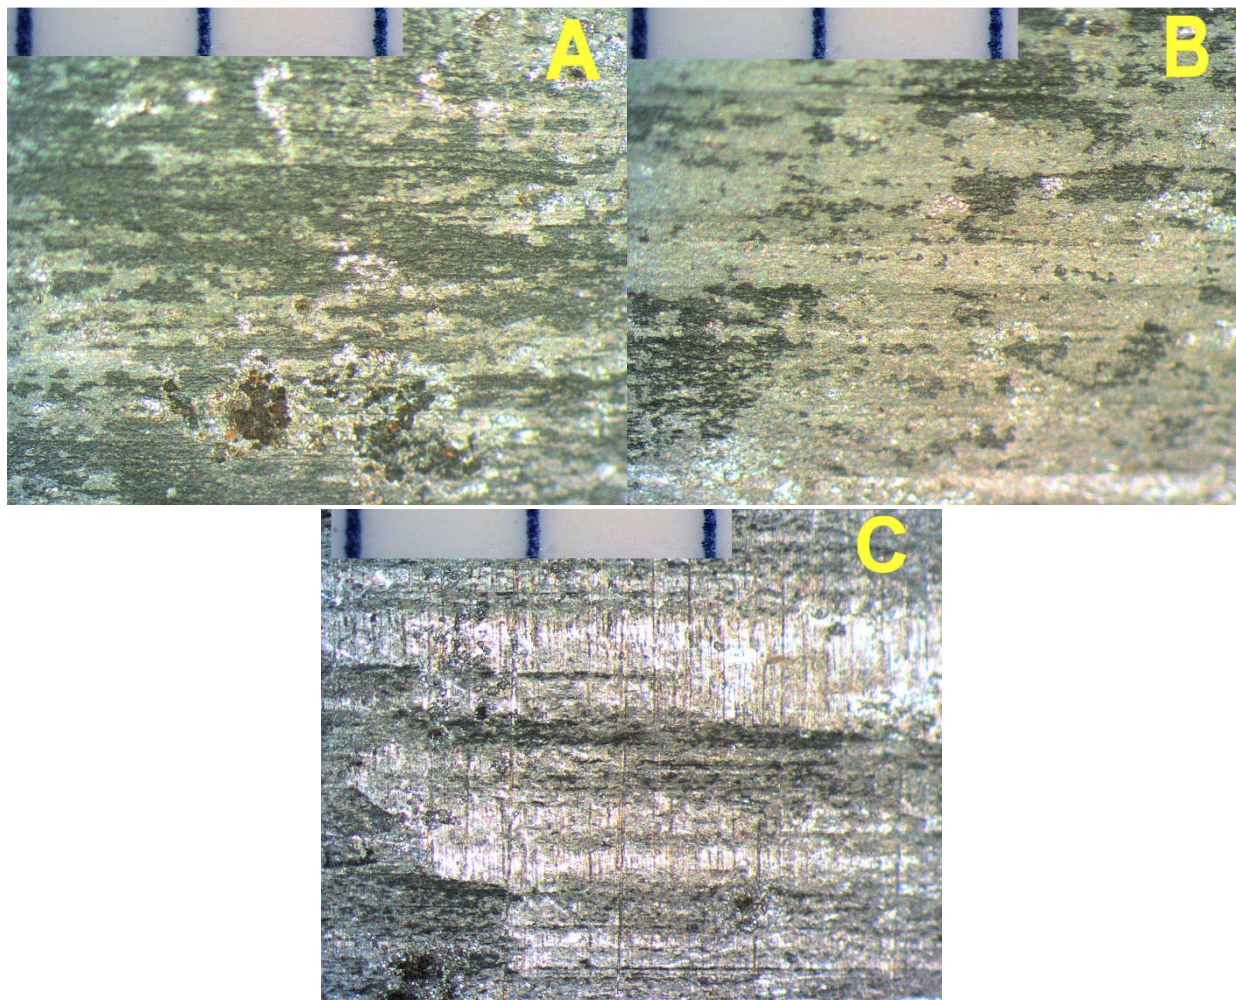
The following figure shows three photomicrographs which are magnified views of different areas on coupon #3. The scale bar in the figures is marked at 1/16-inch increments. Figure 3-29A shows that most of the inner pipe surface is rough bare metal with areas of a darker gray which is possibly a thin oxide layer. A spot of dark-brown material at the bottom of the image and surrounded by a pitted surface is an area of corrosion still on the coupon. Figure 3-28B is another area on the coupon which also shows the bare metal surface with darker patches of a thin possibly oxide layer. One of the horizontal striations is in the middle of the image and is seen as a slightly brighter band running left to right. Figure 3-29C is from the far right of the image where both horizontal and vertical striations are observed.

**Figure 3-29. Photomicrographs of Different Areas on Coupon #3 of Jumper 1 – 4 After Cleaning.**

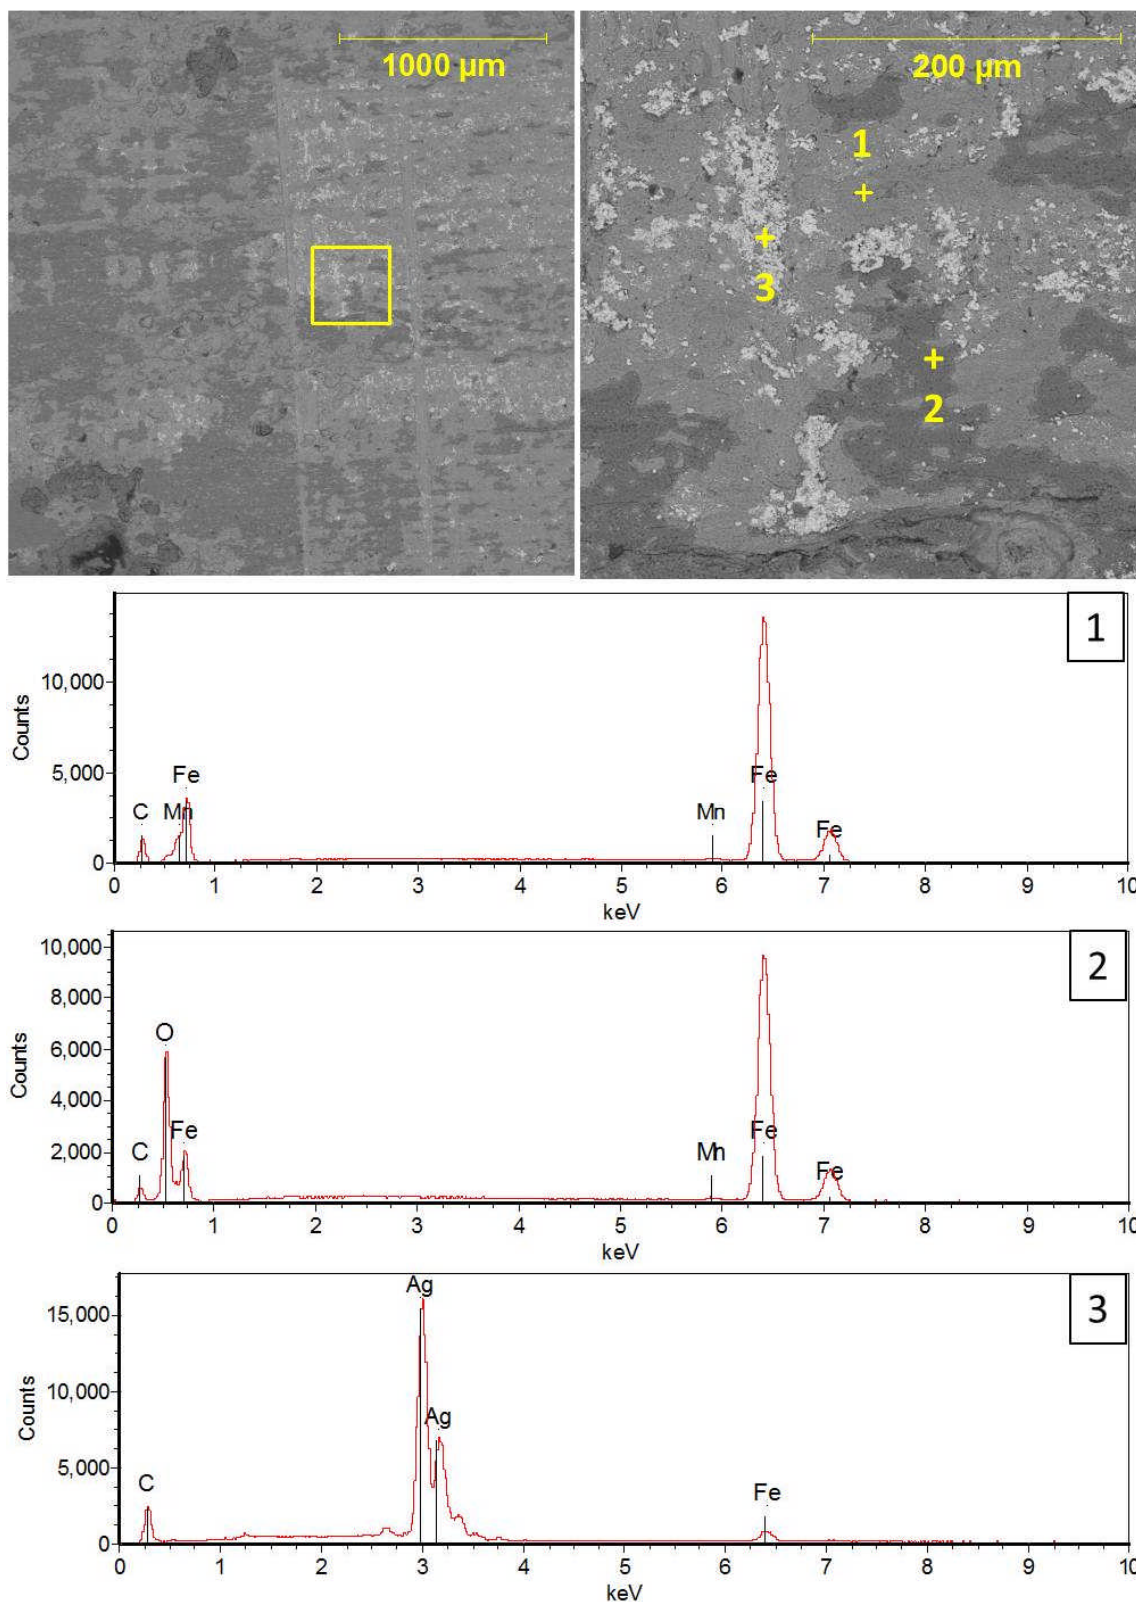
Figure 3-30 shows two BEI images of a general area on coupon #3 of jumper 1 – 4 taken at different magnifications. Since BEI mode correlates the brightness of the image with elemental mass of the species present at that location, it can be seen that there are three main areas on the coupon with three different elemental compositions on the surface of the pipe. The medium gray areas, as analyzed by EDS spot #1, are the bare carbon steel surfaces of the pipe. The darker gray areas, as analyzed by EDS spot #2, are the locations where the metal oxide is still present even after the ammonium citrate treatment. Finally, the bright gray areas, as analyzed by EDS spot #3, are locations on the pipe where silver has plated out from the solution. Silver deposits were also seen on the coupons from the B – 2 jumper, but they were not of as high a density as seen here.

**Figure 3-30. Scanning Electron Microscopy Images and Energy Dispersive Spectrometry Spectra of the Surface of Coupon #3 of Jumper 1 – 4.**

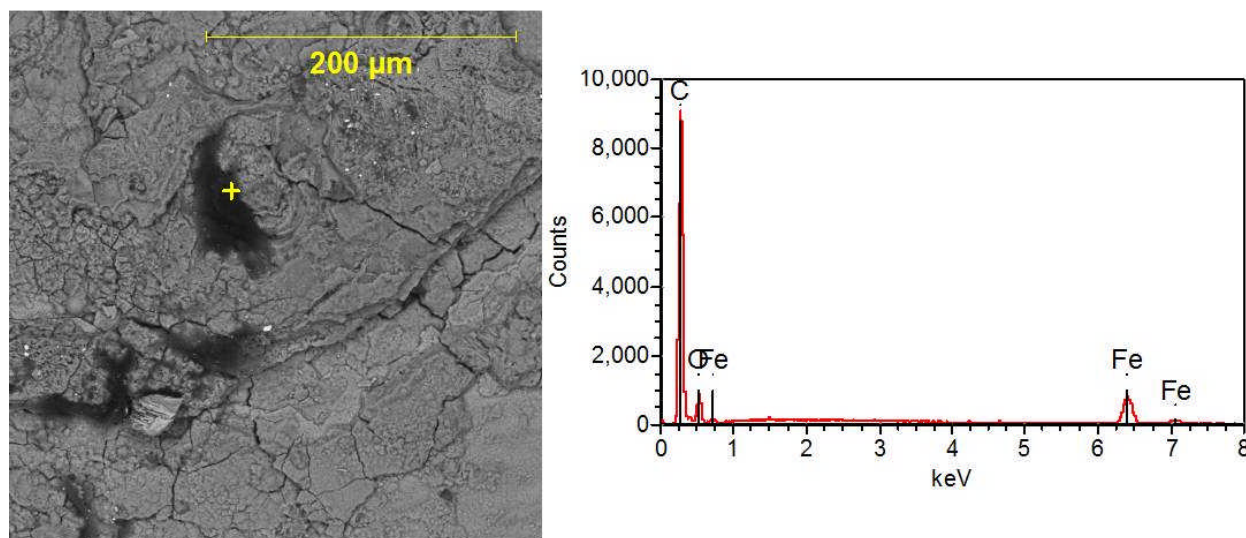
Tank waste material, which remained after the ammonium citrate treatment, was detected in a few locations lodged on areas of corrosion. The material varied from high carbon content which is probably organic material (Figure 3-32) to a calcium aluminum silicate (Figure 3-33).

**Figure 3-32. Scanning Electron Microscopy Image and Energy Dispersive Spectrometry Spectrum of a Carbon-Rich Tank Waste Material on Coupon #3 of Jumper 1 – 4.**

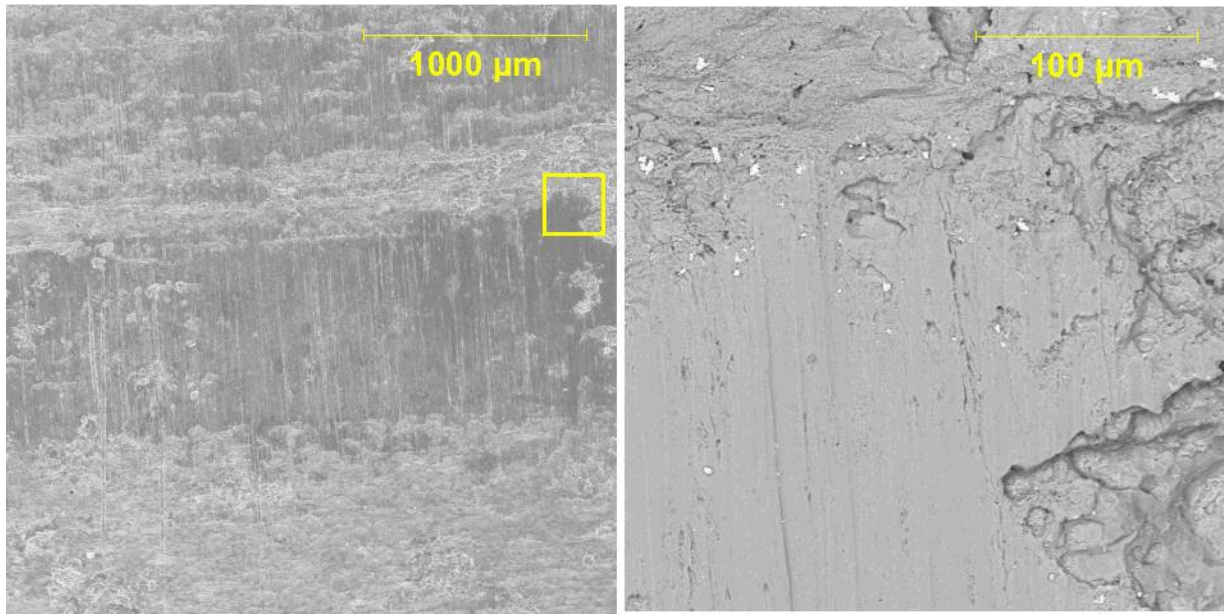
Similar to coupon #1 of jumper 1 – 4, several striations were seen on coupon #3 both with optical microscopy and SEM. Locations of these features were examined in closer detail using the high magnification of SEM to try to determine if these features were present on the pipe before deployment in the tank farm or had formed due to erosion-corrosion from the liquid transfers. Figure 3-34 shows SEM images acquired in SEI mode of one of a larger axial striation where there is a clear demarcation of two surfaces: one smoother and one rougher. The right SEM image is a magnified view of the area in the yellow box. This image shows that the

smoother area resides higher on the inner pipe surface than the rougher area. If the smooth area had been caused by abrasion or erosion, then the surface would be lower than the surrounding areas. Figure 3-35 shows BEI-mode SEM images of a radial striation at two different magnifications. The upper part of the right image shows some brighter silver deposits on the pipe surface. The silver transcends the striation boundary and suggests that the striation was there while the silver was deposited in the pipe from the solution being pumped through it. Again, this seems to indicate that the striation was present in the pipe before the pipe usage or earlier in the pipe usage.

**Figure 3-34. Scanning Electron Microscopy Images of an Axial Striation on Coupon #3 of Jumper 1 – 4.**

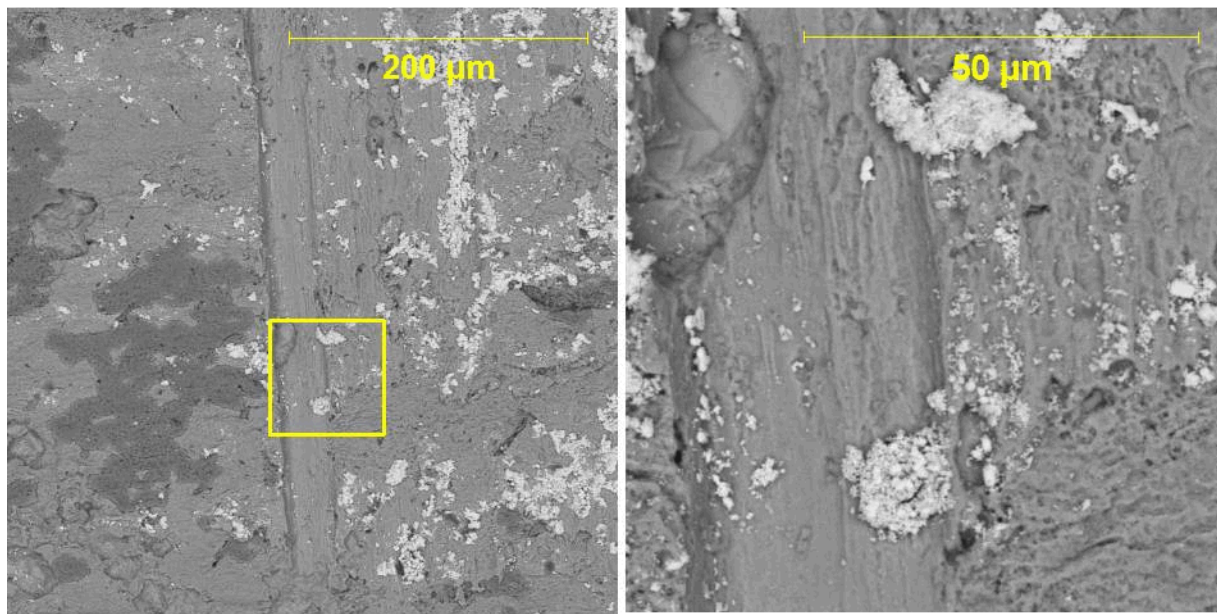
**Figure 3-35. Scanning Electron Microscopy Images of a Radial Striation on Coupon #3 of Jumper 1 – 4.**

In total, coupon #3 of jumper 1 – 4 appears to have very little corrosion, and the ammonium citrate treatment removed a majority of any corrosion and tank waste layers which may have been present on the inner surface of the pipe. A few pits around 10 to 20 mils in diameter were detected on the inner surface of the pipe, although the pipe, in general, appears intact with only a few signs of corrosion and no signs of erosion-corrosion. The striations seen in the optical photography appear to have been on the pipe either before deployment or were present in the pipe earlier in its lifetime.

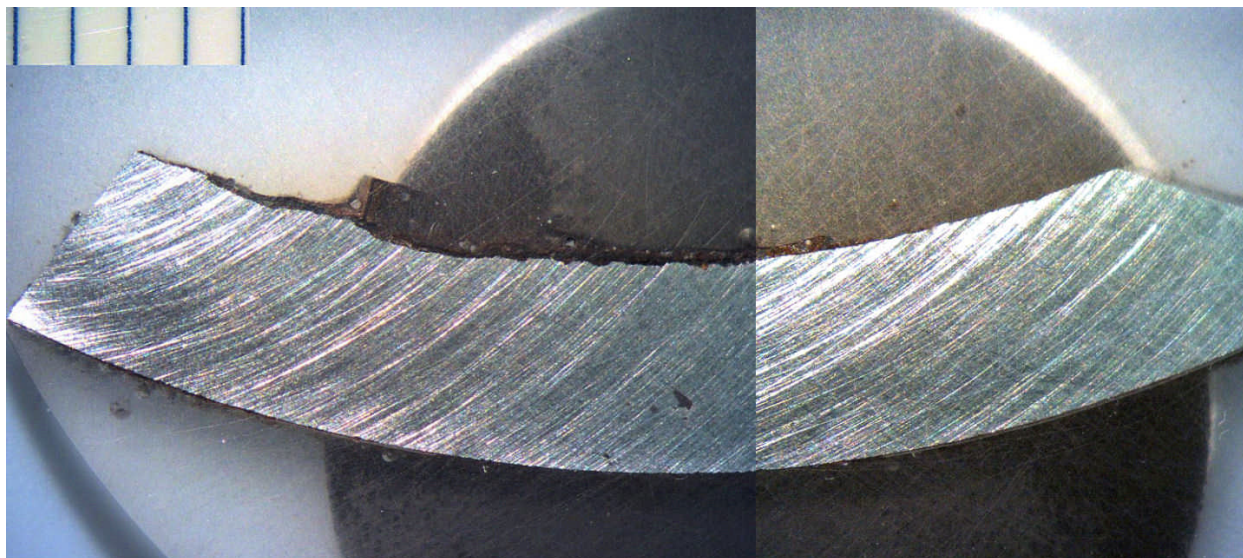
A second coupon was cut from the same area as coupon #3 at a location of the platy corrosion observed on the inside surface of the pipe. This coupon, referred to as coupon #4 with the OmniLims sample #S13R000612B, was cut to isolate a portion of this platy material seen in the left side of Figure 3-36 and in the photo in Figure 3-7. After load out from the hot cell, the coupon was immediately embedded in epoxy, immobilizing the surface material and preserving the features for SEM analysis. After the epoxy cured overnight, the coupon was wafered using a low-speed diamond saw, creating a cross-section of the pipe wall. This cross-section was then polished with sandpapers through consecutive grits ending in a 600-grit finish and mounted onto a SEM sample stub. The mounted cross-section was then photographed using an optical microscope, and the resulting image is shown in Figure 3-36. The size of the cross-section was larger than could be photographed by the microscope, so the image in Figure 3-36 is a mosaic of two separate images. The variation in sanding pattern between the two images is an artifact of the light source which highlights certain score directions. A scale bar is shown in the upper left of the image with marks at 1/16-inch increments. The black circle behind the pipe cross-section is the SEM stub. Epoxy completely surrounds the cross-section.

**Figure 3-36. Microphotograph of the Cross-Section Cut from Coupon #4 of Jumper 1 – 4.**

Visual inspection of the cross-section in Figure 3-36 shows that the pipe wall is intact with no areas of excessive wall thinning due to erosion-corrosion. The left side of the image shows a section of the platy material observed on the pipe and general corrosion, which reduced some of the pipe wall. In contrast, the right side of the image appears less corroded at this magnification, indicating a non-uniform corrosion of the pipe.

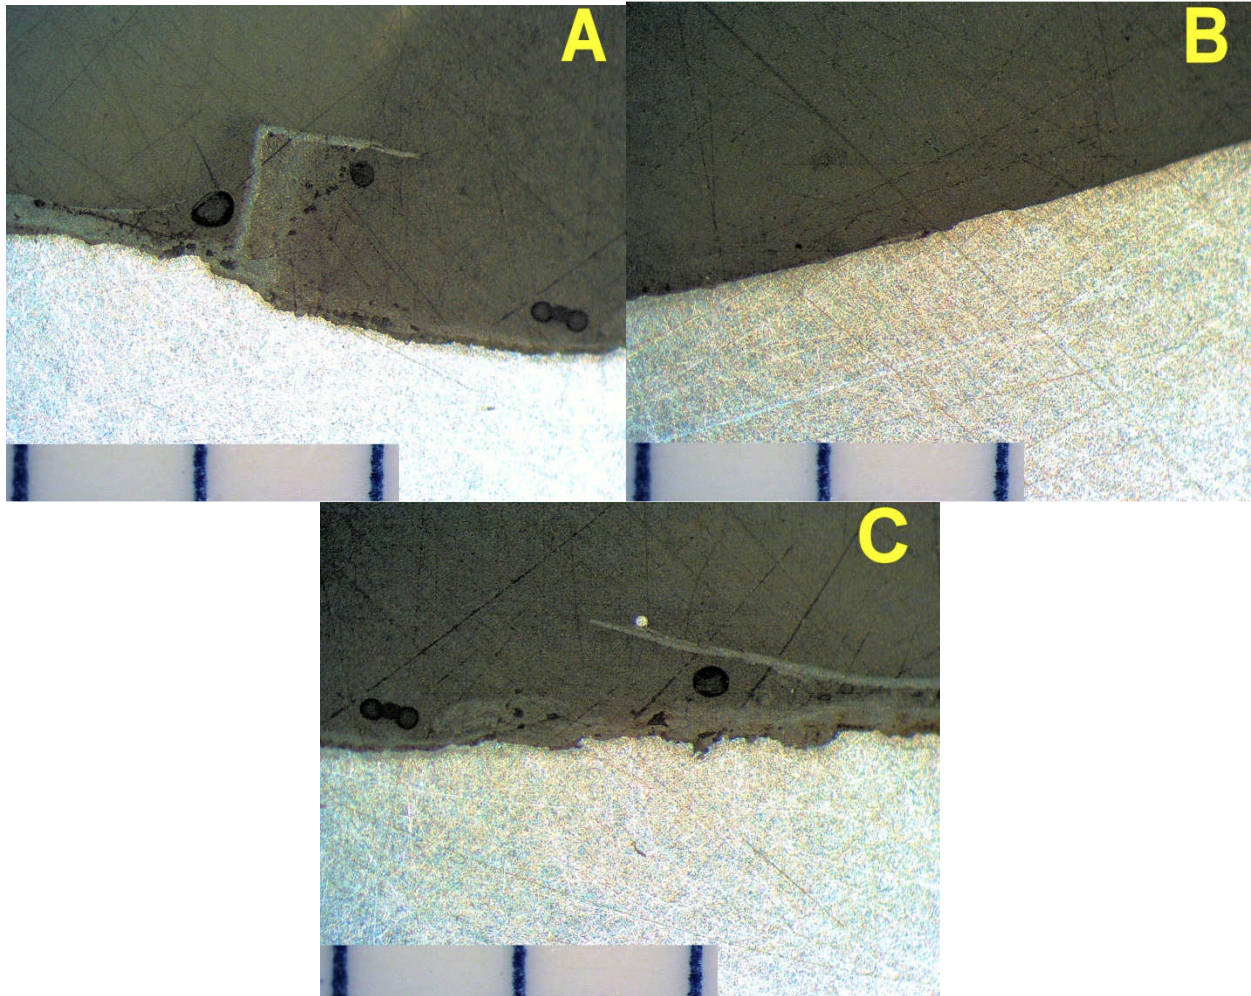
Figure 3-37 shows three microphotographs taken at an increased magnification compared to Figure 3-36. The scale bar is in 1/16-inch increments. The images show locations across the cross-section from the left (A), right (B), and center (C) of the coupon. At this magnification, the varying level of corrosion becomes even more apparent. The left side of the coupon displays general corrosion, which removed some of the inner surface of the pipe causing a wide depression. A part of the platy material can also be seen on top of the surface. In contrast to the left side of the coupon, the pipe surface on the right side is straight with minimal features. The image from the center of the coupon (Figure 3-37C) shows a transition between these two states with a few small pits and corrosion features across the pipe surface. This non-uniform corrosion on the pipe suggests the liquid was in contact with different areas of the pipe at various lengths of time. In other words, the liquid may have pooled on the bottom of pipe after use, causing more corrosion in this area.

**Figure 3-37. Photomicrographs of Different Areas on the Cross-Section of Coupon #4 of Jumper 1 – 4 Showing Varying Levels of Corrosion.**

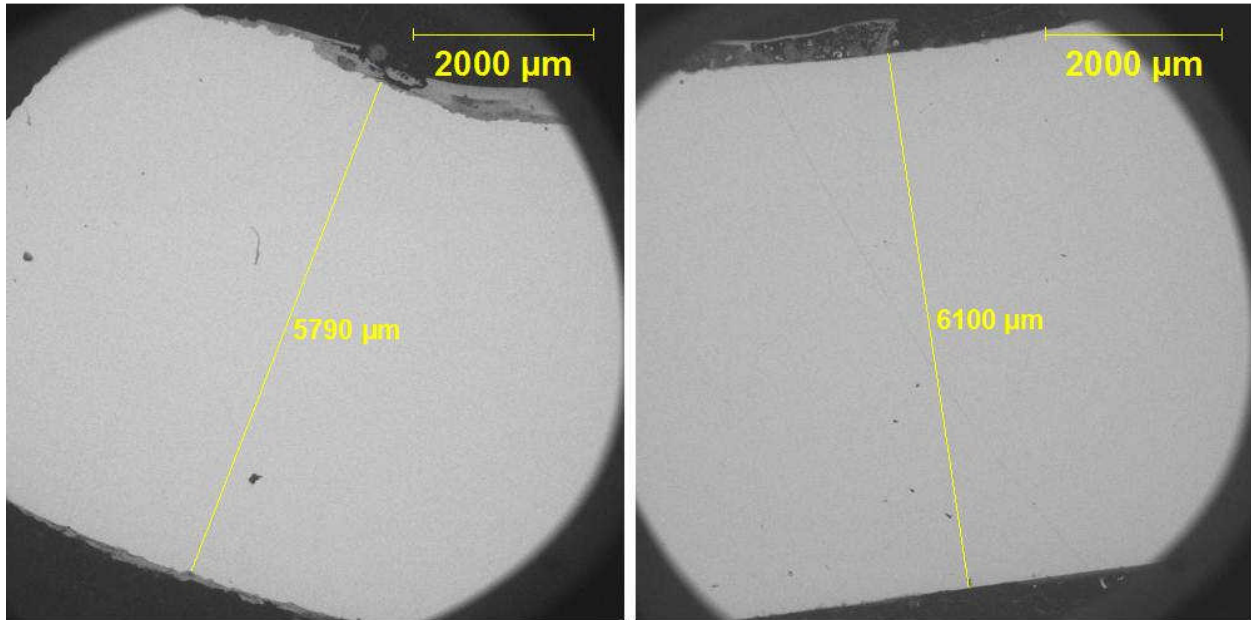
The cross-section was next analyzed by SEM, providing further information on the integrity of this pipe section and the identification of the surface layer. Figure 3-38 contains two SEM images at the lowest instrument magnification to show and measure the entire wall thickness at two different locations on the cross-section (far left and far right sides). Conversion of the SEM measured distances from micrometers to inches shows that the measurements in Figure 3-38 are 0.226 inches on the left and 0.238 inches on the right side of the cross-section. The UT measurements of this coupon ranged from 0.222 to 0.231, Table 3-6.

**Figure 3-38. Scanning Electron Microscopy Images and Measurements of the Pipe Wall Thickness of Coupon #4 of Jumper 1 – 4.**
