# **Final Report for the Erosion-corrosion Analysis of Tank 241-AW-02E Feed Pump Pit Jumpers B-2 and 1-4 Removed from Service in 2013**

**J. S. Page**

Washington River Protection Solutions LLC

March 2014

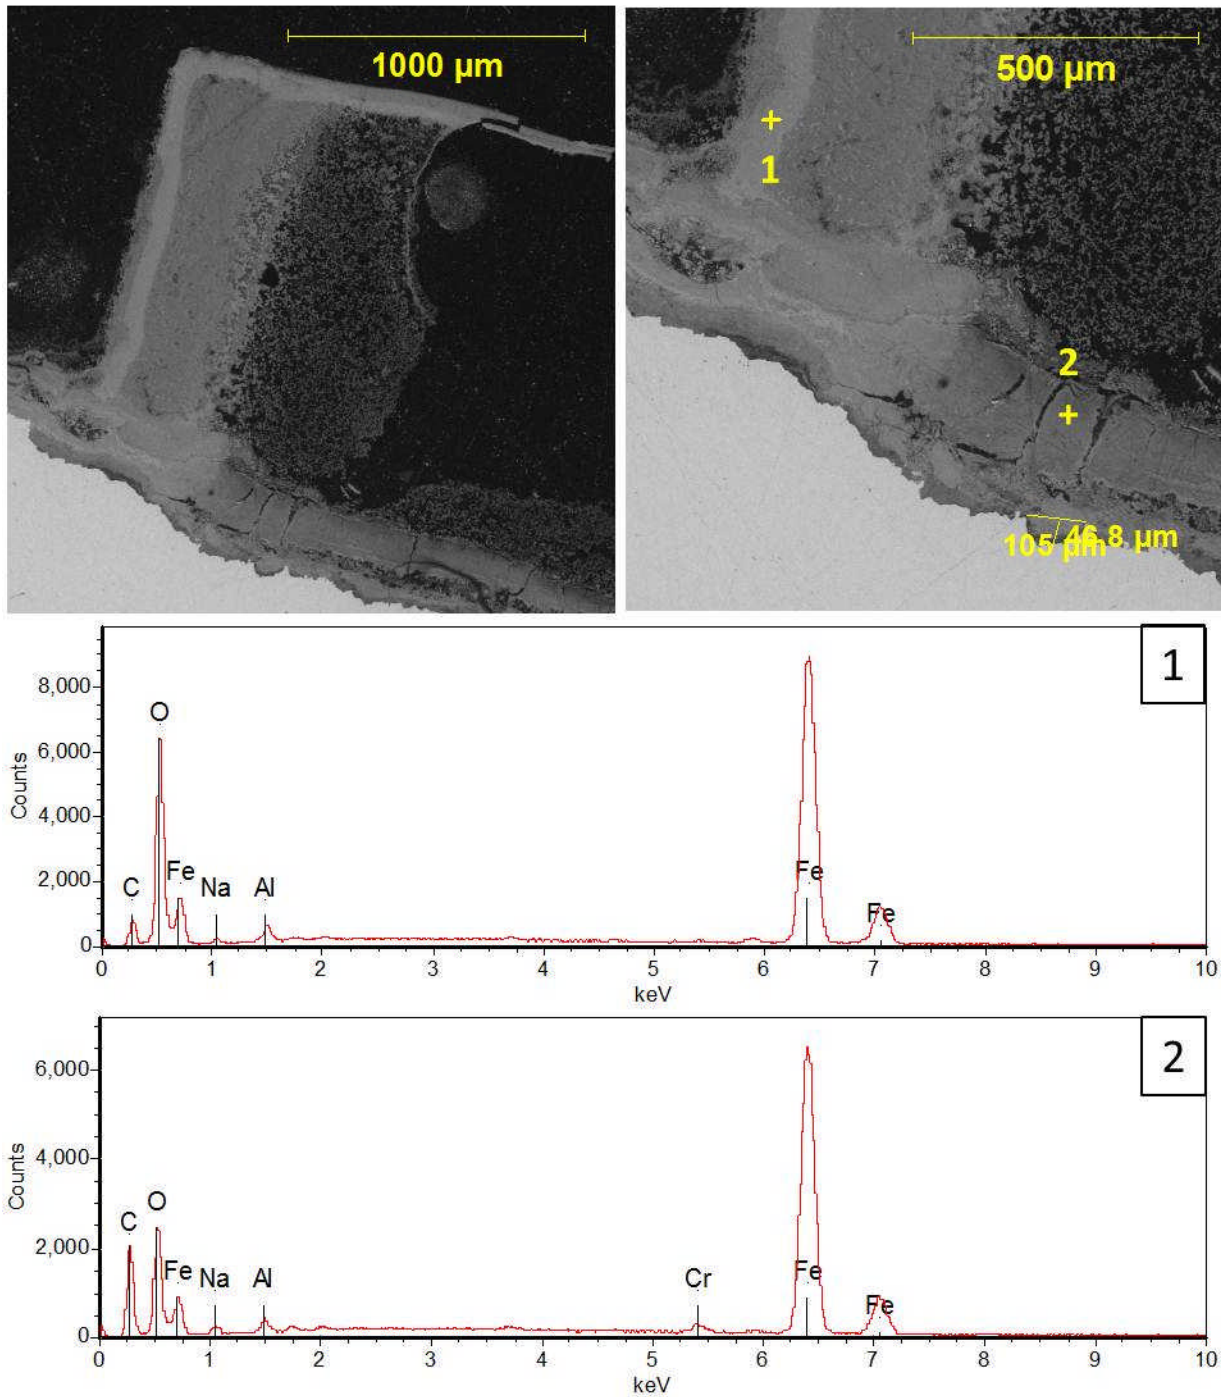
Figure 3-39 shows SEM images taken of the left side of the cross-section at two different magnifications and EDS spectra at two locations of the layer on the pipe surface. The surface displays a continuous general corrosion with some small pitting. The pit in the lower right portion of the right image was measured at 4.1 mils (105 μm) across and 1.8 mils (46.8 μm) deep. Although the layer has dramatic changes in thickness and morphology, the EDS spectra are similar at the two locations and indicate the presence of iron oxide/hydroxide (corrosion product) with trace tank waste elements of sodium, aluminum, and chromium.

**Figure 3-39. Scanning Electron Microscopy Images and Energy Dispersive Spectrometry Spectra of the Left-Side Surface of Coupon #4 of Jumper 1 – 4.**

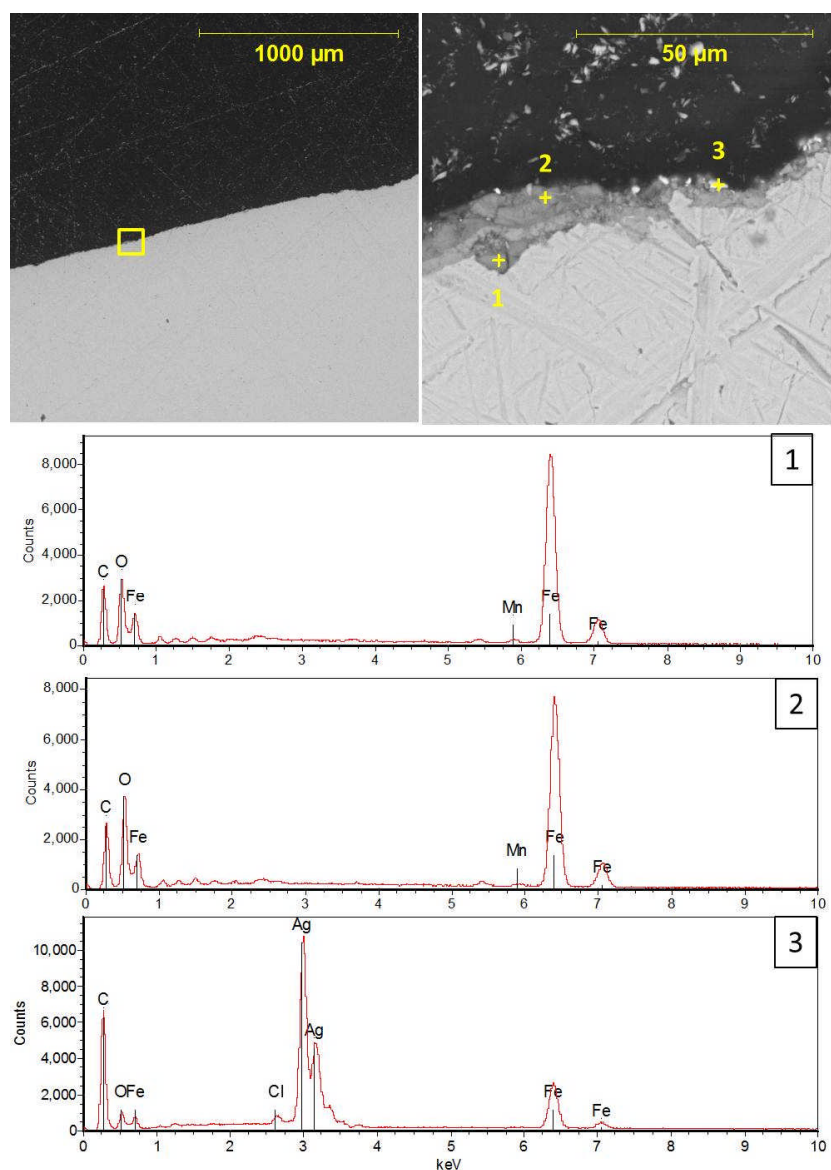
Figure 3-40 contains SEM images at different magnifications of the right side of the cross-section of coupon #4 from jumper 1 – 4. In contrast to the left-side of the coupon shown in Figure 3-39, the right-side displays considerably less corrosion of the pipe metal and less of a

layer on the surface. The magnified image on the right side shows more of the surface features in greater detail. There appears to be some corrosion on the surface, as indicated by the EDS spot #1 and #2, but the features are too small to be considered pits (“Pitting Growth Rate in Carbon Steel Exposed to Simulated Radioactive Waste,” Zapp 1996). The EDS spot #3 shows that brighter particles at the top of the thin corrosion layer are silver-rich, as discussed previously in this report. Since the right side of the coupon shows minimal corrosion and the left side of the coupon shows general corrosion, it is possible to obtain some information on a corrosion rate in this localized area of the pipe (assuming the manufactured pipe wall thickness in this segment of pipe was uniform). The difference in the wall thickness between these two areas is ~12 mils (see Figure 3-38). Knowing that the lifetime of this pipe was 16 years, the average corrosion rate at this location was ~0.8 mils per year.

**Figure 3-40. Scanning Electron Microscopy Images and Energy Dispersive Spectrometry Spectra of the Right-Side Surface of Coupon #4 of Jumper 1 – 4.**

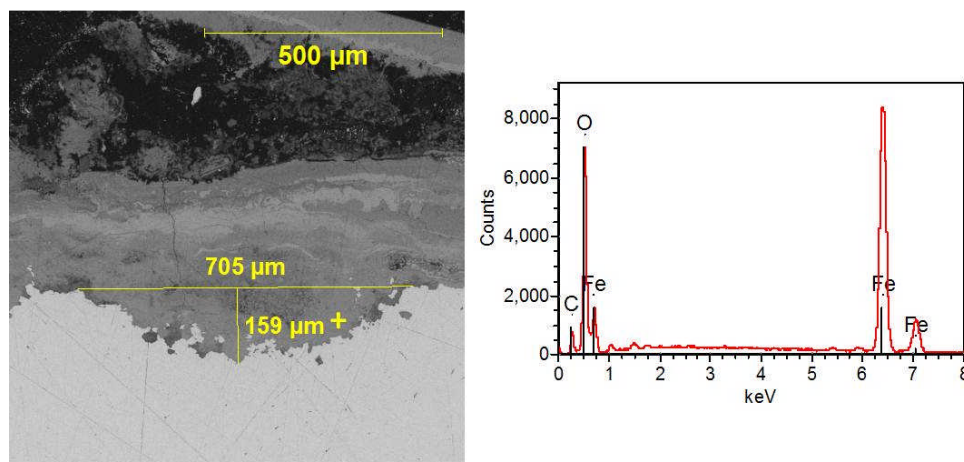
A couple of examples of the pits detected by SEM on the left side of the cross-section are shown in Figures 3-41 and 3-42. The wide, shallow pit in Figure 3-41 measured 27.5 mils (705  $\mu\text{m}$ ) wide and 6.2 mils (159  $\mu\text{m}$ ) deep. The corresponding EDS spectrum shows iron oxide/hydroxide as the material in and above the pit. The vertical pit shown in Figure 3-42 is deeper at 9.1 mils (233  $\mu\text{m}$ ) and 18.6 mils (477  $\mu\text{m}$ ) wide. Both corrosion product (iron oxide/hydroxide) and tank waste residue (calcium phosphate) were detected around the pit. The structure of the corrosion/tank waste layer is complex, indicating a complex history of corrosion, spalling, and deposition.

**Figure 3-41. Scanning Electron Microscopy Image and Energy Dispersive Spectrometry Spectrum of a Wide, Shallow Pit on Coupon #4 of Jumper 1 – 4.**

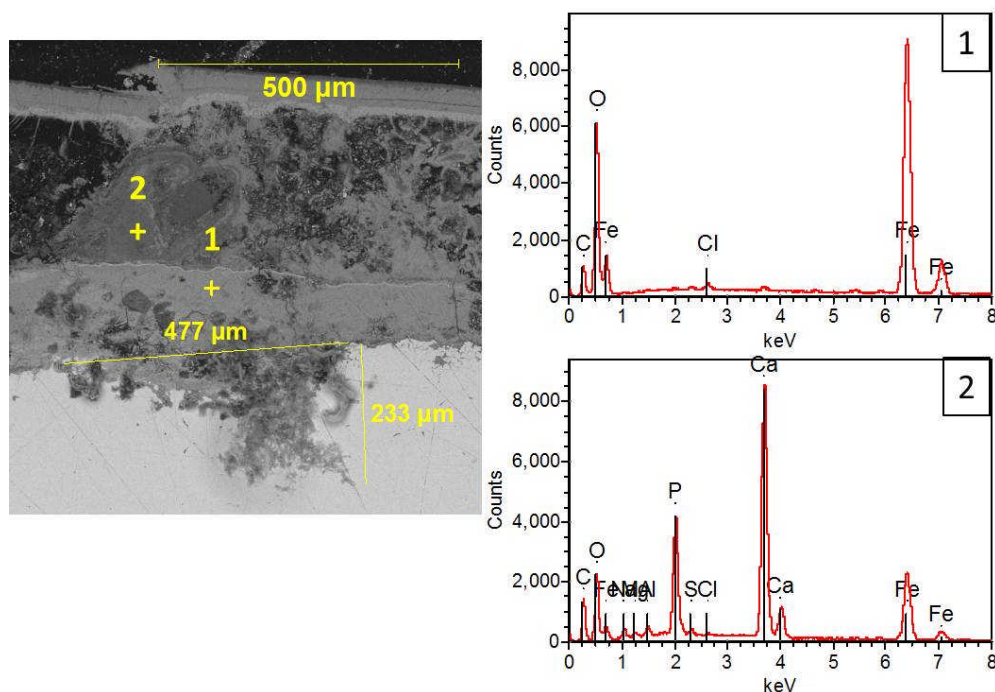
**Figure 3-42. Scanning Electron Microscopy Image and Energy Dispersive Spectrometry Spectra of a Vertical Pit on Coupon #4 of Jumper 1 – 4.**

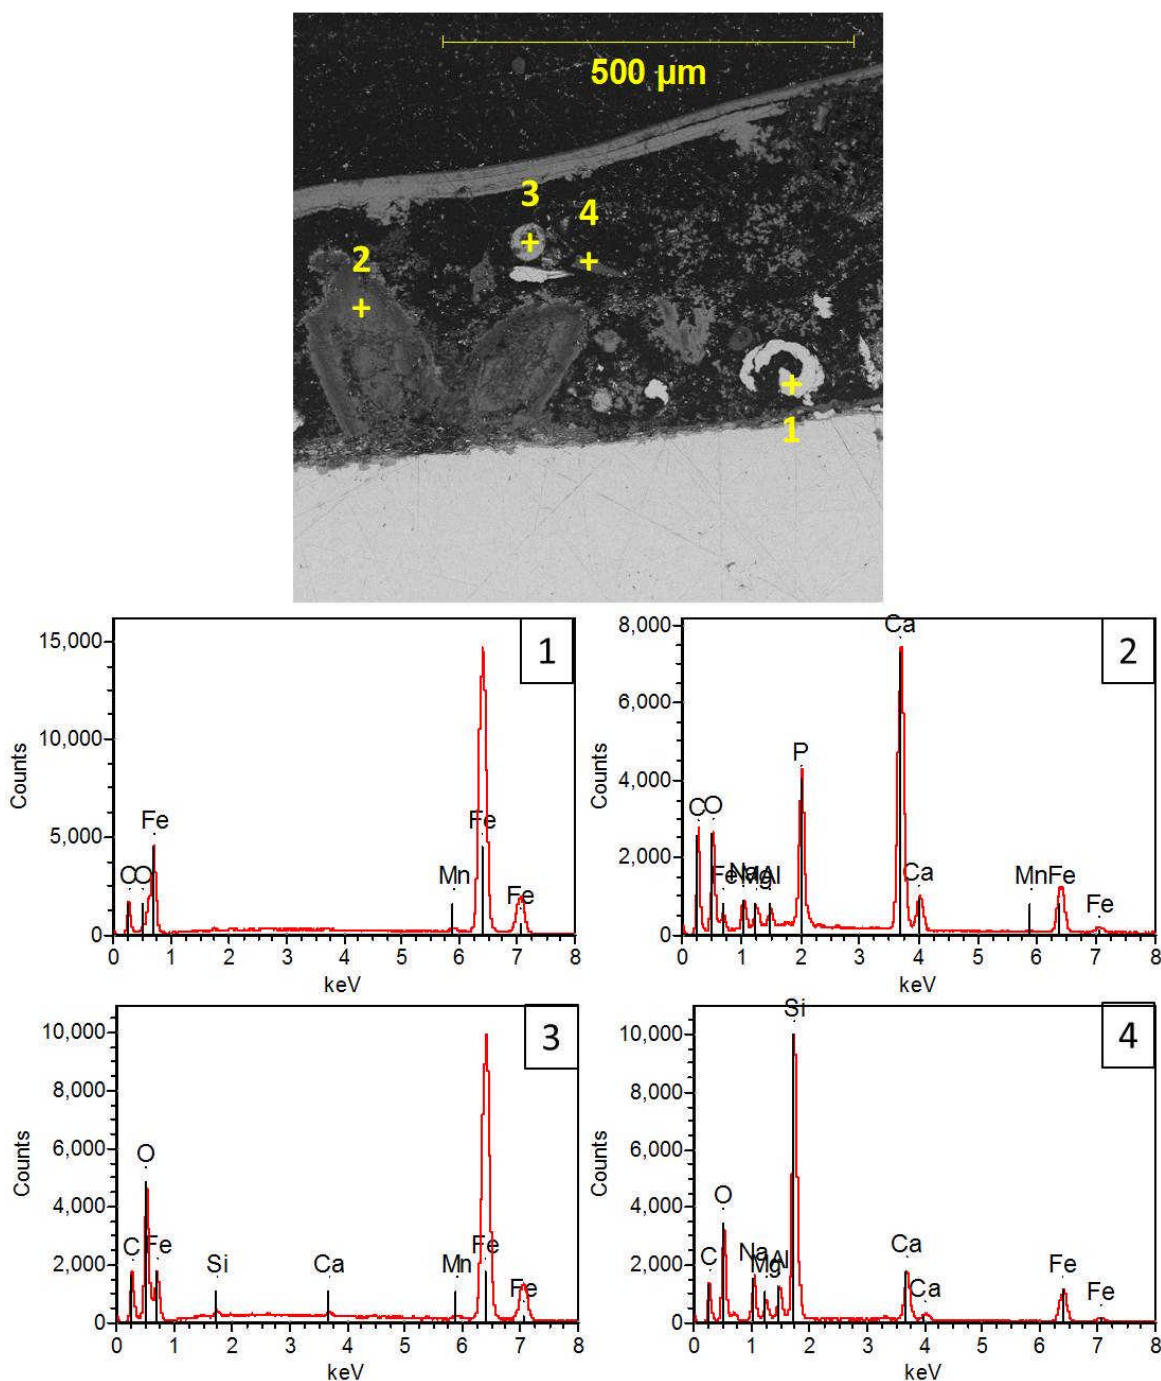
Other particles besides iron oxide/hydroxide and calcium phosphate were detected inside the layer on the inner pipe surface of coupon #4. Figure 3-43 shows that along with these phases, metal particles or shavings were also seen (EDS spot #1). These metal particles are embedded in the corrosion layer and are, therefore, not a result of the coupon cutting process. In addition, a silicate particle was seen at EDS spot #4 and is possibly from Hanford soils.

**Figure 3-43. Scanning Electron Microscopy Image and Energy Dispersive Spectrometry Spectra of Various Particles Embedded in the Layer on Coupon #4 of Jumper 1 – 4.**

In general, coupon #4 of jumper 1 – 4 appears to have a varying level of corrosion across the cross-section with the left side of the coupon displaying a slightly thinner pipe wall, a greater amount of general corrosion and pitting, and more of a corrosion product and tank waste layer on the pipe wall. This could have been caused by a varying amount of exposure to the liquid in the pipe. For example, tank waste liquid or water may have pooled (not fully drained) in the bottom of the pipe after pumping, increasing the amount of corrosion in that area.

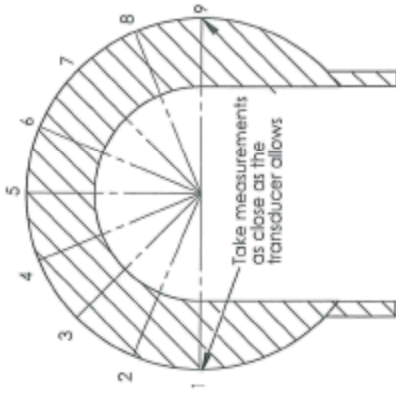
SECTION F-F  
SCALE 1:2

AREA COVERED OVER WITH PROTECTIVE TAPE

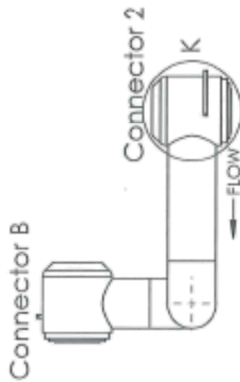
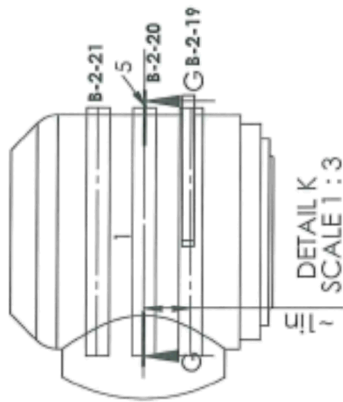
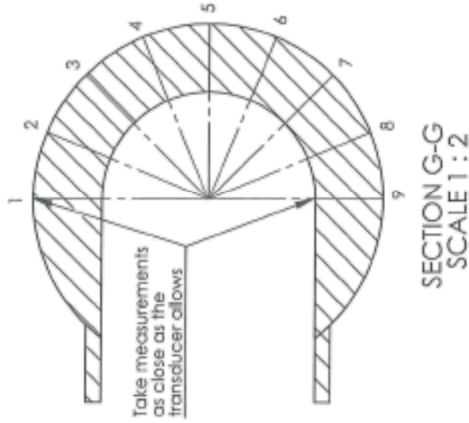
Jumper B-2: Connector 2

REPEAT:  
B-2-20(5) = 0.985  
B-2-20(7) = 0.985
