Double-Shell Tank AY-102 Radioactive Waste Leak Investigation

14178 - Session 116, Storage and Retrieval of HLW

D. J. Washenfelder
Washington River Protection Solutions

Date Published
March 2014

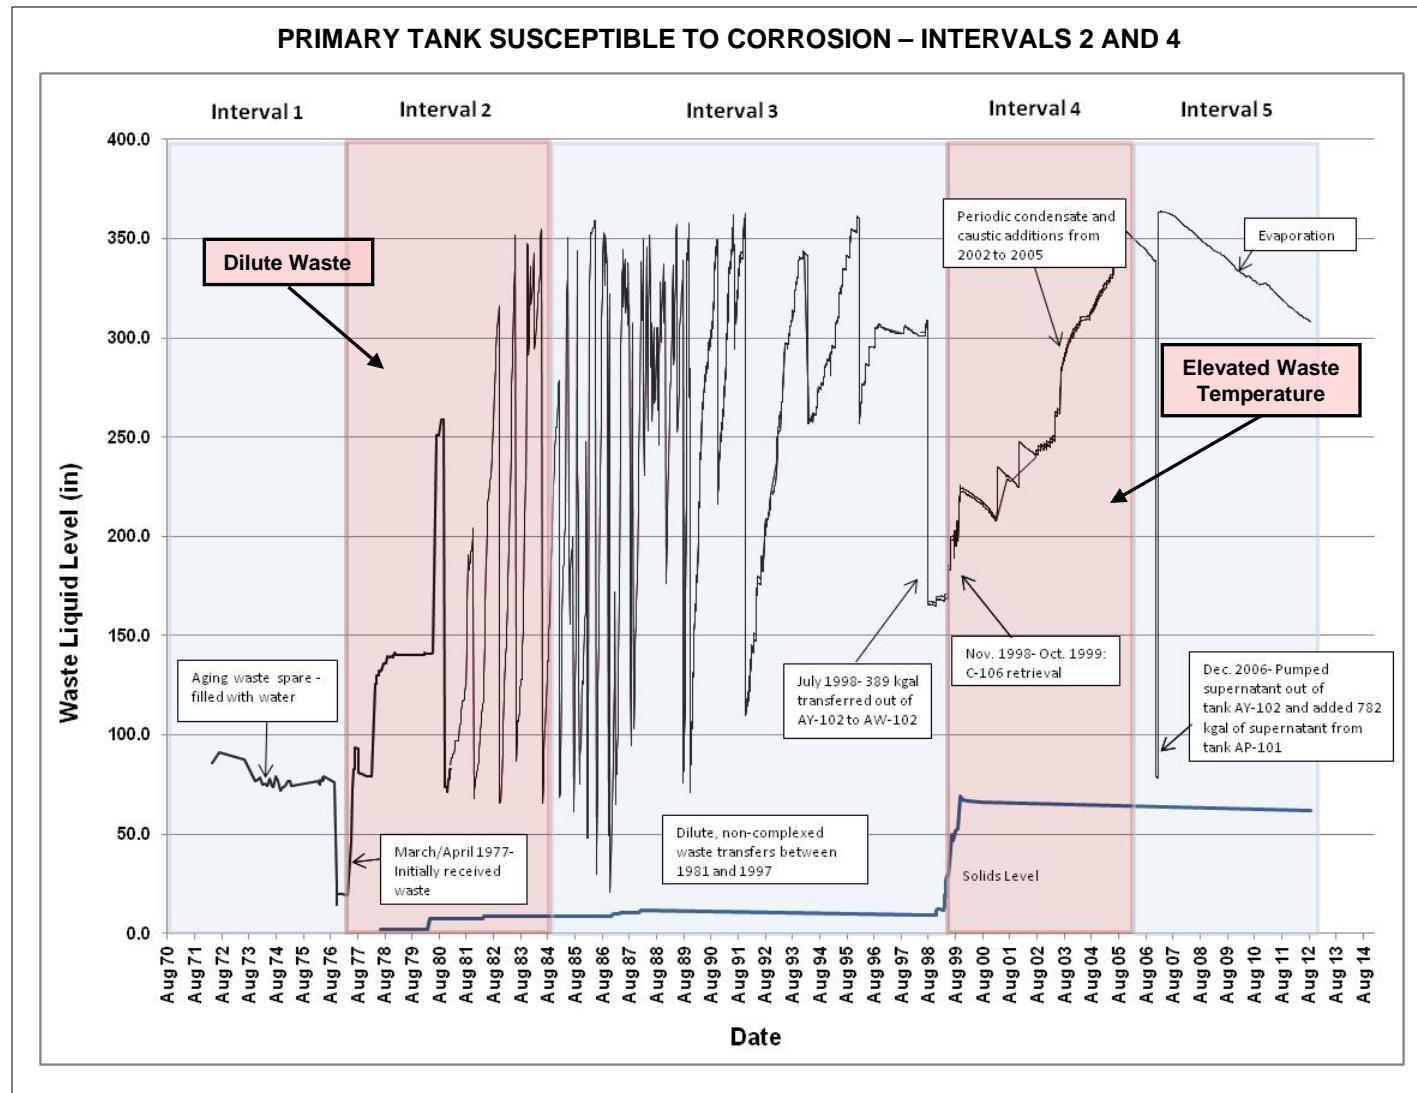
Tank AY-102 Waste Chemistry History (cont.)

- Parameters influencing corrosion of carbon steel liner:
 - Aggressive ions (Nitrate, Carbonate, Chloride)
 - Inhibitory ions (hydroxide and nitrite)
 - Temperature
- Two main corrosion concerns for Hanford waste:
 - Stress Corrosion Cracking in presence of high nitrate ion or carbonate ion concentrations
 - Pitting Corrosion in presence of nitrate or chloride ion concentrations
- Five chronological chemistry phases in Tank AY-102 based on susceptibility to corrosion:
 - The first solids layer deposited in tank AY-102 in 1977 – 1984 (“Interval 2”) have the characteristics which cause pitting corrosion when subjected to higher temperatures experienced after 1999 (“Interval 4”)

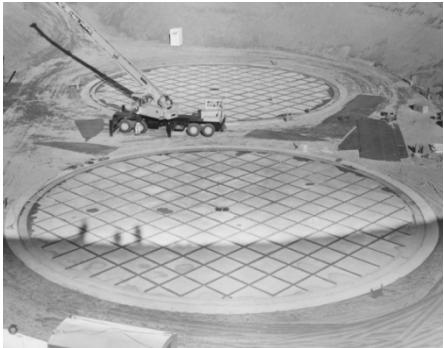
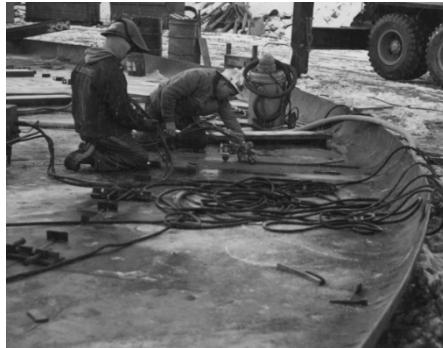
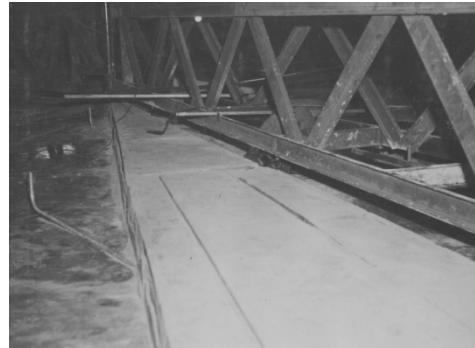
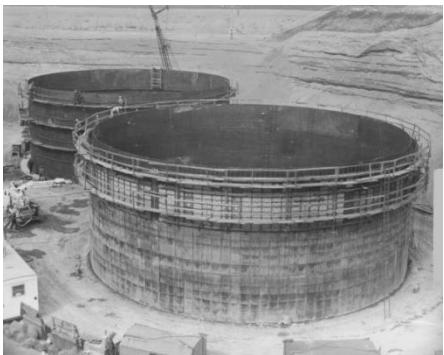
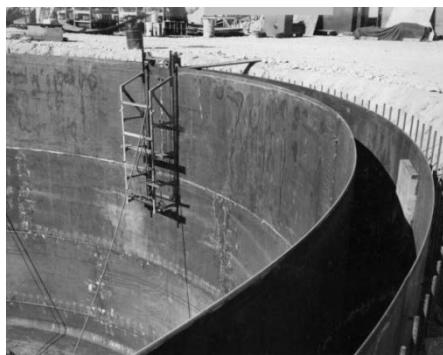
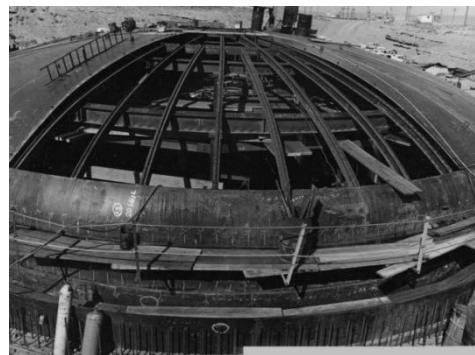
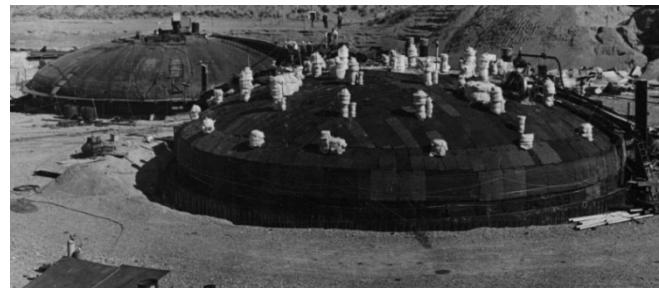
Tank AY-102 Construction Sequence

- First-of-a-Kind Construction at Hanford
 - Secondary Liner Warpage
 - Insulating Refractory Cracking
 - Primary Tank Bottom Plate Weld Rejection
 - Insulating Refractory Damage from Stress Relief and Hydrostatic Testing of Primary Tank

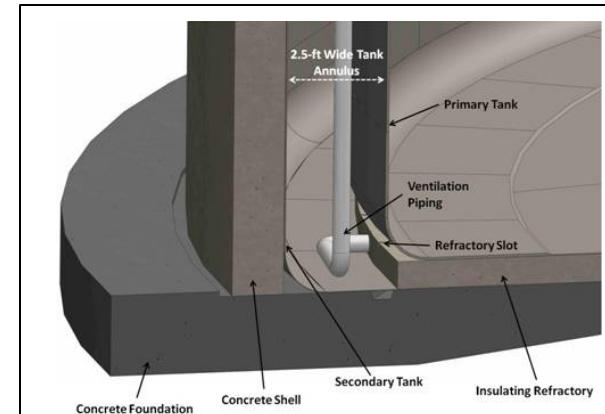
Double-Shell Tank Annulus Detail

- The insulating refractory pad is sandwiched between the bottom of the primary tank and the secondary liner. It supports the primary tank, and protects the structural concrete foundation under the secondary liner from high-temperature damage during post-weld stress relief and from tank contents.
- Cracks 1 to 2-inches deep and up to 7-feet long appeared in cured refractory as pours continued. These were blamed on flexing of the secondary liner from movement of the bulges.
- The cured surface was not flat or level in some locations. In March, 1969, 25 locations were identified with variations up to 1-1/4-inches between the high points and low points. These were corrected.
