Hanford Single-Shell Tank Leak Causes and Locations - 241-T Farm

C.L. Girardot, D.G. Harlow

Key Words: leak location, leak cause, tank, integrity assessment, T Farm, T-106, T-111, leak assessment

Abstract: This document identifies 241-T Tank Farm (T Farm) leak causes and locations for the 100 series leaking tanks (241-T-106 and 241-T-111) identified in RPP-RPT-55084, Rev. 0, Hanford 241-T Farm Leak Inventory Assessment Report. This document satisfies the T Farm portion of the target (T04) in the Hanford Federal Facility Agreement and Consent Order milestone M-045-91F.

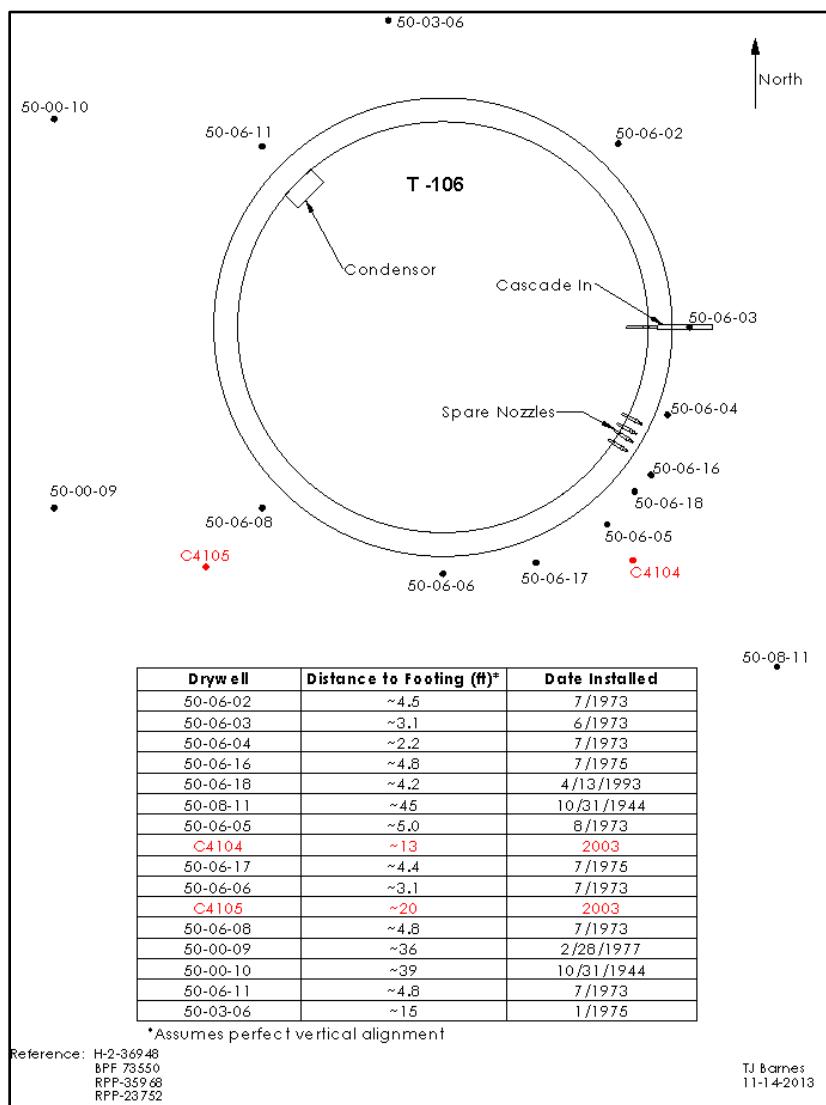
Figure 4-1. Tank T-106 Associated Drywells
Tank inner ring is steel liner; outer ring is outer edge of tank footing

This section provides information on the historical waste loss event associated with Single-Shell Tank (SST) 241-T-106 (T-106). There are 14 drywells located around tank T-106 with specified distances from the drywell to the tank footing shown in Figure 4-1: 50-00-10 and 50-08-11, installed in 1944, 50-06-02, 50-06-03, 50-06-04, 50-06-05, 50-06-06, 50-06-08, and 50-06-11, installed in 1973, 50-06-17, 50-03-06, and 50-06-16, installed in 1975, 50-00-09 installed in 1977, and 50-06-18 installed in 1993. In addition, two nearby direct pushes, C4104 and C4105, were installed in 2003.

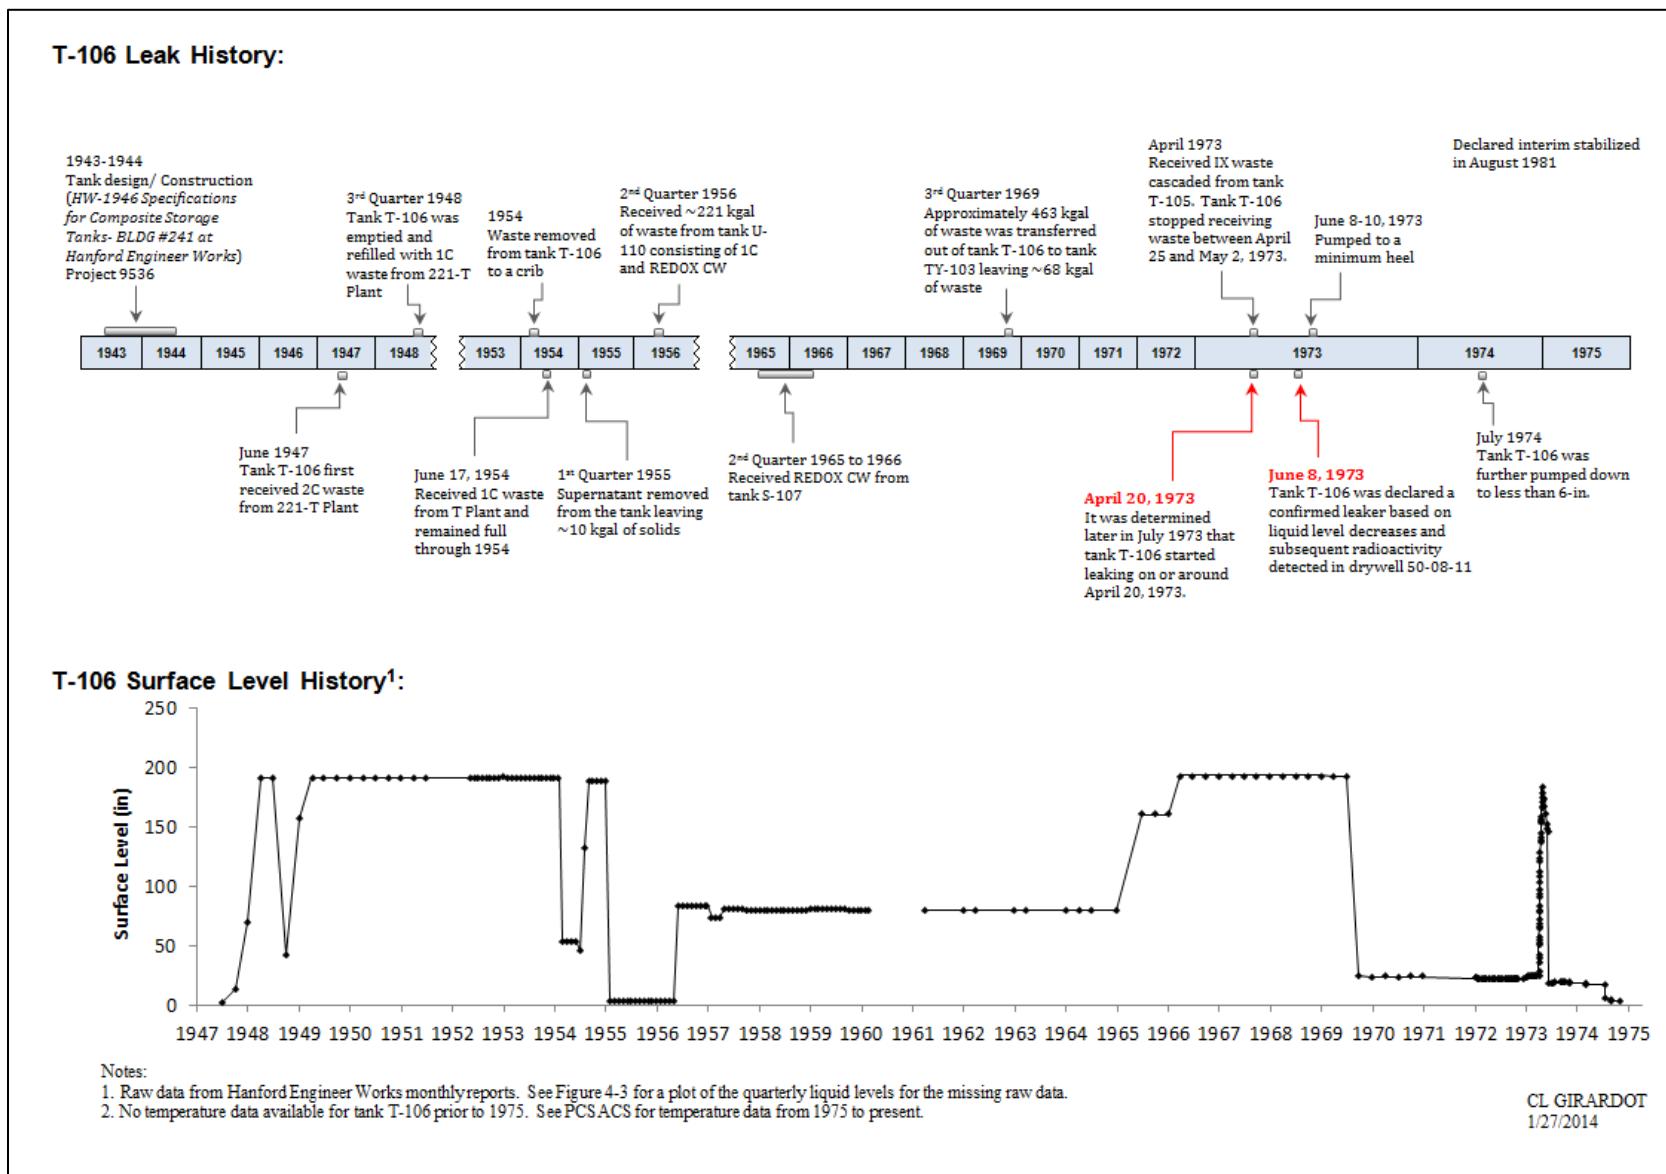
Figure 4-2. Operational Leak History of Tank T-106

The operational history of tank T-106 leak related details including liquid level is charted in Figure 4-2.

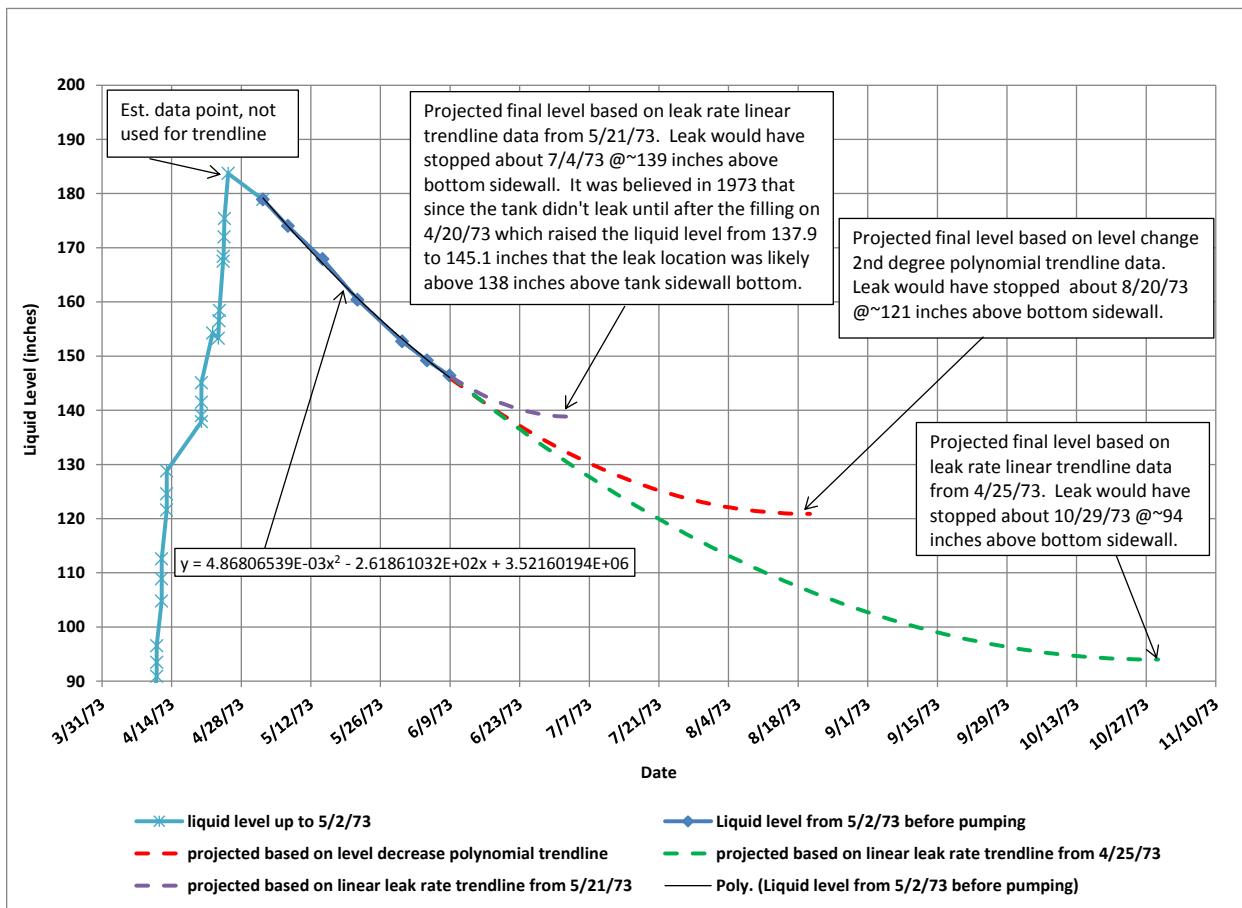
Figure 4-5. Tank T-106 Estimated Level Change if Tank Not Pumped

Figure 4-5 shows the projected final liquid level (or potential sidewall leak location) based on a linear leak rate trend line and a polynomial leak rate trend line using data from various start dates in May 1973 to right before pumping on June 8, 1973. Three projected final liquid levels were determined ranging from 94-in to 139-in above the tank sidewall bottom, supporting a possible sidewall leak. See RPP-RPT-54921, *Estimation of Past Leak Rates for Selected Hanford Single-Shell Tanks* (To be issued), for additional information. The surrounding tank T-106 drywells (see Section 4.5.1) support a leak location at or near the tank bottom. However, a sidewall leak could be possible since the leak may have penetrated the waterproof membrane at any location (possibly near the bottom of the tank) for egress to the soil which could have been detected at a lower BGS level in the nearby drywells.

Note: The purple and green dotted projections were determined through back calculations of liquid level using a decreasing rate with time which was projected into the future.

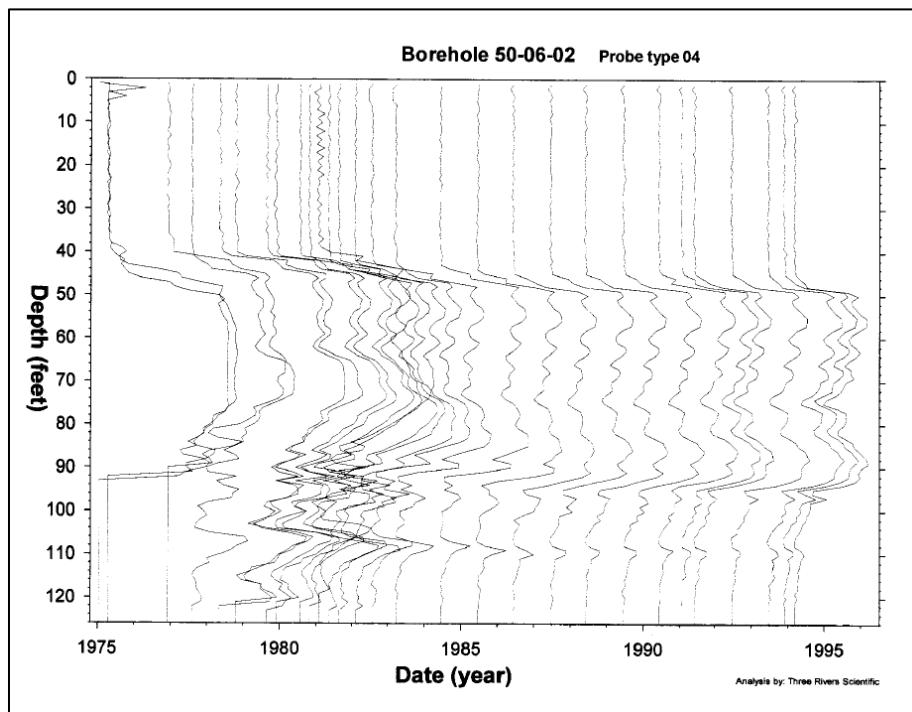
Figure 4-6. Tank T-106 Drywell 50-06-02 (RPP-6088)

In June 1999, Cs-137, Co-60, Eu-154, Eu-152, U-238, and U-235 were the only man-made gamma-emitting radionuclides detected in this drywell (GJ-HAN-120, *Vadose Zone Characterization Project at the Hanford Tank Farms Tank Summary Data Report for Tank T-106*). Document GJ-HAN-120 reports, “*The interval of Co-60, Eu-154, Eu-152, and processed uranium (U-235 and U-238) contamination detected below 45 ft is interpreted to demarcate a contaminant plume that resulted from the T-106 tank leak. The highest concentrations of Co-60 contamination occur within the central portion of the plume (75 to 102 ft), suggesting that the Co-60 contamination traveled primarily through the formation and was not dragged down during drilling. Historical gross gamma log data suggest that the Co-60 contamination within the plume continued to migrate downward from 1973 to 1992.*” Figure 4-6 shows the depths of radioactivity from 1975 to 1995 (RPP-6088).

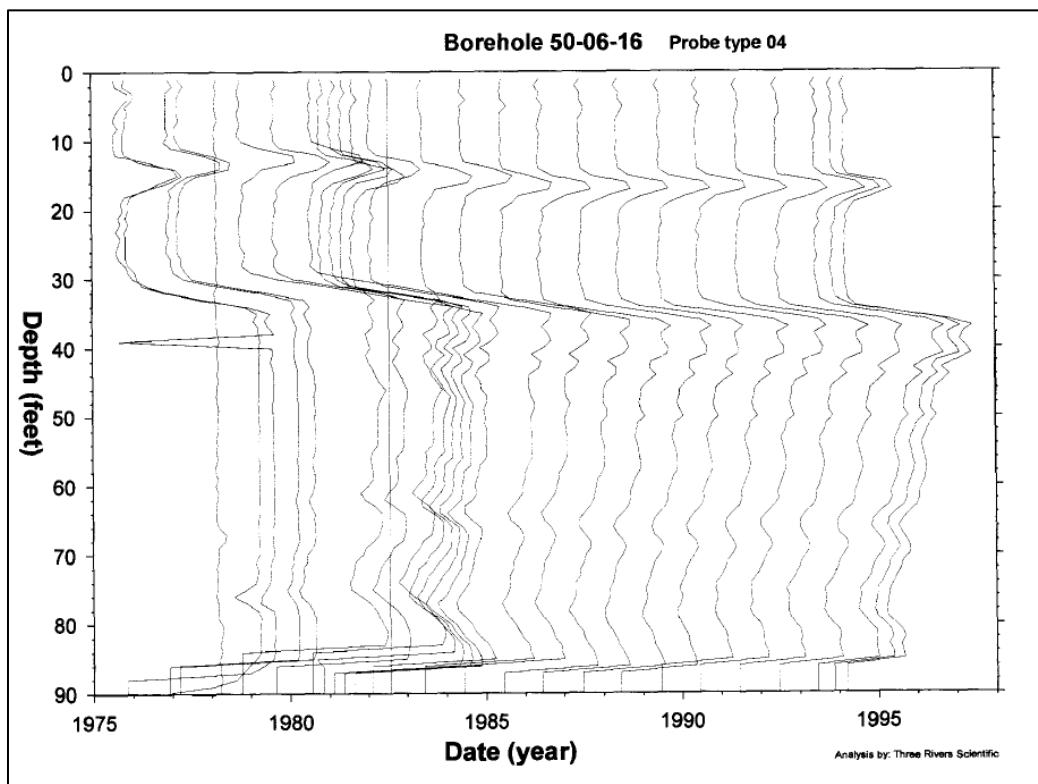
Figure 4-9. Tank T-106 Drywell 50-06-16 (RPP-6008)

In June 1999, Cs-137, Co-60, Eu-154, and Eu-152 were the only man-made gamma-emitting radionuclides detected in drywell 50-06-16 (GJ-HAN-120). Document GJ-HAN-120 reports, *“The zone of very high Cs-137 contamination and the less concentrated zone of Eu-154 detected between 33 and 42 ft originated from the T-106 tank leak. Other radionuclides may be present within this zone that were not detected by the SGLS because of the high dead time in the region. It appears that the waste accumulated and spread along the base of the tank farm excavation to this borehole.”* Figure 4-9 shows the depths of radioactivity from 1975 to 1995 (RPP-6008). Radioactivity at ~15-ft BGS shown in Figure 4-9 is probably due to a pipeline or other near surface source.

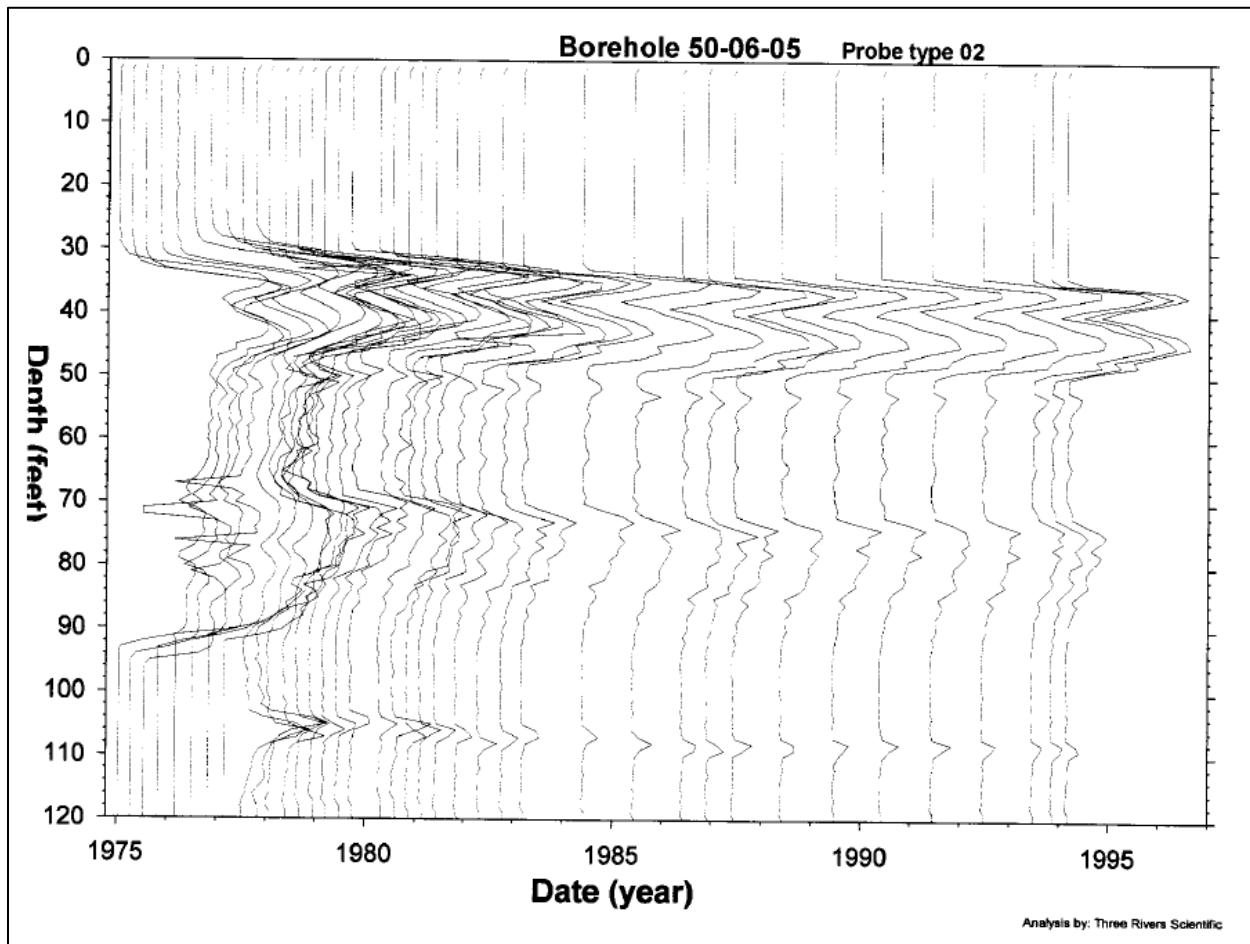
Figure 4-10. Tank T-106 Drywell 50-06-05 (RPP-6008)

In June 1999, Cs-137 and Co-60 were the only man-made gamma-emitting radionuclides detected in drywell 50-06-05 (GJ-HAN-120). Document GJ-HAN-120 reports, “*On the basis of the rate of decrease of the historical gross gamma activity, it was determined that Cs-137 is the primary radionuclide present within the zone of extremely high gamma radiation detected from 33 to 93 ft. The magnitude of the Cs-137 within this region of the vadose zone indicates that the contamination originated from the T-106 tank leak and that this borehole is very close to the leak source.*” Figure 4-10 shows the depths of radioactivity from 1975 to 1995 (RPP-6008).

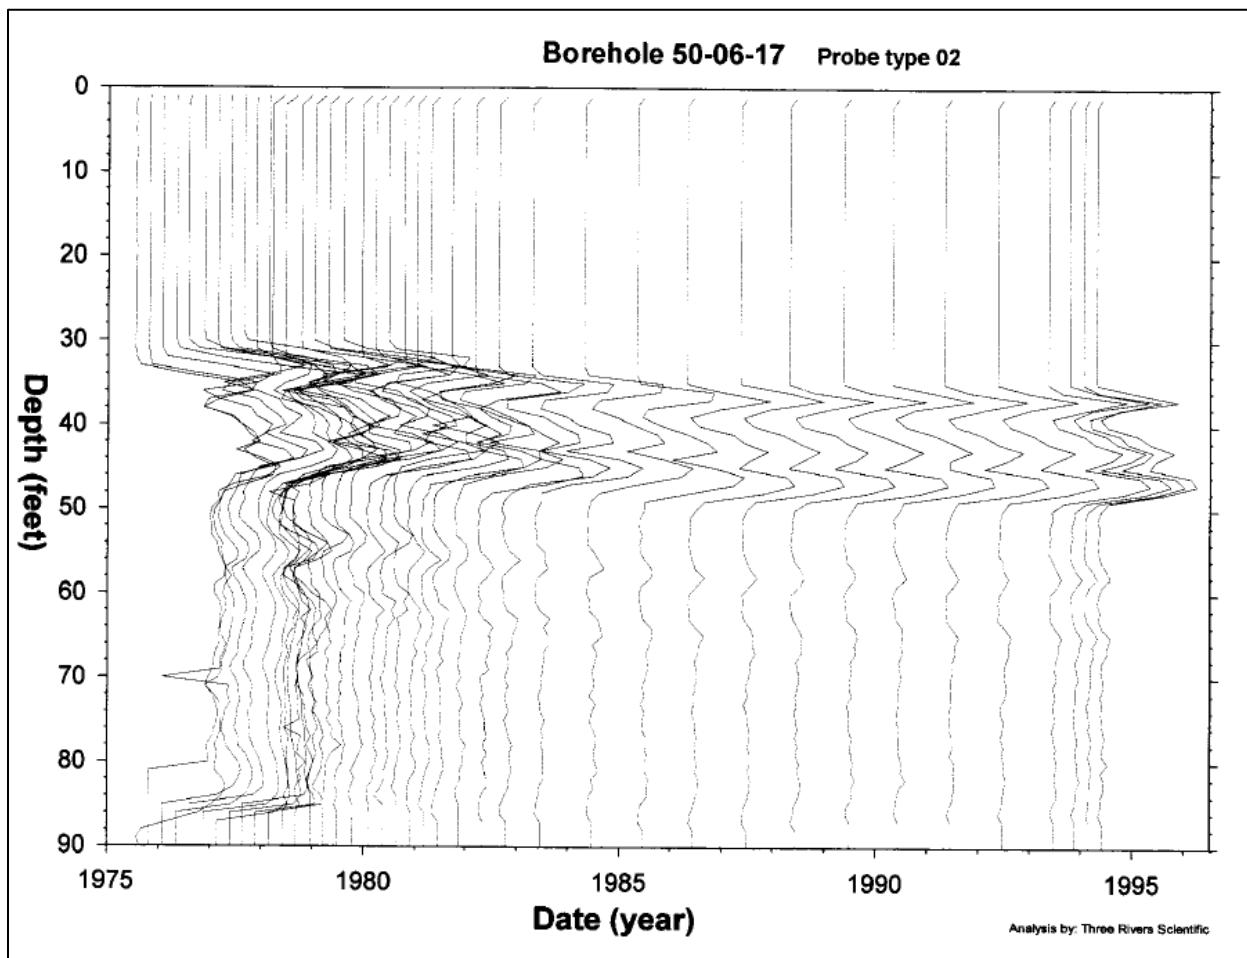
Figure 4-11. Tank T-106 Drywell 50-06-17 (RPP-6008)

In June 1999, Cs-137 and Eu-154 were the only man-made gamma-emitting radionuclides detected in drywell 50-06-17 (GJ-HAN-120). Document GJ-HAN-120 reports, “*The rate of decrease of historical gross gamma activity within the zone of extremely high gamma radiation indicates that Cs-137 is the predominant radionuclide present within the interval from 33 to 50 ft and in the lower portion of the logged interval. Similar to borehole 50-06-05, the potential magnitude of the Cs-137 within these regions of the vadose zone indicates that this contamination originated from the T-106 tank leak and that this borehole is very close to the leak source.*” Figure 4-11 shows the depths of radioactivity from 1975 to 1995 (RPP-6008).

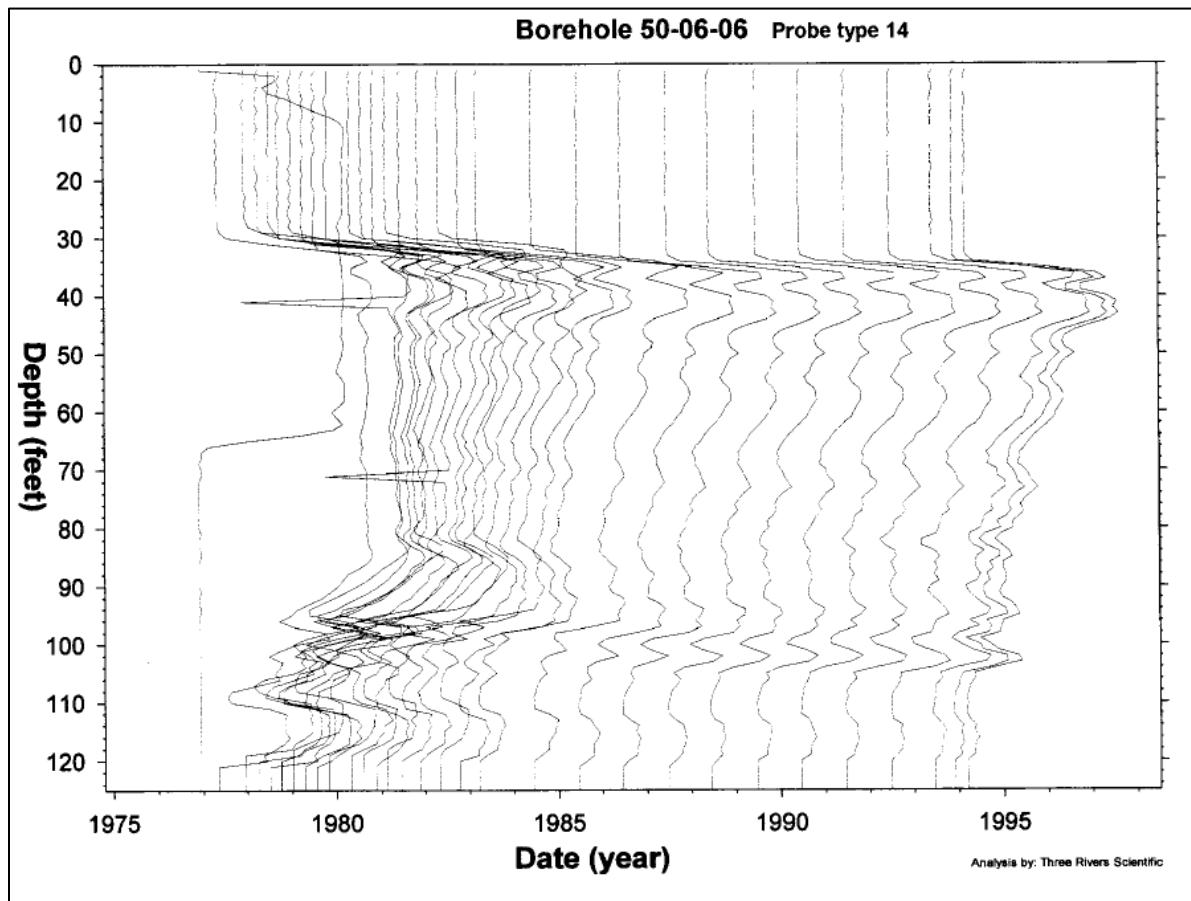
Figure 4-12. Tank T-106 Drywell 50-06-06 (RPP-6008)

In June 1999, Cs-137, Co-60, Eu-154, Eu-152, Sn-126, and Sb-125 were the only man-made gamma and beta emitting radionuclides detected in drywell 50-06-06 (GJ-HAN-120). Document GJ-HAN-120 reports, *“The rate of decrease of the historical gross gamma activity suggests that Cs-137 is the predominant radionuclide present within the zone of extremely high gamma radiation detected from 35 to 46 ft. The Cs-137 contamination originated from the T-106 tank leak, accumulated at the base of the tank farm excavation, and migrated laterally along the perimeter of the tank to this borehole.”* Figure 4-12 shows the depths of radioactivity from 1975 to 1995 (RPP-6008).

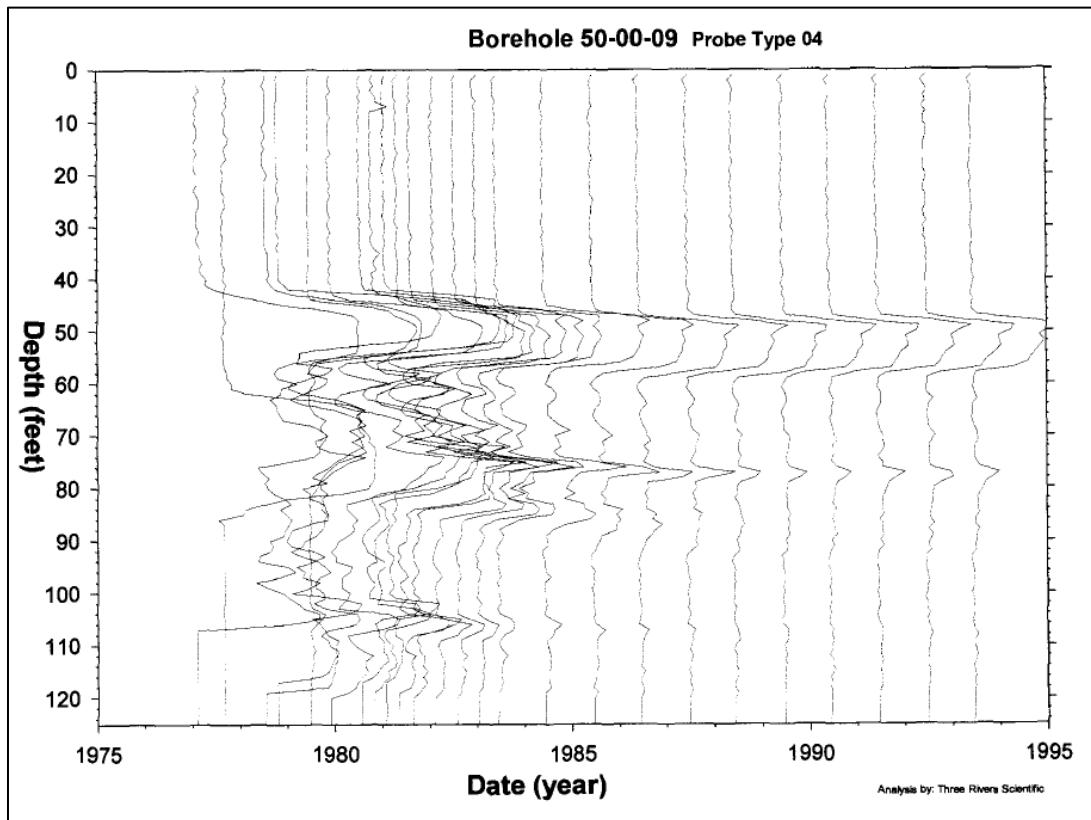
Figure 4-14. Tank T-106 Drywell 50-00-09 Probe 04 (RPP-6088)

Drywell 50-00-09 is located approximately 36-ft from the tank T-106 footing. Drywell 50-00-09 was drilled on February 28, 1977. No historical drywell data were recovered for drywell 50-00-09 except for Figure 4-14 which shows the depths of radioactivity from 1975 to 1995 (RPP-6008).

In June 1999, Cs-137, Co-60, Eu-154, and Eu-152 were the only man-made gamma-emitting radionuclides detected in drywell 50-00-09 (GJ-HAN-120). Document GJ-HAN-120 reports, *“The radionuclide contaminants Co-60, Eu-154, and Eu-152 detected below 46 ft occur within a plume that resulted from the T-106 tank leak. This plume has been identified in all the boreholes located adjacent to the east and southeast sides of the tank between this borehole and borehole 50-06-02.”*

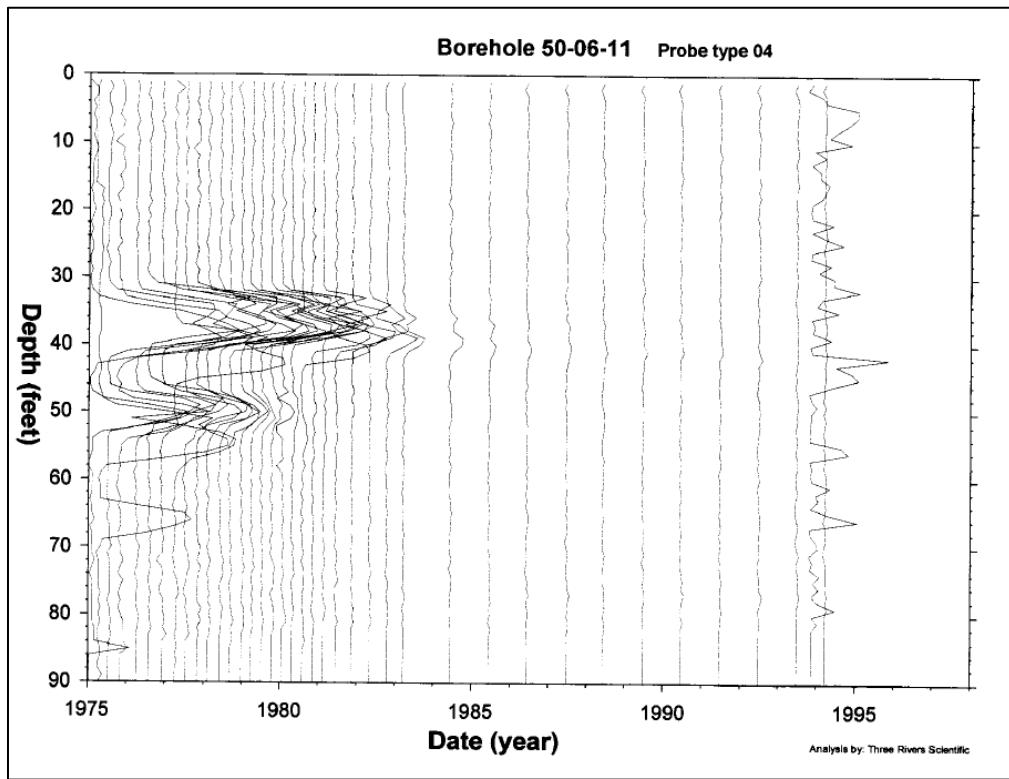
Figure 4-16. Tank T-106 Drywell 50-06-11 (RPP-6008)

50-06-11 (GJ-HAN-120). Cs-137 was detected at the ground surface, 0.5-ft, and 10.5-ft BGS at concentrations of less than 0.5 pCi/g. Small zones of nearly continuous Co-60 contamination were detected from 36 to 41-ft BGS, 76.5 to 78.5-ft BGS, and from 81-ft BGS to the bottom of the logged interval (82.5-ft BGS) ranging from 0.05 to 0.25 pCi/g. Document GJ-HAN-120 reports, *“The Co-60 contamination detected from 38 to 41 ft and 76.5 to 82.5 ft may have originated from the T-106 tank leak or possibly a leak from tank T-103. The upper zone of Co-60 contamination appears to have accumulated at the base of the tank farm excavation along the bottom periphery of the tank and could have migrated from either leak source. The lower zone of Co-60 contamination correlates approximately with the depth of the Co-60 plume detected in borehole 50-03-06, suggesting that tank T-103 is a more likely source.”* Figure 4-16 shows the depths of radioactivity from 1975 to 1995 (RPP-6008).

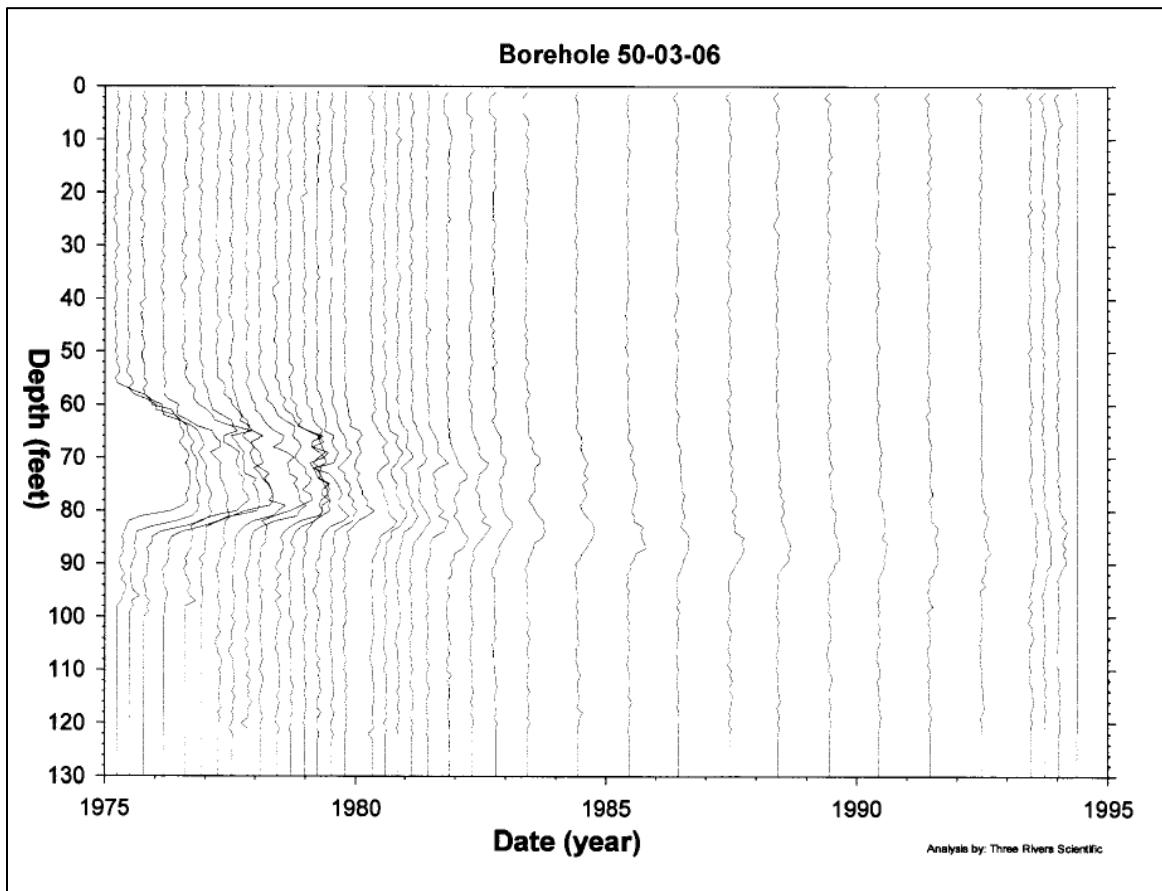
Figure 4-17. Tank T-106 Drywell 50-03-06 (RPP-6008)

In June 1999, Cs-137, Co-60 and Eu-154 were the only man-made gamma-emitting radionuclides detected in drywell 50-03-06 (GJ-HAN-120). Cs-137 was detected at the ground surface with lower concentrations detected below this zone probably from carry down during drilling. Document GJ-HAN-120 reports, *“The plume containing Co-60 and Eu-154 contamination detected between 66 and 95 ft most likely originated from a leak from tank T-103.”* Therefore, drywell 50-03-06 is not included as part of the leak location for tank T-106. Figure 4-17 shows the depths of radioactivity from 1975 to 1995 (RPP-6088).

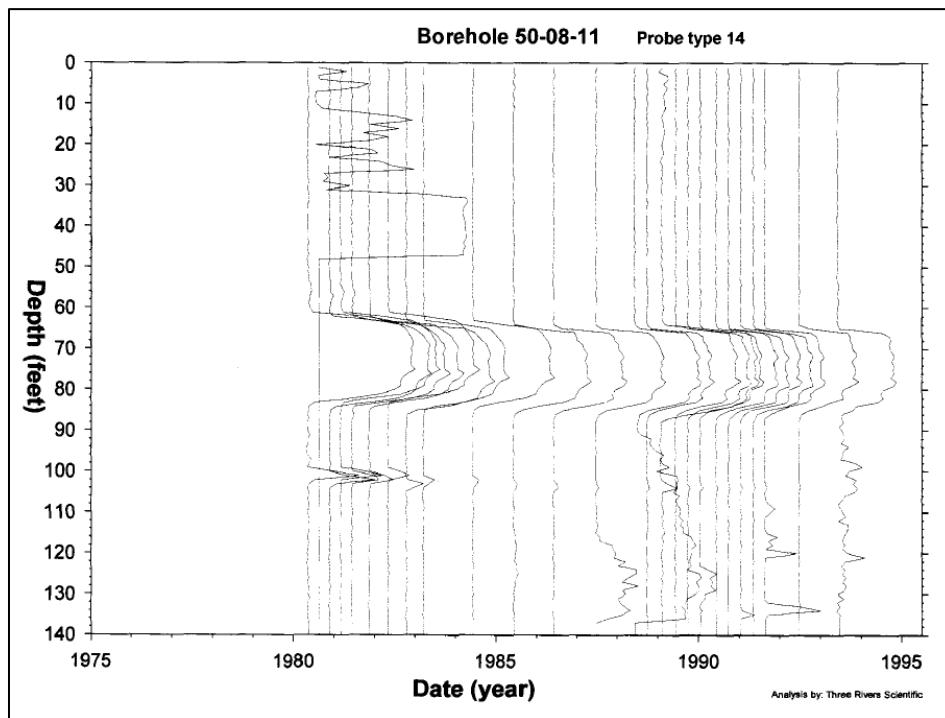
Figure 4-18. Tank T-106 Drywell 50-08-11 (RPP-6008)

In June 1999, Cs-137, Co-60, Eu-154, and Eu-152 were the only man-made gamma-emitting radionuclides detected in drywell 50-08-11 (GJ-HAN-120). Cs-137 was detected almost continuously from the ground surface to 63.5-ft BGS, almost continuously from 85.5 to 97.5-ft BGS, intermittently from 102.5 to 105-ft BGS, and intermittently from 118-ft BGS to the bottom of the borehole (135.5-ft BGS). Co-60 contamination was detected almost continuously from 54.5 to 112.5-ft BGS. A thick zone of Co-60 contamination occurs from about 65 to 86-ft BGS. The maximum Co-60 concentration was 90.5 pCi/g at 70.5-ft BGS. Eu-152 and Eu-154 were detected continuously from ~64 to ~83-ft BGS with peaks at 4.7 pCi/g and 173.3 pCi/g, respectively. Document GJ-HAN-120 reports, “*The Co-60, Eu-154, and Eu-152 contamination detected below about 54.5 ft is probably the result of a tank leak. On the basis of data from historical gross gamma logs, contamination has been present in this interval since at least 1973. A likely source of the Co-60, Eu-154, and Eu-152 contamination is nearby tank T-106, a known leaker.*” Figure 4-18 shows the depths of radioactivity from 1980 to 1995 (RPP-6088).

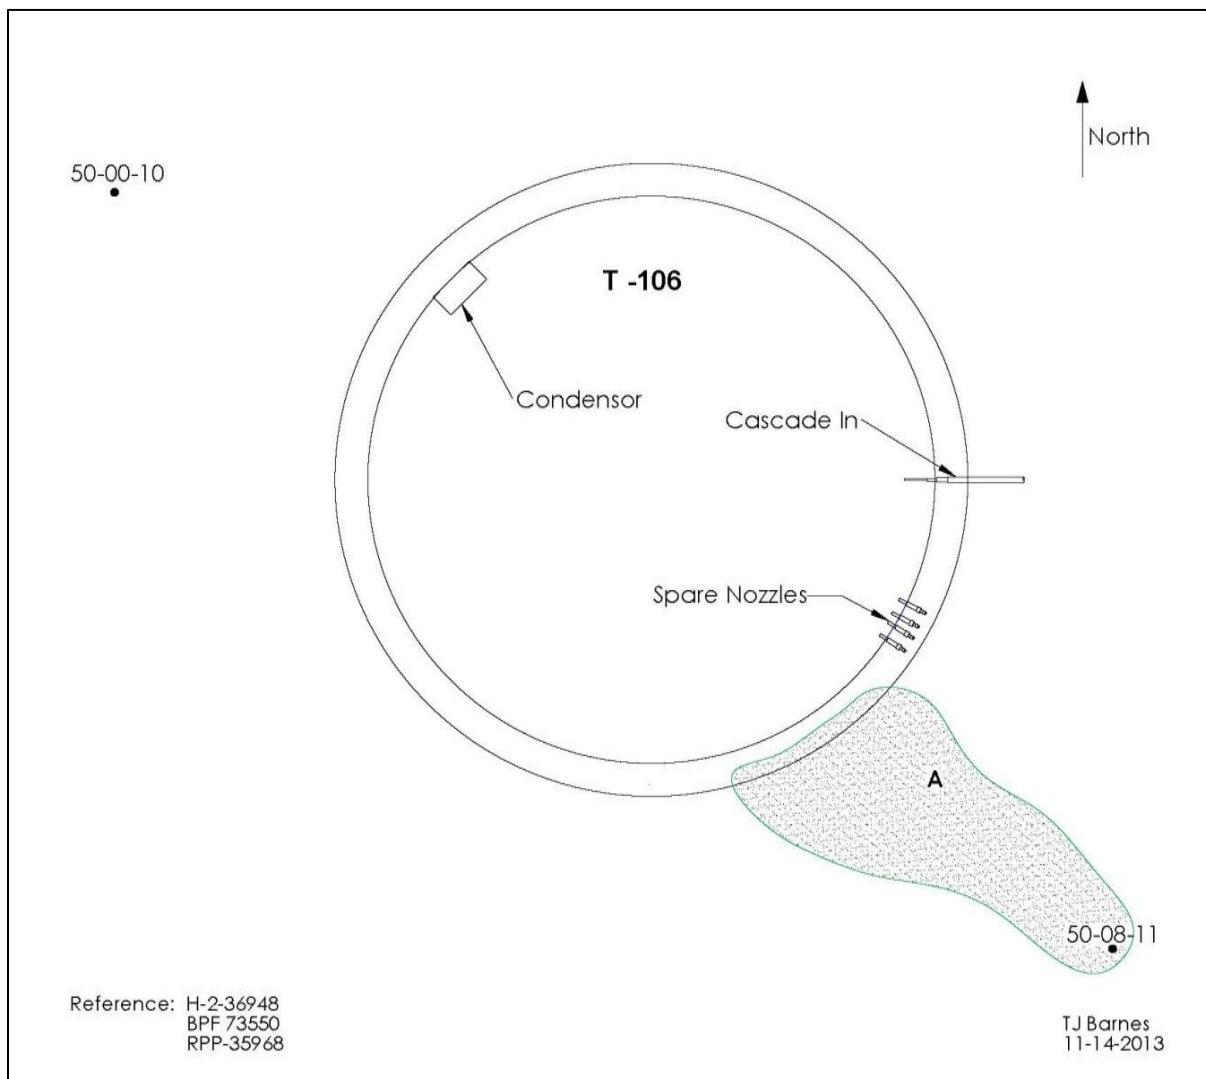
Figure 4-19. Tank T-106 Possible Leak Location (May-June 1973)

The tank T-106 leak was determined to have started on or around April 20, 1973 (see Section 4.2). There were only two drywells (50-08-11 and 50-00-10) near tank T-106 during this time frame. The first recoverable reading for drywell 50-08-11 on May 31, 1973 indicated radioactivity with a peak of 10K cpm at an unspecified BGS depth. Radioactivity continued to increase significantly over the next couple of days (see site A in Figure 4-19). Drywell 50-08-11 radioactivity was coupled with a significant drop in the liquid level confirming the tank T-106 leak.

The tank T-106 was determined to have started on or around April 20, 1973 (see Section 4.4.1). Only two drywells were located near the tank at this time. Additional drywells were installed near tank T-106 beginning in June 1973 and were used to estimate the shape of the leak plume to the likely tank leak location.

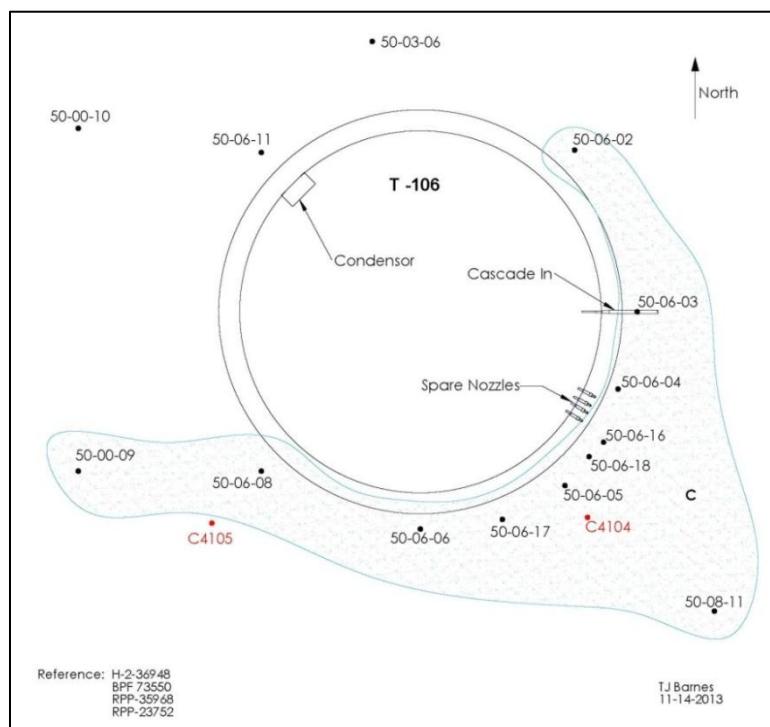
Figure 4-21. Tank T-106 Possible Leak Location (June 1973 to 1977)

It was reported that the initial leak site was located near drywells 50-06-05 and 50-06-17 based on the concentrations detected by SGSL (GJ-HAN-120) with migration to the adjacent drywells (see site C in Figure 4-21). There is a possibility that there are multiple leak sites in this area; however, since these drywells were installed later and data wasn't recovered until months after the tank leak, the number of leak sites in this area remains speculative. Drywell 50-16-18 was installed in 1993 and direct pushes C4104 and C4105 were installed in 2003; these are not included as part of the leak location for tank T-106 since these seem to only confirm the extent of the initial leak.

The tank T-106 was determined to have started on or around April 20, 1973 (see Section 4.4.1). Only two drywells (50-08-11 and 50-00-10) were located near the tank when the tank was first suspected of leaking. Additional drywells shown above were drilled in June 1973 through 1977. Drywell 50-16-18 was drilled in 1993 and direct pushes C4104 and C4105 were installed in 2003.

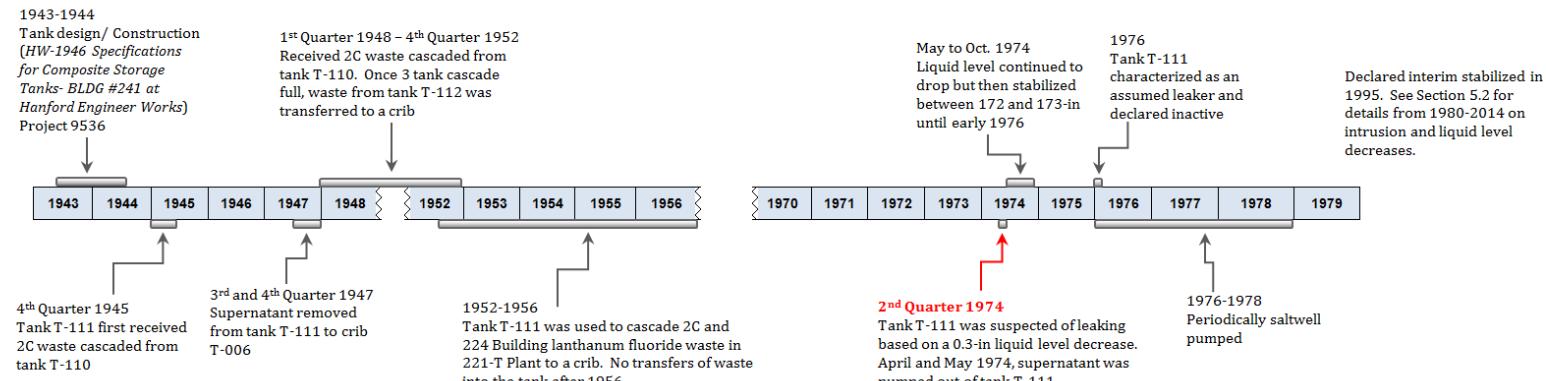
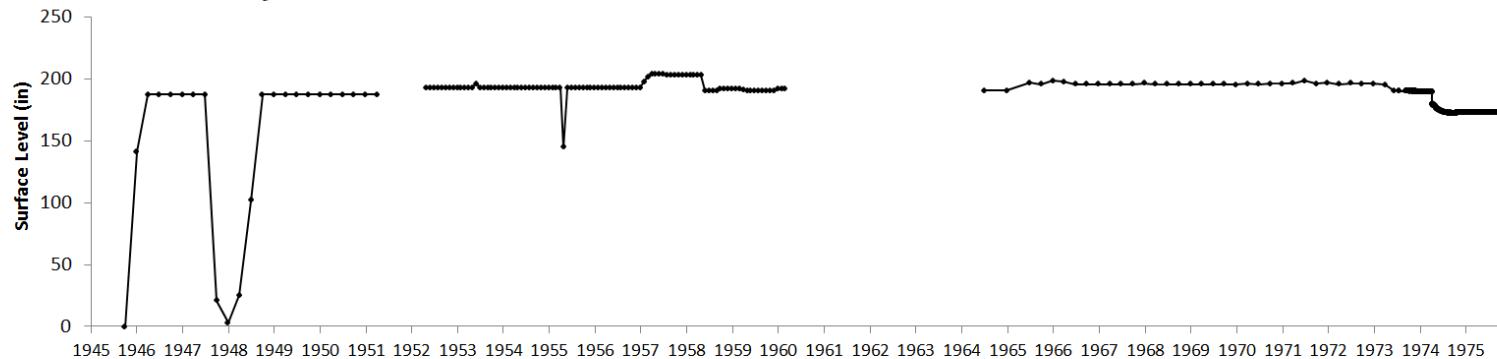
Figure 5-2. Operational Leak History of Tank T-111**T-111 Leak History:**

The operational history of tank T-111 leak related details including liquid level is charted in Figure 5-2.

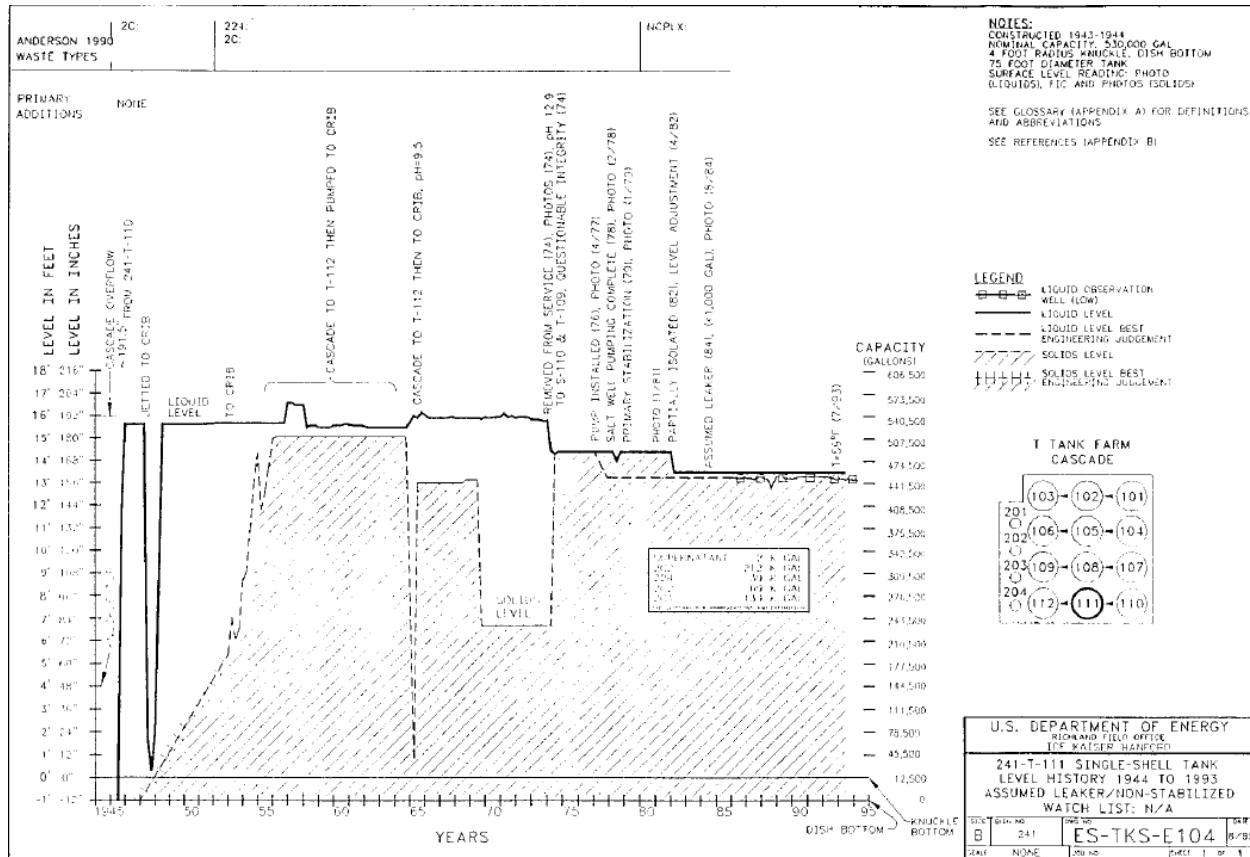
Figure 5-3. Tank T-111 End of Quarter Surface Level

The liquid level plot in Figure 5-3 indicates the transfer activity into and out of tank T-111. The liquid levels are end of quarter levels so this figure may not reflect all transfers into and out of the tank that occurred during the operational history. See Figure 5-2 for historical monthly liquid level readings.

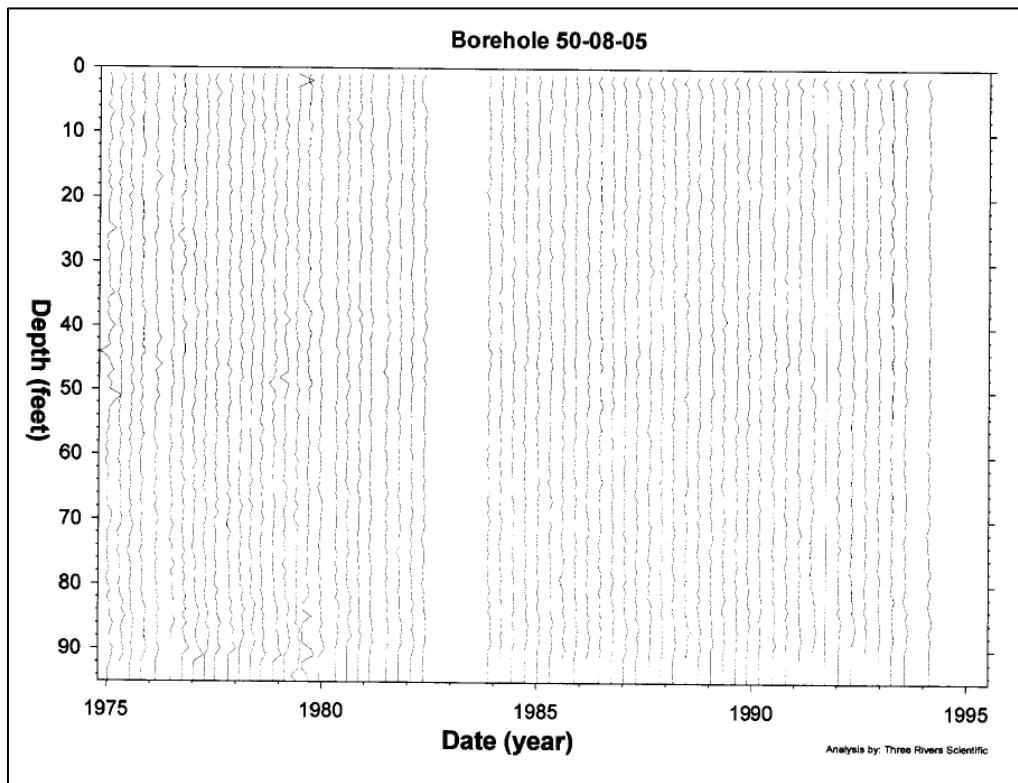
Figure 5-6. Tank T-111 Drywell 50-08-05 (RPP-6088)

Since historical radioactivity in this drywell is very low, the 0.3-in leak volume is very low, and the GJ-HAN-123 report indicated low levels of radioactivity, drywell 50-08-05 is not being included as part of the leak location for tank T-111. Figure 5-6 shows the depths of radioactivity from 1975 to 1995 (RPP-6088).

Drywell 50-08-05 reported small levels of radioactivity at an unspecified BGS depth in the earliest recoverable data in April 1974; however, radioactivity declined to less than values by January 1975. Thus, earlier reported radioactivity could be from short-lived radioisotopes. Therefore, drywell 50-08-05 is not included as part of the leak location for tank T-111.

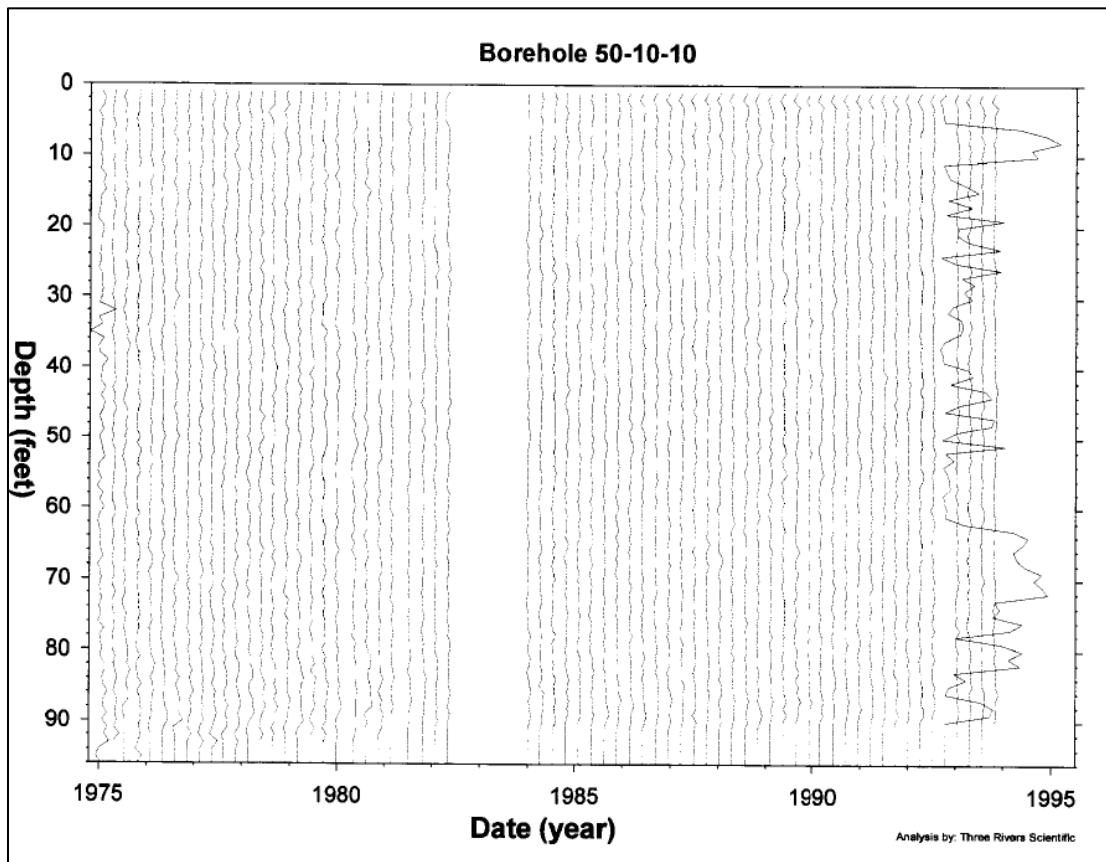
Figure 5-7. Tank T-111 Drywell 50-10-10 (RPP-6088)

Since historical radioactivity in this drywell is very low, the 0.3-in leak volume is very low, and GJ-HAN-123 report indicated low levels of radioactivity, drywell 50-10-10 is not being included as part of the leak location for tank T-111. Figure 5-7 shows the depths of radioactivity from 1975 to 1995 (RPP-6088).

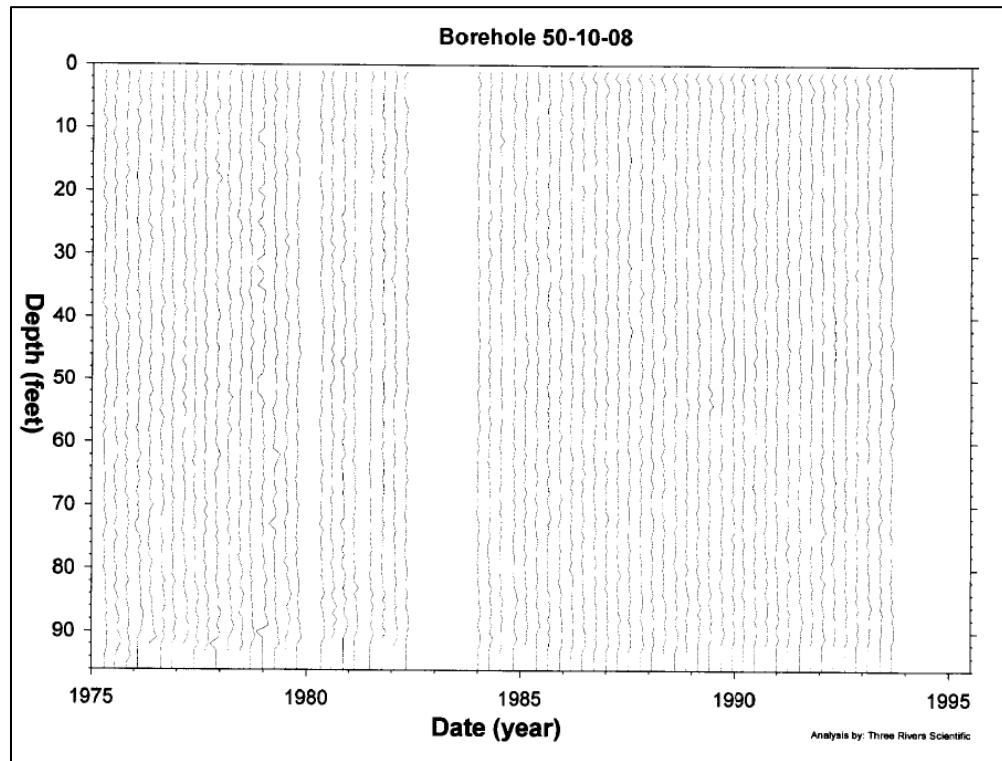
Figure 5-8. Tank T-111 Drywell 50-10-08 (RPP-6088)

Drywell 50-10-08 is located approximately 15-ft from the tank T-111 footing. Drywell 50-10-08 was drilled in March 1975 with the first recoverable reading on April 18, 1975 reported as a less than values (see Appendix A2). Readings continued to be reported as less than values through September 1987.

Since historical radioactivity in this drywell is near the surface, drywell 50-10-08 is not being included as part of the leak location for tank T-111. Figure 5-8 shows the depths of radioactivity from 1975 to 1995 (RPP-6088).
