Hanford Single-Shell Tank Leak Causes and Locations - 241-T Farm

C.L. Girardot, D.G. Harlow

Key Words: leak location, leak cause, tank, integrity assessment, T Farm, T-106, T-111, leak assessment

Abstract: This document identifies 241-T Tank Farm (T Farm) leak causes and locations for the 100 series leaking tanks (241-T-106 and 241-T-111) identified in RPP-RPT-55084, Rev. 0, Hanford 241-T Farm Leak Inventory Assessment Report. This document satisfies the T Farm portion of the target (T04) in the Hanford Federal Facility Agreement and Consent Order milestone M-045-91F.

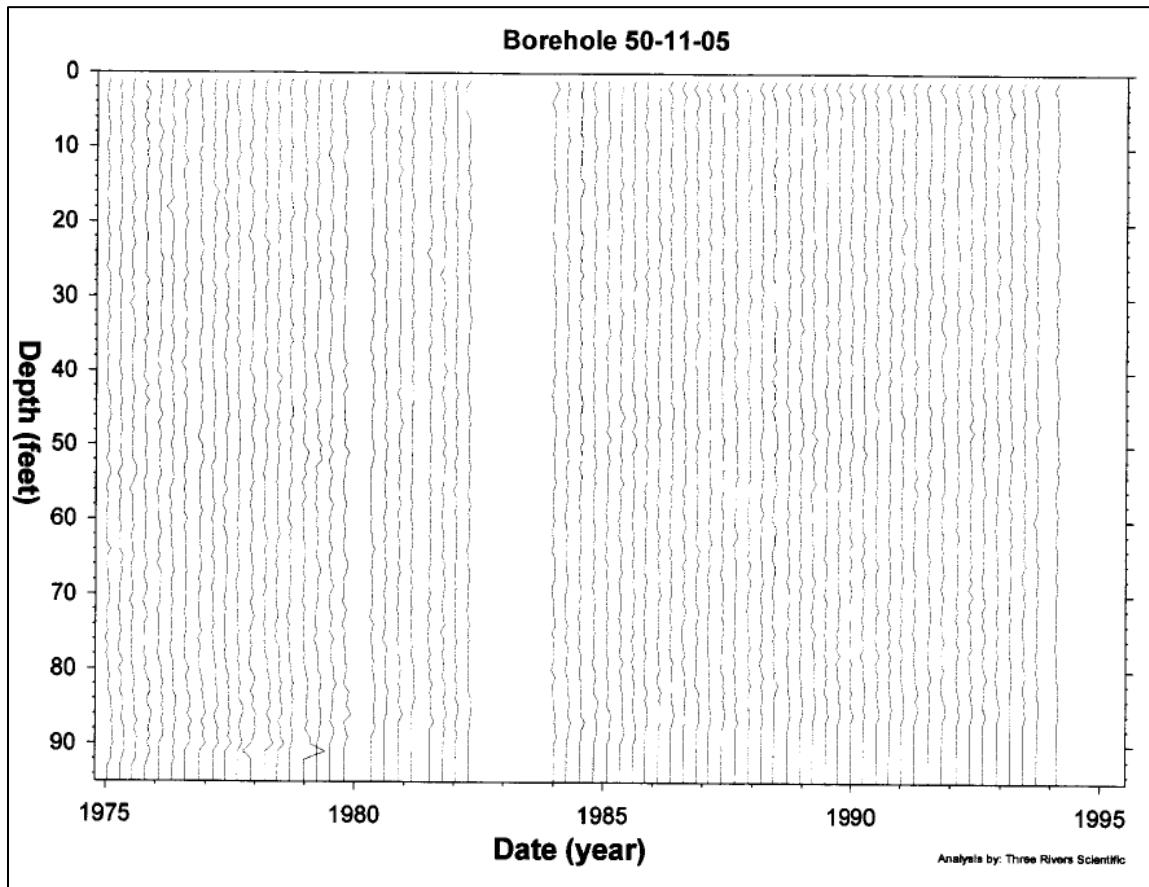
Figure 5-9. Tank T-111 Drywell 50-11-05 (RPP-6088)

Drywell 50-11-05 is located approximately 4.7-ft from the tank T-111 footing. Drywell 50-11-05 was drilled in February 1974 with the first recoverable reading on April 5, 1974 reported as a less than values (see Appendix A2). Readings continued to be reported as less than values through September 1987.

Since historical radioactivity in this drywell was detected at the ground surface, drywell 50-11-05 is not being included as part of the leak location for tank T-111. Figure 5-9 shows the depths of radioactivity from 1975 to 1995 (RPP-6088).

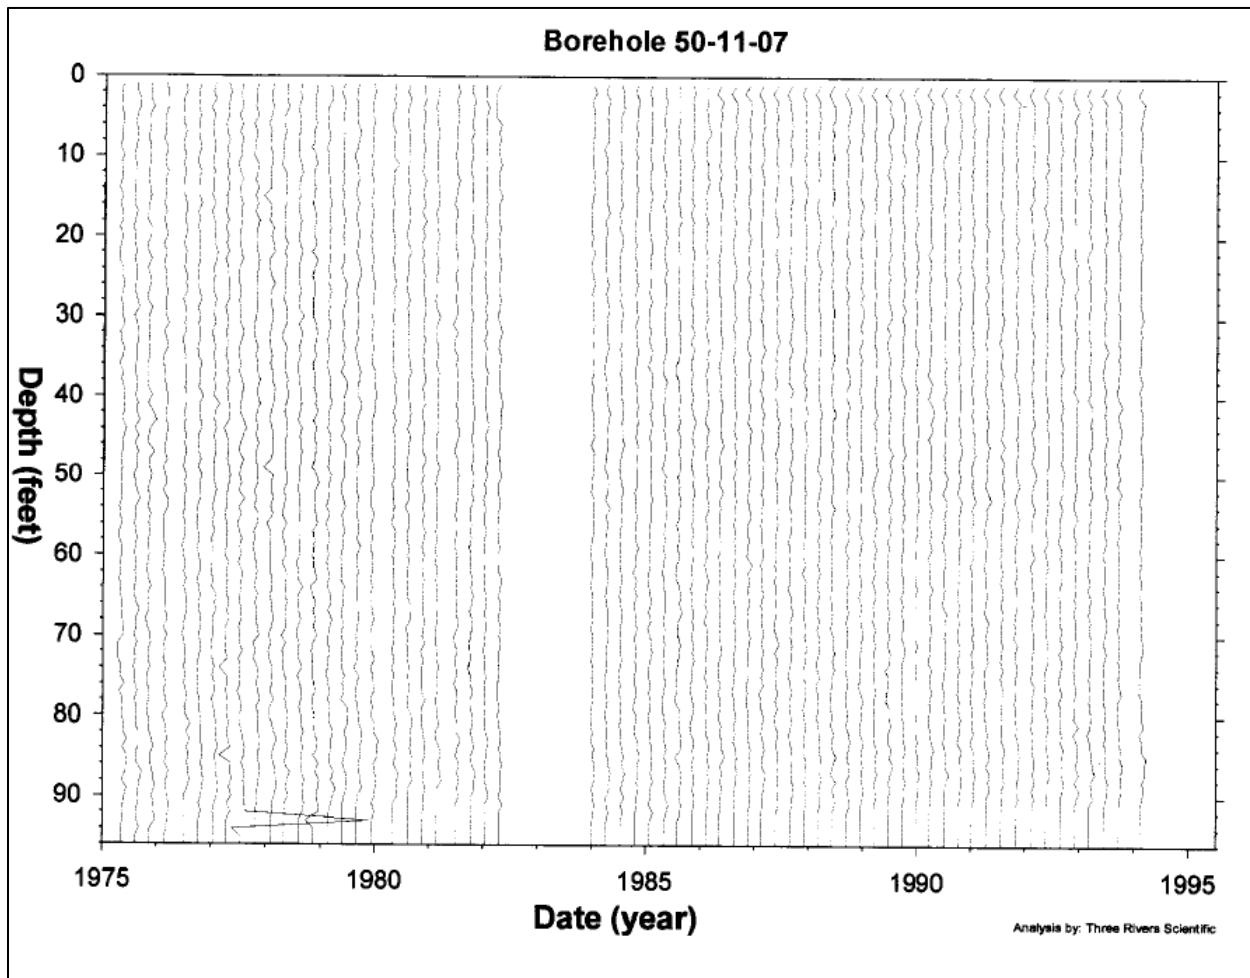
Figure 5-10. Tank T-111 Drywell 50-11-07 (RPP-6088)

Since historical radioactivity in this drywell is very low, the 0.3-in leak volume is very low, drywell 50-11-07 is not being included as part of the leak location for tank T-111. Figure 5-10 shows the depths of radioactivity from 1975 to 1995 (RPP-6088).

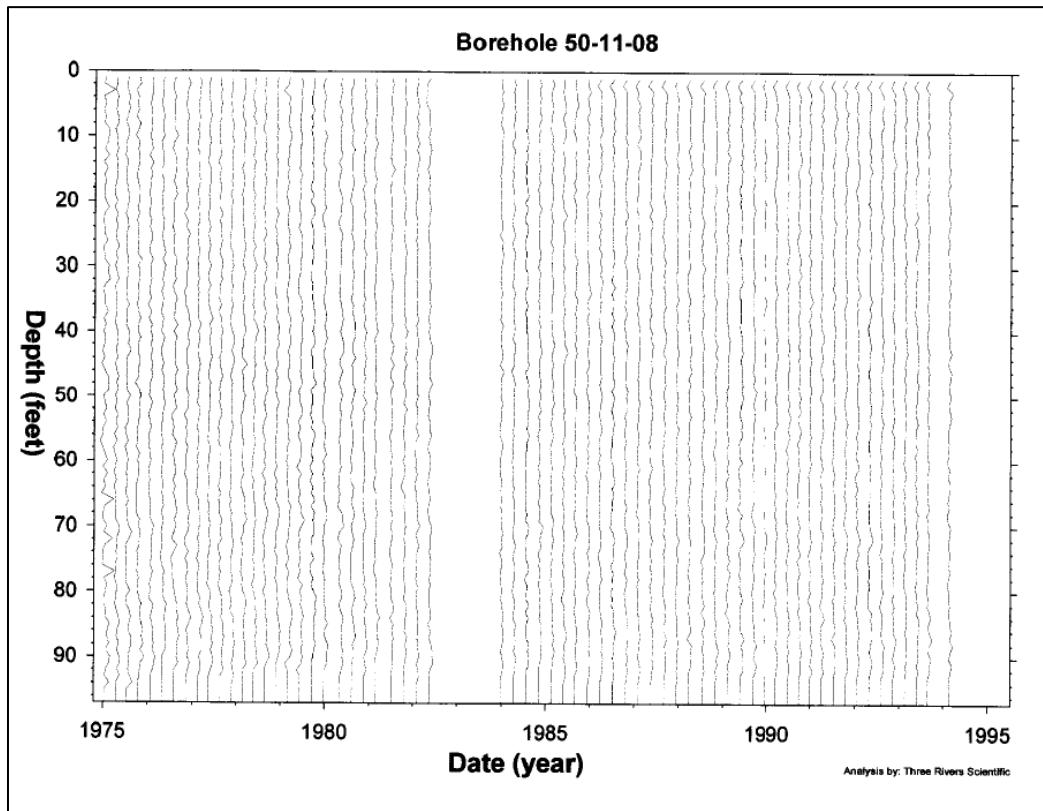
Figure 5-11. Tank T-111 Drywell 50-11-08 (RPP-6088)

Drywell 50-11-08 is located approximately 12-ft from the tank T-111 footing. Drywell 50-11-08 was drilled in February 1974 with the first recoverable reading on April 5, 1974 reported as a less than values (see Appendix A2). Readings continued to be reported as less than values through September 1987.

Since historical radioactivity in this drywell is very low and near the surface, drywell 50-11-08 is not being included as part of the leak location for tank T-111. Figure 5-11 shows the depths of radioactivity from 1975 to 1995 (RPP-6088).

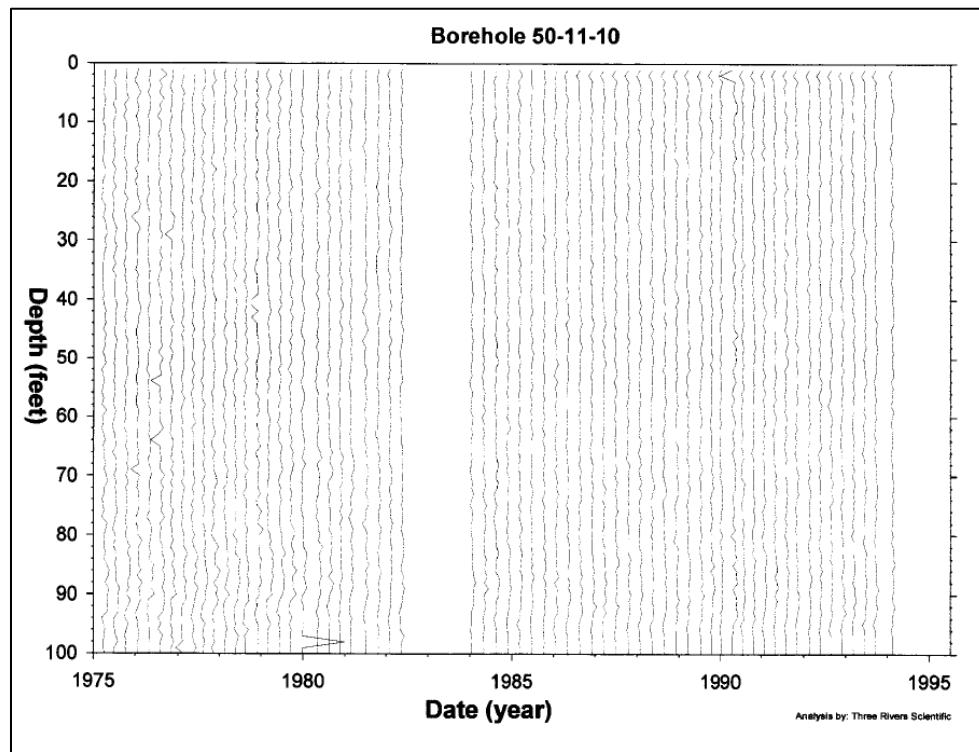
Figure 5-12. Tank T-111 Drywell 50-11-10 (RPP-6088)

Since historical radioactivity in this drywell is very low, the 0.03-in leak volume is very low, and the GJ-HAN-123 report indicated low levels of radioactivity, drywell 50-11-10 is not being included as part of the leak location for tank T-111. Figure 5-12 shows the depths of radioactivity from 1975 to 1995 (RPP-6088).

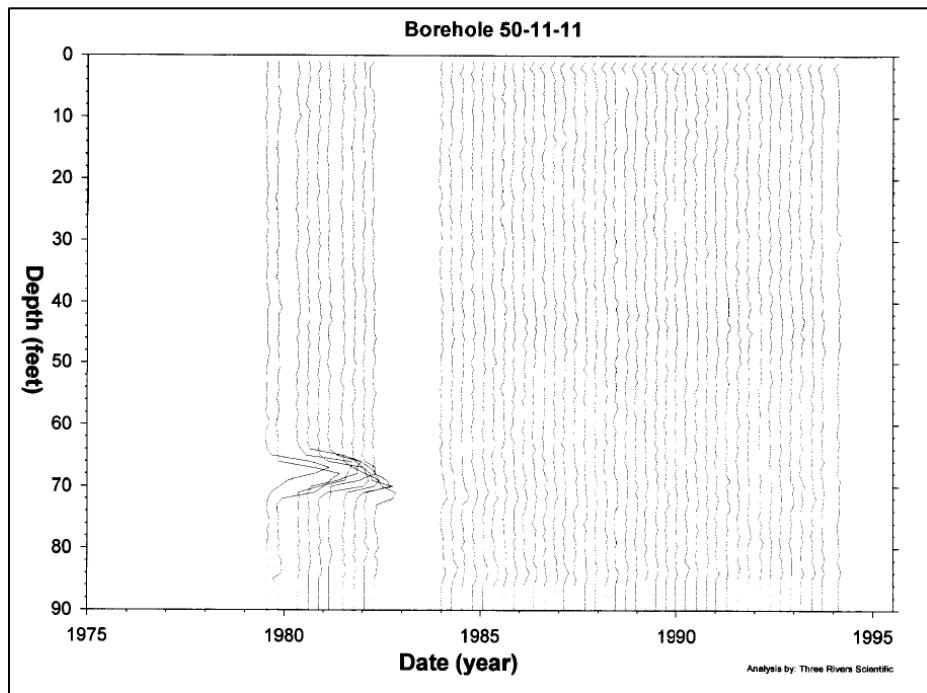
Figure 5-13. Tank T-111 Drywell 50-11-11 (RPP-6088)

Drywell 50-11-11 is located approximately 3.8-ft from the tank T-111 footing. Drywell 50-11-11 was drilled in July 1979 with the first recoverable reading on July 26, 1979 which reported a peak of 46.1K cpm at 67-ft BGS (see Appendix A2). Readings continued to be reported at roughly the same BGS level and activity level through February 5, 1980. Beginning on August 19, 1980, the peak declined to 22.3K cpm at 67-ft BGS and slowly decreased to 2.3K cpm by September 29, 1987 at 73-ft BGS.

Since historical radioactivity in this drywell is low, at a low BGS level, and the drywell was drilled approximately five years after the tank was suspected of leaking, drywell 50-11-11 is not being included as part of the leak location for tank T-111. Figure 5-13 shows the depths of radioactivity from 1975 to 1995 (RPP-6088).

Drywell 50-11-11 reported low level radioactivity in 1979, or about five years after tank T-111 was first suspected of leaking. Radioactivity was reported at a much lower BGS level (~67-ft BGS) compared to the tank footing (~38-ft 1-in BGS). Therefore, drywell 50-11-11 is not being included as part of the leak location for tank T-111.

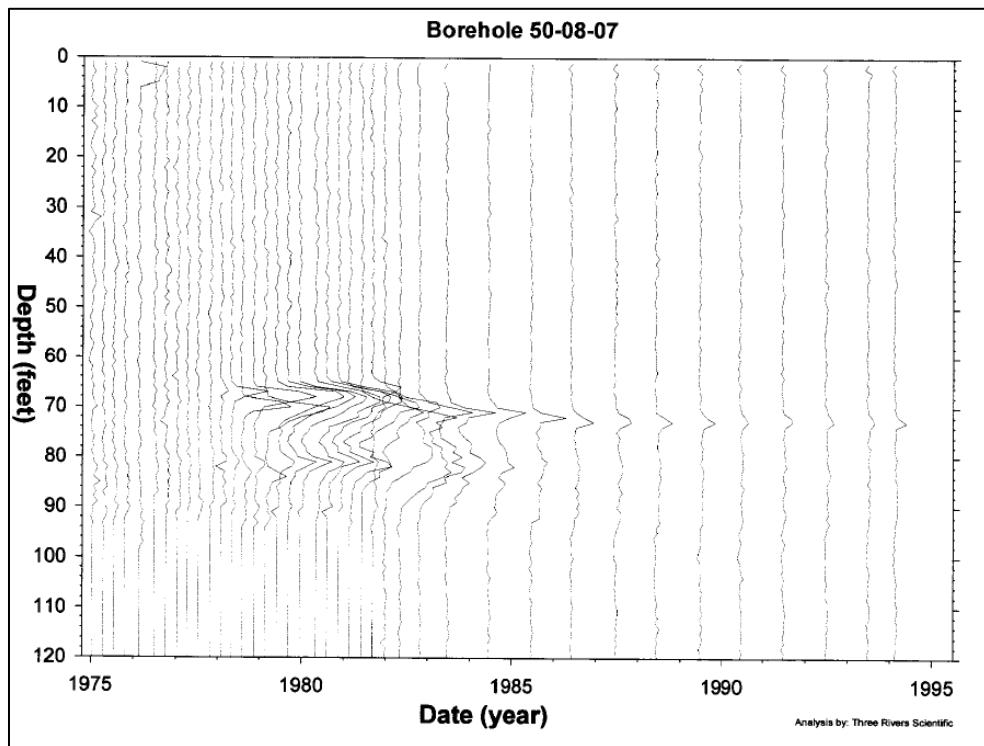
Figure 5-14. Tank T-111 Drywell 50-08-07 (RPP-6088)

Drywell 50-08-07 is located approximately 15-ft from the tank T-111 footing. Drywell 50-08-07 was drilled in February 1974 with the first recoverable reading on April 5, 1974 reported as a less than values (see Appendix A2). Readings continued to be reported as less than values through October 14, 1977. Beginning on January 6, 1978, a peak of 3.2K cpm was reported at 67-ft BGS. The next recoverable reading on May 5, 1978 reported two peaks of 8.9K cpm at 67-ft BGS and 3.2K cpm at 80-ft BGS. Radioactivity continued to increase at both peaks through August 8, 1979, then remained relatively stable through 1981, and then slowly declined through June 1987.

Since historical radioactivity in this drywell is very low in concentration and BGS depth, the 0.3-in leak volume is very low, and the SGLS results indicated low levels of radioactivity, drywell 50-08-07 is not being included as part of the leak location for tank T-111. Figure 5-14 shows the depths of radioactivity from 1975 to 1995 (RPP-6088).

tank footing, drywell 50-08-07 is therefore not included as part of the leak location for tank T-111.
