U.S. DEPARTMENT OF  
**ENERGY**

# 2013 Annual Site Inspection and Monitoring Report for Uranium Mill Tailings Radiation Control Act Title I Disposal Sites

March 2014

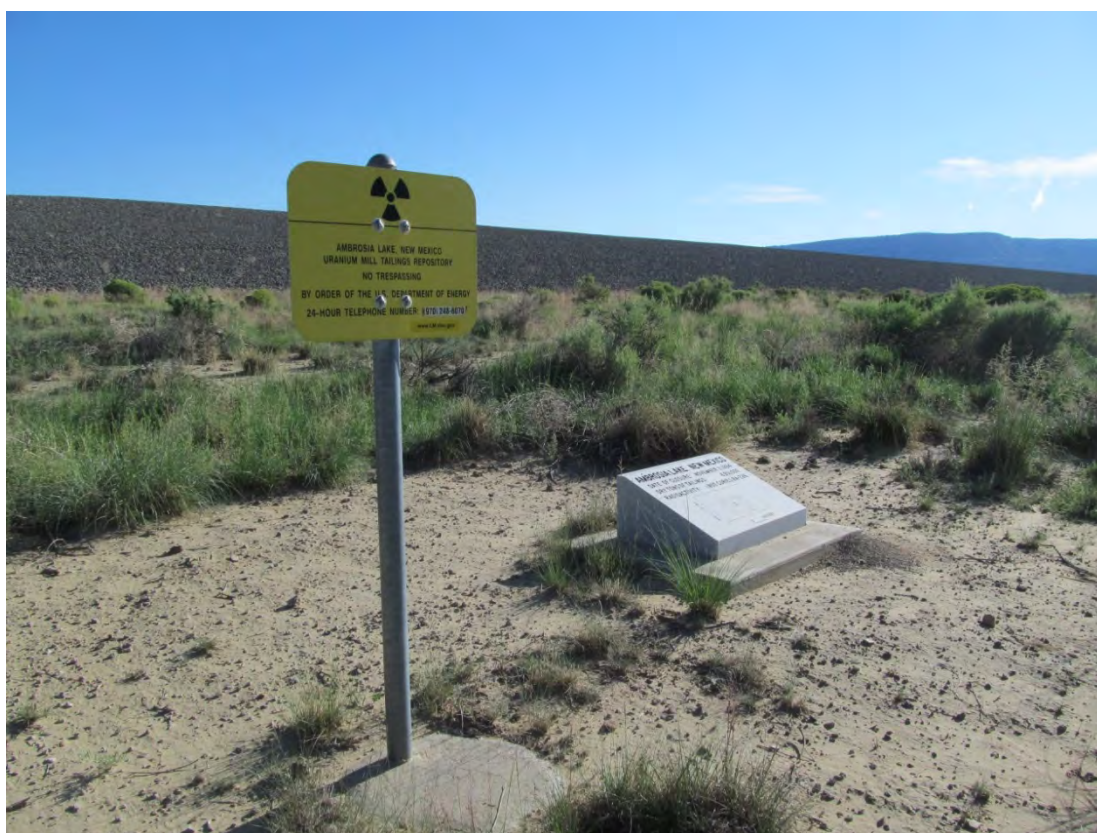
The entrance sign was in good condition (PL-1).

*AMB 8/2013. PL-1. Entrance sign and site marker SMK-1.*

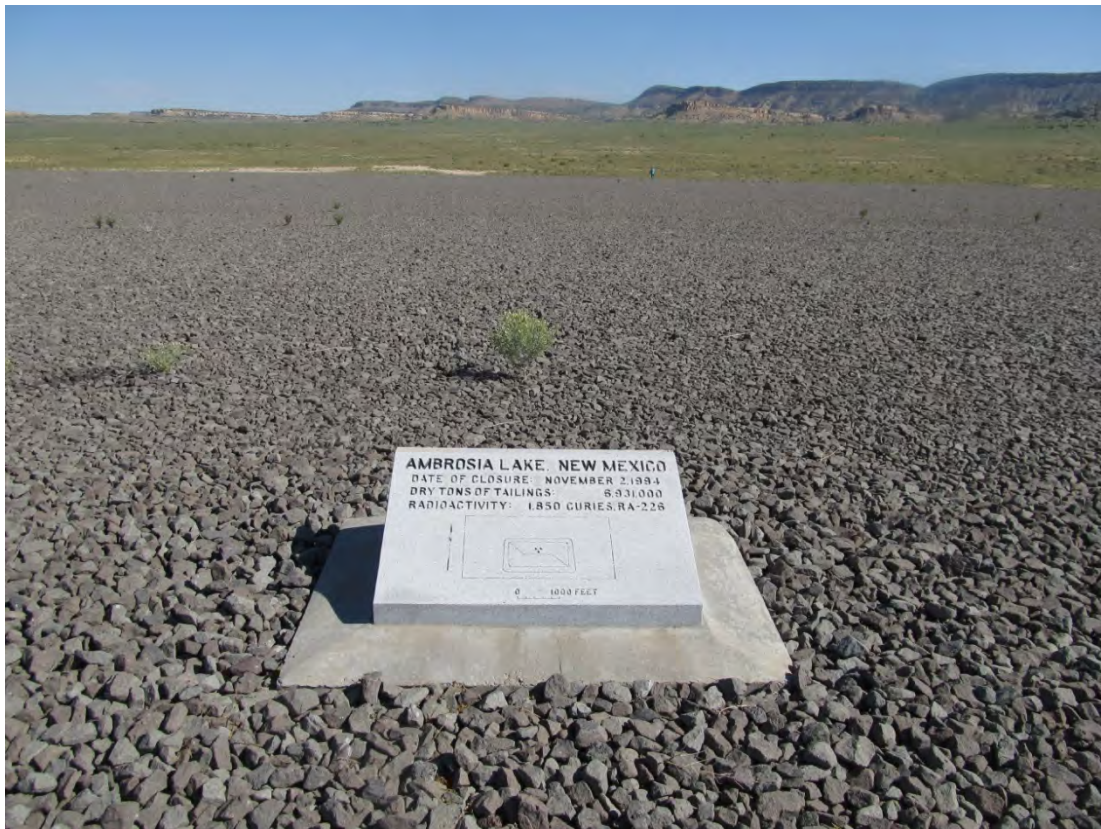
Granite site markers are located near the site entrance and on top of the disposal cell (PL-2). Both site markers were in excellent condition.

*AMB 8/2013. PL-2. Site marker SMK-2 on disposal cell top.*

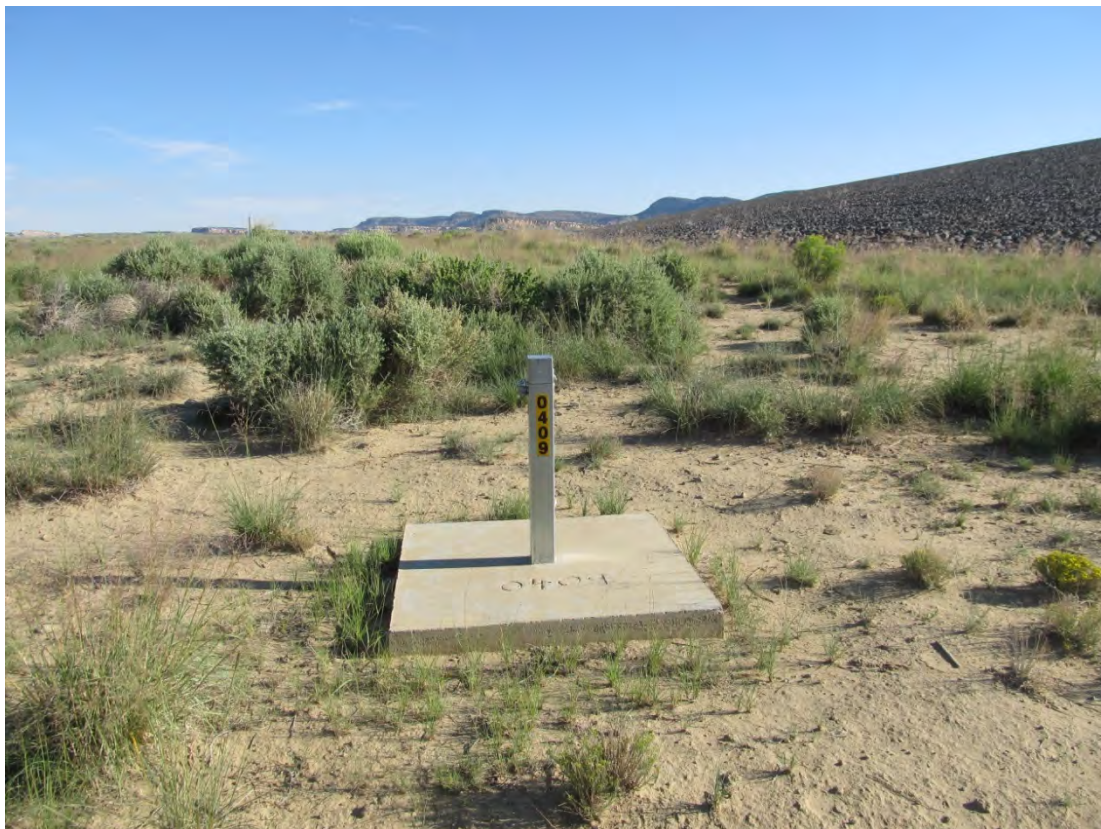
Monitoring wells 0409, 0675, and 0678 were in good condition (PL-3). Gully formation adjacent to monitoring well 0678 appears to be stable, and the well is not impacted by the erosion.

*AMB 8/2013. PL-3. Monitoring well 0409.*

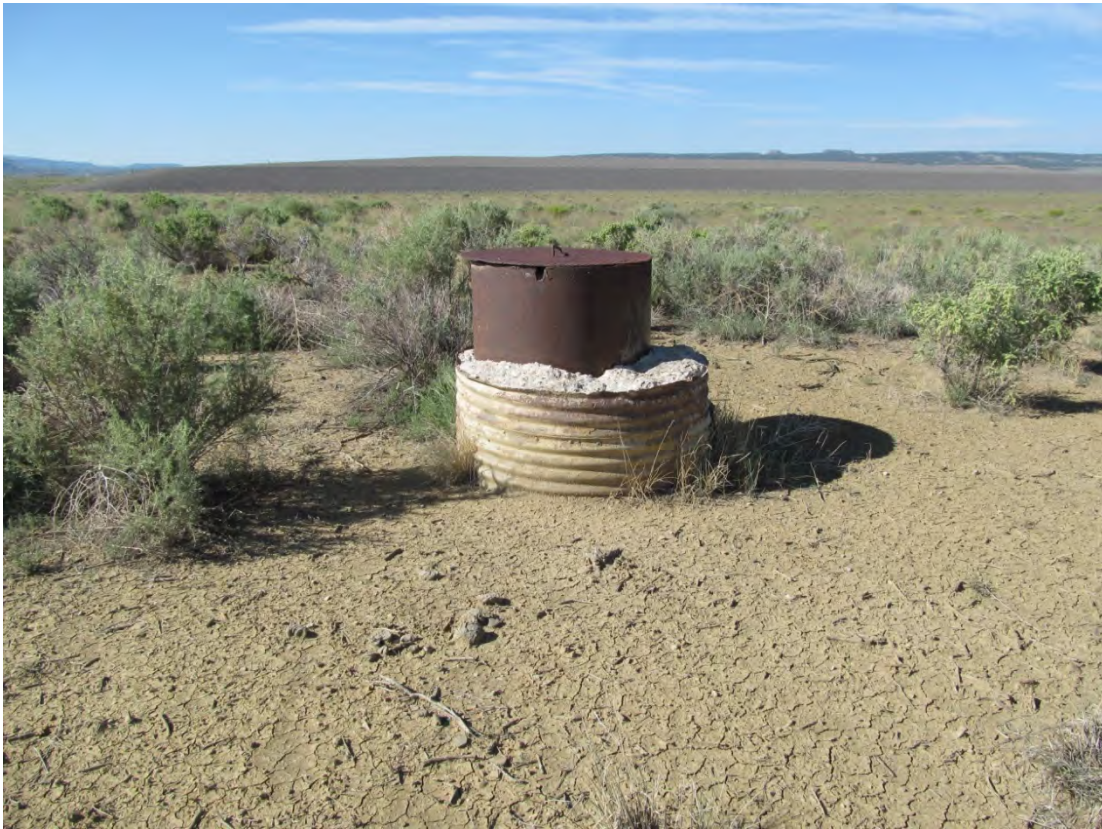
A mine vent shaft, associated with an abandoned underground mine, is within the site boundary in the northern portion of the site. The vent has a casing, which rises approximately 3 feet above the ground, and a spot-welded cover. The vent was secure at the time of the inspection (PL-4). Inspectors will continue to monitor the condition of the vent to ensure that the closure remains secure.

*AMB 8/2013. PL-4. Secured mine vent shaft.*

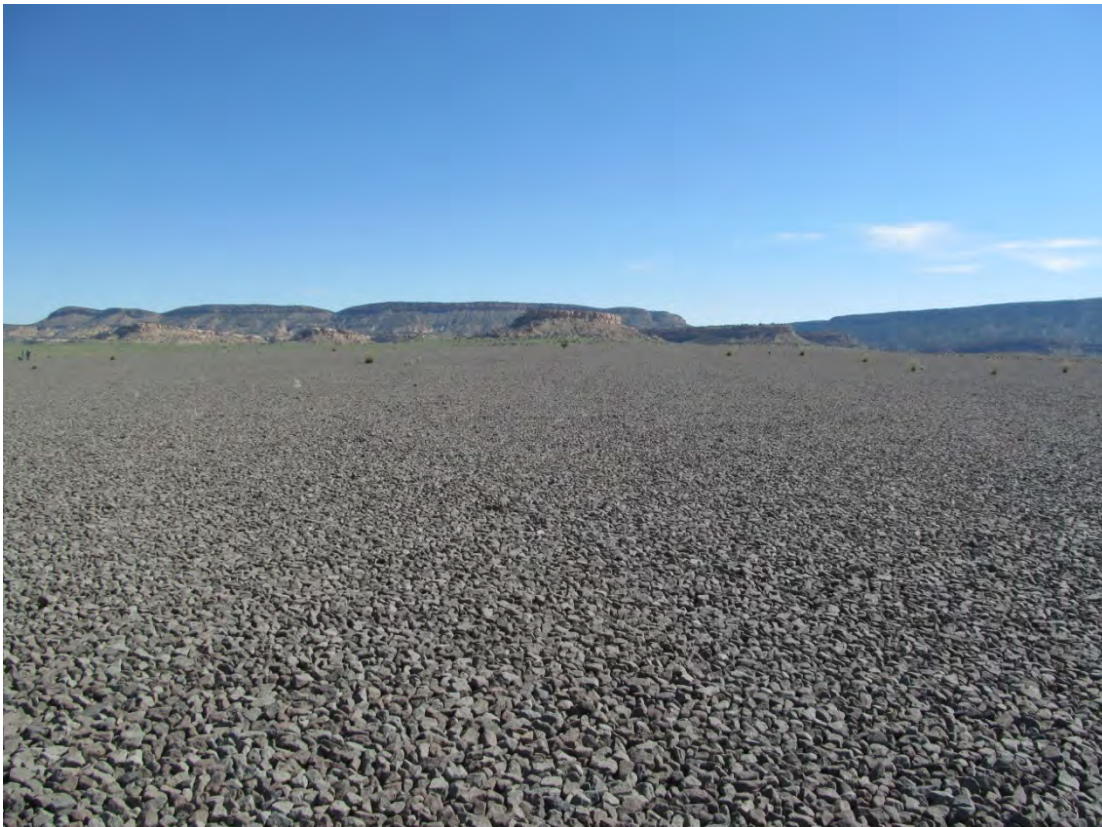
The 91-acre disposal cell was completed in 1994. The basalt riprap-covered top slope of the disposal cell was in excellent condition (PL-5). There was no evidence of cracking, slumping, or erosion.

*AMB 8/2013. PL-5. Disposal cell top slope.*

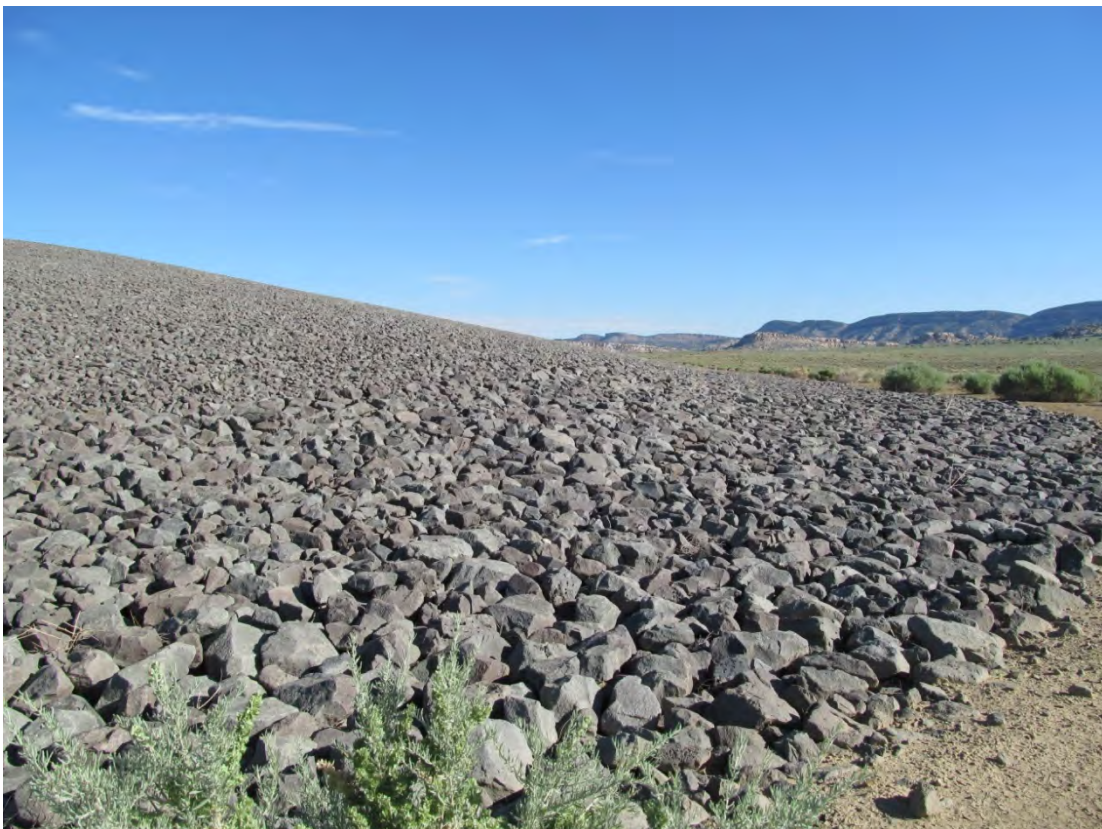
The basalt riprap-covered side slopes and apron were in excellent condition and showed no evidence of cracking, settling, slumping, or erosion (PL-7).

*AMB 8/2013. PL-7. Southeast corner apron and east side slope of disposal cell.*

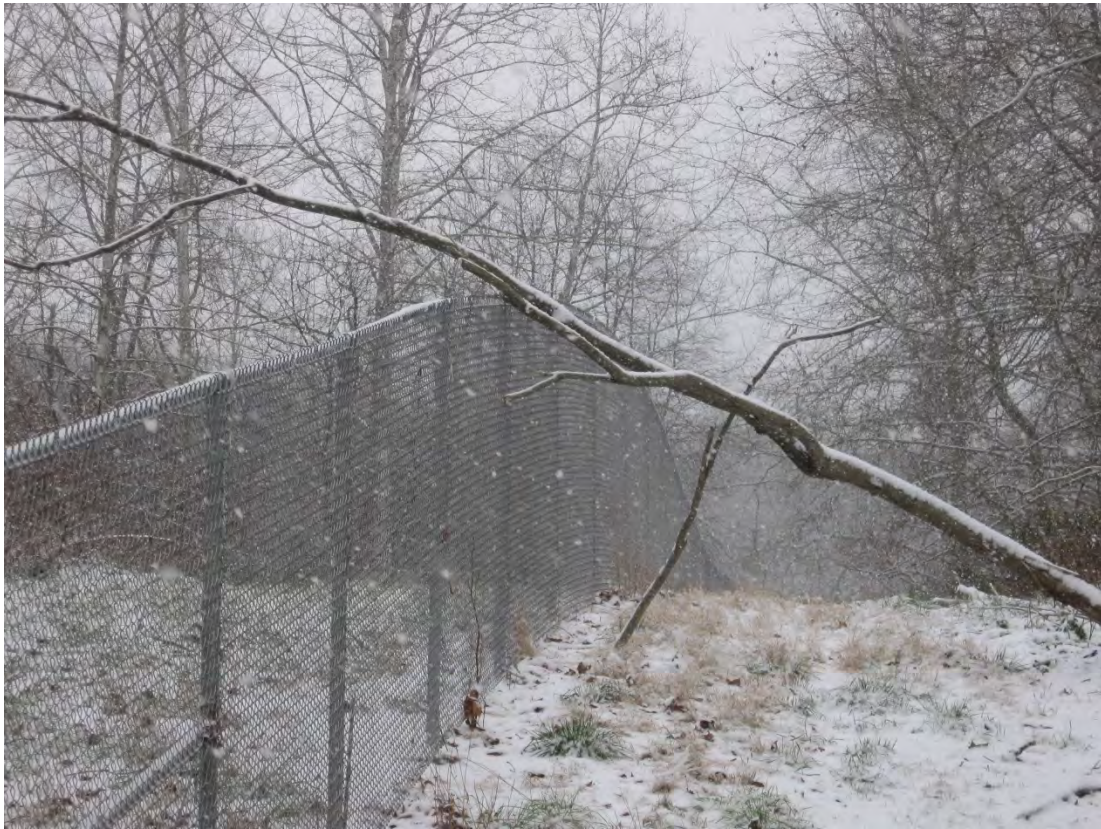
The chain link perimeter fence that encircles the site was replaced in 2007. The fence had minor damage at several locations along the south fence line due to fallen trees (PL-2 thru PL-6).

*BUR 12/2013. PL-2. Tree down on south fence.*

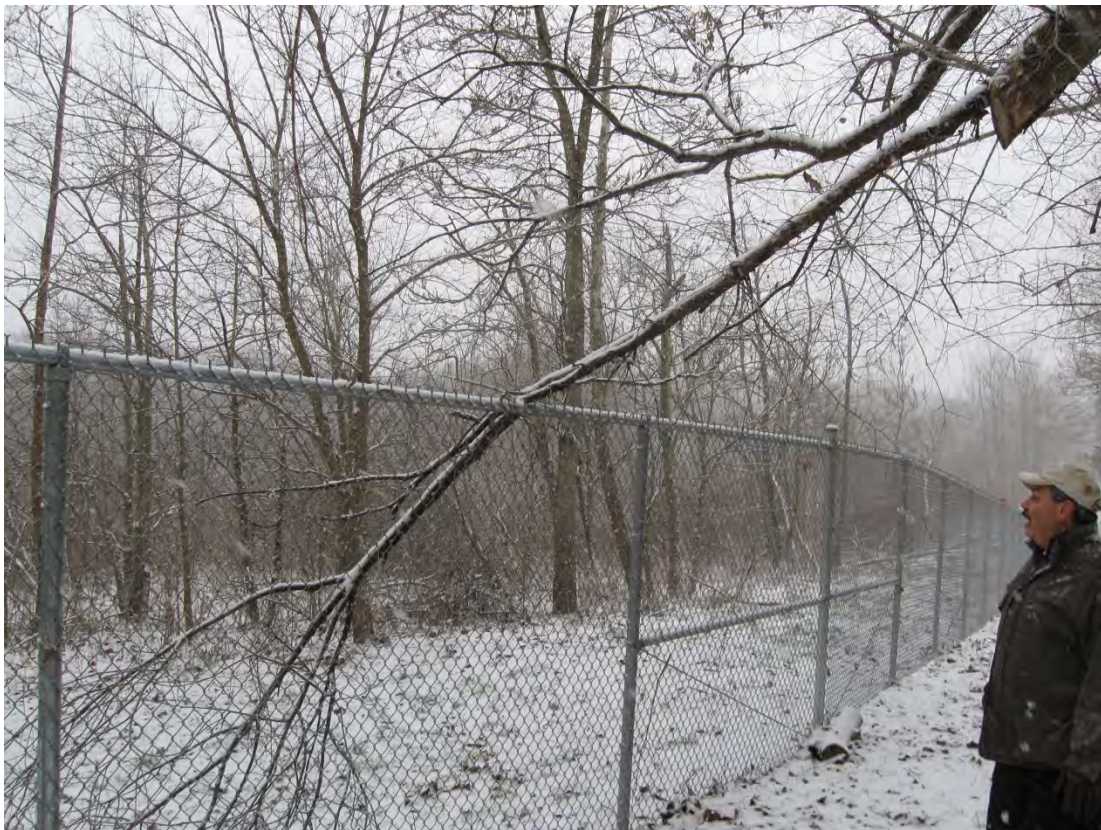
*BUR 12/2013. PL-3. Tree across southern fence.*

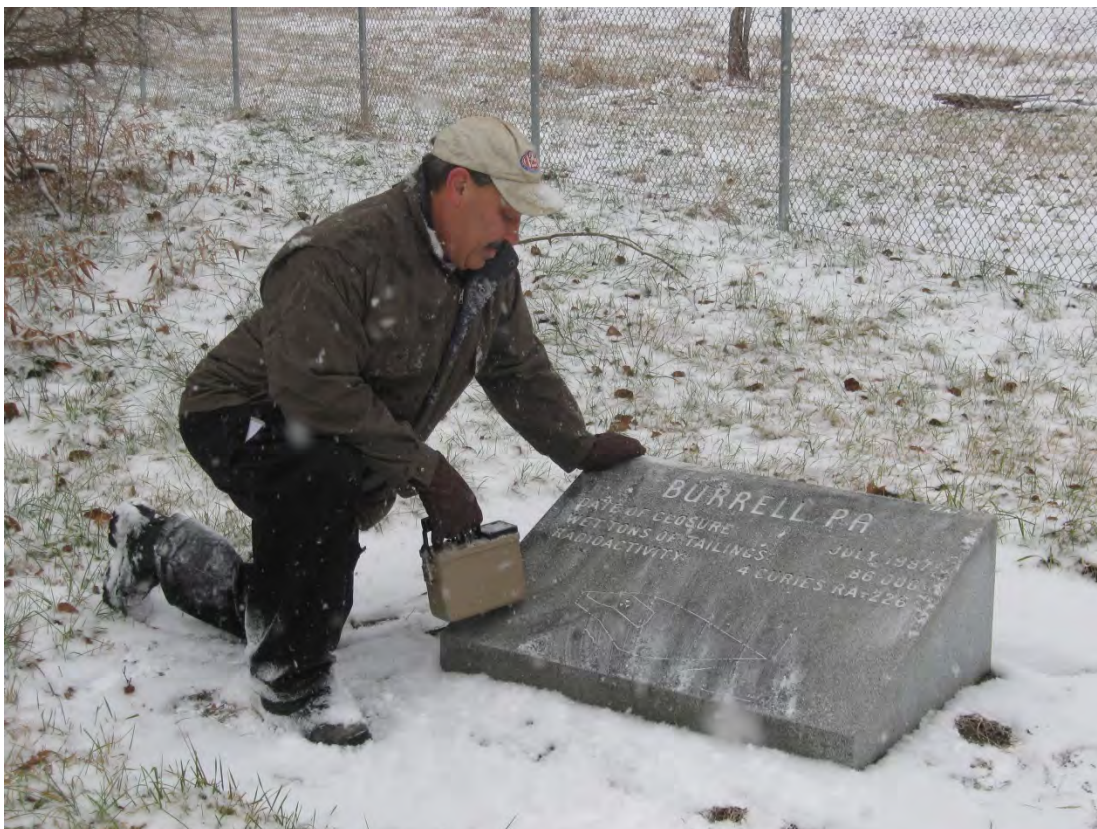
The Burrell site has one site marker. It is located just inside the main entrance gate and was in excellent condition (PL-7).

*BUR 12/2013. PL-7. Inspector at site marker.*

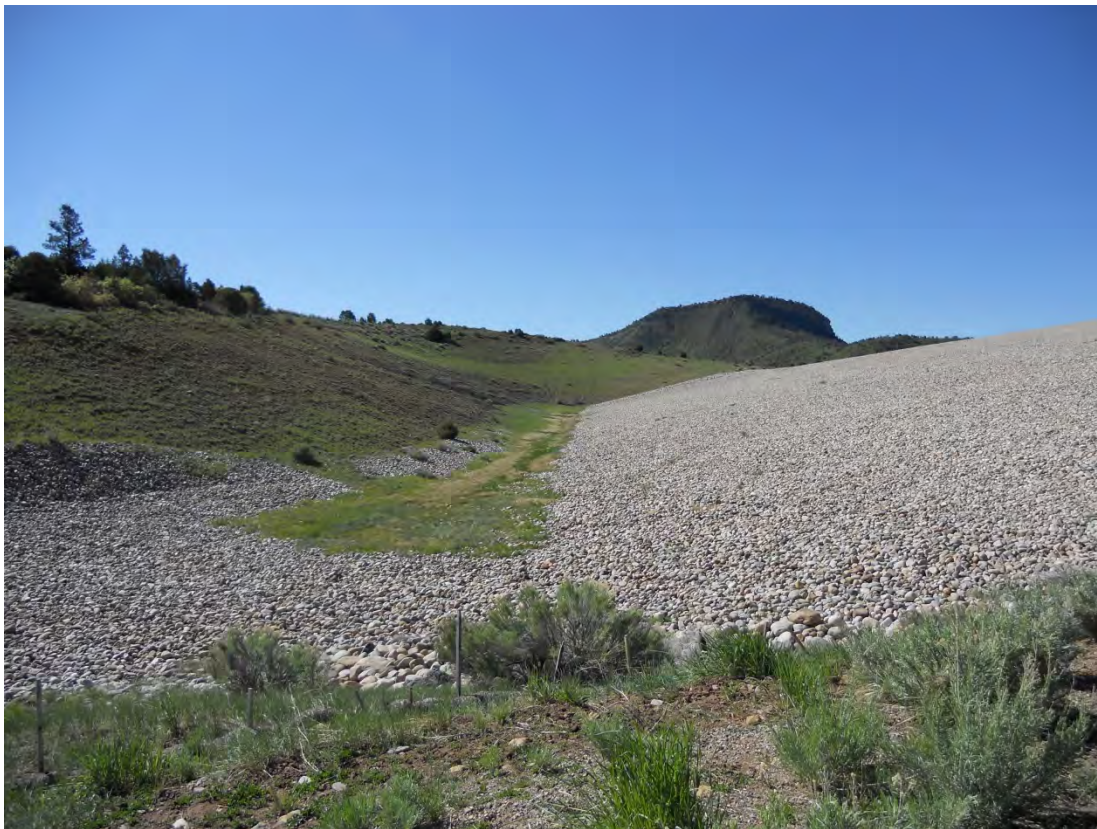
*DUD 5/2013. PL-9. Ditch No. 1 and the east slope of the disposal cell.*

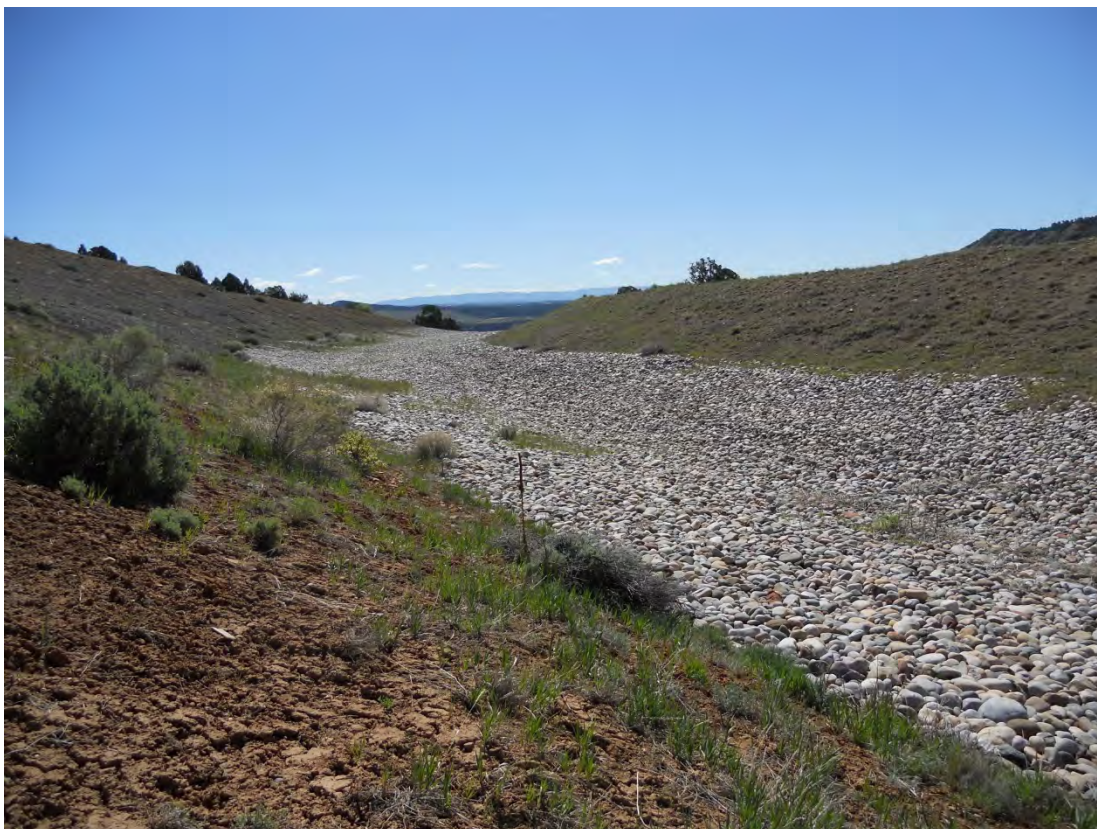
*DUD 5/2013. PL-10. Portion of Ditch No. 2 downslope from disposal cell.*

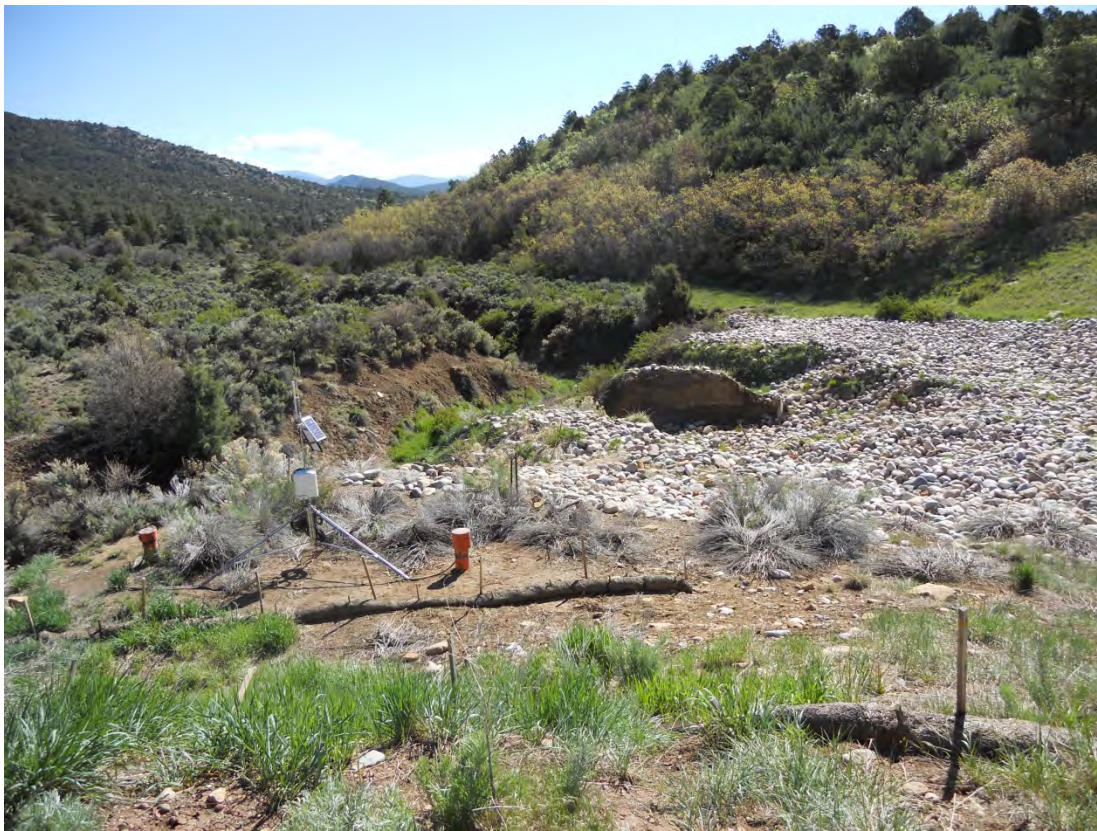
*DUD 5/2013. PL-11. Northeast outflow, showing erosion areas.*

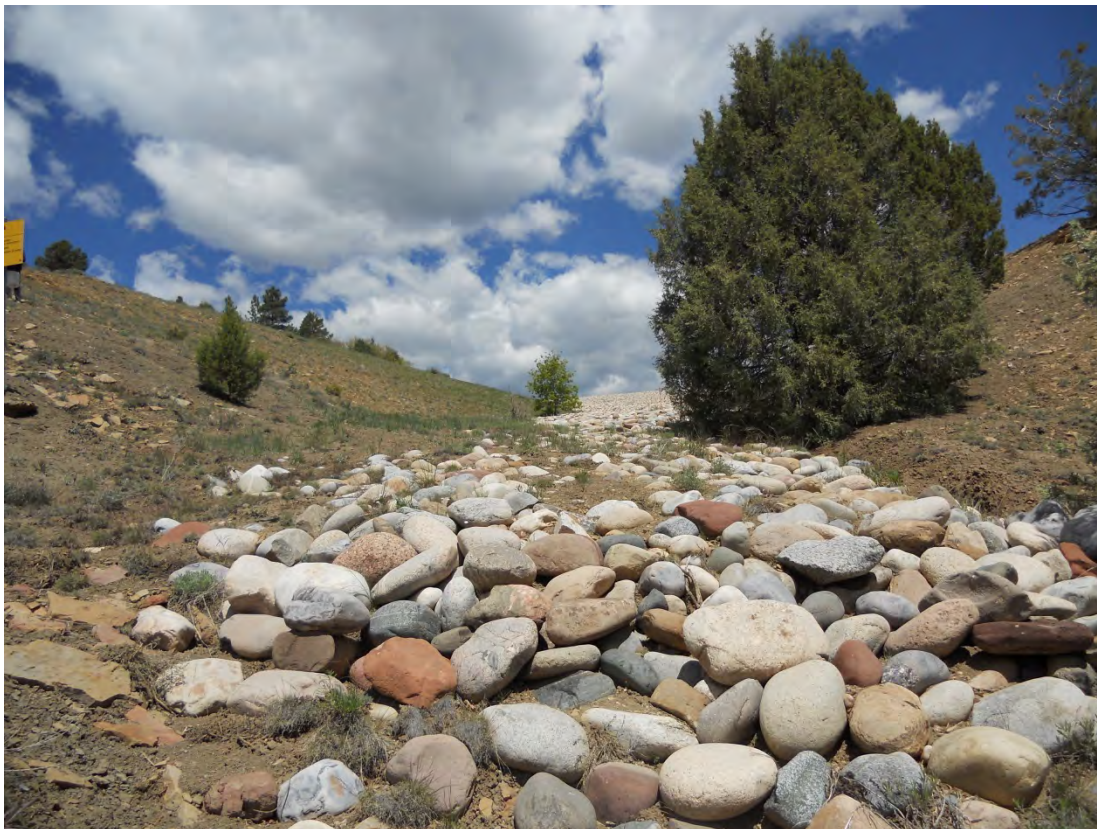
*DUD 5/2013. PL-12. South outflow, view toward repository.*

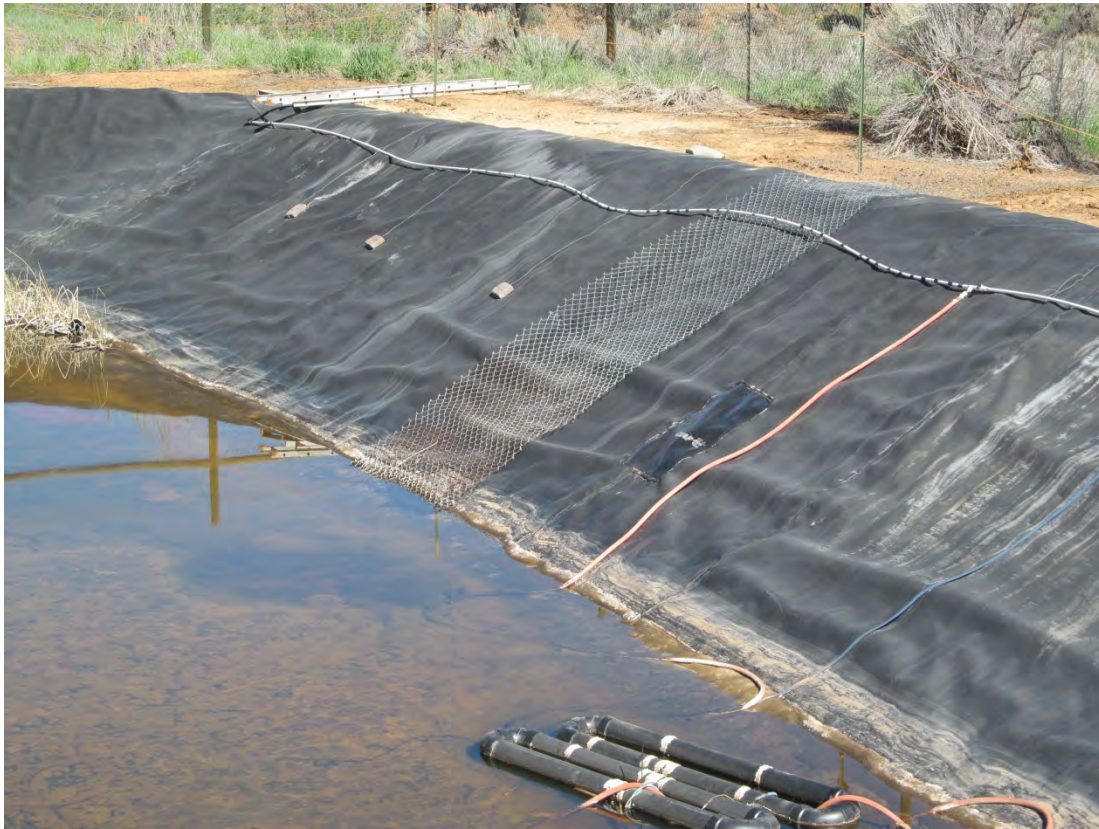
*DUD 5/2013. PL-13. Side and liner of evaporation pond.*

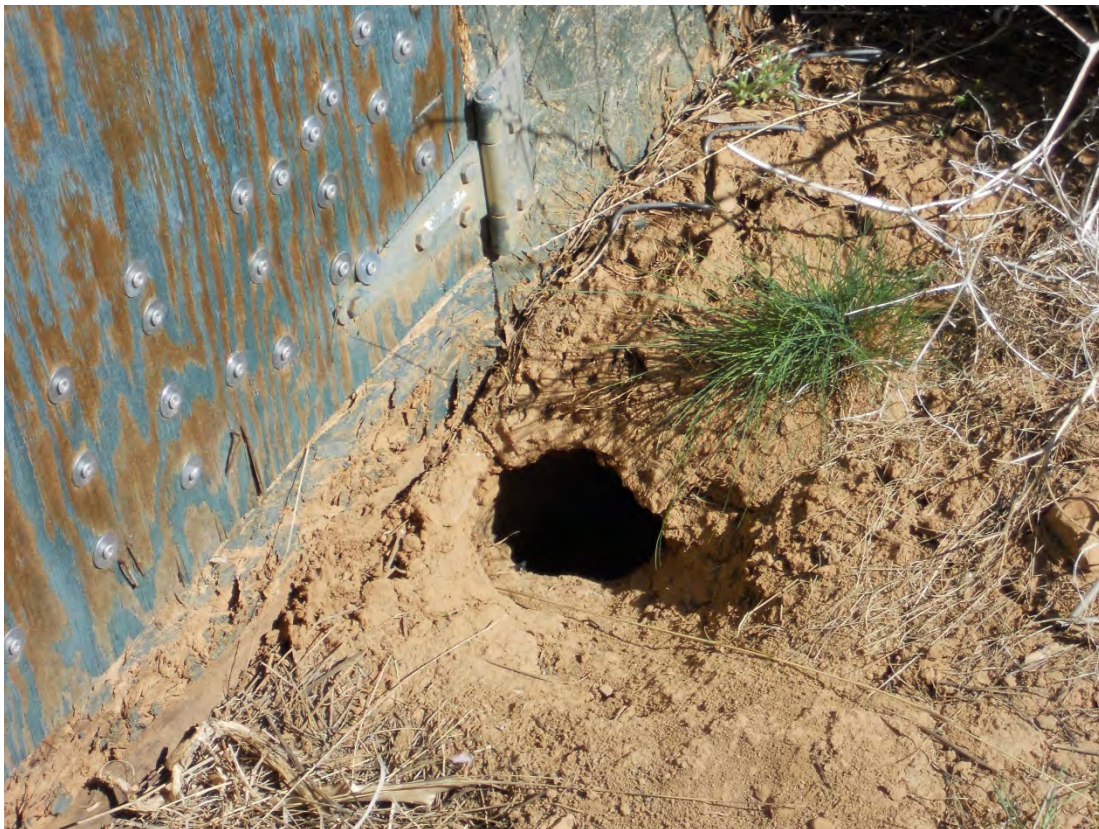
*DUD 5/2013. PL-14. Animal burrow under east side (front) of shed. Edge of pond liner is at top of photo.*

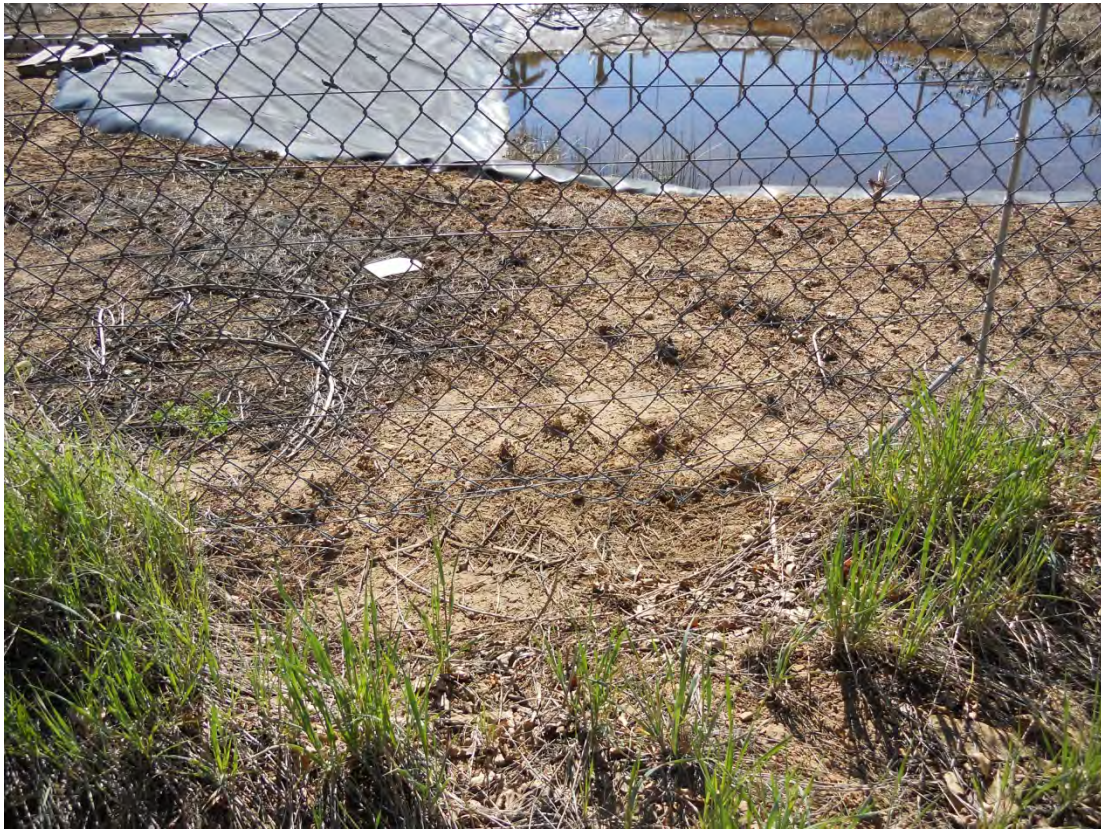
*DUD 5/2013. PL-15. Gap under evaporation pond fence, west side.*

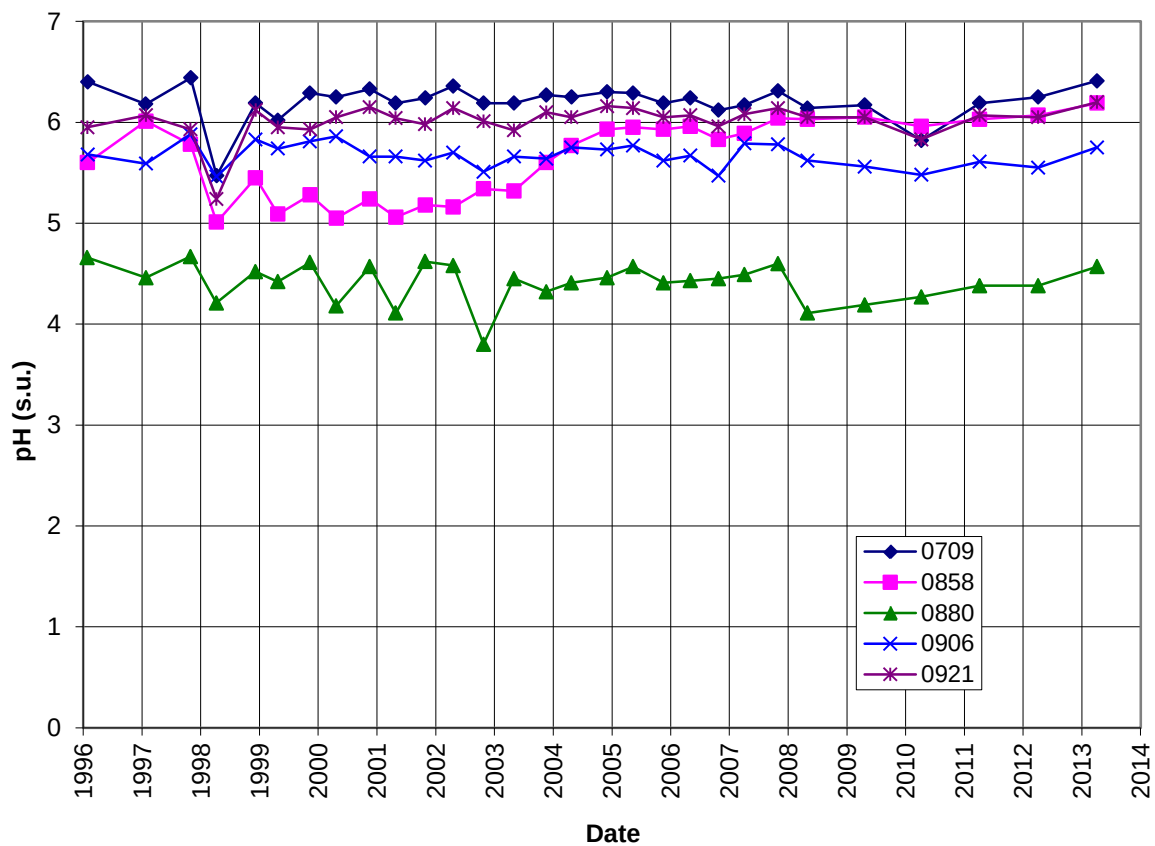
Figure 5-3. pH in Groundwater at Cell Performance Monitoring Locations at the Falls City Disposal Site

At the cell performance monitoring wells, pH levels have historically been higher than the pH in tailings pore fluids, with no significant upward or downward trends. In 2013, the pH levels for the cell performance wells remained within the historical range with the exception of wells 0858 and 0921. The pH measured at well 0858 in 2013 was 6.19, slightly above the previous high of 6.07. The pH measured at well 0921 in 2013 was 6.20, slightly above the previous high of 6.16 (Figure 5-3).

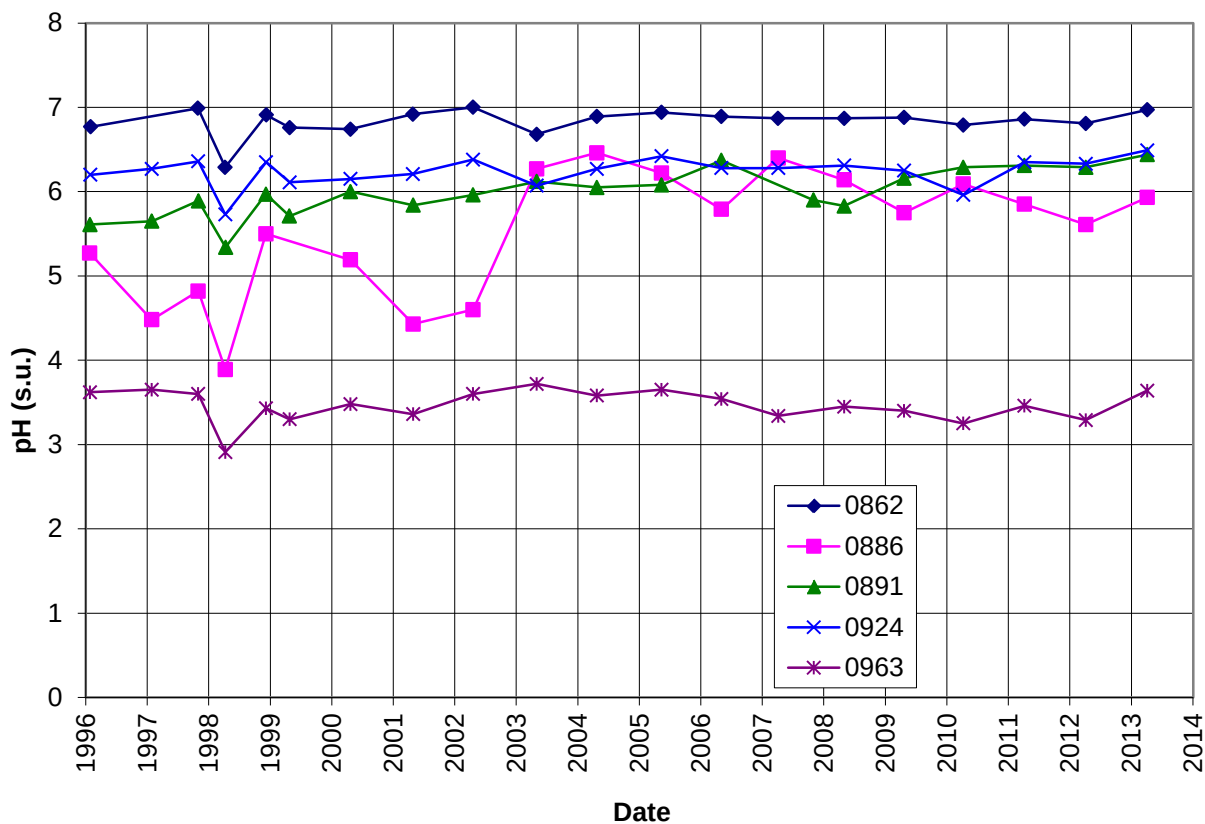
Figure 5-4. pH in Groundwater at Compliance Monitoring Locations at the Falls City Disposal Site

At the groundwater compliance monitoring wells, pH levels have historically been higher than the pH in the plumes of groundwater contaminated by processing activities, with no significant upward or downward trends except at well 0963, where the pH has historically been lower than at the other locations. In 2012, the pH levels for the compliance monitoring wells remained within the historical range with the exception of wells 0891 and 0924. The pH measured in well 0891 in 2013 was 6.44, slightly above the previous high of 6.37. The pH measured in well 0924 in 2013 was 6.49, slightly above the previous high of 6.42 (Figure 5-4).

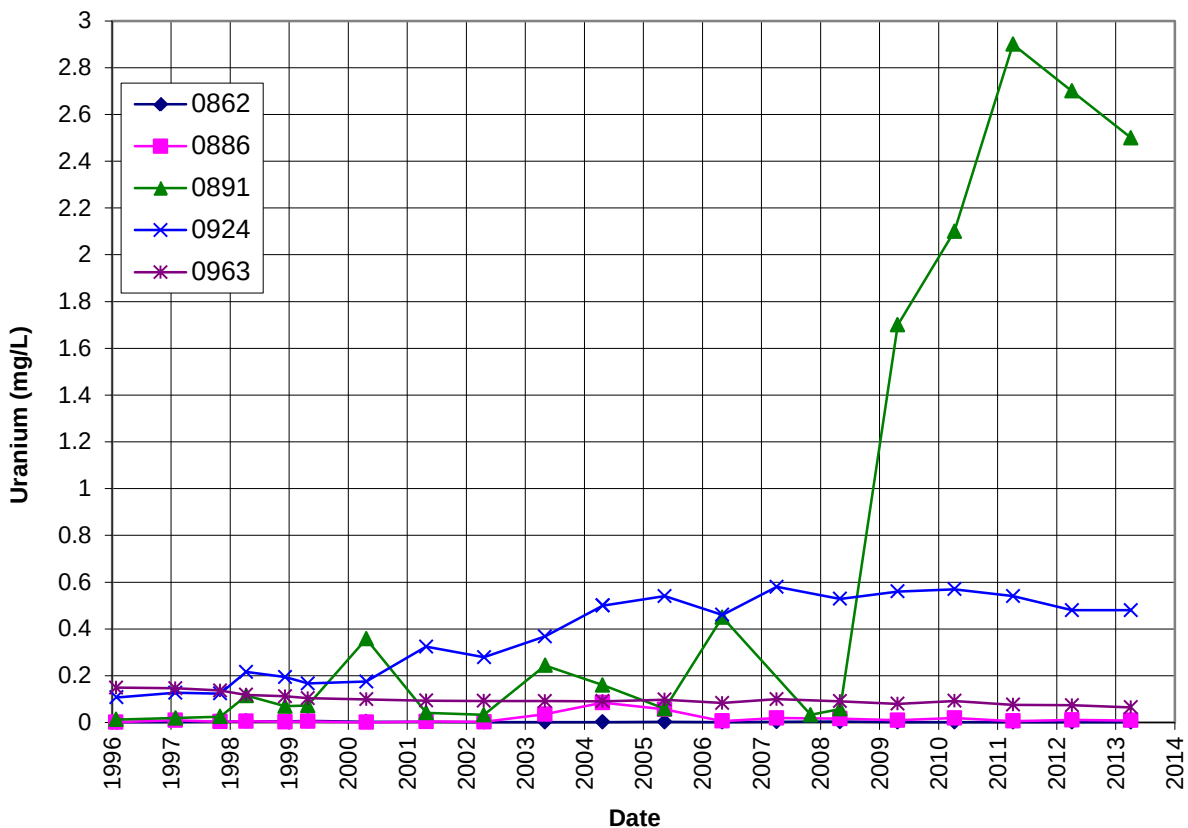
Figure 5-6. Uranium in Groundwater at Compliance Monitoring Locations at the Falls City Disposal Site

The concentration of uranium in groundwater within the compliance monitoring network shows that the uranium concentration trends at monitoring wells 0862, 0886, and 0963 remain stable at low levels (<0.2 mg/L) (Figure 5-6). The increasing uranium concentration trend at well 0924 has leveled off and is fluctuating between 0.5 mg/L and 0.6 mg/L. The uranium concentrations measured at well 0891 in 2009 (1.7 mg/L), 2010 (2.1 mg/L), 2011 (2.9 mg/L), 2012 (2.7 mg/L), and 2013 (2.5 mg/L) are anomalously high compared to historical measurements at the well, but not for the aquifer.

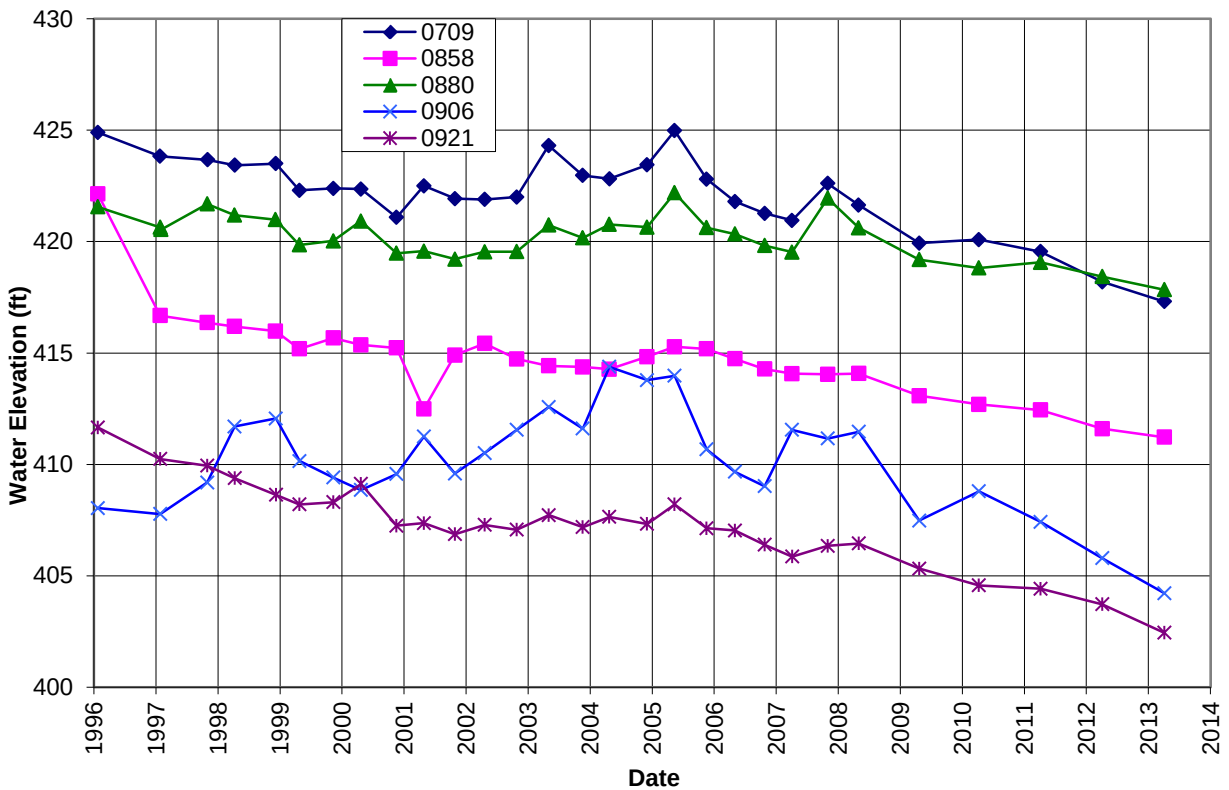
Figure 5-7. Water-Level Measurements at Cell Performance Monitoring Locations at the Falls City Disposal Site

**Groundwater-Level Monitoring Results**—Water levels measured in 2013 in the disposal cell performance network are new lows for each well (Figure 5-7). Since 1996, groundwater levels in the disposal cell performance network wells have fallen slightly. The water level in monitoring well 0906 has fluctuated more than levels in the other wells over the years. Monitoring well 0906 is directly downslope of the disposal cell, and the historical fluctuation may be the result of the infiltration of water shed by and conveyed away from the disposal cell, reflecting variations in annual precipitation. Other contributors that may influence local groundwater levels include (1) the dissipation of the processing-site-related groundwater mound beneath the disposal cell, and (2) the dissipation of transient drainage from the disposal cell.

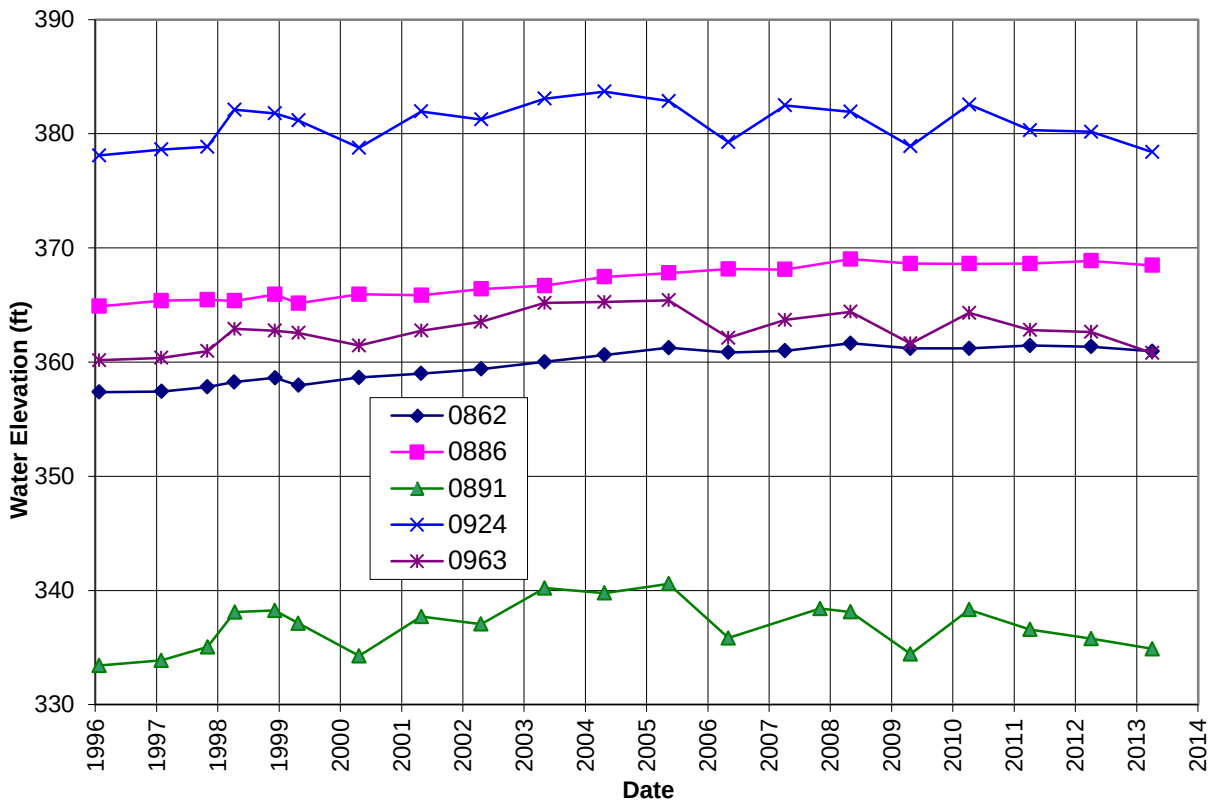
Figure 5-8. Water-Level Measurements at Compliance Monitoring Locations at the Falls City Disposal Site

In contrast, water levels in the groundwater compliance monitoring network wells have all increased slightly between 1996 and 2013 (Figure 5-8).

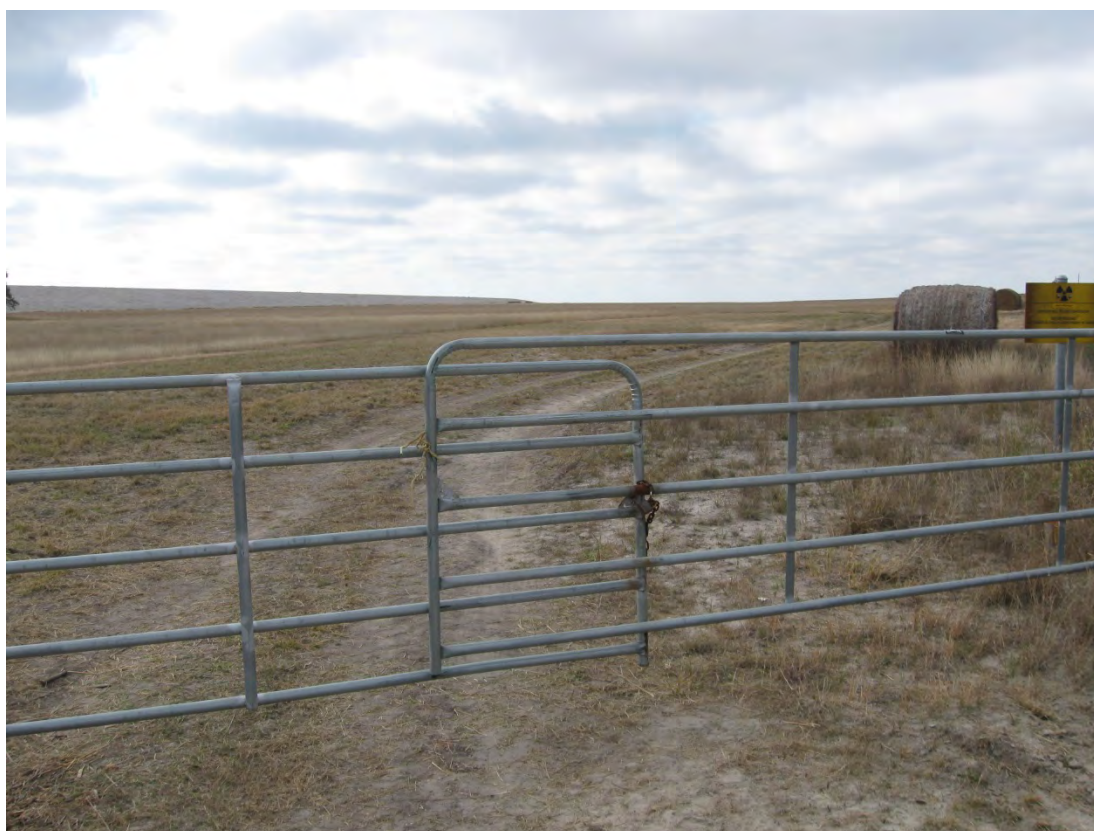
Entrance to the site is directly off of Farm-to-Market Road 1344. The main entrance gate (which was replaced in 2006) and the vehicle gate at the north corner of the site were locked and functional (PL-1). The entrance sign located next to the main entrance gate was in good condition (PL-2).

FCT 1/2013. PL-1. Entrance gate, north corner of property.

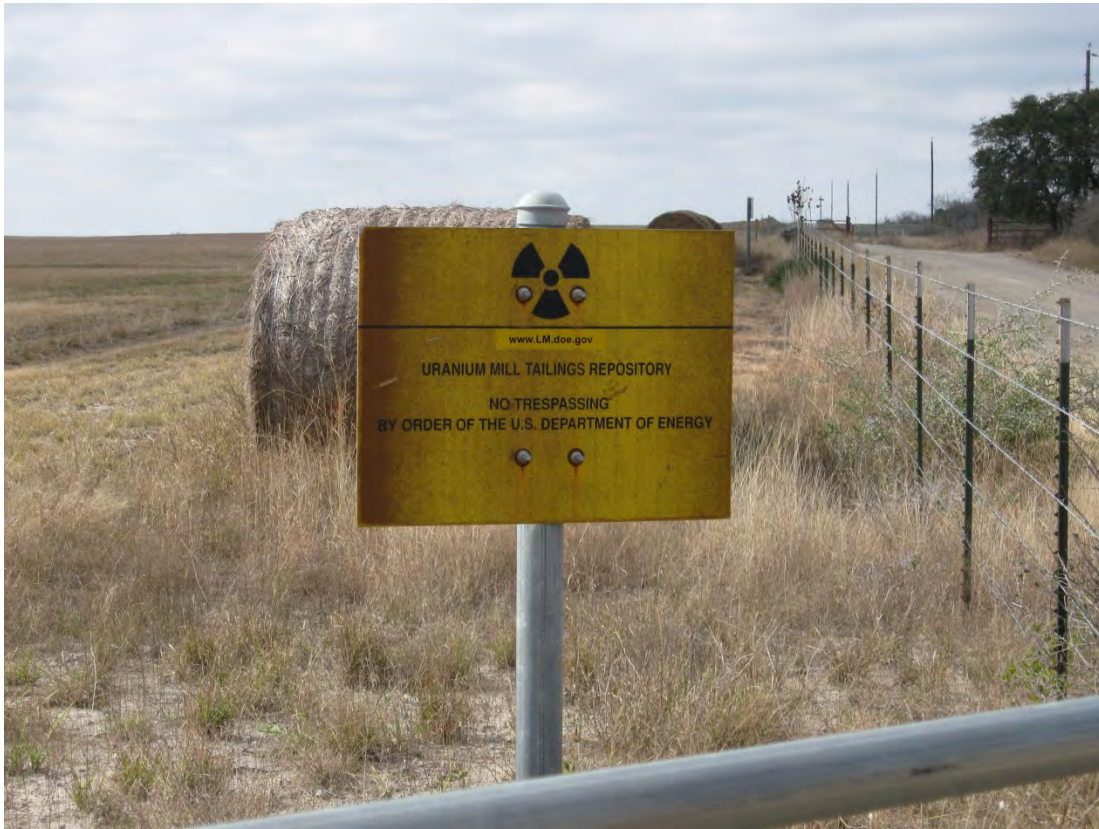
FCT 1/2013. PL-2. Perimeter sign, north corner of property.
