U.S. DEPARTMENT OF  
**ENERGY**

# 2013 Annual Site Inspection and Monitoring Report for Uranium Mill Tailings Radiation Control Act Title I Disposal Sites

March 2014

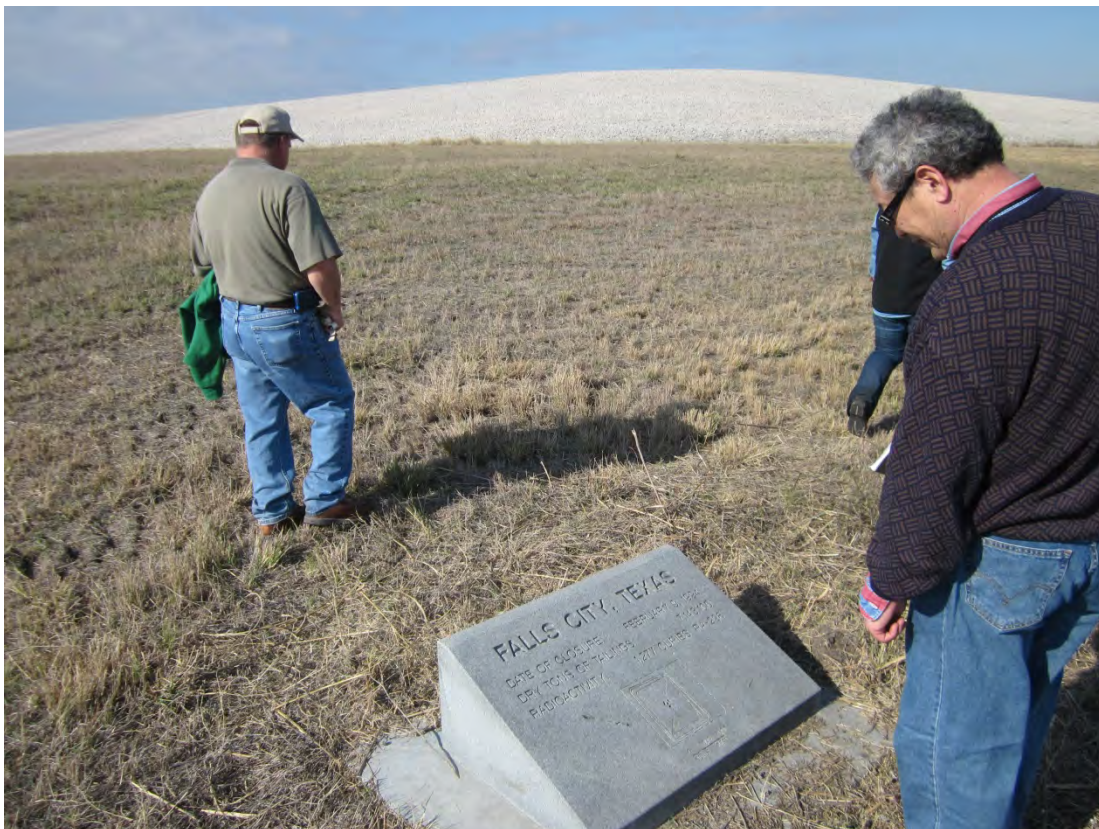
There are two site markers. The marker on top of the disposal cell (SMK-2) was in excellent condition. The marker at the entrance gate (SMK-1) is also in excellent condition (PL-3), but the corners of the concrete base that the marker sits on are cracked. The cracks appear to be unchanged from last year. No corrective action is required at this time to address the cracks.

FCT 1/2013. PL-3. Site marker, east corner of property.

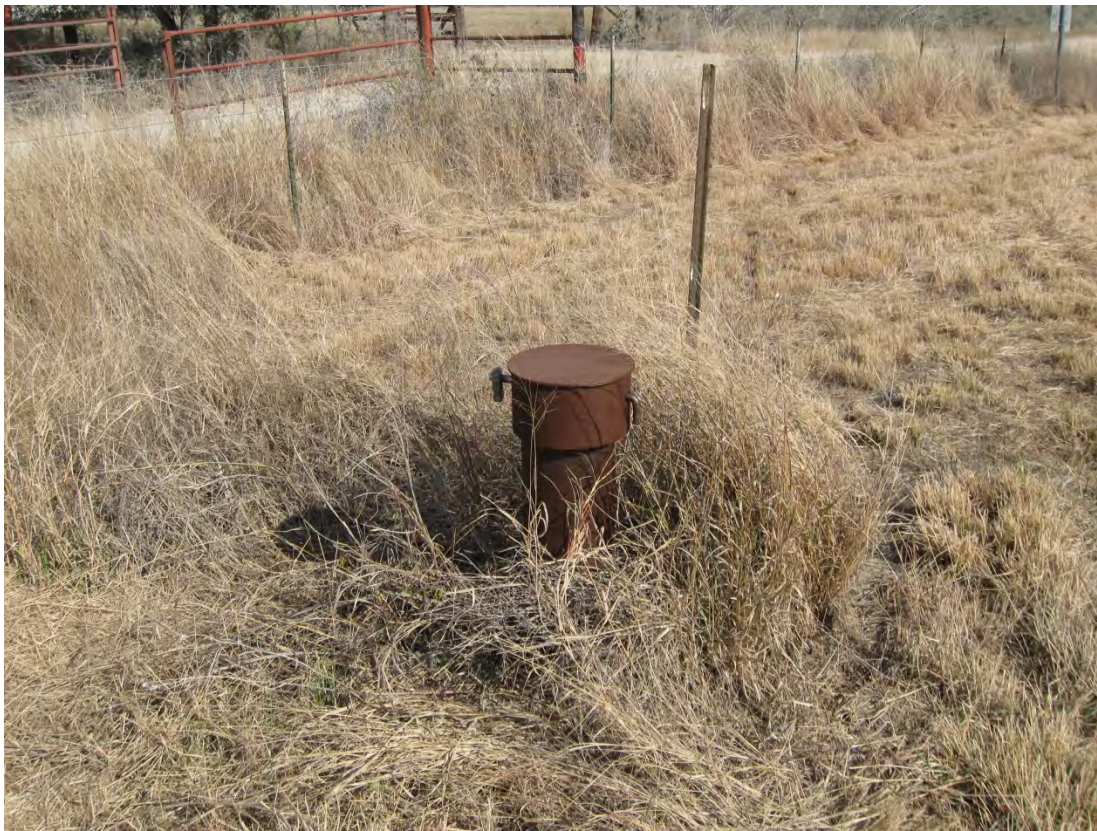
Monitoring wells in the groundwater-monitoring network were inspected when they were sampled in April 2012. At that time, all sampled wells were secure and in excellent condition. All monitoring wells observed during the inspection were checked to make sure that the protective casings were locked (PL-4).

FCT 1/2013. PL-4. Monitoring well 0709.

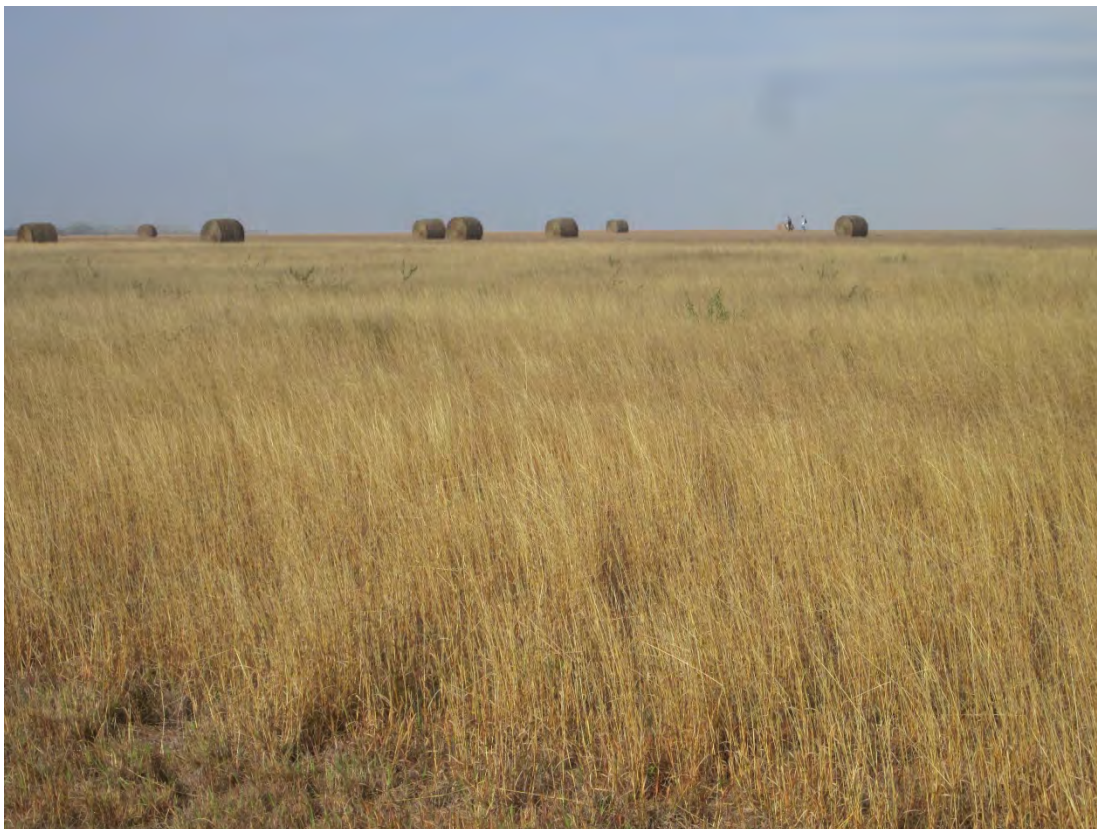
The top of the disposal cell was in excellent condition (PL-5). The cell is covered with well-established coastal Bermuda grass. Kleingrass and other species are interspersed. Mr. Lyssy (maintenance subcontractor) typically takes three cuttings of hay each year from the property, which includes the top of the disposal cell. Two harvests of hay were made in 2012.

FCT 1/2013. PL-5. View across top of cell.

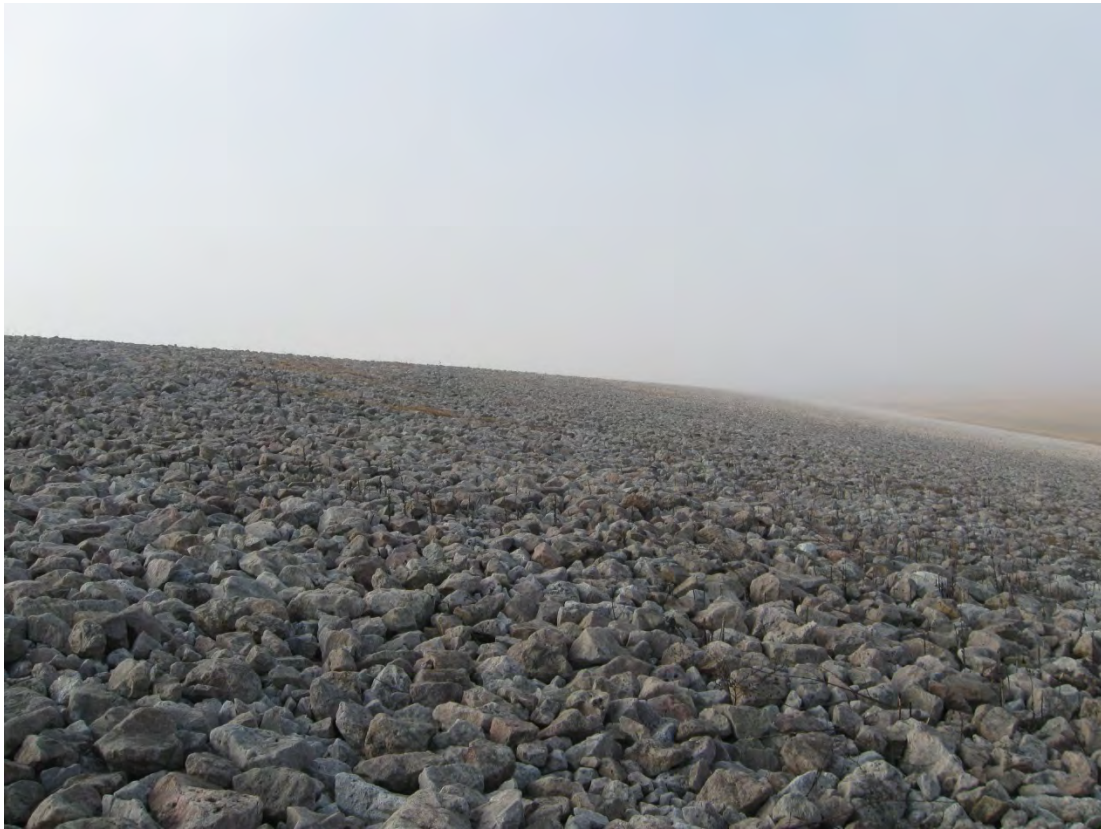
The side slopes are covered with riprap and were in excellent condition (PL-6). A couple of riprap disturbances (depressions) were observed on the northwest side slope of the disposal cell during the 2010 inspection. As reported in 2010, the disturbances did not appear to compromise the protectiveness of the riprap side slope. Since 2010, no changes have been observed.

FCT 1/2013. PL-6. Looking southwest down northwest side slope.

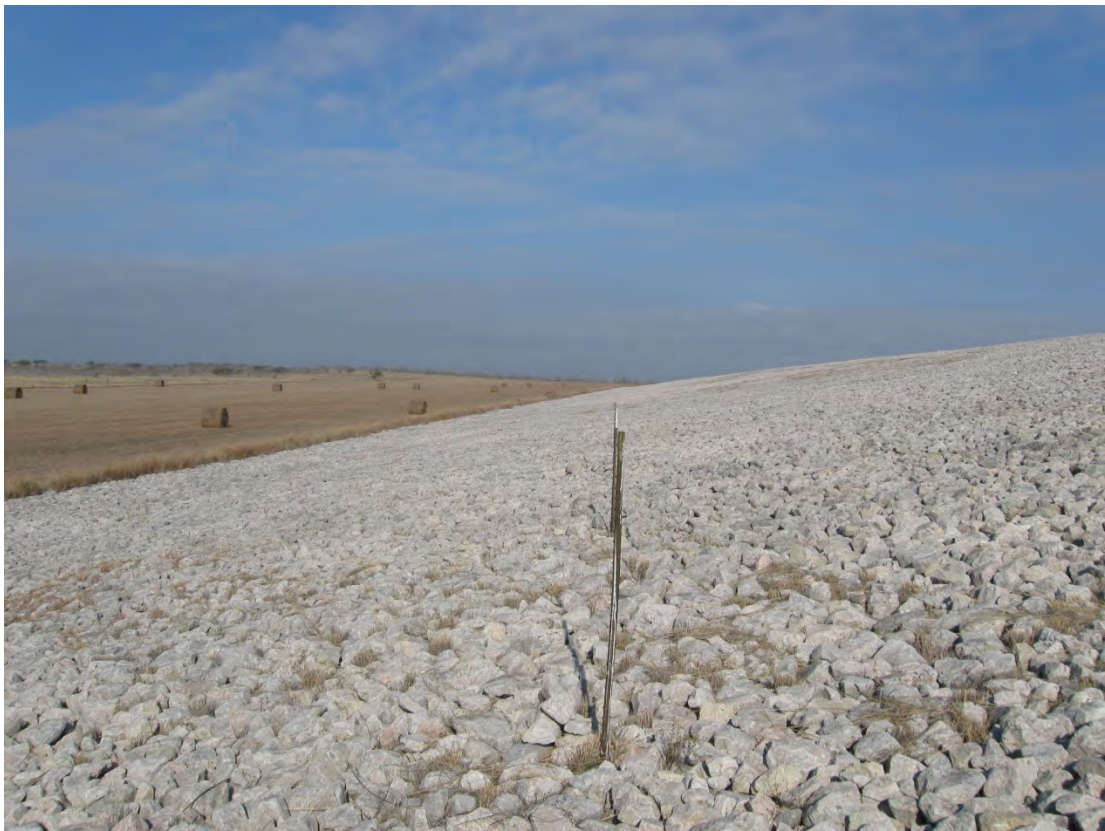
In 2007, inspectors noted a possible slight slumping of riprap at the toe of the south corner of the side slope. In 2008 three t-posts were installed in a straight line running at an orientation of 317 degrees. Each post was installed at a vertical pitch of 90 degrees. These three posts provide reference points that are used to assess if the area is undergoing movement. Movement of a post out of line with the other two posts, or the change in pitch of an individual post will indicate possible movement in the area. The three posts remain in the same straight line at which they were installed (i.e., 317 degrees). The vertical pitch of each post remains unchanged, indicating that no movement has occurred (PL-8).

FCT 1/2013. PL-8. Posts 1 through 3.

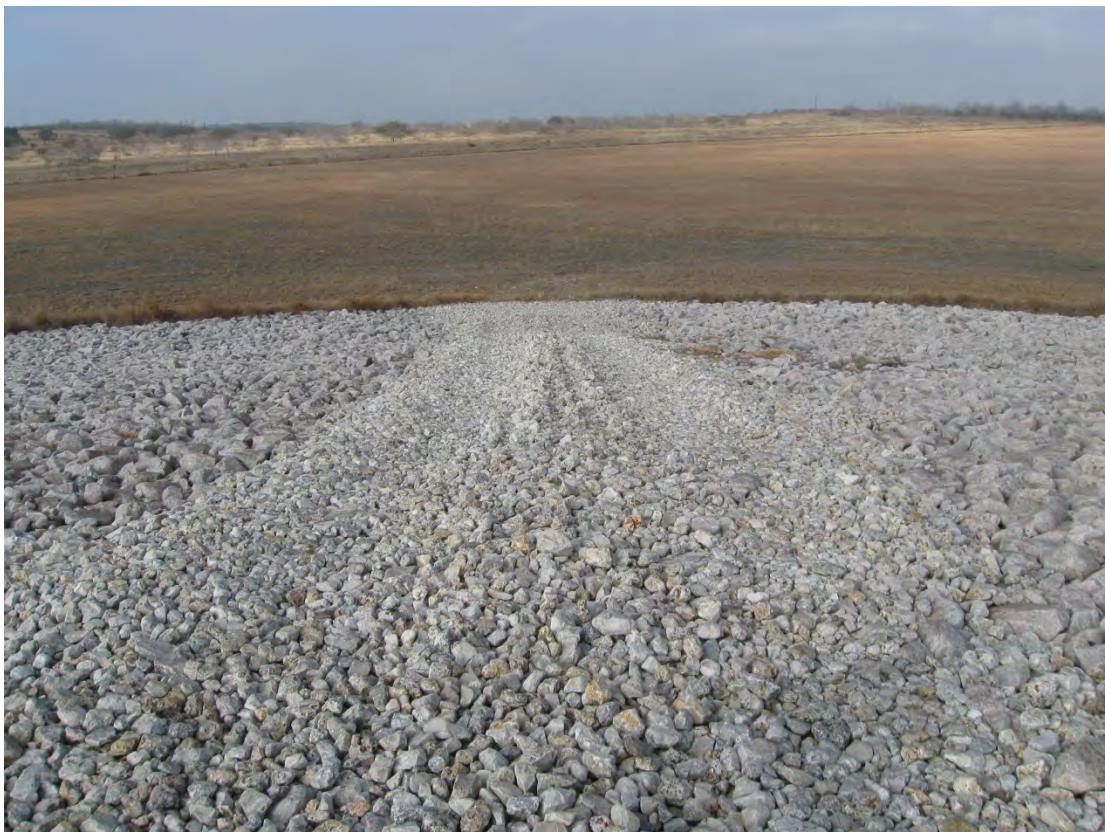
An equipment access ramp to the top of the cell is located at the west corner of the side slope (PL-9). The ramp was installed in 2008 and constructed with clean, angular riprap of progressively smaller sizes to provide a free-draining and stable driving surface that does not encourage vegetation encroachment. The ramp was in excellent condition.

FCT 1/2013. PL-9. Ramp on west corner of cell.

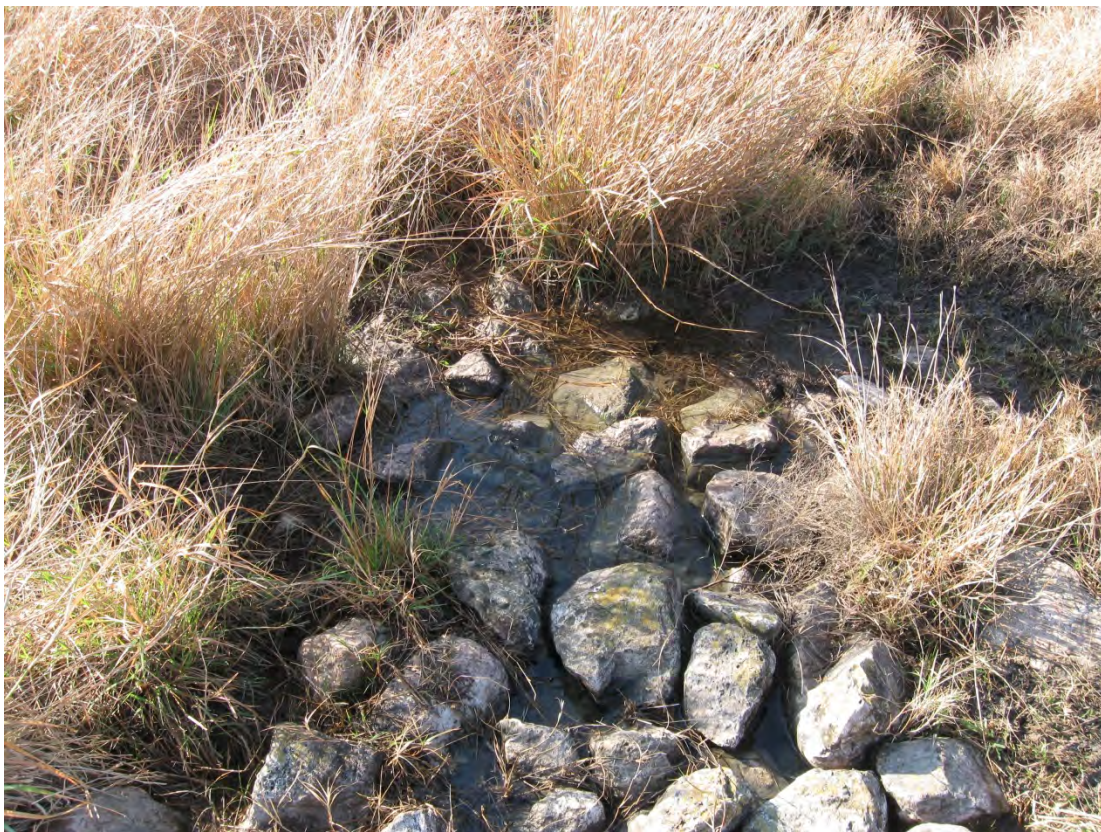
FCT 1/2013. PL-11. Water ponded at outlet of south rock drain.

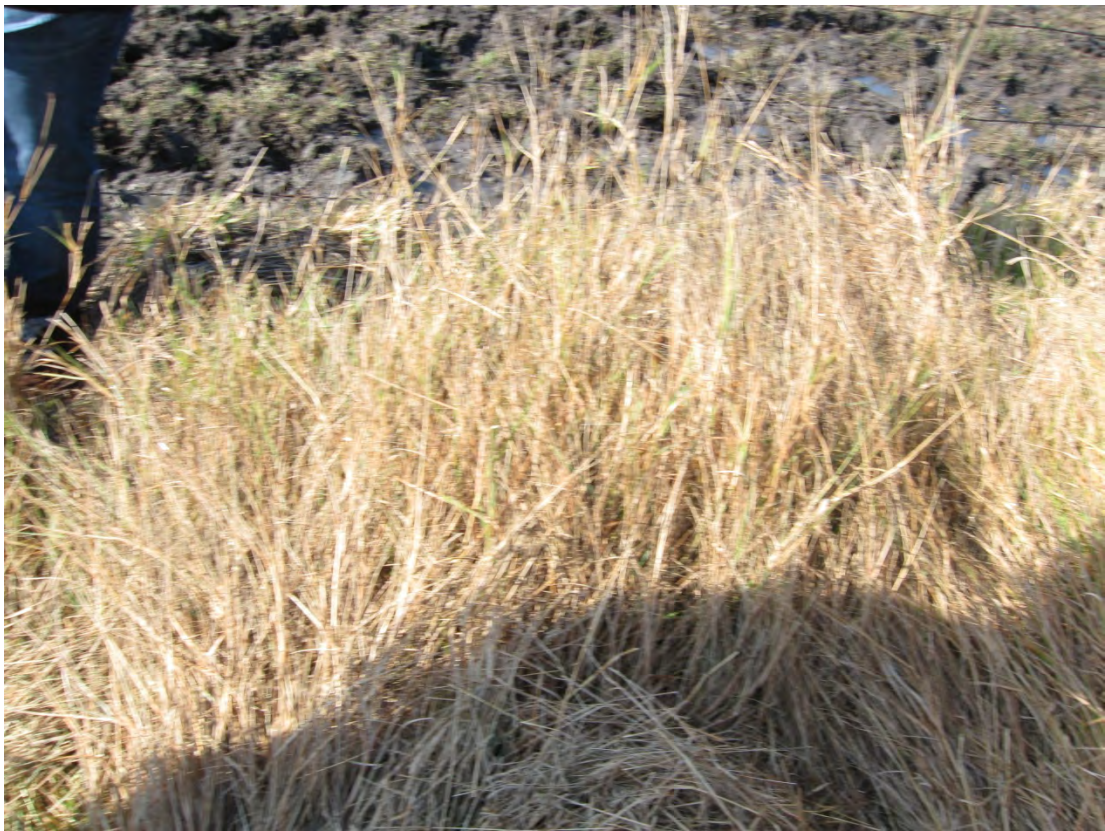
FCT 1/2013. PL-12. Tall grass at outlet of south rock drain.

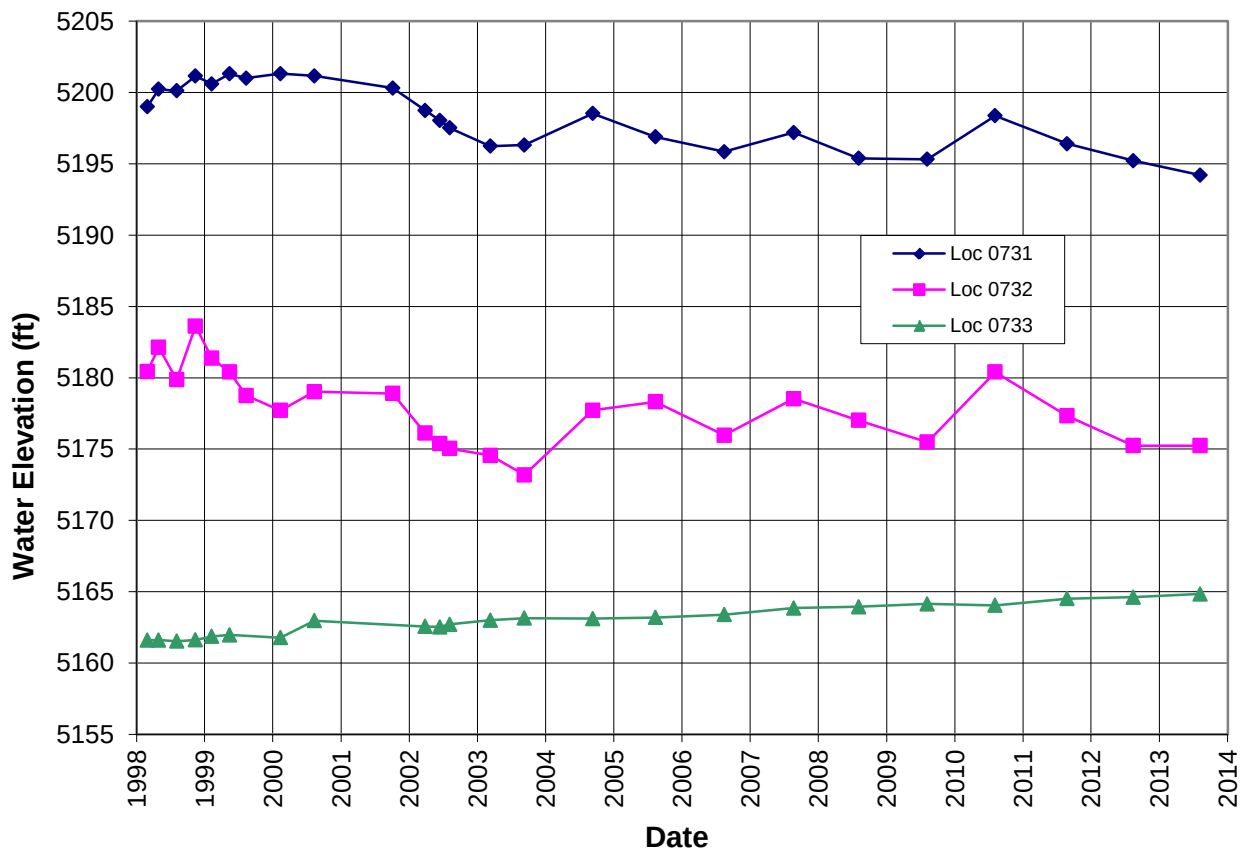
Figure 6-2. Water Level Measurements at the Grand Junction Disposal Site

Since 1998, the water level in disposal cell well 0733 has risen approximately 3.2 feet and has remained significantly lower than the water levels in the two paleochannel monitoring wells (0731 and 0732) (Figure 6-2). Water levels within the two paleochannel monitoring wells have decreased approximately 5 feet since 1998. The trends for wells 0731 and 0732 have been decreasing slightly, with level fluctuations that range from 2 to 5 feet. Given these elevations, groundwater at the base of the disposal cell at well 0733 has no potential to migrate to the paleochannels at wells 0731 and 0732.

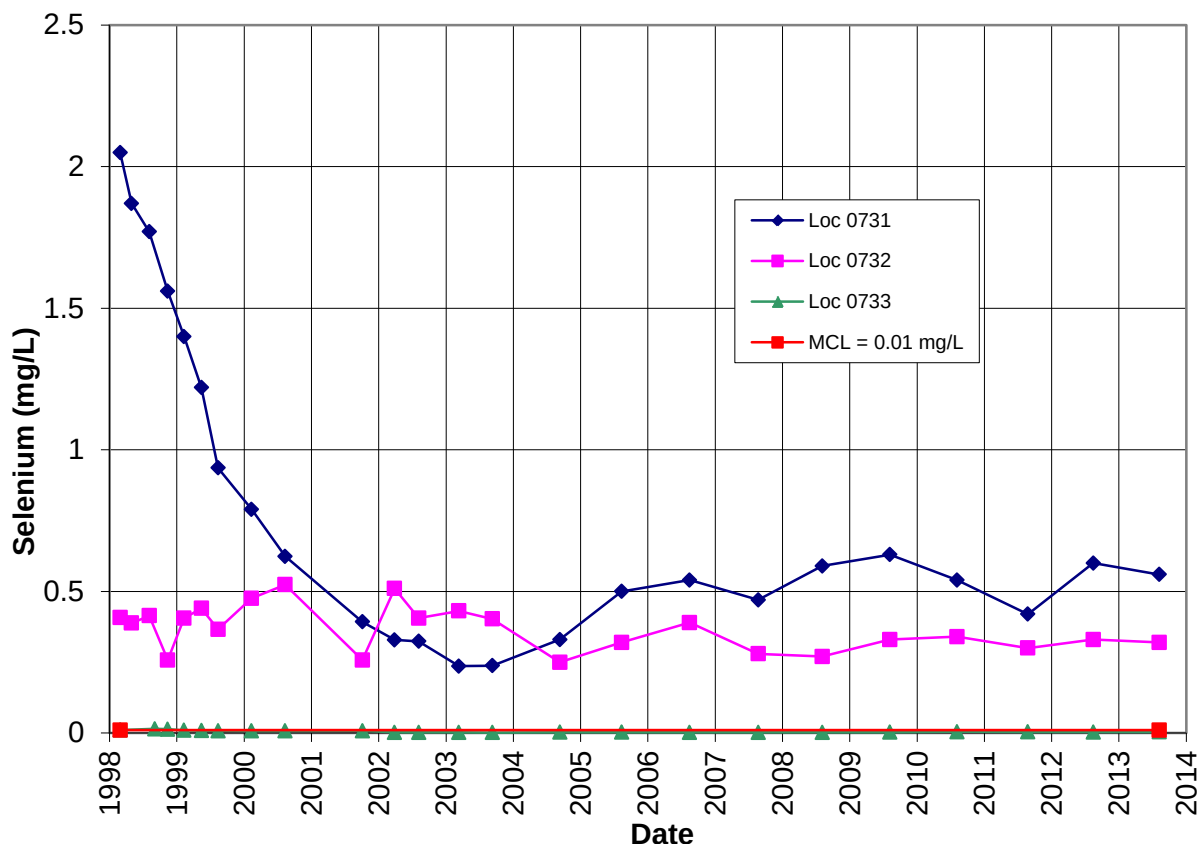
Figure 6-4. Time-Concentration Plots of Selenium in Groundwater at the Grand Junction Disposal Site

Selenium occurs naturally in the Mancos Shale deposits that underlie the disposal cell, and it may be the cause of the elevated concentrations reported in both paleochannel monitoring wells (0731 and 0732). Selenium concentrations continued to exceed the MCL of 0.01 mg/L in the paleochannel monitoring wells (Figure 6-4). Concentrations in well 0731 displayed a sharp decreasing trend, and the decreasing trend continued until 2003, when a slight upward trend began. Selenium concentrations in well 0731 have decreased slightly in 2013. Concentrations in well 0732 continue to display no trend. In well 0733, the selenium concentration of 0.0043 mg/L remained well below the standard, with no trend evident.

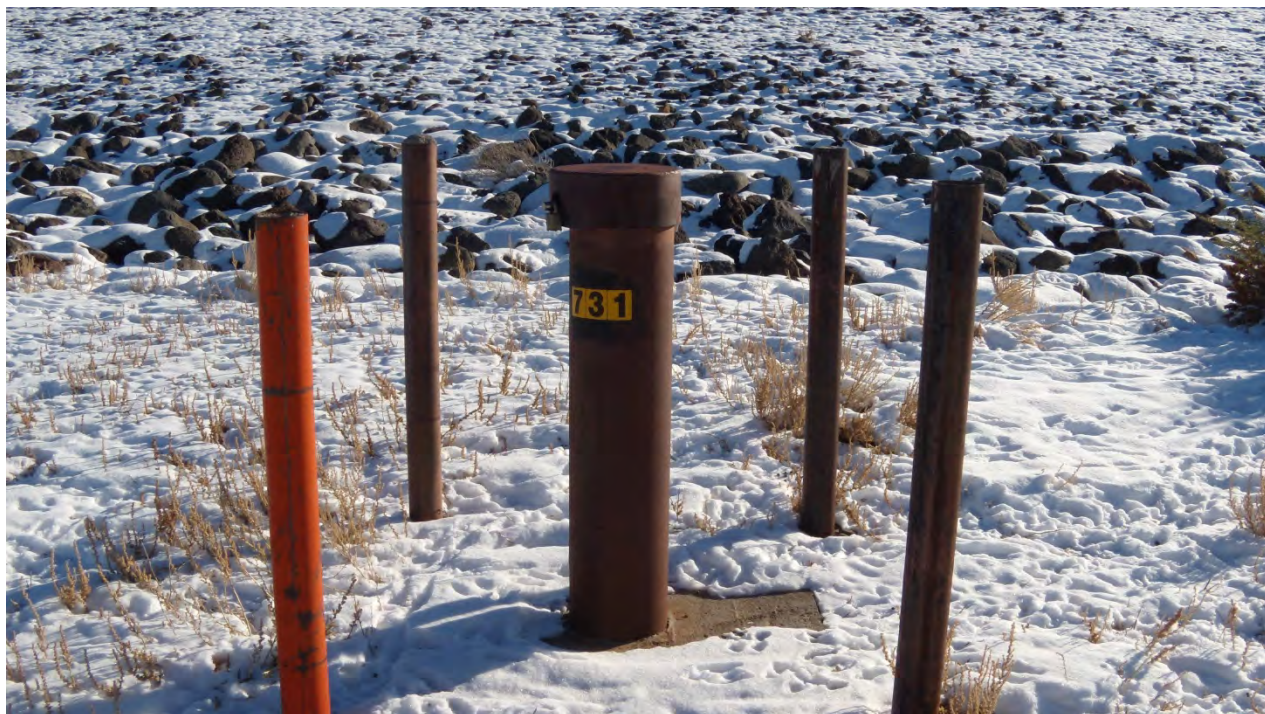
The groundwater monitoring network consists of three monitoring wells. All three are inside the site boundary. The well protective casings were locked and in good condition (PL-5). Shrubs surrounding well 0732 had been treated with herbicide to reduce root intrusion into the well. No live shrubs were identified near any monitoring wells in 2013.

GRJ 12/2013. PL-5. Monitoring well 0731.

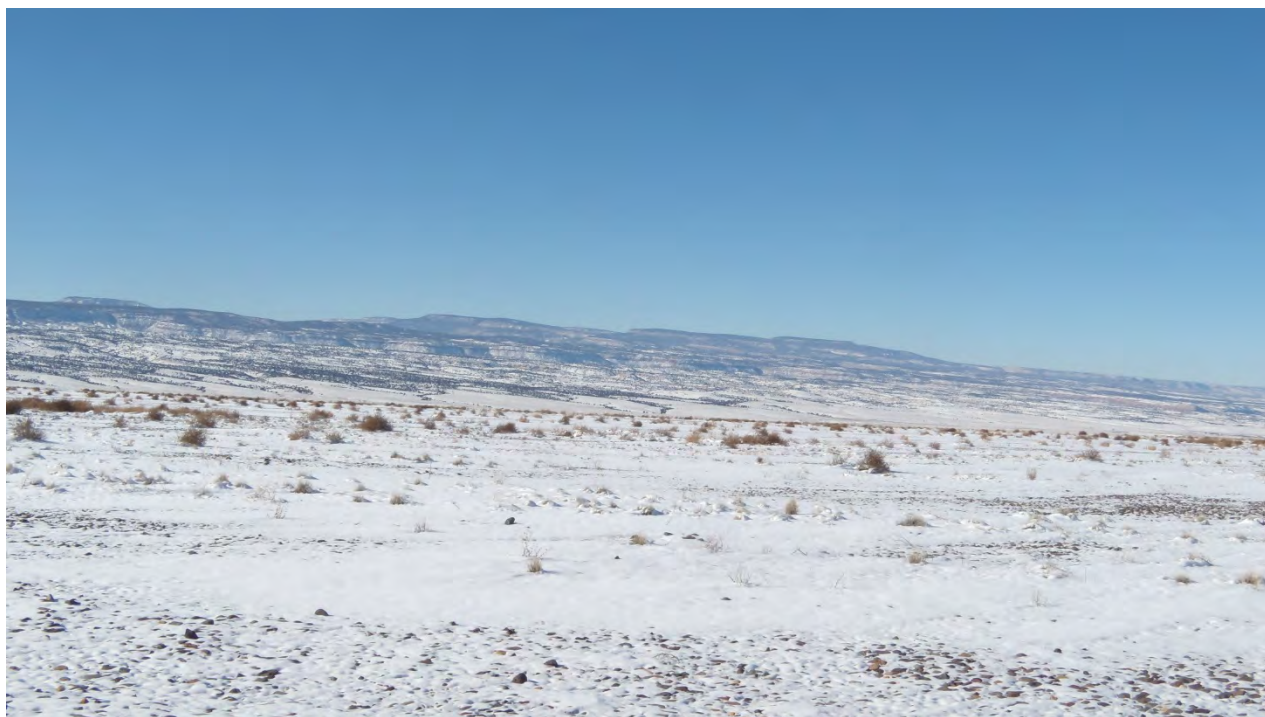
Grasses and weeds were growing on most of the cell cover, and scattered deep-rooted vegetation (primarily fourwing saltbush [*Atriplex canescens*] and rabbitbrush [*Ericameria nauseosa*] shrubs) was also present (PL-8). Historically, shrubs have been periodically treated with herbicide on the cell top. Although treatment is not required by the interim Long-Term Surveillance Plan, DOE will continue to periodically treat shrubs until more is known about the potential effects of vegetation on the cover. Recent studies by DOE and the U.S. Environmental Protection Agency have indicated that evapotranspiration cover designs perform significantly better than the conventional rock-covered compacted soil layer designs (as used at this site) to limit permeability and the percolation of moisture into the disposal cells. A cell cover study area consisting of two lysimeters was constructed at the site in 2007 (not included in the annual inspection; see Figure 6-1) to compare the performance of the existing cover design with a modified evapotranspiration design. Monitoring continues, and DOE will use the results from this study to make long-term surveillance and maintenance decisions at this and similar sites.

GRJ 12/2013. PL-8. Southwest portion of disposal cell cover.

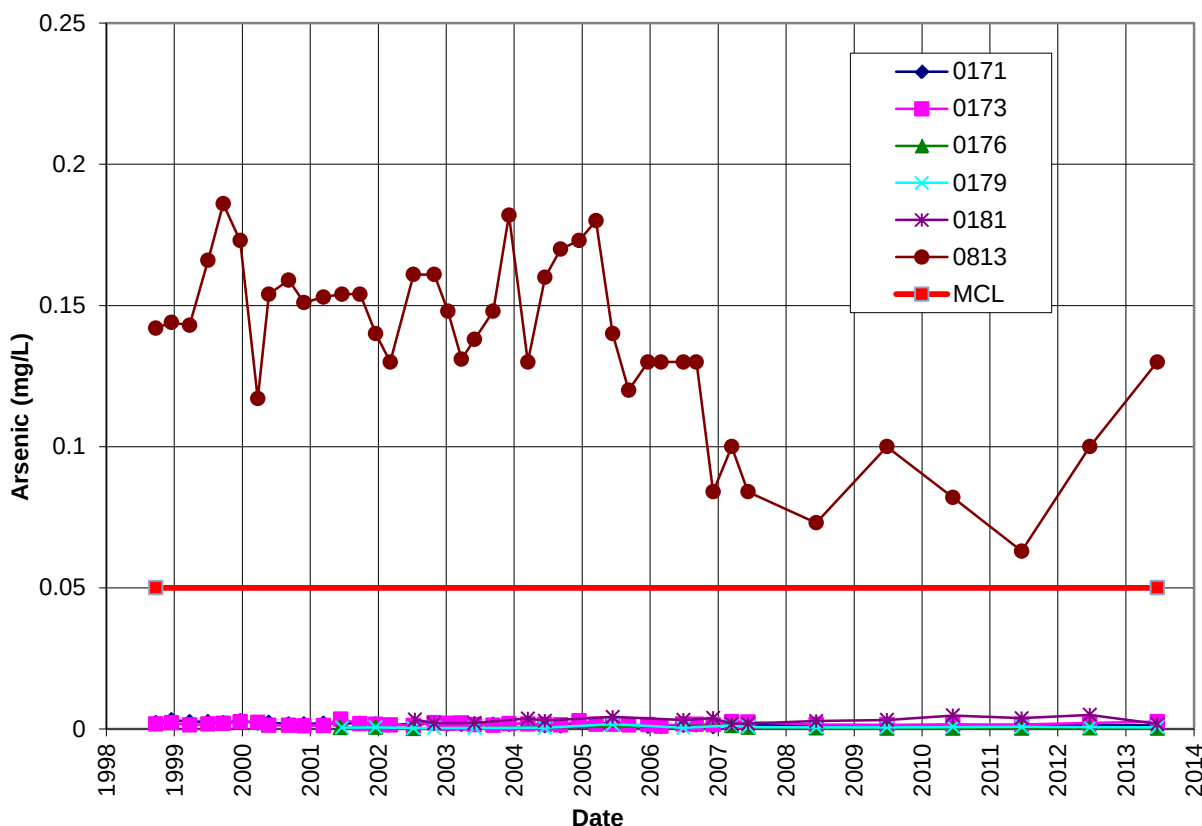
Figure 7-2. Time-Concentration Plots of Arsenic in Groundwater at the Green River Disposal Site

Arsenic concentrations in groundwater remain below the U.S. Environmental Protection Agency (EPA) maximum concentration limit (MCL) of 0.05 milligram per liter (mg/L) in all POC wells except well 0813, and remain considerably below the proposed ACL of 5.0 mg/L in all POC wells. In well 0813, levels continue to exceed the MCL, as shown on Figure 7-2, but are substantially below the proposed ACL.

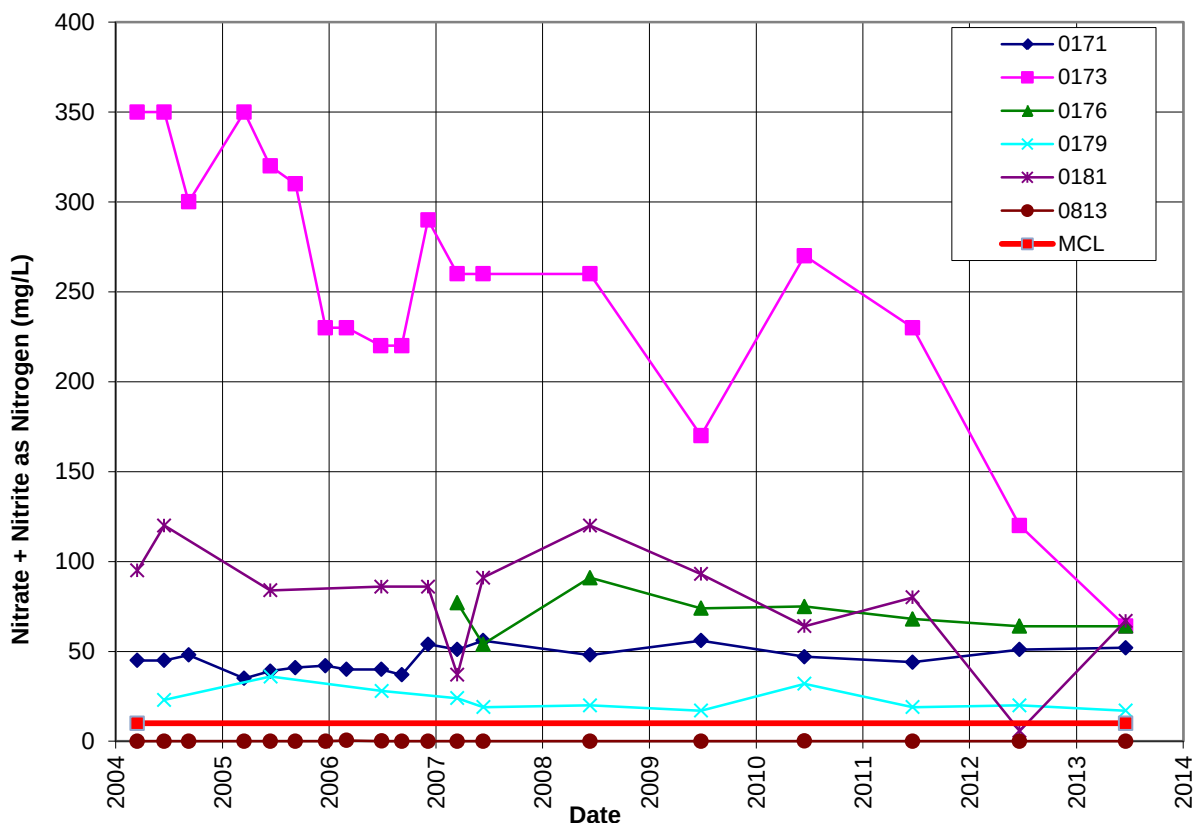
Figure 7-3. Time-Concentration Plots of Nitrate in Groundwater at the Green River Disposal Site

Nitrate concentrations have been measured as nitrate plus nitrite reported as nitrogen since early 2004 (before then, nitrate was reported as NO<sub>3</sub>). Concentrations have continued to exceed the EPA MCL of 10 mg/L in all POC wells except well 0813, but they are considerably below the proposed ACL of 1,000 mg/L in all wells (Figure 7-3). Nitrate concentrations in well 0813

continue to be below the laboratory detection limit. Nitrate concentrations in the other wells are similar to previous measurements.

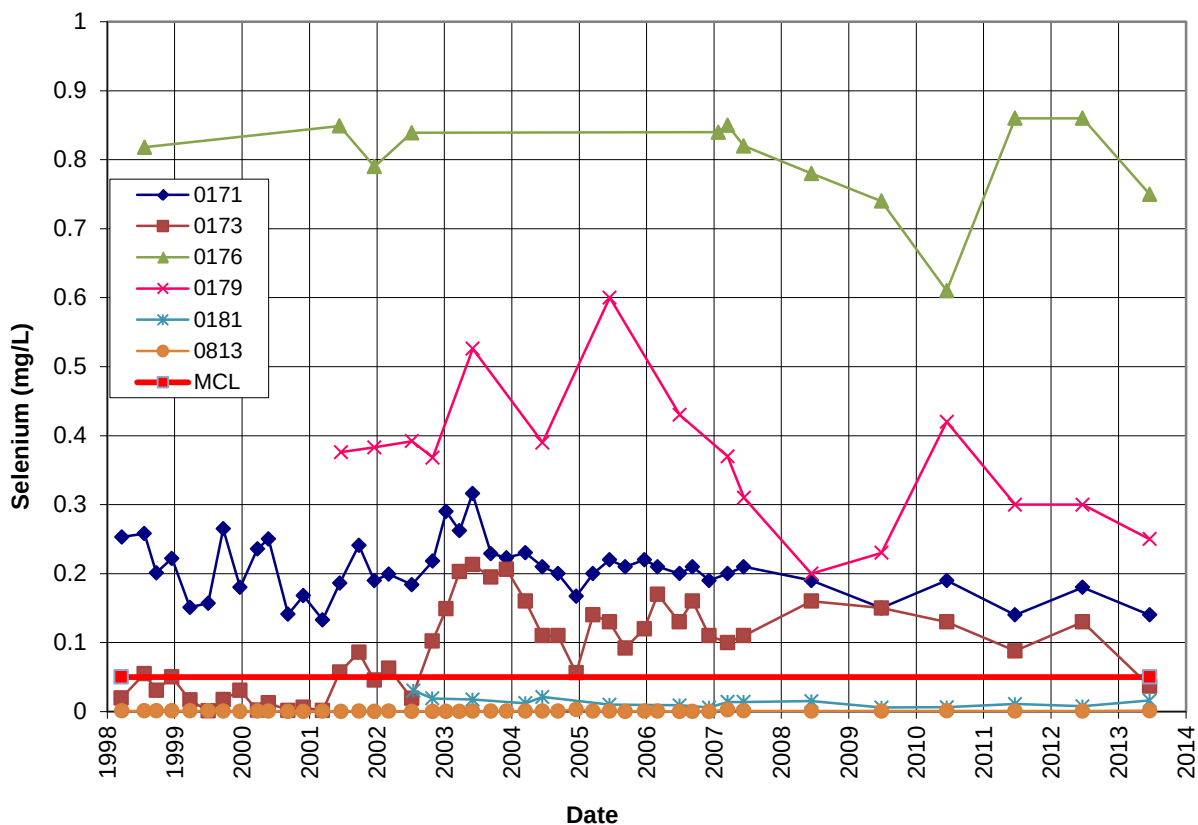
Figure 7-4. Time-Concentration Plot of Selenium in Groundwater at the Green River Disposal Site

Selenium concentrations in wells 0181 and 0813 remain below the EPA MCL of 0.05 mg/L. Concentrations in the other wells continue to be above the standard but are substantially below the proposed ACL of 5.0 mg/L (Figure 7-4).

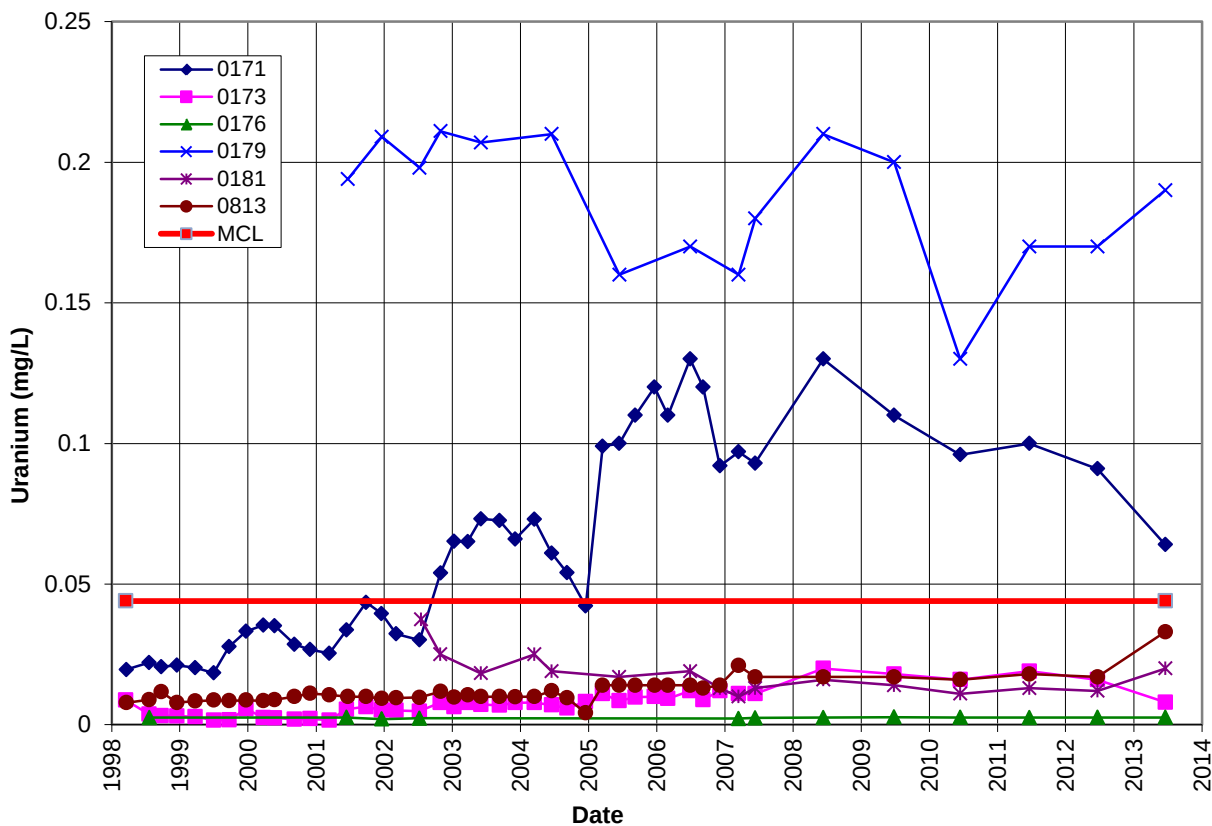
Figure 7-5. Time-Concentration Plot of Uranium in Groundwater at the Green River Disposal Site

Uranium concentrations in groundwater remain below the EPA MCL of 0.044 mg/L in all POC wells except wells 0171 and 0179, and remain considerably below the proposed ACL of 4.4 mg/L in all POC wells. The highest uranium concentrations continue to occur in well 0179 (0.19 mg/L), which is upgradient of the disposal cell. The reason for the elevated concentration of uranium in well 0179 has not been determined, but it may be naturally occurring. At well 0171, concentrations exceed the MCL and indicate an upward trend since 1998 (Figure 7-5). Because uranium is the only constituent of concern that has indicated an upward trend in well 0171, no conclusions regarding the cause of the trend have been reached.

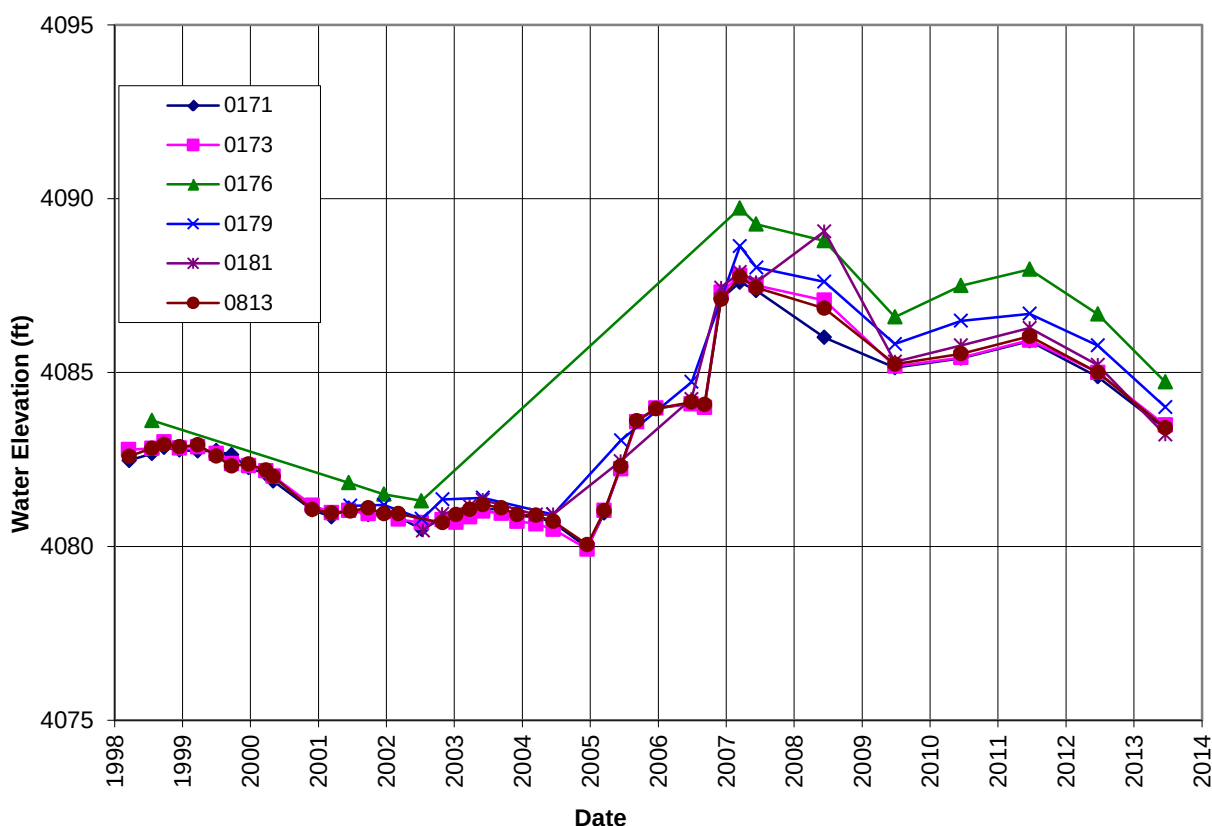
Figure 7-6. Groundwater Elevations at the Green River Disposal Site

Water level hydrographs of the POC wells, completed in the middle sandstone aquifer, indicate that the groundwater elevation decreased approximately 3 feet overall from 1998 through 2004, and then increased approximately 8 feet between 2004 and 2007. Water levels have decreased approximately 2 to 3 feet since 2007, although slight increases occurred in 2010 and 2011 (Figure 7-6).

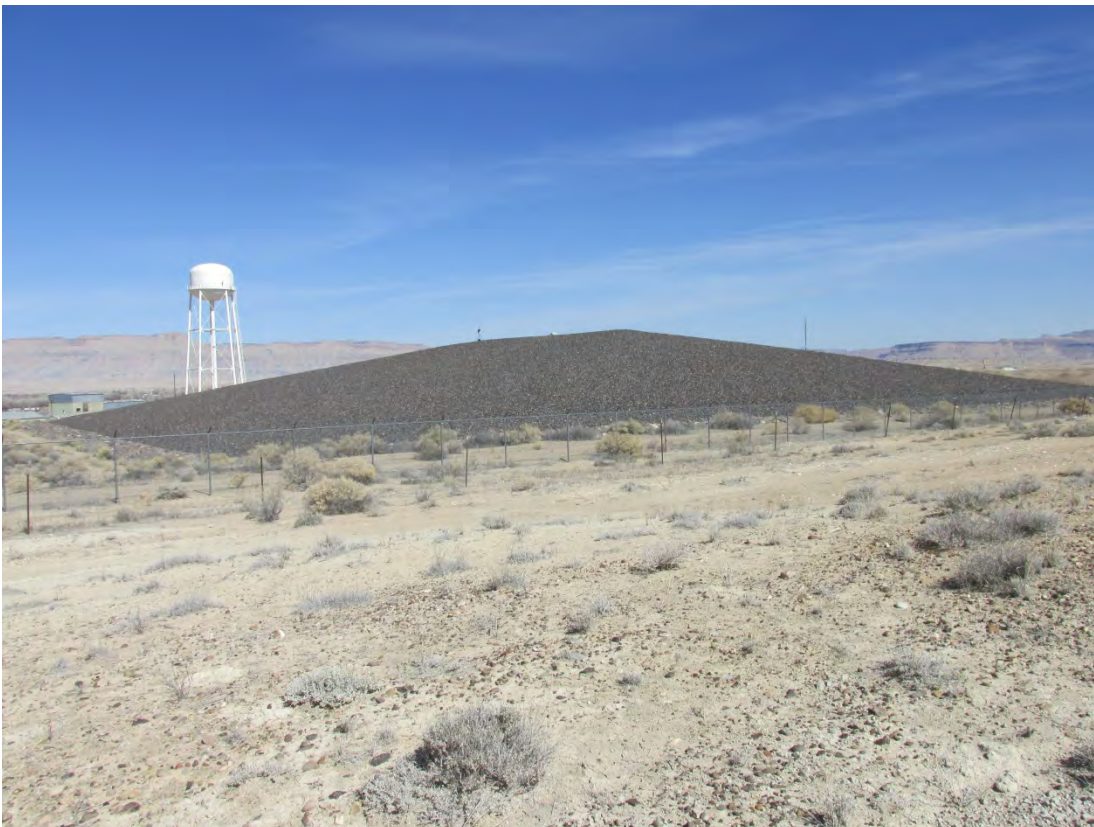
The 6-acre disposal cell was completed in 1989. The slopes of the disposal cell cover are armored with basalt rock (PL-5). No evidence of any disturbance of the cell surfaces was observed. No vegetation was present on the cell. The quality of the rock is excellent, and the disposal cell cover was in excellent condition. A basalt boulder-filled trench, called an apron, surrounds the disposal cell (PL-6). The apron collects all runoff water from the cell, and the water volume is reduced by evaporation, evapotranspiration through deep-rooted shrubs that grow along the apron, and infiltration into the underlying bedrock through the sides and bottom of the apron. The apron was in excellent condition.

*GRN 3/2013. PL-5. Disposal cell.*

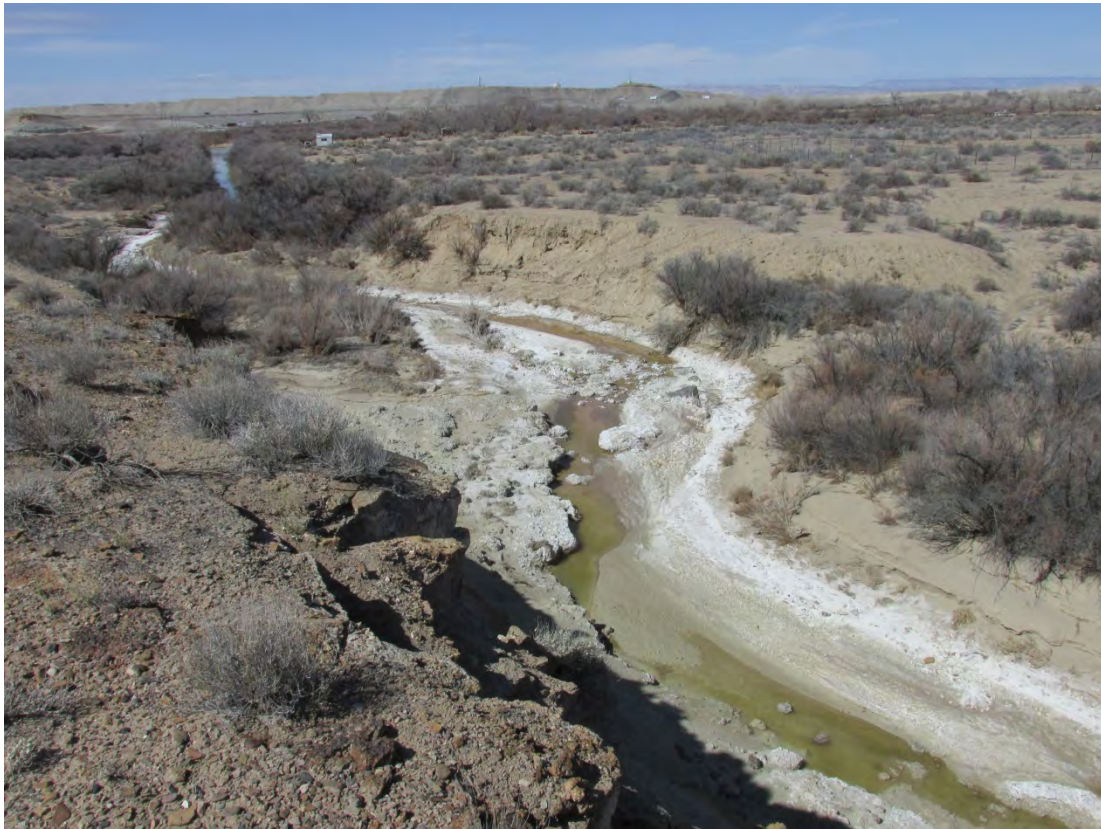
The inspection also included observation of conditions in Browns Wash. Water was flowing in the channel between the road bridge and the backwater area near the confluence with the Green River (PL-8). The streambed upstream of the bridge was dry, which indicates that the flow downstream of the bridge was from seeps. The backwater area near the mouth of Browns Wash is important because of its potential to be a fish-spawning location. The conditions of Browns Wash channel and the backwater area change substantially after each runoff event as sediment is either scoured or deposited along the channel bottom.

*GRN 3/2013. PL-8. Area of seep 0718 at the main Cedar Mountain outcrop area.*

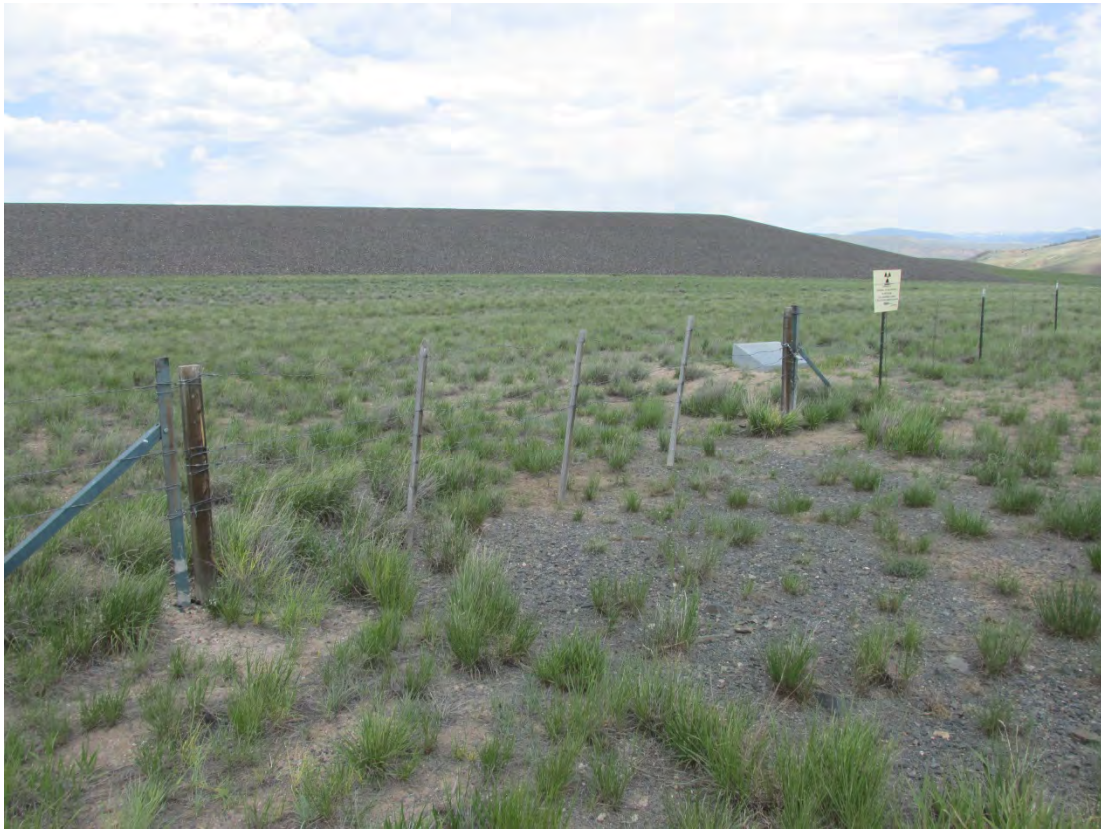
The entrance gate is a simple barbed-wire gate in the stock fence that surrounds the site. The entrance gate, located along the south portion of the perimeter fence, was secured by a padlock and chain to the adjoining post and was in good condition (PL-1).

*GUD 6/2013. PL-1. Site entrance gate.*

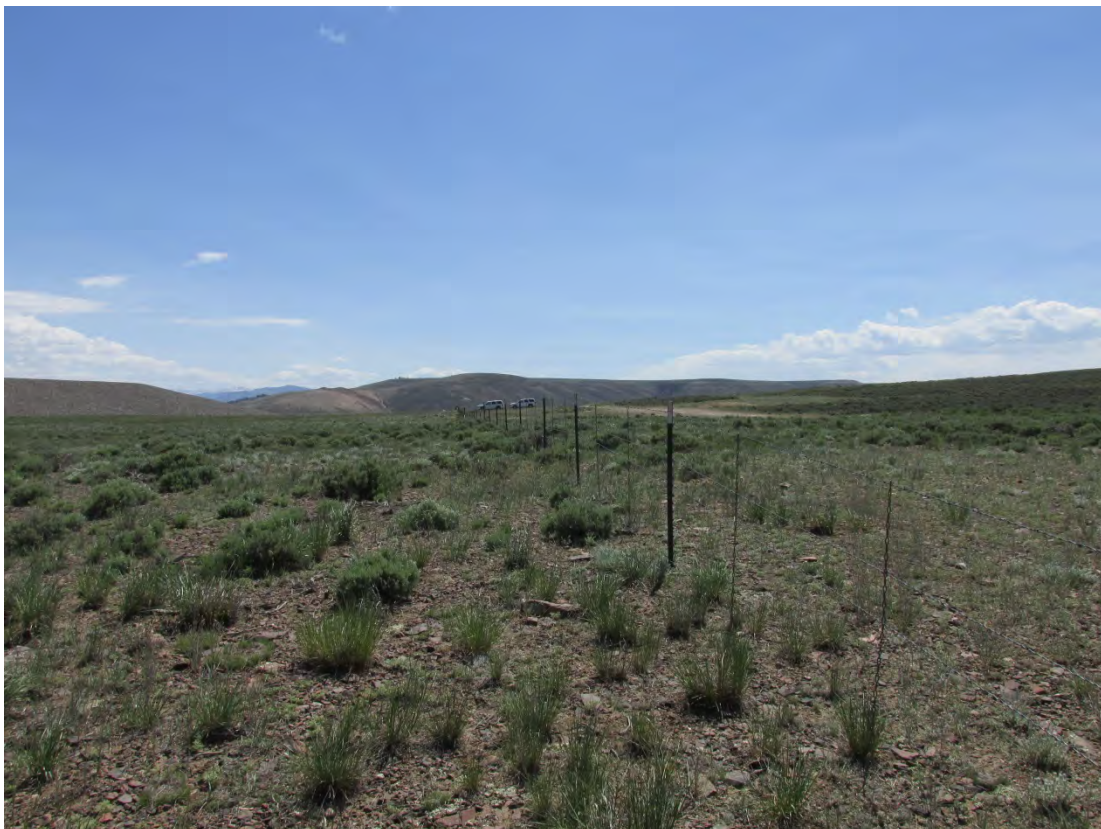
A three-strand, barbed-wire fence delineates the site; most of it is set along the property boundary. The fence was in good condition (PL-2). Two locked barbed-wire gates—one on the north fence line and the other on the east fence line—provide monitoring-well access. The gates were locked and in good condition.

*GUD 6/2013. PL-2. Site perimeter fence looking east from boundary monument BM-8.*
