U.S. DEPARTMENT OF  
**ENERGY**

# 2013 Annual Site Inspection and Monitoring Report for Uranium Mill Tailings Radiation Control Act Title I Disposal Sites

March 2014

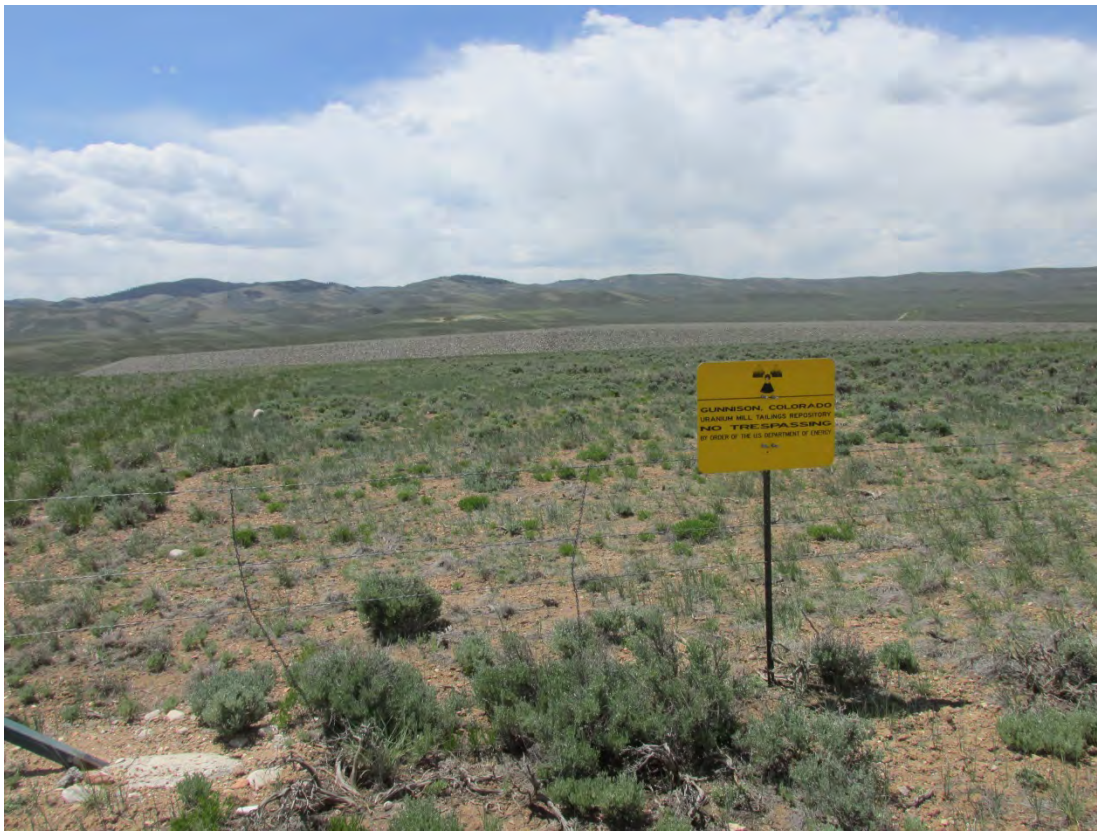
Forty-five perimeter signs are bolted to the perimeter fence posts. Several perimeter signs have bullet holes but were legible. The other signs were in good condition (P-3).

GUD 6/2013. PL-3. Perimeter sign P22 and the disposal cell.

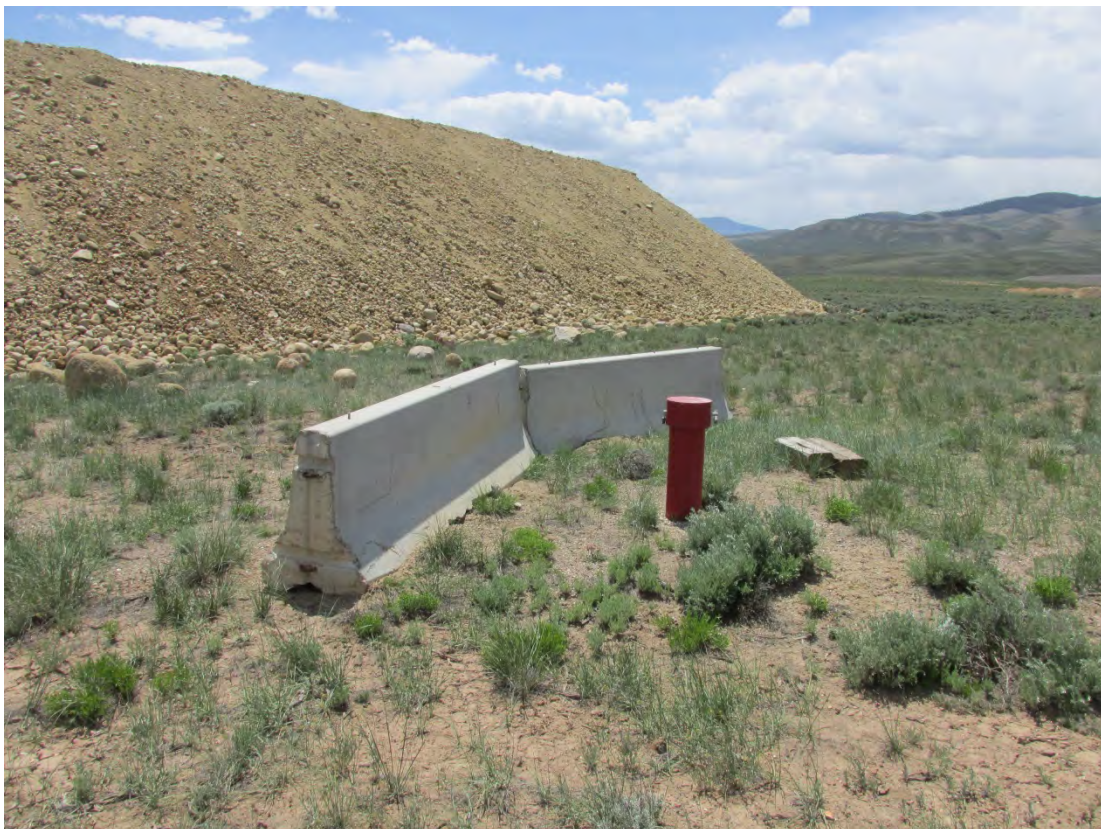
Sixteen wells constitute the groundwater monitoring network for the site. The wells were secure and in excellent condition. The Gunnison County landfill has placed a new overburden spoil pile near monitoring well 0716, which is located on landfill property. The landfill operators have placed concrete barriers to protect the well (PL-6).

*GUD 6/2013. PL-6. Monitoring well 0716 protected by concrete barriers.*

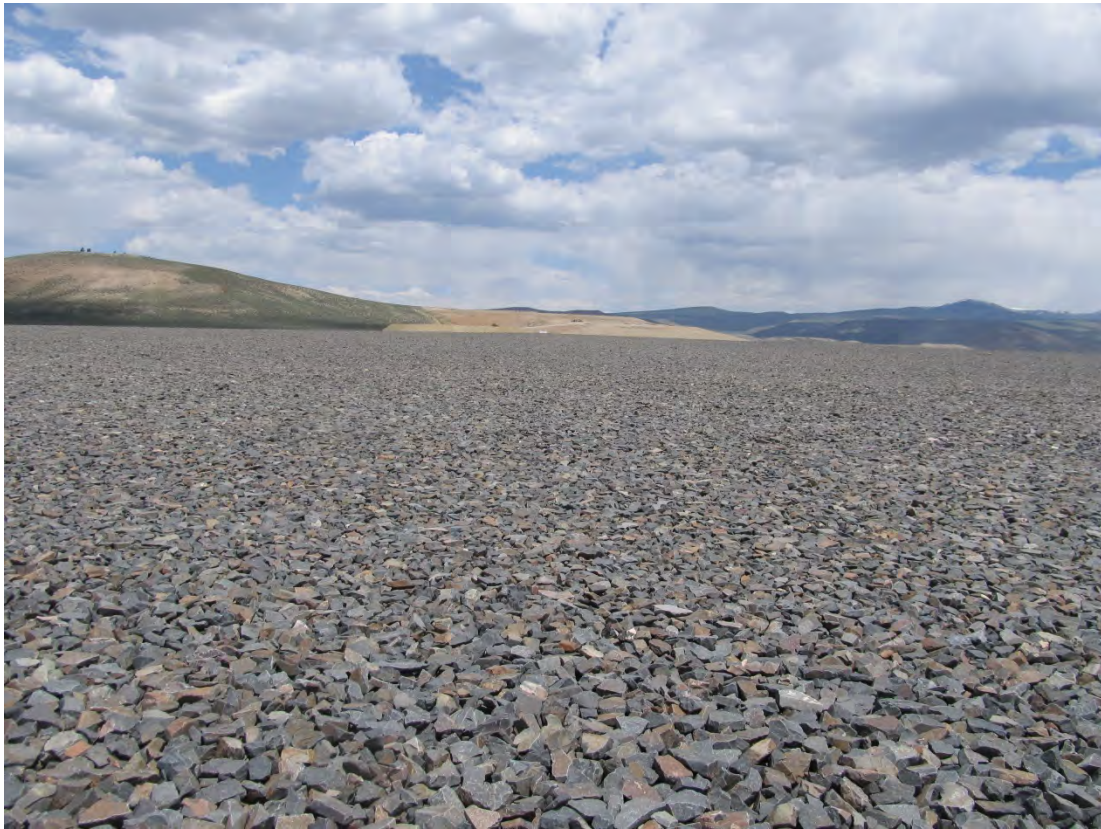
The rock-covered top of the disposal cell was in excellent condition (PL-7). There was no evidence of erosion, settling, slumping, or rock degradation. Several isolated patches of grass are randomly distributed over the disposal cell cover; however, these shallow-rooted plants are not a cause for concern.

*GUD 6/2013. PL-7. Top of the disposal cell and the Gunnison County landfill in the background.*

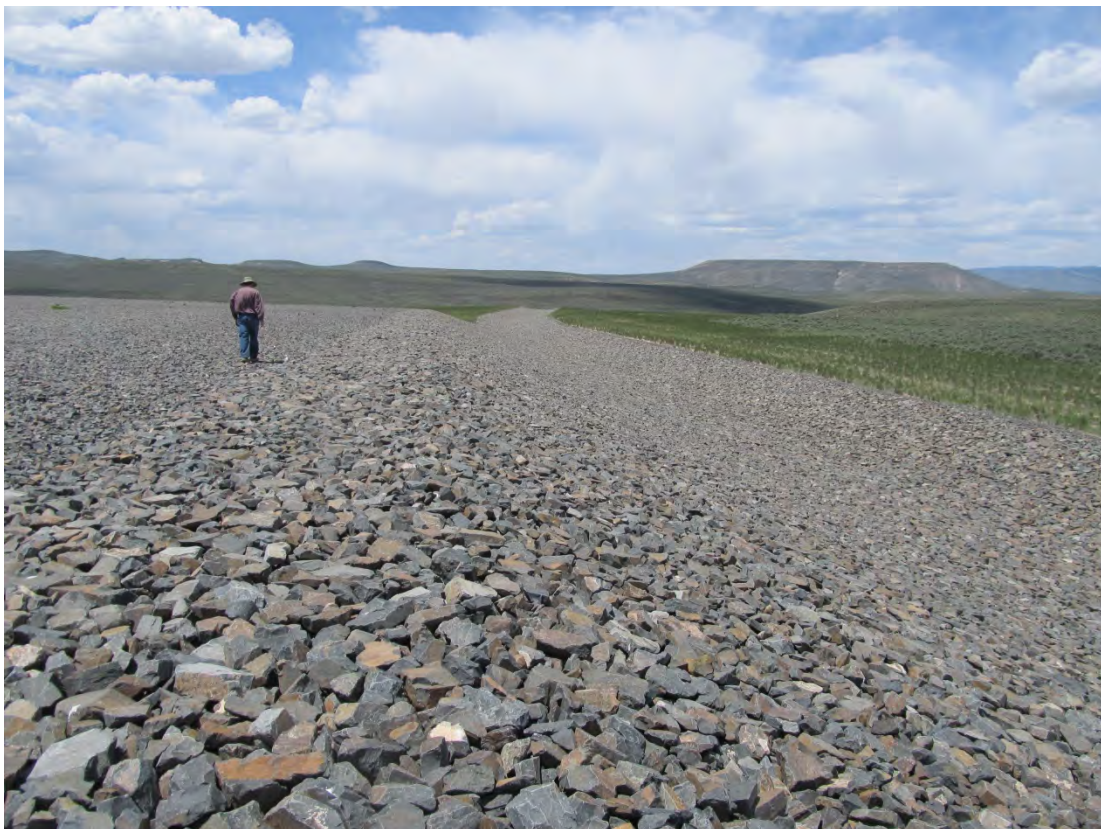
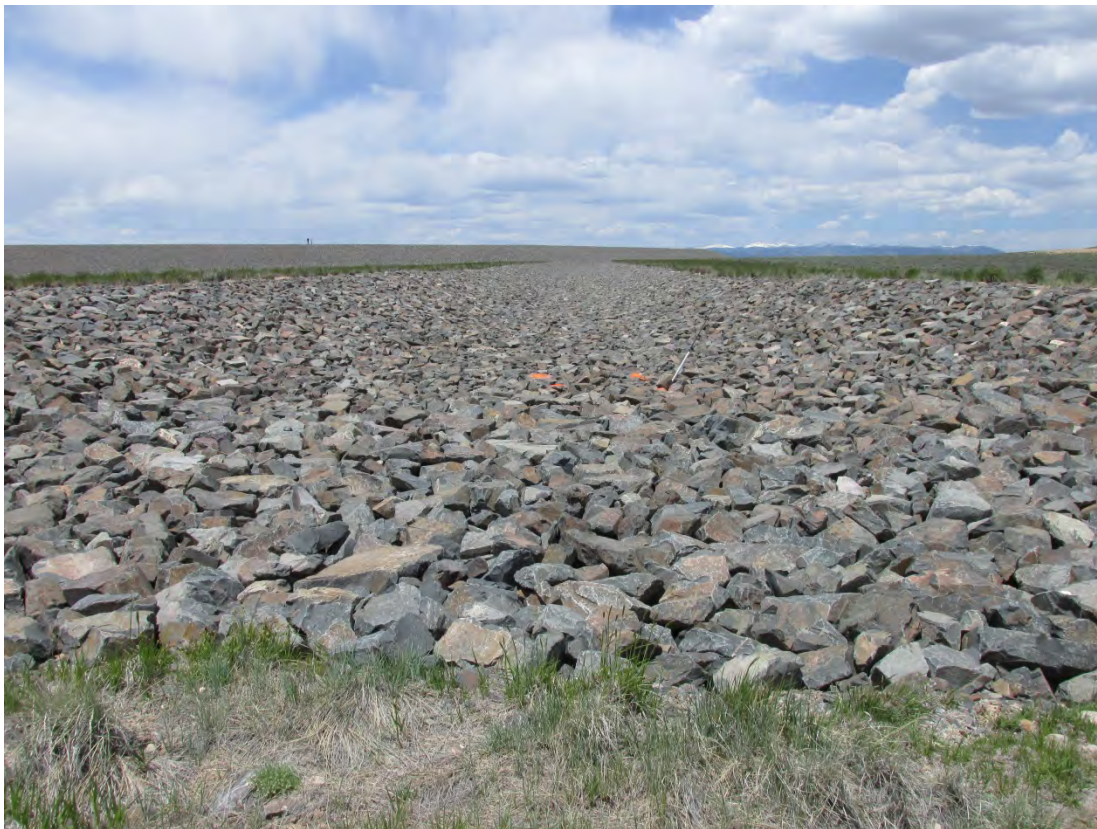
The riprap-covered side slopes, apron, and diversion channels were in good condition (PL-8 and PL-9). No evidence of slumping, settling, rock degradation, or encroachment of vegetation was observed.

*GUD 6/2013. PL-8. Northwest side of the disposal cell and the west diversion channel.*

*GUD 6/2013. PL-9. View upgradient of the east diversion channel.*

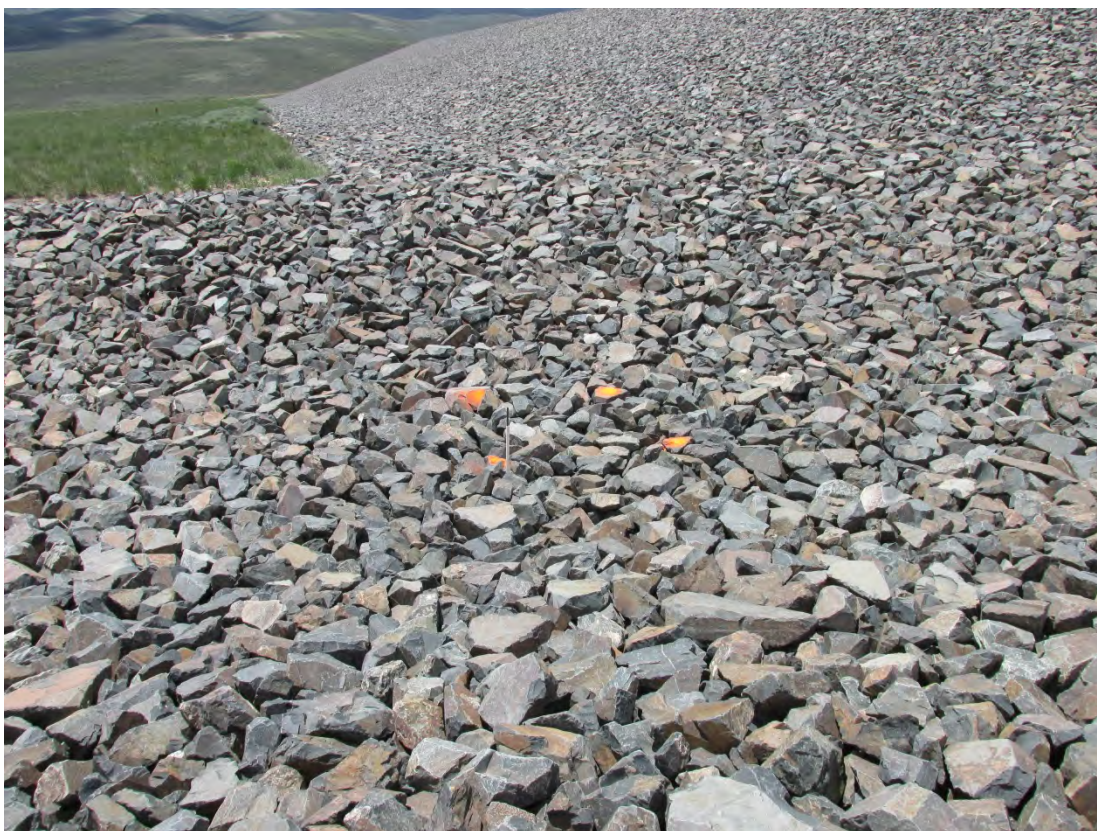
The condition of the riprap in six monitoring test areas was visually inspected. The test areas, each approximately 1 square meter in area, are in critical flow path locations in the apron and diversion channels (PL-10). The corners of each monitoring plot are marked with orange paint. The riprap in all of the test areas was in excellent condition. When the rocks were compared to the photos taken of them in 2012, there was no evidence that individual rocks had split or otherwise been degraded. As outlined in the LTSP, annual photographing and comparing of these test areas was performed through 2002; after that, the LTSP requires the test areas to be photographed every 5 years through 2017. The next and final set of photos will be taken in 2017.

*GUD 6/2013. PL-10. Riprap test area No. 4 in the east diversion channel.*

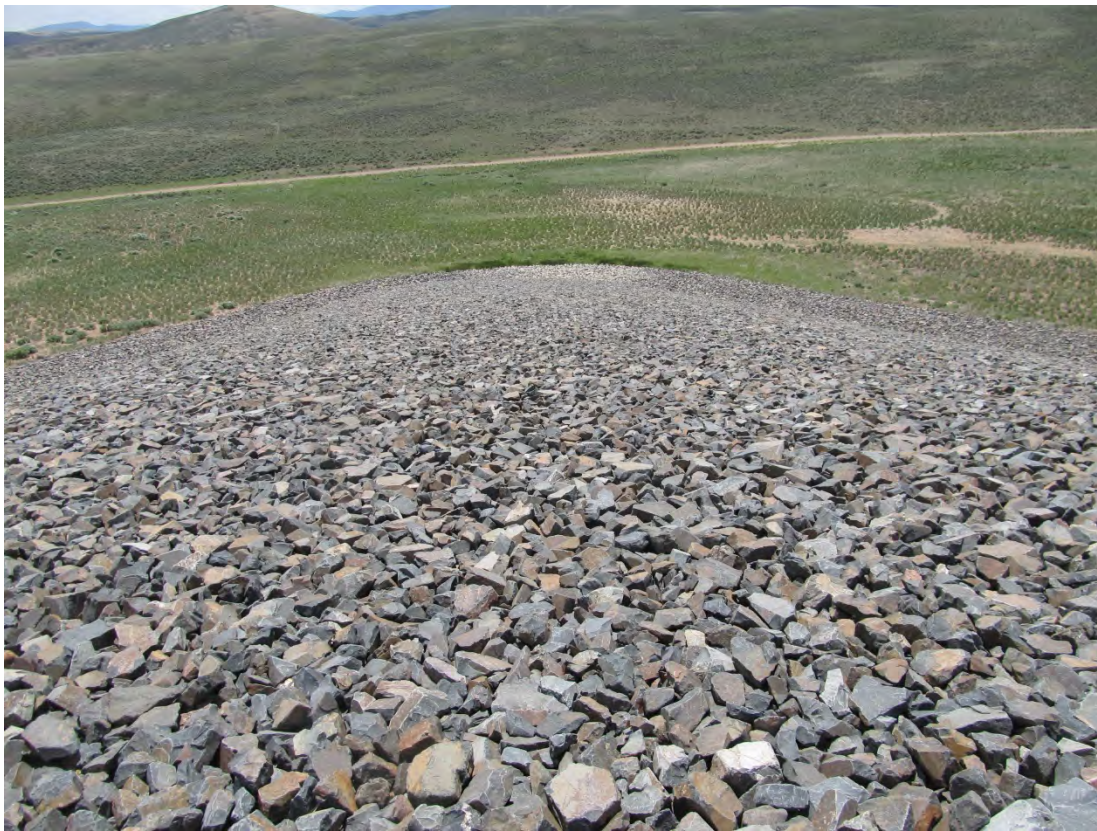
Precipitation runoff from the cell occasionally ponds in a low-lying area along the southeast corner of the cell. The riparian-type vegetation that has become established there indicates that the area retains moisture much of the time. Water collection in this area does not pose a problem because the cell is designed to drain to the southeast, and any water that ponds there is below the elevation of the encapsulated tailings material. This location was dry at the time of the inspection (PL-11).

*GUD 6/2013. PL-11. Southeast corner of the disposal cell (no runoff water accumulation).*

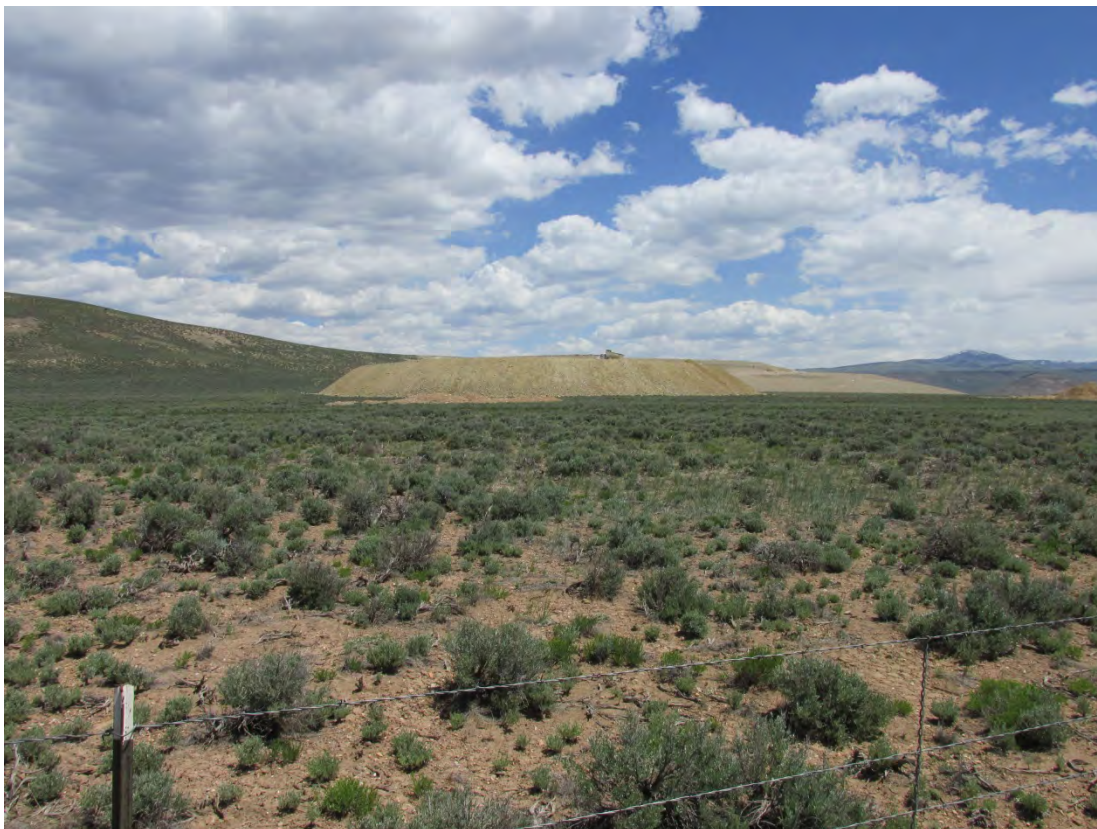
*GUD 6/2013. PL-12. New spoil pile at the Gunnison County landfill.*

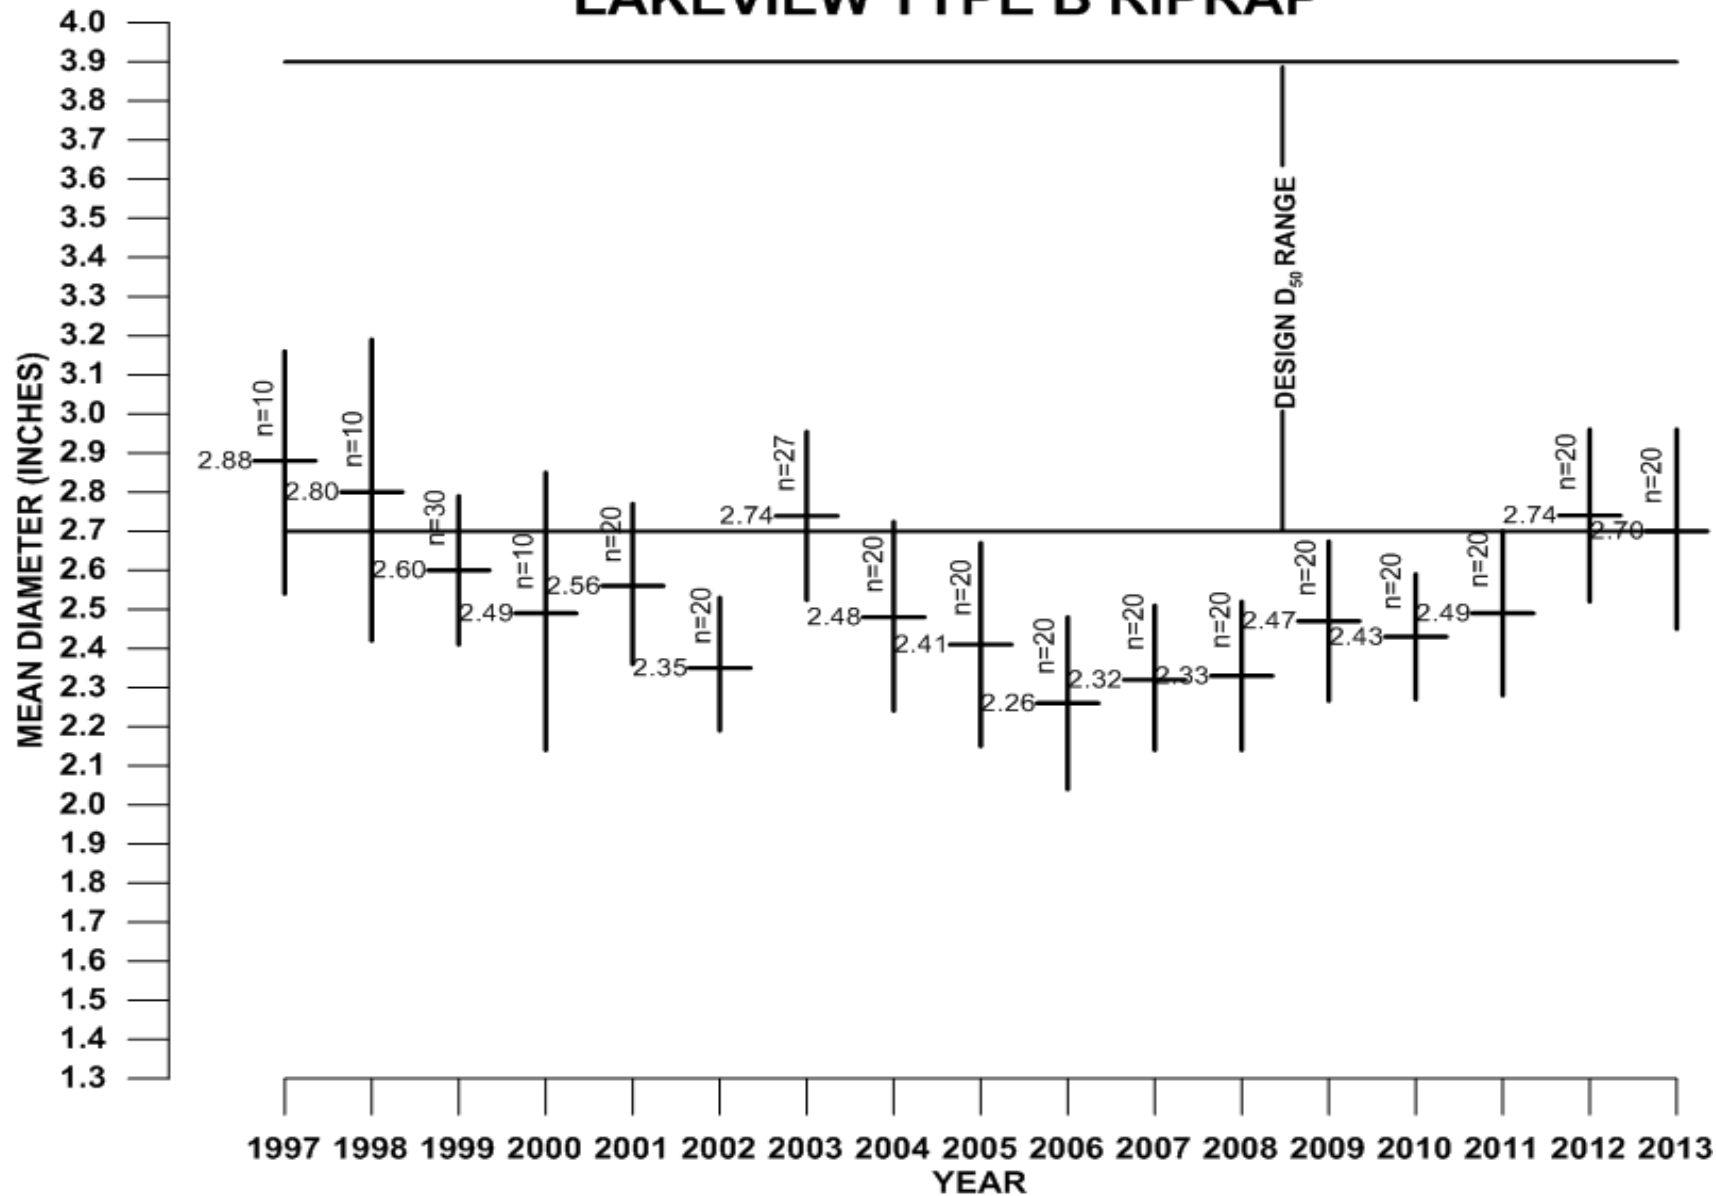
Figure 9-2. Riprap Gradation Monitoring

- 9A** Addendums to the LTSP commit DOE to annually determining the  $D_{50}$  value of the west side slope riprap through gradation monitoring to ensure that the riprap is large enough to protect the disposal cell from a major precipitation event. This gradation monitoring method measures the number of rocks retained per sieve size. In 2013, the gradation monitoring was performed for the 17th consecutive year, as shown in PL-5, PL-6, and PL-7. With NRC's consent, an additional sieve size (1 inch) has been included in the monitoring since 2009. Sampling locations are randomly selected before each monitoring event. Particle size distribution by count data were collected at 20 random locations, and approximately 25 rocks were sampled at each location. An evaluation of the rock size measurement data indicates that the west side slope riprap  $D_{50}$  is 2.70 inches with a 95 percent confidence interval between 2.45 and 2.96 inches. The 2013  $D_{50}$  value is 0.04 inch smaller than the value of 2.74 inches measured during the 2012 gradation monitoring. Figure 9-2 is a graph that shows the results of the gradation monitoring since 1997. As shown on the graph, the downward curve of  $D_{50}$  values appears to have somewhat leveled off over the past 10 years. Earlier results appear to indicate a gradual overall decrease in the cover rock  $D_{50}$  size.

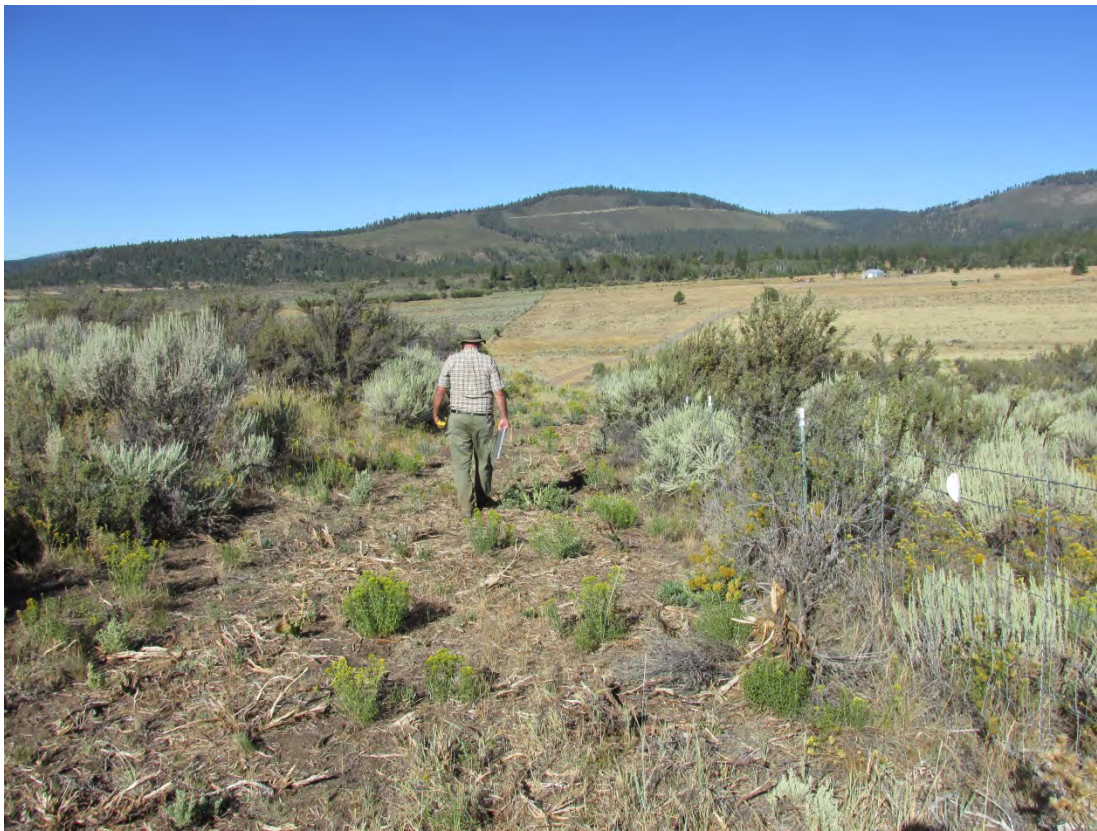
*LKV 8/2013. PL-2. View to west along south fence line. Shrub involvement with fence shown.*

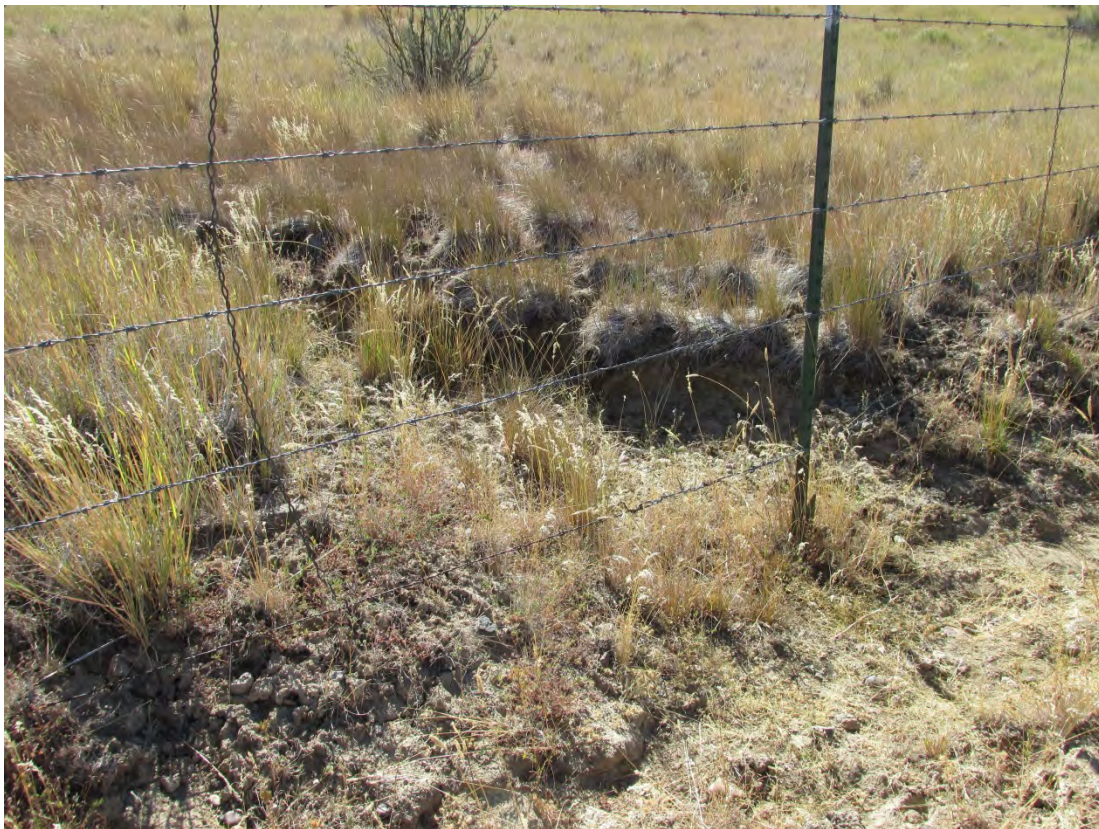
*LKV 8/2013. PL-9. Gullying at west fence line showing erosion around fence stake.*

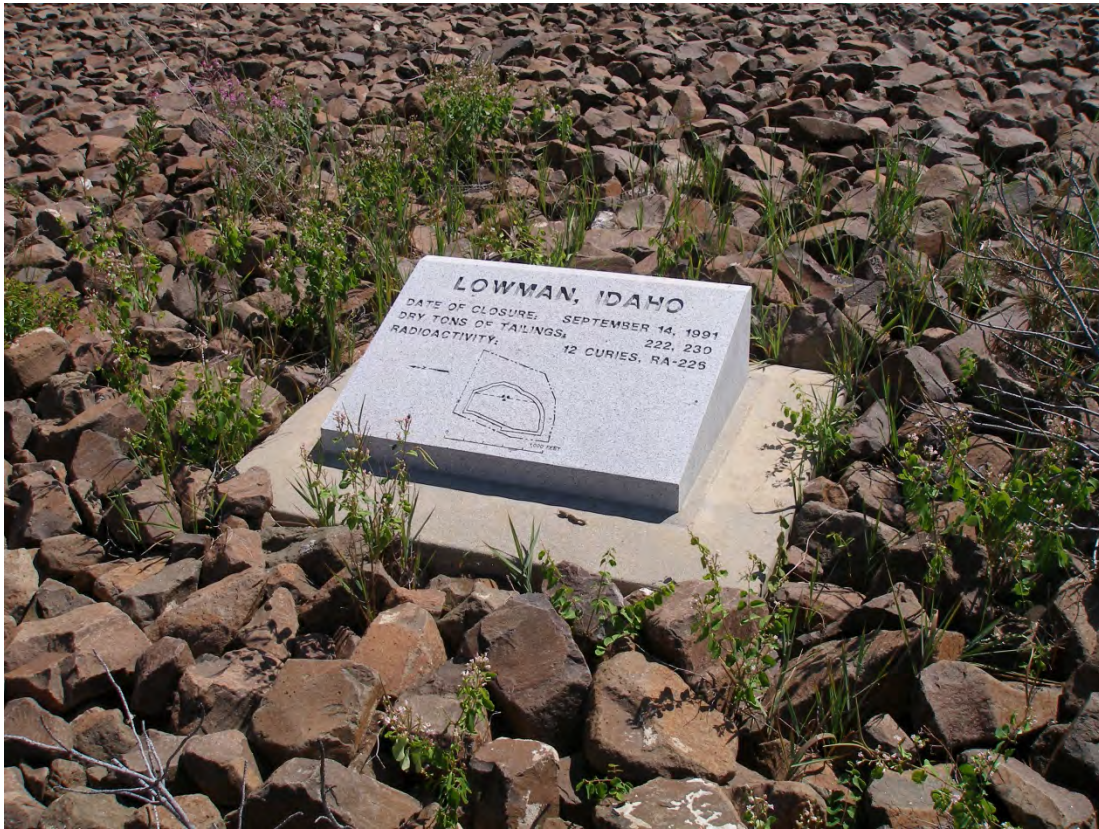
*LOW 7/2013. PL-2. Site marker 2 on cell top.*

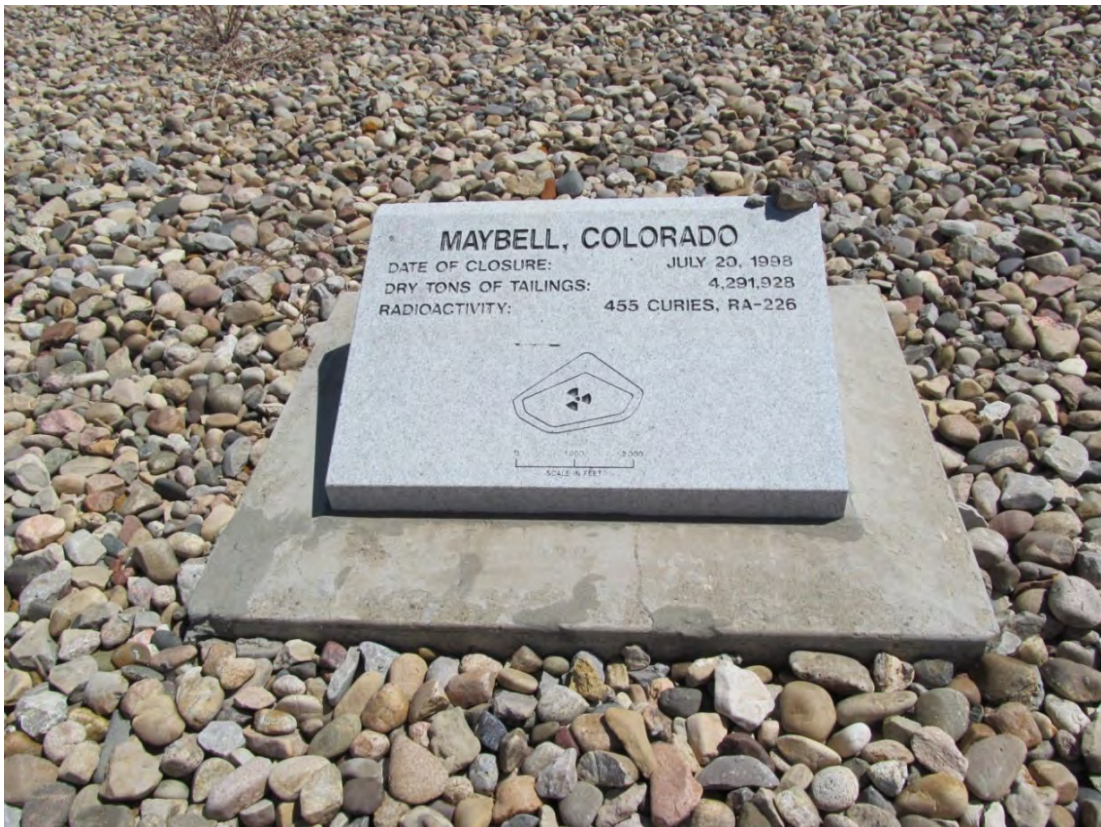
Two standard granite site markers are located onsite. Site marker SMK-1 is located near the entrance gate, and SMK-2 is located on top of the disposal cell (PL-2); both were in good condition.

MAY 8/2013. PL-2. Site Marker No. 2.

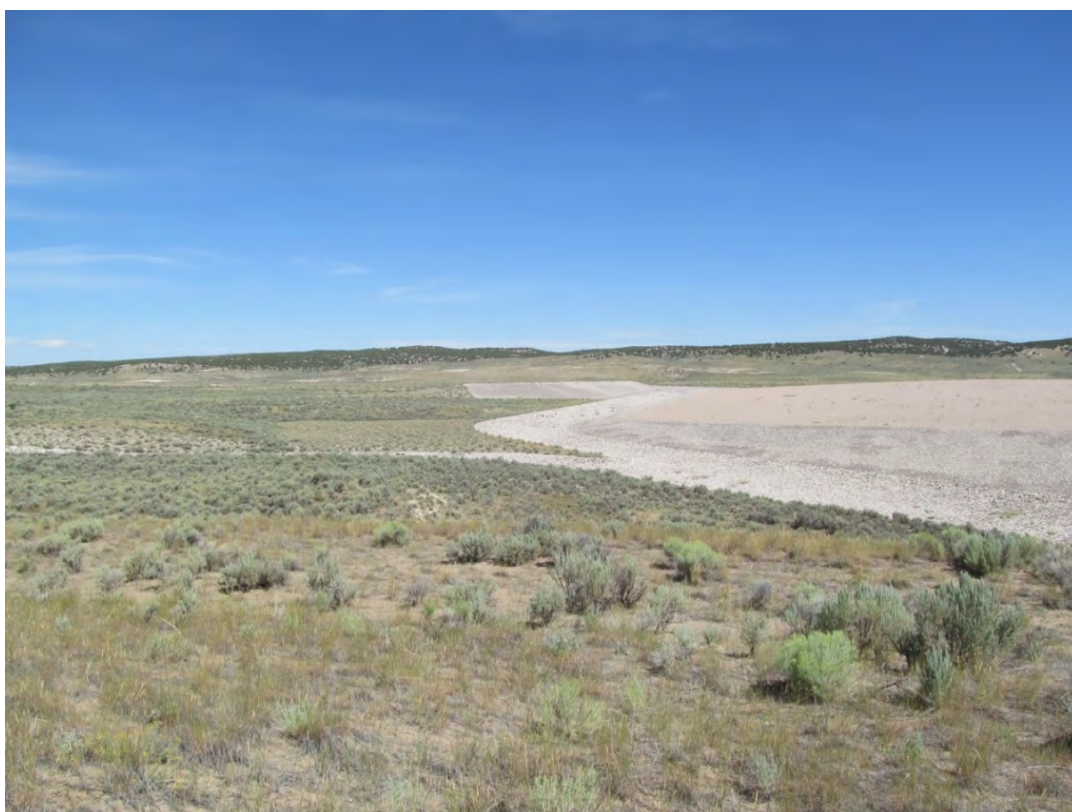
The disposal cell covers approximately 66-acres of the approximately 250-acre disposal site property (PL-4 and PL-5). The roughly pentagonal disposal cell measures about 1,600 feet (ft) by 2,400 ft and is located in the center of the site. The above-grade disposal cell rises to a height of approximately 30 ft and is capped with an approximately 7 ft thick multiple-component cover. The cover consists of a 1.5 ft thick radon/infiltration barrier directly over the tailings, overlain by a 4 ft thick compacted soil layer for protection from freeze-thaw cycles, a 0.5 ft thick bedding layer to promote drainage, and an 8- to 12-inch-thick layer of riprap to prevent erosion of the underlying materials. The side slopes of the disposal cell are at a 20 percent grade to create a stable slope, and the top of the disposal cell has a 3 percent grade to promote drainage toward the west.

*MAY 8/2013. PL-4. Southwestern portion of the disposal cell; confluence of Diversion Channels No. 1 and 2 in foreground.*

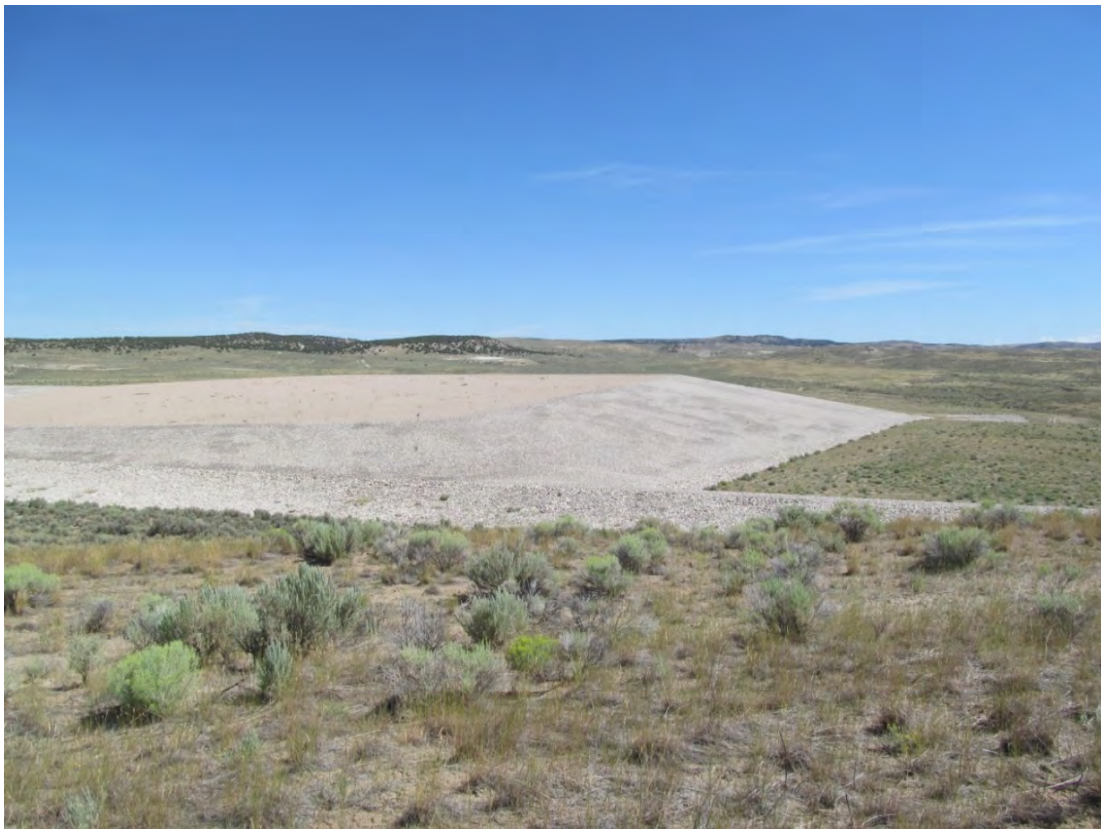
*MAY 8/2013. PL-5. Southeastern portion of the disposal cell; Diversion Channel No. 1 in foreground.*

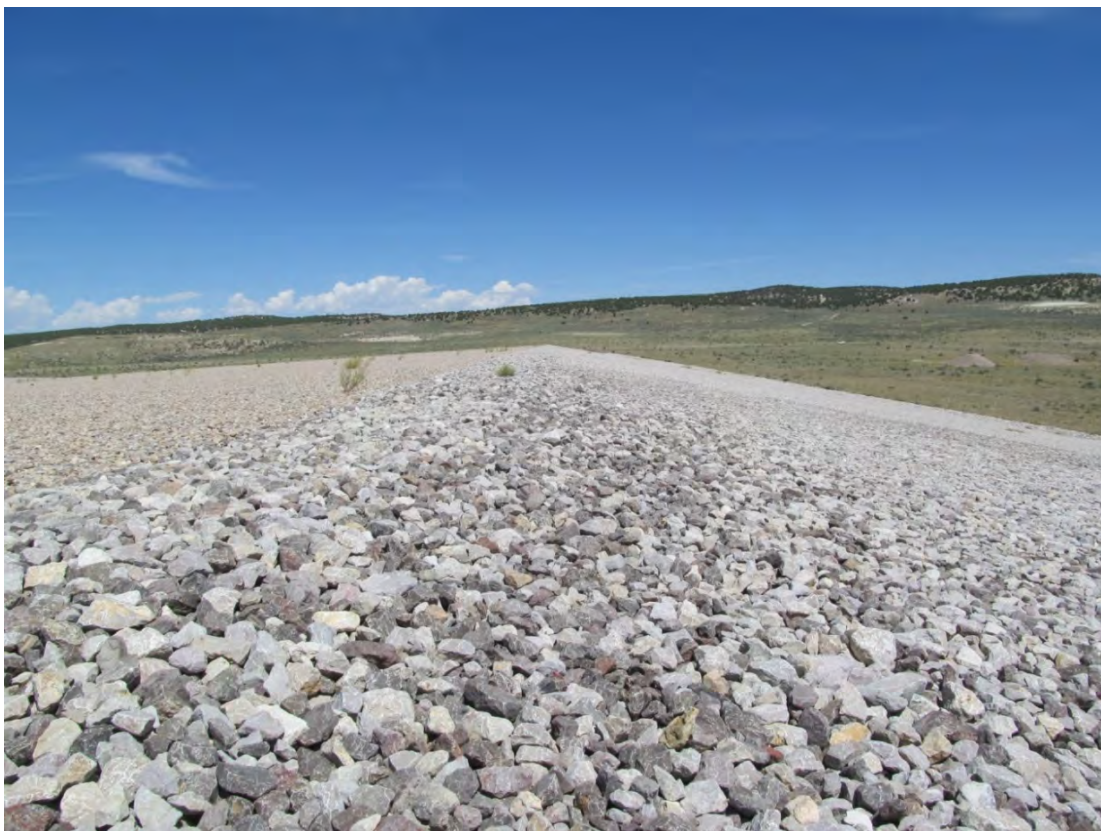
The disposal cell showed no evidence of settlement, slumping, erosion, or rock degradation (PL-6 and PL-7). In 2008 two slight depressions were thought to have been noted on the disposal cell top between settlement plates 6 and 7; these depressions could not be identified in subsequent inspections, including during the 2013 inspection. At the time, these areas were thought to be a result of inconsistencies in grade that occurred during cell construction and not from settlement of the underlying materials. Inspections will continue to include visual monitoring of this area to determine if any settlement of the disposal cell is actually occurring.

*MAY 8/2013. PL-6. Northeastern edge of the disposal cell top.*

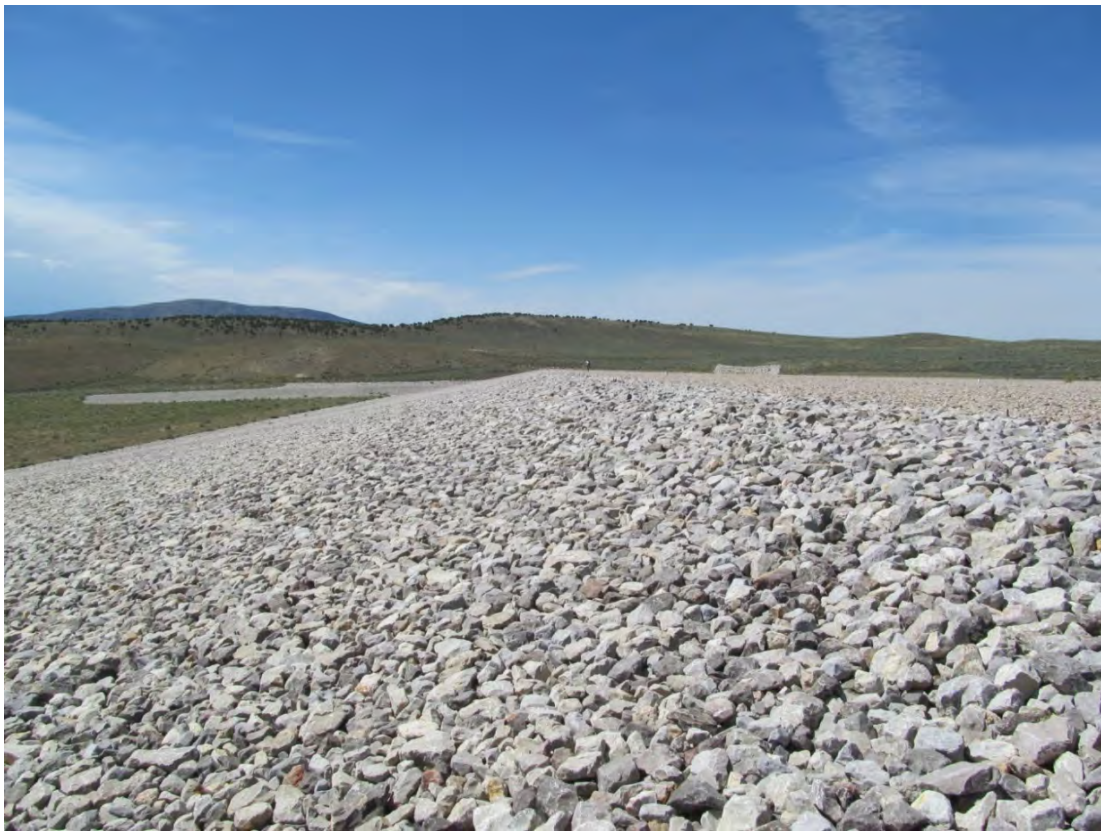
*MAY 8/2013. PL-7. Southeastern edge of the disposal cell top.*

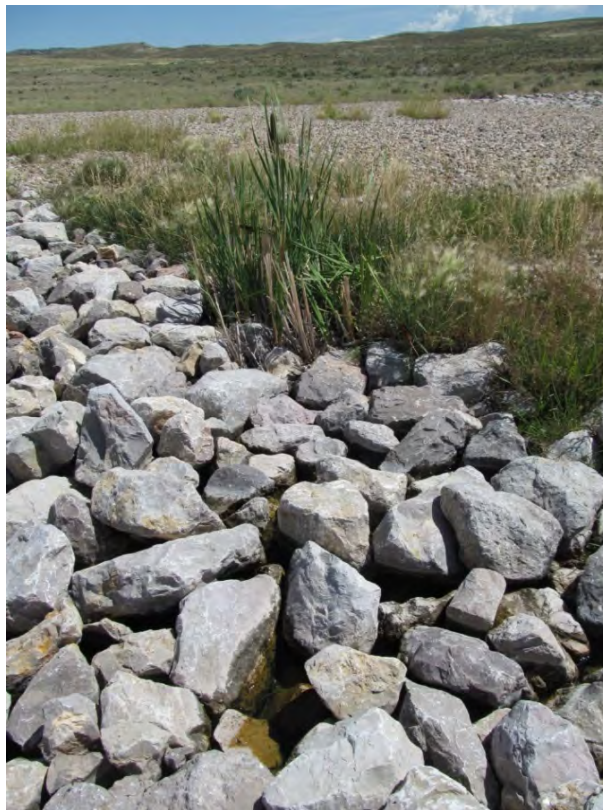
*MAY 8/2013. PL-8. Cattails growing adjacent to the base of the east side slope of the disposal cell; standing water within apron in foreground.*

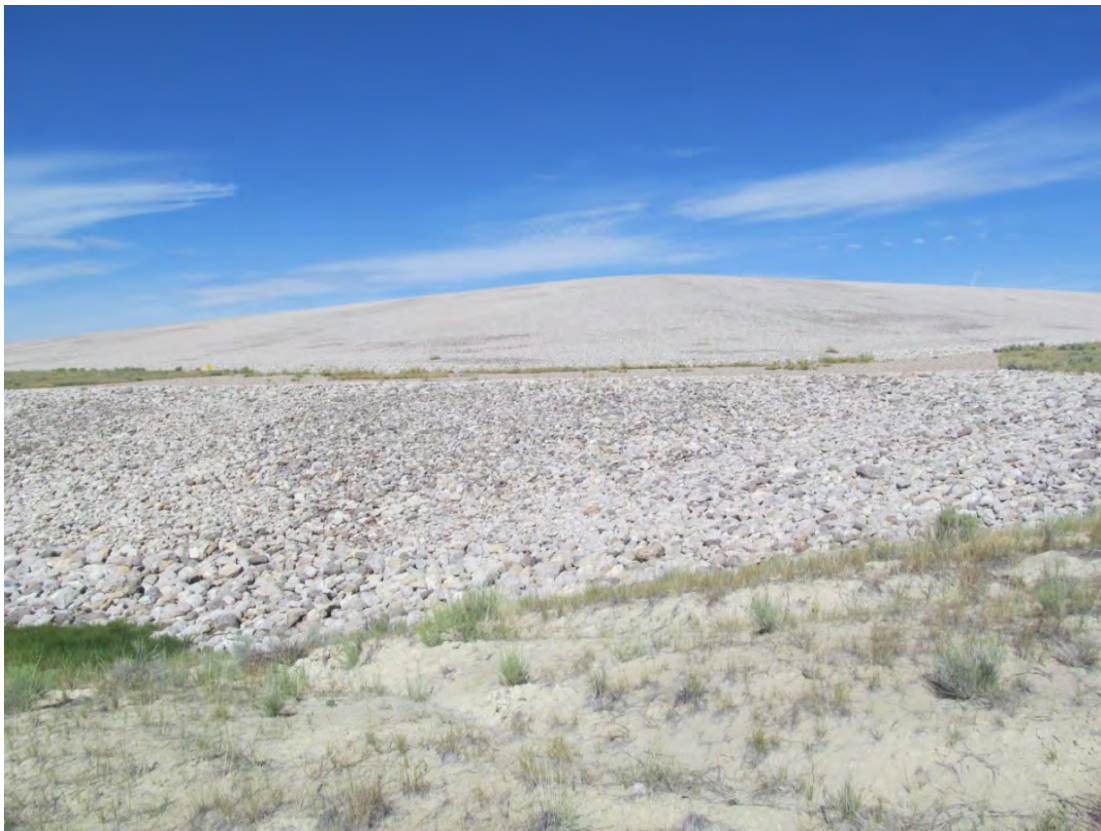
The rock-armored diversion channels, swales, and gullies were in good condition (PL-9 and PL-10). Erosion directly downgradient of the outlets to Diversion Channel No. 1 and Swale No. 1 that has exposed the underlying geo-fabric had not changed significantly. Riprap placed within the outlets continues to provide protection against headcutting. This erosion presents no threat to the integrity of the disposal cell but monitoring of it will continue. Minor rills noted adjacent to Swale No. 1 and Gully No. 1 continue to stabilize due to self-armoring and increased vegetation growth. There was no evidence of any significant new erosion or sediment moving offsite into Johnson Wash. Gabions and riprap installed in 2000, and reinforced in 2001 and 2002, to control erosion in drainage structures east of the cell continue to remain effective.

*MAY 8/2013. PL-9. Armored Gully No. 1; disposal cell in background.*

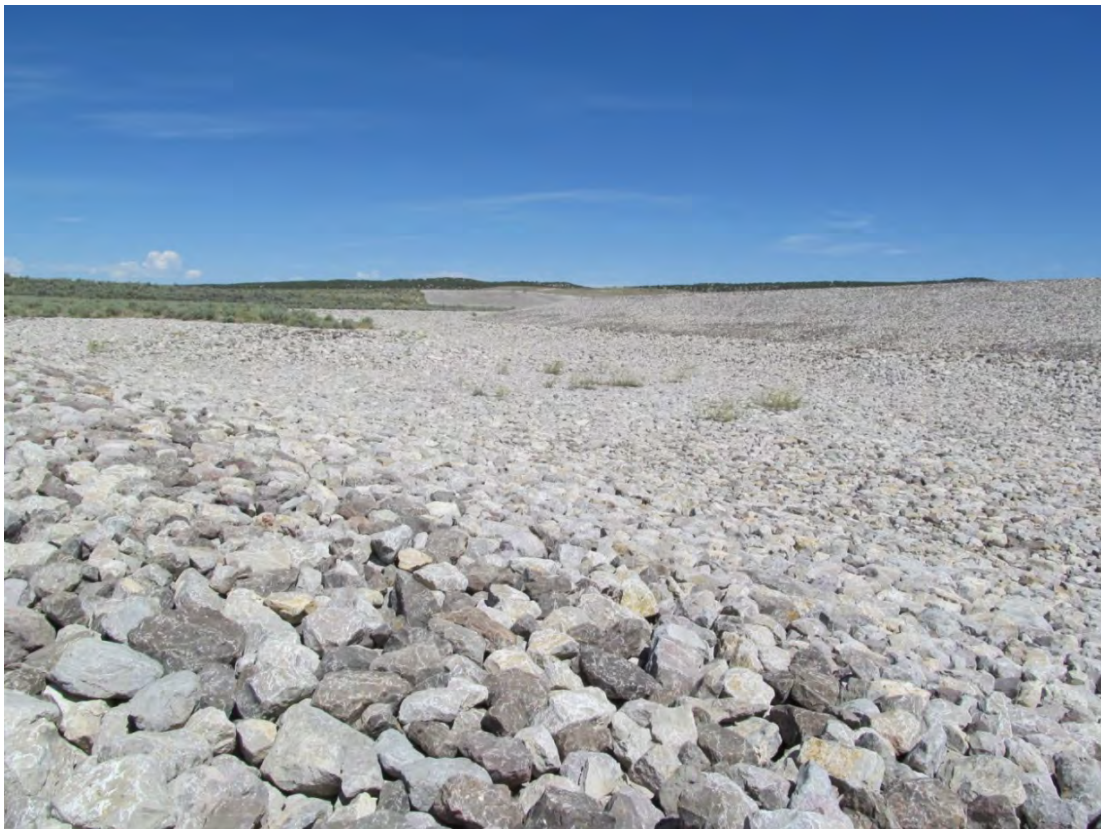
*MAY 8/2013. PL-10. Confluence of Diversion Channels No. 1 and 2.*

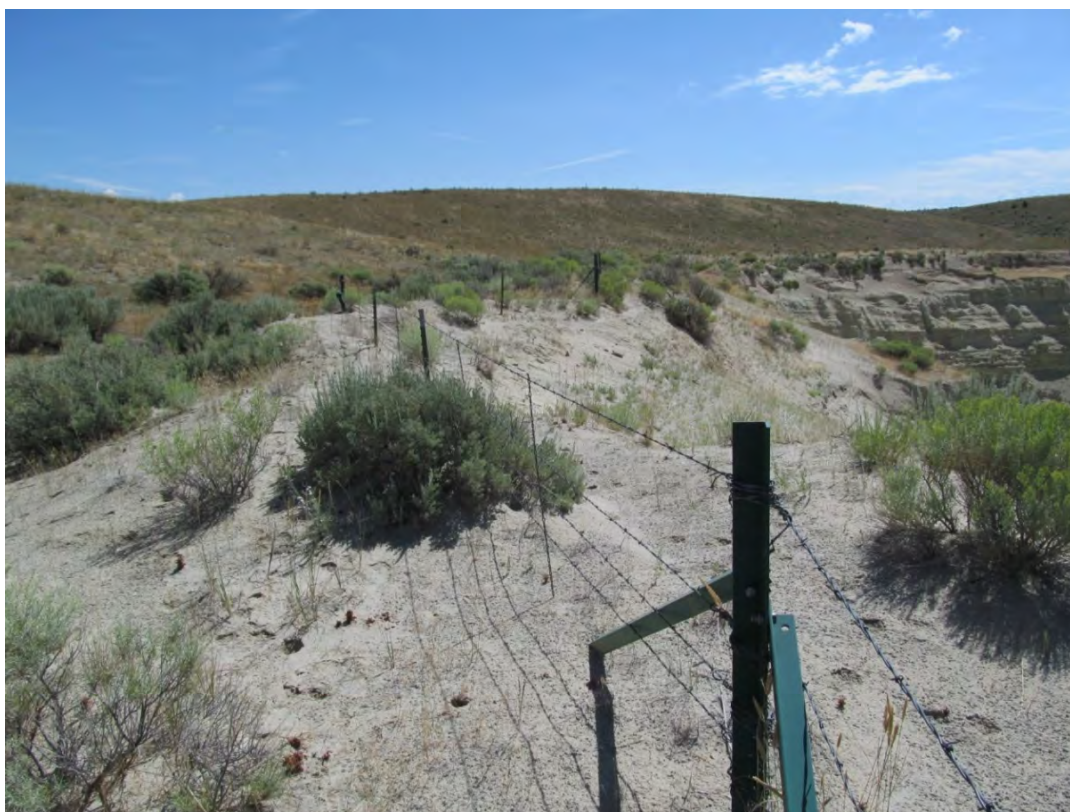
cell and occurred prior to reclamation and transfer of the site to DOE for long-term surveillance and maintenance. Continued observation will be performed to ensure that any additional sloughing of the pit wall does not damage the perimeter fence that runs along the south property line. This encroachment is visually monitored annually and periodically documented with photographs to determine if any further slumping of the pit wall is occurring. In 2013, there was no evidence of any additional encroachment of the pit onto the site. However, windblown sand continues to accumulate along the northern crest of the pit wall along the fence line (PL-12).

*MAY 8/2013. PL-12. Windblown sand accumulation along the south perimeter fence at crest of the northern wall of the Johnson Pit; encroachment of pit in background.*

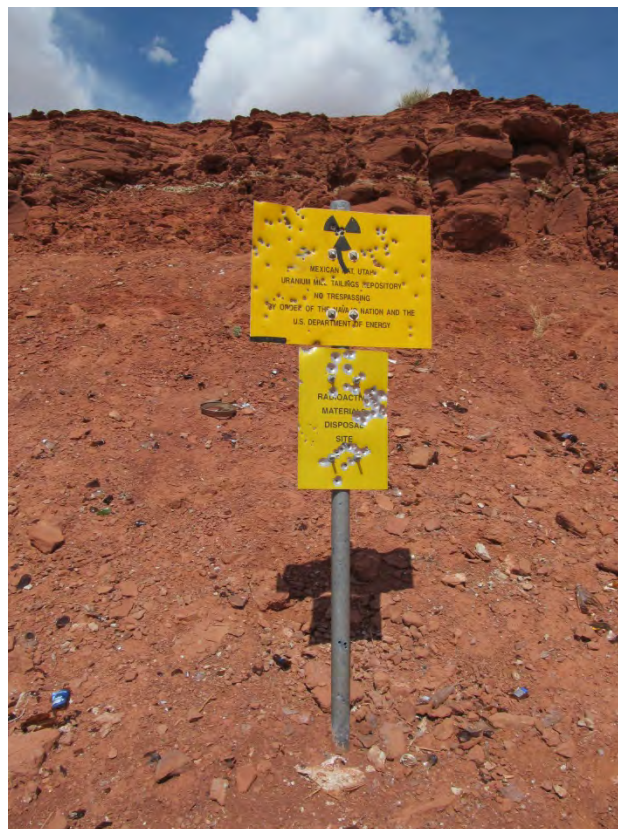
*HAT 4/2013. PL-2. Perimeter sign P20 with bullet holes.*
