U.S. DEPARTMENT OF  
**ENERGY**

# 2013 Annual Site Inspection and Monitoring Report for Uranium Mill Tailings Radiation Control Act Title I Disposal Sites

March 2014

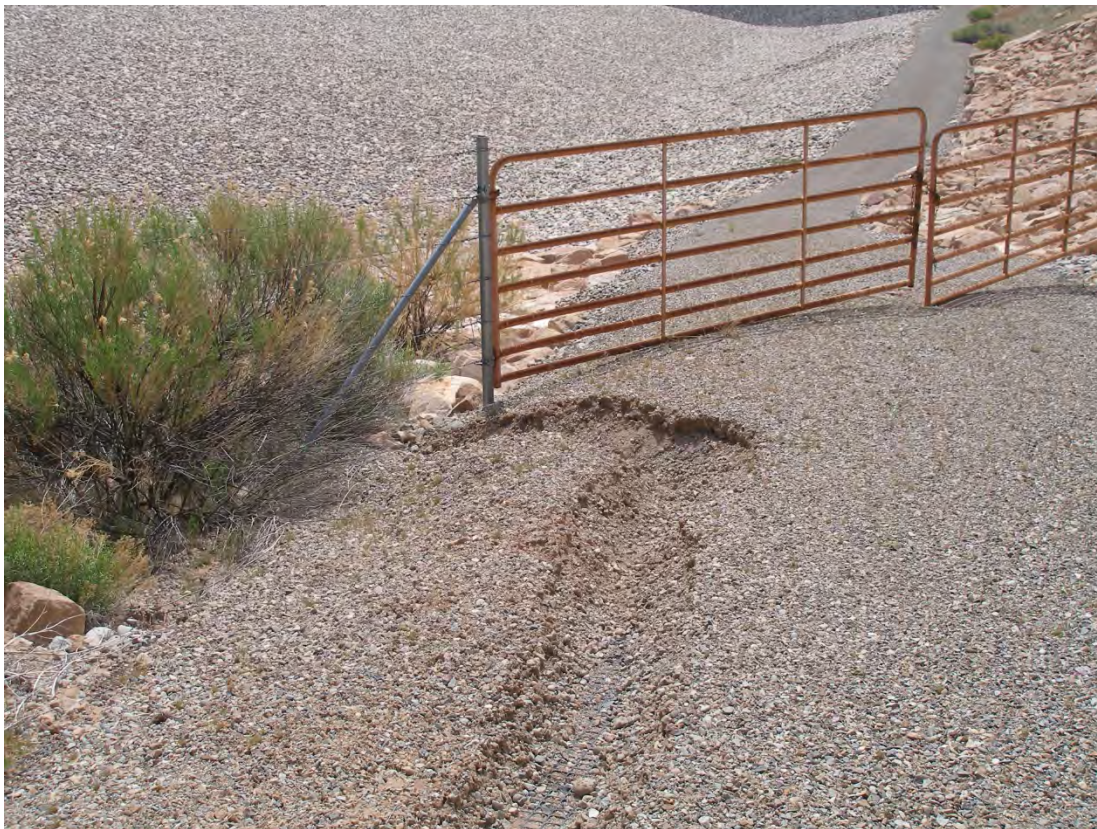
*NAD 5/2013. PL-2. Erosion on access road near upper gate.*

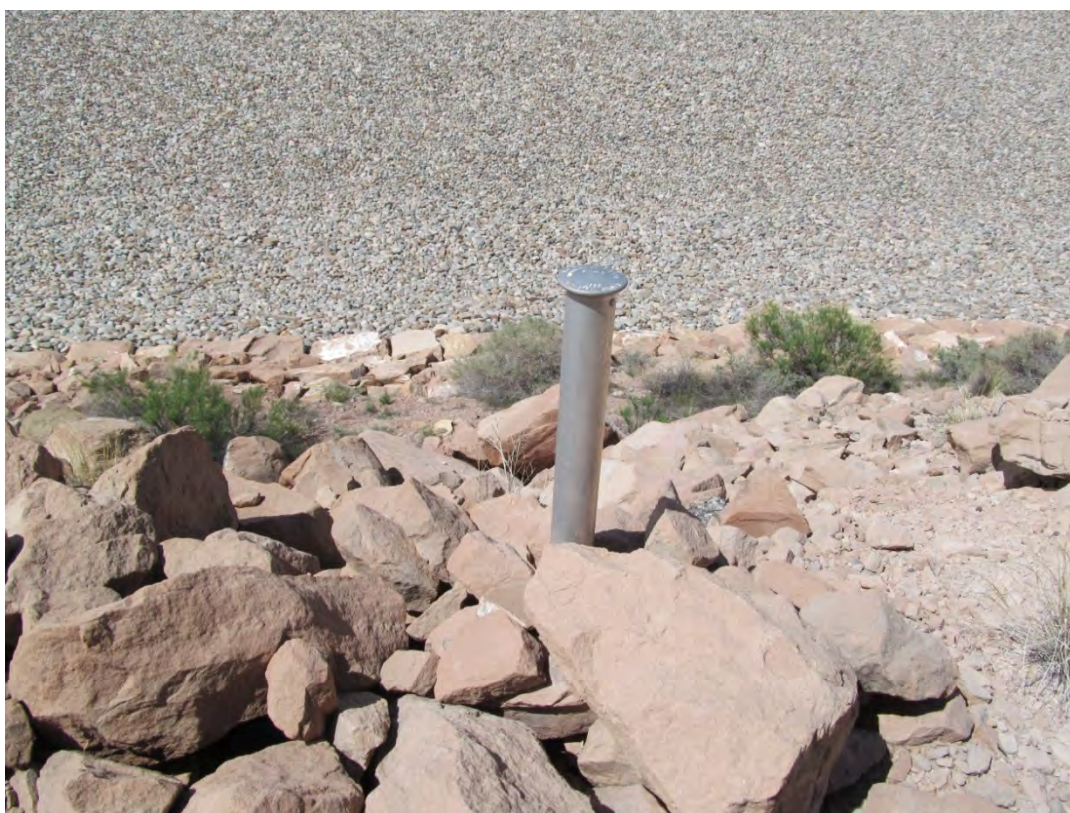
Boundary monuments BM-1 through BM-17 (BM-2/PL-5) mark the property corners. Survey monuments SM-3, SM-4, and SM-11, represent boundary monuments BM-3, BM-4, and BM-11. Both survey and boundary monuments are located with the same precision and serve the same purpose of marking the boundaries for the site. Survey monuments were installed early during site construction for survey control; boundary monuments were installed after

NAD 5/2013. PL-5. Boundary monument number BM-2, typical boundary monument.

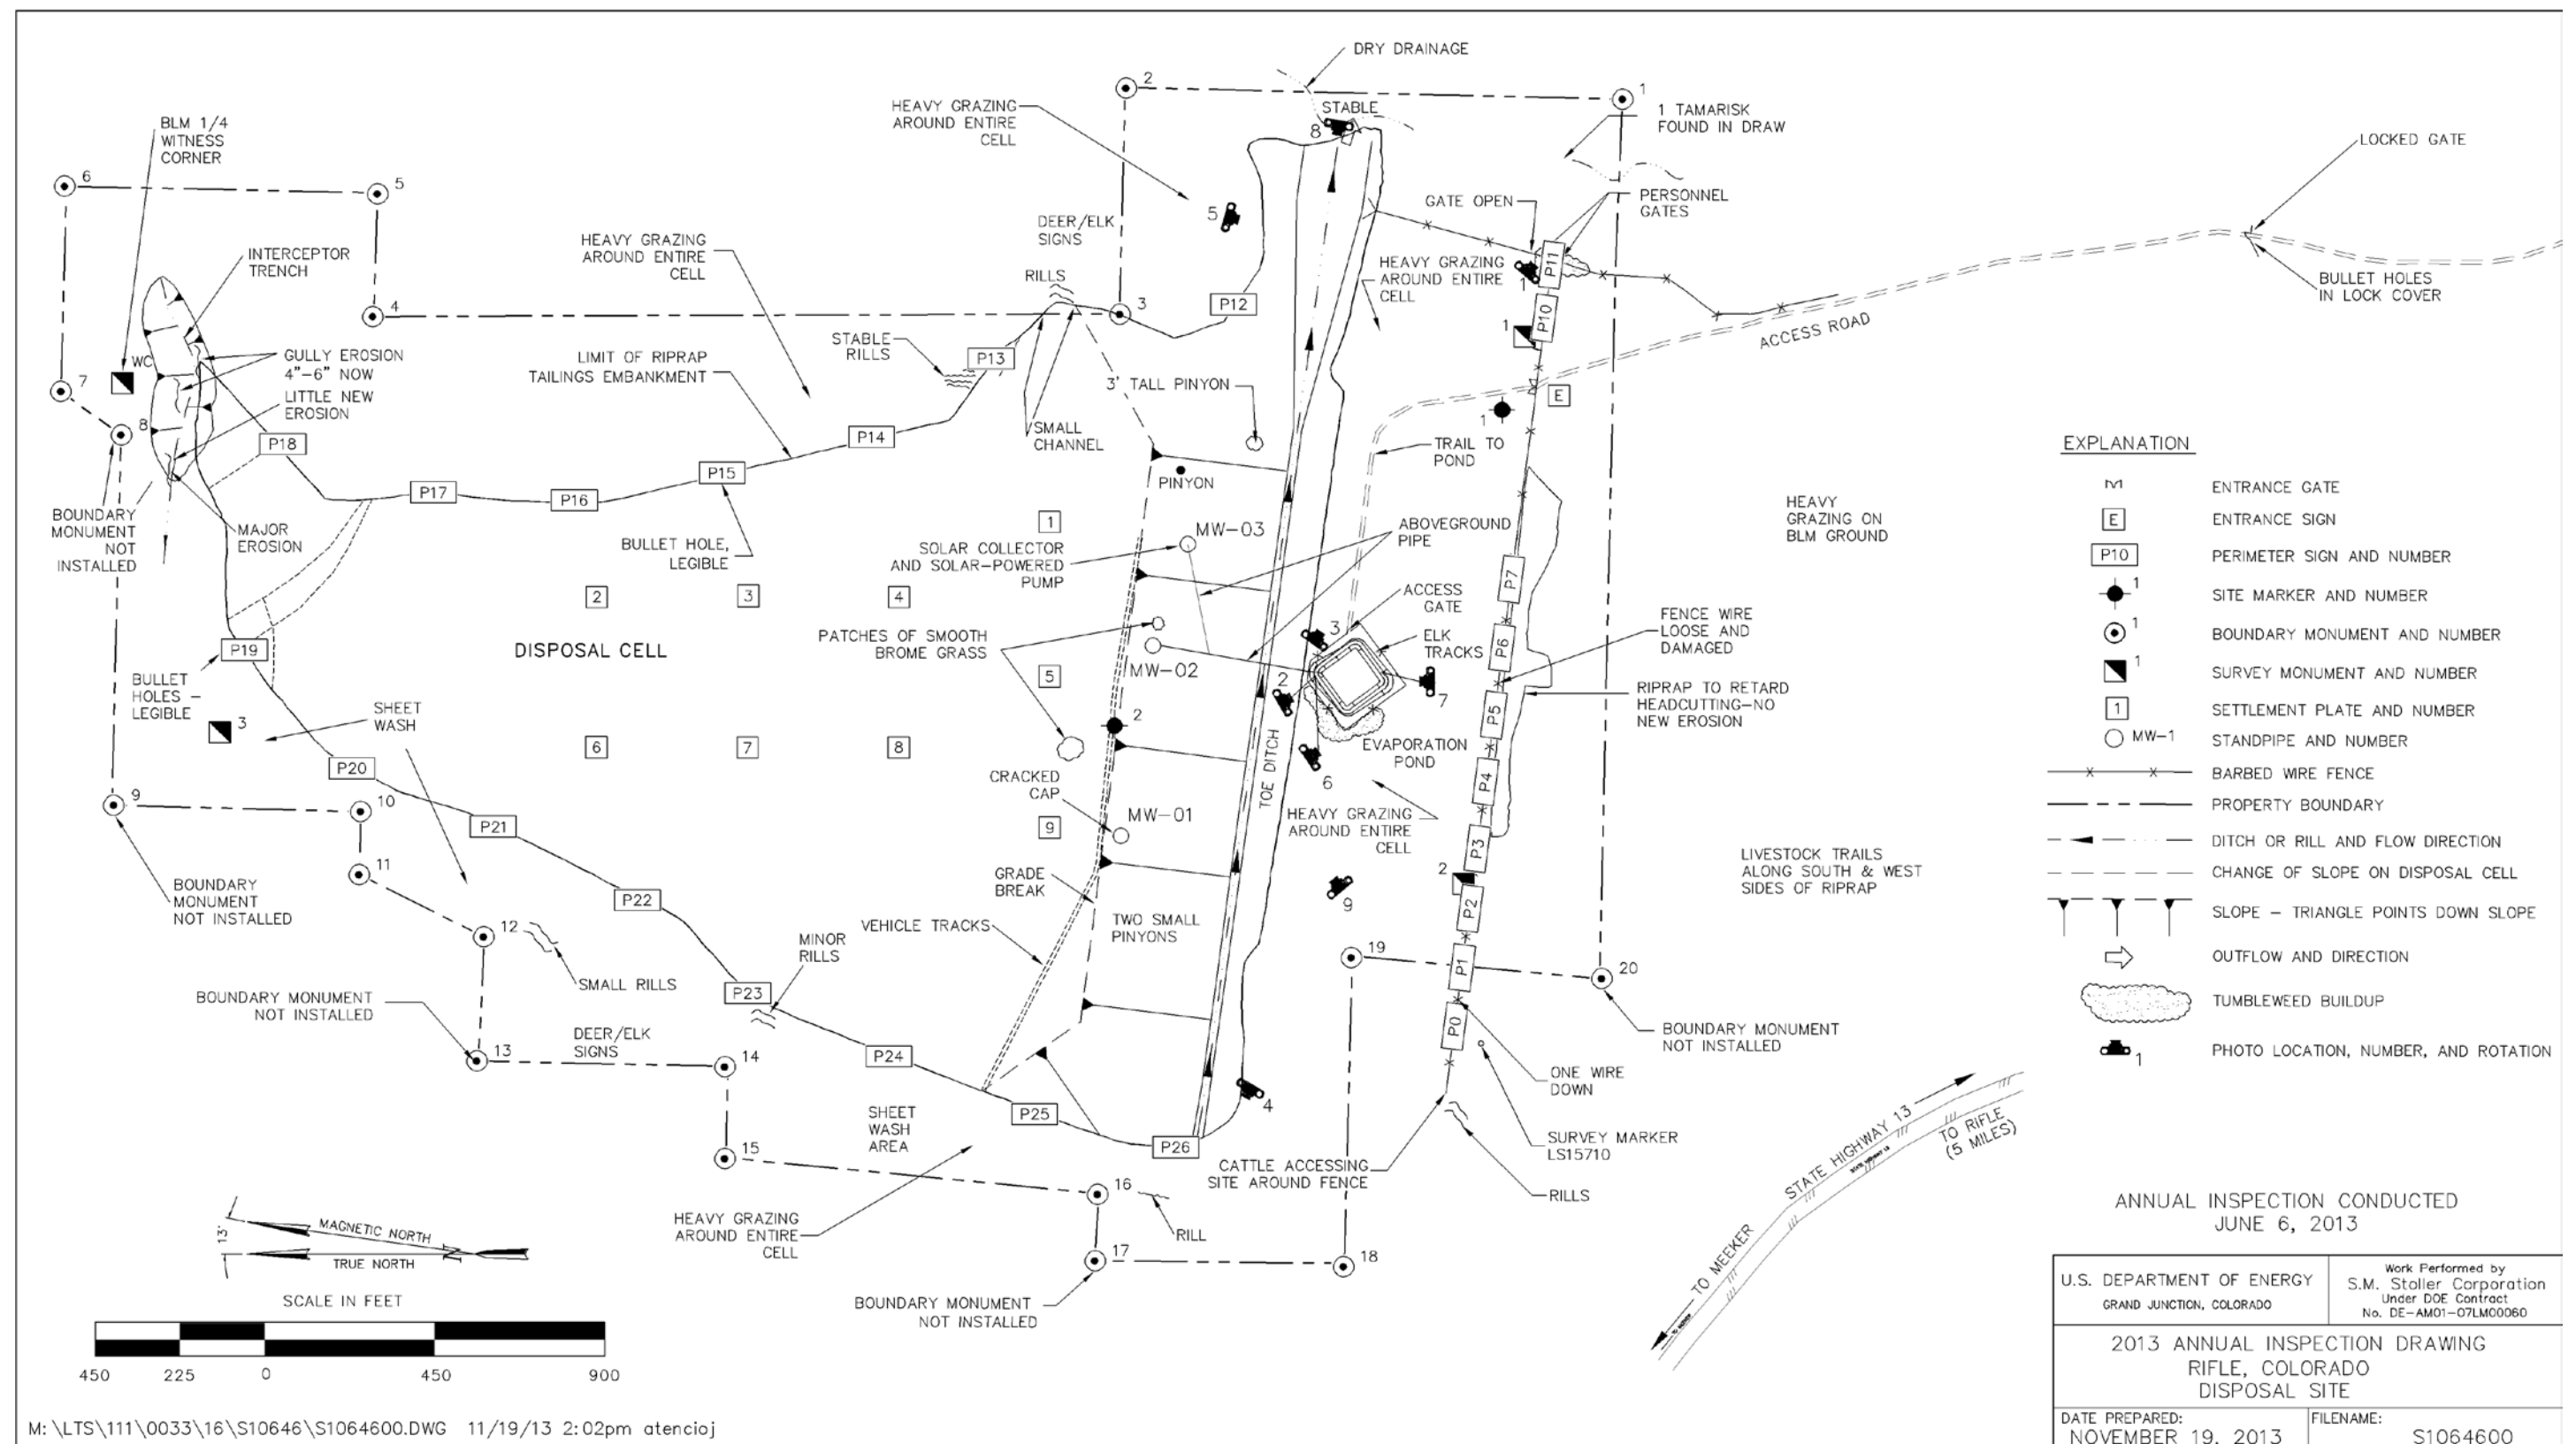
Figure 14-1. 2013 Annual Inspection Drawing for the Rifle Disposal Site

Figure 14-1 shows the locations of site surveillance features. Inspection results and recommended maintenance activities associated with site surveillance features are included in the following subsections. Photographs to support specific observations are identified in the text and in Figure 14-1 by photograph location (PL) numbers.

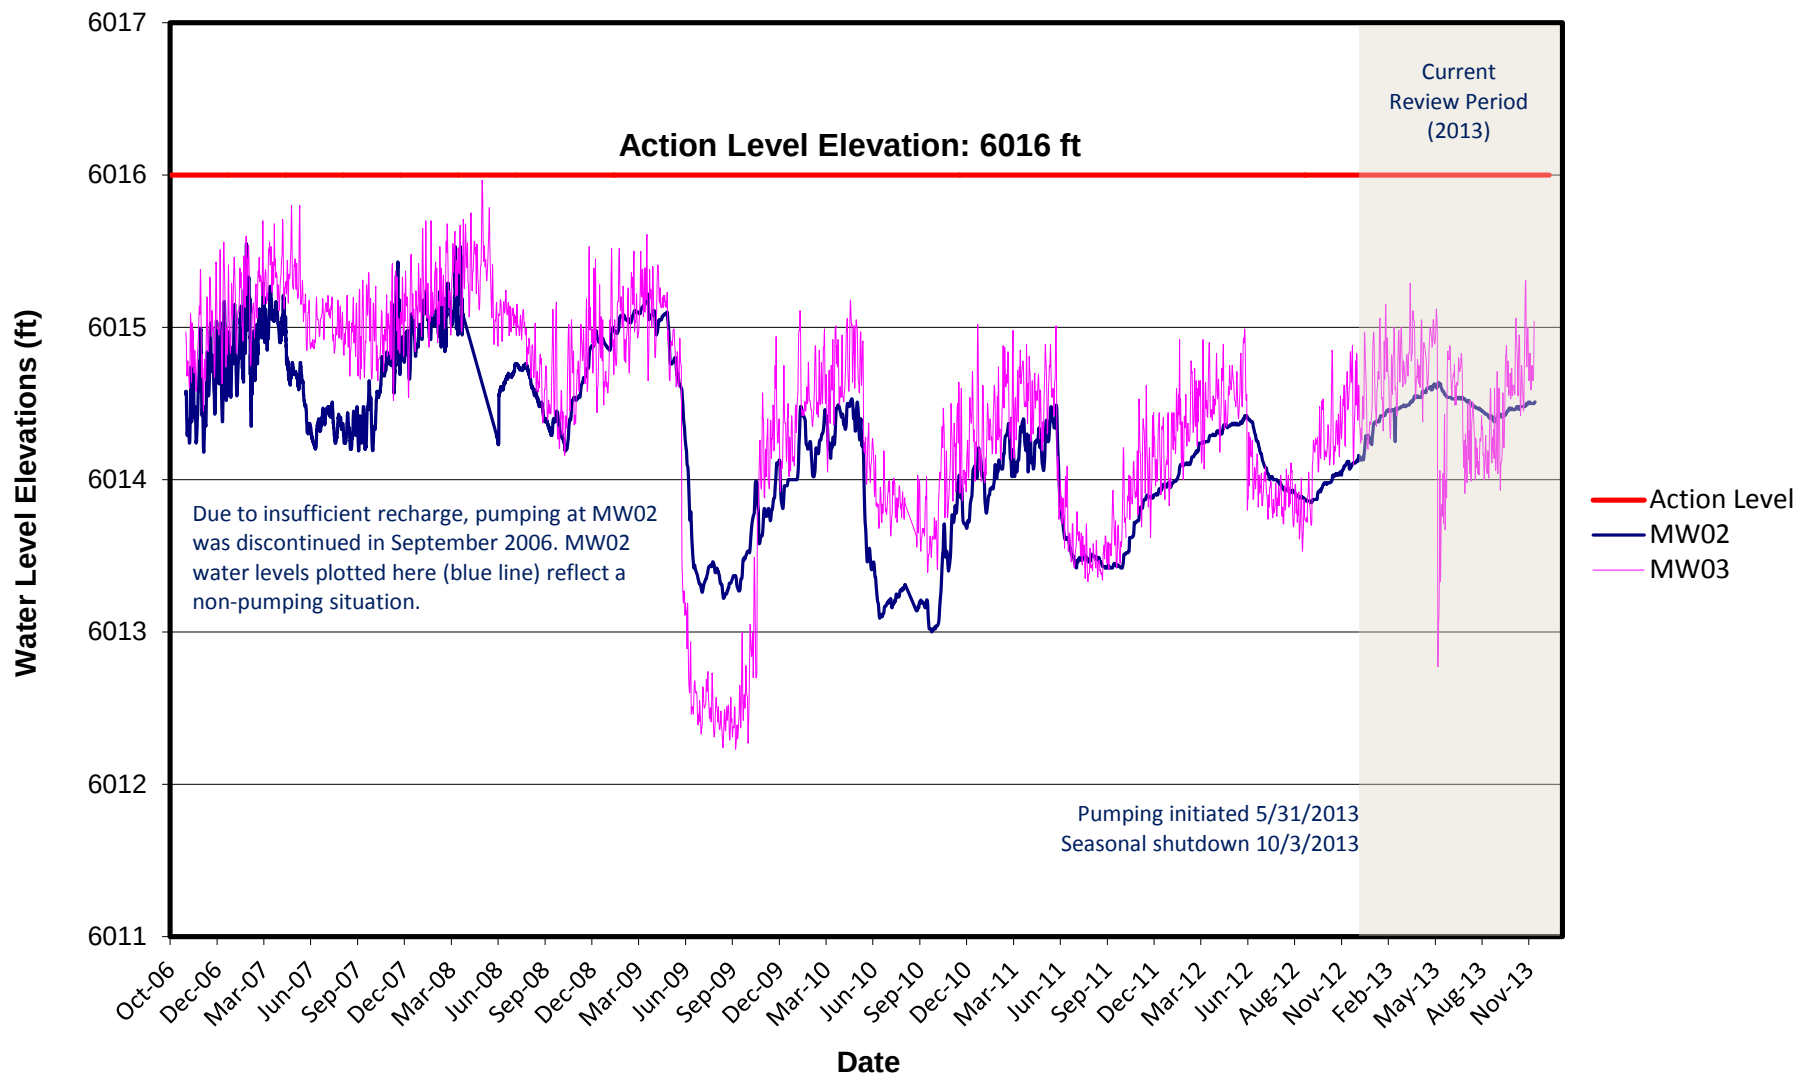
Figure 14-2. Disposal Cell Pore Water Levels in Standpipes MW-02 and MW-03 at the Rifle Disposal Site

Datalogger information for the 2013 reporting period indicates that pore water levels in both standpipes were consistently below the 6,016-foot action level (Figure 14-2). As observed historically, levels were highest during late fall and winter, when pumping is discontinued (in 2013, maximum water levels in MW-02 and MW-03 were 6,014.6 feet and 6,015.3 feet, respectively). Water levels then declined to between 6,013 feet and 6,014 feet in the summer during pumping. For the 2013 pumping season, pumping started on May 31, 2013, and ceased on October 3, 2013. According to the LTSP requirement, pumping will continue until the water levels in the standpipes stabilize at an elevation of 6,014 feet or lower.

The LTSP establishes that corrective action will be taken if the water level in the disposal cell reaches 6,016 feet in elevation. In 2001, when the action level of 6,016 feet was reached, corrective action was initiated with the installation of the cell dewatering system and associated evaporation pond. This continued corrective action has maintained the water level at an acceptable elevation (below the action level) and prevents water from overtopping the disposal cell liner. Dewatering of the cell continued in 2013 and will continue in 2014 and beyond.

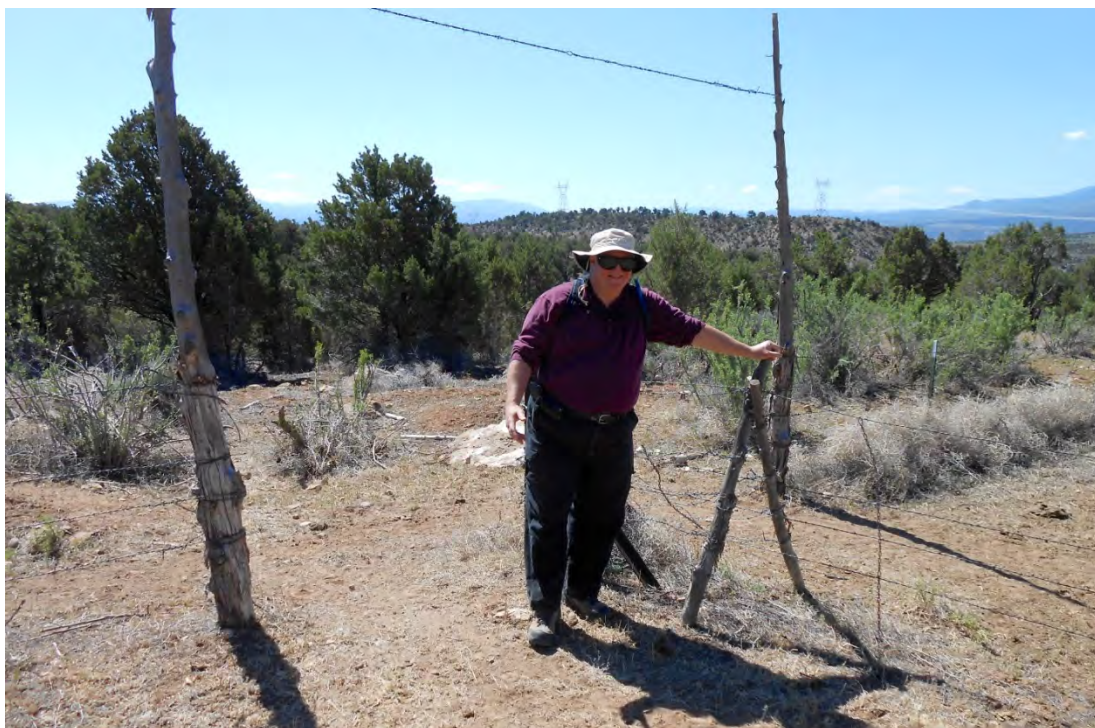
The barbed-wire perimeter fence was damaged at the time of the inspection. The fence extends to the edge of steep-sided arroyos that bound the site on the east and west and act as a deterrent for easy access to the site. The barbed-wire personnel gate at the southeast corner of the site was open (PL-1), and some bent fence posts and broken/loose wires were found in many places along the fence. Cattle had heavily grazed inside the site boundary and around the perimeter of the cell. A comparison between vegetation inside the fence enclosing the evaporation pond (where no grazing had been done) and outside the fence shows the extent of grazing (PL-2 and PL-3). Cattle trails were visible around the site in several locations (PL-4). Cattle were observed slightly offsite to the south and were being herded by wranglers (PL-5). Section 1.4.2.3 discusses cattle grazing issues further. Other signs of deer and elk grazing in the revegetated areas adjacent to and inside the disposal cell site boundary were identified, as has been historically recorded.

*RFL 6/2013. PL-1. Open personnel gate near perimeter sign P11.*

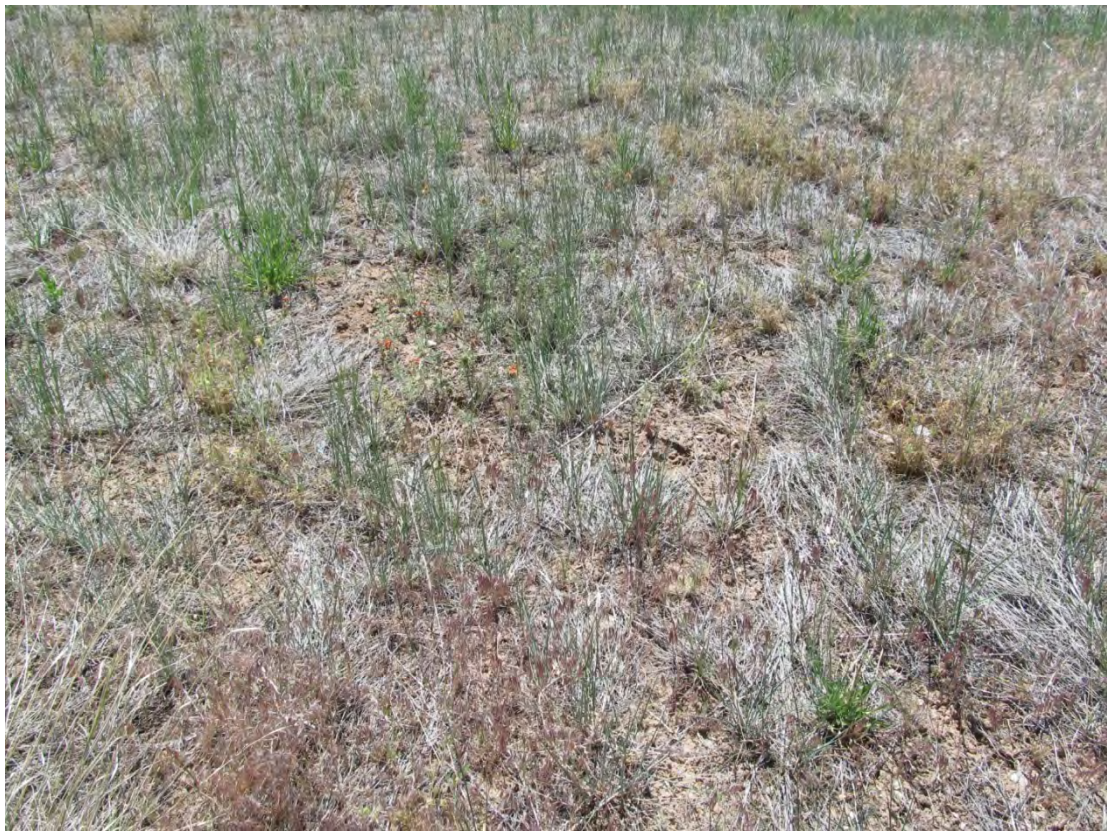
Possible elk tracks were observed inside the evaporation pond fence boundary, but the grass and forbs inside the fence were only lightly grazed. The two one-way gates allowing ingress and egress to this region were checked and were in good working condition. How an elk could gain

*RFL 6/2013. PL-2. Vegetation within evaporation pond fence.*

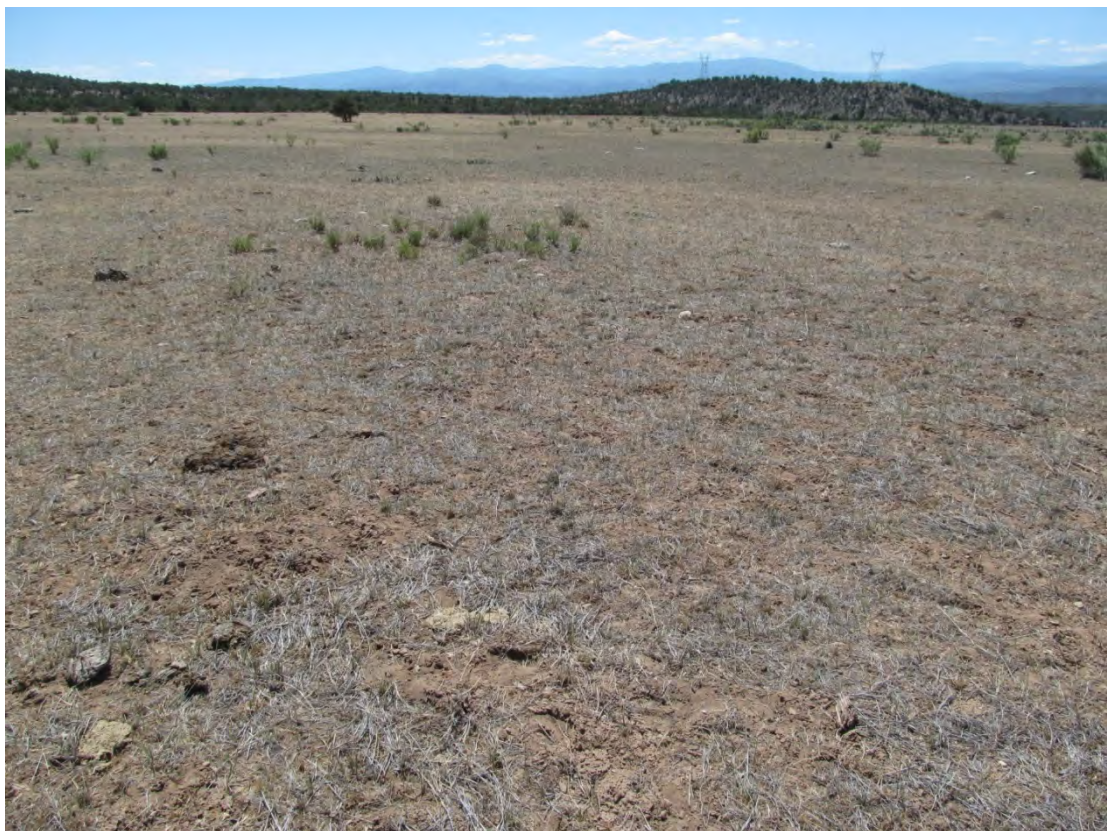
*RFL 6/2013. PL-3. Vegetation outside evaporation pond fence.*

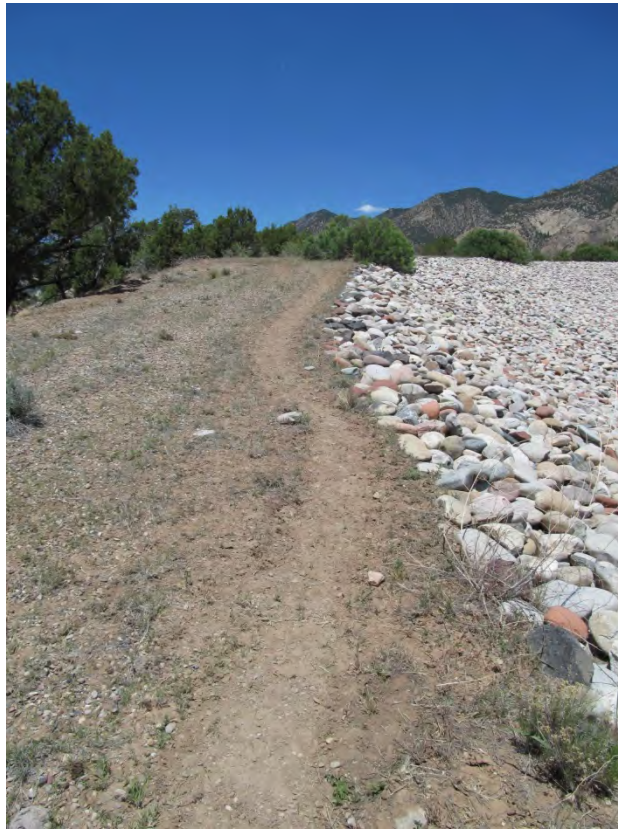
*RFL 6/2013. PL-4. Livestock trail along rock riprap cell cover.*

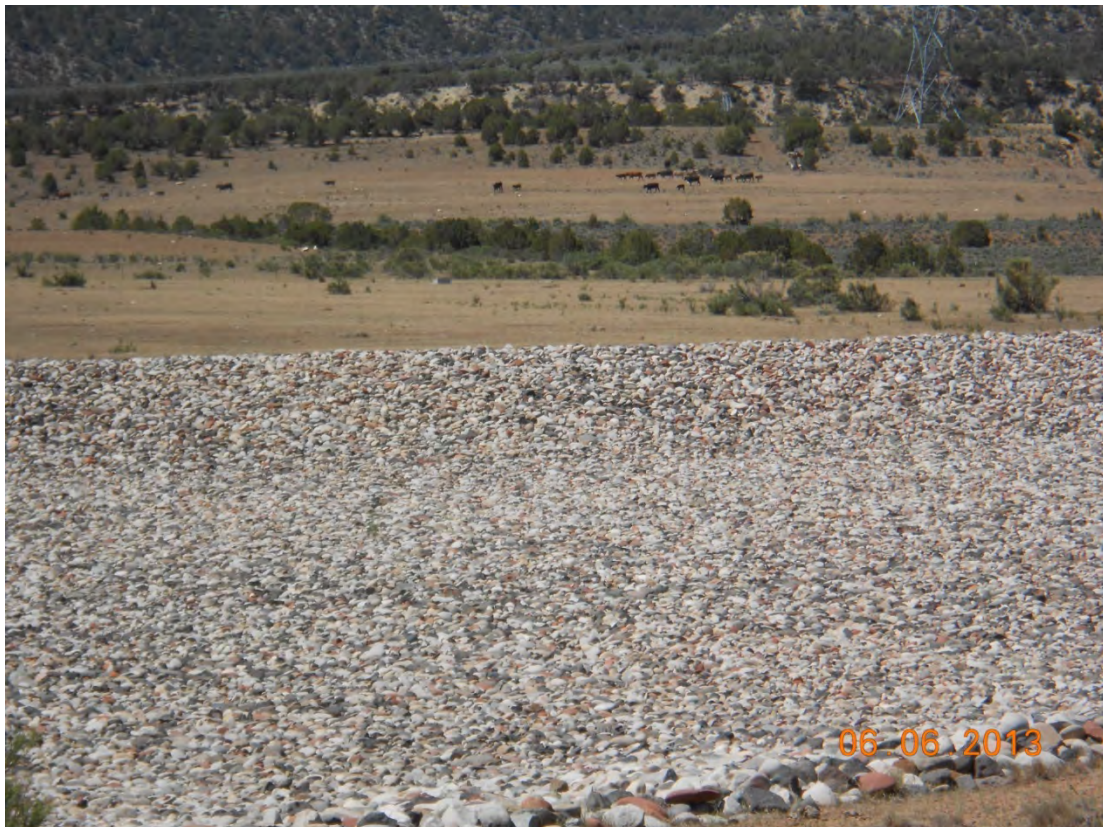
During the past several years, inspectors had found no evidence of cattle or sheep grazing within the site boundaries, only evidence of deer and elk grazing. This changed dramatically in 2012 when heavy grazing by cattle was observed. This year, vegetation was heavily grazed again by cattle. This was described in the Perimeter Fence section of the report (14.4.1.2). Prickly pear cactus were ungrazed by the cattle and were in full bloom (PL-9).

*RFL 6/2013. PL-5. Wranglers driving cattle in outlying area, south of perimeter fence.*

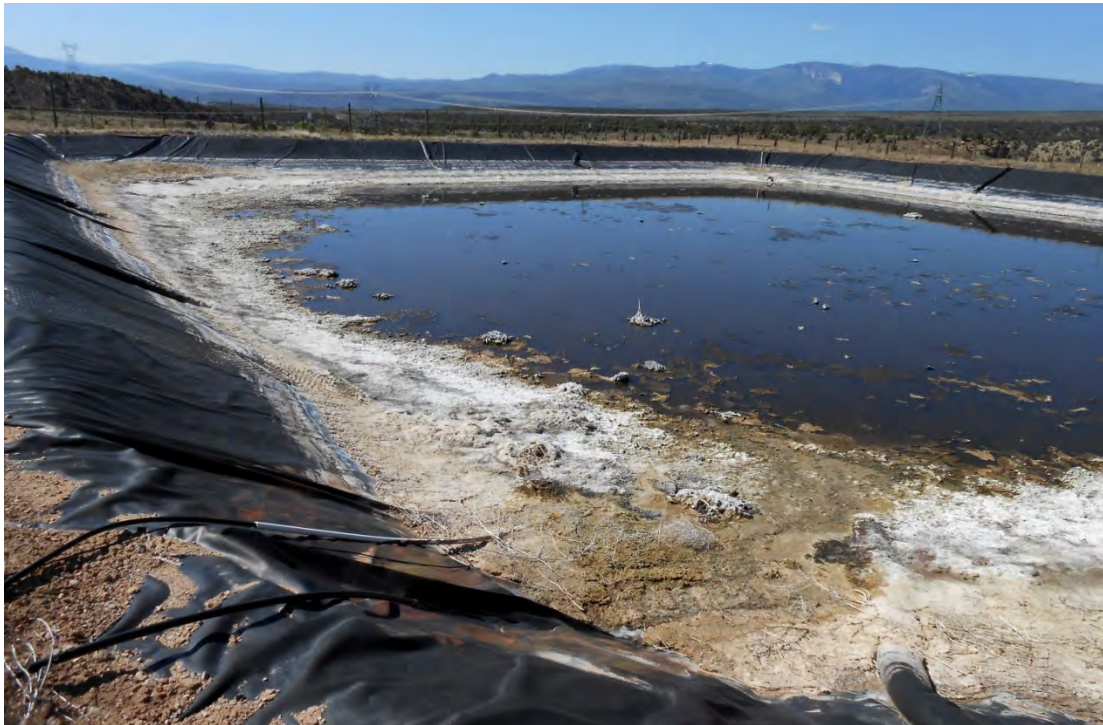
*RFL 6/2013. PL-6. Evaporation pond with low water level.*

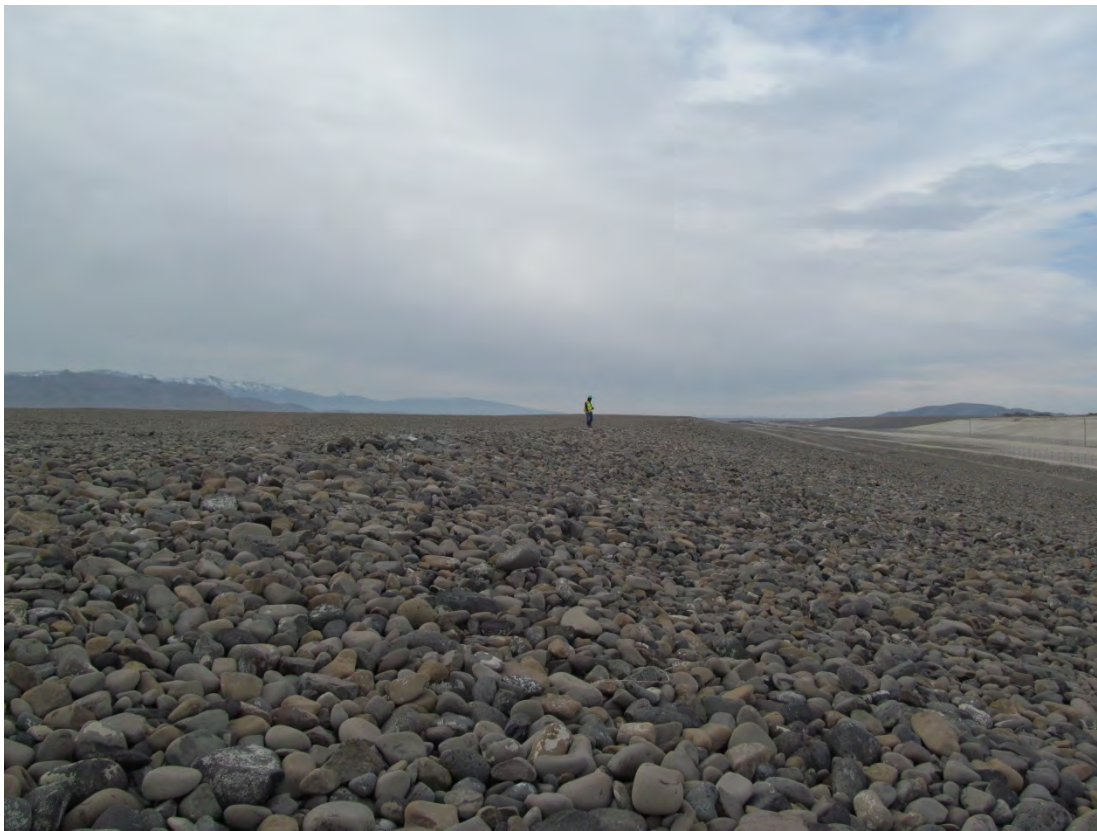
*SLD 3/2013. PL-6. UDEQ personnel illustrating unevenness of the ridge construction along the top of the west slope.*

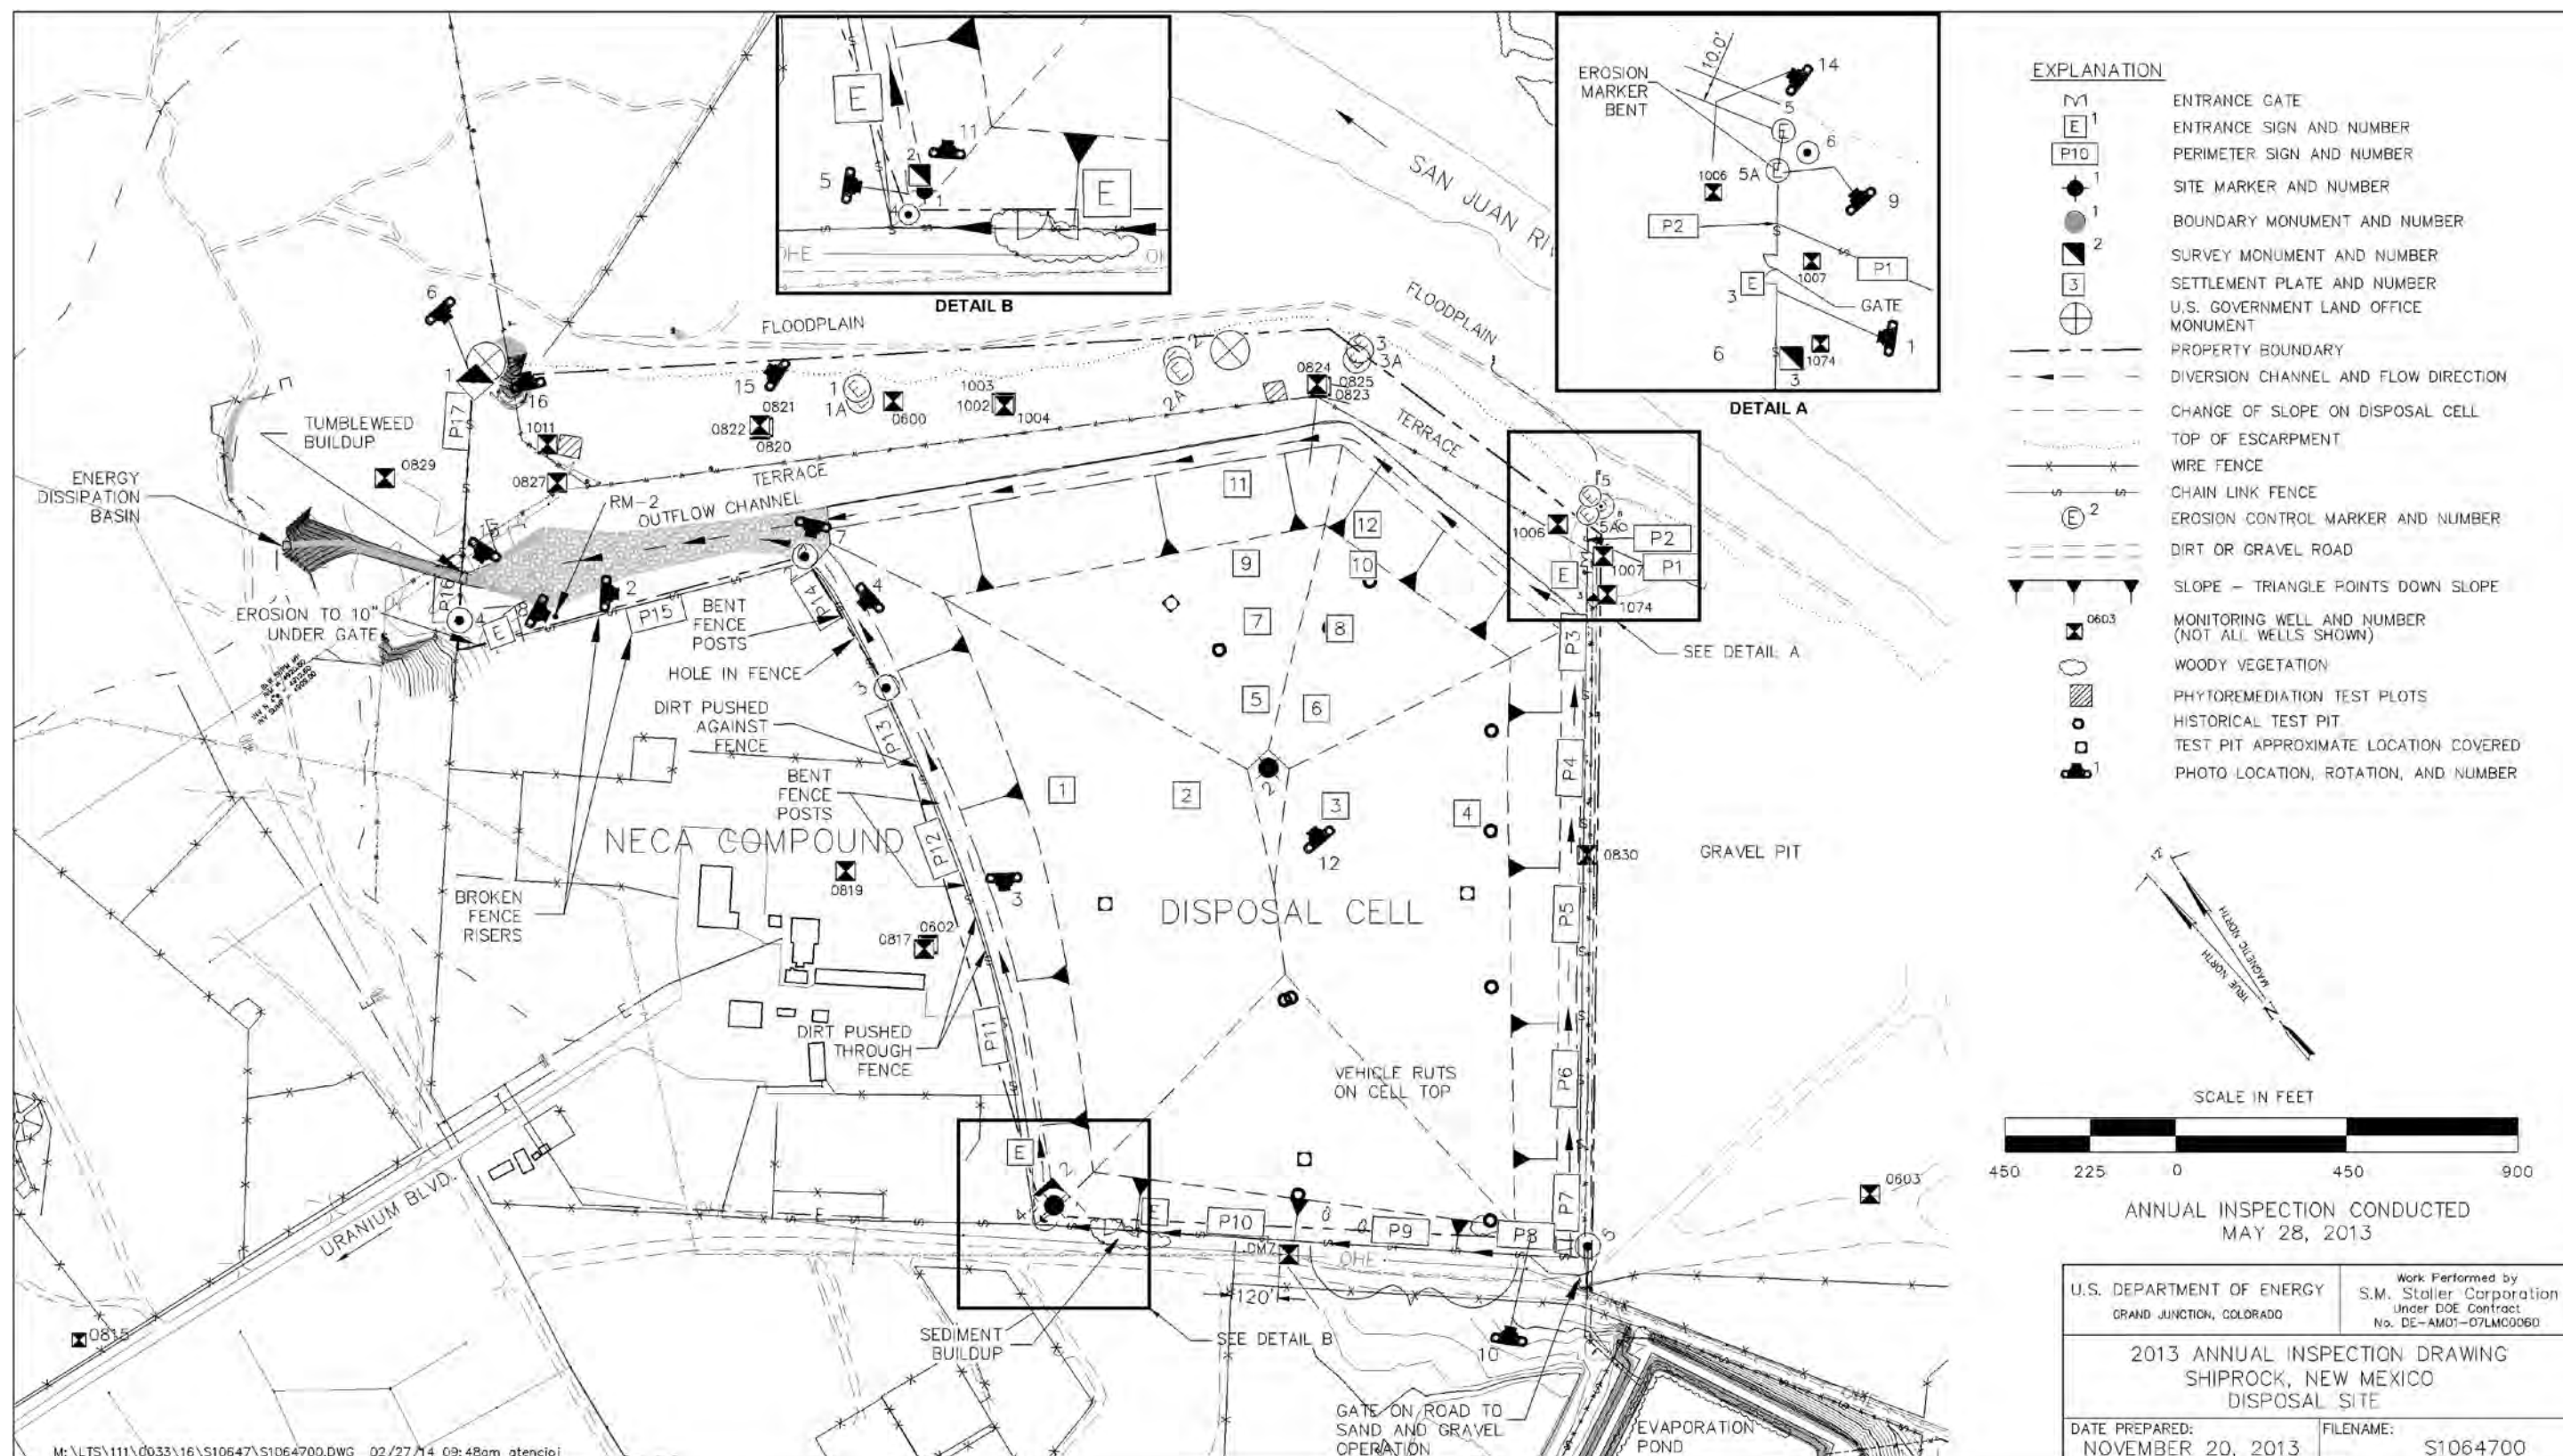
Figure 16-1. Annual Inspection Drawing for the Shiprock Disposal Site

Figure 16-1 shows the locations of site surveillance features. Inspection results and recommended maintenance activities associated with site surveillance features are included in the following subsections. Photographs to support specific observations are identified in the text and on Figure 16-1 by photograph location (PL) numbers.

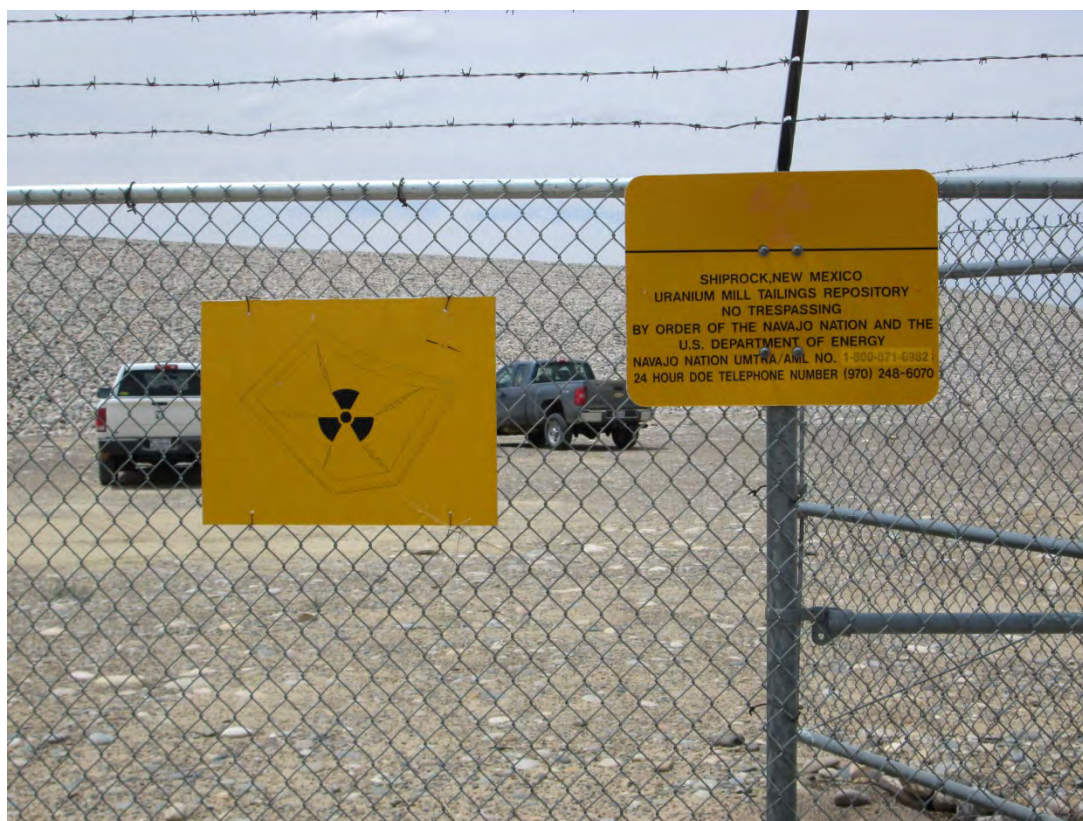
Three gates allow entrance to the site: the east gate (the current main entrance gate near the terrace escarpment), the northwest gate (an auxiliary access gate), and the southwest gate (the former entrance gate). Near each gate, entrance signs are placed in pairs, one text and one pictorial (PL-1). The pictorial sign was missing from the northwest gate. The remaining entrance signs were in good condition; on the signs, contact information for the DOE and the Navajo AML/UMTRA Department was correct. The east and northwest gates were intact and functional. Sediment continually accumulates along the bottom of the southwest gate, which can make the gate difficult to open. Access to the main (east) entrance gate is gained by traveling through a gravel pit. All access roads were in good condition.

SHP 5/2013. PL-1. Entrance sign at main access gate.

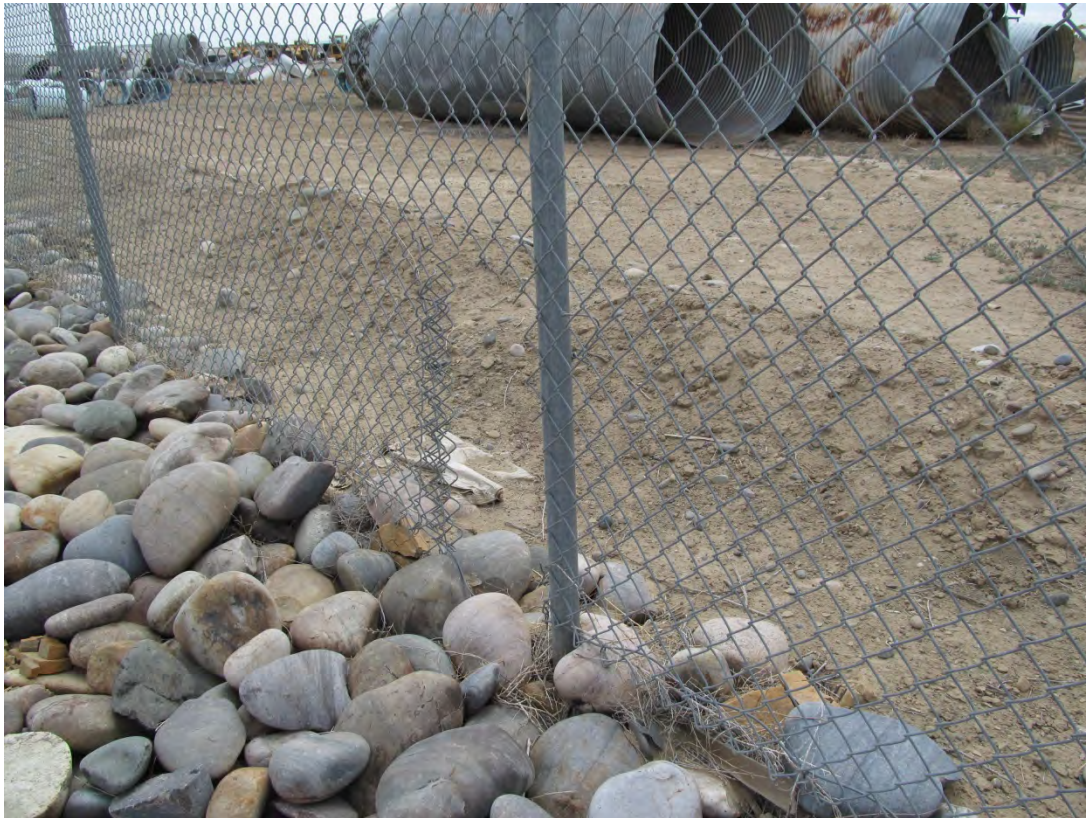
*SHP 5/2013. PL-4. Hole cut into fence near perimeter sign P14.*

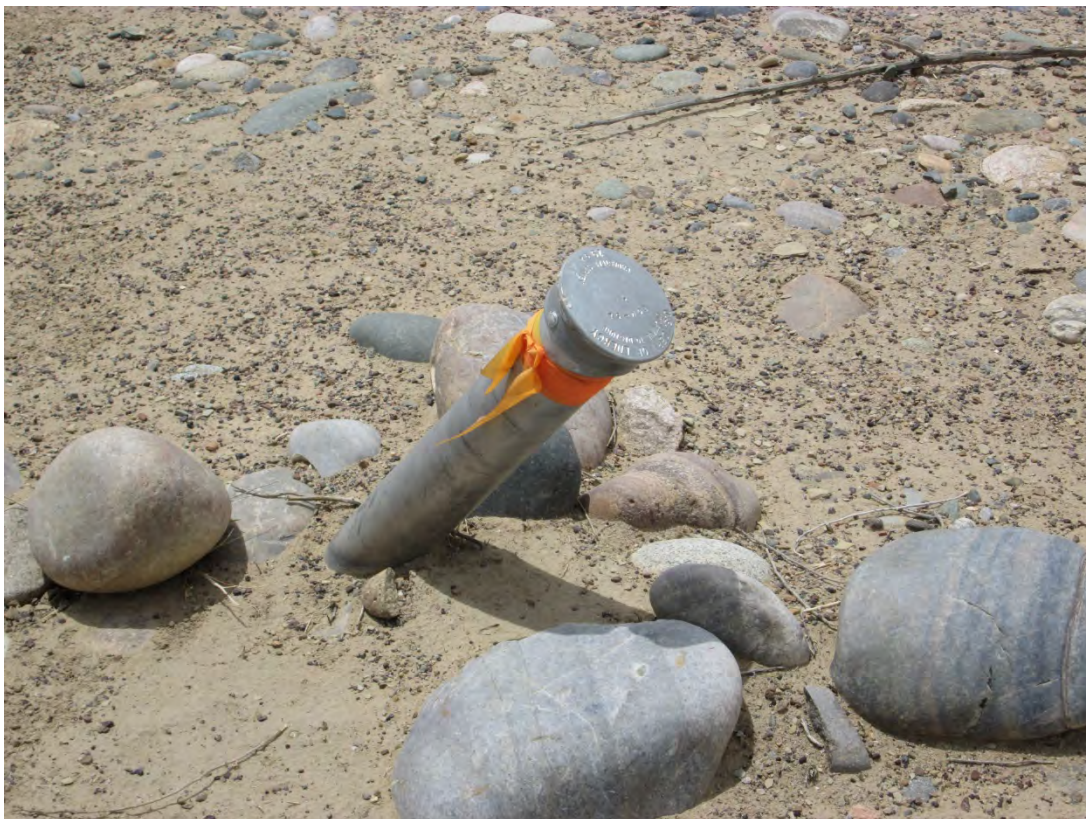
*SHP 5/2013. PL-9. Erosion marker ECM-5A, bent but functional.*

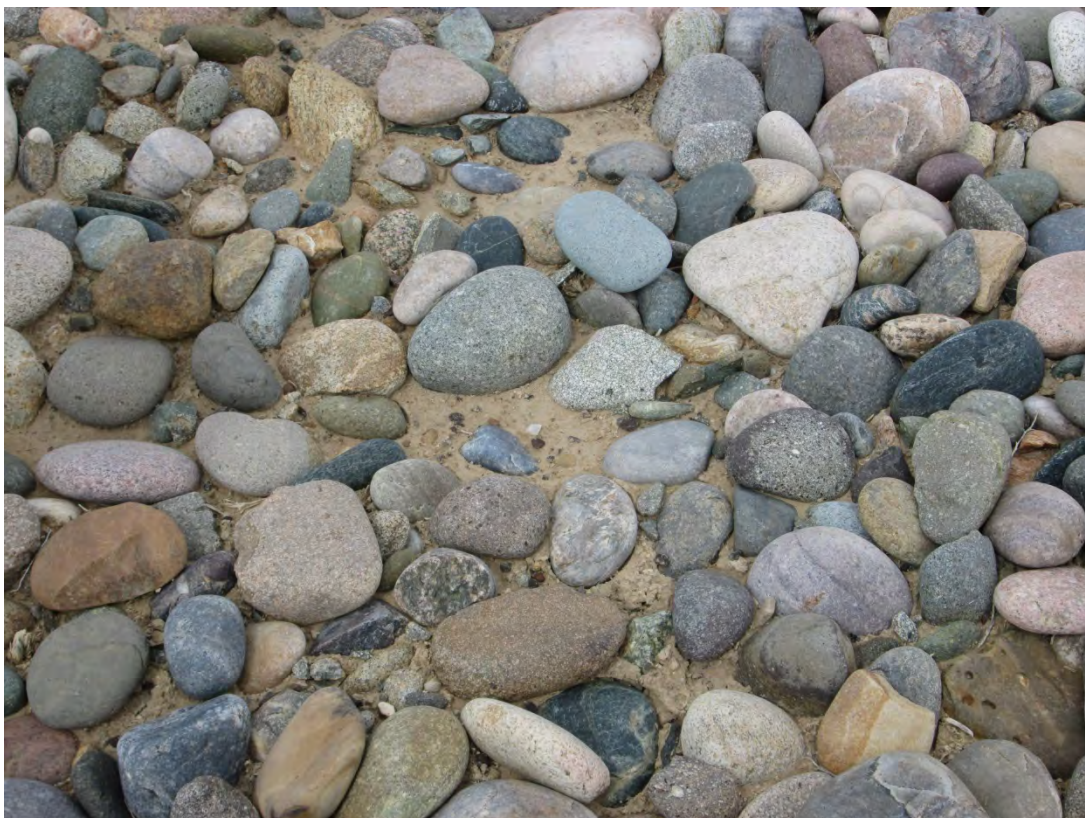
*SHP 5/2013. PL-12. Sediment deposition on cell top.*

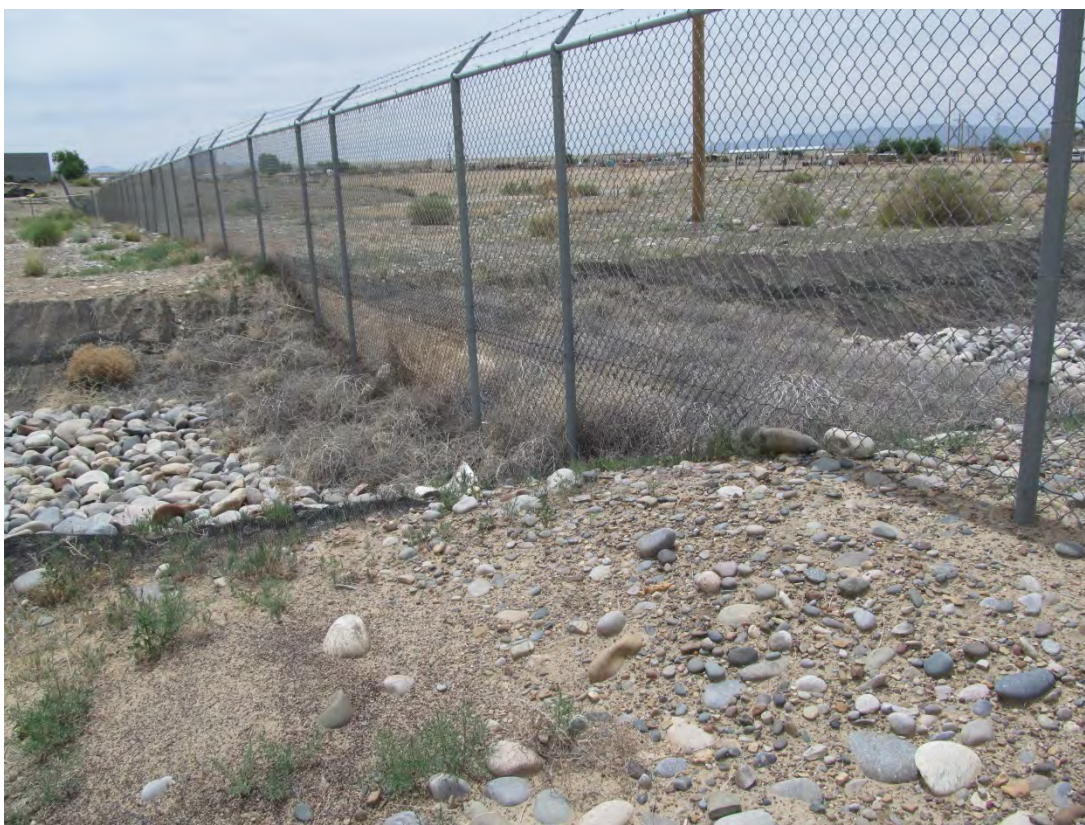
*SHP 5/2013. PL-13. Fence across outflow channel with debris buildup.*
