U.S. DEPARTMENT OF  
**ENERGY**

# 2013 Annual Site Inspection and Monitoring Report for Uranium Mill Tailings Radiation Control Act Title I Disposal Sites

March 2014

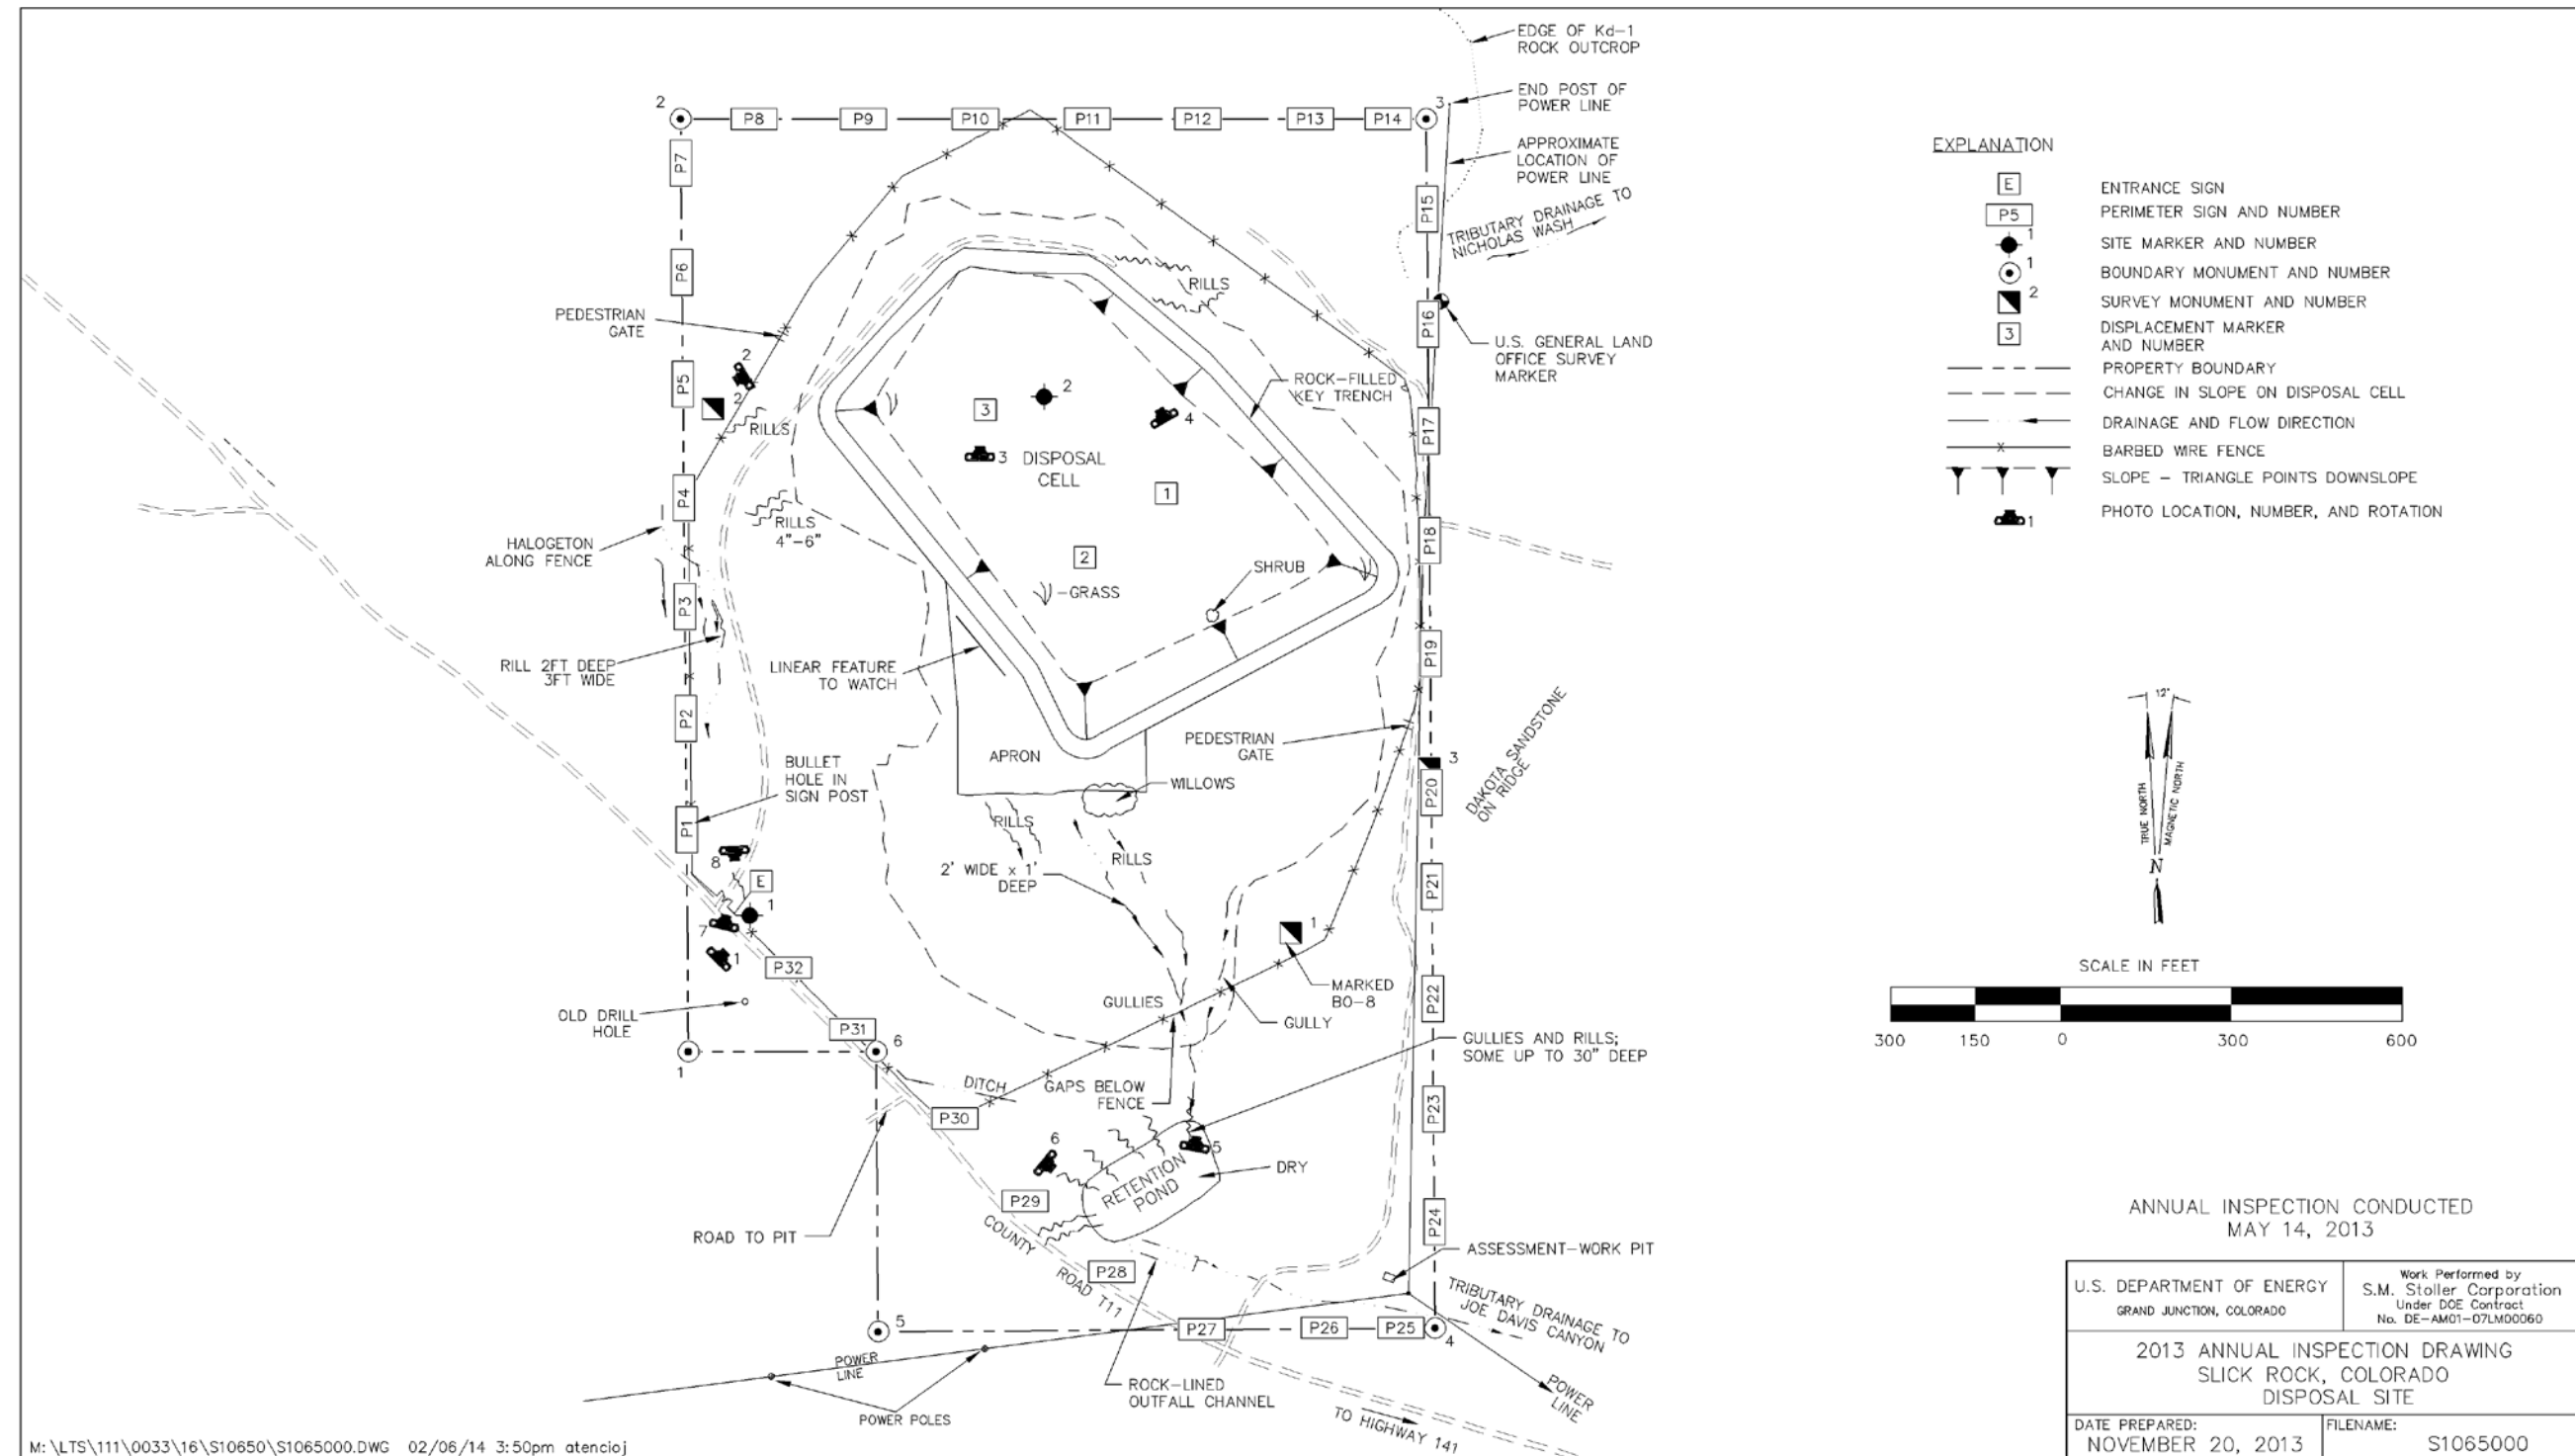
Figure 17-1. 2013 Annual Inspection Drawing for the Slick Rock Disposal Site

Figure 17-1 shows the locations of site surveillance features. Inspection results and recommended maintenance activities associated with site surveillance features are included in the following subsections. Photographs to support specific observations are identified in the text and in Figure 17-1 by photograph location (PL) numbers.

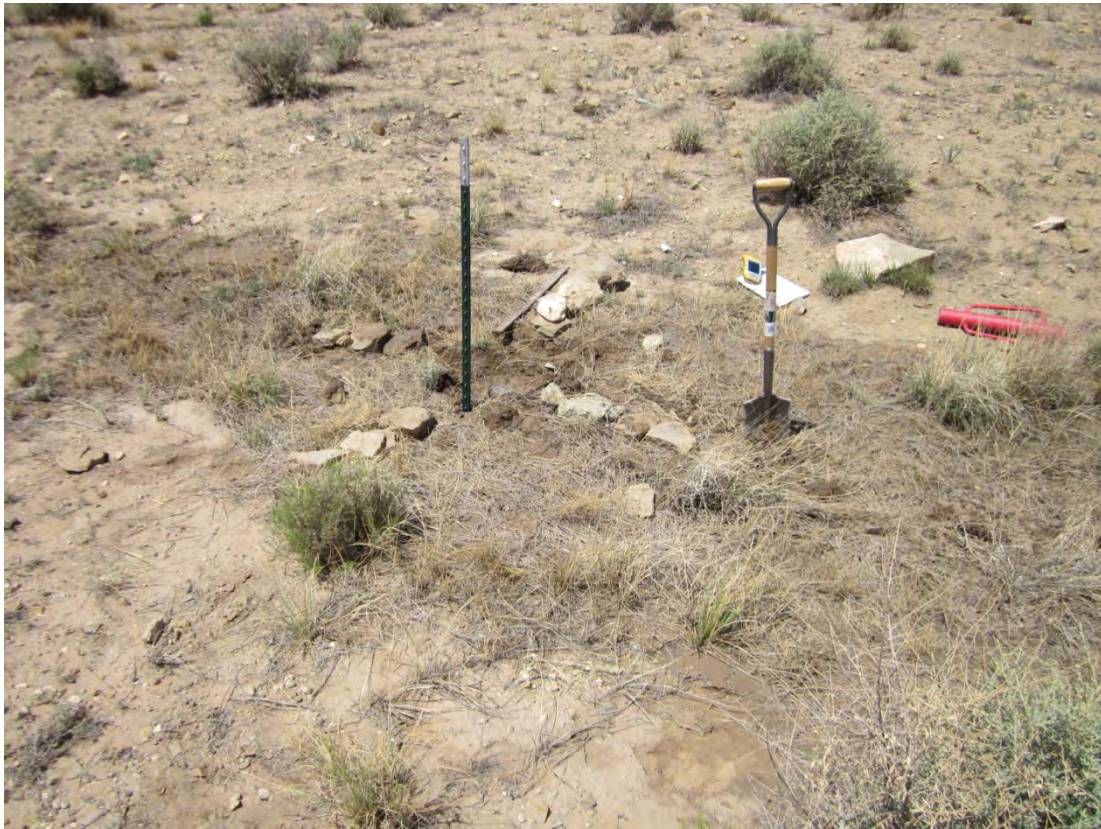
Six boundary monuments define the corners of the site boundary. Survey monument 2, which was not found during the 2012 inspection, had been located under 4 inches of soil during a return visit. Soil was covering most of the monument (brass benchmark) during the 2013 inspection, but a t-post had been placed to mark the location of the monument (PL-2). This monument was set in the bottom of a drainage channel and will be prone to soil coverage. Three displacement markers remain on top of the cell but are not monitored (PL-3). All boundary and survey monuments were in excellent condition.

*SRK 5/2013. PL-2. Survey Monument 2 area, photo from July 2012.*

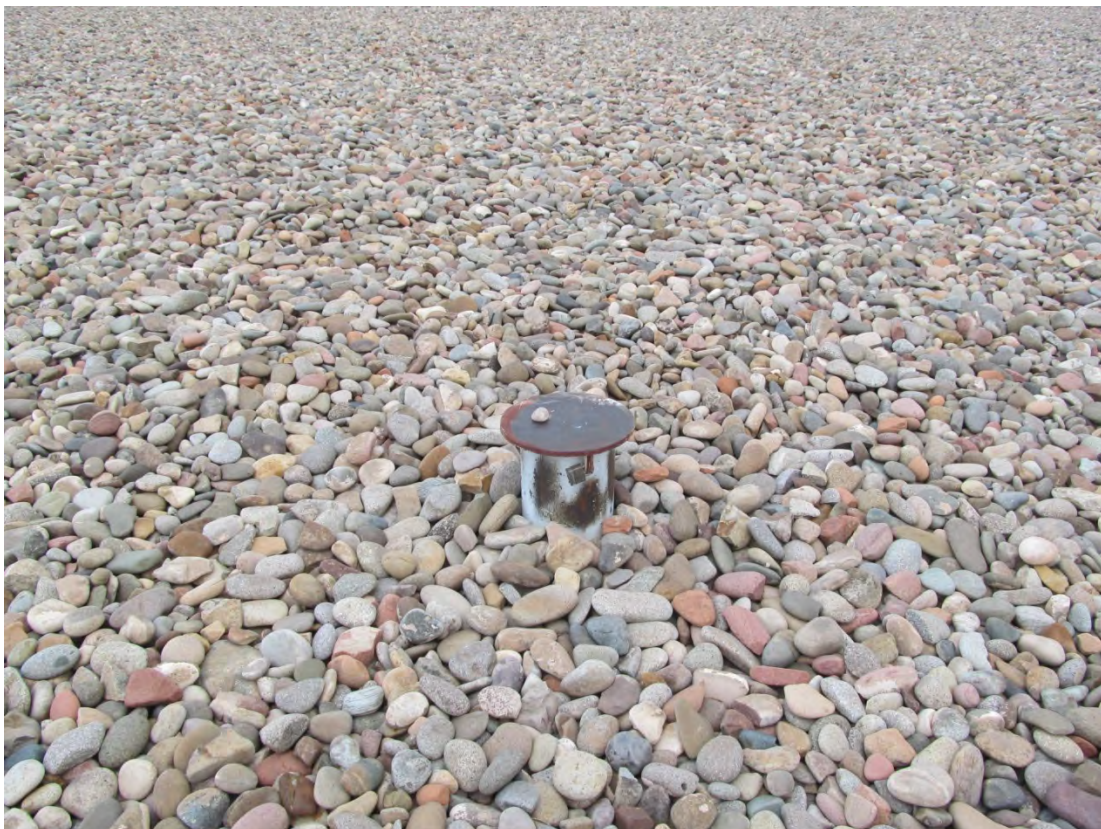
*SRK 5/2013. PL-3. Displacement marker 3.*

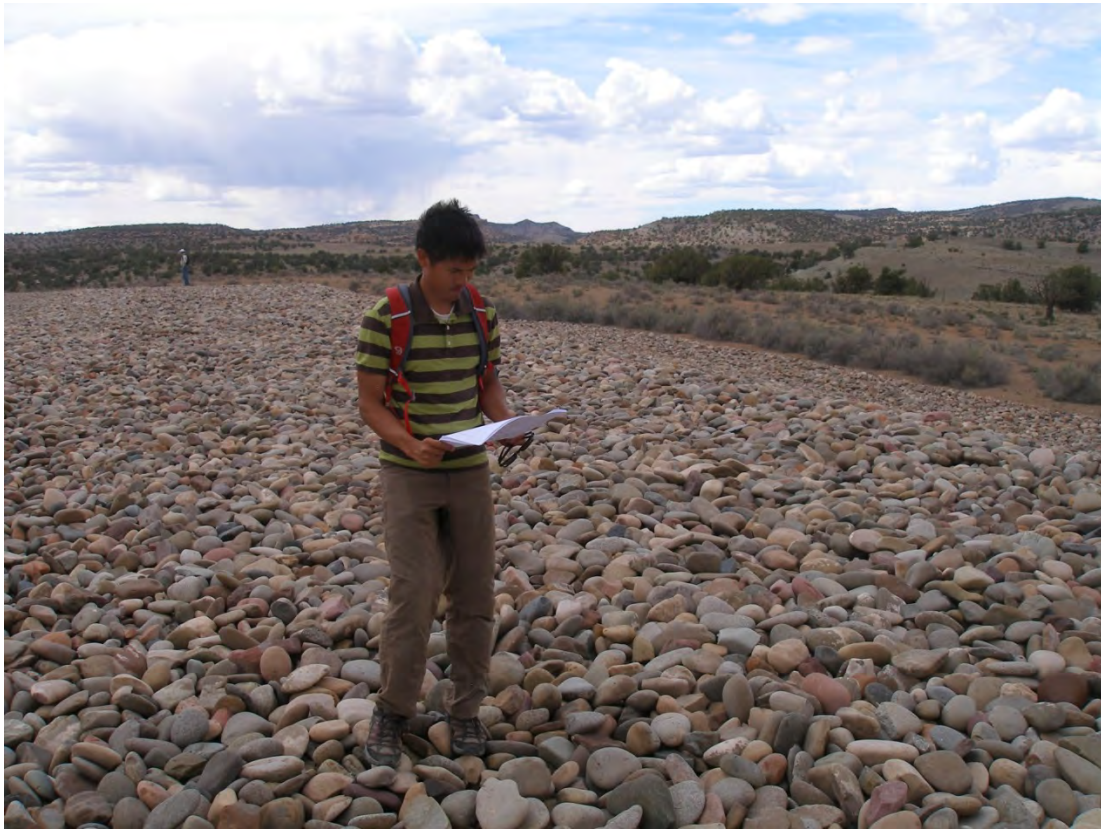
*SRK 5/2013. PL-4. DOE site inspector atop cell.*

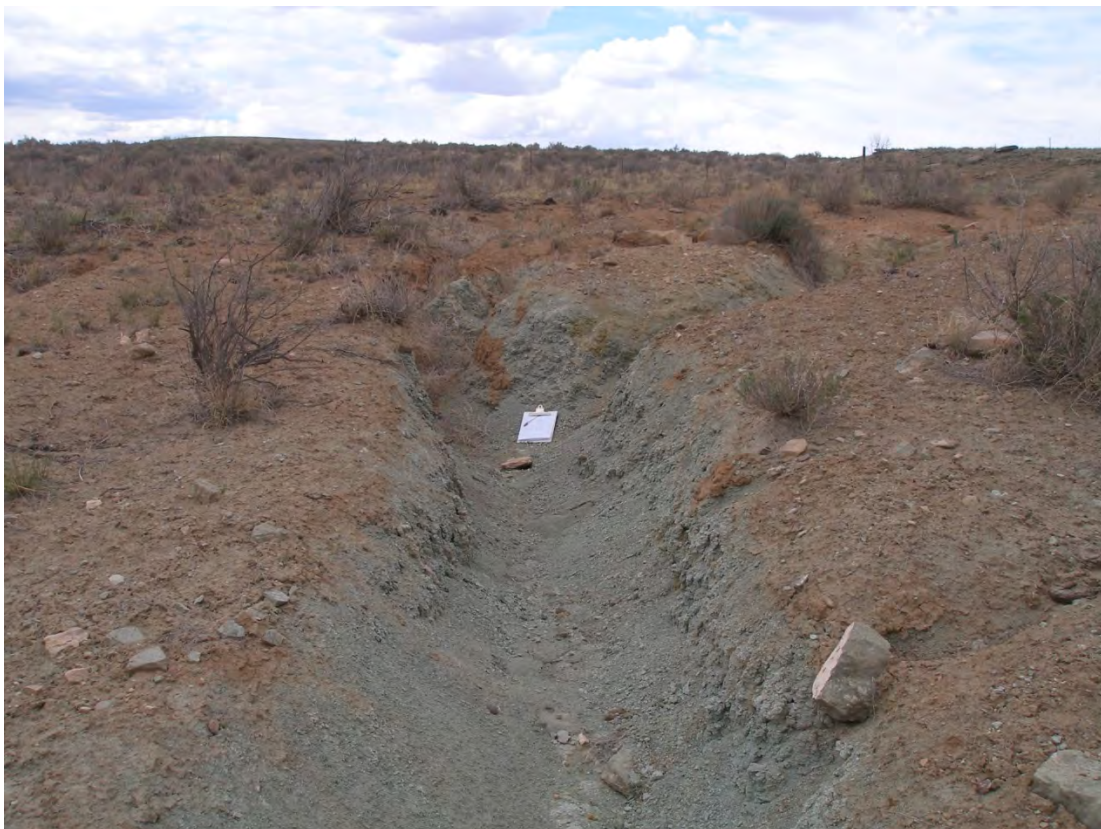
*SRK 5/2013. PL-5. Erosion at northwest corner of retention pond.*

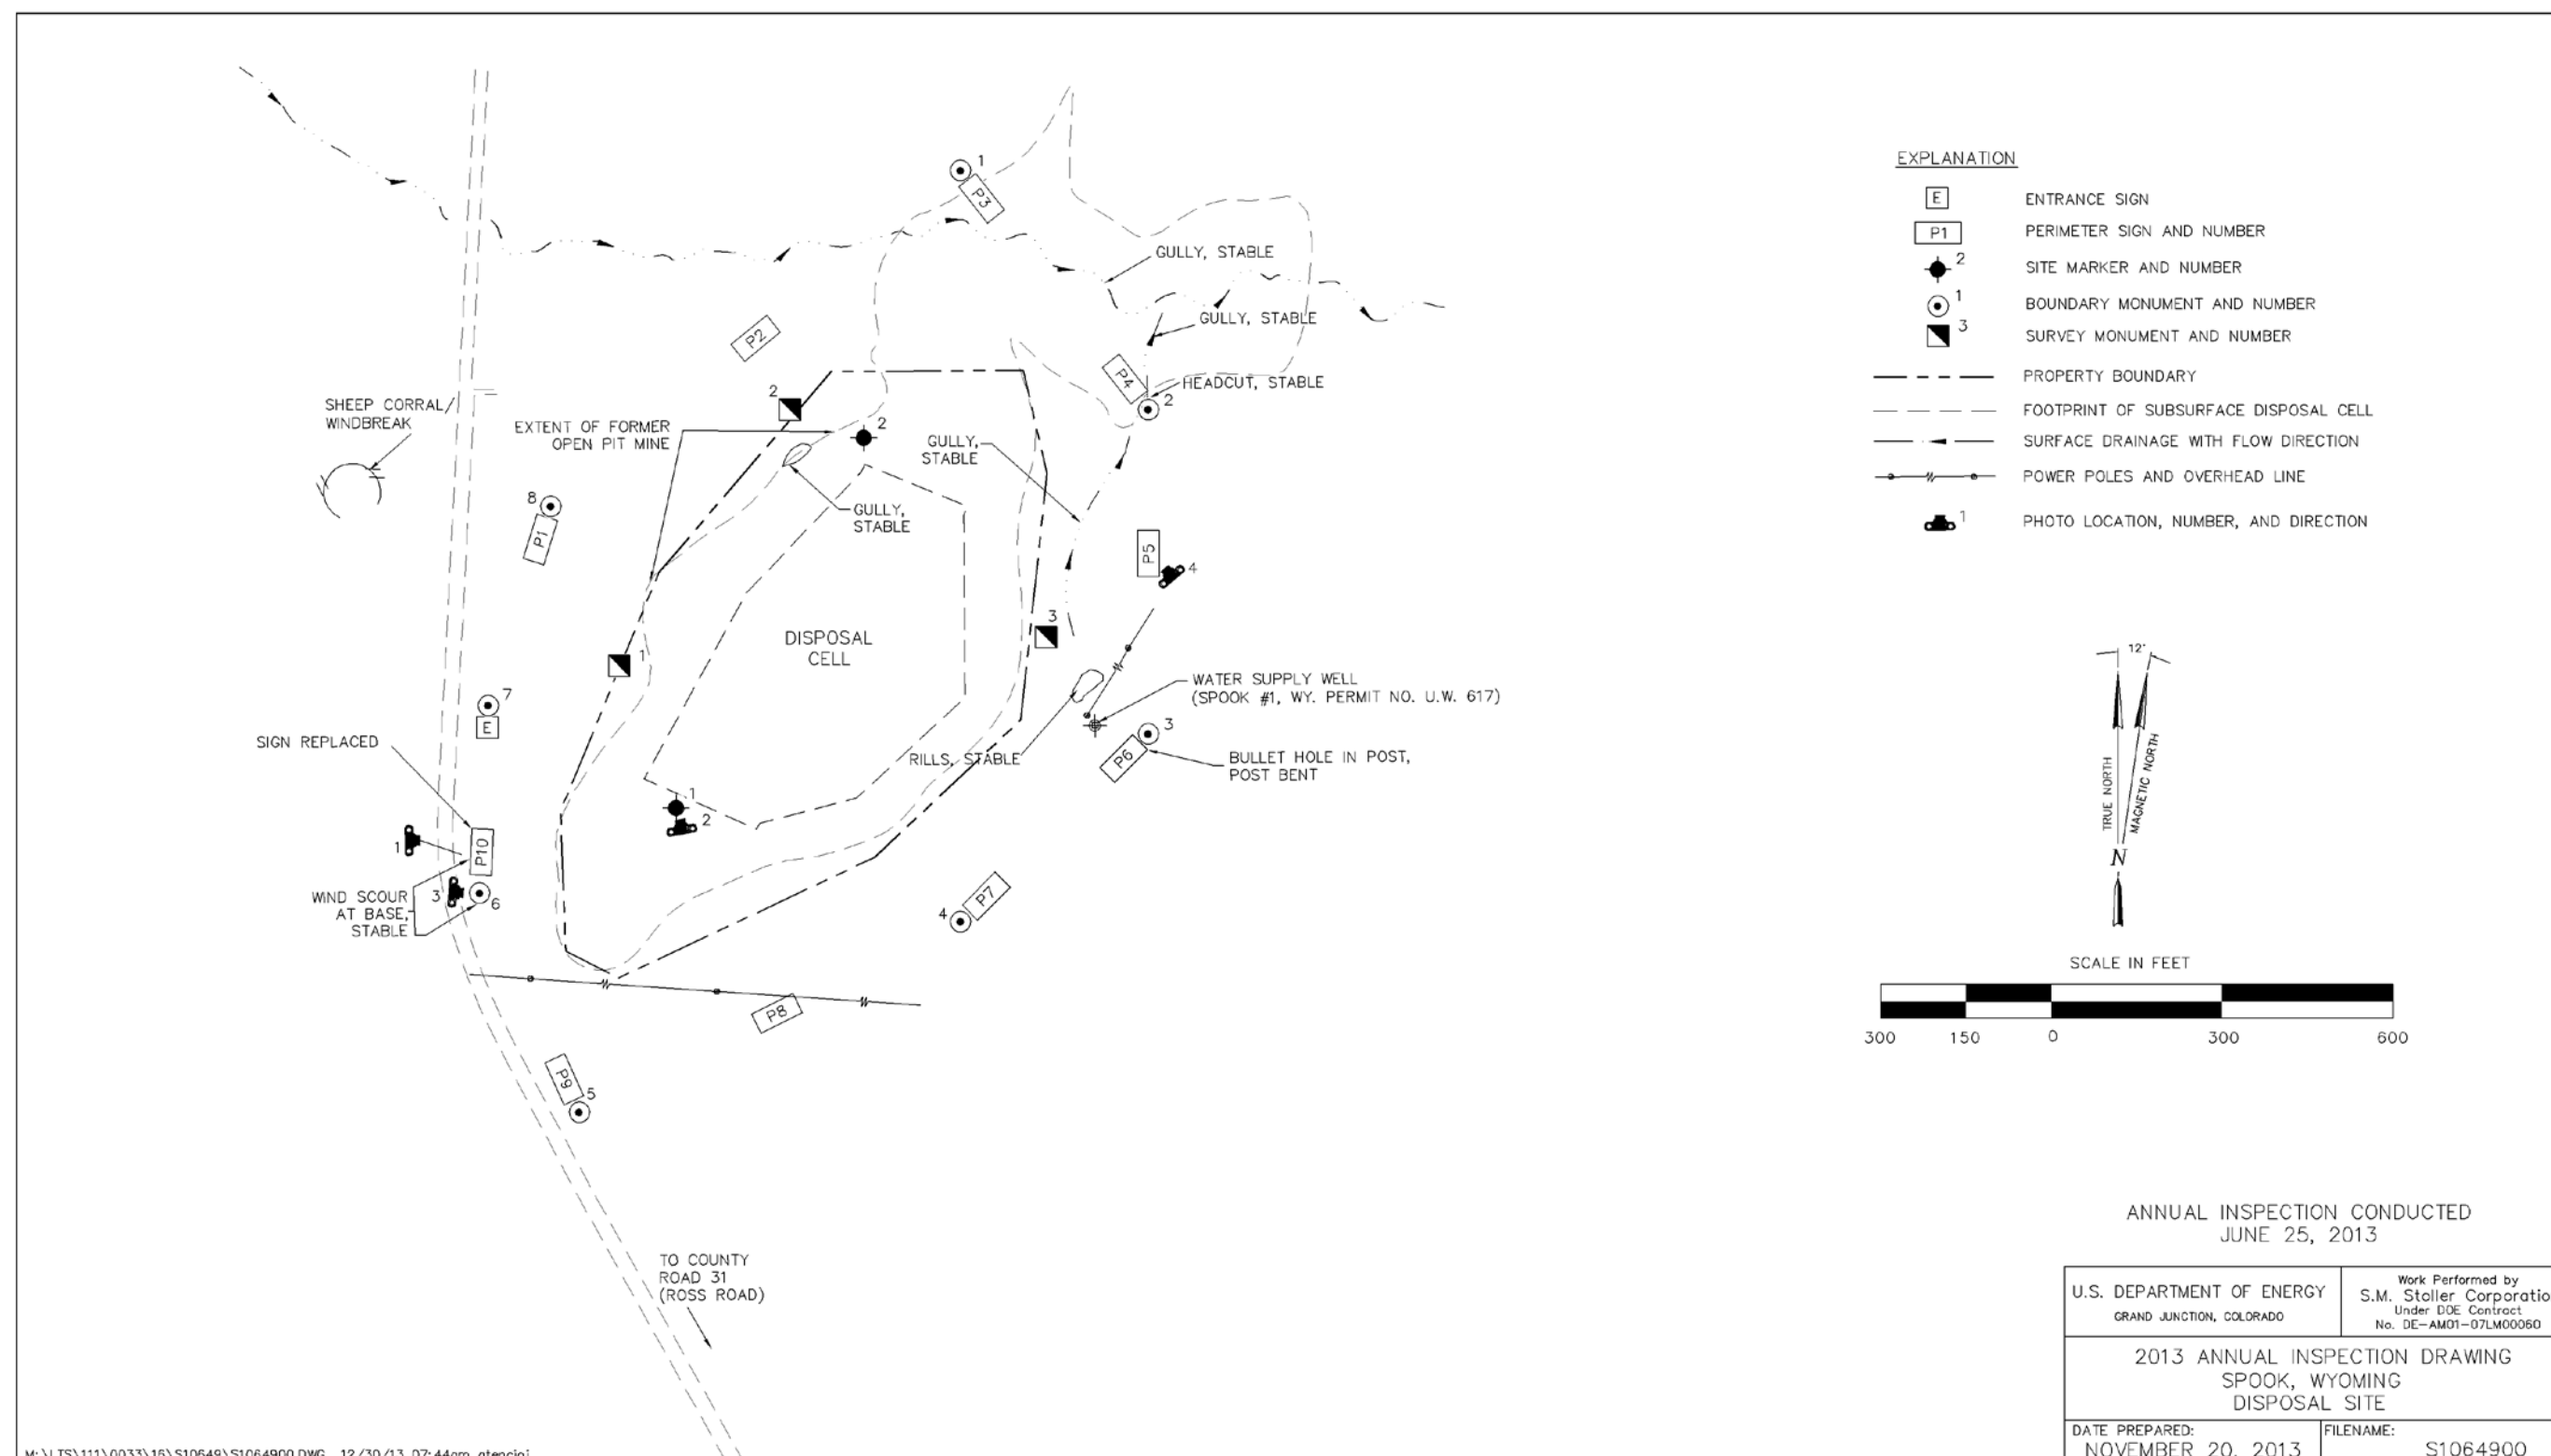
Figure 18-1. 2013 Annual Compliance Drawing for the Spook Disposal Site

Figure 18-1 shows the locations of site surveillance features. Inspection results and recommended maintenance activities associated with site surveillance features are included in

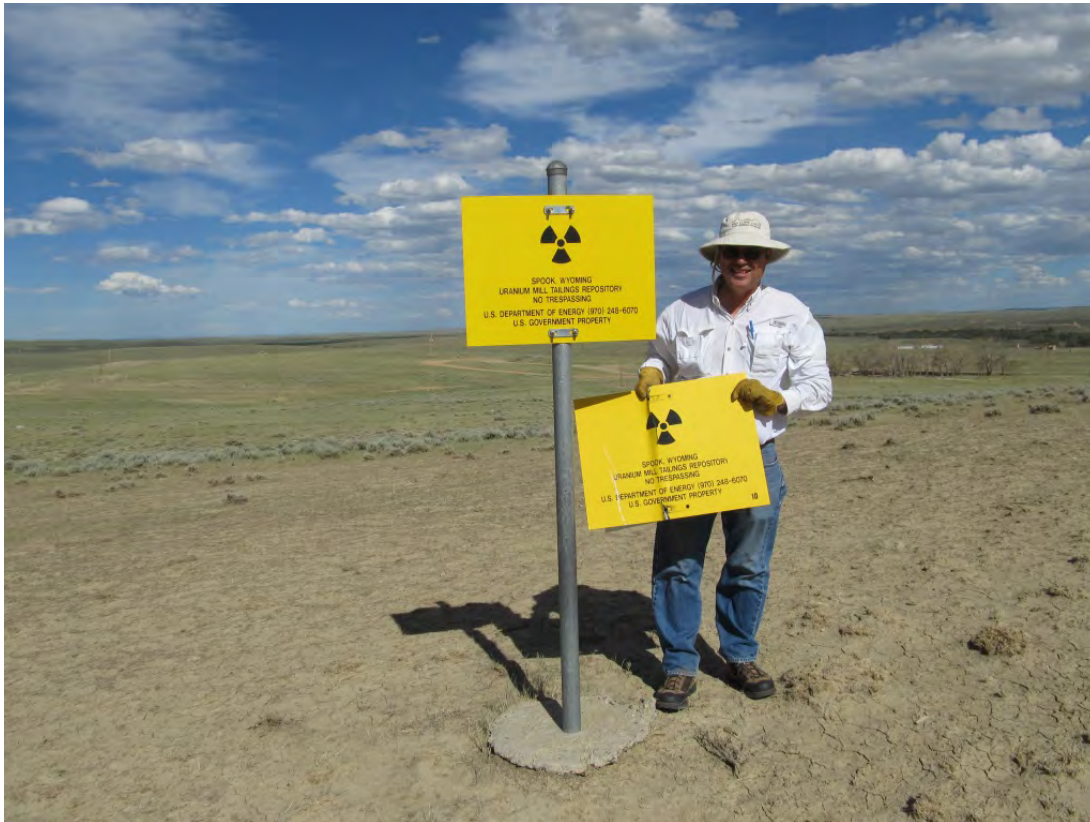
The site is unfenced and defined by 10 perimeter signs. Perimeter sign P10 that had been damaged by wind was replaced during the 2013 inspection (PL-1).

SPK 6/2012. PL-1. New perimeter sign P10.

- 18A** No maintenance needs were identified during the inspection other than the previously mentioned erosion at boundary monument BM-6. Perimeter sign P10 was replaced during this inspection.

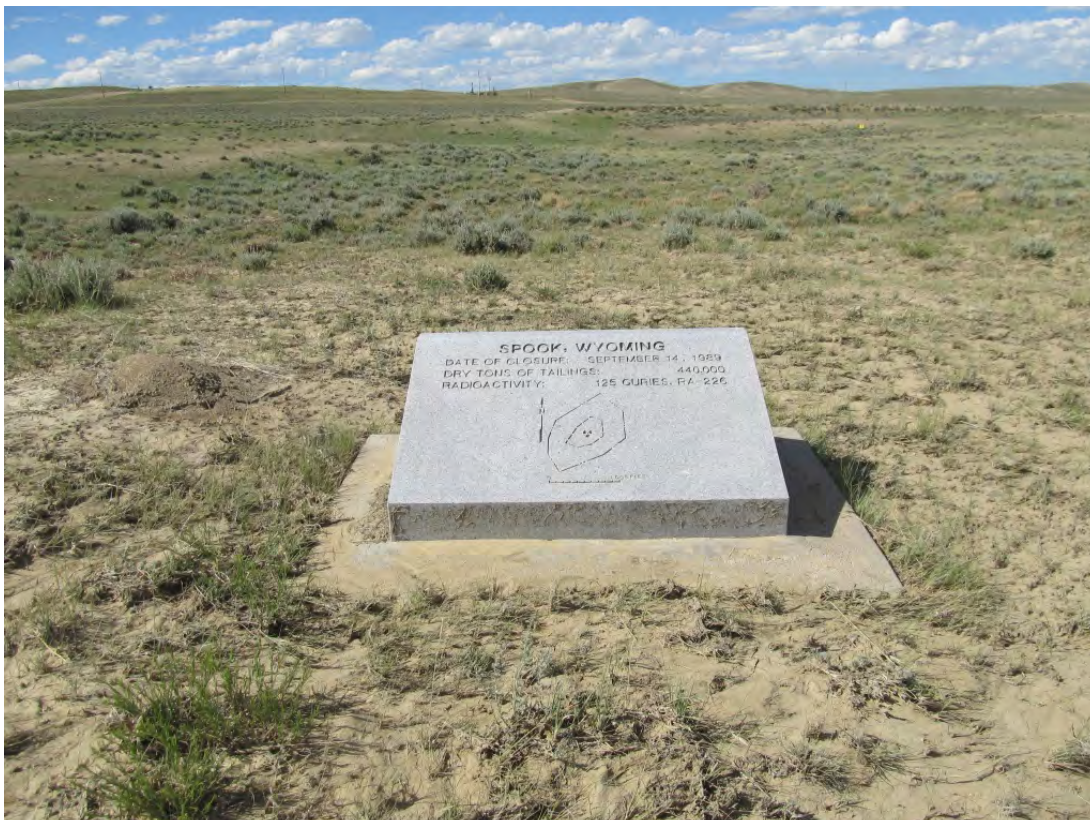
Site marker SMK-2 was in excellent condition (PL-2). The concrete base of site marker SMK-1 is damaged due to spalling but is stable; no changes were observed from the previous year.

SPK 6/2012. PL-2. Site marker SMK-2.

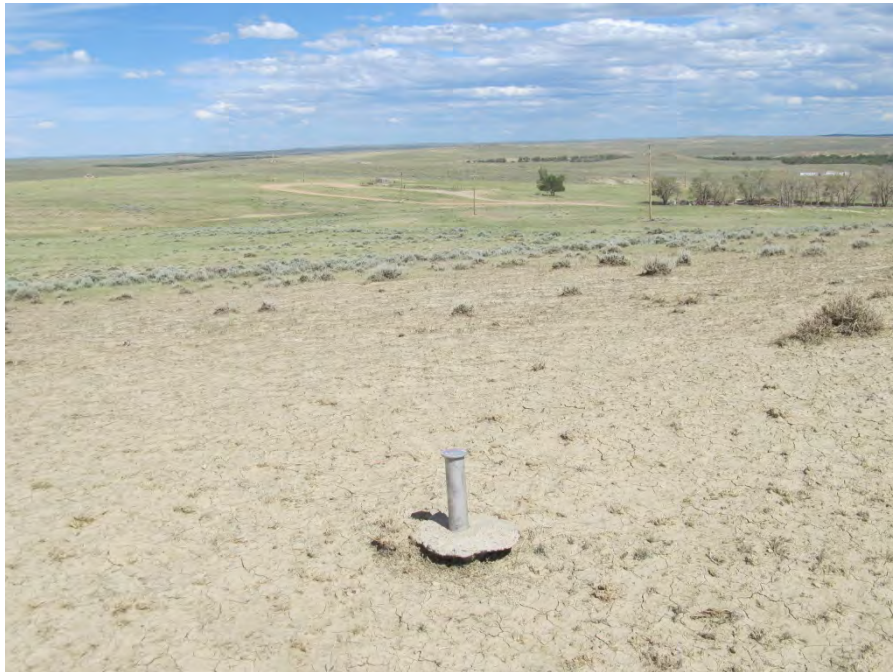
The eight boundary monuments and three survey monuments are in excellent condition. Some wind erosion has exposed the concrete support at the BM-6 monument (PL-3). This will be monitored and evaluated for repair during the next inspection.

*SPK 6/2012. PL-3. Boundary monument BM-6.*

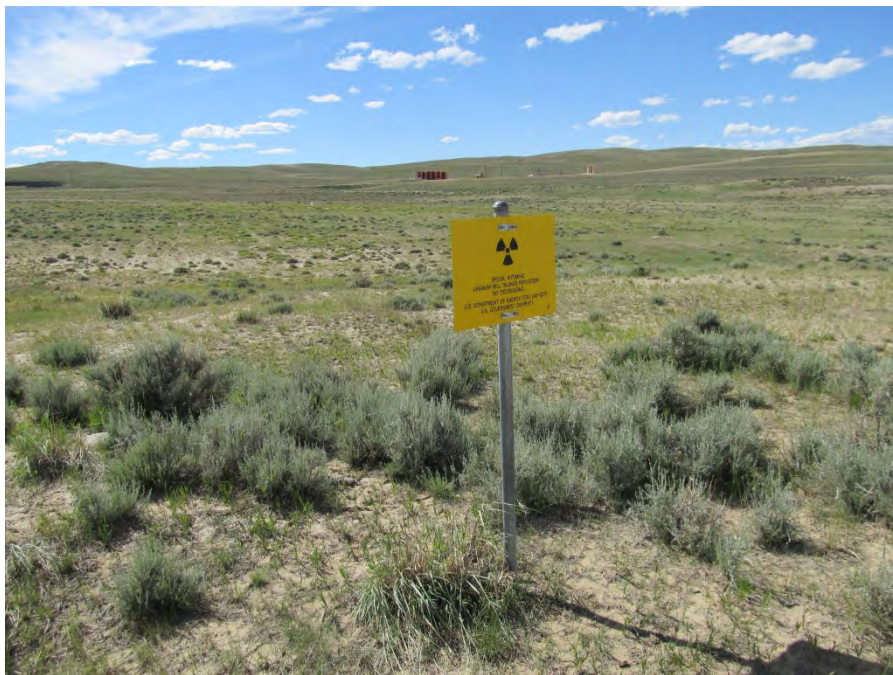
The site is unique among Title I sites in that tailings were encapsulated in the bottom of an open pit mine and covered with 40 to 60 feet of clean fill and topsoil. Therefore, many of the observations and concerns routinely associated with above-grade disposal cells—such as the quality of the riprap, the stability of side slopes, or the presence of deep-rooted plants (biointrusion) above the radon barrier—do not apply to this site. The surface of the 5-acre disposal cell, completed in 1989, was in excellent condition. No evidence of settling was observed over the former mine pit. Vegetation across the cell, consisting of grasses and forbs, appears healthy and is indistinguishable from that growing on the surrounding hills and valleys. The same species are present, and the overall health and density of vegetation are similar (PL-4).

*SPK 6/2012. PL-4. Perimeter sign P5 and northeast portion of the site.*

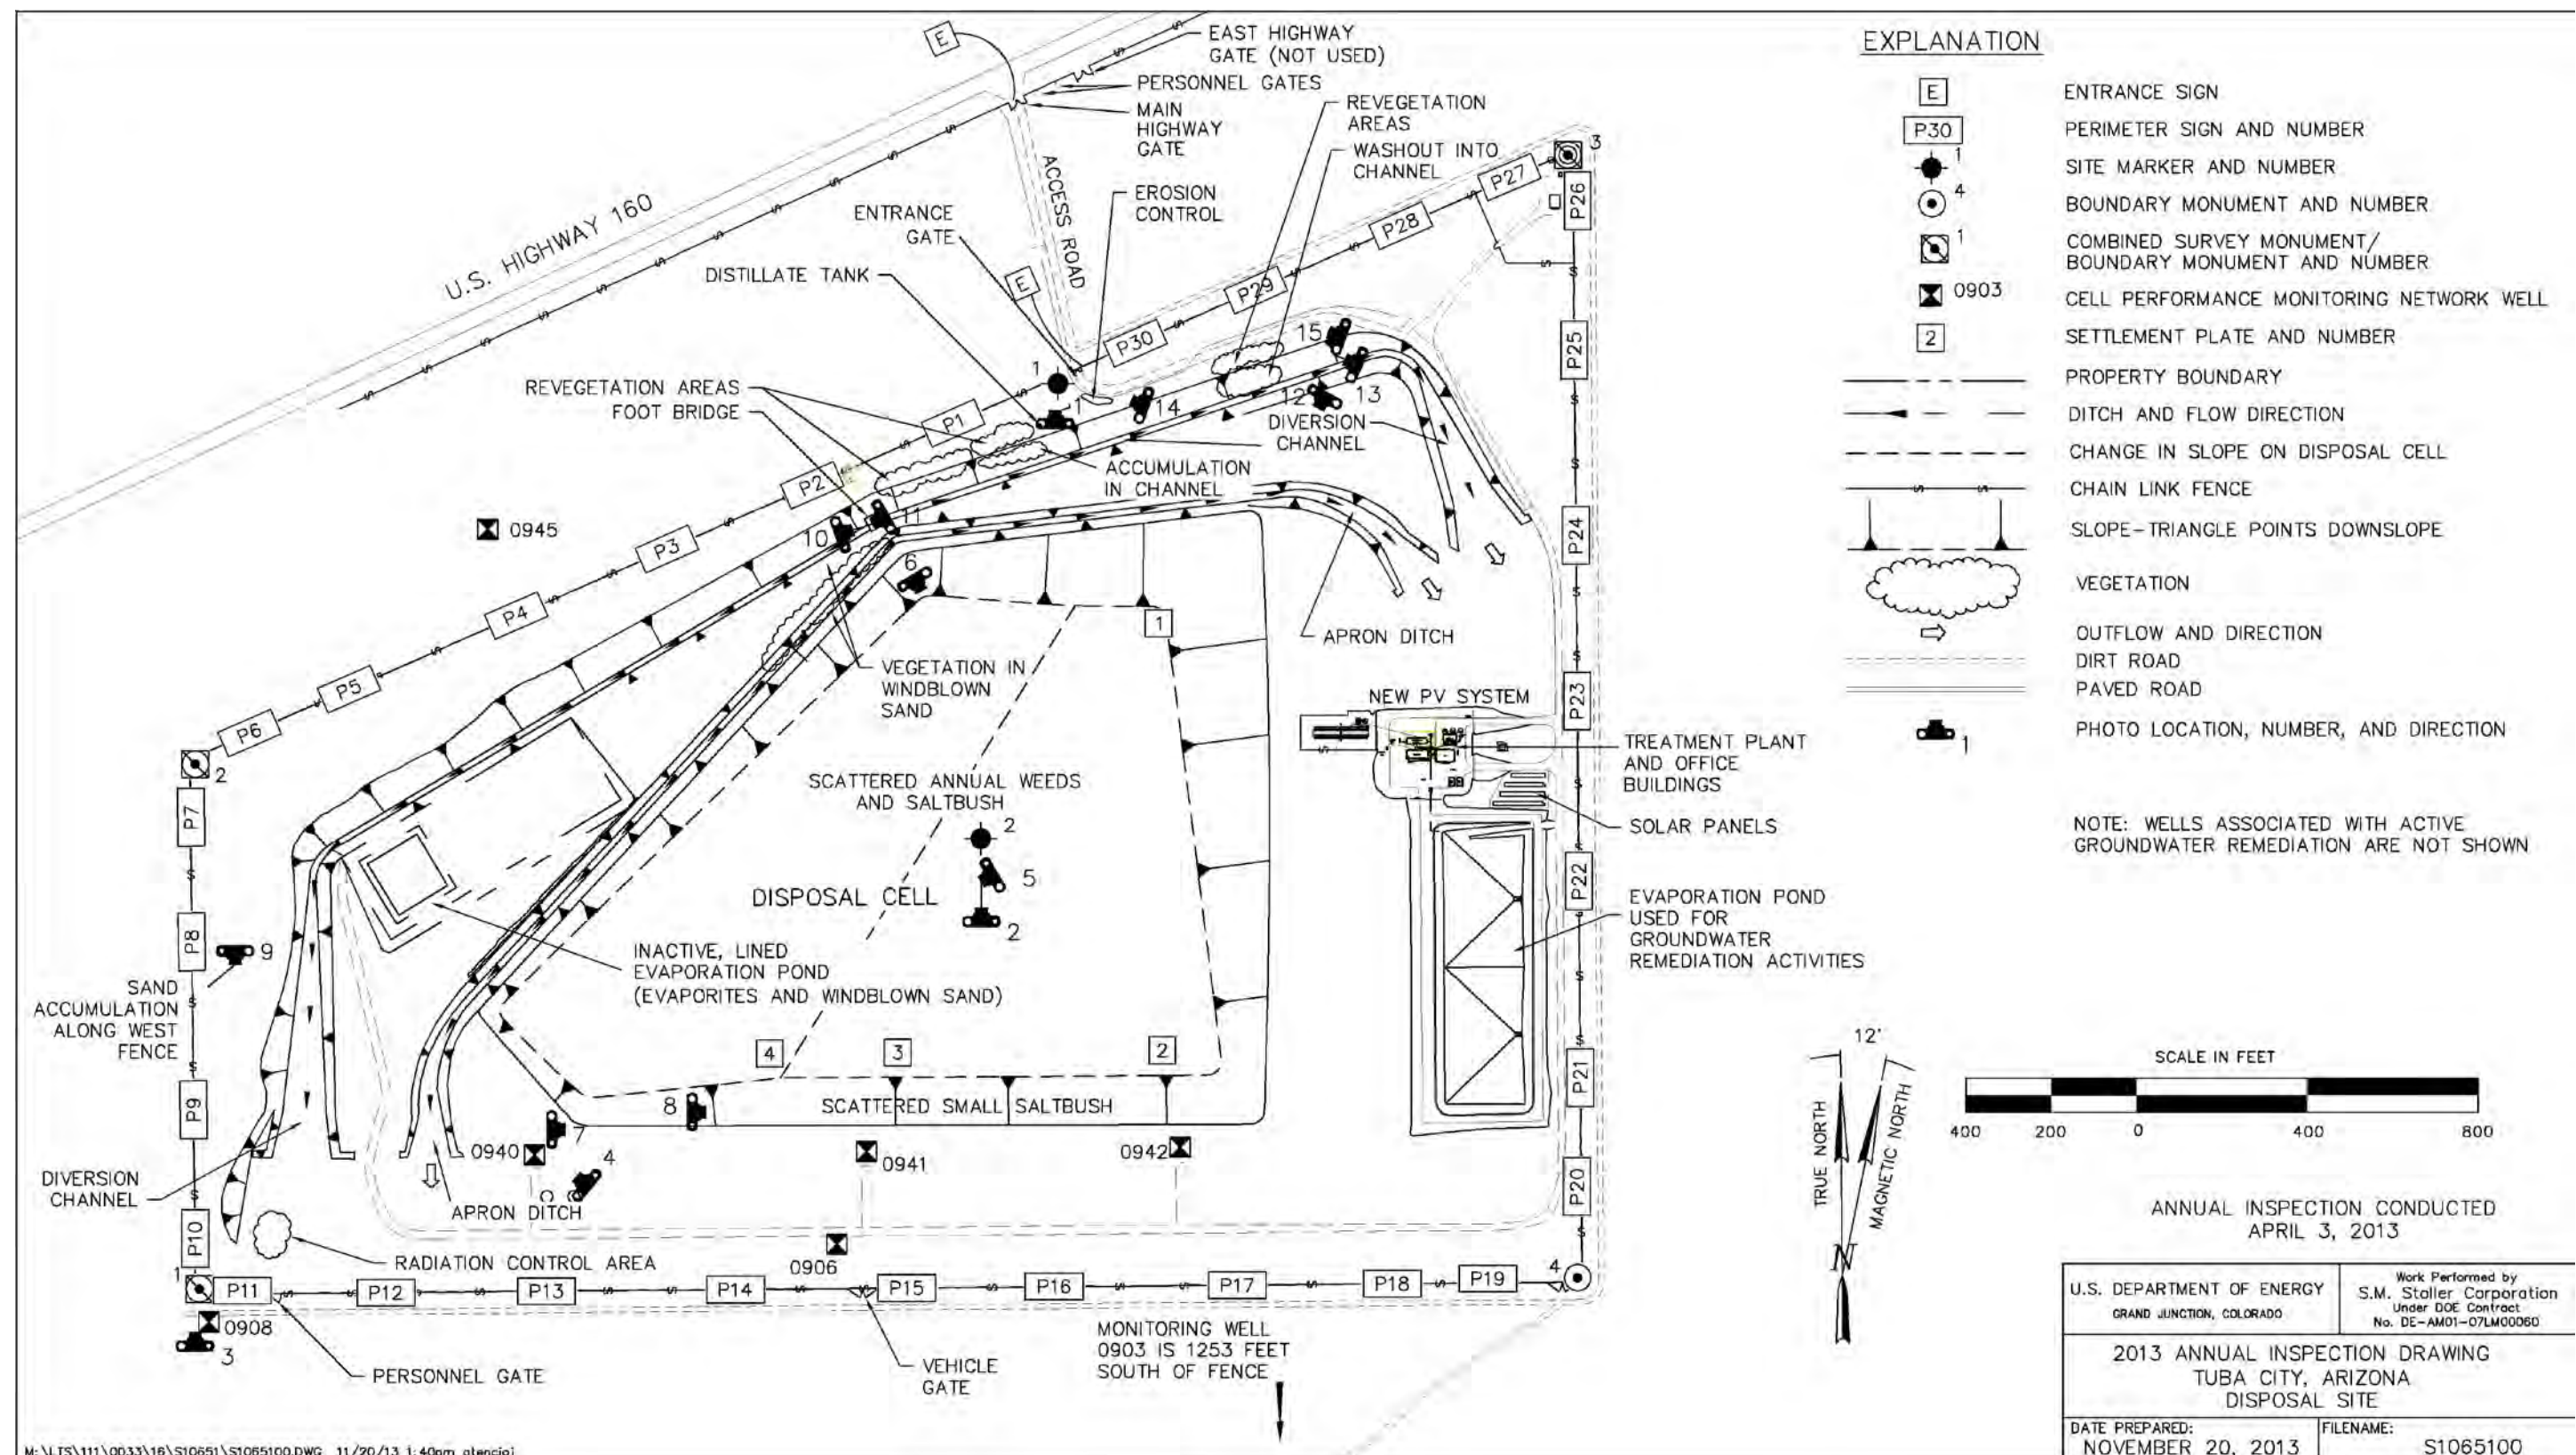
Figure 19-1. 2013 Annual Inspection Drawing for the Tuba City Disposal Site

Figure 19-1 shows the locations of site surveillance features. Inspection results and recommended maintenance activities associated with site surveillance features are included in the following subsections. Photographs to support specific observations are identified in the text and in Figure 19-1 by photograph location (PL) numbers.

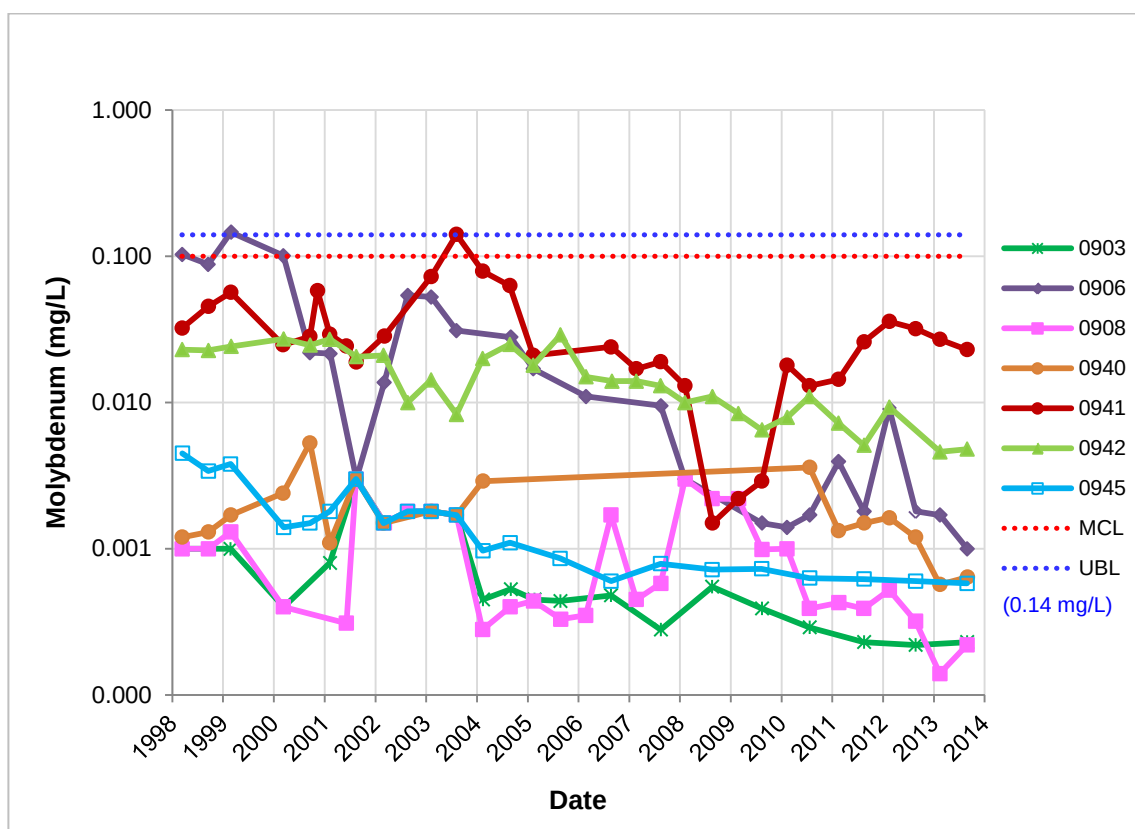
Figure 19-2. Time-Concentration Plots of Molybdenum in Groundwater at the Tuba City Disposal Site

Figure 19-2 shows the time-concentration plot for molybdenum—in this graph, data are plotted in logarithmic scale (base 10), given the differences in magnitude between results for immediately downgradient wells and those for more distal wells. As has been the case since 2004, molybdenum concentrations in groundwater were below both the 0.1 milligram per liter (mg/L) MCL and the 0.14 mg/L UBL in all wells (Figure 19-2). Molybdenum in westernmost wells 0908 and 0940, and in well 0903, has been comparable to background.

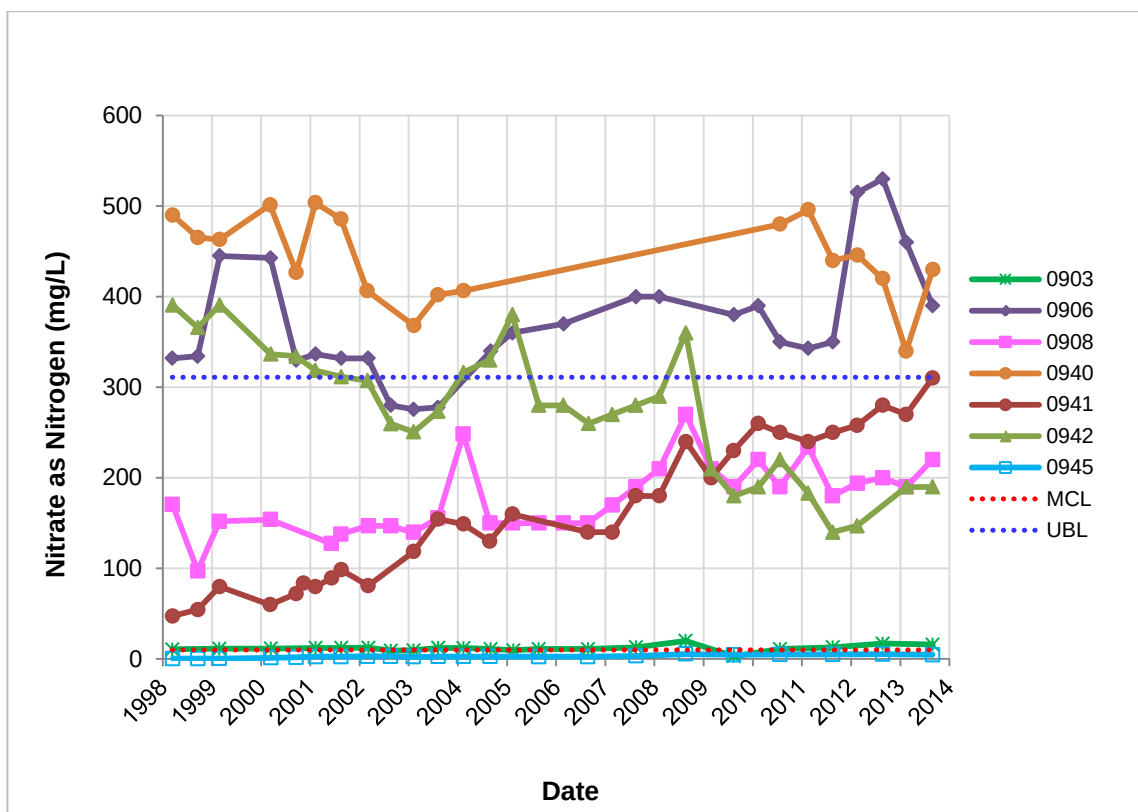
Figure 19-3. Time-Concentration Plots of Nitrate in Groundwater at the Tuba City Disposal Site

Since 1998, nitrate concentrations in all evaluative monitoring wells except 0903 (offsite distal) and 0945 (background) have exceeded the 10 mg/L MCL by an order of magnitude or more (Figure 19-3). Exceedances of the 311 mg/L UBL have only been observed at wells 0906 (currently 390 mg/L), 0942 (last exceedance in August 2008), and 0940 (currently 430 mg/L). Nitrate concentrations in well 0941 have increased fairly steadily from 47 mg/L in March 1998 to 310 mg/L (August 2013 result), essentially equal to the UBL. Well 0941 is centrally located within a dense extraction well network, so historical pumping in this area may account for some (or all) of this observed increase. Apart from decreases in nitrate in well 0942, trending is not apparent in remaining wells. Nitrate concentrations in offsite downgradient well 0903, although slightly above background and occasionally exceeding the MCL, are still well below the UBL.

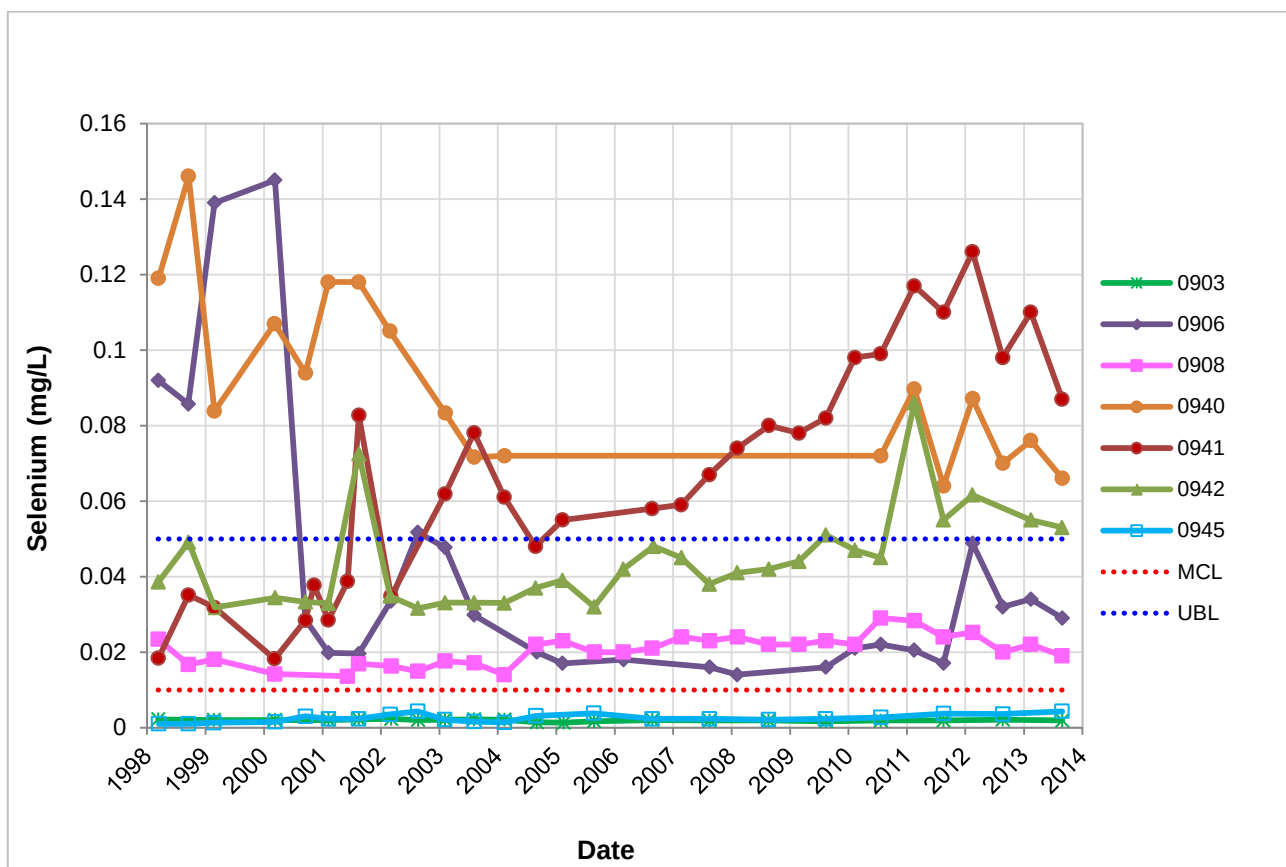
Figure 19-4. Time-Concentration Plots of Selenium in Groundwater at the Tuba City Disposal Site

Selenium concentrations have historically exceeded the 0.01 mg/L MCL in all wells except offsite downgradient well 0903 and background well 0945 (Figure 19-4). Concentrations have exceeded the 0.05 mg/L UBL only in wells 0940, 0941, and 0942, immediately downgradient of the disposal cell. As observed for nitrate, selenium concentrations have increased in well 0941 from 0.018 mg/L in 1998 to 0.09–0.13 mg/L in recent years. Fluctuations in concentrations in wells 0940–0942 and 0906 since 2010 may be due to the previous (October 2010 to September 2011) shutdown of the treatment plant and subsequent resumption of pumping. Selenium concentrations in southernmost well 0903 have consistently been below both the UBL and the MCL and, since late 2004, below levels measured in background well 0945.
