U.S. DEPARTMENT OF  
**ENERGY**

# 2013 Annual Site Inspection and Monitoring Report for Uranium Mill Tailings Radiation Control Act Title I Disposal Sites

March 2014

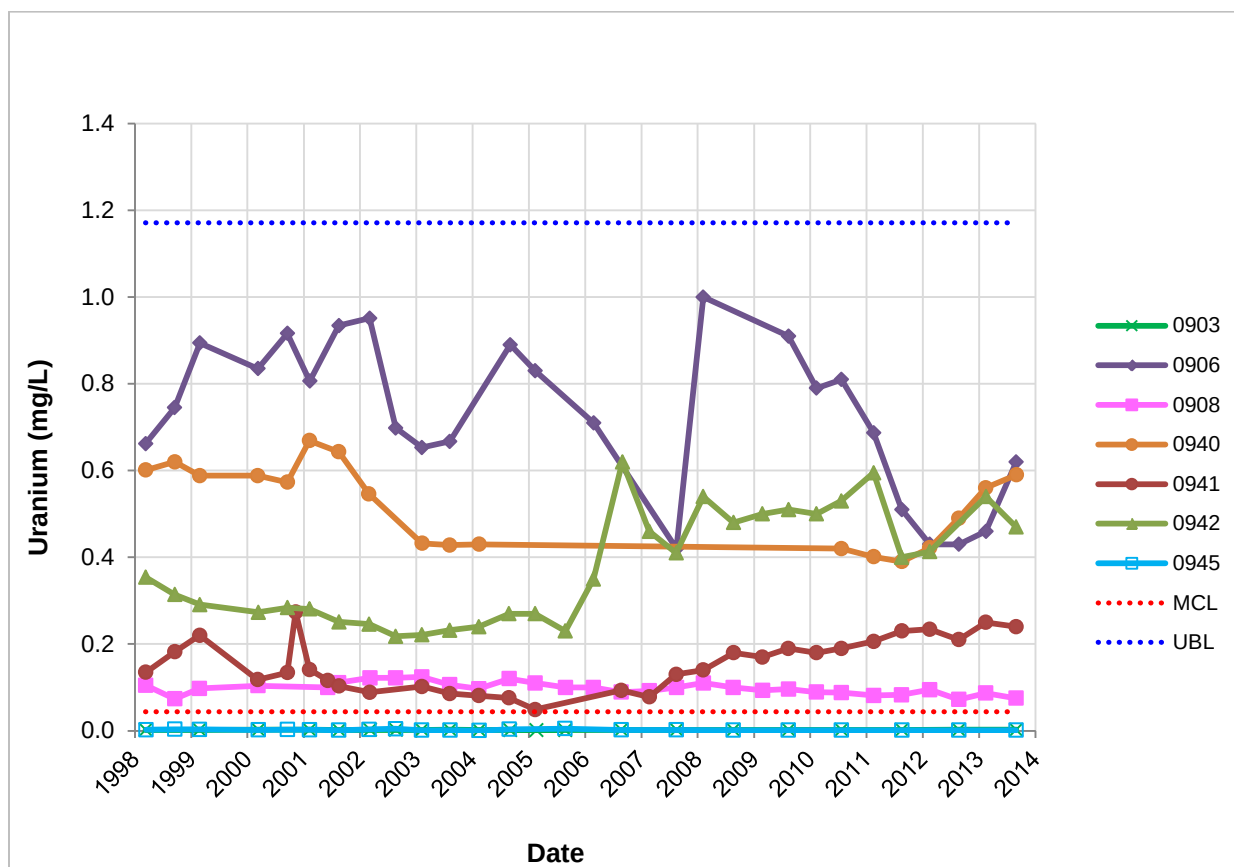
Figure 19-5. Time-Concentration Plots of Uranium in Groundwater at the Tuba City Disposal Site

In 2013, uranium concentrations in groundwater exceeded the 0.044 mg/L MCL but remained below the 1.17 mg/L UBL in all onsite downgradient wells and in well 0908. This has been the case historically, as shown in Figure 19-5. Concentrations in the upgradient well 0945 and offsite downgradient well 0903 remain below the MCL. As observed for nitrate and selenium, uranium concentrations in central downgradient well 0941 have increased gradually since 2007 (from about 0.08 mg/L to 0.2 mg/L). A similar, although not as steady, increase is apparent for well 0942. Uranium concentrations in well 0906 have fluctuated greatly at times, perhaps due to pumping of the extraction wells.

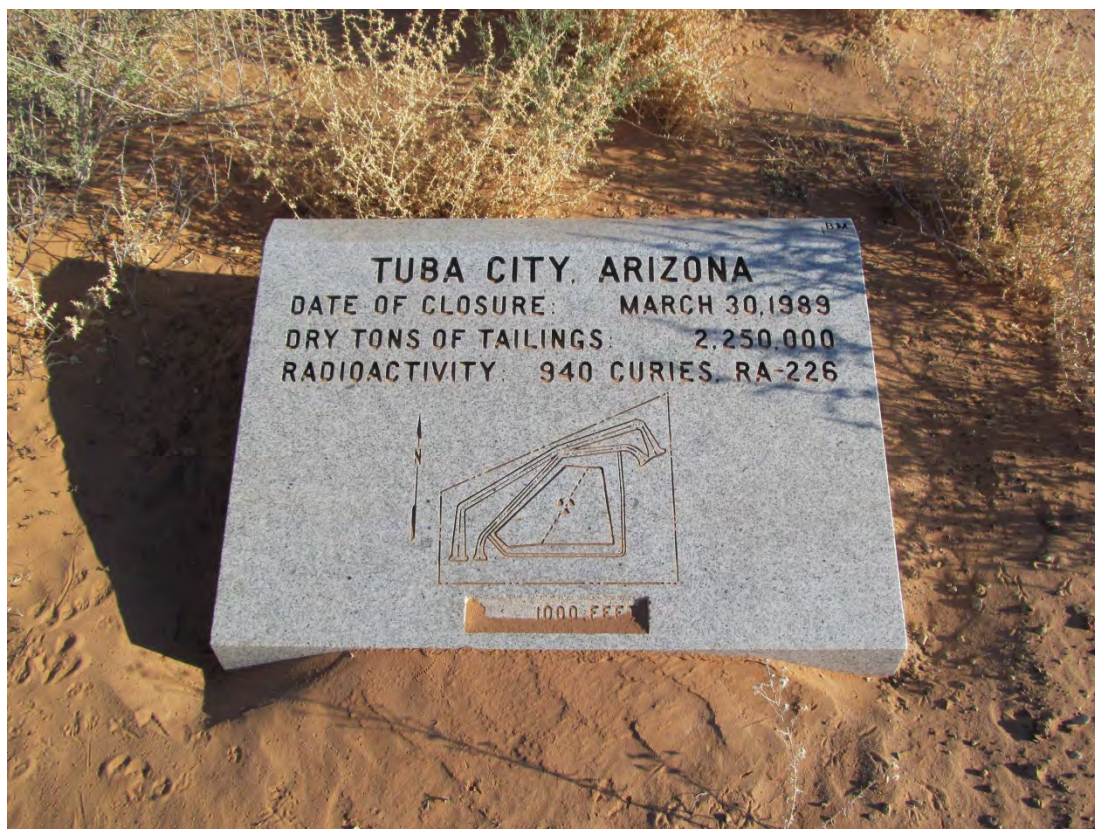
The two granite site markers, one just inside and to the right of the entrance gate (PL-1) and the other on top of the disposal cell (PL-2), were in good condition.

TUB 4/2013. PL-1. Site marker SMK-1.

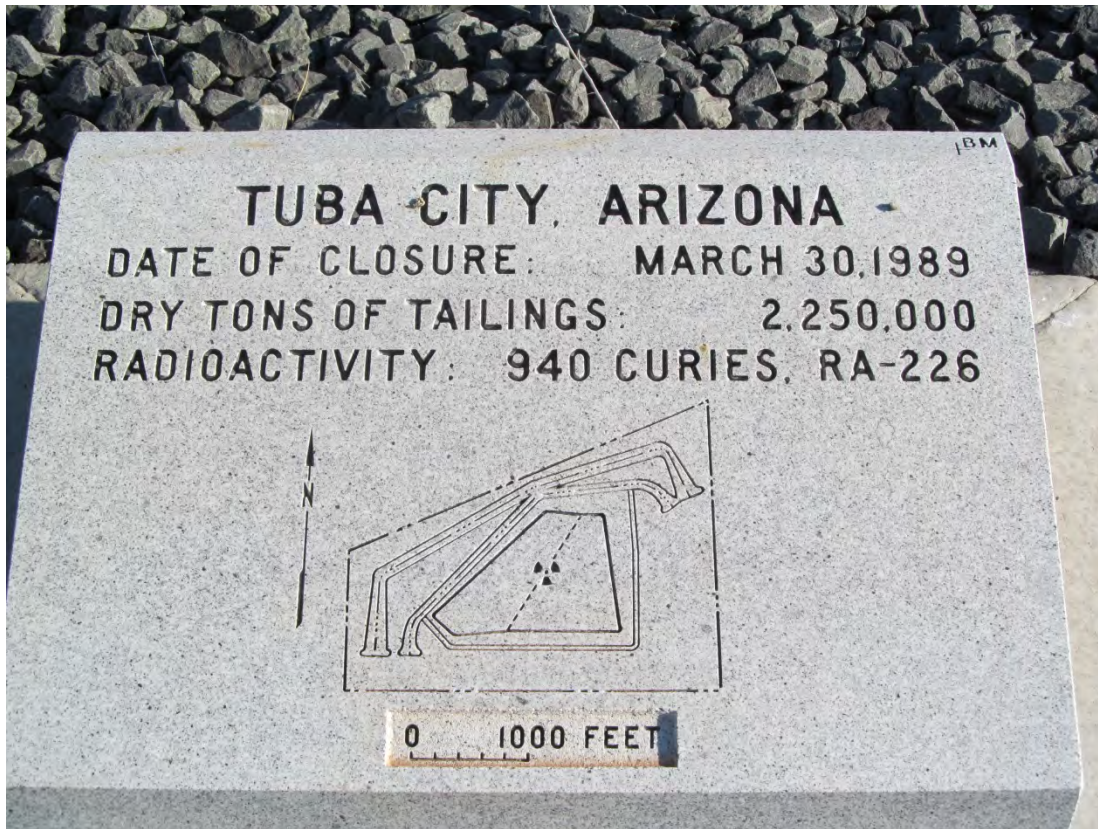
*TUB 4/2013. PL-2. Site marker SMK-2.*

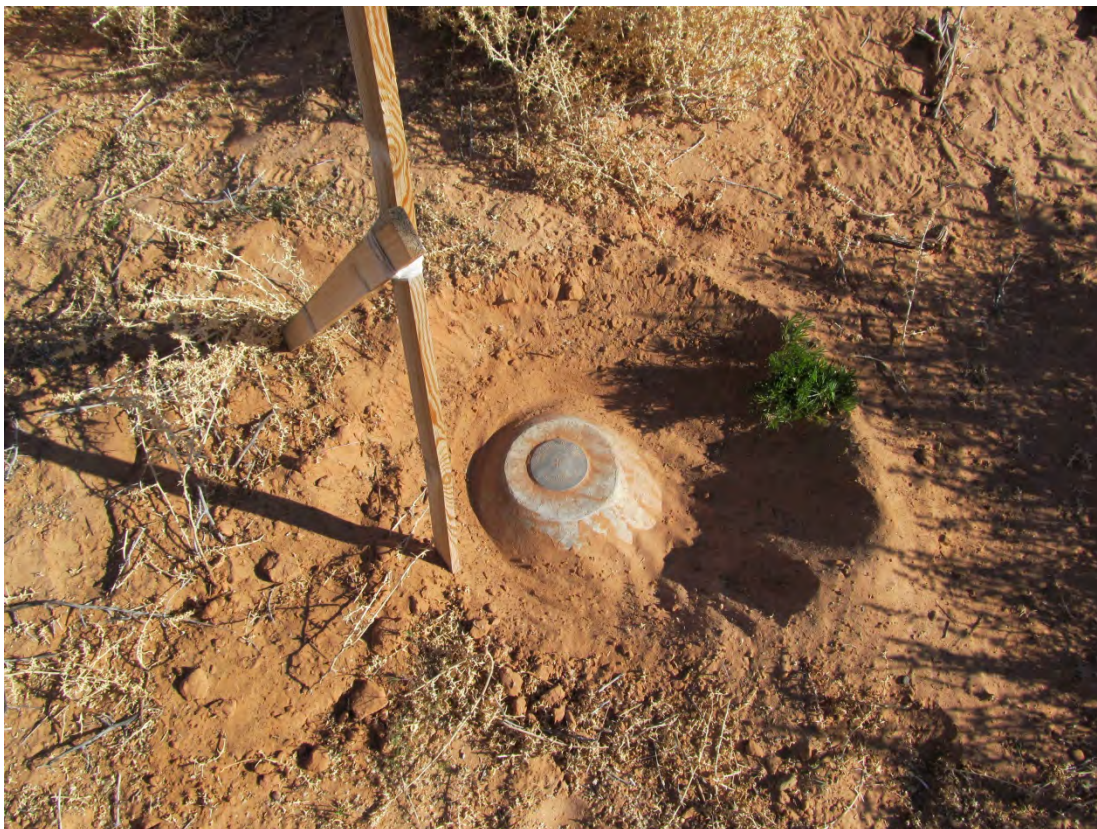
The survey and boundary monuments that were observed were in good condition (PL-3). Boundary monument BM-1, at the southwest corner of the site, was buried by windblown sand.

*TUB 4/2013. PL-3. Benchmark No. 1 southeast corner.*

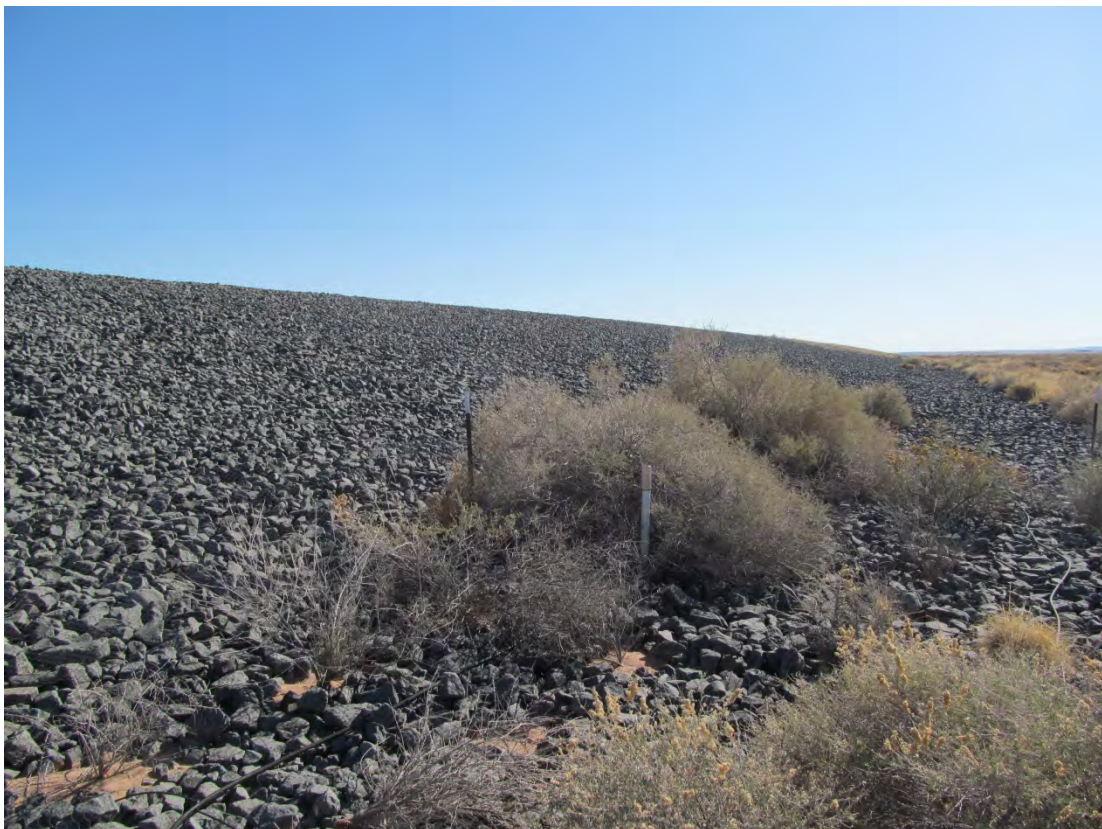
*TUB 4/2013. PL-7. South slope with minor salt brush.*

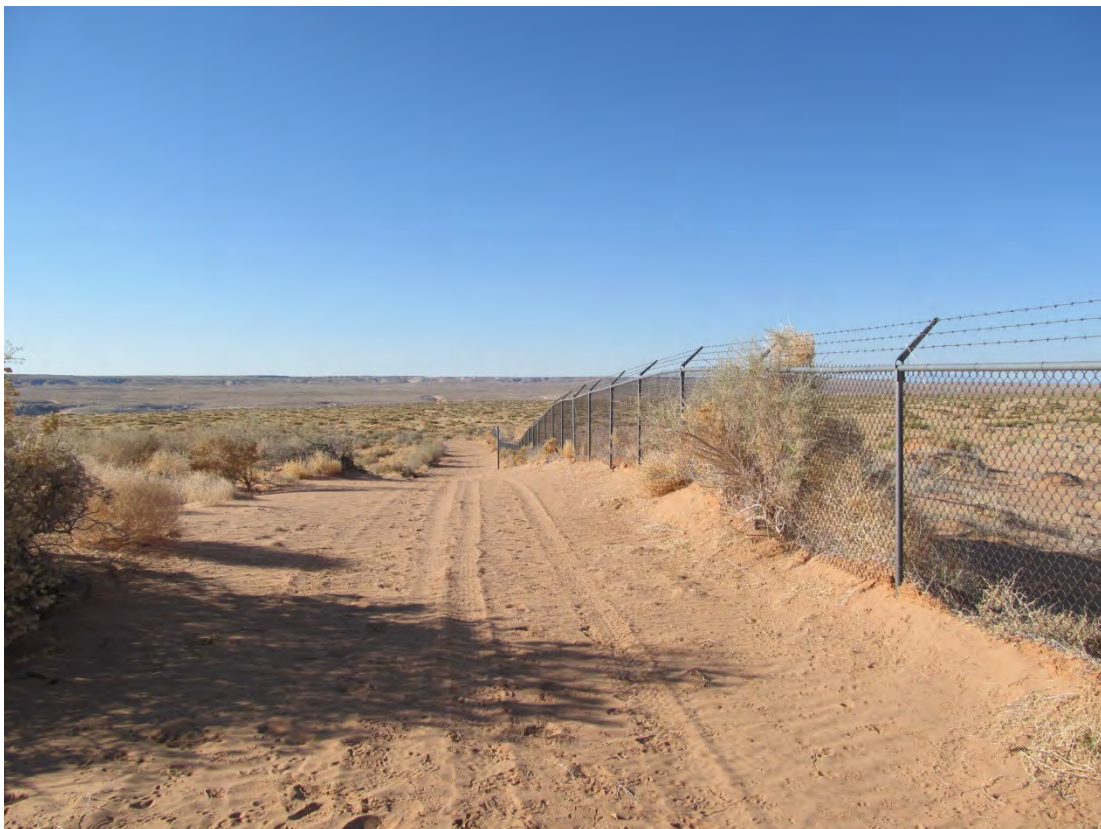
*TUB 4/2013. PL-9. Sand accumulation along west boundary fence.*

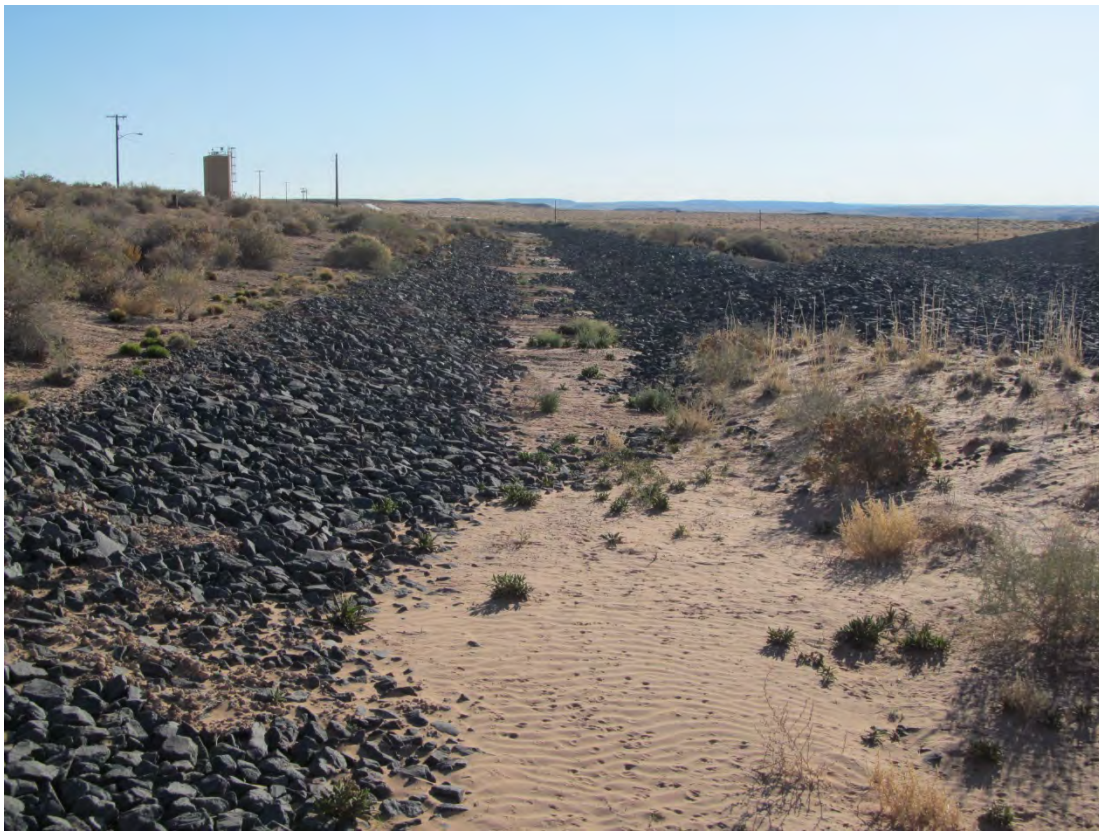
*TUB 4/2013. PL-10. East of footbridge showing sediment in channel.*

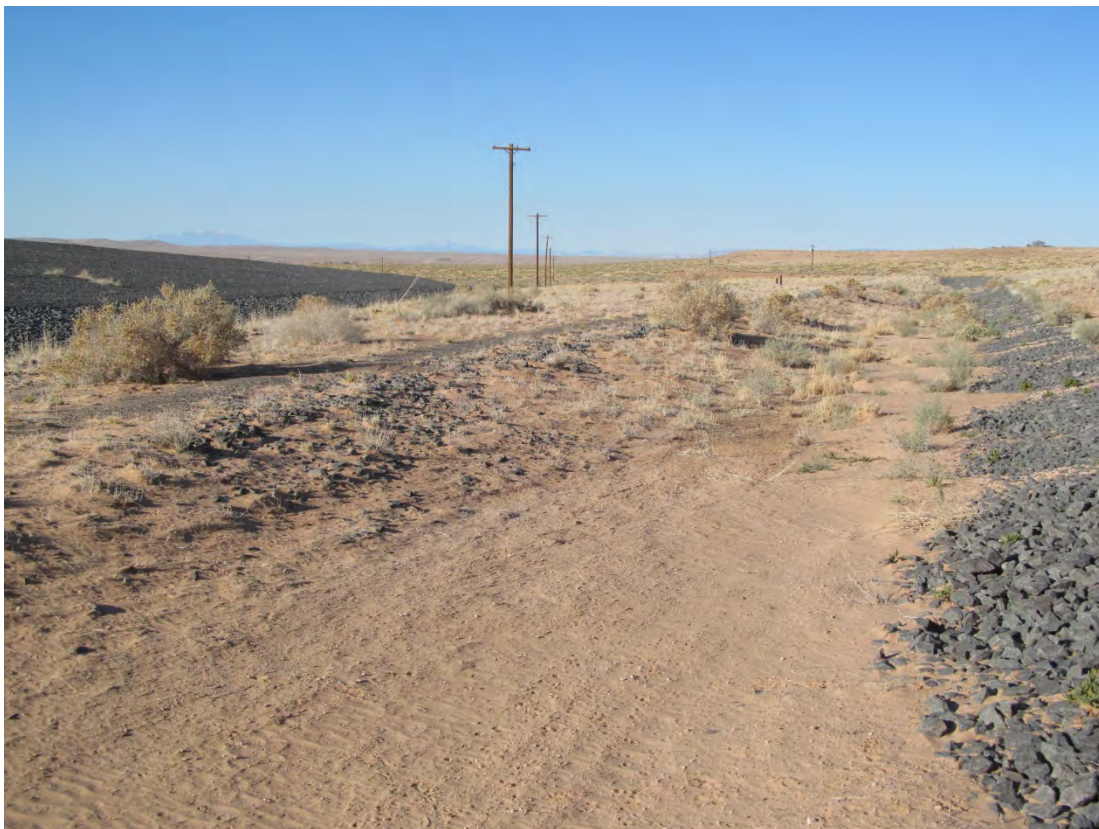
*TUB 4/2013. PL-11. West of footbridge showing sediment in channel.*

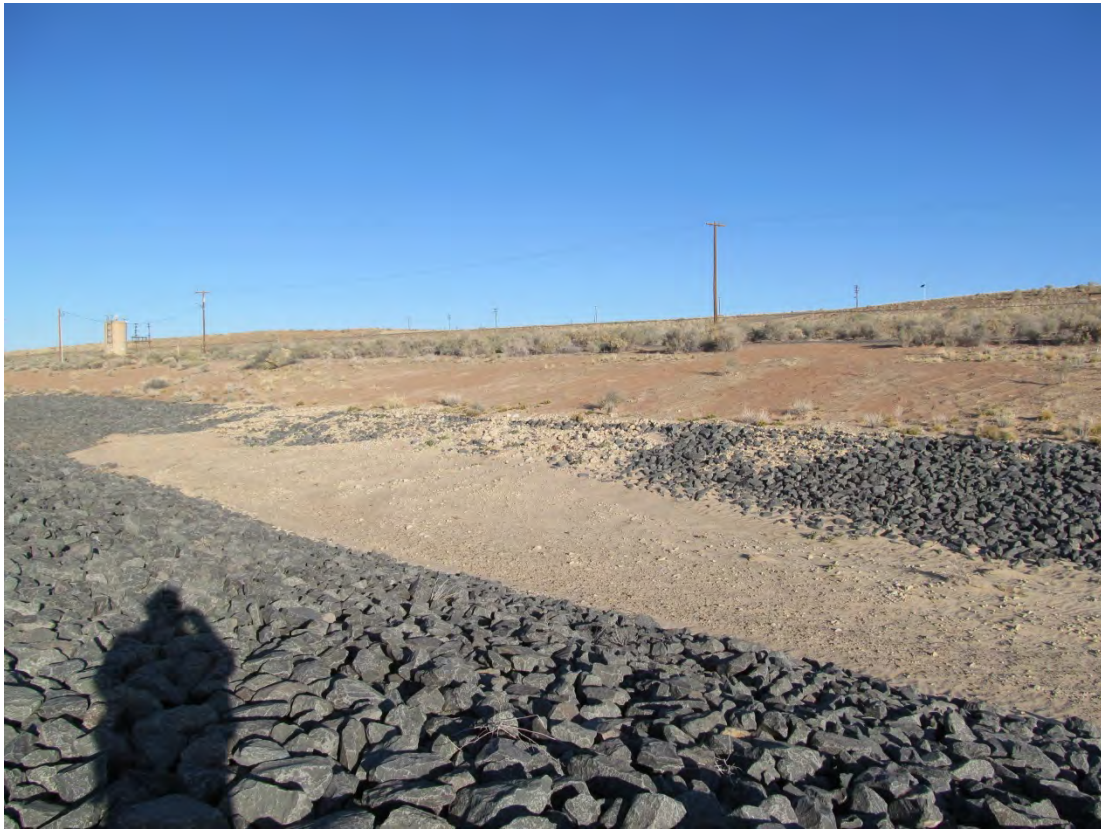
*TUB 4/2013. PL-12. Washout and revegetation area.*

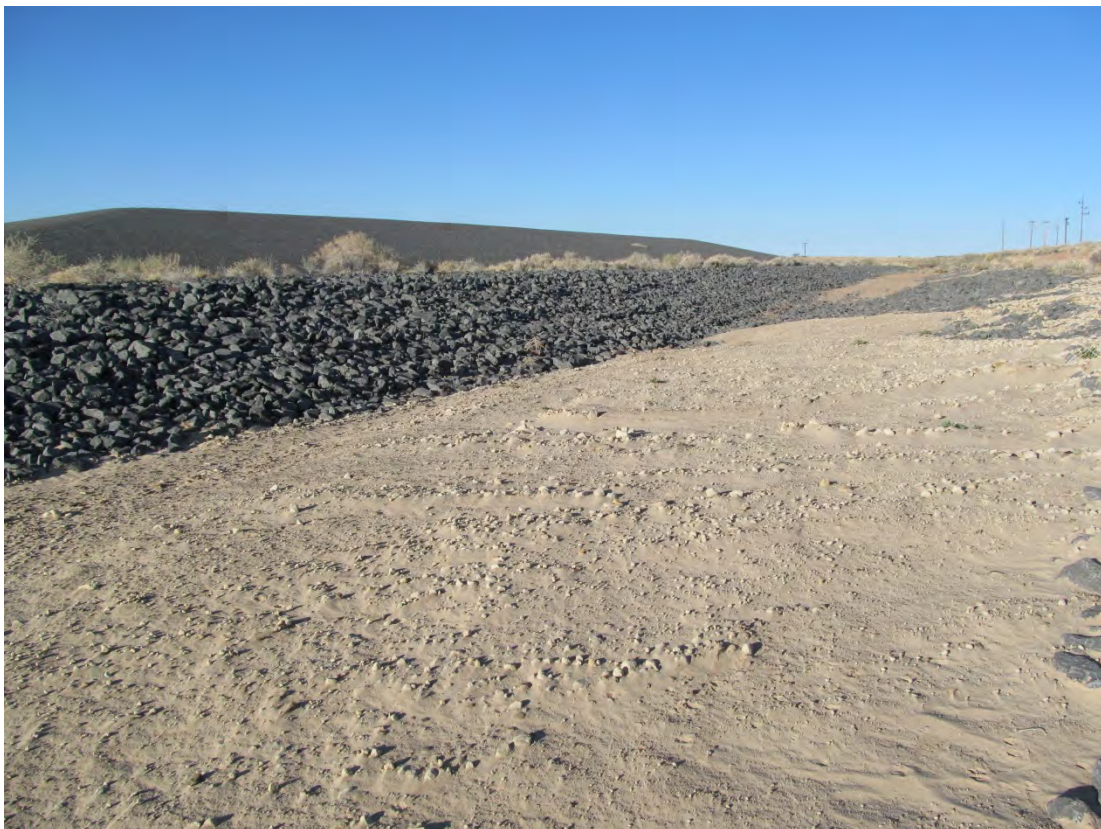
*TUB 4/2013. PL-13. West along base of channel (revegetation and washout).*

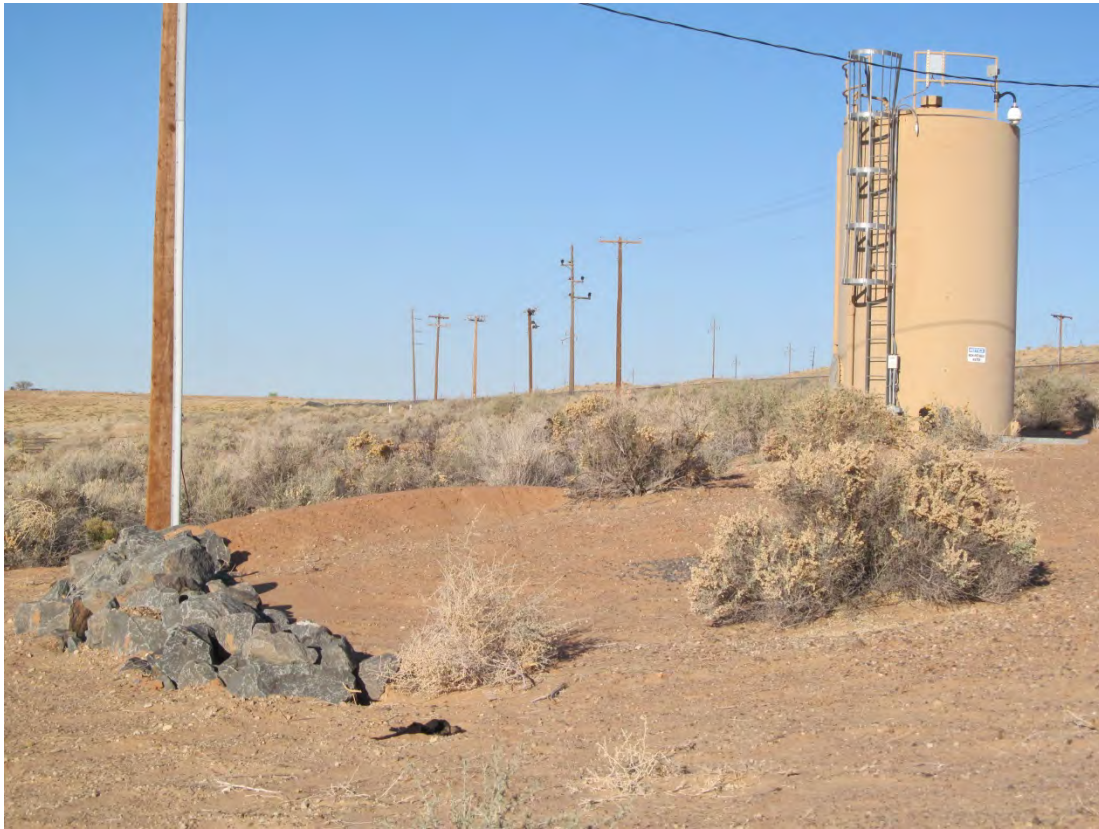
*TUB 4/2013. PL-14. Erosion control at distillate tank*

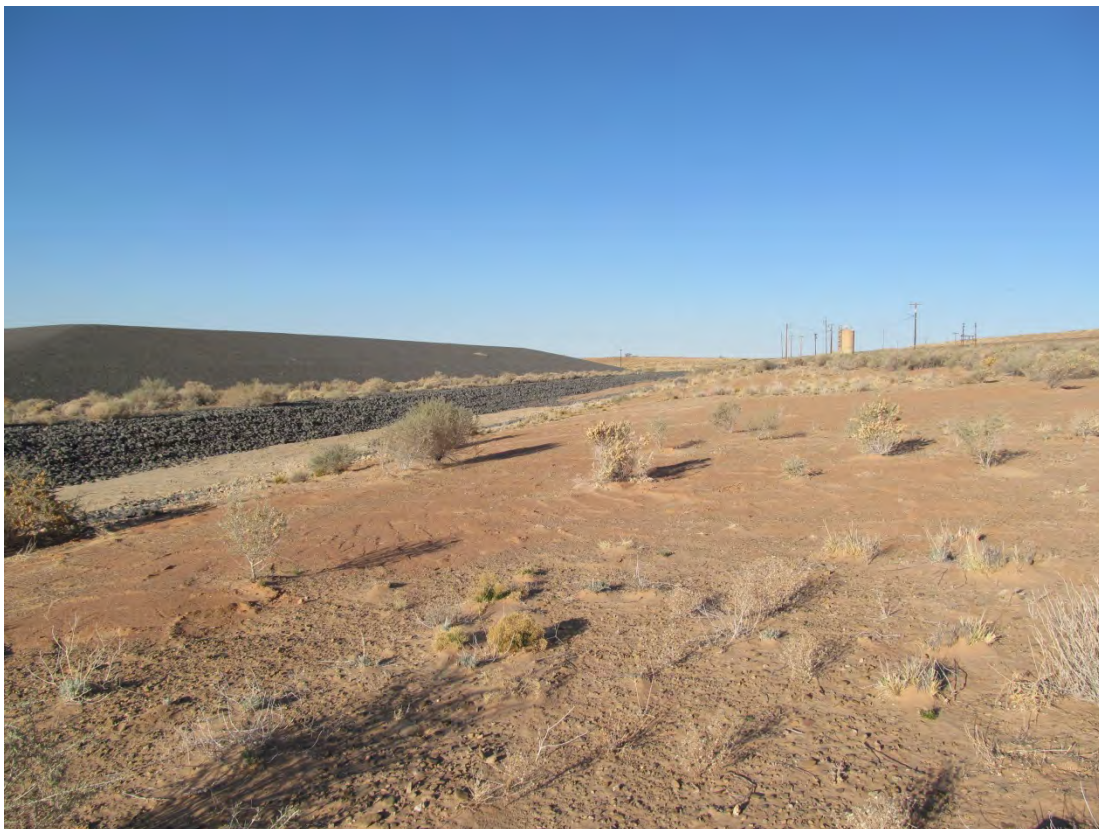
*TUB 4/2013. PL-15. Revegetation areas (two approximately 30 × 250 feet).*
