Failure Mechanisms in High Voltage Mylar Capacitors

Jaemi L. Herzberger¹ and Danelle M. Tanner

Special Use Hi-Rel Capacitors Department, 1732
 Sandia National Laboratories, Albuquerque, NM 87185
jlherzb@sandia.gov

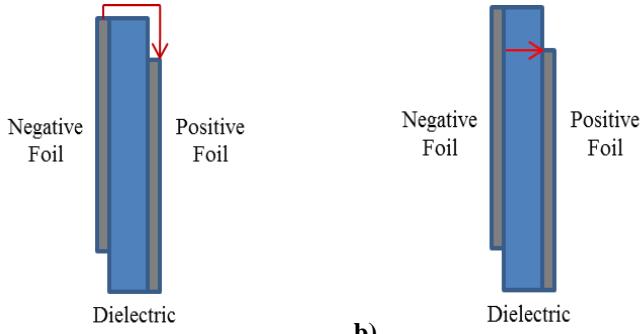
Edge margin arc-over and dielectric punch-through were the two primary failure mechanisms that occurred in these capacitors under high voltage conditions during STB testing. These failures created an electrical short between the conductive foils. Arcing occurs when air breaks down electrically and forms a pathway for the flow of electrons from one conductor to another, often resulting in visible flashes, flames and carbon charring. The pathway taken by the electrons from the negative foil to the positive foil is shown in *Figure 2.a*. The carbon traces left between the conductors increase the conductivity and provide a pathway for the continuous flow of current; however, this conduction path is not a short, so normal C and DF readings can still occur. Small irregularities/defects in either the foil or the Mylar cause electric field enhancements, which results in damage to the dielectric through the movement of normally bound charges and eventual dielectric breakdown, known as dielectric punch-through (*Figure 2.b*). Since this failure typically results in direct foil to foil contact at the failure site, overload readings are seen on the capacitance tester.

Figure 2. a) Arc-over failure diagram and b) dielectric punch-through failure mechanism
