Wedge Assembly Failure Analysis

Kevin Jameson

April 23, 2014

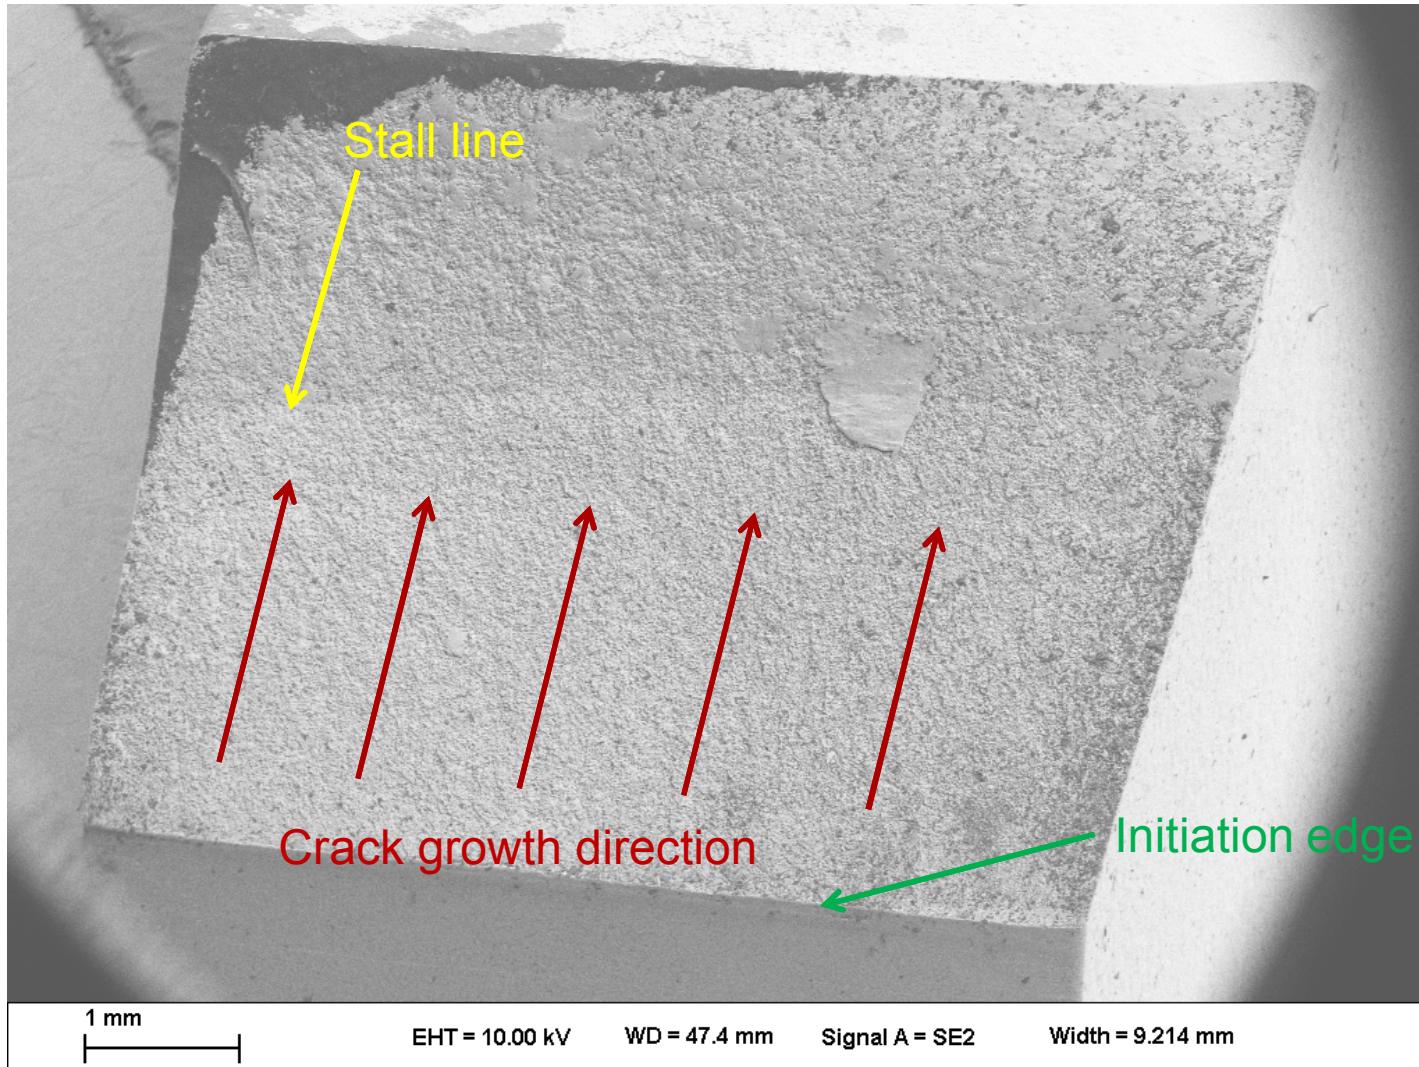
Surface Cracks forming

Results

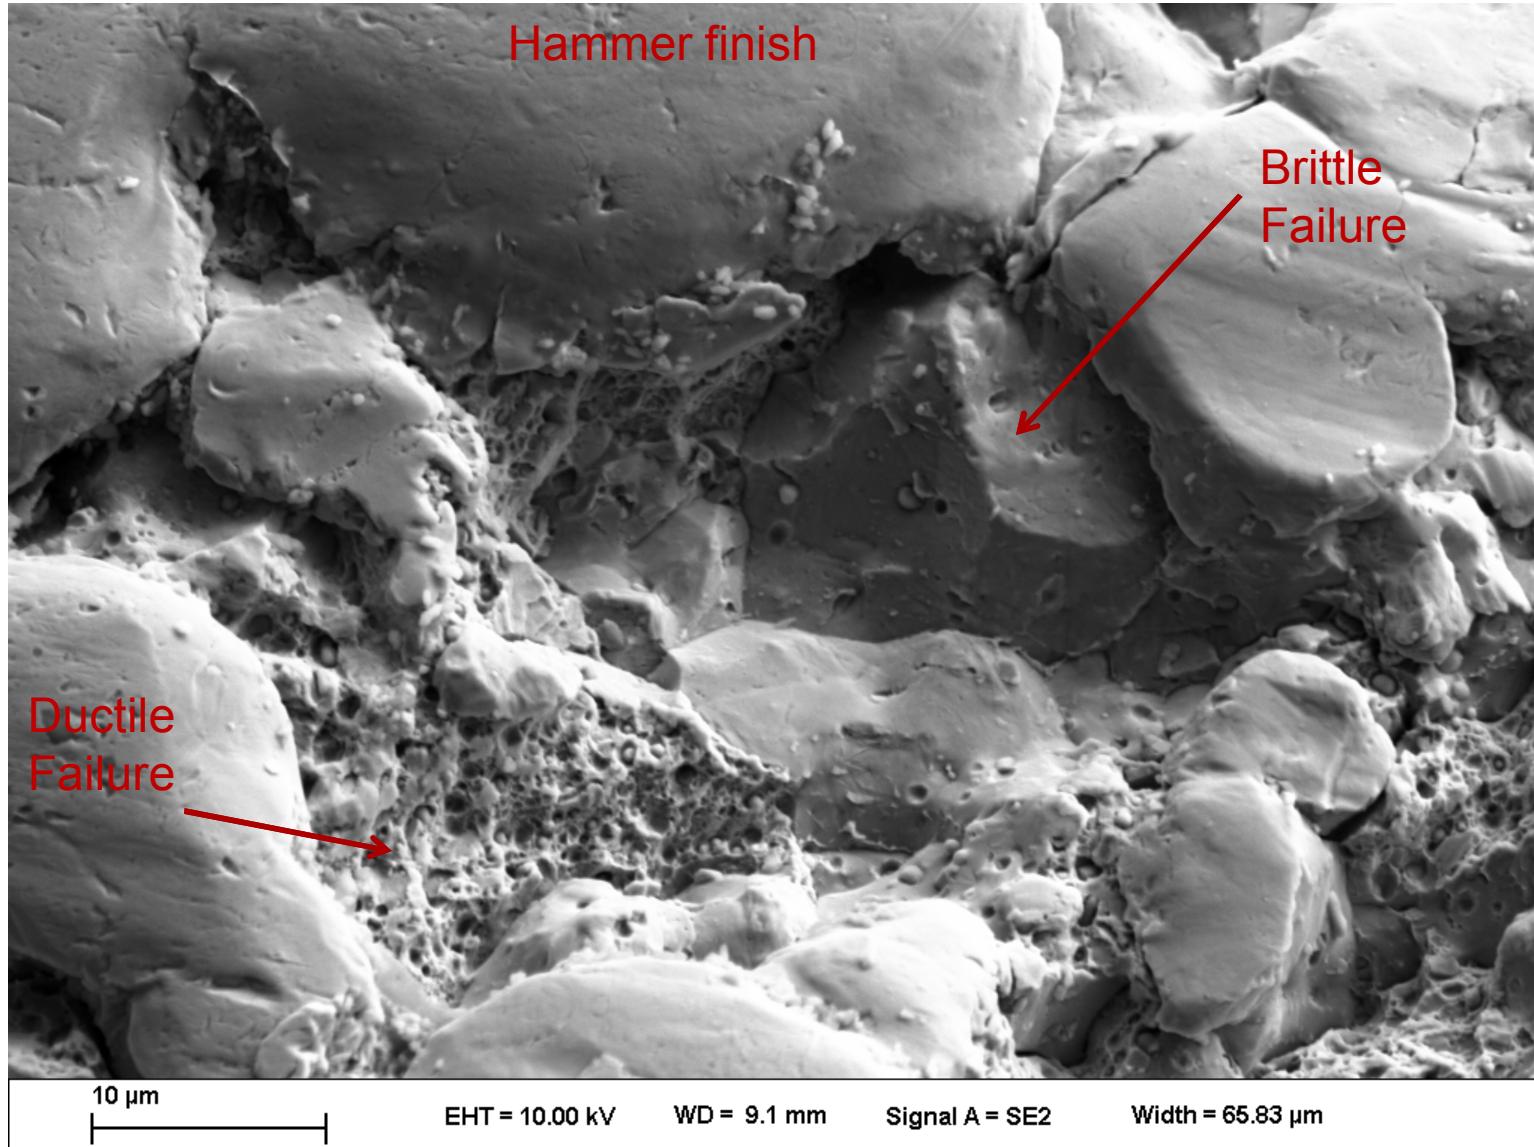
Ductile fracture

Brittle fracture

- Mixed-Mode Failure
- Hydrogen Embrittlement
- Temper Embrittlement

- Remove stress risers on the inside corners
- Relax tolerances on the press fit of the wedge extender into the wedge
- Change design, allow the wedge extender to have the tabs
- Address the water infiltration
- Address the HE and the Temper Embrittlement
