# DOCUMENT RELEASE FORM

# Hanford Single-Shell Tank Leak Causes and Locations - 241-TX Farm

**Abstract:** This document identifies 241-TX Tank Farm (TX Farm) leak causes and locations for the 100 series leaking tanks (241-TX-107 and 241-TX-114) identified in RPP-RPT-50870, Rev. 0, Hanford 241-TX Farm Leak Inventory Assessment Report. This document satisfies the TX Farm portion of the target (T04) in the Hanford Federal Facility Agreement and Consent Order milestone M-045-91F.

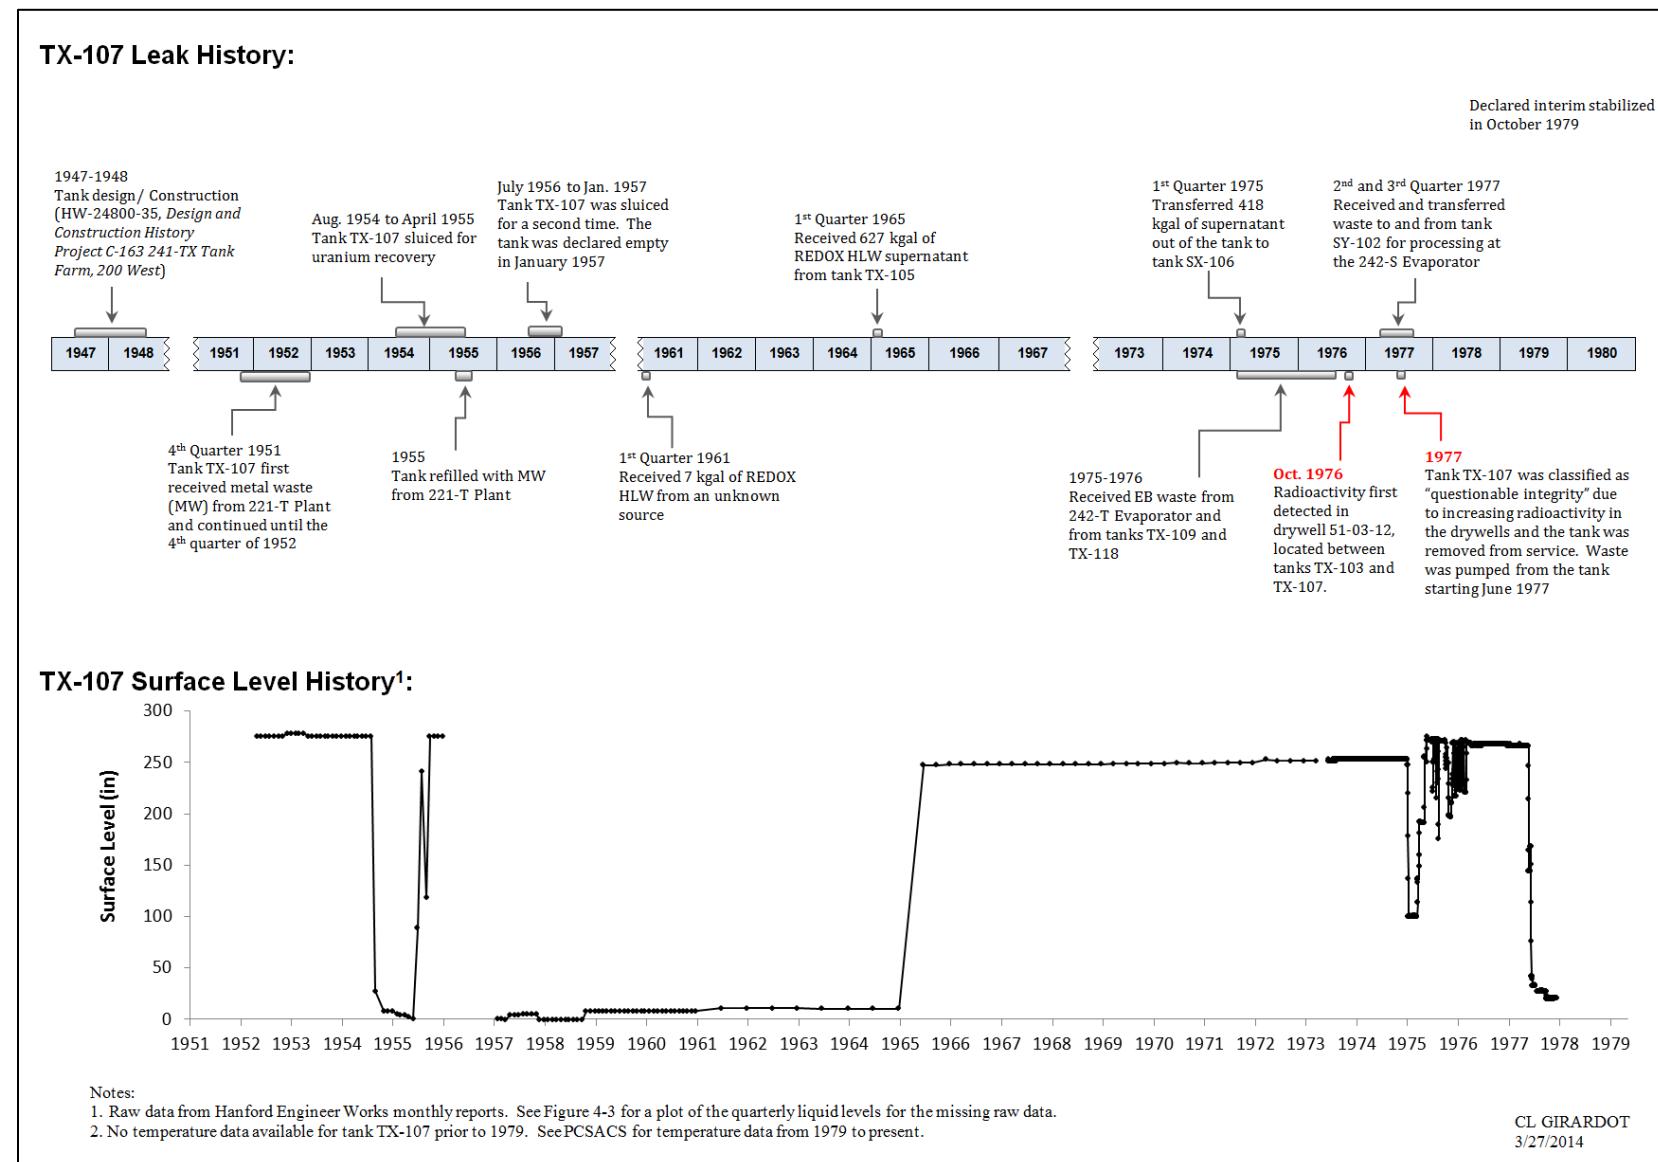
Figure 4-2. Operational Leak History of Tank TX-107

The operational history of tank TX-107 leak related details including liquid level is charted in Figure 4-2.

2. Pg. 4-6, Fig. 4-2. TX-107 was declared "empty" in January 1957 and wasn't refilled until 1961. As the tank was sluiced, there likely was some residual waste in the tank for about 4 years. Could this have effected corrosion for the tank bottom? Please consider.

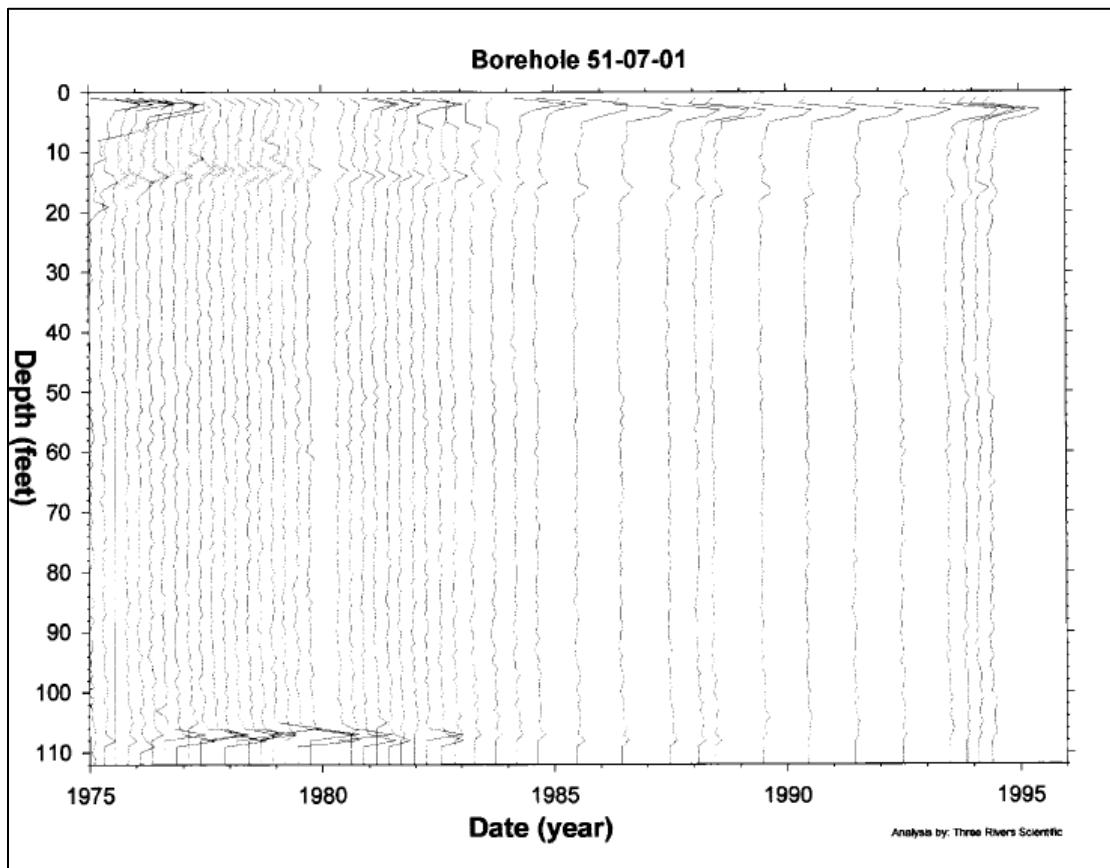
**Figure 4-5. Tank TX-107 Drywell 51-07-01 (RPP-6353)**

Since historical radioactivity in this drywell is very low, and GJ-HAN-48 reported low levels of radioactivity, drywell 51-07-01 is not being included as part of the leak location for tank TX-107. Figure 4-5 shows the depths of radioactivity from 1975 to 1995 (RPP-6353, *Analysis & Summary Report of Historical Drywell Gamma Logs for 241-TX Tank Farm - 200 West*).

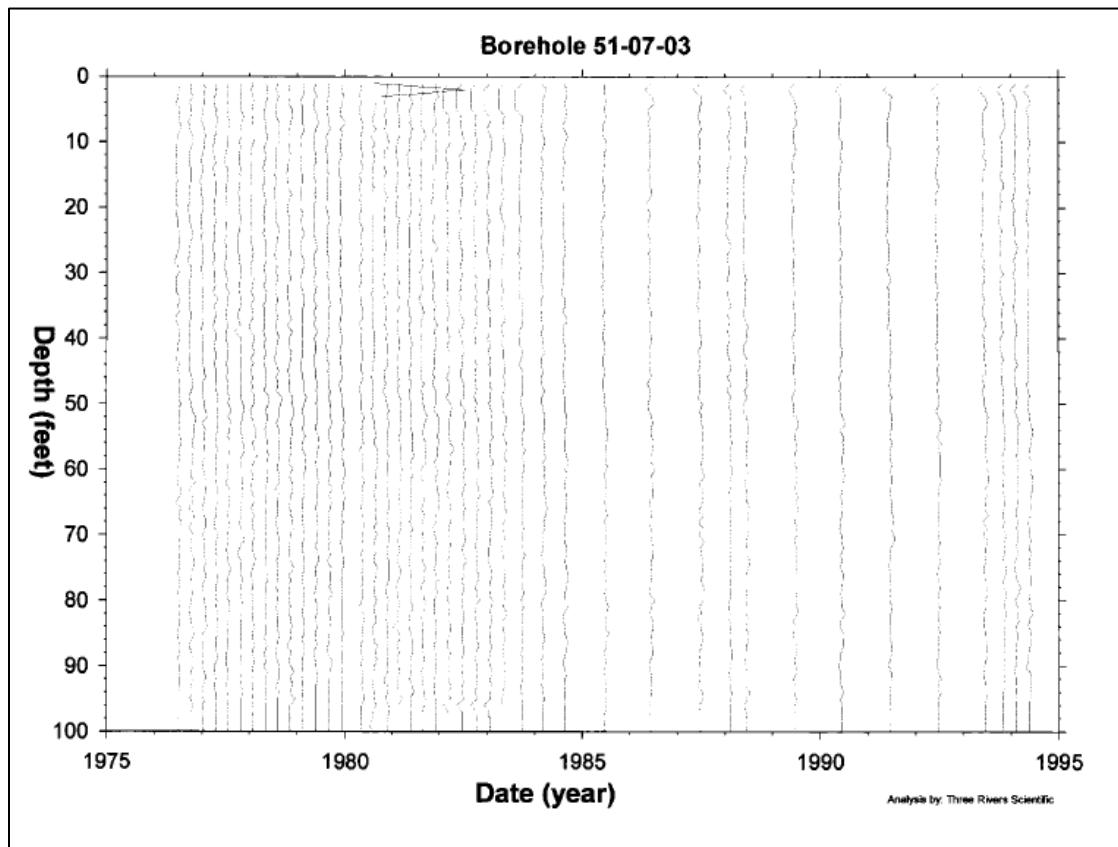
**Figure 4-6. Tank TX-107 Drywell 51-07-03 (RPP-6353)**

Since historical radioactivity in this drywell is very low, and GJ-HAN-48 reported low levels of radioactivity, drywell 51-07-03 is not being included as part of the leak location for tank TX-107. Figure 4-6 shows the depths of radioactivity from 1975 to 1995 (RPP-6353).

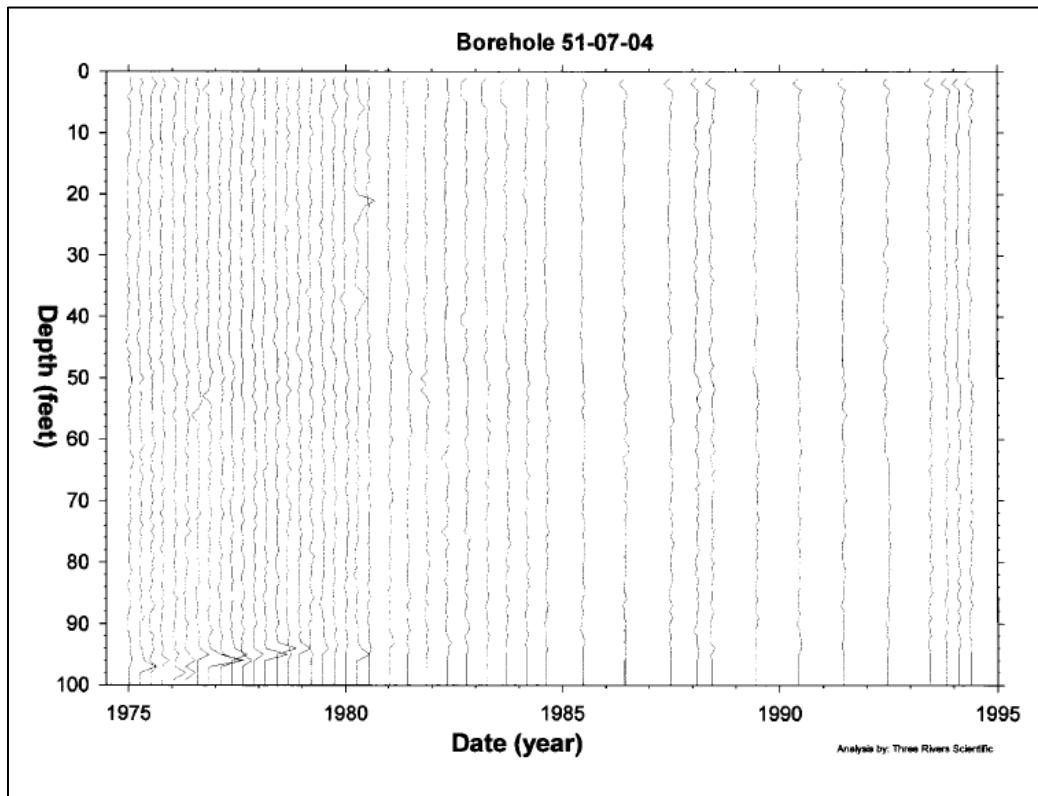
**Figure 4-7. Tank TX-107 Drywell 51-07-04 (RPP-6353)**

Since historical radioactivity in this drywell is very low, and GJ-HAN-48 reported low levels of radioactivity, drywell 51-07-04 is not being included as part of the leak location for tank TX-107. Figure 4-7 shows the depths of radioactivity from 1975 to 1995 (RPP-6353).

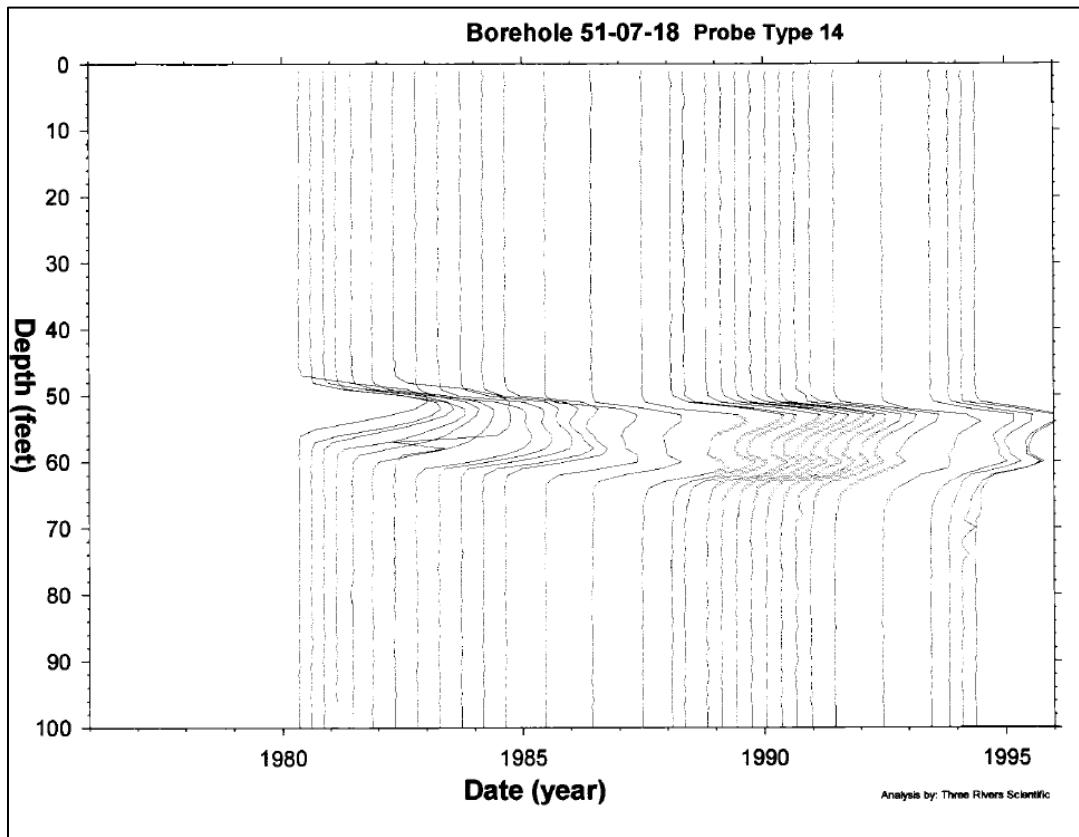
**Figure 4-8. Tank TX-107 Drywell 51-07-18 (RPP-6353)**

Document GJ-HAN-48 reported, “*Low Cs-137 concentrations measured near the ground surface probably originated from a near-surface spill that migrated downward into the formation around the outside of the casing or contamination that was carried down during the drilling of this borehole. The contamination ...[i.e., Co-60 and Eu-154]... “detected between 50 and 75 ft originated from a breach of the TX-107 tank structure.”* Figure 4-8 shows the depths of radioactivity from 1980 to 1995 (RPP-7729).

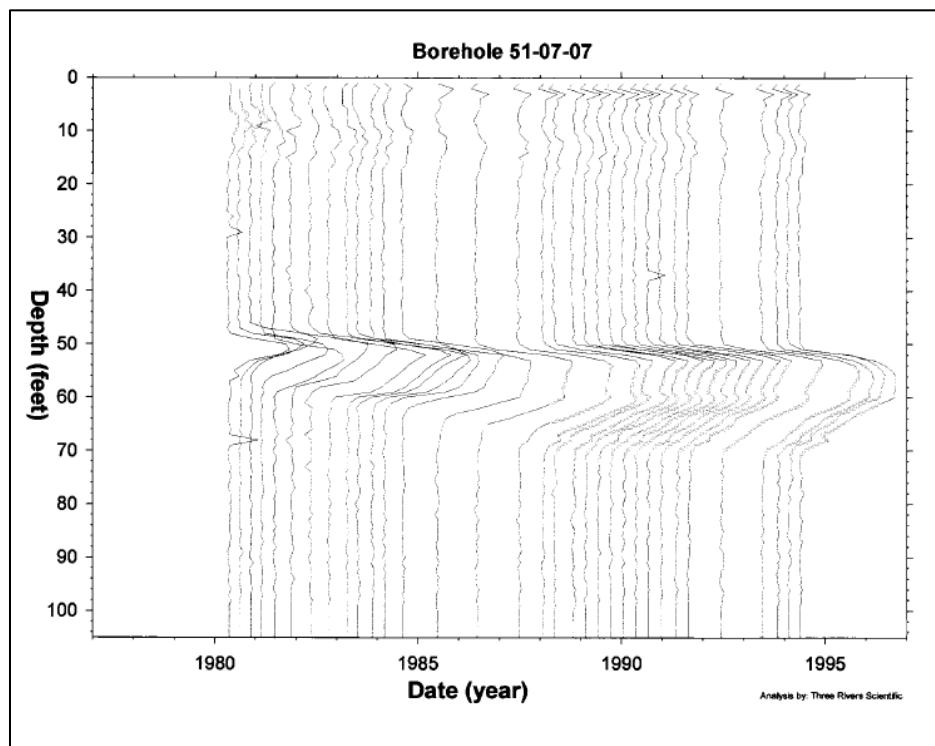
**Figure 4-9. Tank TX-107 Drywell 51-07-07 (RPP-6353)**

In December 1996, Cs-137, Co-60, and Eu-154 were the only man-made gamma-emitting radionuclides detected in drywell 51-07-07 (GJ-HAN-48). Cs-137 was detected continuously from the ground surface to 20-ft BGS, and intermittently to the bottom of the drywell (105-ft BGS). The maximum Cs-137 concentration of 10 pCi/g was detected at the ground surface. Co-60 was measured continuously from 50 to 78-ft BGS with a maximum concentration of 452 pCi/g at 59.5-ft BGS. Eu-154 was detected almost continuously from 51 to 57-ft BGS with a maximum concentration of 42 pCi/g at 52.5-ft BGS. Document GJ-HAN-48 reports, “*Low Cs-137 concentrations measured near the ground surface probably originated from a near-surface spill that has migrated downward around the outside of the casing or contamination that was carried down during the drilling of this borehole. The contamination*”...[i.e., Co-60 and Eu-154]...“*detected between 50 and 75 ft originated from a breach of the TX-107 tank structure.*” Figure 4-9 shows the depths of radioactivity from 1980 to 1995 (RPP-6353).

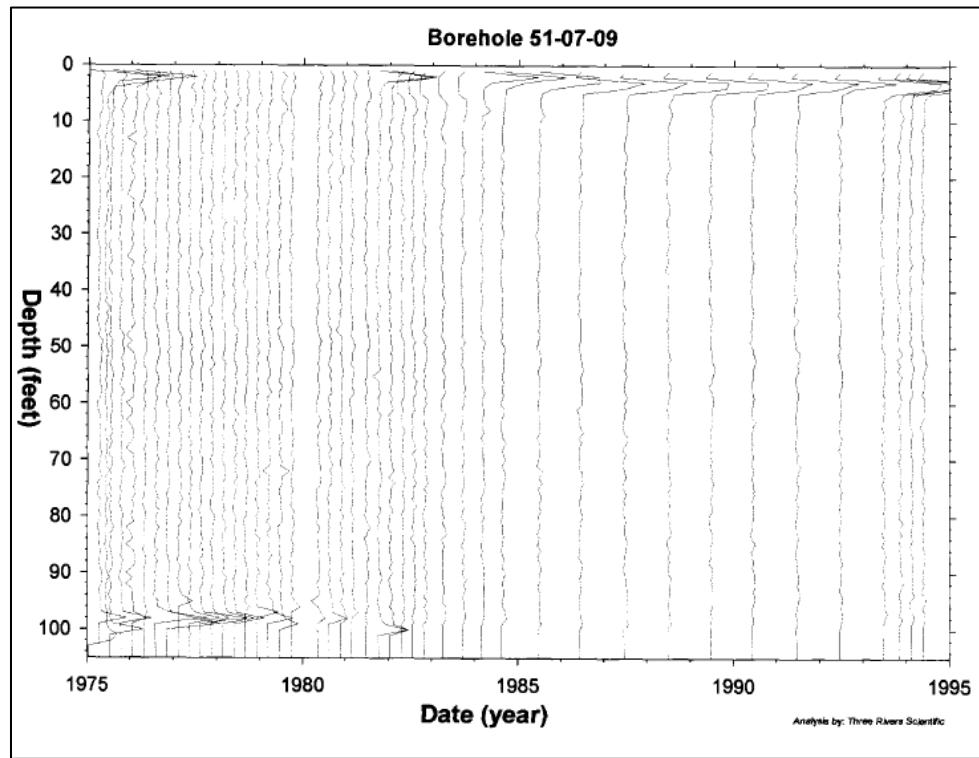
**Figure 4-10. Tank TX-107 Drywell 51-07-09 (RPP-6353)**

Since historical radioactivity in this drywell is very low, and the 1996 SGLS report low levels of radioactivity, drywell 51-07-09 is not being included as part of the leak location for tank TX-107. Figure 4-10 shows the depths of radioactivity from 1975 to 1995 (RPP-6353).

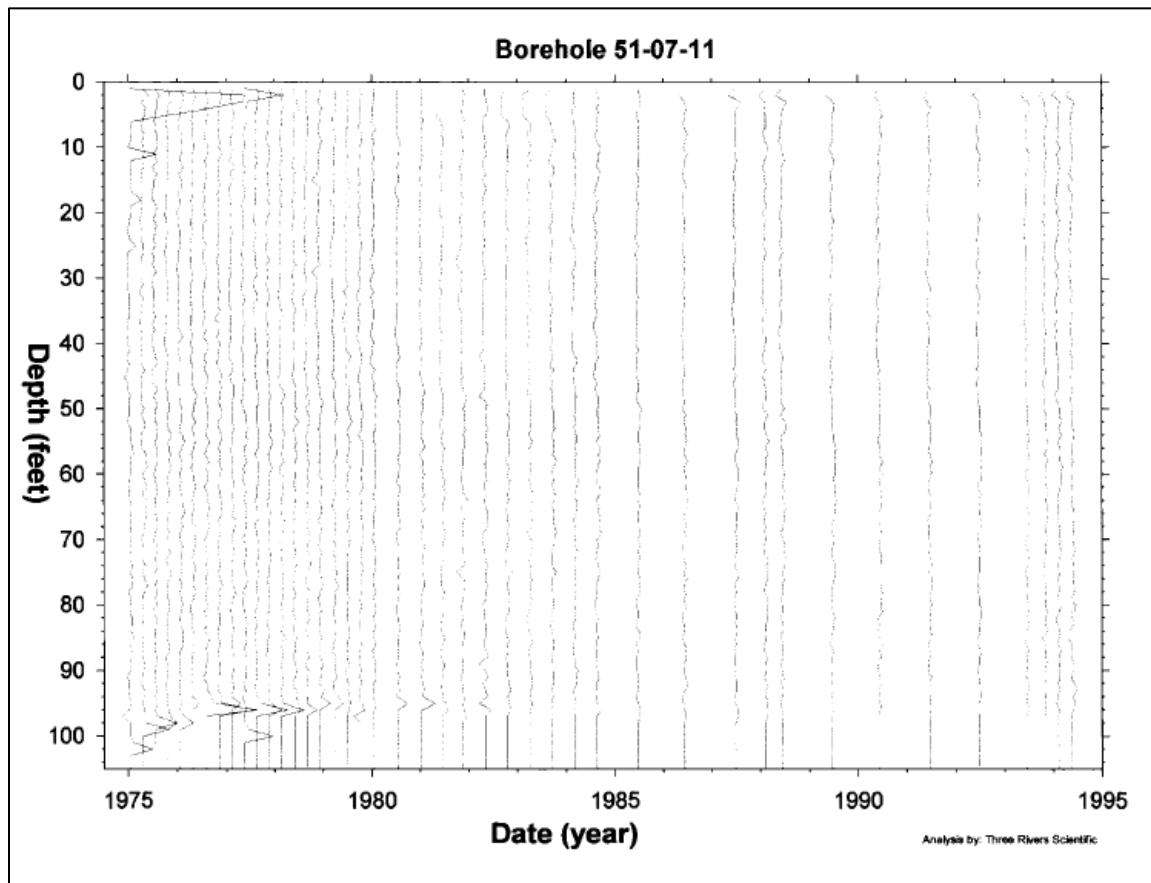
**Figure 4-11. Tank TX-107 Drywell 51-07-11 (RPP-6353)**

Since historical radioactivity in this drywell is very low, and the 1996 SGLS report low levels of radioactivity, drywell 51-07-11 is not being included as part of the leak location for tank TX-107. Figure 4-11 shows the depths of radioactivity from 1975 to 1995 (RPP-6353).

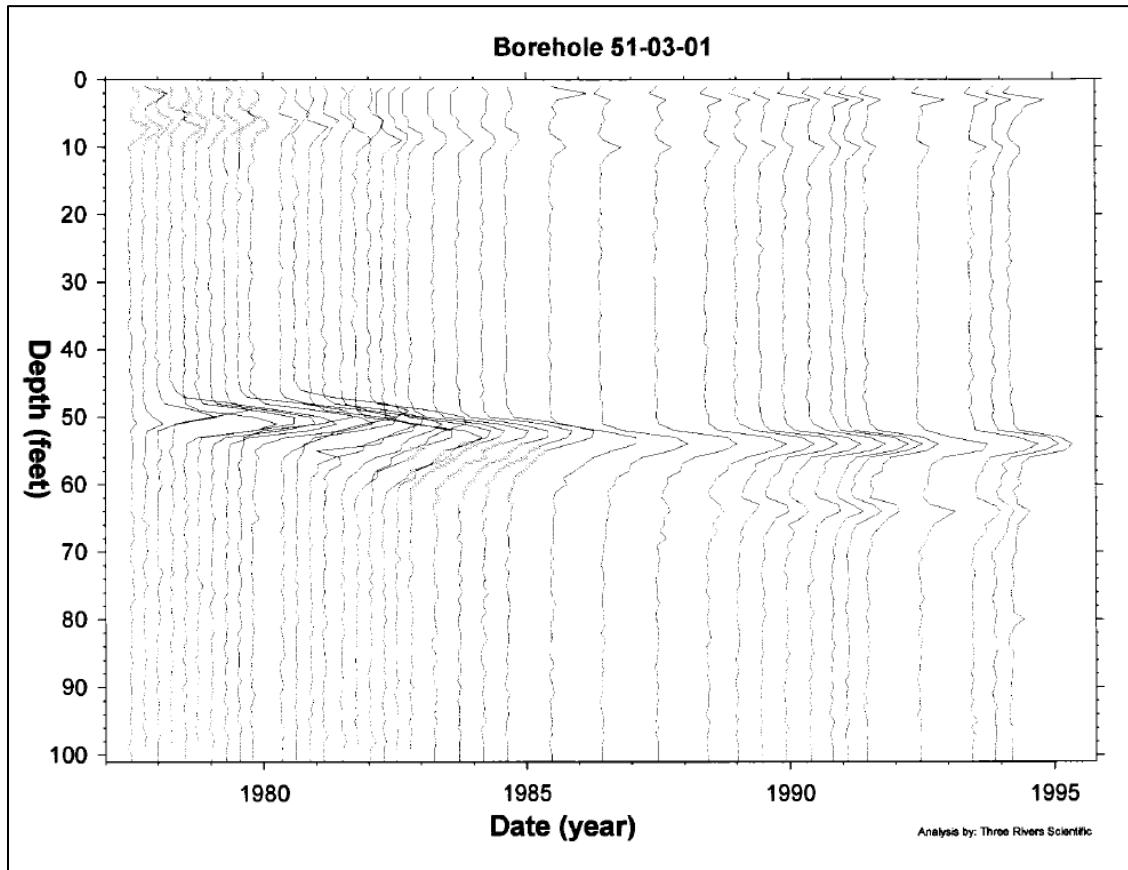
**Figure 4-12. Tank TX-107 Drywell 51-03-01 (RPP-6353)**

Drywell 51-03-01 is located approximately 19-ft from the tank TX-107 footing. Drywell 51-03-01 was drilled on June 8, 1977 with the first recoverable reading on June 8, 1977 reported as less than values through July 6, 1977 (see Appendix A1). Beginning on August 5, 1977, radioactivity was detected at about the 50-ft BGS level and gradually increased to 206.2K cpm by September 19, 1979. Readings then slowly declined from the 206.2K cpm peak reported in September 1979 to 49.7K cpm on June 11, 1986 at 54-ft BGS (see Appendix A1).

In November 1996, Cs-137, Eu-154, and Co-60 were the only man-made gamma-emitting radionuclides detected in drywell 51-03-01 (GJ-HAN-44, *Vadose Zone Characterization Project at the Hanford Tank Farms Tank Summary Data Report for Tank TX-103*). Cs-137 was detected continuously from the ground surface to 16.5-ft BGS, and intermittently at concentrations of 1 pCi/g or less between 19 and 49-ft BGS. The maximum Cs-137 concentration of 50 pCi/g was detected at a depth of 1-ft BGS. Co-60 and Eu-154 were detected from 51 to 68-ft BGS at concentrations ranging from 0.2 to 20 pCi/g for Co-60 and at concentrations less than 10 pCi/g for Eu-154. Document GJ-HAN-44 reports, “*The plume probably originated from a subsurface leak in tank TX-107 and will be discussed more fully in the TSDR for tank TX-107.*” Figure 4-12 shows the depths of radioactivity from 1975 to 1995 (RPP-6353).

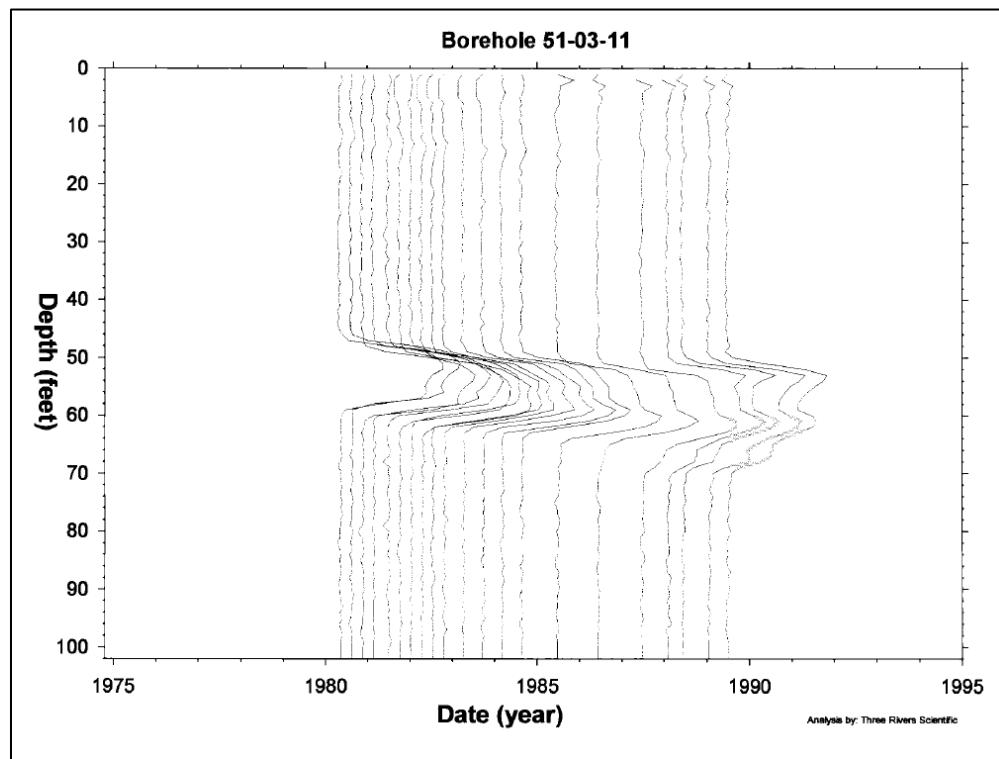
**Figure 4-13. Tank TX-107 Drywell 51-03-11 (RPP-6353)**

Drywell 51-03-11 is located approximately 19-ft from the tank TX-107 footing. Drywell 51-03-11 was drilled on May 25, 1977 with the first recoverable reading on May 25, 1977 reported a peak of 2.8Kcpm at 51-ft BGS (see Appendix A1). Radioactivity slowly increased to 37.9K cpm on October 17, 1977 and then increased to 133.2K cpm by March 8, 1978. On May 8, 1978 a separate peak was recorded at 56-ft BGS at 3.3K cpm. Readings continued to increase and reached 697.9K cpm by February 24, 1981 at 53-ft BGS. Radioactivity then slowly declined to 274.6K cpm by June 11, 1986 at depths ranging from 52 to 69-ft BGS (see Appendix A1).

In November 1996, Cs-137, Eu-154, Eu-152, and Co-60 were the only man-made gamma-emitting radionuclides detected in drywell 51-03-11 (GJ-HAN-44). Cs-137 was detected continuously from the ground surface to 23-ft BGS with the maximum concentration of 25 pCi/g detected at 1-ft BGS. Co-60 was detected from 51 to 68-ft BGS at concentrations ranging from 50 to 114 pCi/g, and from 68 to 100-ft BGS at concentrations ranging from 0.2 to 10 pCi/g. Eu-154 was detected between 51 and 60-ft BGS at concentrations ranging from 1.5 to 17 pCi/g. Document GJ-HAN-44 reports, *“The shallow Cs-137 contamination encountered in the borehole probably originated from a surface spill and is not indicative of a subsurface leak. The Co-60 in the zone below a depth of 61 ft probably originated from a subsurface leak; the top of the plume is well below the base of the tank. However, the leak did not originate from tank TX-103”*... *“The plume may have originated from a leak in tank TX-107.”* Figure 4-13 shows the depths of radioactivity from 1980 to 1995 (RPP-6353).

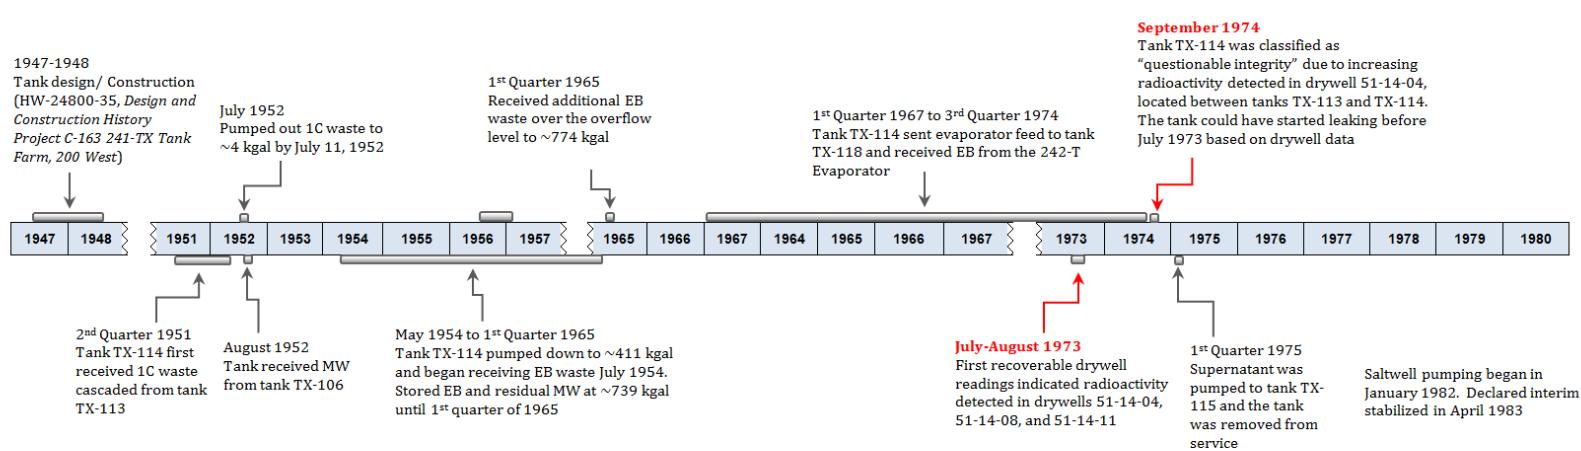
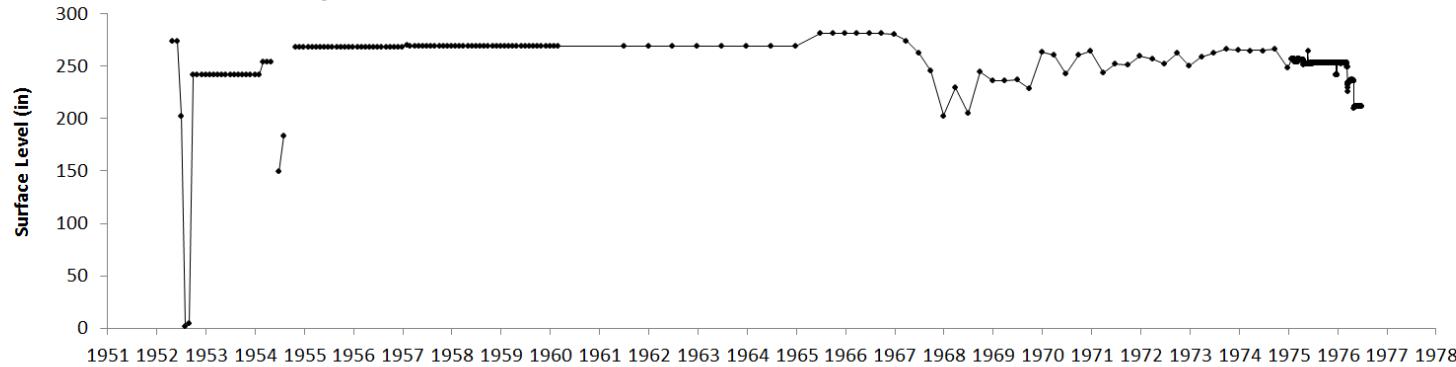
Figure 5-2. Operational Leak History of Tank TX-114

Tank TX-114 was classified as “questionable integrity” in 1974, based on increasing gamma activity in drywell 51-14-04 (SD-WM-TI-356). The Waste Tank Summary Report (HNF-EP-0182) does not report a leak volume estimate for this tank other than assigning an 8,000 gal leak based on the average leak volume estimate for 19 tanks (8901832B R1 – Letter). Jet salt well pumping began in January 1982 and was completed in November 1982. Pumping stopped due to failure of the jet pump. The tank was declared interim stabilized April 5, 1983 with an estimated 15,000 gal of drainable liquid remaining and 4,000 gal of pumpable liquid (HNF-SD-RE-TI-178). The operational history of tank TX-114 leak related details including liquid level is charted in Figure 5-2.

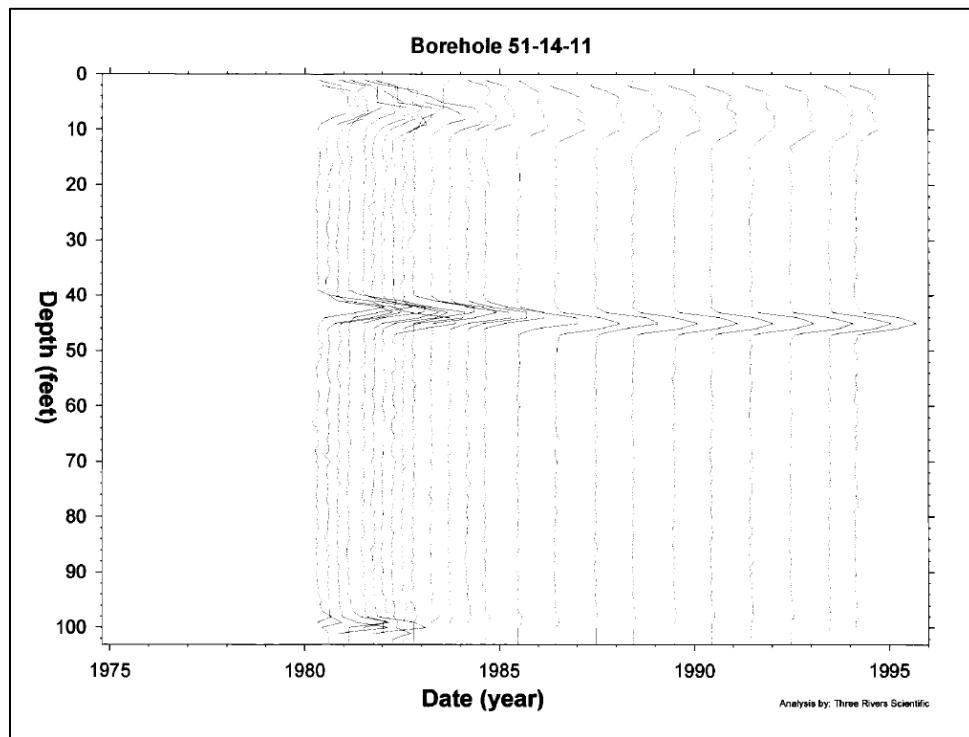
**Figure 5-6. Tank TX-114 Drywell 51-14-11 (RPP-6353)**

Document GJ-HAN-59 reports, “*The Cs-137 contamination detected by the SGLS and historical data suggest a subsurface source such as a leak from either tank TX-113 or TX-114. The proximity of borehole 51-14-04 to tank TX-114, as well as the “extensive tar leakage” and “possible cracks in the liner” identified in 1976 (Jensen 1976b), suggest that tank TX-114 is the most likely source of this contamination. However, tank TX-113 cannot be ruled out as a potential source of contamination. Unfortunately, detailed records that could identify and quantify tank leaks prior to 1973 are not available.*” Drywell 51-14-11 was reported to be more associated with tank TX-114 than tank TX-113 (OR 74-129). Tank TX-117 cannot be ruled out as a possible source of radioactivity from drywell 51-14-11 as there are no other intervening drywells to eliminate tank TX-117 being a source. Therefore, tanks TX-113 and TX-117 cannot be ruled out as possible sources. The RPP-32681 process recommended both of these tanks be further assessed using TFC-ENG-CHEM-D-42 since historical data suggest they are misclassified as assumed leakers. If they are determined to be sound then they would be eliminated as possible leak sources affecting drywell 51-14-11. Figure 5-6 shows the depths of radioactivity from 1980 to 1995 (RPP-6353).

The first recoverable reading for drywell 51-14-11 reported a peak of 342K cpm at 39-ft BGS on August 30, 1973. Readings remained relatively stable through May 1974 and then slowly declined to 53.2K cpm by June 1986. The most likely source of this radioactivity is tank TX-114; however, tanks TX-113 and TX-117 cannot be ruled out as possible sources since both of these tanks have been recommended to be further assessed using TFC-ENG-CHEM-D-42 to determine correct leak integrity status and/or eliminate possible drywell contribution.

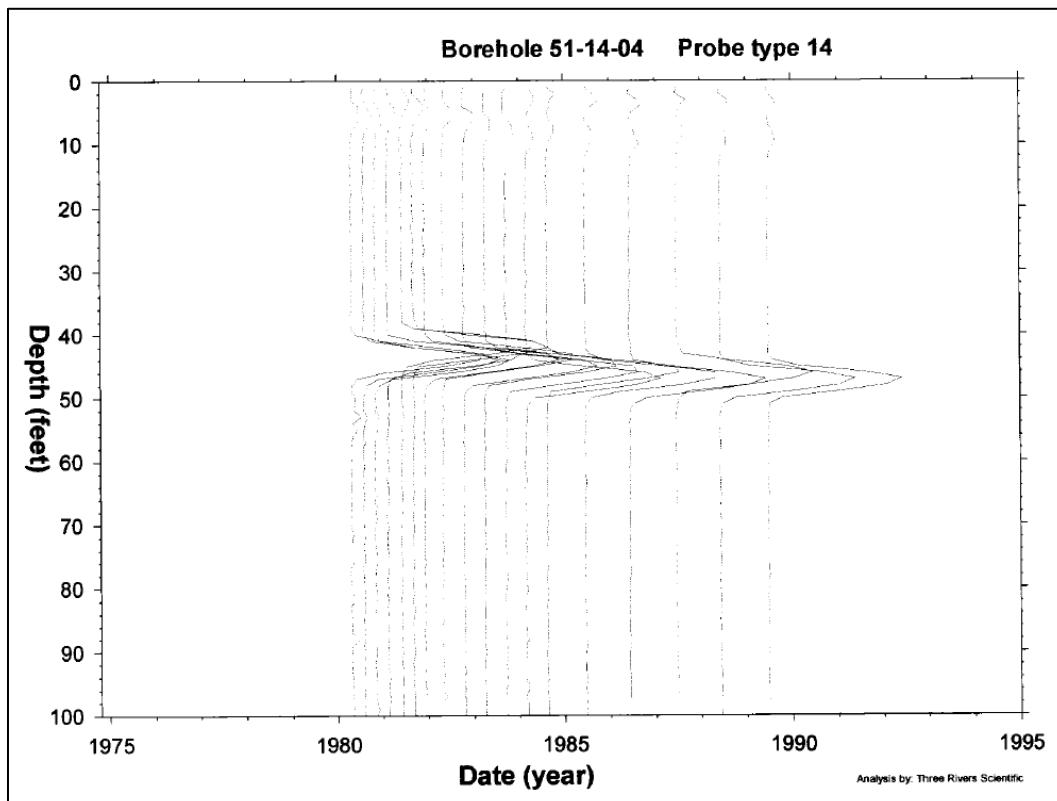
**Figure 5-7. Tank TX-114 Drywell 51-14-04 (RPP-6353)**

In March 1997, Cs-137 was the only man-made gamma-emitting radionuclide detected almost continuously in drywell 51-14-04 from the ground surface to 97.5-ft BGS (GJ-HAN-59). The highest contamination levels (1,843 pCi/g) were observed at a depth of 47-ft BGS. However, higher concentrations are probable between 45 and 46.5-ft BGS since the detector became saturated and radionuclide concentrations could not be calculated. Document GJ-HAN-59 reports, “*The Cs-137 contamination between 42 and 50 ft is probably from a subsurface source (i.e., a leak from tank TX-113 or TX-114).*”

It was suggested tank TX-114 is the more probable source; however, tank TX-113 cannot be ruled out. Figure 5-7 shows the depths of radioactivity from 1980 to 1995 (RPP-6353).

Drywell 51-14-04 (located 1.8-ft from tank TX-114 and 17-ft from tank TX-113) first recoverable reading reported a peak of 2.1K cpm at 42-ft BGS on August 27, 1973. Readings continued to be reported at roughly the same intensity through May 1974 between 42 and 48-ft BGS. Due to the usage of new monitoring equipment, the peak increased to 972.8K cpm at 47-ft BGS on July 26, 1974. The source of this radioactivity is likely from tank TX-114. It is likely the tank TX-114 leak was near drywell 51-14-04 based on later SGLS data (see Figure 5-11 and Figure 5-12) and proximity to tank TX-114. However, tank TX-113 cannot be ruled out as a possible source since this tank has been recommended to be further evaluated using TFC-ENG-CHEM-D-42 to eliminate possible drywell contribution.

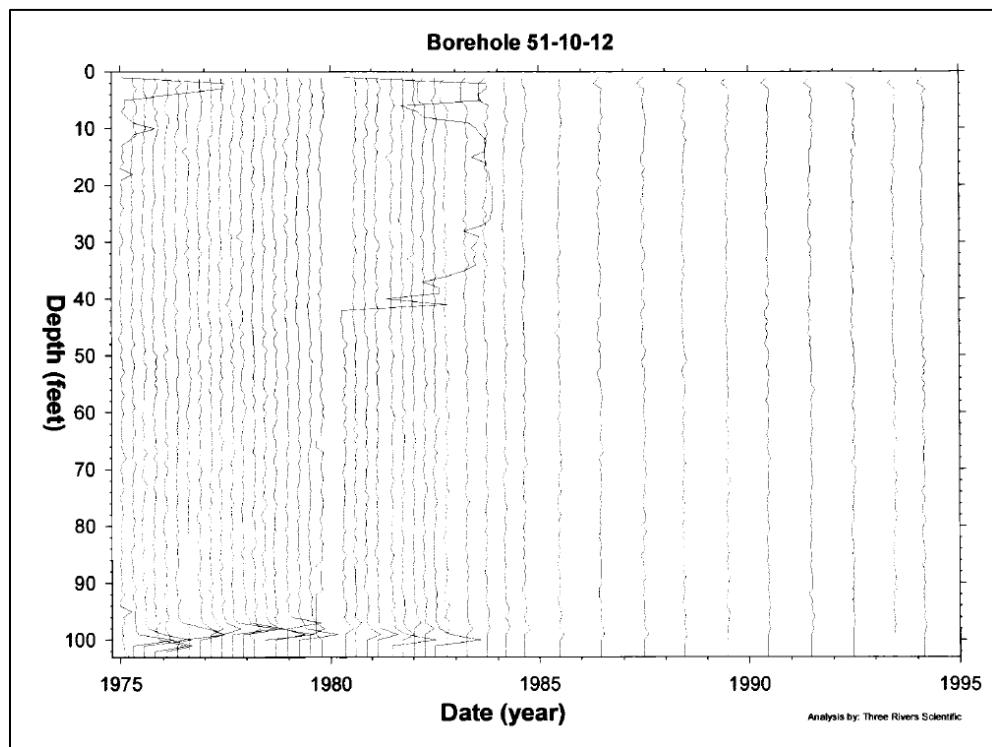
**Figure 5-8. Tank TX-114 Drywell 51-10-12 (RPP-6353)**

Since historical radioactivity in this drywell is very low, and the GJ-HAN-59 report indicated low levels of radioactivity below the surface level, drywell 51-10-12 is not being included as part of the leak location for tank TX-114. Figure 5-8 shows the depths of radioactivity from 1975 to 1995 (RPP-6353).

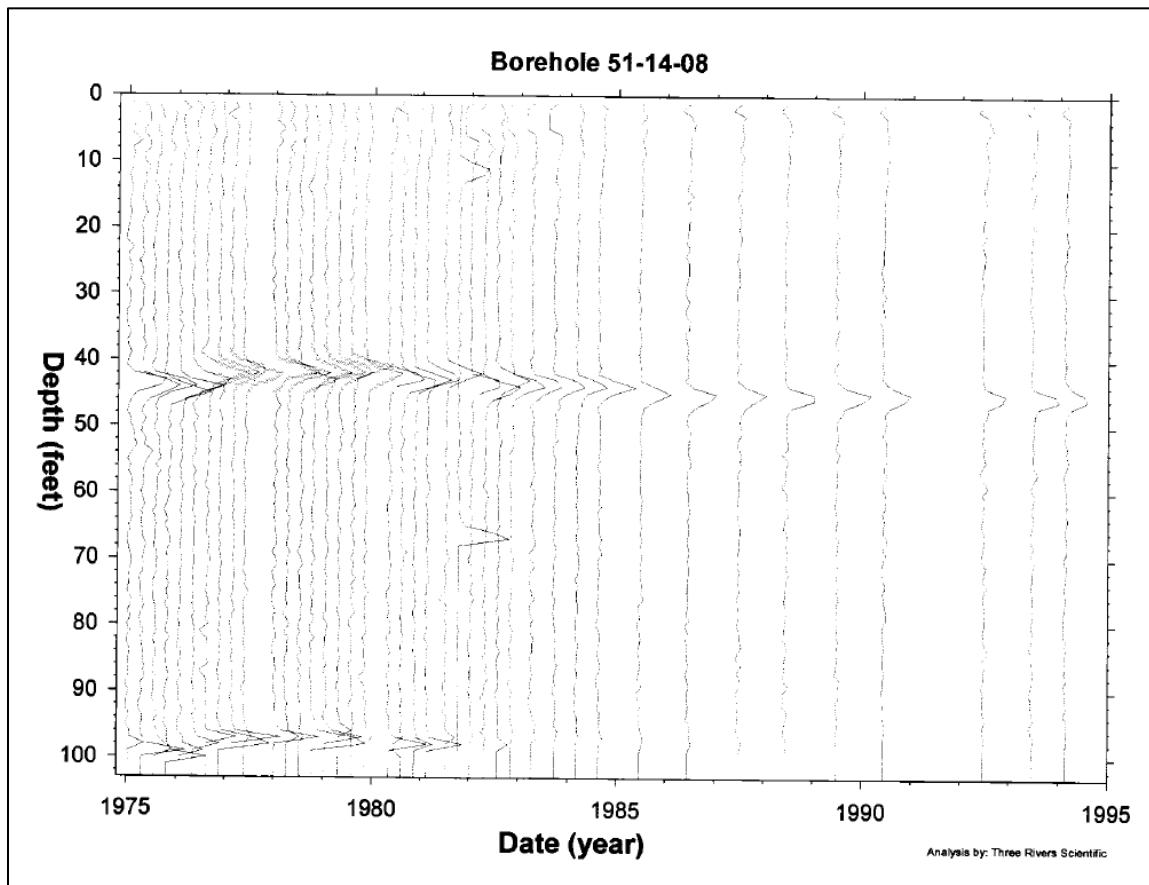
**Figure 5-9. Tank TX-114 Drywell 51-14-08 (RPP-6353)**

In March 1997, Cs-137 was the only man-made gamma-emitting radionuclide detected almost continuously in drywell 51-14-08 from the ground surface to 98-ft BGS (GJ-HAN-59). The maximum concentration of about 10 pCi/g was reported at 3-ft BGS. A distinctive peak was identified at 44-ft BGS with a maximum concentration of 1.9 pCi/g. Document GJ-HAN-59 states, “*The Cs-137 contamination between 43 and 47 ft is probably from a subsurface source such as a leak from tank TX-113 or TX-114.*” However, tanks TX-110 and TX-115 cannot be ruled out as a possible source of radioactivity from this drywell. The RPP-32681 process recommended both of these tanks be further assessed using TFC-ENG-CHEM-D-42 since historical data suggest they are misclassified as assumed leakers. If they are determined to be sound then they would be eliminated as possible leak sources affecting drywell 51-14-08. Figure 5-9 shows the depths of radioactivity from 1975 to 1995 (RPP-6353).

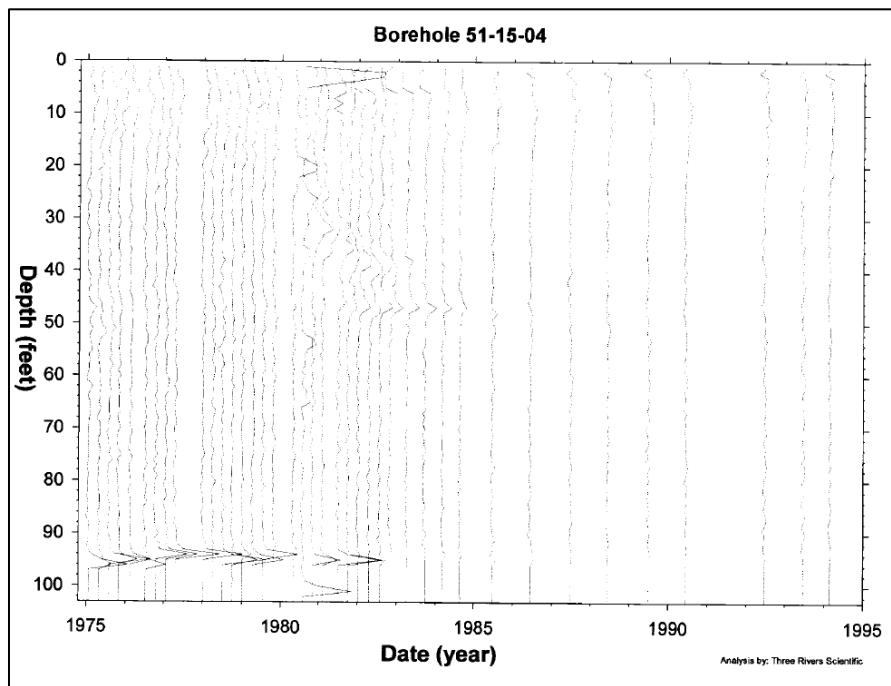
**Figure 5-10. Tank TX-114 Drywell 51-15-04 (RPP-6353)**

Since historical radioactivity in this drywell is very low, and the GJ-HAN-59 report indicated low levels of radioactivity below the surface level, drywell 51-15-04 is not being included as part of the leak location for tank TX-114. Figure 5-10 shows the depths of radioactivity from 1975 to 1995 (RPP-6353).

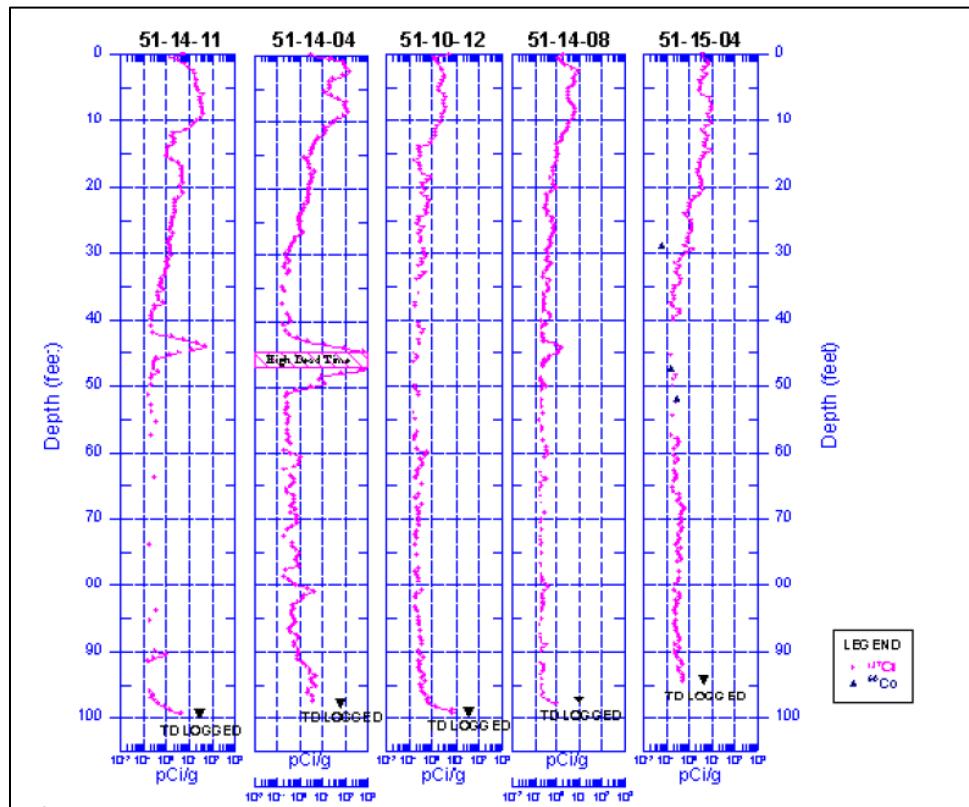
**Figure 5-11. 1996 and 1999 Spectral Gamma Logging Results for Drywells near Tank TX-114 (GJO-HAN-11)**

Tank TX-114 was overfilled 1965 through 1967. A packing leak from the cascade inlet line which is near drywell 51-14-04 as well as a leak from the capped spare inlet lines seem unlikely sources of radioactivity in the drywell. The cascade and spare inlet lines are located 23-ft 6-in BGS and the first recoverable reading in 51-14-04 reported a peak at 42-ft BGS. The relative distance of a potential cascade or inlet line leak to the point of detection would seem to favor a lower sidewall leak as opposed to the higher cascade line packing leak or capped leaking spare inlet lines.
