Laser Spot Weld Repair of MC4779 Shunt Wire Resistance Weld

Dept 1813 Joining & Coating

***IMOG Joining Subgroup
March 12, 2008***

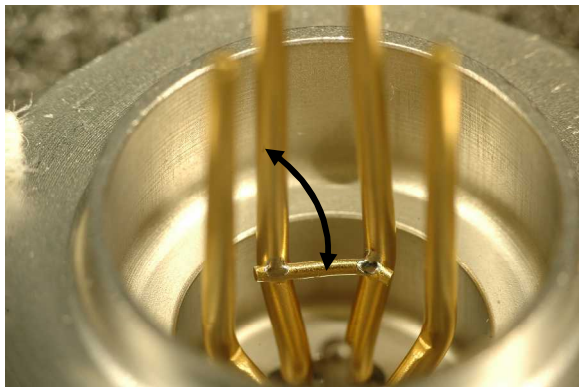
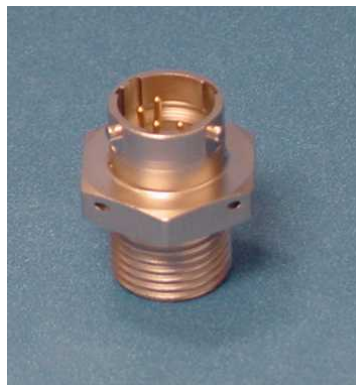
**Igniter Connector
Pin Housing
requires steep
angle for weld and
shooting through
another pair of pins
while avoiding the
pin connector body**

- 5 J/p (220 V at 1.5 Hz)
- 10 ms pulse length
- At focus with 5" f.l. lens
- Igniter Connector Pin Housing requires steep angle for weld
- No clamping of broken weld; i.e., there can exist a small initial gap for the laser spot weld to bridge
- UHP Ar shield gas

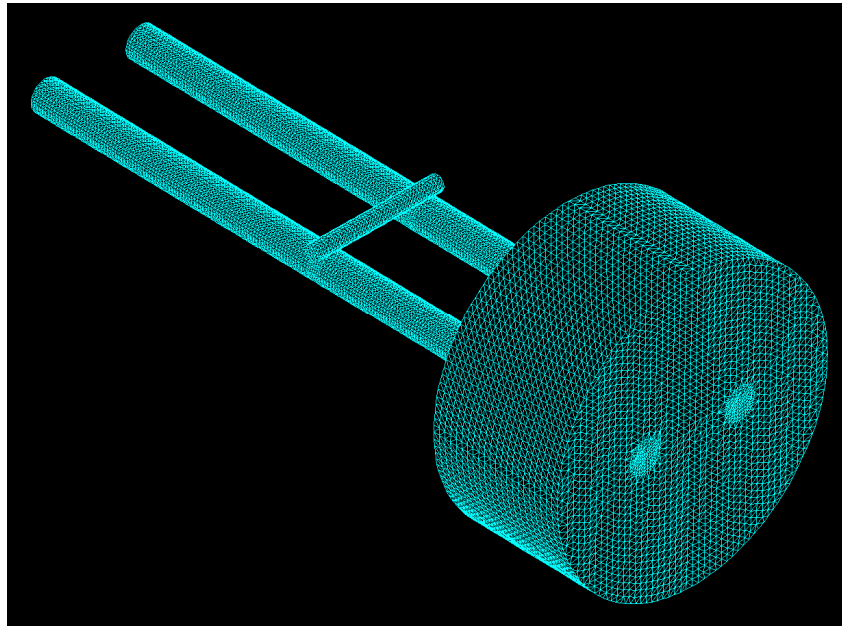
FEA Model to determine Heat rise at Powder surface

Heat transfer can take place along the vertical pins, through the glass seal to the explosive powder !

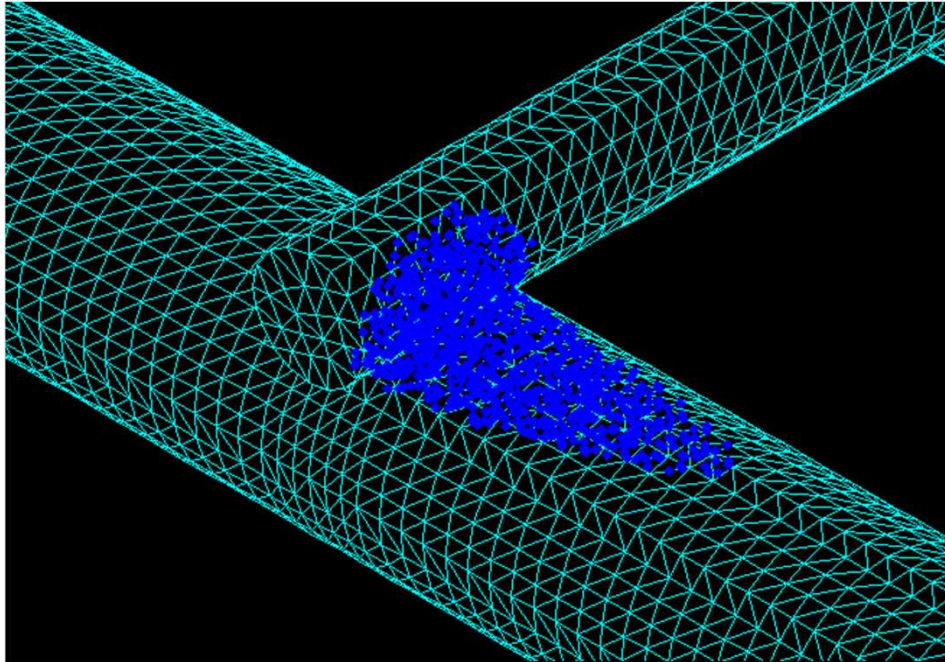
Heat Source

Volume-elements heat source impinging with a slightly more than 50% illumination of vertical post.

Temperature Rise Negligible
