| <b>DOCUMENT RELEASE AND CHANGE FORM</b> | | 1a. Doc No: RPP-RPT-54911    Rev. 01 | | | | | | | | | | | | | | | | | | | | | | | | | | | | | | | | | | | | | | | | |
|---|---|---|---|---|---|---|---|---|---|---|---|---|---|---|---|---|---|---|---|---|---|---|---|---|---|---|--|--|--|--|--|--|--|--|--|--|--|--|--|--|--|--|
| <b>2. Document Title</b><br>Hanford Single-Shell Tank Leak Causes and Locations - 241-BY and 241-TY Farm | | | | | | | | | | | | | | | | | | | | | | | | | | | | | | | | | | | | | | | | | | |

| <b>Purpose of Document:</b> Identifies leak causes and locations for BY and TY Farm tanks | |

Key Words: leak location, leak cause, tank, integrity assessment, BY Farm, TY Farm, BY-103, TY-103, TY-104, TY-105, TY-106, leak assessment

**Abstract:** This document identifies 241-BY Tank Farm (BY Farm) and 241-TY Tank Farm (TY Farm) leak causes and locations for the 100 series leaking tanks (241-BY-103, 241-TY-103, 241-TY-104, 241-TY-105, and 241-TY-106) identified in RPP-RPT-43704, Hanford BY Farm Leak Assessments Report, and in RPP-RPT-42296, Hanford TY Farm Leak Assessments Report. This document satisfies the BY and TY Farm portion of the target (T04) in the Hanford Feder

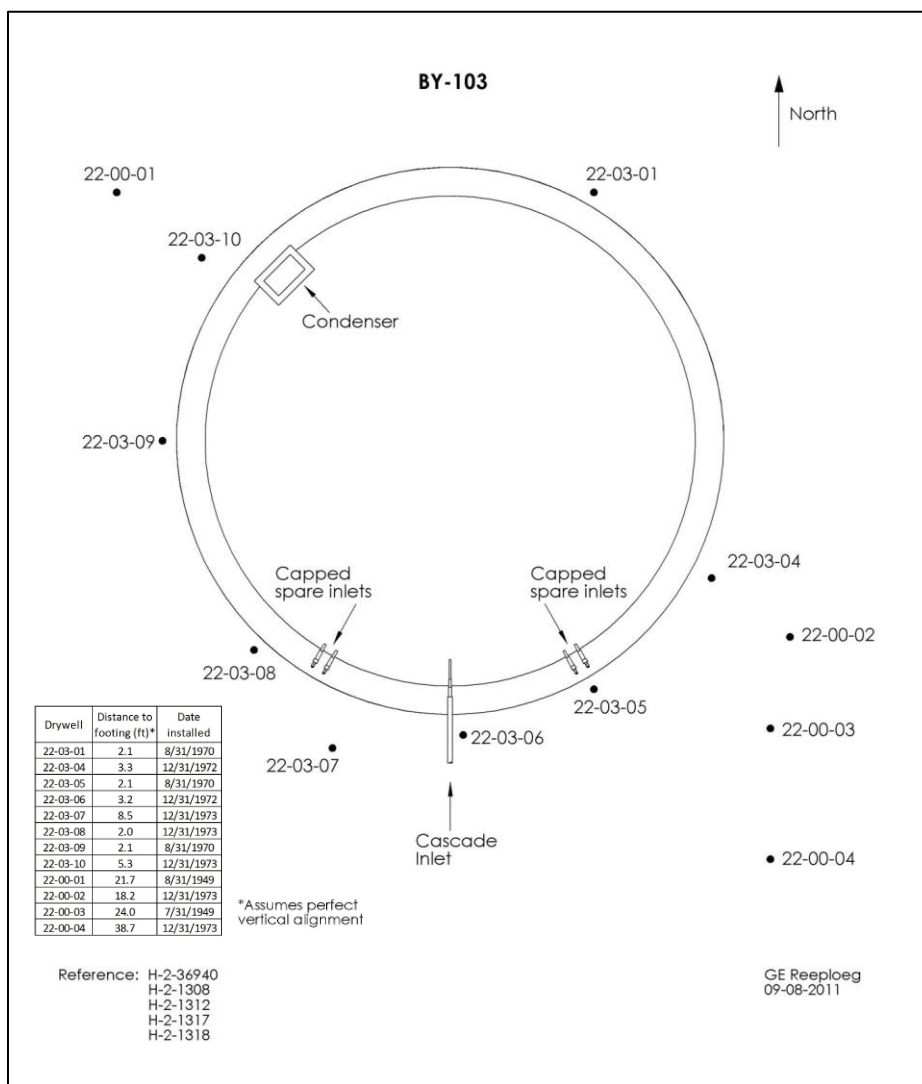
**Figure 4-1. Tank BY-103 Associated Drywells**  
Tank inner ring is steel liner, outer ring is outer edge of tank footing

Radioactivity detected at the higher BGS levels in drywell 22-03-05 does not appear to be the result of leakage from the cascade inlet pipe nor the capped spare inlet lines (see Figure 4-1). The spare inlet nozzles and the cascade inlet pipe are located at approximately 22-ft 1-in BGS and radioactivity was detected at a much lower BGS level in drywell 22-03-05. It appears radioactivity detected at the higher BGS level in drywell 22-03-05 is likely the result of sidewall leak from tank BY-103.

in drywell 22-03-09 at 34-ft BGS indicate a possible sidewall leak and the source of radioactivity at the 18-ft BGS level remains unclear since no pipes that were reported to have leaked are present in this area at these BGS levels (see Figure 4-1). Also, the nearby spare inlet lines at ~22-ft 1-in BGS do not appear to be a likely source location. Radioactivity detected in drywells 22-03-08 and 22-03-10 is likely the result of migration from the leak site that appears to be near drywell 22-03-09.

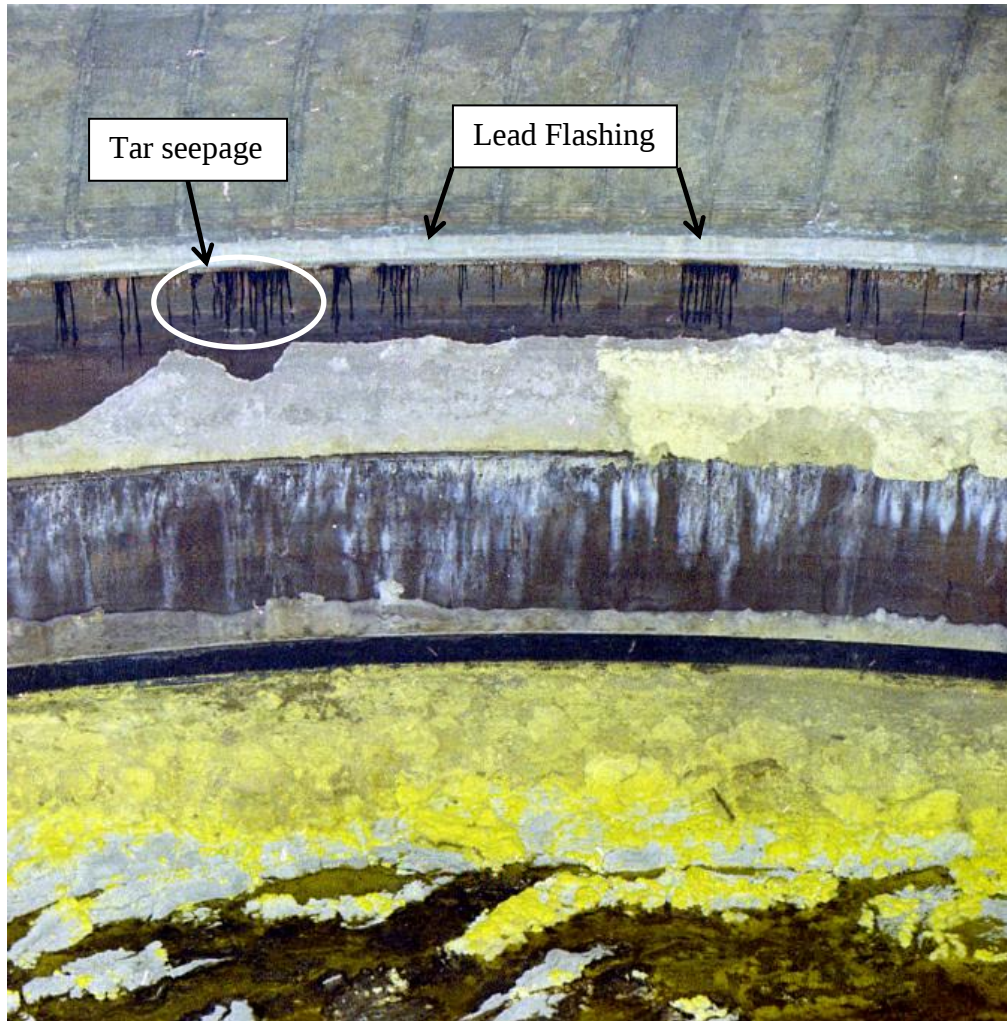
**Figure 4-4. Tank BY-103 Tar Seepage  
March 5, 1981  
(Photograph 9511211 11-CN)**

Tar seepage (asphalt) was visible below the lead flashing at the top of the liner in 1980 photographs of tank BY-103 (see Figure 4-4). In this case only a small portion of the tank circumference was affected. Several other BY and TY tanks experienced tar seepage at the top of the liner and in the side walls (ARH-1496, *Review of Storage Tank Integrity*). The report indicated the mastic compound (three-ply asphaltic membrane waterproofing) placed between the steel liner and the concrete wall during construction could cause the asphalt to flow through a breach in the liner and lead flashing connection at non-boiling waste temperatures. It is unknown if any other asphalt seepage was experienced in tank BY-103 as photographs were not available of the tank wall below the level of the waste indicated in Figure 4-4.

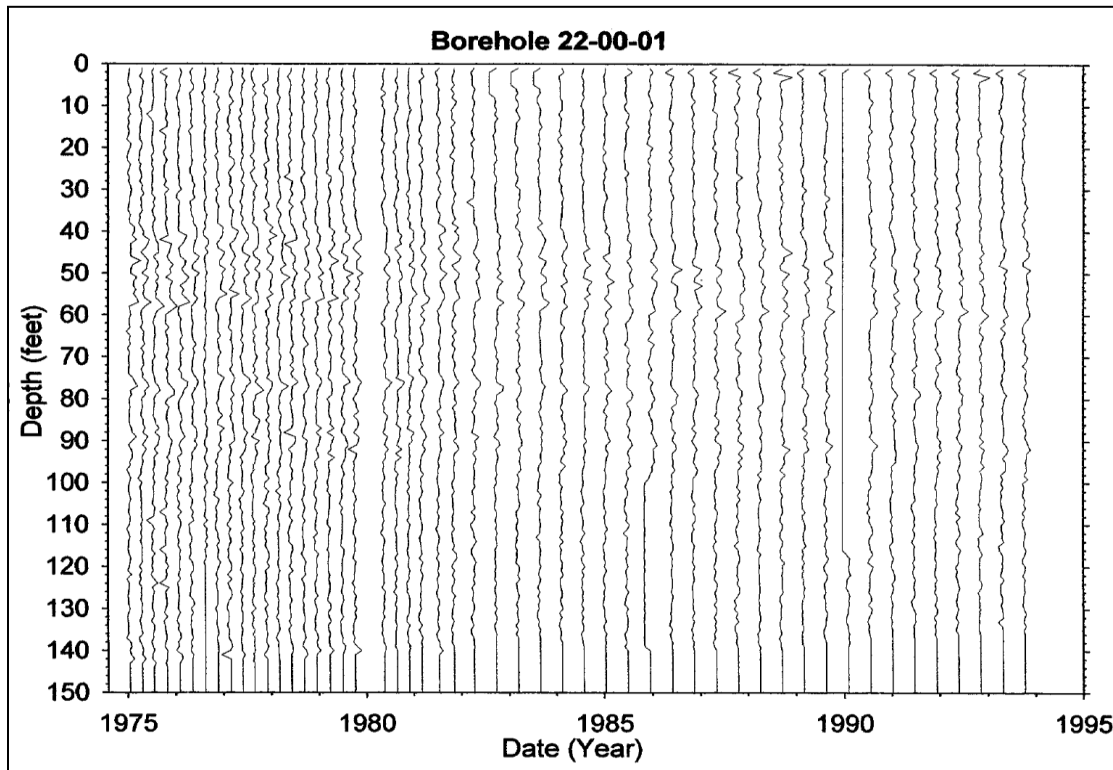
**Figure 4-5. Tank BY-103 Drywell 22-00-01 (HNF-3532)**

In February 1996, Cs-137 was the only man-made contaminant detected reported in this drywell from the surface to 6-ft, from 38 to 60-ft, from 76 to 82-ft, and from 86 to 97-ft BGS (GJ-HAN-20). It appears radioactivity detected in drywell 22-00-01 may not be associated with tank BY-103 as drywell 22-03-10 (installed December 1973), located between tank BY-103 and drywell 22-00-01, first reported radioactivity in early 1975 at a much higher BGS level (see Section 4.5.1.12). GJ-HAN-20 reports, "Contamination below 38 ft probably originated from a subsurface source, because the contamination does not extend to the surface at significant concentrations. Tank BY-103 or BY-106 is the likely source for this contamination." It remains inconclusive the source of radioactivity detected in this drywell, therefore, drywell 22-00-01 is not included as part of the leak location for tank BY-103. Figure 4-5 shows the depths of radioactivity from 1975 to 1994 (HNF-3532).

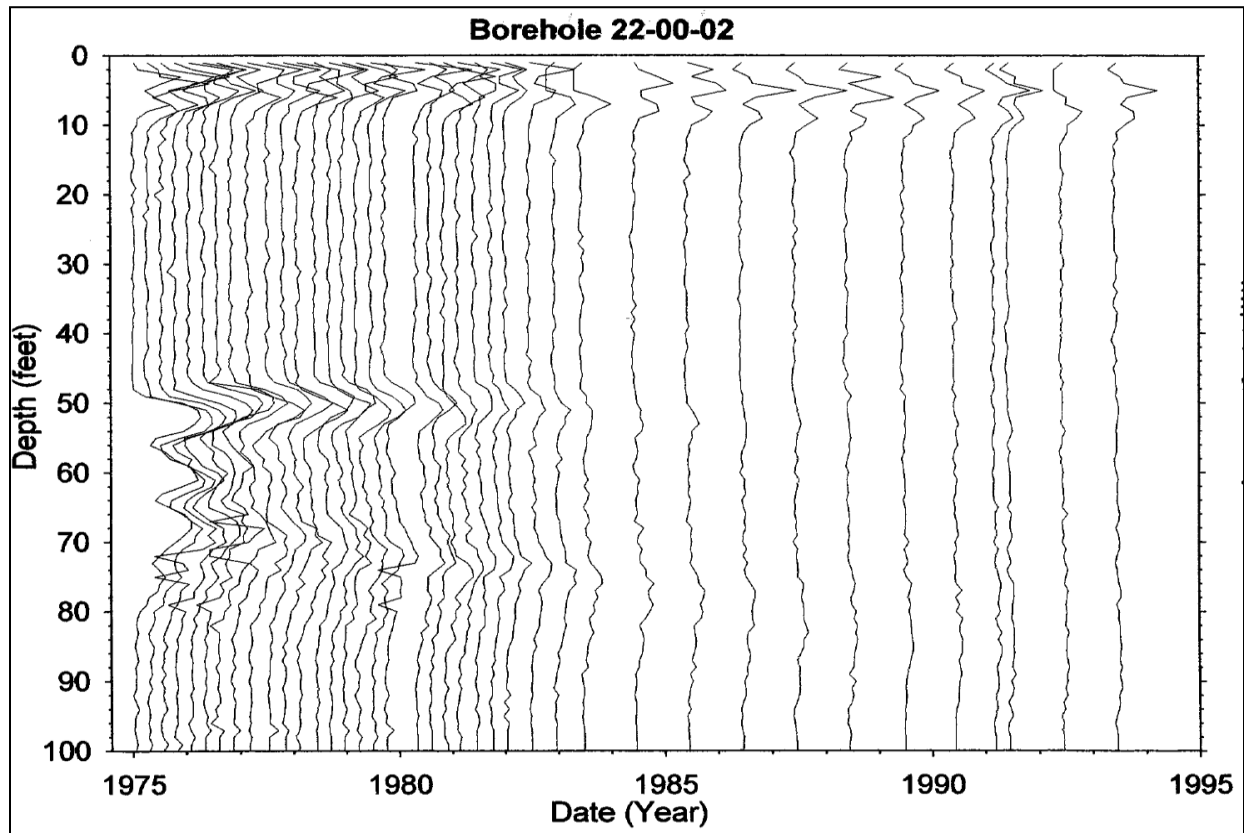
**Figure 4-6. Tank BY-103 Drywell 22-00-02 (HNF-3532)**

Document GJ-HAN-20 states that tank BY-103 is most likely the source of the Co-60 and Sb-125 that was detected at approximately 50-ft BGS. Figure 4-6 shows the depths of radioactivity from 1975 to 1994 (HNF-3532).

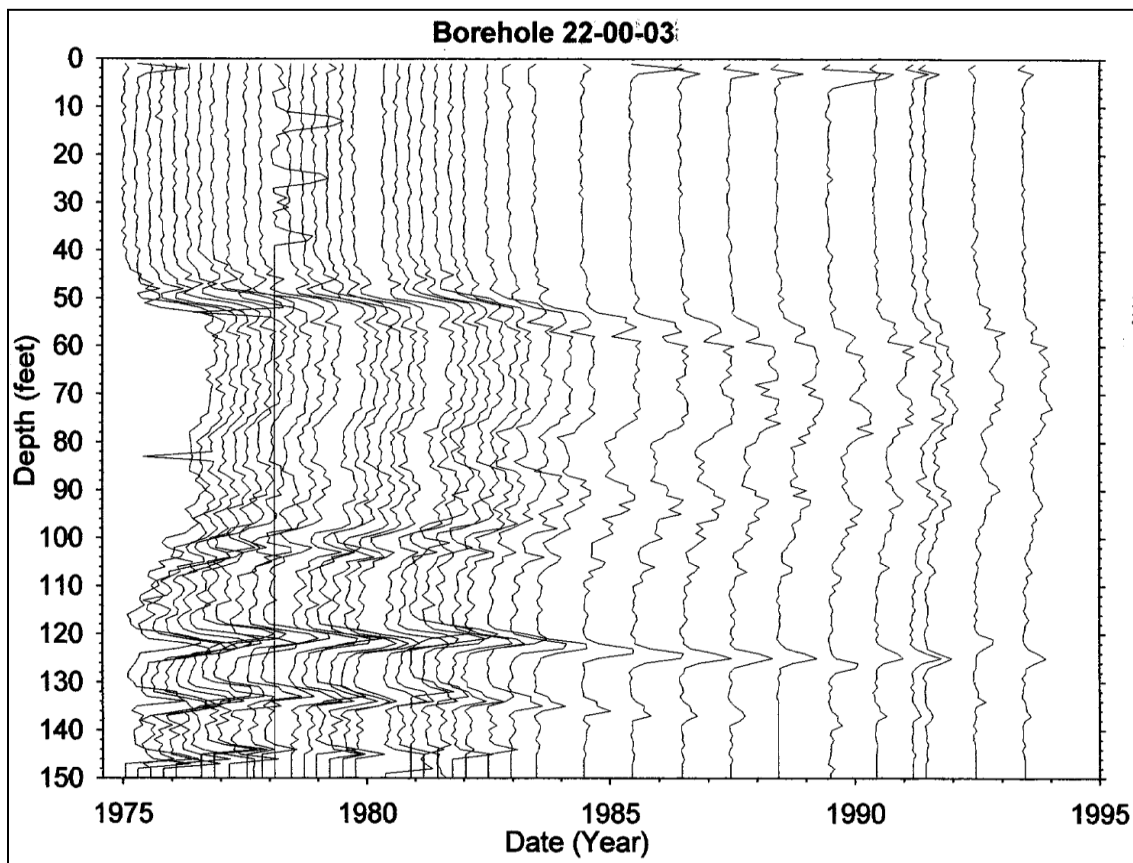
**Figure 4-7. Tank BY-103 Drywell 22-00-03 (HNF-3532)**

In February 1996, Cs-137, Cs-60, and Sb-125 were the only man-made contaminants detected in this drywell (GJ-HAN-20). From the ground surface to about 102-ft BGS, Cs-137 was detected continuously at concentrations up to about 20 pCi/g. Co-60 was detected almost everywhere below 46-ft BGS at concentrations up to 13 pCi/g and Sb-125 was detected from 54 to 72-ft BGS at concentrations of about 2 pCi/g. Document GJ-HAN-20 states the Cs-137, Co-60, and Sb-125 detected in this drywell likely originated from tank BY-103. Tank BY-103 was first suspected of leaking in 1969 based on radioactivity being detected in drywell 22-00-03 (Internal letter "Integrity of tanks 241-BY-103 and 241-TY-103"). Figure 4-7 shows the depths of radioactivity from 1975 to 1994 (HNF-3532).

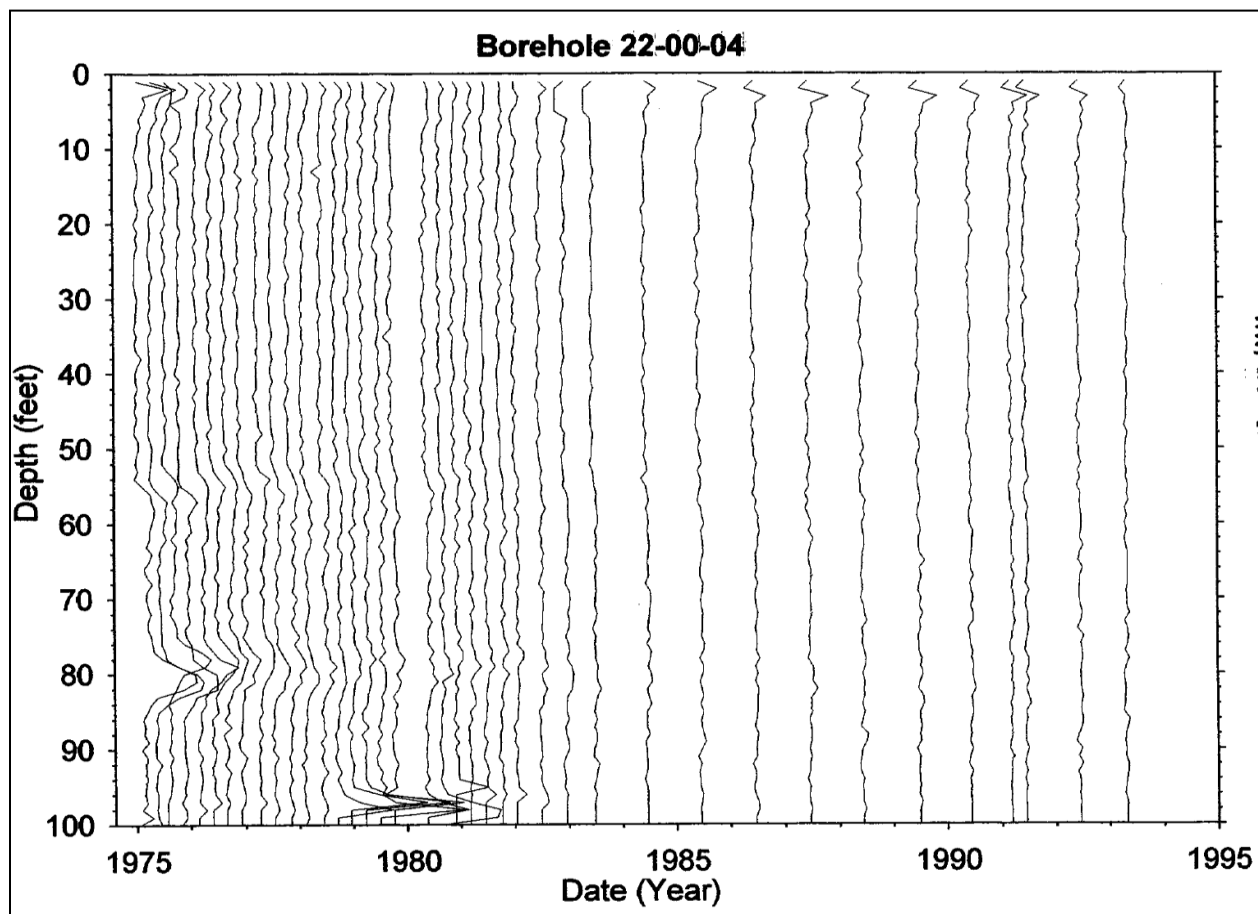
**Figure 4-8. Tank BY-103 Drywell 22-00-04 (HNF-3532)**

In February 1996, Cs-137 and Co-60 were the only man-made contaminants detected in this drywell (GJ-HAN-19, *Vadose Zone Monitoring Project at the Hanford Tank Farms Tank Summary Data Report for Tank BY-102*). From the ground surface to 33-ft BGS and from 95 to 99-ft BGS, Cs-137 was detected continuously and intermittently from 33 to 95-ft BGS. Concentrations of Cs-137 were measured at levels below 1 pCi/g. Co-60 was detected below 56-ft BGS at concentrations less than 1 pCi/g. Document GJ-HAN-19 states, "The Co-60 may have originated from a more distant subsurface source such as tank BY-103." Figure 4-8 shows the depths of radioactivity from 1975 to 1994 (HNF-3532).

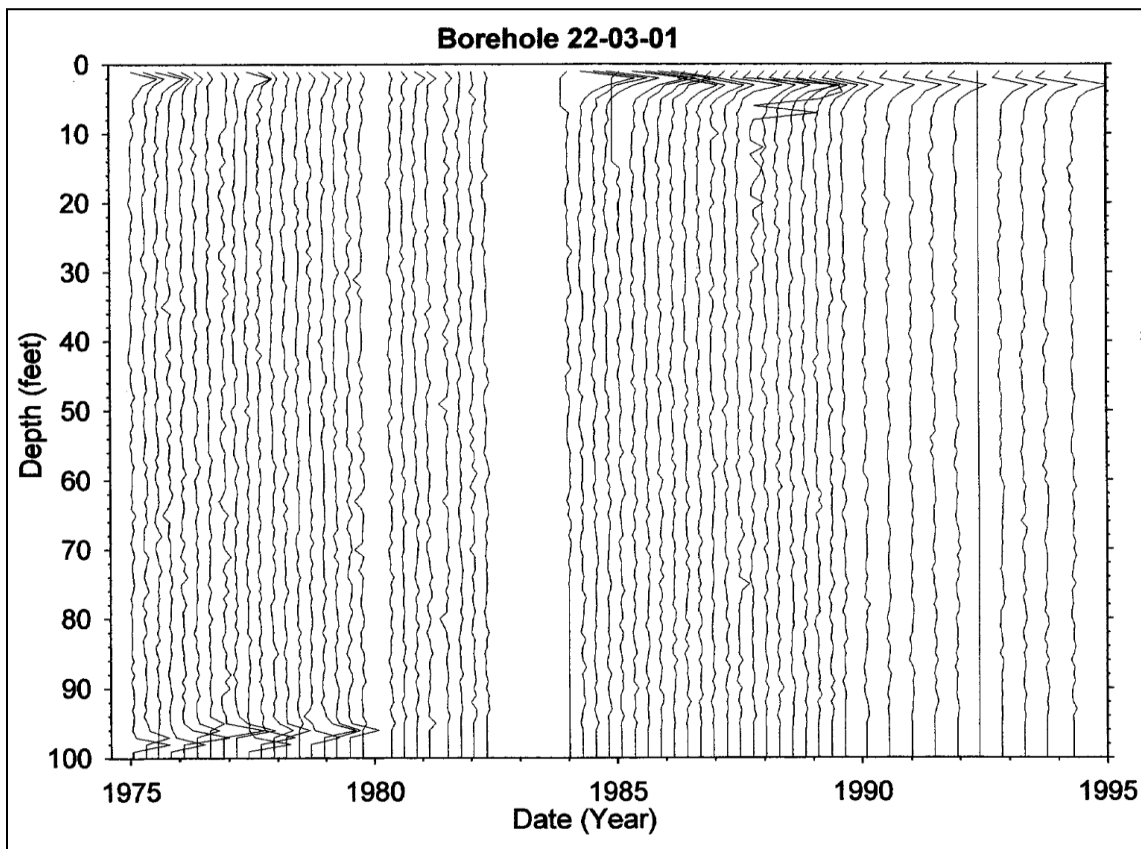
**Figure 4-9. Tank BY-103 Drywell 22-03-01 (HNF-3532)**

In February 1996, Cs-137 was the only man-made contaminant detected almost continuously in this drywell at concentrations of 2 pCi/g or less (GJ-HAN-20). Document GJ-HAN-20 states, "No evidence exists for a subsurface source of contamination near this borehole." Since historical records report little radioactivity in this drywell, drywell 22-03-01 is not included as part of the leak location for tank BY-103. Figure 4-9 shows the depths of radioactivity from 1975 to 1994 (HNF-3831).

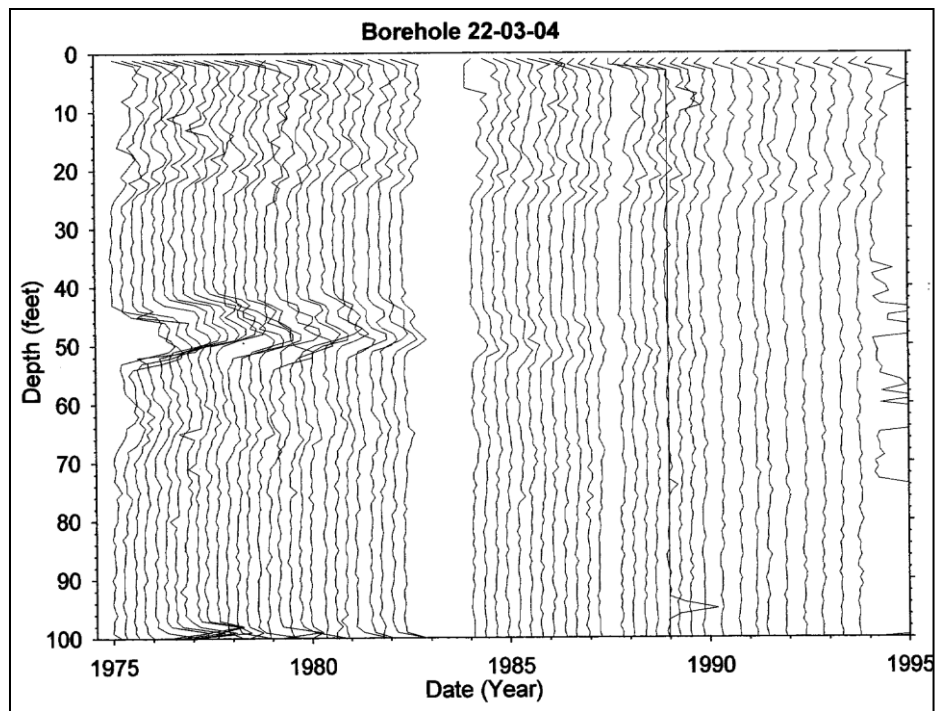
**Figure 4-10. Tank BY-103 Drywell 22-03-04 (HNF-3532)**

In February 1996, Cs-137, Co-60, and Sb-125 were the only man-made contaminants detected in this drywell (GJ-HAN-20). Cs-137 was detected continuously from the surface to about 32-ft BGS and discontinuously below 32-ft BGS with a maximum concentration of ~30 pCi/g. Co-60 was detected in two intervals: one near 49-ft BGS and the other near 75-ft BGS with a maximum concentration of about 1 pCi/g. Sb-125 was detected from 50 to 52-ft BGS at a maximum concentration of about 1 pCi/g. Document GJ-HAN-20 states, “The zone of Co-60 contamination from 45.5 to 58 ft probably originated from a leak of tank BY-103, at or near its bottom at 48 ft in depth. The lower zone of Co-60 contamination near 75 ft also originated from the subsurface, apparently from tank BY-103” and “Sb-125 originated from the subsurface, most likely from the same leak that produced the Co-60 contamination near 50 ft. The source was most certainly tank BY-103, which is the only tank near borehole 22-03-04.” This statement seems appropriate as there is no other nearby sources that would explain the Co-60 contamination. Figure 4-10 shows the depths of radioactivity from 1975 to 1994 (HNF-3532).

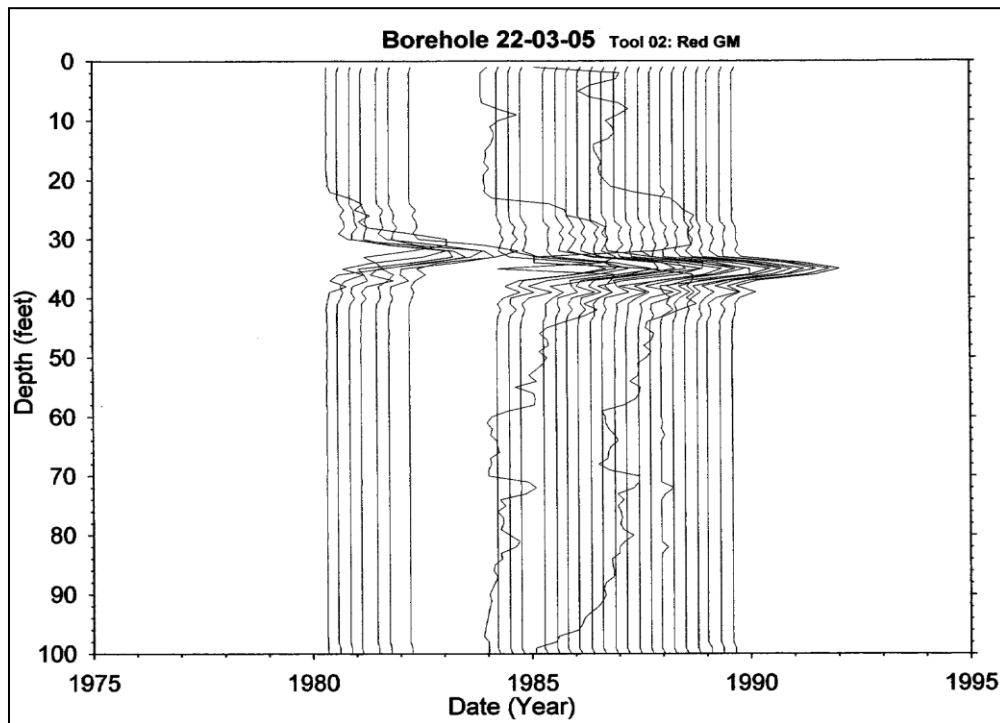
**Figure 4-11. Tank BY-103 Drywell 22-03-05 (HNF-3532)**

In February 1996, Cs-137 and Co-60 were the only man-made contaminants detected in this drywell (GJ-HAN-20). High concentrations of Cs-137 along the entire length of this drywell were reported with the maximum concentration 2,300 pCi/g at 45-ft BGS (GJ-HAN-20). Co-60 was detected near 50-ft BGS with concentrations at ~7 pCi/g. Document GJ-HAN-20 states, “When the tank was filled, the waste level was about 25 ft below ground level. Tank BY-103 or a subsurface pipe (such as the cascade line near depth 25 ft) for that tank is the most likely source of this contamination.” Figure 4-11 shows the depths of radioactivity from 1980 to 1990 (HNF-3532) (see Section 4.5.2). It was not clear why data was not plotted from 1975 to 1980.

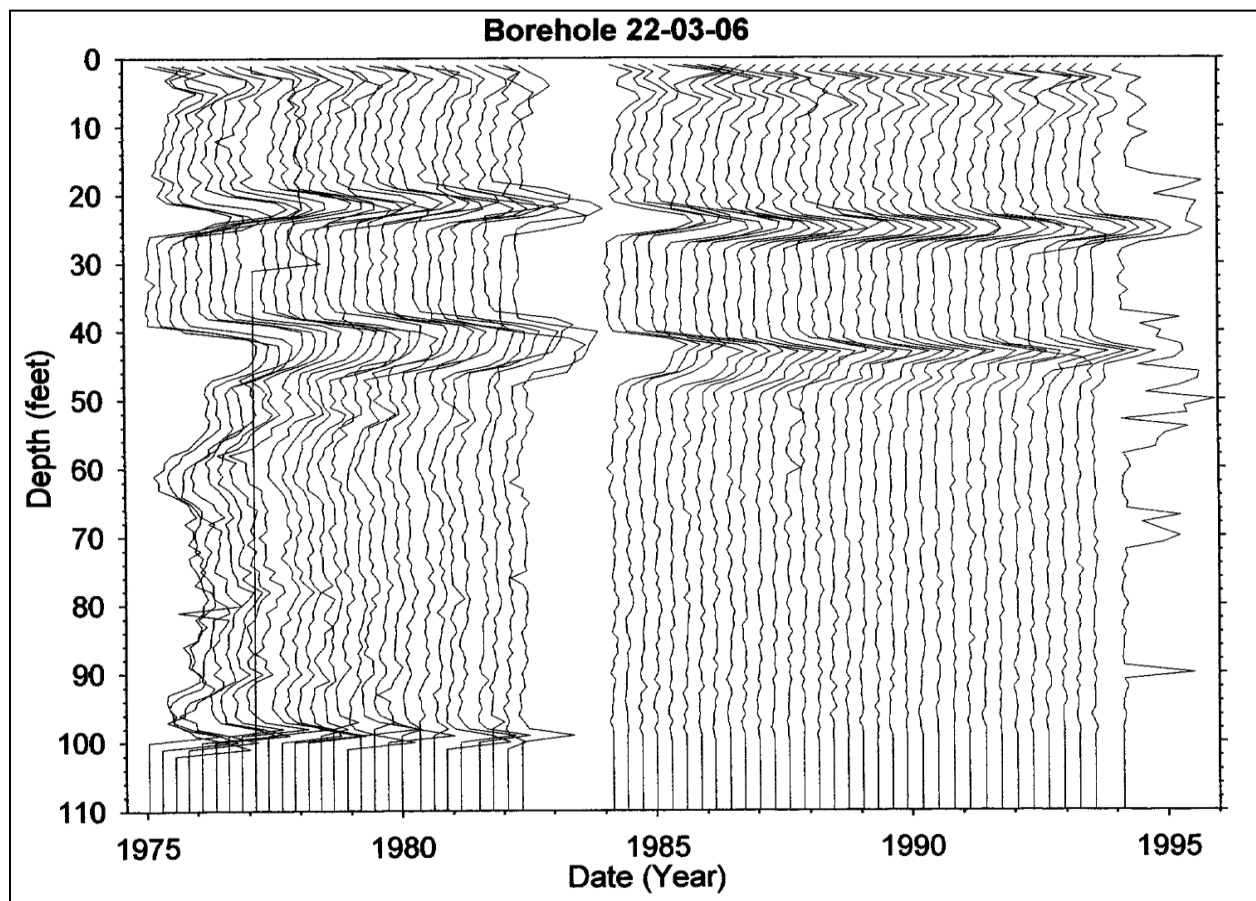
**Figure 4-12. Tank BY-103 Drywell 22-03-06 (HNF-3532)**

In February 1996, Cs-137, Co-60, and Sb-125 were the man-made contaminants detected in this drywell and the most likely source of this contamination is tank BY-103 (GJ-HAN-20). Also stated in this document, "The total gamma-ray peak near 24 ft might be due to contamination in or near the cascade line or other subsurface piping for tank BY-103, or the peak might be due to a leak from tank BY-103" (see Section 4.5.2). Figure 4-12 shows the depths of radioactivity from 1975 to 1994 (HNF-3532).

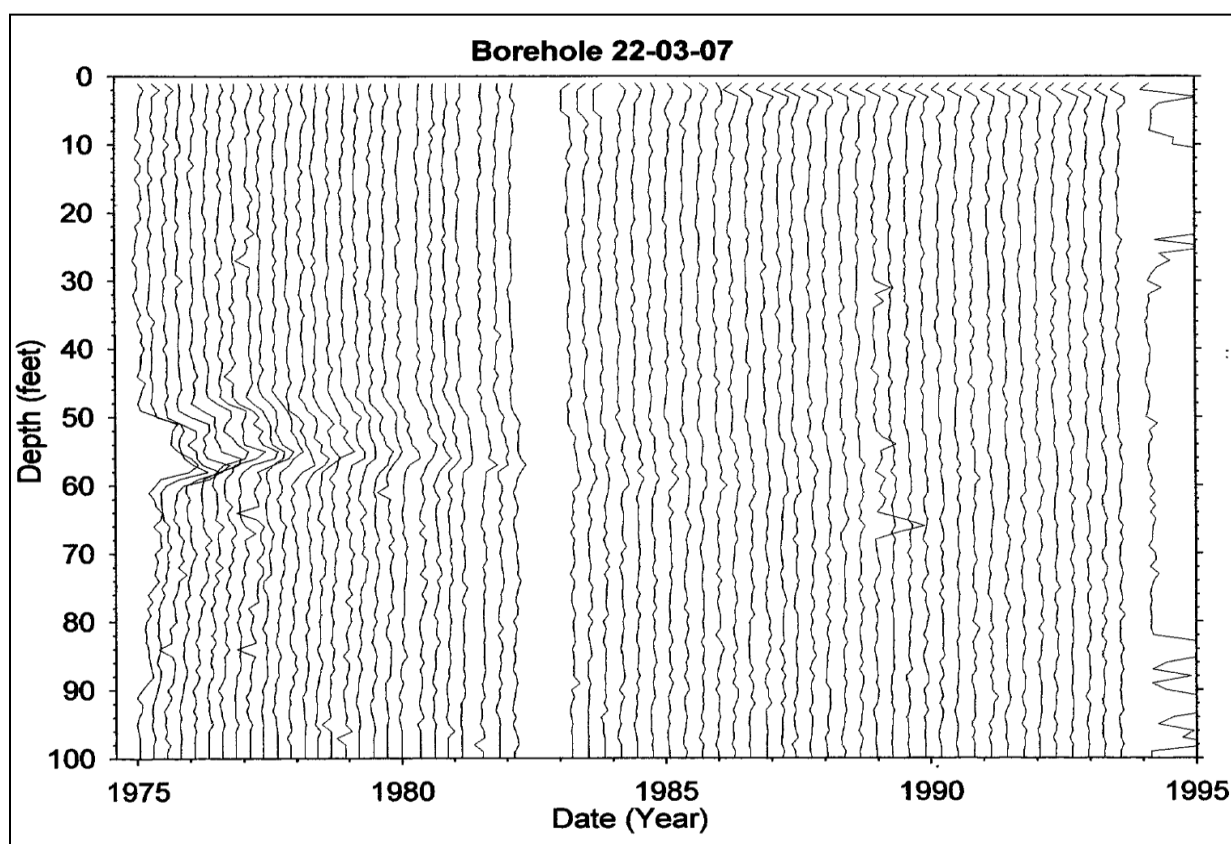
**Figure 4-13. Tank BY-103 Drywell 22-03-07 (HNF-3532)**

In February 1996, Cs-137 and Co-60 were the only man-made radionuclides detected in this drywell (GJ-HAN-20). From the ground surface to about 24-ft BGS, Cs-137 was reported at concentrations less than 10 pCi/g; however, no evidence exists for a subsurface source of Cs-137 at this drywell. From 53 to 94-ft BGS, Co-60 was detected at concentrations less than 0.5 pCi/g. Document GJ-HAN-20 states, "Tank BY-103 or its piping is the most likely source of the Co-60 contamination." However, a tank BY-103 piping leak seems unrealistic at the depth of radioactivity with no radioactivity above 50-ft BGS. Figure 4-13 shows the depths of radioactivity from 1975 to 1994 (HNF-3532).

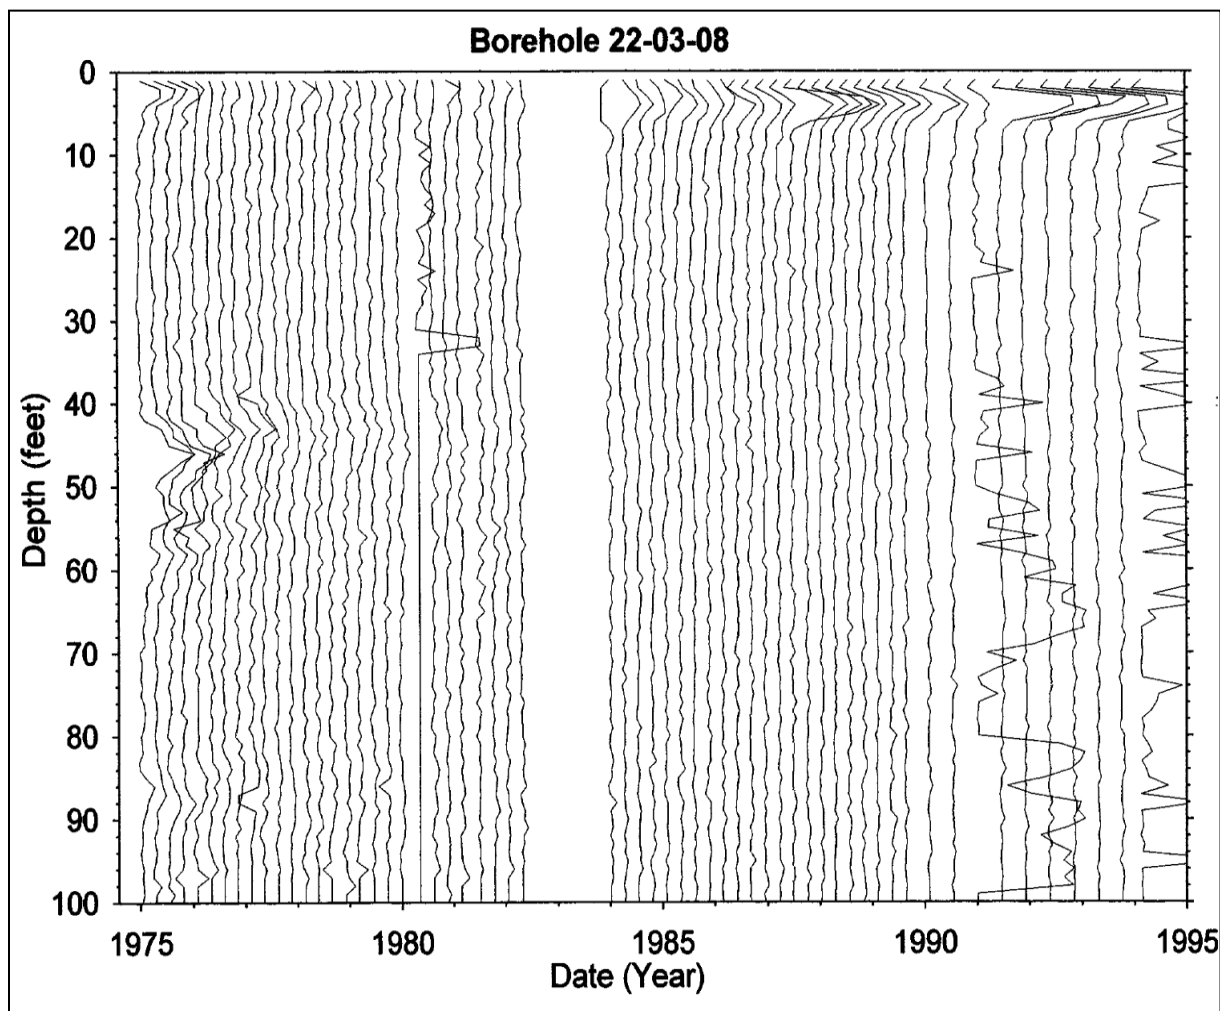
**Figure 4-14. Tank BY-103 Drywell 22-03-08 (HNF-3532)**

In February 1996, Cs-137 and Co-60 were the only man-made contaminants found in this drywell (GJ-HAN-20). From the ground surface to about 12-ft BGS, Cs-137 was detected continuously at concentrations less than 40 pCi/g. Co-60 was detected near 48 and 92-ft BGS at concentrations less than 0.4 pCi/g. Document GJ-HAN-20 reports, "No evidence for a deeper subsurface source, such as a tank leak, exists for Cs-137 at this borehole" and, "The Co-60 contamination near 48 ft most likely originated from tank BY-103, whose bottom is at that depth. The deeper Co-60 contamination probably also originated from tank BY-103, either migrating down through the sediments or following the casing." Figure 4-14 shows the depths of radioactivity from 1975 to 1994 (HNF-3831).

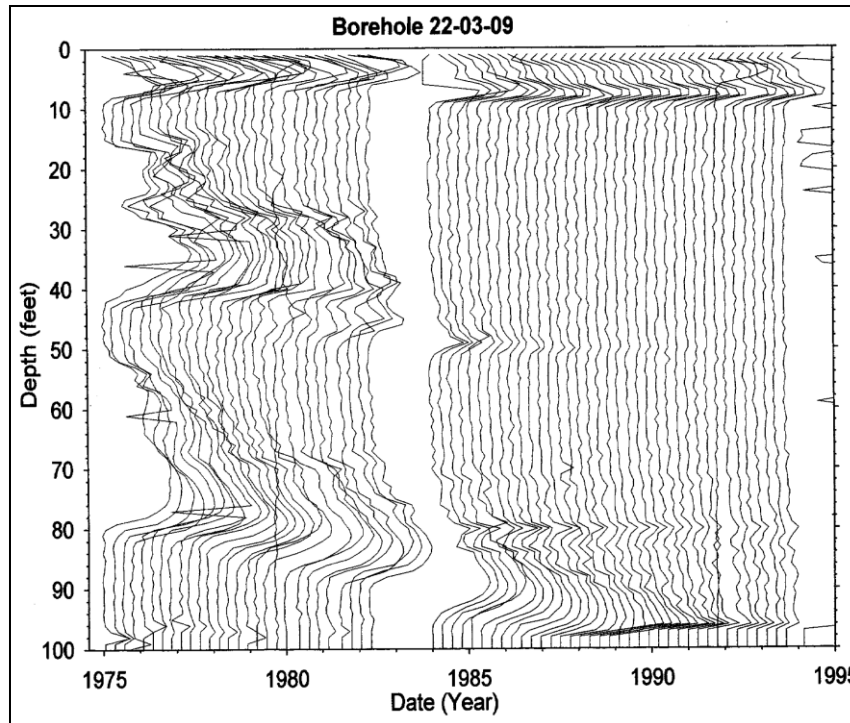
**Figure 4-15. Tank BY-103 Drywell 22-03-09 (HNF-3532)**

Document HNF-3532 reports two broad peaks of radioactivity near 34-ft BGS and 68-ft BGS. In February 1996, Cs-137, Co-60, and Eu-154 were the only man-made contaminants detected in this drywell (GJ-HAN-20). From the ground surface to about 48-ft BGS, Cs-137 was detected; however, GJ-HAN-20 reports, “No evidence of a subsurface source of Cs-137 exists at this borehole.” Co-60 was detected near 6 and 49-ft BGS and Eu-154 was reported near 6-ft BGS. Document GJ-HAN-20 states, “The Co-60 near 49 ft probably originated from tank BY-103” and “Tank BY-106, (to be published), which is also an assumed leaker and is located about 16 ft west of borehole 22-03-09, is also a possible source for this contamination. Figure 4-15 shows the depths of radioactivity from 1975 to 1994 (HNF-3535).

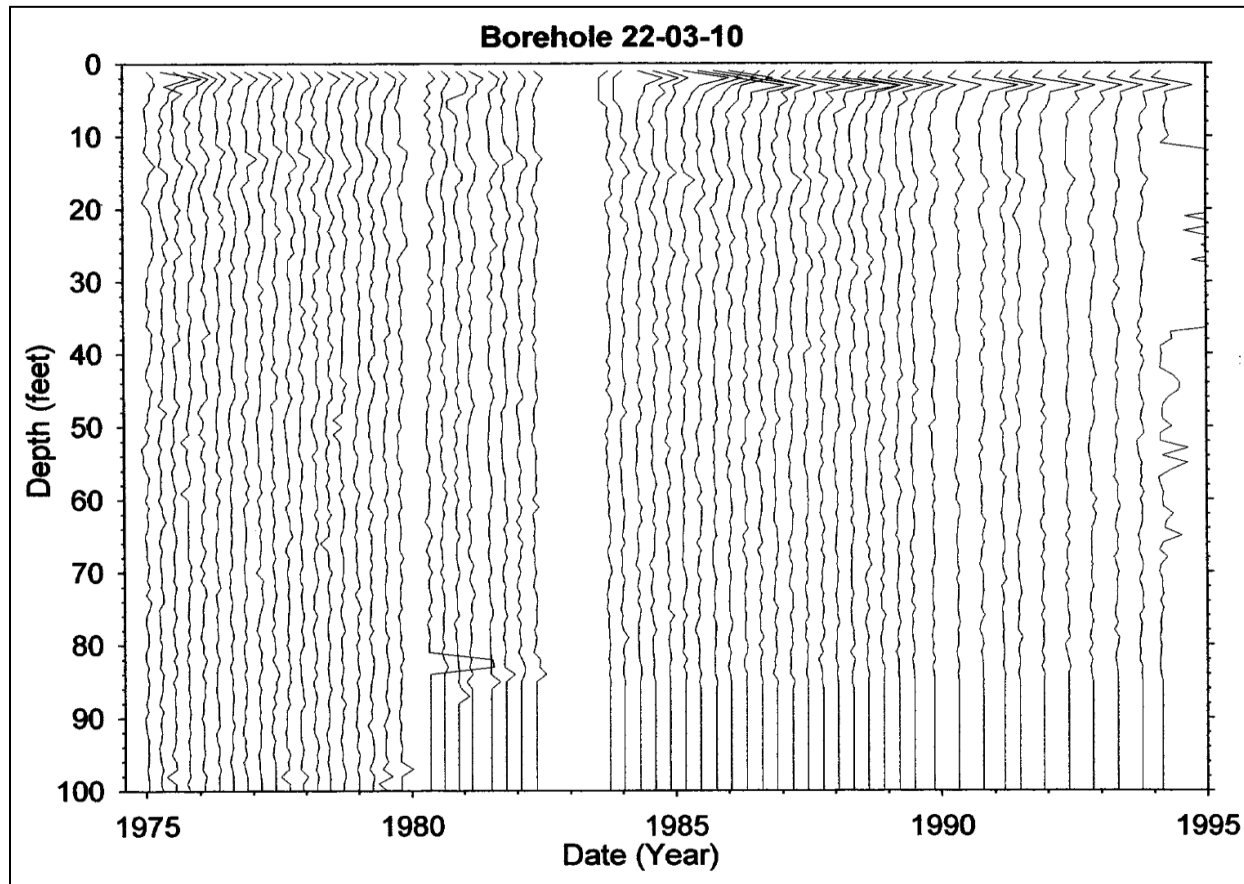
**Figure 4-16. Tank BY-103 Drywell 22-03-10 (HNF-3532)**

In February 1996, Cs-137 was the only man-made contaminant detected in this drywell, occurring continuously from the surface to 50-ft BGS at concentrations less than 50 pCi/g (GJ-HAN-20). Document GJ-HAN-20 reports, "Tank BY-103 (including its ancillary piping) is the most likely source of the subsurface contamination at this borehole. Tank BY-106 (to be published), which is located about 29 ft southwest of borehole 22-03-10, is also a possible source of the contamination." Figure 4-16 shows the depths of radioactivity from 1975 to 1994 (HNF-3831).

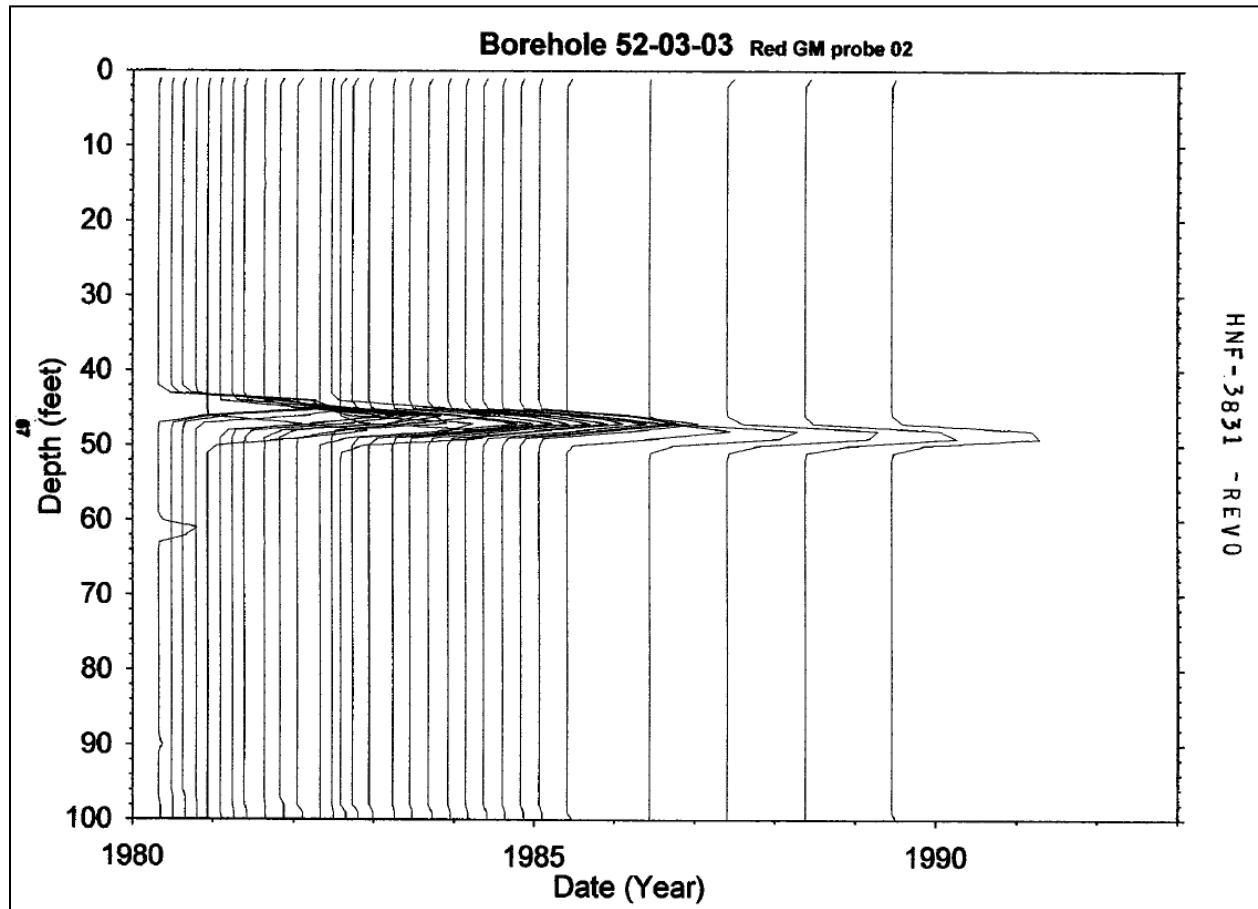
**Figure 5-6. Tank TY-103 Drywell 52-03-03 (HNF-3831)**

the knuckle near borehole 52-03-03.” Figure 5-6 shows the depth of radioactivity from 1980 to 1990 (HNF-3831).

Note: Bottom of the tank footing is ~45-ft 10-in BGS

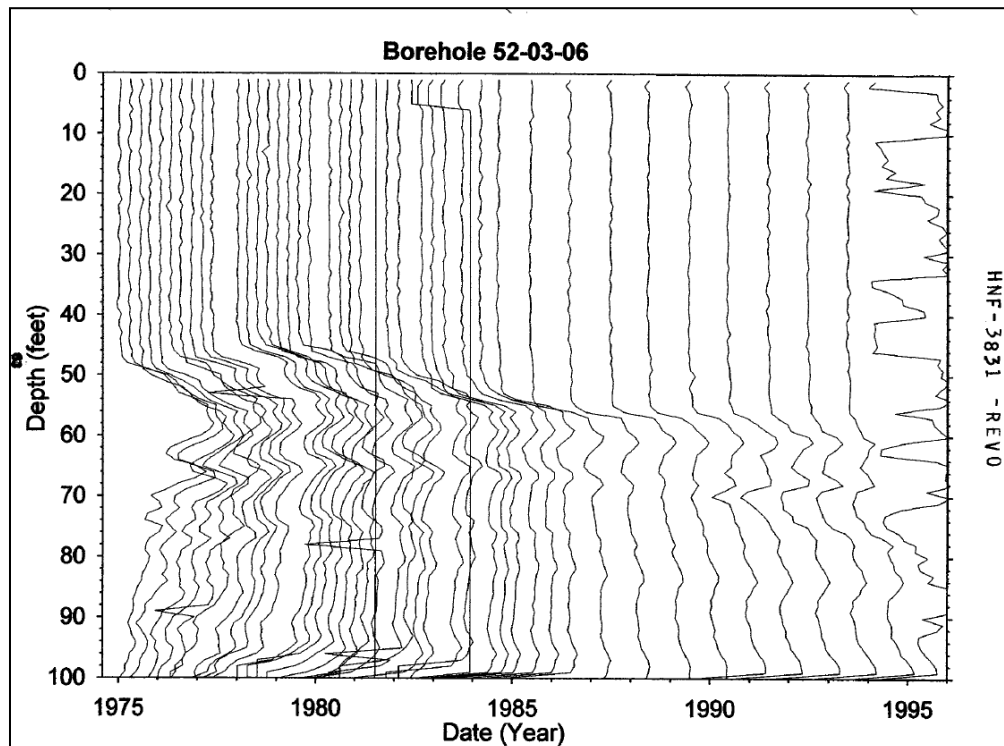
**Figure 5-7. Tank TY-103 Drywell 52-03-06 (HNF-3831)**

Figure 5-7 shows the continuing radiation depth to 1995 (HNF-3831). Drywell 52-03-06 is located between tanks TY-103 and TY-105, and it is possible contamination in this drywell could be associated with the leak from tank TY-103 and/or tank TY-105 (see Tank TY-105 segment). However, it seems unlikely contamination detected in this drywell is associated with tank TY-105 since tank TY-105 leaked in 1960 and radioactivity was reported as less than values prior to August 1972.

Direct pushes C4629 and C4631, located south of tank TY-103, do not report any radioactivity associated with a tank leak despite radioactivity being detected in drywell 52-03-06 at ~55-ft BGS (see Section 5.5.1.2). However, direct pushes C4629 and C4631 were only installed to a depth of 47.3 and 47.4-ft BGS, respectively, and did not intercept the Co-60 detected in 1995.

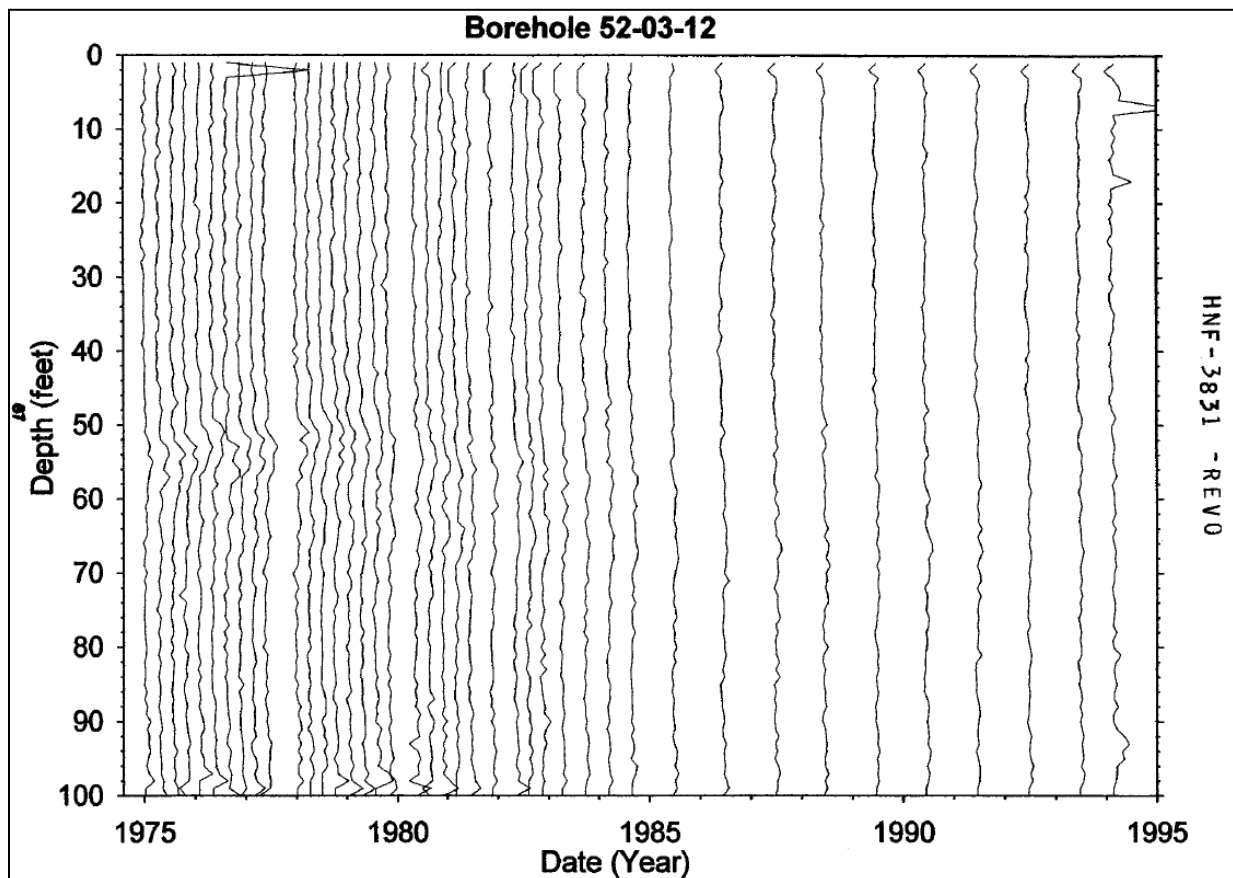
**Figure 5-8. Tank TY-103 Drywell 52-03-12 (HNF-3831)**

In May 1997, Cs-137 and Co-60 were the only man-made radionuclides detected in drywell 52-03-12 (GJ-HAN-66). From the ground surface to 3.5-ft BGS, Cs-137 was detected continuously with a maximum concentration of 3.6 pCi/g reported at 1-ft BGS. From 65 to 70-ft BGS and from 71 to 87.5-ft BGS, Co-60 was detected with the maximum concentration of 0.31 pCi/g reported at 66.5-ft BGS. Document GJ-HAN-66 states, "The SGLS detected relatively low concentrations of Co-60 from 65 to 87.5 ft. This contamination probably originated from a leak in tank TY-101 or TY-103." Figure 5-8 shows the depth of radioactivity from 1975 to 1995 (HNF-3831).

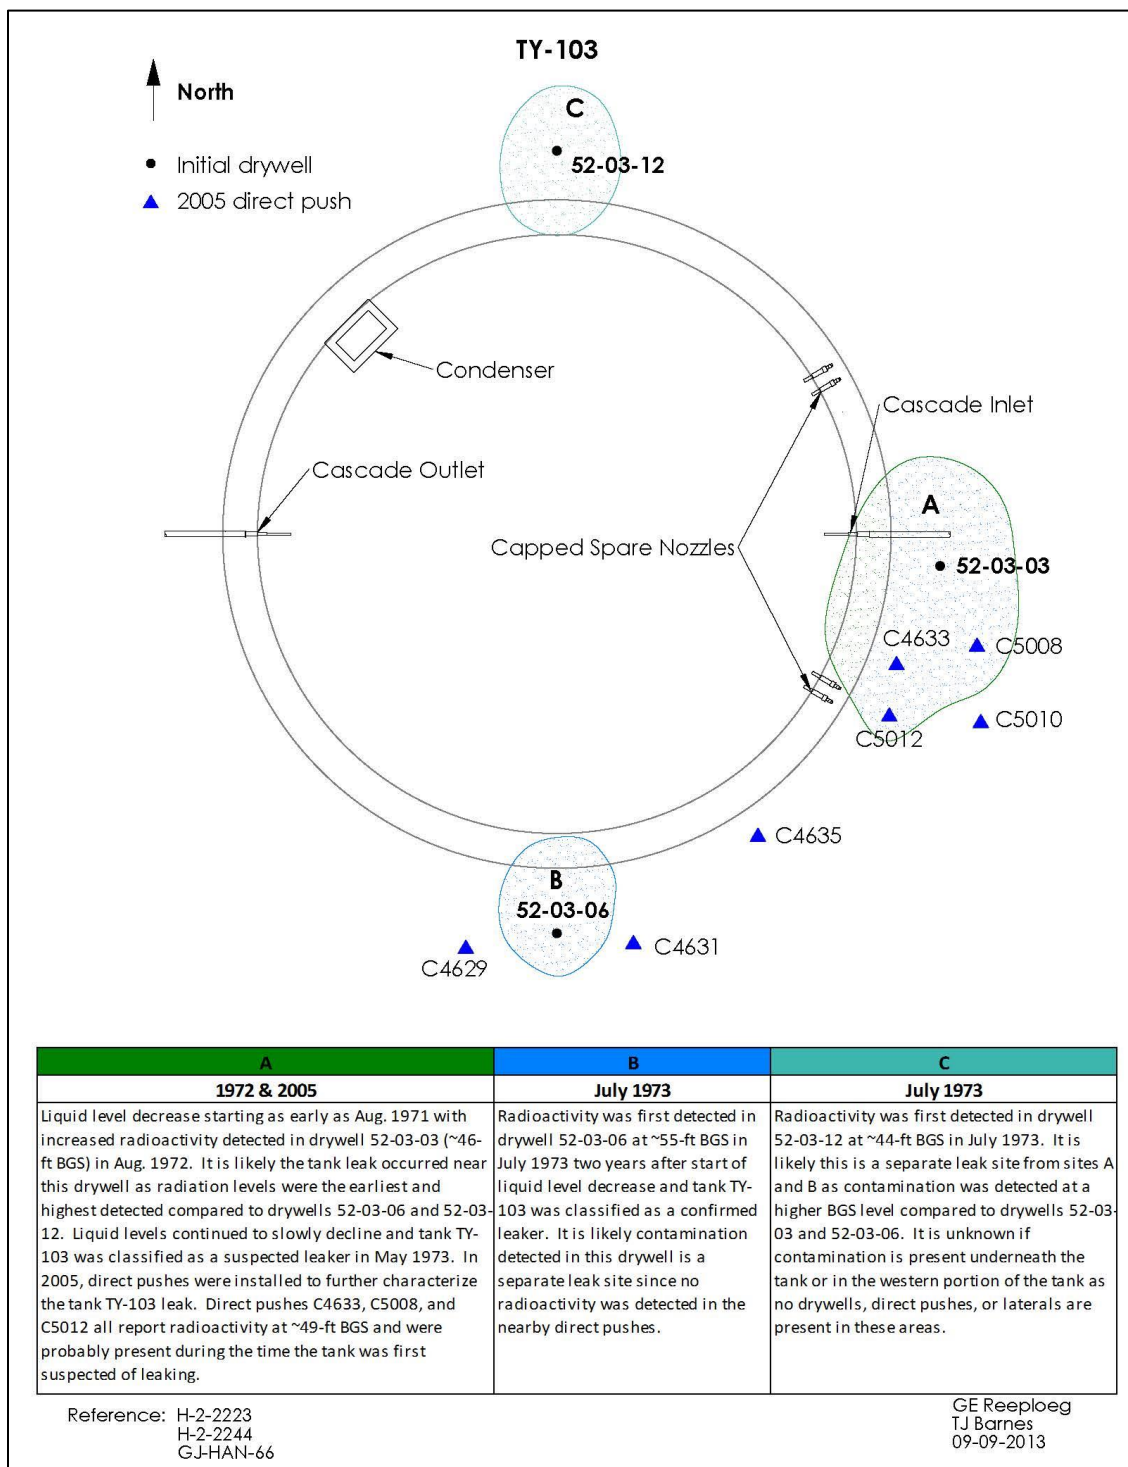
**Figure 5-12. Tank TY-103 Possible Radial Leak Locations**  
 Tank inner ring is steel liner, outer ring is outer edge of tank footing

Tank TY-103 was first suspected of leaking as early as August 1971 due to liquid level decreases with subsequent increases in radioactivity in drywell 52-03-03 in August 1972 at or near the tank footing as shown in site A (see Figure 5-12). It is likely the tank first leaked near drywell 52-03-03 based on the significant amount of radiation detected in this drywell and as stated in GJ-HAN-66, "The zone of highly concentrated Cs-137 contamination in borehole 52 03-03 is close to the depth of the knuckle radius of the tank liner; it is likely that the tank leaked along the seam of the knuckle radius near this borehole." In 2005, direct pushes were installed to further characterize the tank TY-103 leak and radioactivity was detected in direct pushes C4633, C5008, and C5012 which would have likely been present when the tank was first suspected of leaking.

Radioactivity was first detected concurrently in drywells 52-03-06 and 52-03-12 at or below the tank footing in July 1973 after liquid levels continued to decline. It is likely that contamination detected in drywell 52-03-06 (site B in Figure 5-12) is a separate leak site since radioactivity was not present in nearby drywells. Site C appears to be a separate leak site from sites A and B, as radioactivity detected in drywell 52-03-12 was at a higher BGS level compared to the other drywells.

The tank TY-103 leak(s) did not occur far above the tank footing because all of the initial indicators, three drywells and three direct pushes, were located at or near the bottom of the tank. It is possible contamination exists underneath the tank and in the western portion of the tank; however, no drywells or laterals are present in this area so it remains inconclusive.

Leak locations in Figure 5-12 are based on peak readings and are a representation of possible initial boundaries of radioactivity.
