| <b>DOCUMENT RELEASE AND CHANGE FORM</b> | | 1a. Doc No: RPP-RPT-54911    Rev. 01 | | | | | | | | | | | | | | | | | | | | | | | | | | | | | | | | | | | | | | | | |
|---|---|---|---|---|---|---|---|---|---|---|---|---|---|---|---|---|---|---|---|---|---|---|---|---|---|---|--|--|--|--|--|--|--|--|--|--|--|--|--|--|--|--|
| <b>2. Document Title</b><br>Hanford Single-Shell Tank Leak Causes and Locations - 241-BY and 241-TY Farm | | | | | | | | | | | | | | | | | | | | | | | | | | | | | | | | | | | | | | | | | | |

| <b>Purpose of Document:</b> Identifies leak causes and locations for BY and TY Farm tanks | |

Key Words: leak location, leak cause, tank, integrity assessment, BY Farm, TY Farm, BY-103, TY-103, TY-104, TY-105, TY-106, leak assessment

**Abstract:** This document identifies 241-BY Tank Farm (BY Farm) and 241-TY Tank Farm (TY Farm) leak causes and locations for the 100 series leaking tanks (241-BY-103, 241-TY-103, 241-TY-104, 241-TY-105, and 241-TY-106) identified in RPP-RPT-43704, Hanford BY Farm Leak Assessments Report, and in RPP-RPT-42296, Hanford TY Farm Leak Assessments Report. This document satisfies the BY and TY Farm portion of the target (T04) in the Hanford Feder

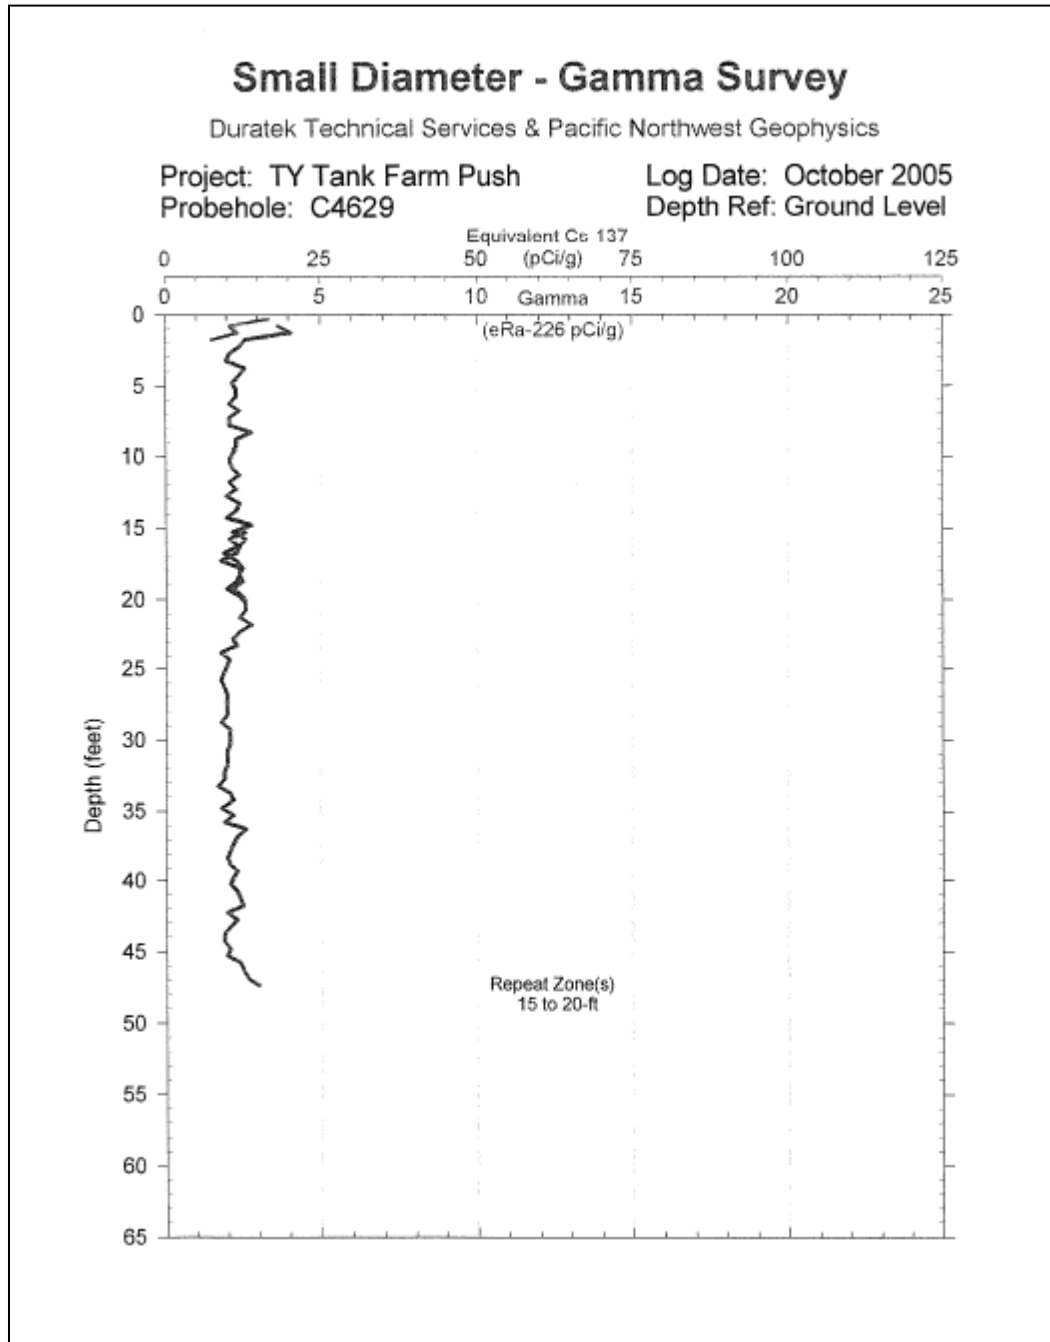
**Figure B2-1. 2005 Gamma Survey Direct Push Hole C4629  
(RPP-RPT-34870)**

Direct pushes C4629 and C4631, located south of tank TY-103, do not report any radioactivity associated with a tank leak despite radioactivity being detected in drywell 52-03-06 at ~55-ft BGS (see Section 5.5.1.2). However, direct pushes C4629 and C4631 were only installed to a depth of 47.3 and 47.4-ft BGS, respectively, and did not intercept the Co-60 detected in 1995.

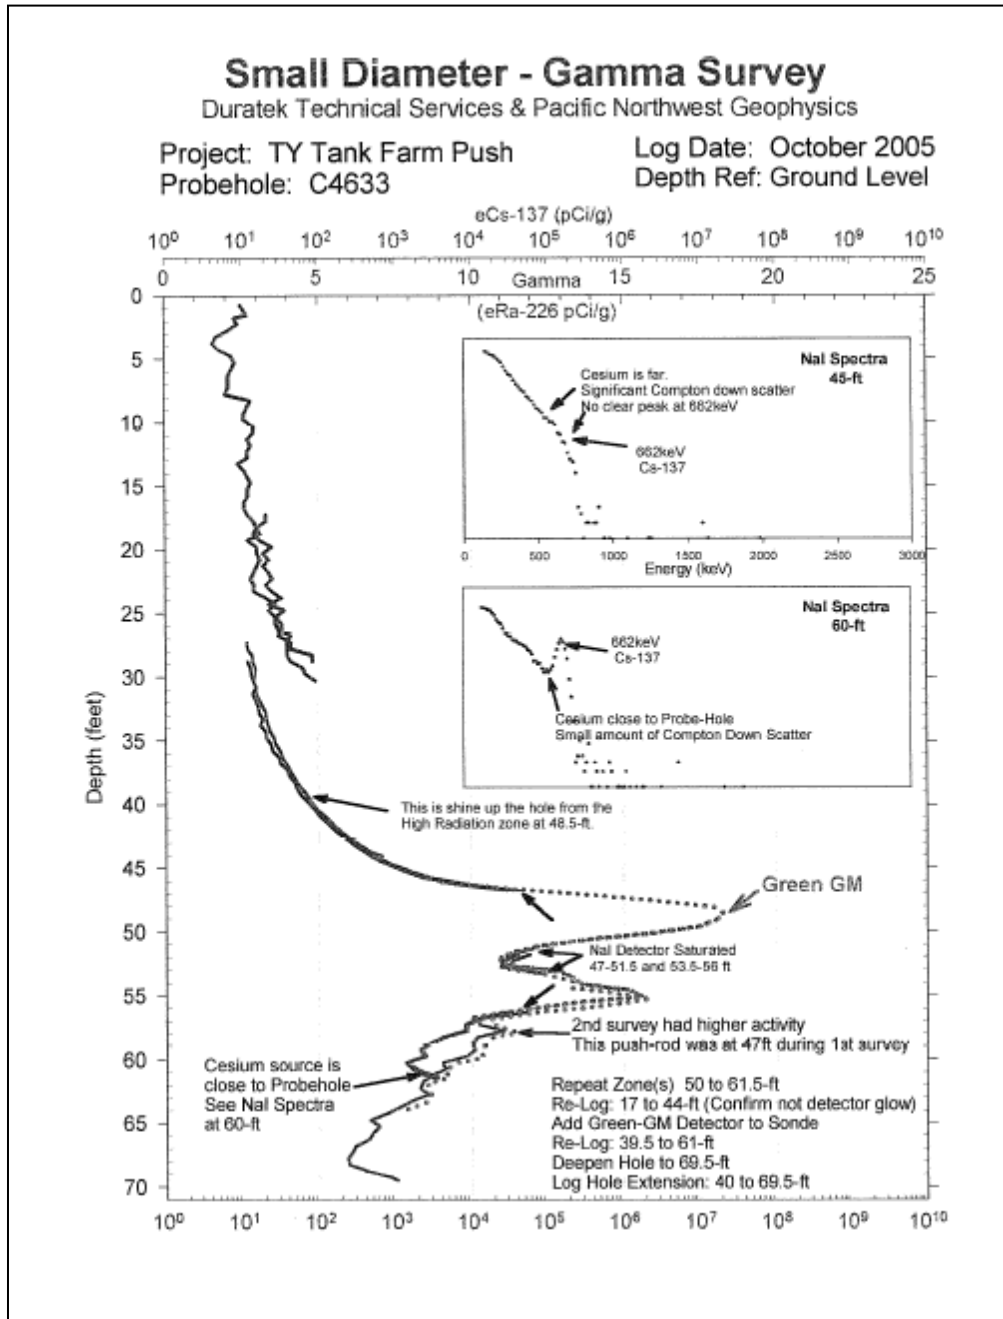
**Figure B2-3. 2005 Gamma Survey Direct Push Hole C4633  
(RPP-RPT-34870)**

Radioactivity was the highest in direct push C4633 with  $2.2 \times 10^7$  pCi/g at 48.6-ft BGS indicating tank TY-103 likely leaked near this direct push. Direct pushes C5008 reported  $6.7 \times 10^6$  pCi/g at 48.5-ft BGS and C5012 at  $2.8 \times 10^5$  pCi/g at 49-ft BGS. It appears tank TY-103 leaked in one location near the tank footing close to direct push C4633 with migration to nearby pushes C5008 and C5012 which is supported by radioactivity detected in drywell 52-03-03.

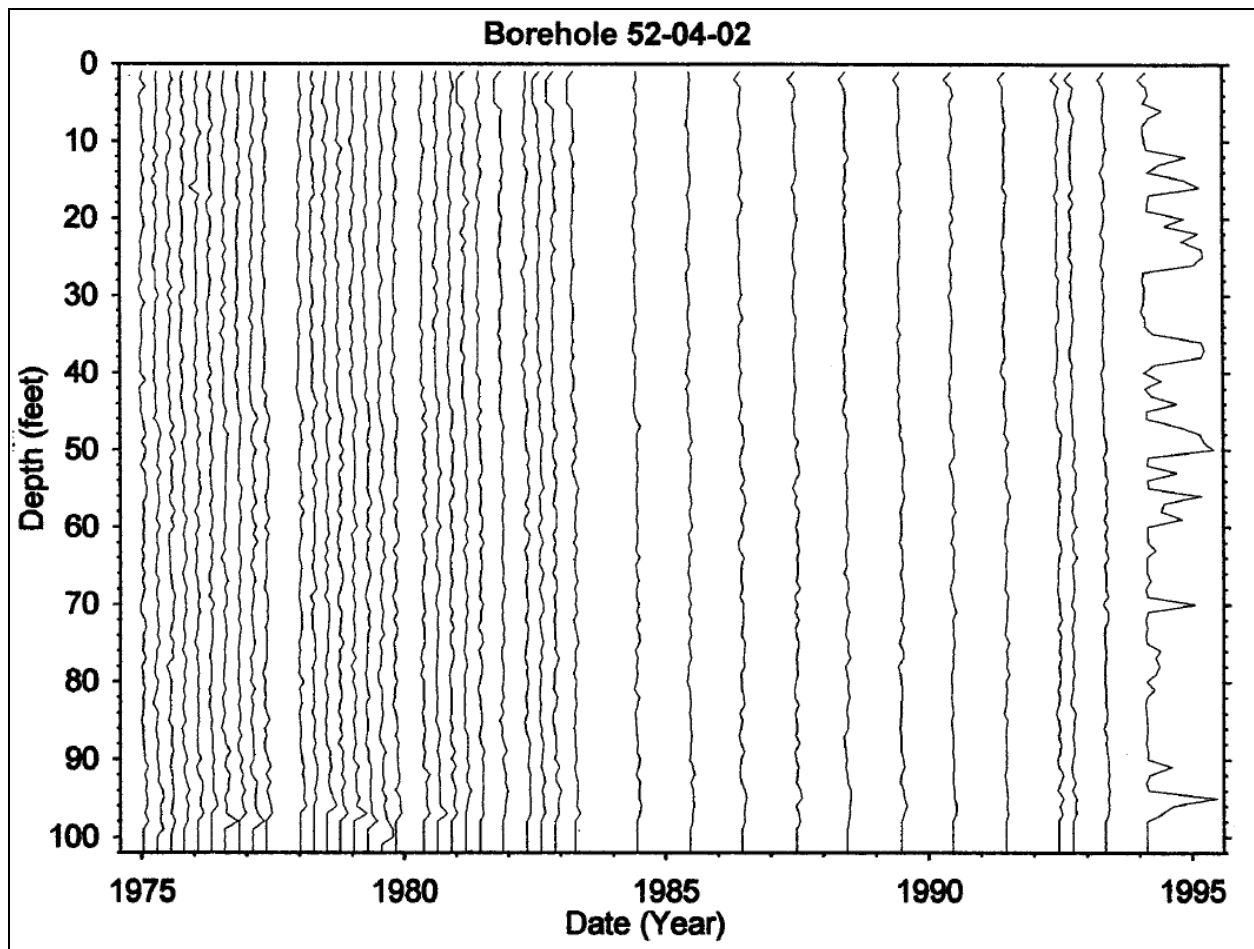
**Figure 6-5. Tank TY-104 Drywell 52-04-02 (HNF-3831)**

In May 1997, Cs-137 was the only man-made radionuclide detected in drywell 52-04-02 (GJ-HAN-67). Cs-137 was detected intermittently between 7.5 and 24-ft, at 89-ft, 91.5-ft, and at 97.5-ft BGS with concentrations less than 0.2 pCi/g below 1-ft BGS. Document GJ-HAN-67 states, "The Cs-137 contamination in this borehole is probably the result of surface spills that have migrated down into the backfill surrounding the borehole or surface contamination that adhered to the drill string and was carried downward during the drilling of this borehole." Since historical records report little radioactivity in this drywell, drywell 52-04-02 is not included as part of the leak location for tank TY-104. Figure 6-5 shows the depths of radioactivity from 1975 to 1995 (HNF-3831).

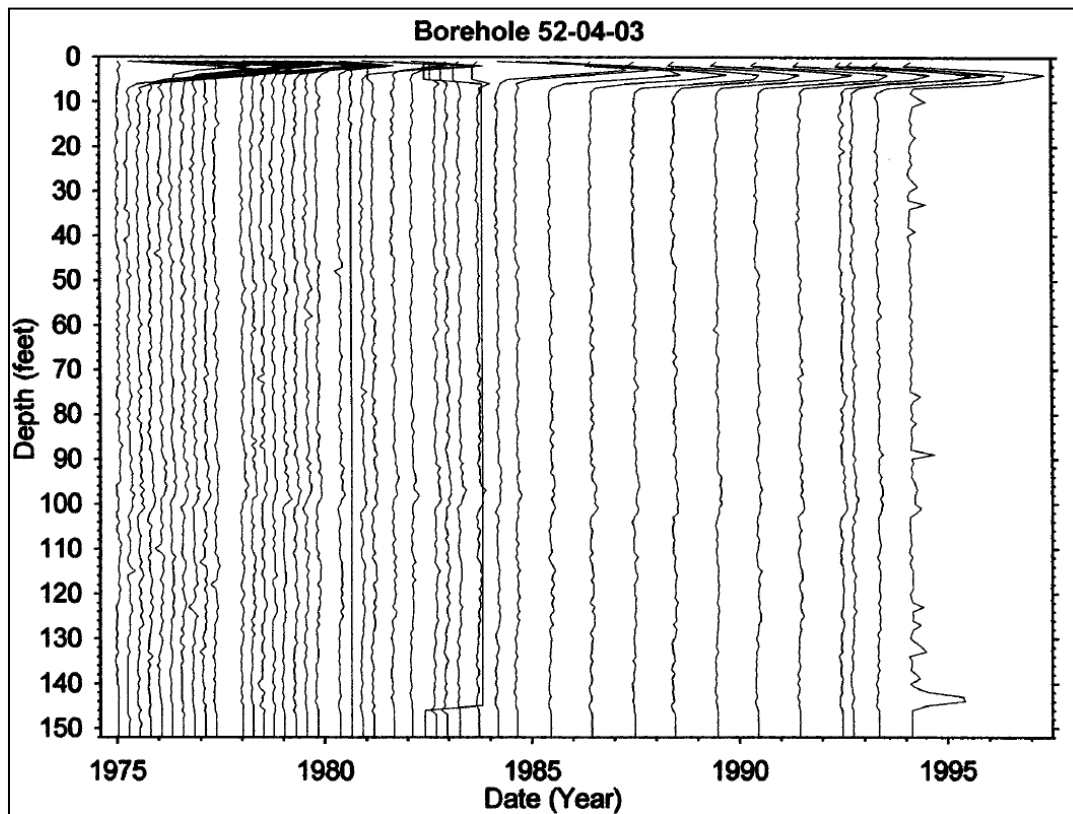
**Figure 6-6. Tank TY-104 Drywell 52-04-03 (HNF-3831)**

In May 1997, Cs-137 and Eu-154 were the only man-made radionuclides detected in drywell 52-04-03 (GJ-HAN-67). Cs-137 was detected from the ground surface to 5.5-ft BGS with concentrations as high as 2,200 pCi/g. Cs-137 was also detected from 16.5 to 18.5-ft BGS with concentrations up to 1 pCi/g, and at 45-ft, 51-ft, 55.5-ft, 65.5-ft, between 80.5 and 81-ft, at 92-ft, between 98 and 98.5-ft, and at 108-ft BGS at concentrations ranging from 0.2 to 0.5 pCi/g. Eu-154 was detected from 2 to 5-ft BGS with a maximum concentration of about 30 pCi/g. Document GJ-HAN-67 states that Cs-137 and Eu-154 contamination are probably related to a transfer line located on the northeast side of the tank. Figure 6-6 shows surface contamination from 1975 to 1995 with no radioactivity detected below the surface (HNF-3831). Surface contamination appeared to not be a concern as radiation readings were reported as less than values (see Appendix A3). Therefore, drywell 52-04-03 is not included as part of the leak location for tank TY-104.

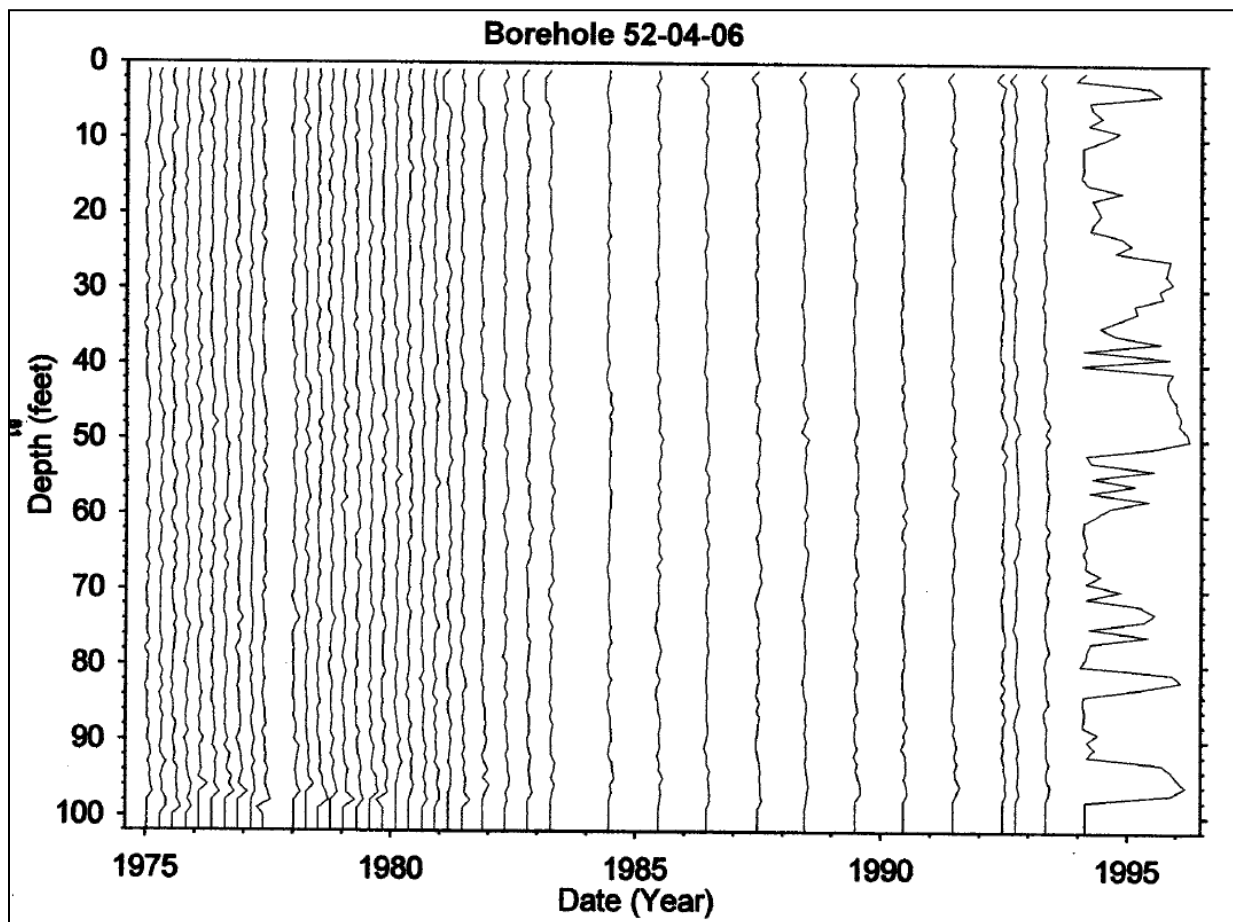
**Figure 6-7. Tank TY-104 Drywell 52-04-06 (HNF-3831)**

In May 1997, Cs-137 was the only radionuclide detected in drywell 52-04-06 (GJ-HAN-67). Cs-137 was detected continuously from the ground surface to 12-ft BGS and at the bottom of the drywell with concentrations ranging from 0.2 to 1 pCi/g at the ground surface and at 0.2 pCi/g at the bottom of the drywell. Document GJ-HAN-67 states, "There is no indication of subsurface contamination at or below the operating level of the tanks." Therefore, drywell 52-04-06 is not included as part of the leak location for tank TY-104. Figure 6-7 shows depths of radioactivity from 1975 to 1995 (HNF-3831).

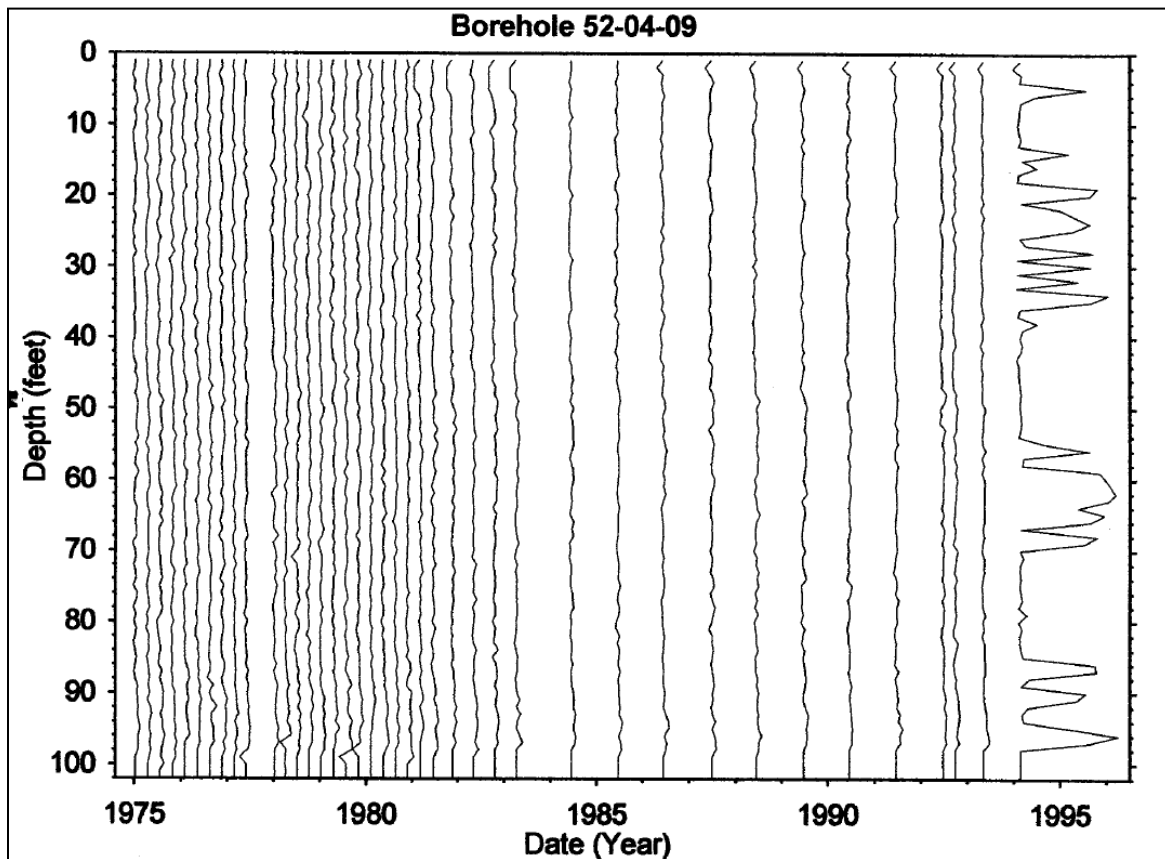
**Figure 6-8. Tank TY-104 Drywell 52-04-09 (HNF-3831)**

In May 1997, Cs-137 was the only man-made radionuclide detected in drywell 52-04-09 (GJ-HAN-67). Measurable Cs-137 was detected at the ground surface (about 0.2 pCi/g) and from 83.5-ft BGS to the bottom of the drywell (at or below 1 pCi/g). Document GJ-HAN-67 states, "The Cs-137 contamination detected by the SGLS between the depths of 83.5 ft and the bottom of the borehole probably originated from a subsurface source such as a leak from one of the tanks within this tank farm, but probably not from tank TY-104. A contaminant plume may have migrated downward from the source and intercepted borehole 52-04-09 at about the 84-ft depth." The conclusion was stated "The low-level contamination in boreholes 52-06-02 and 52-04-09 is related to surface spills or subsurface leaks, but the contamination is not associated with the operation of tank TY-104." Therefore, drywell 52-04-09 is not included as part of the leak location for tank TY-104. Figure 6-8 shows depths of radioactivity from 1975 to 1995 (HNF-3831).

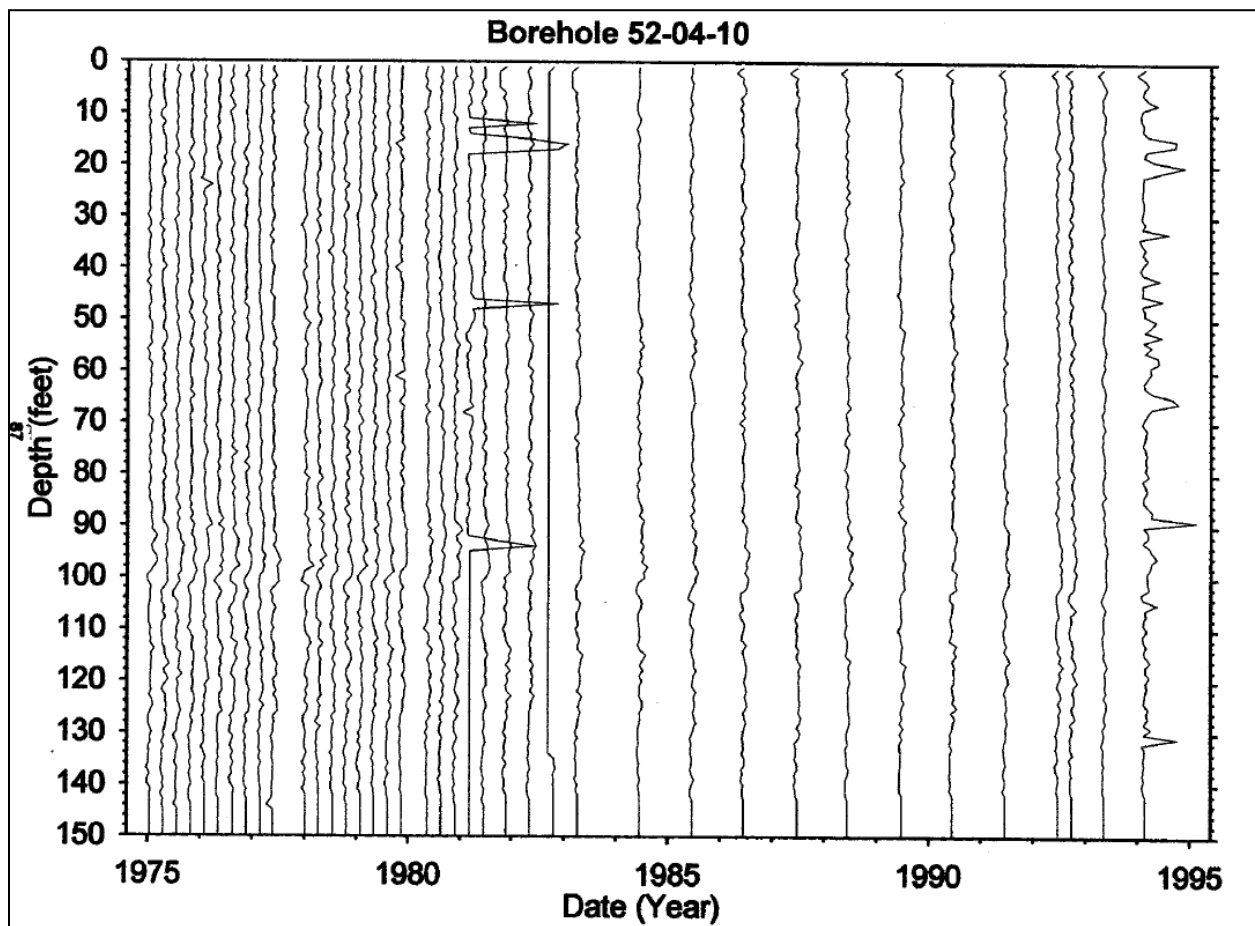
**Figure 6-9. Tank TY-104 Drywell 52-04-10 (HNF-3831)**

In May 1997, Cs-137 was the only man-made radionuclide detected in drywell 52-04-10 (GJ-HAN-67). Cs-137 was detected from the ground surface to 1-ft, at 67-ft, between 87 and 87.5-ft, at 99-ft, and at 129.5-ft BGS. The maximum concentration was about 1 pCi/g at 1-ft BGS. Document GJ-HAN-67 states that radioactivity detected was “probably from surface contamination that migrated along the outside of the casing by the action of surface water.” Therefore, drywell 52-04-10 is not included as part of the leak location for tank TY-104. Figure 6-9 shows depths of radioactivity from 1975 to 1995 (HNF-3831).

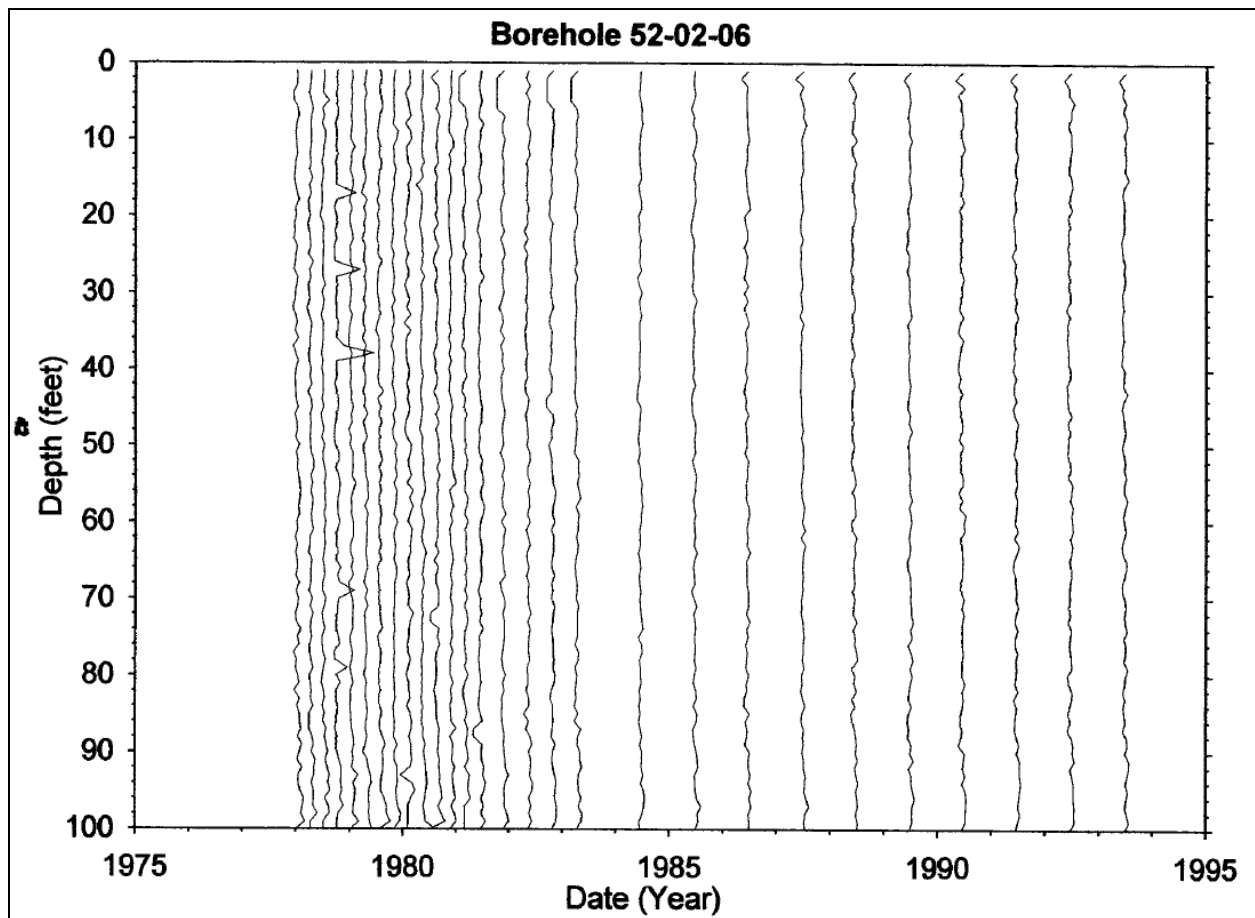
**Figure 6-10. Tank TY-104 Associated Drywell 52-02-06 (HNF-3831)**

In May 1997, Cs-137 was the only man-made radionuclide detected in drywell 52-02-06 (GJ-HAN-67). Cs-137 was detected continuously from the ground surface to 3-ft, 12.5 to 15-ft, and 19.5 to 20-ft BGS with the highest concentration of 1 pCi/g reported at 1-ft BGS. Document GJ-HAN-67 states the Cs-137 contamination probably originated from a surface spill and was carried downward either during drilling operation or by the action of surface water. It was also stated that, "There is no indication in the SGLS logs of contamination originating from subsurface leaks from underground tanks or their associated facilities." Therefore, drywell 52-02-06 is not included as part of the leak location for tank TY-104. Figure 6-10 shows depths of radioactivity from 1978 to 1995 (HNF-3831).

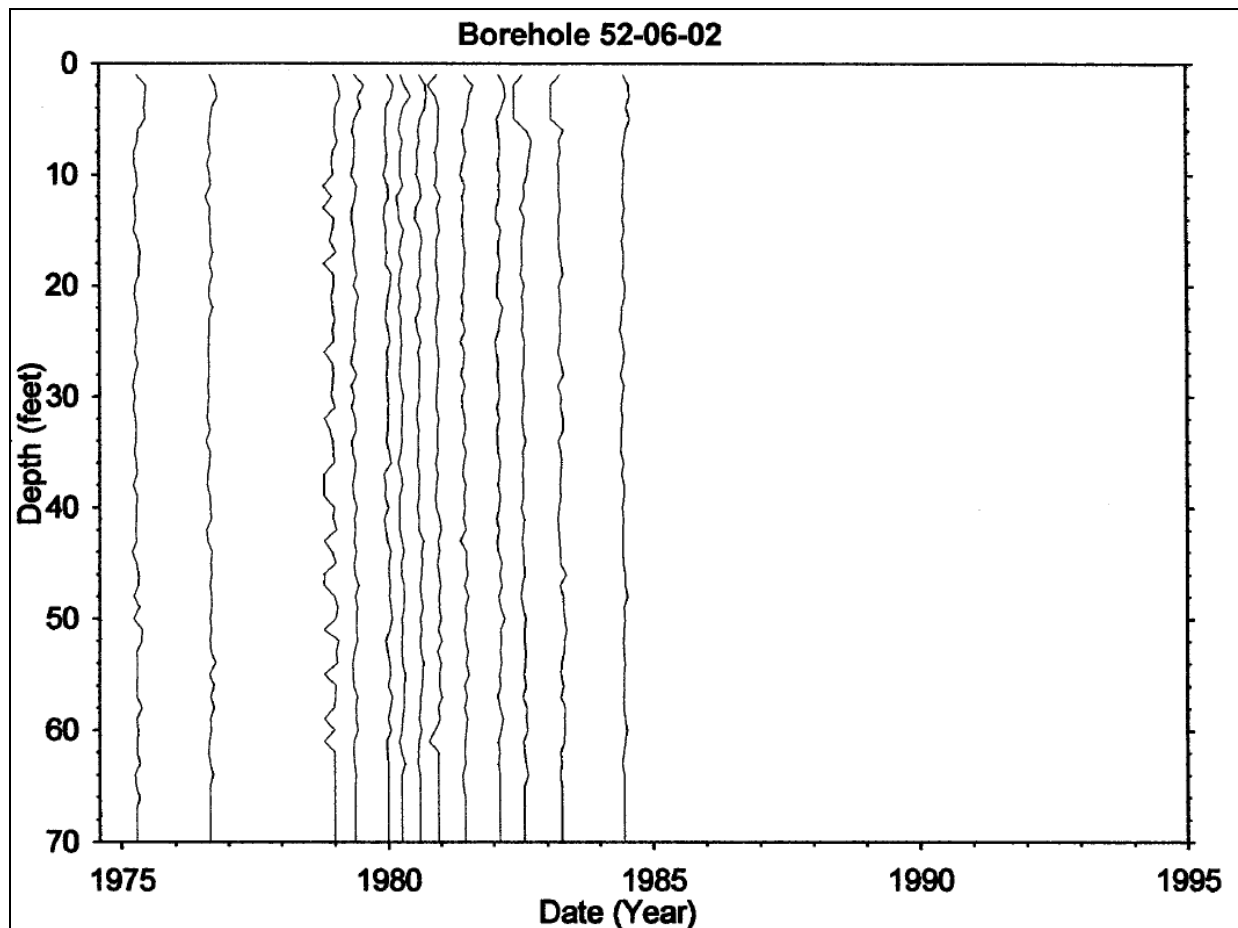
**Figure 6-11. Tank TY-104 Associated Drywell 52-06-02 (HNF-3831)**

In May 1997, Cs-137 was the only man-made radionuclide detected in drywell 52-06-02 which was detected continuously from the ground surface to 64-ft BGS (GJ-HAN-67). Measured Cs-137 concentrations between 3 and 6-ft BGS ranged from about 5 to 13 pCi/g, between 6 and 40-ft BGS concentrations ranged from 1 to 3 pCi/g, and the concentration was less than 1 pCi/g below 40-ft BGS. Document GJ-HAN-67 states, "Reasons for the relative continuity of the contaminated zone compared to other boreholes associated with tank TY-104 are unknown. However, the contamination in borehole 52-06-02 may be related to the much more pervasive surface contamination that occurs in the vicinity of tank TY-105." Drywell 52-04-03 is therefore not included as part of the leak location for tank TY-104. Figure 6-11 shows depths of radioactivity from 1975 to 1985 (HNF-3831).

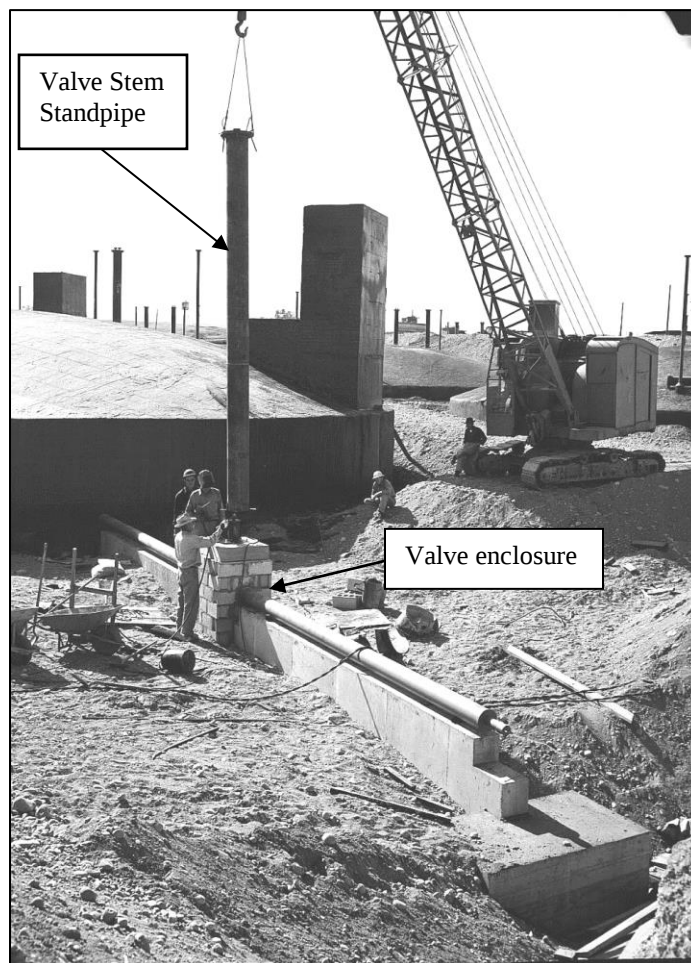
**Figure 6-14. BX Farm Cascade Tie Line**  
Photograph N1D0001321 October 6, 1942

Bonding was used as indicated in Figure 6-13 to provide an electrical connection of the sleeve to the portion of the line at the valve. This indicates a purposeful effort was made to protect the exposed pipe from galvanic corrosion. The valve and slip fit ends of the pipe sleeve were protected in an enclosure similar to the 241-BX Farm photograph in Figure 6-14. However, this area is the most likely to leak or accumulate leakage which would provide moisture and possible electrical connection corrosion.

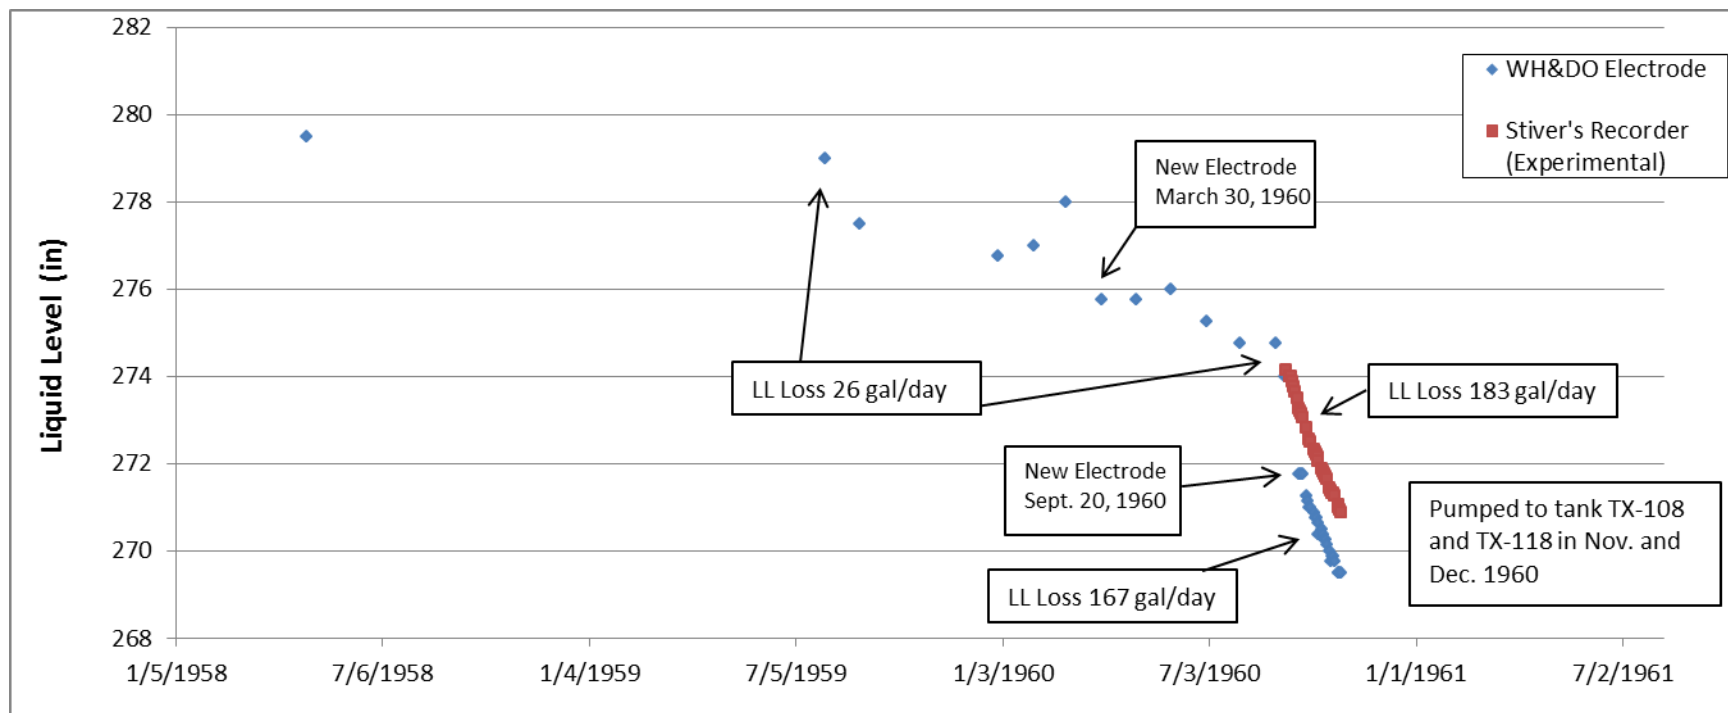
**Figure 7-4. Tank TY-105 Liquid Level April 30, 1958 to October 27, 1960**

*The electrode readings are being confirmed by an independent measuring device developed by FEO and which is calibrated to 1/16-in. Drywells around the tank have been examined and no evidence of a leak has been found.*” It appears the liquid level could have started decreasing as early as July 1959 as shown in Figure 7-4. Decreasing liquid levels during this period could have at least partially been the result of evaporation; however, temperatures were not available to confirm the possible extent of evaporation. Document HW-72858, *Interim Report Waste Tank Liquid Level Measurement Systems 200-E and 200-W Areas*, states, “Reviewing the liquid level records on this tank,” [i.e., tank TY-105], “as taken by the manual electrode method, and knowing that a leak existed, a possible trend was indicated that the tank may have been leaking for 6 months or longer.”

It appears that the tank TY-105 liquid level started decreasing at a slow rate,  $\sim 26$  gal/day from July 30, 1959 to August 30, 1960, and increased in September 1960 to  $\sim 175$  gal/day (average of both sets of data) as indicated from the data graphed in Figure 7-4. As a result, the supernatant from tank TY-105 was transferred to tanks TX-108 and TX-118 in November and December 1960 leaving the liquid level at  $\sim 113$ -in. Liquid levels continued to slowly decline from February 1961 through August 1974 to  $\sim 27$  kgal (RPP-RPT-42296) with saltwell pumping. However, the manual tape used to measure liquid level was reported to be contacting solid waste surfaces within the tank, raising uncertainty about the actual liquid level decline during this time. Evaporation may also have contributed to the liquid level decrease (RPP-RPT-42296).

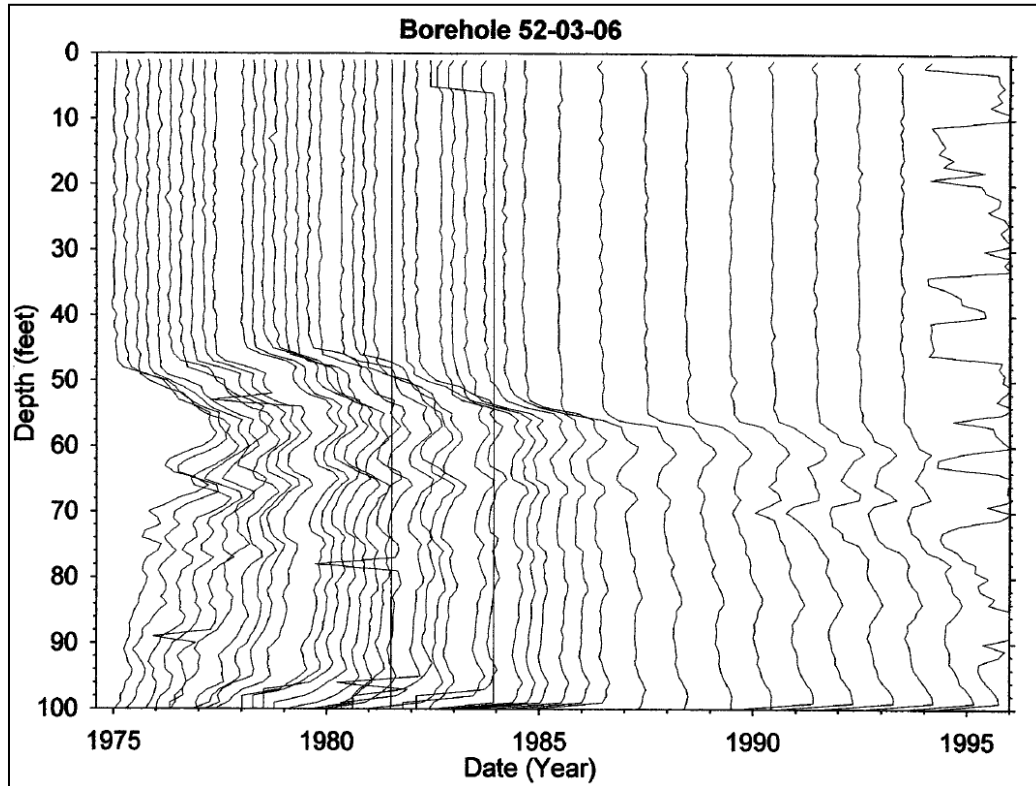
**Figure 7-5. Tank TY-105 Associated Drywell 52-03-06 (HNF-3831)**

Drywell 52-03-06 is located in between tanks TY-103 and TY-105. It is likely radioactivity in this drywell is associated with the leak from tank TY-103 due to similar timing and depth (see tank TY-103 Segment). Also, radioactivity was reported as less than values prior to August 1972, and tank TY-105 was first suspected of leaking in September 1960 due to liquid level decreases (see Tank TY-103 segment). Therefore, drywell 52-03-06 is not included in the leak location for tank TY-105. Figure 7-5 shows the depths of radioactivity from 1975 to 1995 (HNF-3831).

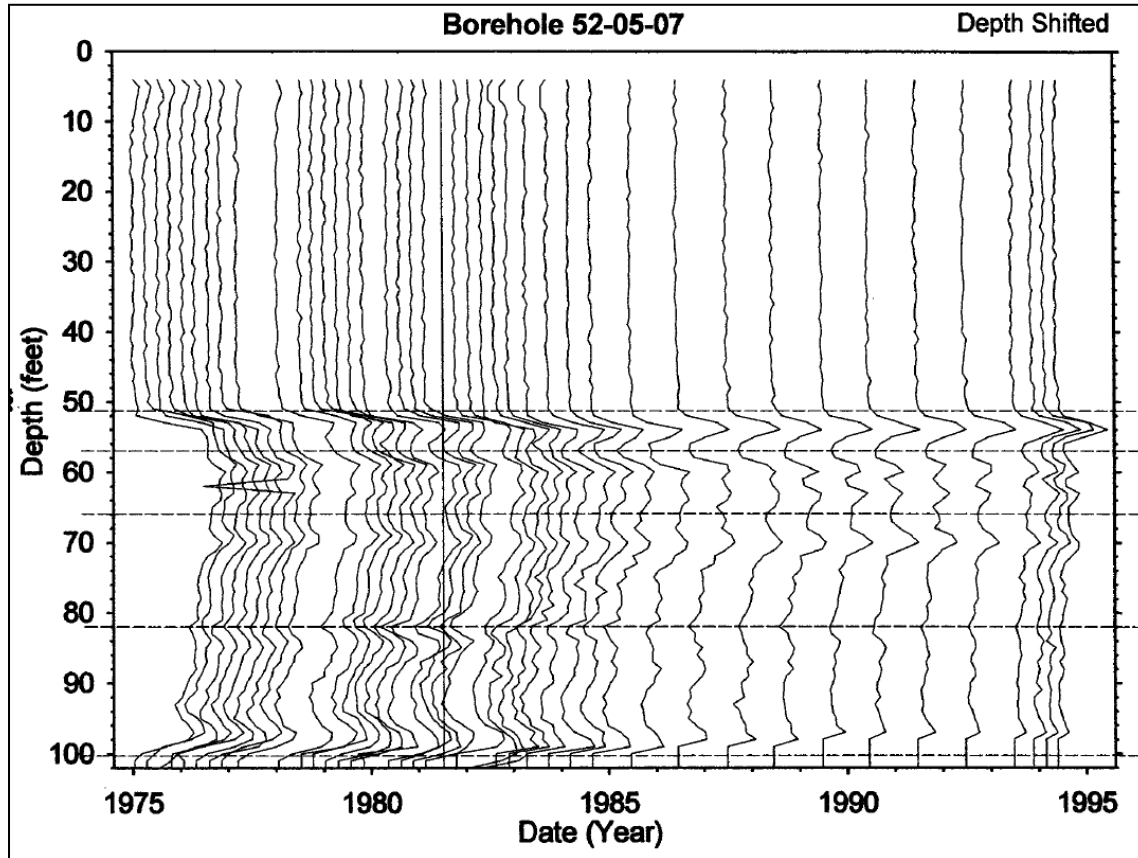
**Figure 7-6. Tank TY-105 Drywell 52-05-07 (HNF-3831)**

In April 1997, Cs-137 and Co-60 were the only man-made radionuclides detected in drywell 52-05-07 (GJ-HAN-68). Cs-137 was detected from the ground surface to 76.5-ft BGS and from 87 to 88-ft BGS with the maximum concentration of 32.4 pCi/g detected at 52.5-ft BGS. Co-60 was detected from 1 to 2.5-ft BGS, 5.5 to 7-ft BGS, and from 51.5 to 97-ft BGS with the maximum concentration of 7.1 pCi/g reported at 62-ft BGS. The historical gross gamma logs show three peaks between 55 and 70-ft (HNF-3831). The SGLS measured Cs-137 and Co-60 contamination between 51 and 97-ft BGS correlates with the historical gross gamma logs. As stated in GJ-HAN-68, “the contamination detected around borehole 52-05-07 probably originated from a leak from tank TY-105.” Figure 7-6 shows the depths of radioactivity from 1975 to 1995 (HNF-3831).

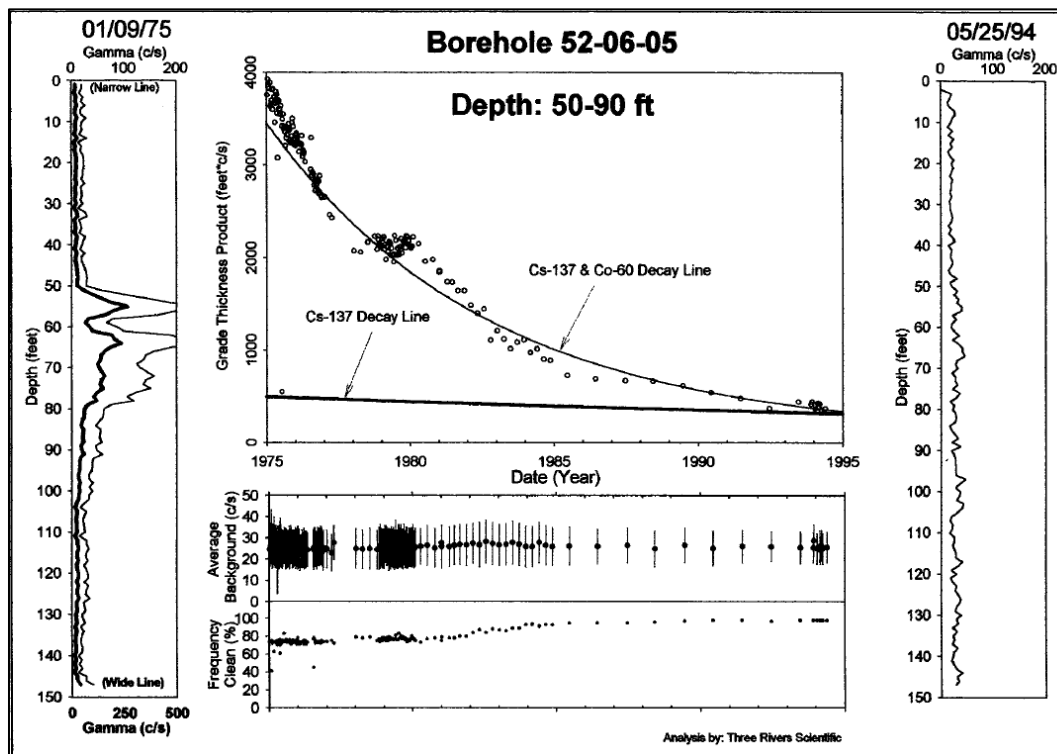
**Figure 7-7. Tank TY-105 Associated Drywell 52-06-05 Cesium (HNF-3831)**

Radioactivity detected in drywell 52-06-05 appears to be the fairly mobile radioisotopes- short lived Ru-106 and also Co-60 both of which decayed away (see Figure 7-7). The tank TY-106 direct pushes near drywell 52-06-05 did not indicate radioactivity down to ~47-ft BGS and were not deepened as there was no indication of further radioactivity (RPP-RPT-39511). Since there was no Cs-137 detected near tank TY-106, indications are that the radioactivity detected in drywell 52-06-05 was the leading edge (mobile radioisotopes) from a tank TY-105 leak. Figure 7-8 shows depths of radioactivity from 1975 to 1994 (HNF-3831).

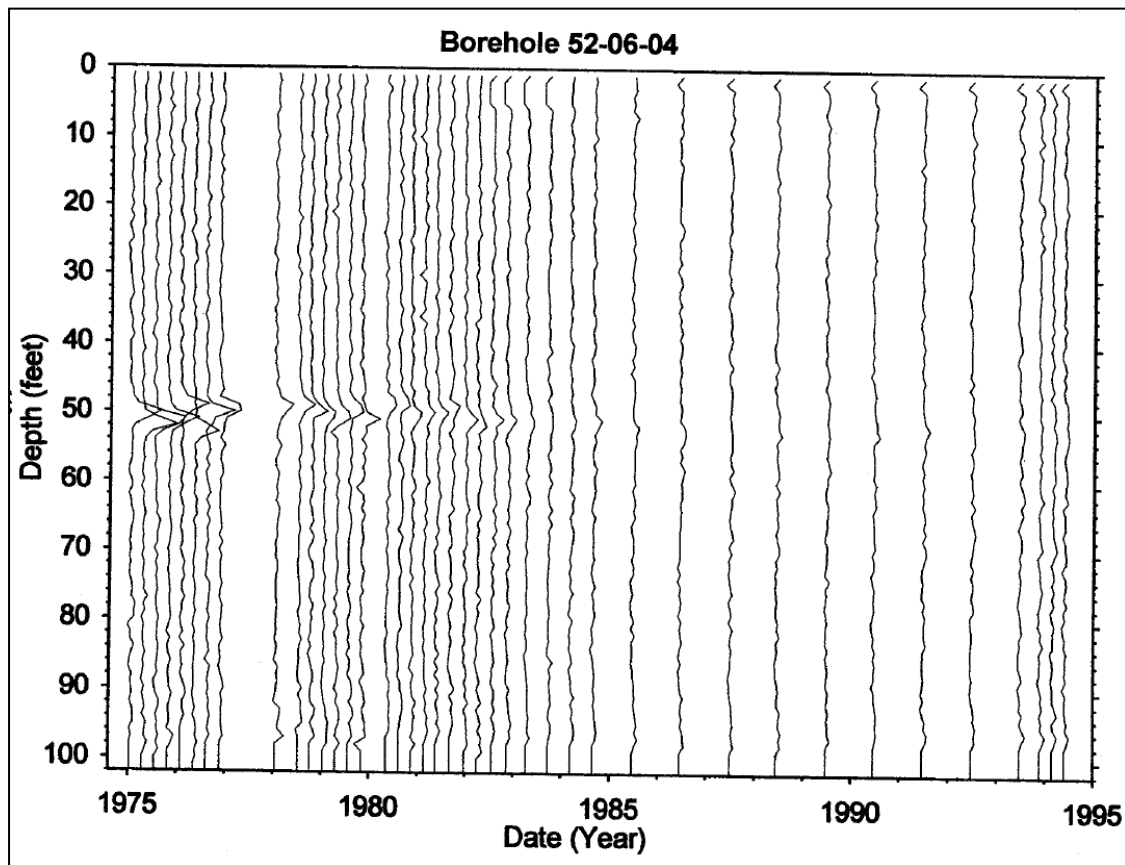
**Figure 7-9. Tank TY-105 Associated Drywell 52-06-04 (HNF-3831)**

In April 1997, Cs-137 was the only man-made radionuclide detected in drywell 52-06-04 (GJ-HAN-68). Cs-137 was detected from the ground surface to 53.5-ft and at 57-ft BGS with the maximum concentration of 1.2 pCi/g reported at 52-ft BGS. Document GJ-HAN-68 states, "it is possible that the Cs-137 contamination originated from a breach in either tank TY-105 or TY-106." However, it seems likely radioactivity detected in this drywell was the result of the tank TY-105 leak (see Section 7.5.3). Radioactivity from 47-56-ft BGS was reported to be stable in document HNF-3831. Figure 7-9 shows depths of radioactivity from 1975 to 1994 (HNF-3831).

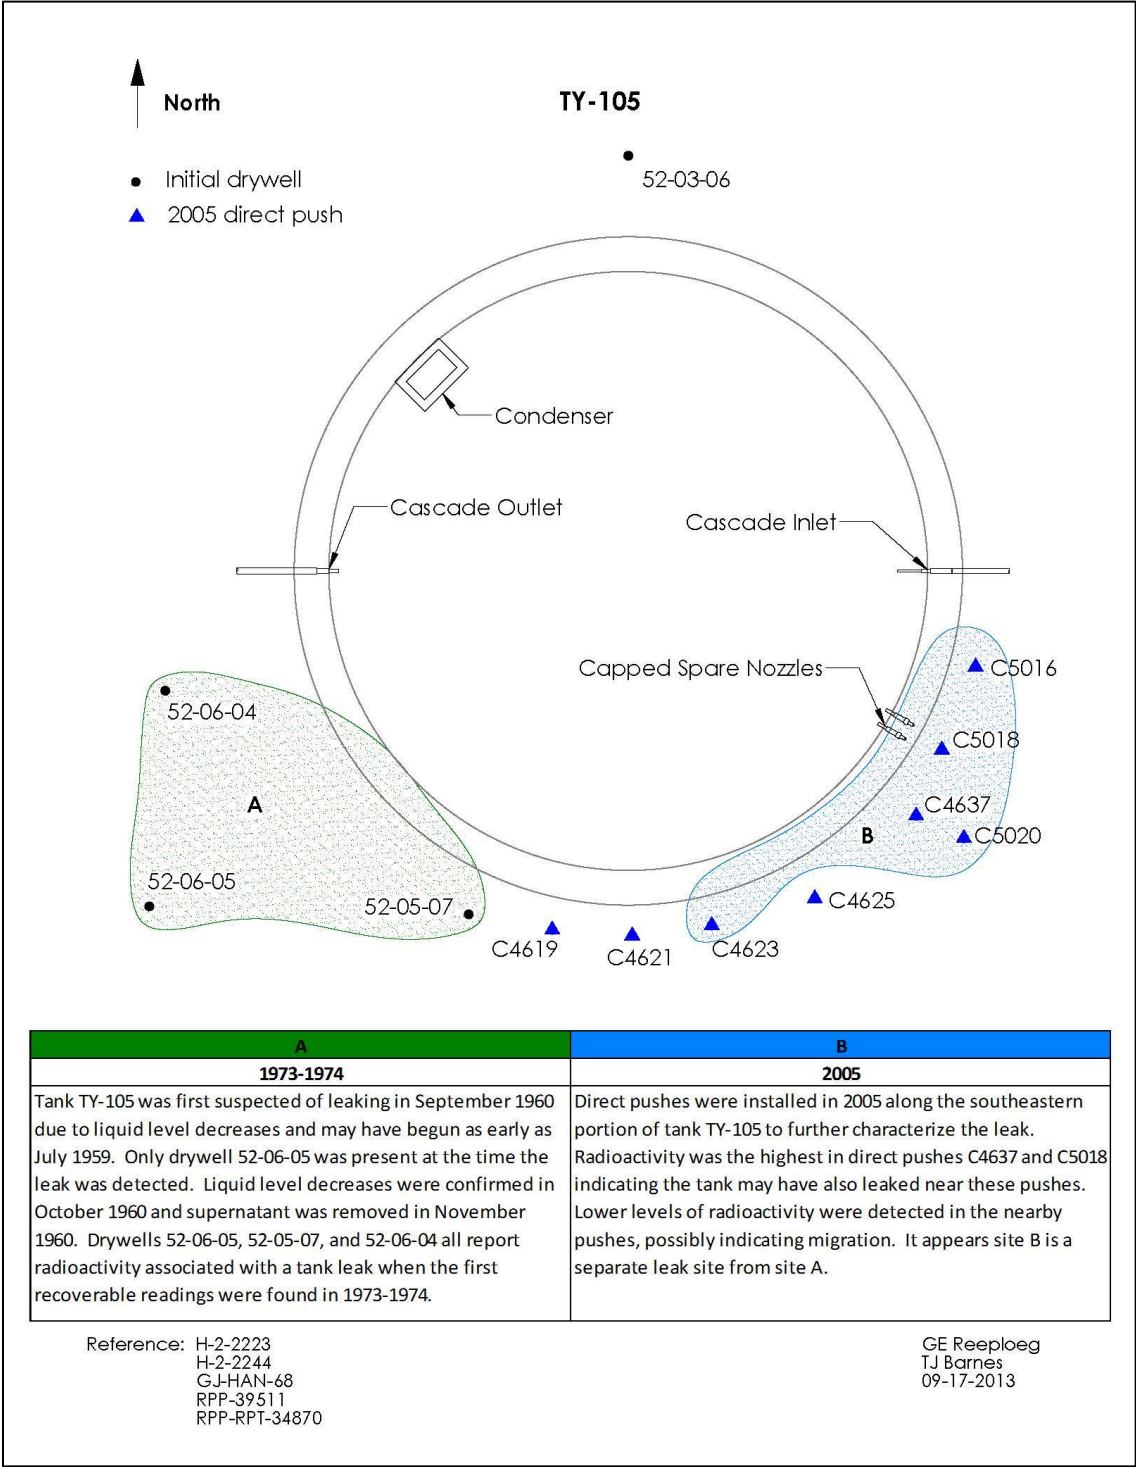
**Figure 7-15. Tank TY-105 Possible Radial Leak Locations**  
Tank inner ring is steel liner, outer ring is outer edge of tank footing

Leak locations in Figure 7-15 are based on peak readings and are a representation of possible initial boundaries of radioactivity.

No evidence was found for a liner bulge occurring in tank TY-105, and it remains unclear if a liner bulge once existed in the tank during its operation. However, tank TY-105 non-boiling temperatures are not likely to be a factor in causing a liner bulge.
