| <b>DOCUMENT RELEASE AND CHANGE FORM</b> | | 1a. Doc No: RPP-RPT-54911    Rev. 01 | | | | | | | | | | | | | | | | | | | | | | | | | | | | | | | | | | | | | | | | |
|---|---|---|---|---|---|---|---|---|---|---|---|---|---|---|---|---|---|---|---|---|---|---|---|---|---|---|--|--|--|--|--|--|--|--|--|--|--|--|--|--|--|--|
| <b>2. Document Title</b><br>Hanford Single-Shell Tank Leak Causes and Locations - 241-BY and 241-TY Farm | | | | | | | | | | | | | | | | | | | | | | | | | | | | | | | | | | | | | | | | | | |

| <b>Purpose of Document:</b> Identifies leak causes and locations for BY and TY Farm tanks | |

Key Words: leak location, leak cause, tank, integrity assessment, BY Farm, TY Farm, BY-103, TY-103, TY-104, TY-105, TY-106, leak assessment

**Abstract:** This document identifies 241-BY Tank Farm (BY Farm) and 241-TY Tank Farm (TY Farm) leak causes and locations for the 100 series leaking tanks (241-BY-103, 241-TY-103, 241-TY-104, 241-TY-105, and 241-TY-106) identified in RPP-RPT-43704, Hanford BY Farm Leak Assessments Report, and in RPP-RPT-42296, Hanford TY Farm Leak Assessments Report. This document satisfies the BY and TY Farm portion of the target (T04) in the Hanford Feder

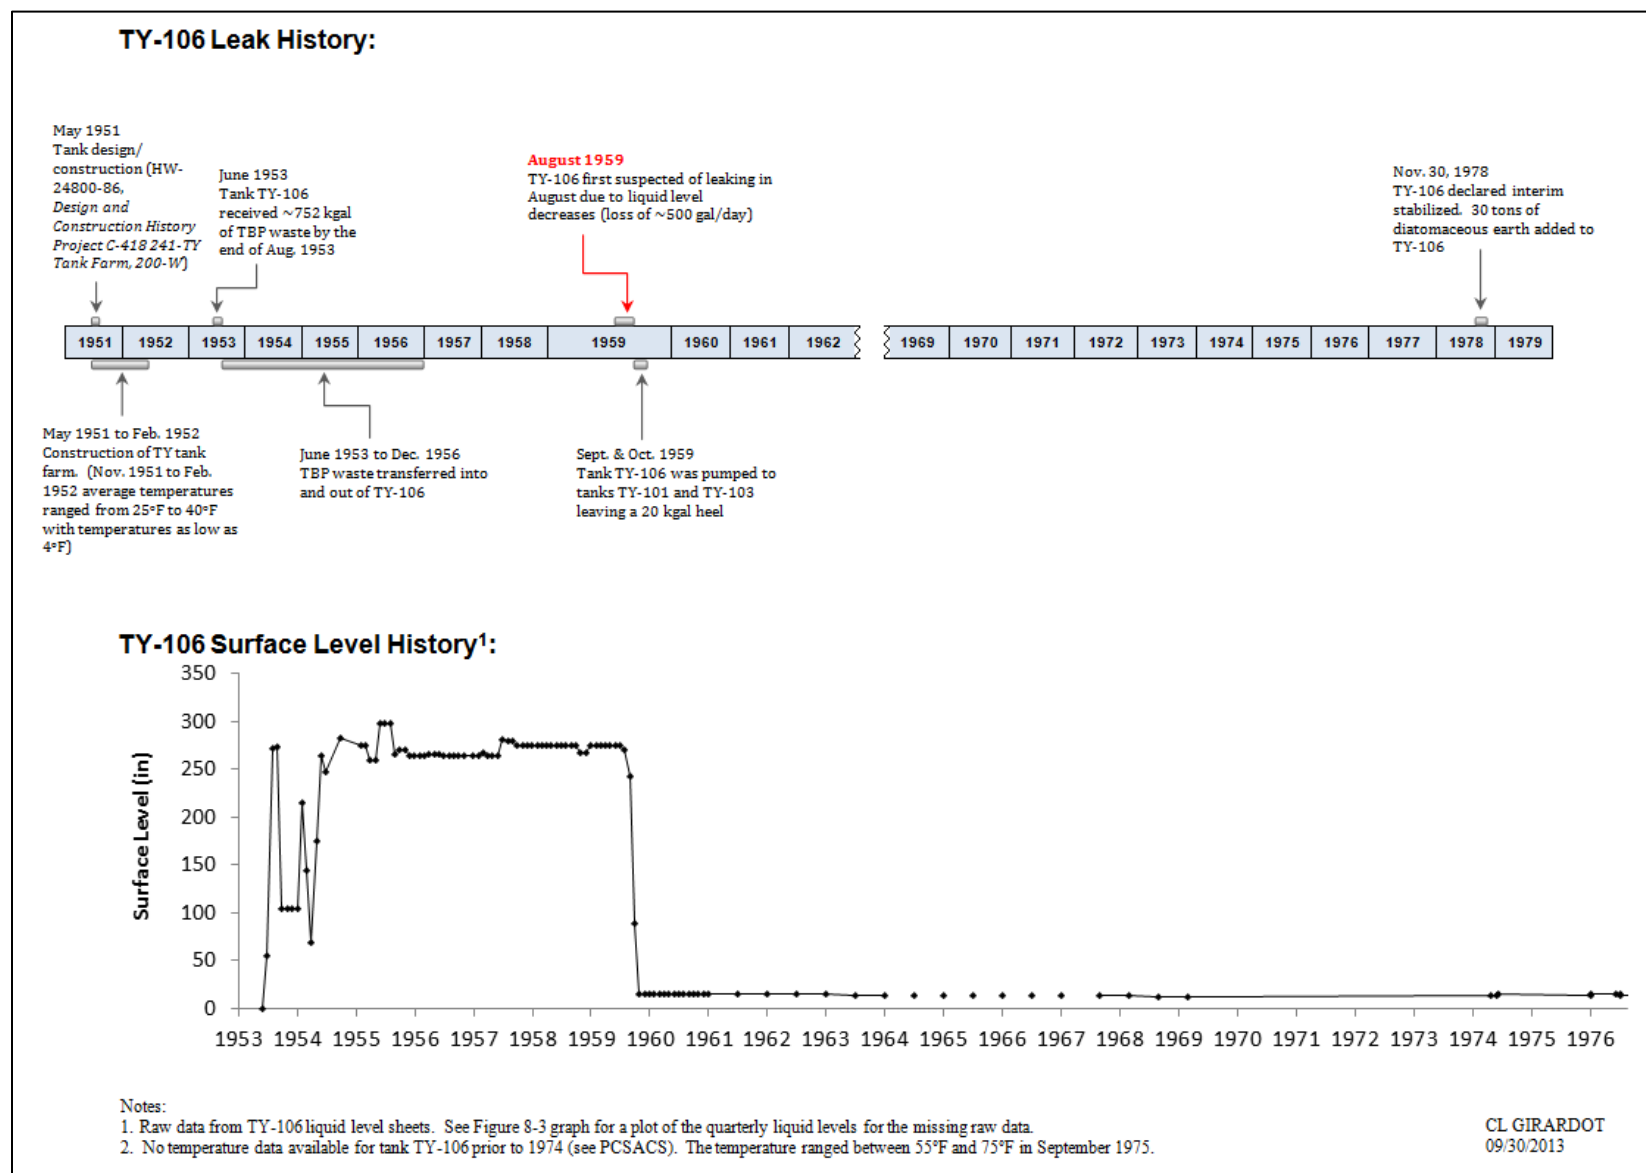
Figure 8-2. Operational Leak History of Tank TY-106

Tank TY-106 was first suspected of leaking in August 1959 when document HW-61952 indicated a loss of approximately 500 gal/day (see Section 8.4.1) and 74 kgal of waste was pumped to tank TY-101 initiated on August 28, 1959 (HW-61952; HW-61736-DEL, *Chemical Processing Department Monthly Report for August, 1959*). Tank TY-106 was removed from service and contents from tank TY-106 continued to be pumped to tank TY-101 and TY-103 in September and October 1959 leaving the volume at ~20 kgal (RPP-RPT-42296).

The operational history of tank TY-106 leak related details and liquid level are charted in Figure 8-2.

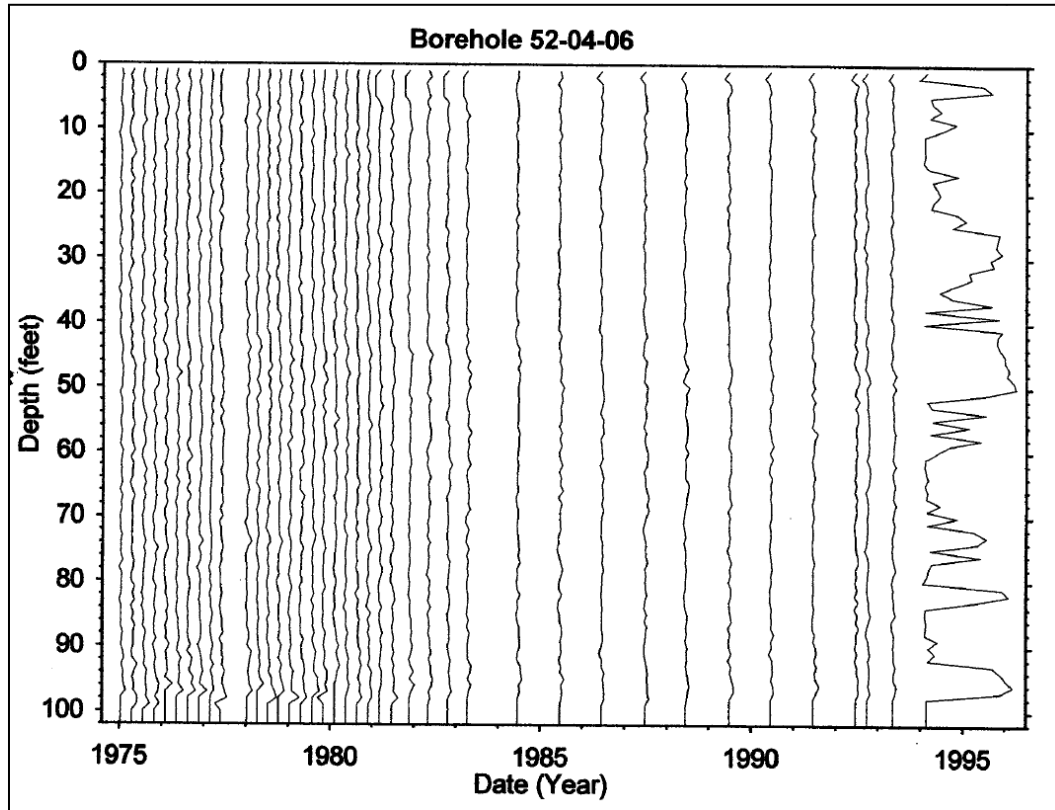
**Figure 8-4. Tank TY-106 Associated Drywell 52-04-06 (HNF-3831)**

In May 1997, Cs-137 was the only man-made radionuclide detected in drywell 52-04-06 (GJ-HAN-69). Cs-137 was detected from the ground surface to 12-ft BGS and at the bottom of this drywell with the highest concentration (0.79 pCi/g) at 1.5-ft BGS. Document GJ-HAN-69 states, "The near-surface contamination (0 to 12 ft) probably resulted from surface spills that have migrated down into the backfill surrounding the borehole or contamination that was carried down during the drilling of this borehole." Since historical records report less than values for radioactivity, drywell 52-04-06 is not included as part of the leak location for tank TY-106. Figure 8-4 shows depths of radioactivity from 1975 to 1994 (HNF-3831).

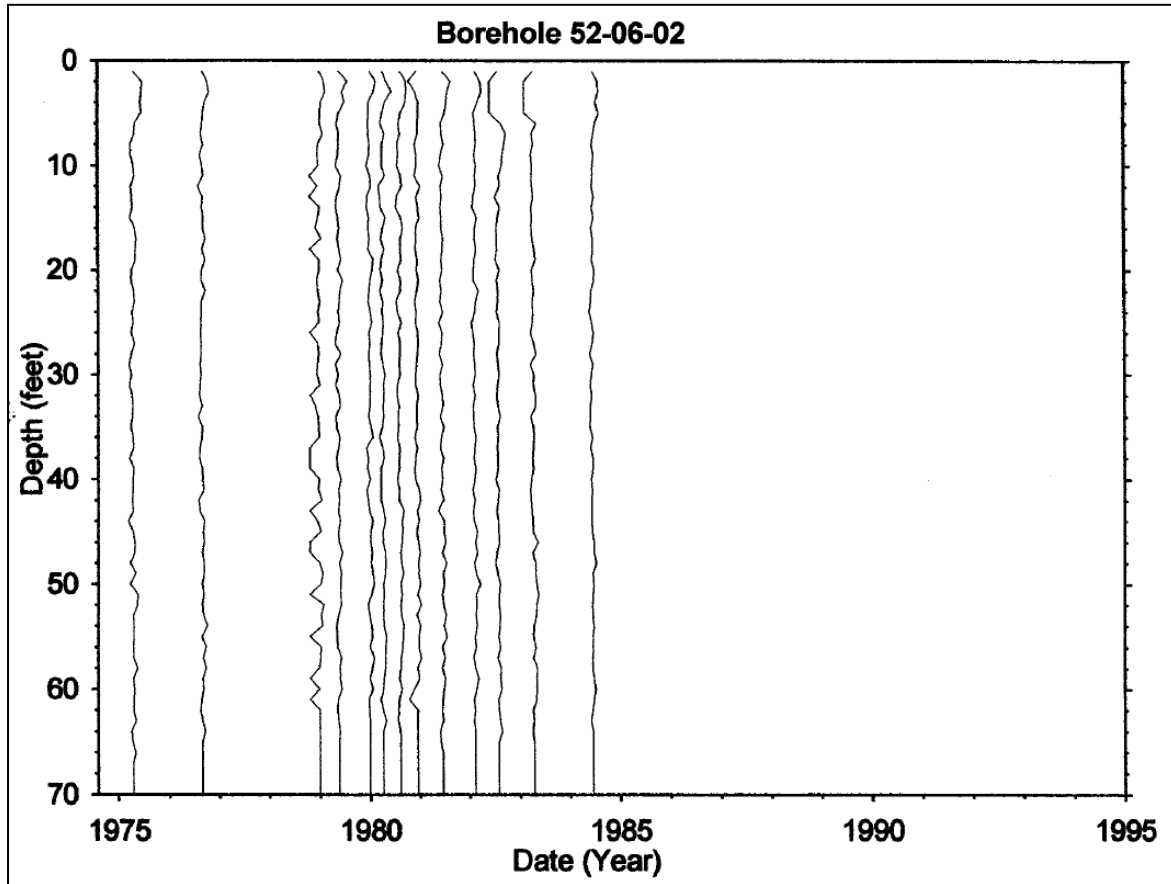
**Figure 8-5. Tank TY-106 Drywell 52-06-02 (HNF-3831)**

Drywell 52-06-02 is therefore not included as part of the leak location for tank TY-106. Figure 8-5 shows depths of radioactivity from 1975 to 1984 (HNF-3831).

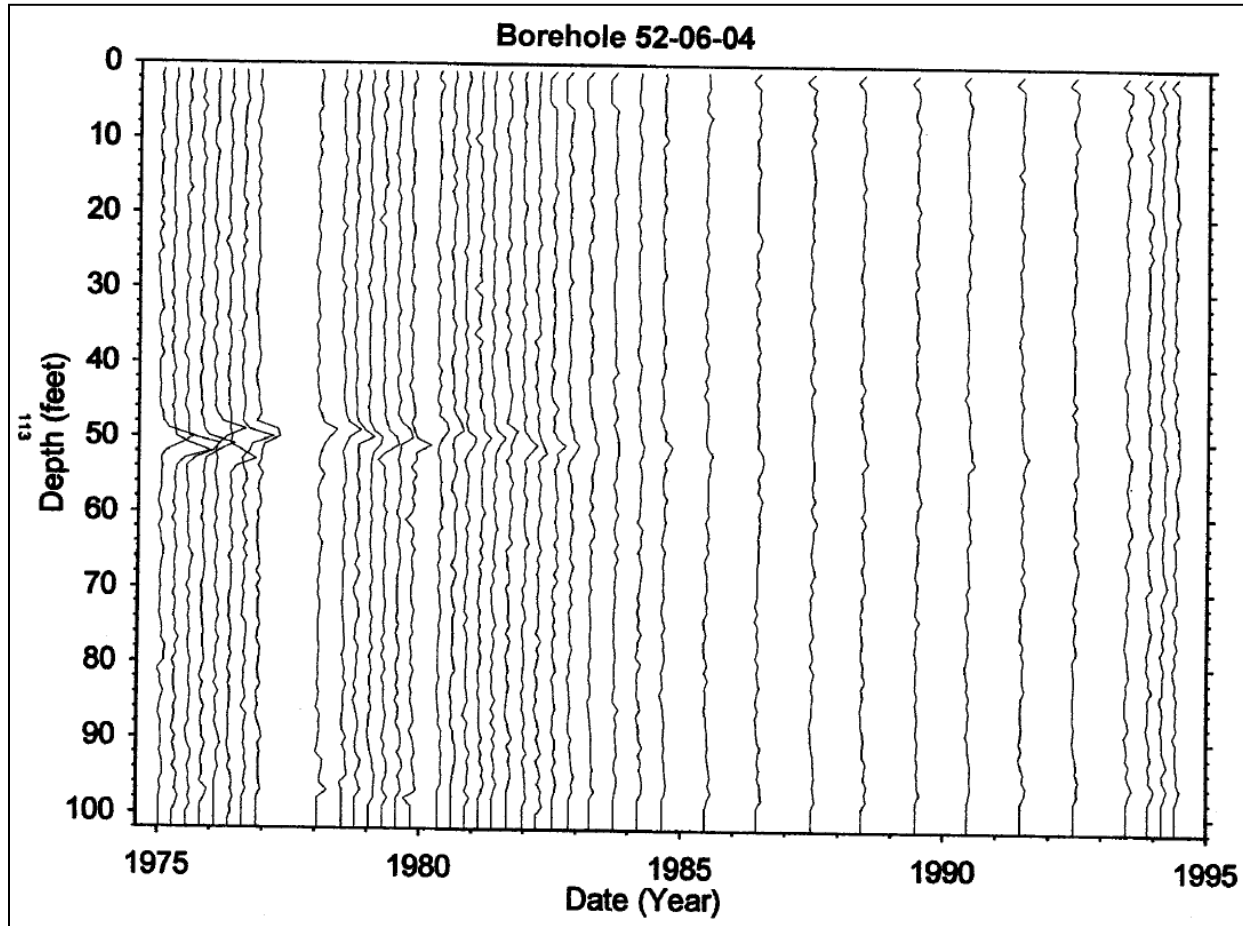
**Figure 8-6. Tank TY-106 Drywell 52-06-04 (HNF-3831)**

In May 1997, Cs-137 was the only man-made radionuclide detected in drywell 52-06-04 (GJ-HAN-69). Cs-137 was detected from the ground surface to 53.5-ft BGS and at 57-ft BGS with the maximum concentration of 1.2 pCi/g reported at 52-ft BGS. Radioactivity from 47 to 56-ft BGS was reported to be stable in document HNF-3831. Document GJ-HAN-68 states, "it is possible that the Cs-137 contamination originated from a breach in either tank TY-105 or TY-106." It appears radioactivity detected in this drywell was the result of the tank TY-105 leak; however, tank TY-106 cannot be entirely ruled out (see tank TY-105 Segment). Figure 8-6 shows depths of radioactivity from 1975 to 1994 (HNF-3831).

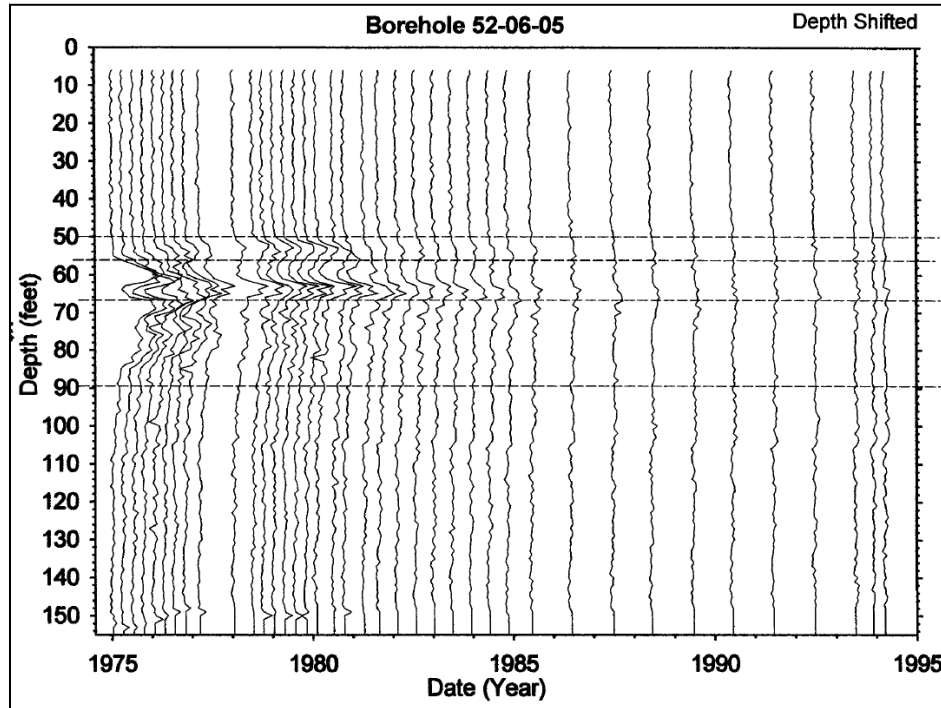
**Figure 8-8. Tank TY-106 Drywell 52-06-05 (HNF-3831)**

Two occurrence reports were written for increased activity in drywell 52-06-05 (OR-74-102, *Leakage Symptoms as Indicated by Dry Well Activity at Waste Tank 105-TY* and OR-74-88, *Symptoms Of Leakage As Indicated By Activity In Dry Well 52-06-05 At 106-TY Waste Tank*). Occurrence report OR-74-88 identifies the source of the drywell 52-06-05 contamination as tank TY-105. Figure 8-8 shows depths of radioactivity from 1975 to 1994 (HNF-3831).

In May 1997, Cs-137 and Co-60 were the only man-made radionuclides detected in drywell 52-06-05 (GJ-HAN-69). Cs-137 was detected from the ground surface to 133.5-ft BGS with the maximum concentration of 1.2 pCi/g reported at 111.5-ft BGS. Co-60 was detected at 2.5-ft BGS, from 52 to 90-ft BGS, from 92.5 to 98.5-ft BGS, and from 130 to 148-ft BGS with the maximum concentration of 3.2 pCi/g reported at 144.5-ft BGS. Radioactivity detected in drywell 52-06-05 appears to be the fairly mobile radioisotopes, short lived Ru-106 and also Co-60, both of which decayed away (see Figure 8-7). The tank TY-106 direct pushes near drywell 52-06-05 did not indicate radioactivity down to ~47-ft BGS and were not deepened as there was no indication of further radioactivity (RPP-RPT-39511). Since there was no Cs-137 detected near tank TY-106, indications are that the radioactivity detected in drywell 52-06-05 was the leading edge (mobile radioisotopes) from a tank TY-105 leak.

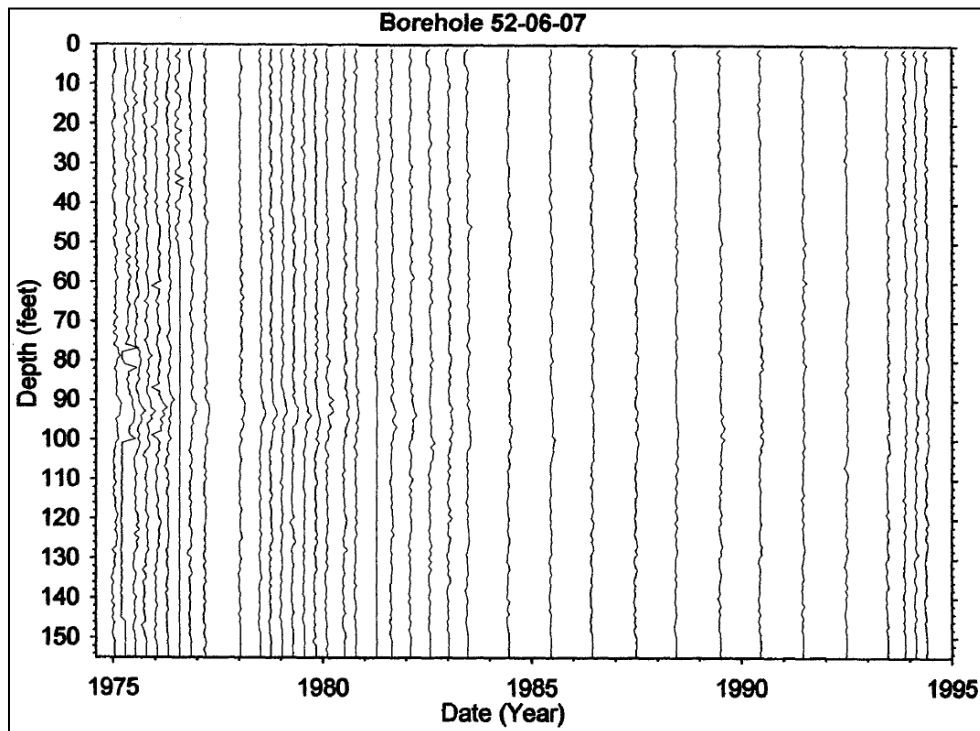
**Figure 8-11. Tank TY-106 Drywell 52-06-07 (HNF-3831)**

Therefore, drywell 52-06-07 is not considered as part of the leak location for tank TY-106. However, there is a remote possibility that the radioactivity reported in drywell 52-06-07 between 75-ft and 89-ft BGS was a part of the leading edge of a tank TY-106 leak near the southern edge of the tank but the depth seems too low to be a direct link. Also, the BGS level of the 6,000 cpm radioactivity reported in Internal memo "105-TY Waste Storage Tank Leak" remains unknown. The 1973-1974 drywell 52-06-07 radioactivity remains unexplained. Figure 8-11 shows some low level radioactivity in 1975 which decays away (HNF-3831) as is indicated by the Appendix C5 data.

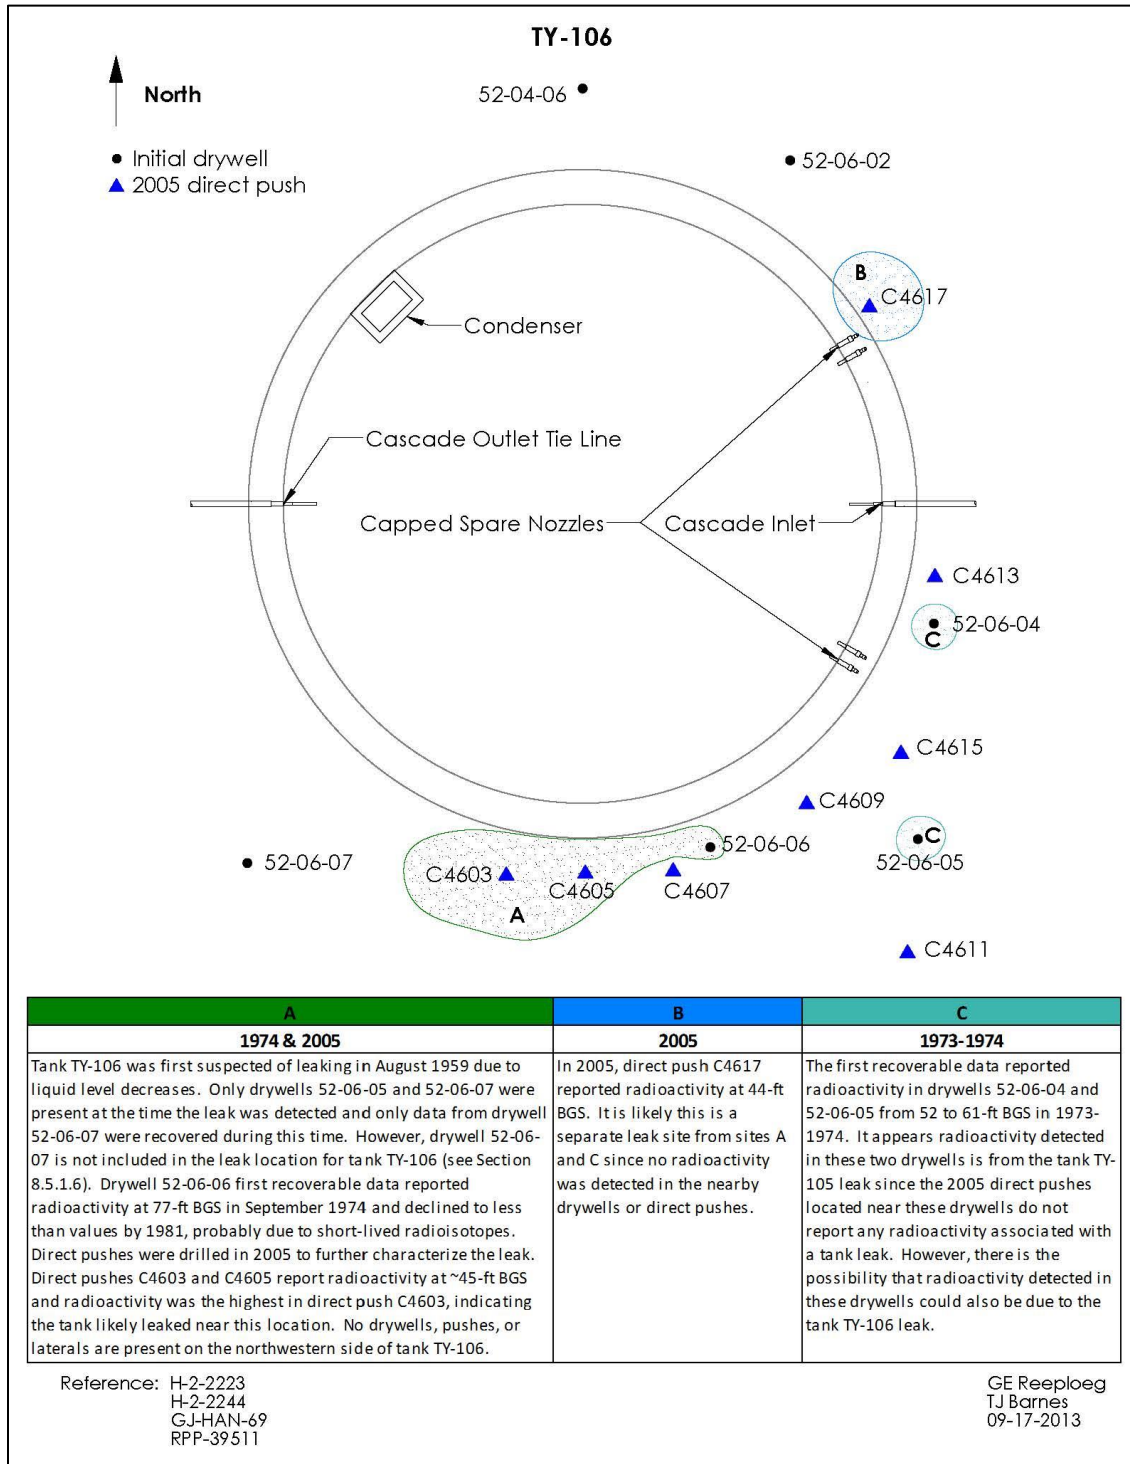
**Figure 8-15. Tank TY-106 Possible Radial Leak Locations**  
 Tank inner ring is steel liner, outer ring is outer edge of tank footing

Tank TY-106 was first suspected of leaking due to liquid level decreases in August 1959. The first leak site was determined from 1974 drywell 52-06-06 and 2005 direct pushes C4603 and C4605 which reported radioactivity at or near the tank footing as shown in Site A (see Figure 8-15). It appears the leak site is located near direct push C4603 as radioactivity levels were the highest in 2005.

High levels of radioactivity were detected in direct push C4617 in 2005 as shown in site B (see Figure 8-15). Site B appears to be a separate leak site from sites A and C, as the nearby drywells and direct pushes do not detect any radioactivity associated with a tank leak.

Radioactivity was detected in drywells 52-06-04 and 52-06-05 at a lower BGS level in 1973-1974 as shown in site C (see Figure 8-15). It appears radioactivity detected in these drywells are the result of the tank TY-105 leak; however, it is possible radioactivity in these drywells could be the result of the tank TY-106 leak and/or a combination of the two leaks.

Leak locations in Figure 8-15 are based on peak readings and are a representation of possible initial boundaries of radioactivity.

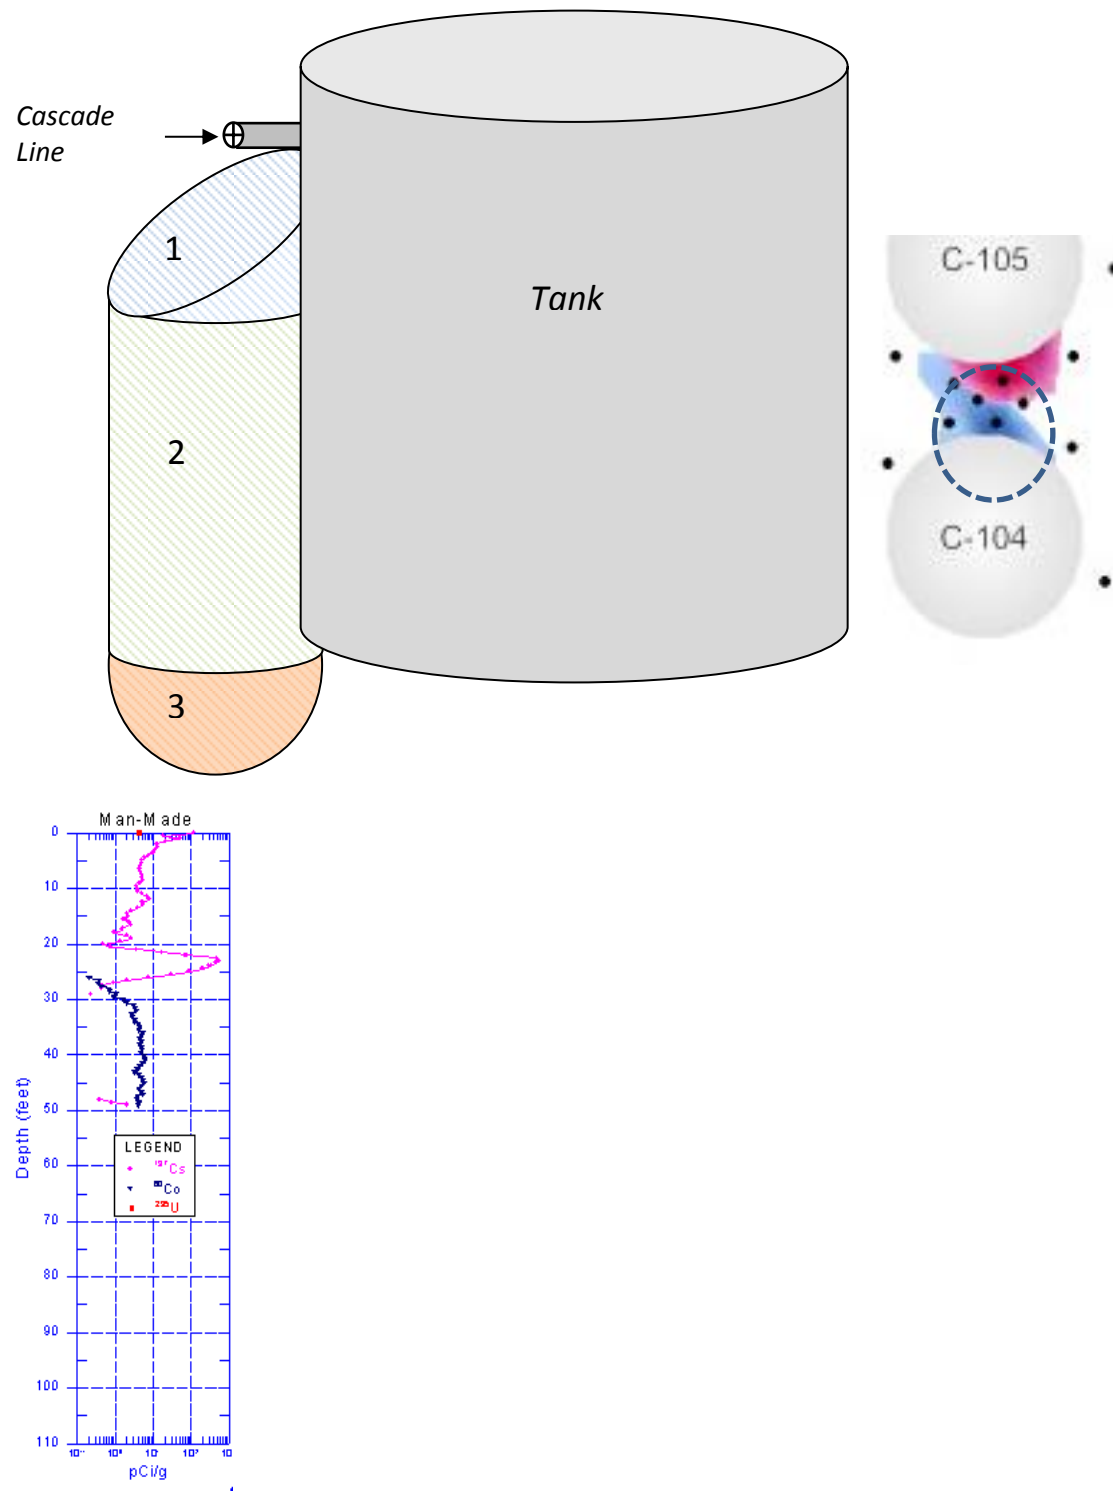
**Figure 2: C-104 Conceptual Waste Plume Visualizations & Drywell Logging Data**

For comparison purposes, if an assumed plume volume was described as an increase in the water (wetted) content from a "background" of ~4% to 9% (a 5% increase) would account for approximately 23,000 gallons (see calculations for a modeled Co plume in Table 2). Assuming the waste released was CWP1 the mass of  $^{137}\text{Cs}$  was estimated to be slightly over 60 curies at 23,000 gallons and 80 curies for a 28,000 gallon release. This mass could easily be masked next to the tank at the soil cesium saturation concentration of  $\sim 1\text{E}7$  pCi/g. Using CWP1 waste composition would also result in a ~28,000 gallons release; and ~1.3 Ci  $^{60}\text{Co}$  at the time of the release. It was assumed that the  $^{60}\text{Co}$  plume extended past the measured depth in the drywell to 80 feet; thereby resulting in a release that could have been ~28,000 gallons. Figure 2 shows the conceptual plume configurations and drywell data.
