Date Published
November 2014

Hanford Double-Shell Tank Extent-of-Condition Construction Review – 15498

ABSTRACT

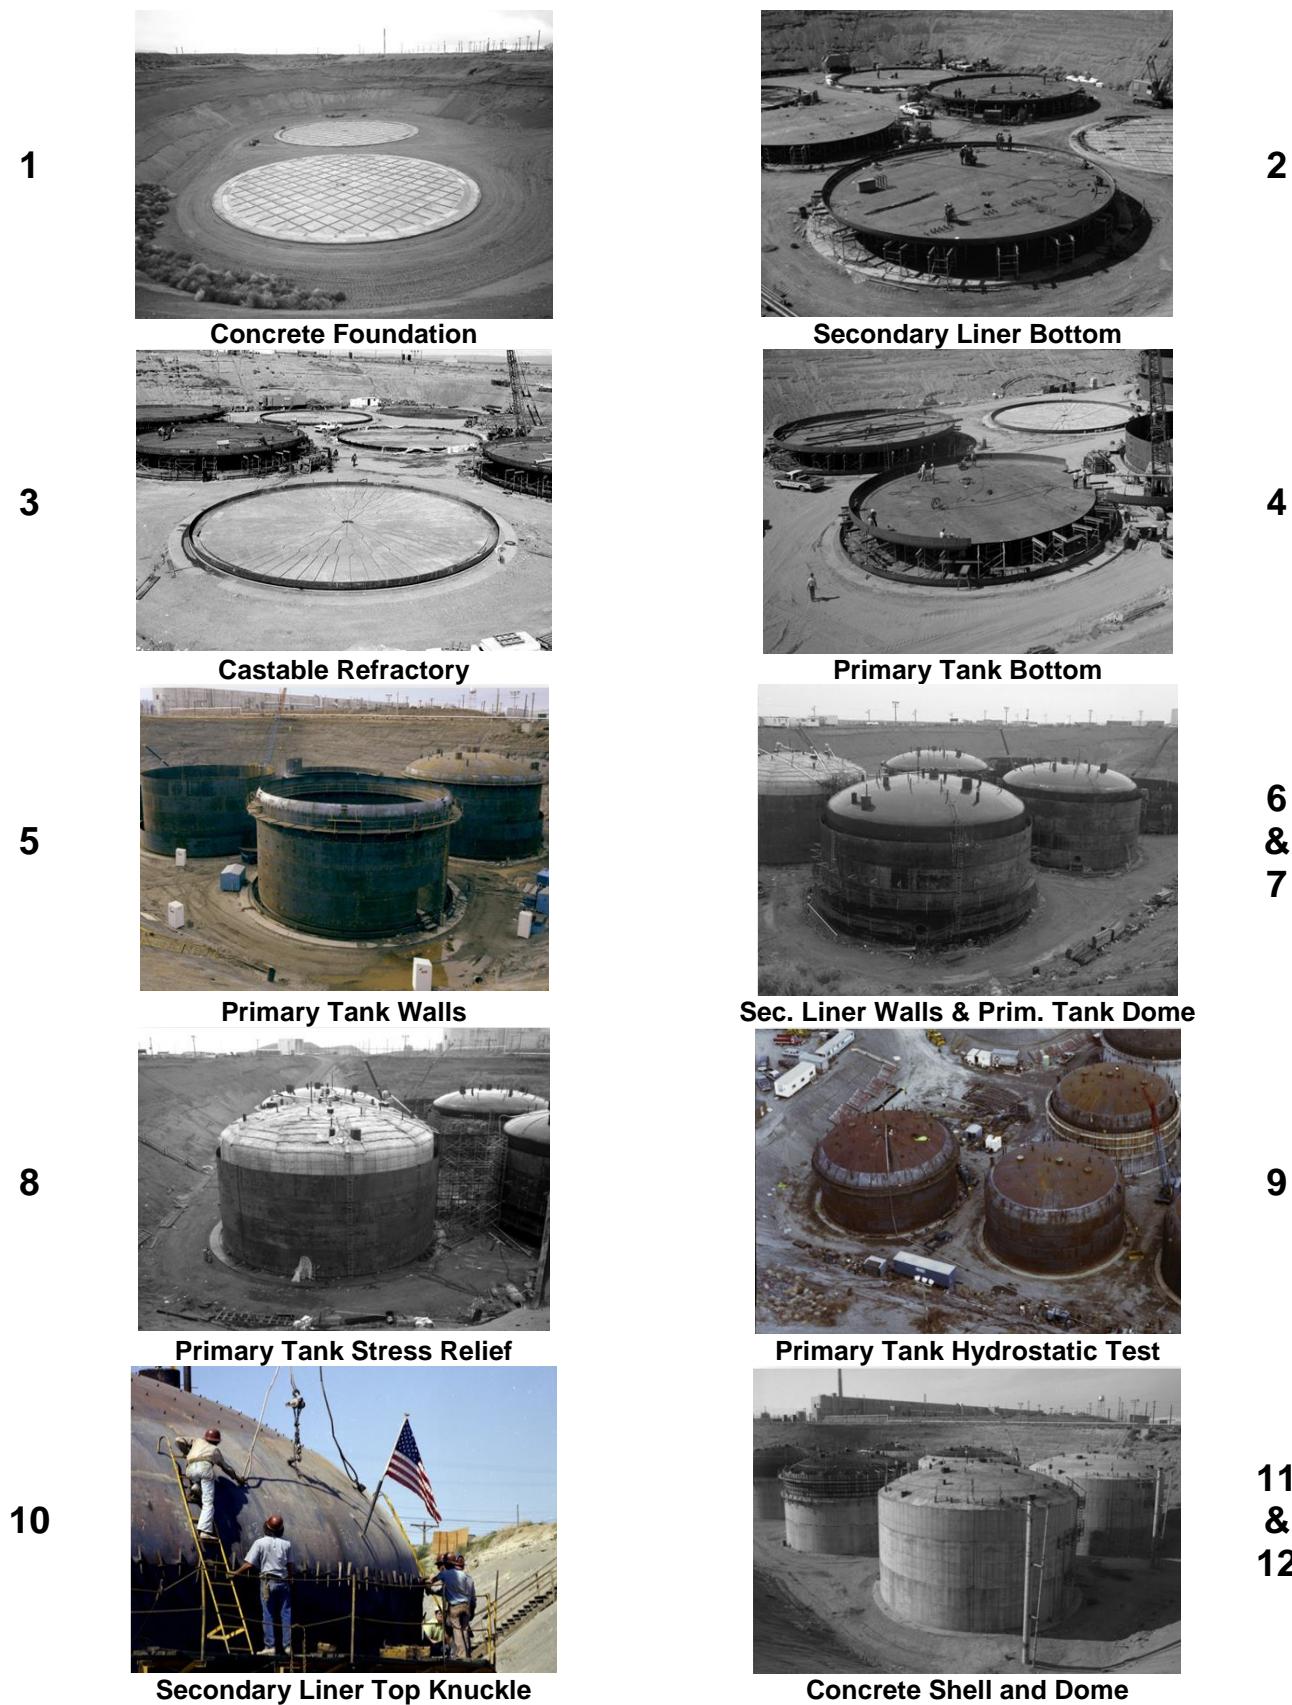
Figure 2: Double-Shell Tank Construction Sequence Gallery

Changes to the construction sequence seen in other farms typically involved the sequence of liner fabrication, concrete wall construction, and backfill. Completing the secondary liner first created challenges in welding the more important primary tank liner by restricting primary tank access to the annular space. Subsequent tank farms were built by simultaneously building the primary and secondary liners or completing primary liner fabrication first.
